**Recommendations of the Rock Carvings Consultancy Study
and the Responses of the Antiquities and Monuments Office**

I. Study Reports submitted by the consultants

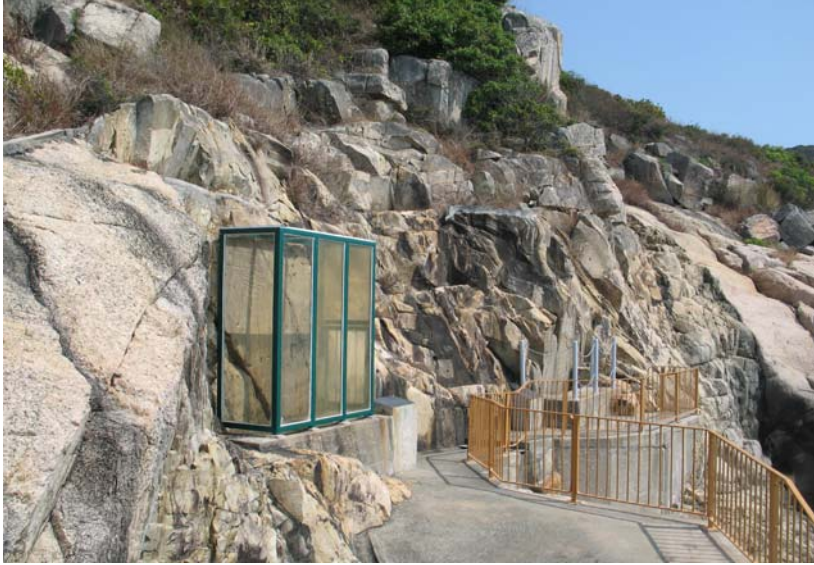
Shelter of the Rock Carving (left side) and barrier of the Rock Carving (right side)

Recommendations / Comments	Consultants	Follow up actions/ Responses
7. The shelter cannot protect the carving and it should be redesigned. It is suggested that visitor facilities should also be enhanced.	R.A. Engelhardt	Agreed. The consultant commissioned by AMO to design new protection and visitor facilities will take the comments into account and improvement work, based on the consultant's recommendations, will be arranged.

9. The shelter and the Perspex screen adversely affect the micro-climate of the rock carvings. Any protective structure should prevent visitors from touching the carved rock face, but should not block any natural elements such as wind, rain, sunshine and sea spray.	W. Meacham	Noted. The consultant commissioned by AMO to design new protection and visitor facilities will take the comment into account and improvement work, based on the consultant's recommendations, will be arranged. Furthermore, repeated climatic studies have been carried out by the Central Conservation Section of LCSD within the shelter and no notable deviation from the patterns of the ambient condition has been found.

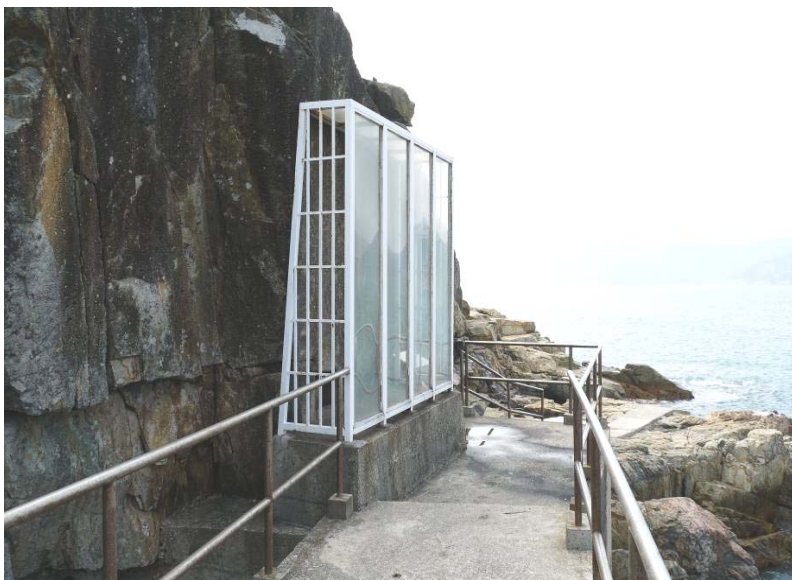
Shelter of the Rock Carving

6. The shelter must be redesigned to prevent vandalism and protect the carving from wind erosion.	R.A. Engelhardt	
7. The shelter alters the micro-climate of the rock carving. All concrete structures and the shelter should be removed to reinstate the natural setting of the site. Any protective structure should prevent visitors from touching the carved rock face, but should not block any natural elements such as wind, rain, sunshine and sea spray.	W. Meacham	Noted. The Central Conservation Section of LCSD will continue carrying out climatic study and monitor the site closely.

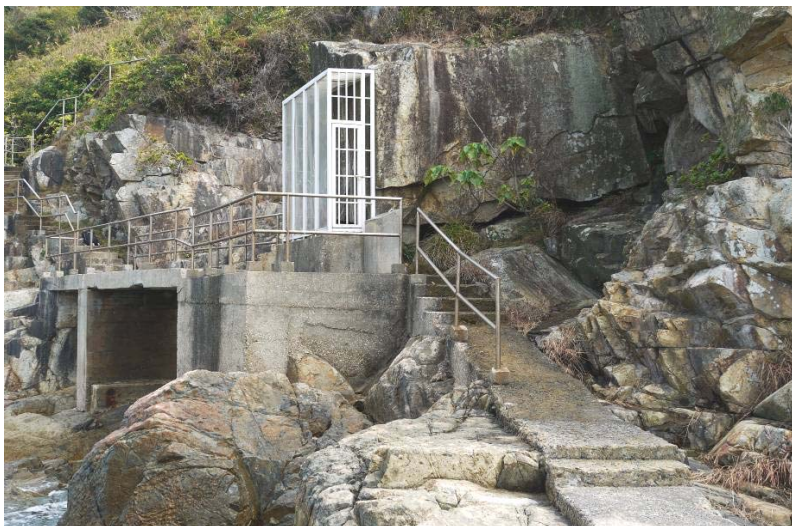
Walkway towards the Rock Carving

Recommendations / Comments	Consultants	Follow up actions/ Responses
8. Construction of an alternative path along the coast to the site to avoid climbing a steep staircase	W. Meacham	Noted. Difficult to implement due to site constraint.

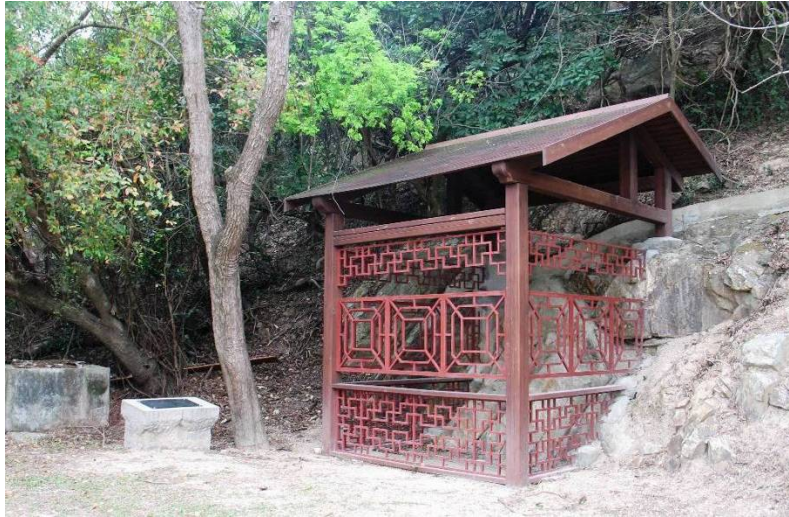
Shelter of the Rock Carving

Recommendations / Comments	Consultants	Follow up actions/ Responses
9. The existing shelter cannot cover the entire rock carving and it should be redesigned to provide better protection for the site. Any protective structure should prevent visitors from touching the carved rock face, but should not block any natural elements such as wind, rain, sunshine and sea spray.	W. Meacham	Agreed. The consultant commissioned by AMO to design new protection and visitor facilities will take the comment into account and improvement work, based on the consultant's recommendations, will be arranged.

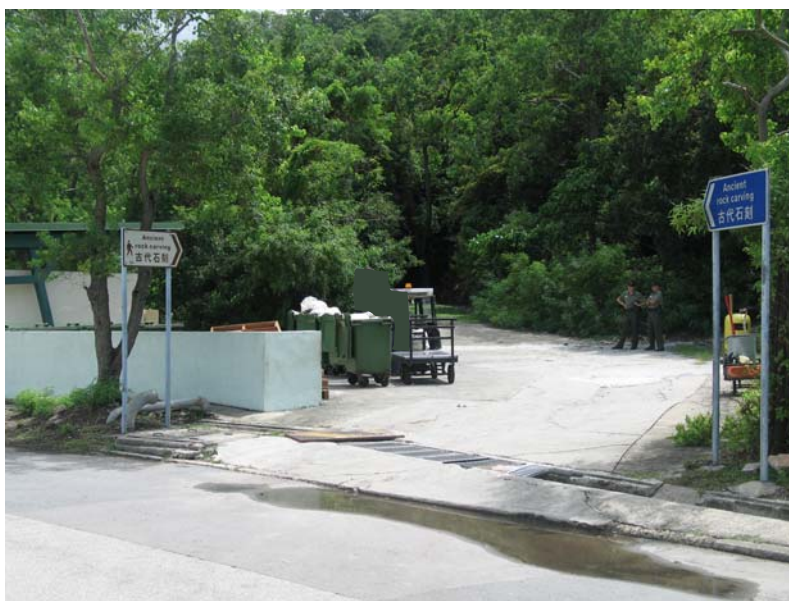
Refuse collection point at the entrance of the Rock Carving site

Recommendations / Comments	Consultants	Follow up actions/ Responses
8. The refuse collection point should be relocated further away from the site.	R.A. Engelhardt V. Magar W. Meacham	Correctional Services Department cleaned up the surrounding area of the rock carving (Photos 3 and 4 in Annex F). Renovation works of the refuse collection point will be arranged by ArchSD and completed by end 2011 tentatively.

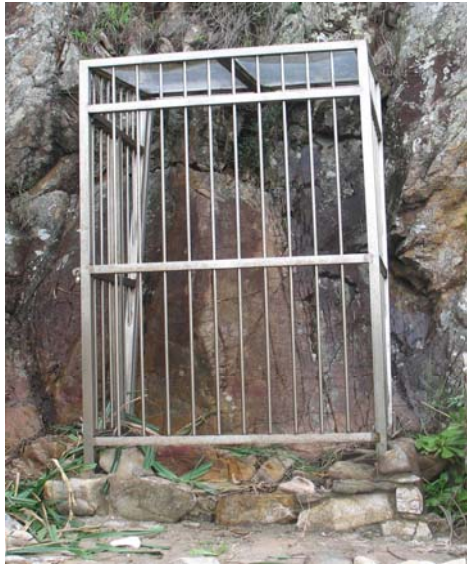
Front view of the shelter

Recommendations / Comments	Consultants	Follow up actions/ Responses
1. Although the site is located in a remote area, the shelter may draw the vandals' attention. It is recommended to remove the shelter and maintain the routine site maintenance works.	R.A. Engelhardt V. Magar W. Meacham A. Thorn	Noted. ArchSD removed the shelter in June 2011 (Photos 5 and 6 in Annex F). AMO will continue monitoring the site frequently.

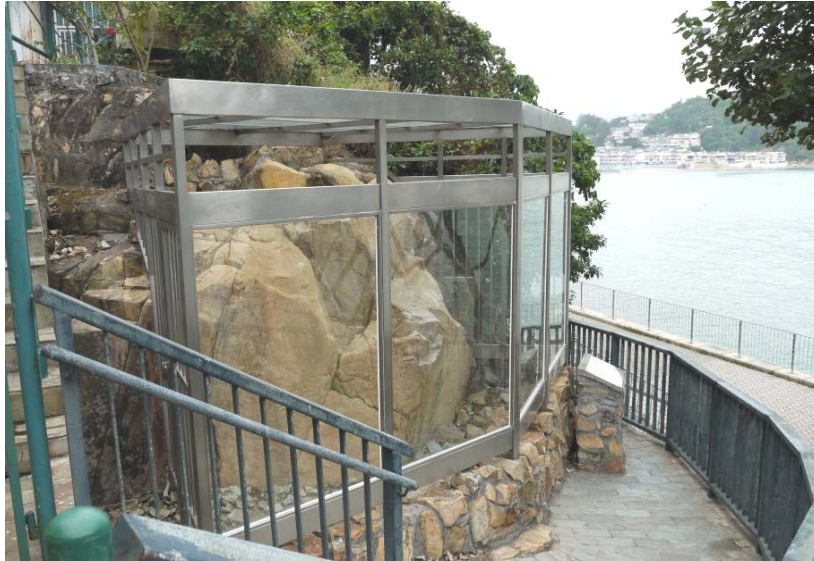
Shelter of the Rock Carvings

Recommendations / Comments	Consultants	Follow up actions/ Responses
6. The glass enclosures will create a micro-climate around the rock carving and should be replaced.	R.A. Engelhardt	The in-situ environmental data collected by the Central Conservation Section of LCSD reveal that the micro-climate within the enclosure follows the same patterns of the ambient condition.

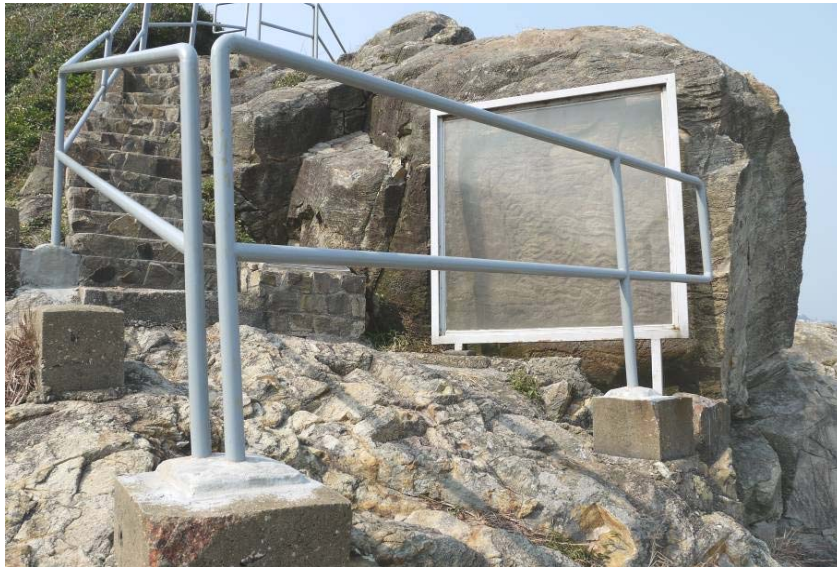
Protection screen of the Rock Carving and the railings nearby

Recommendations / Comments	Consultants	Follow up actions/ Responses
1. The Perspex screen does not protect the rock and affects visitors' appreciation of the engraving. A better-designed shelter and visitor interpretation kiosk with supportive facilities should be constructed.	R.A. Engelhardt	Agreed. ArchSD has removed the screen (Photos 12 and 13 in Annex F). The consultant commissioned by AMO to design new protection and visitor facilities will take the comments into account and the improvement work, based on the consultant's recommendations, will be arranged.
2. The Perspex screen does not protect the rock and affects visitors' appreciation of the engraving. It should be removed.	W. Meacham	
3. The Perspex screen does not protect the rock and affects visitors' appreciation of the engraving.	A. Thorn
