**MEMORANDUM FOR MEMBERS OF THE
ANTIQUITIES ADVISORY BOARD**

PROGRESS REPORT ON ROCK CARVINGS CONSULTANCY STUDY

**Recommendations of the Rock Carvings Consultancy Study
and the Responses of the Antiquities and Monuments Office**

**Photos of Improvement Works carried out
in connection with Rock Carvings and Inscription**

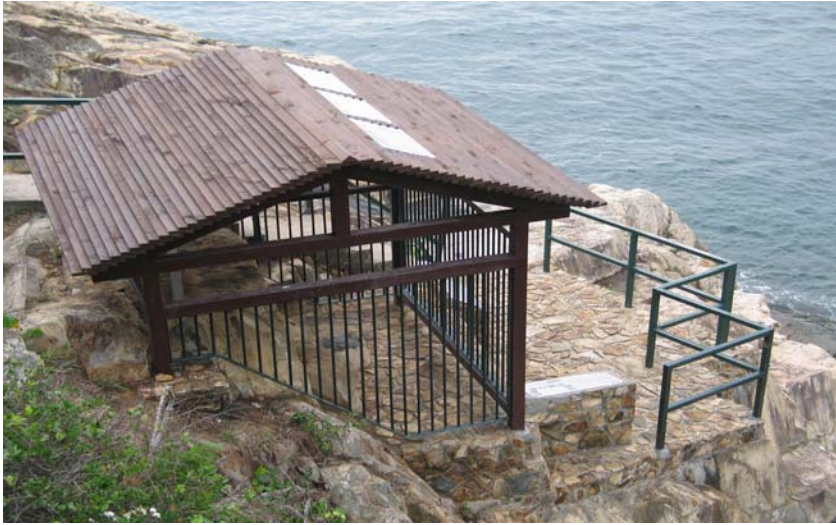
Shelter of the Rock Carving

10. The roof of the pavilion, which creates a micro-climate underneath	W. Meacham	Noted. The Central Conservation Section of LCSD will continue

Recommendations / Comments	Consultants	Follow up actions/ Responses
the rock carving, should be redesigned.		carrying out climatic studies and monitor the site closely.
11. The installation of CCTV to monitor the site is recommended.	W. Meacham	Noted. Difficult to implement due to site constraint.

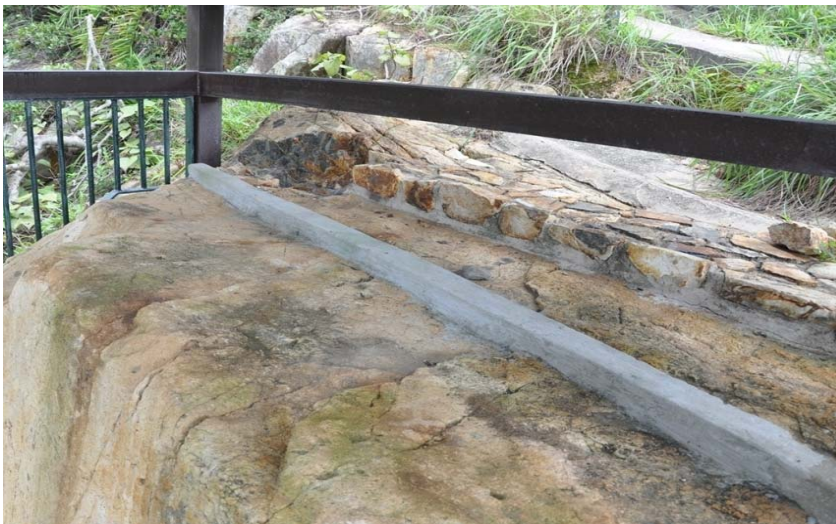
Water diversion dam above the Rock Carving

Recommendations / Comments	Consultants	Follow up actions/ Responses
1. The cement water diversion dam should be removed as it is ineffective to intercept the water flow below the rock surface and soluble salts will be leached out from the cement and affect the rock carving.	R.A. Engelhardt A. Thorn	Agreed. ArchSD removed the dam in August 2011 (Photos 1 and 2 in Annex F).

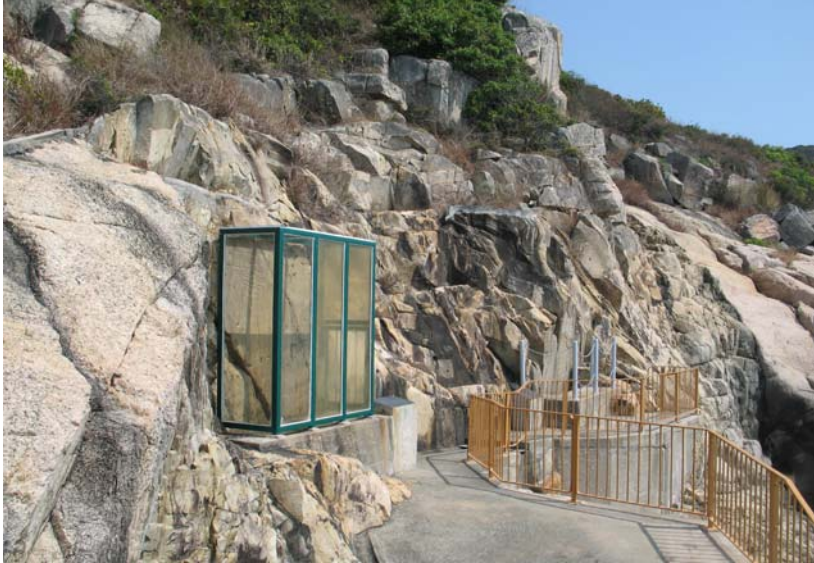
Shelter of the Rock Carving (left side) and barrier of the Rock Carving (right side)

Recommendations / Comments	Consultants	Follow up actions/ Responses
7. The shelter cannot protect the carving and it should be redesigned. It is suggested that visitor facilities should also be enhanced.	R.A. Engelhardt	Agreed. The consultant commissioned by AMO to design new protection and visitor facilities will take the comments into account and improvement work, based on the consultant's recommendations, will be arranged.

9. The shelter and the Perspex screen adversely affect the micro-climate of the rock carvings. Any protective structure should prevent visitors from touching the carved rock face, but should not block any natural elements such as wind, rain, sunshine and sea spray.	W. Meacham	Noted. The consultant commissioned by AMO to design new protection and visitor facilities will take the comment into account and improvement work, based on the consultant's recommendations, will be arranged. Furthermore, repeated climatic studies have been carried out by the Central Conservation Section of LCSD within the shelter and no notable deviation from the patterns of the ambient condition has been found.

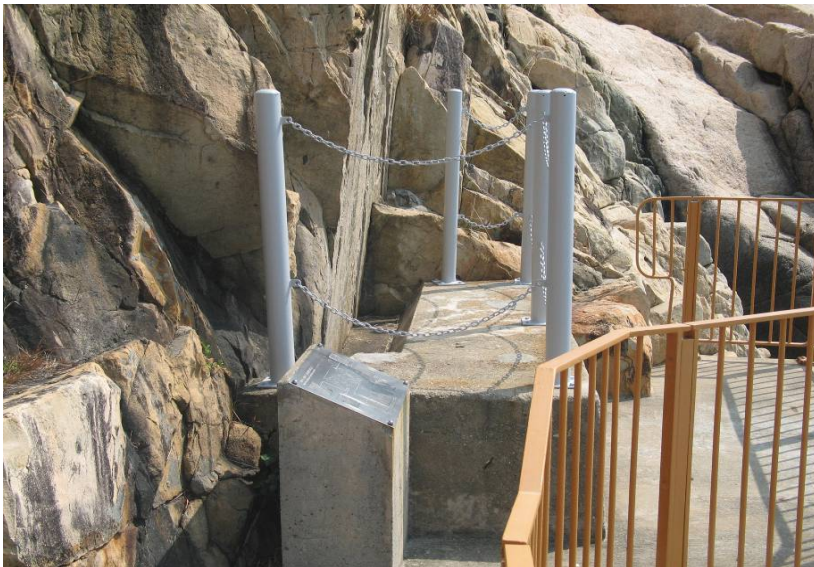
Barrier of the Rock Carving

11. The destruction of a protection case in 2009 had completely exposed one of the rock carvings to possible vandalism.	W. Meacham	Noted. A barrier was installed at the site to protect the exposed rock carving in 2009. Furthermore, the consultant commissioned by AMO to

Recommendations / Comments	Consultants	Follow up actions/ Responses
		design new protection and visitor facilities will take the comment into account and improvement work, based on the consultant's recommendations, will be arranged.

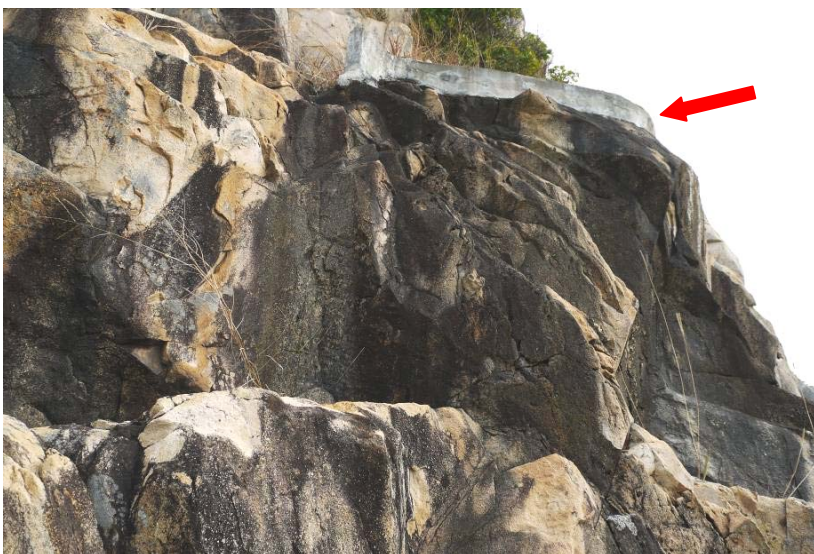
Water diversion dam above the Rock Carving

Recommendations / Comments	Consultants	Follow up actions/ Responses
1. Reconstruction of the cement water diversion dam above the right engraving	R.A. Engelhardt	Agreed. ArchSD will reconstruct the dam with suitable material above the right engraving.
2. Reconstruction of the cement water diversion dam above the right engraving by small granite stones and lime-sand mortar	V. Magar	
3. Reconstruction of the cement water diversion dam above the right engraving by siliceous grout materials	A. Thorn	
4. Removal of the dam above the left engraving	R.A. Engelhardt V. Magar A. Thorn	Agreed. ArchSD will remove the dam above the left engraving.

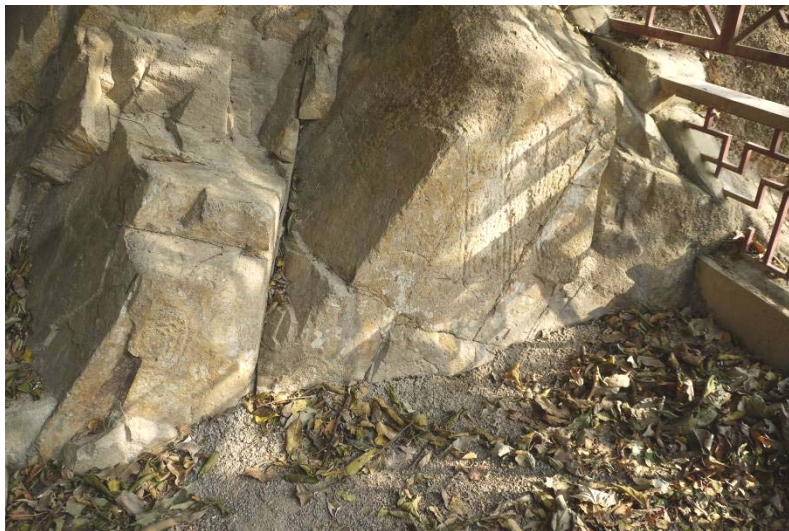
Part of the Rock Carving is buried by soil

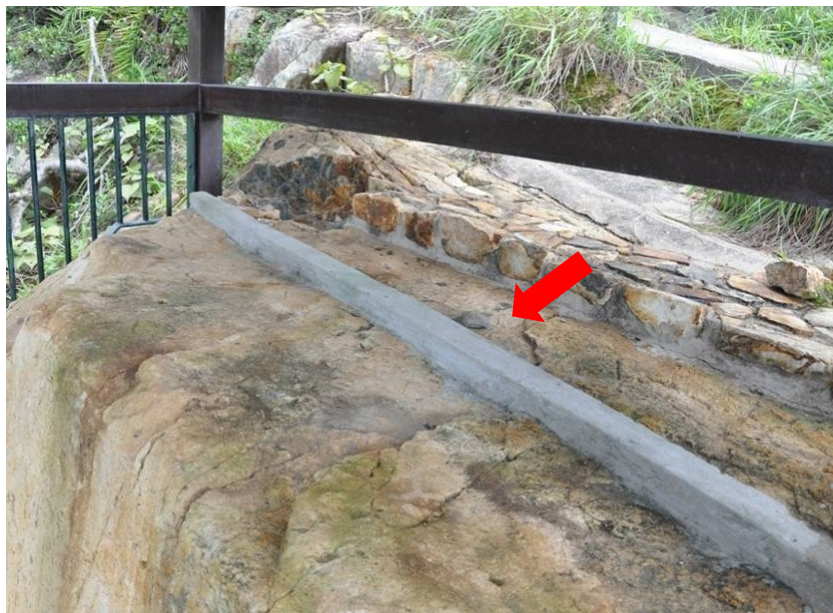
Photo 1: Water diversion dam above the Rock Carving

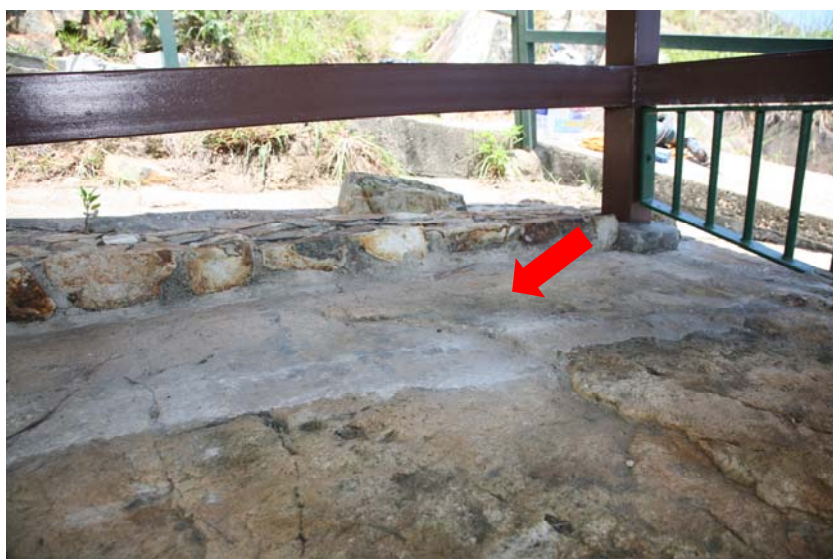
Photo 2: After removal of the water diversion dam

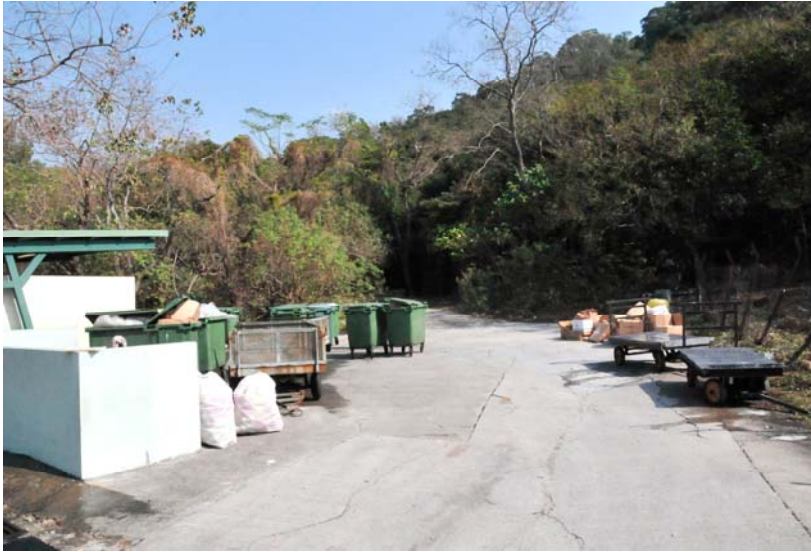
Photo 3: Refuse collection point at the footpath leading to the Rock Carving site

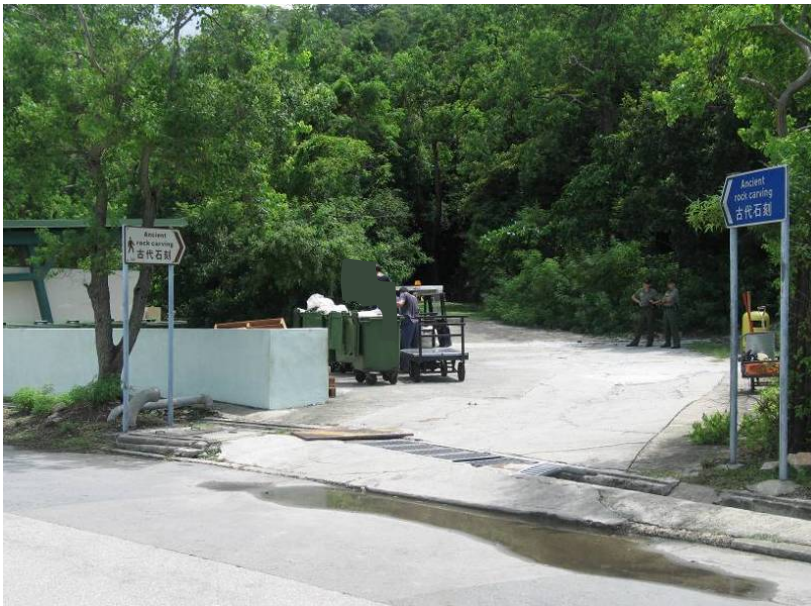
Photo 4: After cleaning up of the refuse collection point

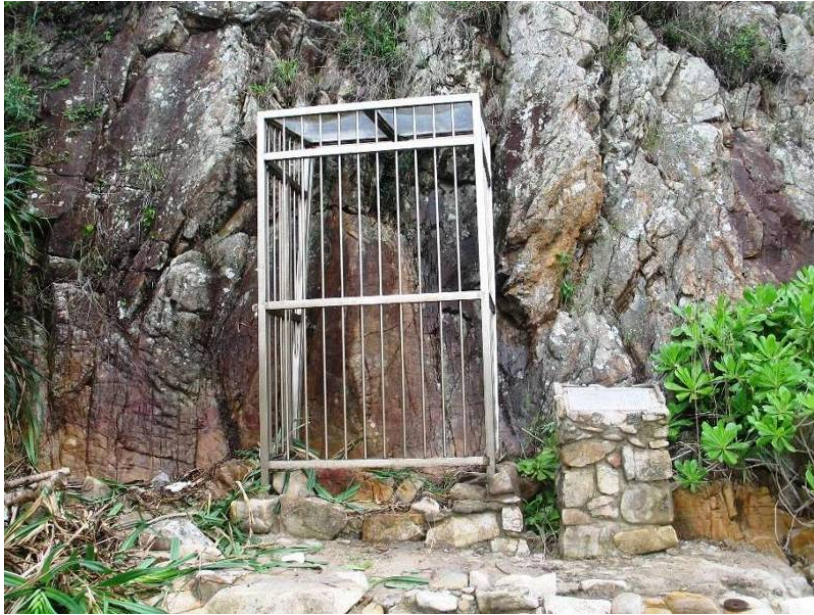
Photo 5: Shelter of the Rock Carving

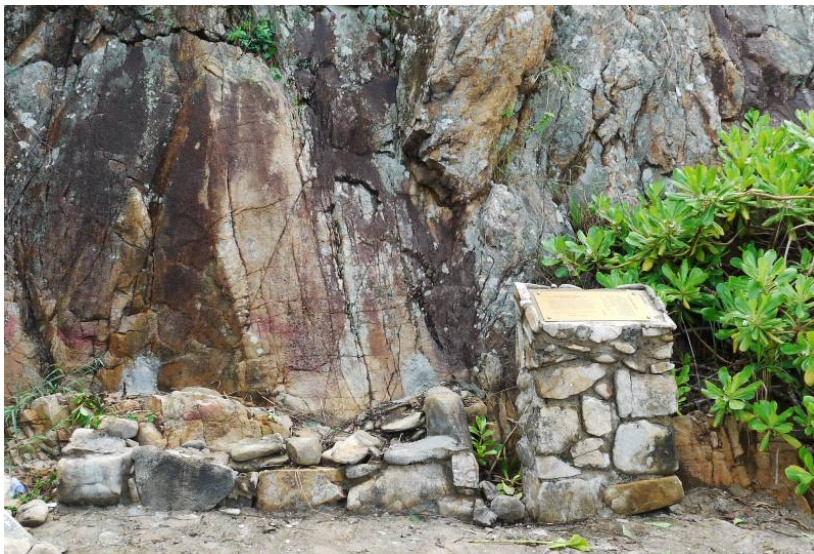
Photo 6: Rock Carving after removal of the shelter

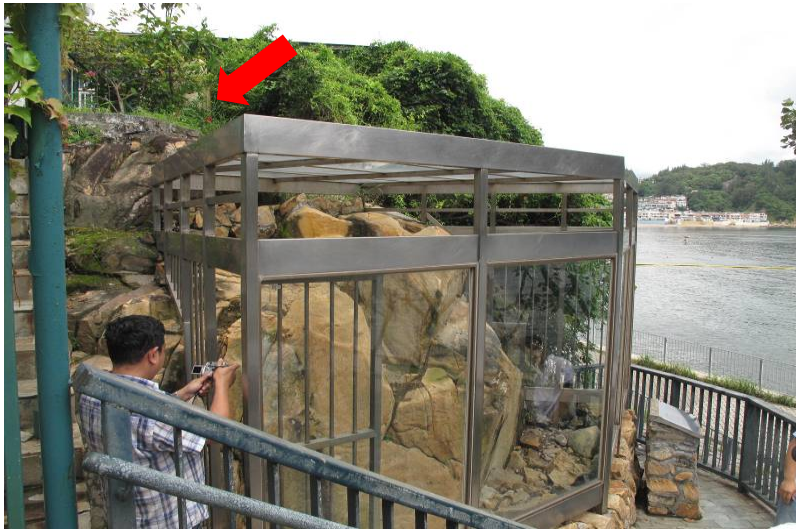
Photo 7: Planter above the Rock Carvings

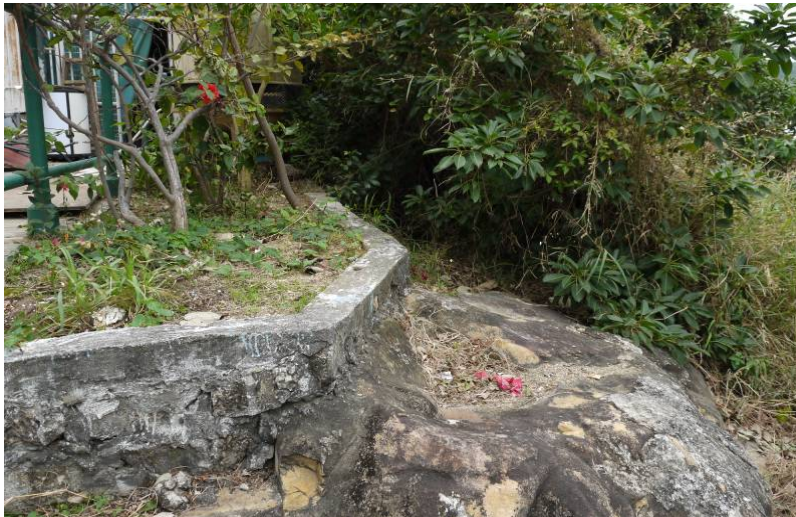
Photo 8: Planter after removal of some plants

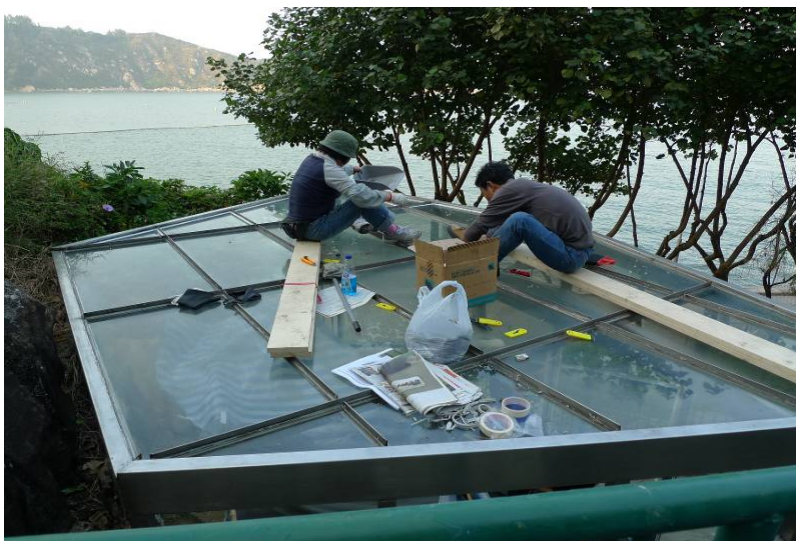
Photo 9: Re-seal of the glass roof to stop the water leakage

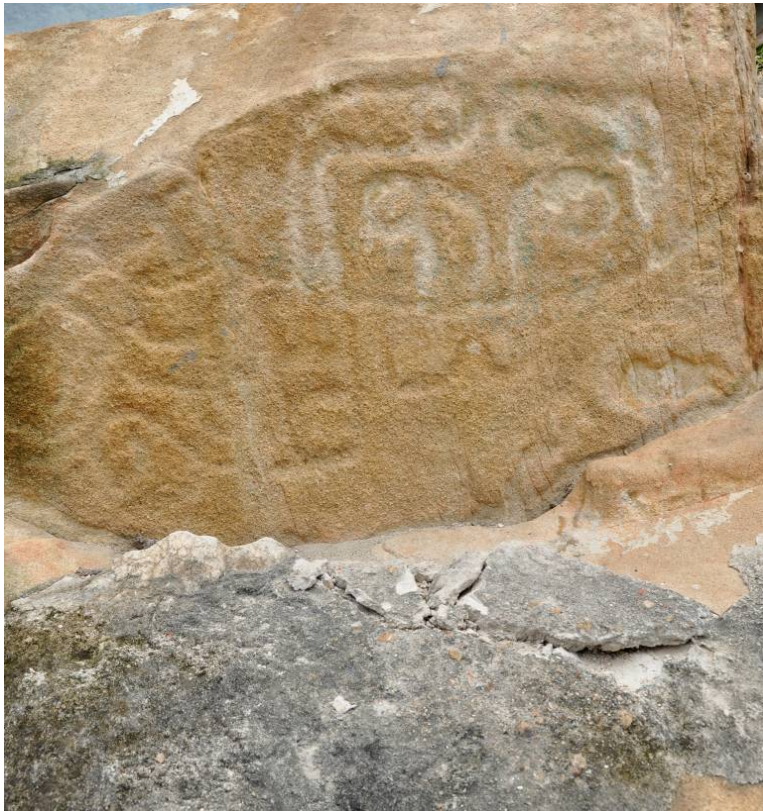
Photo 10: Cement capping at the base of the Rock Carvings

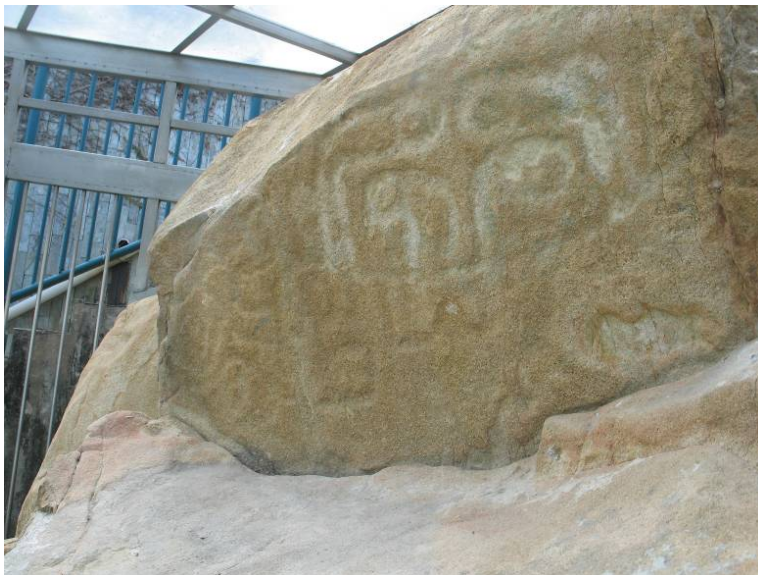
Photo 11: Rock Carvings after removal of the cement capping

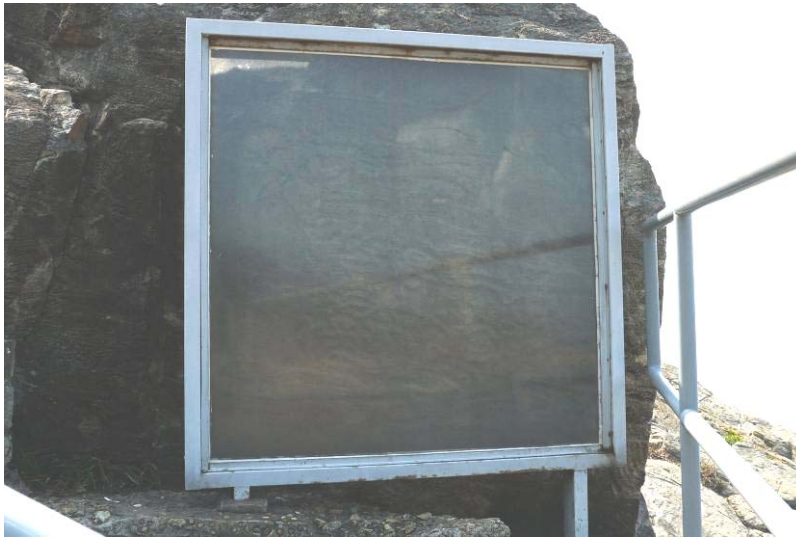
Photo 12: Protection screen of the Rock Carving

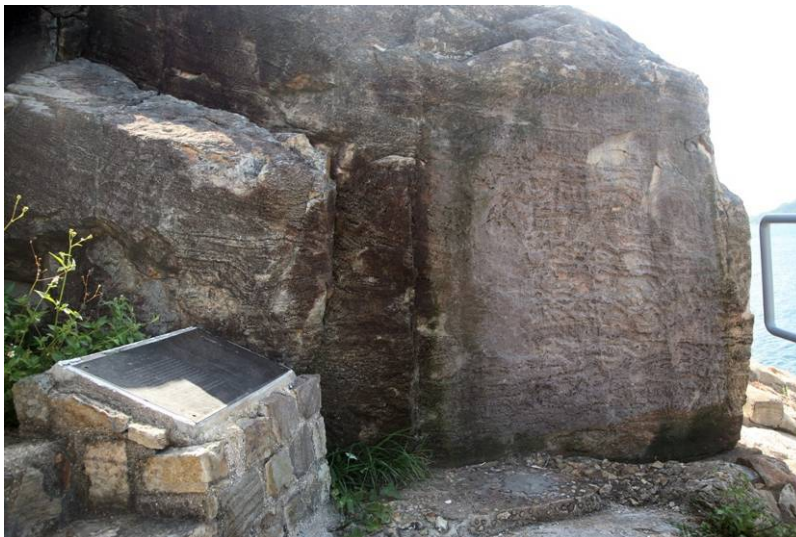
Photo 13: Rock Carving after removal of the protection screen

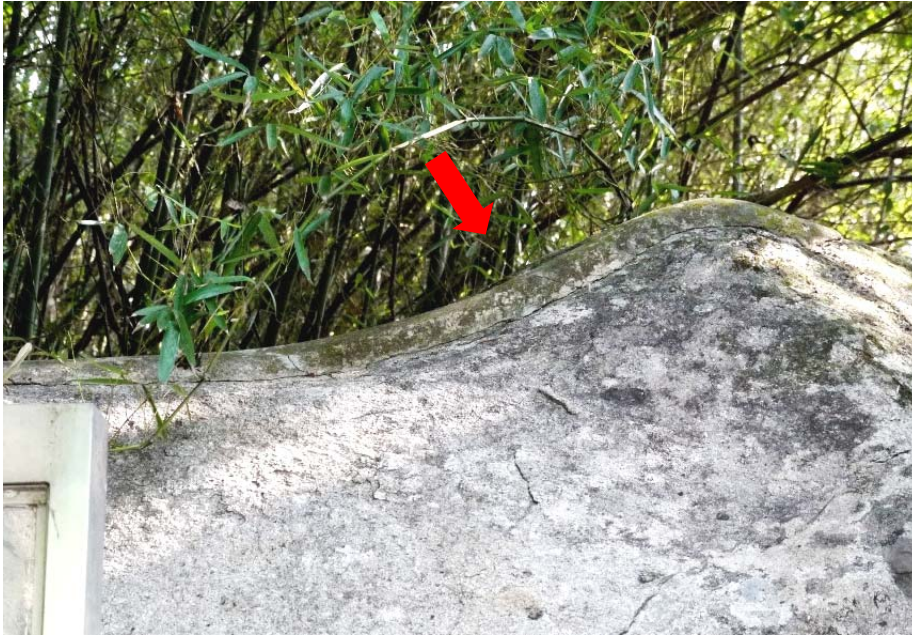
Photo 14: Water diversion dam above the Rock Inscription

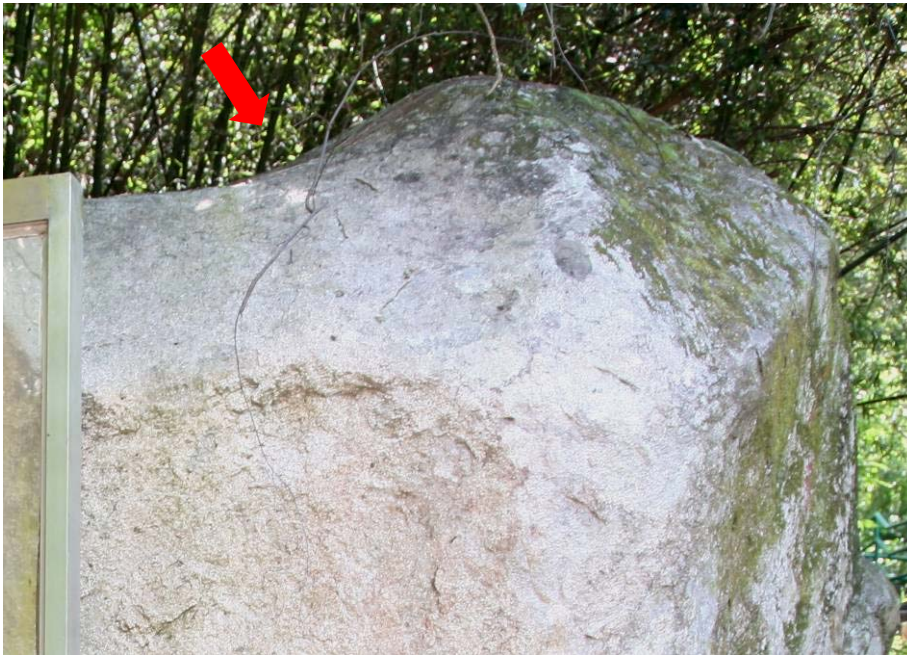
Photo 15: After removal of the water diversion dam
