Development Projects/Cases related to Preservation of Historic Buildings
(Progress as at 15 November 2022)

LATEST TECHNICAL APPRAISAL FOR BLOCK 4 THE CENTRAL POLICE STATION COMPOUND

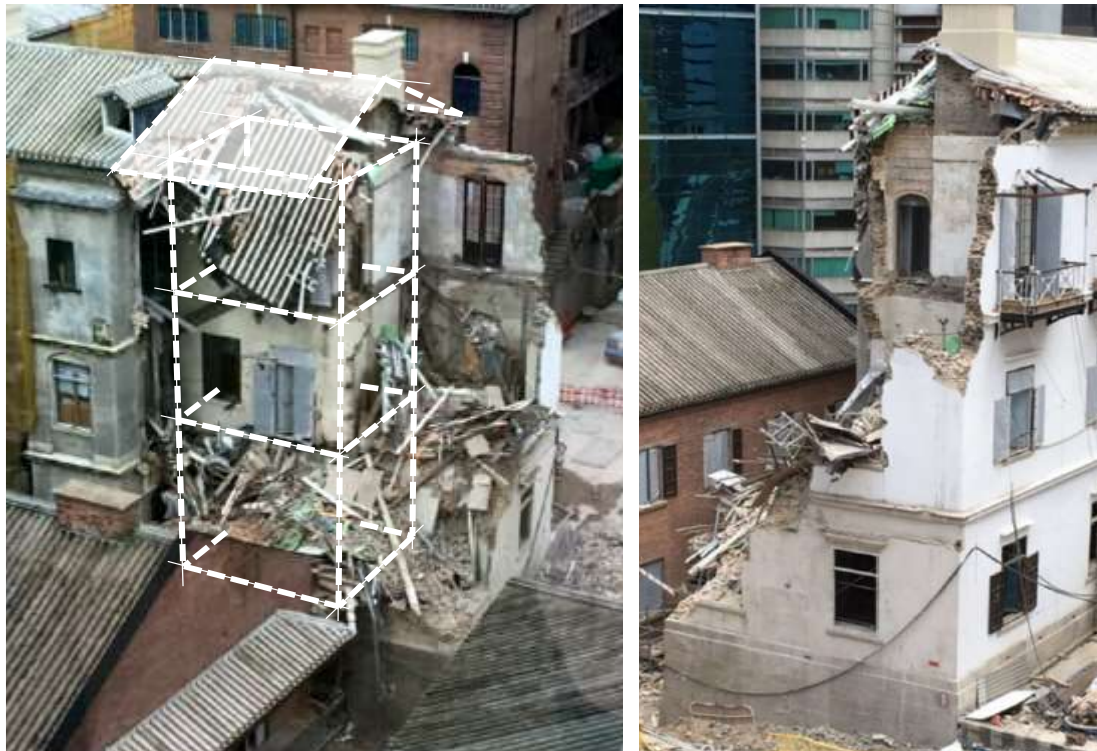
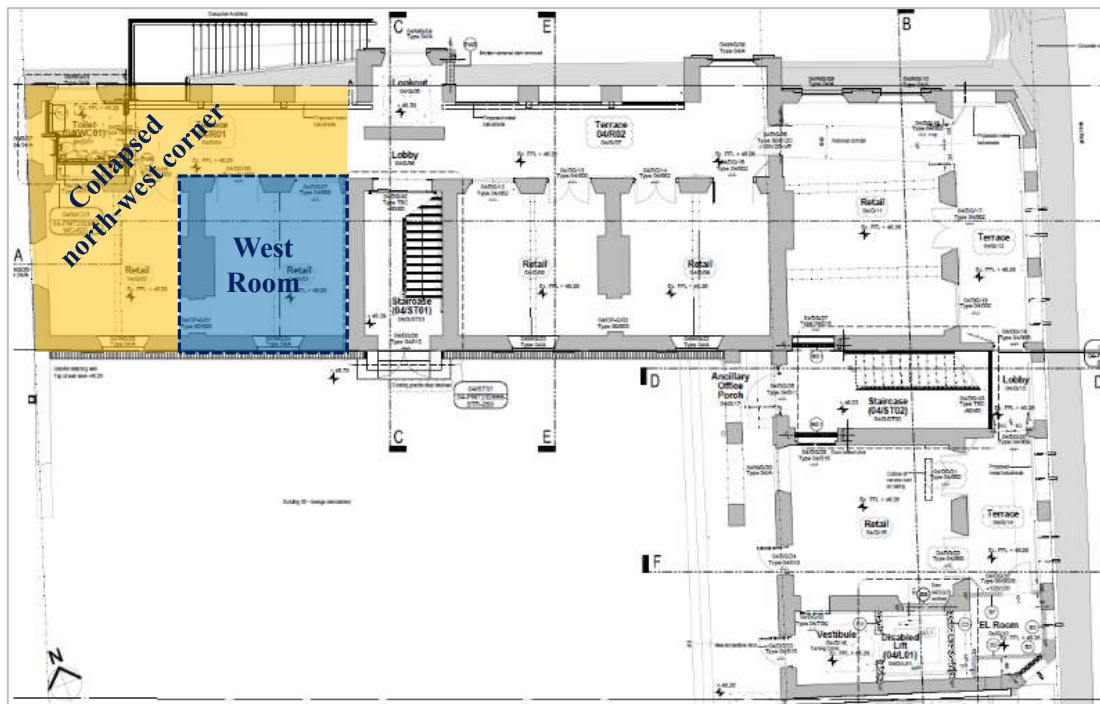
2. This Paper explains the latest development of the Updated Recovery Plan for Block 4, which suffered a partial collapse (Figure 1) on 29 May 2016. Specifically, AAB members are invited to note the following, which is explained later in detail.

Figure 1 – (a) Aerial views of partially collapsed Block 4 (North Wing) with extent of West Room indicated diagrammatically in broken lines;
(b) Ground floor plan indicating location of partially collapsed portion and West Room

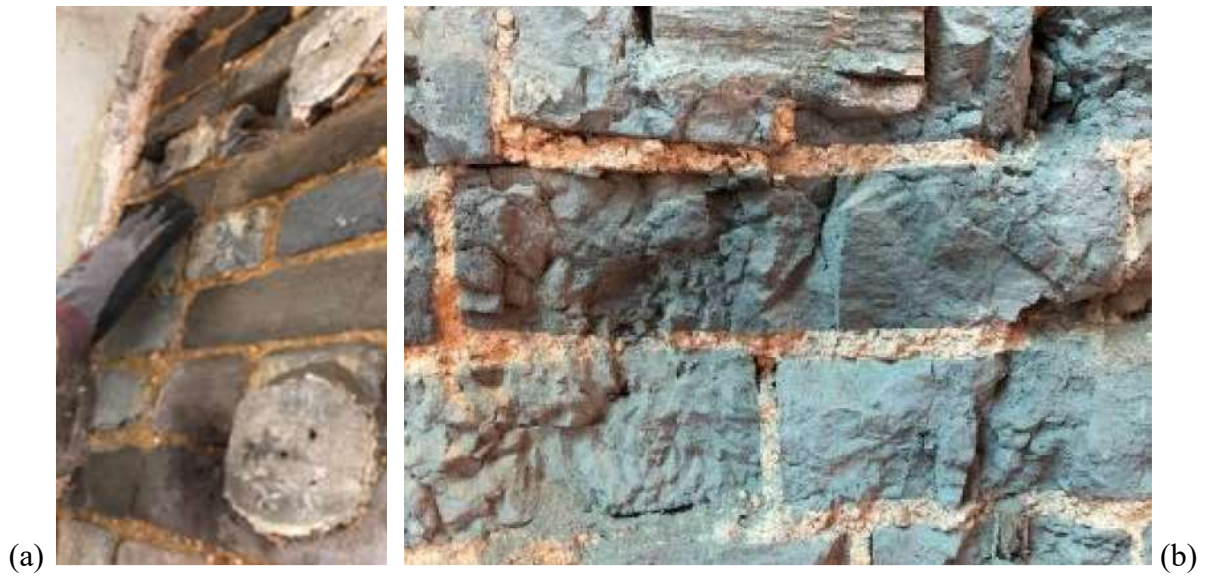
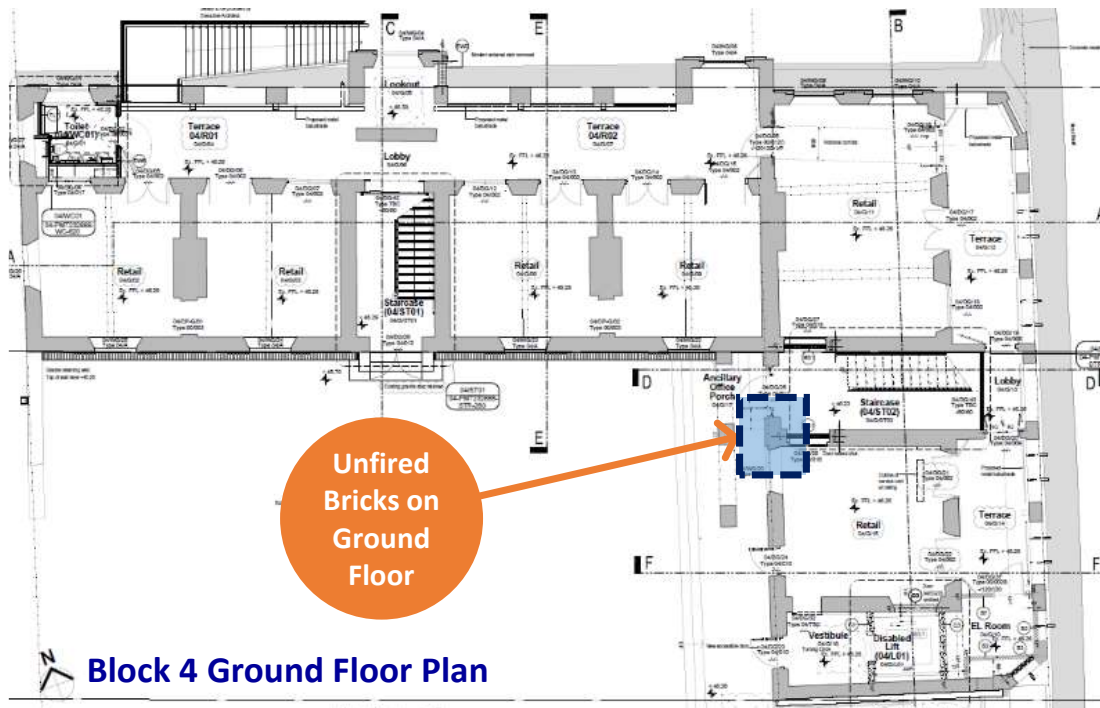
Figure 4 – (a) & (b) Views of brickwork after removal of plaster. Some bricks appeared to be unfired and could be rubbed away by hand;
Ground floor plan indicating location of unfired bricks (one of many locations)

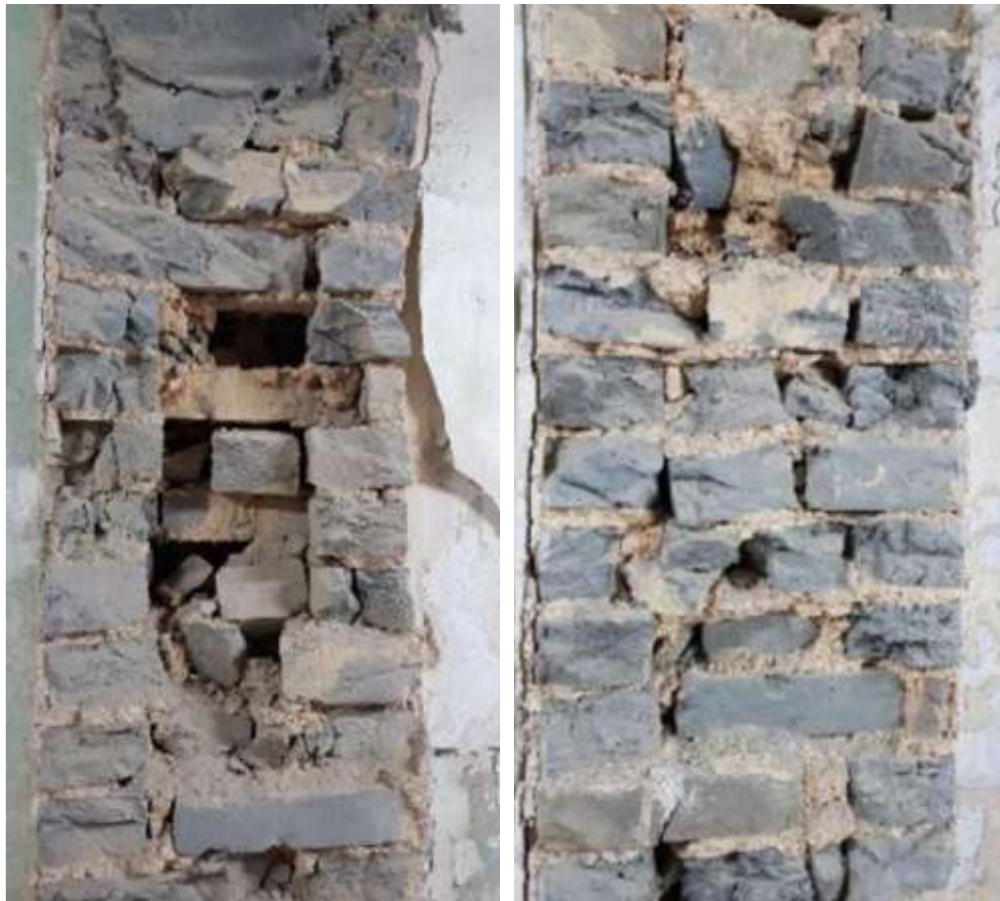
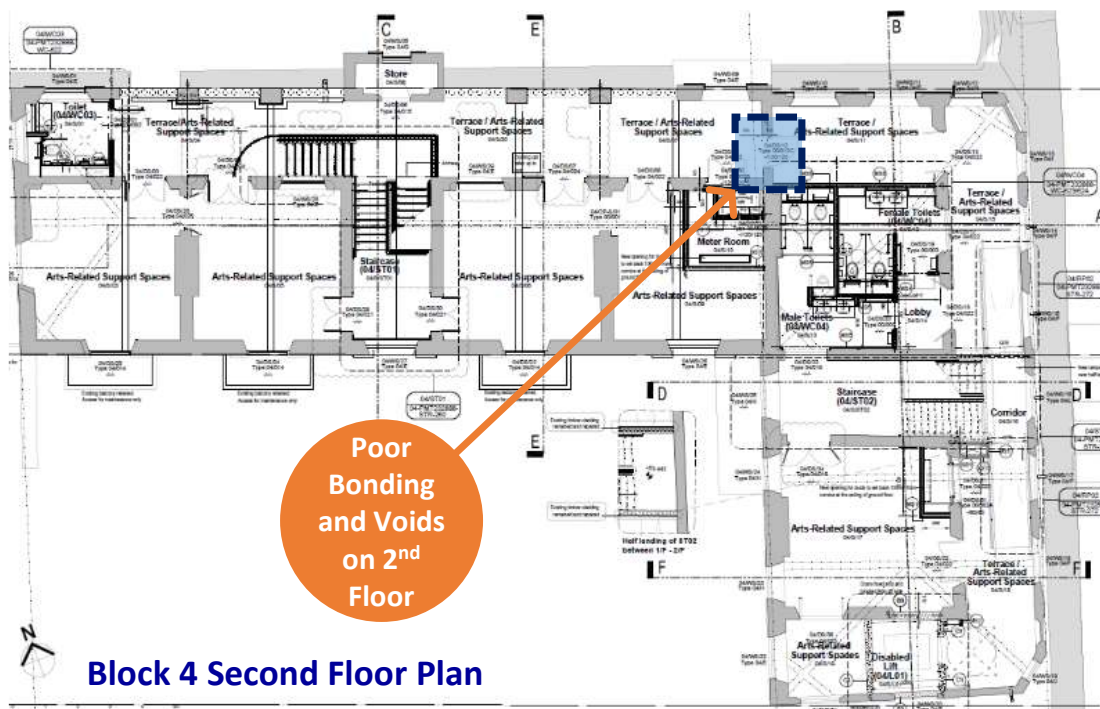
Figure 5 – Views of brickwork showing poor bonding and voids in the centre of the walls whilst cutting new door openings;
Second floor plan indicating location of walls with poor bonding and voids

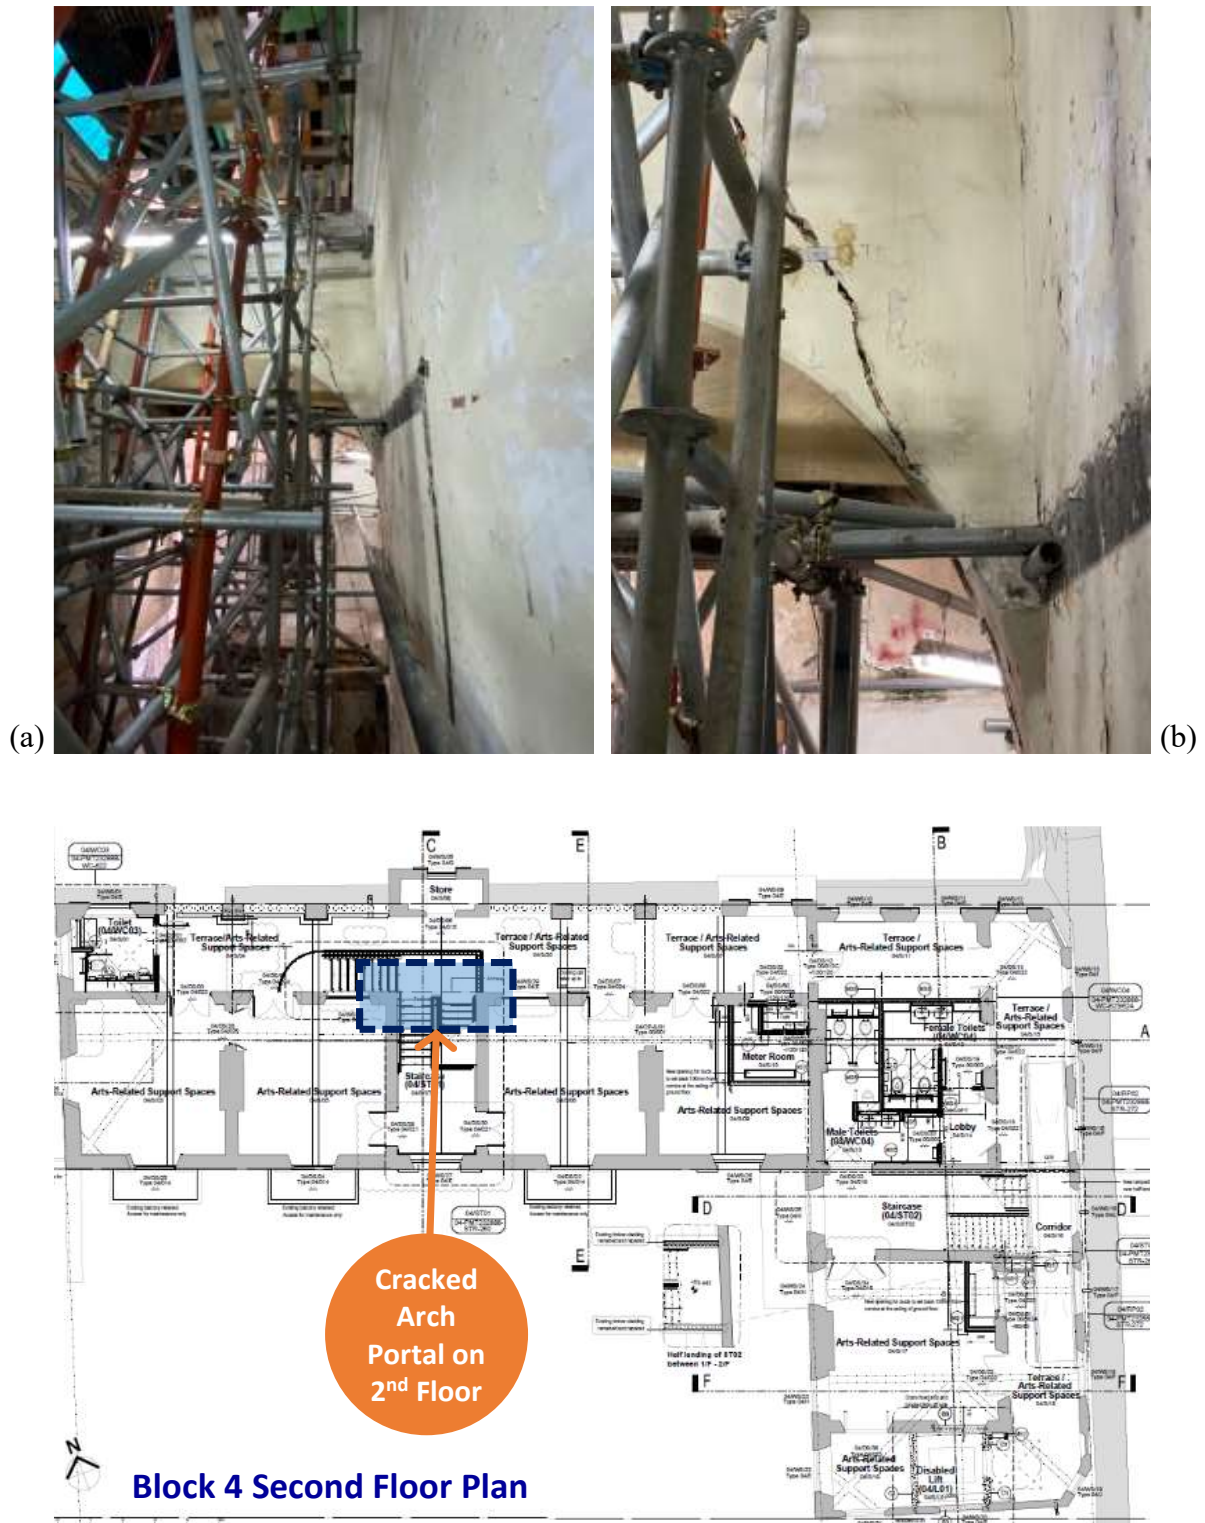
9. During the removal of the West Room, four movement incidents were detected during daily inspections (Table 1). These building movements included enlargement of existing cracks in both vertical and horizontal directions (Figure 7), tilting, and settlement. Whilst small movements are not uncommon during construction works, in view of the 2016 partial collapse, these movements caused considerable alarm because they also included slight but unexpected movements of the east façade facing Arbutnot Road, some twenty metres away from the West Room where the removal work was being carried out.

Figure 7 – (a) Overview of second floor arch portal;
 (b) Close-up view of second floor arch portal showing enlargement of exiting crack;
 Second floor plan indicating location of arch portal

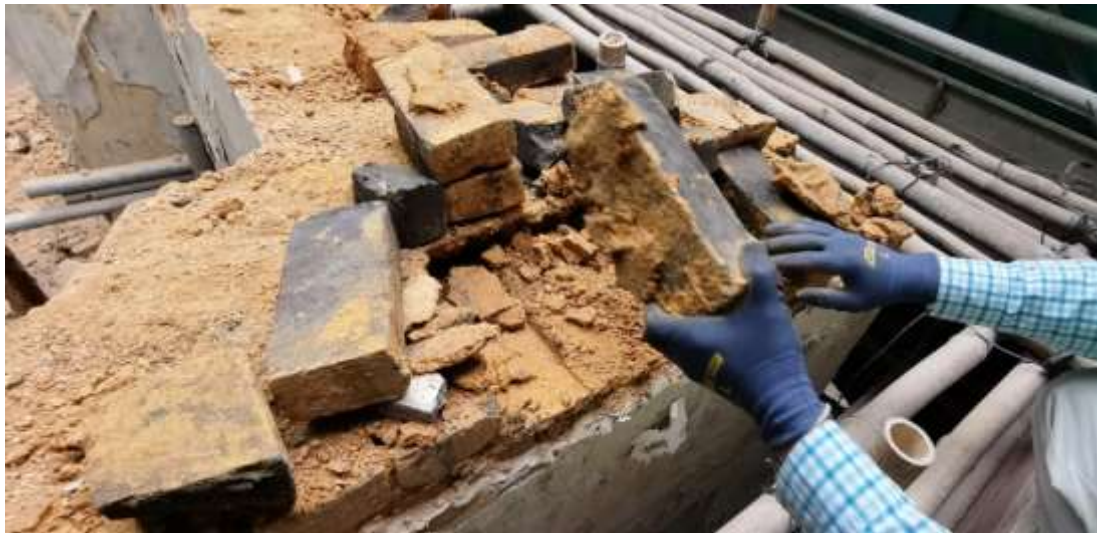
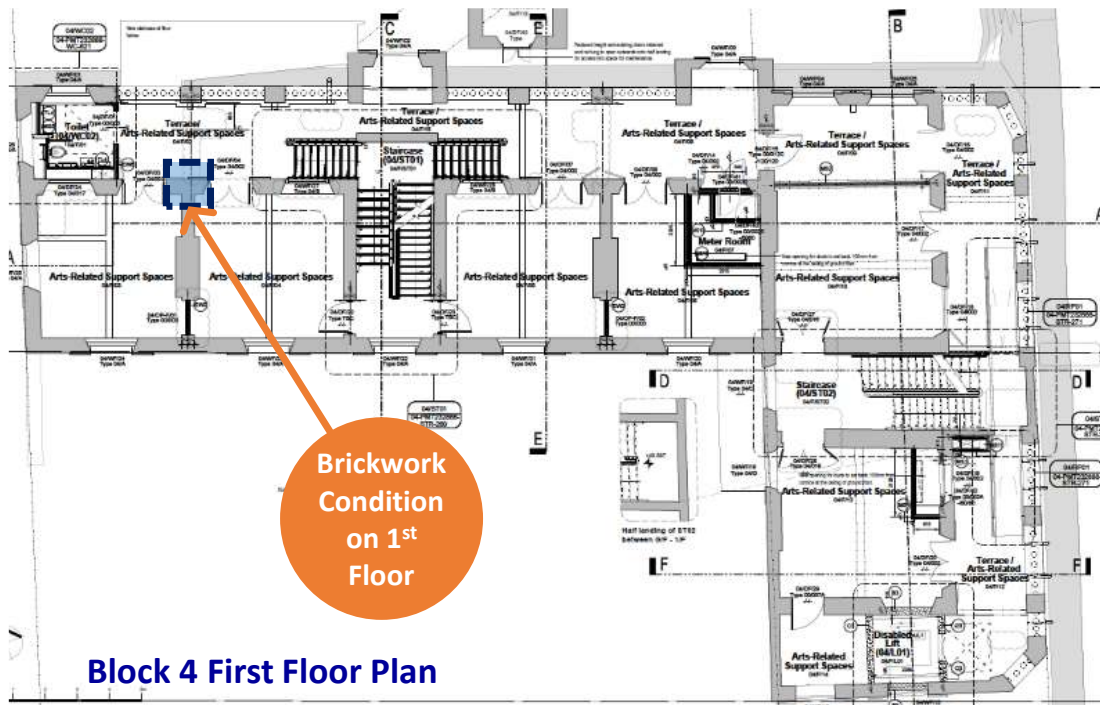
- *Visual Inspection* – The mortar in the West Room construction would have been prepared locally. Inspections revealed that large areas of the mortar have a powdery composition, with very little cohesion. It is so weak that it is possible to separate the bricks by hand easily (Figure 8). Thus the brick walls should be described as a loose assembly of low-strength bricks in a matrix of weakly-bound sand (Figure 9) rather than a cohesive structural unit.

Figure 8 – Mortar is weak and powdery with little cohesion, and it is possible to separate bricks by hand easily
First floor plan indicating location of poor brick condition

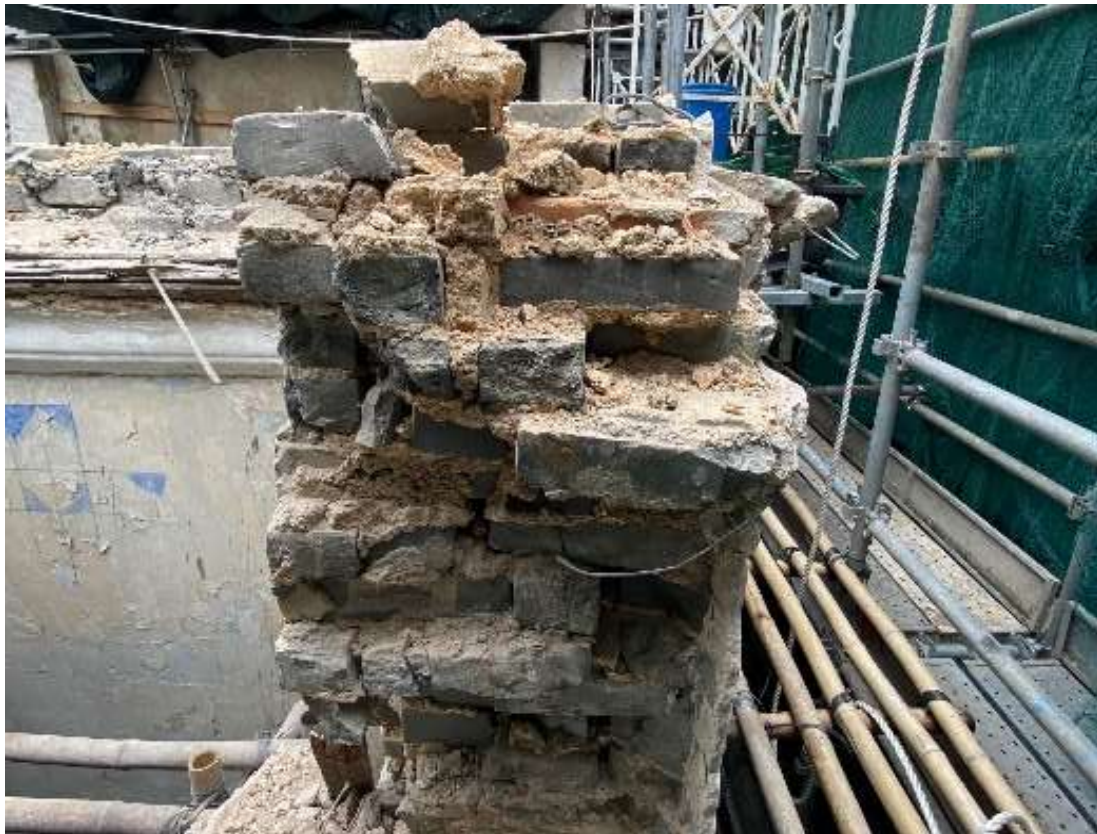
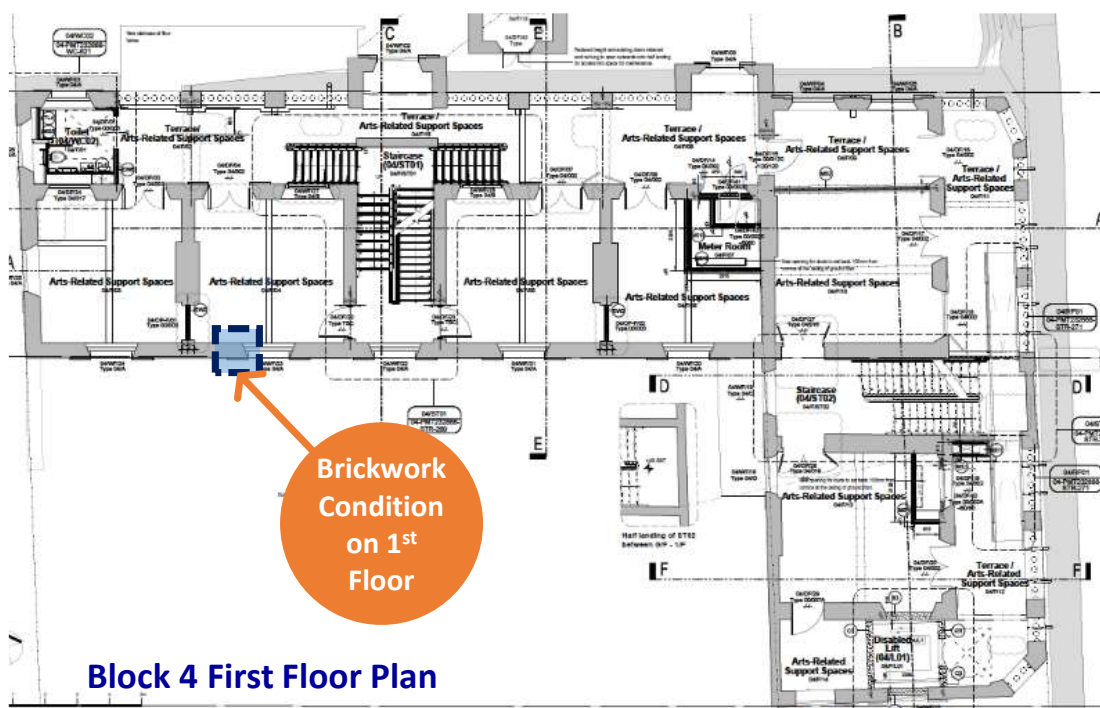
Figure 9 – View of brickwork during removal of the West Room, showing powdery mortar with very little cohesion. Brick walls are more an assembly of weak bricks in a matrix of sand than a cohesive structural units
First floor plan indicating location of poor brick condition

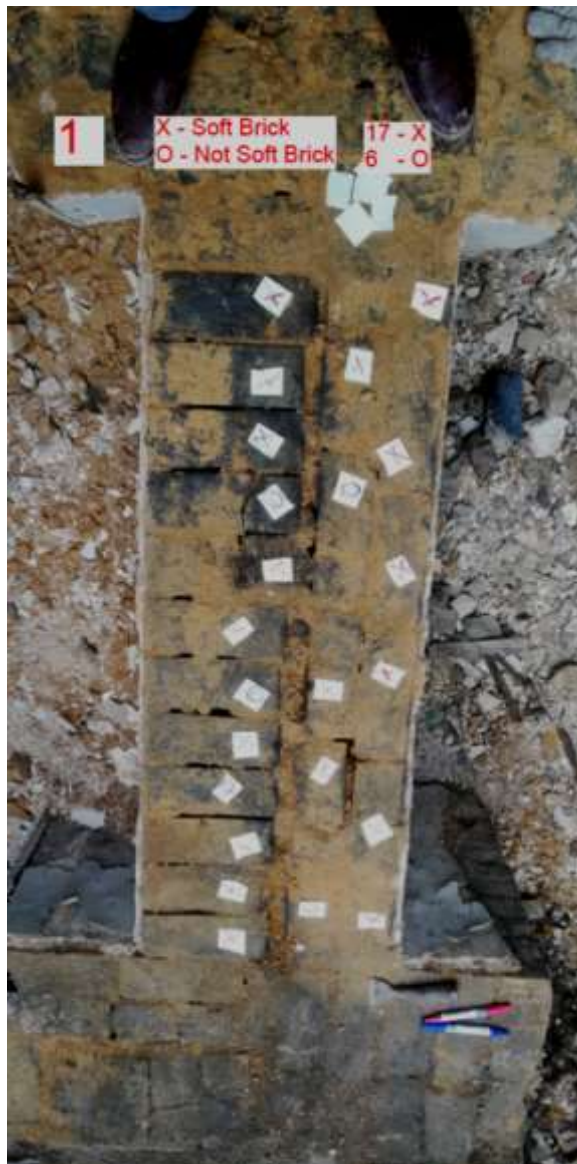
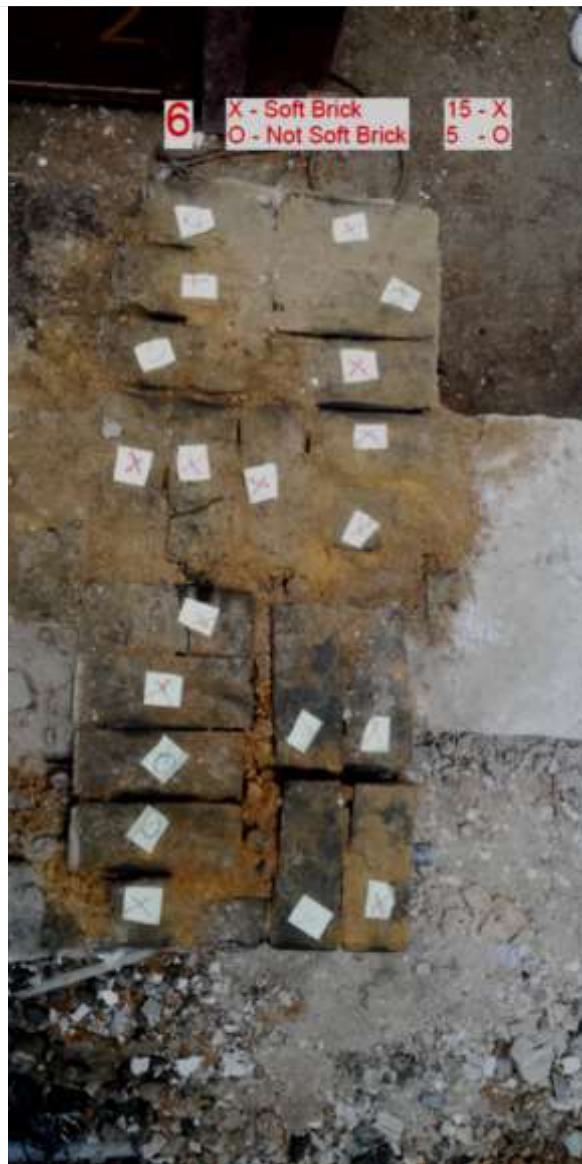
Figure 11 – (a) Approximately 75% of the bricks in random locations were considered soft (“X” Soft brick; “O” Not soft brick)

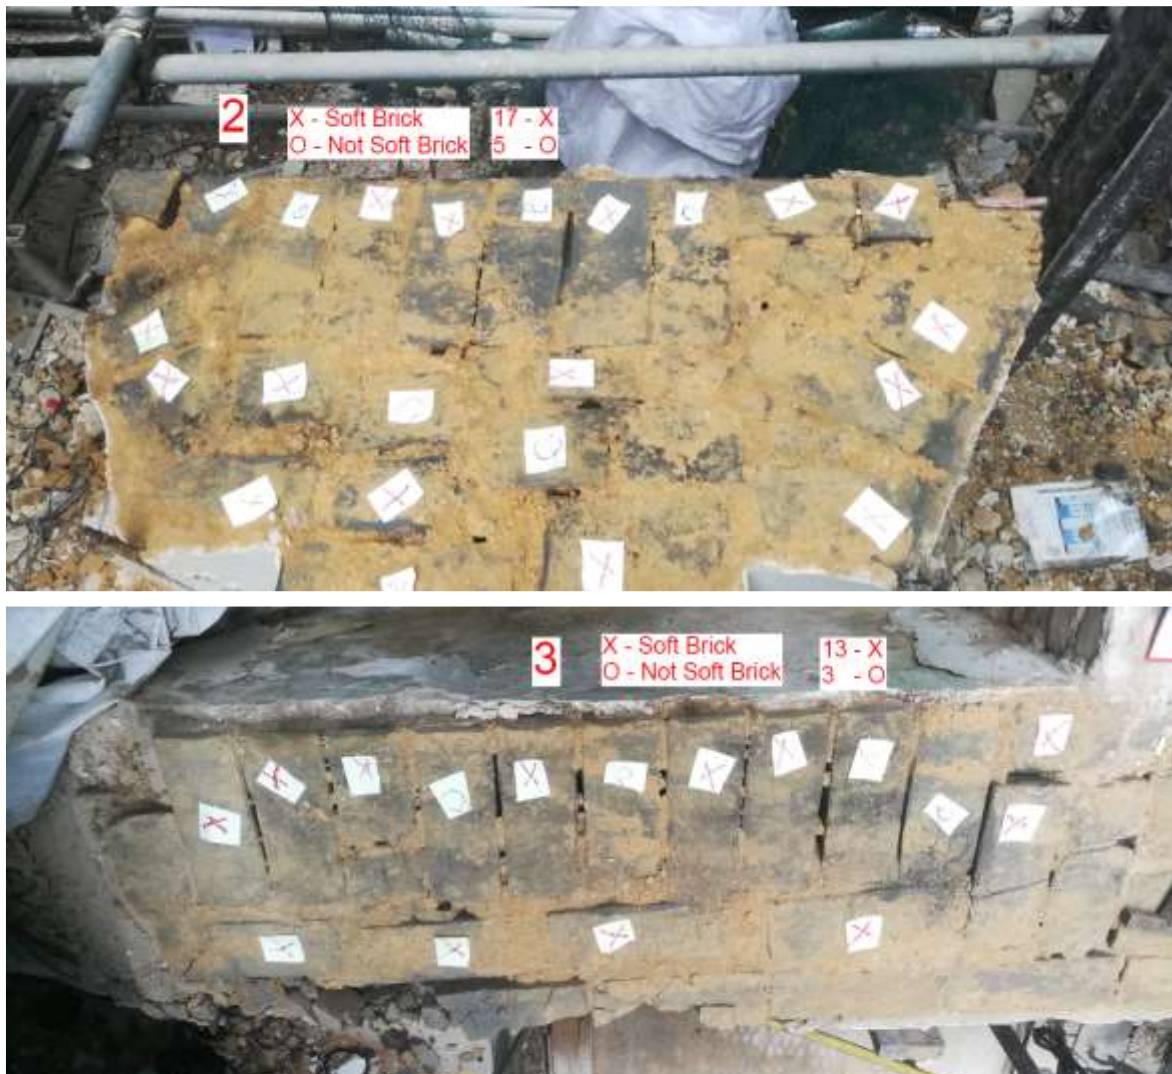
Figure 11 – (b) Approximately 75% of the bricks in random locations were considered soft (“X” Soft brick; “O” Not soft brick)

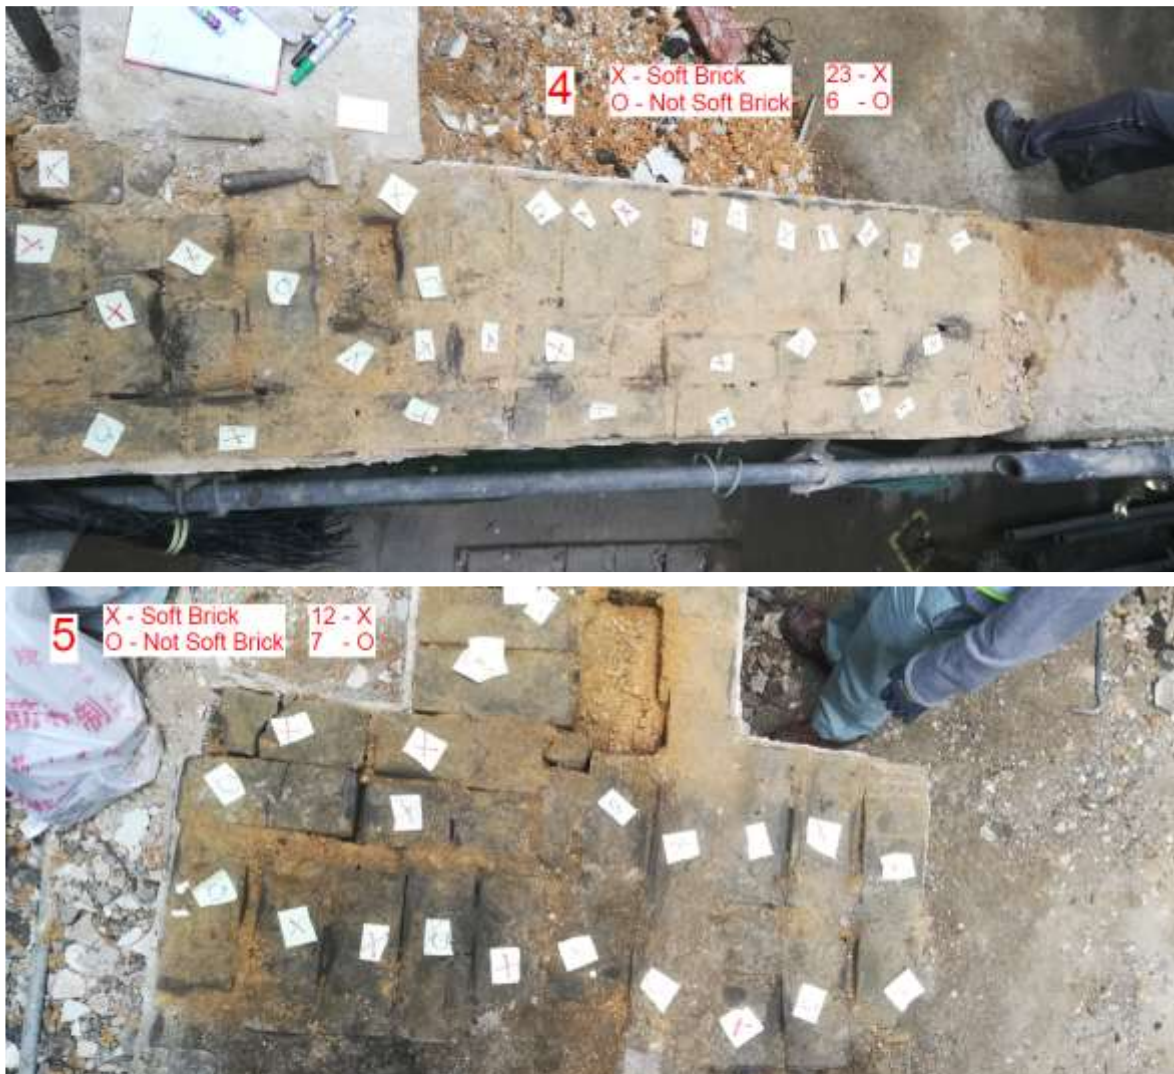
Figure 11 – (c) Approximately 75% of the bricks in random locations were considered soft (“X” Soft brick; “O” Not soft brick)

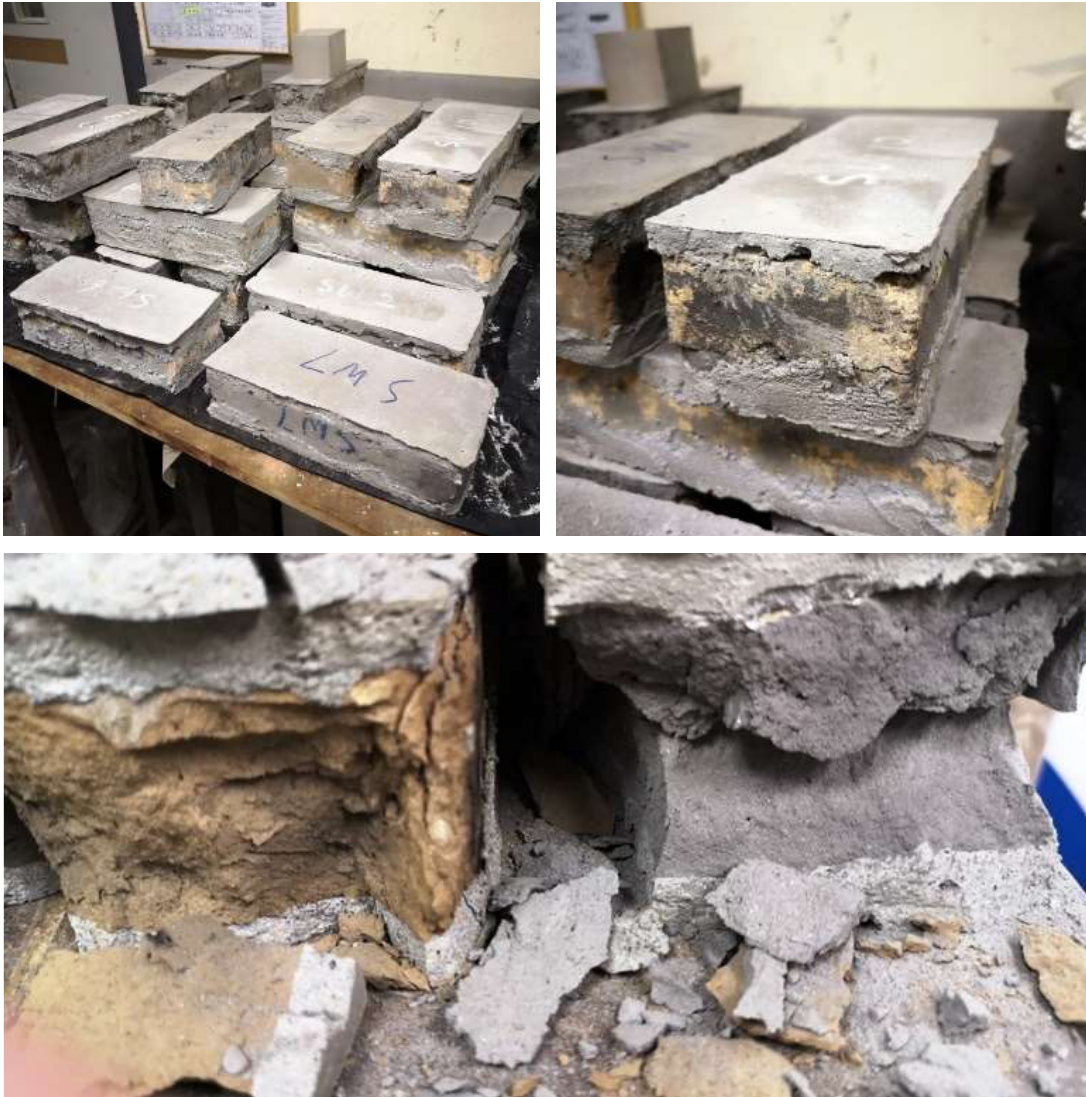
Coupled with the weak and powdery mortar, the low brick compressive strength means the brickwork (i.e. the combined strength of bricks and mortar) would likely be weaker than the lowest characteristic value of 2.2 N/mm² (□) as recommended in Table 2 of BS 5628 – *Code of practice for use of masonry* (see extract below).

Figure 12 – Forty brick samples were collected for compression tests with results showing that the characteristic compressive strength of the bricks was only 4.32 N/mm²

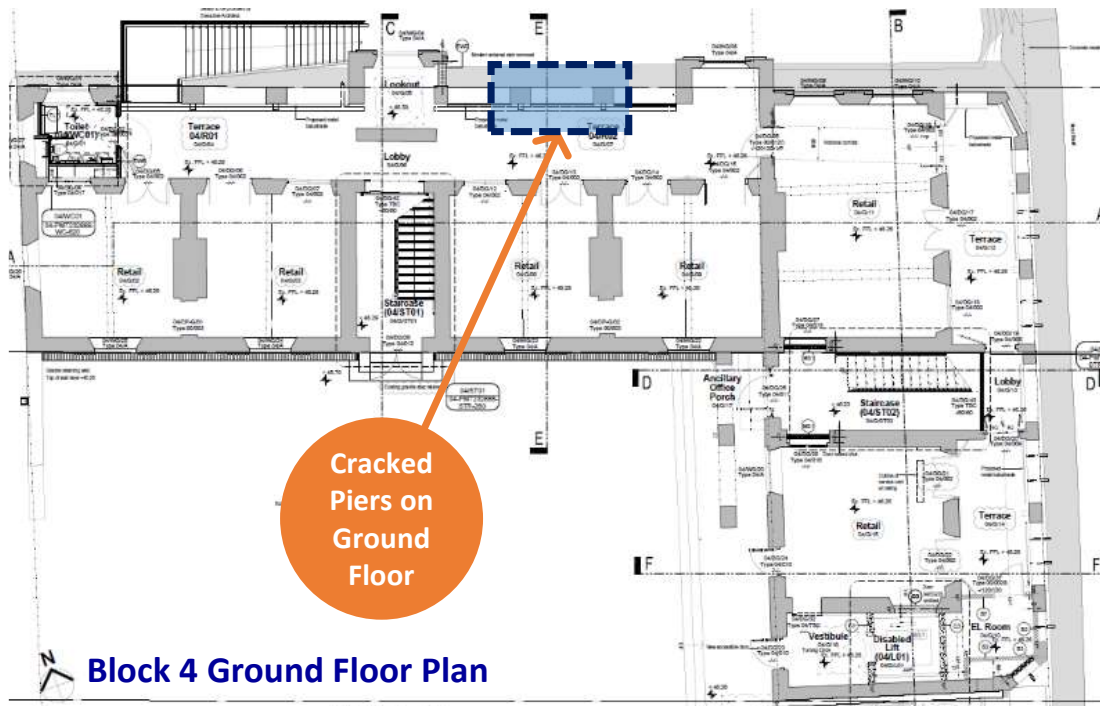
Figure 13 – 2009 structural survey identified cracked piers in the north façade which would require further investigation and structural repair;
Ground floor plan indicating location of cracked piers

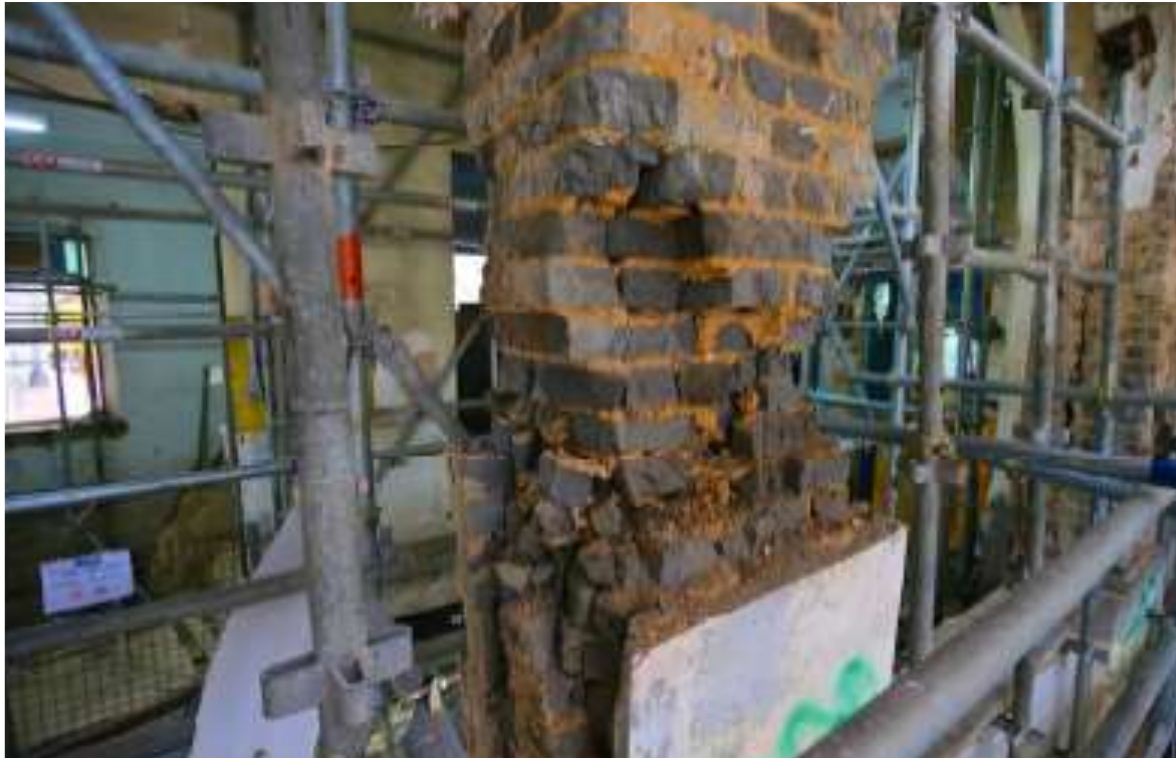
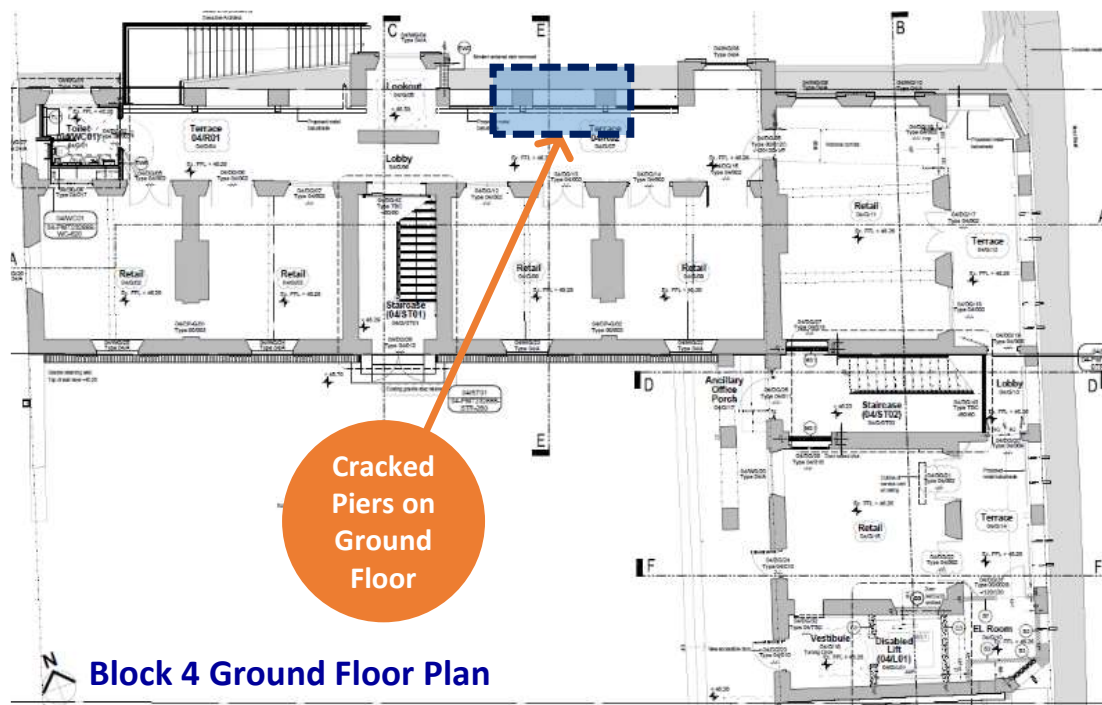
Before rebuilding (discovered on 27 September 2014)
Extract from Appendix D2, 214A Repair Survey Report Revised, Building 04 – Married Inspectors, North Elevation, Central Police Station Hong Kong, Stonewest (HK)

Figure 14 – 2014 repair works, major cracks in two brick piers on north facade discovered (Note – These two brick piers were repaired);
Ground floor plan indicating location of cracked piers

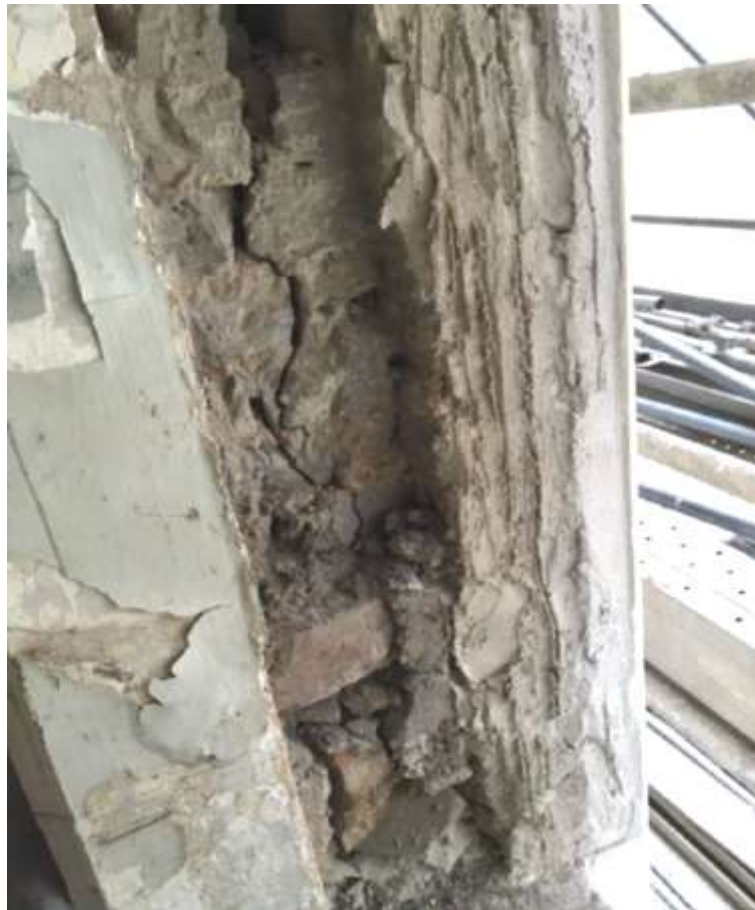
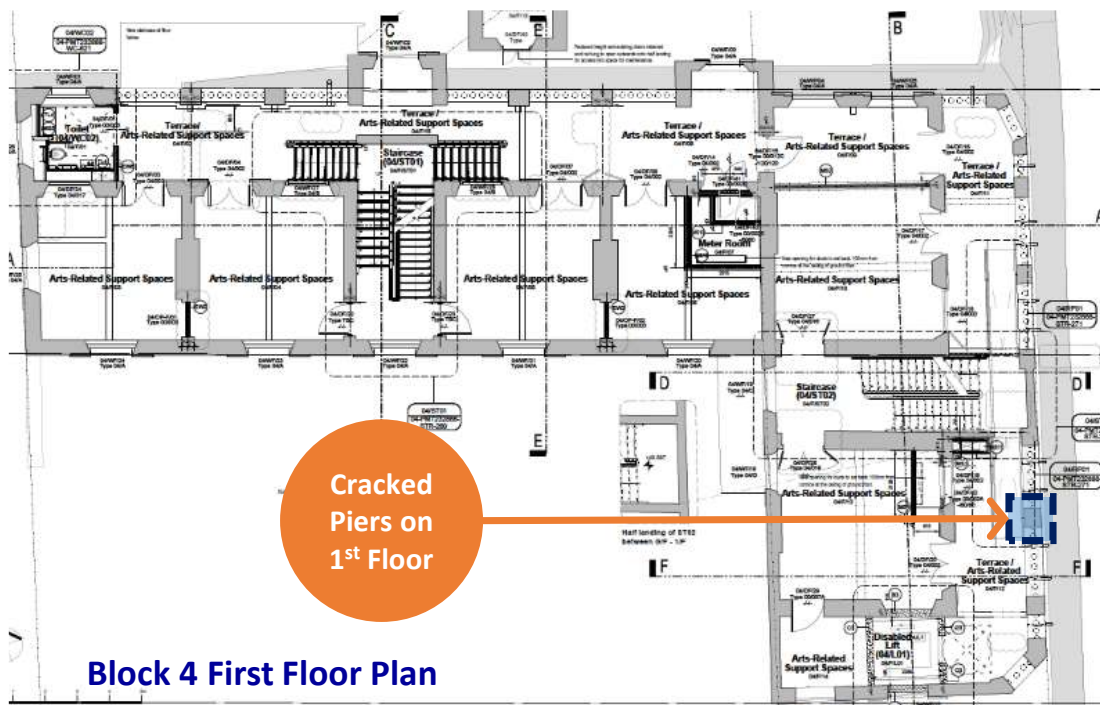
Figure 15 – Hidden cracks in brick piers which were revealed after removal of window frames on ground floor and first floor;
First floor plan indicating location of cracked piers

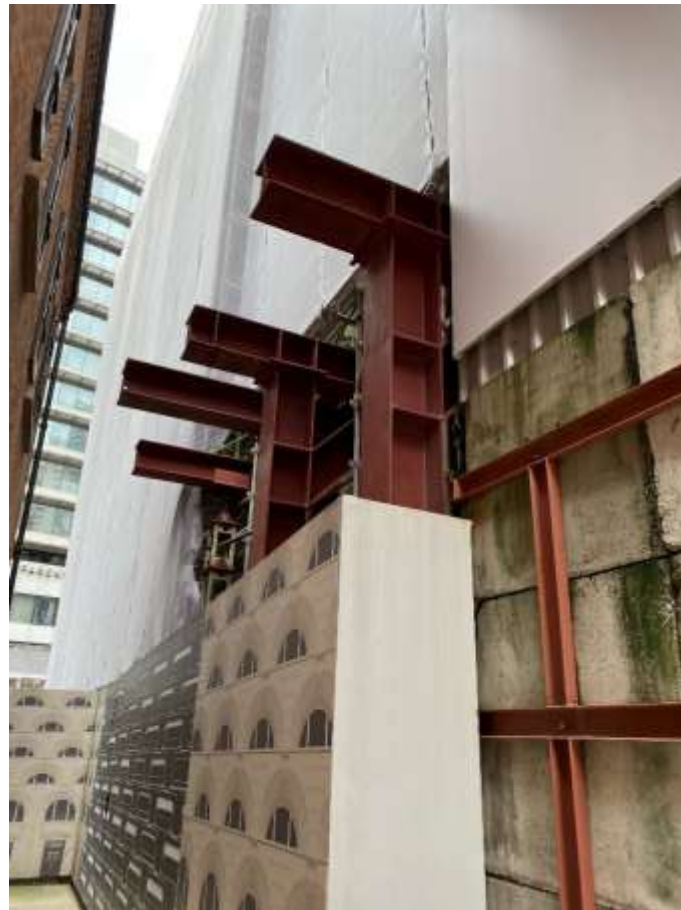
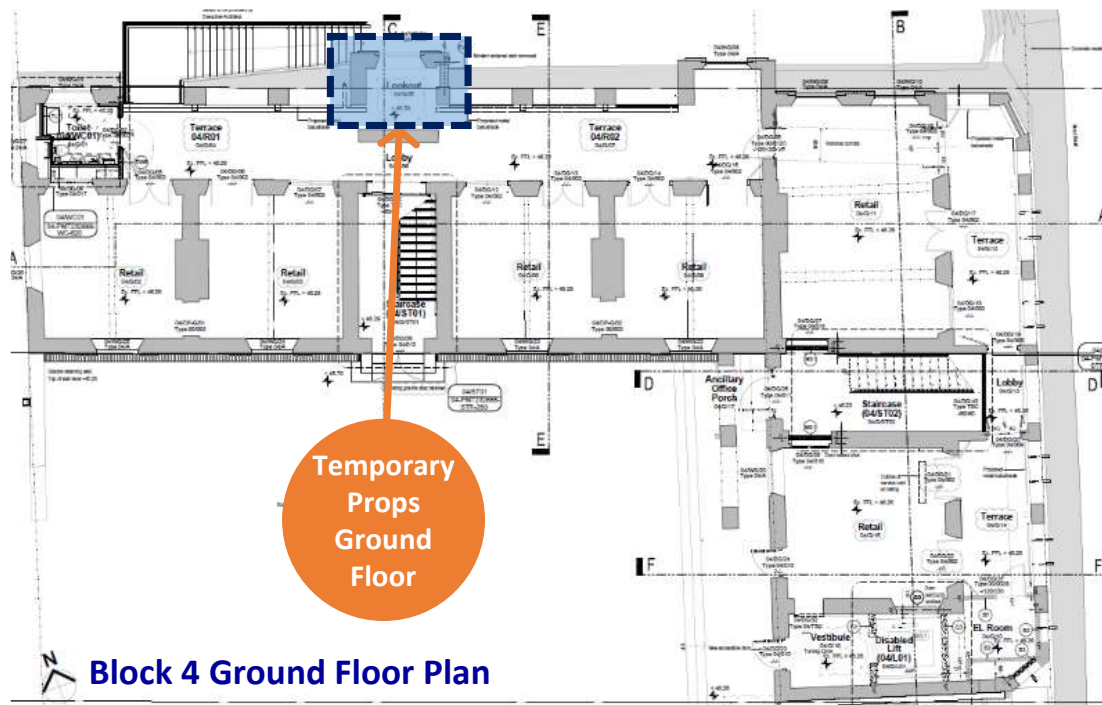
Figure 16 – Temporary props to projecting bay on north facade (needs to be replaced by permanent supports which is a high hazard operation)
Ground floor plan indicating location of temporary props to projecting bay

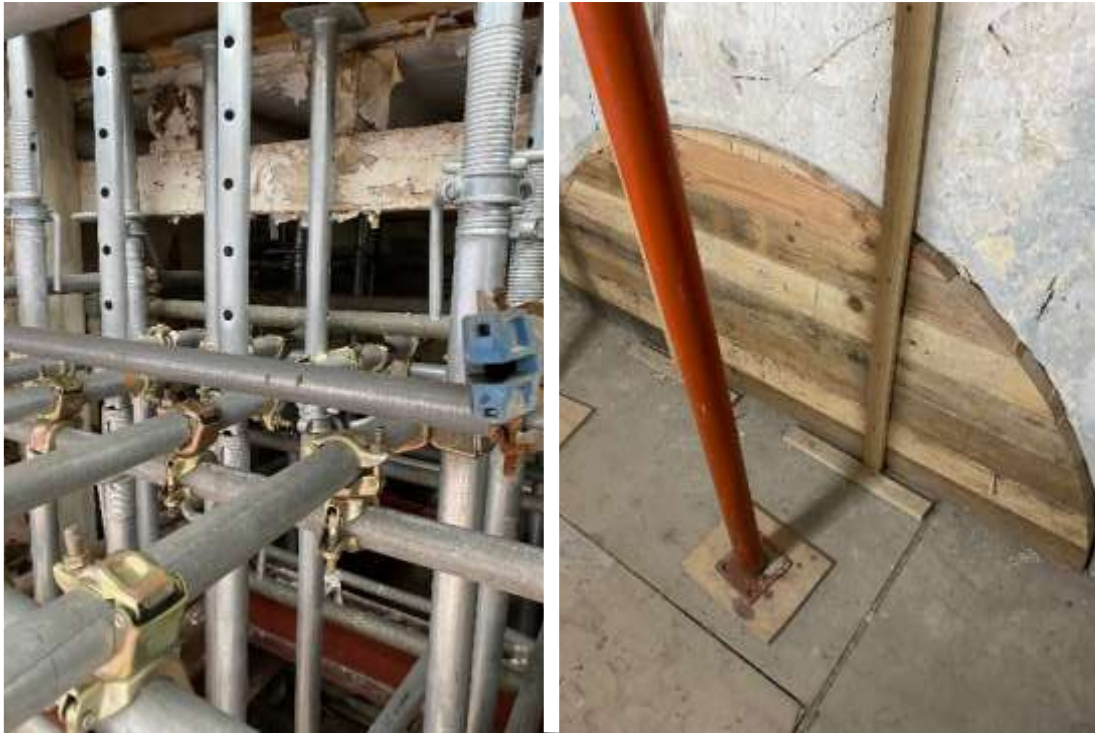
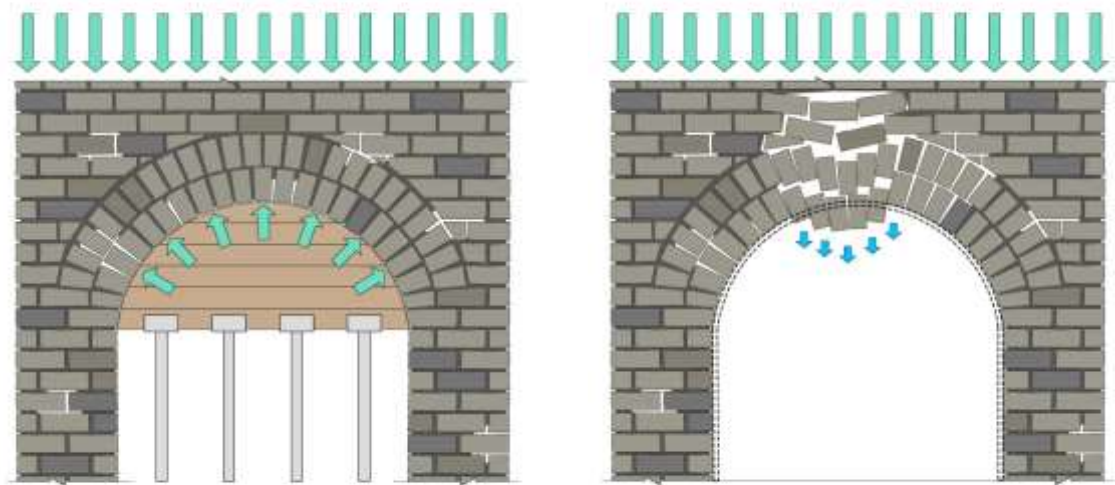
Figure 17 – Replacing temporary timber pack (supported by steel props) by permanent steel brackets, inducing hazards as it is difficult to envisage a sequence where brick arches are not left unsupported
