Development Projects/Cases related to Preservation of Historic Buildings
(Progress as at 15 November 2022)

LATEST TECHNICAL APPRAISAL FOR BLOCK 4 THE CENTRAL POLICE STATION COMPOUND

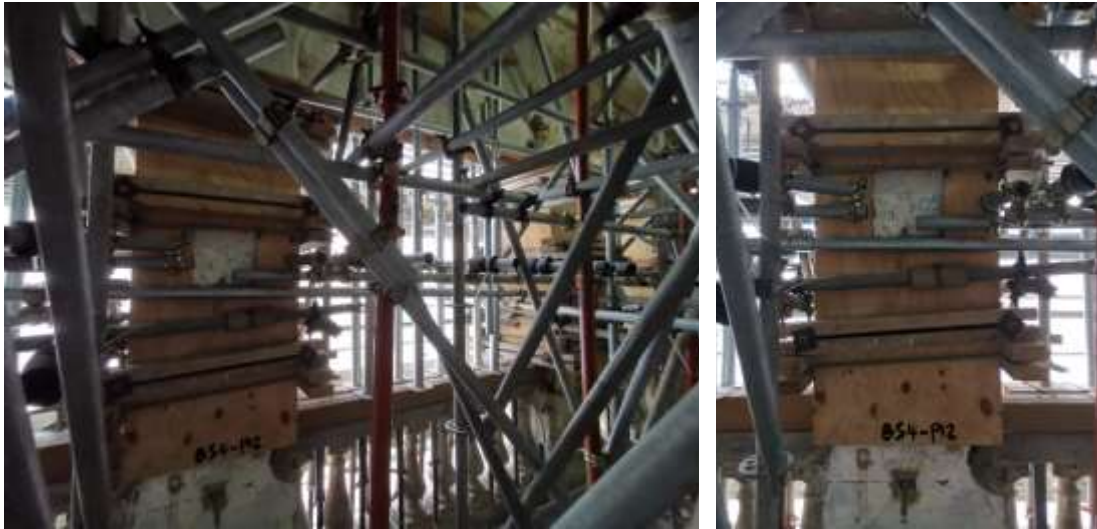
Figure 18 – Slender and cracked brick piers in poor condition remain standing (supported by temporary works), and substantial repairs will be required in recovery work

- Repairing and, if necessary, rebuilding the slender piers (Figure 18). Given the poor condition of the brickwork, there is no certainty that a viable temporary works scheme can be developed for this operation;
- Temporary removal of the roof timber trusses, which are acting as ties between the outer walls, to facilitate the construction works owing to restricted site work area.

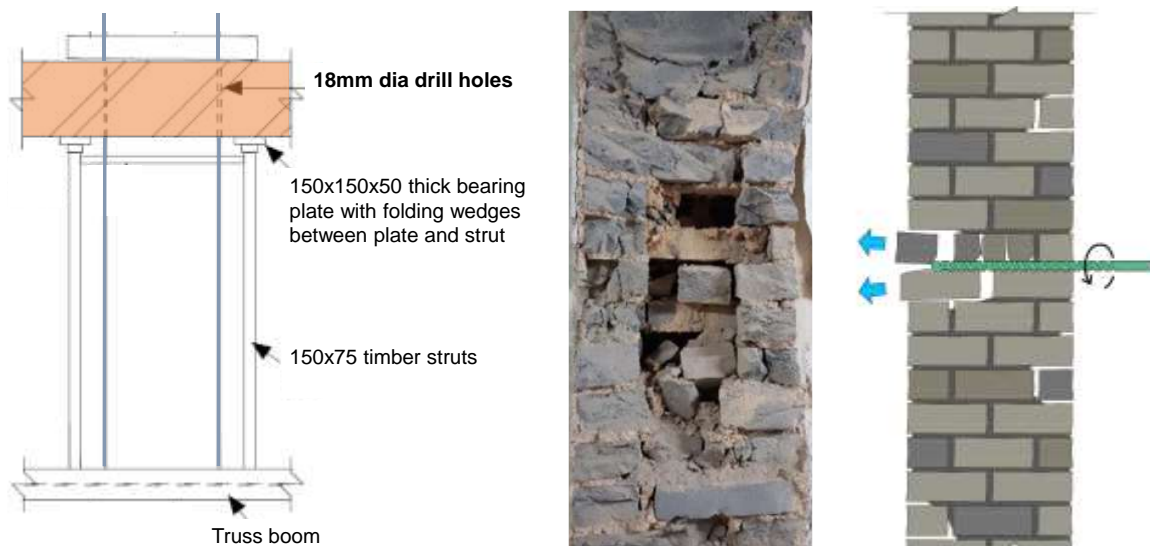
Given the hidden weaknesses within the masonry, the technically feasible design / interventions are now considered particularly ambitious. As recent testing in 2020–21 has reduced confidence in the masonry, the construction will be more hazardous than was the case when the **Updated Recovery Plan** was developed.

Figure 19 – Hole-drilling through masonry facade, several hundred in quantity, is required to restrain the facade to a shoring system; this type of structural interventions are now considered ambitious as recent testing had reduced confidence in the masonry

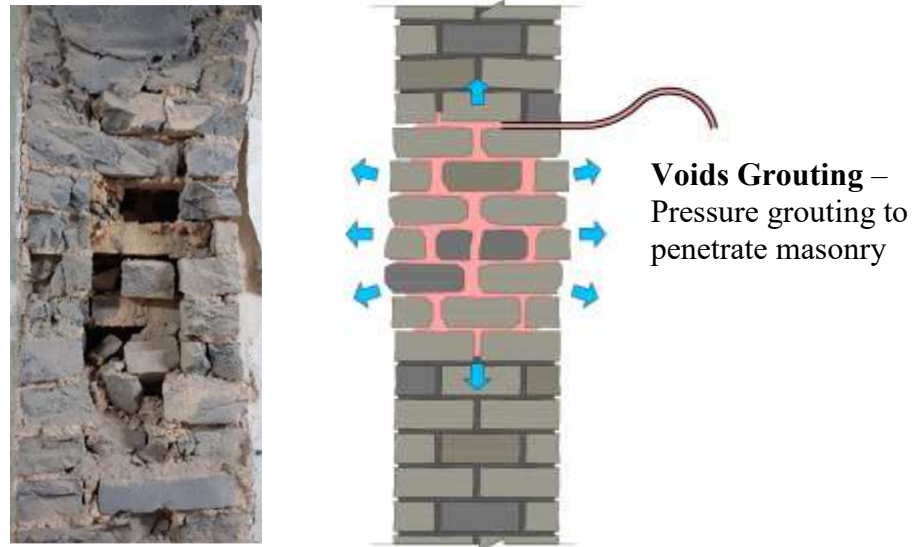
The extent of voids and limited bonding arrangement / integrity within the walls of Block 4 is a concern when applying a pressurised grout⁹. Such increase in internal pressure could cause bulging of the weak masonry walls (Figure 20). When the weaknesses are random in location and widespread, it is not feasible to confirm the long-term integrity of the wall because of the inability to guarantee the extent of grouting or bonded masonry undertaken.

Figure 20 – Grouting of voids in masonry walls is required to restore integrity. However, the increase in grout pressure could cause sudden bulging of weak brick walls; this type of structural interventions are now considered ambitious as recent testing had reduced confidence in the masonry

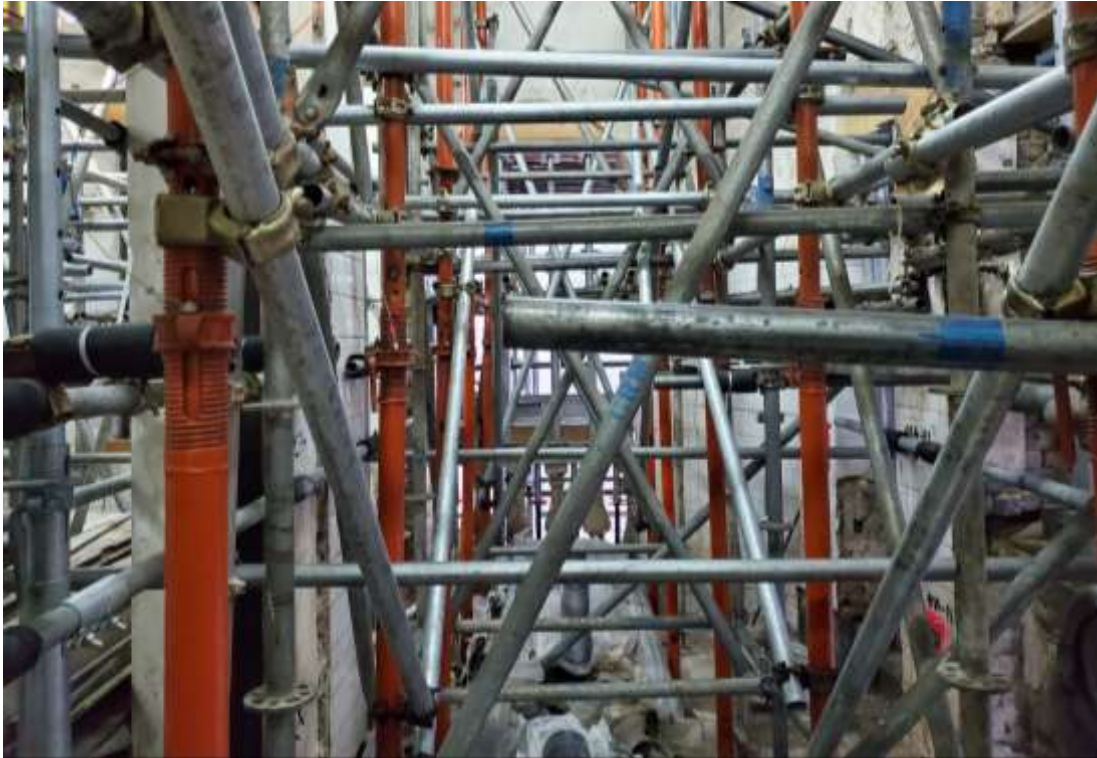
Figure 24 – Presence of densely installed propping (making it harder to undertake follow-on works safely)

30. In the short term, Block 4 has been kept in a stable condition by extensive temporary support (Figure 24; Table 3). The building condition is also monitored daily by detection devices and by the inspection of a care and maintenance contractor. It is however necessary to acknowledge that, according to the expert team, the condition of Block 4 has continued to deteriorate despite careful protection. Hence, the parts of the extant building fabric that are unsafe to retain must be removed as soon as practicable before the ongoing dilapidation further weakens the building fabric, making it more hazardous to handle. A removal work schedule is thus proposed in that the preparation for the removal works will start in June 2023, with physical removal works starting in the non-typhoon season in November 2023. **To enable this, a Section 6 permit application will be made in early 2023 for approval.**
