與保護歷史建築物有關的發展項目／個案
(截至二零二二年十一月十五日的進展)

LATEST TECHNICAL APPRAISAL FOR BLOCK 4 THE CENTRAL POLICE STATION COMPOUND

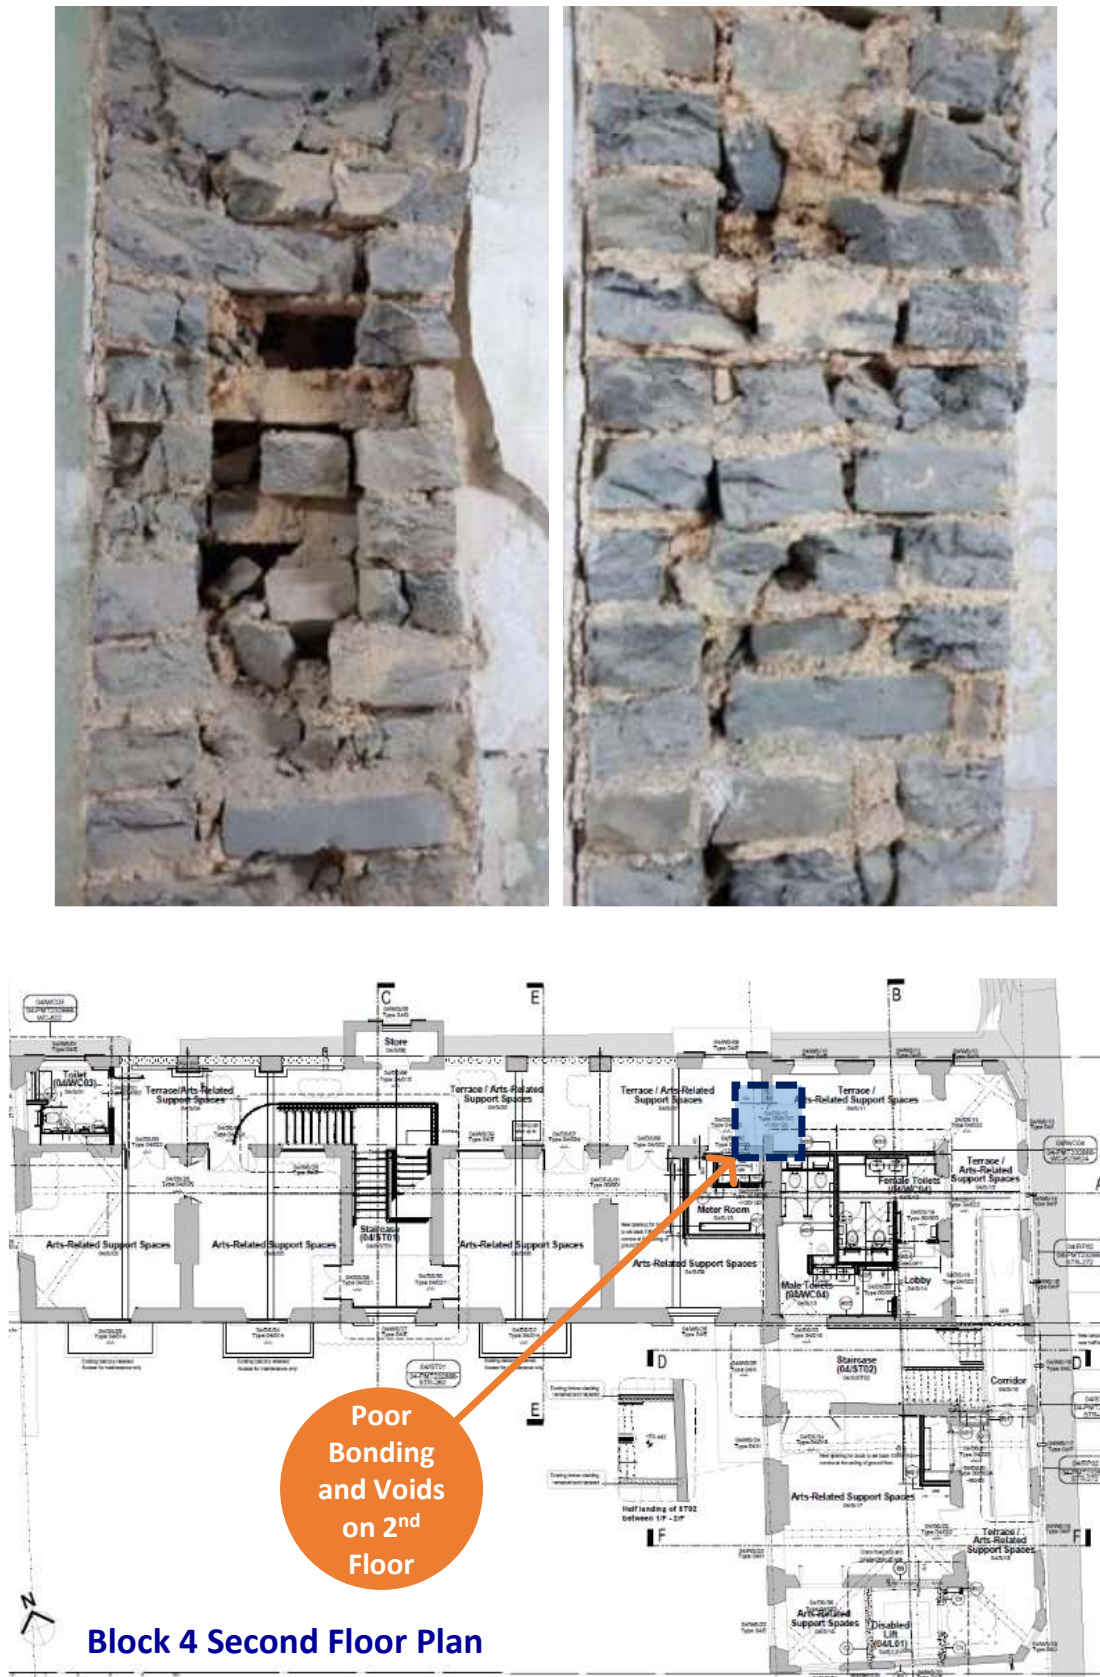
Figure 5 – Views of brickwork showing poor bonding and voids in the centre of the walls whilst cutting new door openings;
Second floor plan indicating location of walls with poor bonding and voids

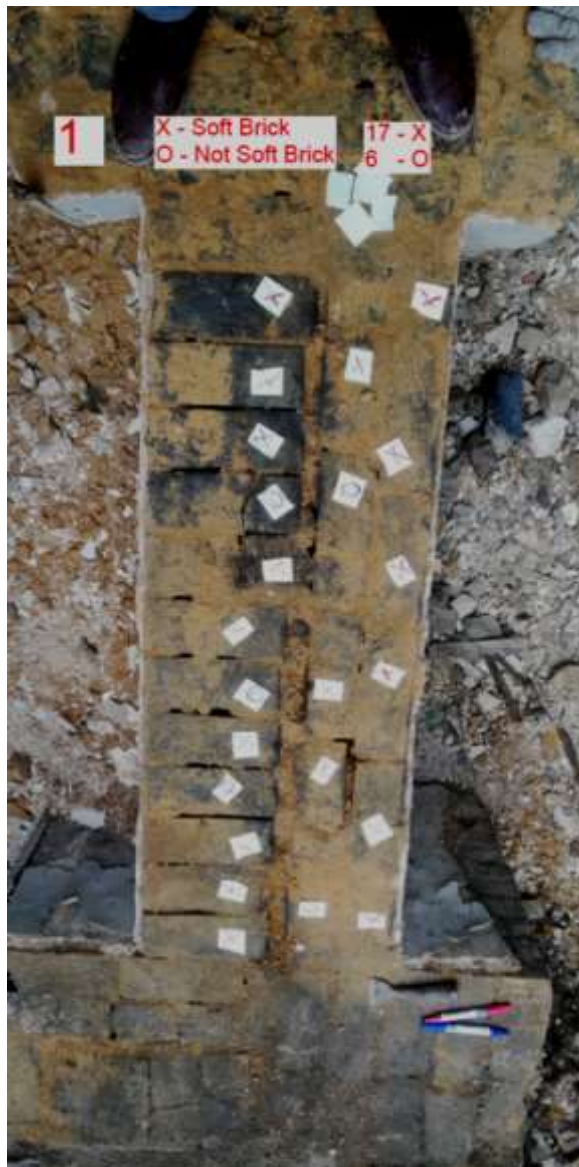
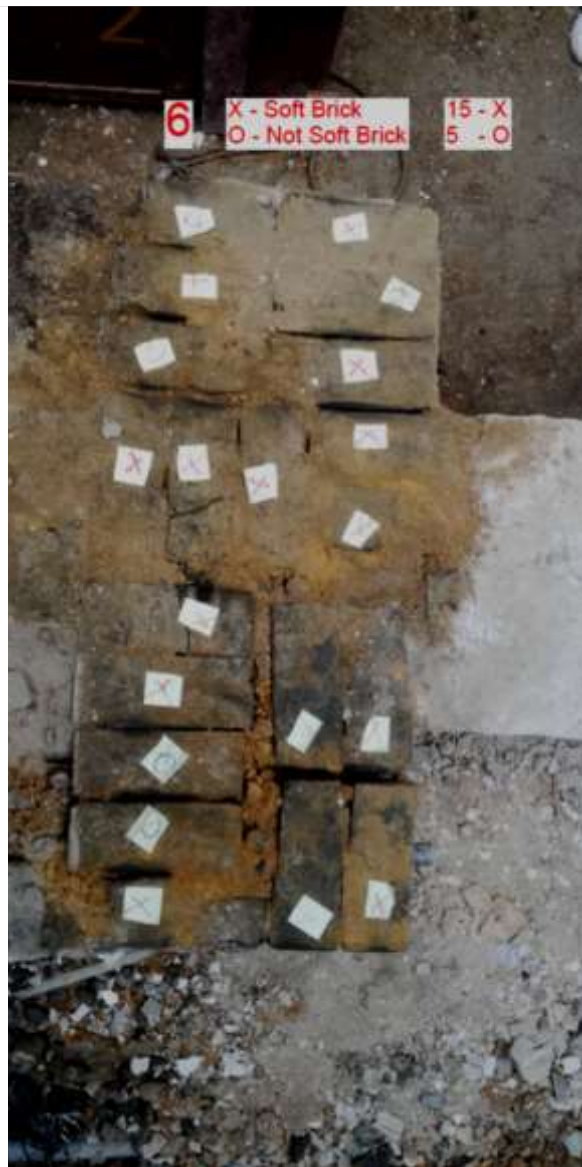
Figure 11 – (a) Approximately 75% of the bricks in random locations were considered soft (“X” Soft brick; “O” Not soft brick)

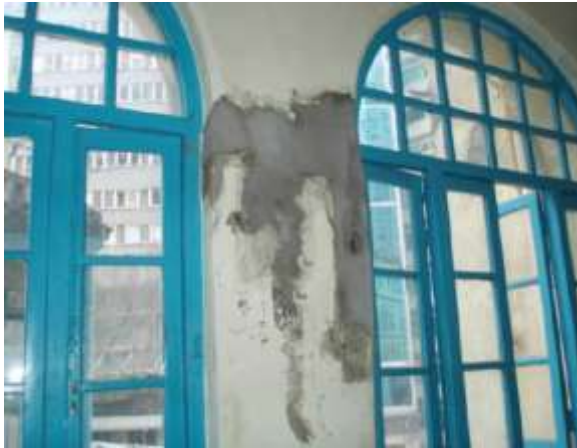
Defect No **DB-19**, Photo Ref. **P4163120**

Figure 13 – 2009 structural survey identified cracked piers in the north façade which would require further investigation and structural repair;
Ground floor plan indicating location of cracked piers

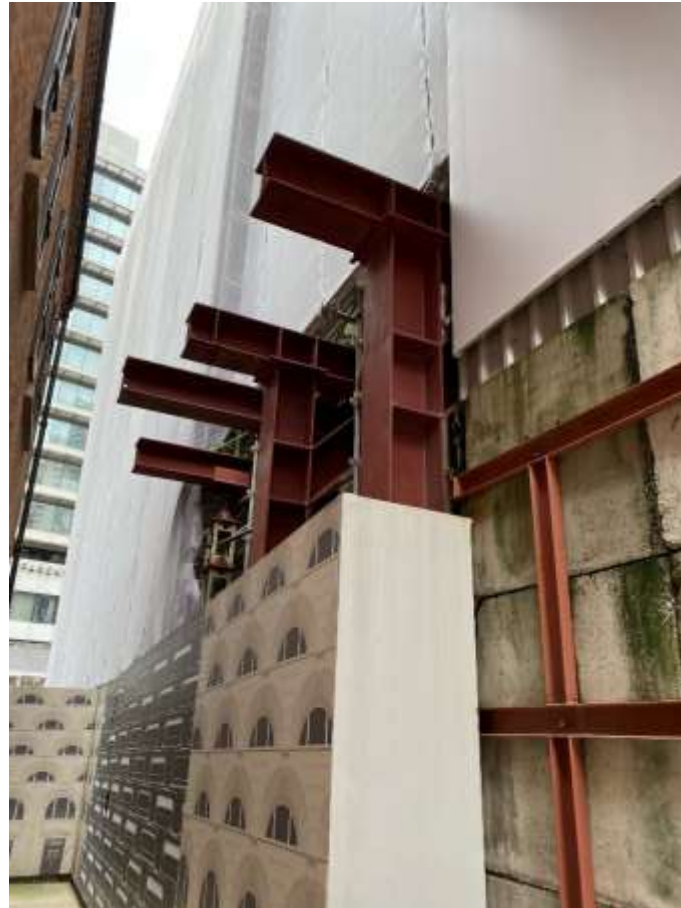
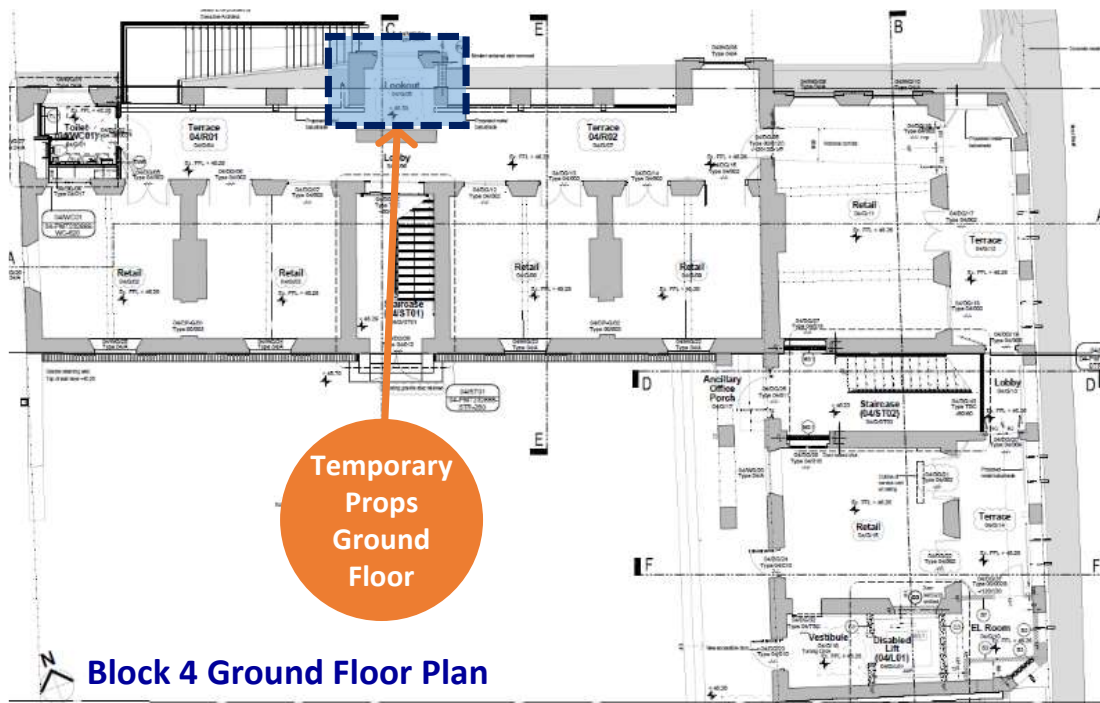
Figure 16 – Temporary props to projecting bay on north facade (needs to be replaced by permanent supports which is a high hazard operation)
Ground floor plan indicating location of temporary props to projecting bay

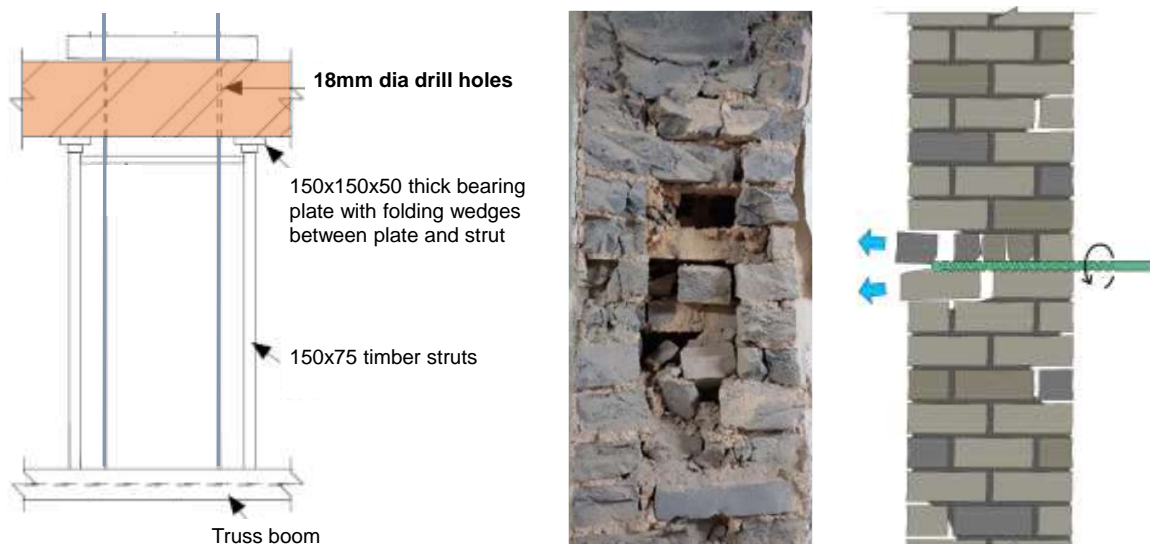
Given the hidden weaknesses within the masonry, the technically feasible design / interventions are now considered particularly ambitious. As recent testing in 2020–21 has reduced confidence in the masonry, the construction will be more hazardous than was the case when the **Updated Recovery Plan** was developed.

Figure 19 – Hole-drilling through masonry facade, several hundred in quantity, is required to restrain the facade to a shoring system; this type of structural interventions are now considered ambitious as recent testing had reduced confidence in the masonry
