## Preservation of Nine Rock Carvings in Hong Kong

### A Consultancy Study of Ancient Rock Carvings

William Meacham Jan. 10, 2010

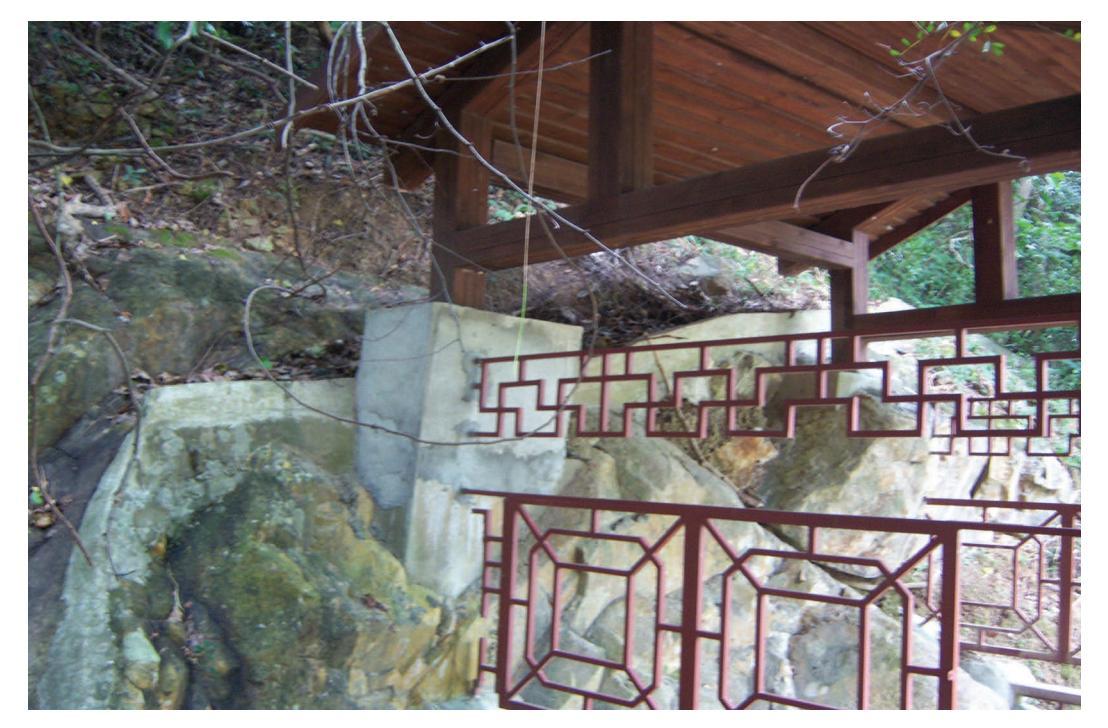
The second potential threat arises from the concrete that has been used to implant the new pavilion type structure, and also added at the back of the rock face as a small dam to divert surface water away from the carvings. In addition to being unsightly and terribly crowding the carving, the presence of concrete in close proximity to the carved

rock poses a threat. According to Australian rock art conservator Andrew Thorne, "concrete contains very destructive salts and while these may be washed away by rain they can become quite aggressive in an enclosed site" and "concrete sitting above the site ... is a potential disaster and perhaps the best way to destroy rock."

All concrete should be removed from the rock outcrop. The roof should be replaced by metal mesh or chainlink fence so as to allow sunlight through to the rock. To control surface water and slope stability, a screen of low bush vegetation should be planted behind rock outcrop.

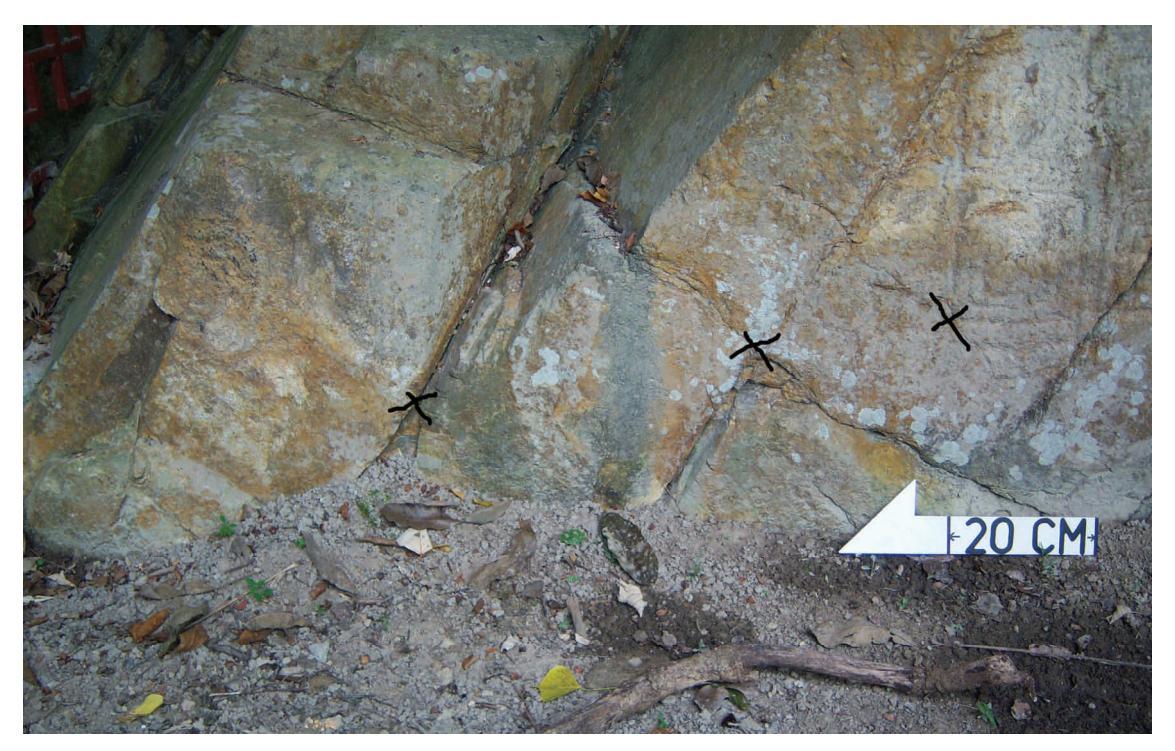
wider so that the visitor can appreciate the whole rock outcrop where the carving was made, not only the small area of the carving itself. Also, one of the patterns is now totally buried in soil, and another one partially. There is about 40 cm of soil covering these two patterns. Compare the points marked with Xs on the photo below taken in

October 2009 with that taken in 1975 on page 26 of my book. This soil should be removed so that all the carved patterns can be seen.

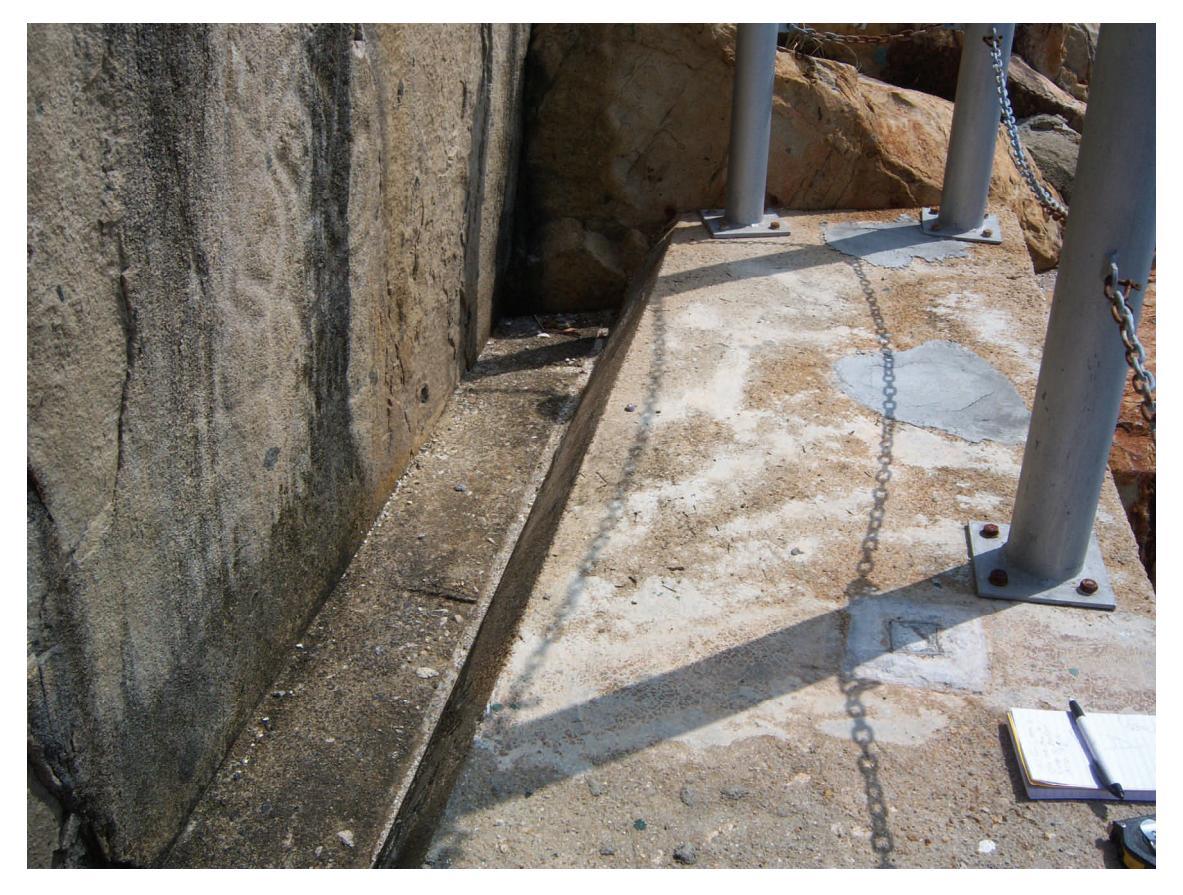
The most objectionable aspect of the current display is the concrete platform that completely obscures the archaeological setting of the carvings. There was a natural rock platform that connected the eastern and western carvings at Po Toi (see the upper photograph on page 33 of my 2009 book), and this platform undoubtedly played a role in the selection of the site and its ceremonial use. This ledge has been buried in concrete. Even worse is the smaller ledge in front of the eastern carvings which could well have served as an altar. Not only does the concrete block completely bury this feature, but it runs into the rock art face itself, just a few centimeters below the carving. This is an archaeological, aesthetic conservation outrage and should never have been allowed.

Worse, it poses a serious hazard to one of Hong Kong's most impressive carvings. The archaeological and natural setting of this site has thus been radically altered, but the original rock is still there, and it can and should be re-instated.

After all the concrete has been removed, hand rails can be installed at the edge of the rock outcrop overlooking the sea, well away from the platform and the carvings but as a safety measure to prevent visitors from falling into the water. See the design suggestions in Part Two of this report.

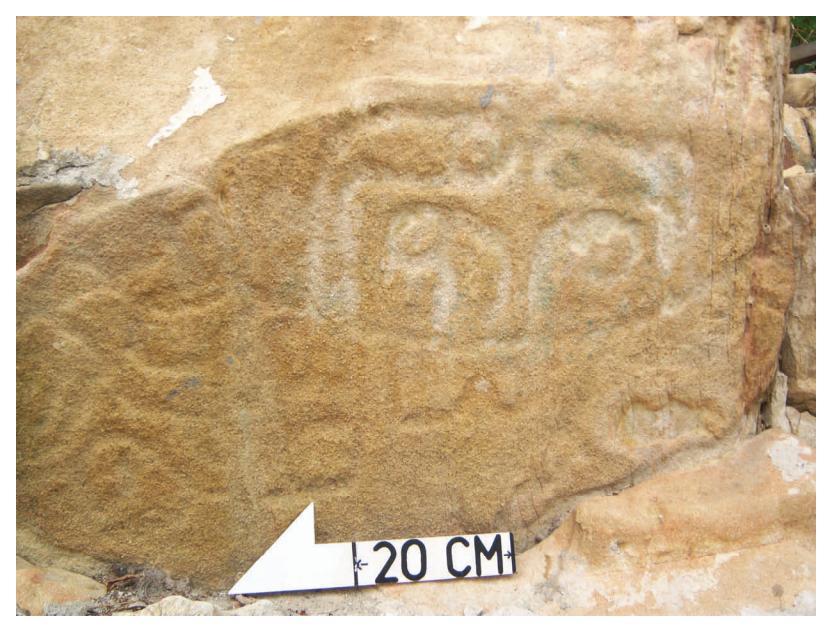
The most striking change in the rock outcrop from the 1970s to today is that a grey accretion of some sort that was present all over the rock outcrop is almost entirely gone: compare the photograph taken in 1975 (on page 52 of my book) with this one taken in October 2009:

The colour of most of the rock has changed from grey to yellowish brown. Inspection of the grey coating that remains today suggests that it is either a man-made sandy slurry, possibly used in construction, or more likely it is a naturally formed and rather thick skin on the rock. Its removal might have taken place during the attempt to remove the painting, or it has gradually worn off over the years. It does not seem to pose any threat to the rock, so no action is needed to remove what remaining.

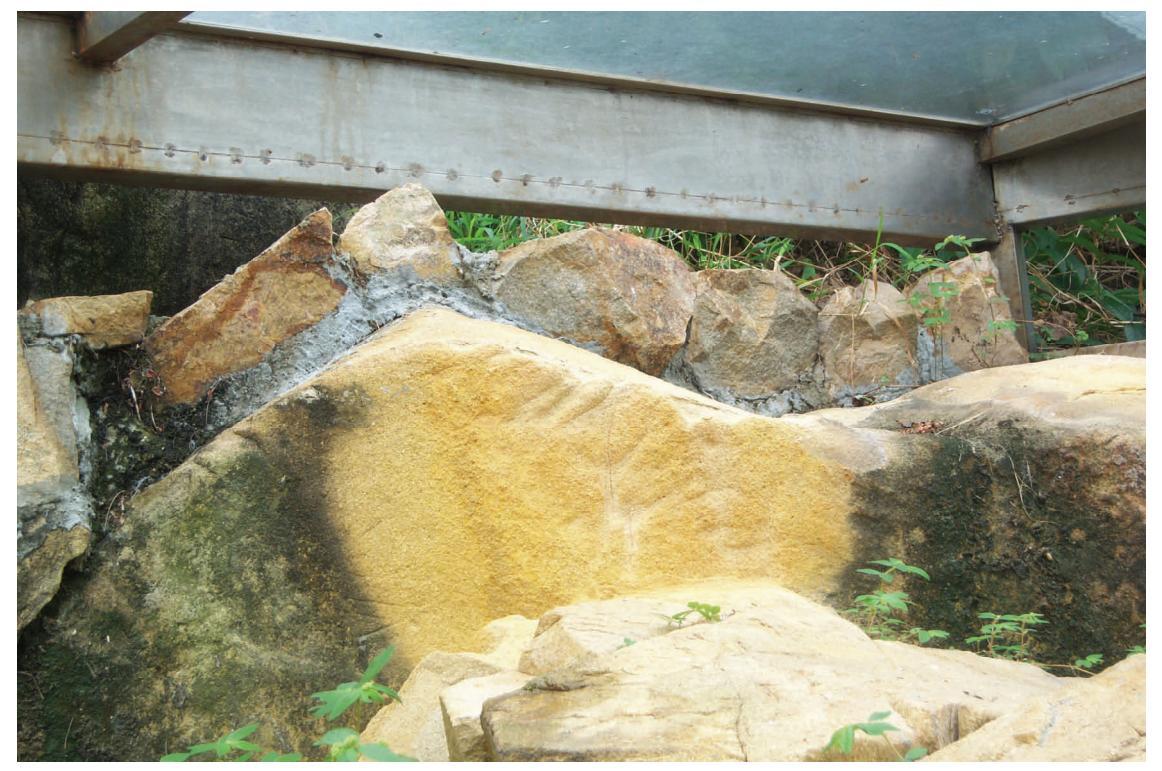
The enclosure however does pose a long-term threat to the rock carvings and it should be modified or replaced altogether. That a microclimate is created inside this enclosure cannot be denied, as wind, sunlight, sea spray and rain are all largely blocked. The disintegration of the grey layer coating the rock could well be due to this altered climate. In the 1970s, this grey layer was hard and fast on the rock; now where it still exists it is loose and easily pulled off. More importantly, just behind the upper rock carving, one large rock face is experiencing extreme degradation (see the photo below), and turning into a silty powder. It is not known what is causing this, it could be water dripping from the roof of the enclosure, wind focused by the openings in the

enclosure, salt crystals expanding and disintegrating the rock structure, or other processes. The phenomenon should be investigated immediately by a competent geologist. Should the focus of this degradative process shift onto the face with carving, the result would be disastrous. The condition of the rock outcrop cannot be said to be "stable."

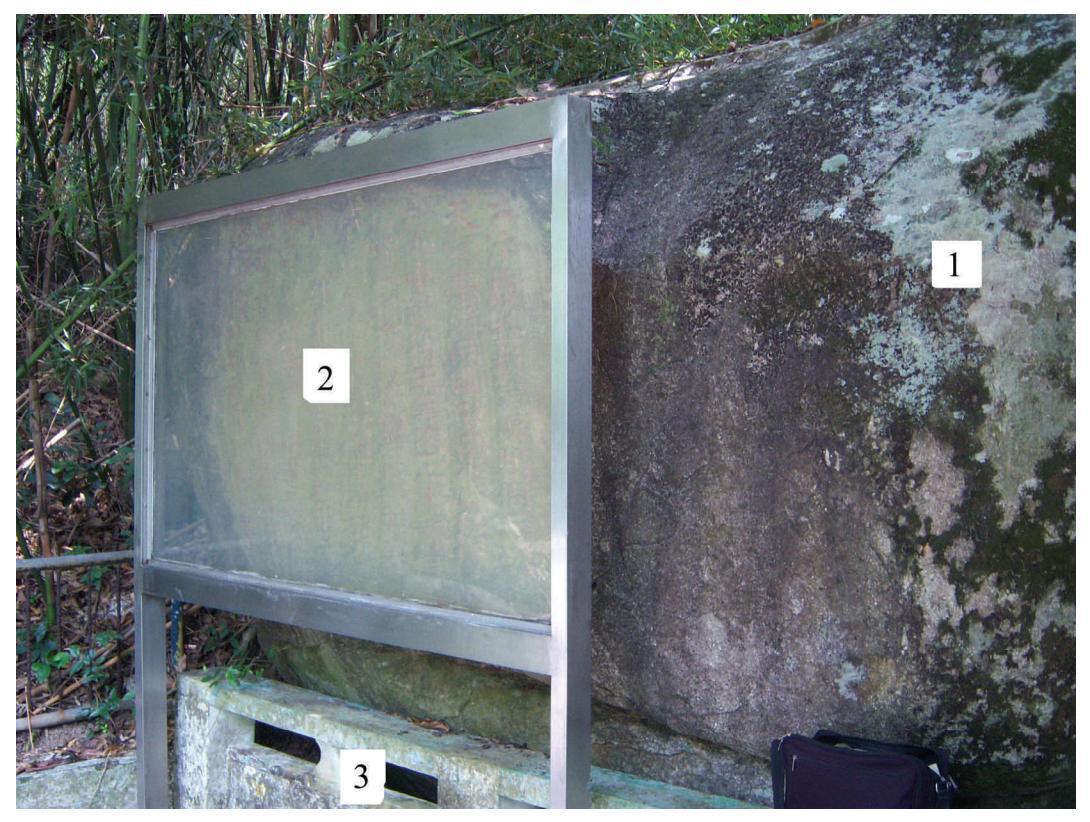
The Perspex is cloudy and dirty on the inside and out, and thus prevents the viewer from obtaining a clear and unobstructed view and appreciation of the inscription. It should be replaced with a glass window set in a stainless steel frame covering also the four edges to prevent any touching of the inscription. The structure should be set even further away (40 cm) from the inscription to give a better view, and regular cleaning of the glass should be done.

- 1. Multiple growths of different kinds and colours!
- 2. Cloudy screen detracts from view.
- 3. Messy railing needs painting, or better complete removal.

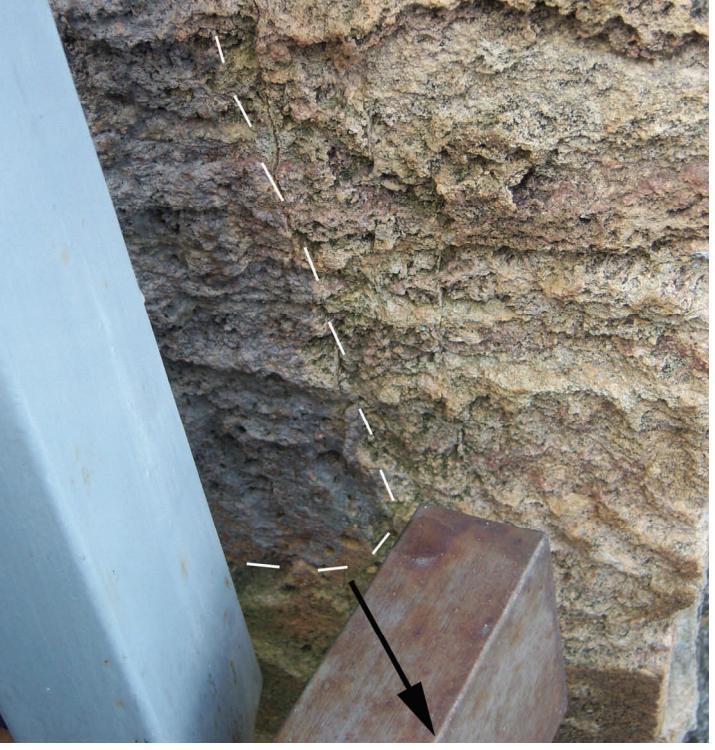
While silane-based water proofing might allow water vapour to escape, both it and especially the consolidant would block liquid water from escaping. With a rock as porous as that at Lung Ha Wan, it is unavoidable that some water would seep through pores where consolidant has not completely closed them, or enter from above the consolidated zone, but then become trapped behind the surface where consolidant and water-proofing does effectively seal off the exit. See the further discussion of silane

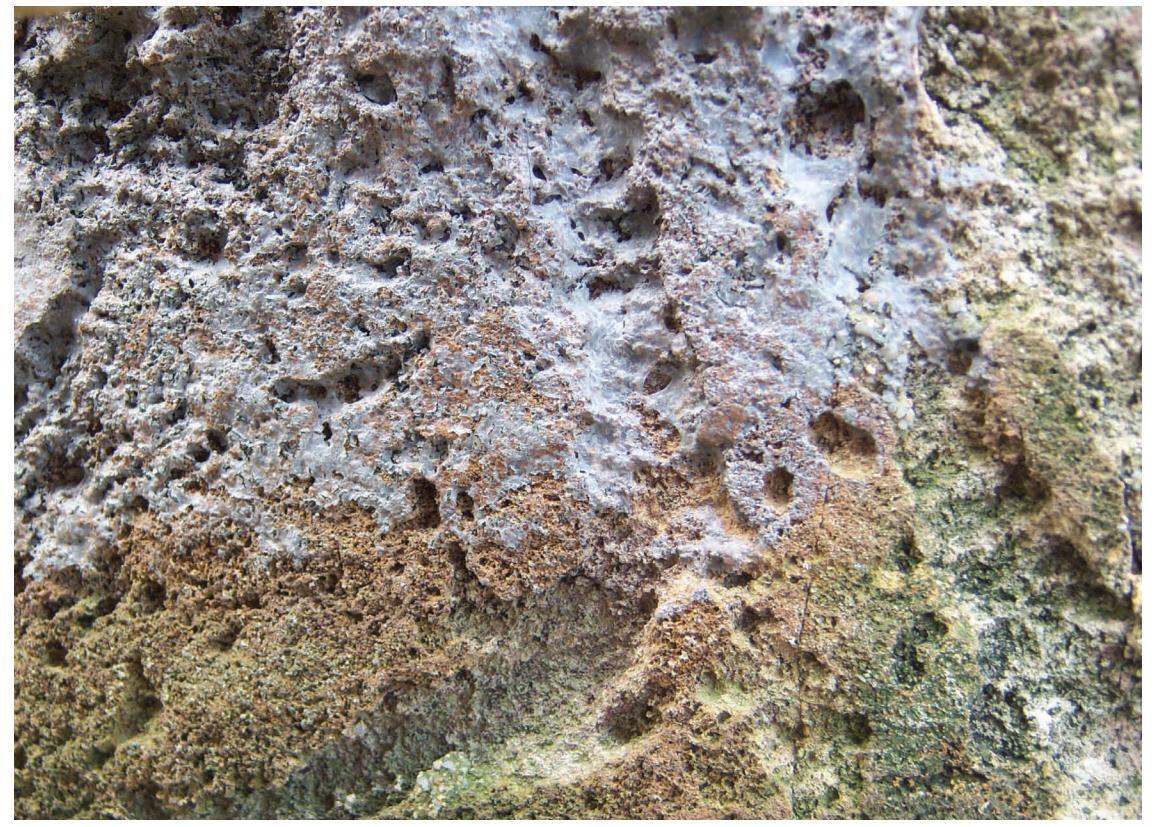
The Perspex screen further exacerbates the situation by partially blocking sunlight, wind and sea spray. The evidence of a microclimate behind the screen is especially dramatic and undeniable at this site. The consolidant residing on the surface is visible as a creamy light brown paper-thin layer (seen in the photos). Although the consolidant was applied to the entire rock face with "carving" it now survives as a surface coating only behind the screen and has weathered away around the outer part of the rock face. Clearly the screen has enabled the consolidant

layer to remain by reducing the natural elements that have gotten rid of it where unshielded by the screen.

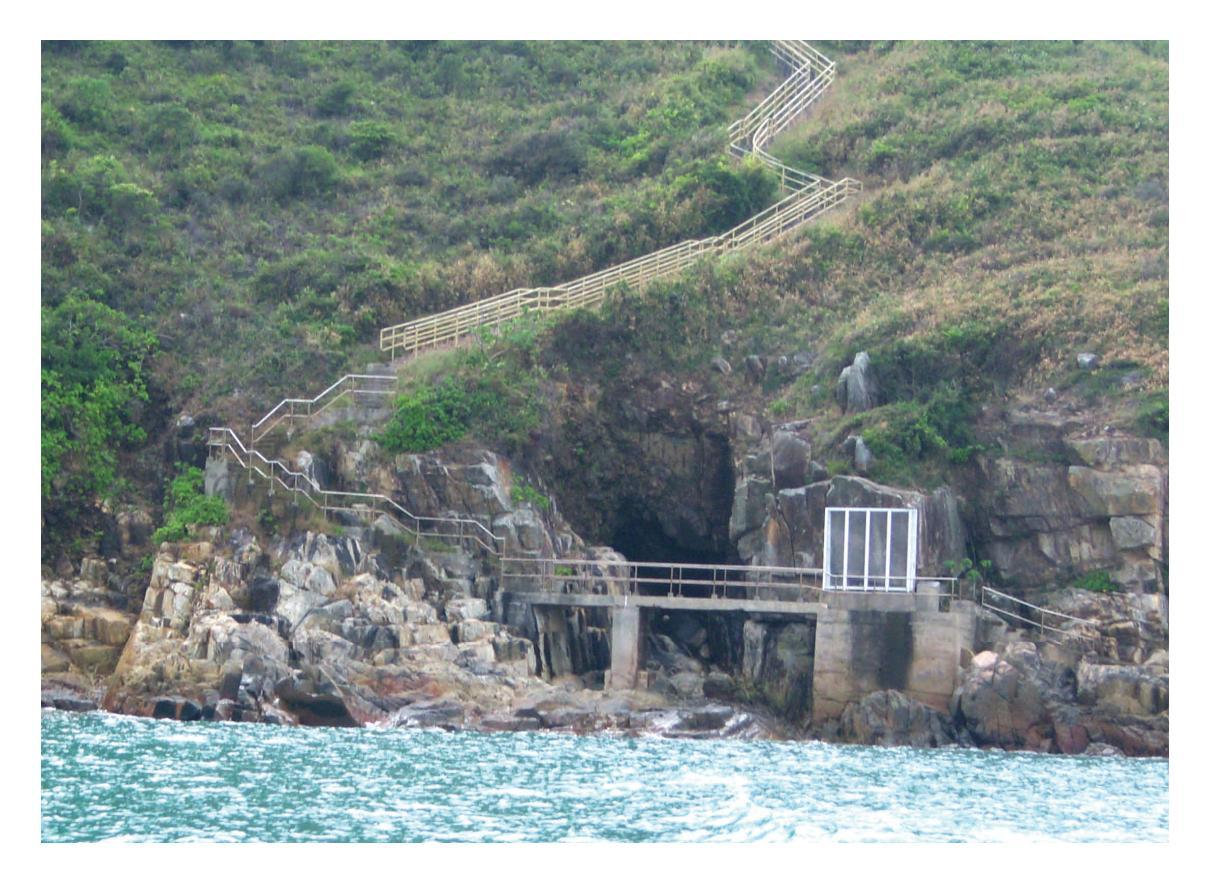
A geologist and former senior civil servant visited the site in November 2009 and remarked to me that it was "hideous: cloudy case, no good photo angle, cement all over the site, long slog down the hill and back up again." I also heard similar comments from visitors when I was at the site in the summer. Two teenaged hikers remarked that there was "nothing to see" and a lady said "maybe the pattern had been washed away by acid rain." This carving is the most impressive of all Hong Kong petroglyphs, and to hear such reaction from visitors is highly regrettable. To truly appreciate this magnificent carving, one needs to view it from at least 3 or 4 metres away. Clearly significant improvements are needed, and redesigning the site without concrete and Perspex case as suggested above will go a long way to make the site as impressive as it should be for the ordinary person. The enclosure would have to include the lower flat boulder immediately in front of the rock art face (since it is rather small), and part of the sloping boulder leading up to it. An elevated steel walkway can replace the present concrete viewing platform, as suggested in the drawing and altered photograph in Part Two, allowing the visitors to appreciate the unique setting of this monument. A much improved plaque along the lines suggested in section IV.4 is also needed.

An alternate footpath from the pier along the coast at a low elevation is absolutely necessary, so that visitors are not faced with a harrowing climb back up the very steep

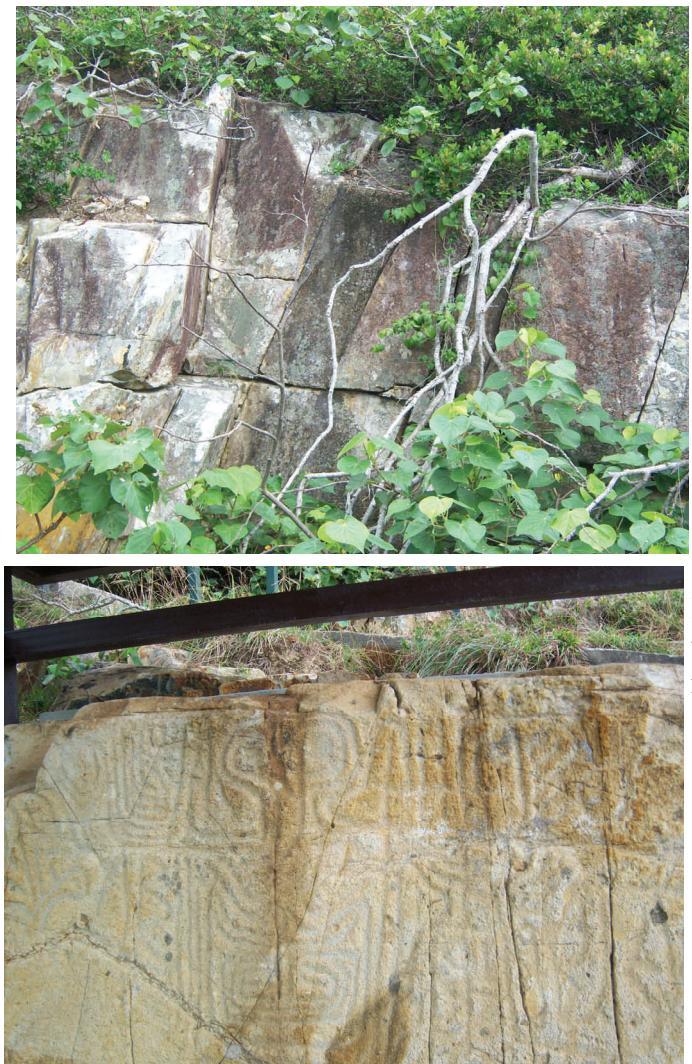
Although the structure does allow nearly full access to wind and sea spray, the roof reduces the rain and sunshine on the rock, again creating a microclimate underneath. While not as serious as the Perspex cases, it still may have a long-term possibly negative impact. There has been a dramatic change in the colour of the rock since the 1970s. Photographs taken at the time (see pages 46 and 47 of my book) show the rock with carving to be the same colour as all the surrounding rocks, namely grey-black. Now the rock with carving is a light, yellowish brown, in sharp contrast to the surrounding rocks which remain the same as in the 1970s. A similar colour change has occurred

Above — Adjacent rocks remain the same grey colour as they were in the 1970s. Below — The rock inside the enclosure has changed to a yellowish brown. at Cheung Chau as noted above. The information disk does not record any serious chemical or mechanical cleaning at either site, but it does note that the Big Wave Bay carving was encased in a steel cage with glass from 1983 to 1995. The microclimate created inside the glass would have been more pronounced, and combined with the continued reduction of sunlight and rain since 1995, it may have caused the loss of the grey-black skin colour of the rock. The serious implication of this is that the microclimate is acting on the surface of the rock, and in the longer term could reduce the relief of the carving itself. The statement on the information disk that "the overall condition of the rock carving is stable" is thus incorrect.

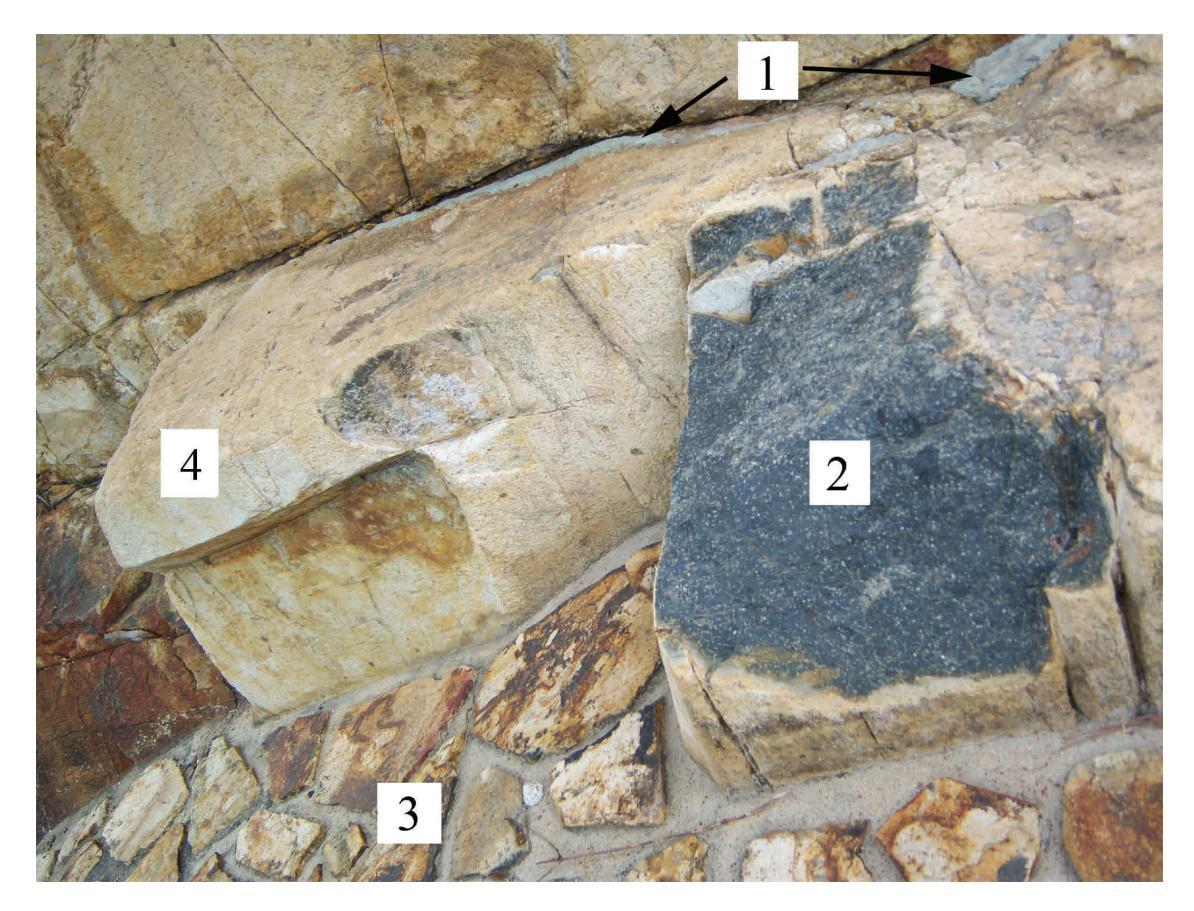
As in the case of Po Toi and Tung Lung, the archaeological site and context of this rock carving has not been preserved. The natural platform in front of the rock has been buried in concrete, the smaller ledge directly beneath the carving has had a concrete and rubble stone slab attached to it. Concrete dabs are also at the base of the carving and on each side, apparently from previous construction. And part of a large rock forming the smaller ledge has broken off, probably also during construction activities. All of these aspects reflect very poorly on the "preservation and conservation practice," indicating a total lack of proper controls.

- 1. Dabs of concrete on the rock just below the carving
- 2. Large break that has occurred after 1975
- 3. Intrusive concrete and stone rubble slab
- 4. Position of left hand in lower photo, page 47 of my book

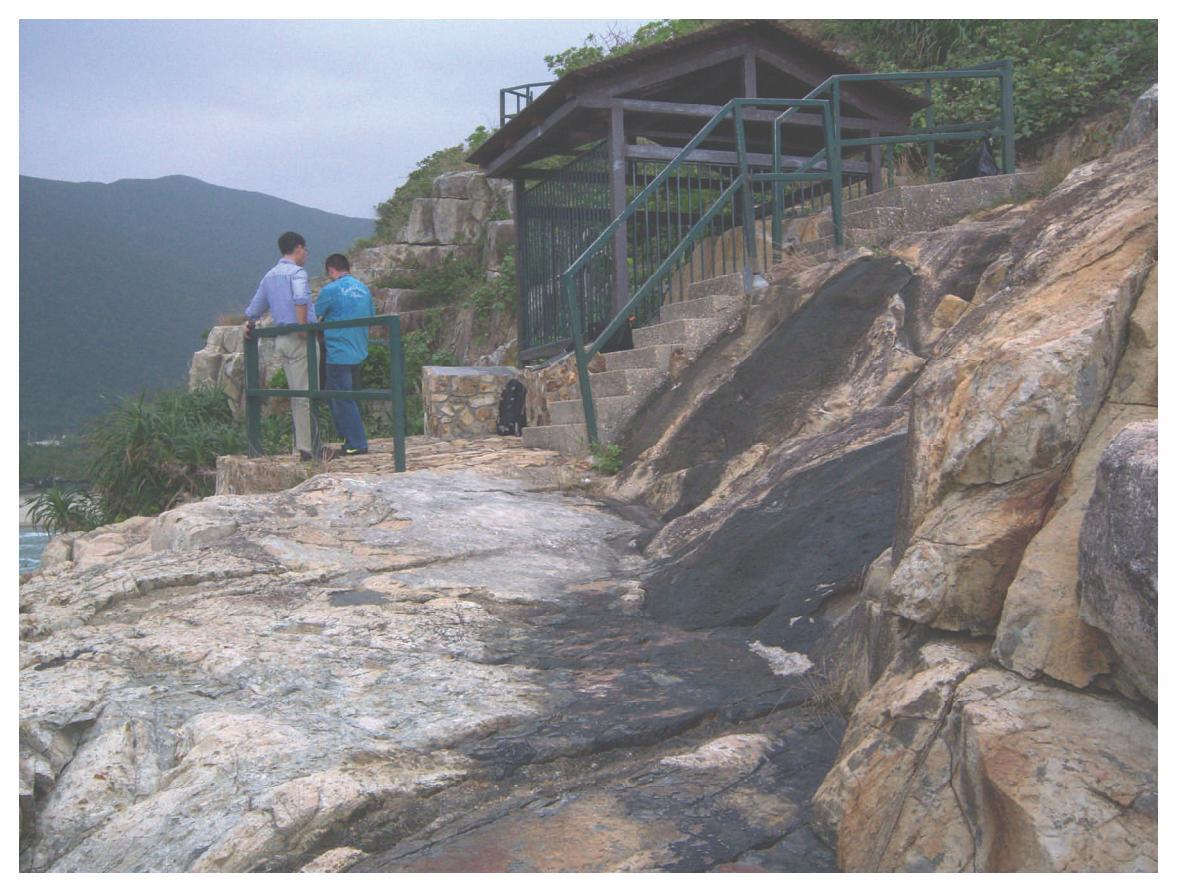
Natural ramp leading to the (very cluttered) rock art site. Visitors should use this approach, and all man-made construction should be removed.

All of the present construction on the site within 10 m of the carving should be removed, including the concrete footpath and steps. The path should be diverted onto the rocks and around to the very prominent natural ramp leading up to the carving, at which point it should stop. A handrail at the edge of the rocks would prevent visitors

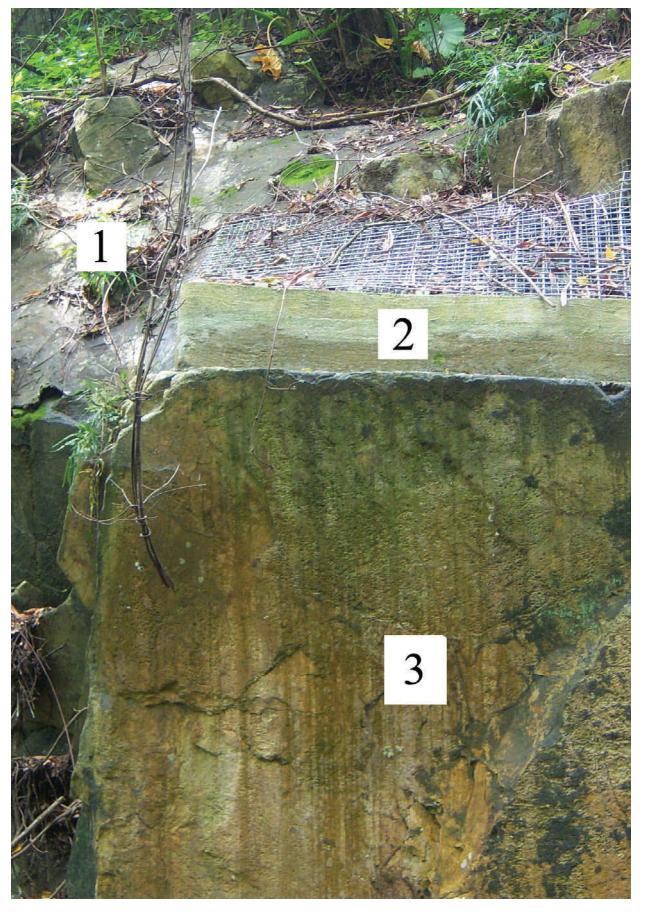
There is also a steep slope directly above the carvings, with ruins of squatter huts and an old chunam that covers the slope down to the edge of the rock face. Surface water run-off is thus directed right onto the rock art and creates the potential for damaging biological growths. The concrete dam recently installed above the rock face is ineffectual, as illustrated by the drip lines below it, and it may cause pooling during heavy rain.

- 1. Chunam covering the slope
- 2. Concrete dam
- 3. Drip lines below dam
