Proposed Recovery Work for Block 4 at

The Central Police Station Compound

PURPOSE OF PAPER

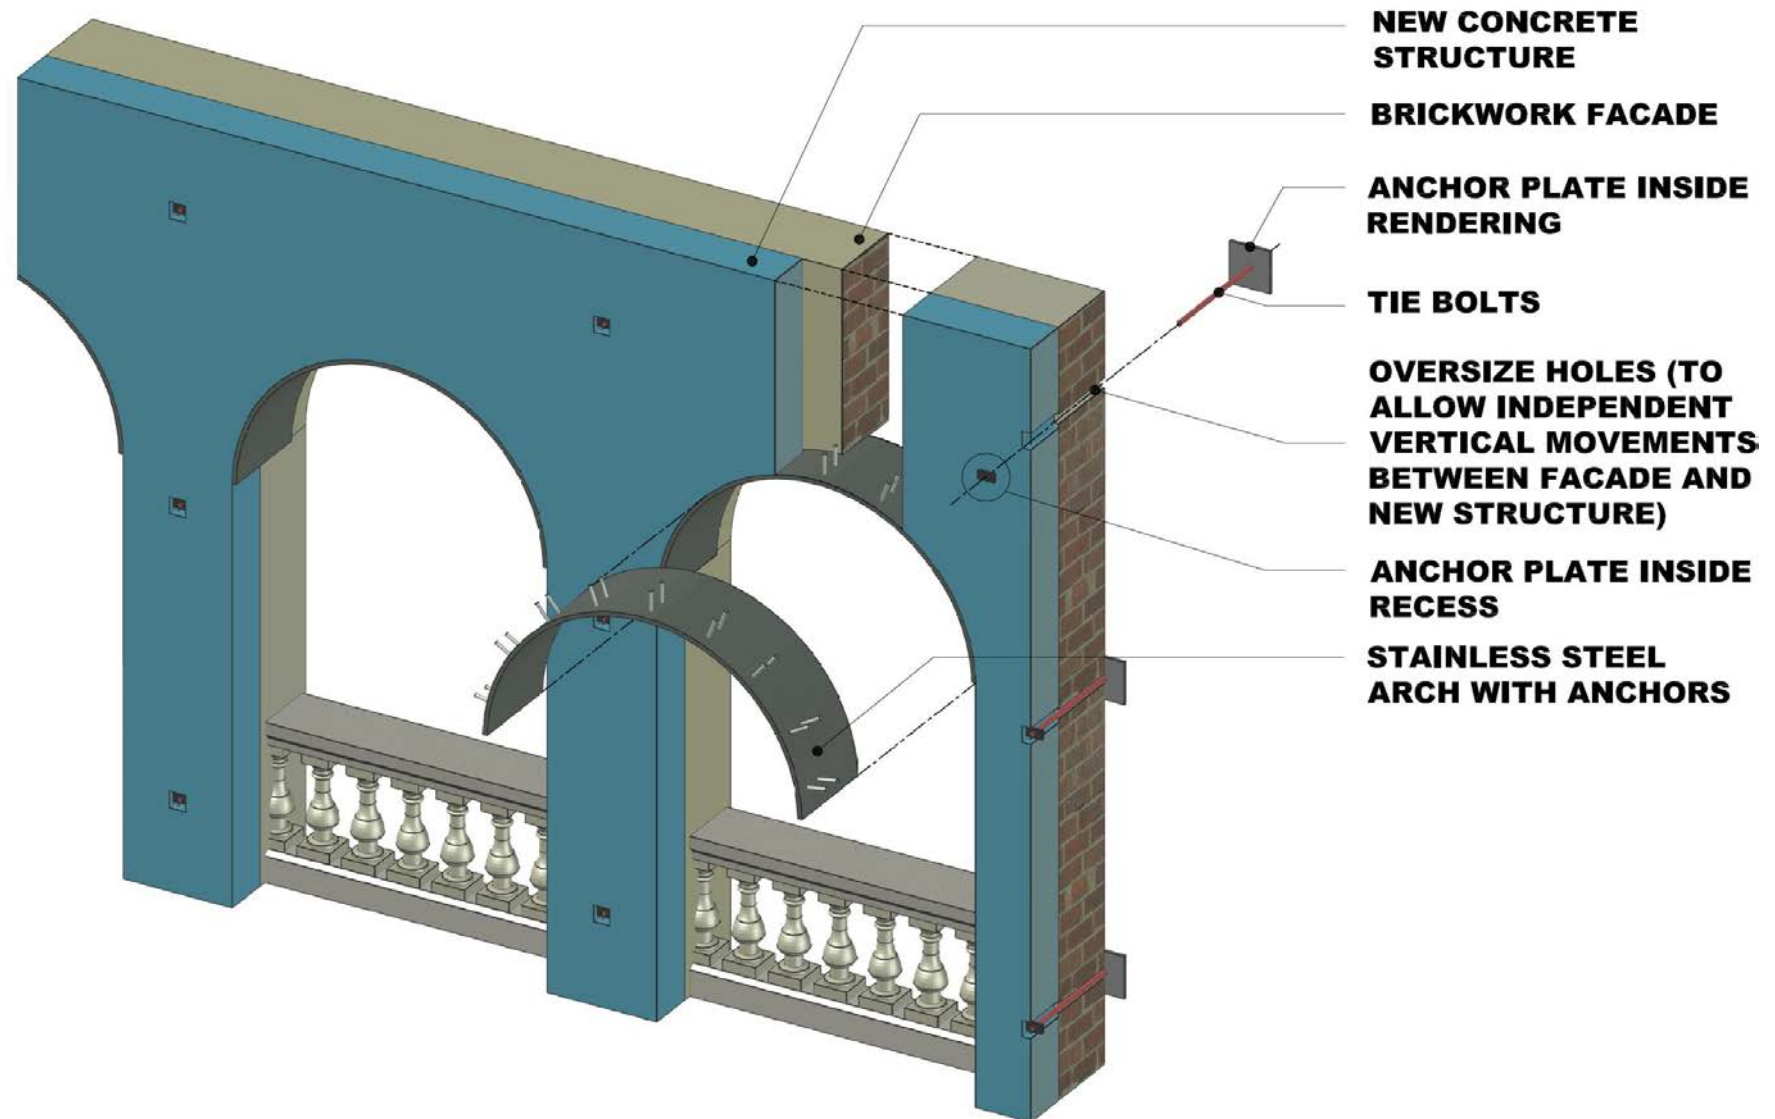
Structural frame: In order to safely recover Block 4, priority must be given to retaining the exterior walls of the extant part as they are the façade of the building. The prerequisite to strengthening the exterior walls is to create a structural frame inside the building, thus taking the load away from the external walls (Refer to Appendix II for plan and sections). The existing brick walls cannot be relied upon for strengthening because they, too, are very weak and supported with props. Reinforced concrete frame was selected as the optimal solution as it is easier to adapt to the uneven profile of the building and offers the best protection with the lowest risk. The new concrete frame will comprise new concrete floors, columns and walls. The concrete walls will also act as stiff shear walls to reduce wind loads transferred to the weak brickwork.² The concrete frame will be tied to the external brick walls with stainless steel bolts. Vertical sliding joints will be added between the concrete frame and the brickwork to take away vertical loads from the brickwork. In addition, brick arches will be supported by stainless steel arches underneath, which can prevent the bricks from falling and thereby enable it to function (Refer to Appendix III).

TIE BOLTS AND STEEL ARCH TO SUPPORT BRICKWORK FACADE

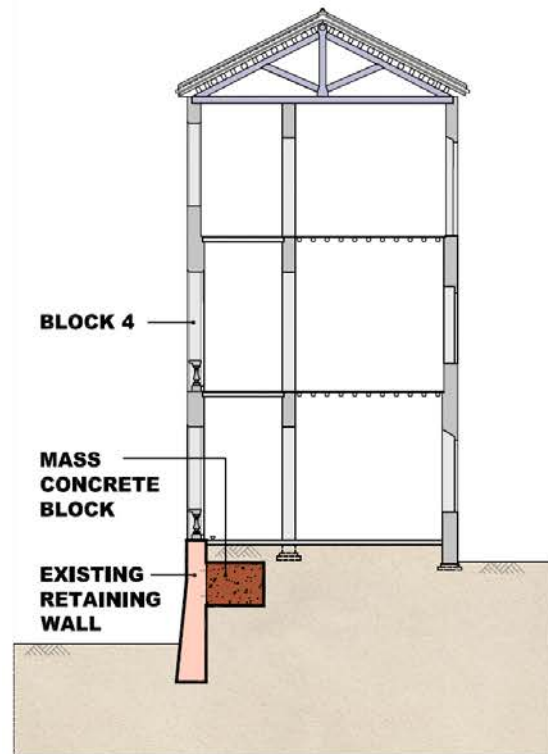
Retaining wall: Block 4 as a whole will bear new weight after adding the new strengthening materials mentioned above. It is therefore important to ensure that the weight will not create undue load to the granite retaining wall adjacent to Arbuthnot Road, on which Block 4 is sitting. In this respect, a number of possible approaches were explored, including the use of soil nails and building a supplementary retaining wall. It was concluded that the least disruptive solution was to install a cast mass concrete behind the existing retaining walls. This will help stabilise the retaining wall, another important heritage feature of the CPS Compound, without any visual impact on it.

RETAINING WALL STABILIZATION

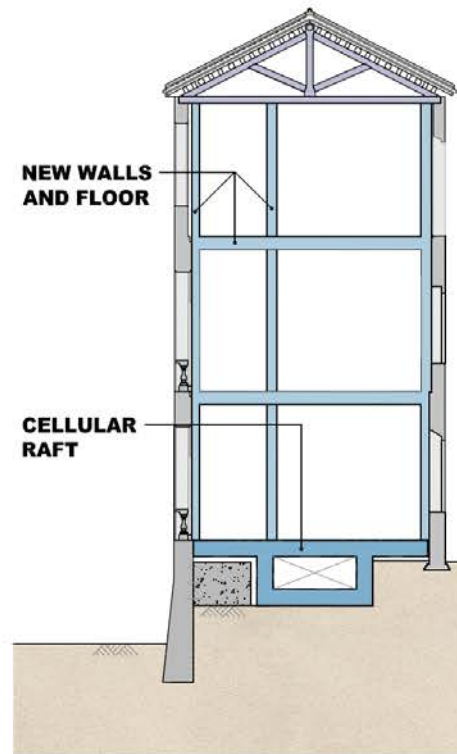
Foundation: On building a new foundation for the extant part of Block 4, a number of methods were considered. These included pile foundation and construction of a shallow raft, a deep raft, or a cellular raft. It was concluded that a cellular raft system was the only viable option as it could even out the load across the footprint of the building and sit well with the

cast mass concrete behind the retaining wall. Furthermore, the system can provide a uniform load platform for the whole building because the new annex will also be built on a cellular raft foundation. This method will also require removing the existing interior walls and floors during work and reinstating them after the construction of the foundation system (Refer to Appendix IV).

NEW CELLULAR RAFT FOUNDATION
