AGREEMENT NO. CE 20/2020 (CE) - SITE FORMATION AND INFRASTRUCTURE WORKS FOR PUBLIC HOUSING DEVELOPMENTS AT MA ON SHAN TSUEN ROAD – INVESTIGATION, DESIGN AND CONSTRUCTION

Heritage Impact Assessment Report (Final – Issue3)

PROJECT NO.: 2512216A

DATE: JUNE 2023

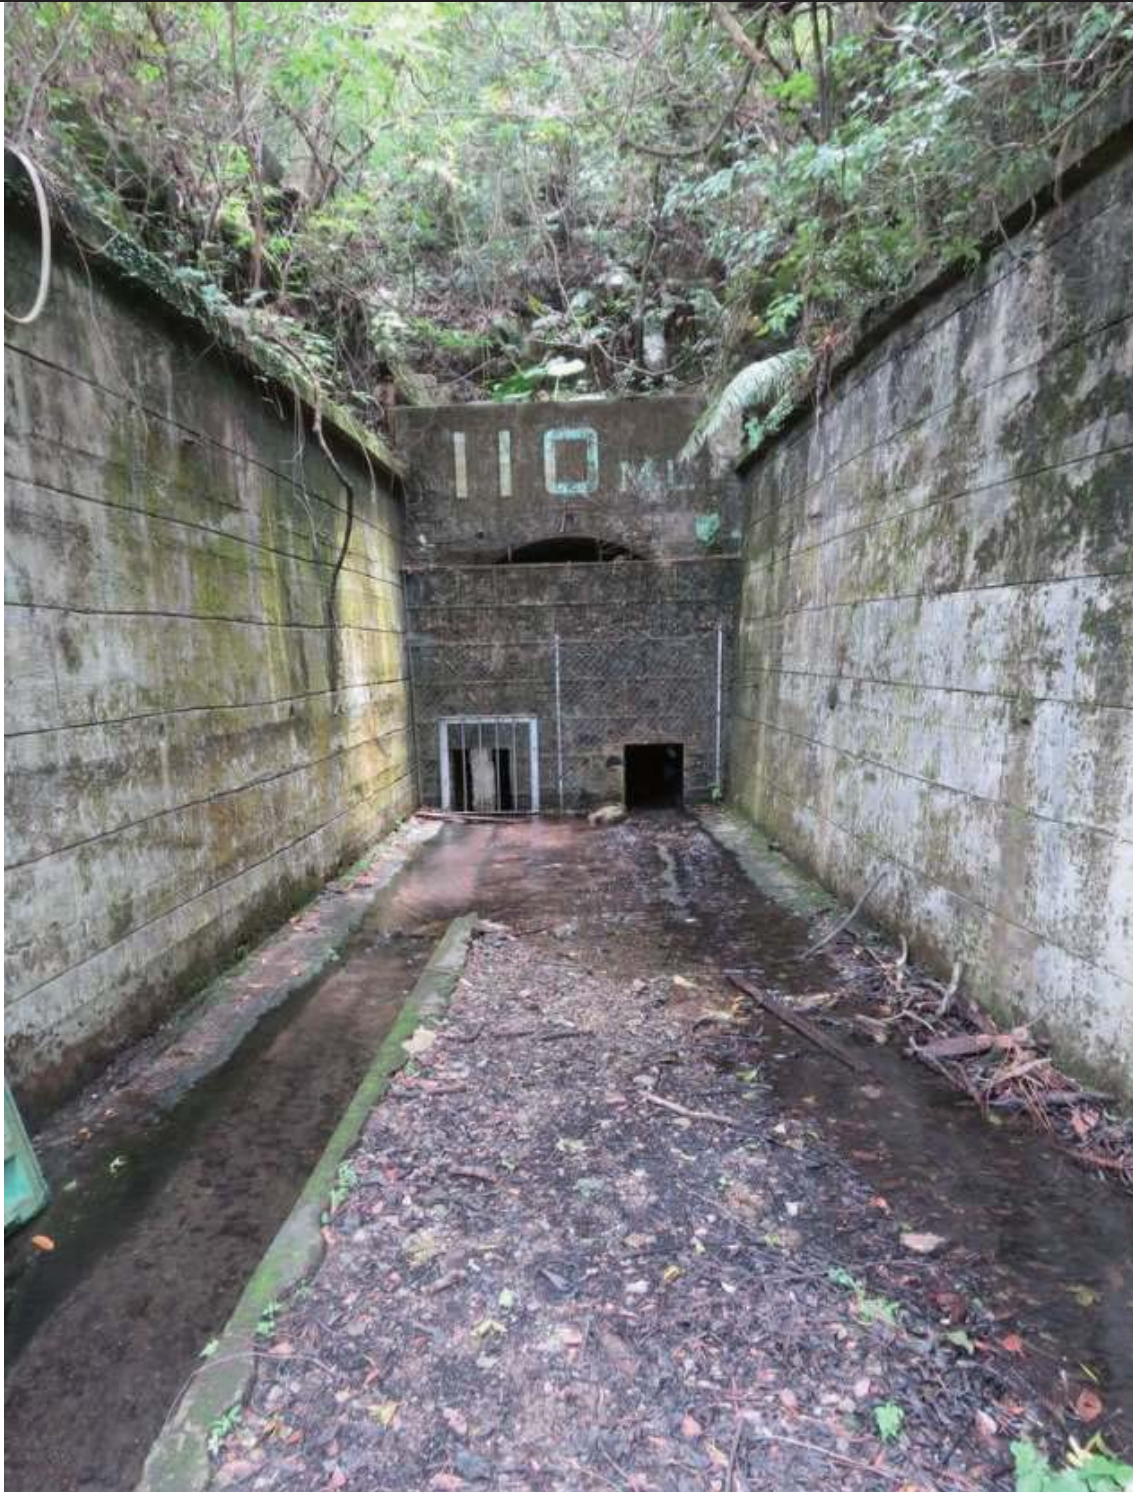
GB-02-1 portal close-up view

Interior: Walls, ceiling and ground intact; window glasses battered; wooden door damaged		
Existing Condition: Abandoned and some minor damage.		
Past and Present Uses: Industrial and now abandoned		
Modifications: Not observed.		
Photos:

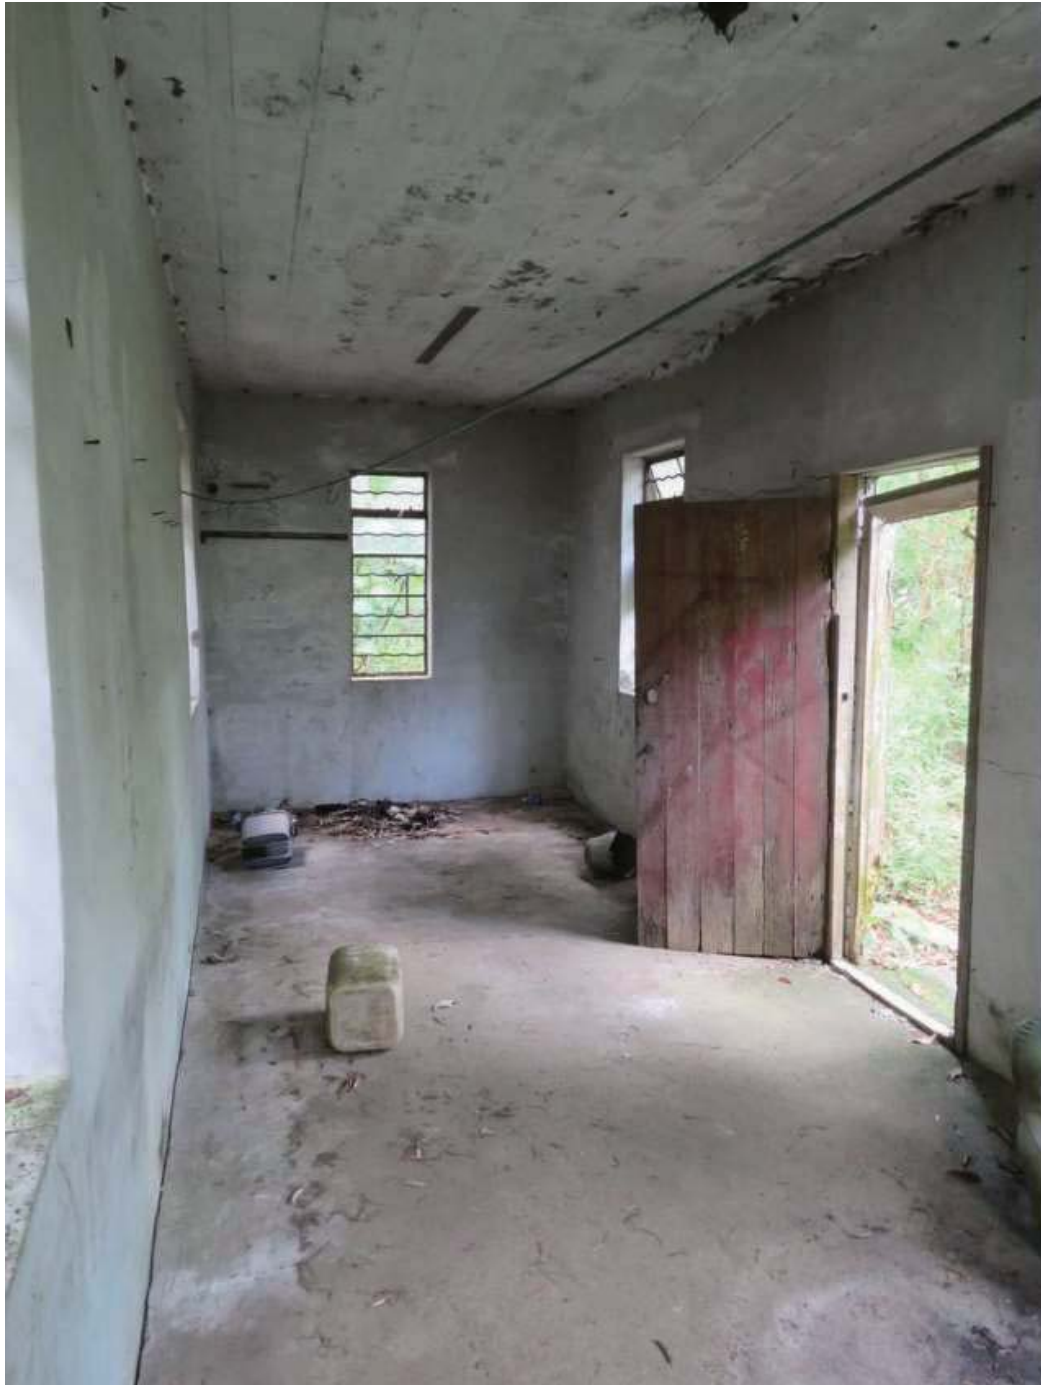
GB-02-2 internal view
Office building next to 110ML portal

Interior: Walls and ground intact; ceiling and doors collapsed and window glasses battered.		
Existing Condition: Abandoned and partially damaged.		
Past and Present Uses: Industrial, now abandoned		
Modifications: N/A		
Photos:

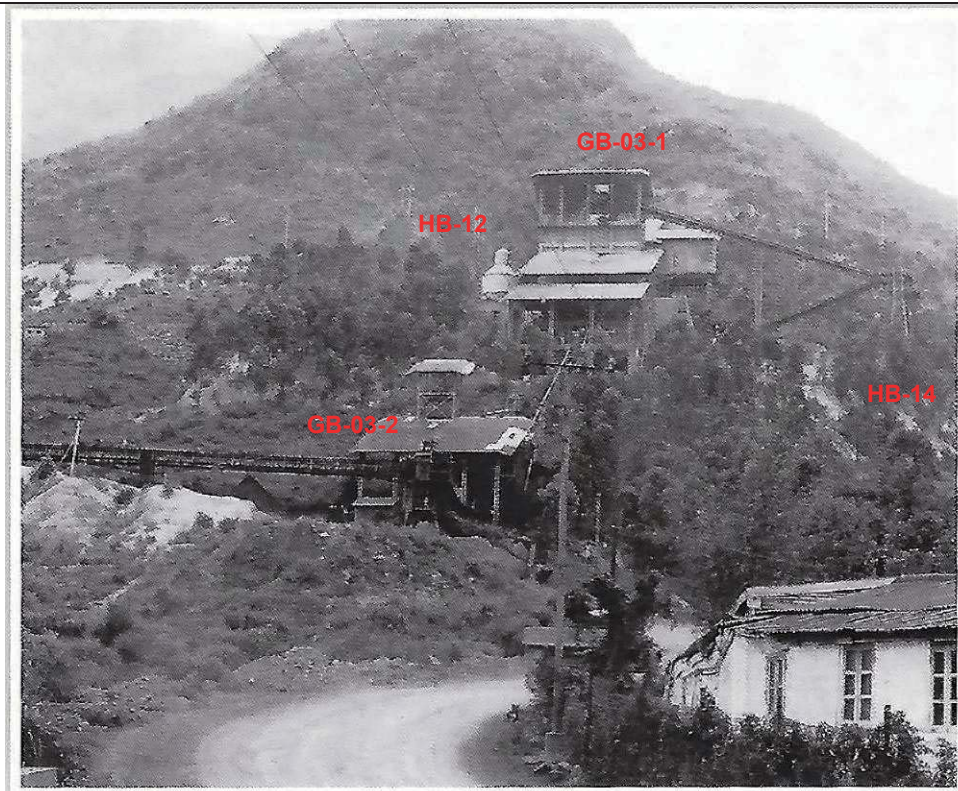
Existing Condition: Abandoned and overgrown by vegetation; could pose danger to hikers as thick vegetation covers openings on ground level.

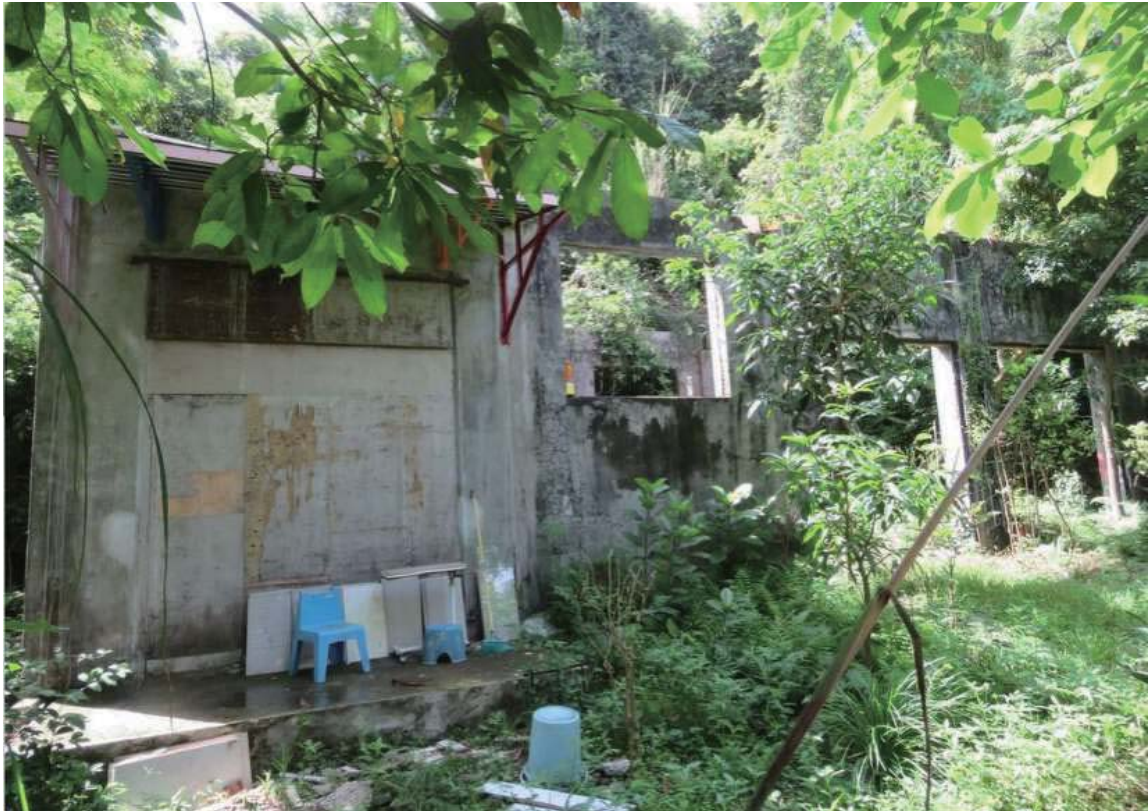
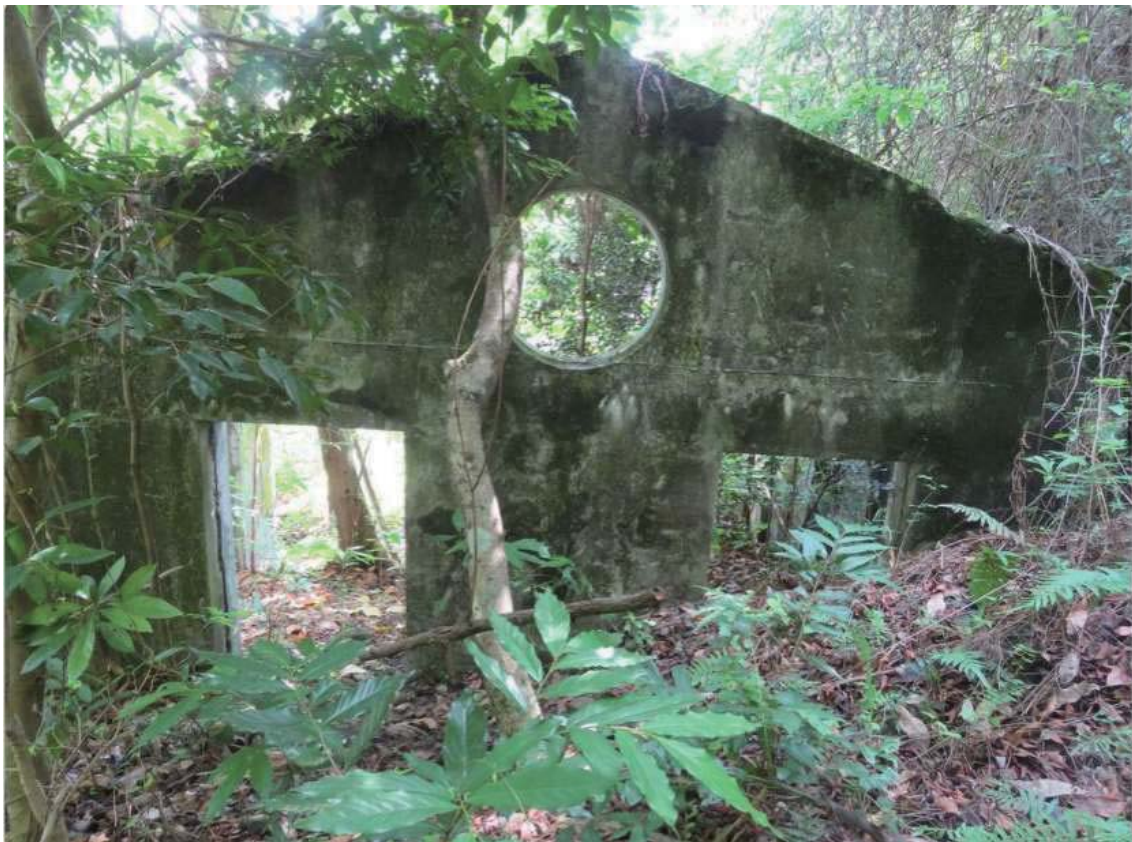
GB-03-3 general views

Interior: ground partially intact, partially invaded by vegetation;		
Existing Condition: Abandoned and overgrown with vegetation; storage contents include disposed deity idols, flowerpots and other living supplies, suggesting a lateral occupation.		
Past and Present Uses: Industrial		
Modifications: ceiling, windows and doors removed		
Photos:

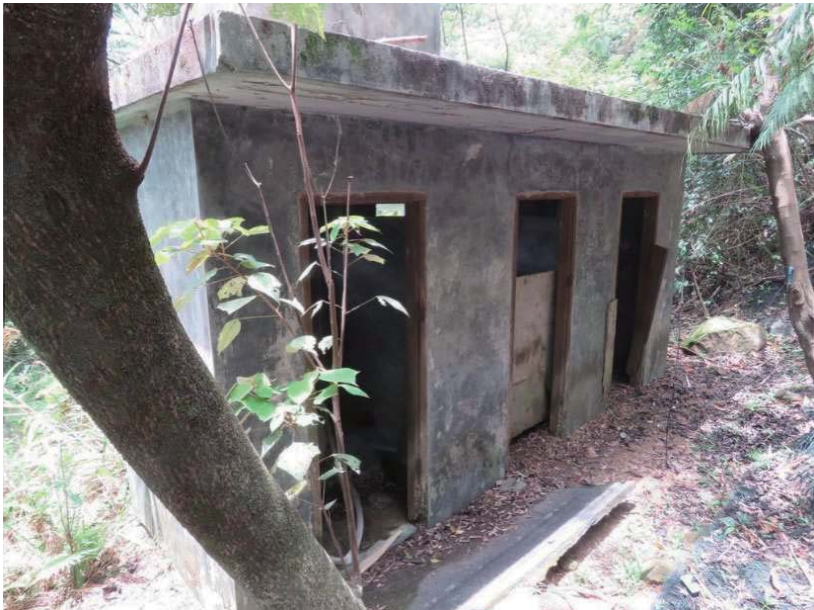
<p>HB-01 General view of front</p>

Interior: Three toilet compartments		
Existing Condition: Abandoned and partly collapsed.		
Past and Present Uses: Industrial, abandoned		
Modifications: N/A		
Photos:

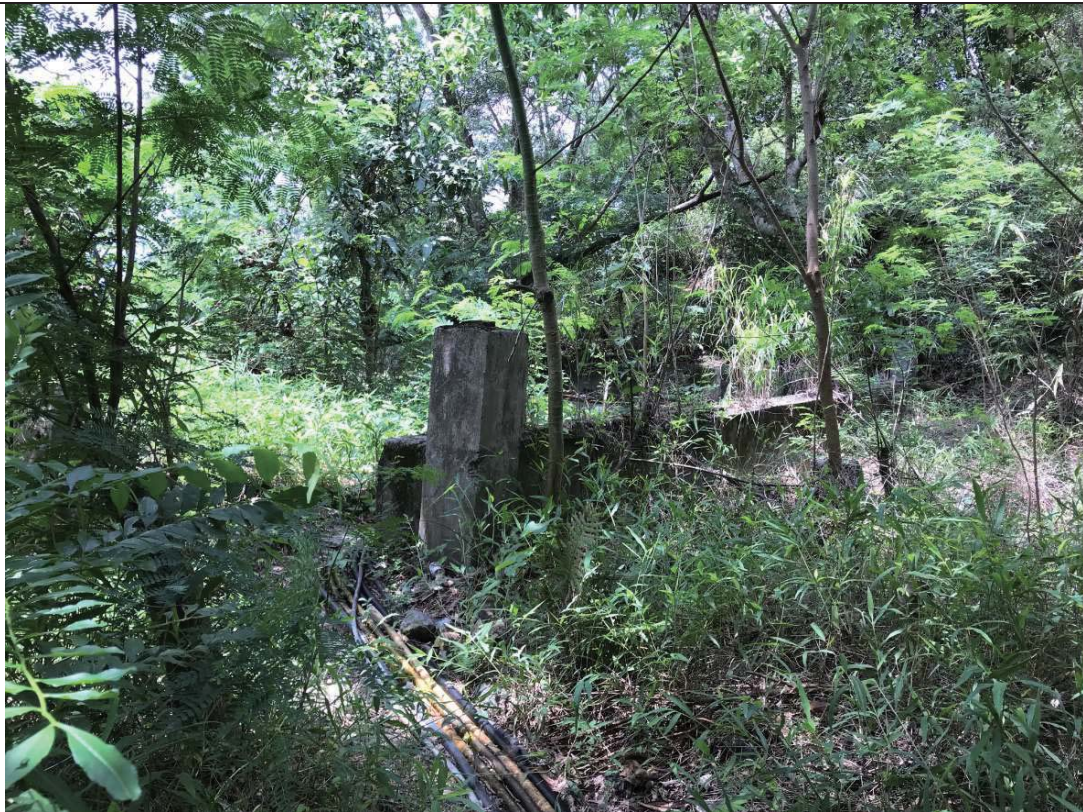
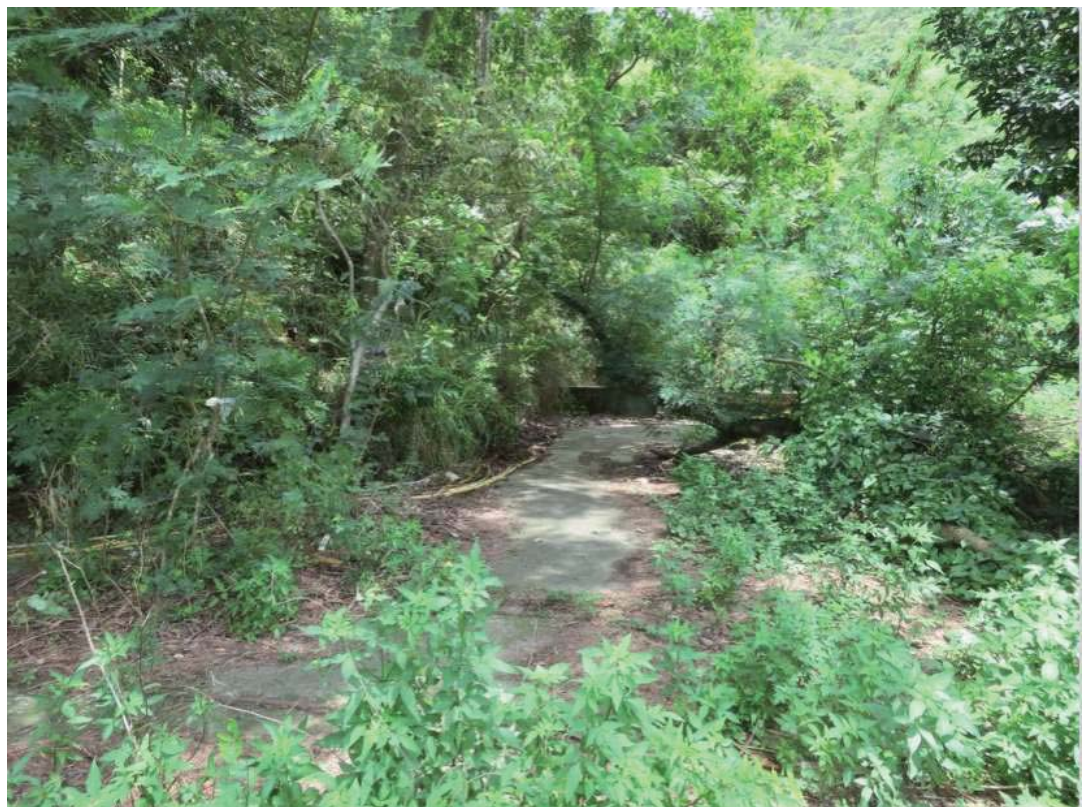
HB-02 General views

Existing Condition: Abandoned		
Past and Present Uses: Industrial, abandoned and overgrown.		
Modifications: N/A		
Photos:

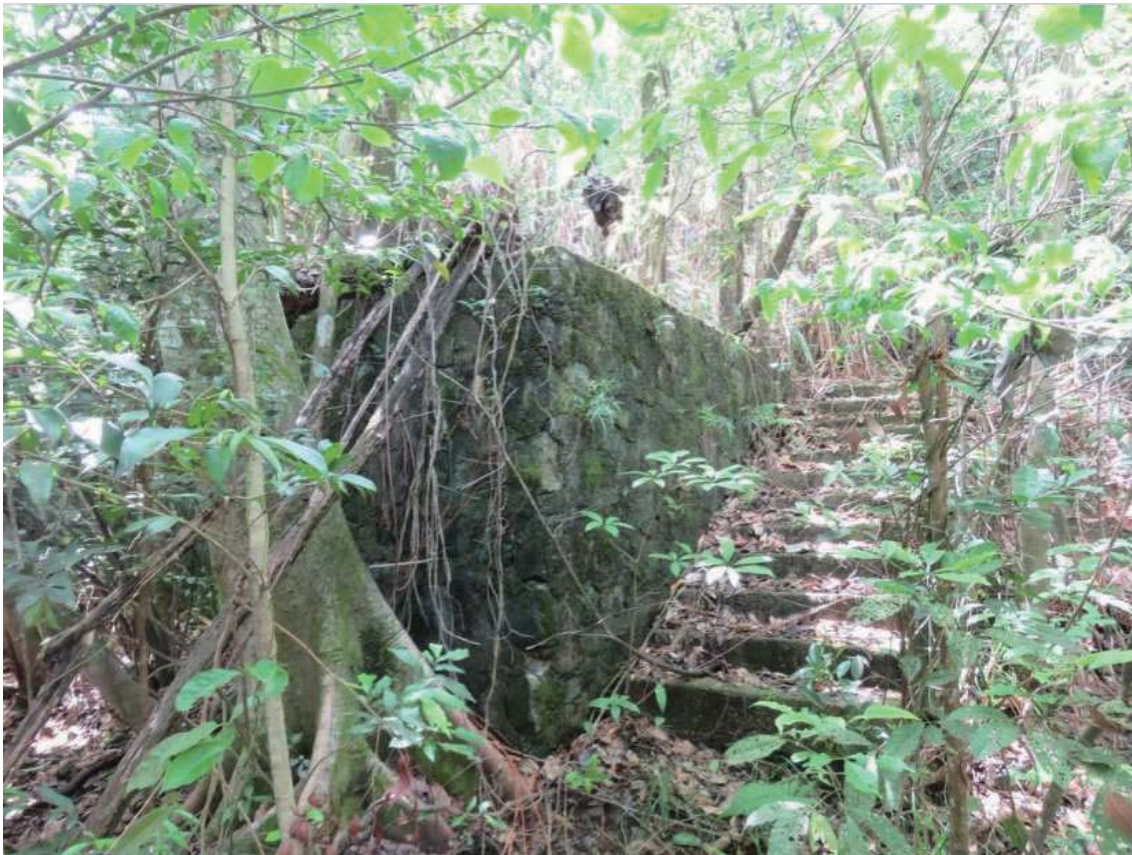
Existing Condition: Abandoned and partly collapsed.		
Past and Present Uses: Industrial, abandoned		
Modifications: N/A		
Photos:

HB-03 General view of electric transformer building with stairs

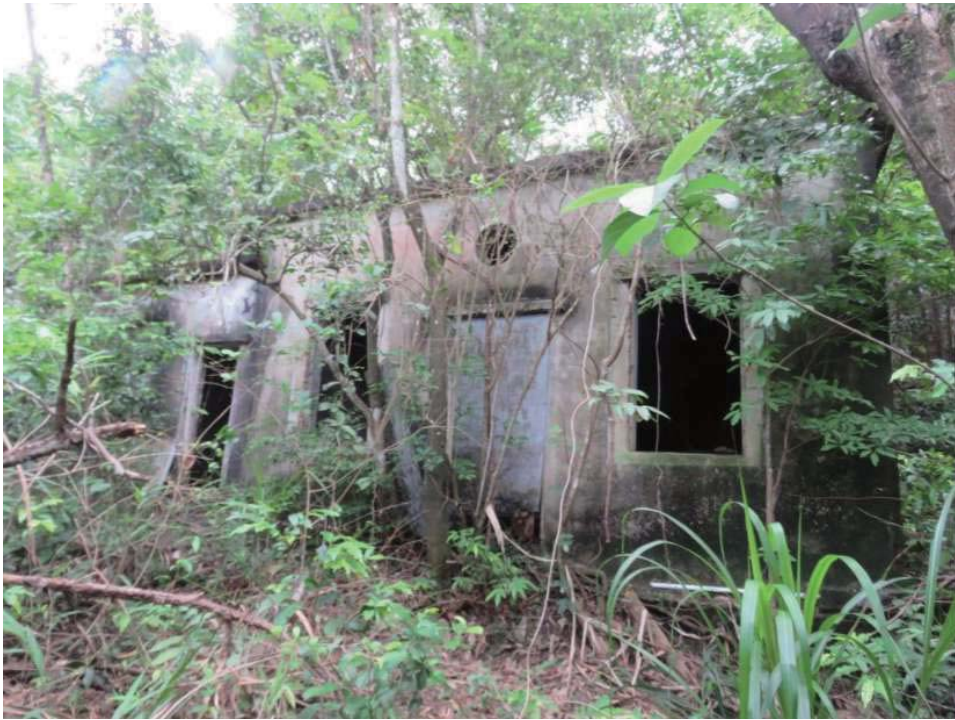
Existing Condition: Abandoned and partly collapsed.		
Past and Present Uses: Industrial, abandoned		
Modifications: N/A		
Photos:

<p>HB-04 General view of electric substation</p>

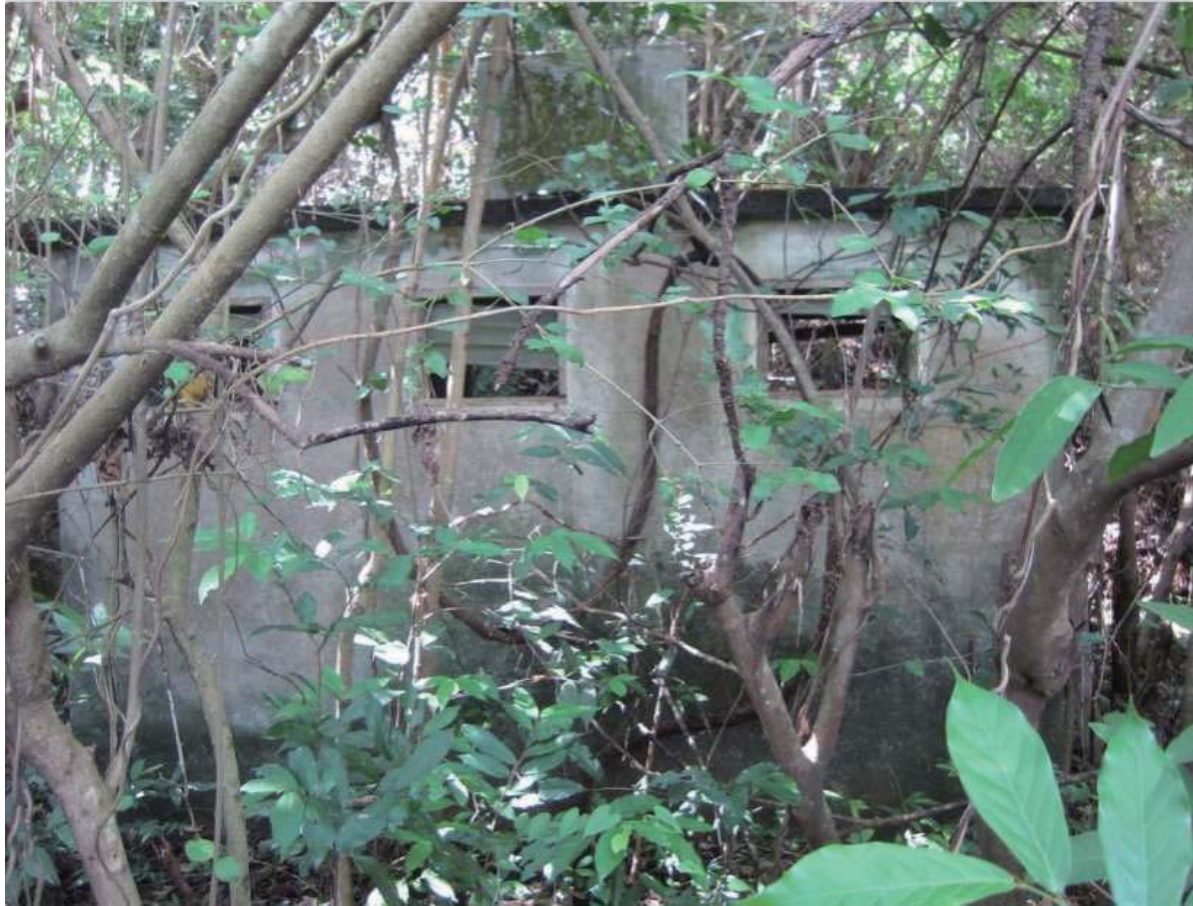
HB-07 General view of outside of building

Interior: Three toilet compartments		
Existing Condition: Abandoned and partly collapsed.		
Past and Present Uses: Industrial, abandoned		
Modifications: N/A		
Photos:

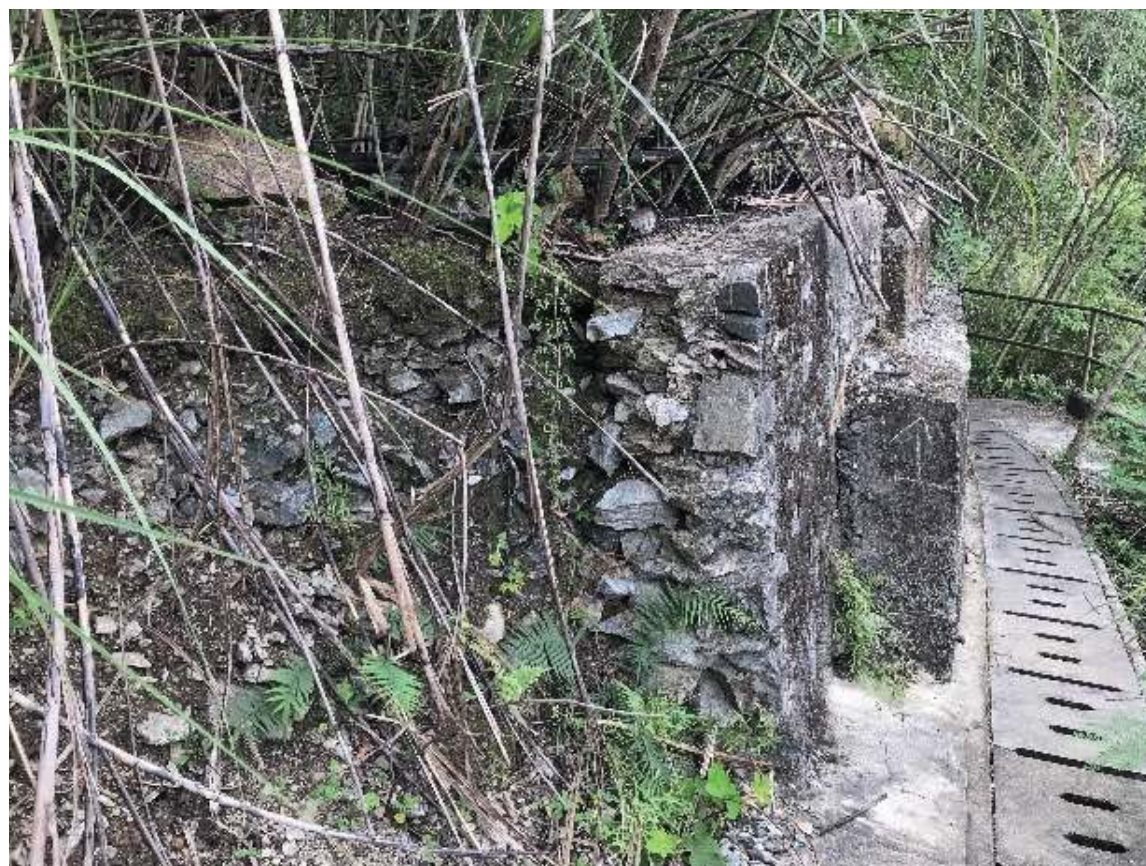
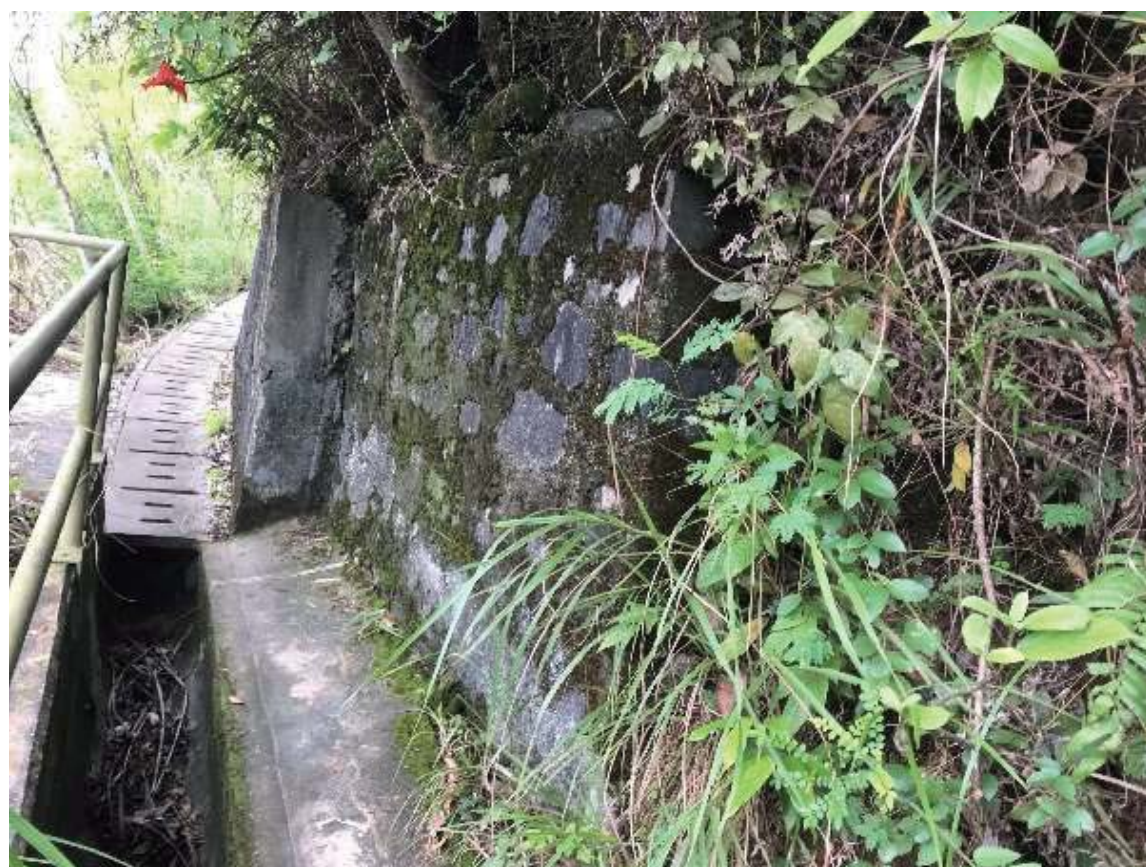
Existing Condition: fair		
Past and Present Uses: Industrial, abandoned		
Modifications: possible broken during later road or slope works		
Photos:

HB-10 General view of stone and concrete retaining wall

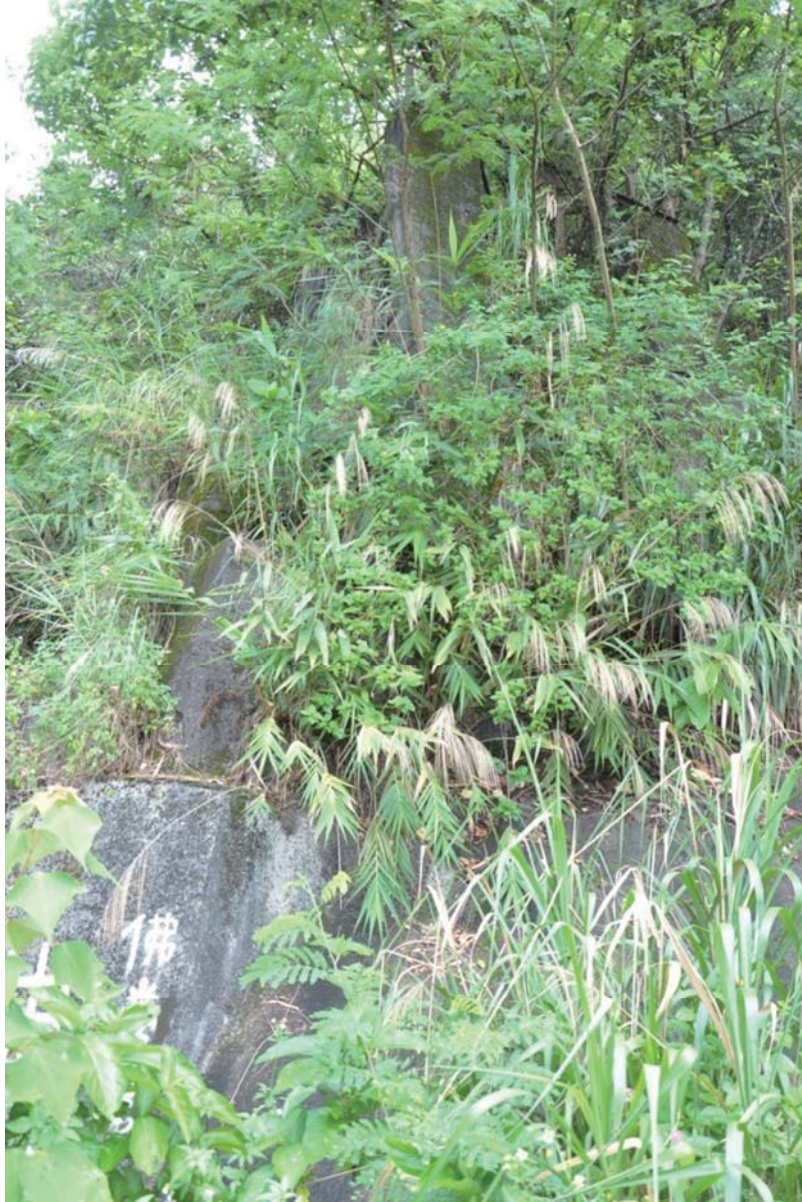
HB-14 general view

<p>Inscriptions: Chinese character 佛 Buddha and phrases 佛光普照, 國泰民安, were written in white paint on base of MPP-5. 佛光普照 means Buddha's grace illuminates all, and 國泰民安 means the preying of the country's prosperity and the people can enjoy peace.</p>		
<p>Architectural Appraisal: HB-14 is a square structure built on a raised platform on hillside. It is built of concrete, iron bars can be seen attached to the top of the structure.</p>		
<p>Interior: Largely obscured by vegetation on a raised platform, the interior is neither accessible nor observable.</p>		
Existing Condition: Abandoned and damaged		
Past and Present Uses: Industrial, abandoned		
Modifications: Conveyor belt removed.		
Photos:

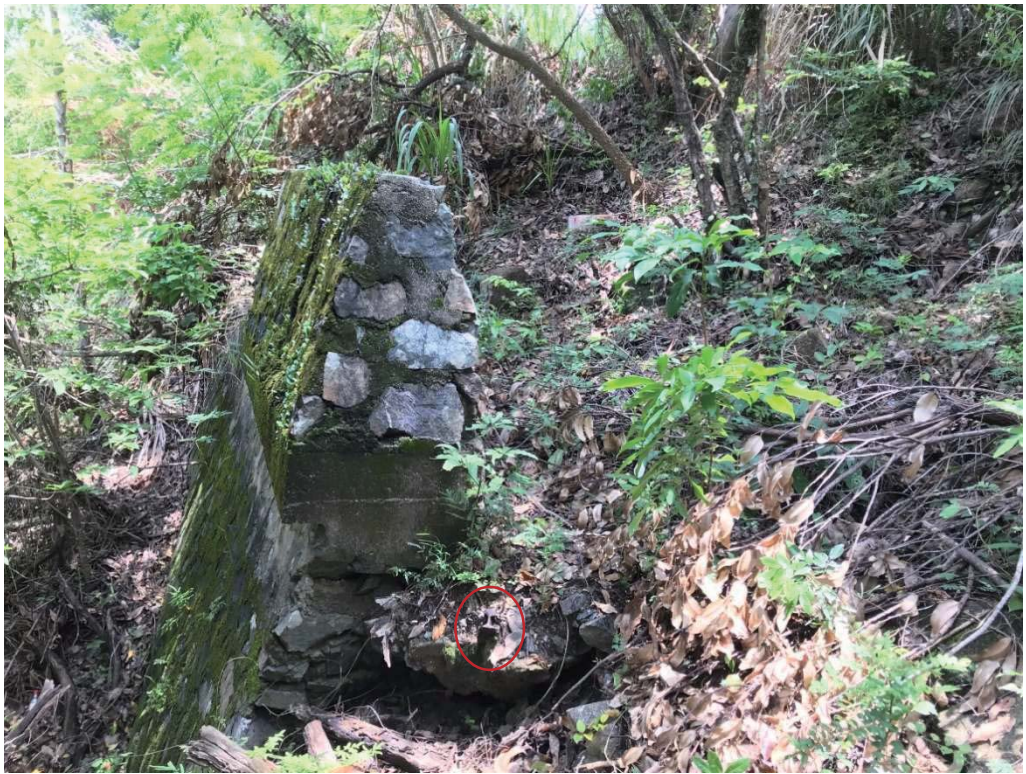
Existing Condition: Abandoned and partly collapsed.		
Past and Present Uses: Industrial, abandoned		
Photos:

HB-16 General view with railway evidence in red circle
