Heritage Impact Assessment Report for Fitting-out Works for Office Accommodation for Operations Section of Cyber Security and Technology Crime Bureau at Former Yau Ma Tei Police Station

Nov 2017 Rev. F

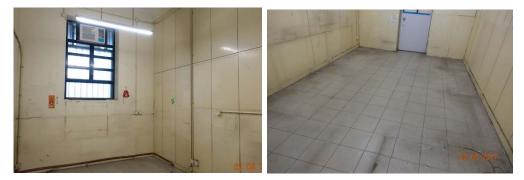
On the ground floor, the original large offices for senior officers, dormitories and other sizable rooms were divided into smaller accommodations. (Fig. 45) Chimney breasts remained, however, the fireplaces were blocked and mantelpieces were removed. The plastered ceiling with decorative mouldings are generally kept intact, but covered by modern suspended ceiling in some rooms. (Fig. 51) The windows are generally modern aluminium. (Fig. 47) Some original ledged and paneled timber doors are found in corridor, staircase and rooms. A few of them are well preserved with authentic components while the others were altered with the fanlight blocked or panelled door leaf replaced. The floor was paved with modern tiles. (Fig. 48)

Fig. 47. The windows are generally modern aluminium. (left) Fig. 48. The floor was paved with modern tiles. (right)

No.	Photo	CDE	Suggested treatments
-		Plastered ceiling with decorative moulding in most of the rooms on G/F and 1/F	 Make good the surface and re-paint.
I-3		Timber plank flooring	 Remove existing carpet to reveal original timber plank flooring. Remove all existing coatings on timber surfaces. Repair and make good plank flooring. Replace defective plank flooring with new timber plank of matching species. Apply wood preservative primer and protective finish coating on timber surface.
I-4	02 06 2017	Red ceramic floor tiles with black border at rooms for back of house facilities	 Clean with diluted domestic detergent.
1-5		Plastered skirting at the interior rooms and along the corridors	 Make good the surface and re-paint.
I-6		Glazed French doors with fanlights atop and open to the verandah	 Remove all existing coatings on timber surfaces. Repair and make good the door panels, fanlights and frames. Replace defective timber components with new timber of matching species. Replace missing or damaged glazing with new glazing to match with existing Apply wood preservative primer and protective finish coating on timber surface. Make good all original ironmongeries. Supply and install new ironmongeries to match with originals.

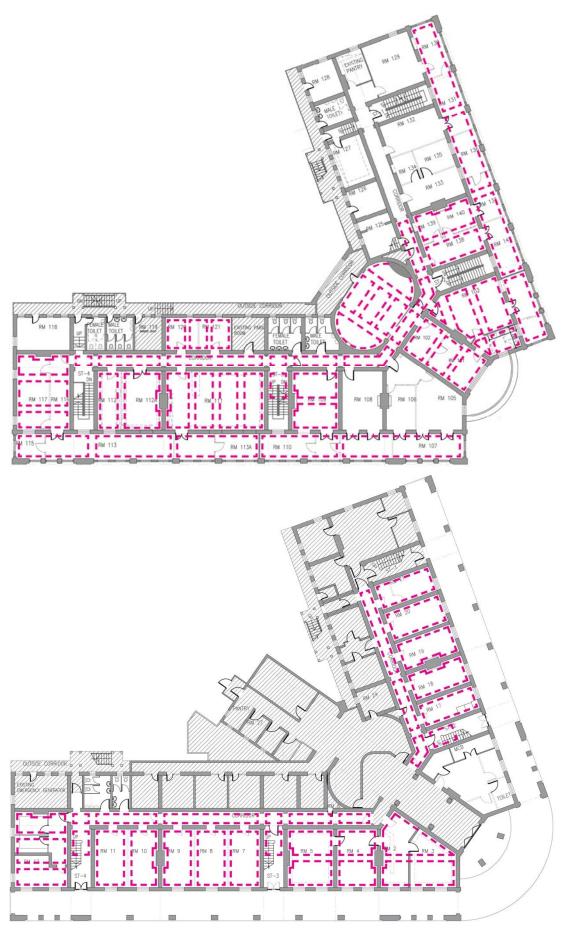
Fig. 50. Plastered ceiling with decorative moulding on G/F (lower) and /F (upper).

Treatment/ Mitigation Measures	
		 The new suspended ceiling should not disturb the decorative moulding at ceiling. The design of new suspended ceiling shall be compatible to the historical atmosphere. It should be discernible from the original historical fabrics, and of simple design that would not overwhelm the original architectural features. 	
B-11	Assessment Items	Affected CDEs / fabric	Level of significance
	Replace existing modern floor finishes with new	Not applicable	Not applicable
	finishes	Impact Level	
		Acceptable impact with mitigation measures	
		Treatment/ Mitigation Measures	
		 The design of new floor finishes shall be compatible to the historical atmosphere. It should be discernible from the original historical fabrics, and of simple design that would not overwhelm the original architectural features. The design of new skirting at the corridor on G/F and I/F may make reference to the original plastering skirting with curved profile retained on the 2/F.

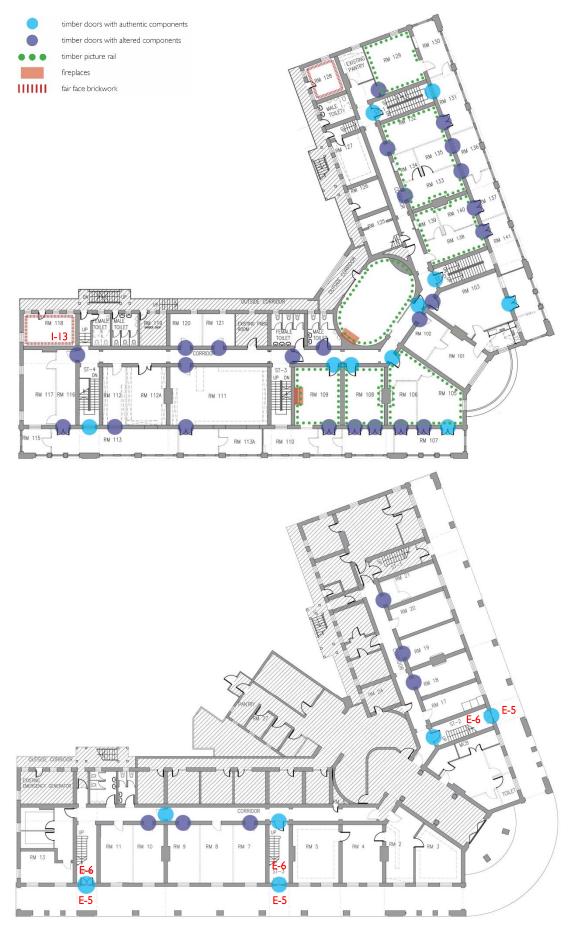
Fig. 51. Timber doors with authentic components, timber doors with altered components, timber picture rail, fireplaces and fair face brickwork on G/F (lower) and 1/F (upper).

I-7	Panelled door in the corridor and rooms with fanlight atop.	 Remove all existing coatings on timber surfaces. Repair and make good the door panels, fanlights and frames. Replace defective timber components with new timber of matching species. Replace missing or damaged glazing with new glazing to match with existing Apply wood preservative primer and protective finish coating on timber surface. Later replaced modern door leaves will be replaced with new door leaves according to user's requirements. Install new door locks, including electronic digital locks, or replacement of the existing broken door locks with similar models
1-8	Glazed timber paneled door with fixed light above and at the sides at staircase	 Remove all existing coatings on timber surfaces. Repair and make good the door panels, fanlights and frames. Replace defective timber components with new timber of matching species. Replace missing or damaged glazing with new glazing to match with existing Apply wood preservative primer and protective finish coating on timber surface. Install new door locks, including electronic digital locks, or replacement of the existing broken door locks with similar models

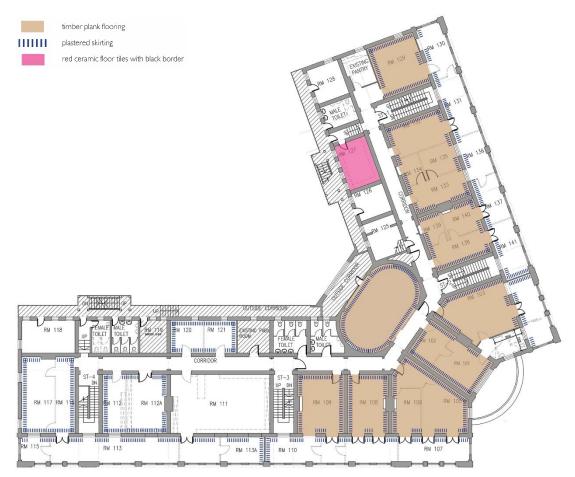
Fig. 52. Timer plank flooring, plastered skirting and red ceramic floor tiles with black border on 1/F.
