Annex A Figures

Annex B

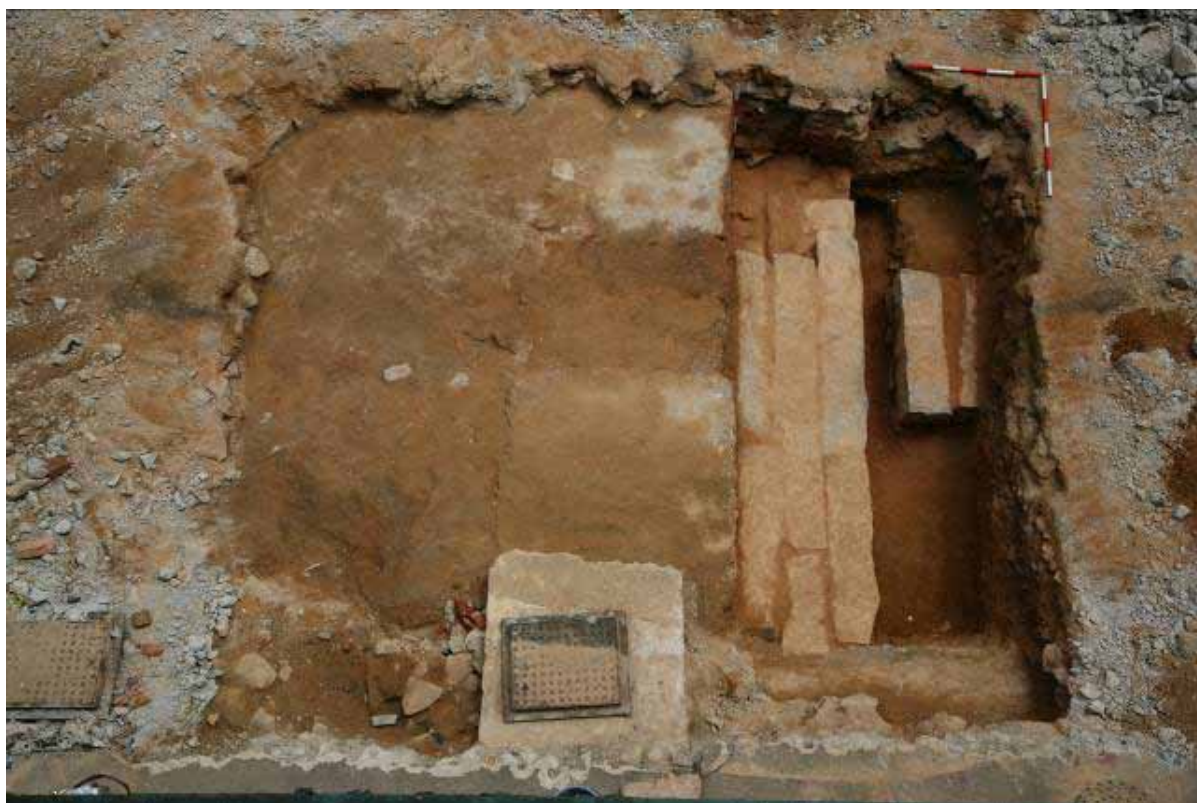
1.Top view of Foundation No.2 in first phase (From South to North)

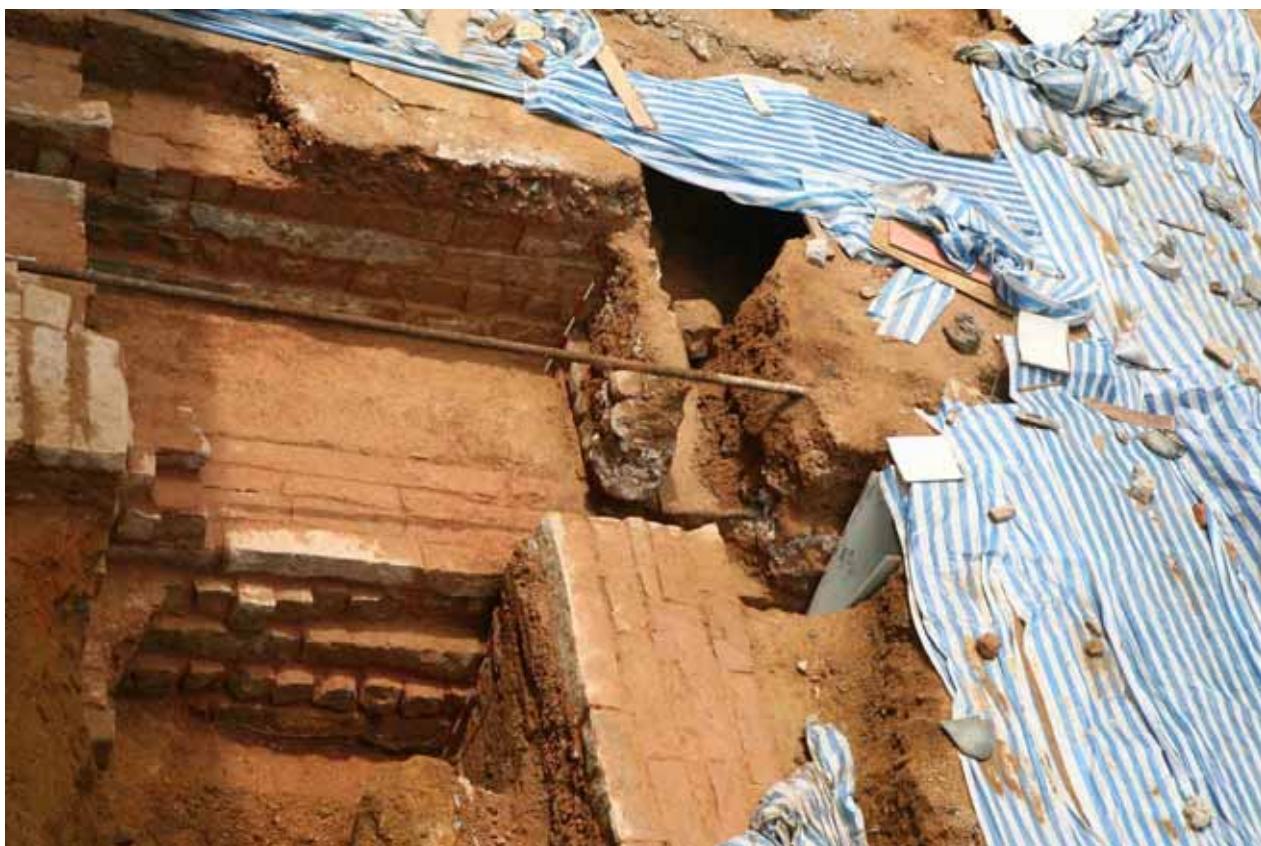
1. Foundation No.2 & No. 3 (From Northeast to Southwest)

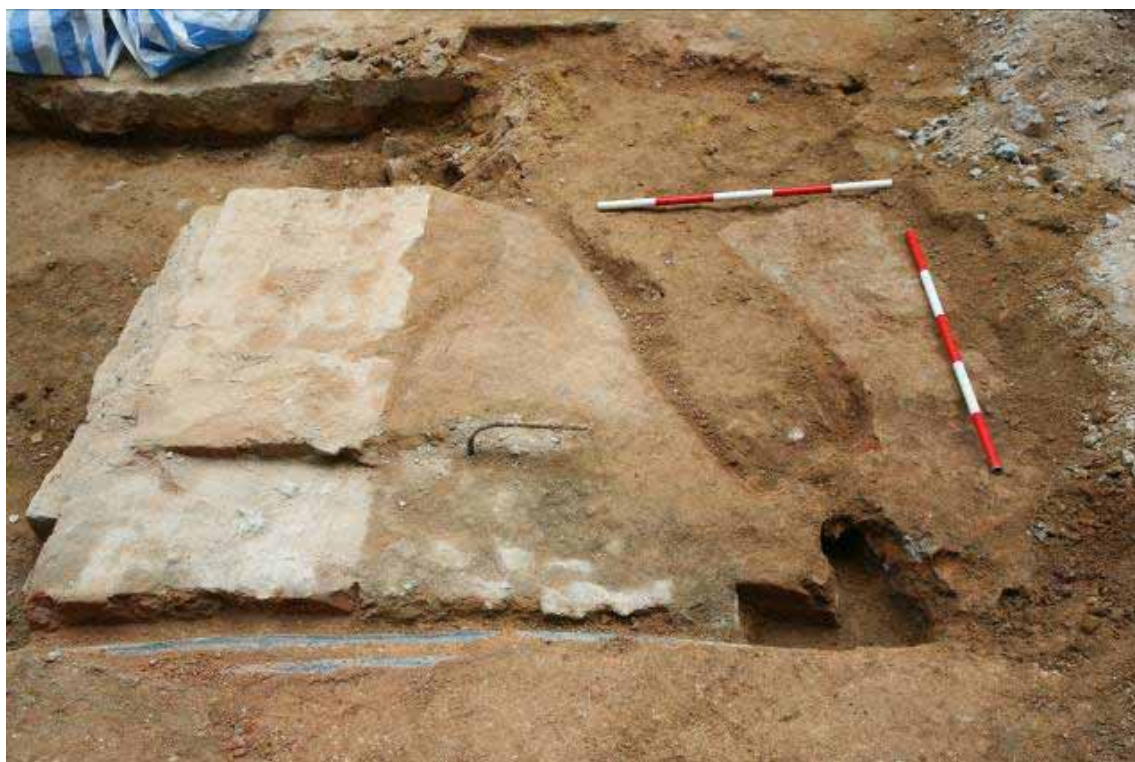
1. Foundation No.4 (From North to South)

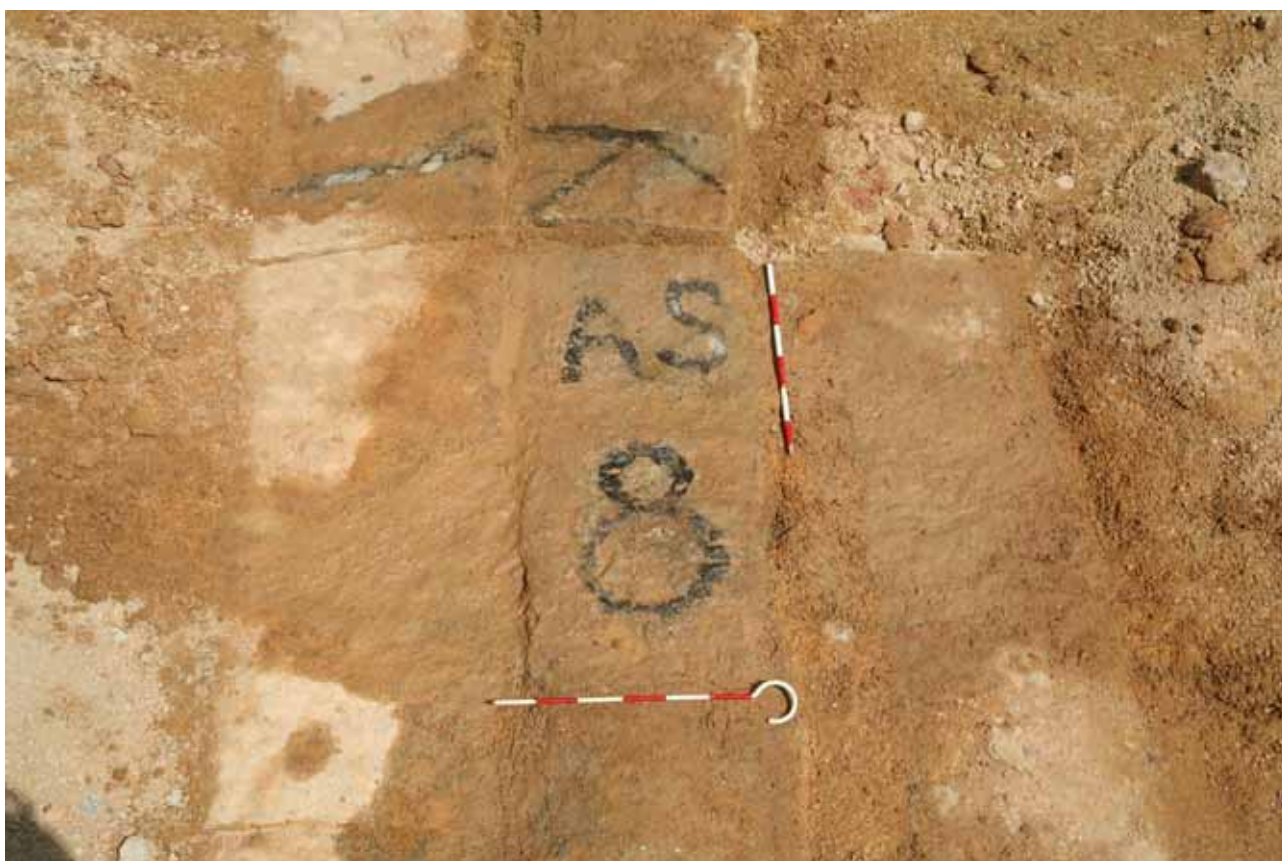
1. Inked marks on the southern part of Foundation No. 3 (From East to West)

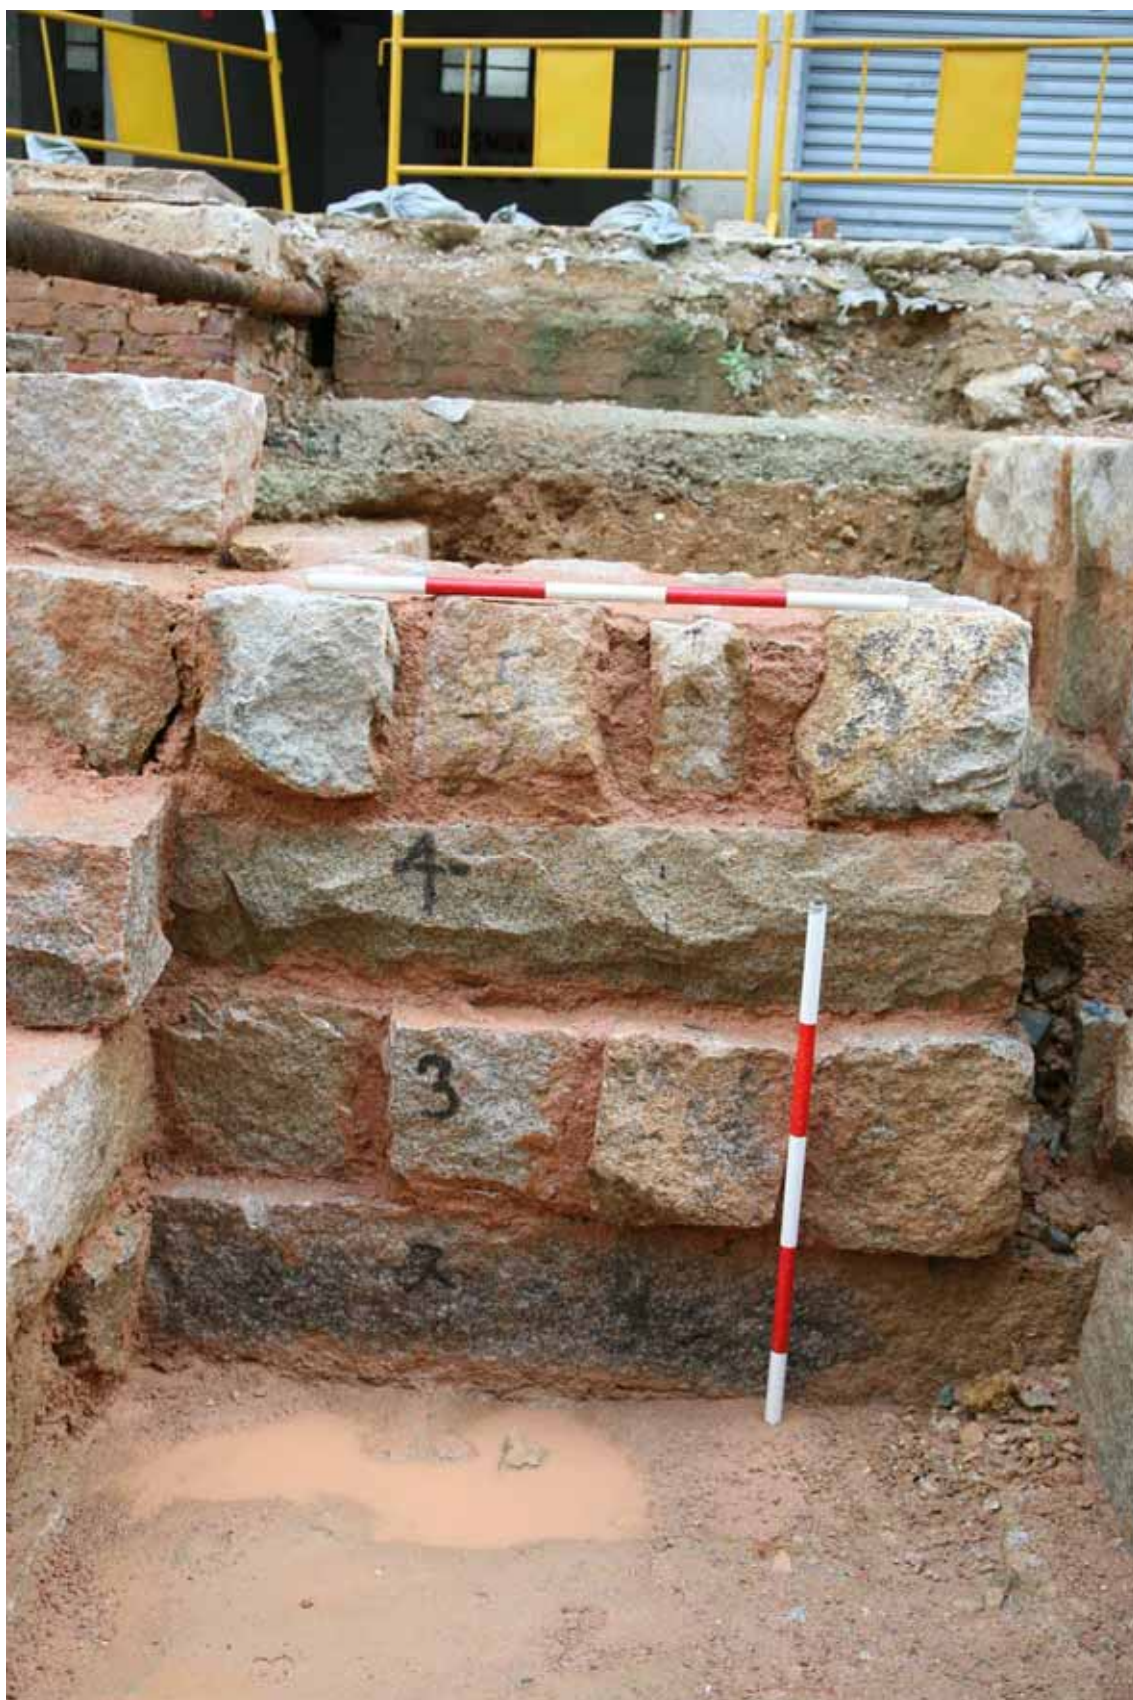
1. Inked marks “2”, “3”, “4” and “5” on the southern part of Foundation No.3
(From north to south)

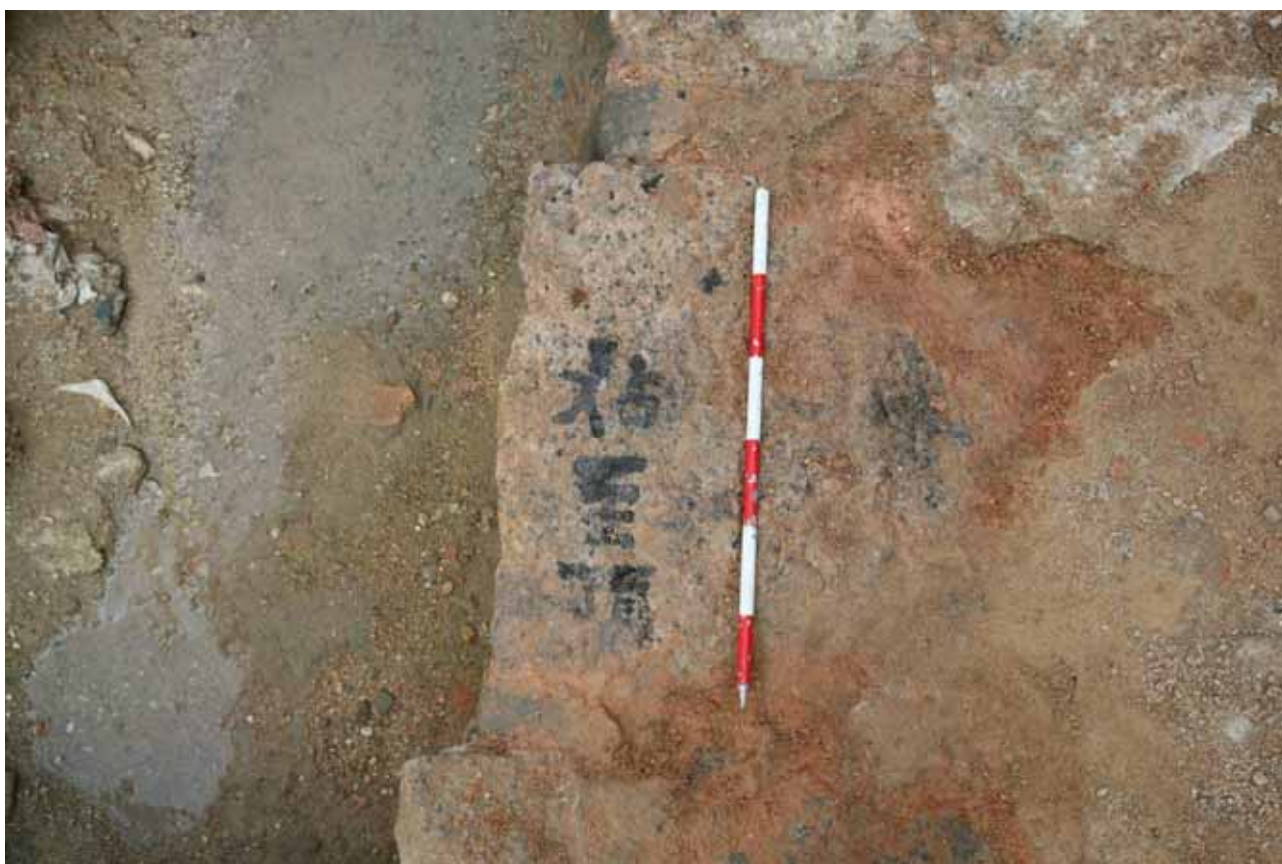
10. Inked marks of three Chinese Characters “又占至頂” on the buttress of Foundation No. 8

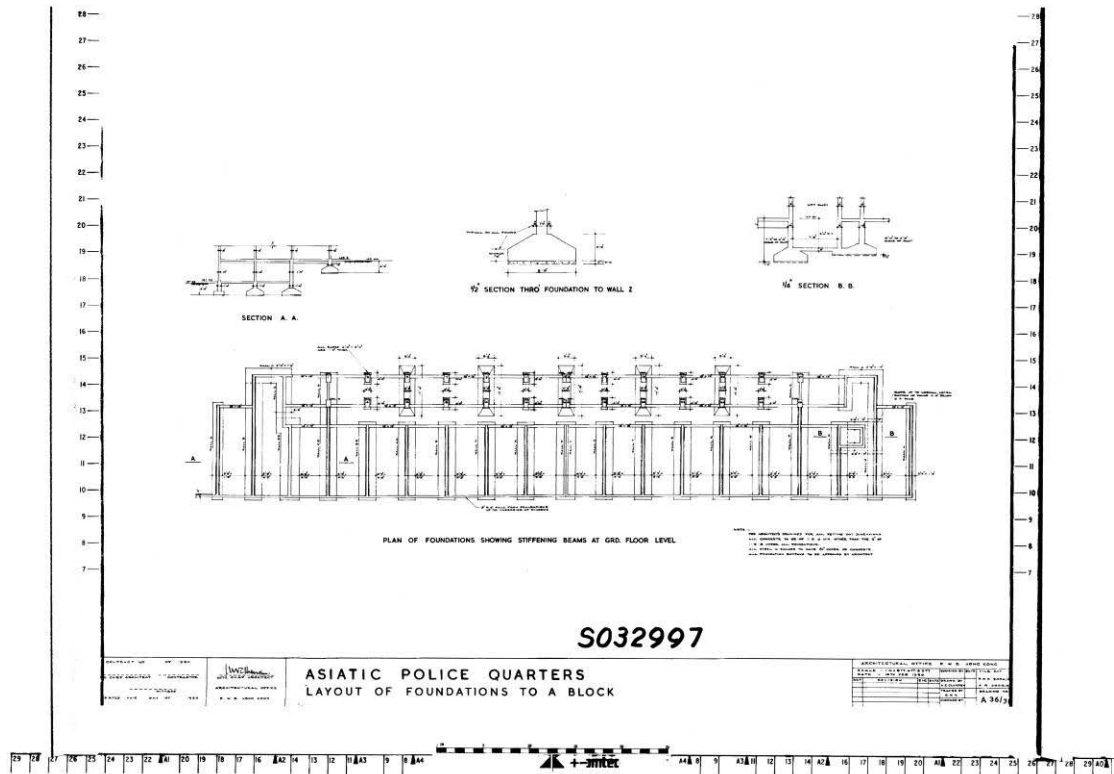
26. Layout of Foundations to Block A of Asiatic Police Quarters, 1950

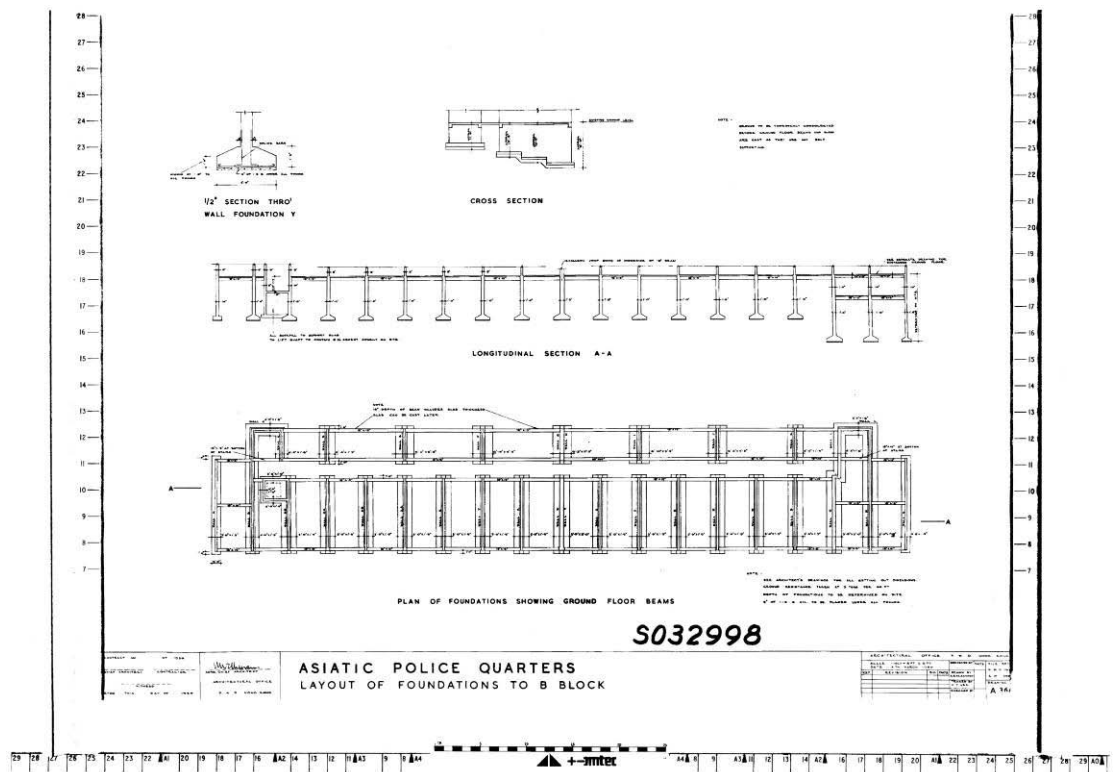
27. Layout of Foundations to Block B of Asiatic Police Quarters, 1950
