Site 1 Tung Lung Chau

Design approach 1 - controlled pathway

Design approach 1 for Site 1_Tung Lung Chau

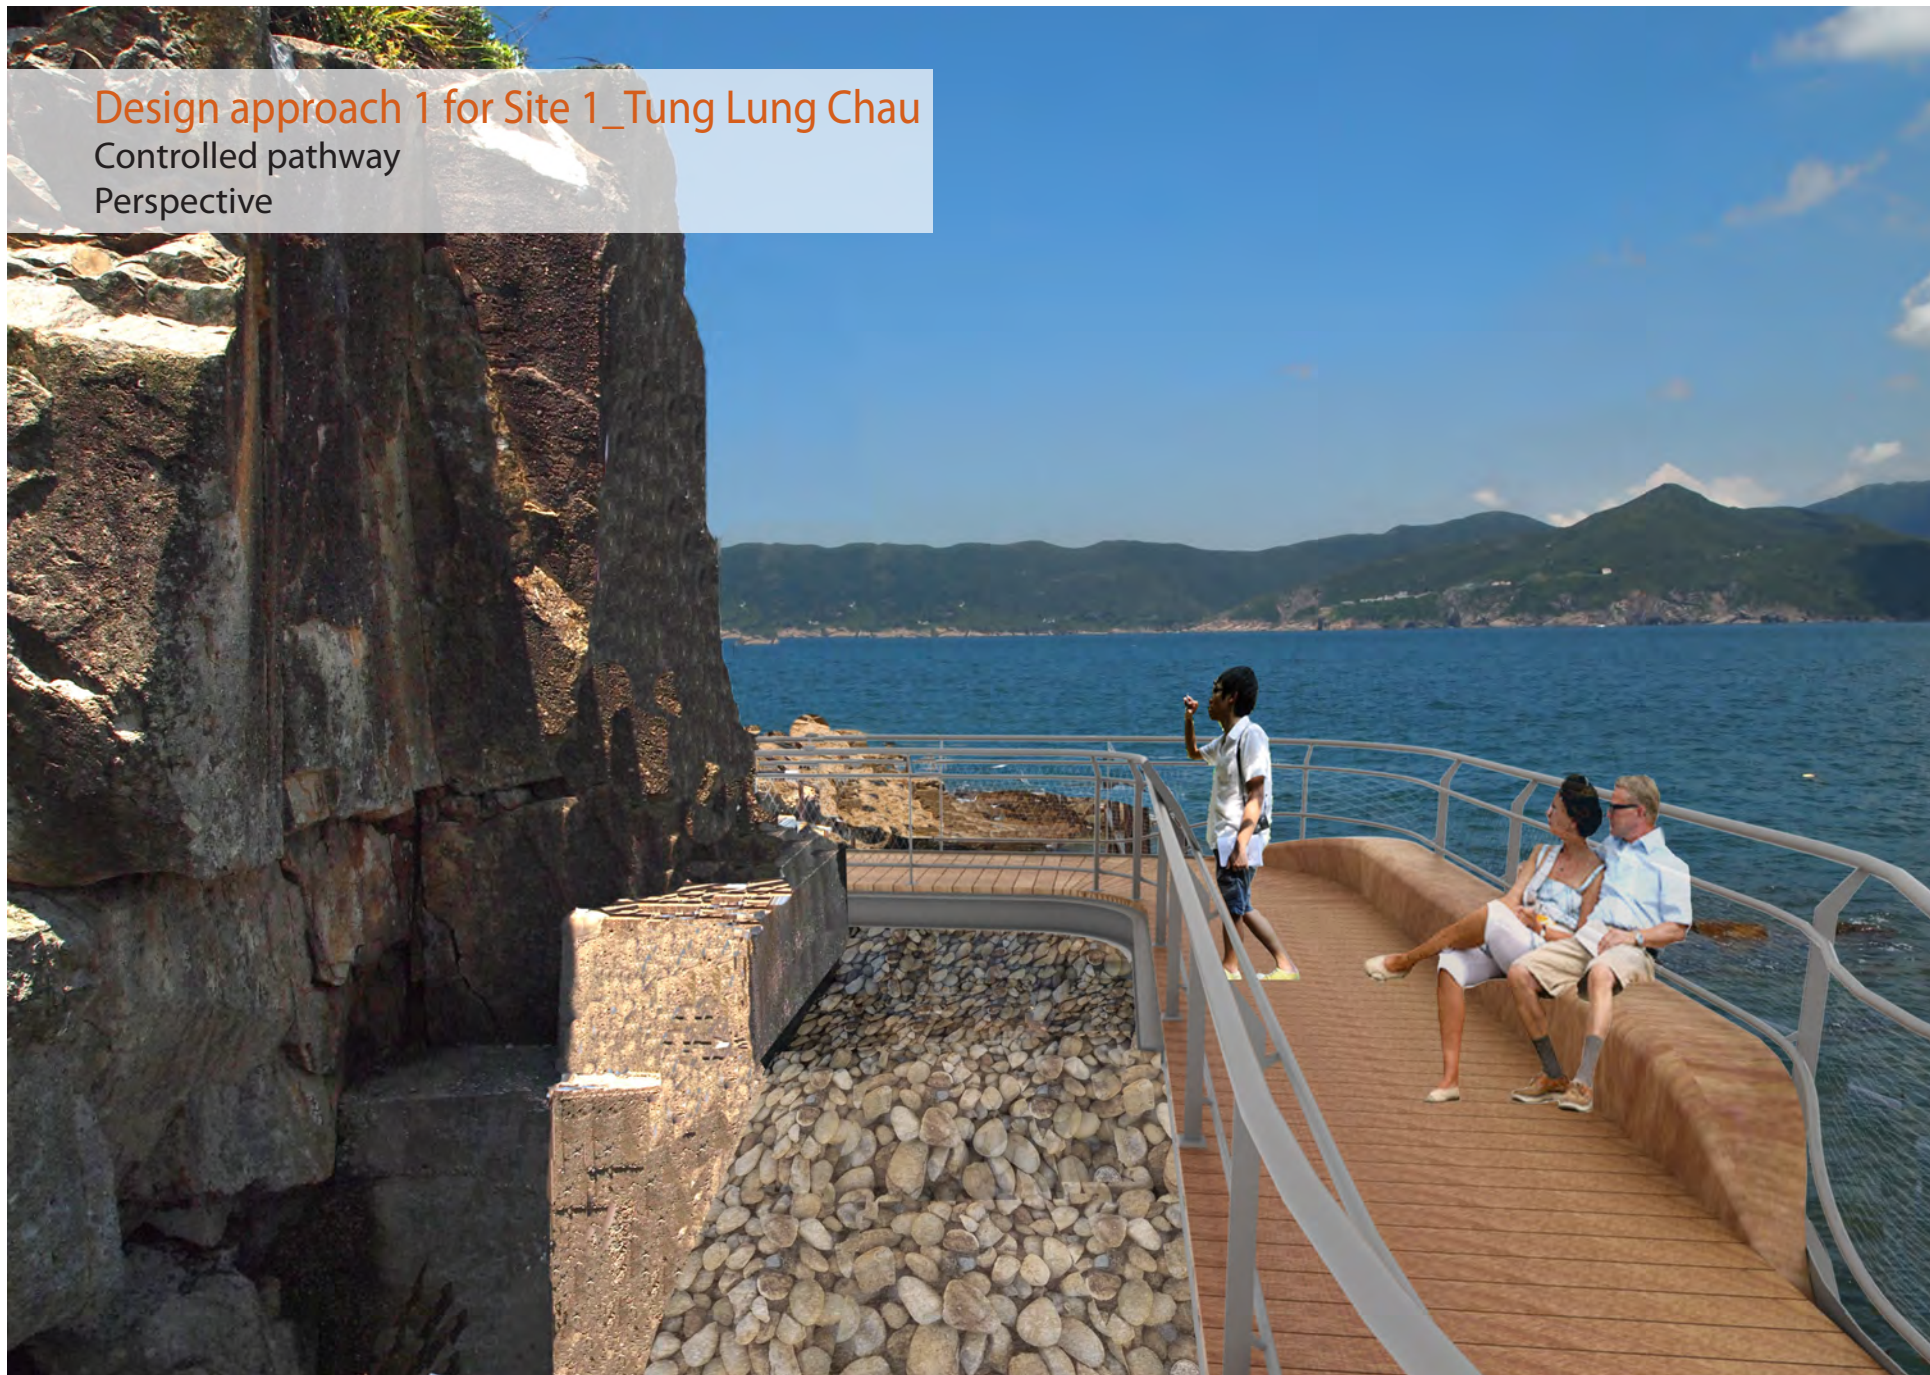
Design approach 1 for Site 1_Tung Lung Chau
Controlled pathway
Perspective

Suggested actions in the Rock Carvings Consultancy Study	Purpose	Suggested architectural approach by CPW
Physical measure	<ul style="list-style-type: none">· To remove Perspex screen· To move metal cage	<ul style="list-style-type: none">· To increase visibility· To prevent formation of micro-climate	<p>We suggest constructing an extended walkway starting from the existing concrete platform. This is to prevent vandalism by increasing the distance between visitors and the carving.</p> <p>The new walkway is to serve as an alternative route to the steep staircase. Interpretation plate is to be incorporated with the railing structure.</p>
Interpretation plate	<ul style="list-style-type: none">· To be incorporated with the balustrade	<ul style="list-style-type: none">· To provide more background information of the rock· To educate visitors to protect the cultural heritage of Hong Kong.	
Chemical & geographic conditions	<ul style="list-style-type: none">· To remove suspected residue of chalk· To conduct further studies on wave action to determine whether to retain the current concrete support	<ul style="list-style-type: none">· To stabilize the concrete plinth in light of the strong wind load.

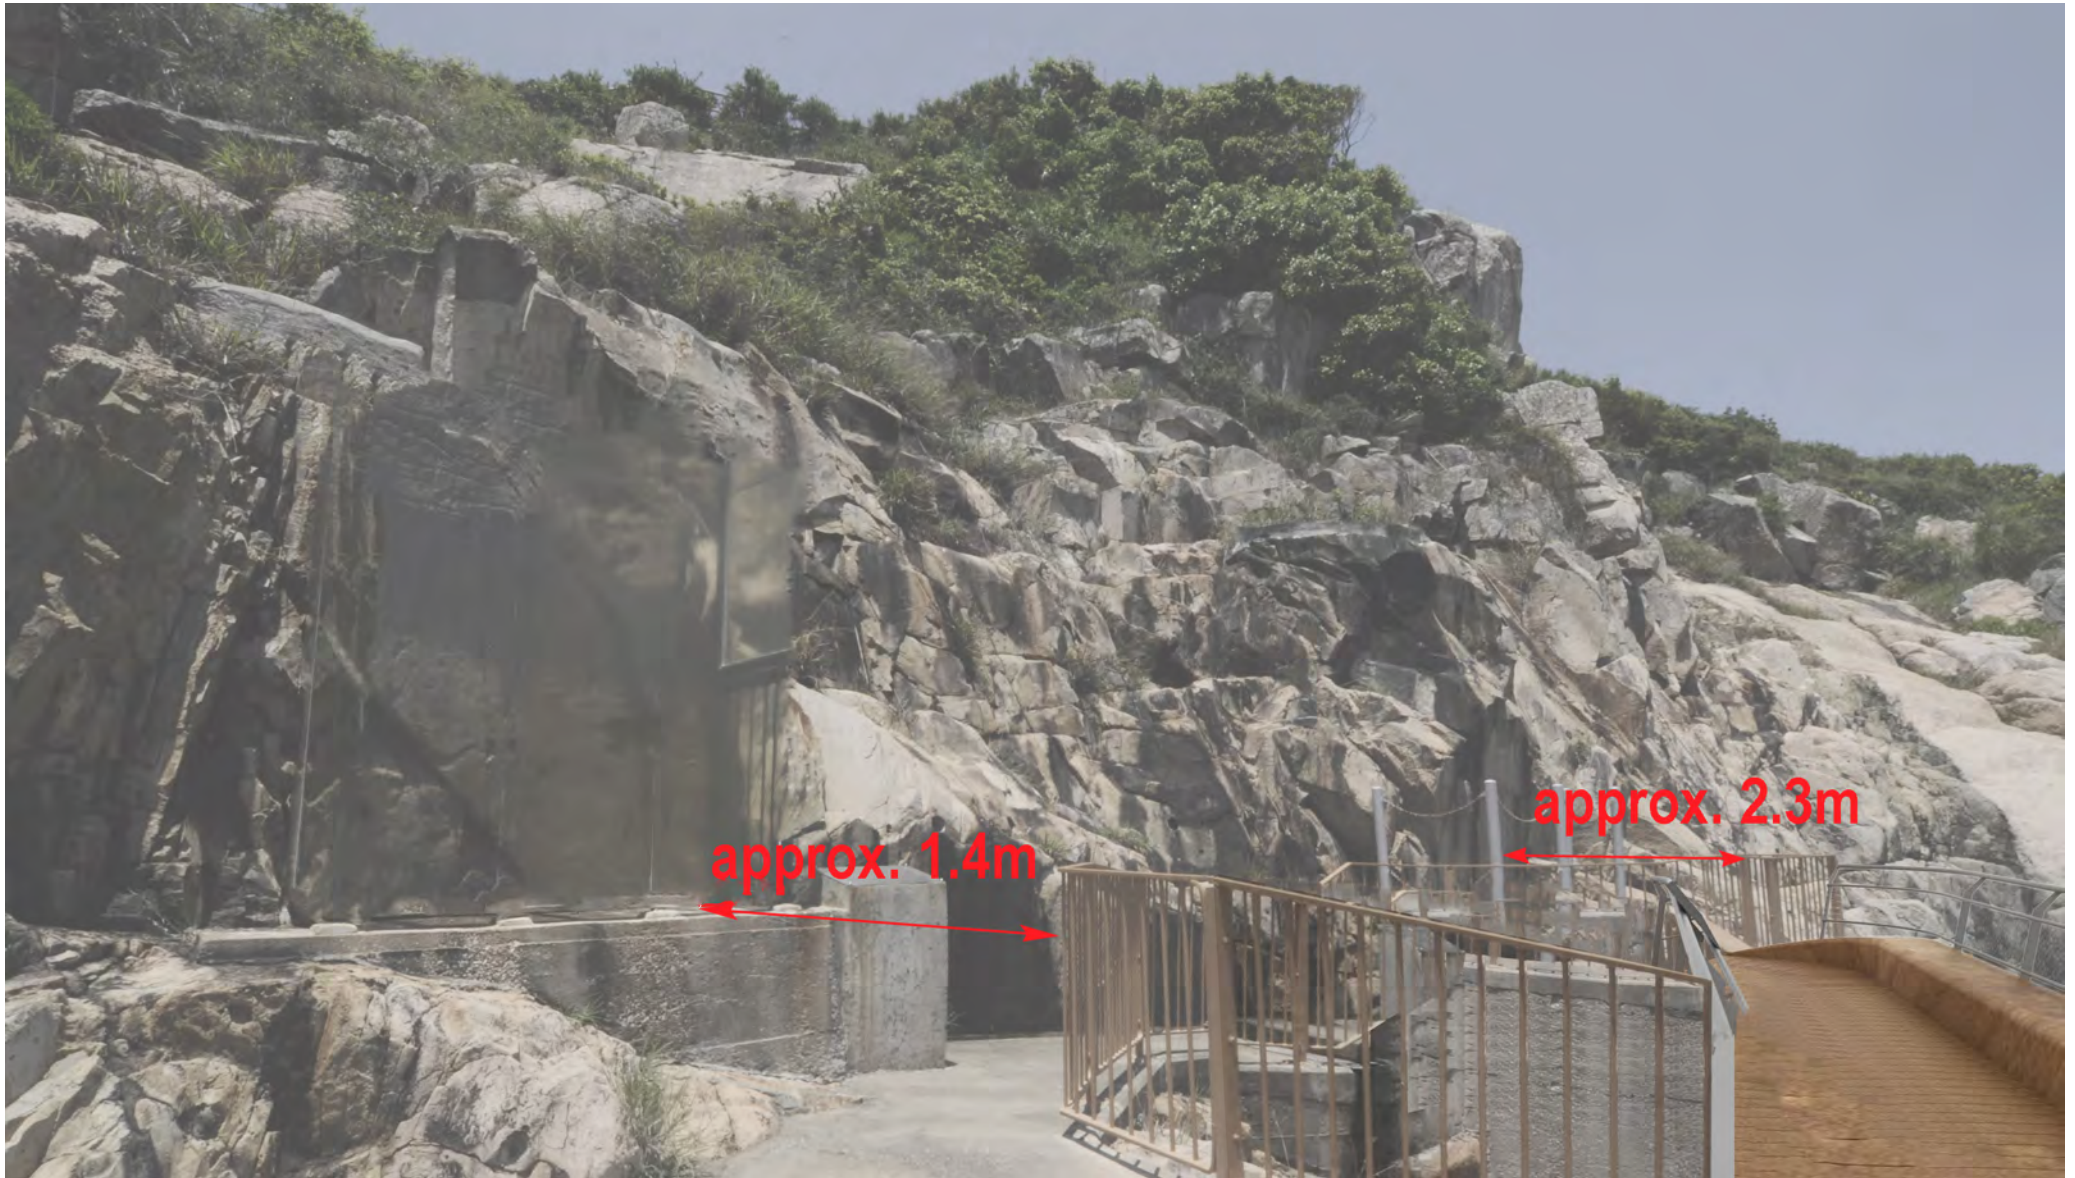
Design approach 1 for Site 2_Po Toi Island
Controlled pathway

Suggested actions in the Rock Carvings Consultancy Study	Purpose	Suggested architectural approach by CPW
Physical measure	· To remove Perspex screen	· To increase visibility	We propose to construct an extended walkaway from the existing concrete platform so that vandalism can be prevented due to the increased distance between visitors and the carving. The new walkway is to serve as an alternative route to the existing steep staircase. Interpretation plate is to be incorporated with the railing structure.
	· To remove metal cage	· To prevent formation of micro-climate	
	· To replace the cement water diversion dam	· To prevent seepage of rain water into the rock	
Interpretation plate	· To be incorporated with the balustrade	· To provide more background information of the rock · To educate visitors to protect the cultural heritage of Hong Kong	
Chemical & geographic conditions	· To remove existing concrete base · Further geo-technical studies required	· To reveal the original setting · To avoid soluble salt from concrete and salt deposition in the long term · To acquire information on slope stability and water infiltration

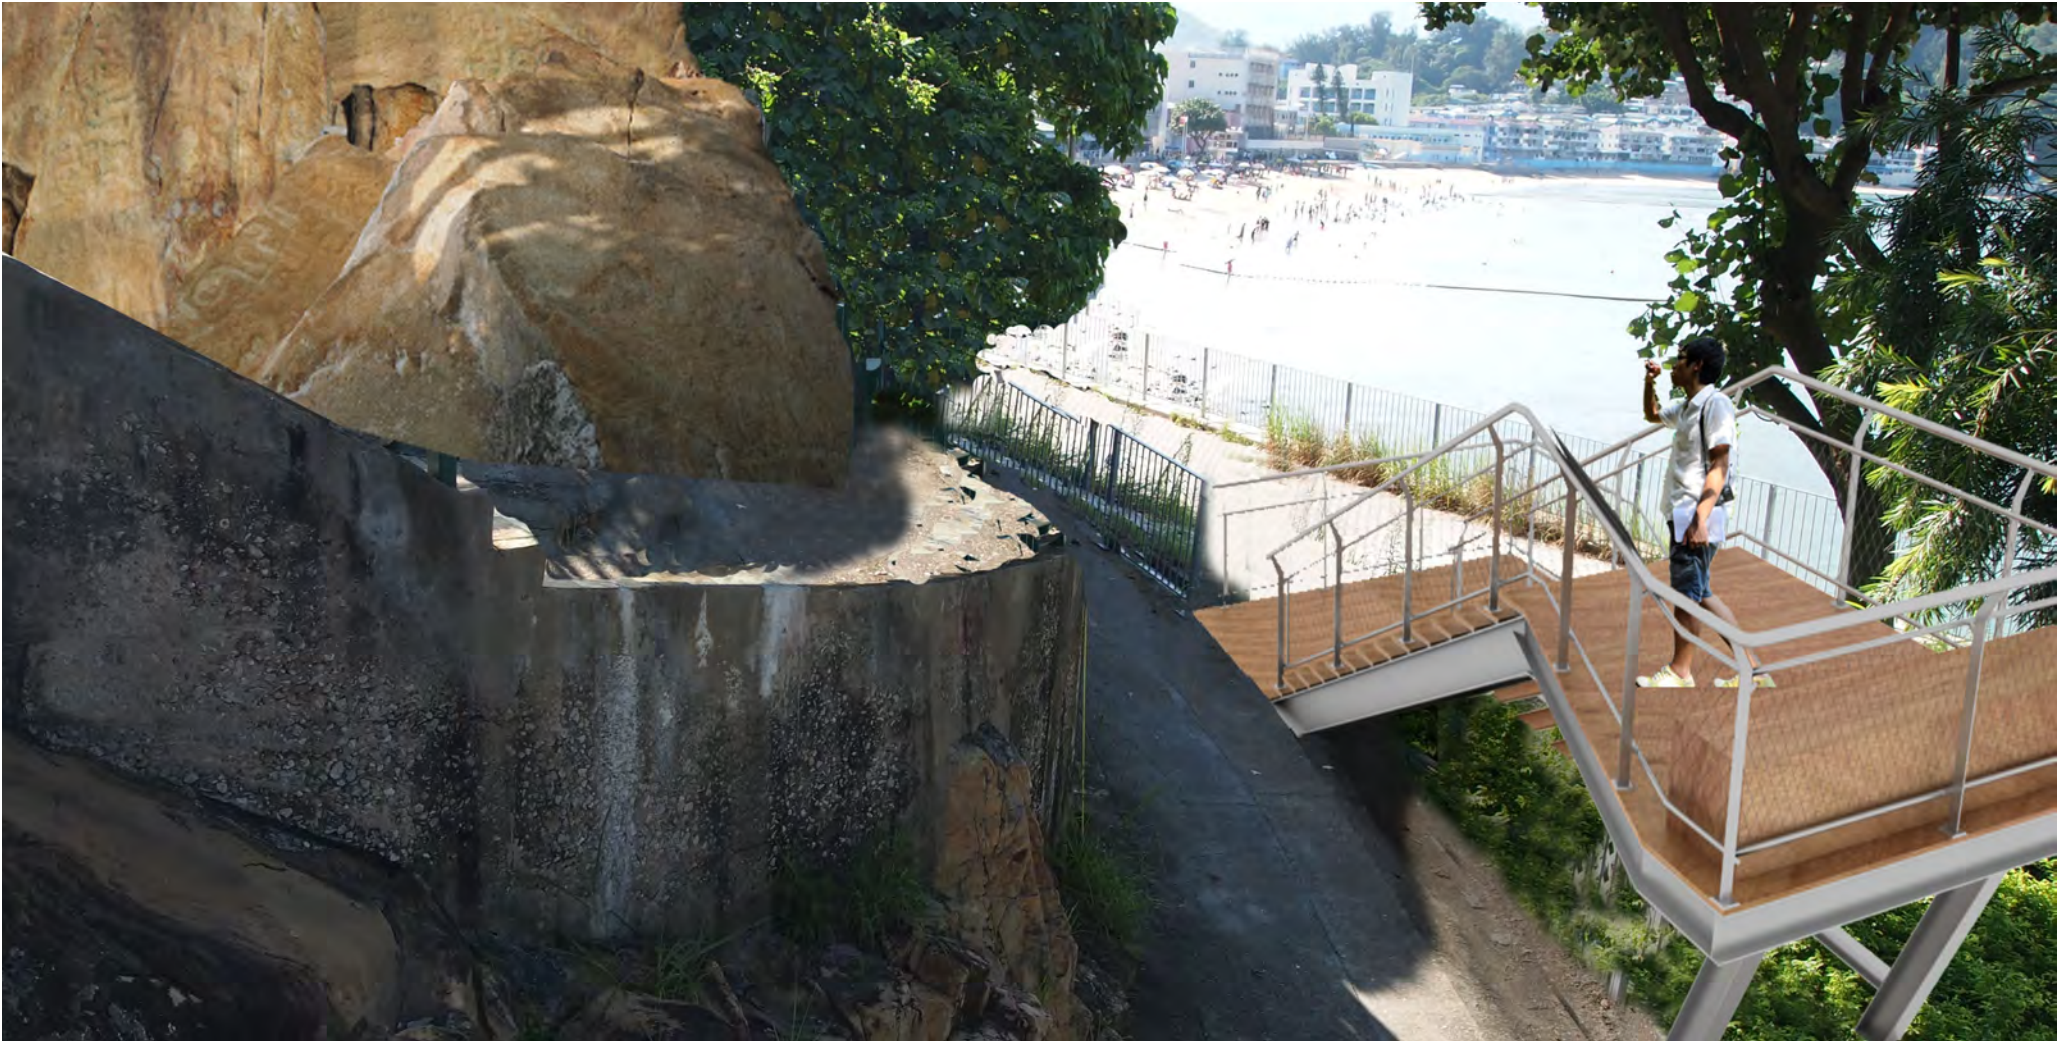
Design approach 1 for Site 3_Cheung Chau

Controlled pathway (viewing platform)

Suggested actions in the Rock Carvings Consultancy Study	Purpose	Suggested architectural approach by CPW
Physical measure	<ul style="list-style-type: none"> To remove glass enclosure To remove all cement capping on the surface 	<ul style="list-style-type: none"> To prevent formation of micro-climate To increase visibility To prevent growth of micro-organisms 	<p>We aim to reduce impact to the rock carving to the minimum and keeping visitors away from the rock by constructing a viewing platform which is accessible from two beach side walkways.</p> <p>Interpretation plate is to be incorporated with the railing structure</p>
	<ul style="list-style-type: none"> To remove all stone rubble structures 	<ul style="list-style-type: none"> To reinstate the natural setting 	
	<ul style="list-style-type: none"> To replace the cement water diversion dam with stone, lime-based mortar and clay 		
	<ul style="list-style-type: none"> To remove vegetation in the planter above the rock carving 	<ul style="list-style-type: none"> To prevent water seepage and leakage

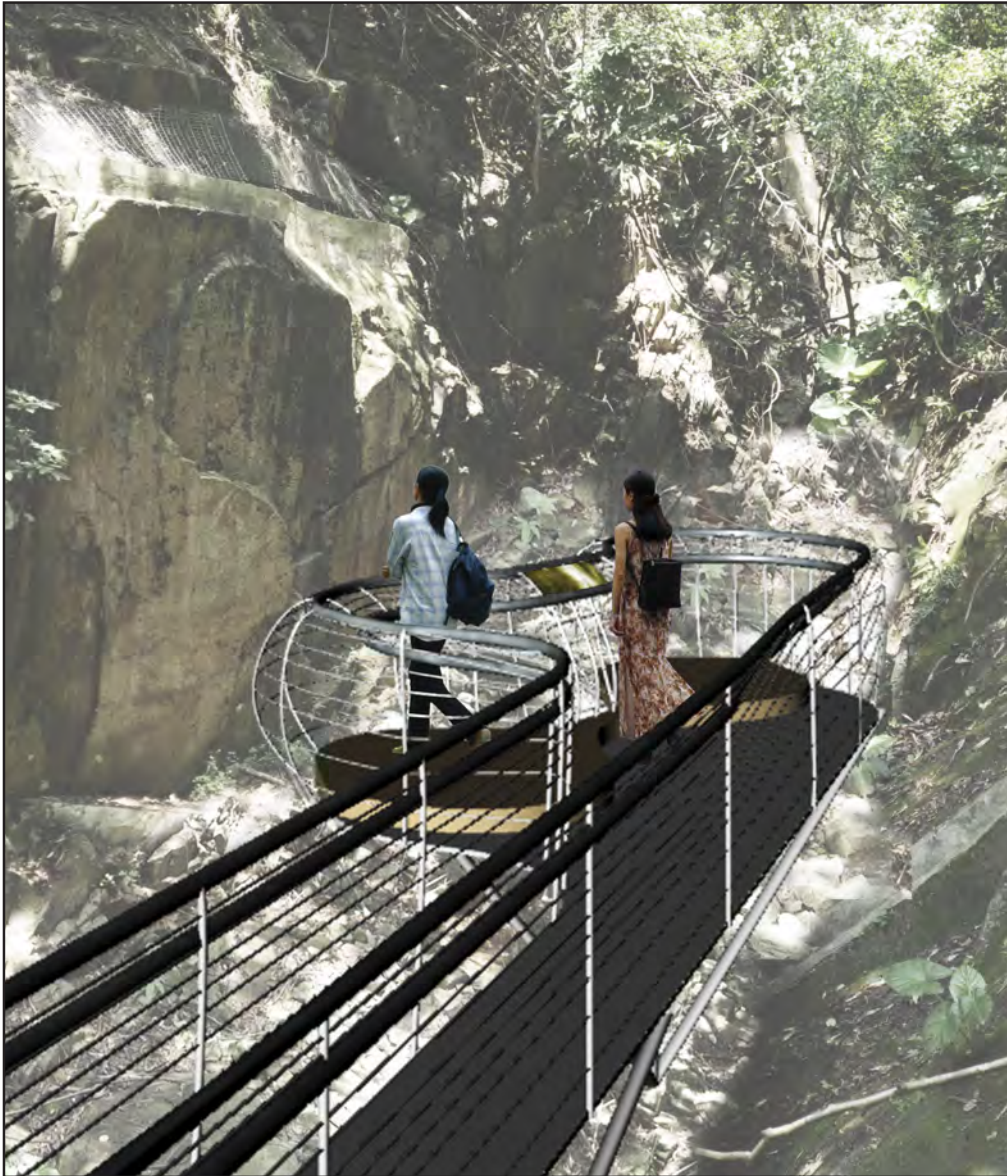
Design approach 1 for Site 4_Wong Chuk Hang

Controlled pathway (viewing bridge)

Suggested actions in the Rock Carvings Consultancy Study	Purpose	Suggested architectural approach by CPW
Physical measure	<ul style="list-style-type: none">· To remove the cement water diversion dam· To remove Remnants of squatter huts and concrete capping on the slope· To extend wooden platform from the existing concrete platform	<ul style="list-style-type: none">· To avoid problems from soluble salts· To enhance drainage· To prevent vandalism by increasing the distance between visitors and the	<p>An extended walkway from the existing concrete platform is to be constructed. Vandalism is prevented by increasing the distance between visitors and the carving.</p> <p>The new walkway is to serve as an alternative route to the steep staircase. Interpretation plate is to be incorporated with the railing structure.</p>
Interpretation plate	<ul style="list-style-type: none">· To be incorporated with the balustrade	<ul style="list-style-type: none">· To provide more information on the historical background of the rock carving· To educate visitors to protect the cultural heritage of Hong Kong

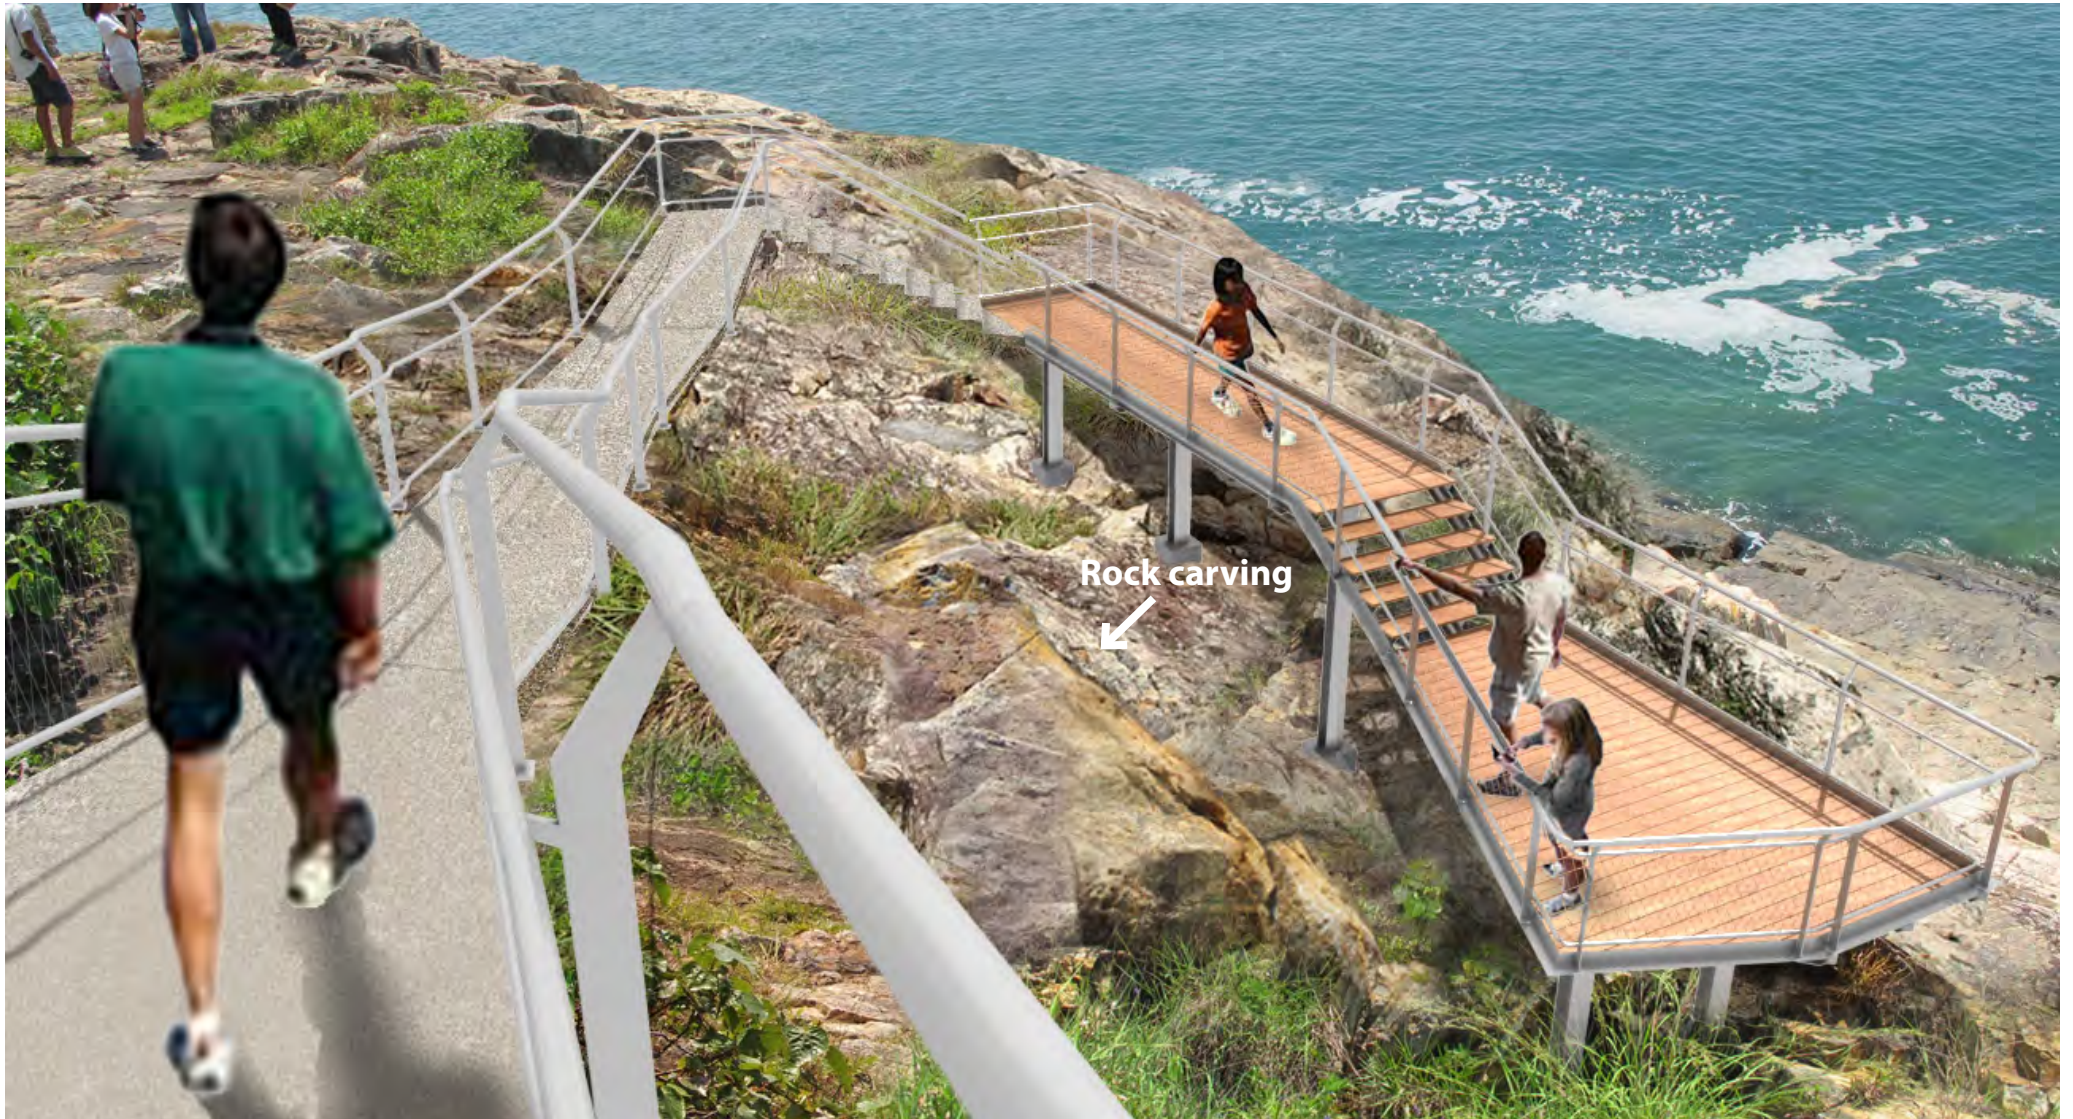
Perspective

Design approach 1 for Site 5_Big Wave Bay

Controlled pathway

Suggested actions in the Rock Carvings Consultancy Study	Purpose	Suggested architectural approach by CPW
Physical measure	<ul style="list-style-type: none">· To remove Portland cement structures· To remove roof structure· To remove cement structure along with the cement steps and footpath	<ul style="list-style-type: none">· To avoid problems from soluble salts· To enhance water drainage· To prevent formation of micro-climate· To reveal natural and original setting of the site· To prevent vandalism by redirecting the path	<p>We suggest to redirect the current footpath by constructing a wooden footbridge. The footbridge will be an effective physical barrier to keep visitors away from the rock while reducing impact to original setting to the minimum.</p> <p>Interpretation plate is to be incorporated with the railing structure</p>
Interpretation plate	<ul style="list-style-type: none">· To be incorporated with the balustrade	<ul style="list-style-type: none">· To provide more background information of the rock· To educate visitors to protect the cultural heritage of Hong Kong

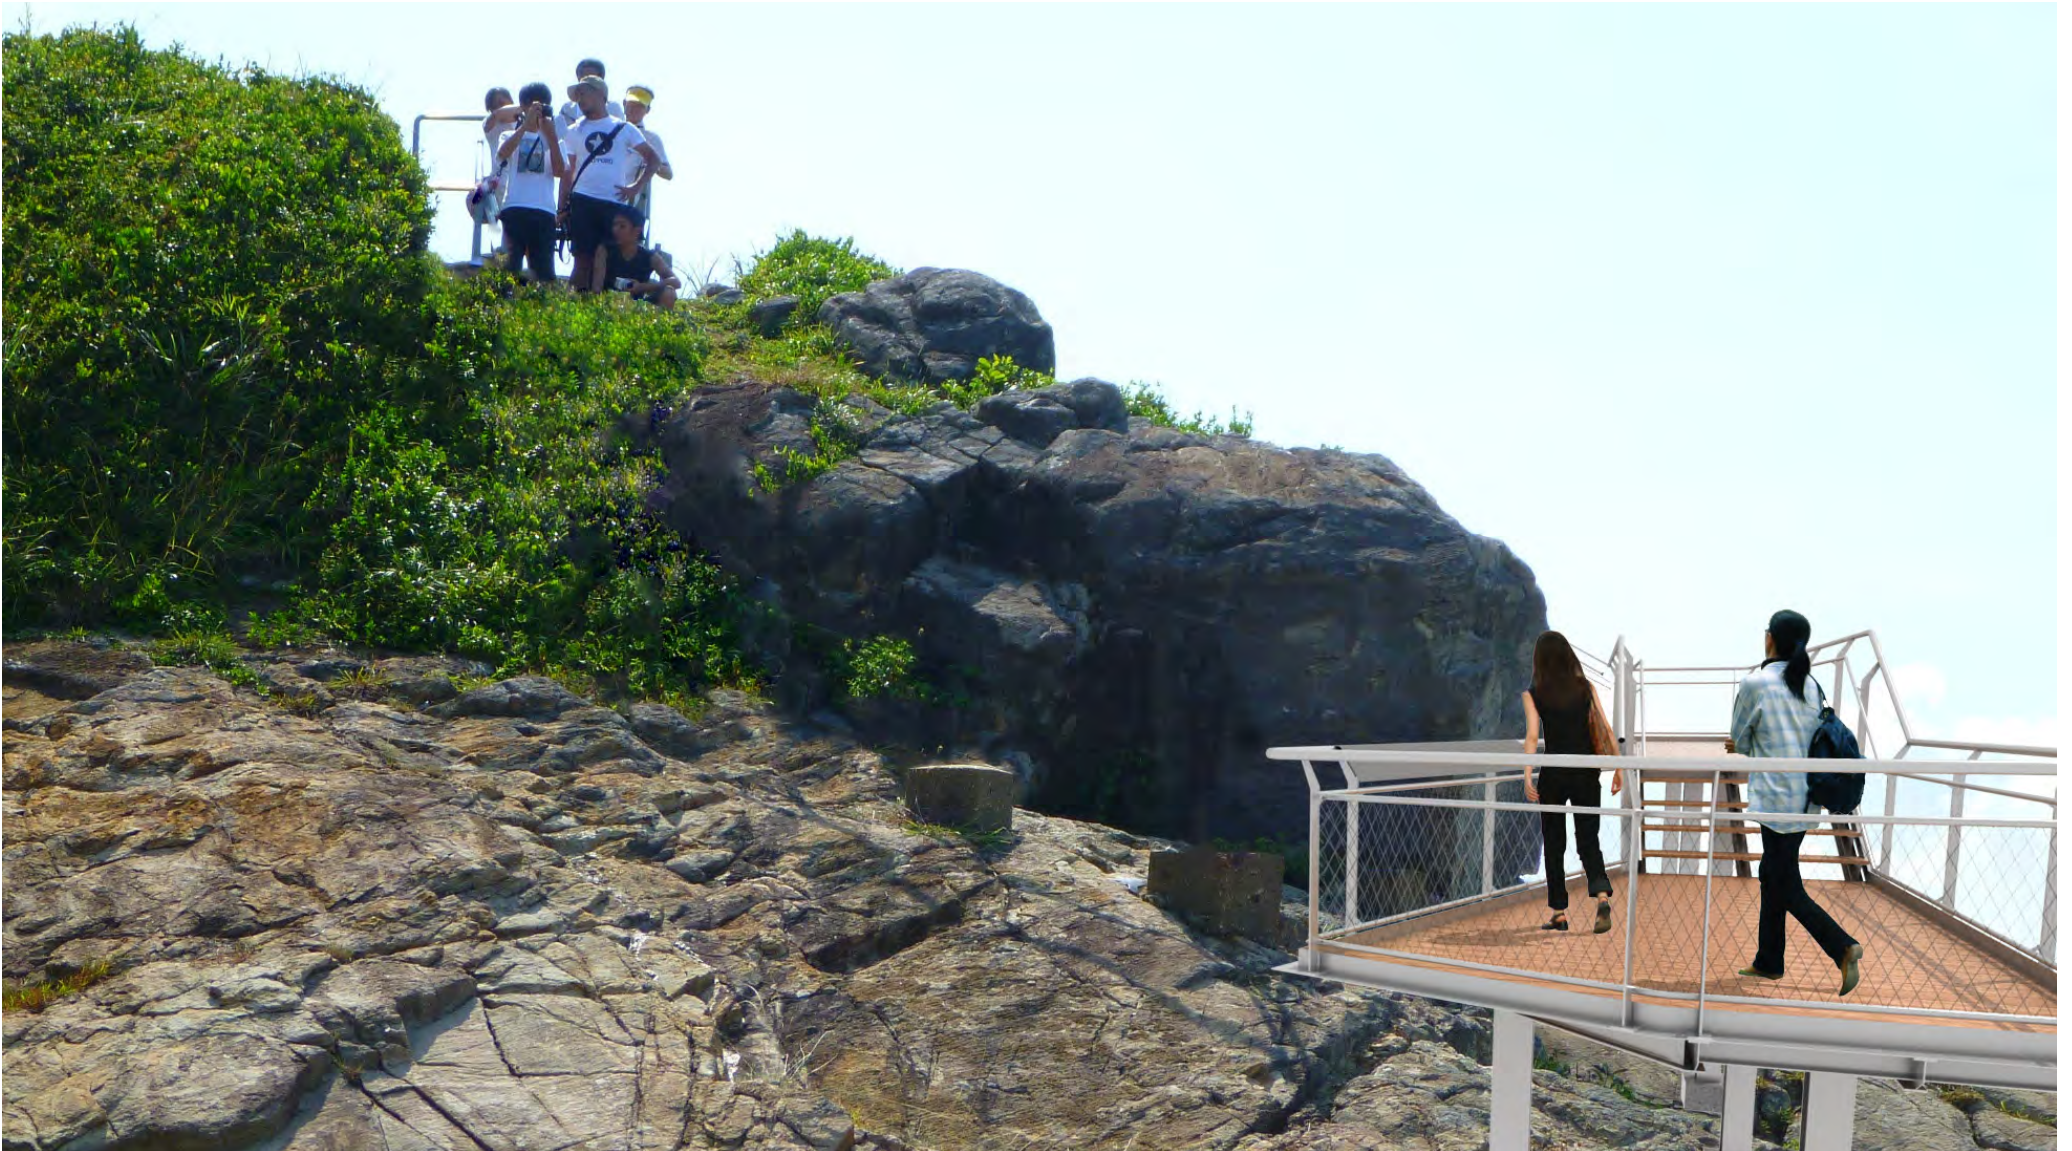
Design approach 1 for Site 6_Lung Ha Wan

Controlled pathway (remove steps)

Suggested actions in the Rock Carvings Consultancy Study	Purpose	Suggested architectural approach by CPW
Physical measure	<ul style="list-style-type: none"> To remove Perspex screen 	<ul style="list-style-type: none"> To increase visibility 	<p>We suggest to redirect the current footpath by constructing a wooden footbridge. The footbridge will be an effective physical barrier to keep visitors away from the rock yet reducing impact to original setting to the minimum.</p> <p>Interpretation plate is to be incorporated with the railing structure.</p> <p>*It is agreed among the experts that the site should not be developed into a popular tourist destination so as to ensure minimum disturbance to the carving and the environment. It has also been strongly recommended that the site should have minimal facilities.</p>
Interpretation plate	<ul style="list-style-type: none"> To be incorporated with the balustrade 	<ul style="list-style-type: none"> To provide more background information of the rock To educate visitors to protect the cultural heritage of Hong Kong

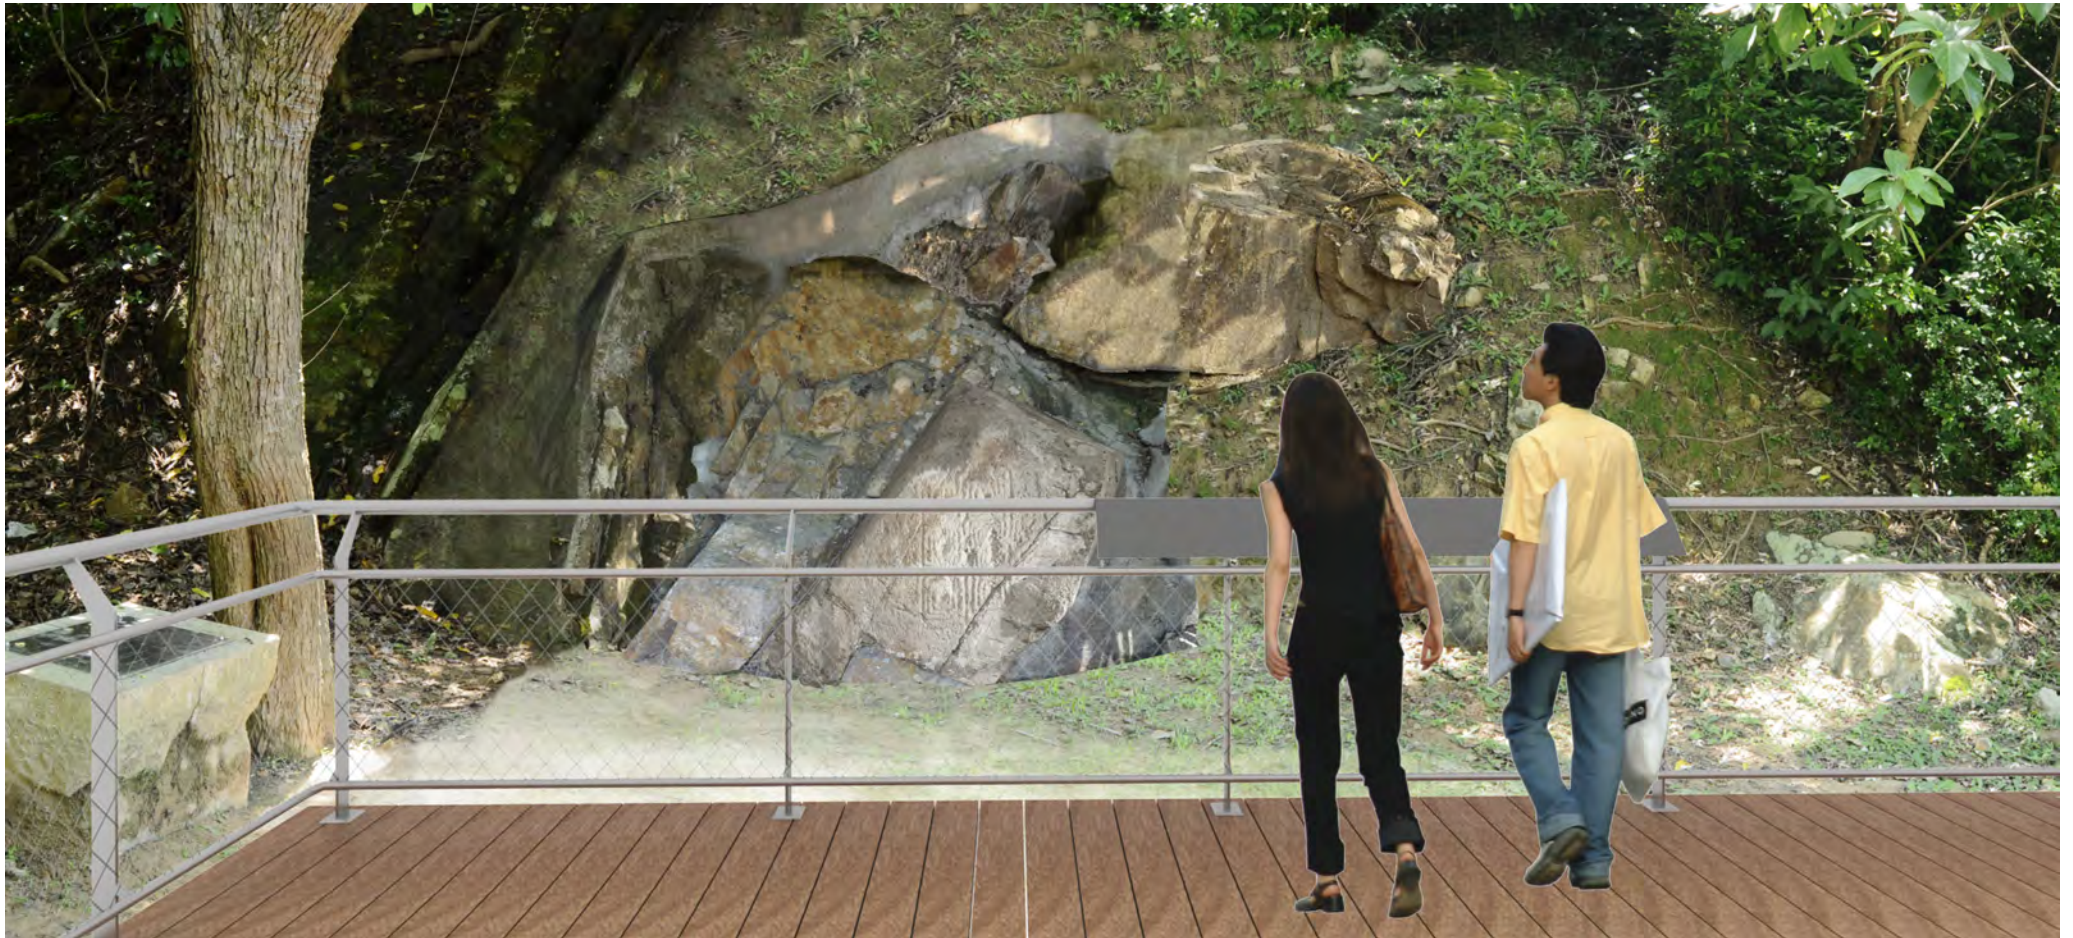
Perspective

Design approach 1 for Site 7_Shek Pik

Controlled pathway

Suggested actions in the Rock Carvings Consultancy Study	Purpose	Suggested architectural approach by CPW
Physical measure	<ul style="list-style-type: none"> To remove all concrete from the surrounding area of the carving 	<ul style="list-style-type: none"> To avoid problems from soluble salts To enhance drainage 	<p>A wooden footbridge is to be constructed as an effective physical barrier to keep visitors away from the rock yet keeping impact to original setting to the minimum.</p> <p>Interpretation plate is to be incorporated with the railing structure</p> <p>*We also recommend that the condition of the footpath to the rock carving be improved.</p>
	<ul style="list-style-type: none"> To remove roof structure 	<ul style="list-style-type: none"> To prevent formation of micro-climate 	
	<ul style="list-style-type: none"> To erect wooden fence around the refuse collection point 	<ul style="list-style-type: none"> To create a better environment around the rock carving site and to enhance the visiting experience for the public To prevent spreading of odours from the refuse collection point

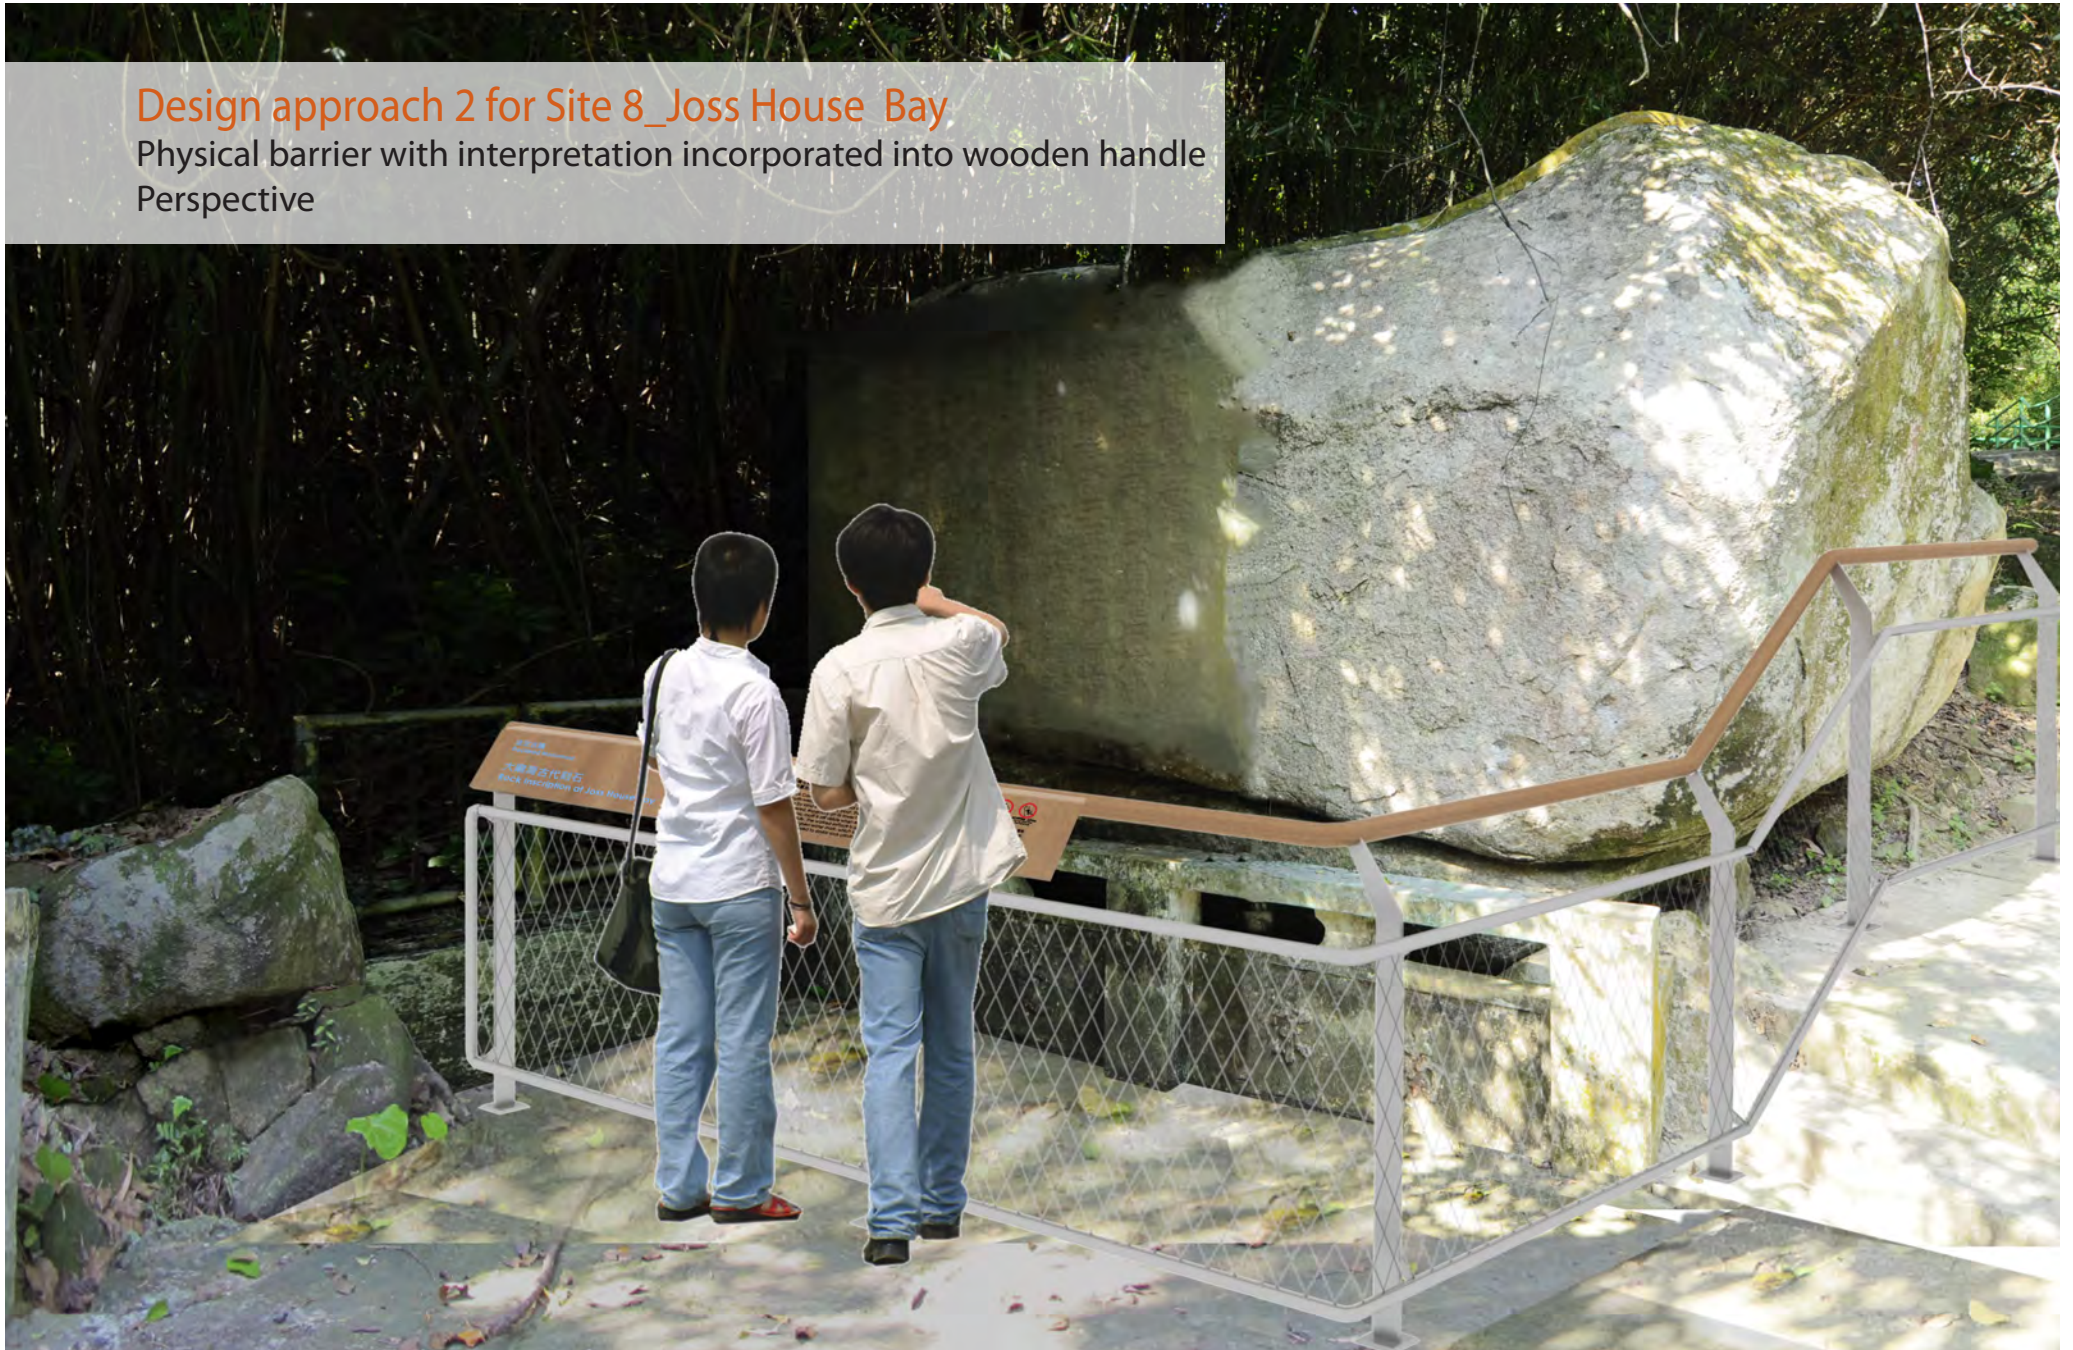
Design approach 2 for Site 8_Joss House Bay

Physical barrier with interpretation incorporated into wooden handle
Perspective

Suggested actions in the Rock Carvings Consultancy Study	Purpose	Suggested architectural approach by CPW
Physical measure	<ul style="list-style-type: none">· To remove Perspex screen	<ul style="list-style-type: none">· To increase visibility	Being the only readable rock carving, it is most prone to vandalism. We propose erecting a physical barrier since there are site constraints for extension or construction of alternative pathway. Interpretation plate is to be incorporated with the barrier structure.
Interpretation plate	<ul style="list-style-type: none">· To be incorporated with the balustrade	<ul style="list-style-type: none">· To provide more background information of the rock· To educate visitors to protect the cultural heritage of Hong Kong	
Chemical & geographic conditions	<ul style="list-style-type: none">· To remove existing concrete plinth	<ul style="list-style-type: none">· To reveal the original setting· To avoid soluble salt from concrete and protect the rock in the long term

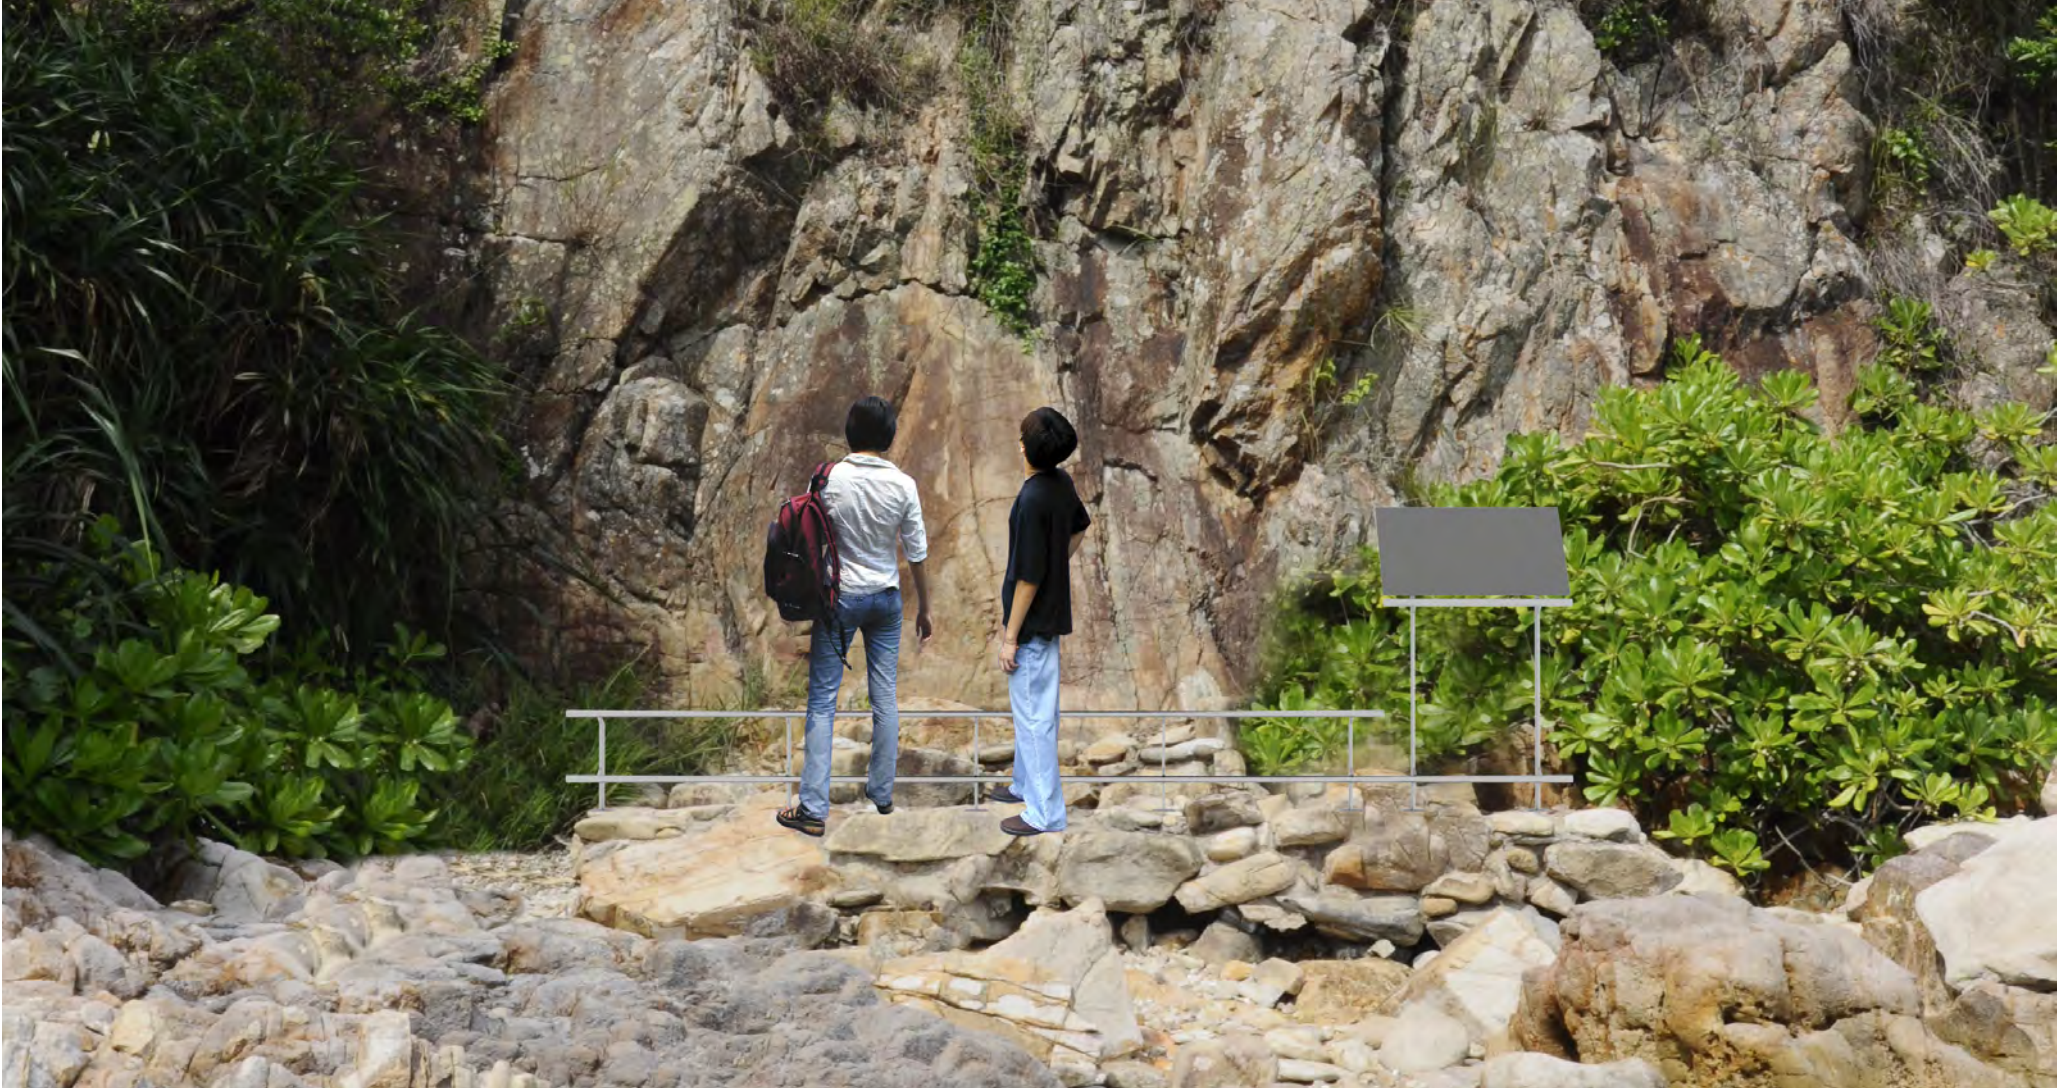
Perspective

Design approach 3 for Site 9_Kau Sai Chau

Interpretative panel as psychological barrier

Suggested actions in the Rock Carvings Consultancy Study	Purpose	Suggested architectural approach by CPW
Physical measure	<ul style="list-style-type: none">· To stabilize rocks above the carving	<ul style="list-style-type: none">· To increase visibility	Only a standalone interpretation plate is to be installed. *It is agreed among the experts that the site should not be developed into a popular tourist destination as to ensure minimum disturbance to the carving and the environment. It has also been strongly recommended that the site should have minimal facilities.
	<ul style="list-style-type: none">· To remove all existing structures	<ul style="list-style-type: none">· To prevent formation of micro-climate	
Interpretation plate	<ul style="list-style-type: none">· To be incorporated with the balustrade	<ul style="list-style-type: none">· To provide more background information of the rock· To educate visitors to protect the cultural heritage of Hong Kong.
