**Heritage Impact Assessment on  
Block M at the Kowloon Hospital at No. 147A Argyle Street, Mong Kok**

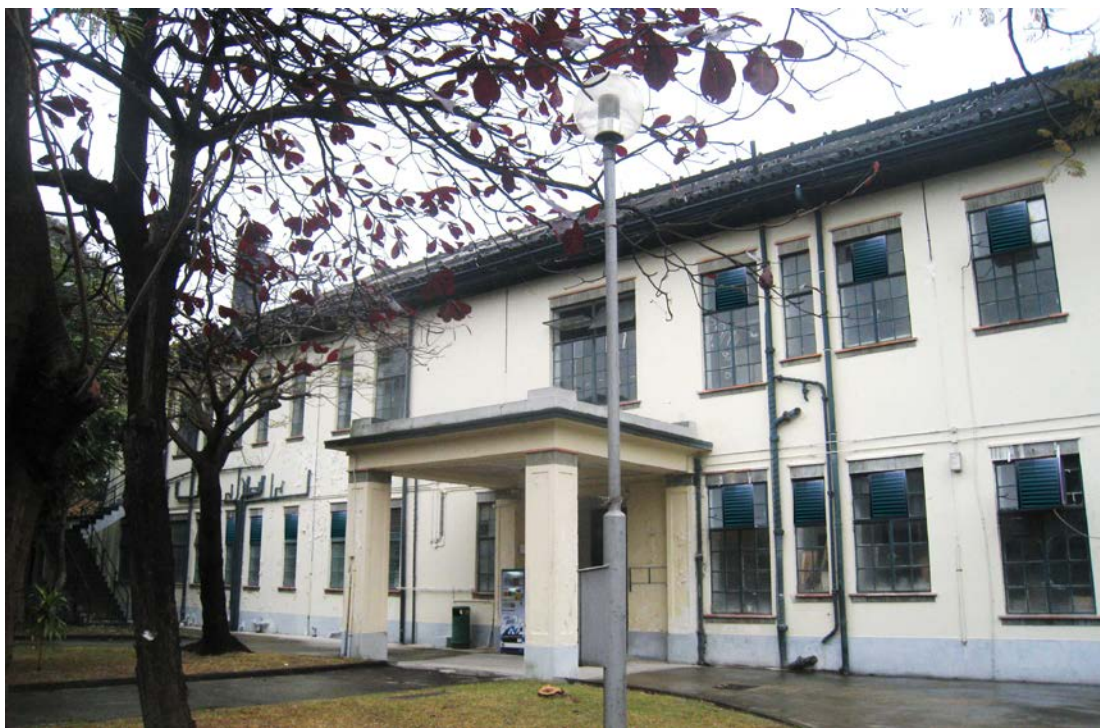
Figure 7 Artist impression of the restored façade with new louvres  
for the new air-conditioning system

- (vi) New louvres would be installed at the original location of window air-conditioning units to avoid making new openings on the walls (please refer to Figure 7).

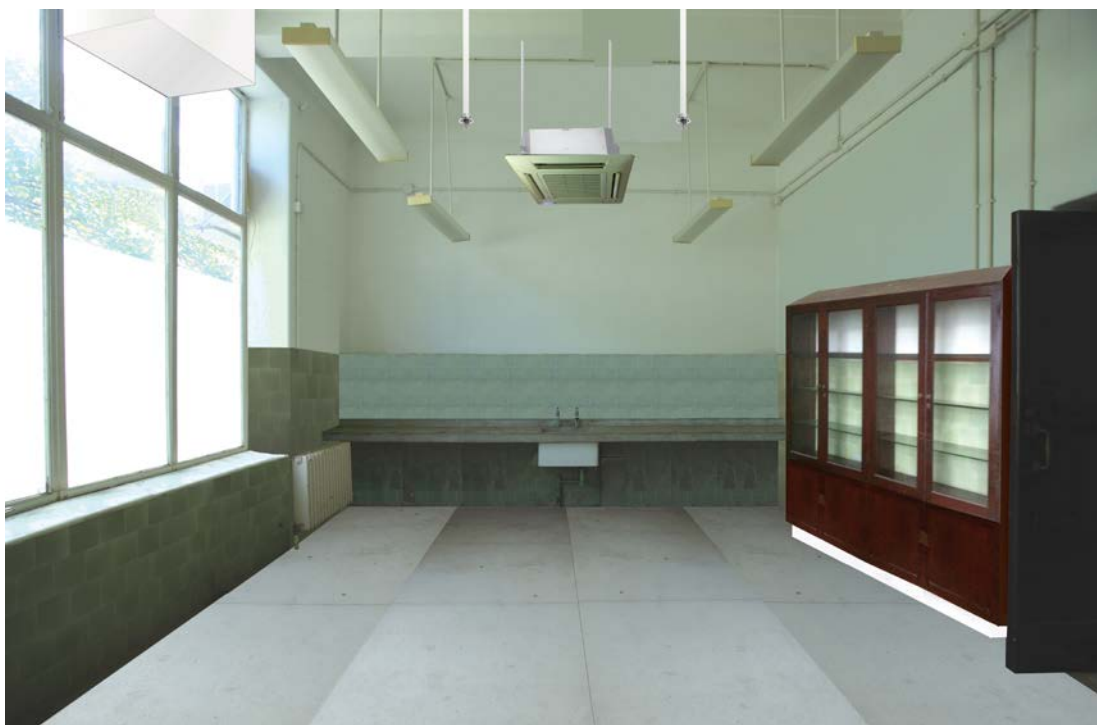
Figure 8 Artist impression of the preserved delivery room on the G/F

- (i) The original delivery room on the G/F would be preserved including the original headroom, floor and wall finishes, electric lighting fixtures/ fans / heating devices, terrazzo counter top with sink etc. A cabinet found on the delivery room on the 1/F would be relocated here (please refer to Figure 4 & 8).
- (ii) One of the wards on the 1/F would be preserved including the original headroom, floor and wall finishes, and cupboards with basin and wardrobe (please refer to Figure 6 & 9).

- (v) Level of the new false ceiling on the 1/F and G/F would be installed at a level higher than existing fanlights and windows (3.4m H). Treatment of the edge would try to inform the original high headroom of the corridor and rooms (please refer to Figure 8).

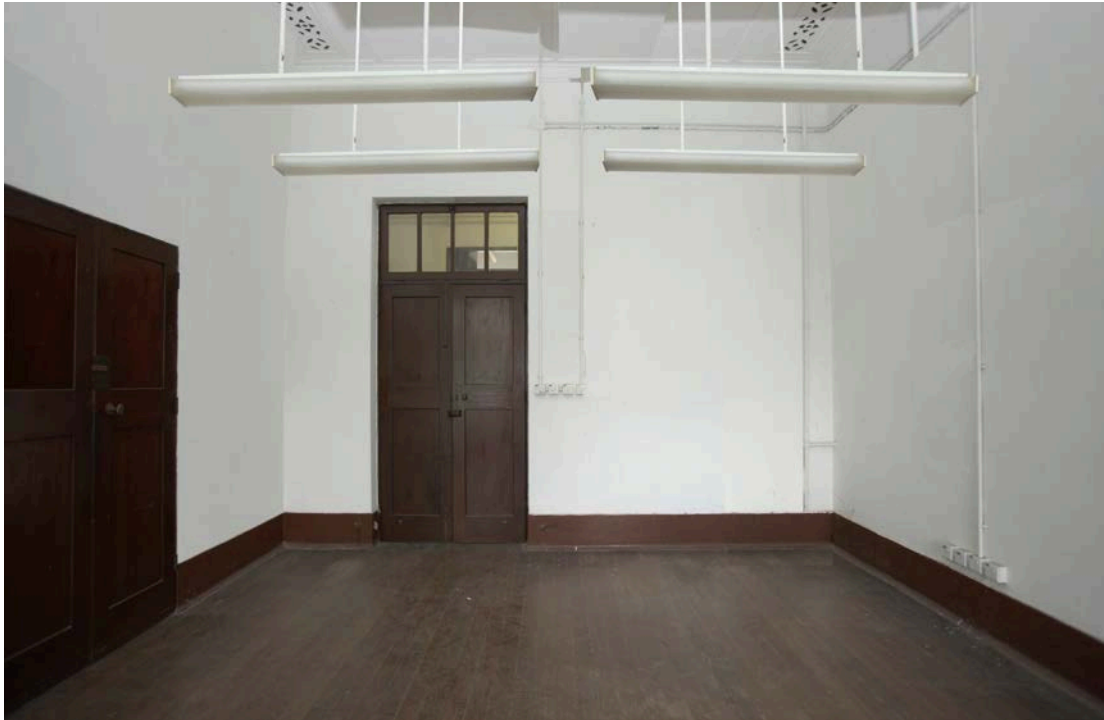
Figure 9 Artist impression of the preserved ward on the 1/F

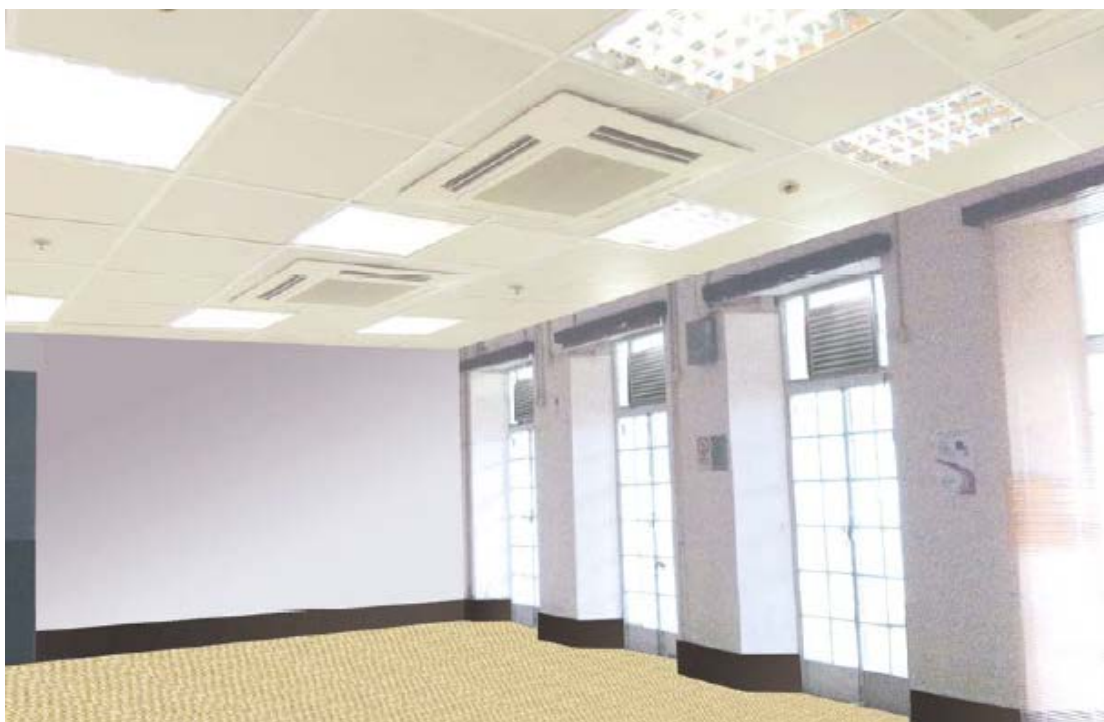
Figure 10 Artist impression of one the training rooms on the G/F  
with the new false ceiling maintaining at 3.4m from the floor level

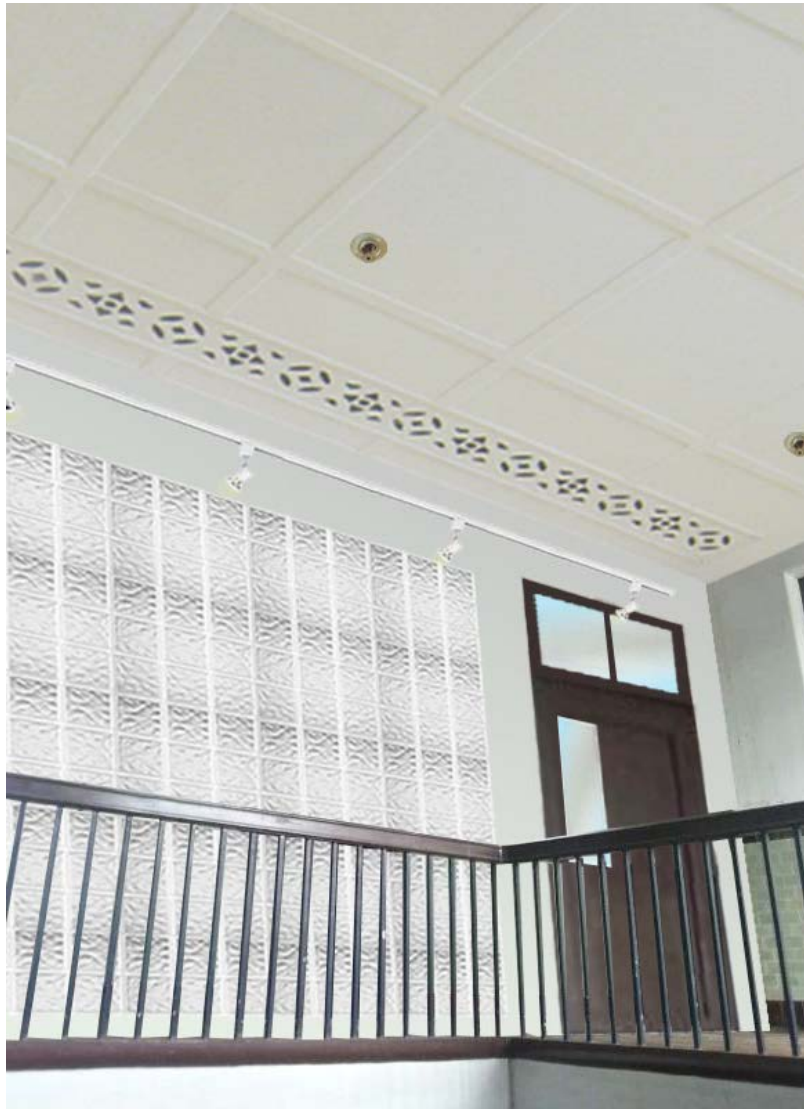
Figure 11 Artist impression of new fire rated glass block wall  
at the 1/F landing of the grand staircase

- (b) Upgrading of fire safety provisions and building services systems
- (i) Red bricks from the demolished parapet walls would be salvaged for reuse.
  - (ii) Materials with high transparency such as fire rated glass blocks would be used to enhance the transparency of the new fire rated wall at 1/F landing, and allow natural lighting to reach the central corridor (please refer to Figure 11).
