**HERITAGE IMPACT ASSESSMENT
IN RESPECT OF BLOCK 3 AT OLD LEI YUE MUN BARRACKS**

Architectural Services Department

September 2016

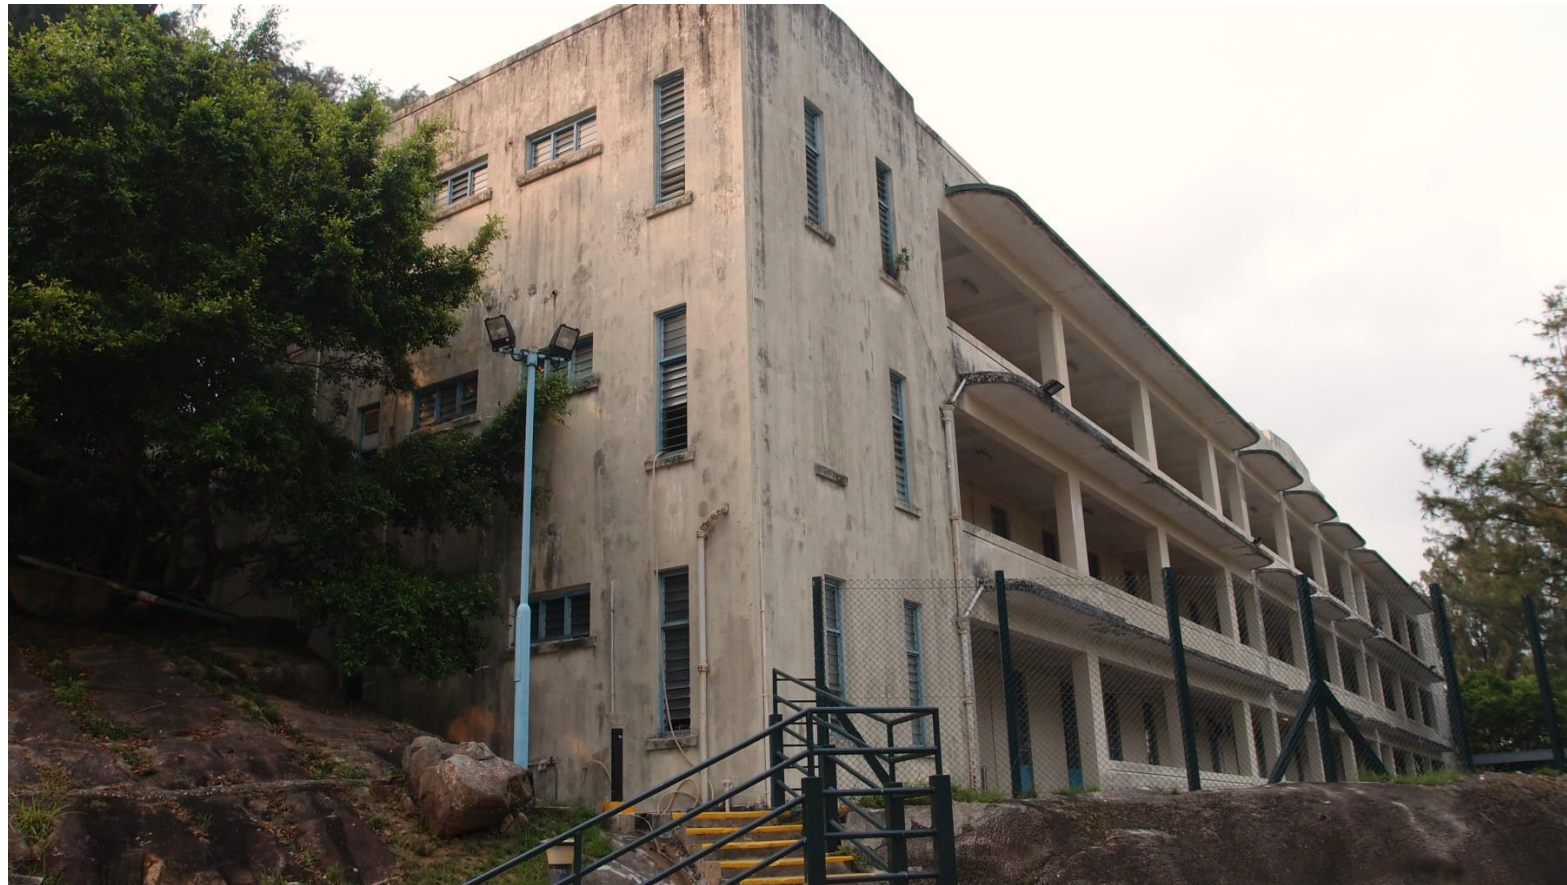
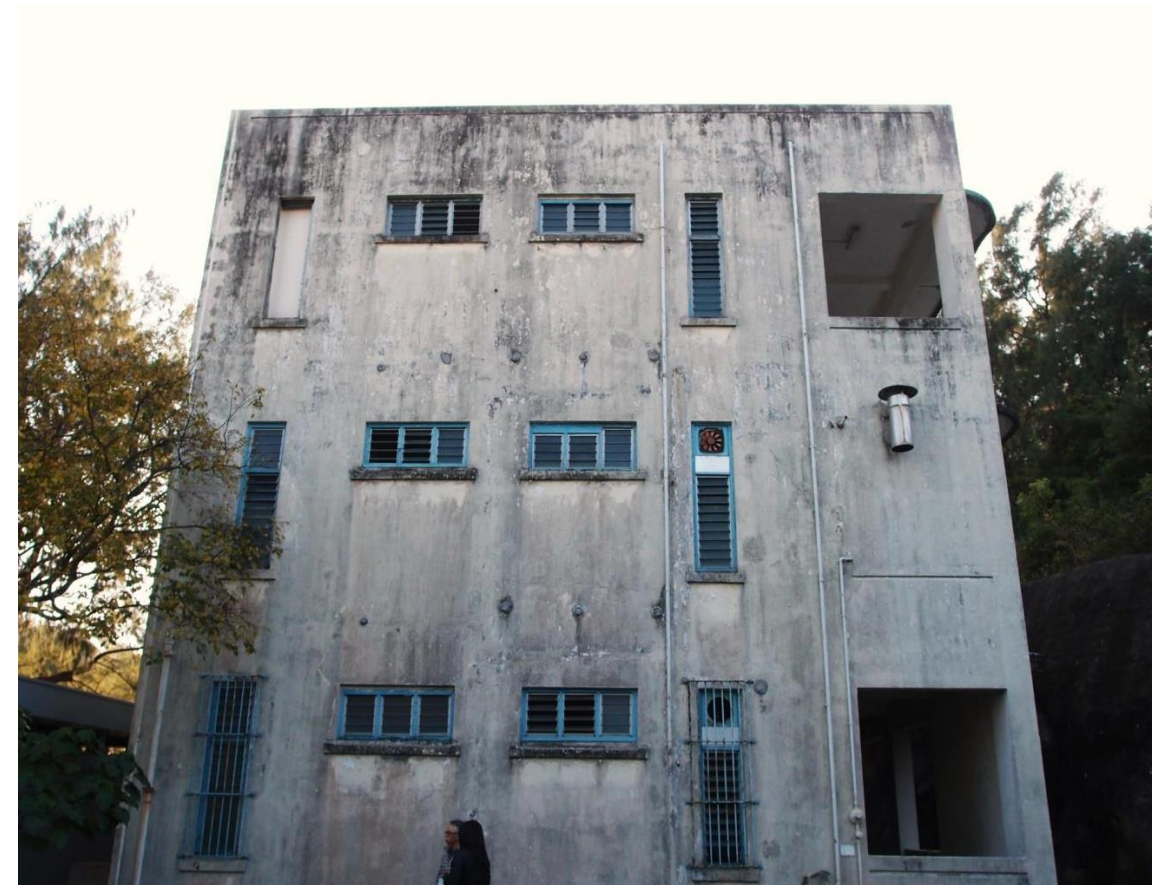
Figure 1: Overview of Block 3

3. Eventually, Block 3 of the LYMP is chosen as the site for the dedicated quarantine facility. Block 3 is a three-storey standalone building (please refer to **Figure 1** for the overview of the Block) in a relatively secluded part of the LYMP (please refer to **Figure 2** for the location plan of Block 3). It was accorded as a Grade 2 historic building by the Antiquities Advisory Board in 2009.

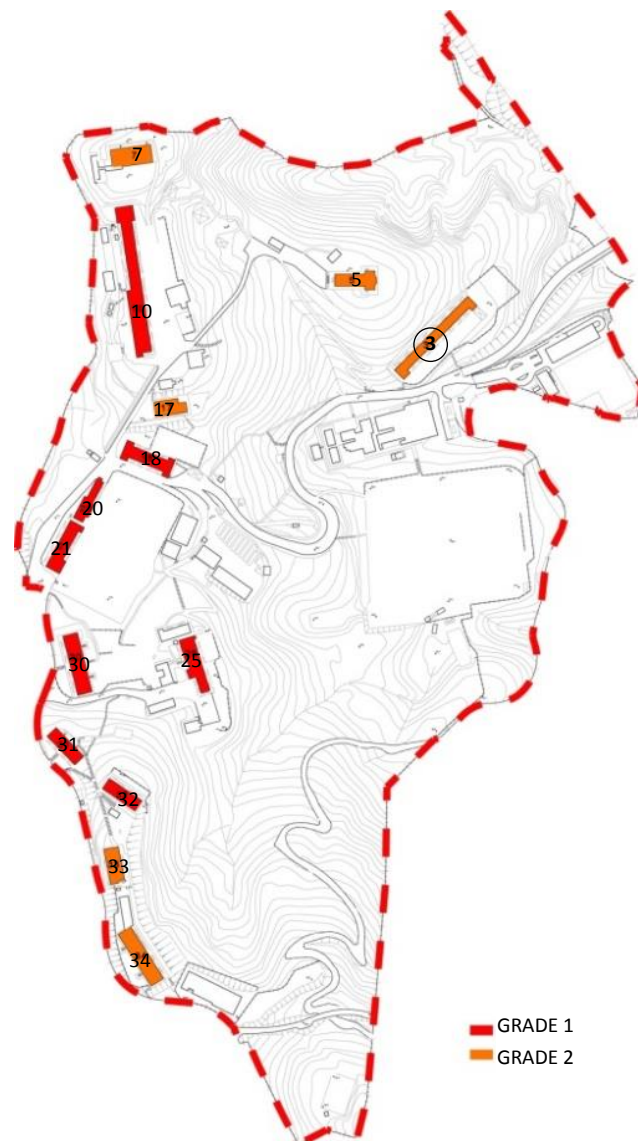
Figure 3: Location plan of all graded blocks at LYMP

There are a total of eleven graded historic buildings, including Block 3, and three declared monuments, within the site of the LYMP. The buildings together formed a historic complex of significant heritage values (please refer to **Figure 3**).

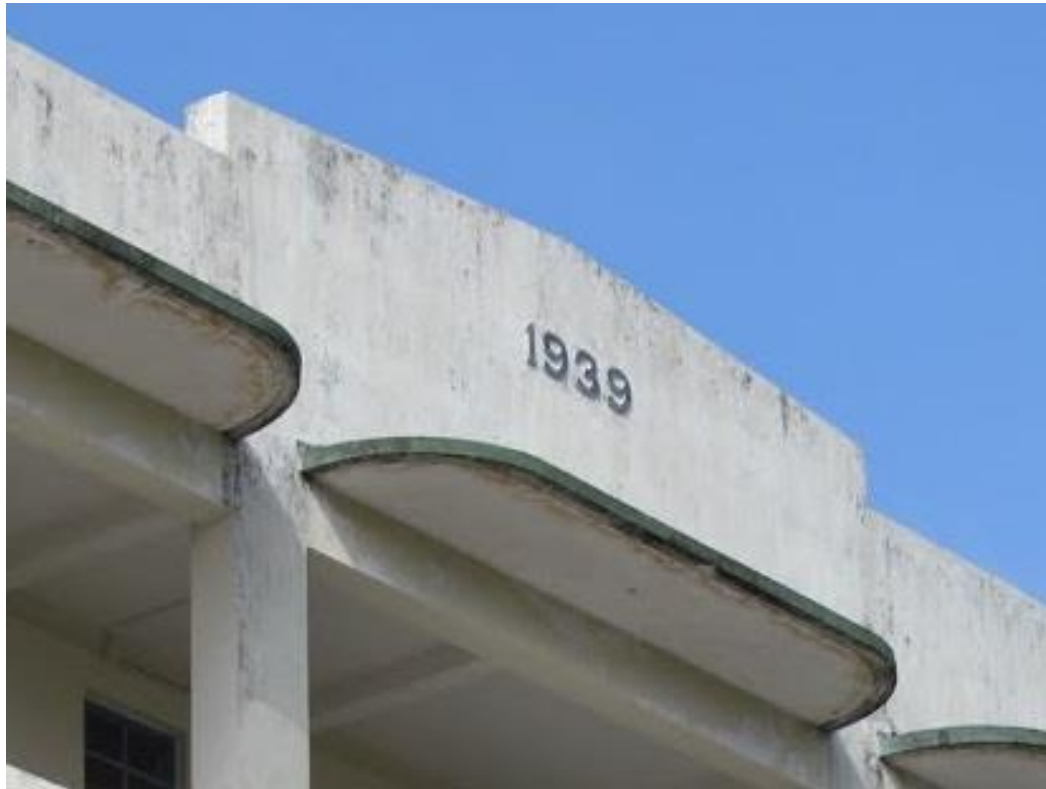
Stepped “ziggurat” shaped parapet wall with the construction year “1939”

The barrack rooms open on to the verandahs and have steel framed doors and windows. The roof is flat with a stepped “ziggurat” shaped parapet wall on the front façade. The whole building is painted a pale cream color with dark green trim to the edges of the typhoon canopies.

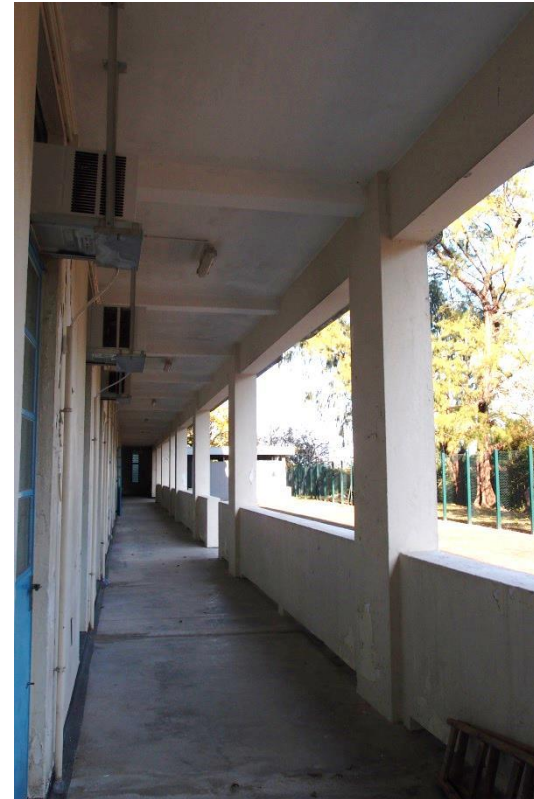
Open verandah

The front façade consists of open colonnaded verandahs with each open bay protected by a projecting cantilevered typhoon canopy with rounded corners.

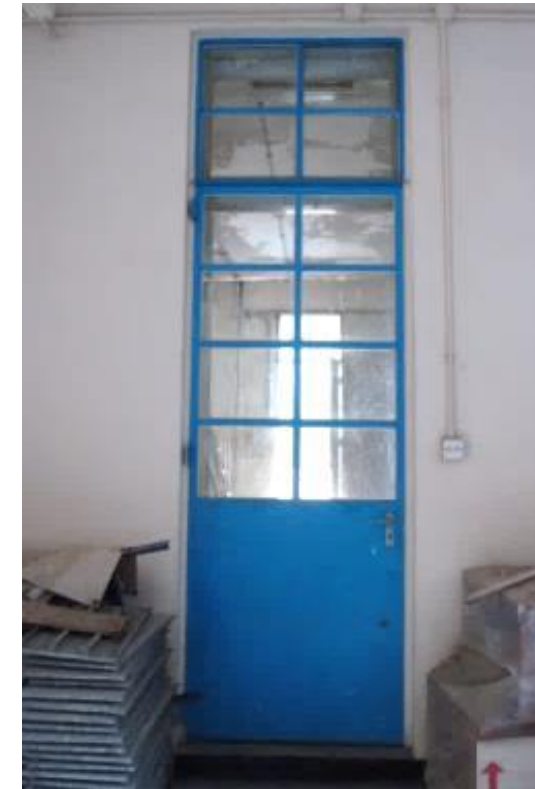
Metal door

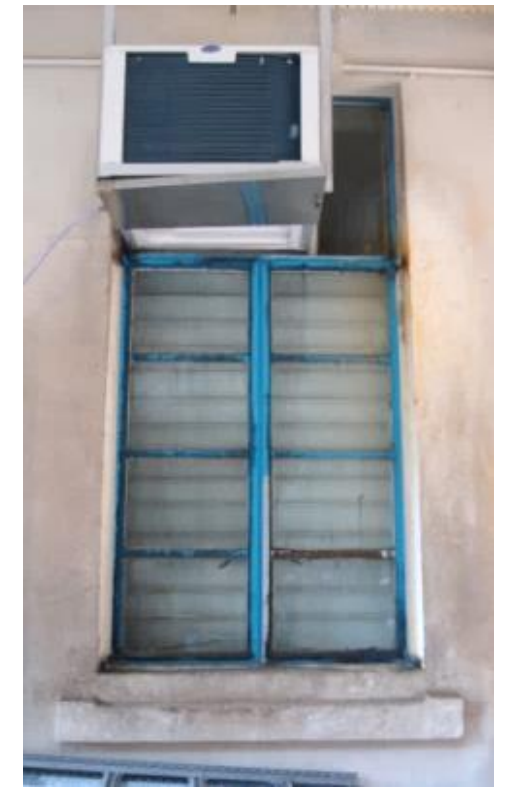
Metal window

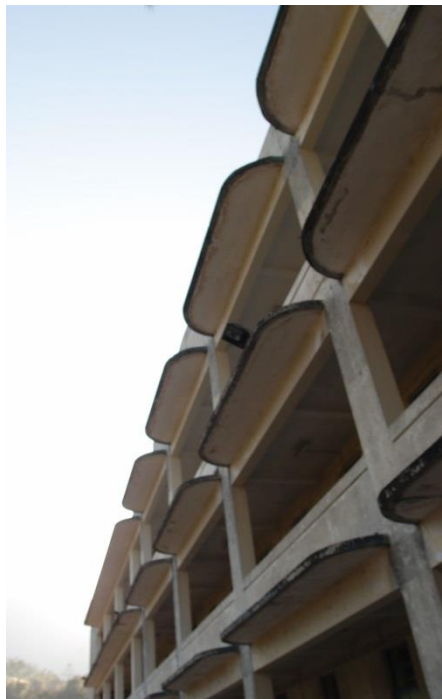
Typhoon canopies

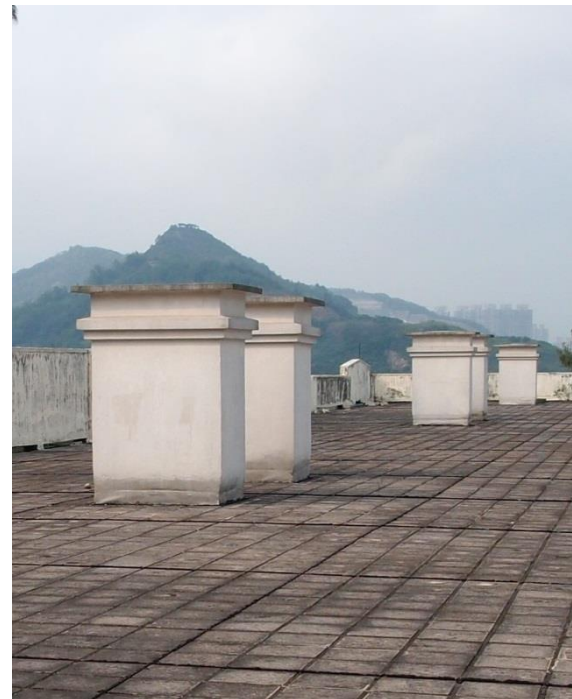
Chimneys

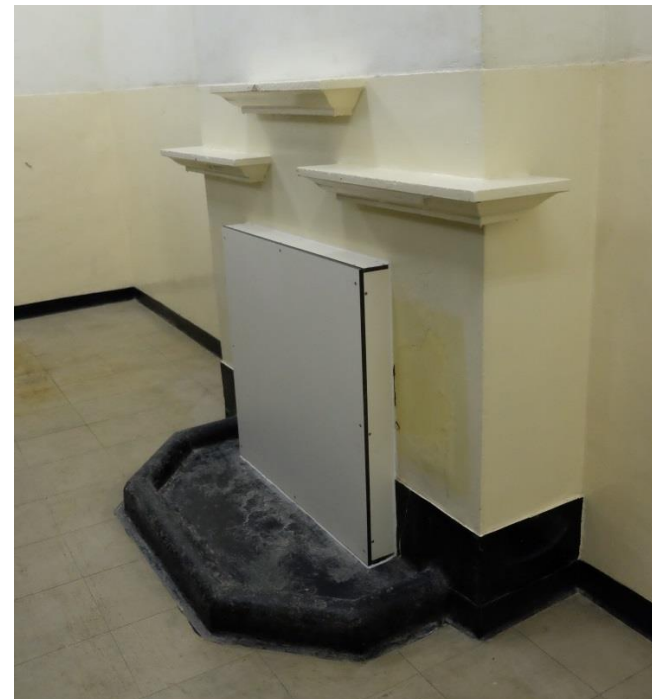
Fireplaces

Old fireplaces and other artifacts in the 3-person room on 1/F of Block 3 will be preserved *in-situ* for interpretation of the daily living in the past.

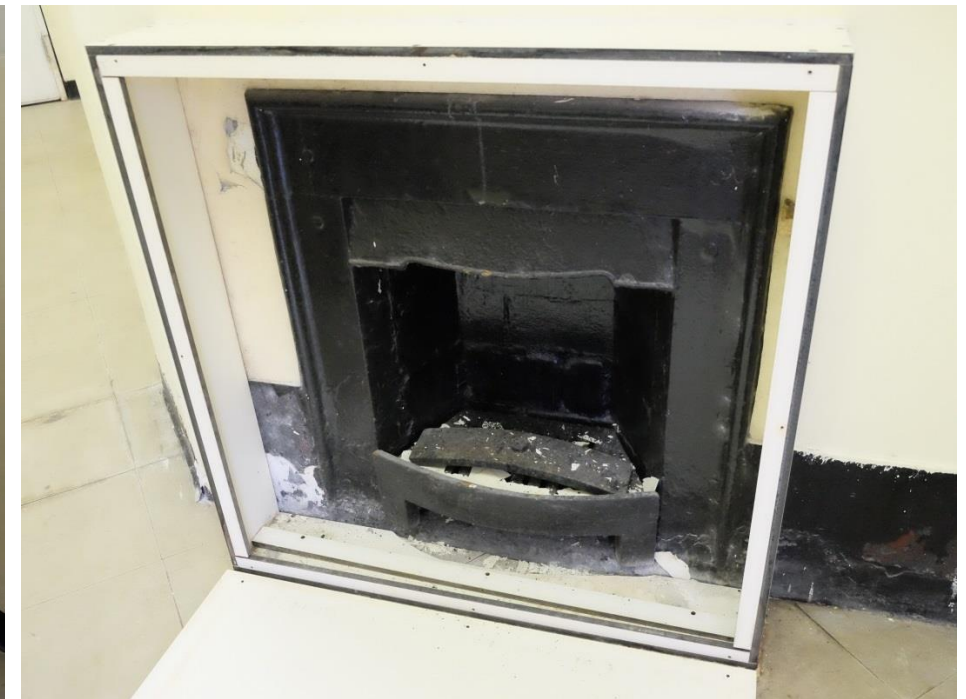
Figure 4: Key CDEs

- a. Authenticity of Block 3 and its architectural merits should be maintained with minimum intervention. The key character-defining elements (CDEs) identified should be preserved *in-situ* and restored as far as possible (please refer to **Figure 4**).

- b. Heritage building fabrics including building form, fenestration, stepped “ziggurat” shaped roof parapet wall, typhoon canopy, verandah, and chimney stacks, staircase, handrail, fireplaces, etc. would be preserved and restored as far as possible.

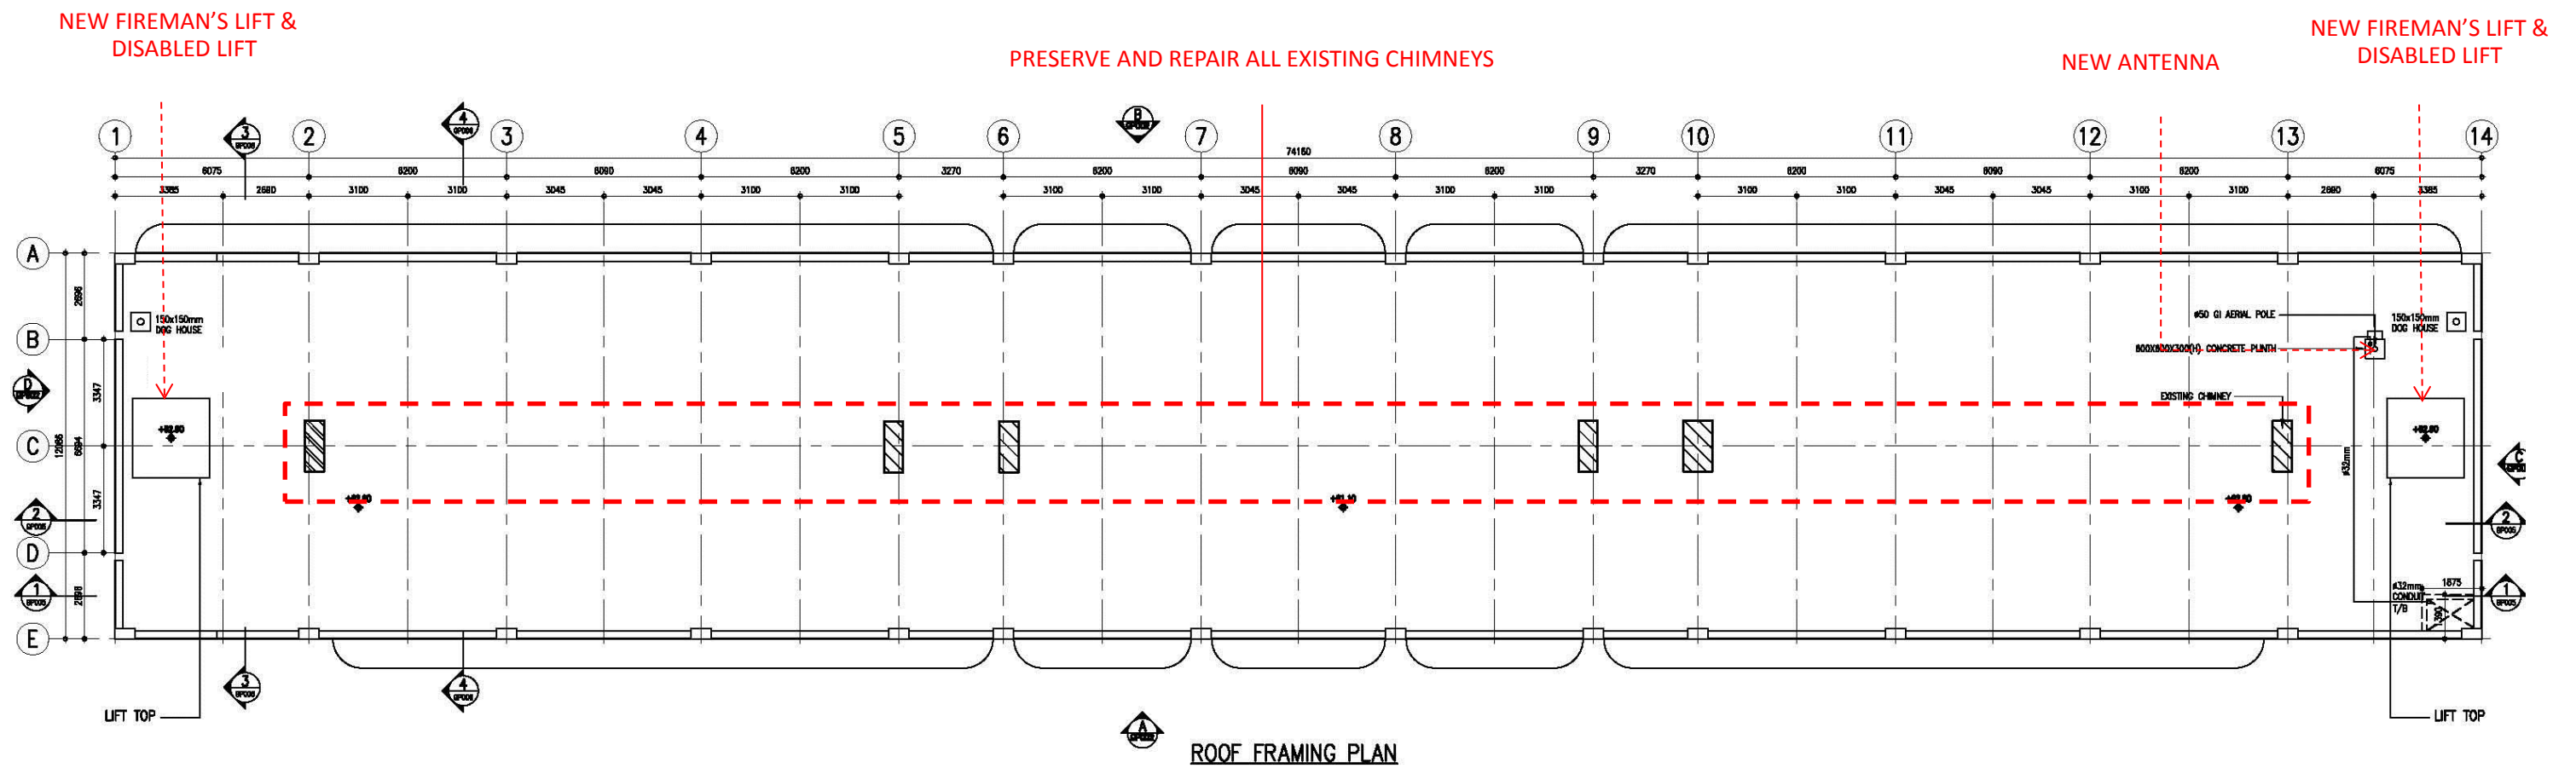
Figure 13: Proposed layout plan of R/F

- a. New addition and alteration should be of compatible design, in terms of suitable material, color and texture. It should not impose visual impact on the building.
- b. New plants and equipment shall not affect the structural stability of the historic structures and should be placed at a less prominent location away from the perimeter of the roof to minimise visual impact on the building and its surrounding area.
