**Agreement No. CE 8/2022 (CE)
Site Formation and Infrastructure
Works for Public Housing
Developments at Sha Po, Shap Pat
Heung and Tai Kei Leng, Yuen Long -
Investigation, Design and Construction**

**Final Heritage Impact Assessment Report
(Sha Po)(SP-A21)**

4110336/BIN/SP/035/Issue 3

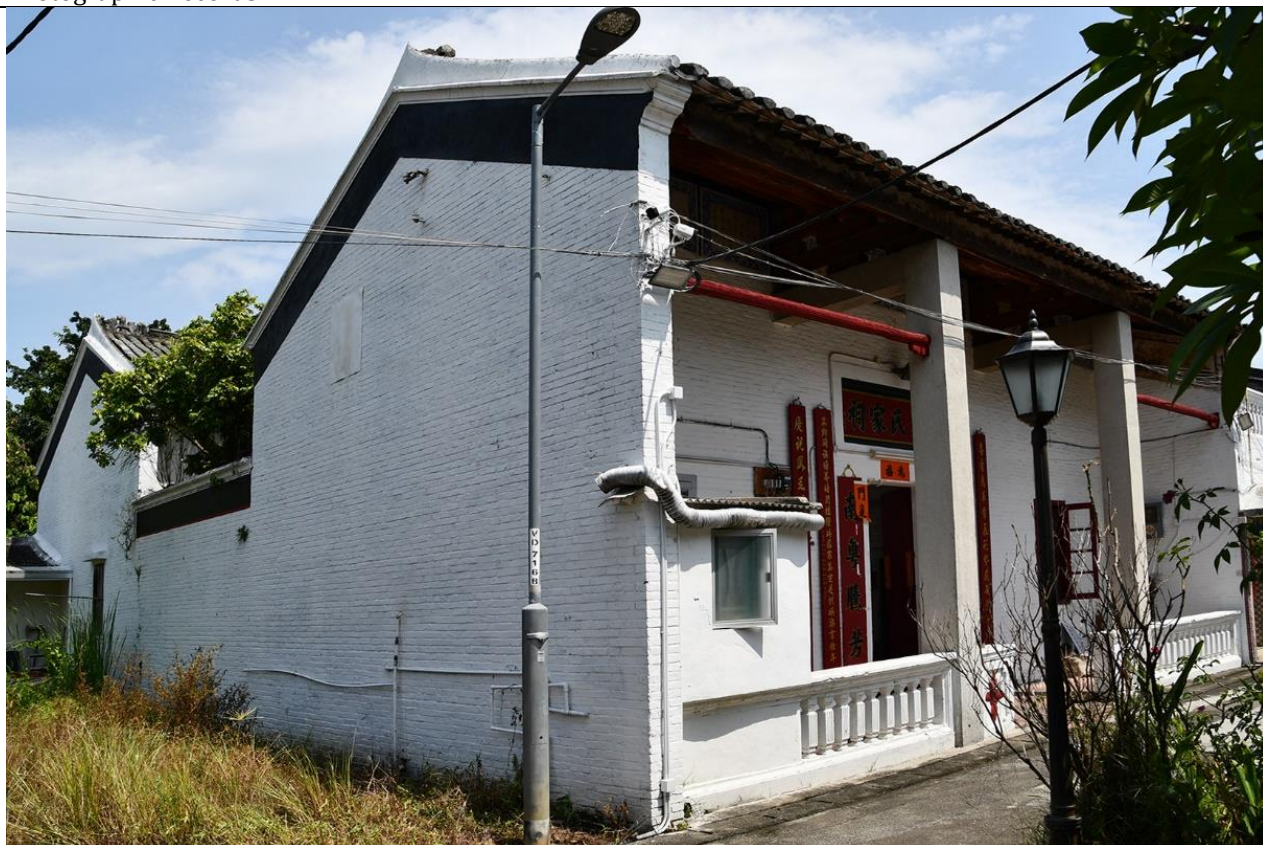
Modifications: Entrance Hall has slight alteration to equip residential needs, including a small temporary structure added to the façade, pipelines, air-conditioners and etc installed. The side rooms of the entrance hall have interior walls pasted with ceramic tiles. Also, the entire exterior walls have been repainted as informed by Mr. Shum, grandson of General Shum.

General view of GB-01, showing northwest and southwest elevations, looking east.

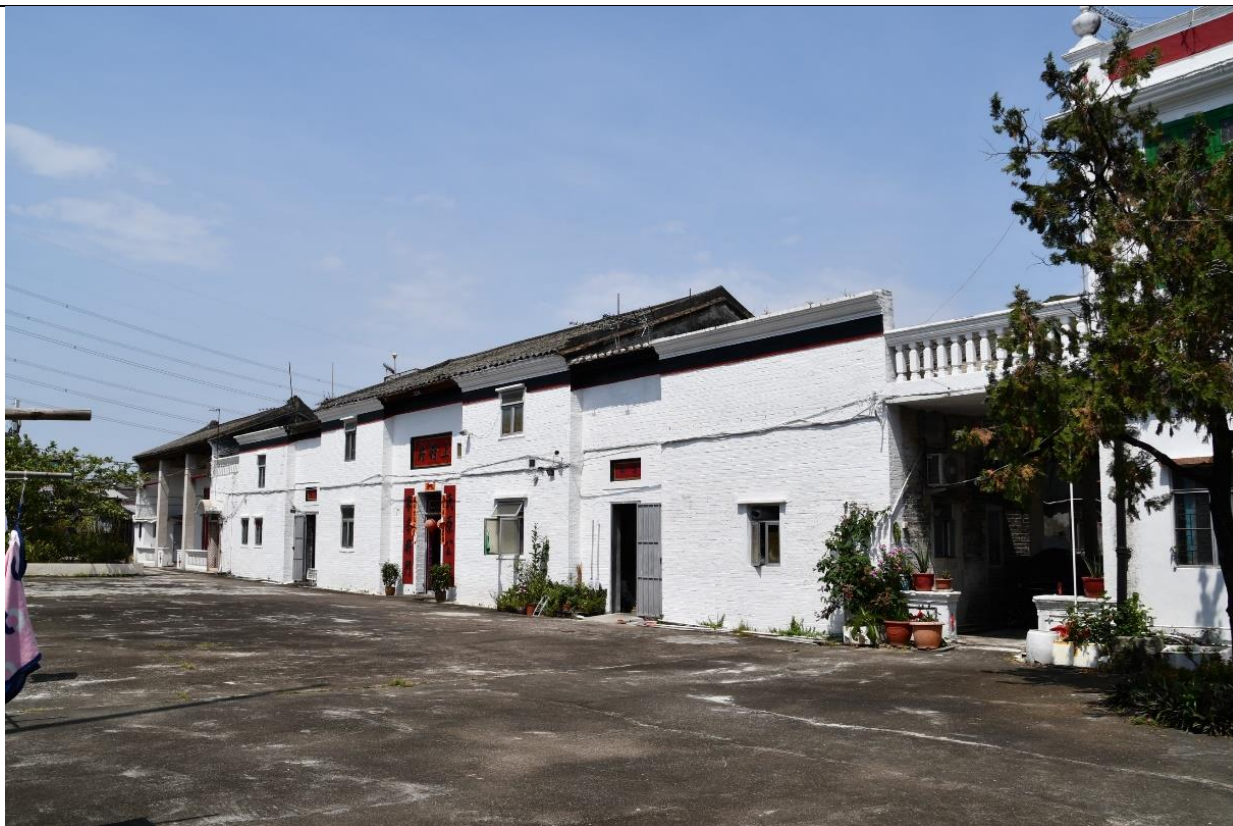
Interior: See “Architectural Appraisal” section above.		
Existing Condition: Good.		
Past and Present Uses: Residential		
Modifications: Façade wall repainted. Most windows and gates have been replaced by modern style ones. Entrance area in the north side was added and shows later elements such as ceramic wall and floor tiles. Some parts of exterior wall of the living-room unit have been paved. Air-conditioners, pipelines and wires added.		
Photographic Records

General view of GB-02, showing southwest elevation, looking north.

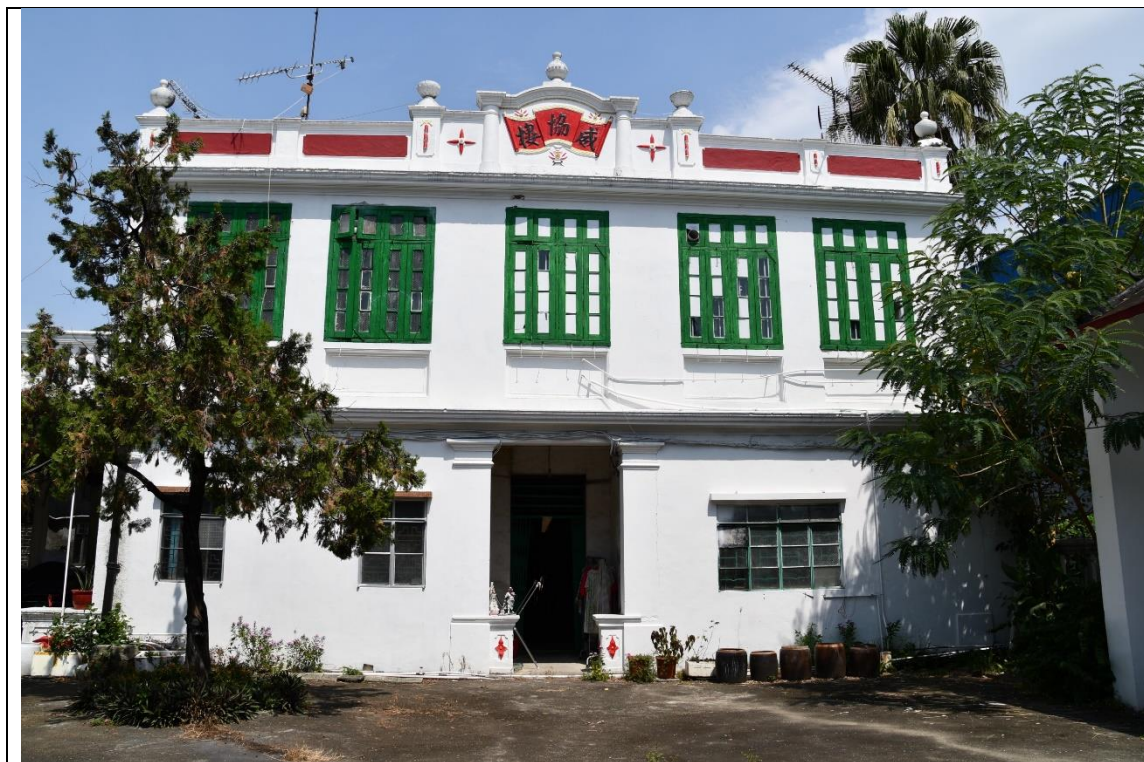
Interior: No Access.		
Existing Condition: Good.		
Past and Present Uses: Residential		
Modifications: Window settings see different phases of repairs and replacements. Façade wall repainted while the other facing walls seen repaired lines. Air-conditioners and wires added.		
Photographic Records

Front view of GB-03, showing southwest elevation, looking northeast.

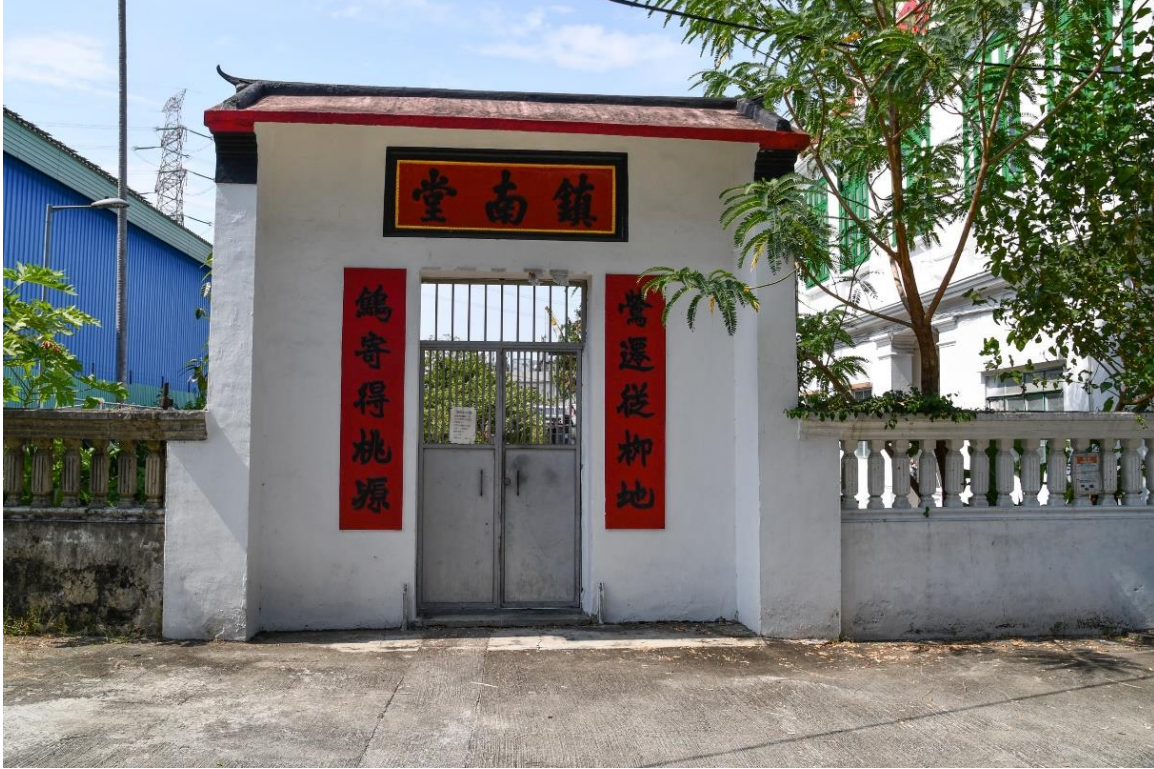
Modifications: Entrance gate has its exterior repainted, iron shutters probably not original ones.

Front view of HB-01, showing southeast elevation, looking northwest.

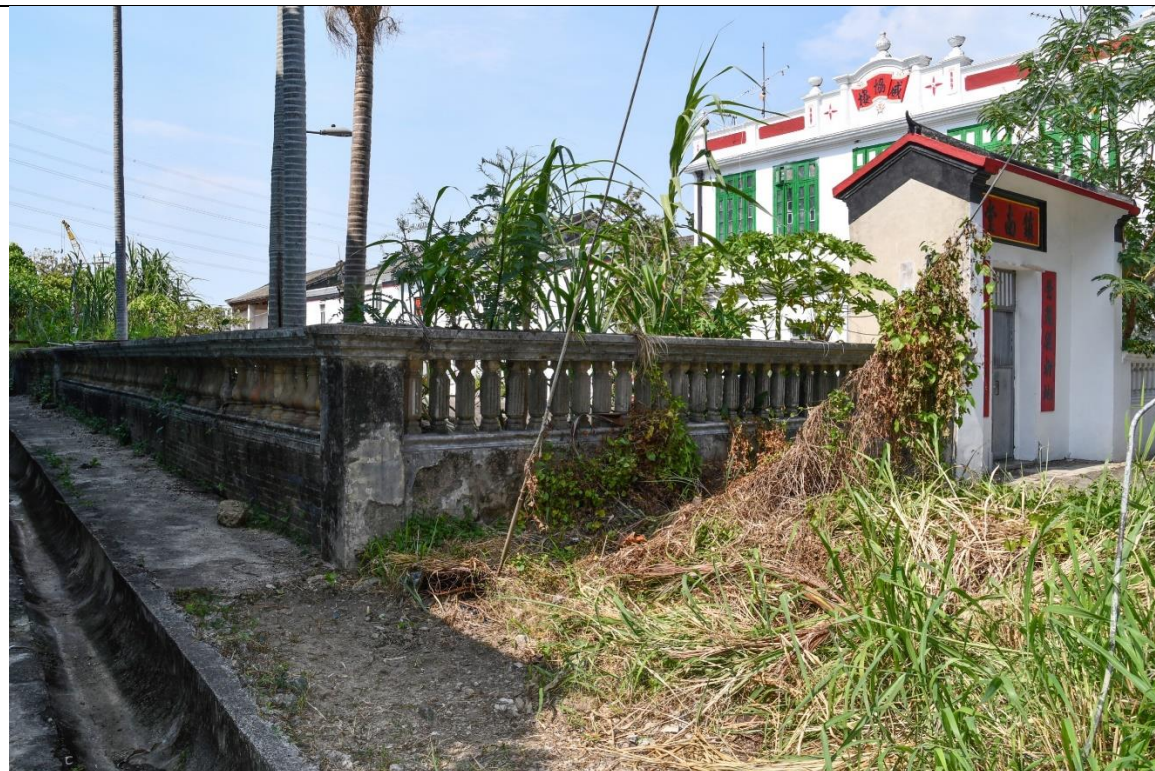
Existing Condition: Poor; cracks show at places and signs of dislocation appear along the southwest alignment supposed by concrete buttresses.		
Past and Present Uses: Fence of Residential Compound		
Modifications: not observed.		
Photographic Records

General view of fence, looking north.

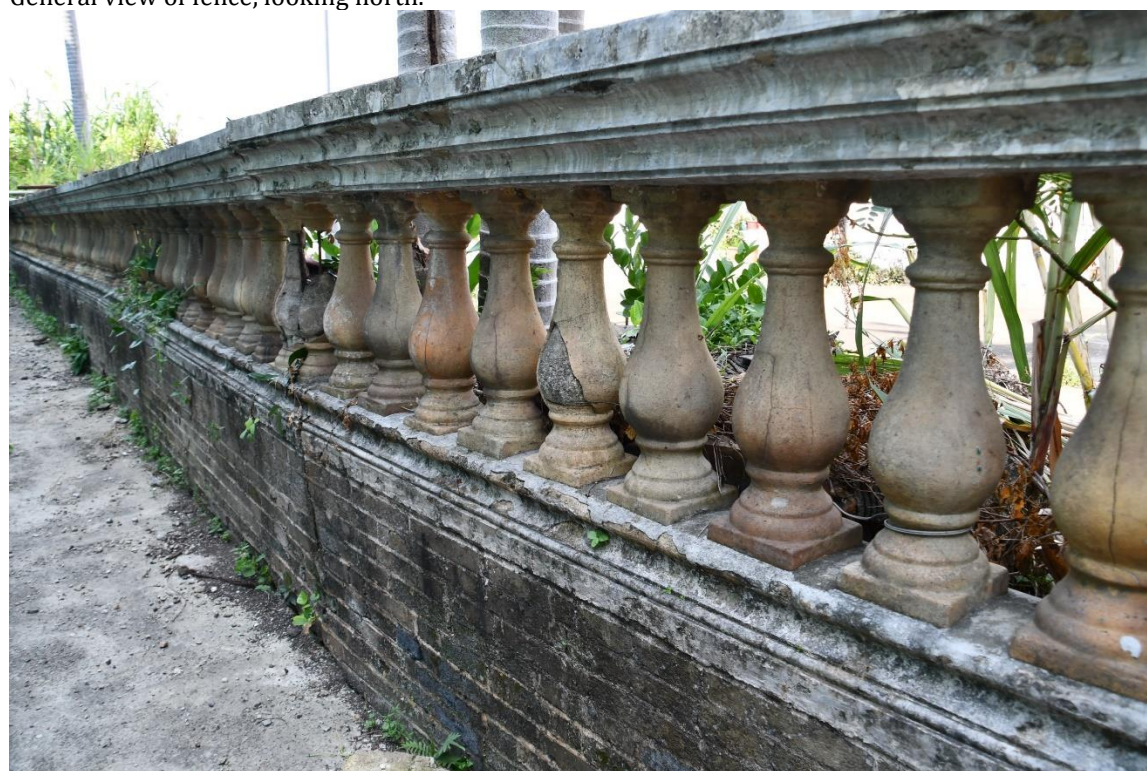
Dislocated and cracked fence, looking north.

- 4.1.5 The balustrade fence is also part of the original compound construction and the use of balustrade in the fence is a typical 1930s design element. The condition of the fence however, especially along the west is poor and has been altered by buttresses in some places. The proposed significance level is thus deemed **moderate**.

- 4.3.10 The boundary of the sport/leisure facilities are located 3.8m to the west of balustrade fence. The condition of the balustrade fence is poor and the potential for physical contact, vibration, settlement and tilting impacts to the Graded Historic Buildings is possible.

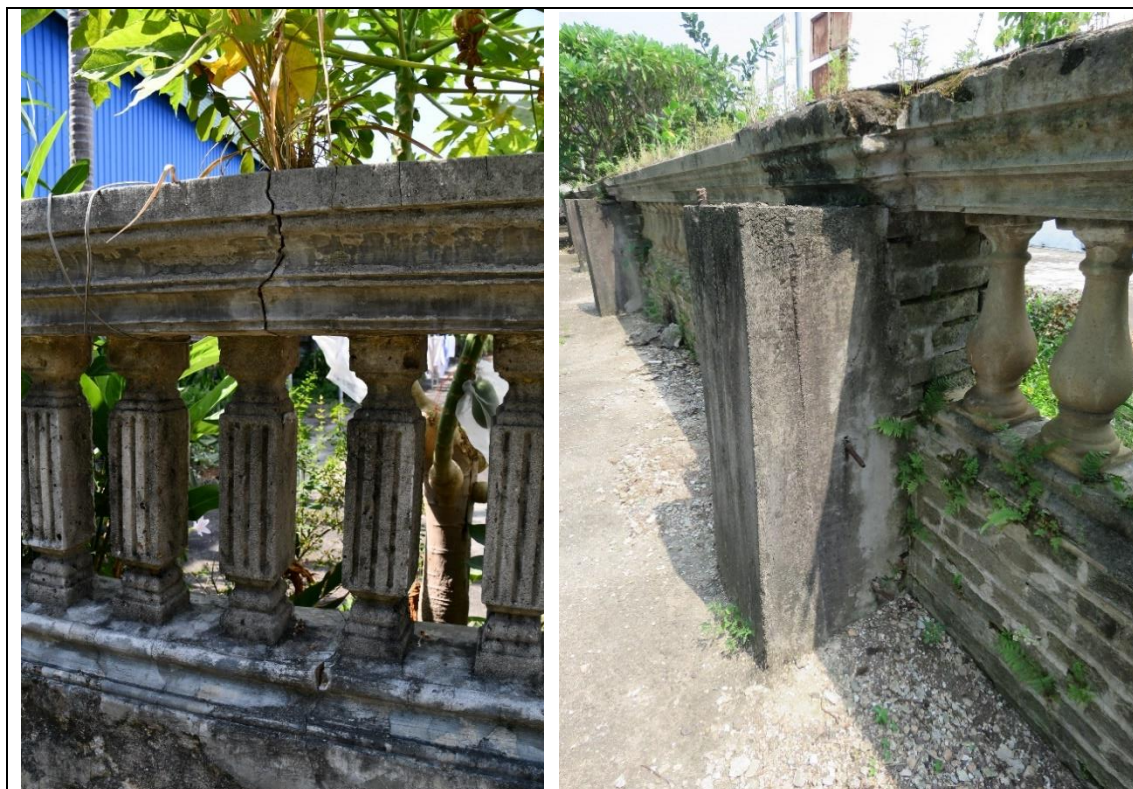
Close up of cracked section, looking northwest; and view of concrete buttresses; looking northeast

- 2.5.4 The entrance gate at the south in contrast is in very good condition and well maintained. To the front and south of the houses is a balustrade fence, built, according to the local informant at the same time as the houses and ancestral hall. Its condition is relatively poor and, in the past, concrete buttresses were constructed to support the fence along the west (**Plate 9**).

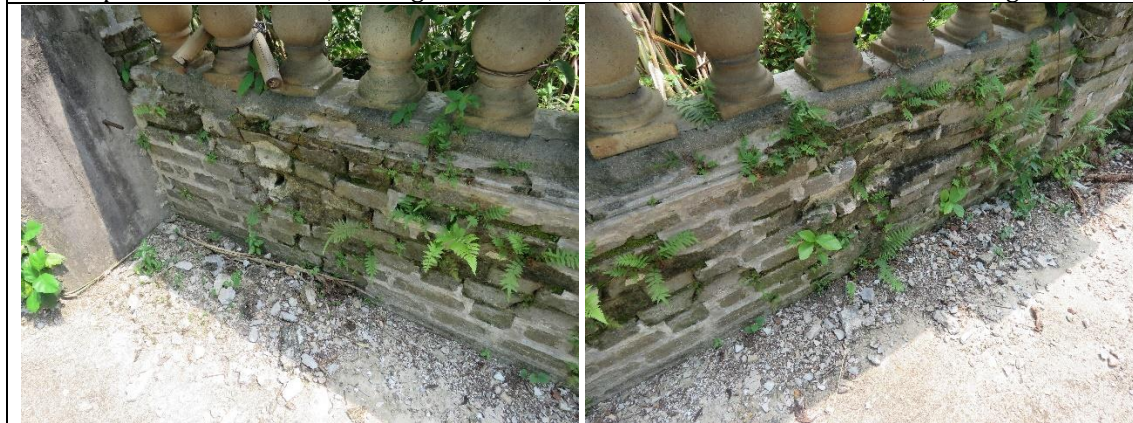
Condition of the brick part of the fence

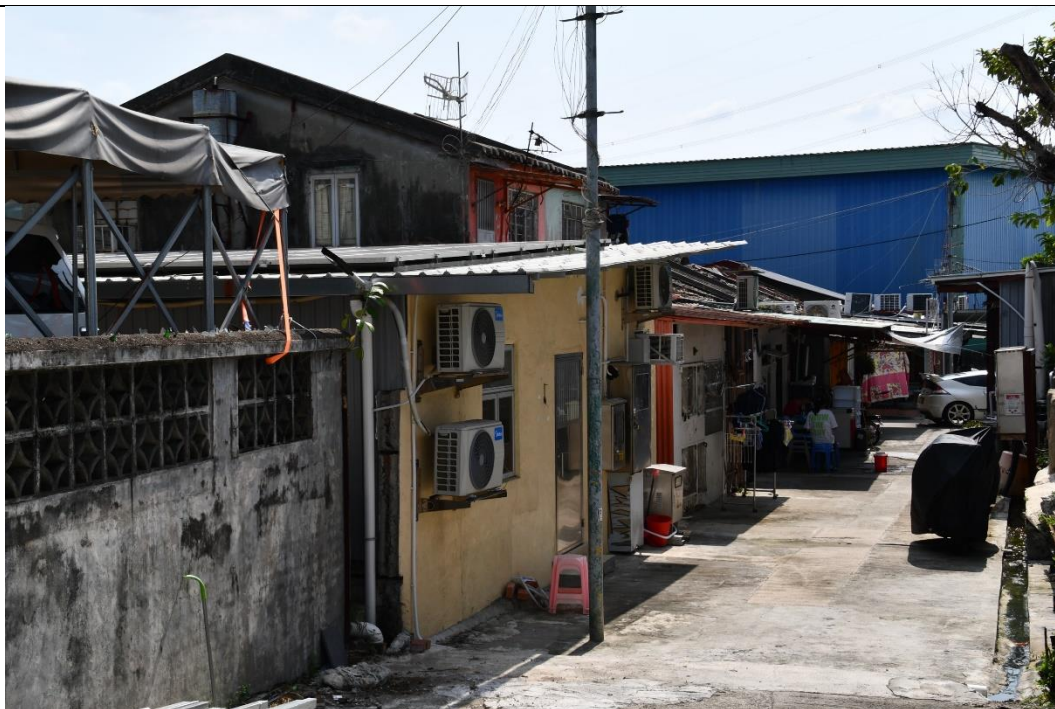
Existing Condition: Overall the condition of the buildings is poor or heavily modified.

Modifications: Houses have additions to their façade and rear wall; windows and gates have been replaced with new ones. Air-conditioners, wires and pipelines installed. Very little features remain with exception of the entrance house.

General view of HB-03, showing northwest elevation, looking southwest.

Due to their low heritage significance, it is deemed acceptable to demolish the row of structures. The modification to the structures is significant and preservation by record of current condition will not reflect the original row of houses with exception of the entrance gate. If the entrance gate cannot be retained, preservation by record of entrance gate is recommended. The preservation by record should include full cartographic, photographic record of the wall sections and interior. Report is to be submitted and agreed by AMO prior to demolishing of the entrance gate, if applicable.

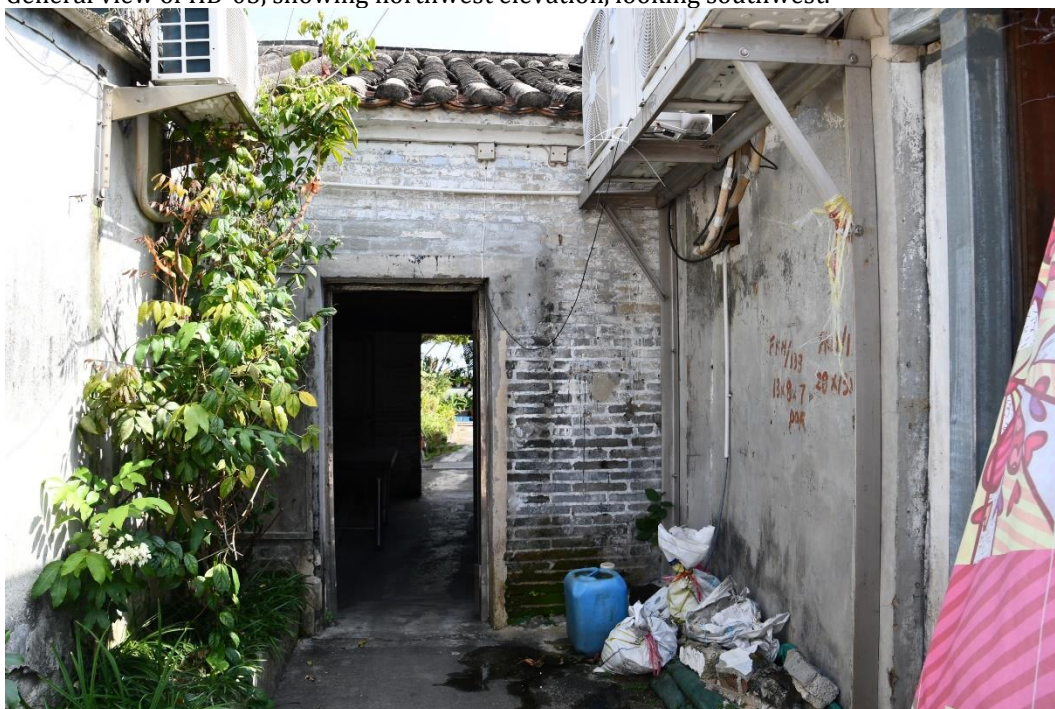
Entrance roughly set in the middle of HB-03, leading into the General House compound, looking southeast.

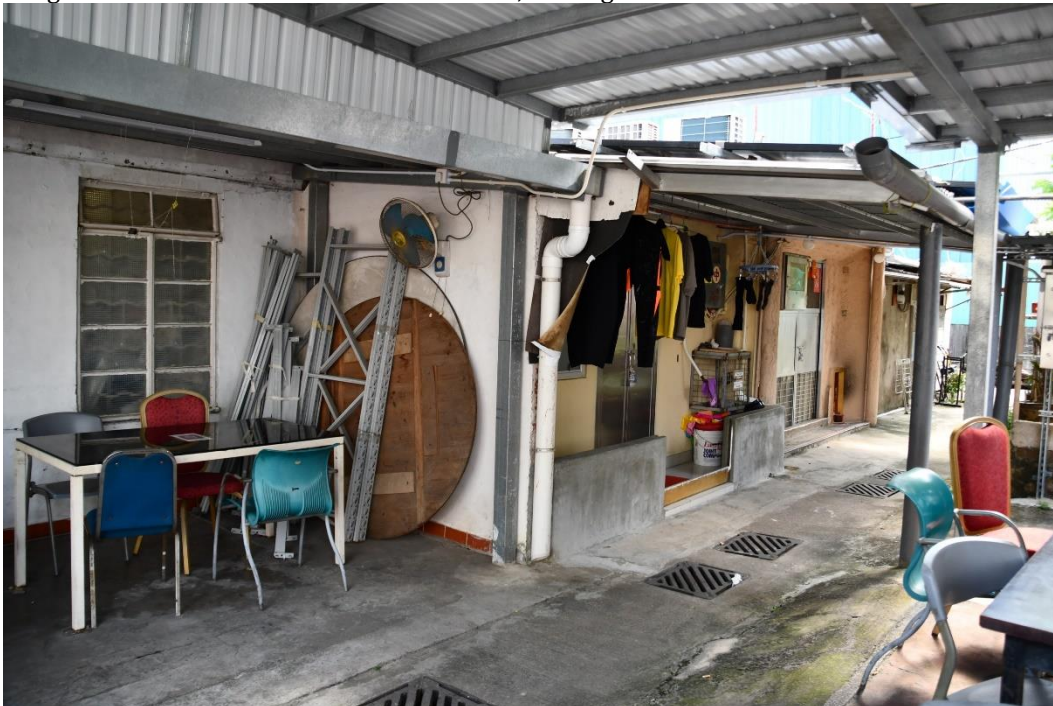
West portion of HB-03, looking southwest.

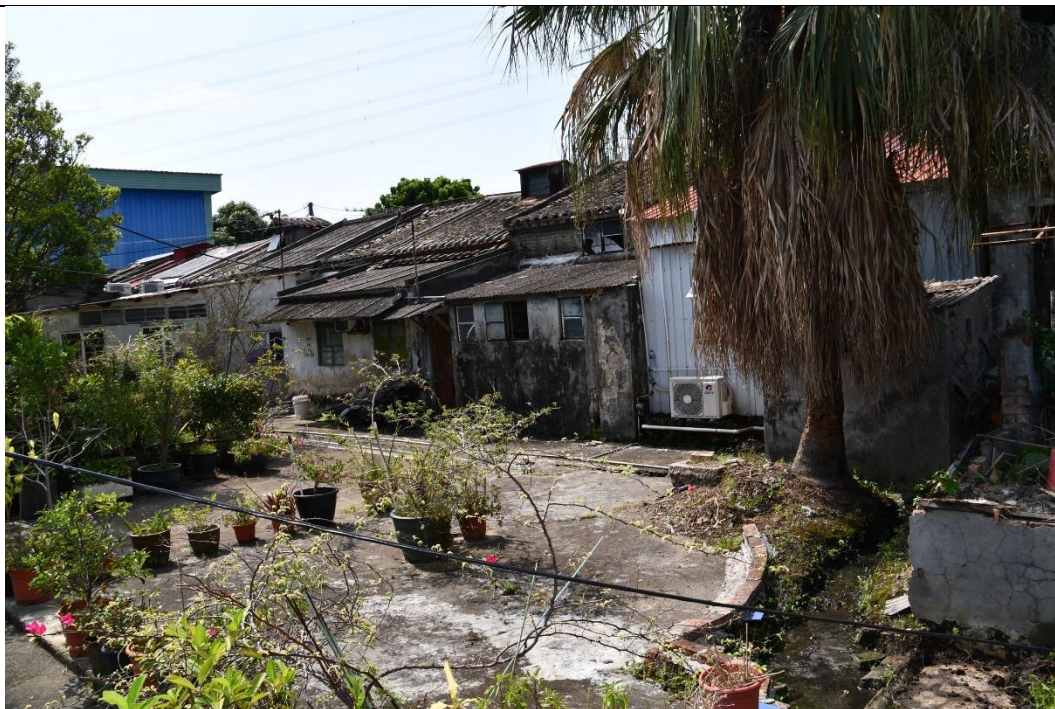
Rear view of HB-03, showing southeast elevation, looking northwest.

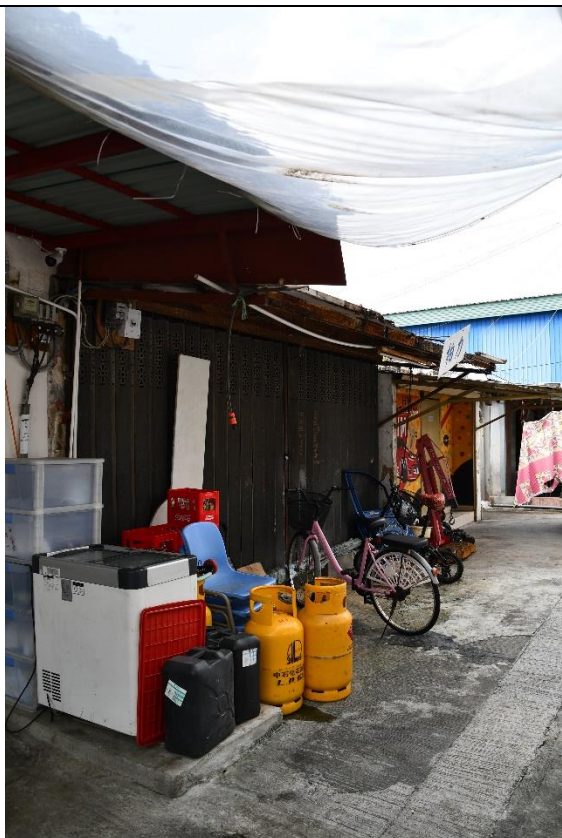
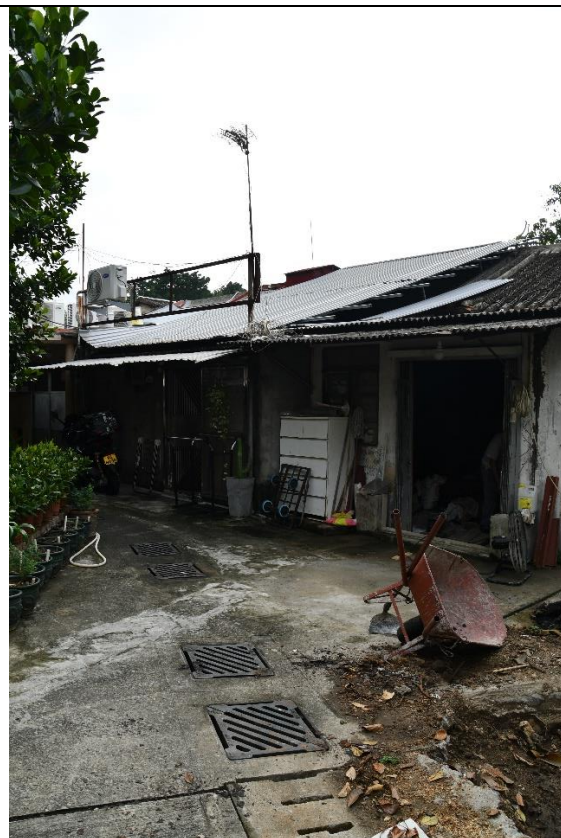
Plate 7 Photos showing condition of the row of houses to the north (HB-03)

- 2.5.3 The changes to the row of houses along the north is severe, with the buildings modified, added to and/or in poor condition (see **Plate 7**). In the centre of the row, however, it is a typical small entrance gate in fair condition (**Plate 8**).

Row of houses to north Low heritage significance	Other Built Heritage Resource	Within proposed Government facilities	<p>The condition of the row of houses to the north of the Compound is very poor, with exception to the entrance gate, and overall, few original elements remain.</p> <p>The heritage significance of the row of structures, including the entrance gate, is low and the proposed development impact is deemed acceptable with mitigation.</p>
Chong Lie Tsz/ Gai Sin Tong Low heritage significance	Other Built Heritage Resource	Within proposed Government facilities	<p>Chong Lie Tsz currently sits within factories and warehouses. The heritage significance of Chong Lie Tsz is low and is tied to its association with General Shum only. The proposed development impact is deemed acceptable with mitigation.</p> <p>The location of Gai Sin Tong could not be located possibly due to fencing around</p>
