**National History Education Centre (Youyou Villa) Limited**

# Heritage Impact Assessment in Respect of the Revitalisation of Homi Villa into Centre of National History Education Youyou Villa

Revitalising Historic Buildings Through Partnership Scheme (Batch VI)

**Final Report**

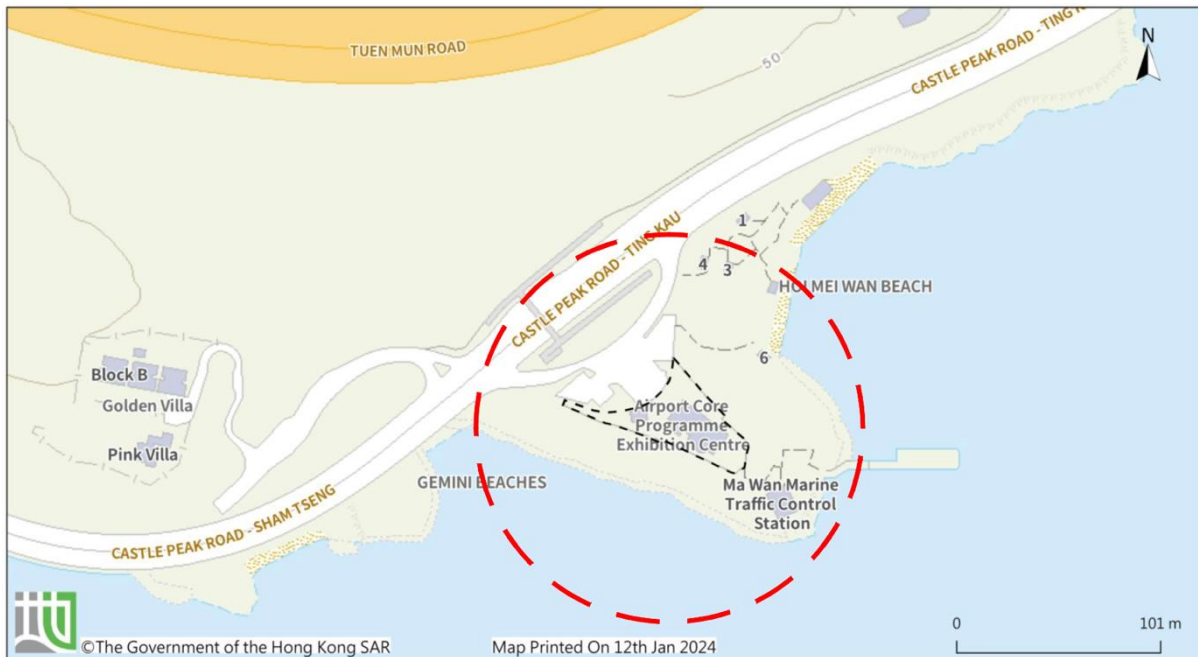
**2.3-1** 50m boundary of the project site boundary (red dotted lines). The project site boundary is in black dotted lines (Source: Geoinfo Map 2023, edited by Substance Lab Limited).

- 2.3.1 According to DEVB Technical Circular (Works) No. 1/2022, “Heritage Sites” include all declared monuments, proposed monuments, sites and buildings/ structures graded by AAB, sites/ buildings/ structures in the list of new items pending for grading assessment by AAB, all sites of archaeological interest, and government sites identified by AMO. There is no other Heritage Site partly or wholly within 50 metres of the project site boundary (inclusive of works area).

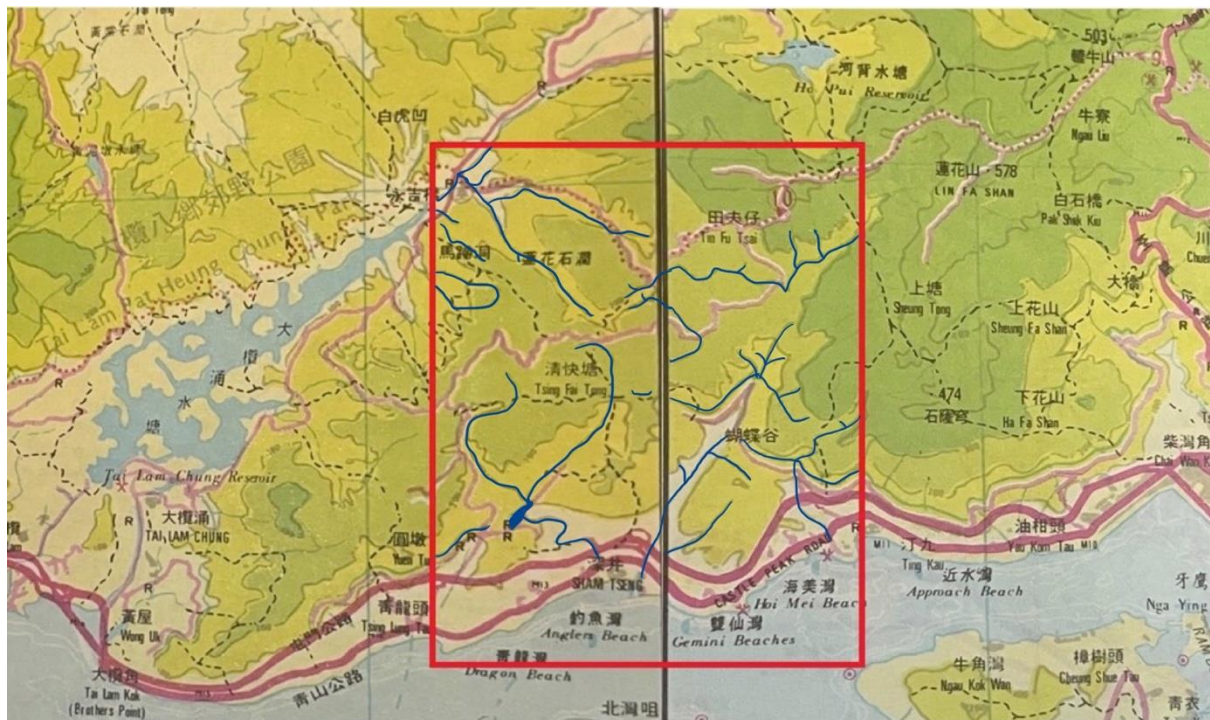
**3.5-2** 1986 map of Sham Tseng. Location of Sham Tseng, Tsing Fa Tong and different springs (the very light blue lines) running to Sham Tseng. The blue lines that indicate the location of springs in the red box are traced in blue colour. The black dotted lines on the map indicate footpaths. The middle black line is the edge of the both pages. Therefore, how springs were connected or whether there were extra springs at the area of the black line were not known. (Source: 通用圖書有限公司 1986: 69, 70, edited by Substance Lab Limited).

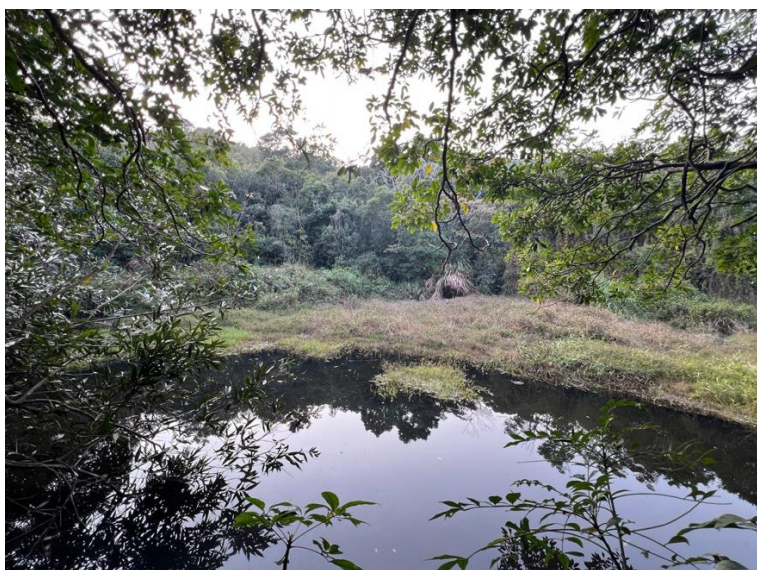
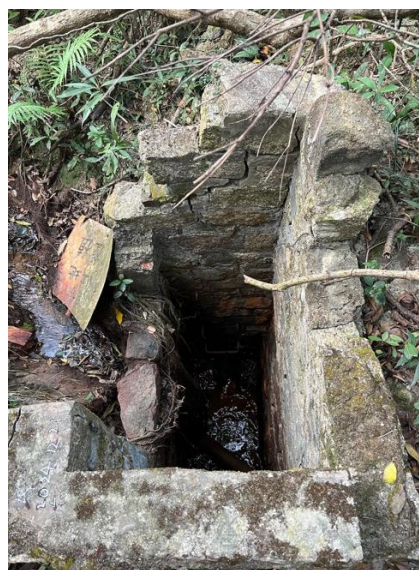
**3.5-5,6** The abandoned man-made water pool and its outlet. A collapsed metal sign bearing the Chinese text which reads “Notice: Private Land – Please Do Not Plant” is found next to the outlet which advised the fact that the land on which the farm was established was privately owned (Photos taken on 16<sup>th</sup> January, 2025).

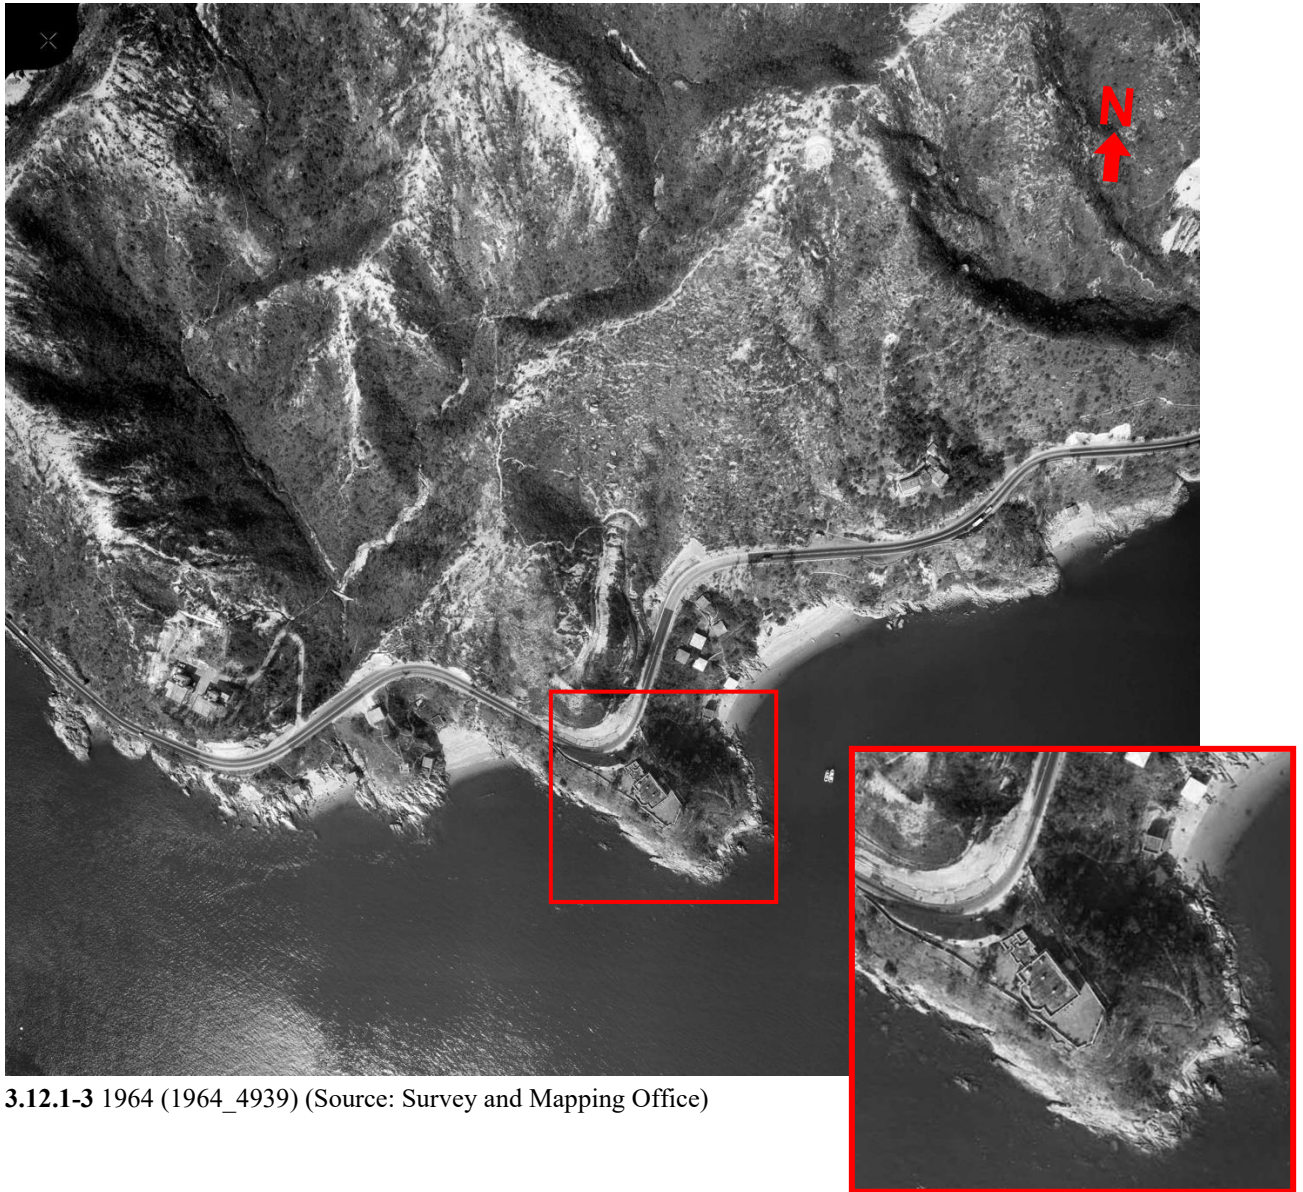
3.12.1-3 1964 (1964\_4939) (Source: Survey and Mapping Office)

- The building form of Homi Villa can be seen very clearly in this aerial photo. The kitchen and the servants' quarters in the annex building were not detached, but not entirely attached (The plan of Homi Villa to be provided in Chapter 4). They were connected by the toilet core. More information on the building form of Homi Villa are included in Chapter 4.

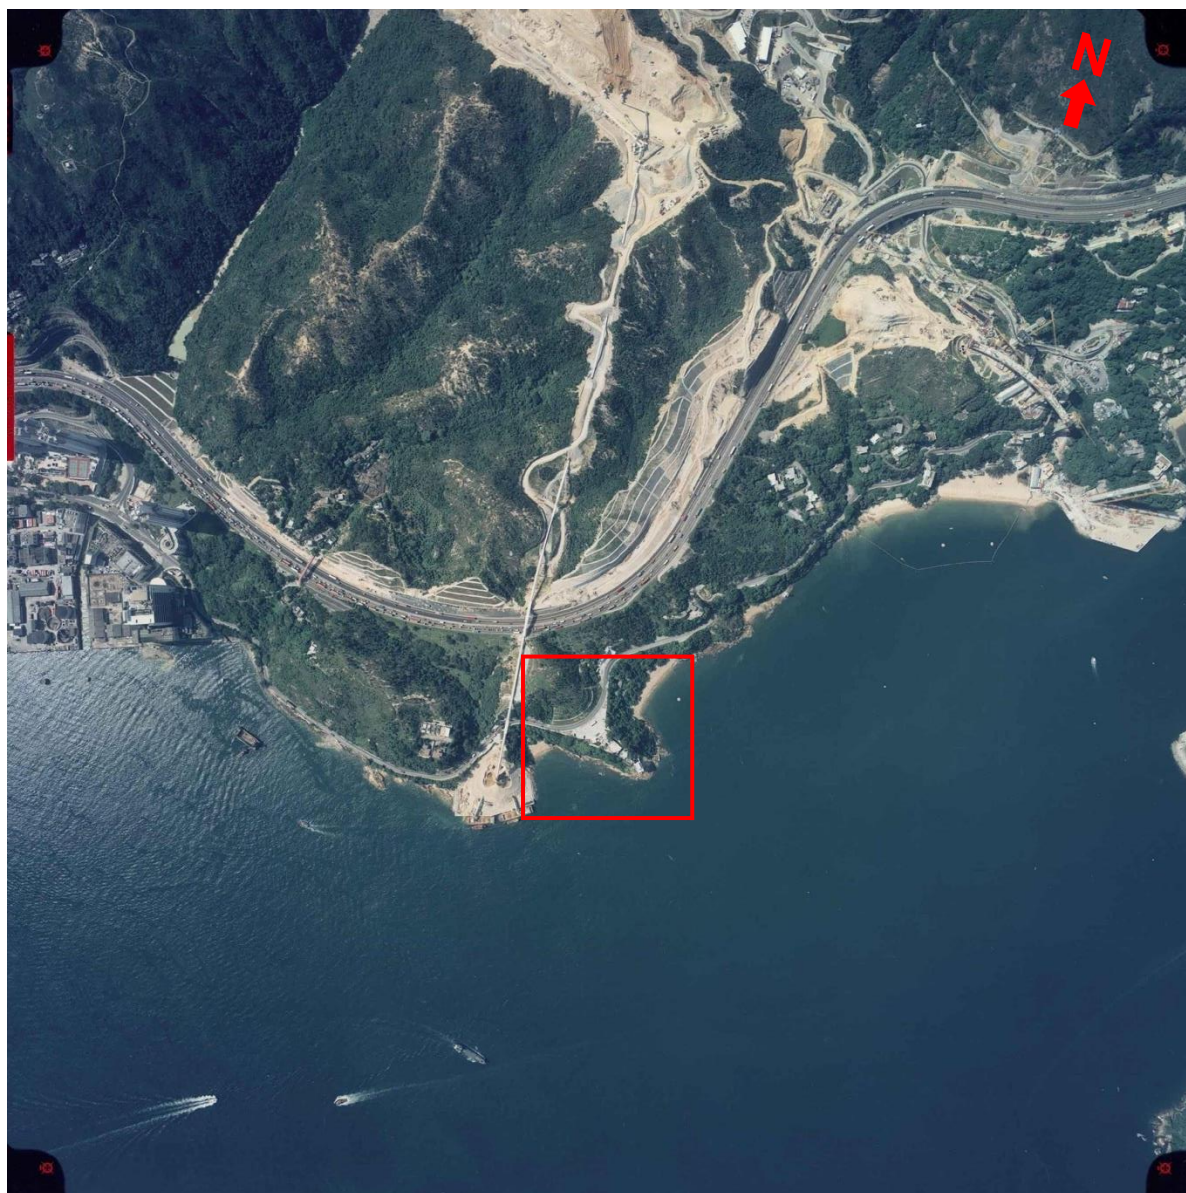
3.12.1-5 1996 (1996\_CN14256) (Source: Survey and Mapping Office)

- The Airport Core Programme Exhibition Centre started operation.
- A public car park on Castle Peak Road was newly built to the Northwest of Homi Villa.

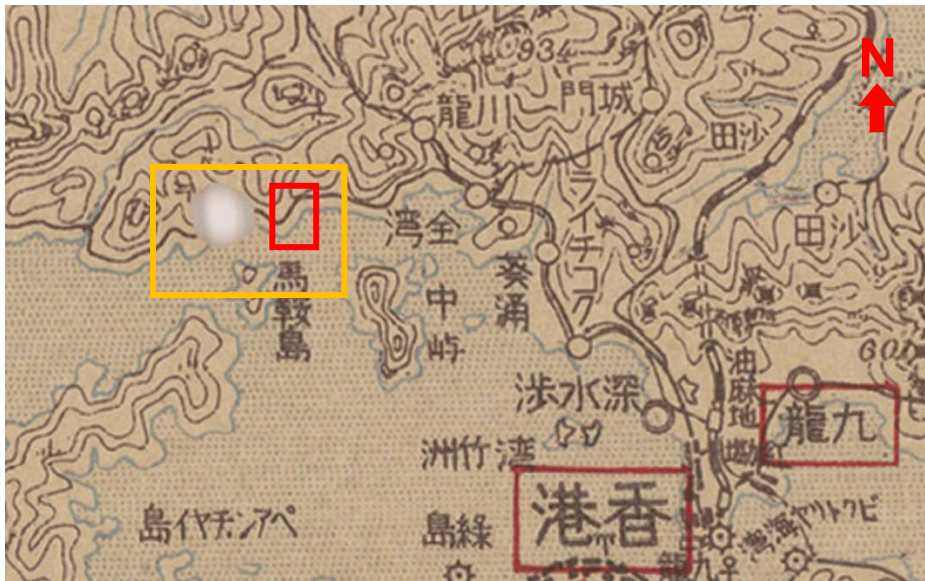
3.12.2-6 1938 (Source: HK Maps)

- The map is “廣東省水路圖”, produced by the Japanese “波集團司令部”. There are some differences in the names of the places, eg. “馬鞍島” refers to Ma Wan. Two dark red boxes “香港” and “九龍” were drawn originally on the map.
- The area where Sham Tseng and Ting Kau was situated at is blurred in the map. The promontory of where Homi Villa would be situated in the 1930s (red box) cannot be seen in this map due to the scale of the map.

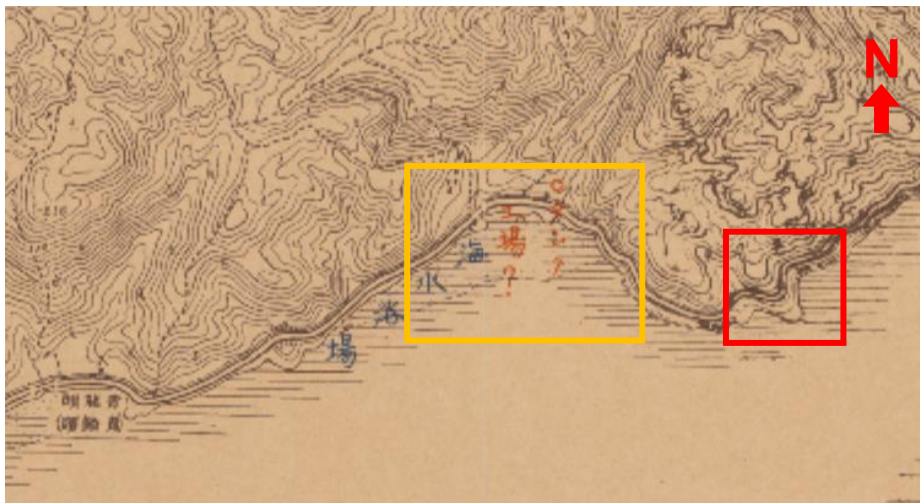
3.12.2-7 1938 (Source: HK Maps)

- The map is “防禦施設圖”, produced by the Japanese “陸地測量部 參謀本部”.
- Sham Tseng (yellow box) and the promontory of Homi Villa (red box) can be seen.
- There are markings marked on the map. “工場?” was marked on the map at the area of where the Brewery should be situated at. Together with the previous 1938 map in which the Sham Tseng, Ting Kau and Homi Villa area was blurred, there might be a possibility that accurate maps of the late 1930s or those produced in Hong Kong were missing.

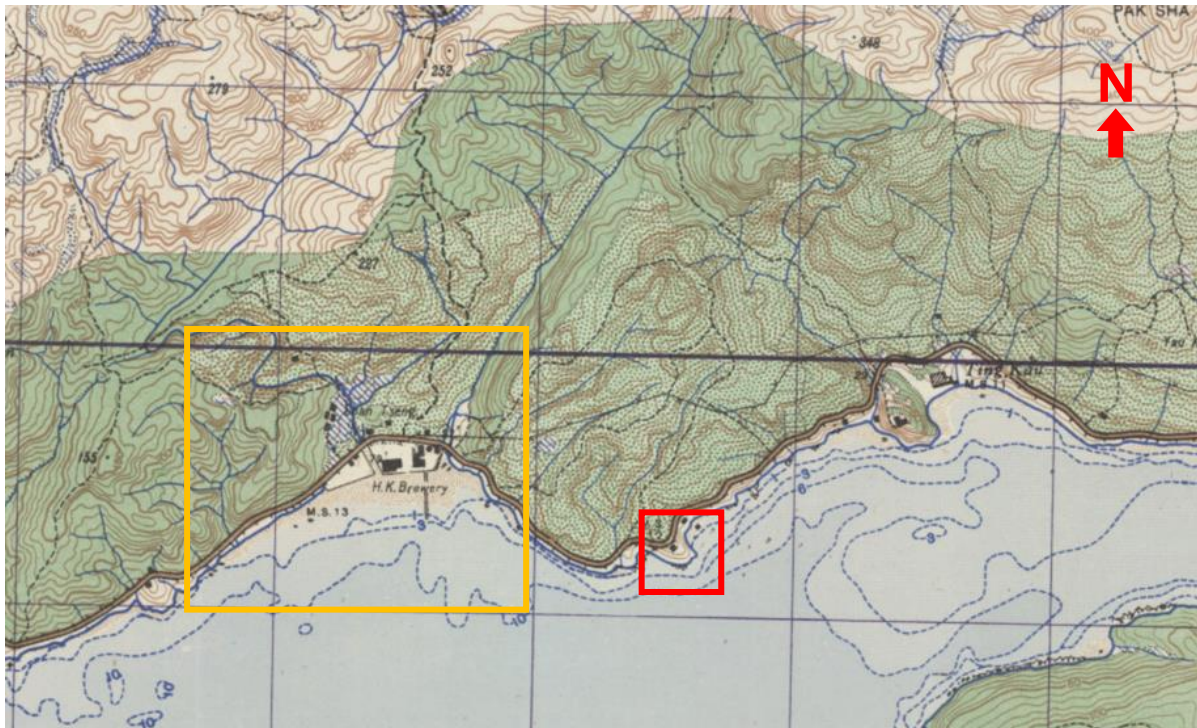
3.12.2-8 1945 (Source: HK Maps)

- The map shows both Homi Villa (red box) and Sham Tseng (yellow box).
- The Hong Kong Brewery and Distillery Limited was indicated as “H.K. Brewery” in this map.

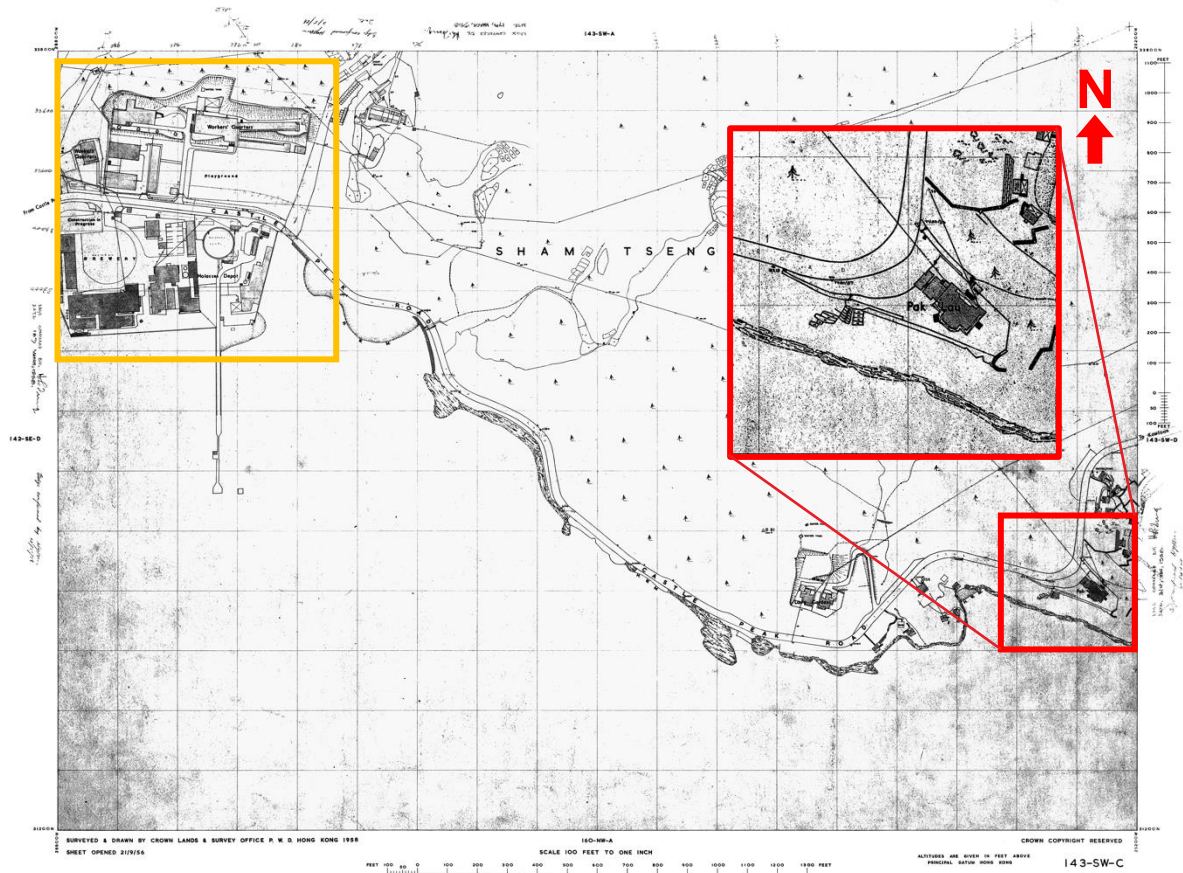
### 3.12.2-9 1958 (Source: Survey and Mapping Office)

- The map shows both Homi Villa (marked in red) and the Brewery (marked in yellow).
- Homi Villa was annotated as “Pak Lau” (白樓).

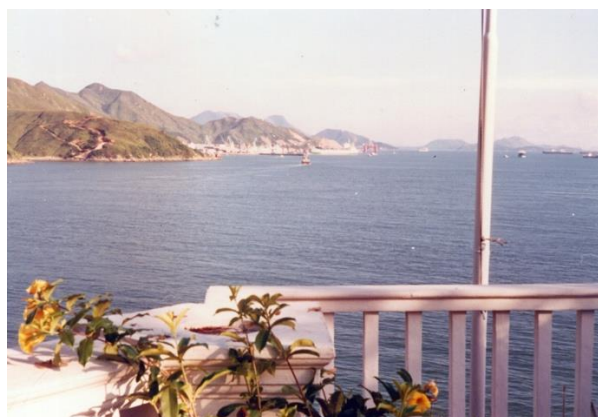
4.3-3 (left) Views to the south from the lawn of HV, showing Tsing Yi, in the 1980s. (Source: Courtesy Joshua Law)

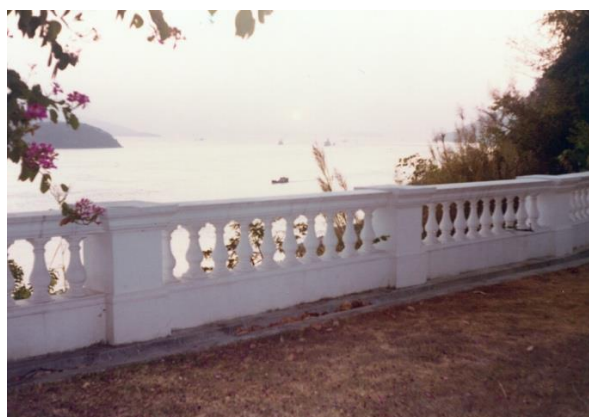
4.3-4 (right) Balustrades surrounding the lawn of the site in the 1980s. (Source: Courtesy Joshua Law)

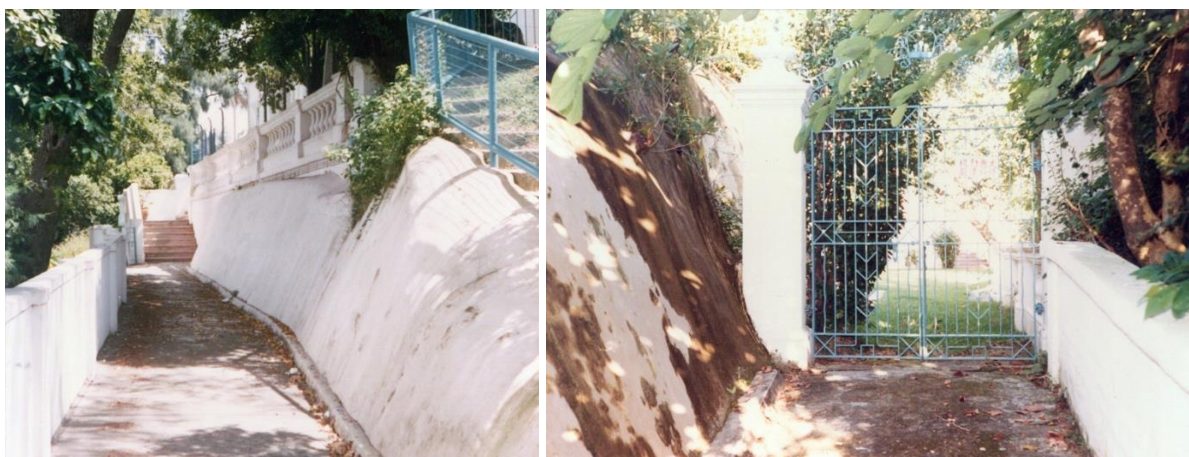
**4.3-6, 7** The main access to the site from the north (left) and back access to the site from the the west (right), taken in the 1980s. (Source: Courtesy Joshua Law)

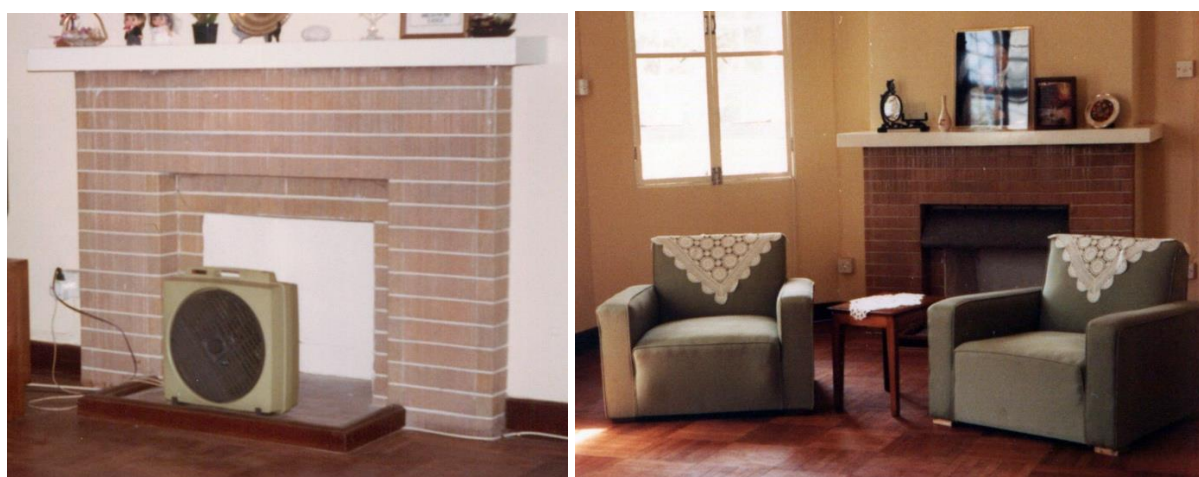
**4.3-9, 10** Fireplaces at the original sitting room (left) and living room (right) in the 1980s. (Source: Courtesy Joshua Law)

- 4.3.7 The design of MB generally adopted a symmetrical plan, typical of Classical architecture, and the core of the building is basically rectangular in shape divided into three bays. The sitting room, the largest room of the building of around 31 square metres, and an additional octagonal room at the end as the living room, of around 28 square metres, were placed along the central bay, which forms the axis of MB. Meanwhile, the three bedrooms and the dining rooms, each having similar sizes of 19 square metres, were arranged along the side bays with two rooms on each side. All rooms were once equipped with fireplaces to keep the house warm in cold weather.

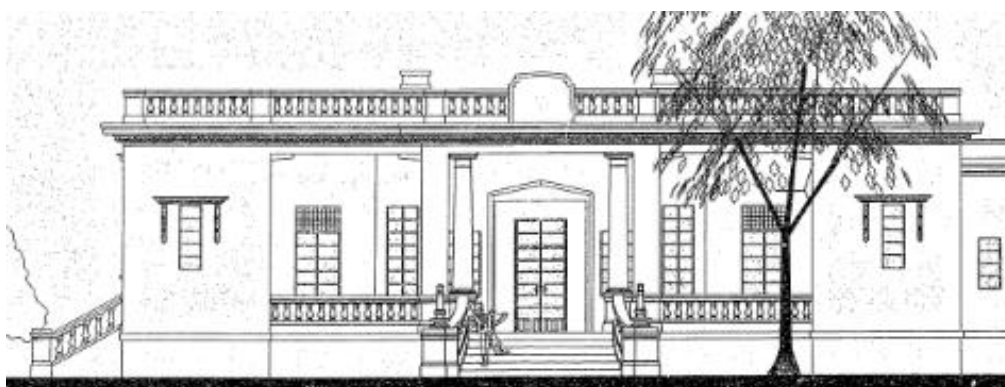
**4.3-11** Drawing of the main elevation of MB in 1992, showing from top to bottom: The centre-piece with urn-shaped balustrades on roof level, round columns of Tuscan Order, and the fanned main entrance staircase. These features collectively demonstrate high order of symmetry. (Source: Property Services Branch, ArchSD, 1992)

- 4.3.10 MB has a multitude of architectural features which were influenced by both European and Parsee architecture.
- 4.3.11 Neoclassical features include the commanding deep eave projection<sup>106</sup> all around the flat roof which is decorated with tooth dentil cornice along its external walls, a pair of majestic round columns of Tuscan Order at the main entrance, pillars on the remaining facades, the centre-piece on the roof level of the main facade, the fanned main entrance staircase<sup>107</sup> and urn-shaped balusters. The moulding at the main entrance resembles the original entrance gateway at the Ruttonjee Hospital, demonstrating some Art Deco influence, which was also a prevalent architectural style in the 1930s.

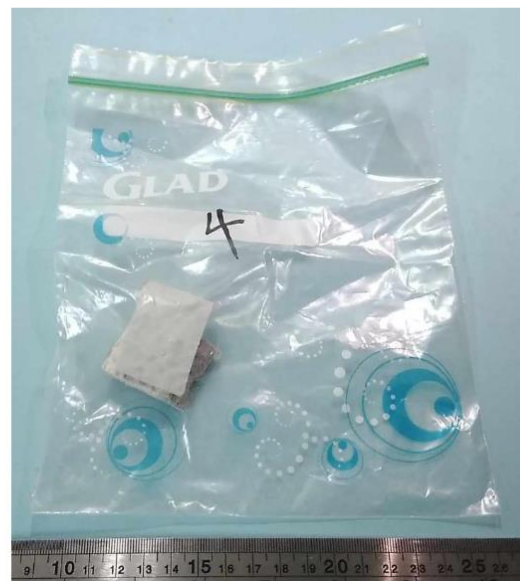
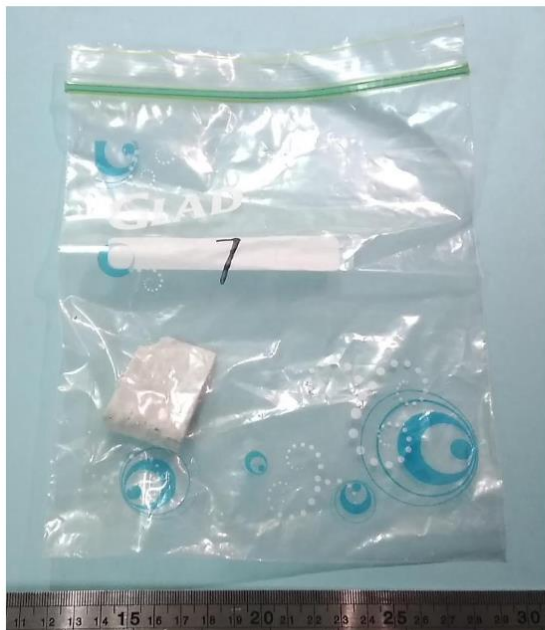
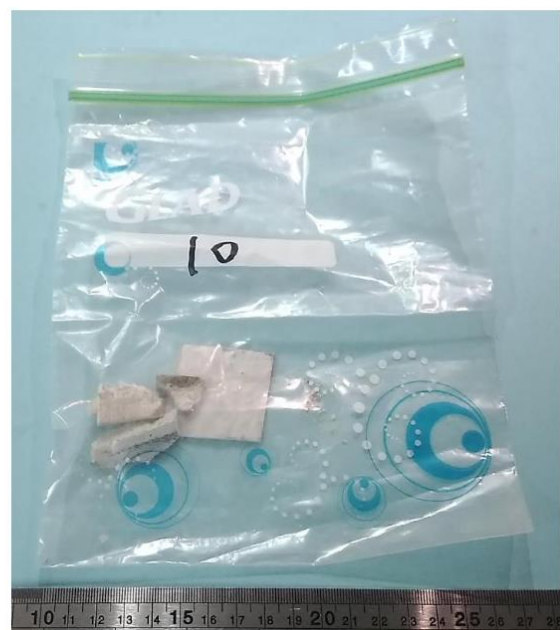
4.3-13 As-received sample photos of Samples 1, 4, 7 & 10. (Source: Prime Testing Group Limited, 2024)

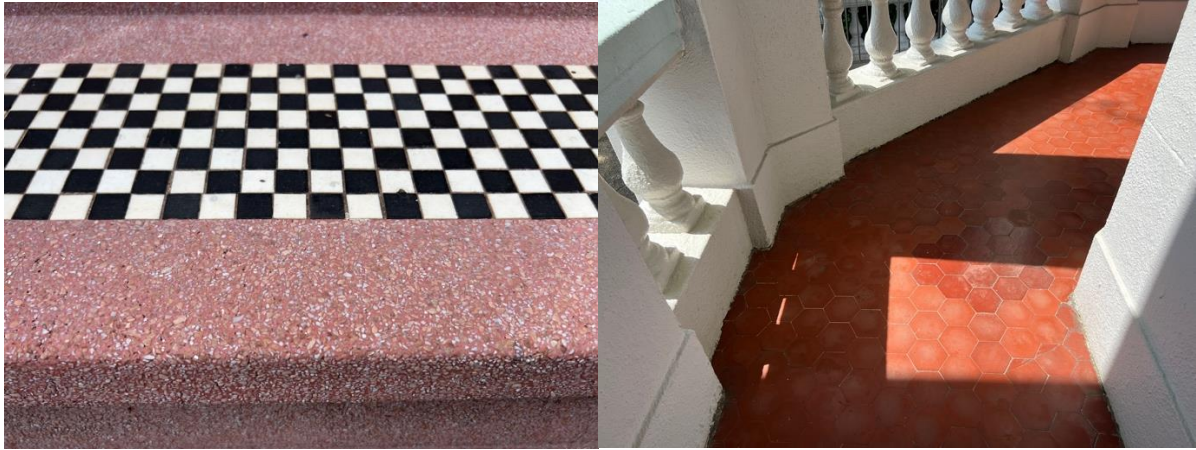
- 4.3.15 Other features include the use of white and black mosaic tiles at the three staircases, and the use of red colour for the terrazzo of staircases and floor tiles of the verandahs. The hexagonal shape might be chosen for the red floor tiles because it is a symbol which stands for harmony and balance and also male and female energy.

**4.3-14, 15** Red terrazzo staircase with white and black mosaic tiles (left) and red hexagonal floor tiles (right), as in 2023. (Source: Substance Lab Limited)

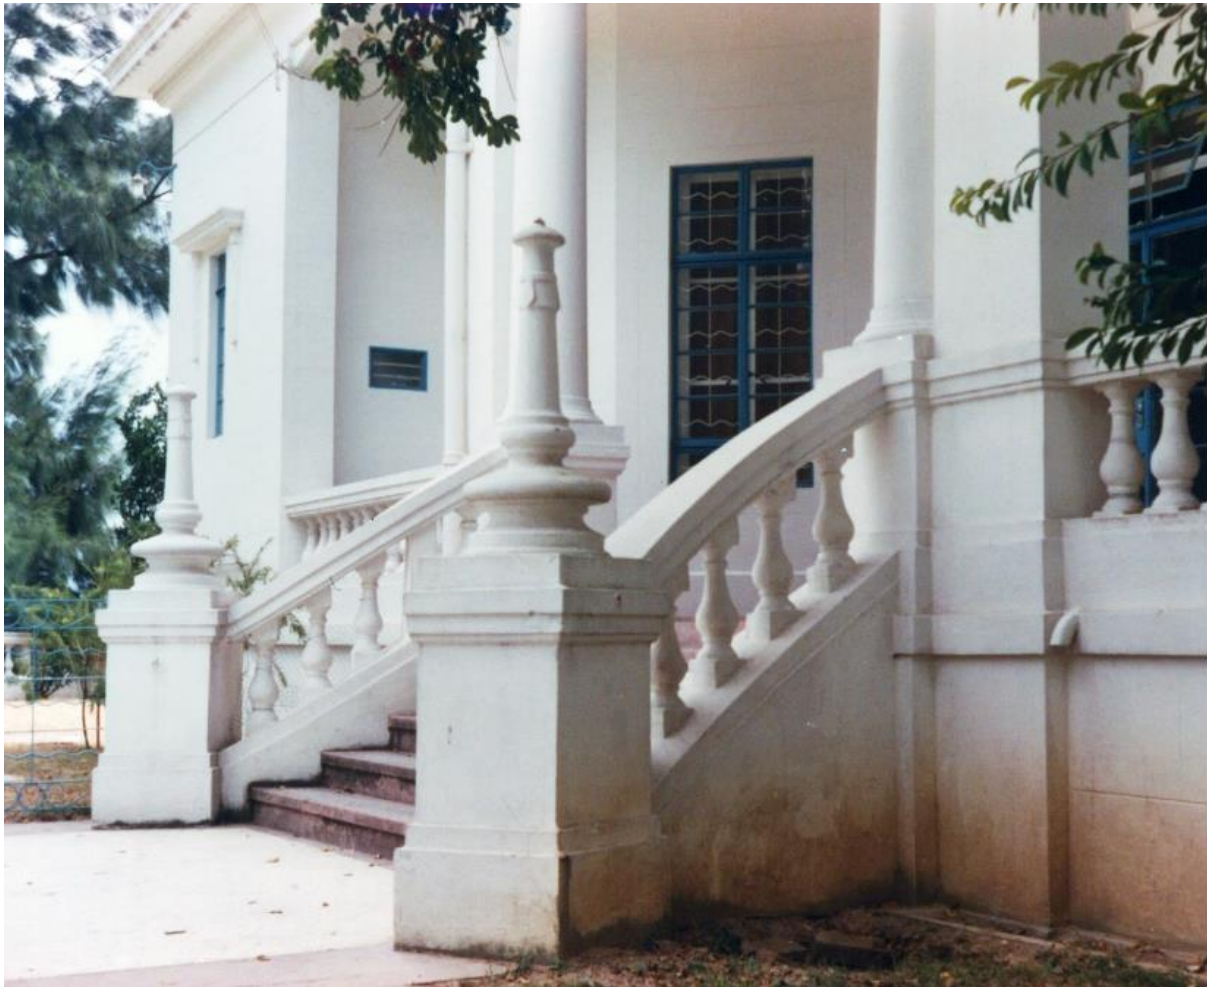
4.3.16 Other Zoroastrianism architectural features once found at the exterior of MB include the pair of statues symbolising lamps or fire at the end pillars of the curved balustrades at the main entrance staircase, and the pair of statues also symbolising lamps or fire atop the access gate pillars. However, they were demolished during the intervention in the 1990s.

**4.3-16** Pair of statues at the main entrance fanned staircase in the 1980s. (Source: Courtesy Joshua Law)

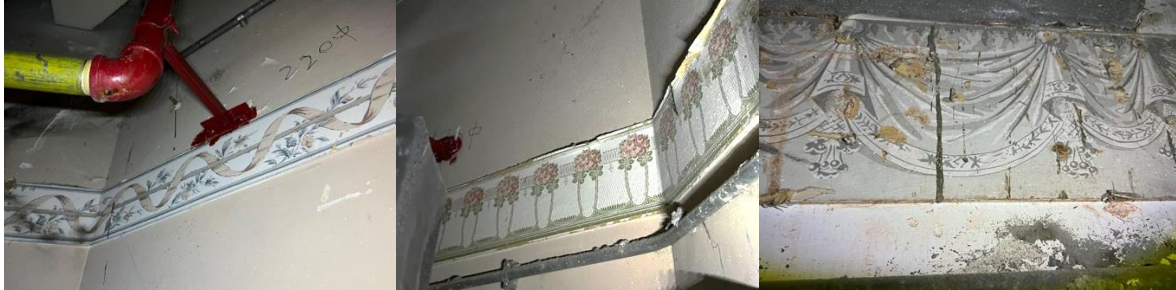
- 4.3.17 In the interior of MB, portions of decorative timber panels with three different wallpaper patterns can be found at the high level of two of three bedrooms on the two side bays, as well as the living room at the central bay. They are not only traces of the original decorations, but also evidence which proves the original layout and design intent of the rooms.

**4.3-17-19 (from left to right)** Three different wallpaper patterns, covered up by false ceiling as in 2023. The pattern shown on 4.3-17 and 4.3-18 were found at rooms originally marked as Bedroom 1 and Bedroom 2 respectively in the record plan of the 1970s (refer to Figure 4.3-8), while the pattern shown on 4.3-19 was found at original living room. (Source: Substance Lab Limited)

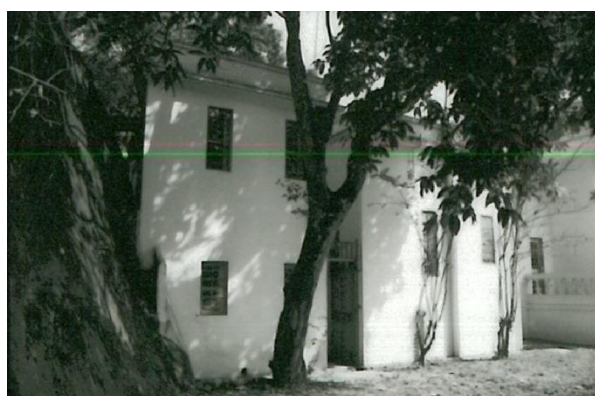
**4.3-21 (left)** View of the SQB (to the left) and KB (to the right), with MB at the background. Taken in 1991. (Source: AMO, 1991)

**4.3.18** The Kitchen Block (KB) and Servants' Quarters Block (SQB) were found to the northwest of the MB, with the KB found between MB and SQB. KB (with a pantry, a store, a kitchen) and SQB had its own entrance. They were connected with the staircase core which provided access to the roof of KB where a flight of steps connecting the flat roof of MB was located.

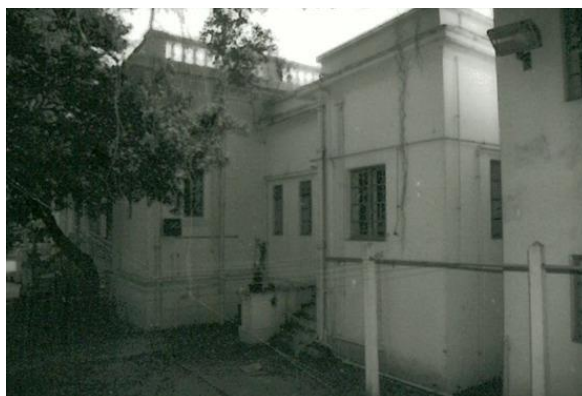
**4.3-22 (right)** View of the SQB (at the foreground), the pantry and entrance staircase to the Annex Blocks, with MB at the background. Taken in 1991. (Source: AMO, 1991)

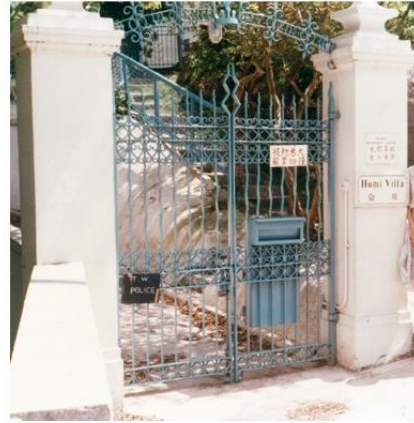
4.5-6 Lease plan (left) dated 1929 showing the location of the natural mount (circled in red) and a photograph (right) showing the original entrance pillars with gates in the 1980s. (Source: Lands Department (left); Courtesy Joshua Law (right))

4.5.7 **Outdoor area:** When the natural headland of the Site was formed into a flat land for the construction of HV and the garden, there used to be a left-over natural mount to the NW of HV acting as a screen between HV and Castle Peak Road. In the 1990s, the natural mount was removed and turned into an accessible ramp as BFA and a staircase. The original entrance pillars with gates were also demolished, but there are still traces of the fence walls belonging to the original path to the building. The original grass lawn which is a typical bungalow setting was also turned into hard monolithic paving. Some portions of the balustrades with classical urn-shaped balusters and pillars were altered, and new metal railing was installed beside the balustrades surrounding the lawn.

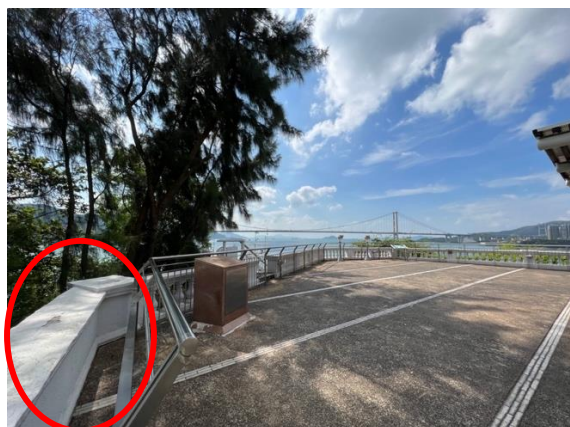
**4.5-9** New metal railing beside the balustrades surrounding the original lawn, taken in 2023. The balustrade portions next to the red ACP memorial (circled in red) appears to have already been blocked in photos in the 1980s. (Source: Substance Lab Limited [left]; Courtesy Joshua Law [right])

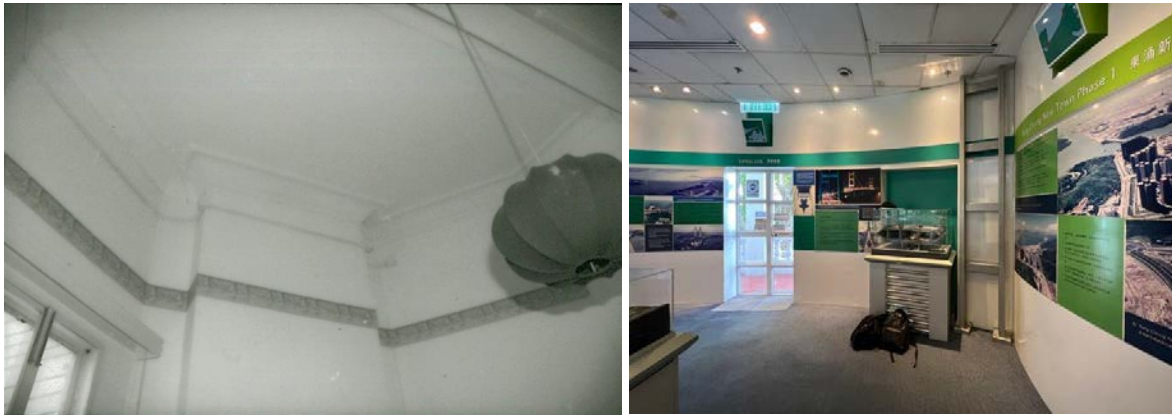
4.5.10 Besides the alterations to internal spatial configurations, new structural framing was also introduced to MB. False ceilings were introduced to conceal the building services installations. As a result, the original mouldings and decorative features along the ceilings were also concealed.

4.5-15, 16 Photos showing the ceiling of the original living room in 1991 (left) and 2023 (right). (Source: AMO, 1991 (left); Substance Lab Limited (right))

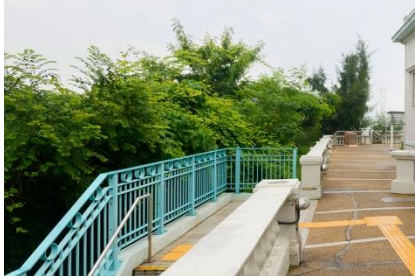
<p>1.1b and 1.1f</p>

<p>1.1d and 1.1e</p>	<p><b>1.1 Setting /Surrounding grounds:</b></p> <ul style="list-style-type: none"> <li>a. The general topography</li> <li>b. Old access path at the north side (mainly the approach but not the entire alignment)</li> <li>c. Old access path at the west side</li> <li>d. Old access gate pillars leading to the rear garden (not including the gate) at the west side</li> <li>e. Gate at the old access leading to the rear garden at the west side</li> <li>f. Metal balustrades along and finishes of old access path at the north side</li> <li>g. Metal balustrades along old access path at the west side</li> <li>h. The remaining balustrades of the old access path at the north side</li> </ul> <p><i>Justification</i></p> <p>a. The general topography at the three sides of the historic main building facing the sea has remained unchanged. The area to the Northwest has drastic redevelopment where a natural mound has been levelled in 1990s for the adaptive reuse of the Site as the ACP Exhibition Centre.</p>	<p>Medium</p> <p>High</p> <p>High</p> <p>Exceptional</p> <p>Neutral</p> <p>Neutral</p> <p>Neutral</p> <p>High</p>	<p>(The use of blue and red colours for the annotations and arrows are for clarity sake)</p>

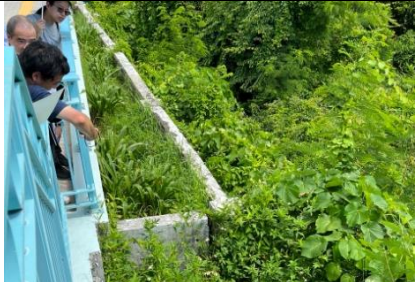
<p>1.1h</p>	<p><i>b &amp; c. The old access paths are located at the original location but substantially repaved. They reflect the original layout and setting of the historic residence. The path at the west side is believed to be used by servants in the past. The urn-shaped balustrades are original but not the metal balustrades.</i></p> <p><i>d. The old gate pillars (not including the gate) are original and are located at the original location. The features symbolizing fire or lamp at the top are Zoroastrianism features.</i></p> <p><i>h. The remaining original balustrade at the old access path at the north side is believed to be original. They were found in 1980s historic photo.</i></p>

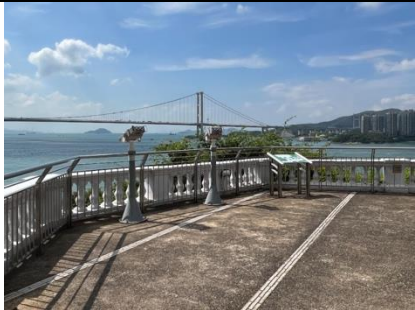
<p>1.2</p>	<p><b>1.2 Vista to surroundings</b></p> <p><i>Justification</i>  The unobstructed views of the surrounding environment from the Site including Tsing Ma Bridge and Tin Kau Bridge of ACP project and Ma Wan Channel are unique to the location being on the promontory.</p>	Exceptional

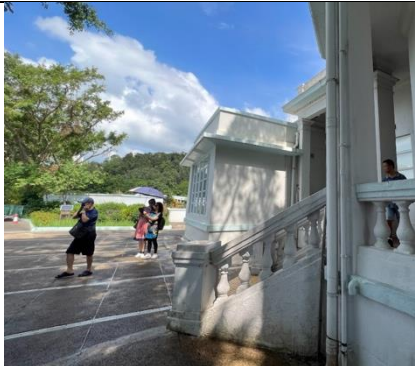
<p>1.3</p>	<p><b>1.3 Open space</b> at the northeast, Southeast and southwest of HV</p> <p><i>Justification</i>  The open space contributes to the original setting of HV. It is also a typical yet significant feature of bungalow, reflecting the origin of the original owner. It has been changed from grass lawn to hard paving.</p>	High

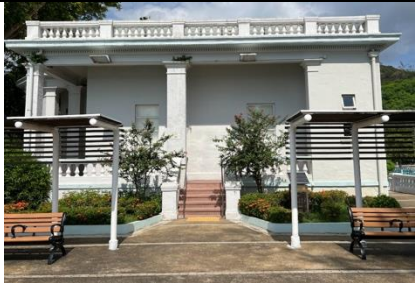
<p>1.4</p>	<p><b>1.4 Shelters and seating at open space at the southeast of HV</b></p> <p><i>Justification</i> The shelters and seating were introduced in the 1990s for the ACP Exhibition Centre and possess no cultural heritage value.</p>	Neutral	<p>(The use of blue and red colours for the annotations and arrows are for clarity sake)</p>

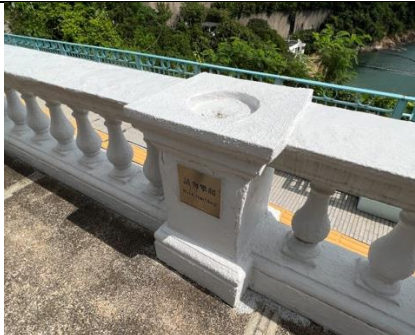
<p>1.5</p>	<p><b>1.5 Balustrade with classical urn-shaped balusters and pillars (with a circular recess on the top plane) at intervals fringing the open space at the Northeast, Southeast and Southwest of HV (not including the portion at the 1990s accessible ramp)</b></p> <p><i>Justification</i> The design of the balustrade is typical in colonial architecture and bungalow. The provision of a drain hole at the circular recess on the top of the pillars prevent rainwater from accumulating. Certain decorative elements are believed to have been placed there.</p>	Exceptional

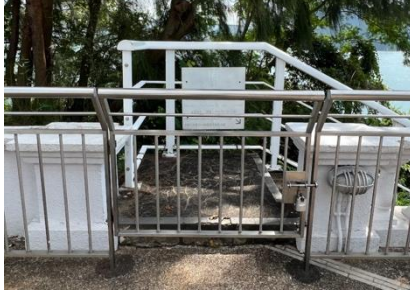
<p>1.6a and 1.6b</p>	<p><b>1.6a Metal balustrade and 1.6b Access to Marine Traffic Control Station</b></p> <p><i>Justification</i>  a. The metal balustrade is believed to have been introduced in the 1990s for the ACP Exhibition Centre.  b. The access to Marine Traffic Control Station has been here since the establishment of HV and has been renovated in the past. They possess no cultural heritage value.</p>	<p>Neutral Neutral</p>

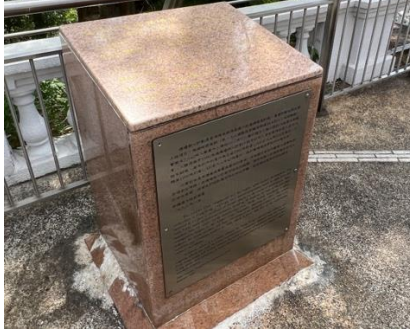
<p>1.7</p>	<p><b>1.7 Red Airport Core Programme marble memorial on the promotion of safety of the construction industry</b></p> <p><i>Justification</i>  The memorial pays tribute to the 49 fatalities at the ACP construction sites which led to the introduction of safety management system for construction industry in Hong Kong.</p>	<p>Medium</p>

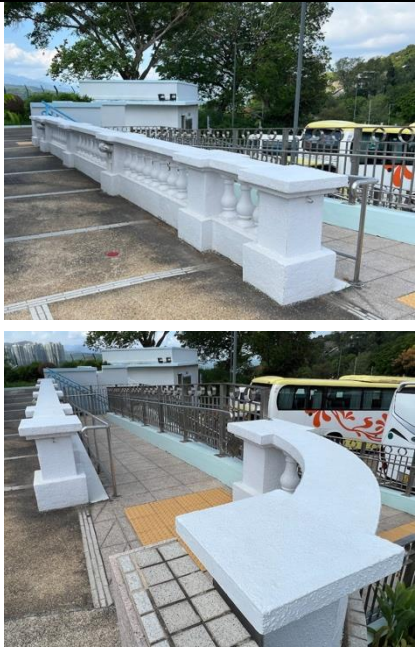
<p>1.8</p>	<p><b>1.8 1990s ramp</b> with replicated balustrades mimicking classical urn-shaped balusters and metal protective barriers to the Northeast of HV</p> <p><i>Justification</i>  The ramp and the inauthentic balustrade with new urn-shaped balusters that mimics the existing balustrades and metal protective barriers obstruct the appreciation of the historic Main Building. The replicated balustrades confuse the public about the original setting.</p>	Intrusive

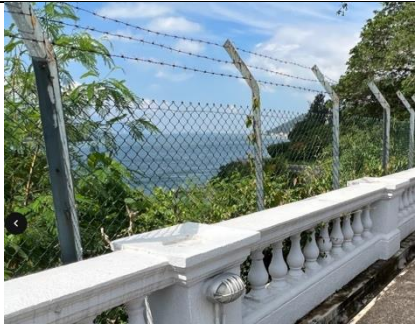
<p>1.9</p>	<p><b>1.9 Chain-link fence</b> at the fringe of the Site</p> <p><i>Justification</i>  The chain-link fence provides the safety barriers along the boundaries of the Site that are next to the existing slopes. They are functionally necessary. They should have been introduced since 1990s. They do not possess any cultural heritage significance.</p>	Neutral

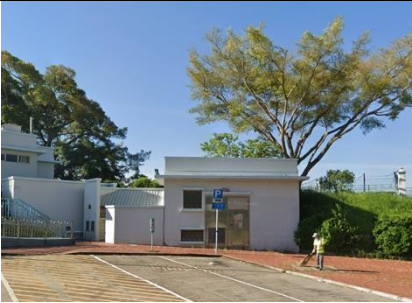
<p>1.10</p>	<p><b>1.10 The Electrical Substation (ESS), Refuse Collection Point (RCP) and there access</b></p> <p><i>Justification</i>  The Electrical Substation (ESS) and Refuse Collection Point (RCP) were introduced in the 1990s for the ACP Exhibition Centre so were the access to the ESS and RCP. They do not possess any cultural heritage significance.</p>	<p>Neutral</p>

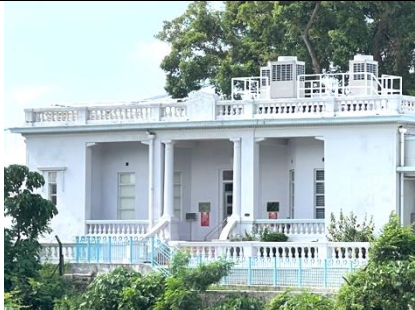
<p>2.1</p>	<p><b>2.1 Massing, form and white colour of MB</b></p> <ol style="list-style-type: none"> <li>Massing: a single storey building with a high headroom and a flat roof</li> <li>Form: a building shaped like a rectangular prism raised from the ground. Its plan is symmetrical and primarily rectangular featuring a splayed bay at the rear</li> <li>White colour of the facades</li> </ol> <p><i>Justification</i>  <i>a &amp; b. HV is a bungalow which is single storey but raised from the ground. Its flat roof creates a monolithic gesture. It has verandahs on three sides. The massing and form have been kept intact since HV was built.</i>  <i>c. The white colour is commonly used in Zoroastrianism which reflects the religion of J.H. Ruttonjee as a Parsee.</i></p>	<p>Exceptional</p> <p>Exceptional</p> <p>Exceptional</p> <p>Exceptional</p>

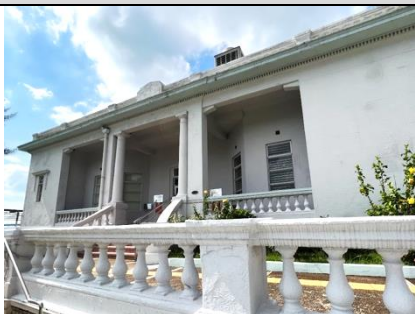
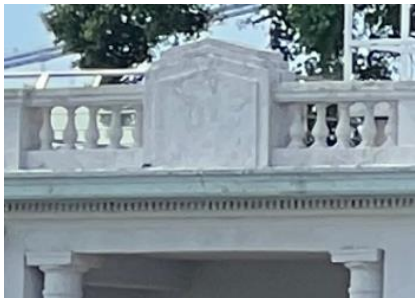
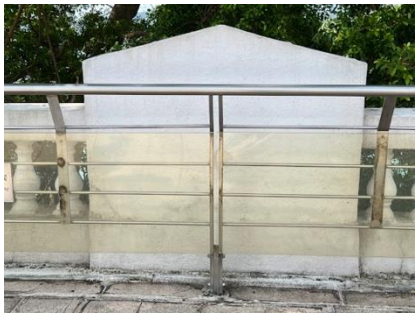
<p>2.2a (on SW elevation)</p>	<p><b>2.2 External building facades of MB including:</b></p> <ol style="list-style-type: none"> <li>Centre-pieces incorporated into the roof balustrade right above the main entrance at the northeast elevation, and at the southwest elevation</li> <li>Balustrades with classical urn-shaped balusters and pillars on the roof</li> <li>Horizontal protruding roof eaves with dentil cornice</li> <li>Architrave and corbels</li> <li>Circular columns on Tuscan Order and pillars with capitals at main entrance</li> <li>External pillars</li> <li>White stucco-work rendering with groove lines imitating masonry construction and moulding at the base</li> <li>Relief moulding surrounding the main and rear entrances</li> <li>Window head with label moulding over window</li> <li>Window sill</li> <li>Original openings on the wall for doors and fenestration</li> <li>Balustrades with classical urn-shaped balusters and pillars (with a circular recess on the top surface) on the G/F verandahs</li> <li>1990s windows, doors and louvres</li> </ol>	<p>Exceptional</p> <p>Exceptional</p> <p>Exceptional</p> <p>Exceptional</p> <p>Exceptional</p> <p>Exceptional</p> <p>Exceptional</p> <p>Exceptional</p> <p>Exceptional</p> <p>Exceptional</p> <p>Exceptional</p> <p>Exceptional</p> <p>Intrusive</p>

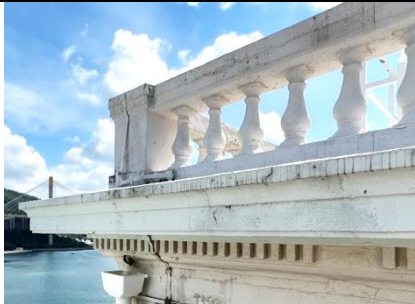
<p>2.2b &amp; 2.2c</p>	<p><i>Justification</i></p> <p><i>a. to l. The exterior is composed of architectural features commonly found in both Parsee temples and vernacular buildings, and Neo-Classical architecture, reflecting the origin of the original owner. They are the original features retained on Site.</i></p> <p><i>m. The current windows and doors found at the Site are not the original ones. The windows have aluminium frames, and the doors are clad with reflective metal panels. They were installed in the 1990s for the ACP Exhibition Centre, which the original designs are believed to be steel doors and windows.</i></p>

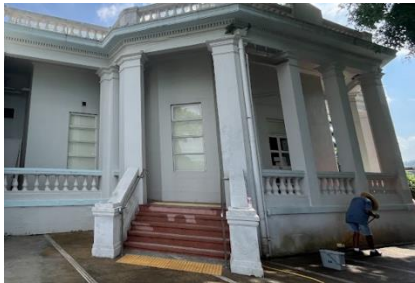
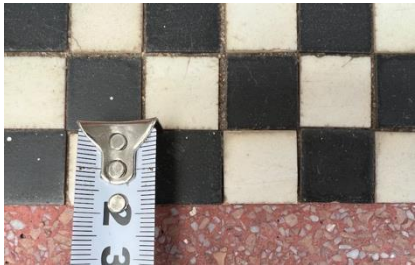
<p>Mosaic tiles and terrazzo</p>	<p>b. A straight staircase at the southeast entrance</p> <p>c. A straight staircase at the west entrance</p> <p><i>Justification</i>  <i>The fanned staircase at main entrance is a feature which is often used in Zoroastrianism temples. White, black and red are the three basic colours of Zoroastrianism which reflects J. H. Ruttongee's religion.</i></p>	<p>Exceptional</p> <p>Exceptional</p>

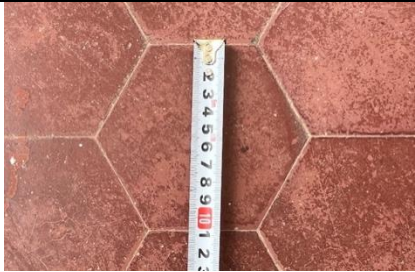
<p>2.4a</p>	<p><b>2.4 Opened verandahs on northeast, southeast and southwest façade of MB including:</b></p> <ol style="list-style-type: none"> <li>Vermilion hexagonal clay floor tiling</li> <li>Rendered skirtings</li> <li>Crown mouldings at ceilings</li> </ol> <p><i>Justification</i></p> <p>a. Verandah is a typical spatial design of bungalow. Red is one of the three basic colours of Zoroastrianism.</p> <p>b. Rendered skirtings are found at the external wall area used by the residents and their guests, which are original design.</p> <p>c. Crown mouldings are found at ceilings of front-out-house areas that used by the residents and their guests, which are original design.</p>	Exceptional
