**National History Education Centre (Youyou Villa) Limited**

# Heritage Impact Assessment in Respect of the Revitalisation of Homi Villa into Centre of National History Education Youyou Villa

Revitalising Historic Buildings Through Partnership Scheme (Batch VI)

**Final Report**

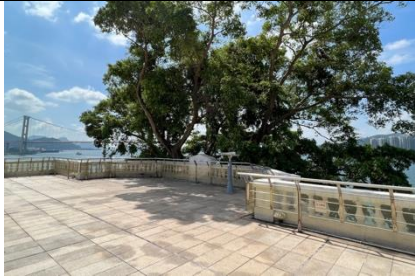
<p>2.5</p>	<p><b>2.5 Flat roof of MB</b></p> <p><i>Justification</i>  The flat roof is original. However, 3 chimneys were removed in 1990s and the original floor finishes have been replaced.</p>	High

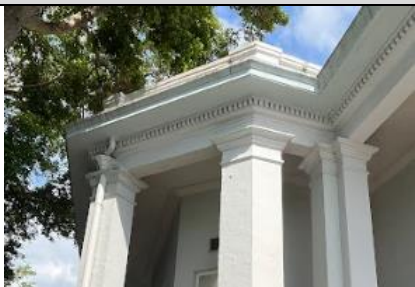
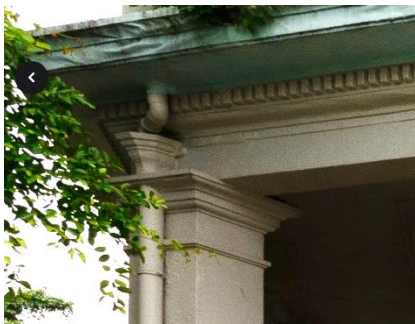
<p>2.6a An original hopper</p>

<p>2.6a Close-up of an original hopper</p>

<p>2.6a Original drainage outlets</p>	<p><b>2.6 Roof, soil, waste drainage, rain water pipings, hoppers, outlets, and other fittings of MB</b></p> <ul style="list-style-type: none"> <li>a. Original cast iron ones</li> <li>b. Replaced ones</li> </ul> <p><i>Justification</i>  <i>A few components of the pipings and fittings are original e.g. the rain water hopper at the splayed bay facing south, while most have been replaced, e.g. the rain water hoppers on the front and southeast façades, and all of the rainwater down pipes.</i></p>	High Intrusive

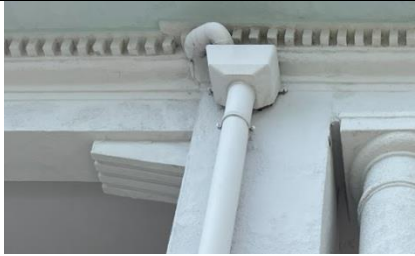
<p>2.6b A replaced hopper</p>

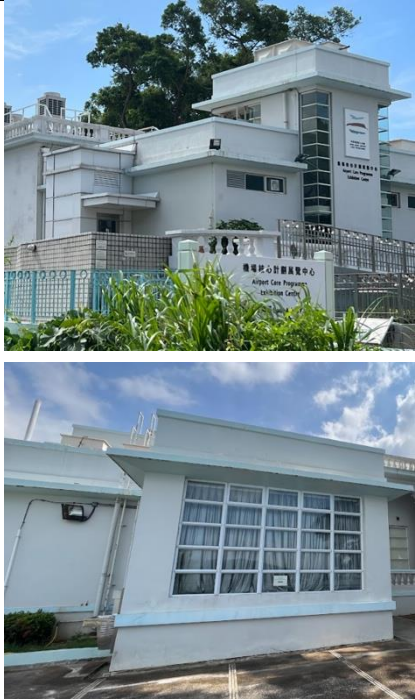
<p><b>2.7 1990s Extension (EXT) to the northwest of MB</b></p> <p><i>Justification</i>  <i>The 1990s extension has greatly impaired the balance portrayed by MB. Its excessive height is not respecting the scale of MB. Besides, its design is also incompatible to that of the main building.</i></p>	Intrusive

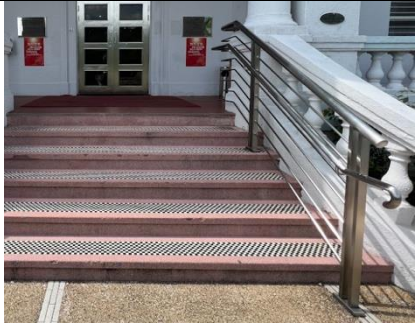
<p>2.8 At main entrance staricase</p>

<p>2.8 At rear staricase</p>	<p><b>2.8 Stainless steel balustrades and railings at staircases</b></p> <p><i>Justification</i>  <i>The historic staircases are a CDE with exceptional significance. The later-added s.s. balustrades and railings with acrylic panels at the staircases were constructed to fulfill the requirements for protective barriers. They are considered an intervention with minimal impact to the historic staircases.</i></p>	Intrusive

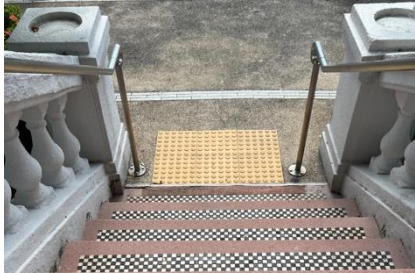
<p>Architectural drawings showing the Northeast, Southeast, and Southwest elevations of the building. Red arrows and labels '2.8' indicate the locations of the stainless steel balustrades and railings on the staircases.</p>

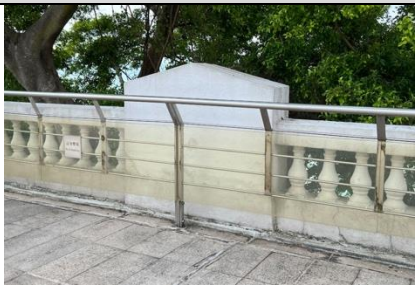
<p>2.9</p>	<p><b>2.9 Stainless steel balustrades and railings with acrylic panels at roof of MB</b></p> <p><i>Justification</i> The balustrades with urn-shaped balusters are a CDE with exceptional significance. The later-added s.s. balustrades and railings with acrylic panels at the roof are obscuring the appreciation of the exceptional CDEs.</p>	Intrusive

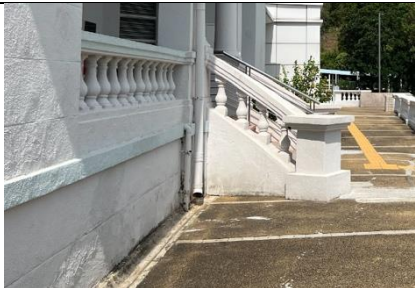
<p>2.10</p>	<p><b>2.10 Surface channel around MB</b></p> <p><i>Justification</i> The surface channel complements the drainage system of MB where rainwater collected by the hoppers and down pipes are channeled here.</p>	Low

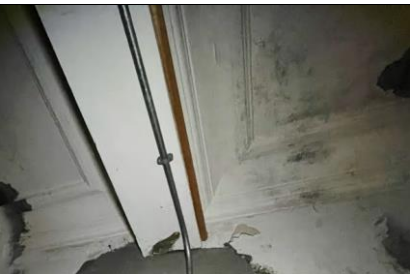
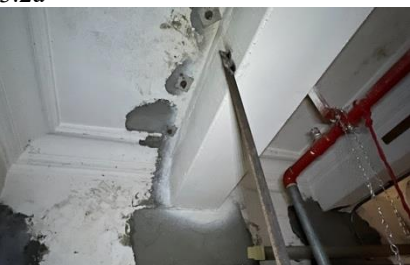
<p>3.2a</p>

<p>3.2b</p>	<p><b>3.2 Original building structure and elements of MB</b></p> <p>a. Original beams, columns, structural masonry walls and slabs b. Later-added R.C. beams in 1990s</p> <p><i>Justification</i> The building structure and elements includes the structural walls, beams, columns, G/F slab and roof slab of MB. Original structural beams have corner mouldings on both sides. The walls are also elements that determine the spatial design as they partition the space. There are later-added structural beams introduced to strengthen MB for the use as ACP</p>	High Intrusive	<p><b>3.2a</b></p>

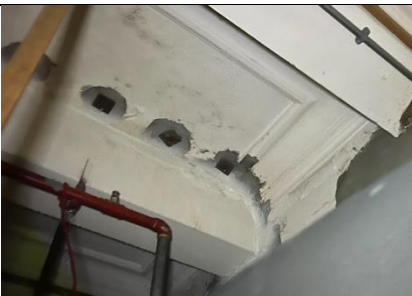
<p><b>3.3 Ceiling mouldings</b></p> <p><i>Justification</i>  <i>The decorative mouldings are original and are found on the ceiling and at the corners of walls and beams with the ceiling. They advise that there were no false ceilings in the original design and the interior space has a high headroom.</i></p>	High

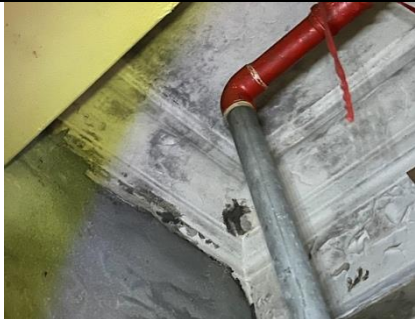
<p>3.3</p>

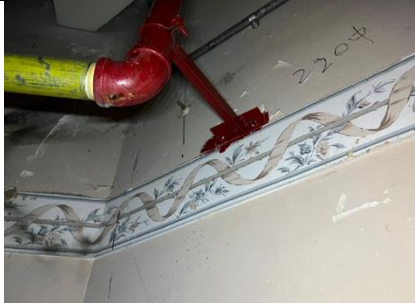
<p>3.4a</p>

<p>3.4b</p>	<p><b>3.4 Decorative timber panels</b> at high levels of walls of two side bedrooms and the living room with splayed corners, MB</p> <p><i>Justification</i>  <i>Segments of 3 types of timber panels with different wall paper patterns are found at the high level of 3 of the 5 rooms believed to be original bedrooms or living room.</i></p>	High

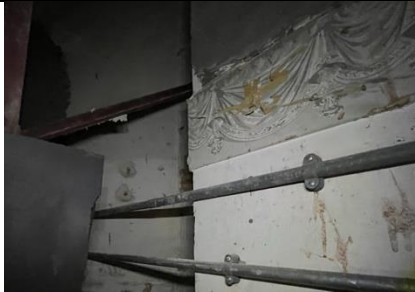
<p>3.5</p>	<p><b>3.5 Original chimney breast at the original living room and the side bedrooms and dining room, MB</b></p> <p><i>Justification</i>  The chimney breast at the original living room protruding from the wall has been substantially damaged with the lower portion entirely removed. Others, subject to further on site open-up inspection. It helps to advise the original location of one of the fire places.  The other chimney breasts are currently covered by the exhibition panels pending further investigation.</p>	Medium

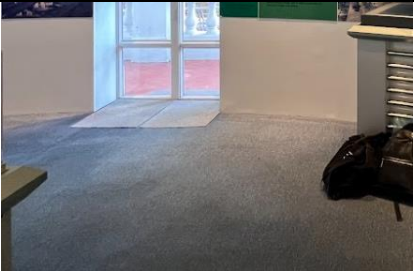
<p>3.6</p>	<p><b>3.6 Existing floor finishes, MB</b></p> <p><i>Justification</i>  <i>The original parquet floor has been replaced. The current floor finishes are carpet tiles</i></p>	Neutral
