## Heritage Impact Assessment

in respect of the Revitalisation of  
Fong Yuen Study Hall into  
Fong Yuen Study Hall – Experiential Learning Center

26 Feb 2024

Heritage Impact Assessment in respect of the Revitalisation of Fong Yuen Study Hall into Fong Yuen Study Hall – Experiential Learning Center under Revitalising Historic Buildings Through Partnership Scheme Batch VI

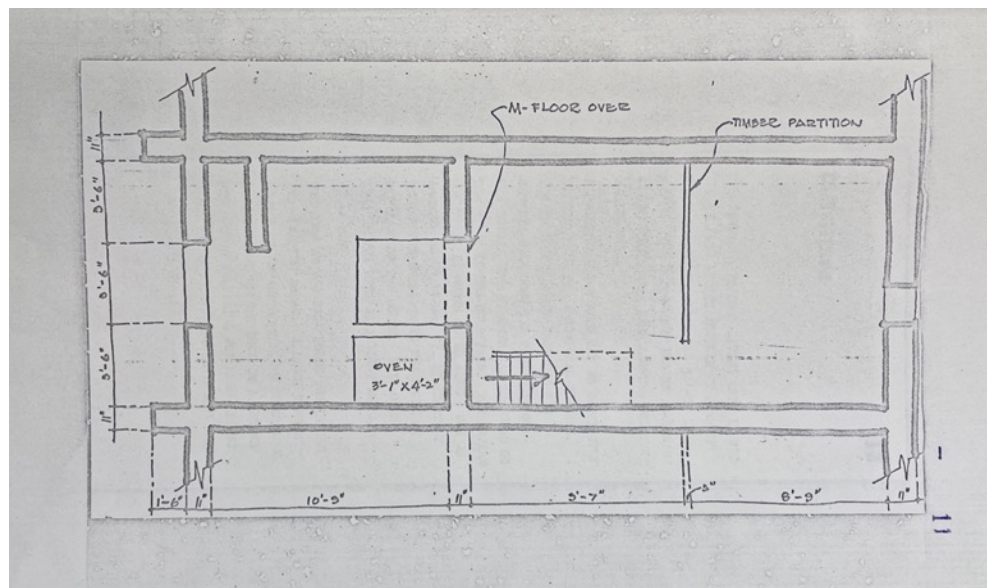
Figure 40 Typical layout of dwellings in Tin Liu village, sketch drawn in late 1960s<sup>83</sup>

In comparison, the scale of these typical village houses matches with the modularity in the layout of Fong Yuen Study Hall's. The dimensions of each of the two bays of the Fong Yuen Study Hall is roughly equal to the dimensions of a typical dwelling unit.

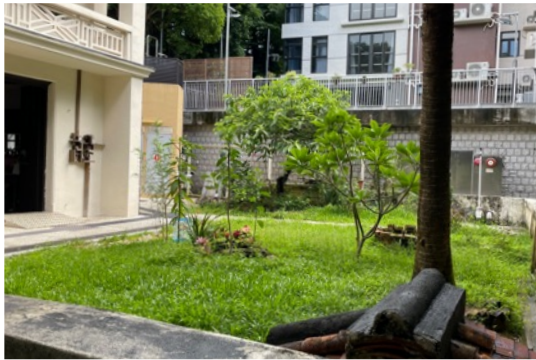
*Figure 56 Forecourt in 2023.*

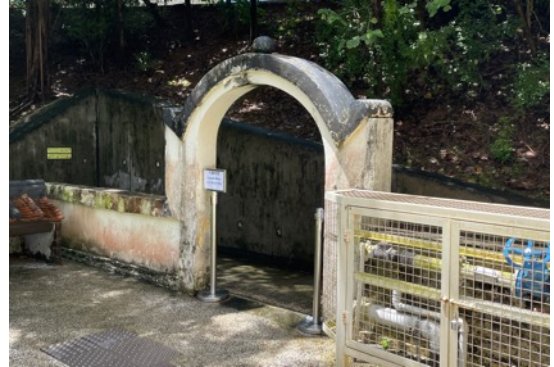
*Figure 57 Round arch doorway in 2023.*

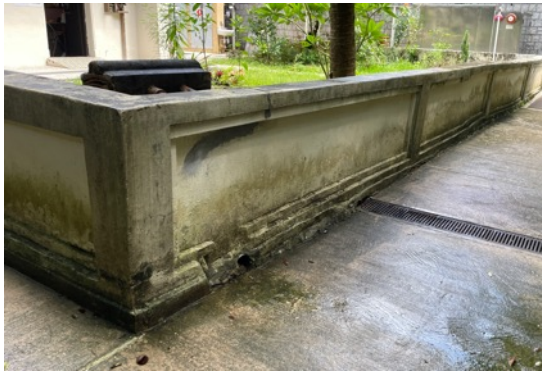
*Figure 58 Low boundary wall of the forecourt in 2023.*

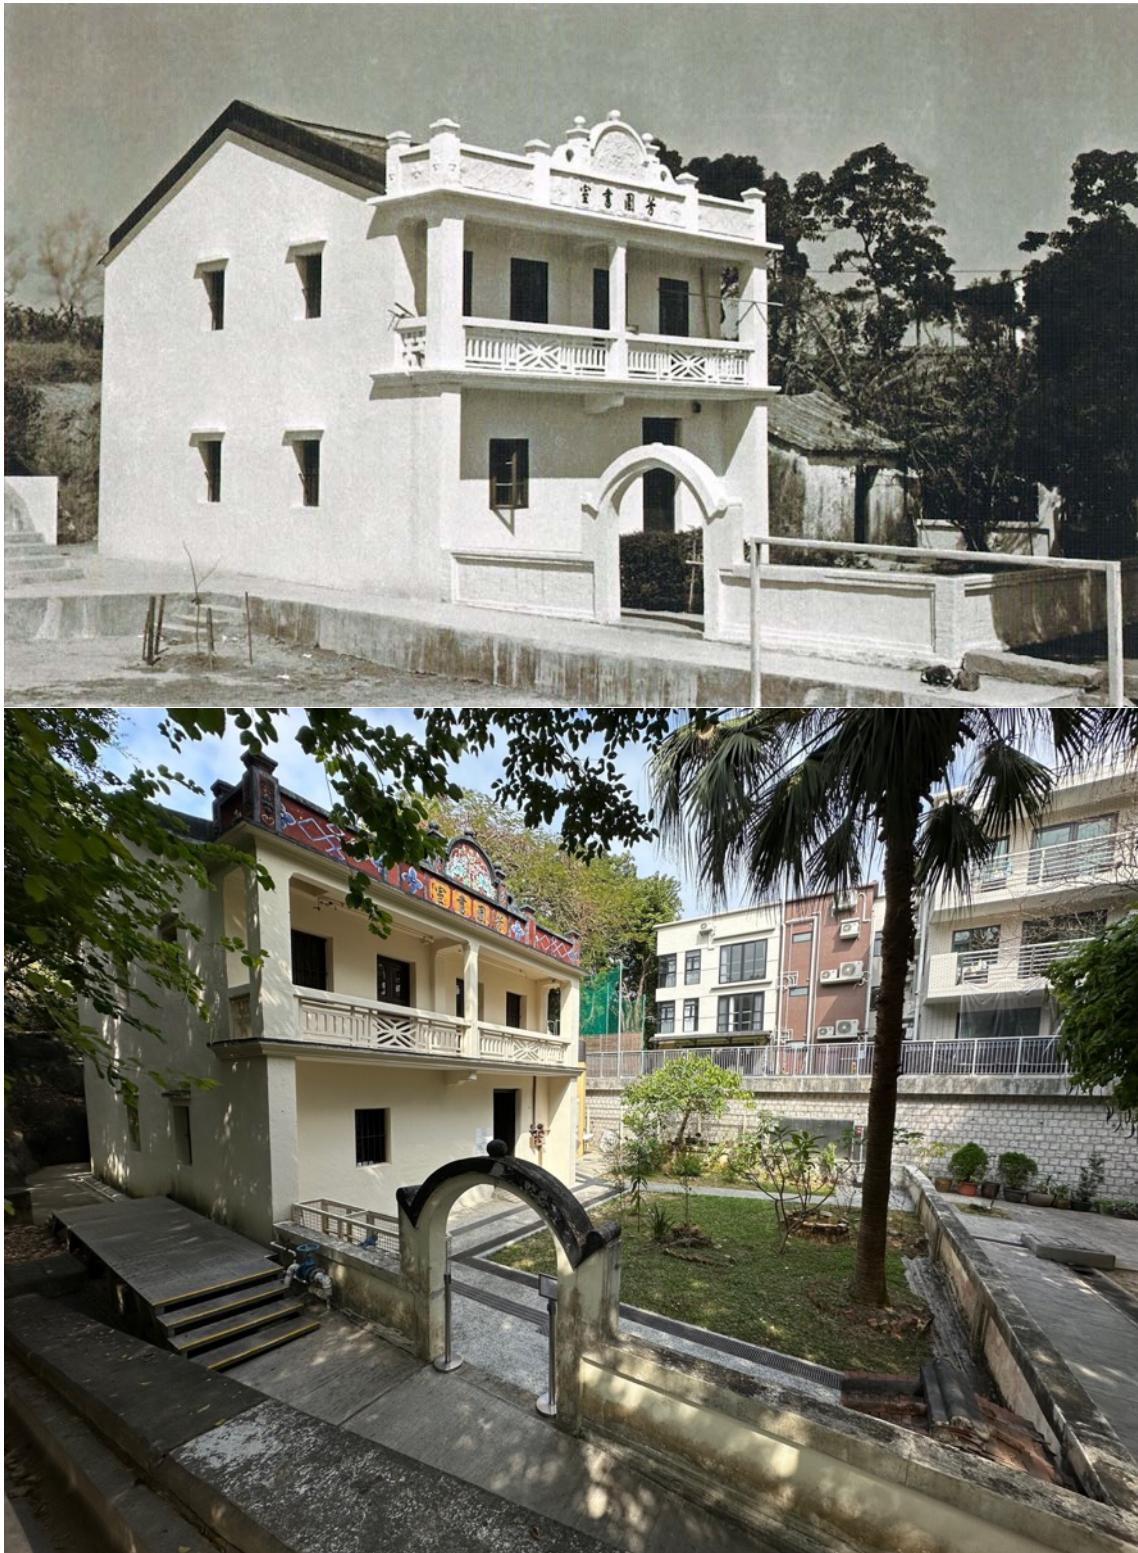
*Figure 60 Comparison of the surrounding of the Fong Yuen Study Hall in the 1950s-60s (image above)<sup>138</sup>, and 2024 (image below)*

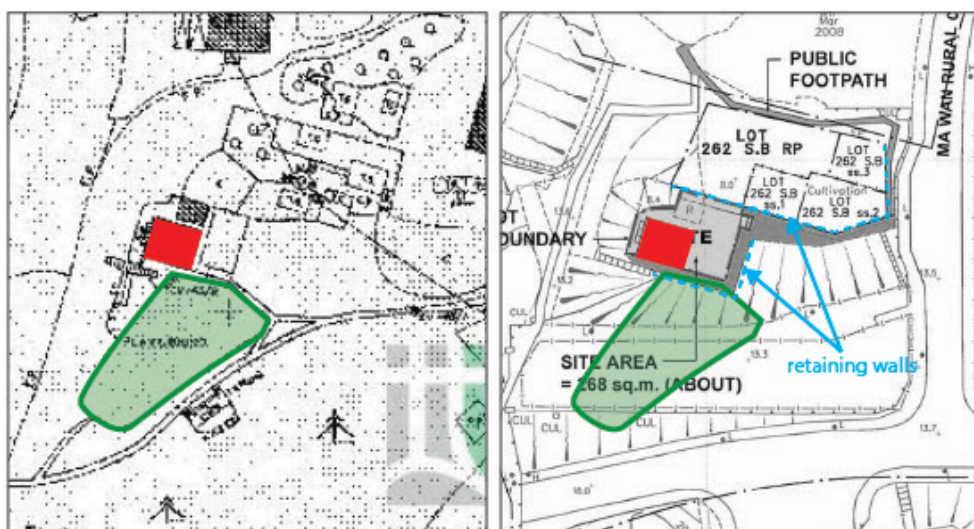
Figure 61 Mapping of the Fong Yuen Study Hall (coloured in red) and the playground (coloured in green) in 1962 Lands Department Survey Map<sup>139</sup> (left image) compared to the current site condition (right image).

Based on the earliest available survey map dating back to 1962, it is noteworthy that the ancillary building and forecourt were already in existence at that time. Additionally, the presence of an external staircase, albeit faintly visible, linking the ground to the first floor at the rear facade of the study hall can be observed. Students were able to enter the school building through the main entrance, traversing the forecourt. Alternatively, they could utilize the rear staircase for direct access to the classrooms on the first floor. The school provide lodging for the school's teachers employed from other parts of Hong Kong.<sup>159</sup> According to oral accounts, the teachers would slept on first floor.<sup>160</sup> The ancillary building was used as toilet and kitchen.<sup>161</sup>

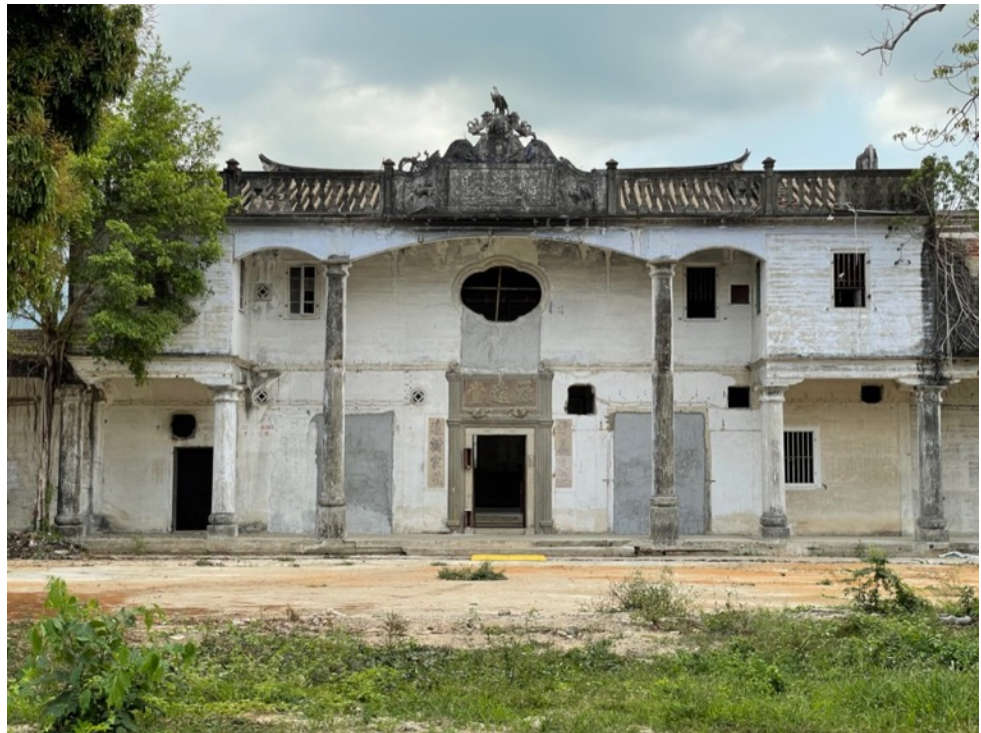
Figure 65 Front elevation of Kong Har Wai(江夏圍), 2021. (grade 3 historic building)

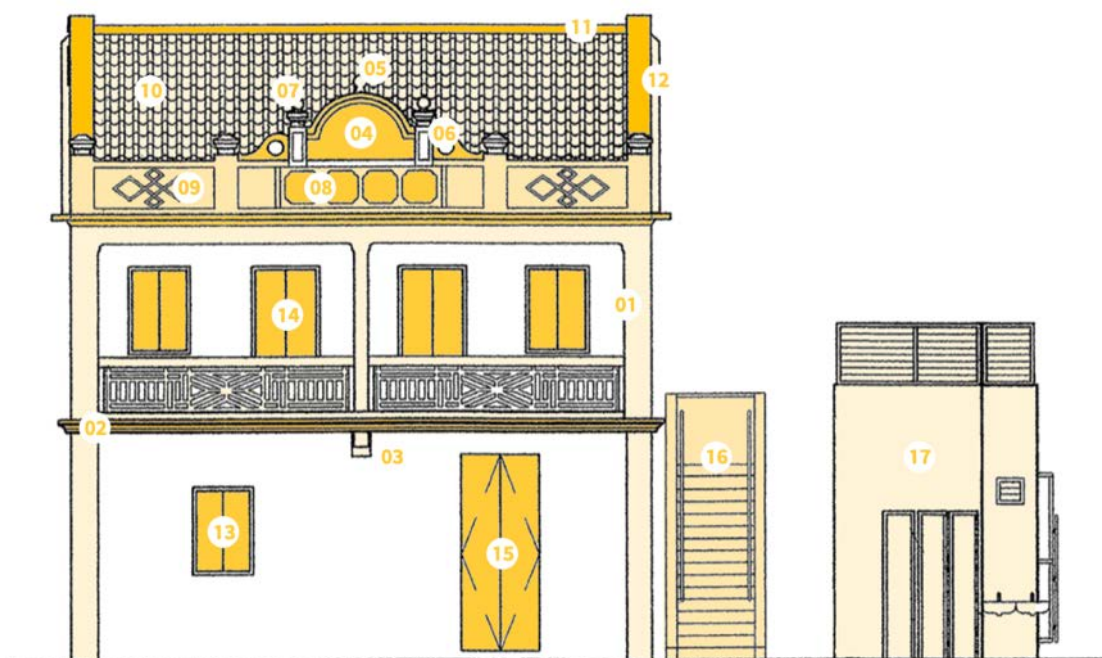
- 01/ Balcony
- 02/ Cornice
- 03/ Shaped Bracket
- 04/ Pediment
- 05/ Acroterion
- 06/ Pedestal
- 07/ Finial
- 08/ Plastered Character
- 09/ Parapet
- 10/ Roof
- 11/ Main Ridge
- 12/ Gable Ridge
- 13/ Window
- 14/ French Door
- 15/ Entrance Door
- 16/ Metal Staircase
- 17/ Toilet Block

Figure 66 Glossary of architectural elements of Fong Yuen Study Hall.

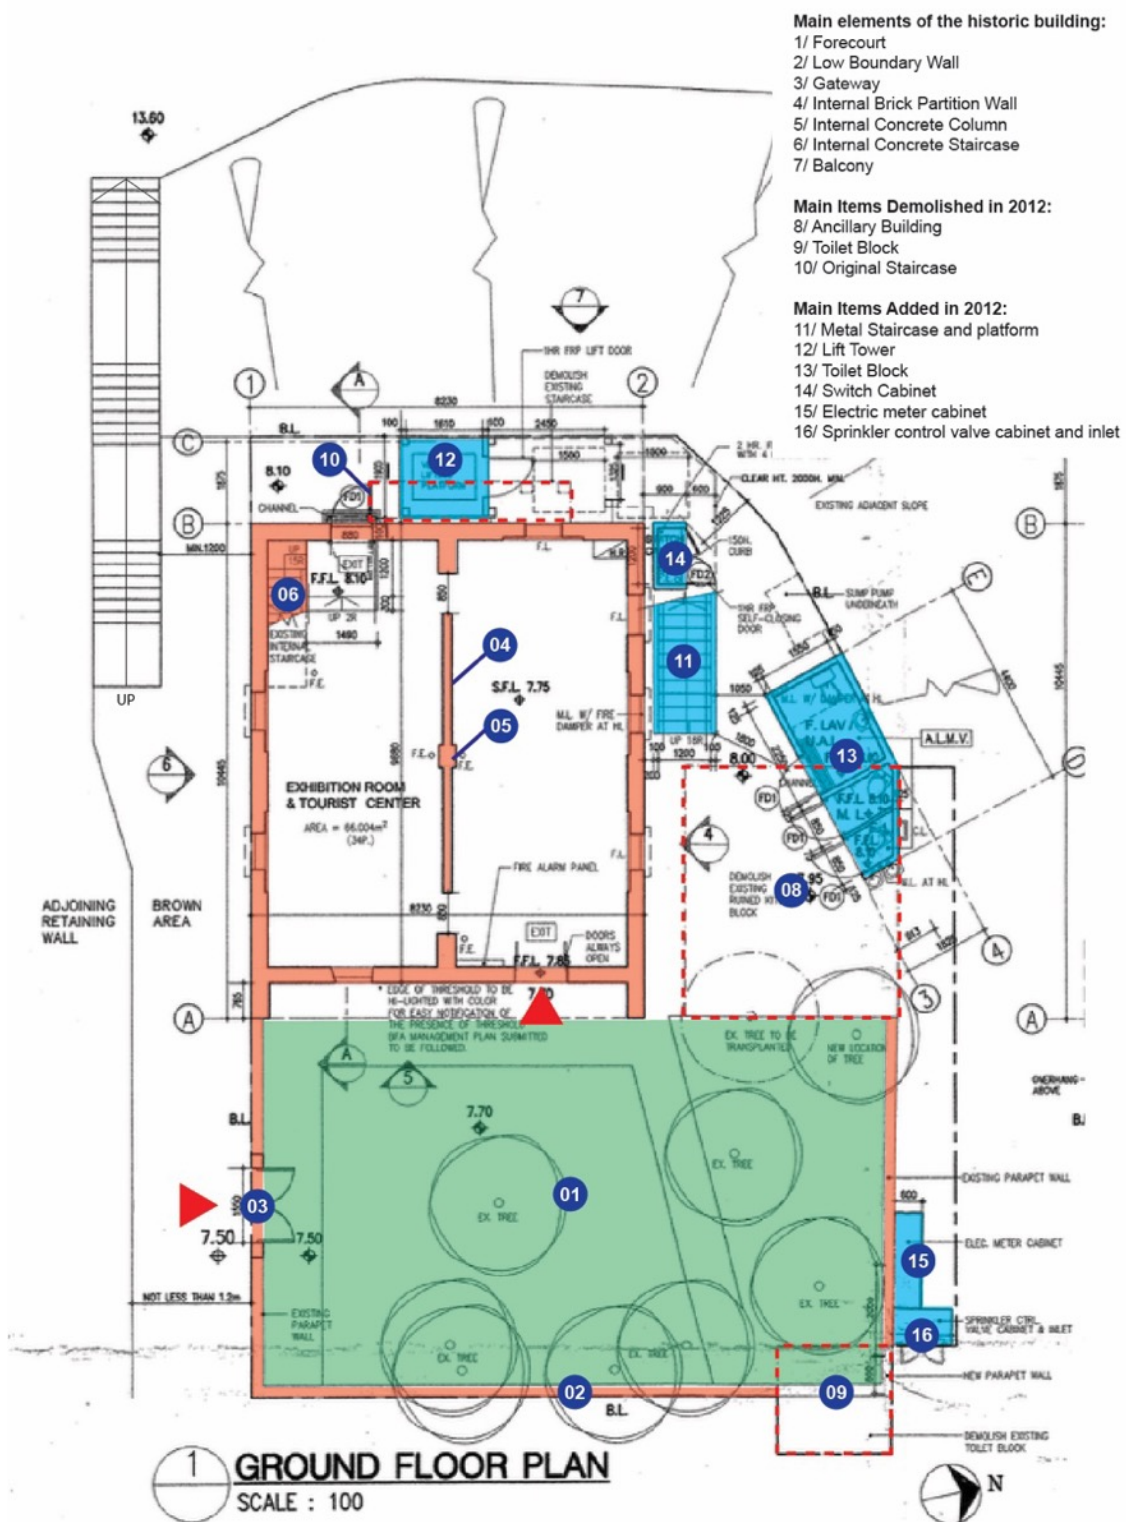
Figure 67 Architectural elements of the current Fong Yuen Study Hall (G/F)

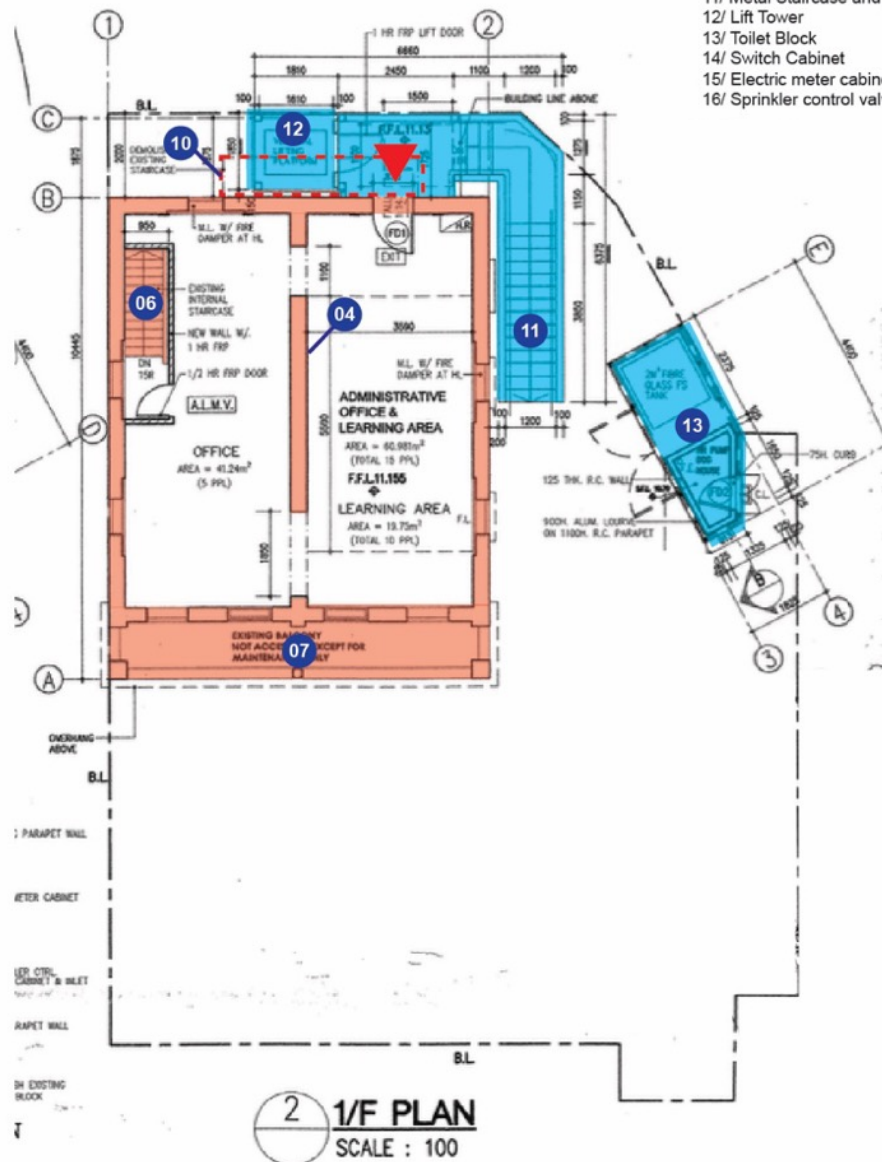
- 11/ Metal Staircase and platform
- 12/ Lift Tower
- 13/ Toilet Block
- 14/ Switch Cabinet
- 15/ Electric meter cabinet
- 16/ Sprinkler control valve cabinet and inlet

Figure 68 Architectural elements of the current Fong Yuen Study Hall. (1/F)

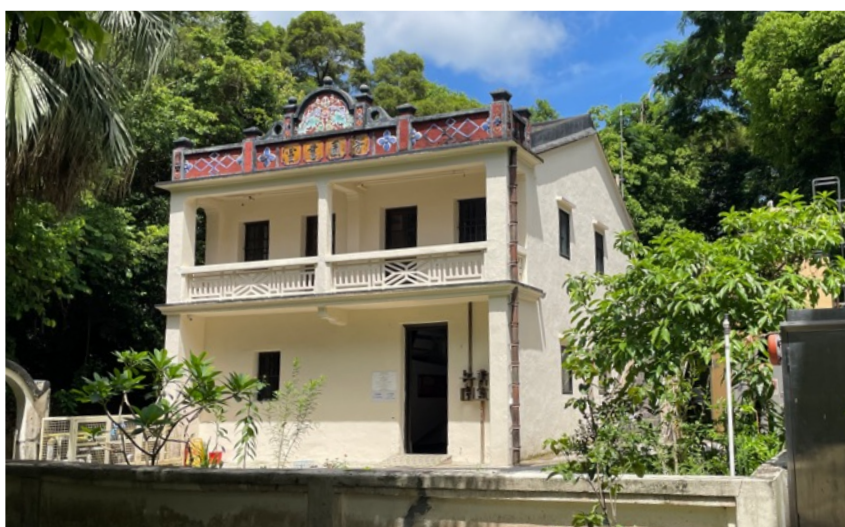
The roof parapet, acroteria, and pediment above the balcony featured projecting profiles, pedestals with decorative finial, and decorative relief in both Chinese and Western styles. Plastered characters of the name of the school “Fong-Yuen Study Hall” - “芳園書室” in Chinese calligraphy is featured at the centre of the roof parapet.

The main entrance of the building is situated towards the right end of the facade. This elevation features a plain, cream-coloured plaster-rendered surface.

Figure 69 Front view of Fong Yuen Study Hall in 2023.

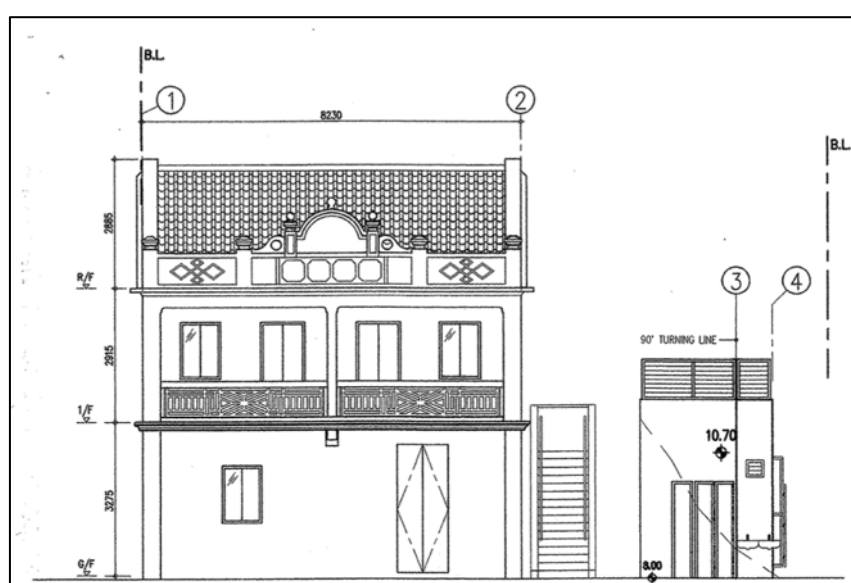
Figure 70 Front elevation of the Fong Yuen Study Hall (As-built drawing (2012), extracted from Fong Yuen Study Hall – Resource Kit. 2019).

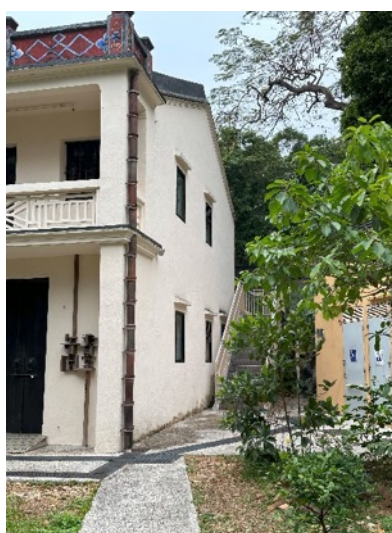
The north elevation of the building features a metal staircase attached to it, providing access to a side entrance located at the rear elevation, specifically leading to the first floor. A PVC rainwater downpipe existed on north elevation before Batch I revitalization works. During the Batch I revitalization works, a ceramic encasement was installed over a replaced PVC rainwater downpipe in order to restore the appearance of the pipeworks of the period. The outlook of the ceramic encasement made reference to the ceramic downpipe found at nearby historic village houses constructed in the similar period.

There are two rows of timber windows with security bars, including hood mouldings, which are partially blocked by the later-added metal escape staircase. During the last revitalization, fixed glass panels were installed in the windows on this elevation, replacing the original open-air configuration.

Figure 72 North elevation of Fong Yuen Study Hall in 2020.

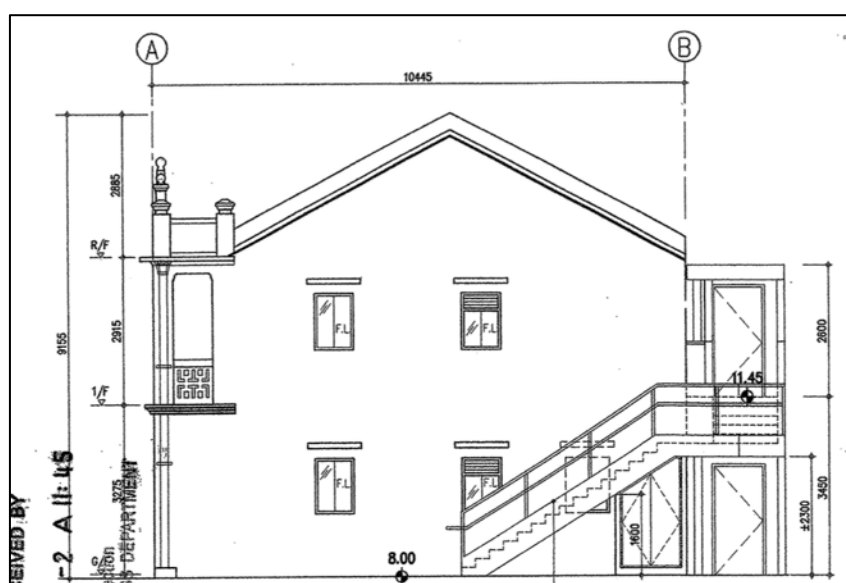
Figure 73 North elevation of the Fong Yuen Study Hall (As-built drawing (2012), extracted from Fong Yuen Study Hall – Resource Kit. 2019).

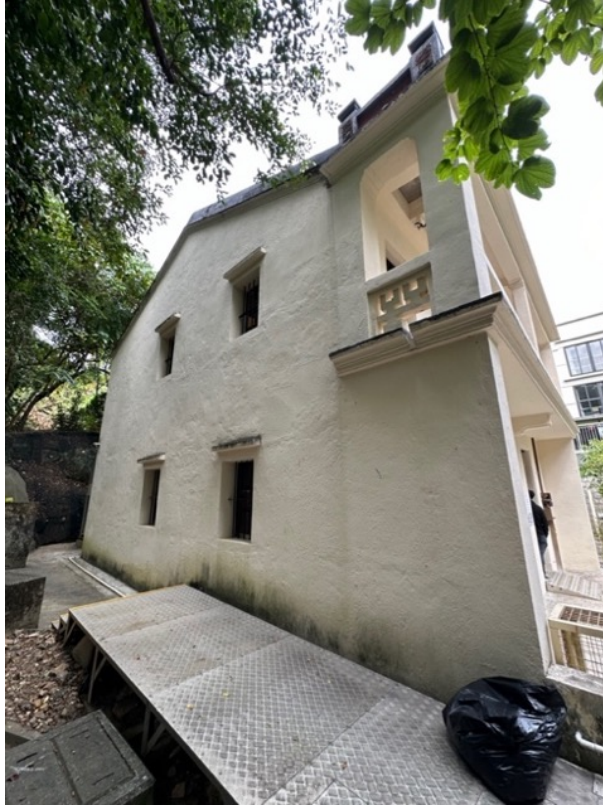
The south elevation of the building faces a slope and includes the low boundary wall of the forecourt along with a round arch gateway. This section also features two rows of timber windows with security bars, including hood mouldings. These windows are set against a plain plaster-rendered surface, painted in a creamy white colour.

Figure 74 South elevation of Fong Yuen Study Hall in 2023.

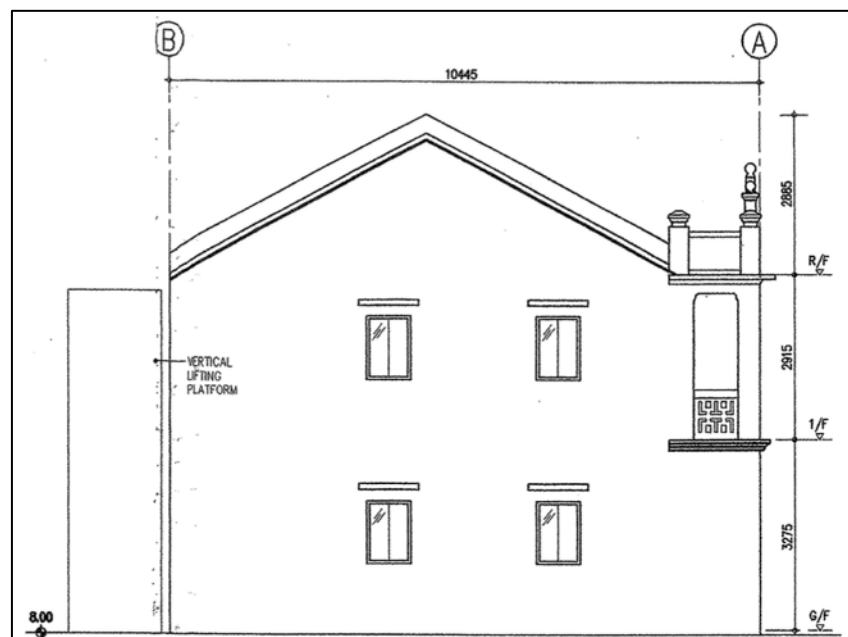
Figure 75 South elevation of the Fong Yuen Study Hall (As-built drawing (2012), extracted from Fong Yuen Study Hall – Resource Kit. 2019).

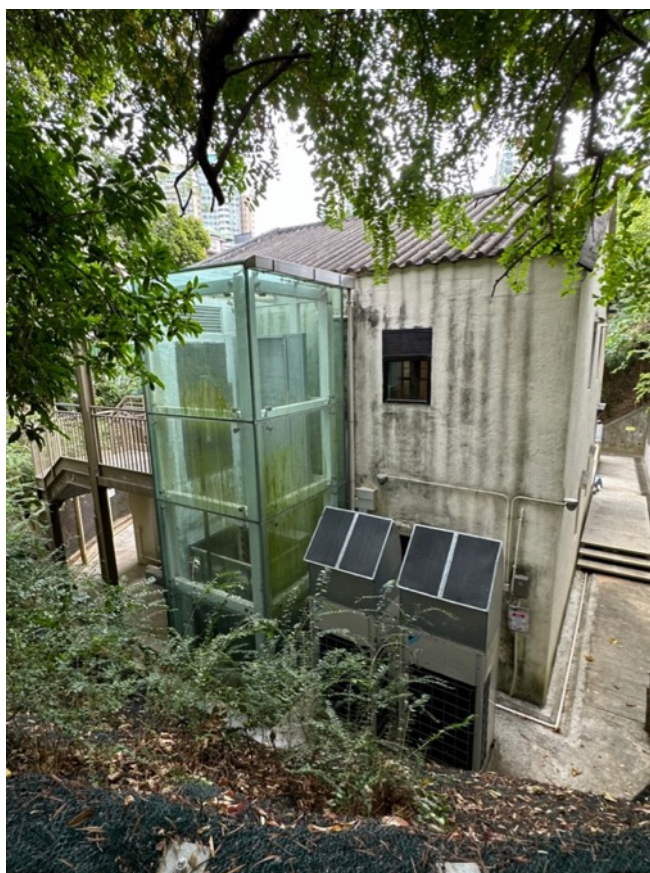
The rear elevation of the building faces a retaining wall. There were almost no distinct aesthetic features, and the main focus of this facade is functionality rather than visual appeal. It includes a single door on the ground floor providing access to the existing exhibition area and another door on the first floor, accessible via the metal staircase from the North Elevation. There are also two window openings on different floors. Additionally, a vertical lift tower is present on this façade.

Figure 76 Rear elevation of Fong Yuen Study Hall in 2020.

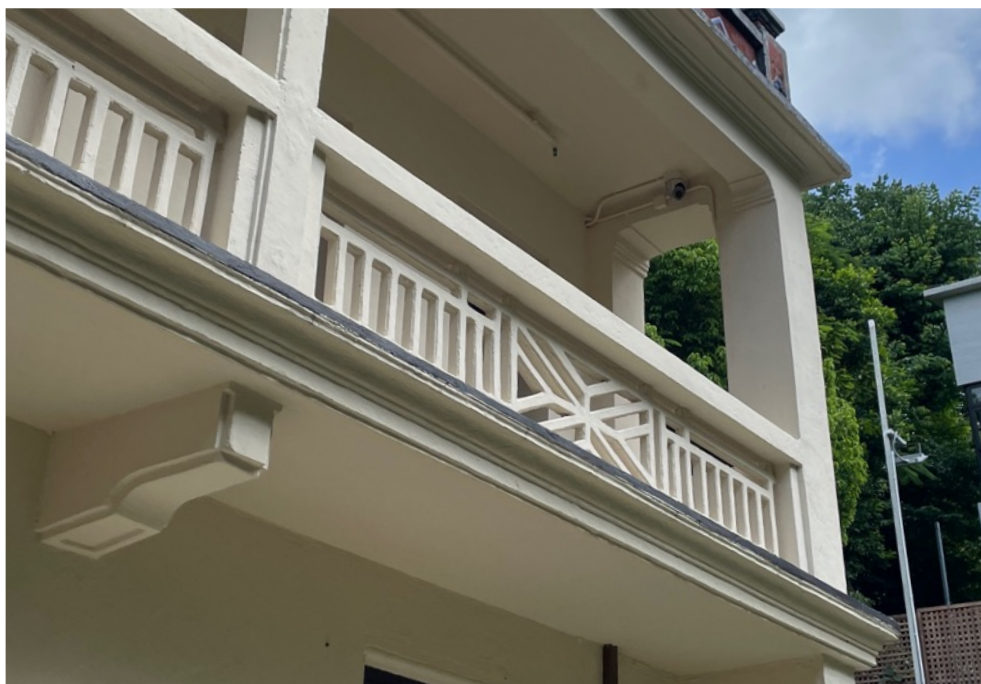
The balcony of the Fong Yuen Study Hall is an open space that is fenced by geometric pattern screen balustrades with coping rails. It is constructed with reinforced concrete and designed as a cantilevered balcony, supported by columns and brackets. The balusters located at both ends of the balcony are intricately carved with longevity symbols.<sup>144</sup> The projecting floor slab of the balcony showcases cornice moulding. Its edge is currently painted in black. There is an opening in the ceiling of the balcony that provides access to the flat roof through the use of a cat ladder.

*Figure 78 Balcony in 2023.*

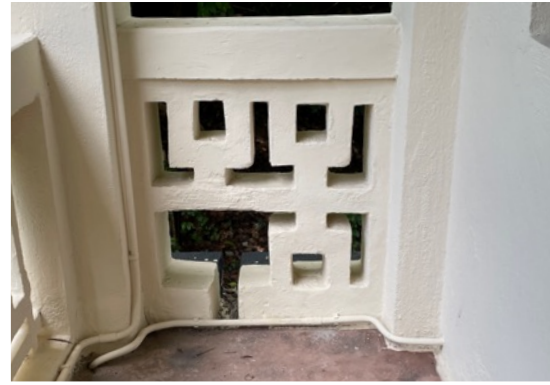
*Figure 80 Pattern balustrades of longevity symbol with drain outlet in 2023.*

From the photograph taken in Figure 61 (ca. 1950s-1969s) and 63 (1980s), water stains caused by water draining from a drainage hole on the balustrade of the balcony can be observed. It can also be observed that the patterned balustrade was incomplete on this side of the balustrade, presumably because of the provision of the drainage hole on this side.

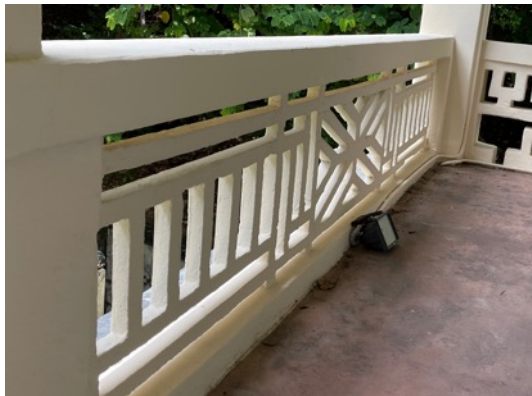
*Figure 81 Pattern balustrades in 2023.*

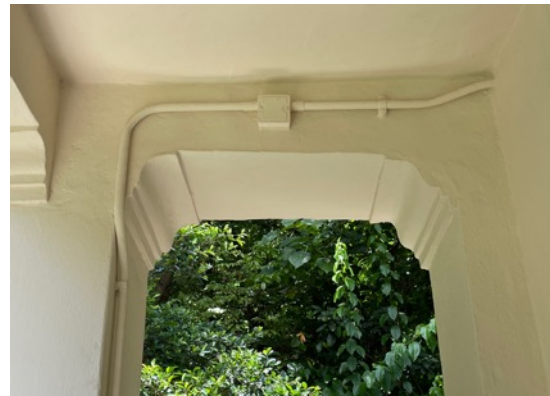
*Figure 82 Moulding at balcony in 2023.*

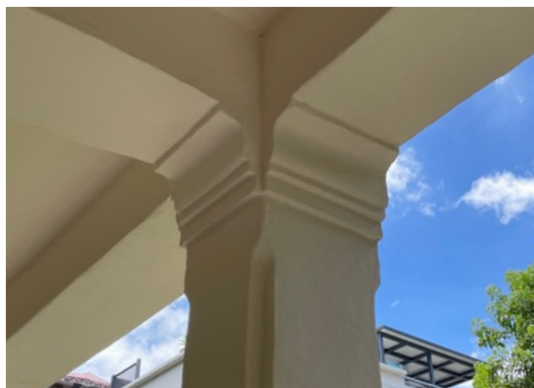
*Figure 83 Column of balcony in 2023.*

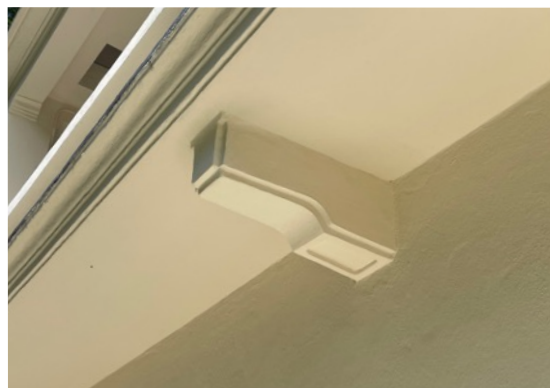
*Figure 84 Bracket underneath balcony in 2023.*

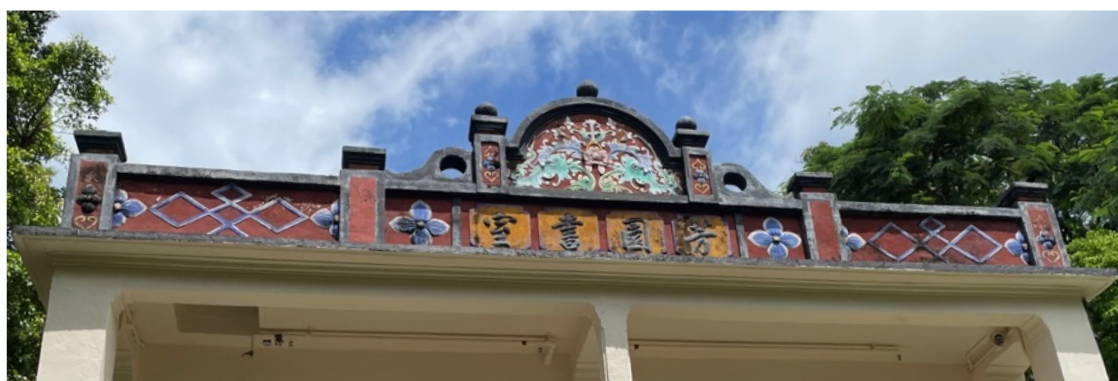
The upper part of the Fong Yuen Study Hall showcases a blend of Western and Chinese architectural elements. The roof parapet, which consists of a pediment and acroteria, reflects common Western architectural decoration and practices, while the surface of the parapet features plastered reliefs depicting Chinese auspicious motifs. The parapet and pediment feature a symmetrical design, adorned with acroterion, pedestal and decorative finials. The outline of the pediment followed those commonly found in Baroque architecture. This practice can be seen in other examples of *Qiaoxiang* architecture as well.<sup>145</sup> The parapet is inscribed with the Chinese characters '芳園書室' (Fong Yuen Study Hall), along with Western style diamond-shaped geometric patterns and the *Shidi* pattern (柿蒂; four-lobed persimmon pedicel pattern).<sup>146 147</sup> On the pediment, there is a plastered floral pattern known as *Baoxianghua* (寶相花), which was commonly used as an auspicious flower motif during the Tang Dynasty.<sup>148</sup>

Figure 85 Roof parapet and pediment in 2023.

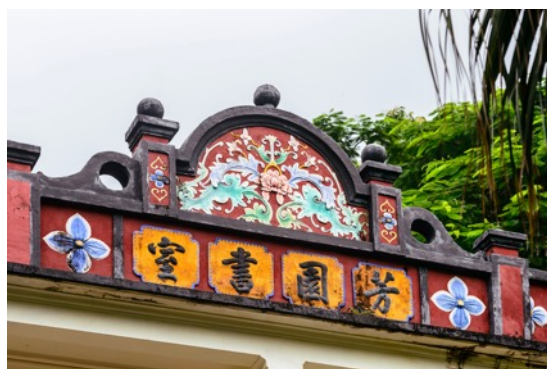
Figure 86 Pediment with *Baoxianghua* pattern in 2023.

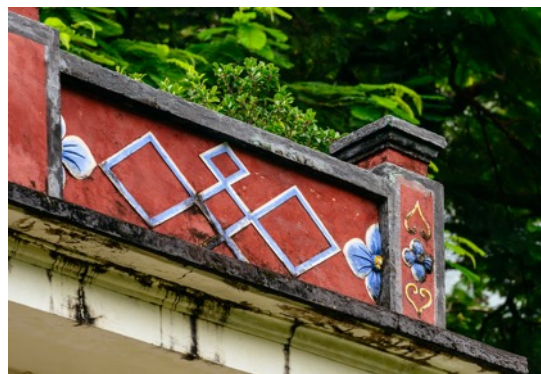
Figure 87 Roof parapet with Western style diamond-shaped geometric patterns and *Shidi* patterns in 2023.

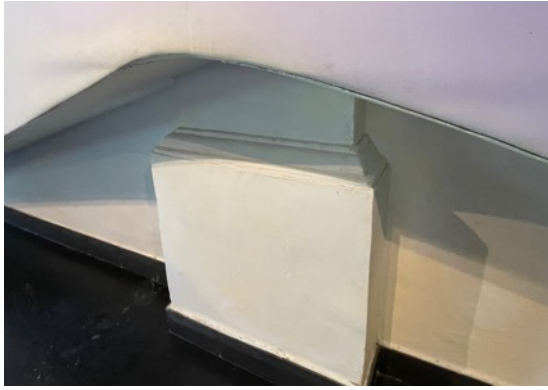
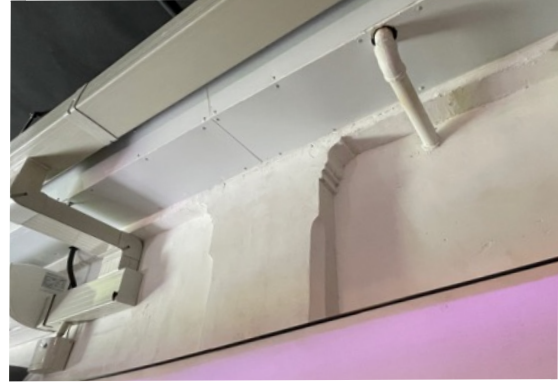
Fong Yuen Study Hall is structurally supported by reinforced columns and load-bearing walls made of brick and granite blocks. The interior partitions are constructed using bricks, while the flat roof-slab, floor slab, and beams are made of reinforced concrete. Notably, the columns and beams feature decorative moulding elements, which enhance the visual appeal of the building. The moulding decorations on the columns and beams of both the ground floor and first floor have been preserved in the last revitalisation.

*Figure 95 Column with decorative moulding, 2023.*

*Figure 96 Column with decorative moulding, 2023.*

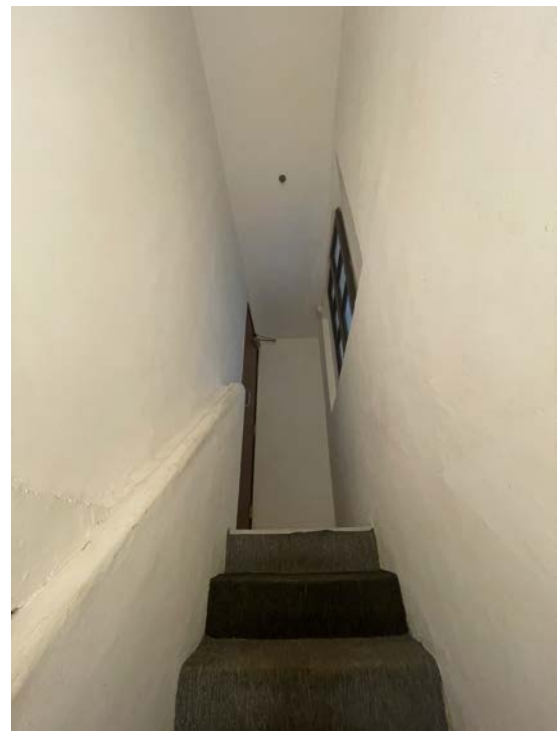
*Figure 98 Internal concrete staircase, 2021.*

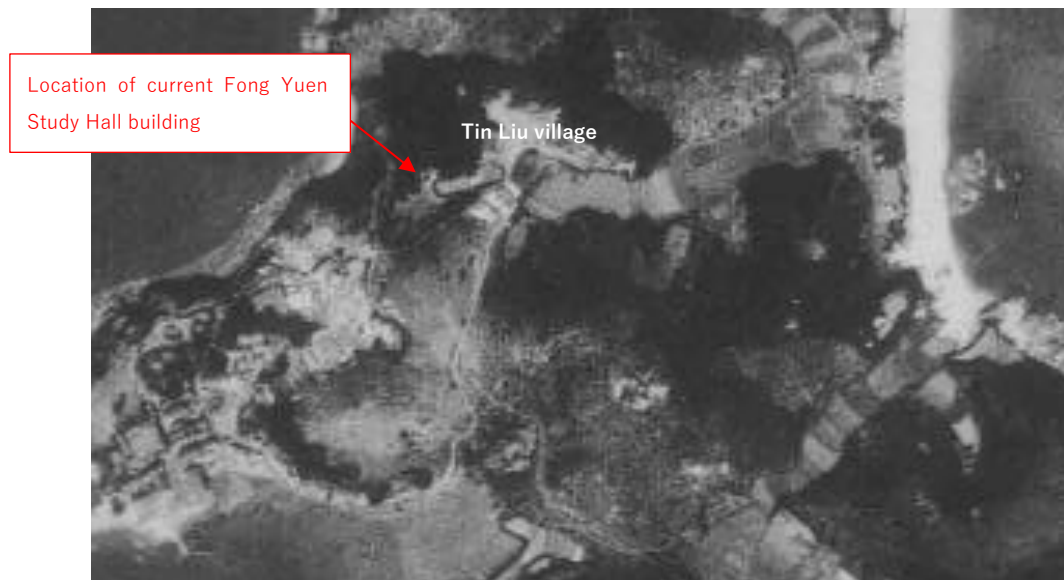
Figure 104 Aerial photograph of Ma Wan in 1924 (Lands Department, Aerial Photo No. H41-0008, November 20, 1924)

As shown in an aerial photograph of the area in 1924, the current location of the Fong Yuen Study Hall was located to the west of the Tin Liu village. Due to the resolution of the photograph, it is unclear whether the current Fong Yuen Study Hall building is present. As of the time of writing, there is no direct evidence indicating the exact date of construction for the current Fong Yuen Study Hall. However, in a record dated 1906, it was mentioned that a traditional Chinese-style school building in Ma Wan covering an area of approximately 0.03 acres (121 square meters), which is similar to its present-day dimensions.<sup>158</sup> However, as it was iterated in section 2.3.1, it is important to note that it is unclear whether the school building mentioned in this 1906 record was the current Fong Yuen Study Hall building.

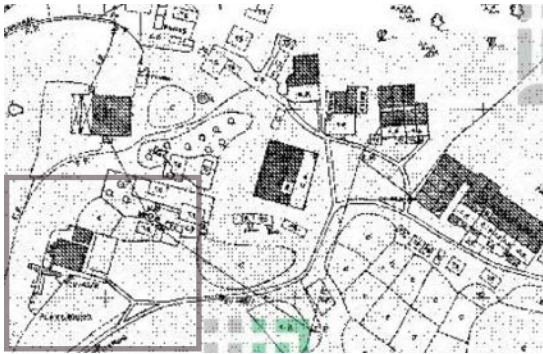
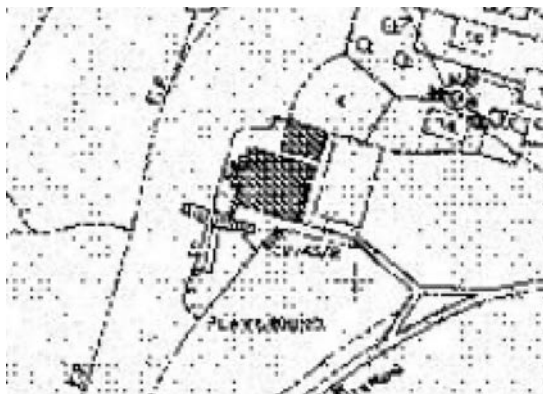
Figure 105a Survey map in 1962 of Tin Liu village. (Lands Department, Survey Map No. 159-NE-D, 1962.)

Figure 105b Zoom-in of Figure 105a

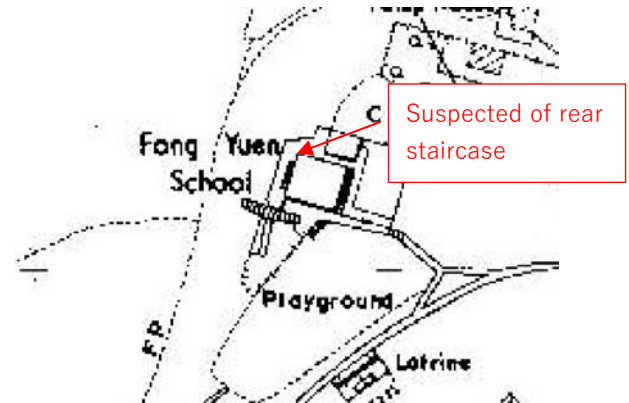
Figure 106b Zoom-in of Figure 106a

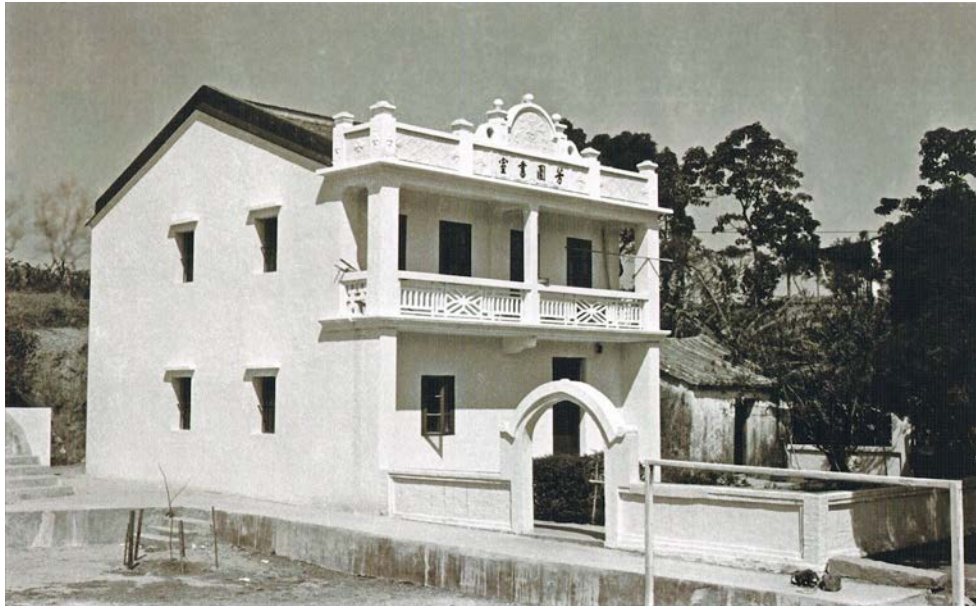
Figure 107 Fong Yuen Study Hall in the 1950s to 1960s.<sup>162</sup>

The building was observed to have timber windows and metal grilles installed at the window openings in the past. The metal grilles were positioned on the exterior side of the side elevation, while the window panels were installed on the interior and opened inward. However, it should be noted that the ground floor window on the front facade featured a timber casement window that opened outward, distinguishing it from the other windows in the building.

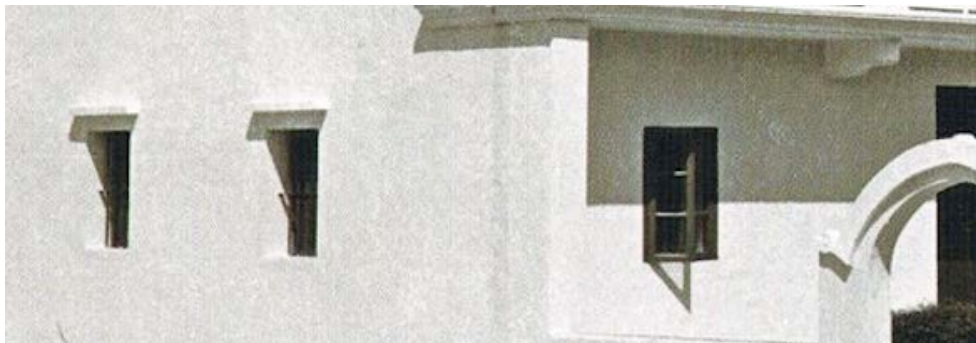
Figure 108 Zoom-in of figure 107, showing timber windows in the 1950s to 1960s.

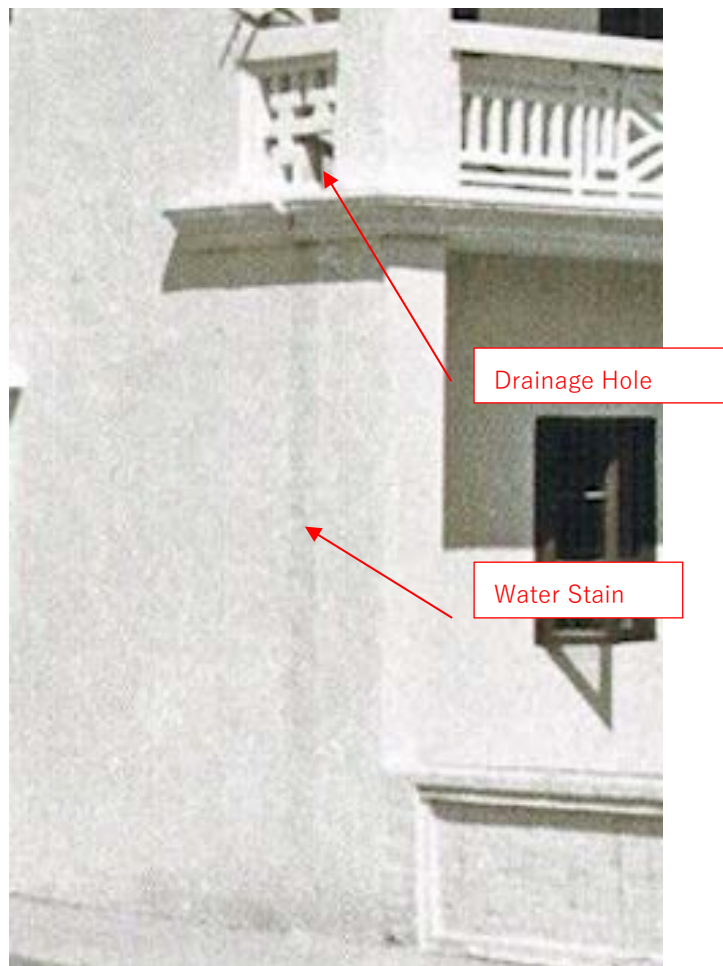
*Figure 109 Blow up figure 107, showing drainage hole and water stain*

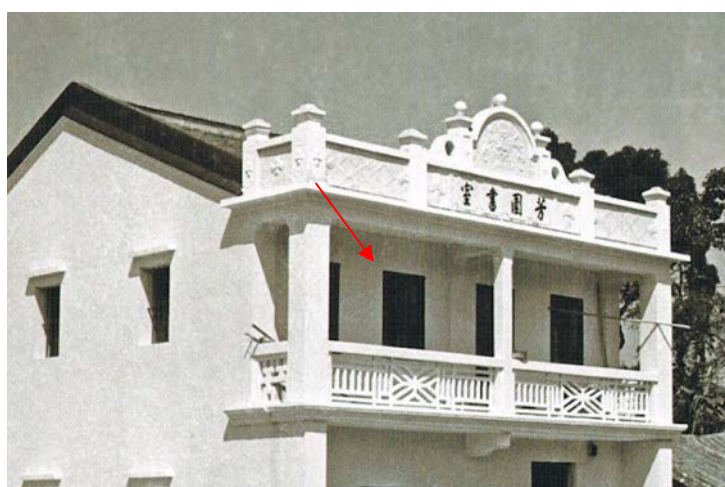
In the 1990s, Fong Yuen Study Hall underwent two renovations.<sup>163</sup> It was likely that during one of these renovations, the traditional Chinese tiled pitched roof was removed and replaced with a metal corrugated plate. Additionally, the original windows were replaced with metal casement windows, and the metal grilles were also removed. Furthermore, one window opening was converted to a door opening on the first floor to provide access to the balcony area.

Figure 110 Fong Yuen Study Hall in the 1950s to 1960s. Marked location (currently a door opening) was originally a window (the wall is solid below the window).<sup>164</sup>

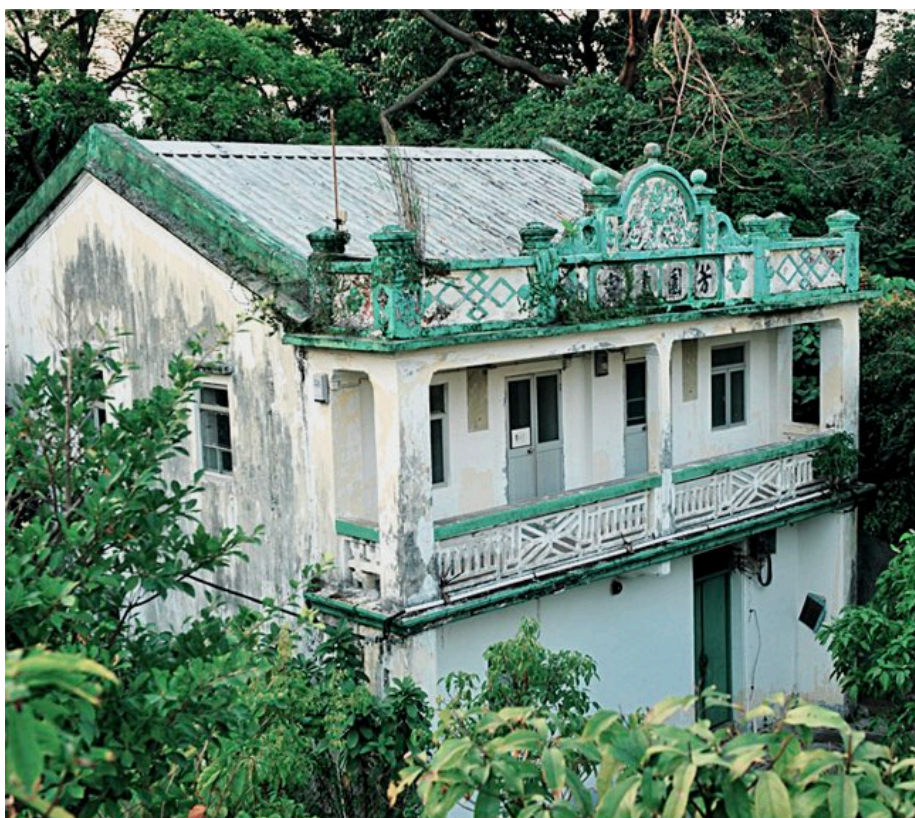
Figure 112 Fong Yuen Study Hall in 2008.<sup>166</sup>

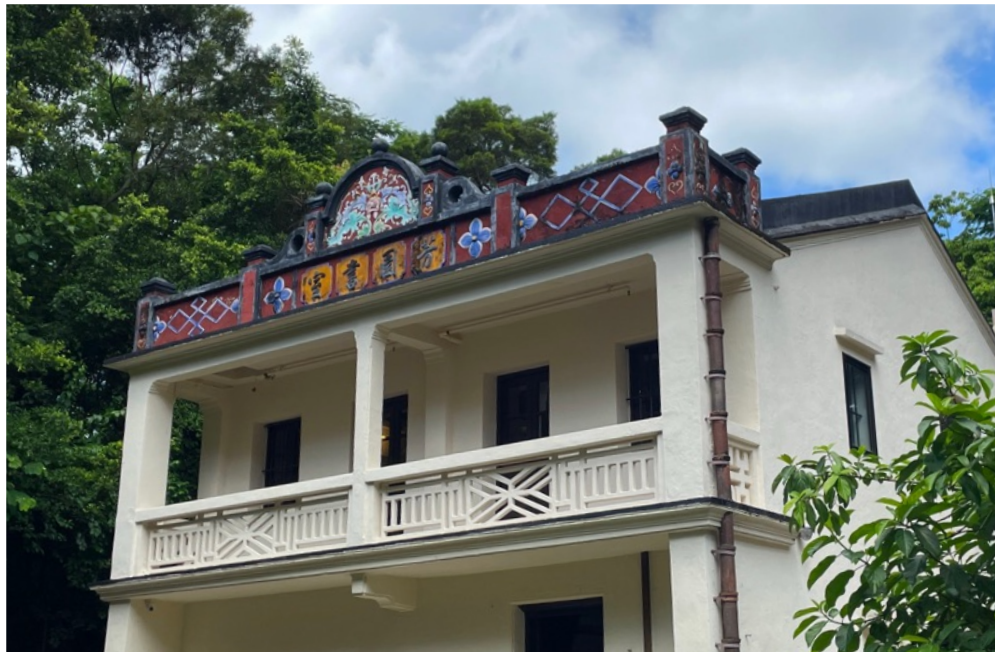
*Figure 113 Fong Yuen Study Hall in 2023.*

Significant changes were made to the exterior of the building. The later-added metal roofing was replaced, and was restored with pan-and-roll tiles based on the type of roof found in the demolished kitchen block. Although it was suspected that the original tiled roof was in Hakka style, evidence is insufficient and solid conclusion could not be made. Therefore, in 2012, the team made reference to the demolished kitchen which also had a pan-and-rolled tiled roof, and restored the roof accordingly. If in the future new evidences pointing to the original style of the historical roof is found, further restoration work could be reviewed and considered.

According to AMO's record, a ceramic downpipe casing was installed over a replaced PVC rainwater downpipe, due to aesthetic reasons and to restore the appearance of pipeworks of the period. The parapet and pediment and the decorative elements were repainted in burglary red and black colours. It is believed to be the original colour scheme. According to AMO's record, after stripping the later-applied top-layer finishes during the last revitalisation, traces of the old paint layer was revealed. The parapet and pediment and the decorative elements were subsequently repainted according to the colours of the old paint layer.

Likewise, the metal windows were substituted with timber windows that featured grilles, while the metal doors were replaced with timber doors.

The ancillary building and the toilet block were demolished, and a new toilet block was constructed. Additionally, an escape staircase, as well as a lift tower, were erected to replace the original rear external staircase. Fire-rated fixed light windows were added on the external side of windows within the six meter of the external staircase as per the recommendations of the fire-engineering study.
