## Heritage Impact Assessment

in respect of the Revitalisation of  
Fong Yuen Study Hall into  
Fong Yuen Study Hall – Experiential Learning Center

26 Feb 2024

Heritage Impact Assessment in respect of the Revitalisation of Fong Yuen Study Hall into Fong Yuen Study Hall – Experiential Learning Center under Revitalising Historic Buildings Through Partnership Scheme Batch VI

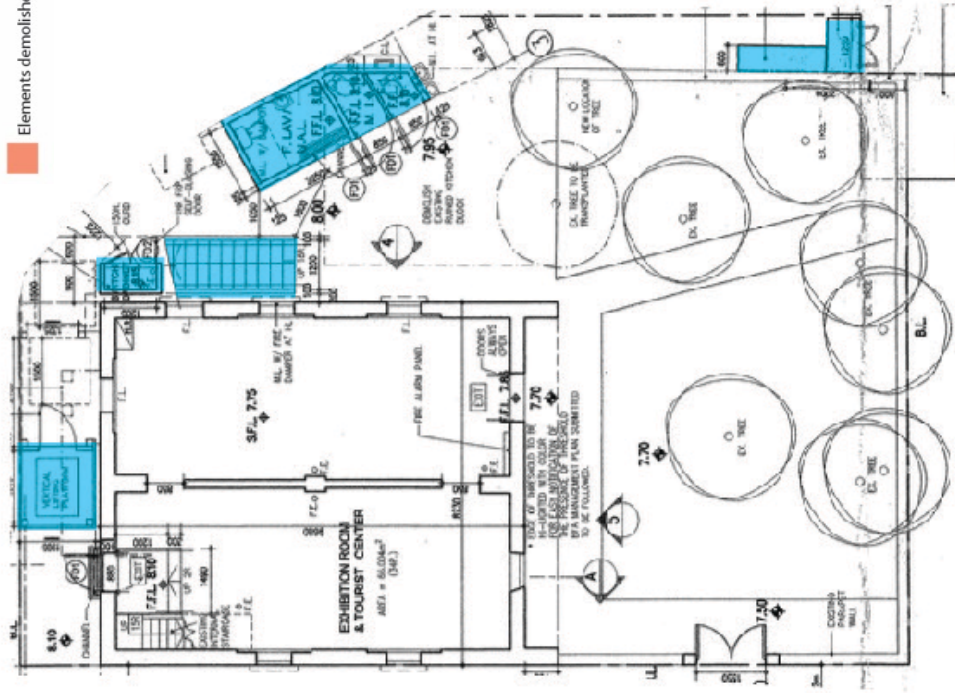
G/F Plan (As-built drawing, 2012)

■ Elements added in 2012  
■ Elements demolished in 2012

The ancillary building and the toilet block were demolished, and a new toilet block was constructed. Additionally, an escape staircase, as well as a lift tower, were erected to replace the original rear external staircase. Fire-rated fixed light windows were added on the external side of windows within the six meter of the external staircase as per the recommendations of the fire-engineering study.

Internally, the overall layout of the study hall was generally preserved, with minor modifications made to improve circulation. Part of the partition wall on the first floor was removed to enhance the flow between spaces. Currently, the two ground floor areas serve as exhibition spaces, while the two upper rooms, formerly used as offices, remain unoccupied.

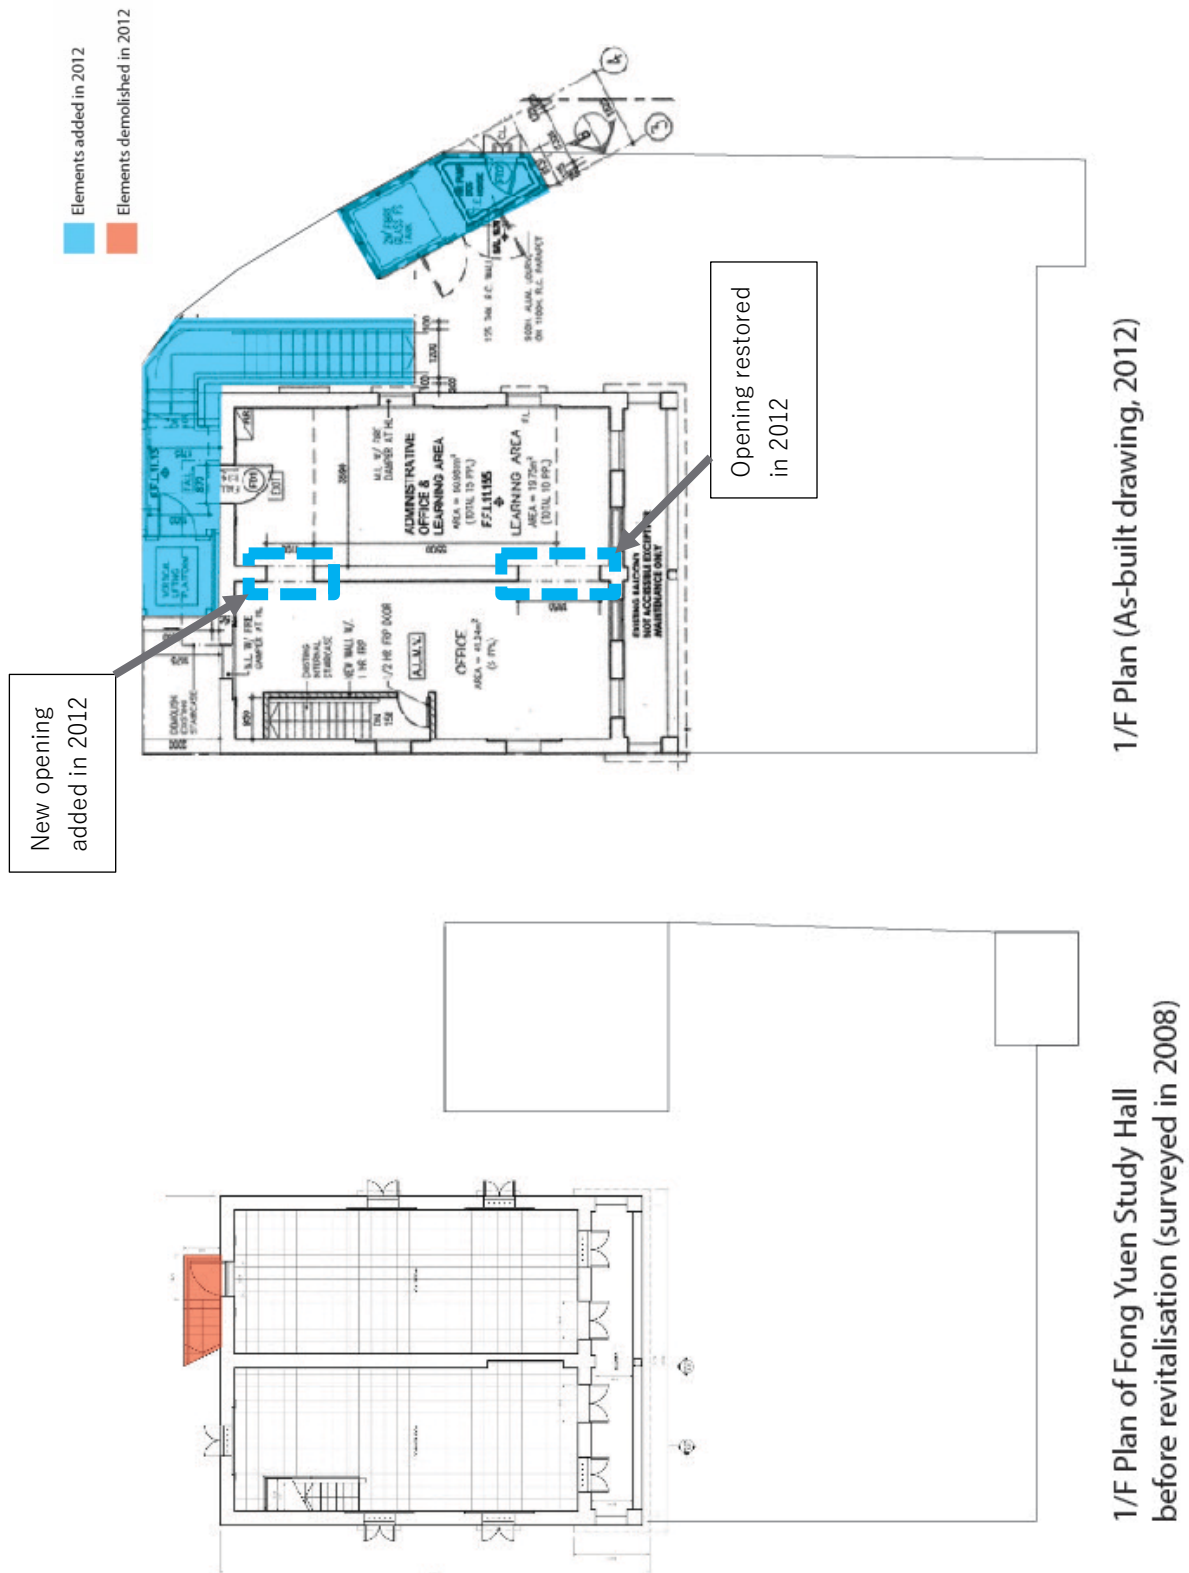
Figure 115 Diagram showing elements demolished (in red colour) and elements added (in blue colour) in the last revitalisation in 2012 (1/F plans).

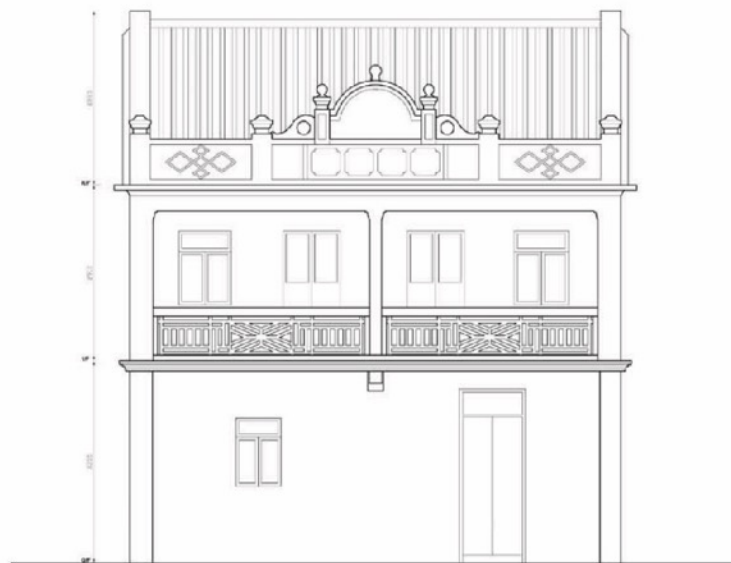
East Facade of Fong Yuen Study Hall  
before revitalisation (Survey drawing in 2008)

Figure 117 Diagram showing elements added or altered in the last revitalisation in 2012

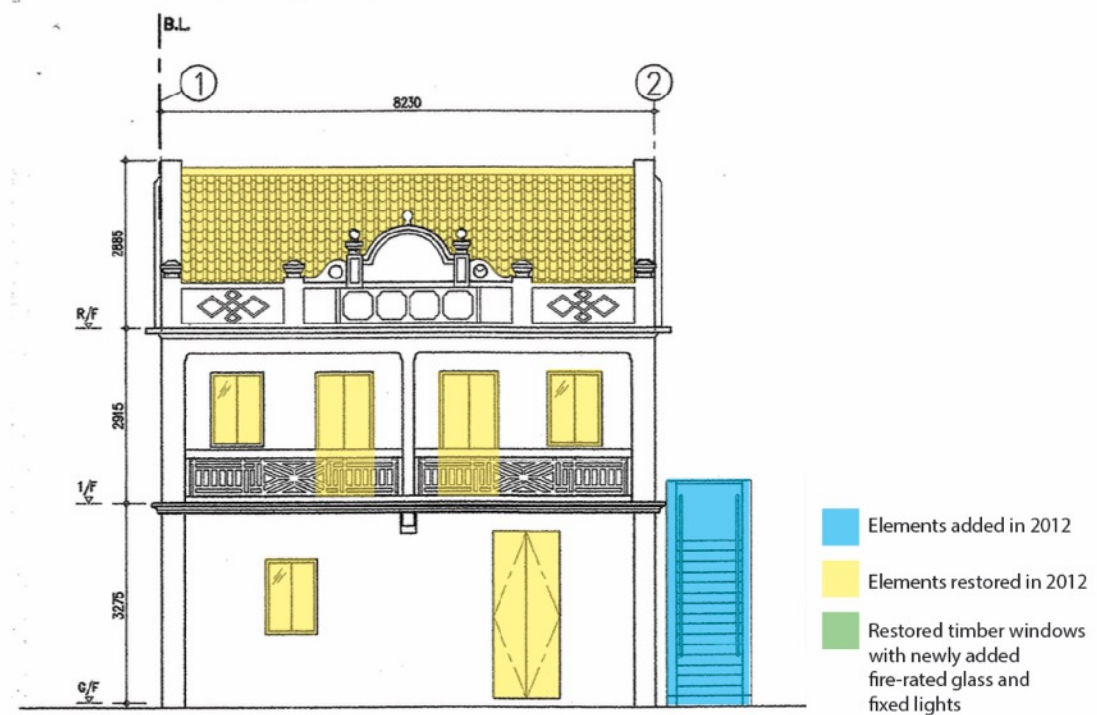
East Facade (As-built drawing, 2012)

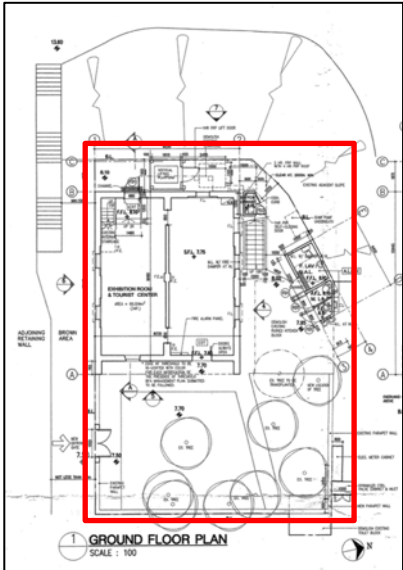
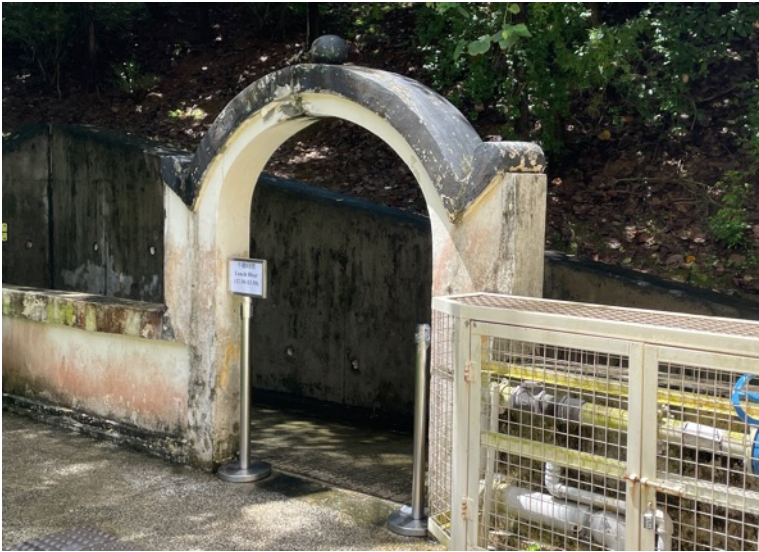
<p>GROUND FLOOR PLAN SCALE : 100</p>
A2	Description of the Element	<p>Entrance gateway</p> <ul style="list-style-type: none"> <li>• Ornamental arch-shaped</li> <li>• Use as entrance to the forecourt and the building</li> </ul>
	Level of Significance	High
	Notes/ Justifications	The entrance gateway is original, and in good condition, and contribute greatly to the overall significance of the place.
	Photo(s)

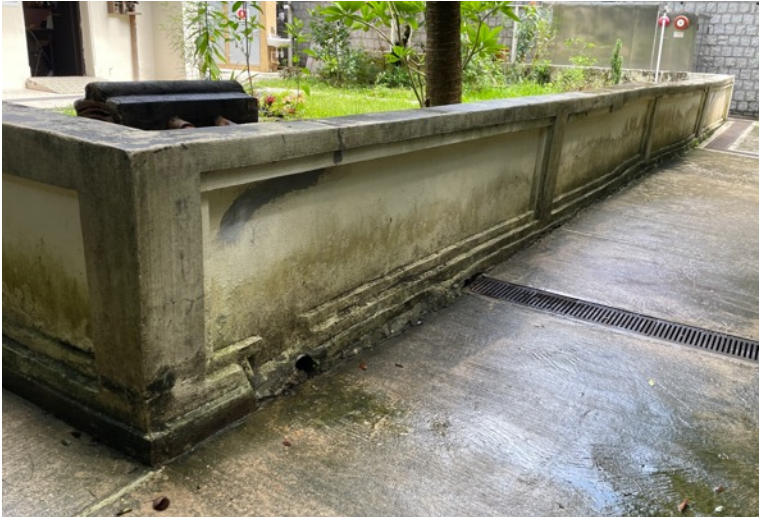
A3	Description of the Element	<p>Low boundary walls</p> <ul style="list-style-type: none"> <li>Fence walls with paneled design</li> </ul>
	Level of Significance	High
	Notes/ Justifications	<p>The element is intact and original, although minor repairs and cleaning may be required. A portion of the element near the north-eastern corner (where the original toilet block was) was reconstructed during the revitalisation. Overall speaking, the element contributes greatly to the overall significance of the place.</p>

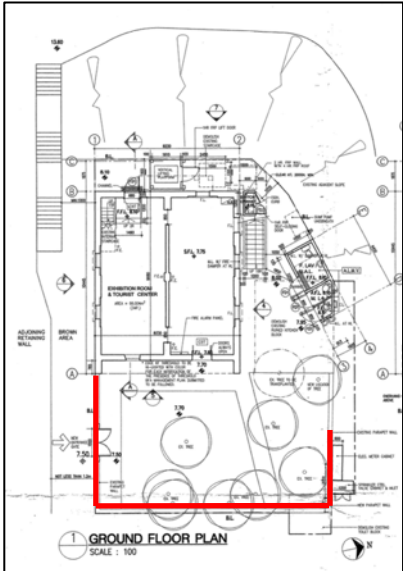
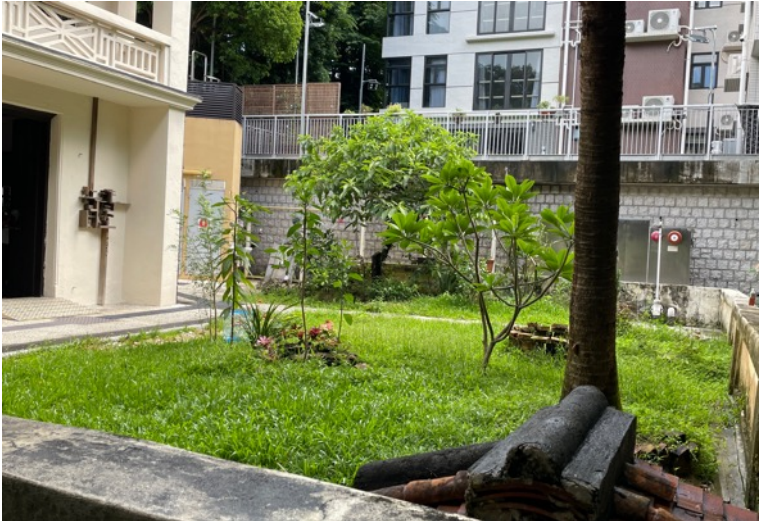
A4	Description of the Element	<p>Forecourt Spatial Setting</p> <ul style="list-style-type: none"> <li>The setting of having open spaces in front of the front elevation of the building</li> </ul>
	Level of Significance	High
	Notes/ Justifications	The openness of the forecourt is original and is an integral part of the character of the place. The existing landscape elements and floor finishes were replaced in the last revitalization.

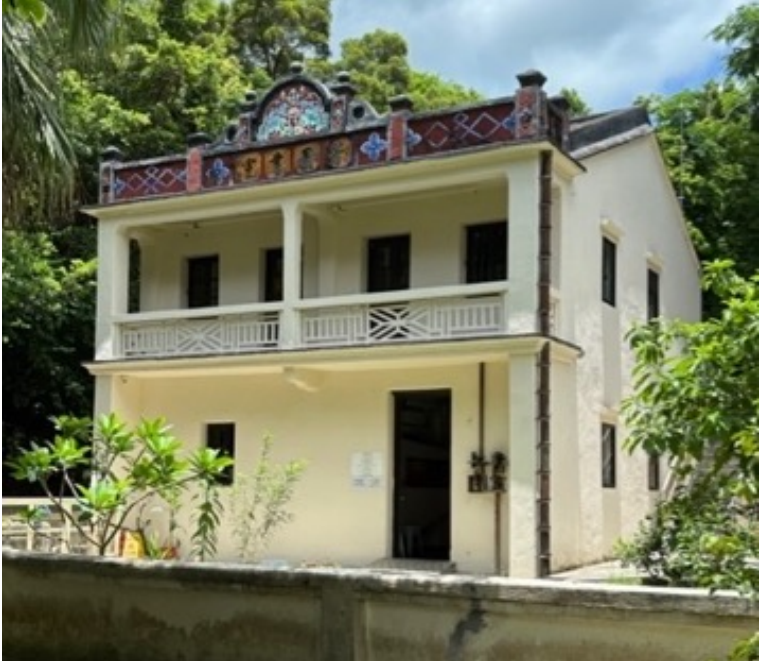
<b>Fong Yuen Study Hall - Exterior</b>		
B1	Description of the Element	<p>Front elevation</p> <ul style="list-style-type: none"> <li>• Roof parapet and pediment with decorative motifs</li> <li>• Balcony and its supporting structures</li> <li>• Balcony balustrade</li> <li>• Windows and doors, and their openings on the wall</li> </ul>
	Level of Significance	High
	Notes/ Justifications	The front elevation remains largely unaltered and original, and contributes greatly to the character of the historic building.

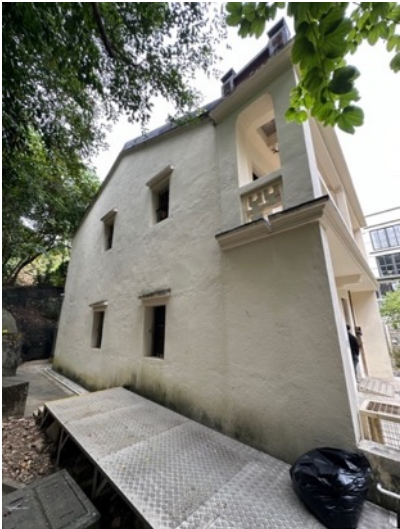
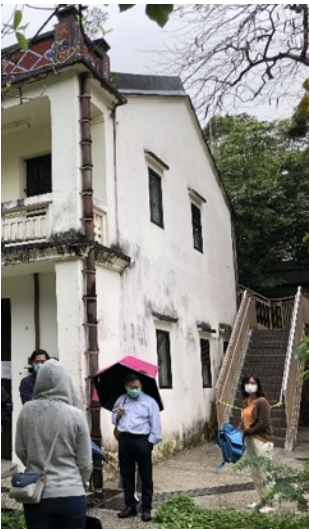
B2	Description of the Element	Side Elevation (excluding the hanging points) <ul style="list-style-type: none"> <li>• Masonry gable walls</li> <li>• Projecting fins above windows</li> </ul>
	Level of Significance	High
	Notes/Justifications	The side elevation is largely unaltered and original, with minor additions such as the fire-rated glass and PVC downpipe with ceramic encasement. The element contribute greatly to the overall character of the historic building.

Photo(s)	<div> <div>South Façade:</div>

The north elevation of the building features a metal staircase attached to it, providing access to a side entrance located at the rear elevation, specifically leading to the first floor. A PVC rainwater downpipe existed on north elevation before Batch I revitalization works. During the Batch I revitalization works, a ceramic encasement was installed over a replaced PVC rainwater downpipe in order to restore the appearance of the pipeworks of the period. The outlook of the ceramic encasement made reference to the ceramic downpipe found at nearby historic village houses constructed in the similar period.

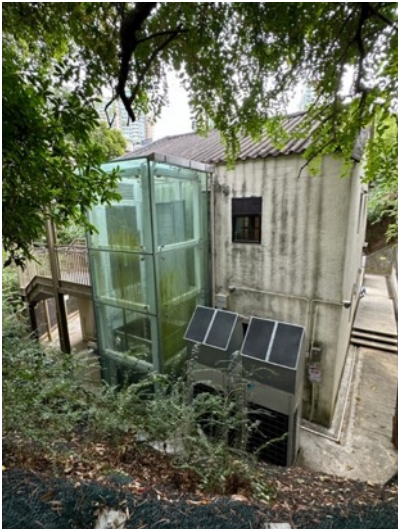
<p>2 1/F PLAN SCALE : 100</p> </div>
B3	Description of the Element	Rear elevation <ul style="list-style-type: none"> <li>Window and door openings and the overall composition of the rear façade</li> <li>Projecting fins above the rear exit door</li> </ul>
	Level of Significance	Low
	Notes/ Justifications	<p>The rear façade has much less architectural features and is not prominent. It is extensively covered by the later-installed building service elements, such as the lift tower and platform.</p>

Photo(s)	<p>West Façade:</p>

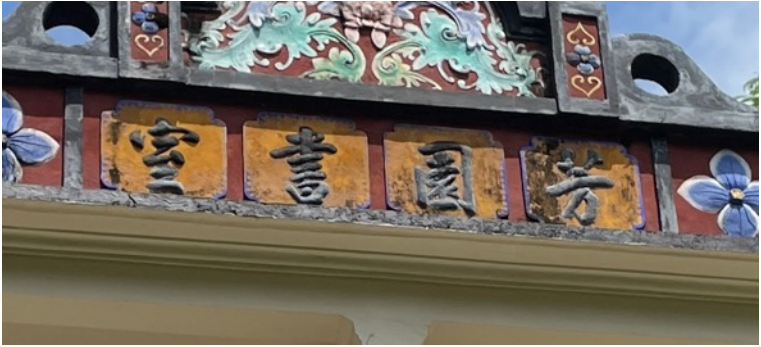
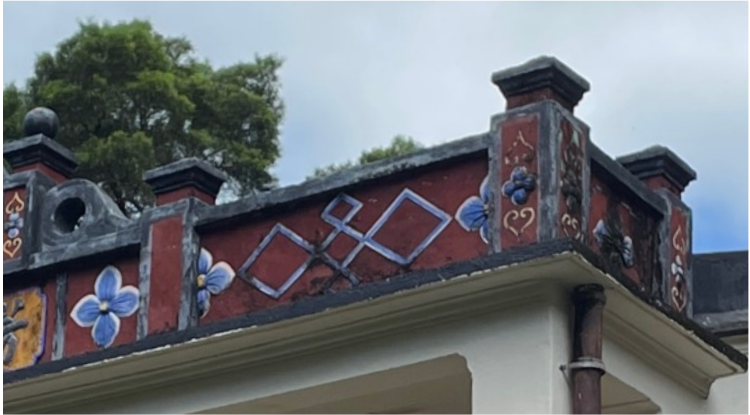
B5	Description of the Element	<p>Roof Parapet and Pediment</p> <ul style="list-style-type: none"> <li>• Roof parapet, acroteria and pediment with projecting profiles and decorative motifs in plastered relief around the flat roof with access hatch panel</li> <li>• Pedestals with decorative finial</li> <li>• Decorative motifs in plastered relief</li> <li>• Plastered characters “芳園書室” (name of the school “Fong Yuen Study Hall”) in Chinese calligraphy</li> </ul>
	Level of Significance	High
	Notes/ Justifications	According to the heritage consultant of the last revitalization, after cleaning and removing the top layer paints, it was discovered that the colours of the roof parapet and pediment was in other colour. The elements was subsequently painted according to the colour of the paint below the top-layer. The elements and its decorations remain intact and original.
	Photo(s)

The upper part of the Fong Yuen Study Hall showcases a blend of Western and Chinese architectural elements. The roof parapet, which consists of a pediment and acroteria, reflects common Western architectural decoration and practices, while the surface of the parapet features plastered reliefs depicting Chinese auspicious motifs. The parapet and pediment feature a symmetrical design, adorned with acroterion, pedestal and decorative finials. The outline of the pediment followed those commonly found in Baroque architecture. This practice can be seen in other examples of *Qiaoxiang* architecture as well.<sup>145</sup> The parapet is inscribed with the Chinese characters '芳園書室' (Fong Yuen Study Hall), along with Western style diamond-shaped geometric patterns and the *Shidi* pattern (柿蒂; four-lobed persimmon pedicel pattern).<sup>146 147</sup> On the pediment, there is a plastered floral pattern known as *Baoxianghua* (寶相花), which was commonly used as an auspicious flower motif during the Tang Dynasty.<sup>148</sup>

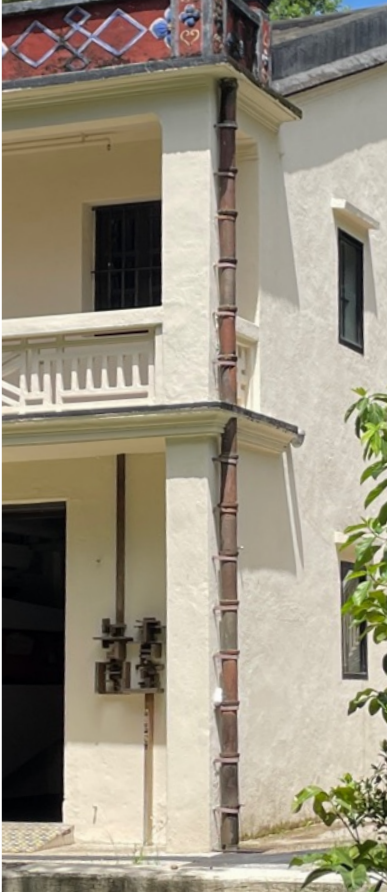
Location Plan	 
B7	Description of the Element	Ceramic downpipe encasement

Level of Significance	High
	Notes/ Justifications	Although the ceramic downpipe encasement was not an original element and was added to encase the UPVE pipe in the last revitalization, the encasement was restored during the last revitalisation according to the outlook of downpipes found in nearby historic village houses constructed in similar period. However, the historic outlook of the ceramic downpipe encasement may cause confusions in whether or not it is an authentic historical element.
	Photo(s)

According to AMO's record, a ceramic downpipe casing was installed over a replaced PVC rainwater downpipe, due to aesthetic reasons and to restore the appearance of pipeworks of the period. The parapet and pediment and the decorative elements were repainted in burglary red and black colours. It is believed to be the original colour scheme. According to AMO's record, after stripping the later-applied top-layer finishes during the last revitalisation, traces of the old paint layer was revealed. The parapet and pediment and the decorative elements were subsequently repainted according to the colours of the old paint layer.

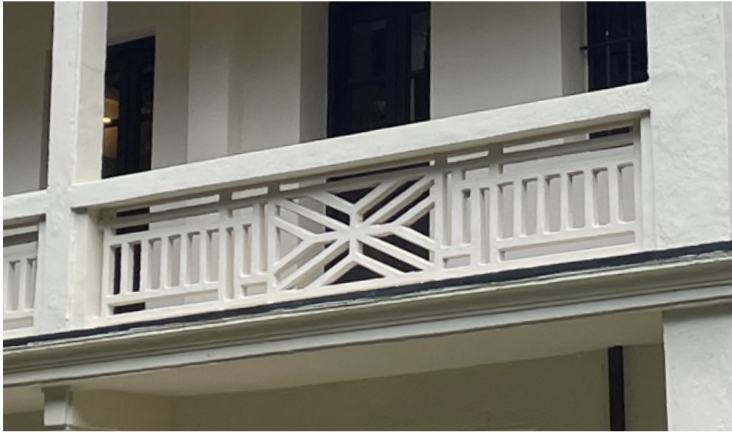
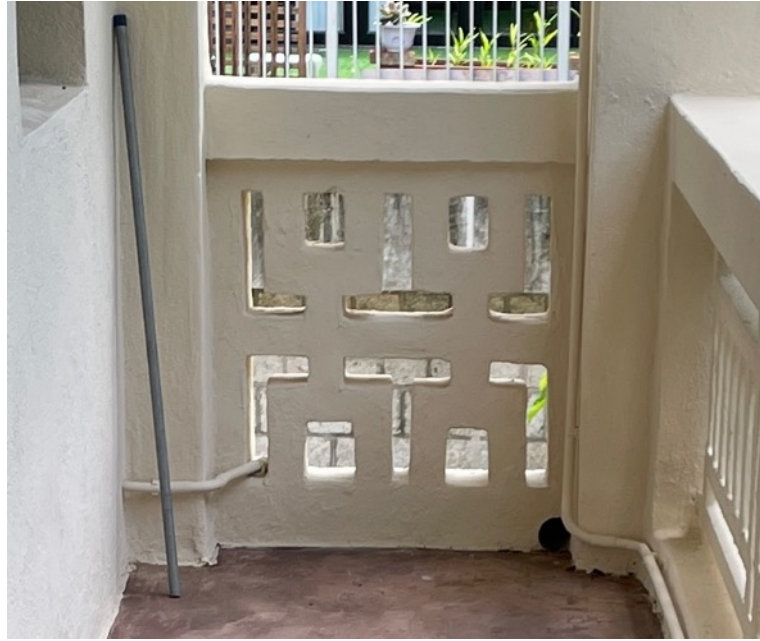
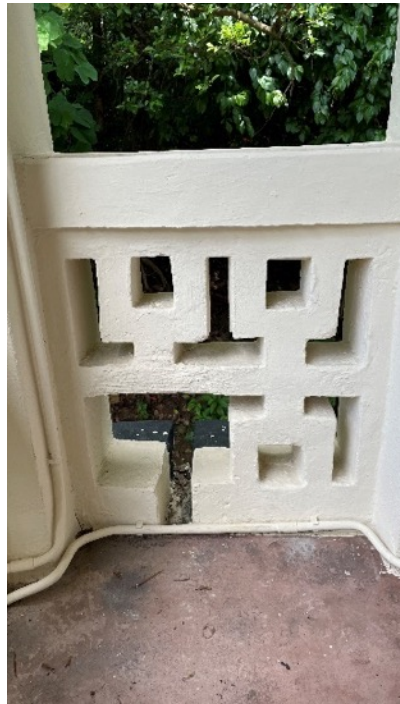
B8	Description of the Element	Coping Rails and balustrades with geometric, cross-like patterns (front) and traditional longevity symbol patterns (both sides) with coping rails
	Level of Significance	High
	Notes/ Justifications	<p>One of the longevity symbol on the balustrade was incomplete. It is, however, likely to be original and was done to make room for the floor drainage hole of the balcony.</p> <p>The element remains intact and original, and is an integral part of the character of the historic building.</p>
	Photo(s)

From the photograph taken in Figure 61 (ca. 1950s-1969s) and 63 (1980s), water stains caused by water draining from a drainage hole on the balustrade of the balcony can be observed. It can also be observed that the patterned balustrade was incomplete on this side of the balustrade, presumably because of the provision of the drainage hole on this side.

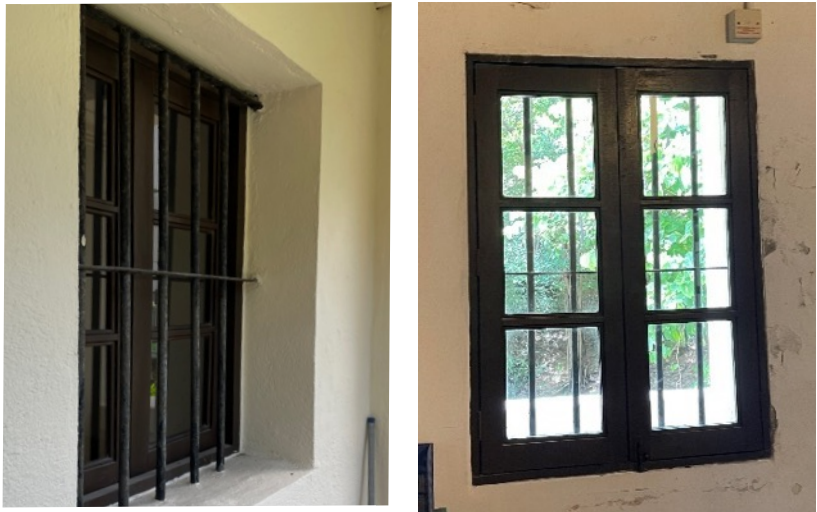
B9	Description of the Element	<p>Restored timber windows</p> <ul style="list-style-type: none"> <li>• Restored timber casement window</li> <li>• Restored metal grille</li> </ul>
	Level of Significance	High
	Notes/ Justifications	Casement windows and metal grill were restored in 2012 to the style of the period.
	Photo(s)

Likewise, the metal windows were substituted with timber windows that featured grilles, while the metal doors were replaced with timber doors.

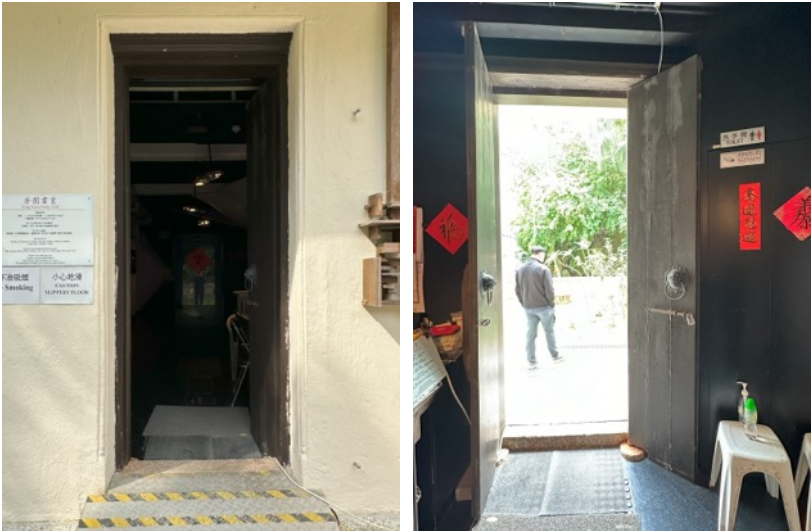
<p>The image shows two architectural floor plans. The left plan is the 'GROUND FLOOR PLAN' at a scale of 1:100, and the right plan is the '1/F PLAN' at a scale of 1:100. Both plans feature red rectangular boxes highlighting the locations of the main entrance doors on the ground floor and the first floor.</p>
B10	Description of the Element	<p>Restored main Entrance door (G/F)</p> <ul style="list-style-type: none"> <li>• Chinese-style timber double-leaf doors</li> <li>• Original floor hinges</li> <li>• Traditional timber door lock (interior side) and metal door lock (exterior side)</li> <li>• Original granite threshold</li> <li>• Door jambs and head with decorative mouldings</li> <li>• Metal door pulls</li> <li>• Decorative plaster moulding at the corner of the door opening</li> </ul>
	Level of Significance	High
	Notes/ Justifications	<p>Door leaves and door frame was reconstructed to the style of the period in the last revitalization.</p> <p>Most of the other elements are intact and original, and is an integral part of the character of the historic building.</p>

<p>The image contains two photographs of the restored main entrance door. The left photograph shows an interior view looking out through the doorway, with a sign on the left wall that reads '小心地滑' (Slippery Floor) and '小心碰撞' (Beware of Collision). The right photograph shows an exterior view looking in through the doorway, with red decorative paper (Fu) on the door and a small table with a bottle on the right.</p>

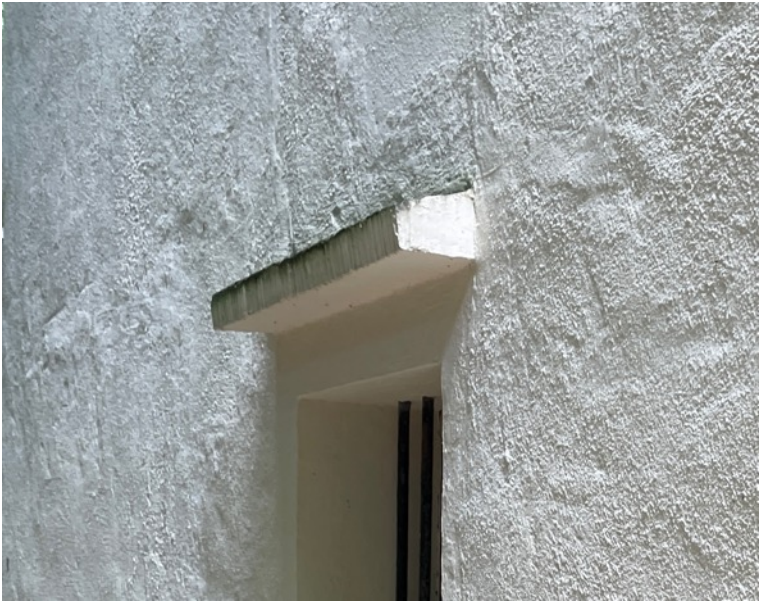
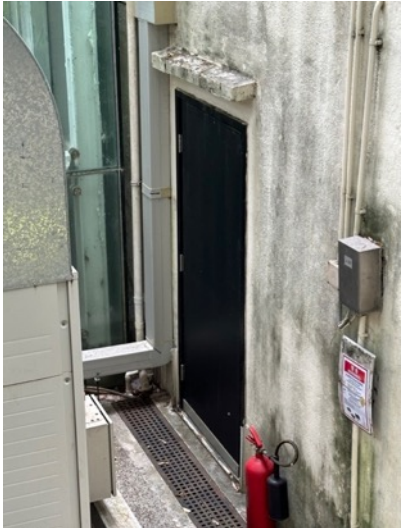
<p>GROUND FLOOR PLAN SCALE: 1:100</p>
B12	Description of the Element	Projecting fins above windows/rear exit door (G/F)
	Level of Significance	High
	Notes/Justifications	The element remains intact and original, and is an integral part of the character of the historic building
	Photo(s)

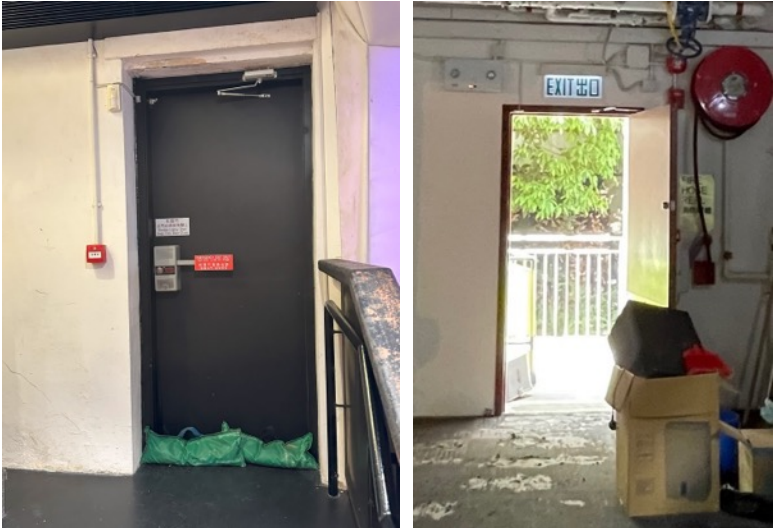
B13a	Description of the Element	Rear exit door (G/F) and (1/F) - door opening
	Level of Significance	High
	Notes/Justifications	The door opening is original and is an integral part of the character of the historic building.

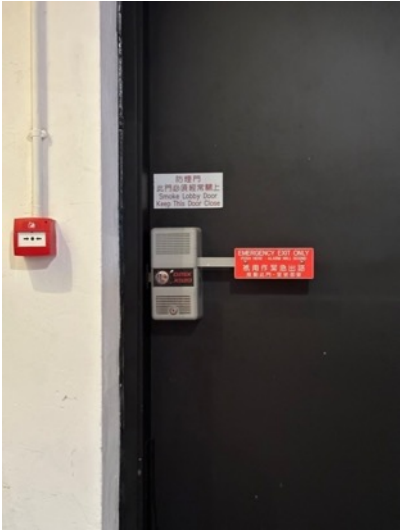
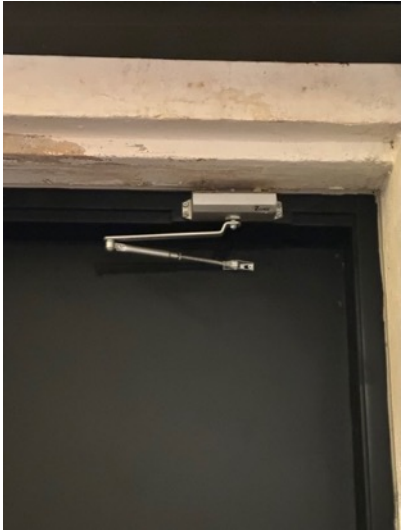
B13b	Description of the Element	Rear exit door (G/F) – newly-installed door leaf and door frame, including hinges, door drum, and fire door alarm
	Level of Significance	Neutral
	Notes/Justifications	Newly installed in the last revitalisation

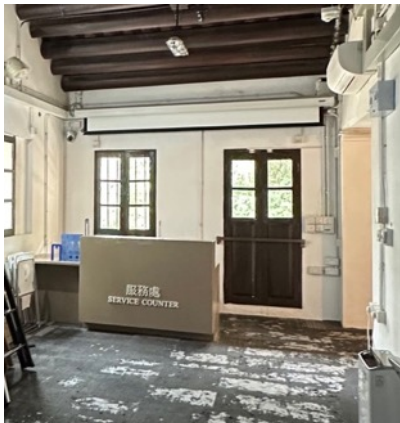
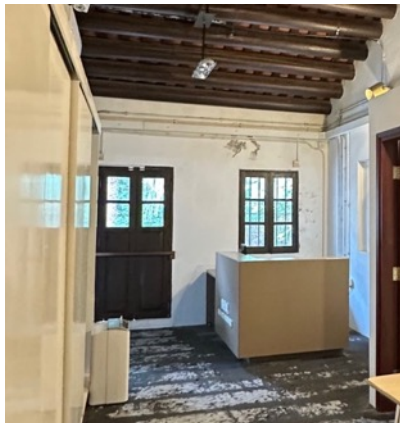
B14a	Description of the Element	Door to balcony (1/F) – door opening
	Level of Significance	High
	Notes/Justifications	The element is intact and original, and is an integral part of the character of the historic building.
	Photo(s)	<div>Door near north side:</div>

<div>Door near south side:</div>

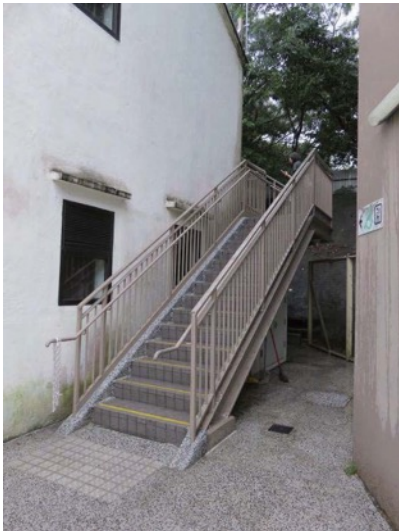
Photo(s)	<p>Door near north side:</p>   <p>Door near south side:</p>  
	Location Plan	 
B15	Description of the Element	External Staircase
	Level of Significance	Neutral

Notes/ Justifications	Added in last revitalisation
	Photo(s)

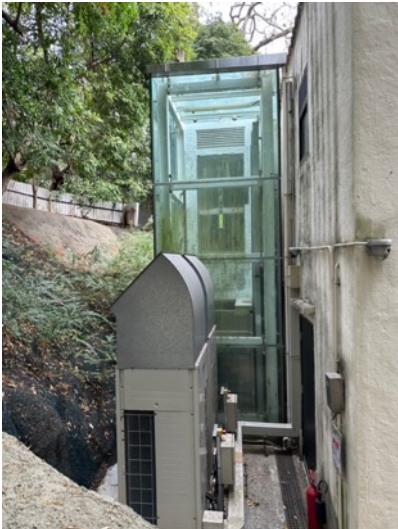
B16	Description of the Element	Lift tower and landing platform

Level of Significance	Neutral
	Notes/Justifications	Added in last revitalisation
	Photo(s)

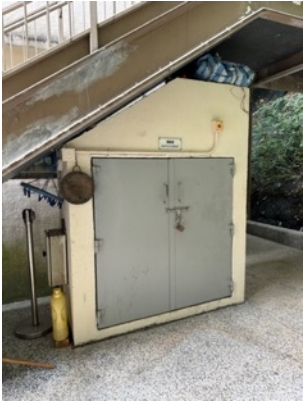
B17	Description of the Element	Switch Cabinet
	Level of Significance	Neutral
	Notes/Justifications	Added in last revitalisation

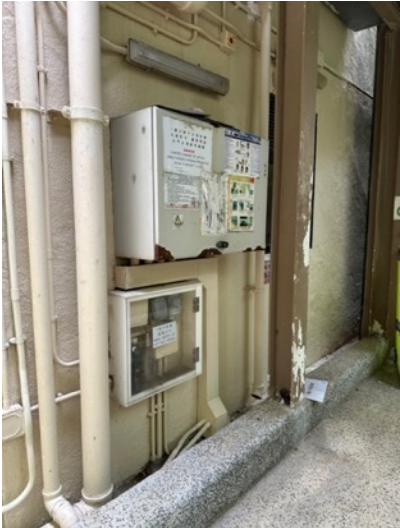
B18	Description of the Element	Control Cabinet of Lift
	Level of Significance	Neutral
	Notes/Justifications	Added in last revitalisation

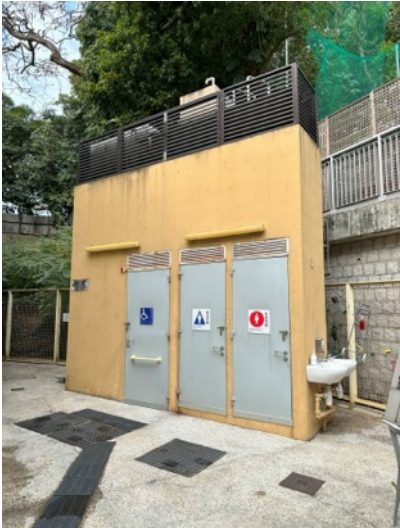
B19	Description of the Element	Toilet Block
	Level of Significance	Neutral
	Notes/Justifications	Added in last revitalisation

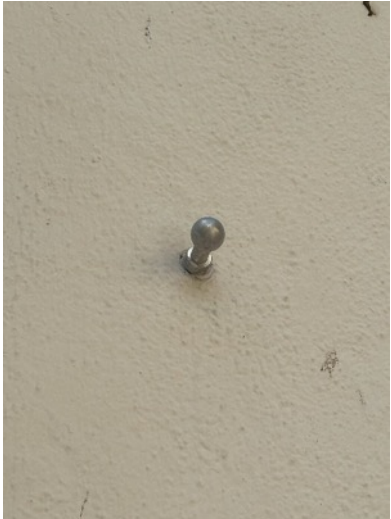
B20	Description of the Element	Hanging points on north facade
	Level of Significance	Neutral
	Notes/Justifications	Added in last revitalisation

- Signage on the right-hand side of the main entrance should be removed and replaced with a signage located further away from the historic building.
- Hanging points on the side elevation should be removed.
- Elements that were/are reconstructed according to the historic style of the building should be marked with the year of their restoration in less visible locations, so that the authenticity of the elements can be well-communicated and better interpreted.

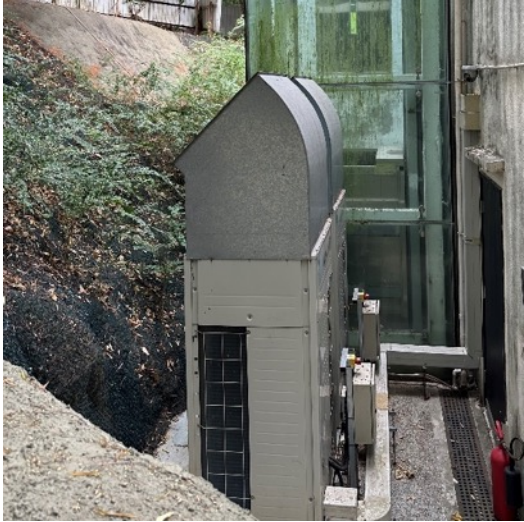
B21	Description of the Element	Outdoor unit of air-conditioning system
	Level of Significance	Neutral
	Notes/Justifications	Added in last revitalization. Element will be kept and reused in this revitalization.

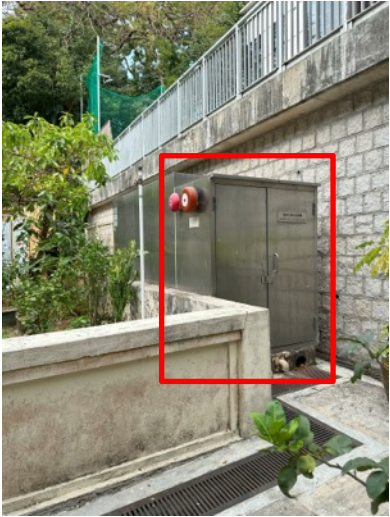
B22	Description of the Element	Sprinkler control valve cabinet and inlet
	Level of Significance	Neutral
	Notes/Justifications	Added in last revitalization. Element will be kept and reused in this revitalization.

Regarding the sprinkler system, the source of water supply for the sprinkler system is directly linked to the Town's Main Connection. The sprinkler system incorporates fast-response type sprinklers which activate more swiftly than standard-response sprinklers under identical conditions for enhanced efficiency. The existing improvised sprinkler system, without a sprinkler water tank, will remain unchanged. However, its layout may be reconfigured to accommodate the alterations proposed in the revitalization project.

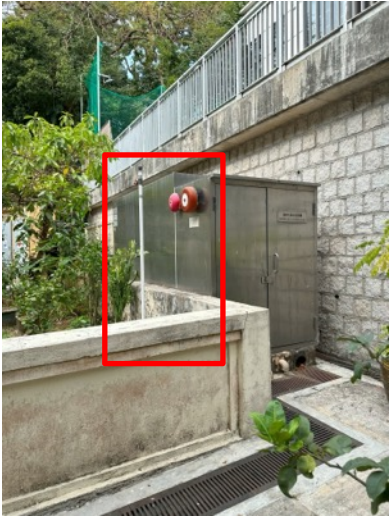
B23	Description of the Element	Electric meter cabinet
	Level of Significance	Neutral
	Notes/Justifications	Added in last revitalization. Element will be kept and reused in this revitalization.

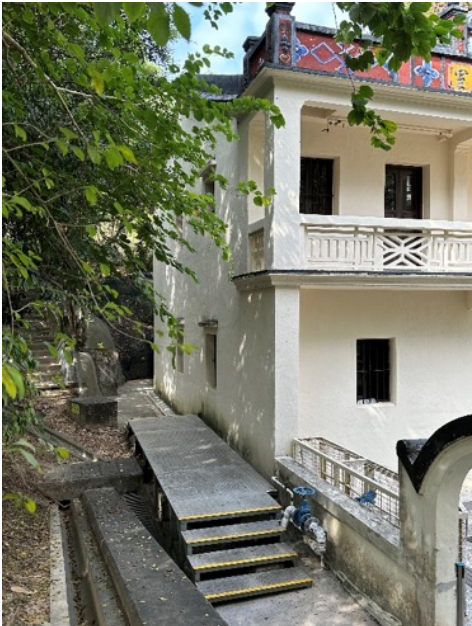
B24	Description of the Element	Metal deck at south elevation
	Level of Significance	Neutral
	Notes/Justifications	Added in last revitalization. Element will be kept and reused in this revitalization.

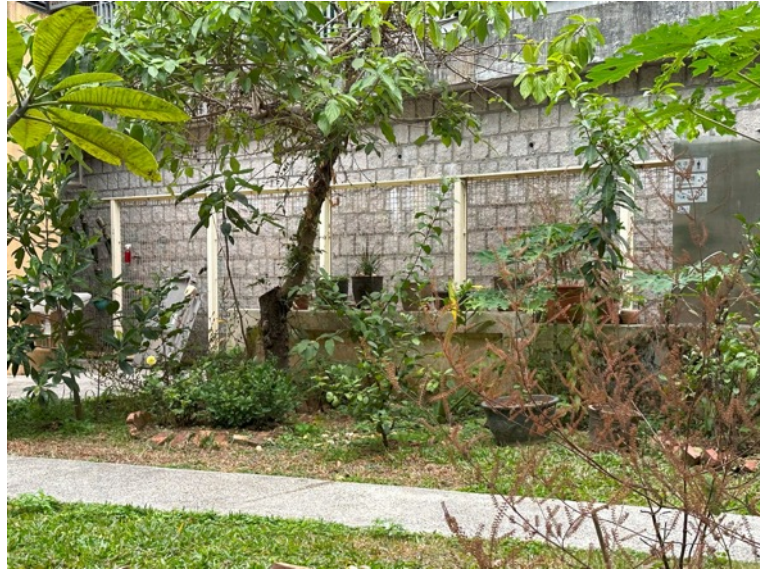
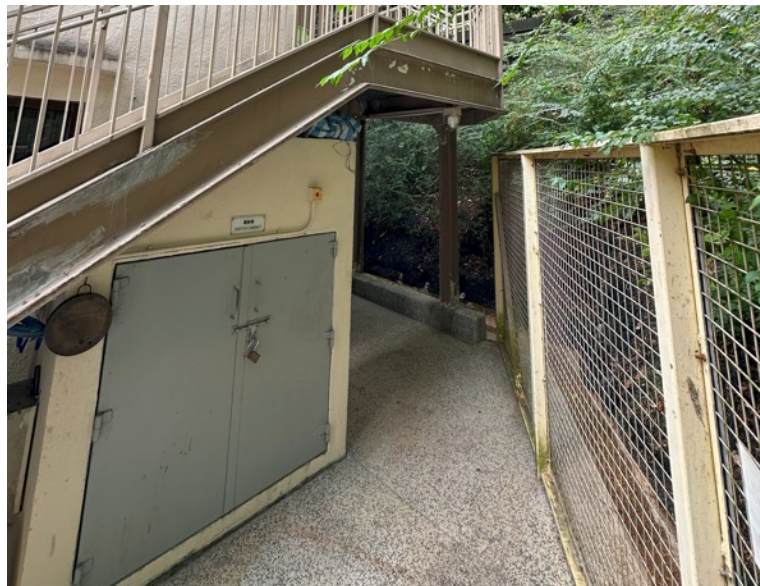
B25	Description of the Element	Metal fences
	Level of Significance	Neutral
	Notes/Justifications	Added in last revitalization.

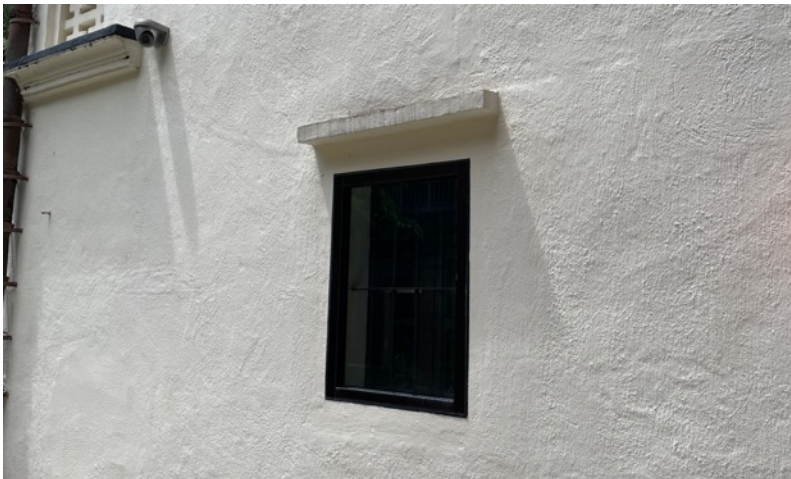
B26	Description of the Element	Fire-rated glasses and metal fixed lights
	Level of Significance	Neutral
	Notes/Justifications	Added in last revitalization.
	Photo(s)

The fire engineering study in 2012 indicated that all openings within 6 metres of the external staircase would be provided with fire rated wall and door, fixed lights or fire shutters with a fire resistance period (FRP) of at least half an hour. It ensures that occupants inside the building will be shielded from fire hazards outside for at least 30 minutes. With design considerations, the fixed lights will be relocated to the internal side of the window openings.

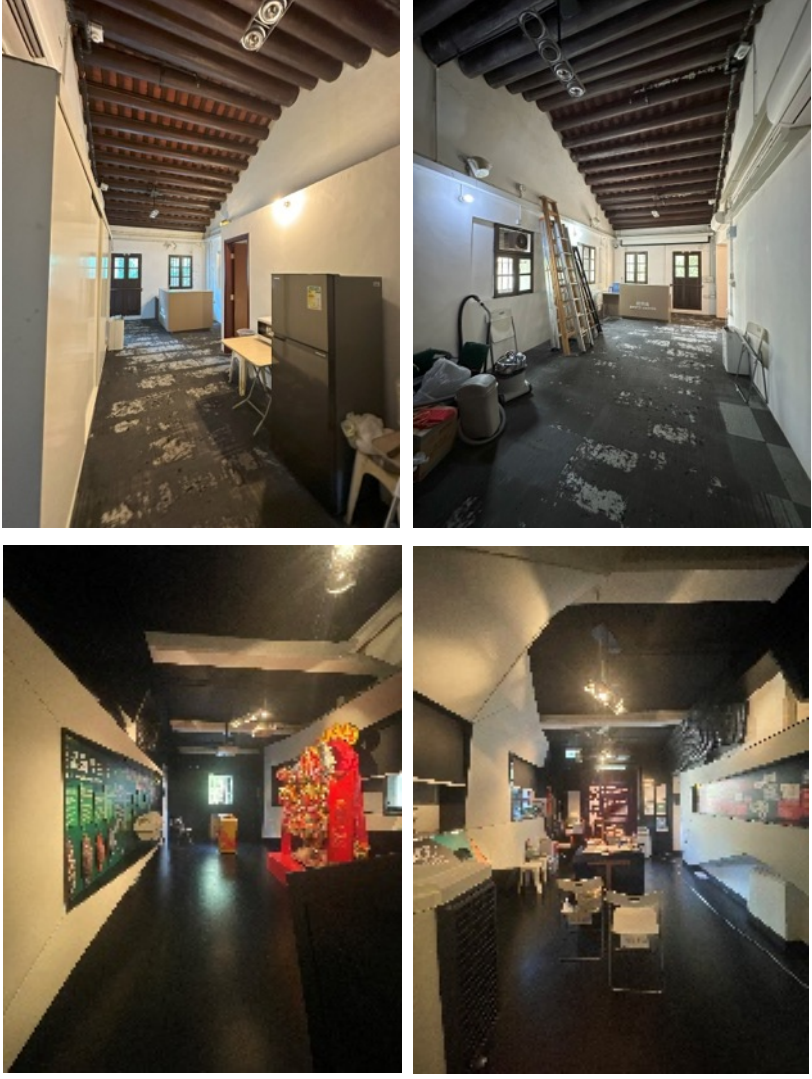
<b>Fong Yuen Study Hall – Interior</b>	
C1	Description of the Element	Interior Spatial Configurations (G/F & 1/F) with two open-floor spaces separated by a brick partition wall on each floor.
	Level of Significance	High
	Notes/ Justifications	The partition and the two partitioned spaces on each floor is the original spatial configuration of the historic building, and is an integral part of the character of the historic building.
	Photo(s)

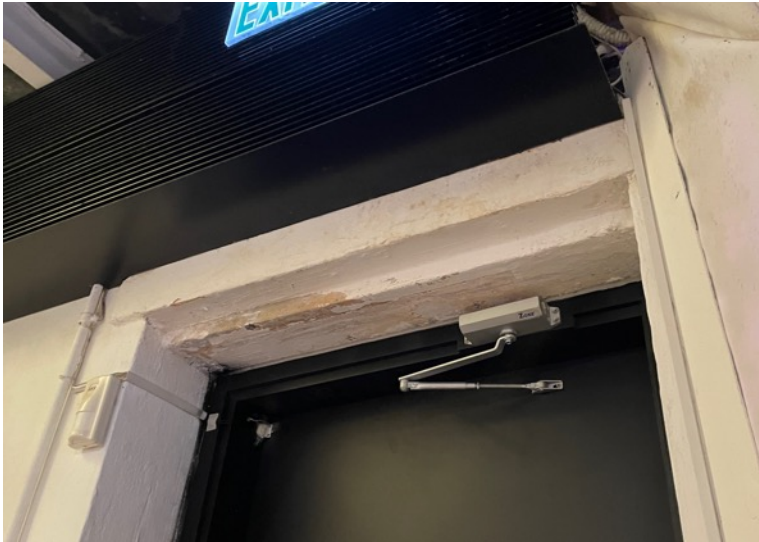
C2	Description of the Element	Rear exit door (G/F) - door lintel above G/F rear exit door
	Level of Significance	High
	Notes/Justifications	The element is intact and original, and is an integral part of the character of the historic building.
	Photo(s)

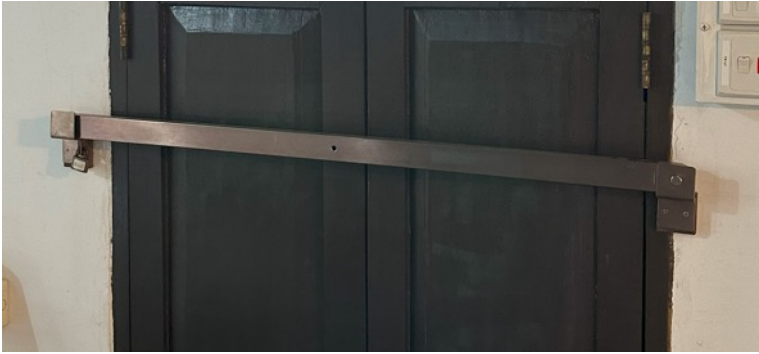
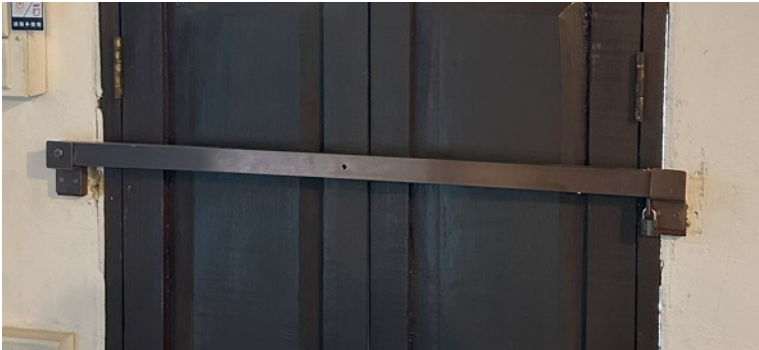
<p>GROUND FLOOR PLAN SCALE : 100</p>
C3	Description of the Element	Door to balcony (1/F) – metal door security bar
	Level of Significance	Neutral
	Notes/Justifications	Added in the last revitalisation
	Photo(s)	<p>Door security bar of door near north side:</p>

<p>Door security bar of door near south side:</p>

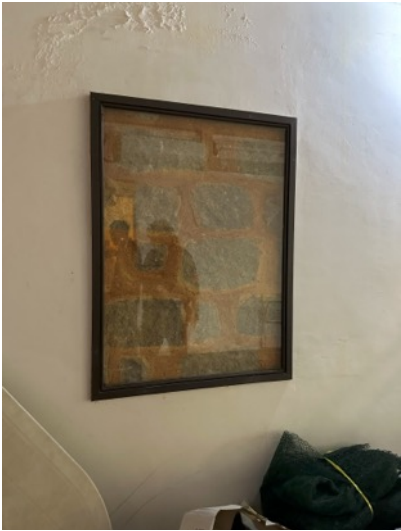
C4	Description of the Element	Exhibit window of exposed stone wall (1/F)
	Level of Significance	Neutral
	Notes/Justifications	The exhibit window was added in 2012. It protects the exposed granite blocks underneath the plastering layer of the wall.
	Photo(s)

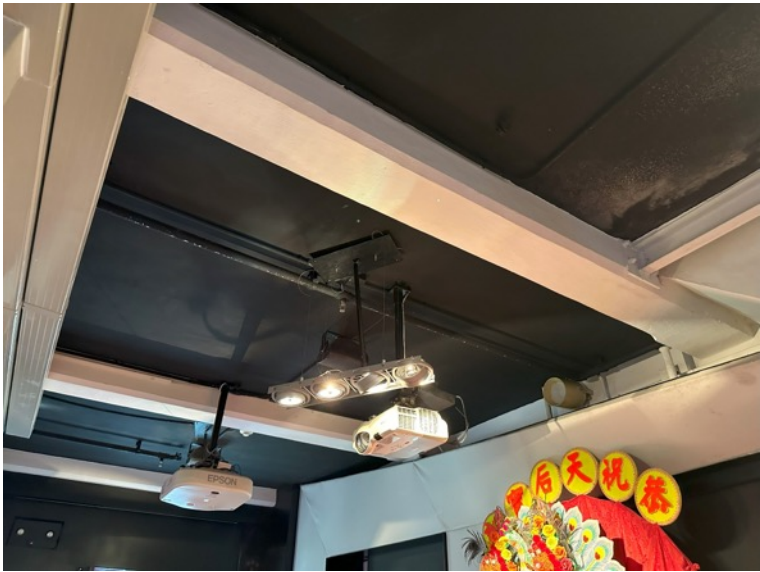
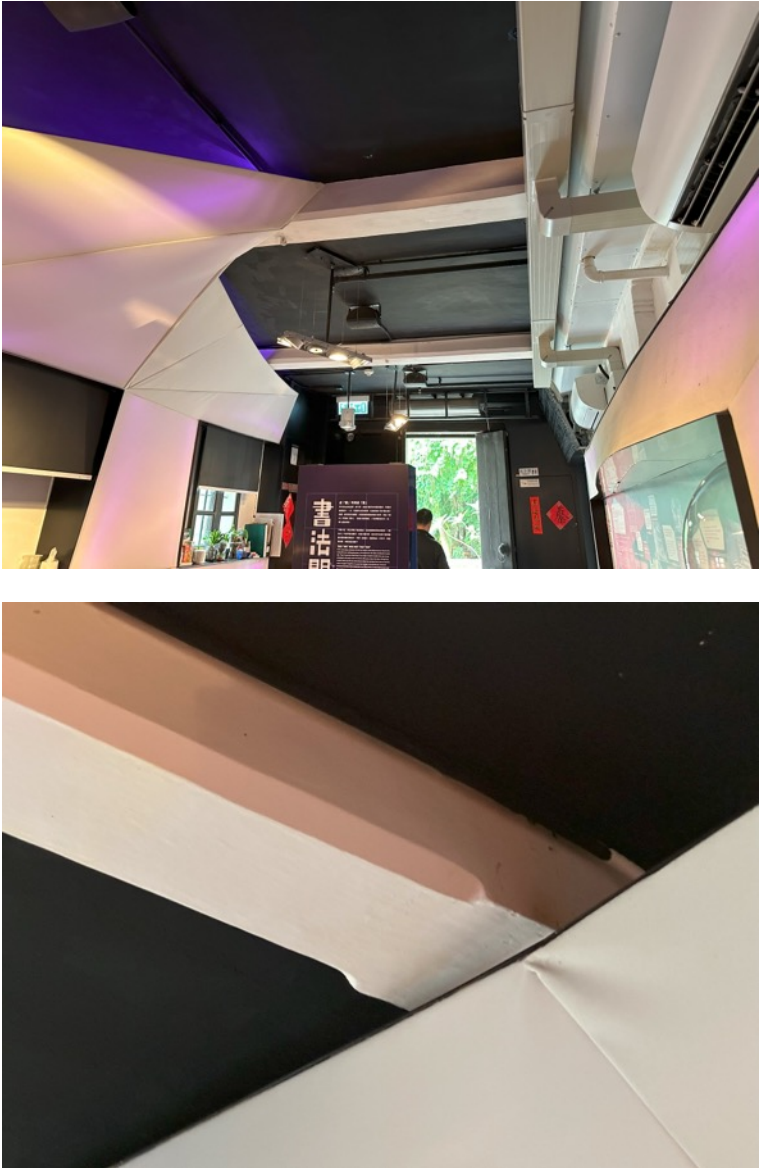
<p>Architectural floor plan of the 1/F floor slab. The plan shows various rooms including an OFFICE, ADMINISTRATIVE OFFICE, and LEARNING AREA. A red rectangle highlights a specific structural beam area. The plan is labeled 'DOCK HOUSE 1/F FLOOR PLAN' and includes a scale of 1:100.</p>
C5	Description of the Element	Structural Beams of 1/F floor slab with decorative mouldings
	Level of Significance	High
	Notes/ Justifications	The element is intact and original, and is an integral part of the character of the historic building.
	Photo(s)

<p>Photograph of the interior of the building, showing the structural beams of the 1/F floor slab. The beams are painted white and feature decorative mouldings. A large red and yellow floral arrangement is visible in the foreground.</p>
