## Heritage Impact Assessment

in respect of the Revitalisation of  
Fong Yuen Study Hall into  
Fong Yuen Study Hall – Experiential Learning Center

26 Feb 2024

Heritage Impact Assessment in respect of the Revitalisation of Fong Yuen Study Hall into Fong Yuen Study Hall – Experiential Learning Center under Revitalising Historic Buildings Through Partnership Scheme Batch VI

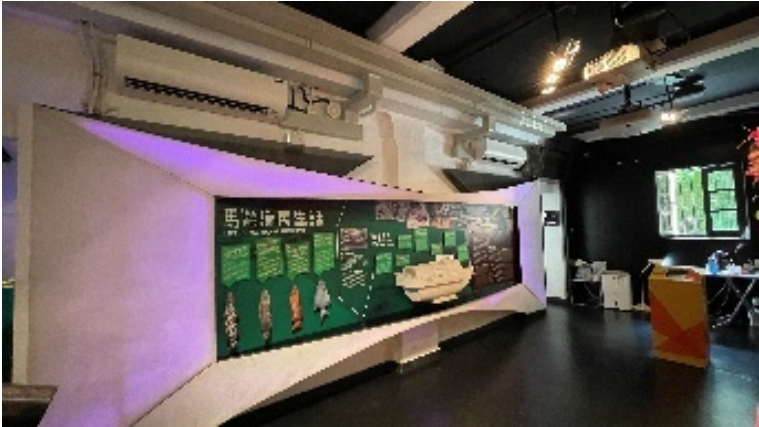
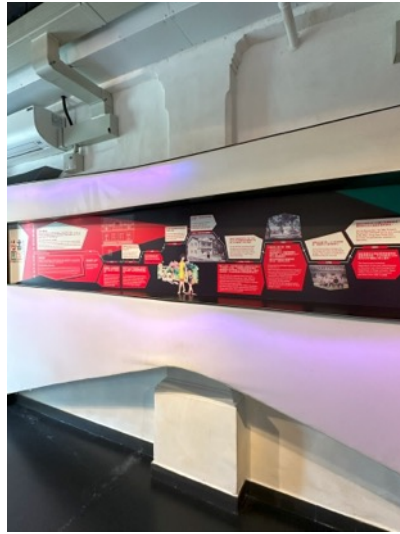
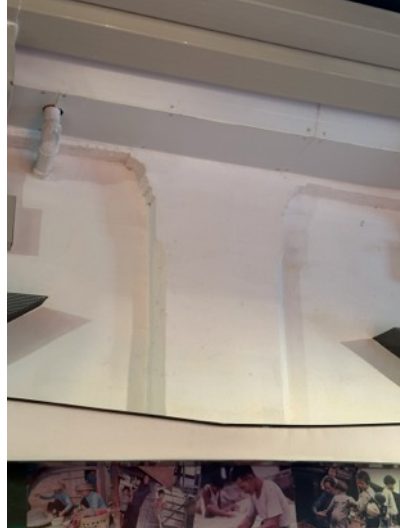
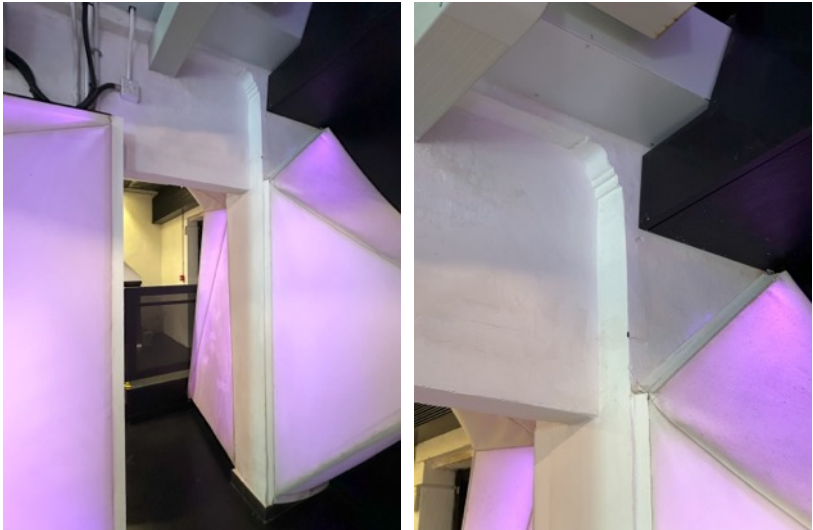
C6	Description of the Element	<p>Interior column and brick partition wall (G/F ) with original openings and decorative mouldings:</p> <ul style="list-style-type: none"> <li>• Two original openings</li> <li>• Decorative mouldings on both sides of the wall in these locations: <ul style="list-style-type: none"> <li>• around the base of the column</li> <li>• at the top of the column</li> </ul> </li> </ul> <p>at the corner near the rear opening</p>
	Level of Significance	High
	Notes/Justifications	<p>Openings on G/F existed before last revitalisation (please refer to survey drawings from 2008 HIA report).</p> <p>The element is intact and original, and is an integral part of the character of the historic building.</p>
	Photo(s)

Decorative mouldings at the top of the column:

Decorative mouldings at the base of the column:

<p>Decorative mouldings at the corner near the rear opening:</p>

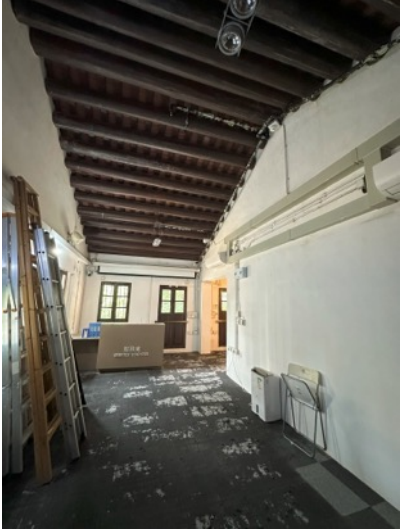
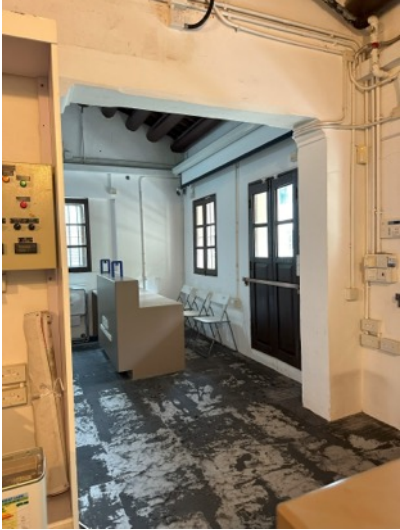
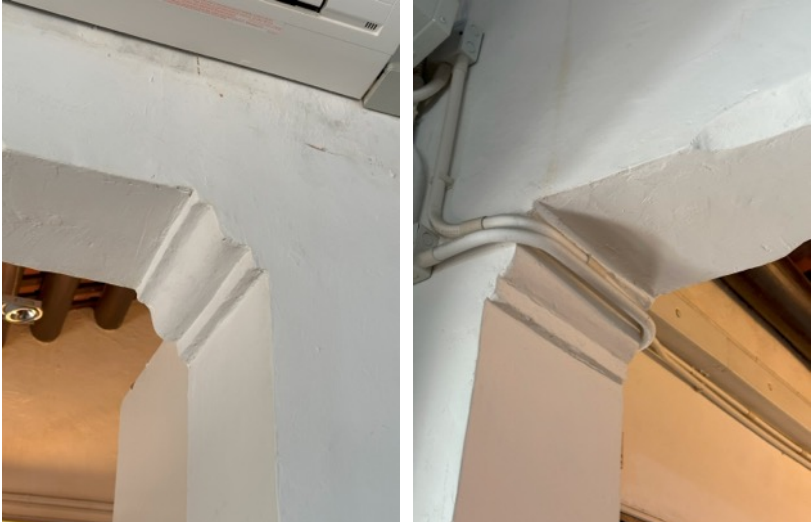
C7	Description of the Element	<p>Interior brick partition wall (1/F ) with original opening near the front part of the building and decorative mouldings at both the top corners of the front opening.</p>	
	Level of Significance	<p>High</p>	
	Notes/ Justifications	<p>The front openings on 1/F did not exist before last revitalization. However, according to 2008 survey drawing, the wall thickness at the location of the current front opening was thinner than the rest of the partition wall. This may suggest that an opening may have existed originally, and may have been blocked by users before the last revitalization. It was then re-opened during last revitalization.</p> <p>Although there are minor alternations of the element, the element is original and is an integral part of the character of the historic building.</p>

<p>Front Opening:</p>

<p>Decorative Mouldings at Corners of Front Opening:</p>

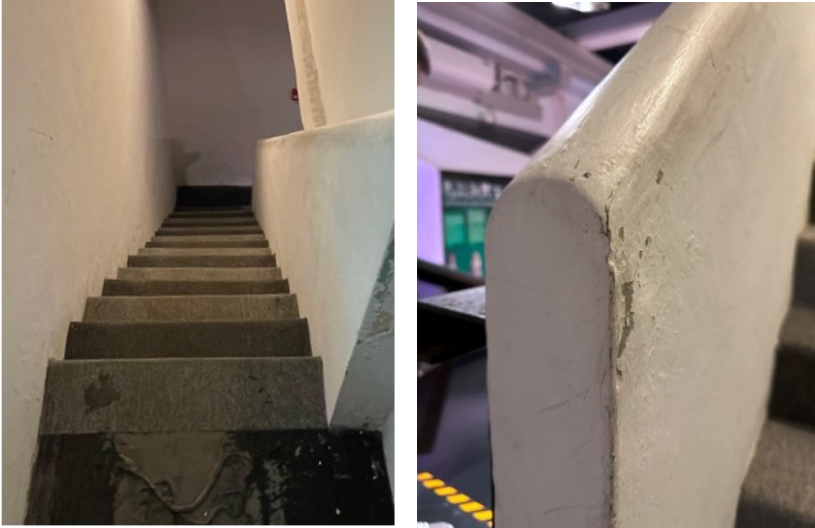
C9	Description of the Element	<p>Internal staircase</p> <ul style="list-style-type: none"> <li>• Concrete staircase</li> <li>• Balustrade with round profile at the top</li> </ul>
	Level of Significance	High
	Notes/Justifications	The concrete staircase is currently covered by carpet. But the element is intact and original, and is an integral part of the character of the historic building.
	Photo(s)

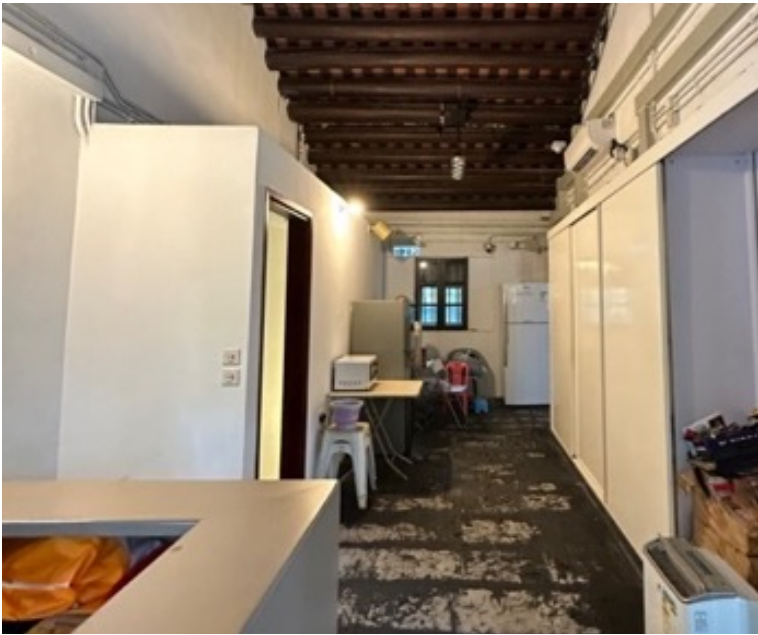
C10	Description of the Element	Staircase enclosure and fire door
	Level of Significance	Neutral
	Notes/Justifications	Staircase enclosure and fire door was added in the last revitalisation
	Photo(s)

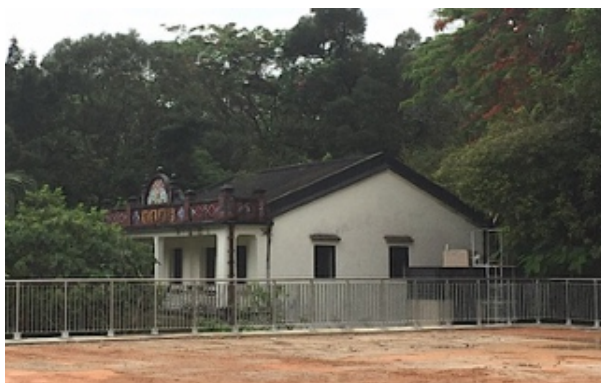
Schedule of Materials for the toilet block	
Reinforced Concrete	Concrete grade: C35/20 Concrete cover: - Slab 25mm - Wall 25mm - Footing 50mm Reinforcement: - High yield steel bar: 460N/mm <sup>2</sup>

Figure 121 Side view of the existing toilet block.

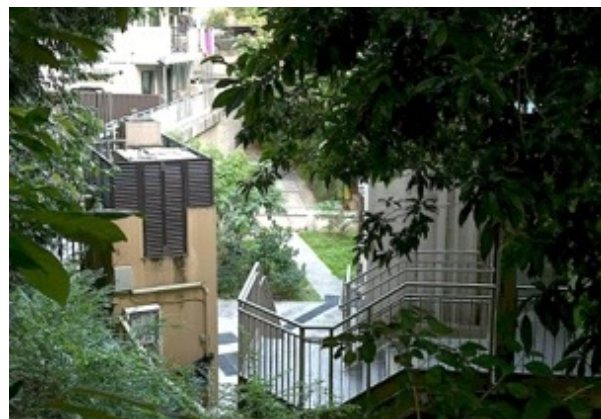
Figure 122 Rear view of the existing toilet block.

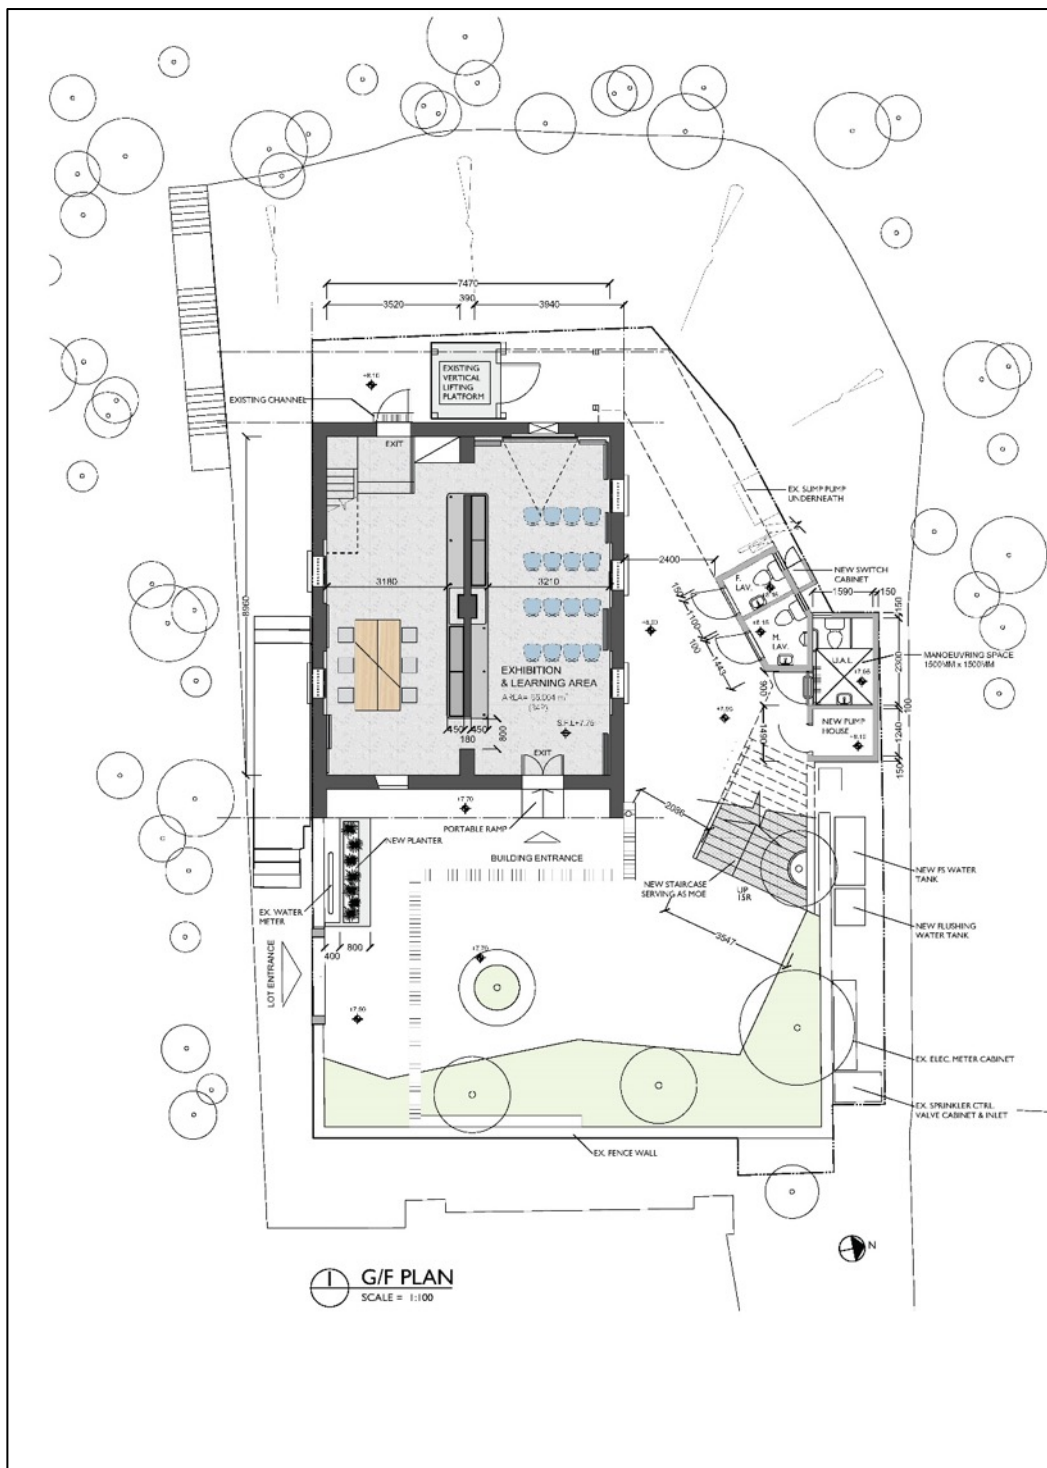
Figure 123 Proposed Design ground floor plan

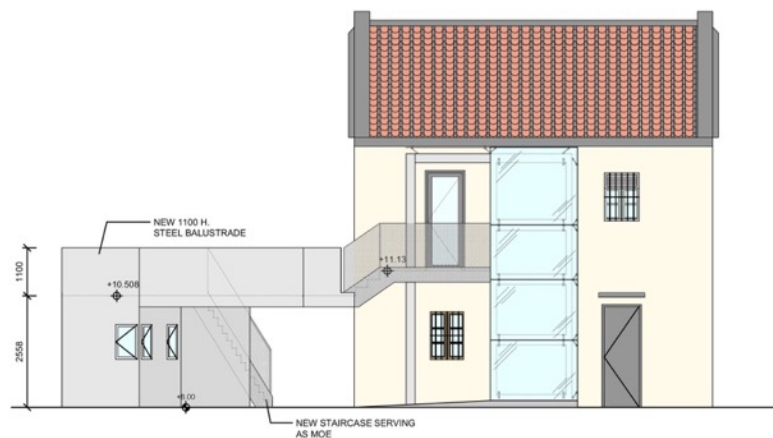
Figure 125 Proposed Design - Elevation

5 REAR ELEVATION  
SCALE = 1:100

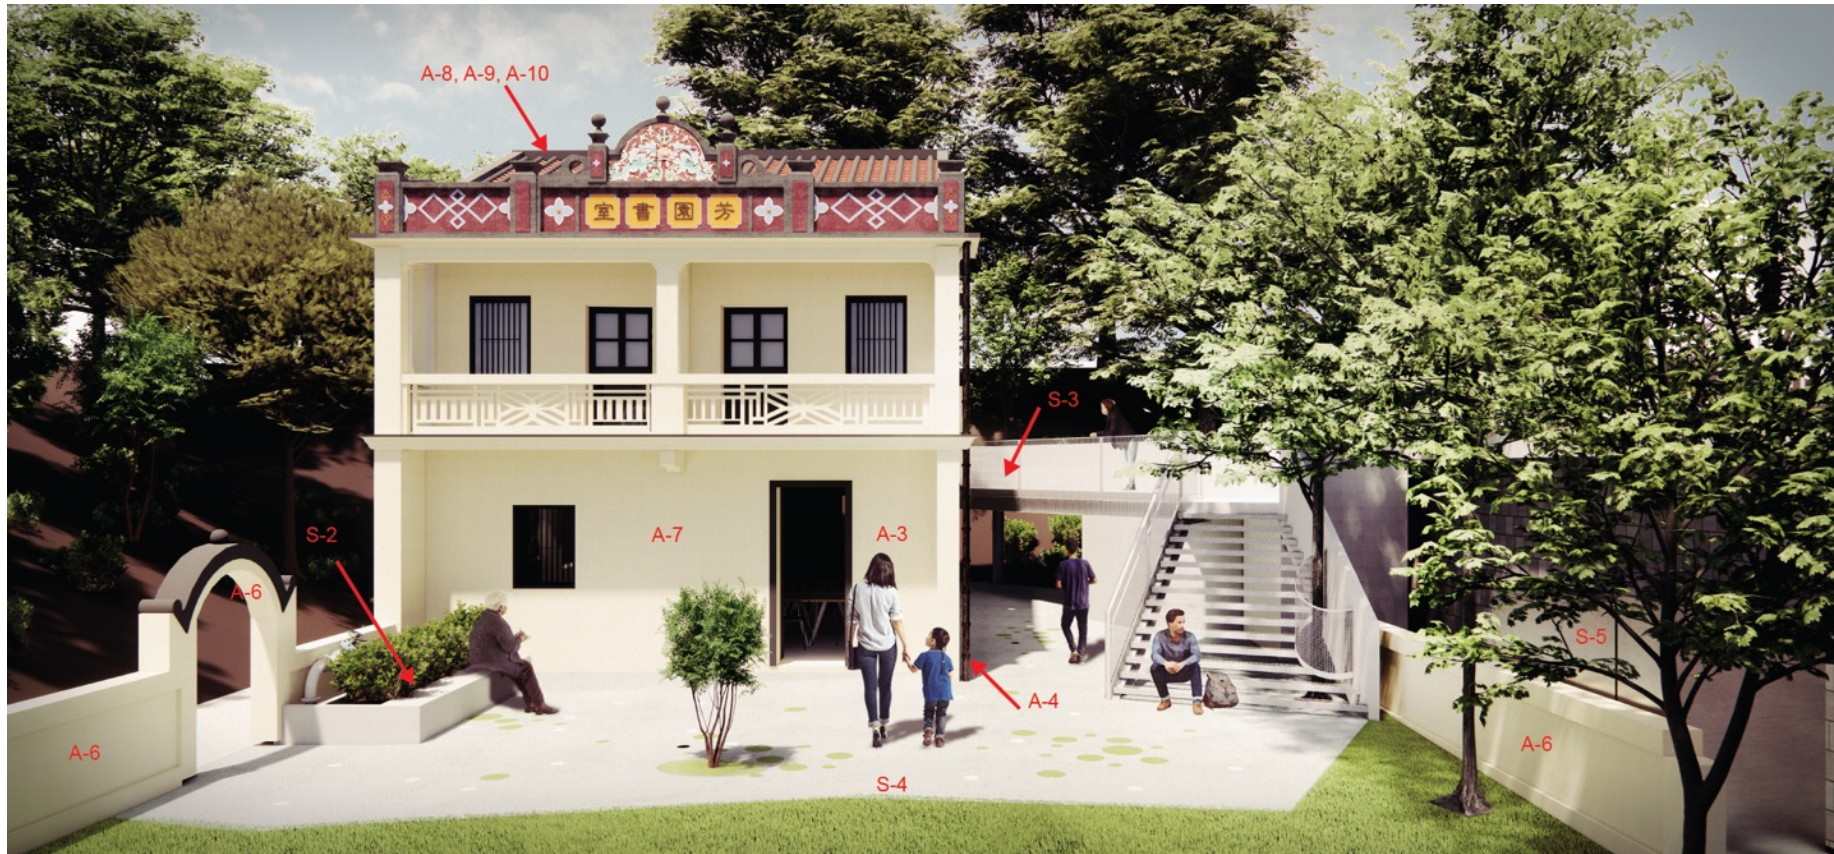
Figure 126 Indication of Assessment Items – Artist impression of the Front Elevation of the Proposed Design

No.	Assessment Items	Element no.	Description of Element	Level of Significance	Reasons for Proposed Changes	Recommendations / Mitigation Measures	Impact Level
						Laboratory tests should be conducted to investigate and determine the ingredients and mixing ratio of plastering material.	
B-9	Demolition of existing floor finish and construction of new terrazzo floor	-	-	-	<i>same as above</i>	<ul style="list-style-type: none"> <li>Demolish existing flooring with care.</li> <li>Investigation should be done before the commencement of construction to study the historic layers of flooring material.</li> <li>If historic flooring material other than generic cement screed (such as tile) is discovered, further investigation should be done to determine whether reveal and restoration is possible.</li> <li>The new terrazzo floor should be in minimal and subtle design, so as to make it distinguishable from the historic fabrics and make sure it will not overwhelm the historic elements in the interior space</li> </ul>	Beneficial impact

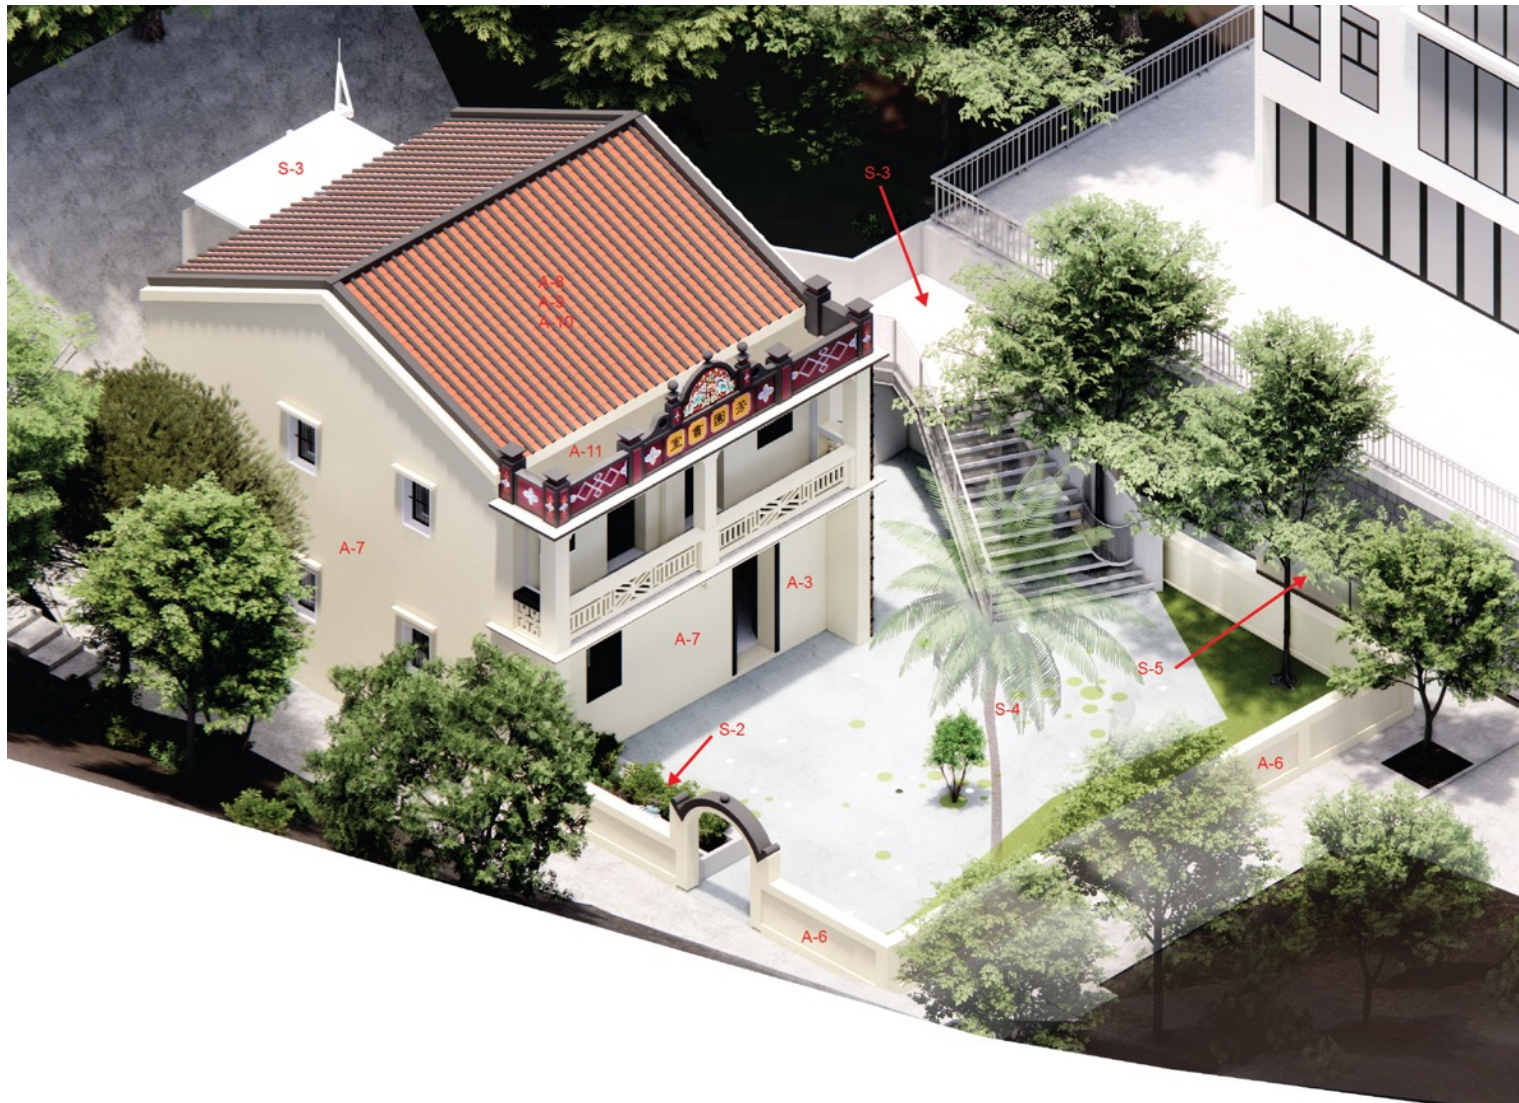
Figure 127 Indication of Assessment Items - Axonometric Drawing of the Proposed Design

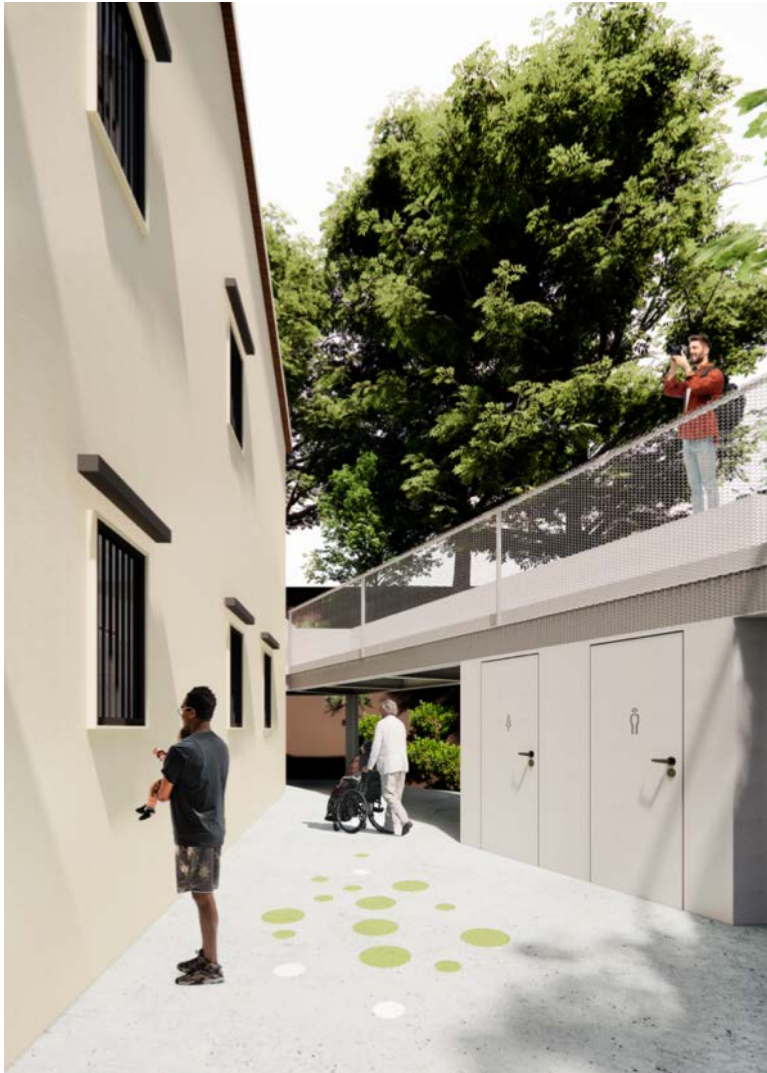
Figure 128 Artist impression of the proposed new toilets block design

- Any new building block, which replaces the existing one (added in last revitalisation) should be as compact as it is technically possible, while balancing the need of future user.
- New building block should maintain a visual and architectural distinction with the original historic building. The massing of the building block should be separated from the original historic building as far as possible.
- The material finishes chosen for the new stair platform should contrast with the materials of the historic building, so that the new and the old parts remain visually legible.

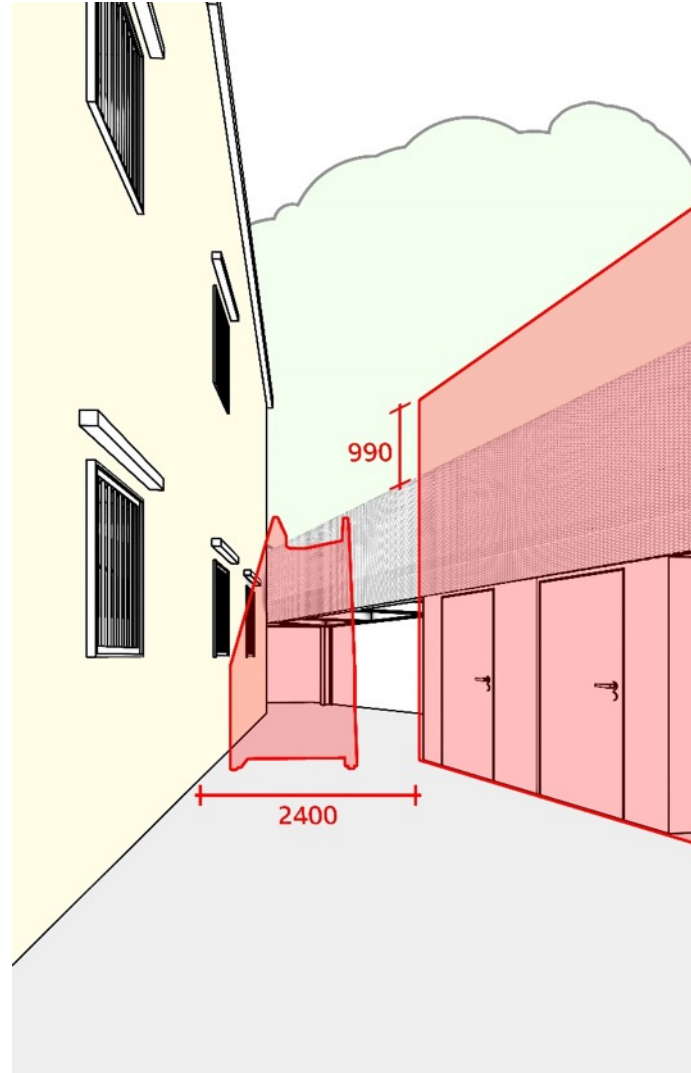
Figure 129 Comparison between the new design (base drawing) and existing staircase and toilet block (highlighted in red).

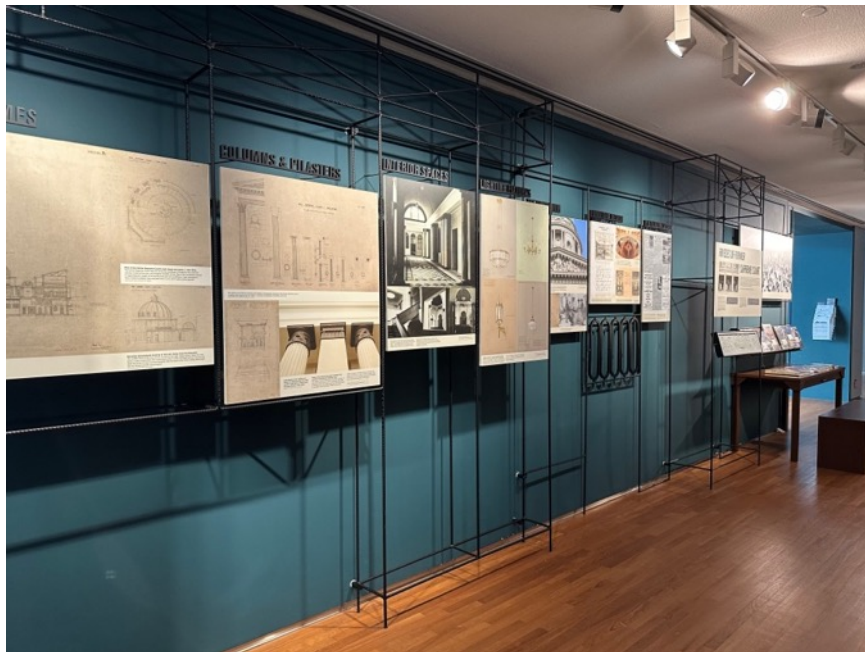
*Figure 134 Exhibition panels/displays mounted on a frame offset from the wall.  
(image: National Museum of Singapore)*
