REVITALISATION SCHEME FOR BLOCK 4 THE CENTRAL POLICE STATION COMPOUND

ABSTRACT

6. This paper is an update on the technical appraisal presented to the AAB in December 2022. It aims to brief Members of the AAB on the findings of the visual inspections and testing conducted *before* and *during* the removal of the unsafe building fabric and the Concept Design of the new revitalisation scheme. The AAB is invited to note this project update before the revitalisation work is conducted on Block 4.

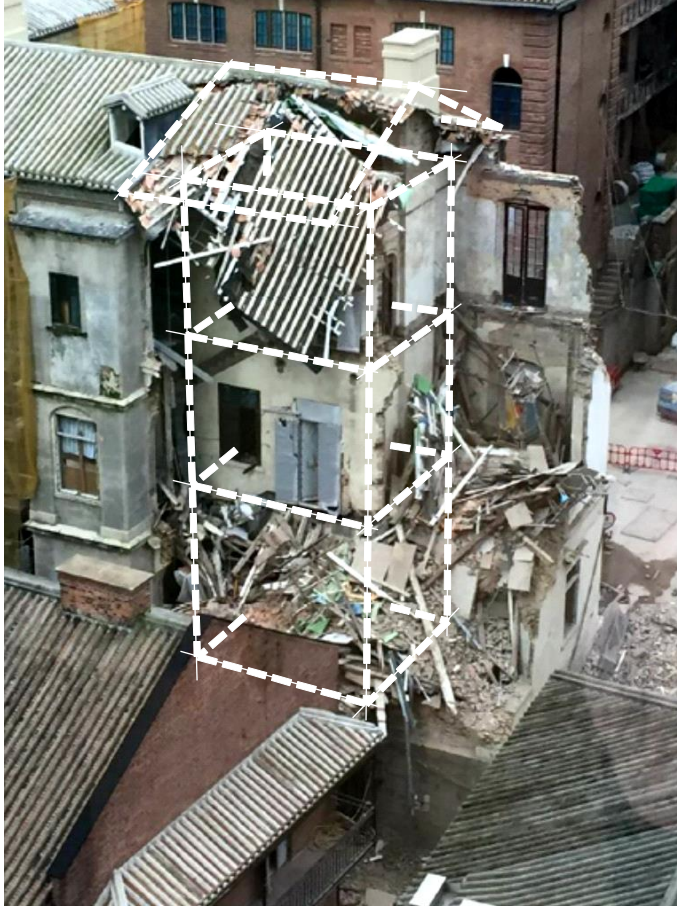
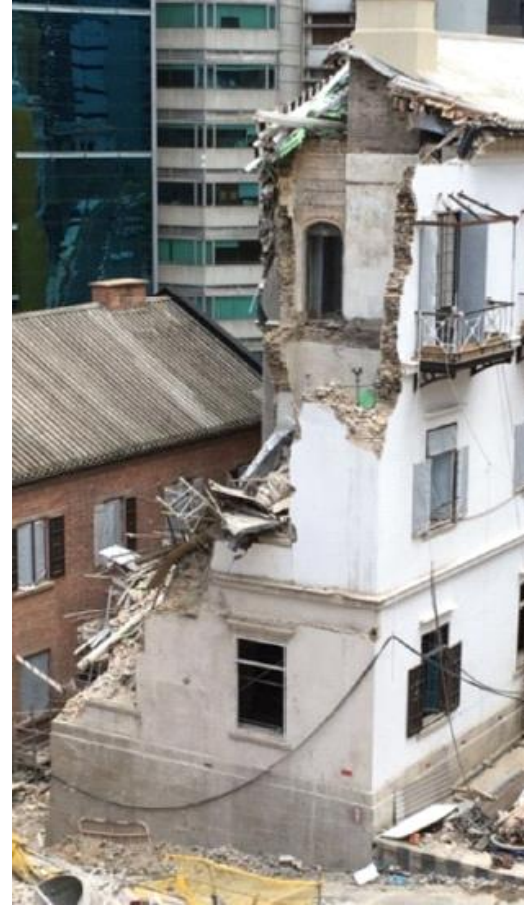
Figure 1 – Aerial views of partially collapsed Block 4 (North Wing) with extent of West Room indicated diagrammatically in broken lines

2. Since the partial collapse of the Married Inspectors’ Quarters (“Block 4”) in May 2016 (Figure 1), the HKJC and the Government have been reporting the progress of the recovery work to the Antiquities Advisory Board (“AAB”) and the public^{1, 2, 3, 4}. The latest technical appraisal⁵ presented to the AAB on 8 December 2022 explained that Block 4 showed signs of continuing deterioration, despite careful protection, and that the parts of the extant building fabric that are unsafe to retain must be removed as soon as practicable before ongoing dilapidation further weakens the building fabric, which would make it more hazardous to handle. The HKJC submitted an application for a permit under Section 6 of the Antiquities and Monuments Ordinance (“Section 6 Permit”) to the Antiquities and Monuments Office (“AMO”) for undertaking further investigations, testing, and removal works that were considered strictly necessary to make safe the building superstructure.

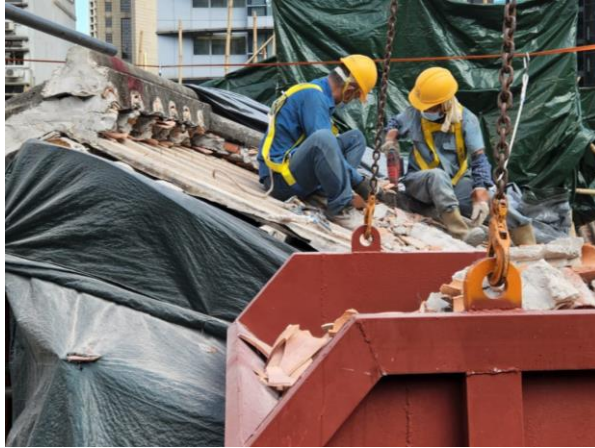
Figure 2 – Removal of roof coverings and relocation of timber trusses of Block 4

Removal of clay
tiled roof coverings

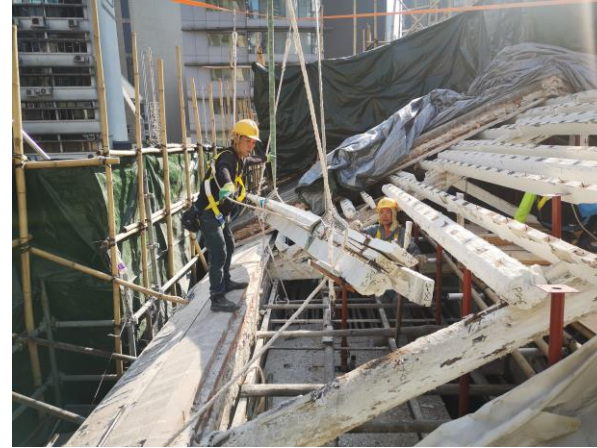
Removal of
timber purlins

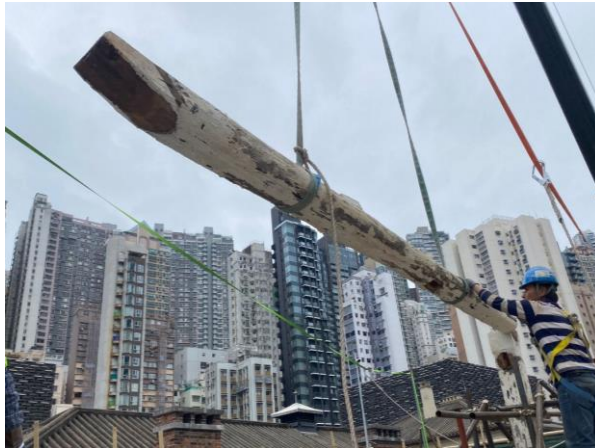
Removal of
timber rafters

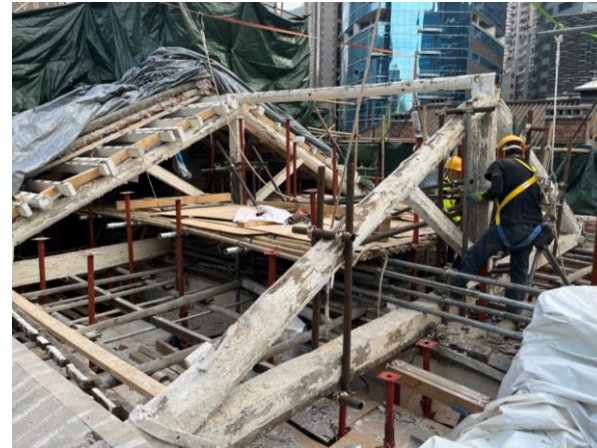
Removal of
timber trusses

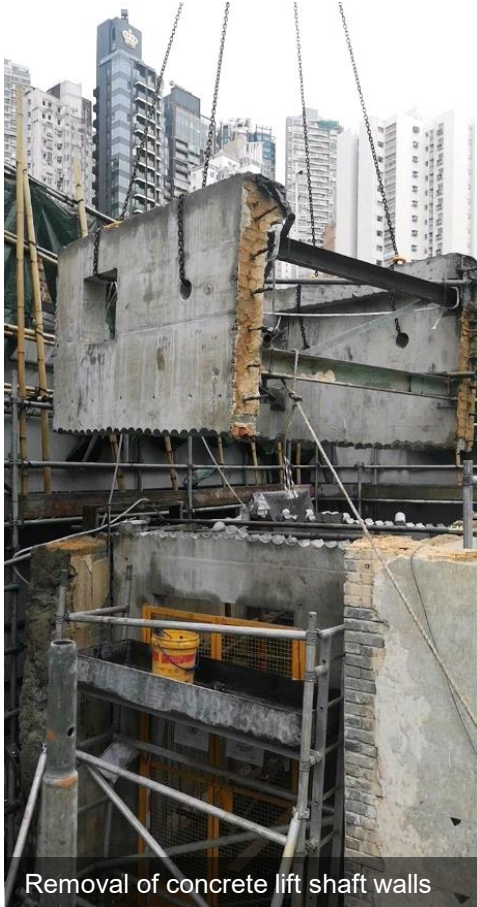
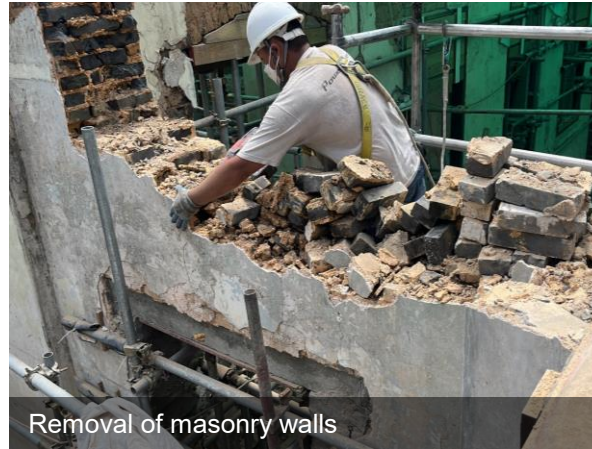
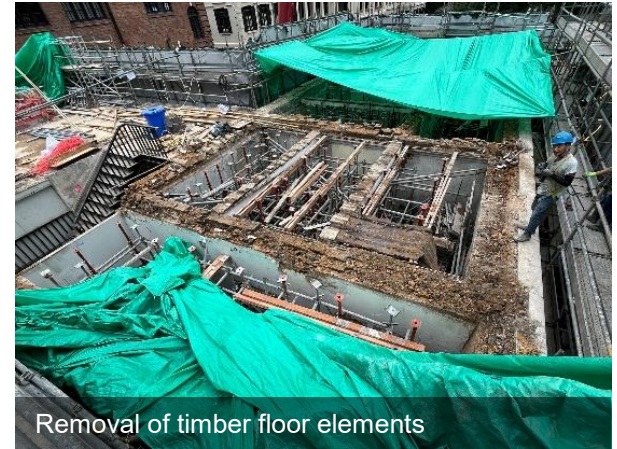
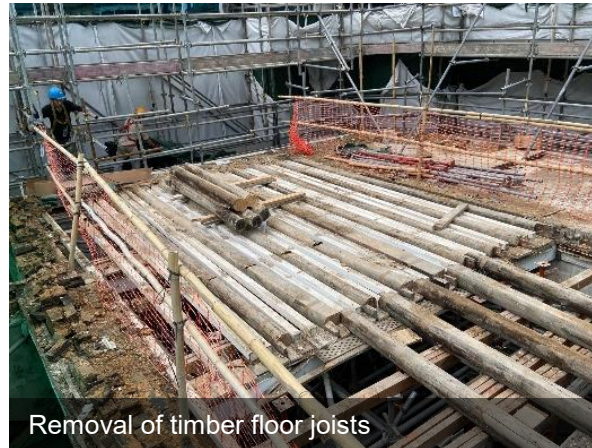
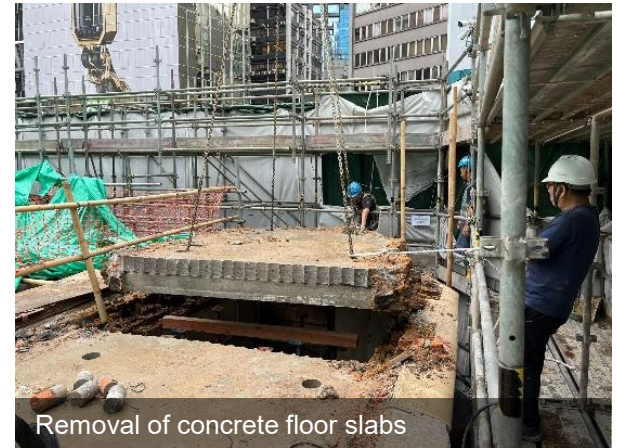
Figure 3 – Removal of unsafe building fabric at 2/F and 1/F of Block 4

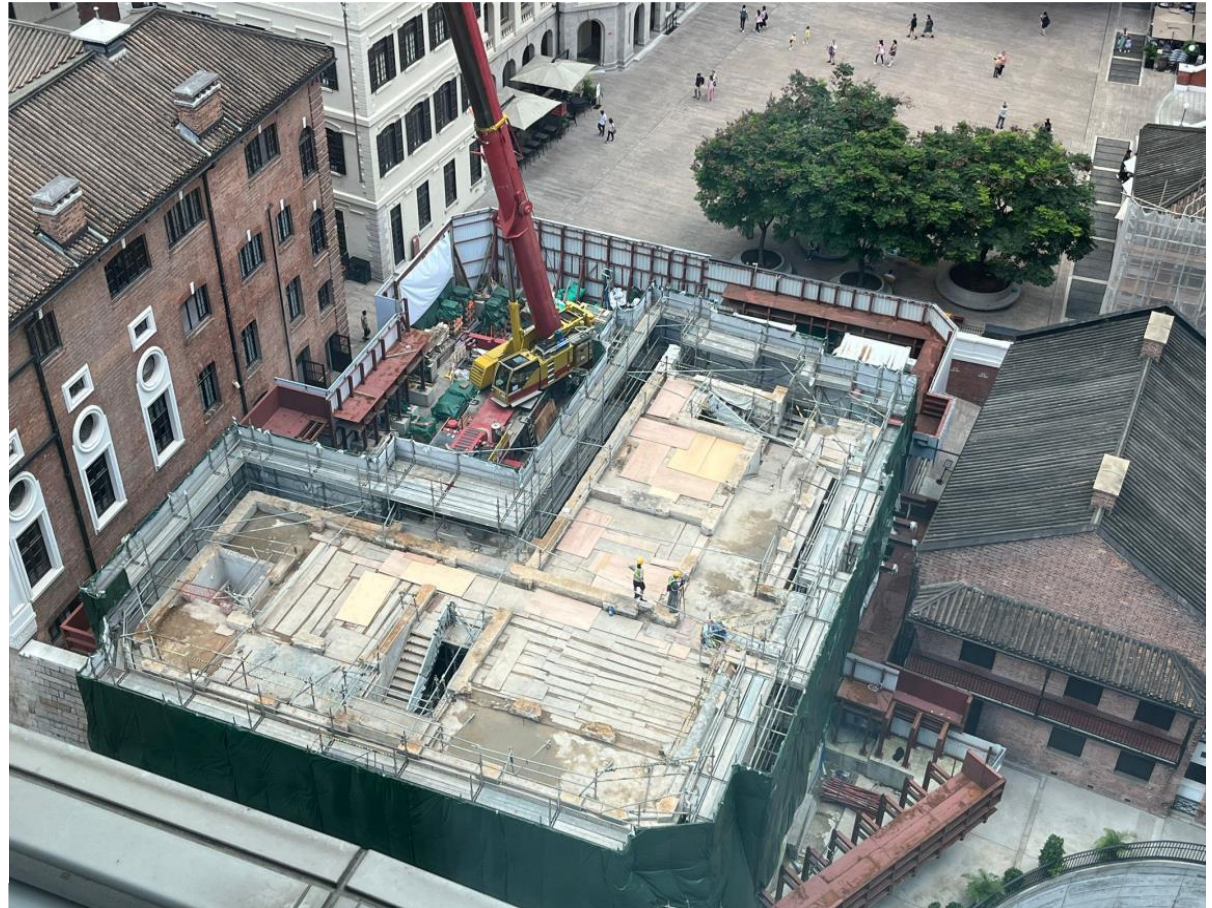
Figure 4 – Stage-completion of removal of unsafe building fabric (completion by June 2024)

Aerial view taken on 03 Jul 2024

4. The topmost level of the retained building structure now stands temporarily at 300mm above the 1/F floor level (**Figure 4**). Under the Section 6 Permit, an assessment will be conducted to identify what further work is required for the remaining building fabric to achieve a safe condition. In parallel, the HKJC has reassembled the original Block 4 design team which includes Herzog & de Meuron (“HdM”), Purcell, Rocco Design Architects, Arup, etc. to explore two revitalisation options, i.e., (a) *Conserve-as-Found* and (b) *New Building*. Given that the new building option would inevitably lead to a total loss of the extant building fabric and foundations, the HKJC has accepted its consultants’ view that a revitalisation scheme based on the so-called conserve-as-found concept would offer a better solution, noting its potential for maximising retention of the remaining building fabric.

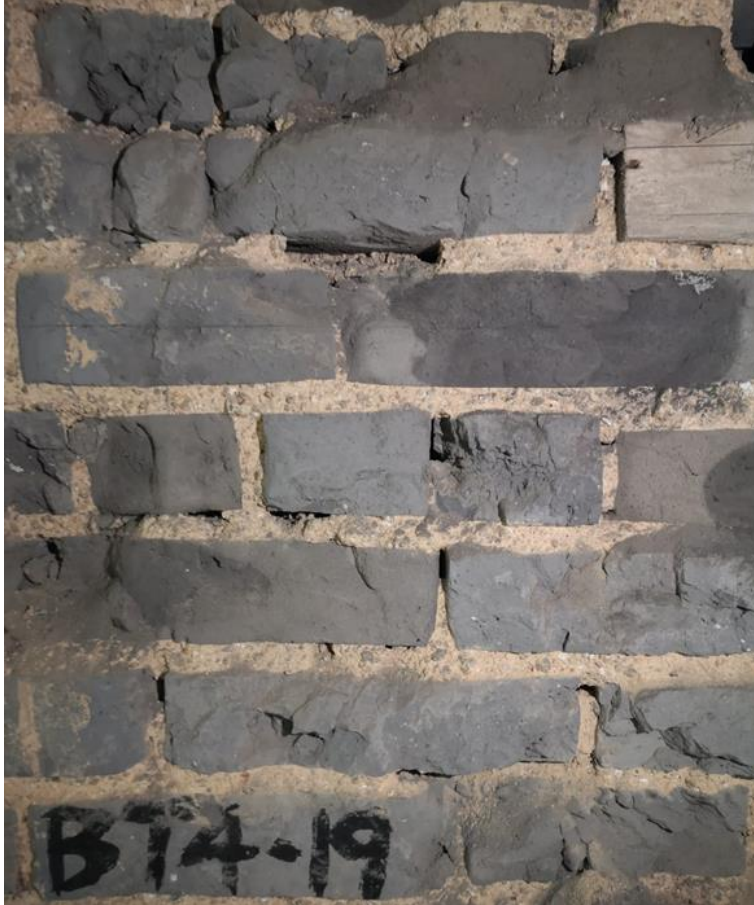
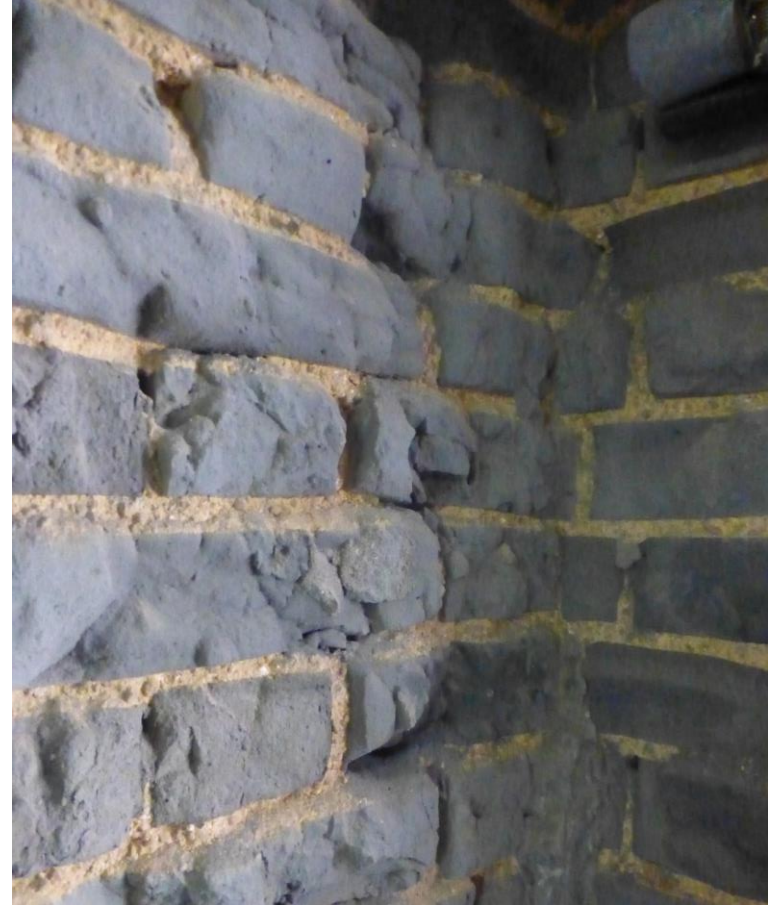
Figure 6 – Low-strength bricks seen in most areas of exposed brickwork
(Location: Wall Zone W1 on 1/F)

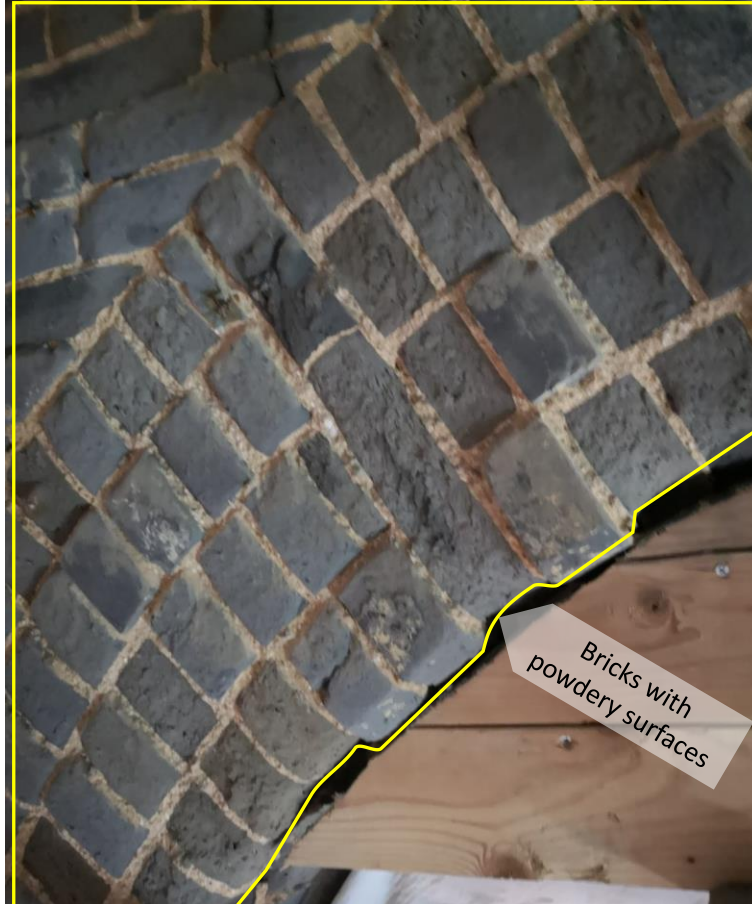
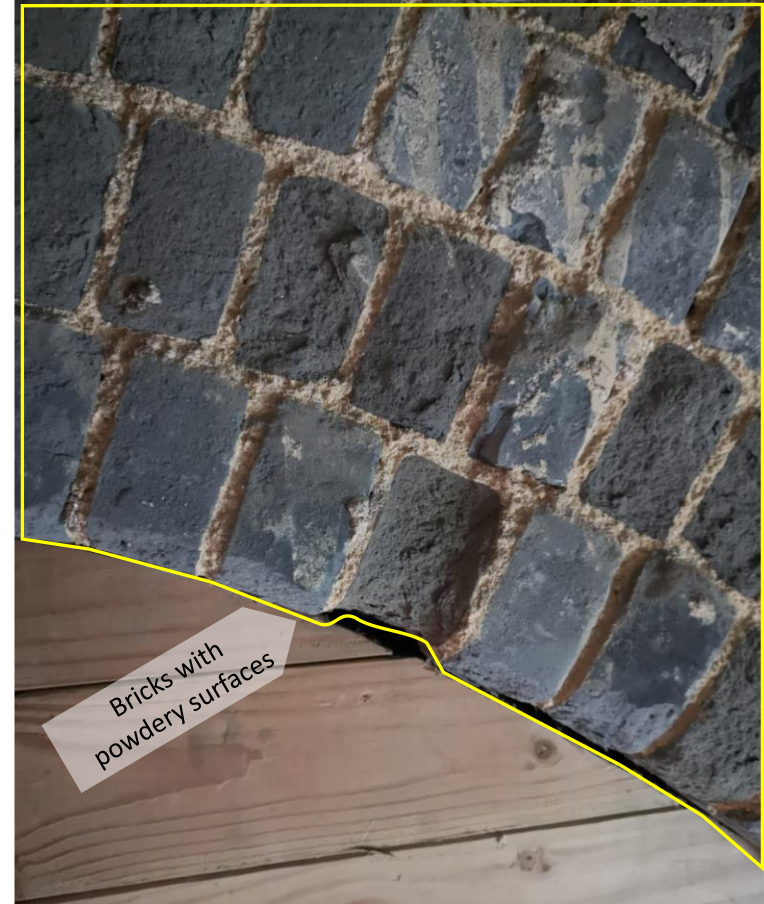
Figure 7 – Bricks with powdery surfaces seen in most areas of exposed brickwork
(Location: Wall Zone W1 on 1/F)

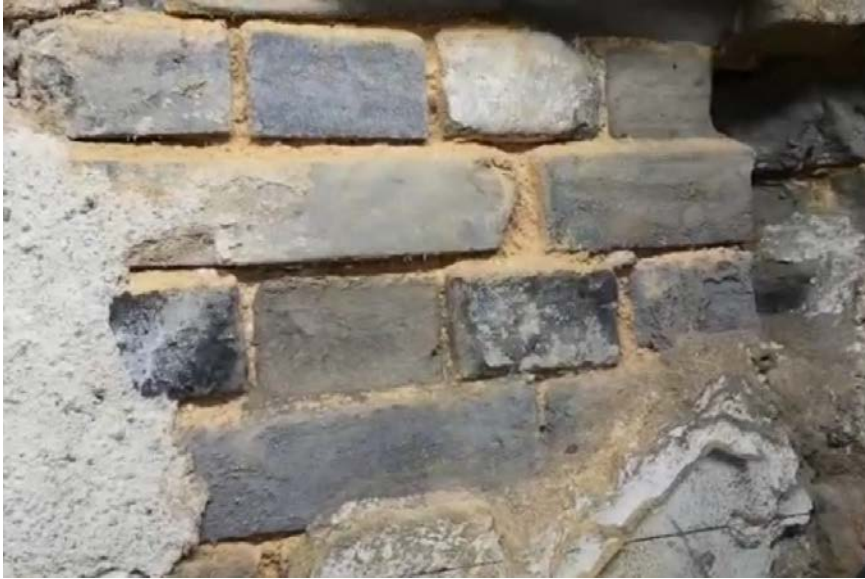
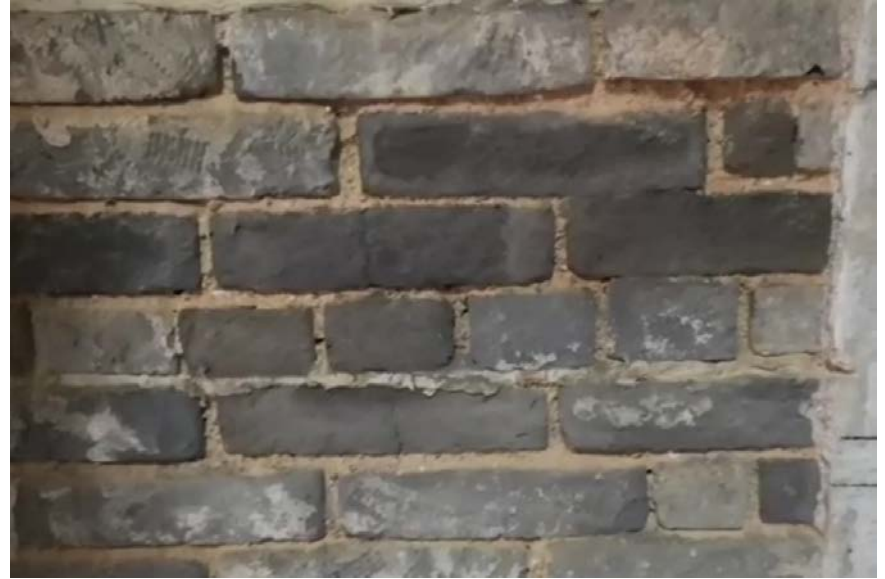
Figure 8 – Weak and non cohesive mortar (can be rubbed away by hand easily) seen in most areas of exposed brickwork (Location: Wall Zone W6 on G/F)

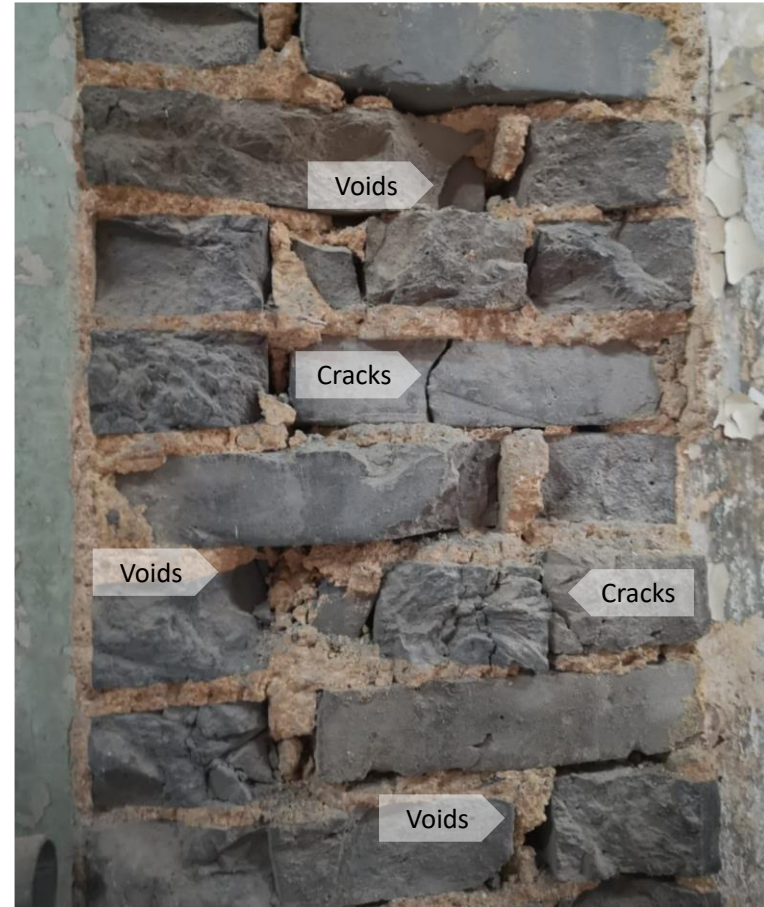
Figure 9 – Brickwork at door opening (section) showing substantial cracked bricks, voids and poor bonding in wall core (Location: Wall Zone W5 on 1/F)

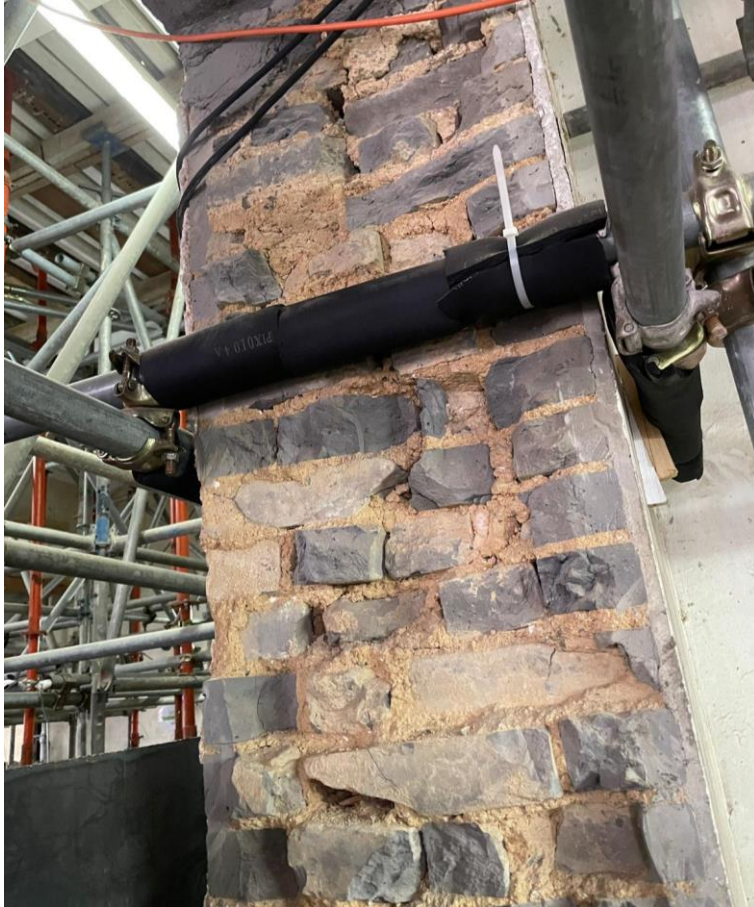
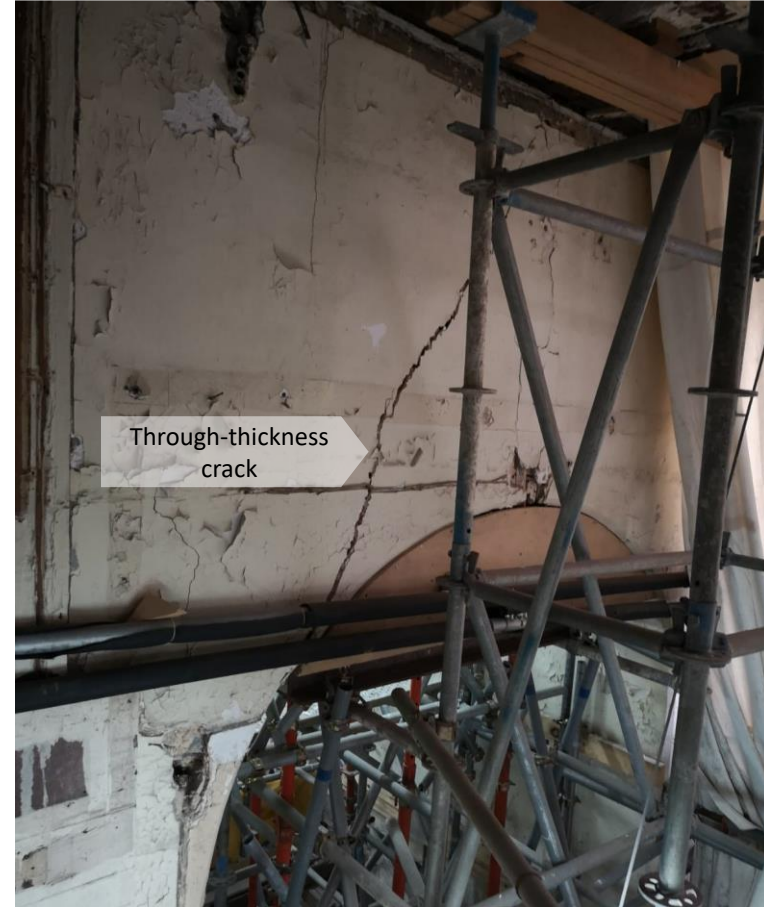
Figure 10 – (a) Poor bonding of brickwork, erratic in pattern and level (Location: Wall Zone W6 on G/F)
(b) Through-thickness cracks in the west staircase portal (Location: Wall Zone W5 on 2/F)

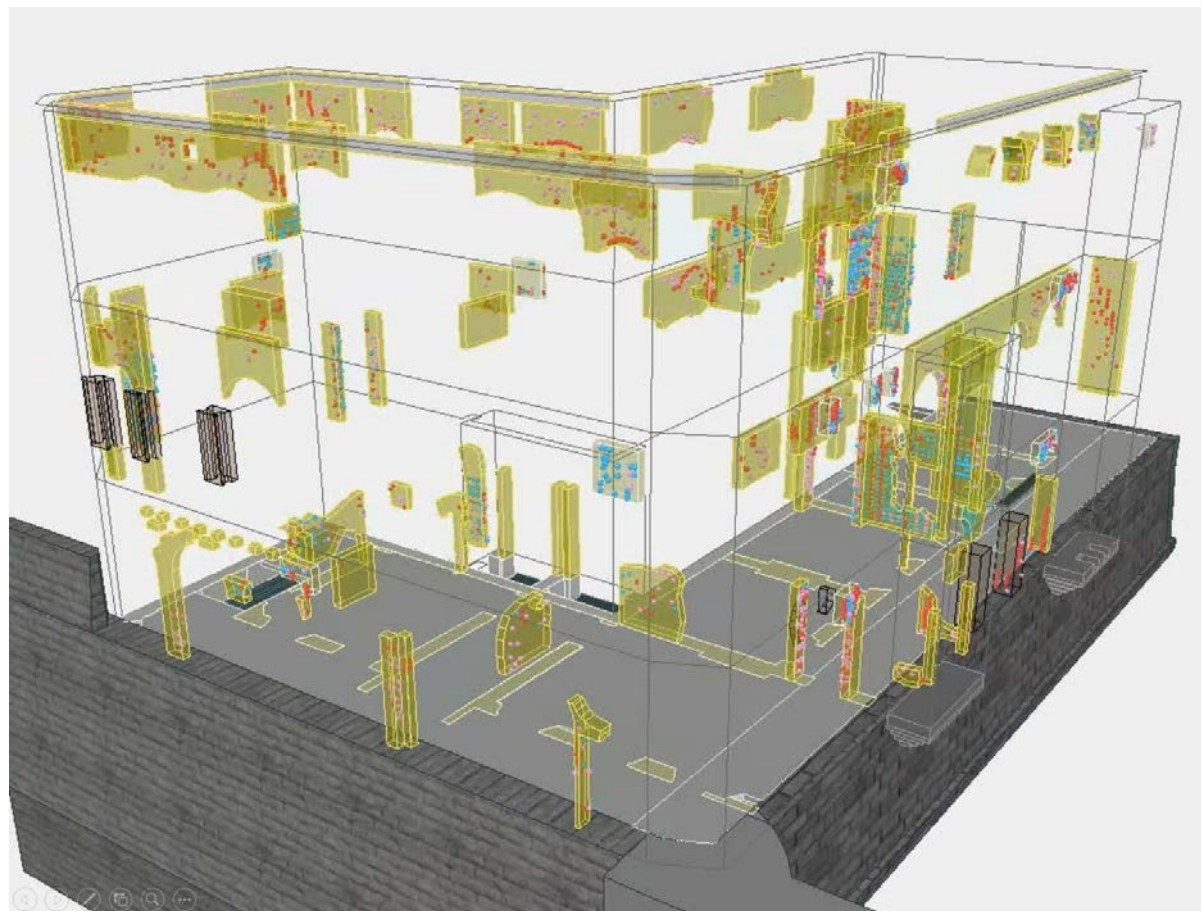
Figure 11 – Consistent types of defects seen in most areas of exposed brickwork

Block 4 illustrated as a wireframe for clarify, showing exposed areas visually inspected and defects identified

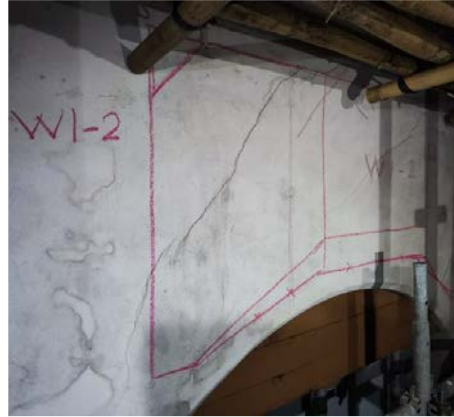
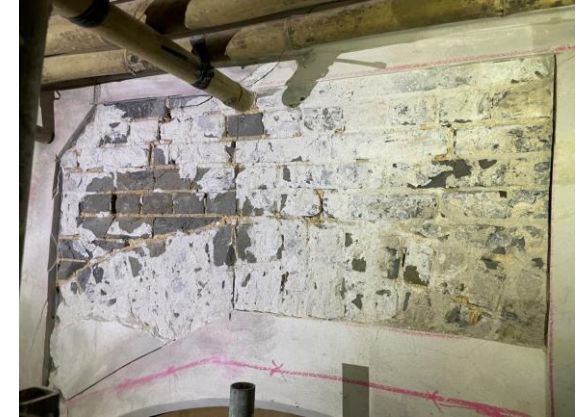
Figure 12 – Visual inspection of twelve newly opened-up locations and respective findings

Location W1-2: View of render surface condition before open-up

- Surface cracks on rendering can be seen

Location W1-2: View of brickwork condition after open-up

- Structural cracks through-brick-thickness can be seen, indicating bricks are low in shear strength
- Cracks along mortar joints can be seen, indicating mortar is weak leading to poor bonding
- Surface cracks noted in unopened-up areas are likely to reflect structural cracks in the brickwork underneath

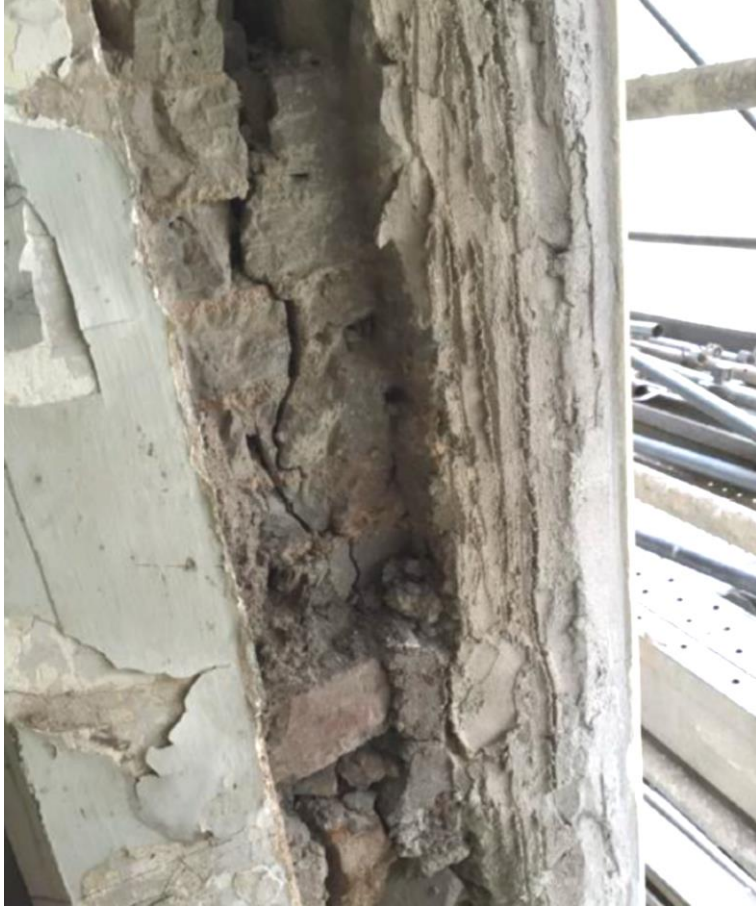
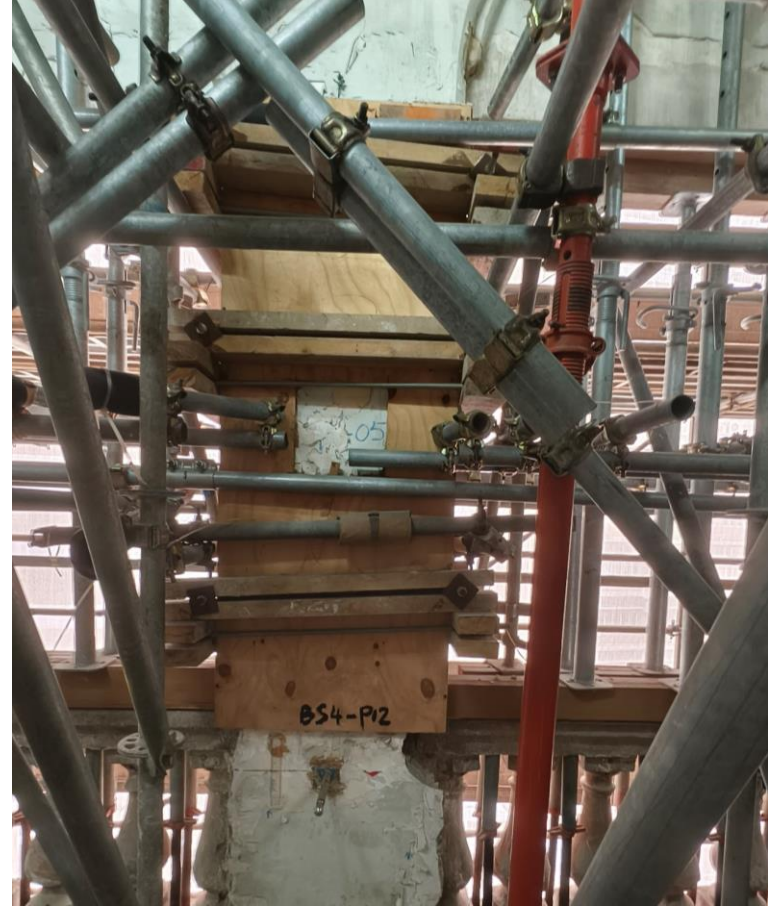
Figure 13 – (a) Cracks in brick pier noted after removal of window frame (Location: Wall Zone W4 on 1/F)
(b) Failed pier stabilised by clamped timber boards (Location: Wall Zone W4 on 1/F)

12. Defective brickwork aside, one of the more unusual structural features of Block 4 is the verandahs on the north and east sides where nineteen slender brick piers support arched openings in the external façades. Brick and mortar testing shows that the brickwork is very weak. Engineering assessment indicates that the ground floor piers, having a characteristic compressive strength of approximately 1.0 MPa (N/mm²), are close to failure owing to the self-weight of the brickwork alone.⁷ Visual inspection of the external surfaces of the piers has identified compressive failures of five piers (**Figure 13**) – a dangerously high failure rate of 26 percent for any built structures.

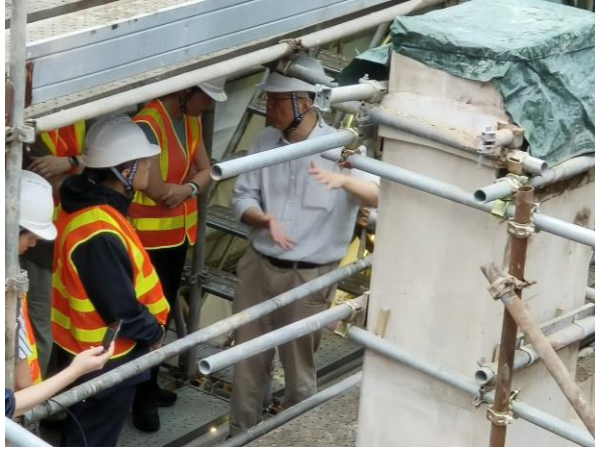
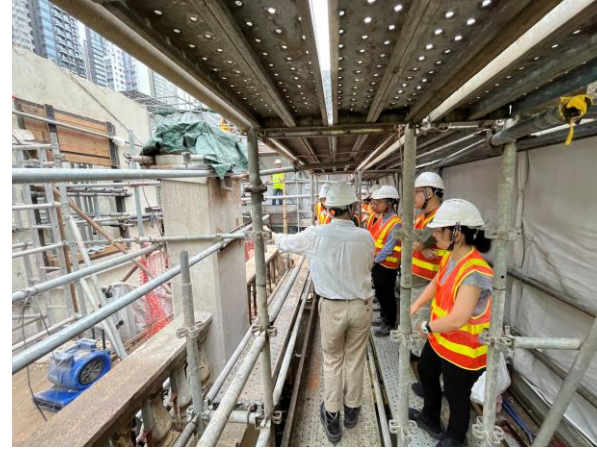
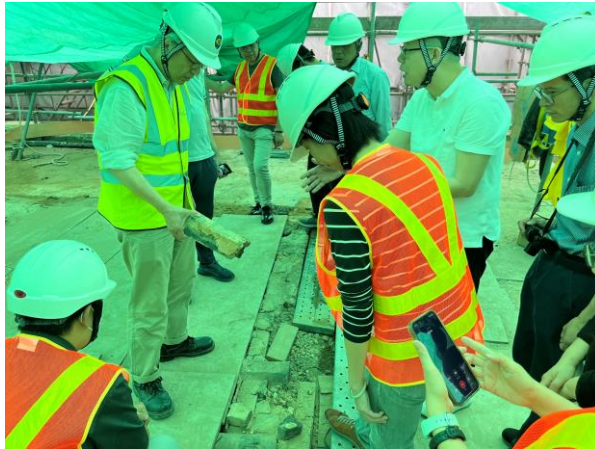
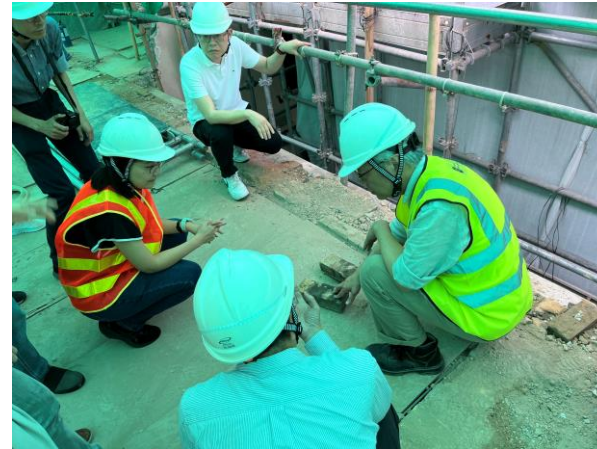
Figure 15 – Brick pier showing a lack of cross-bonding brickwork in middle zone, preventing a robust brick pier to be formed

13. **During Removal Works** – Visual inspections including those by the Vetting Panel (**Figure 14**) were conducted during the removal works between February and June 2024, allowing understanding of the actual core condition of the walls and piers in a way not possible before. Typical findings are explained below. **Figure 15(a)** shows the elevation of a brick pier on 2/F. The mortar at horizontal planes A and B (**Figures 15(b) and 15(c)**) was carefully removed to expose the brickwork condition. In both planes, cracked bricks, voids, and a lack of mortar in brick joints can be seen. Also, a rubble-filled core, albeit localised, is noted at plane B. The bonding arrangement observed is of serious concern because the bricks laid do not provide sufficient cross-bonding in the middle zone to form a robust brick pier. When the pier is stressed under normal working loads, it would very likely lose its integrity and crack (split) vertically through the middle zone in the same way observed at the failed piers. **Figure 13(a)** shows one of these piers where the crack is approximately in the middle zone through the height with a noticeable zig-zag pattern where inadequate cross-bonding is evident.

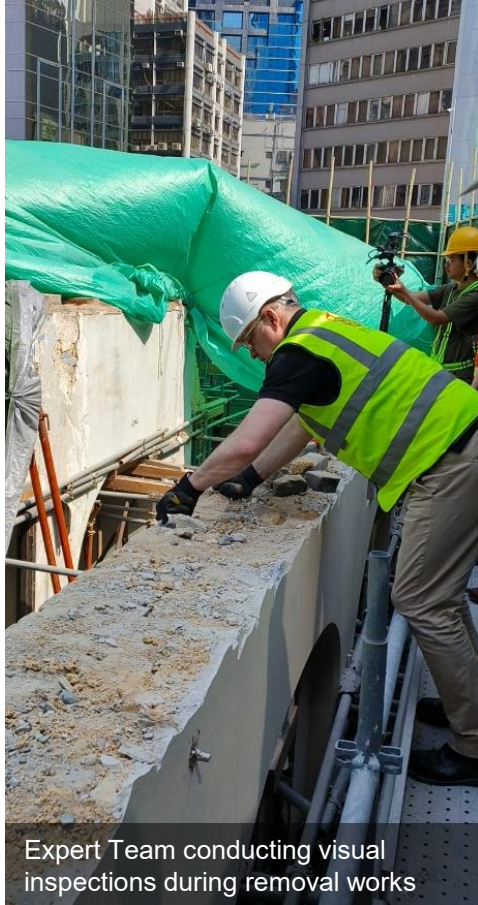
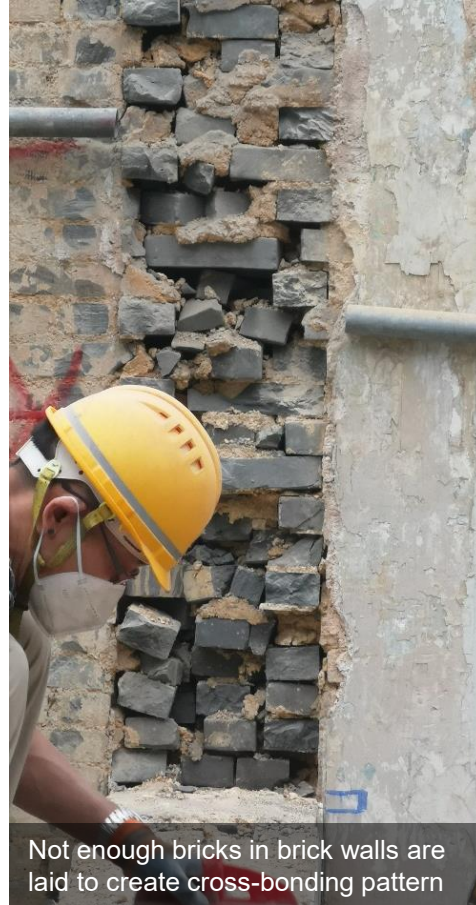
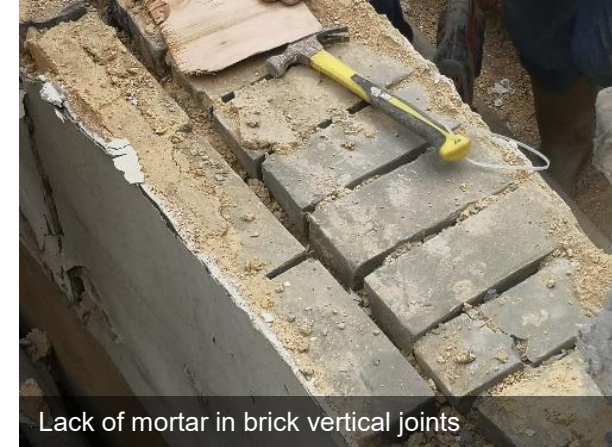
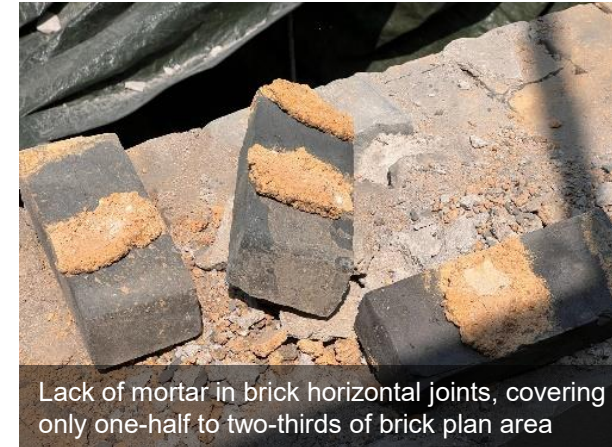
Figure 16 – Visual inspection during removal works, revealing copious evidence of substantial and widespread voids in brick vertical and horizontal joints

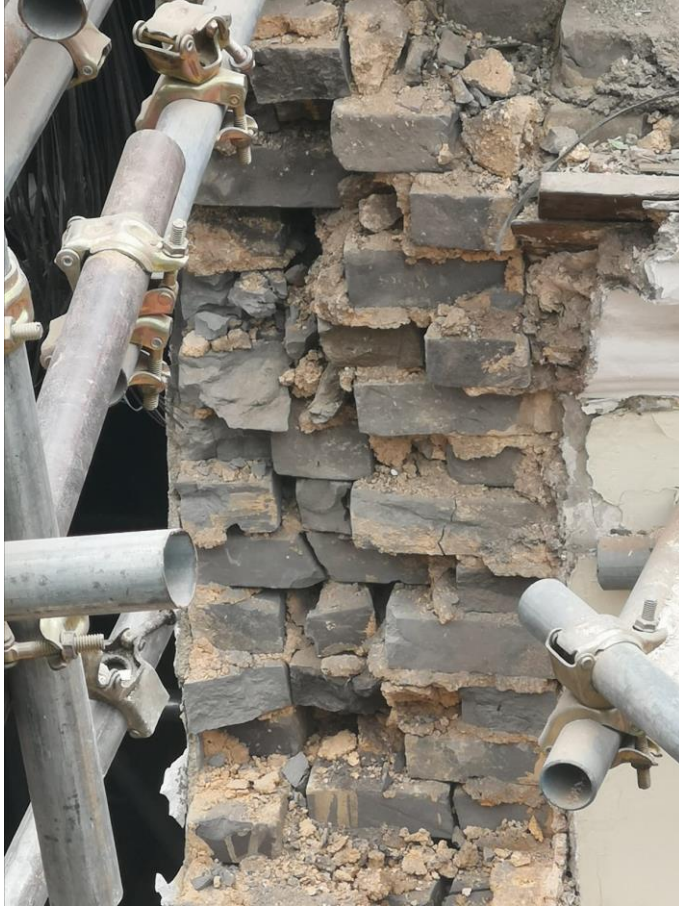
Figure 17 – Cracked bricks, voids and a lack of mortar at brick joints observed; individual bricks removed easily from main body of brick walls

joints is approximately one-half to two-thirds of the brickwork plan area. The vertical load transfer is confined to a much-reduced area, and hence the compressive stress in individual bricks is much higher than expected. The partially filled brick joints also change the intended composite characteristic of the brickwork to a stack of individual bricks working independently. This lack of mortar and weak composition means that individual bricks can be easily removed from the main body of walls as noted above (Figure 17).

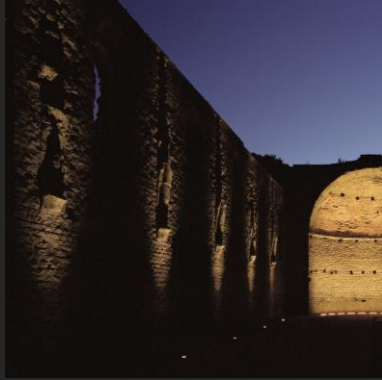
Lighting

Use of lighting to activate the elevation of Block 6, 7, 9 and the open space of Block 4 as one singular zone, enhancing Tai Kwun's presence along Arbuthnot Road and Wyndham Street

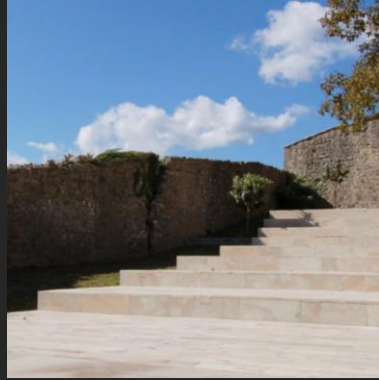
Public Space

Remains of Block 4 to be incorporated into a semi open / open space with hard landscape design, creating a unique blend of history and urban intervention, an extended space of the Parade Ground

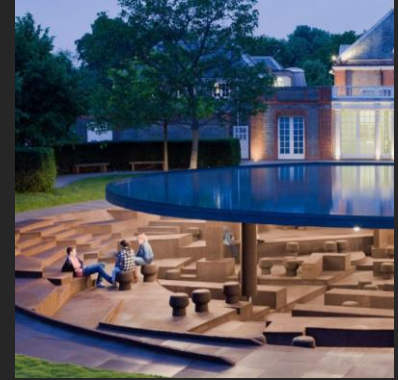
Future Events

The open space completed with a permanent canopy structure to showcase innovative design, engage with the environment, serve as a hub for cultural events, talks, and performance

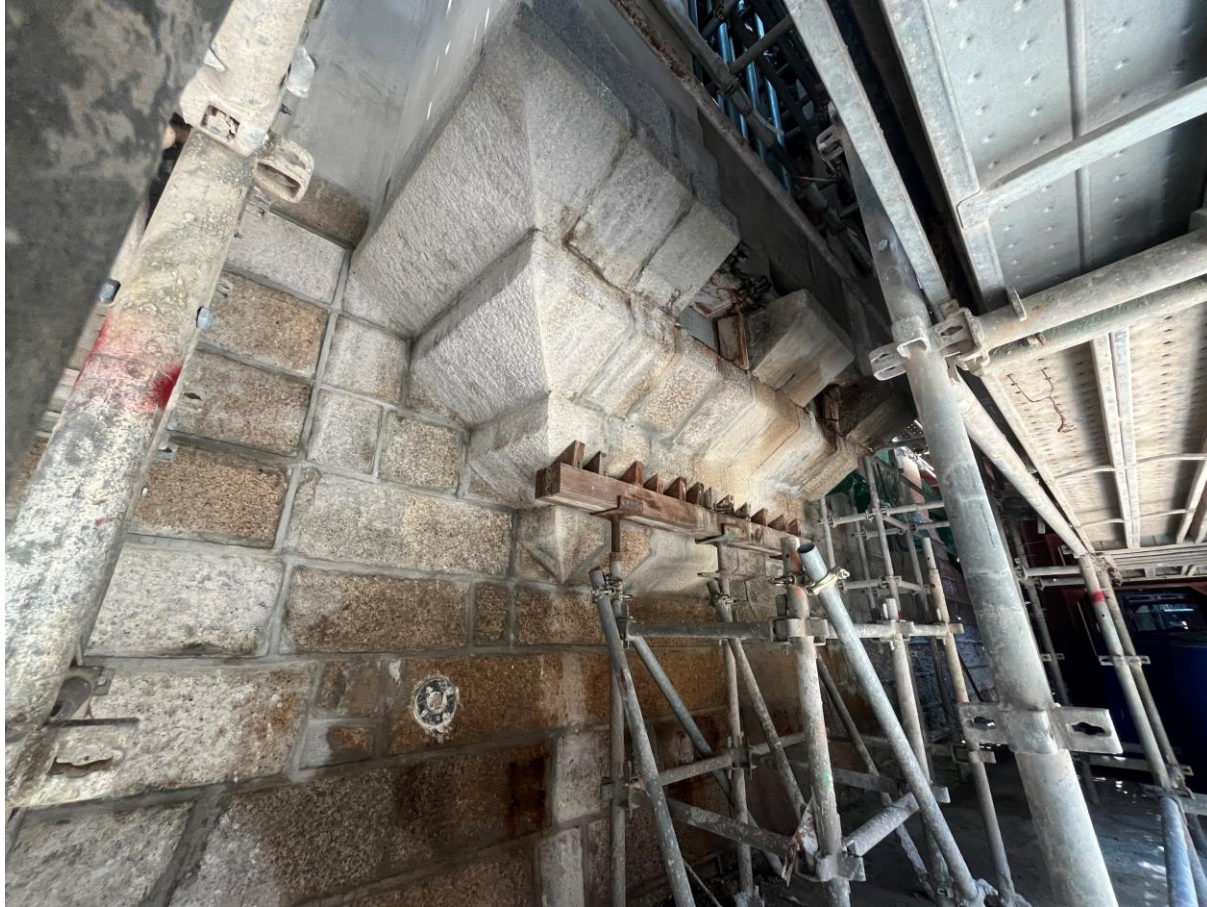
Figure 32 – Granite corbels of Block 4 supporting projecting bays

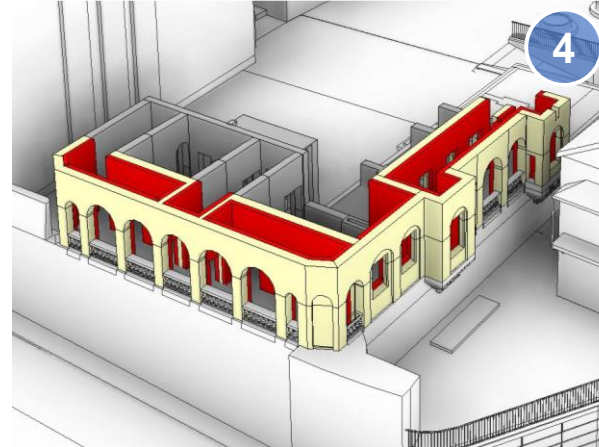
(d)

Perspective view showing extent of strengthened facades (Walls in **red** represent new exoskeletal concrete frame)

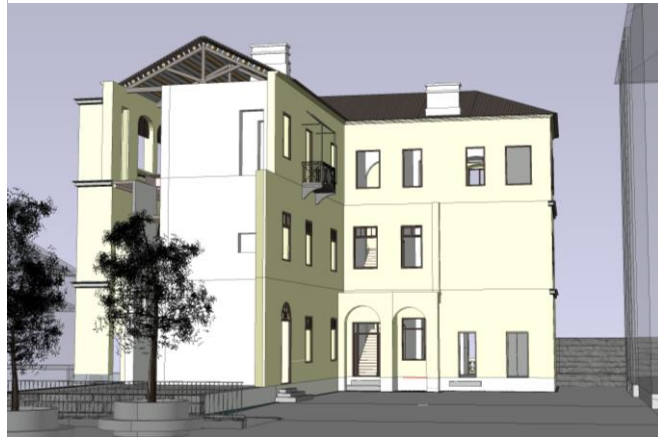
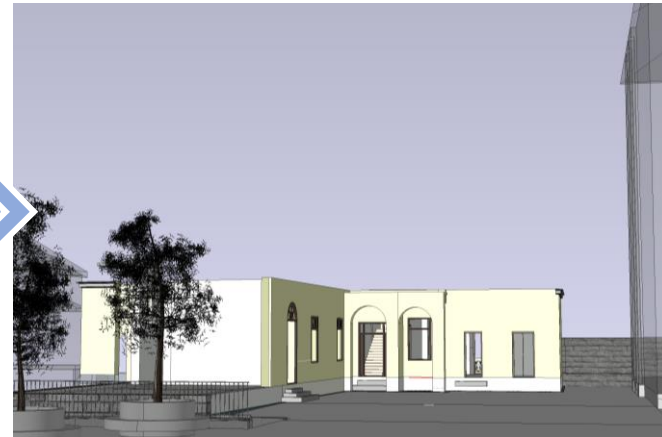
Figure 40 – Possible seating and stage areas with G/F rooms and staircases retained;
stage and seating area (with 117 seats where 62 seats by collapsible bleachers)

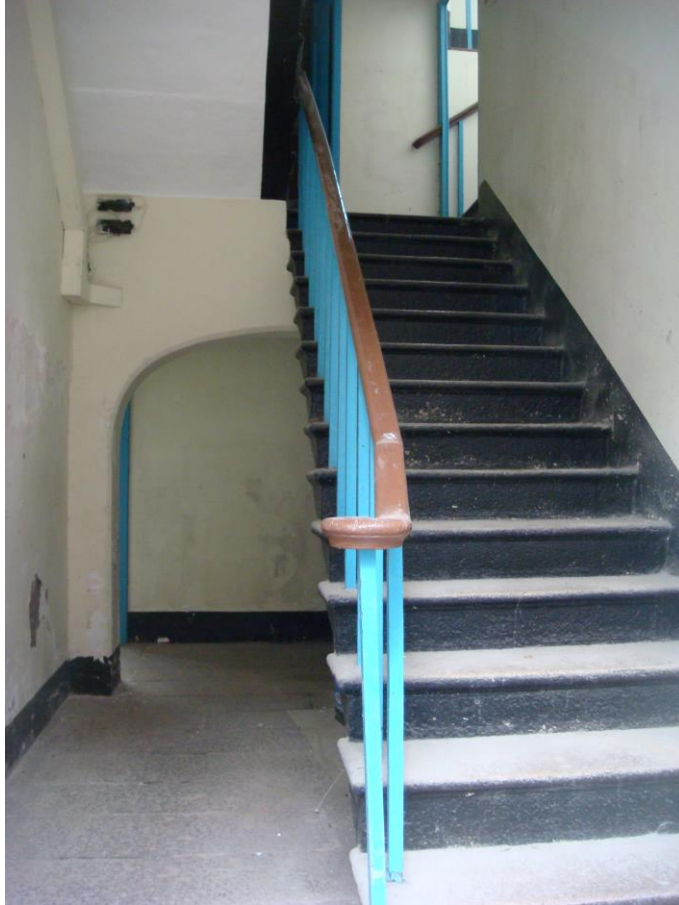
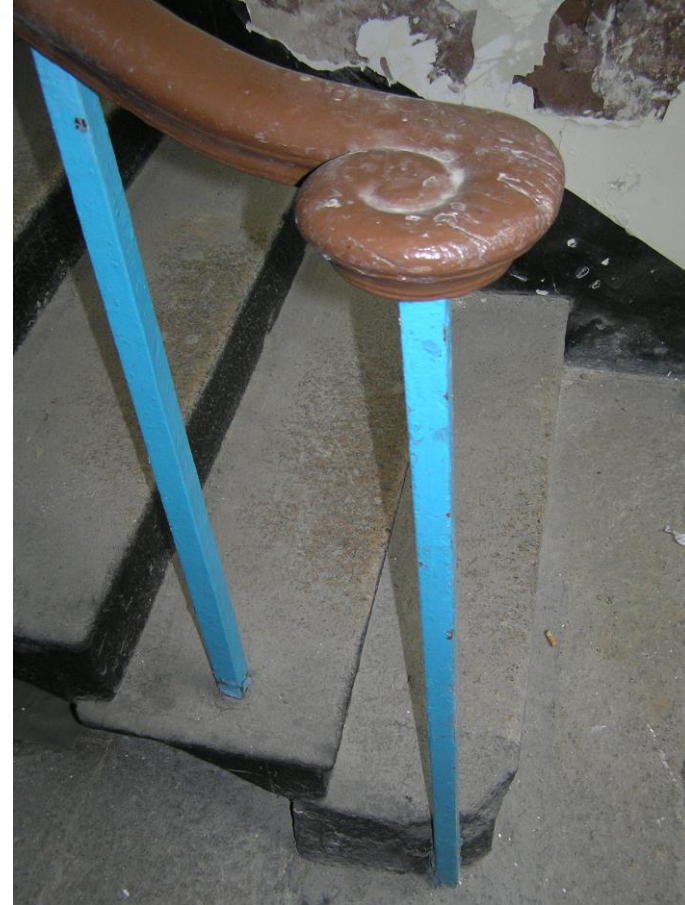
Figure 43 – Timber staircase ST2 in Block 4

31. **Granite and Timber Staircases** – There are two extant staircases in Block 4, granite staircase ST1 having simple balusters and moulded hardwood handrail (Figure 42) and timber staircase ST2 (Figure 43). Neither of these staircases is in full compliance with the current safety standards, as is the case with all other retained original staircases in the CPS Compound. However, what would be different in this case is that the terms of the Buildings Ordinance would be applied strictly due to the extent of alteration to the building generally. This would make reuse of these staircases unfeasible as they would need substantial
