REVITALISATION SCHEME FOR BLOCK 4 THE CENTRAL POLICE STATION COMPOUND

ABSTRACT

6. This paper is an update on the technical appraisal presented to the AAB in December 2022. It aims to brief Members of the AAB on the findings of the visual inspections and testing conducted *before* and *during* the removal of the unsafe building fabric and the Concept Design of the new revitalisation scheme. The AAB is invited to note this project update before the revitalisation work is conducted on Block 4.

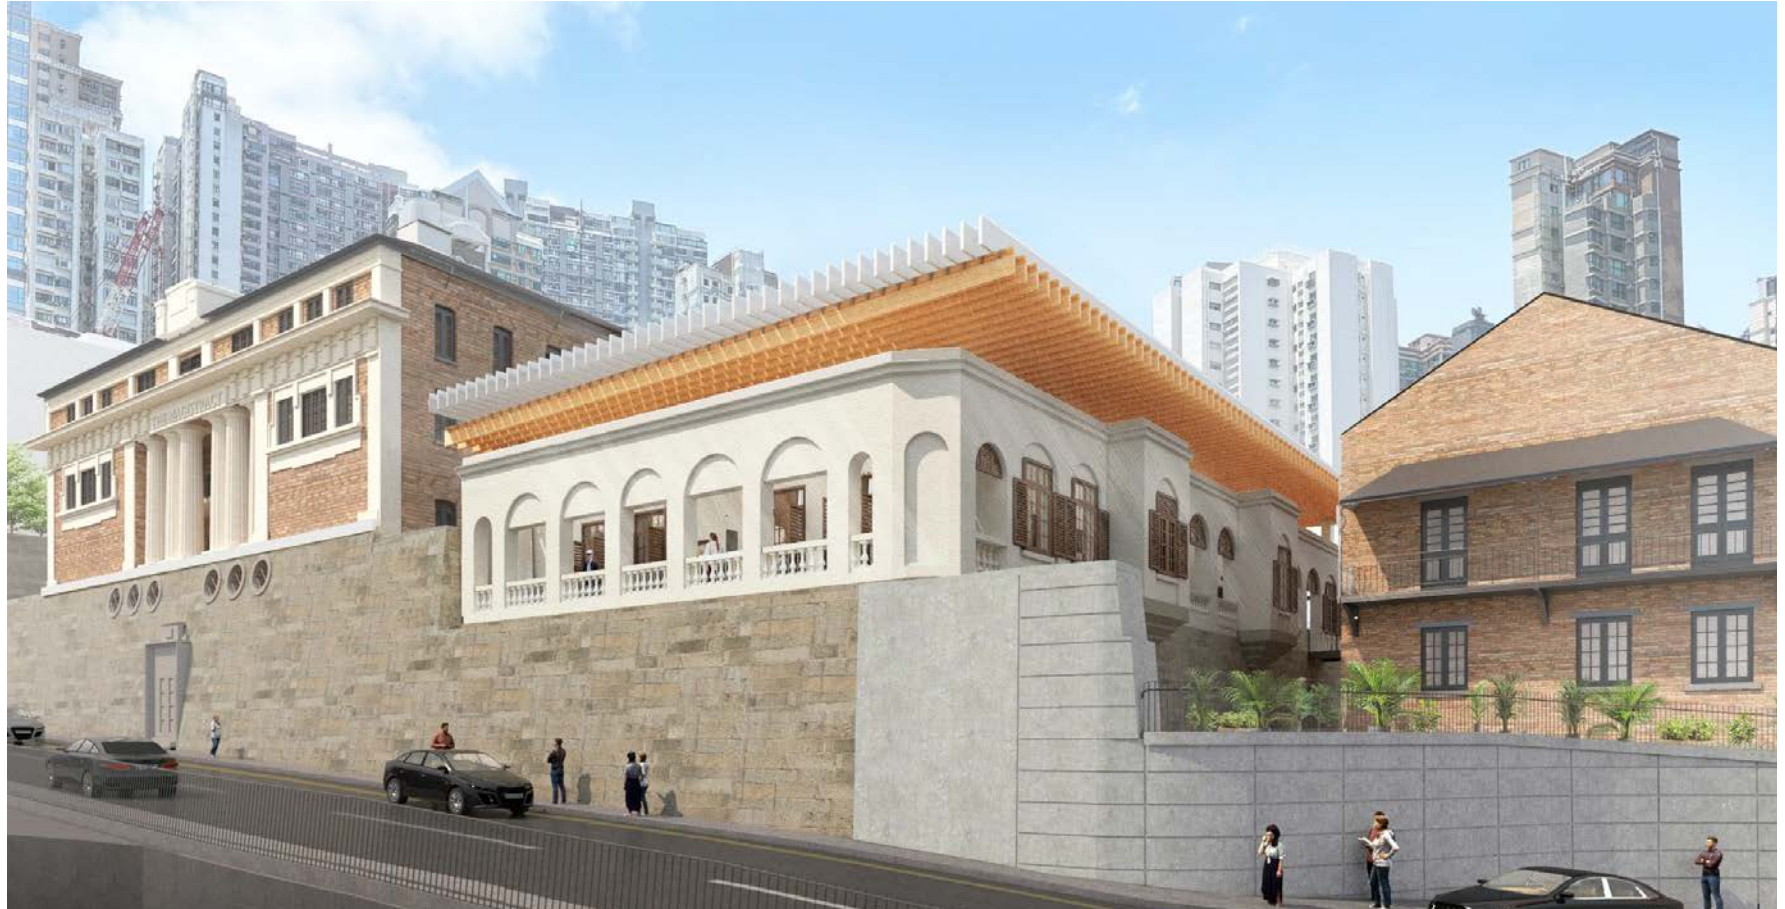
Figure 50 – Proposed permanent canopy, creating reinterpreted sense of “enclosed” Parade Ground (View from Parade Ground)

37. **Permanent Canopy** – HdM aspires to use a permanent canopy to create a holistic zone unifying the Block 4 site with its neighbours. The concept design began with a general site analysis, studying the CPS Compound and elevation of Block 4 on Arbuthnot Road and from the Parade Ground (Figure 47). Based on this topography, a simple canopy having a near-rectangular plan shape, oversailing the Block 4's original U-shape footprint including the long-demolished Servants' Wing is proposed (Figure 48), with aims to provide primary weather protection of the remains of Block 4 and shading of the open space, and as a whole unifying Block 4 with the adjacent blocks (Figure 49) and the Parade Ground.

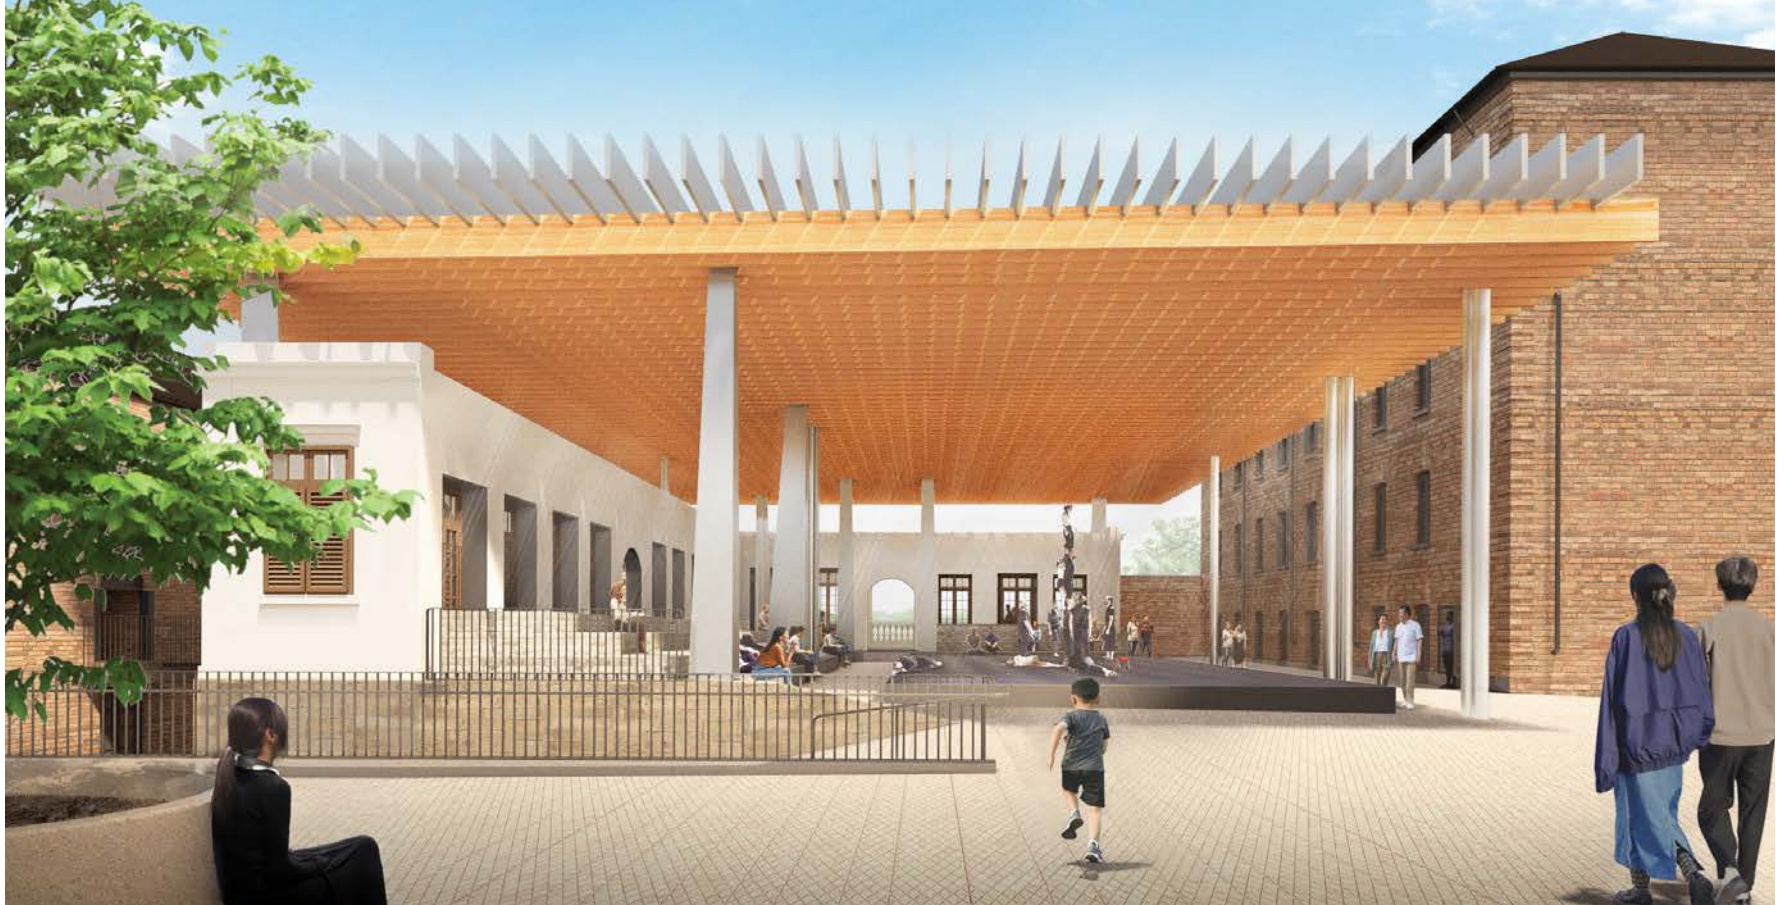
Figure 51 – Use of salvaged materials (salvaged bricks and granite blocks) from CPS Compound, repurposed to create seating, preserving tangible connection to building's past

42. Under the new setting, suitable salvaged materials from the site are proposed to be repurposed to create seating areas in the form of a stepped terrace, preserving a tangible connection to the building's past. To enable the G/F room layout for reinterpretation, the brick walls of the rooms are proposed to be taken down to align with the stepped terrace profile, i.e., the portion of the brick walls below the terrace profile and the foundations will be retained where it is feasible. As such, the G/F room layout can be seen and thus remain tangible (Figure 51). The activities under the heritage permanent exhibition will be carried out in this newly reconfigured open space (Figure 52).

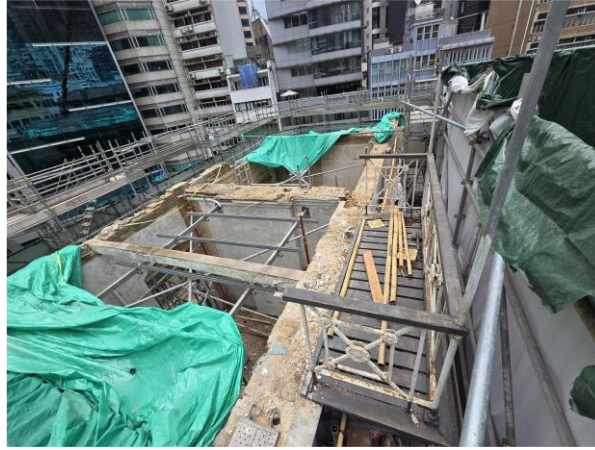
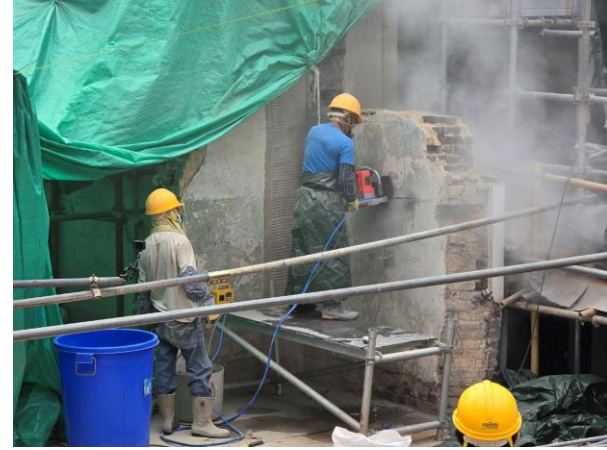
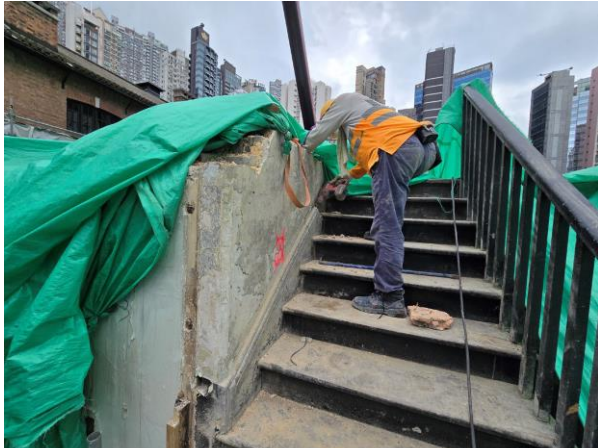
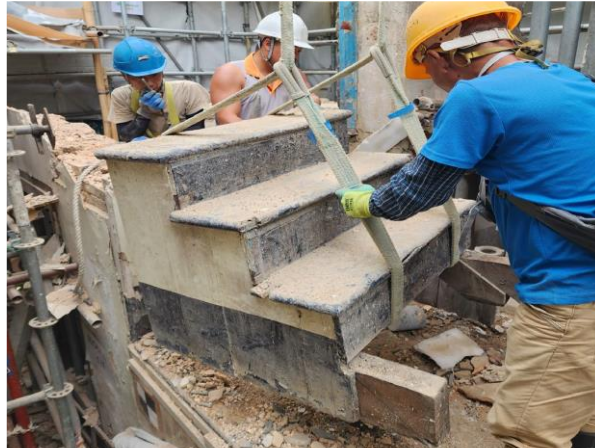
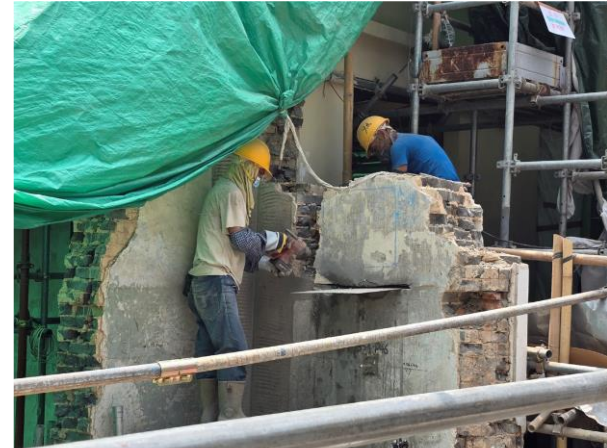
Figure 58 – Some character defining elements salvaged during removal works for potential reuse or reinterpretation

45. **Character Defining Elements** – The CDEs of Block 4 have been fully cataloged by Purcell and submitted to the AMO before the removal works. The partial collapse of Block 4 in 2016 caused a substantial loss of the CDEs and the recent removal of the unsafe building fabric at the roof, 2/F and 1/F has inevitably resulted in further loss. Notable remaining CDEs include the external balcony, timber floor joists, brick internal walls and plaster finishes, and staircases (Figure 58). Regarding other CDEs such as bottle balustrades, granite balustrade copings, and plinths on the verandahs, they will be reinstated if they cannot be preserved in-situ. For joinery items such as floorboards, panelled doors, architraves, skirtings, timber staircases, etc., preserving in-situ or reinstatement appears not practicable owing to a change in environmental condition, i.e., some items that were originally internal would effectively become external and therefore exposed to the weather, albeit sheltered by the new canopy. For other salvaged materials, their future use could be for reinstatement if feasible; and / or interpretation as art pieces or reference materials. Further review of this will be conducted in subsequent design stages.

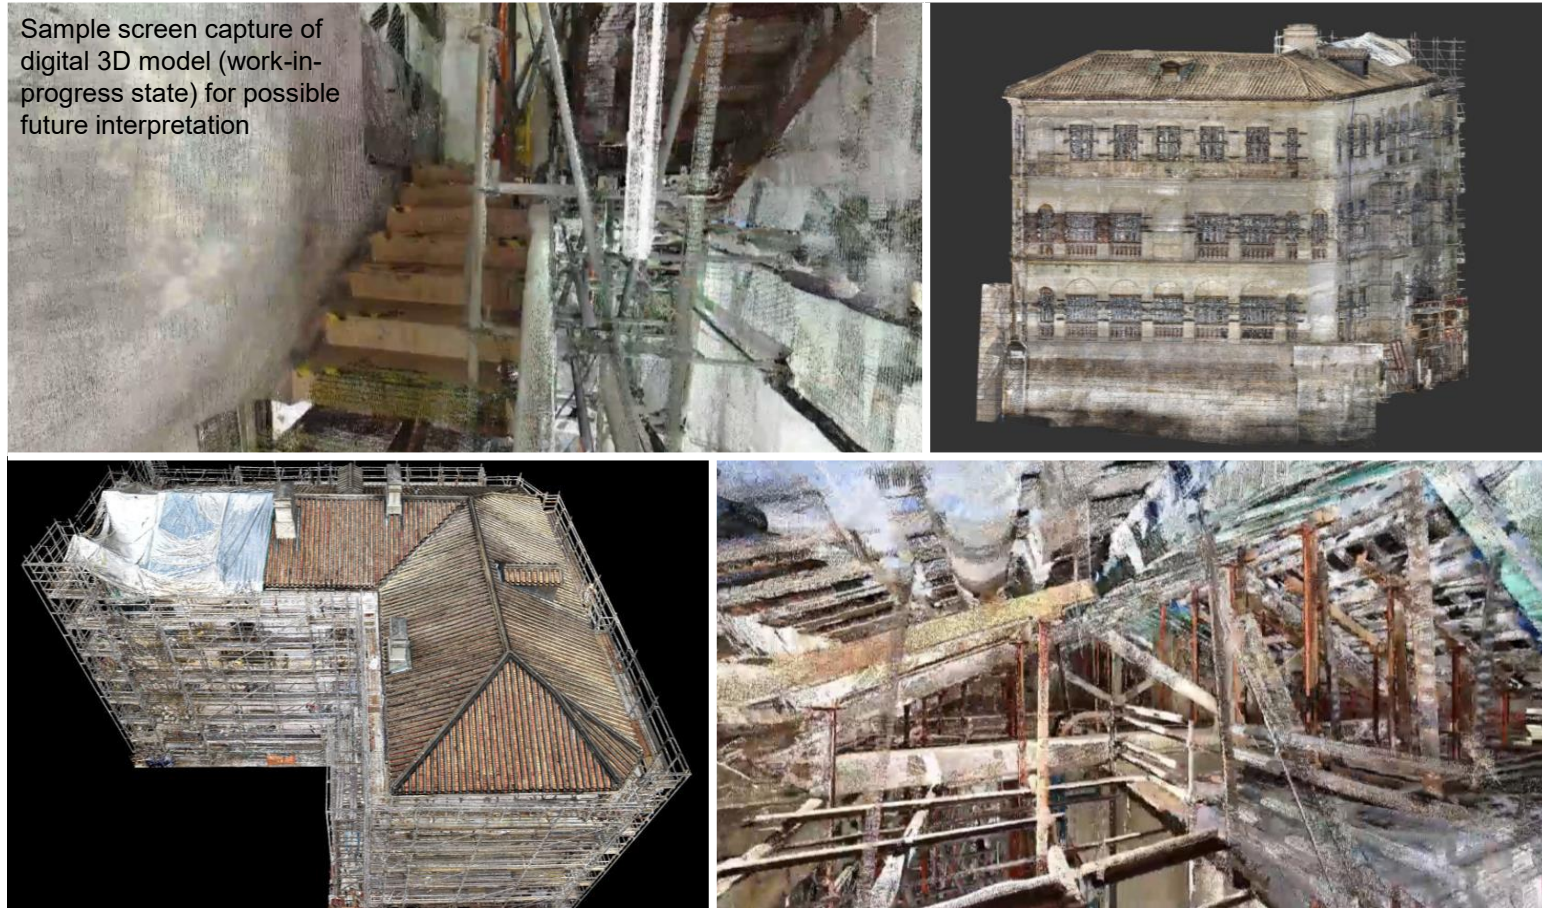
Figure 59 – Sample screen captures of digital 3D model of Block 4 for record and future interpretation

49. As briefly explained in the heritage permanent exhibition ([paragraph 24](#)), the historical narrative of Block 4 will be preserved in various forms, including a digital 3D model for future interpretation (some sample screen captures of the model in a work-in-progress state are shown in [Figure 59](#)), and comprehensive documentation of the navigation process of change and transformation of Block 4 as a declared monument, which will no doubt serve as an informative case study in heritage conservation in Hong Kong.
