RENOVATION OF BLOCK P IN KOWLOON HOSPITAL

HOSPITAL
AUTHORITY

Heritage Impact Assessment

June 2026

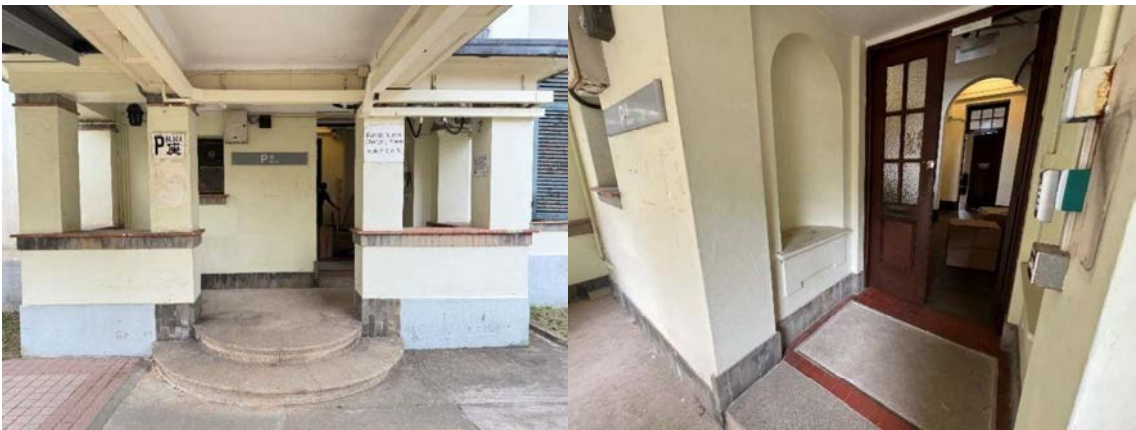
Fig 2.7.2 The entrance porch at G/F portion.

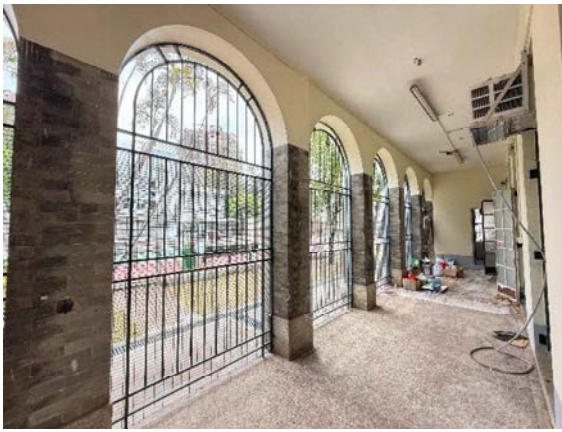
Fig 2.7.4 The open colonnade and arched verandah on G/F.

G/F verandah is supported by jointless grey gauged brick columns (See Fig 2.7.4). Open colonnaded and arcaded verandahs adorn the east and south elevations on both ground and first floors, offering ventilation and shading in Hong Kong's humid climate while enhancing the building's elegance (See Fig 2.7.5).

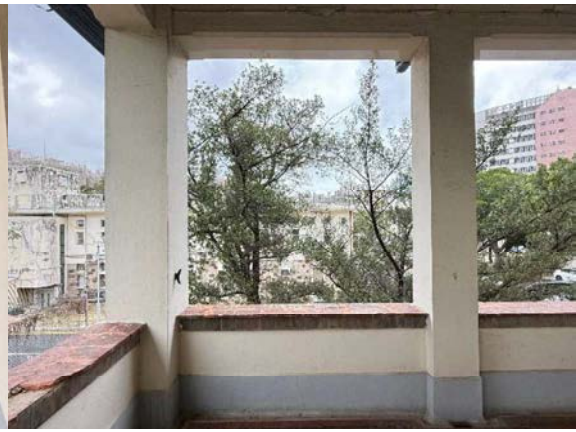
Fig 2.7.5 The open colonnade and arched verandah on 1/F.

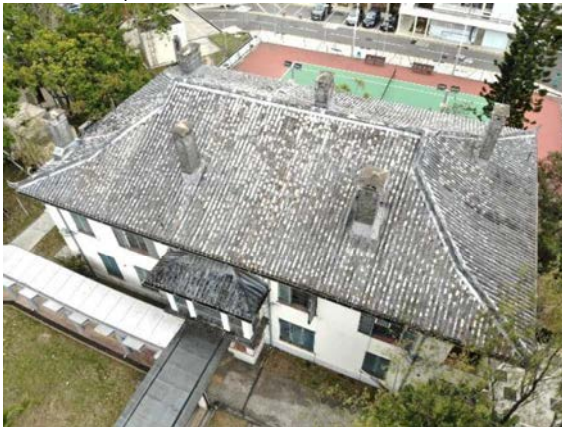
The building's most striking feature is its Chinese tiled hip-and-gable roof (歇山頂, adorned with "cow's horn" curling ends at the ridges and corners, lending a distinctive Oriental aesthetic (See Fig 2.7.6 & 7). The roof is supported by timber trusses and purlins, with tiles laid in a double-roll-double-pan style (雙筒雙瓦), a hallmark of colonial architecture in Hong Kong. Rafters rest on the purlins beneath the tiles (See 2.7.8 & 9).

Fig 2.7.6 The Chinese tiled hip-and-gable roof.

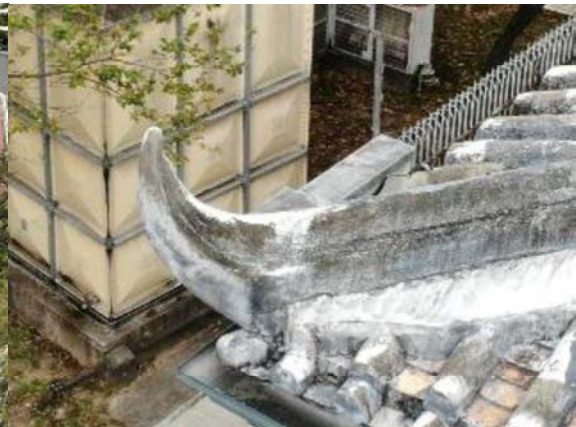
Fig 2.7.7 The "cow's horn" curling end.

The "cow's horn" design, a unique curling ridge end on the Chinese tiled roofs of all Kowloon Hospital blocks, including Block P, is a rare feature in Hong Kong, found only at the Lady Ho Tung Welfare Centre (何東夫人醫局) in Sheung Shui Kwu Tung (上水古洞) (See Fig 2.7.19 & 20). Despite its distinctiveness, the design's origin remains unknown, as it does not align with any established architectural style, making it a mysterious yet significant element of the hospital's 1920s heritage.

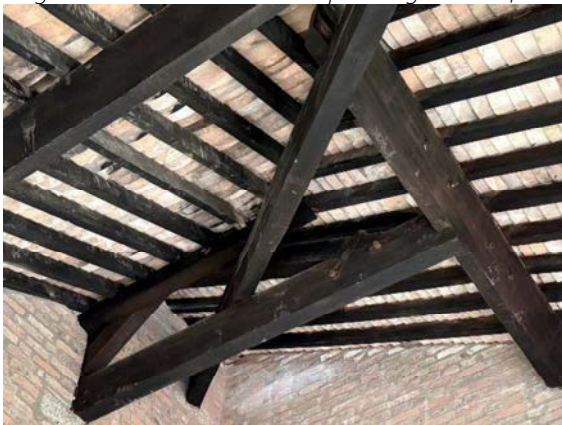
Fig 2.7.8 Trusses and purlins as roof structure.

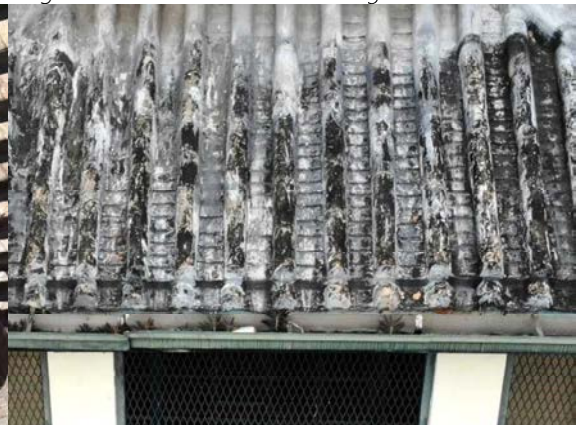
Fig 2.7.9 The roof tiles laid in a double-roll-double-pan style.

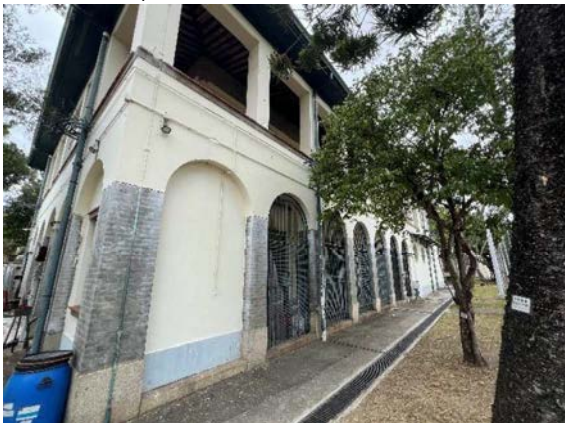
The external walls are rendered and painted in a cream finish, accentuated by jointless grey gauged brickwork (絲縫磚) used for verandah columns, window trims (See Fig 2.7.10 & 11).

Fig 2.7.10 External walls are painted in a cream finish and jointless grey gauged brick verandah column on G/F.

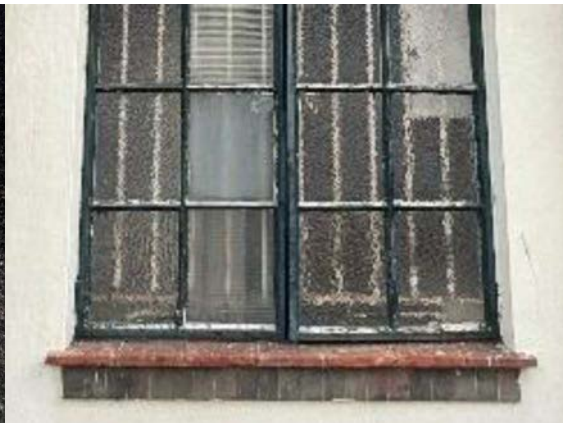
Fig 2.7.11 Jointless grey gauged brick window trims.

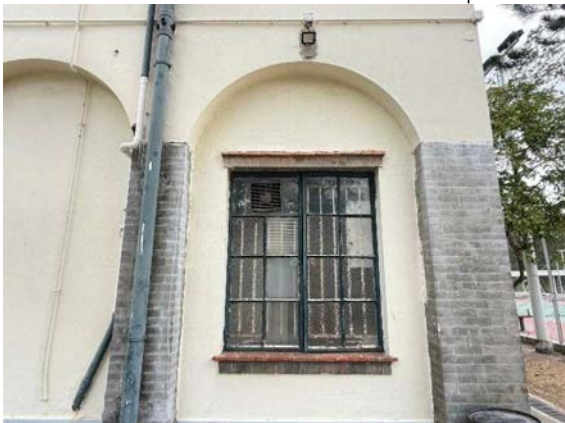
Crittall windows, painted dark green and divided into small panes, and shutter windows enhance the design, ensuring ample light and ventilation (See Fig 2.7.12 & 13). Distinctive elements, including three circular porthole windows, and six chimney stacks, further define Block P's unique architectural character (See Fig 2.7.14 & 15).

Fig 2.7.12 Crittall window.

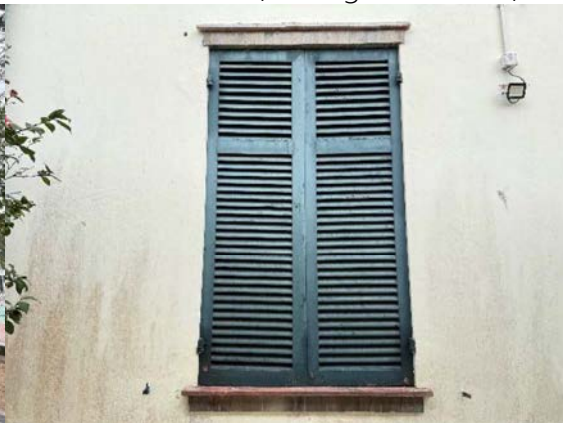
Fig 2.7.13 Shutter window.

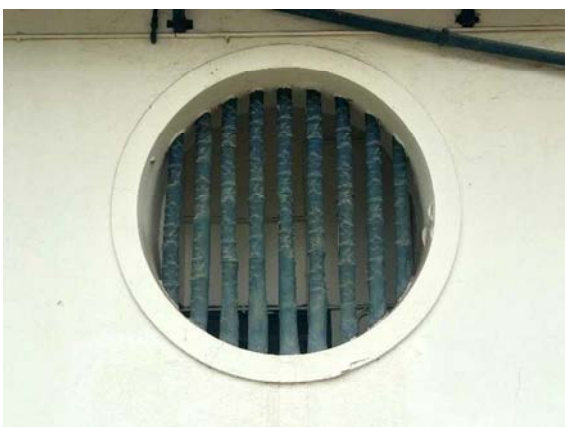
Fig 2.7.14 The circular porthole window.

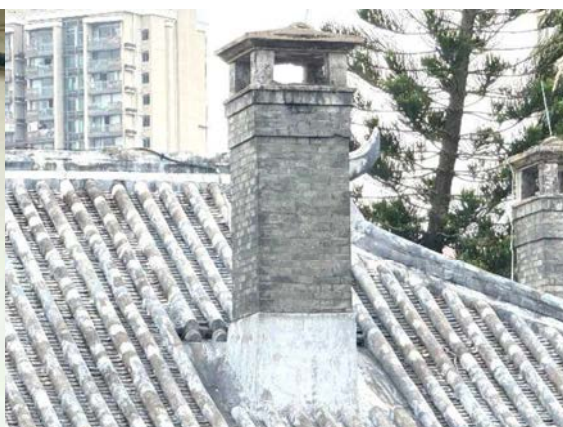
Fig 2.7.15 The chimney stack.

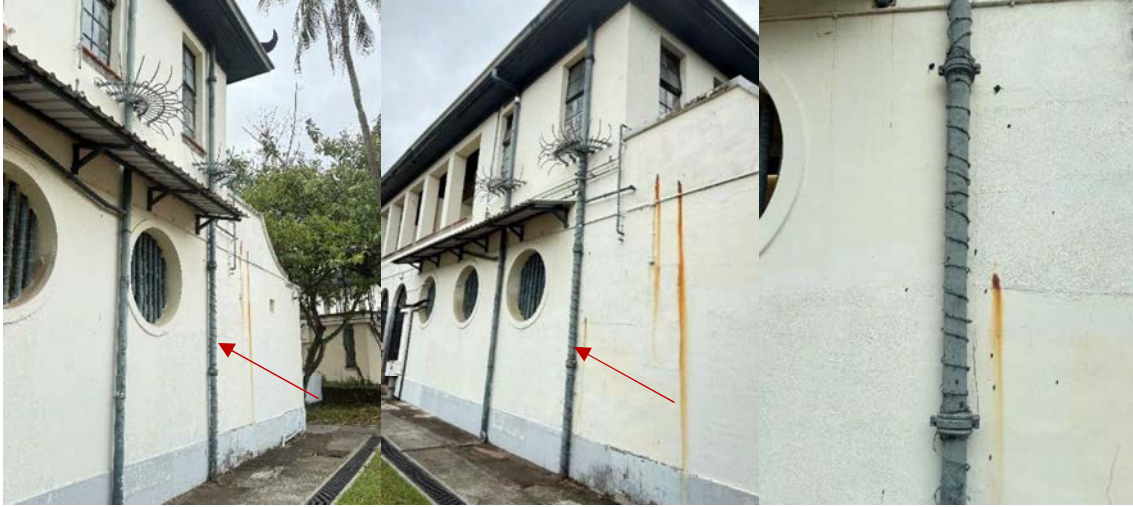
Fig 2.7.16 to 18 The only remaining cast iron rainwater downpipe at Block P.

Exposed rainwater downpipes ensure efficient drainage while contributing decorative flair to Block P. However, only one cast iron downpipe, believed to be original, remains (See 2.7.16 to 18). All other downpipes have been replaced with PVC types.

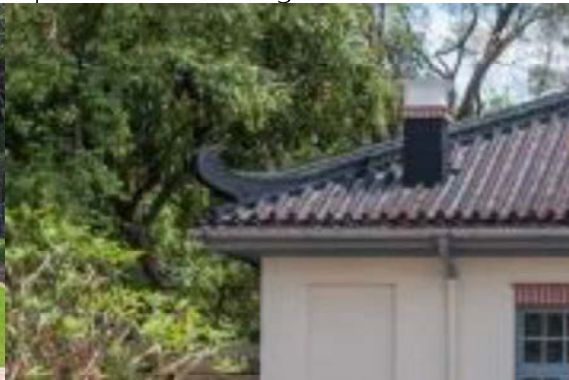
Fig 2.7.20 Cow's Horn at the ridge end.

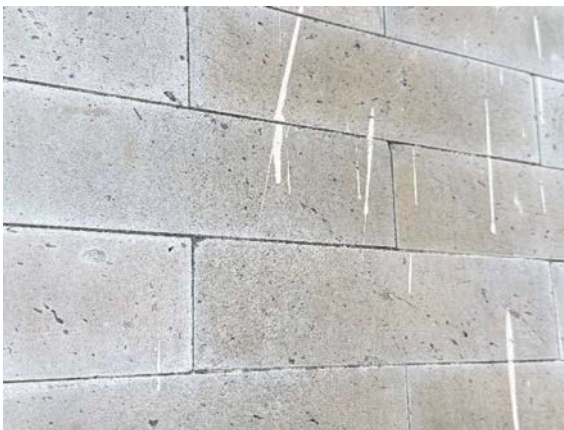
The jointless grey gauged brickwork at Kowloon Hospital, adorning all blocks including Block P, is a rare feature in Hong Kong, characterized by its precise 1-2mm joints that demand high-quality bricks and exceptional craftsmanship, a technique typically seen in wealthy residences in China (See Fig 2.7.21). This distinctive brickwork, shared only with the Main Hall Building of Kwong Wah Hospital (now Tung Wah Museum) (See Fig 2.7.22) among Hong Kong's heritage buildings, enhances the hospital's 1920s architectural significance, reflecting a level of artistry and material excellence uncommon in the region.

Fig 2.7.21 Jointless grey gauged brickwork at Block P Kowloon Hospital

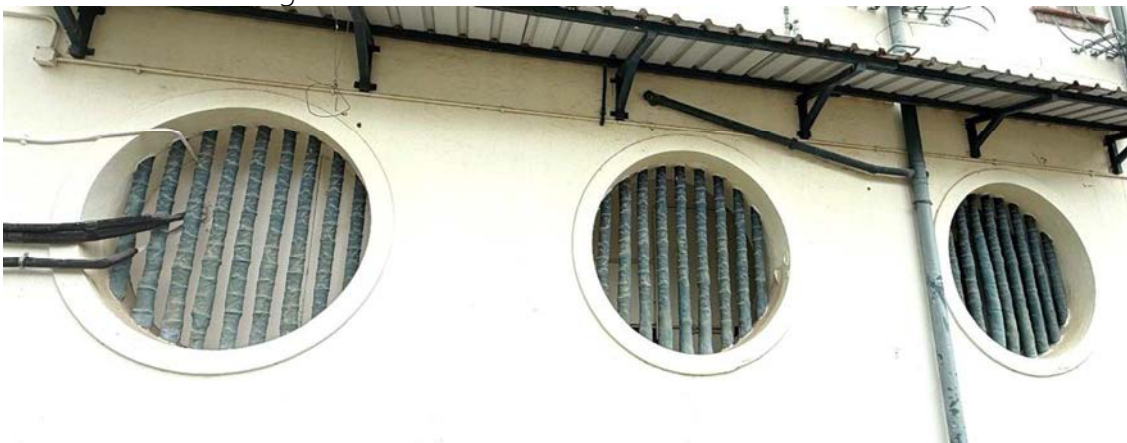
The Circular Porthole with Circular Grilles at Block P is a distinctive and rare feature within Kowloon Hospital, unique to this block, showcasing ceramic tube grilles in a bamboo pattern that were originally a fresh green colour but are now painted a darker leaf green. (See Fig 2.7.23 & 24) This special design, not commonly seen, enhances Block P's 1920s architectural character, adding a vibrant and intricate aesthetic element exclusive to its heritage.

Fig 2.7.23 The overall view of Circular Porthole with Ceramic Circular Grilles

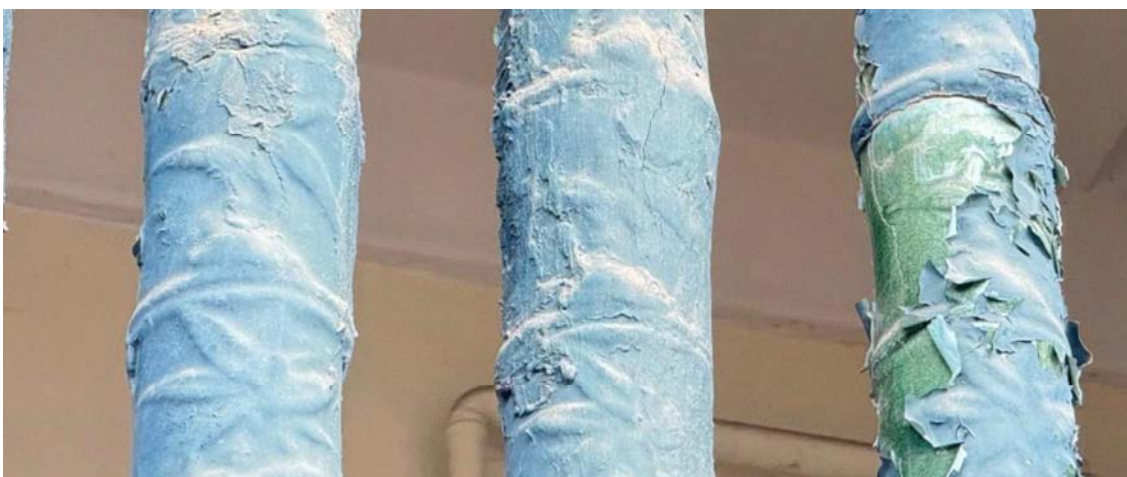
Fig 2.7.24 The close-up view of Circular Porthole with Ceramic Circular Grilles

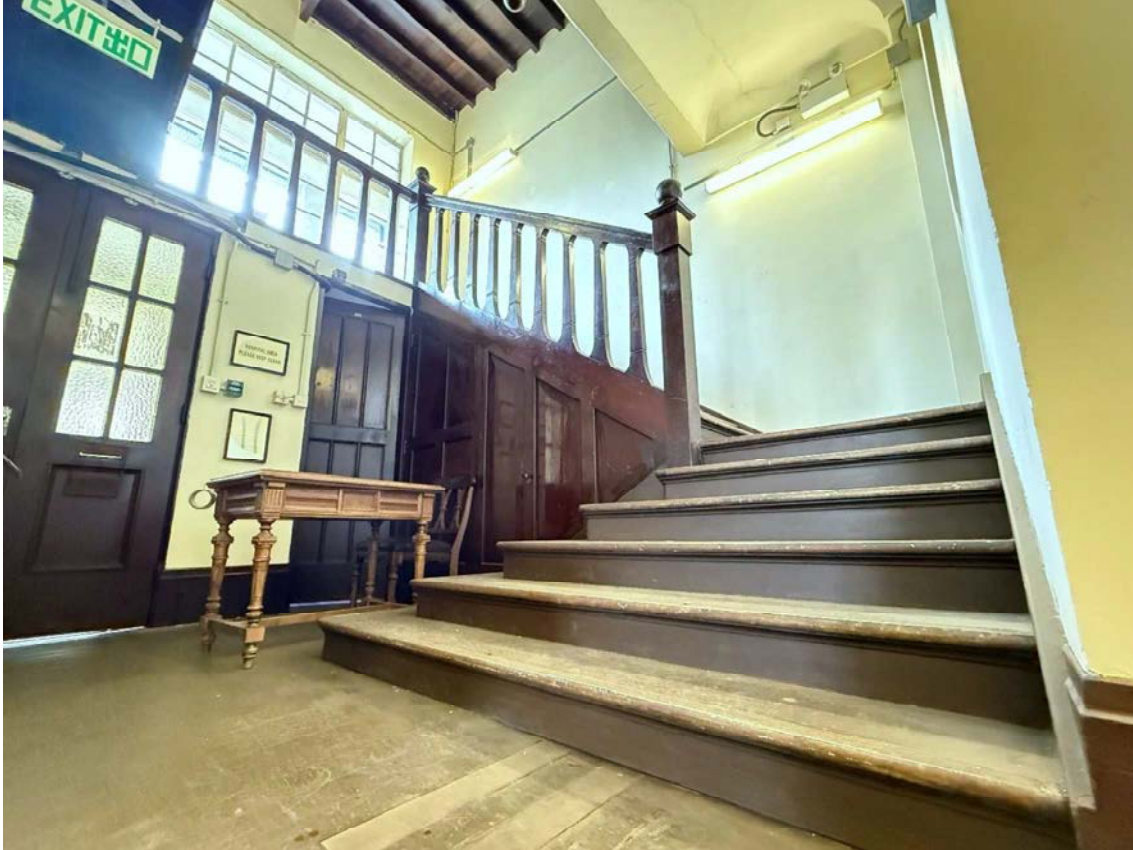
Internally, Block P is designed to a symmetrical plan with a central corridor serving as the primary circulation spine on both floors, ensuring efficient access to all functional spaces. The main entrance leads to a porch and lobby, which connects to the central corridor and a centrally located main staircase, a key vertical circulation element (See Fig 2.8.1). The staircase, positioned off the lobby, is designed for durability and frequent use, reflecting the building's practical focus.

Fig 2.8.1 The main staircase.

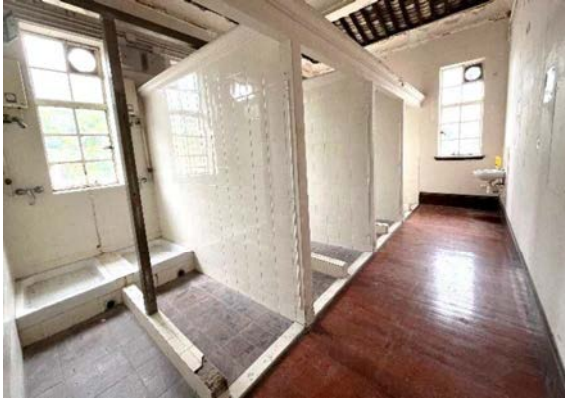
Bathrooms and toilets, located primarily at the northern end, are designed for accessibility and hygiene. The internal spaces are enhanced by steel-framed windows, which allow ample natural light and ventilation, improving comfort (see Fig. 2.8.10 & 11). Two original timber toilet cubicle doors remain in the bathroom, a rare feature. Both the doors and their ironmongery are intact and may be functional after repair (See Fig 2.8.12 & 13).

Fig 2.8.10 The view of the bathroom.

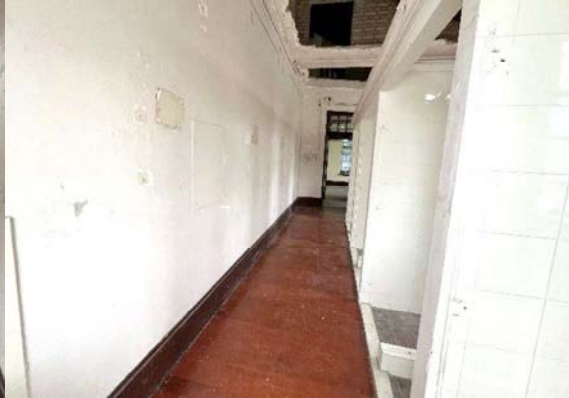
Fig 2.8.11 The view of the bathroom.

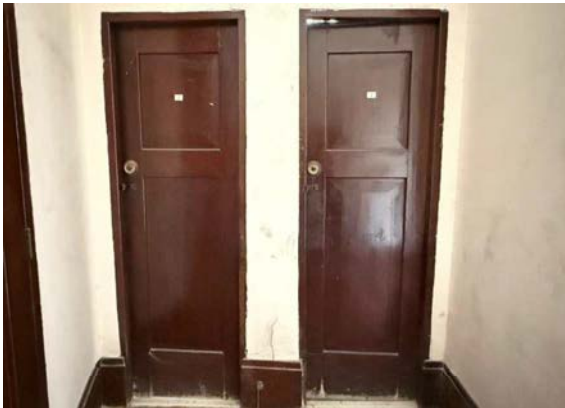
Fig 2.8.12 The original toilet cubicle doors.

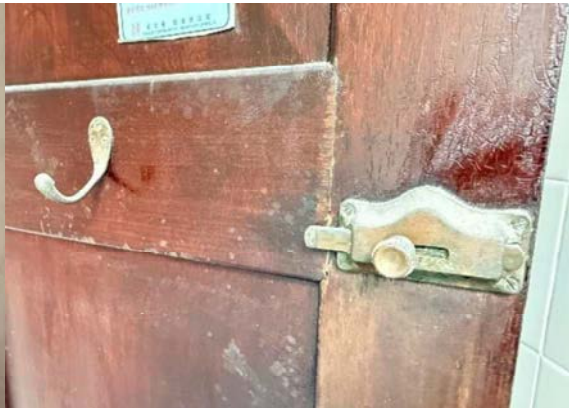
Fig 2.8.13 The ironmongeries at the door.

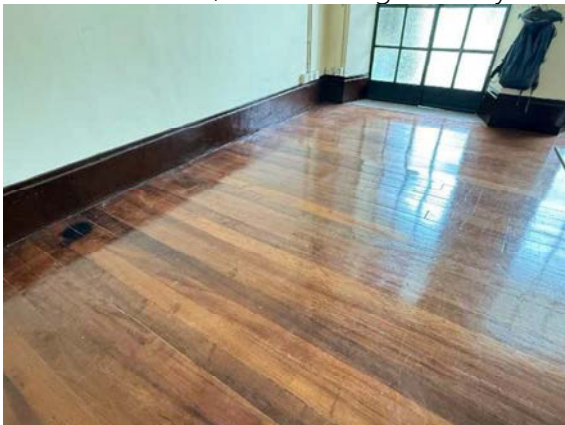
The interior of Block P retains its authentic original appearance, characterized by materials typical of 1920s institutional architecture, including plastered walls, painted surfaces, and teak or tiled flooring (See Fig 2.8.14 & 15). Minor modern adaptations, such as the addition of shelves and cabinets for its use as nurse changing and rest areas since 1991, have not significantly altered the original layout.

Fig 2.8.14 Teak floor.

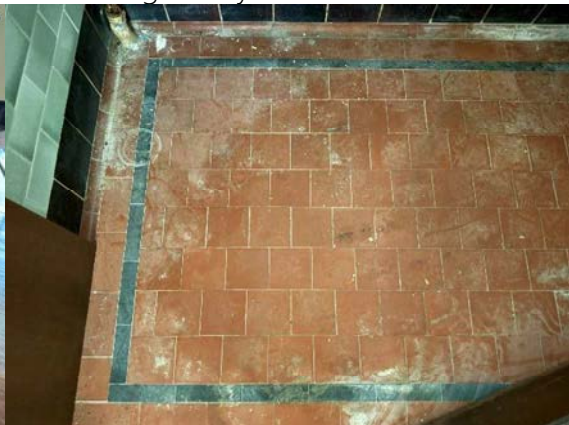
Fig 2.8.15 Tiled floor

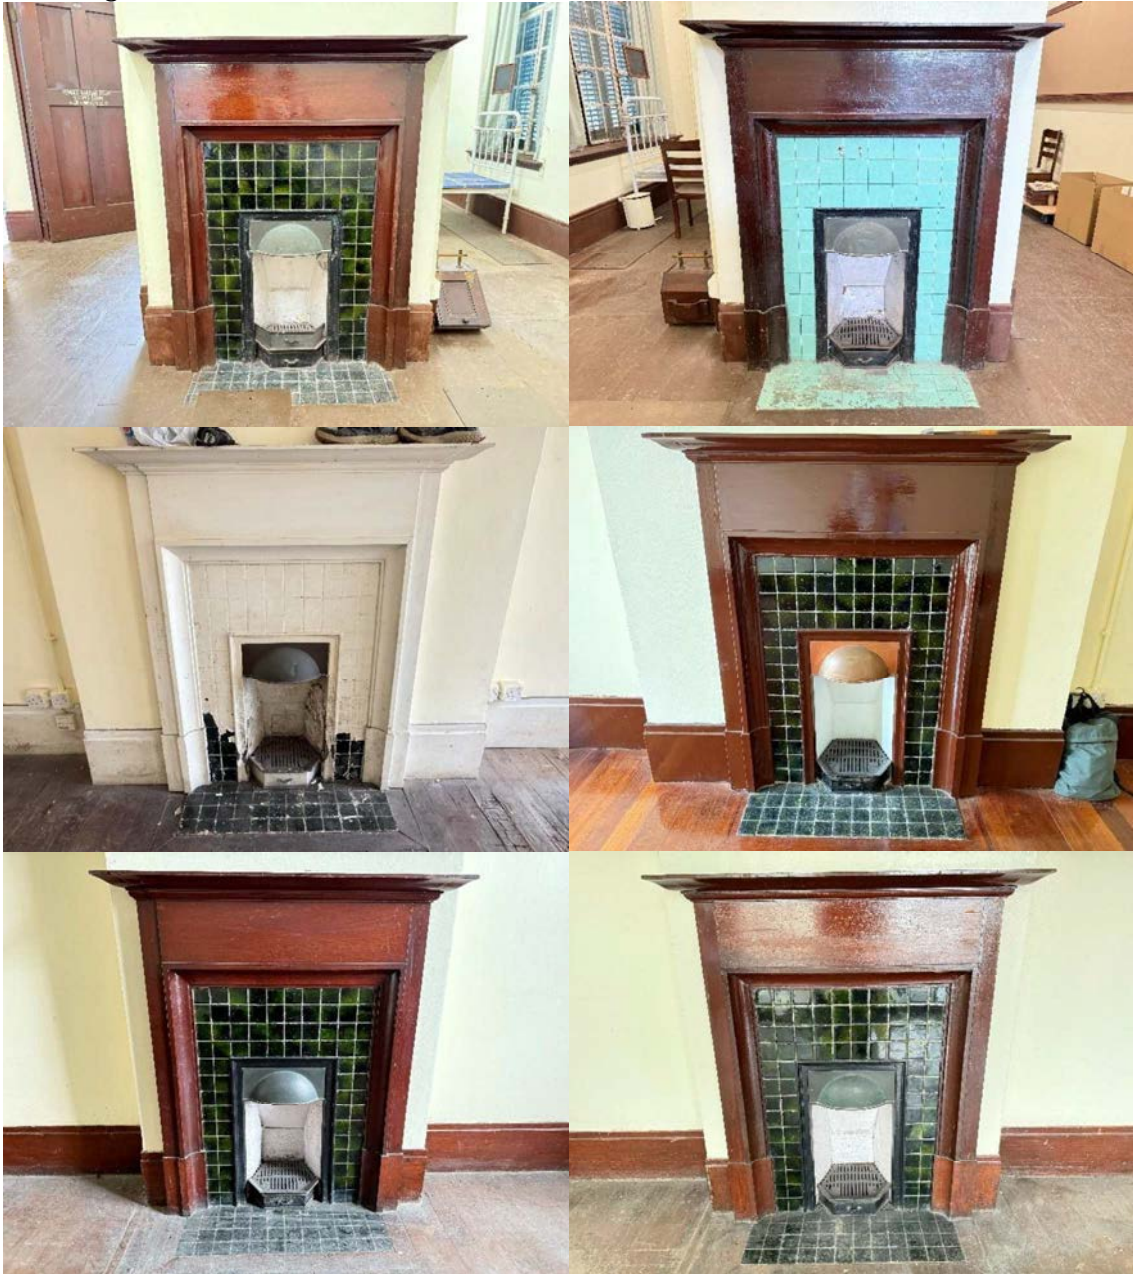
Fig 2.8.16 to 21 The general views of fireplaces (showing 6 out of 14).

There are fourteen well-preserved fireplaces in Block P, each adorned with timber surrounds and green ceramic tiles, are evocative remnants of 1920s daily life for Western residents, offering a glimpse into the warmth and domestic comfort sought by the nursing staff who lived there. These intact fireplaces, strategically placed in sitting room and bedrooms, not only served a functional role in heating the Sisters' Quarters but also reflect the architectural influence of Western design in colonial Hong Kong, enhancing Block P's historical authenticity and social significance as a rare surviving feature of that era.

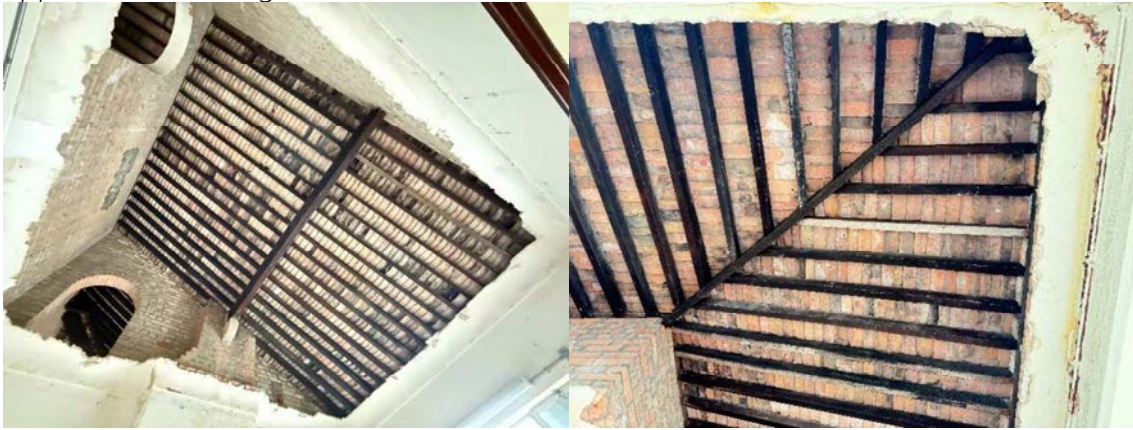
Fig 2.8.22 & 23 The original timber ceiling has been removed, leaving the roof exposed.

The timber ceiling of Block P at Kowloon Hospital, once a defining feature of its 1920s interior, has been largely removed due to severe termite damage, leaving the roof exposed (See Fig 2.8.22 & 23), with only the timber ceiling joists above the main staircase on the 1/F surviving (See Fig 2.8.24 & 25). Although the original timber ceiling at the 1/F verandah has also been lost, a record has been found to know its original appearance (See Fig 2.8.26).

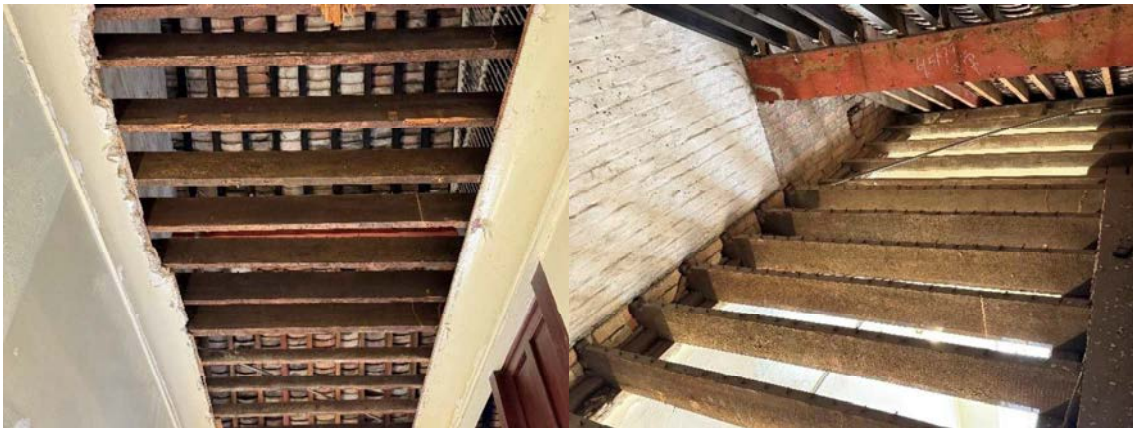
Fig 2.8.24 & 25 The surviving timber ceiling joist above the main staircase on the 1/F.

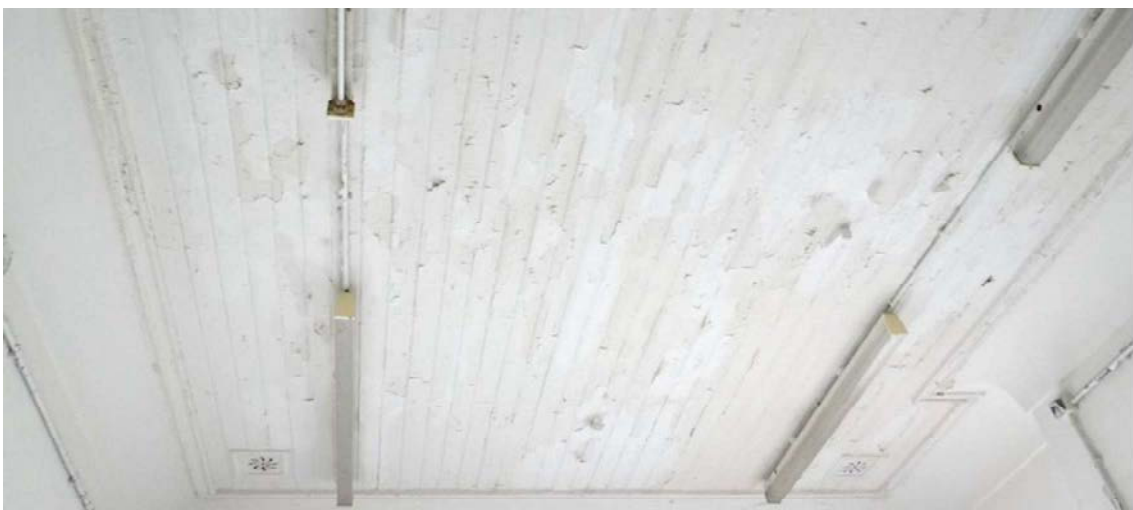
Fig 2.8.26 The original timber ceiling design.

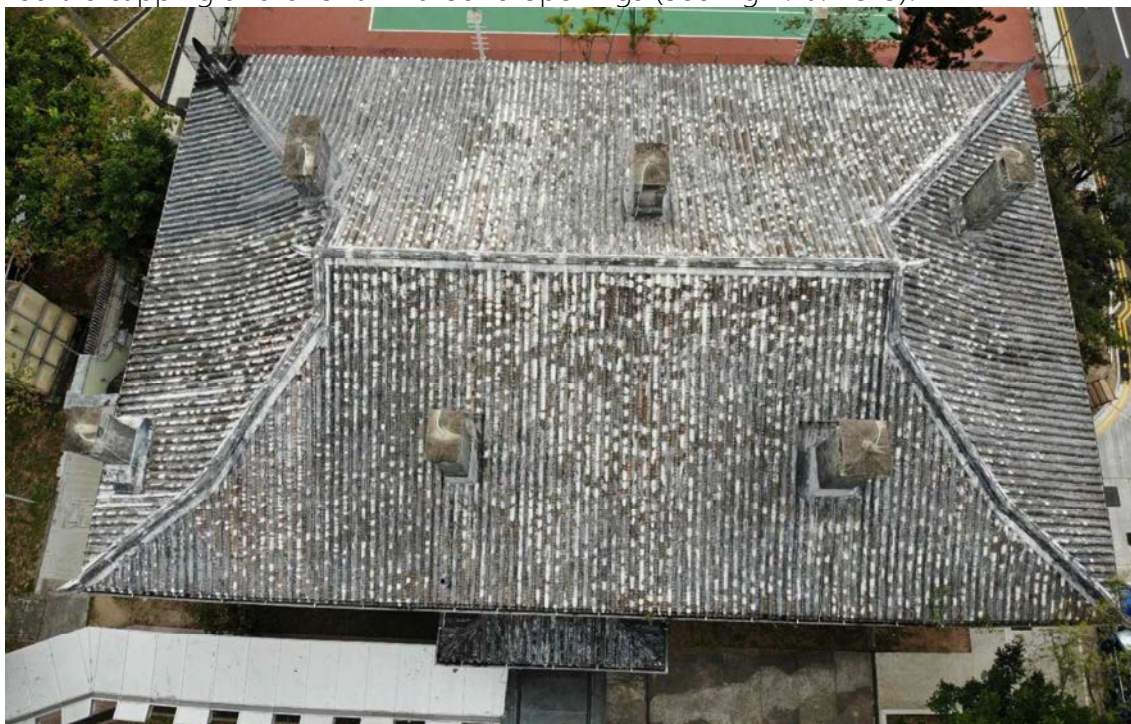
Fig.2.10.1 The roof with the multiple minor repairs and a deteriorating waterproofing membrane.

A visual inspection indicates that Block P is in satisfactory condition overall, thanks to regular maintenance and cleaning. The roof exhibits minor leaks, with evidence of multiple repairs and a deteriorating waterproofing membrane, though the timber roof structure shows no significant defects (See Fig 2.10.1). The external walls, verandahs, and windows require conservation attention, with issues including peeling paint, disintegrating seamless grey gauged brickwork on verandah columns, and cracks in red tile capping and brick trim around openings (See Fig 2.10.2 & 3).

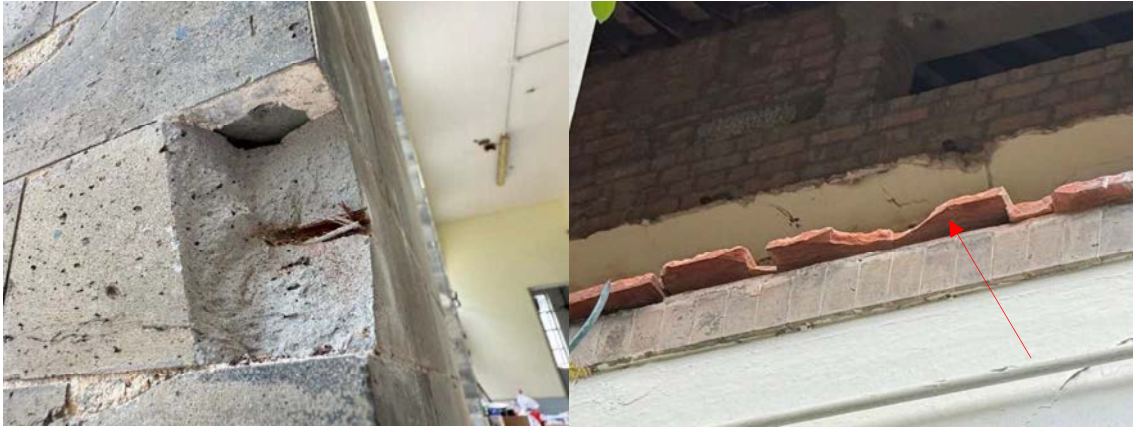
Fig 2.10.2 The broken Jointless Grey Gauged Brickwork. Fig 2.10.3 Broken of the red tile capping.

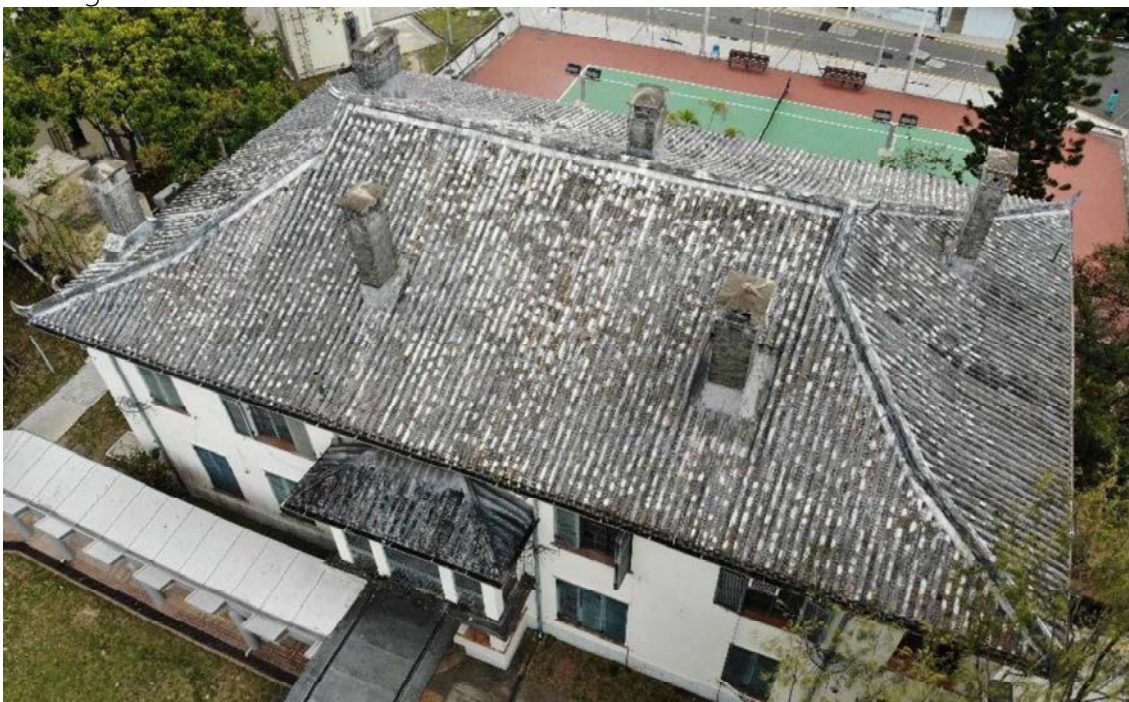
No.	Elements	Level of Significance
AR01	Chinese Style Hip-and-Gable Roof (歇山頂)	Exceptional

It exemplifies the unique blend of Eastern and Western design influences in Block P, making it a standout feature of its 1920s construction.

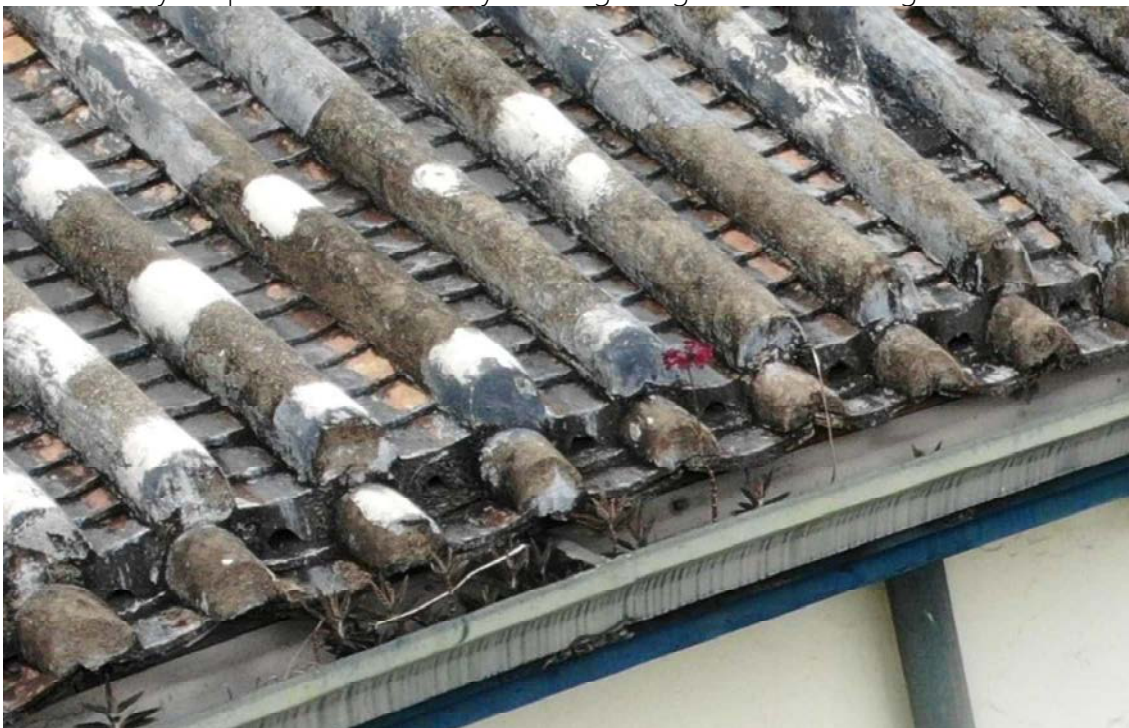
No.	Elements	Level of Significance
AR02	Double-Roll Double-Pan (雙筒雙瓦) Roof Tiling	Considerable

It reflects the roof's traditional Chinese technique, contributing to its historical authenticity despite its commonality in Hong Kong colonial buildings.

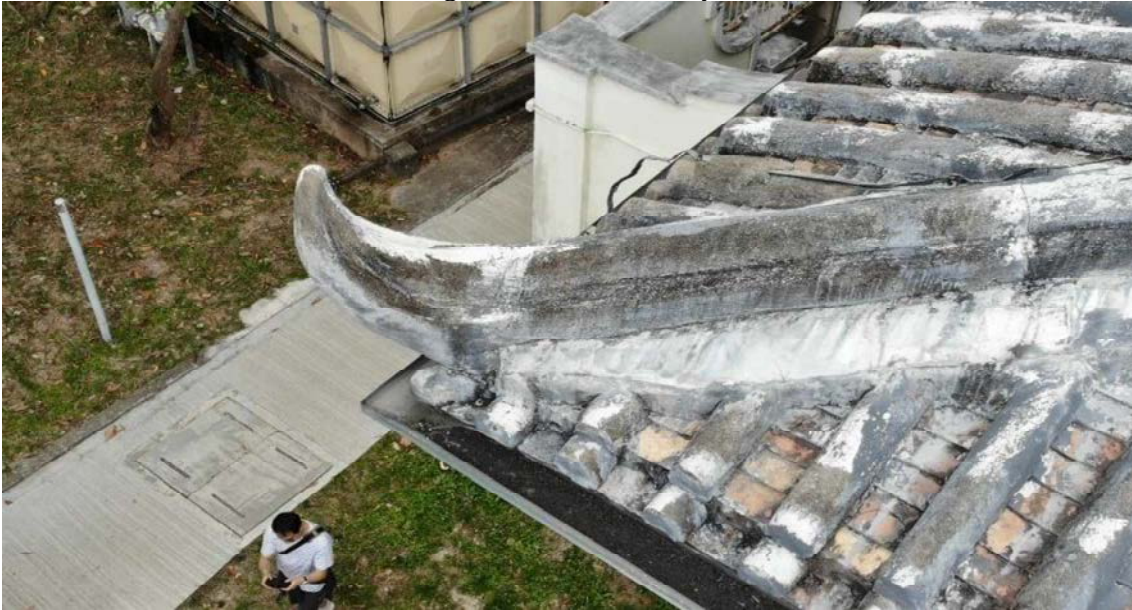
No.	Elements	Level of Significance
AR03	"Cow's Horn" Curling Ends at the Ridge and the Roof Corners	Exceptional

They represent a rare and visually striking architectural feature, unique to the Blocks in Kowloon Hospital, contributing to its cultural rarity and visual prominence.

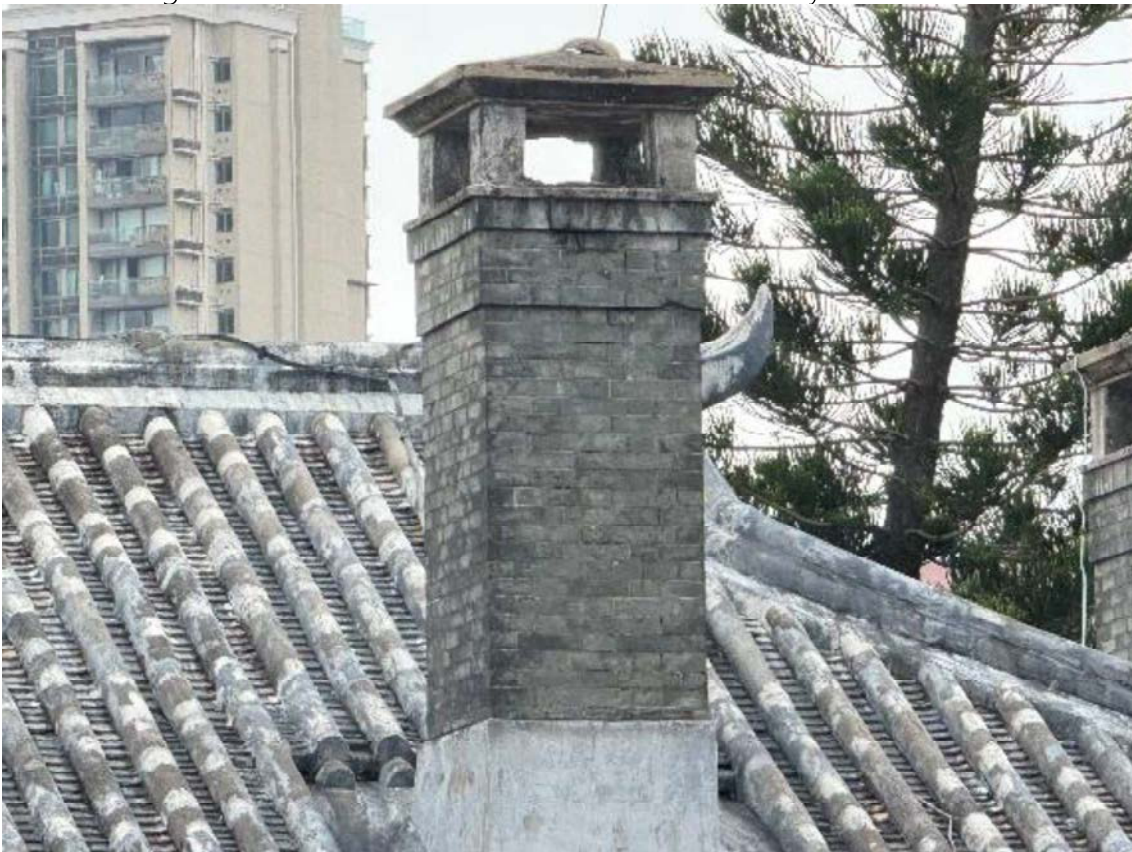
No.	Elements	Level of Significance
AR04	Chimney in Jointless Grey Gauged Brick Stack at Roof	Considerable

It reflects the functional and aesthetic design of 1920s institutional architecture, contributing to the roof's silhouette and historical authenticity as a nurses' residence.

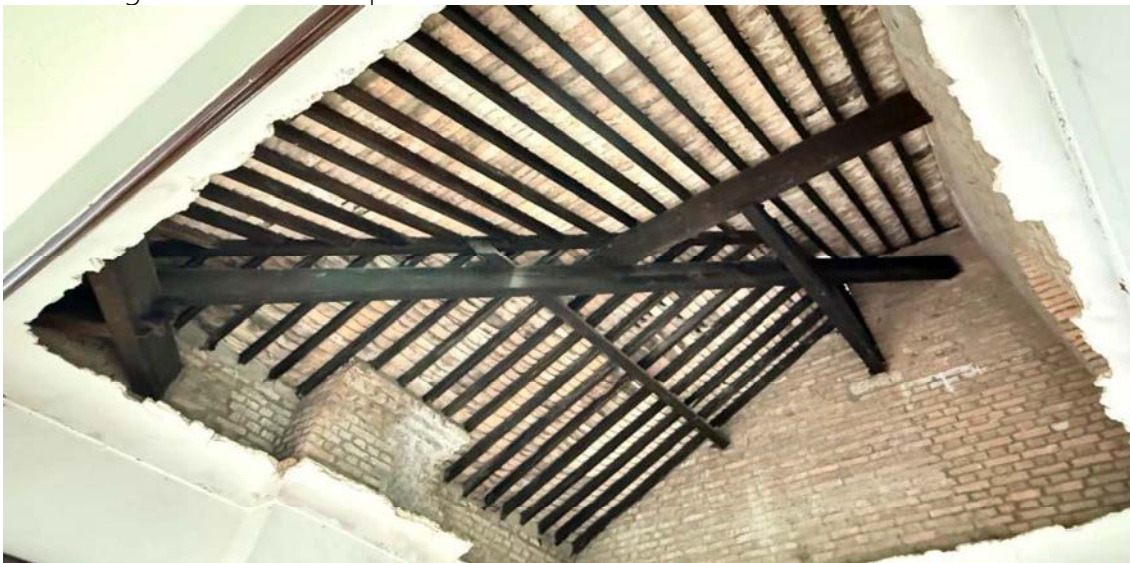
AR05	Timber Ridge-Batten-Purlin Roof Structure System	Considerable
------	--	--------------

It represents the traditional construction technique used in Block P's 1925 roof, underpinning the integrity of the Chinese tiled hipped-and-pitched roof and reflecting the craftsmanship of the era.

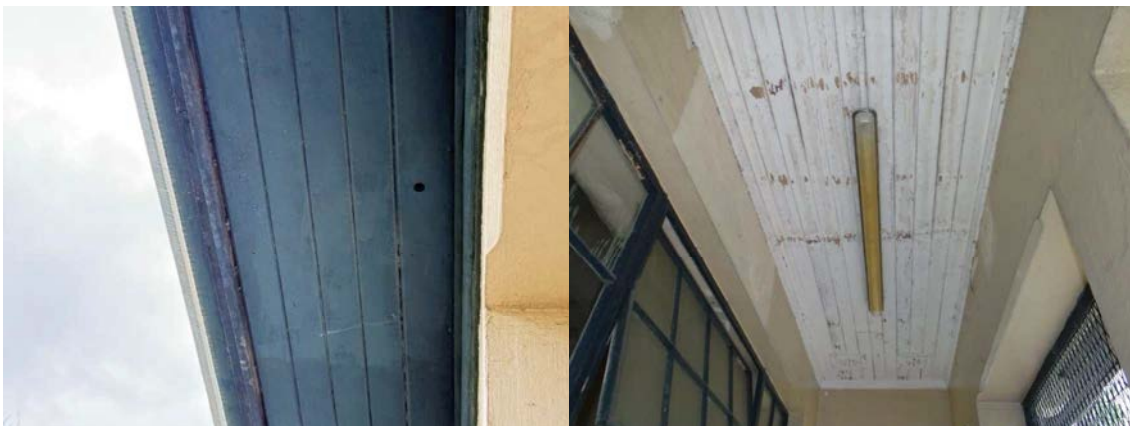
AR06	Timber Plank Ceiling under Eave & at Verandah on 1/F	Some
------	--	------

It defines Block P's 1920s roof design with their traditional craftsmanship, enhancing the roof's historical authenticity and aesthetic detail despite the timber ceiling at verandah has been removed.

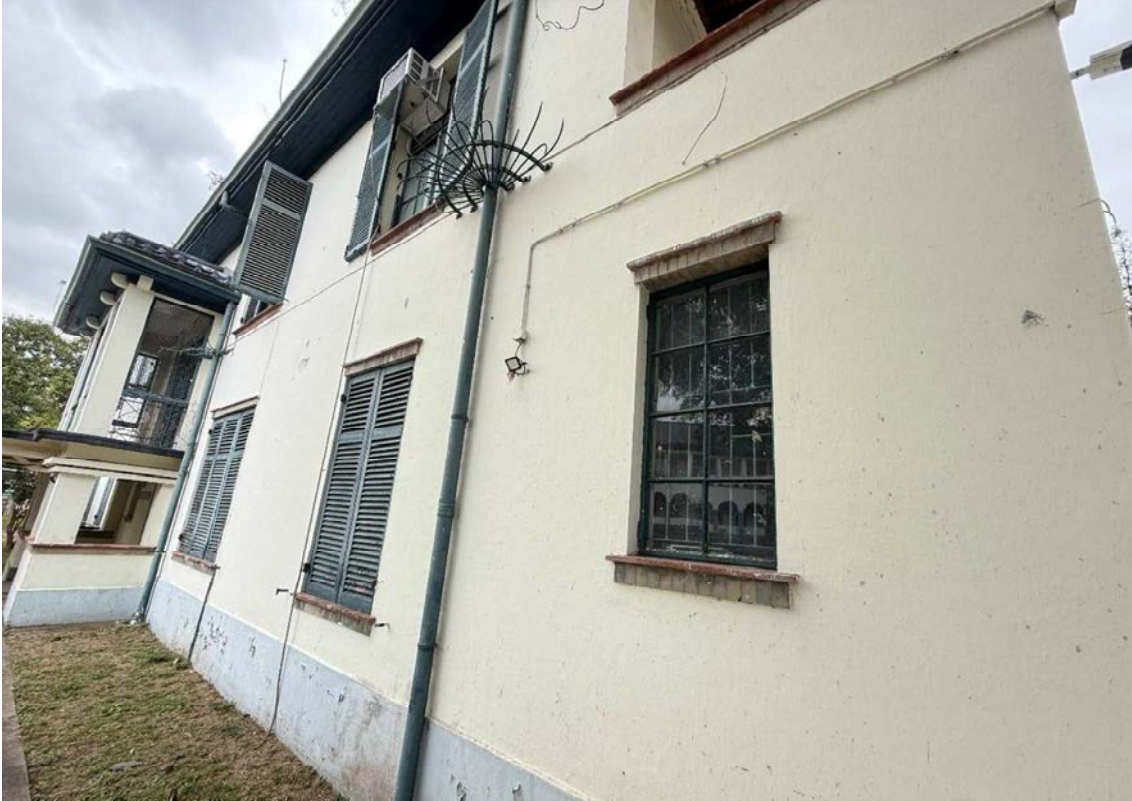
No.	Elements	Level of Significance
AR07	Rendered And Painted External Brickwork Walls Painted in Cream Colour and Grey Skirting with Jointless Grey Gauged Brick Accents at all facades	Considerable

It defines Block P's Classical Revival style with their 1920s craftsmanship, enhancing its visual identity and group value within the hospital complex.

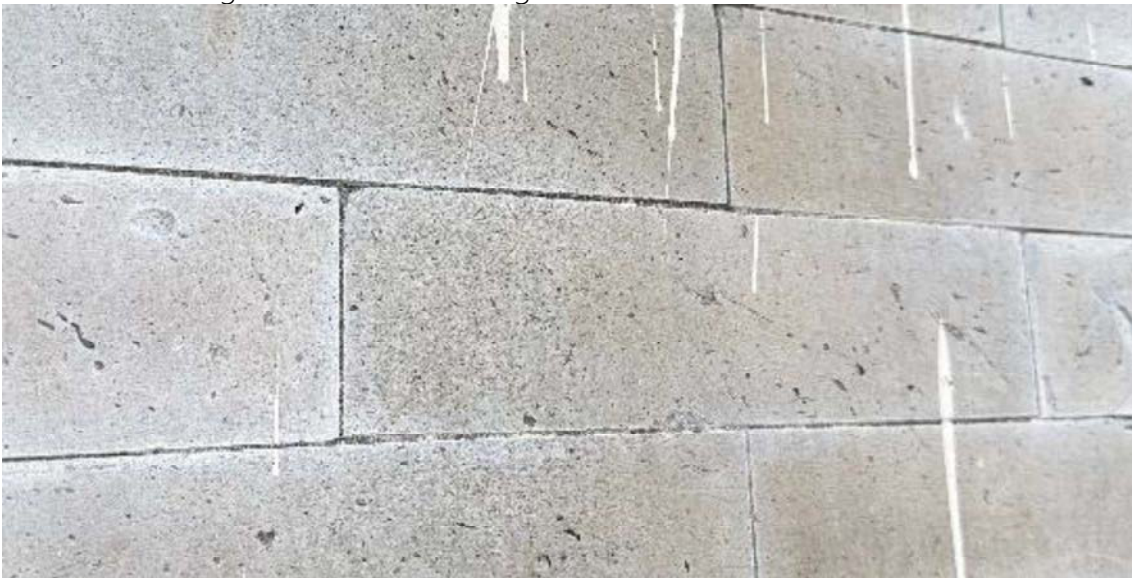
No.	Elements	Level of Significance
AR08	Jointless Grey Gauged Brickwork on the G/F verandah columns and chimneys at roof.	Exceptional

Jointless grey gauged brickwork is rare in Hong Kong. It defines Block P's Classical Revival style with Chinese influence and its rare jointless craftsmanship, enhancing its aesthetic elegance and historical significance.

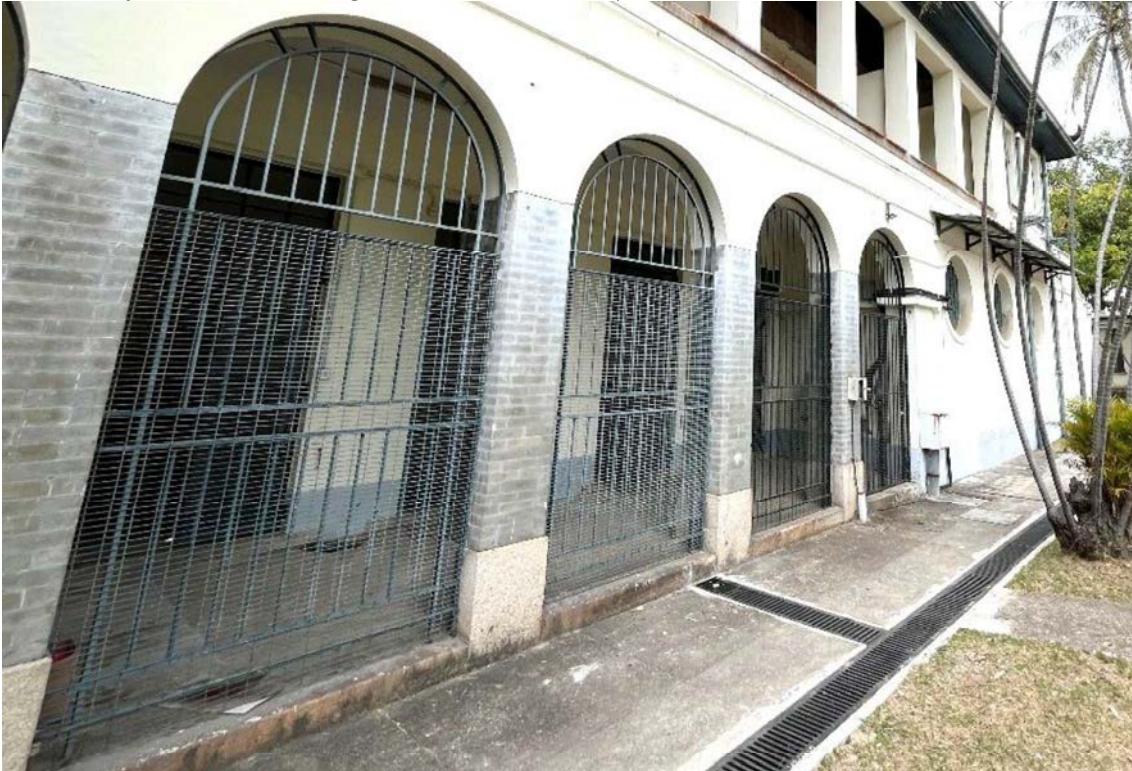
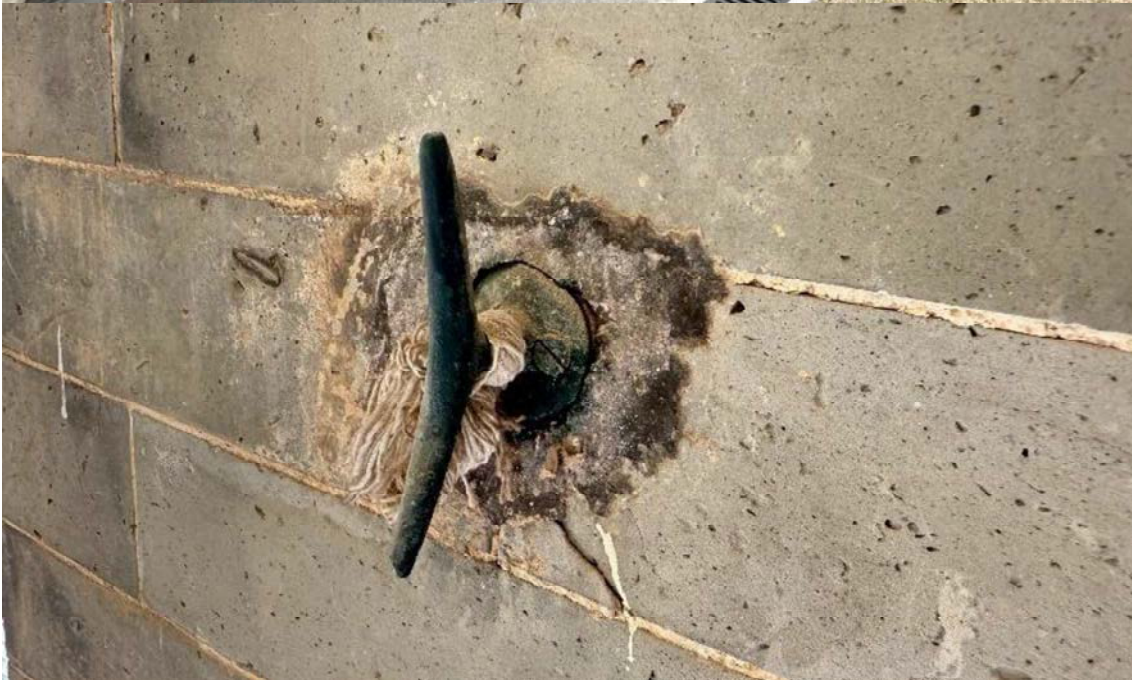
No.	Elements	Level of Significance
AR09	Arches With Grey Gauged Brickwork Column Shaft and Granite Base at the G/F Verandah at the South and East Elevation	Exceptional

It defines Block P's G/F verandah with their Classical Revival design with Chinese influence, enhancing its aesthetic elegance and historical functionality. The existing wall-mounted cleats used to wrap the control rope for curtains suggests that there were likely curtains, awnings, or shades in the past.

The wall-mounted cleats are installed on the Grey Gauged Brickwork Column, facing inward toward the verandahs.
