RENOVATION OF BLOCK P IN KOWLOON HOSPITAL

HOSPITAL
AUTHORITY

Heritage Impact Assessment

June 2026

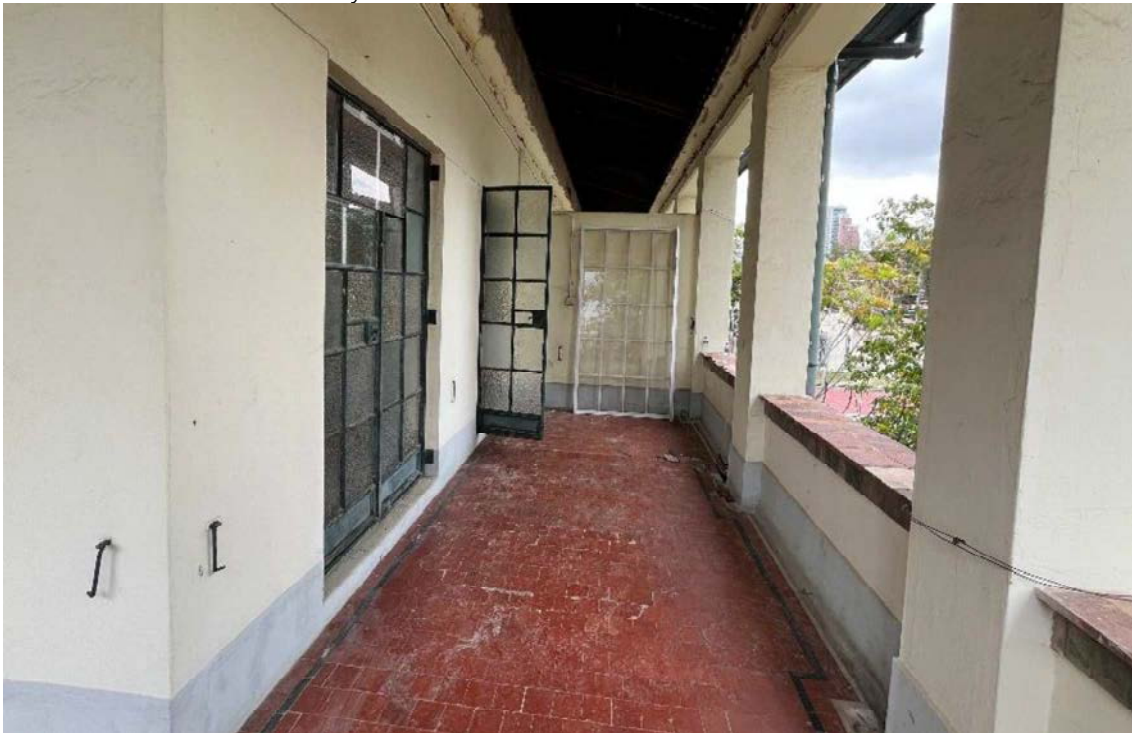
No.	Elements	Level of Significance
AR10	Verandah on the 1/F	Exceptional

It defines Block P's 1920s Classical Revival design, enhancing its aesthetic elegance and historical functionality.

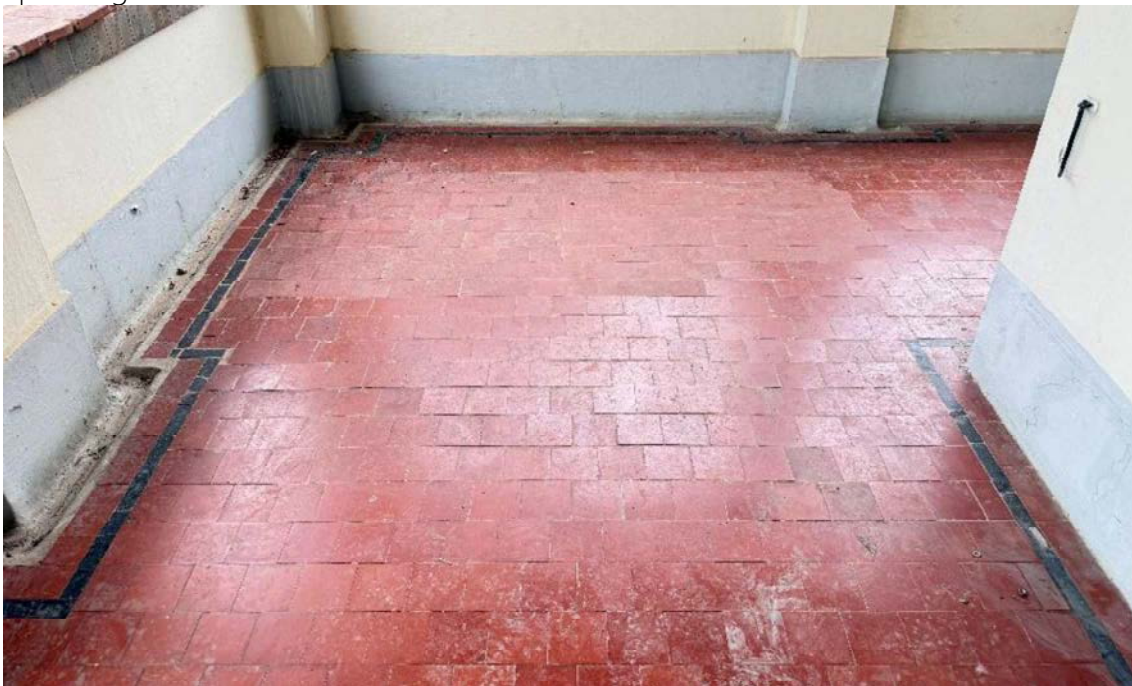
No.	Elements	Level of Significance
AR11	Red and Black Floor Tiles on 1/F Verandah	Some

It is a common feature of 1920s architecture, providing a durable and aesthetically pleasing surface.

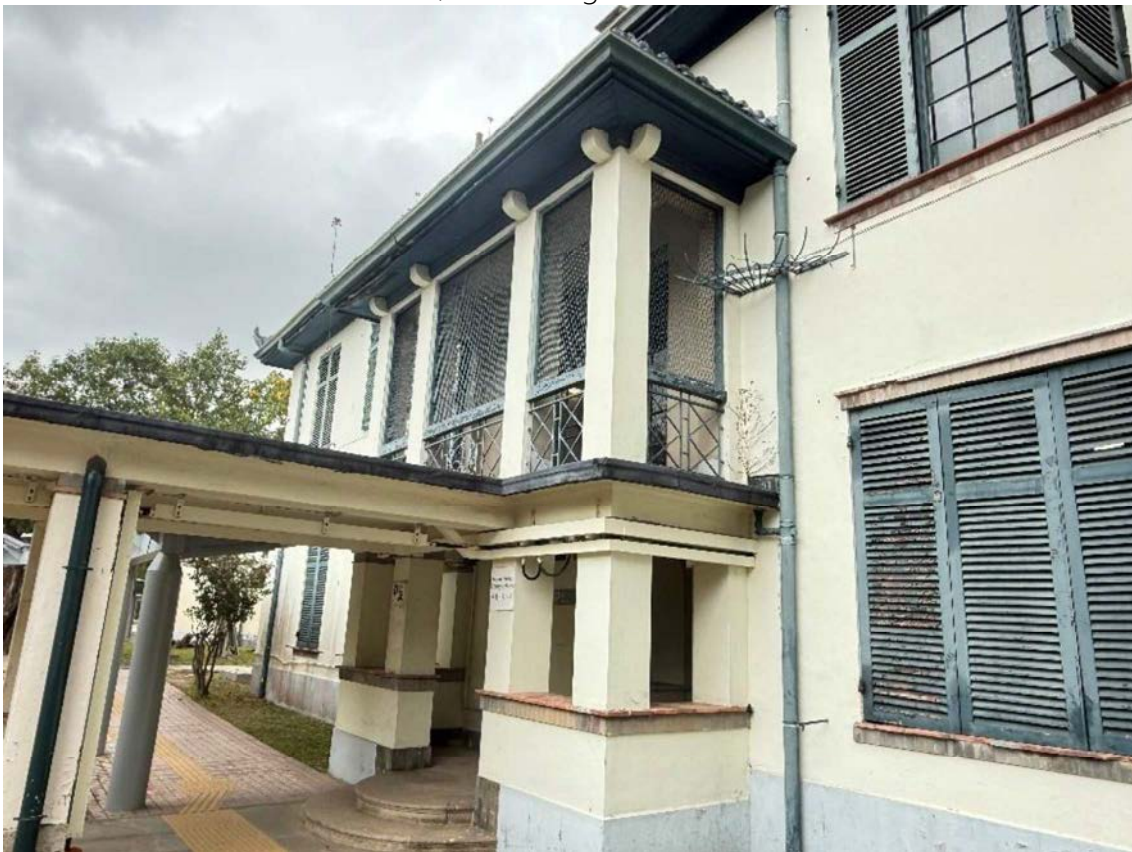
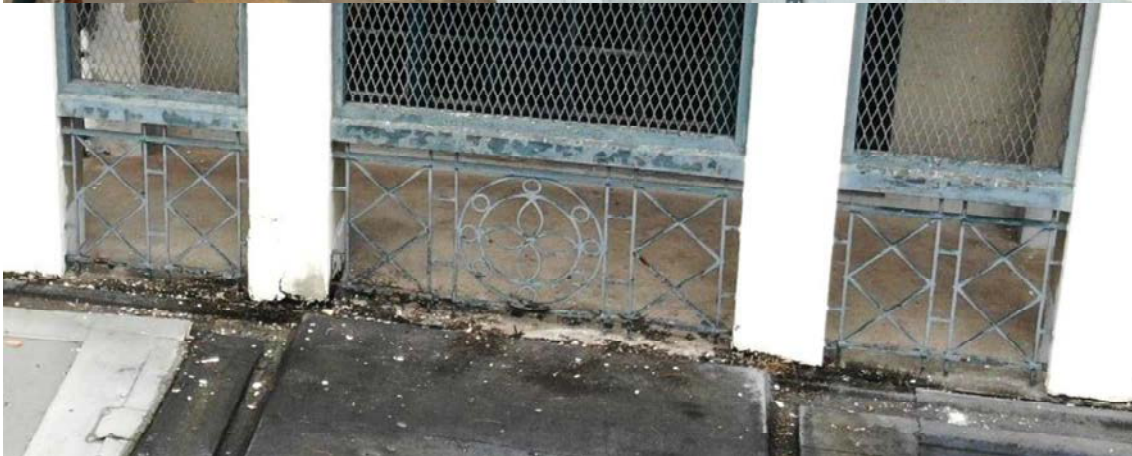
No.	Elements	Level of Significance
AR12	Entrance Porch with Square-Section Columns and Pitched Roof Supported by Brackets on the Main Facade	Considerable

It serves as the primary access point to Block P, reflecting its 1920s architectural design and functional role as Sisters' Quarters, while its square-section columns, pitched roof, and brackets contribute to its aesthetic and historical character. The decorated metal balustrade at 1/F reflecting the Arts and Crafts influence.

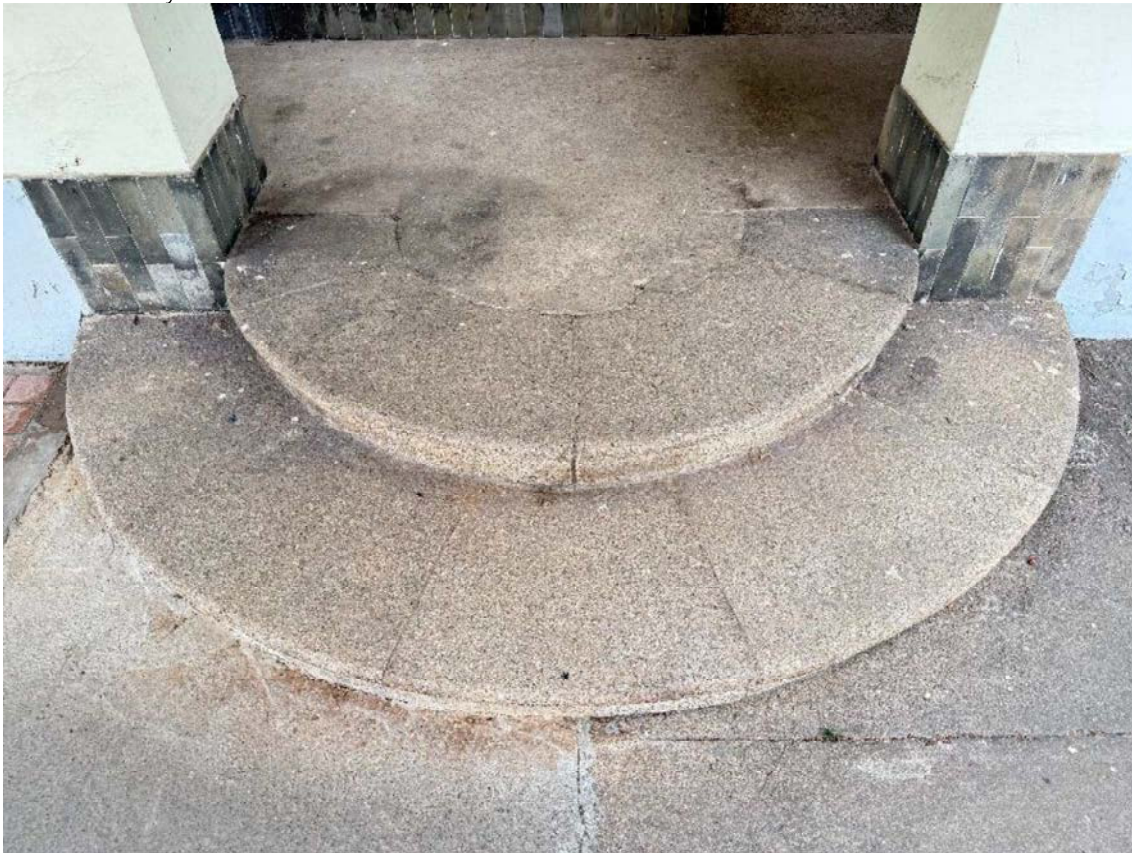
No.	Elements	Level of Significance
AR13	Fan-Shaped Stone Steps at the Main Entrance	Considerable

It marks the primary access to Block P, reflecting its 1920s architectural design and enhancing the entrance's prominence, while contributing to the building's historical functionality as Sisters' Quarters.

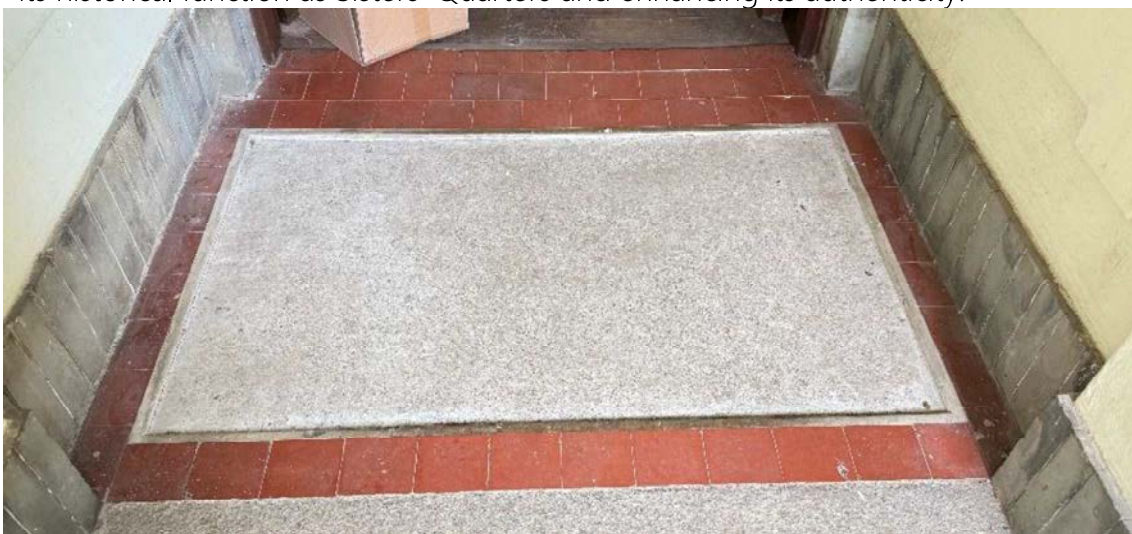
No.	Elements	Level of Significance
AR14	Mat Well / Recessed Mat Area at the Main Entrance	Some

It defines Block P's entrance with its practical 1920s design for cleanliness, reflecting its historical function as Sisters' Quarters and enhancing its authenticity.

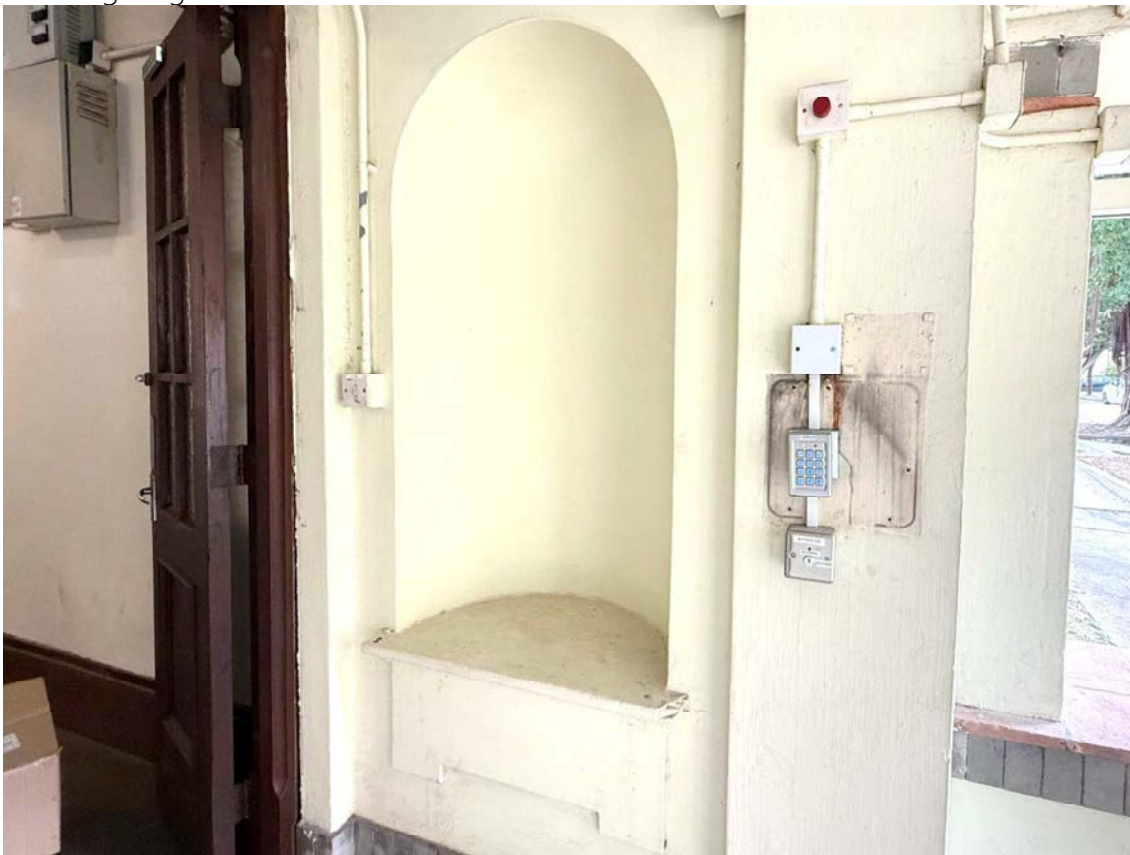
No.	Elements	Level of Significance
AR15	Arched alcove at the Main Entrance	Considerable

It reflects Block P's historical function as Sisters' Quarters with its 1920s design for holding religious icons.

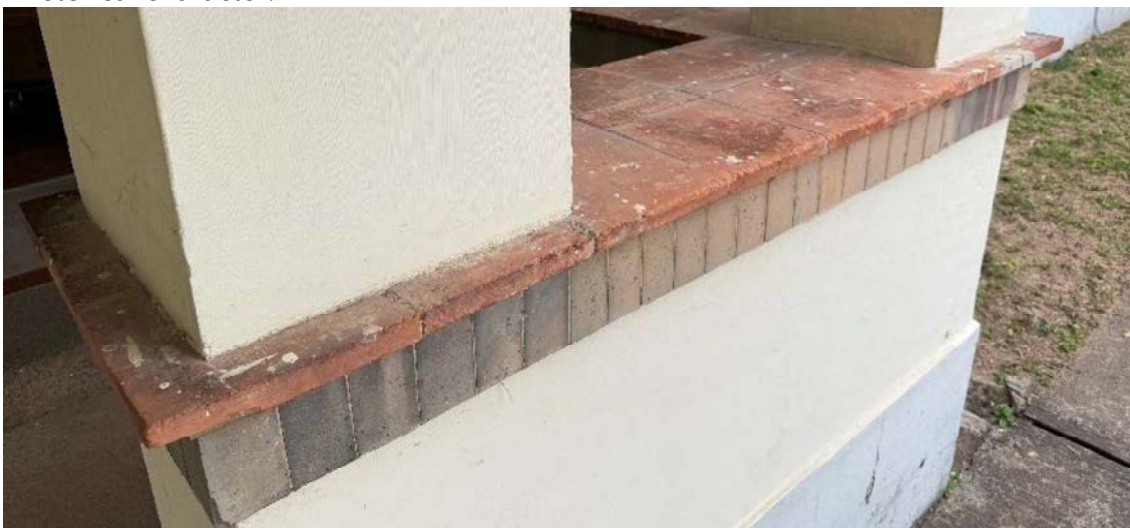
No.	Elements	Level of Significance
AR16	Red Tiled Topping of The Parapet Wall at the Main Entrance, Window Sills, and parapet walls of the 1/F Verandah.	Some

It reflects the 1920s architectural practice of using tiled finishes for both functional and decorative purposes, contributing to Block P's aesthetic coherence and historical character.

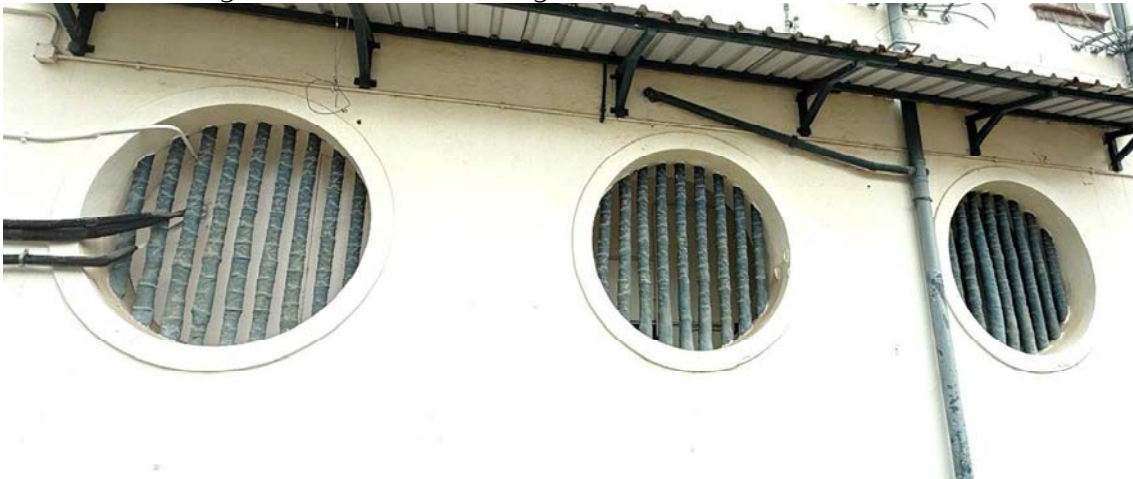
No.	Elements	Level of Significance
AR17	Circular Porthole with Ceramic Circular Grilles in Bamboo Pattern in South Elevation.	Considerable

It is unique design among the blocks in Kowloon Hospital. It reflects 1920s institutional architecture in Hong Kong, showcasing an Arts and Crafts and Chinese influence through their decorative design.

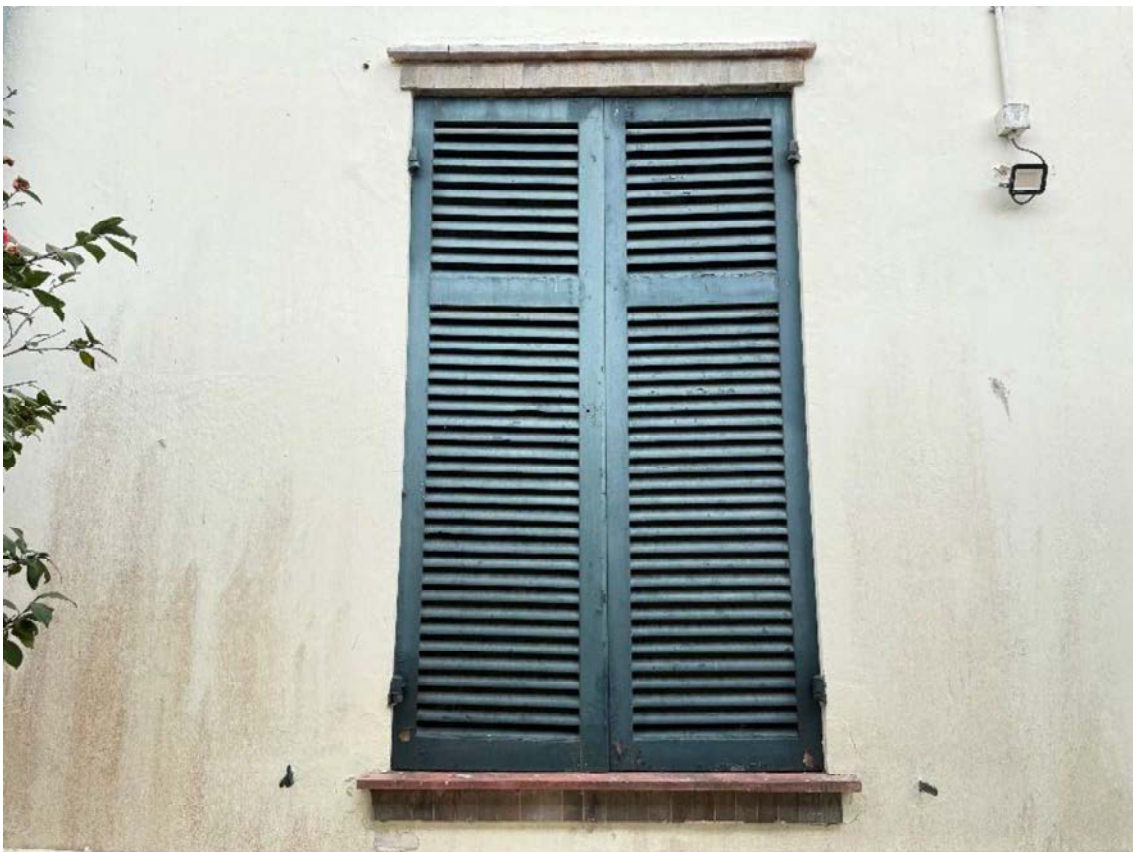
No.	Elements	Level of Significance
AR18	Louvered Shutter Window on North and South Elevations	Some

It reflects the functional and aesthetic design of 1920s institutional architecture, enhancing the building's ability to adapt to Hong Kong's climate while contributing to its historical character.

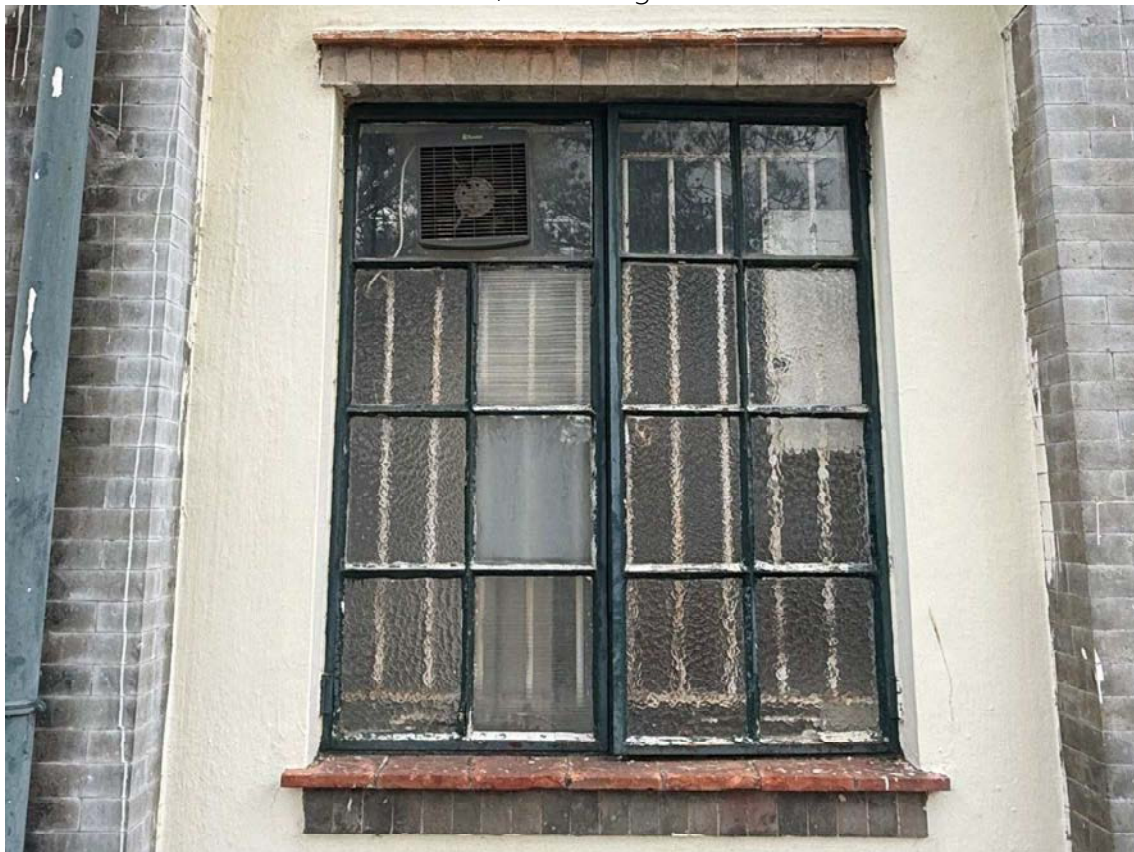
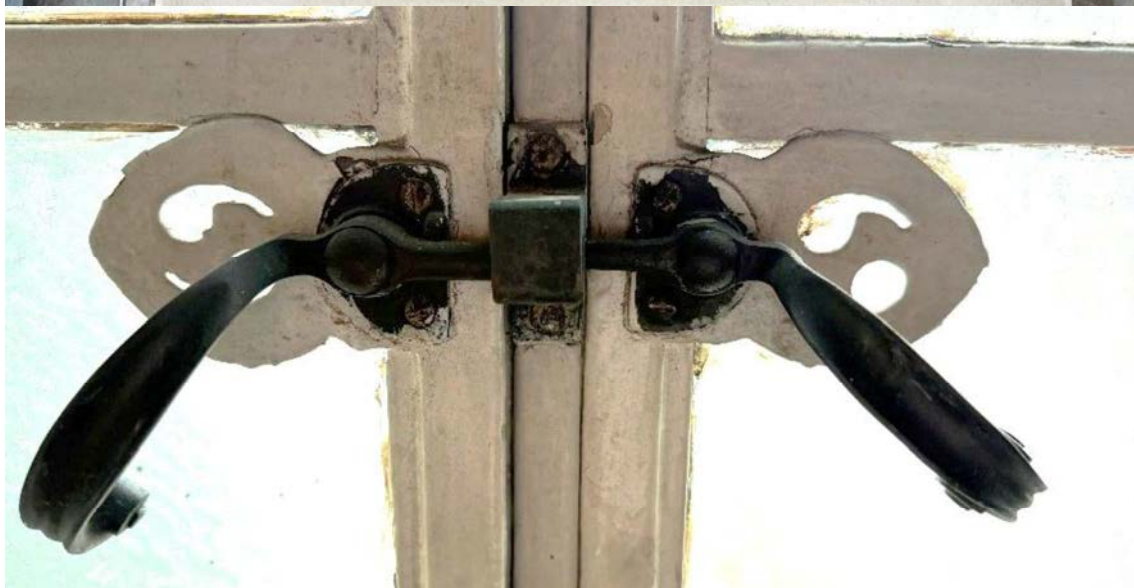
No.	Elements	Level of Significance
AR19	Metal Crittall Window Painted Dark Green with Red Tiled and Grey Gauged Brick Window Sill	Some

It combines functional and decorative features typical of 1920s institutional architecture, contributing to Block P's aesthetic coherence and historical character. The ornate handles and decorative backplates with a curvilinear pattern add an Arts and Crafts influence to the windows, enhancing their aesthetic value.

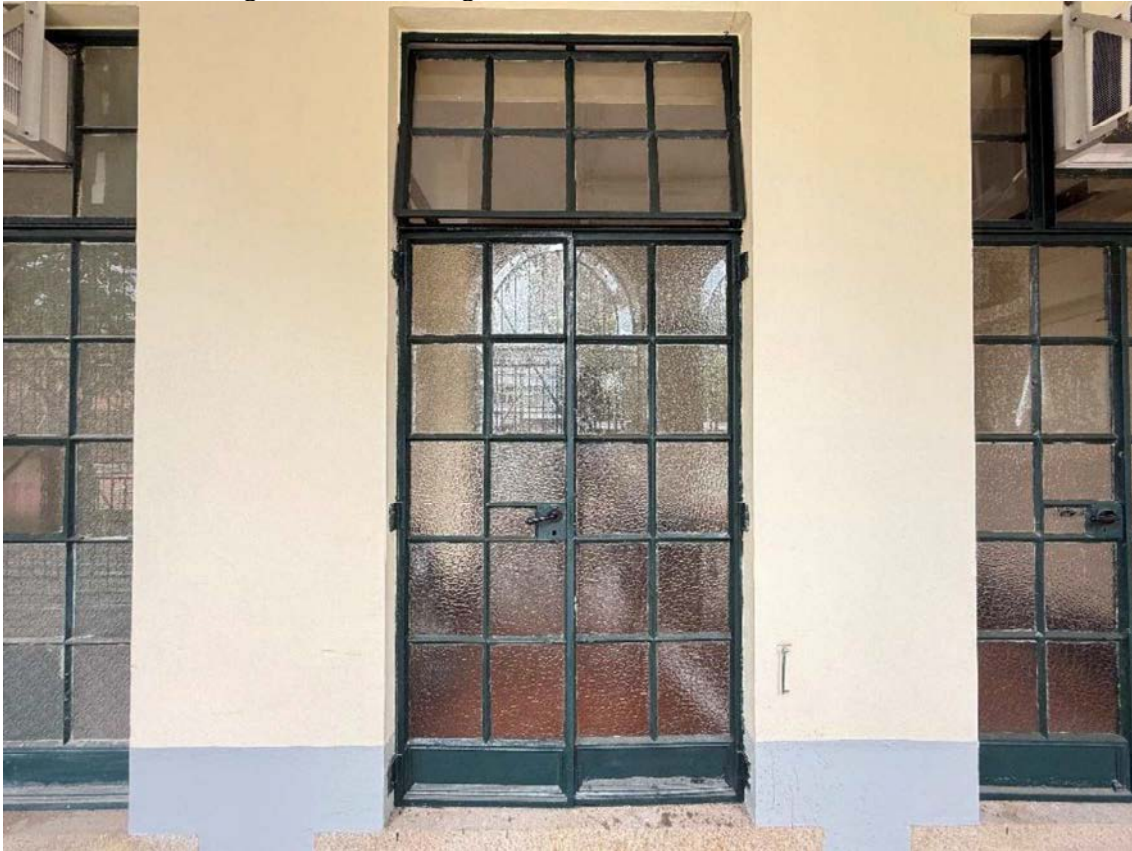
No.	Elements	Level of Significance
AR20	Multi-Paned Glass Door at facades	Considerable

It defines the first-floor verandah's 1920s design, enhancing its historical functionality and aesthetic elegance. Some original door holders still exist and intact.

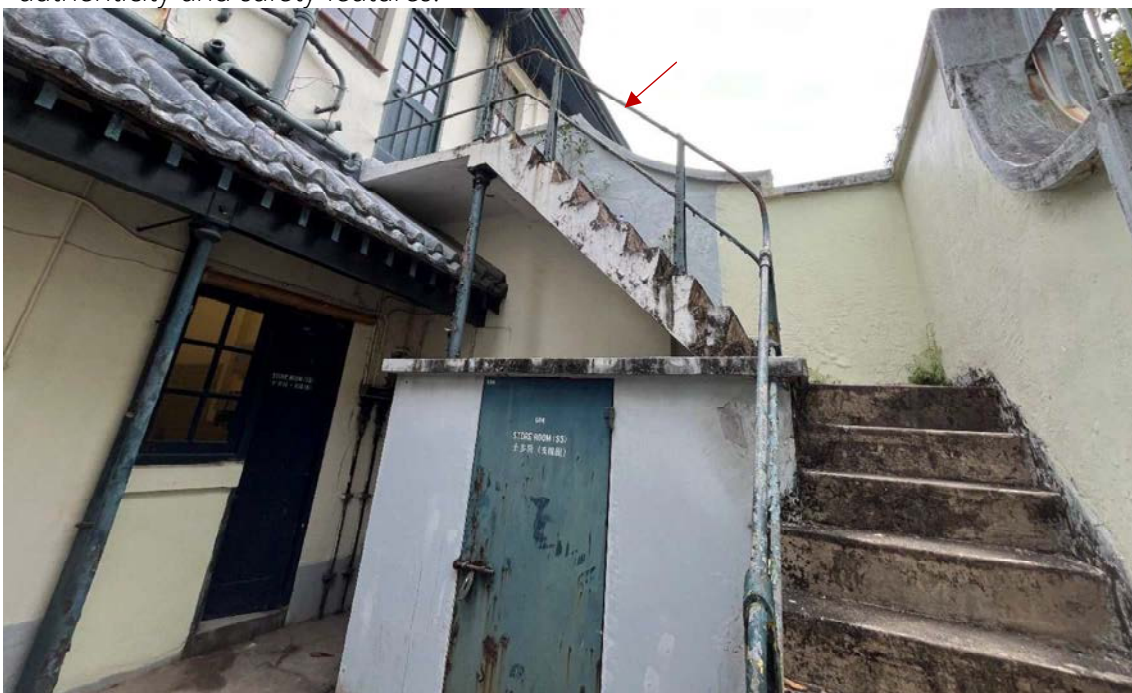
No.	Elements	Level of Significance
AR21	Metal Staircase Railing at the Service Yard	Some

It defines the service yard's 1920s functional design, enhancing its historical authenticity and safety features.

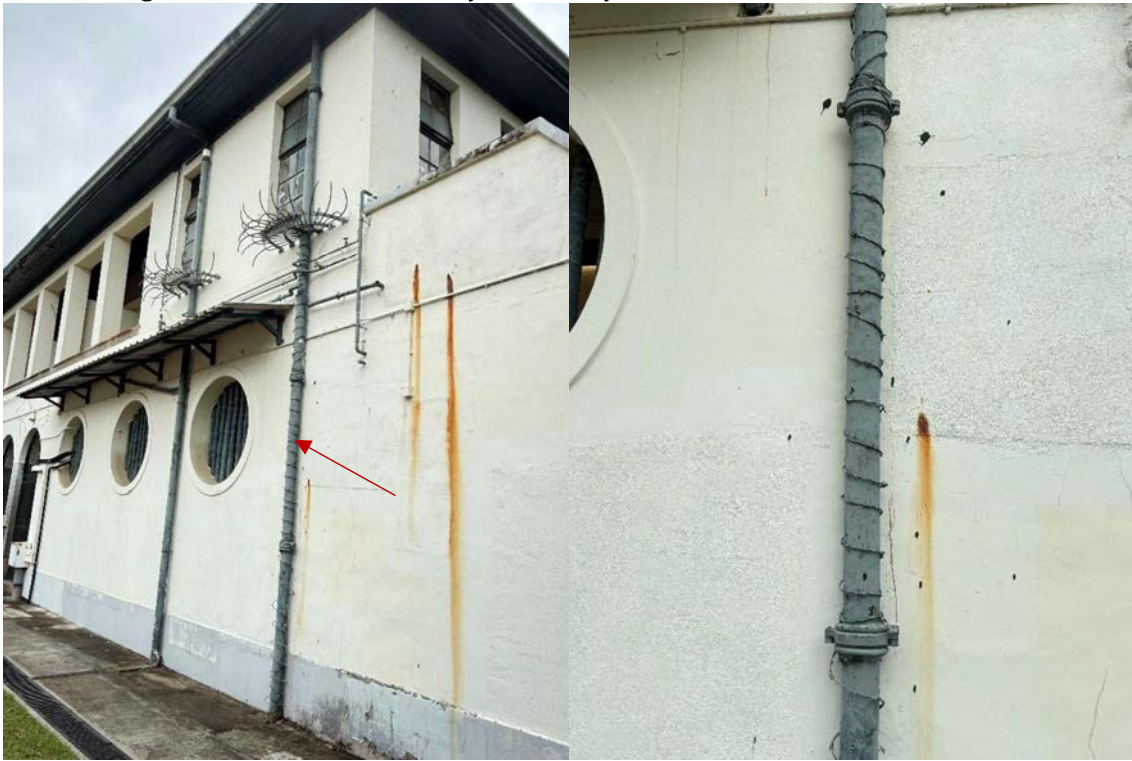
No.	Elements	Level of Significance
AR22	Cast Iron Rainwater Downpipe at South Facade	Considerable

It defines Block P's 1920s functional design as the only remaining original downpipe, enhancing its historical authenticity and rarity.

Exposed rainwater downpipes ensure efficient drainage while contributing decorative flair to Block P. However, only one cast iron downpipe, believed to be original, remains (See 2.7.16 to 18). All other downpipes have been replaced with PVC types.

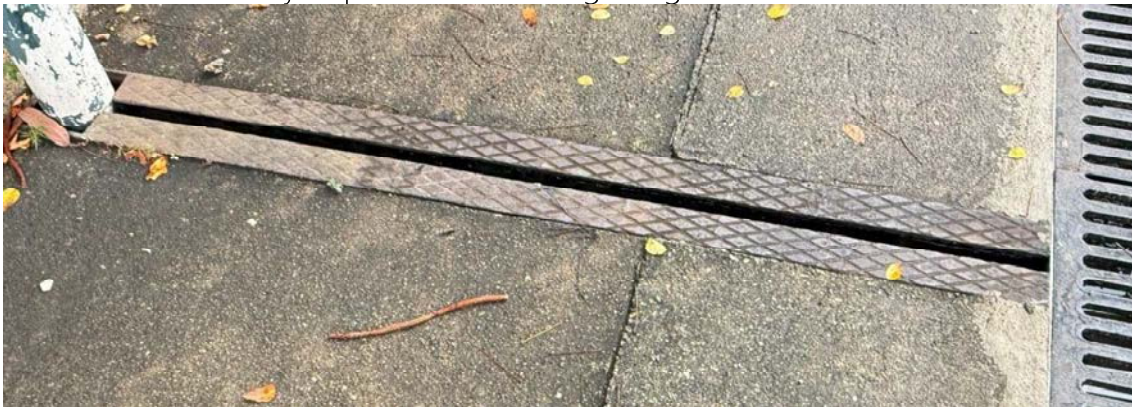
No.	Elements	Level of Significance
AR23	Cast Iron Slot Drain Cover at South Facade	Some

It defines Block P's 1920s drainage system with its functional design, enhancing its historical authenticity as part of the building's original infrastructure.

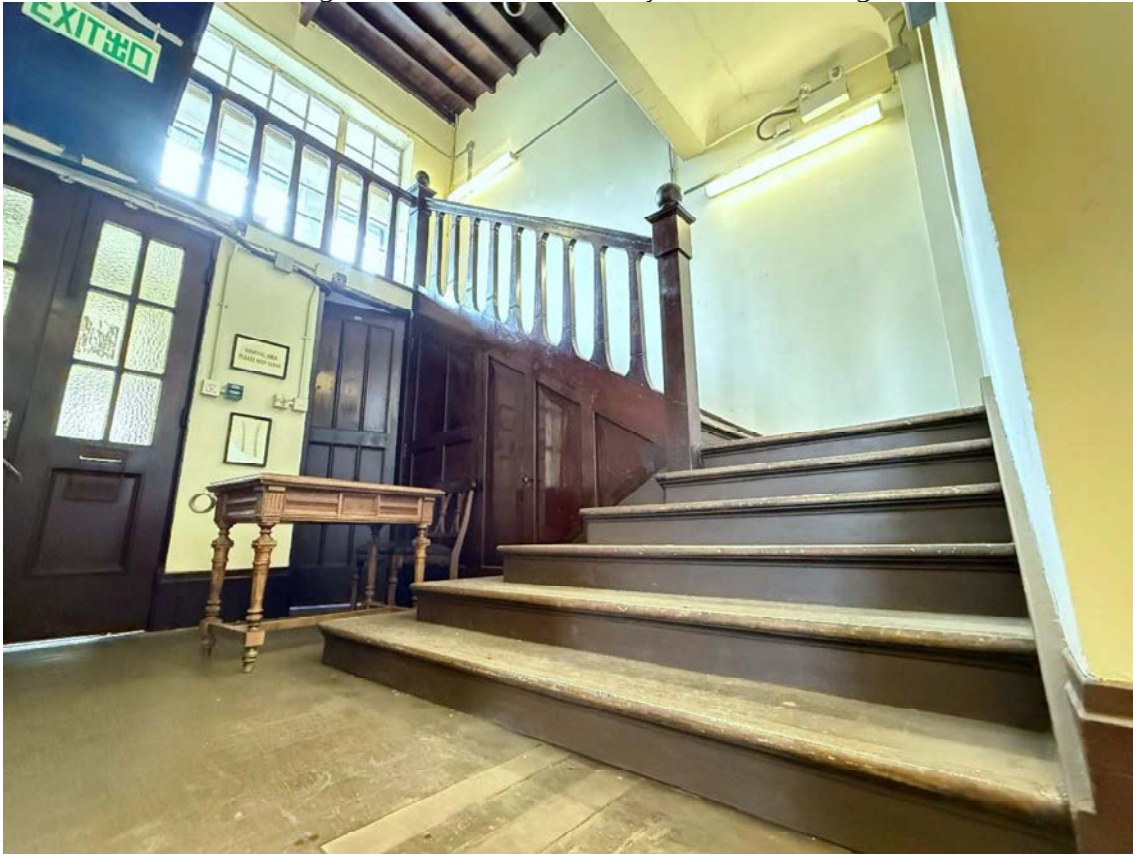
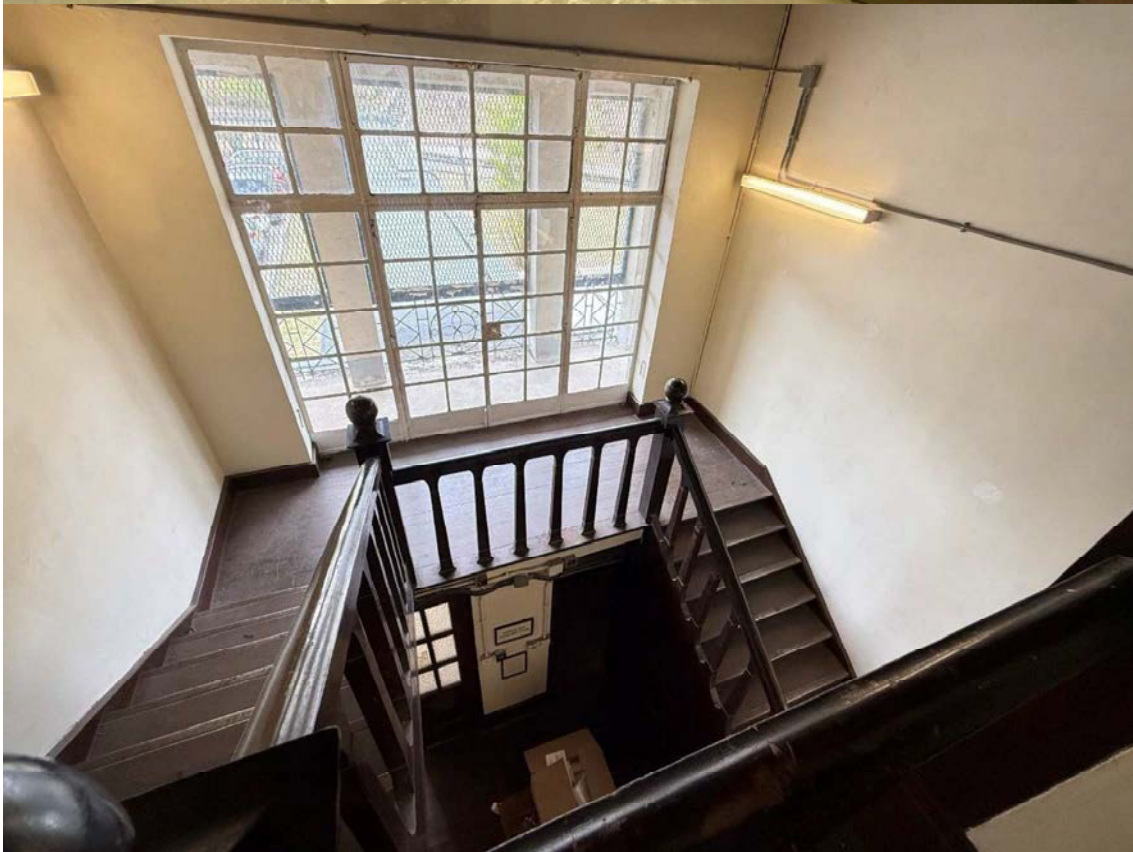
No.	Elements	Level of Significance
AI01	Grand Timber Staircase with Timber Railing	Exceptional

It is common in 1920s colonial architecture. It represents 1920s craftsmanship and aestheticism, enhancing its historical authenticity and aesthetic grandeur.

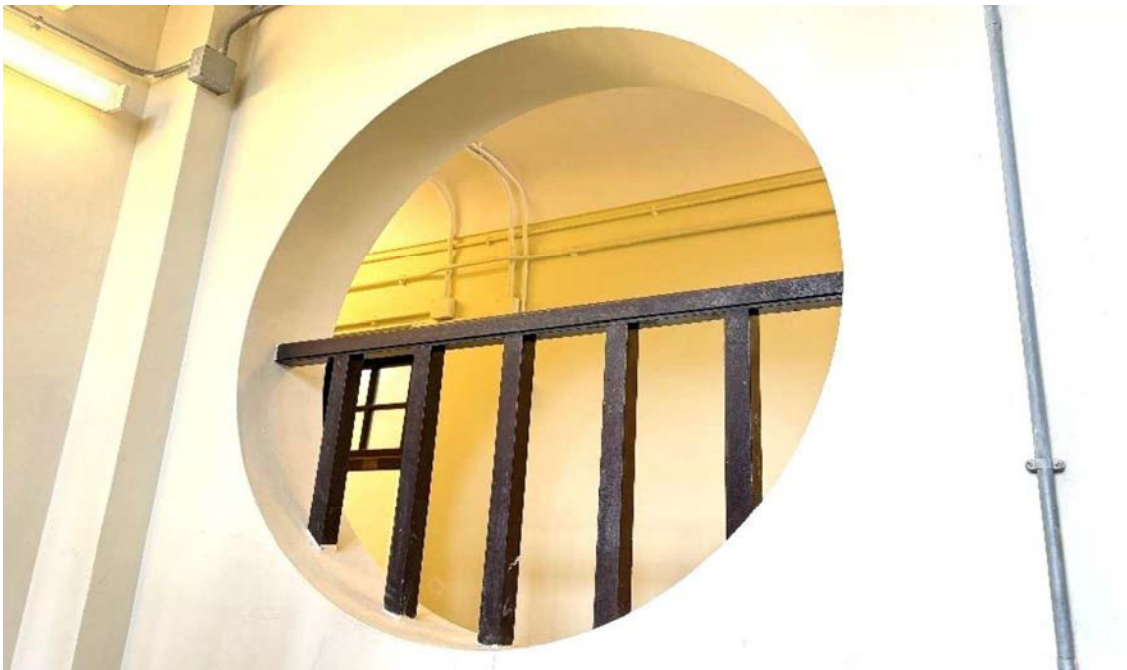
No.	Elements	Level of Significance
AI02	Circular Wall Opening with Timber Rails Next to the Grand Timber Staircase	Considerable

Along with the Grand Timber Staircase, this staircase area showcases the 1920s design with its decorative element, enhancing its aesthetic charm and historical ambiance.

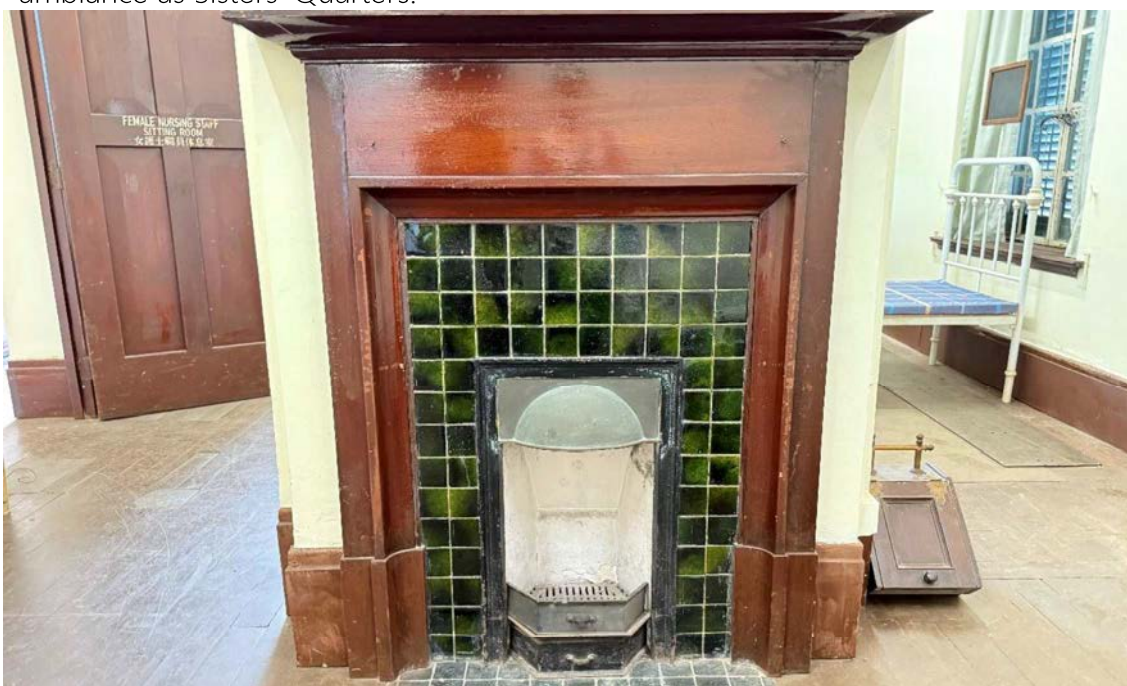
No.	Elements	Level of Significance
AI03	Fireplace (G/F: Function Rooms, Offices ; 1/F: Offices, Multi-Function Room)	Exceptional

Fourteen fireplaces showcase 1920s domestic design in an institutional setting. Their original timber and tiled design, enhancing its historical authenticity and domestic ambiance as Sisters' Quarters.

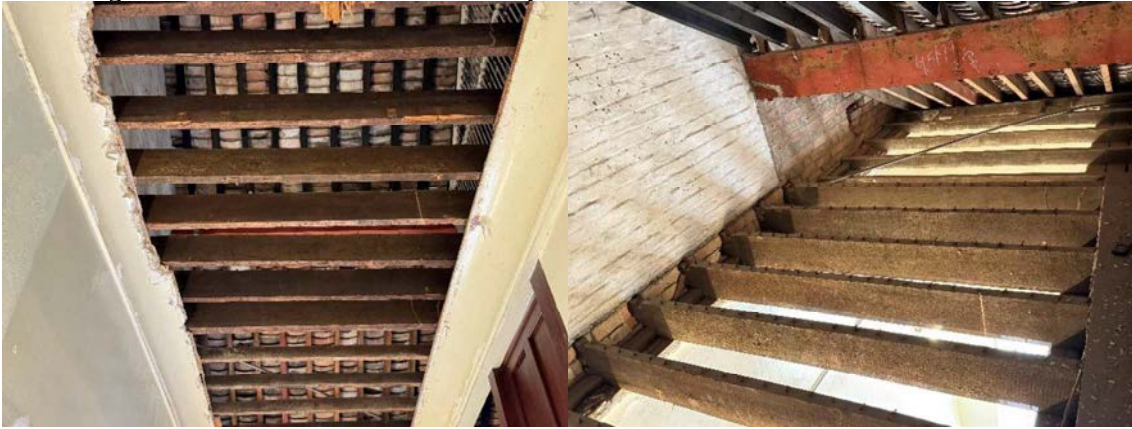
No.	Elements	Level of Significance
AI04	Timber Ceiling Joist	Some

It only remains on the ceiling of grand staircase on 1/F. It is a characteristic of colonial construction, exemplifying 1920s construction techniques and contributing to the building's interior structural authenticity.

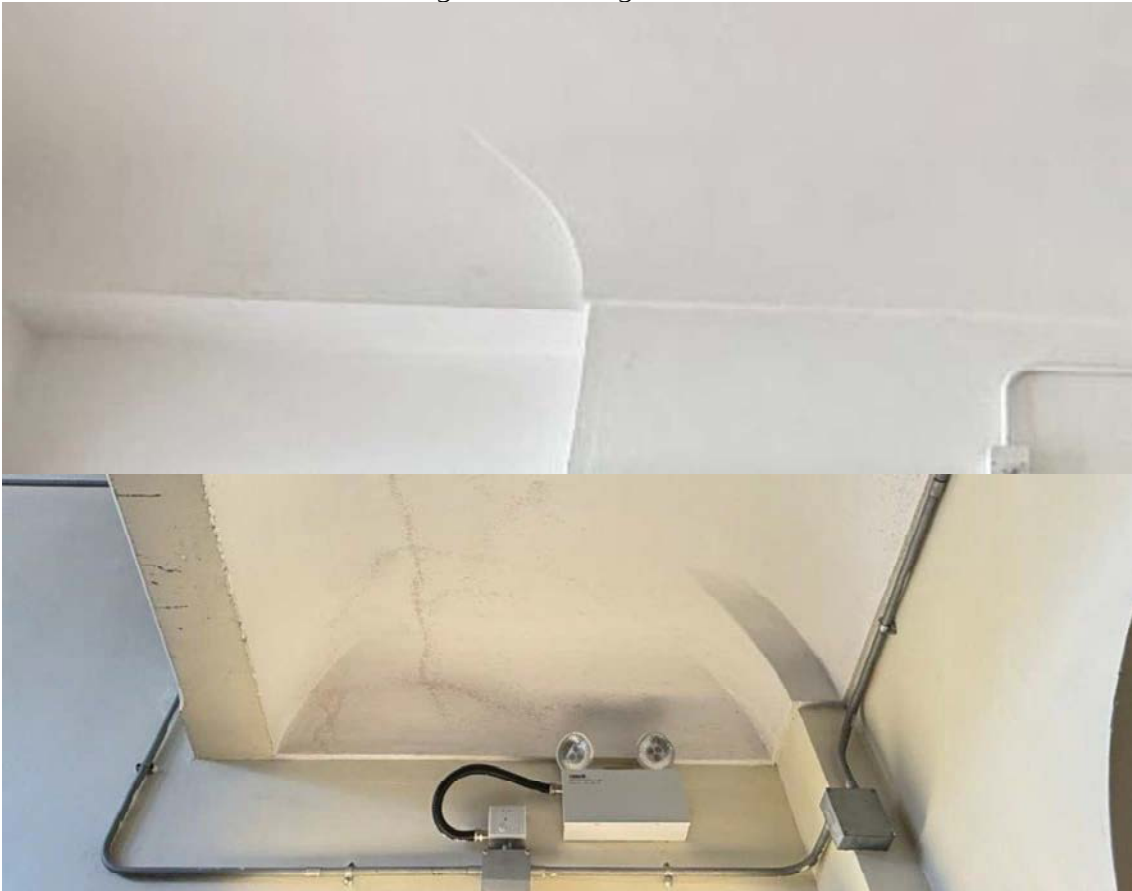
No.	Elements	Level of Significance
AI05	Coved Ceiling at the G/F Ceiling, excepting Staff Pantry and Toilets	Some

It reflects the 1920s architectural style and also represent a common interior design feature in 1920s colonial buildings, showcasing attention to detail and refinement.

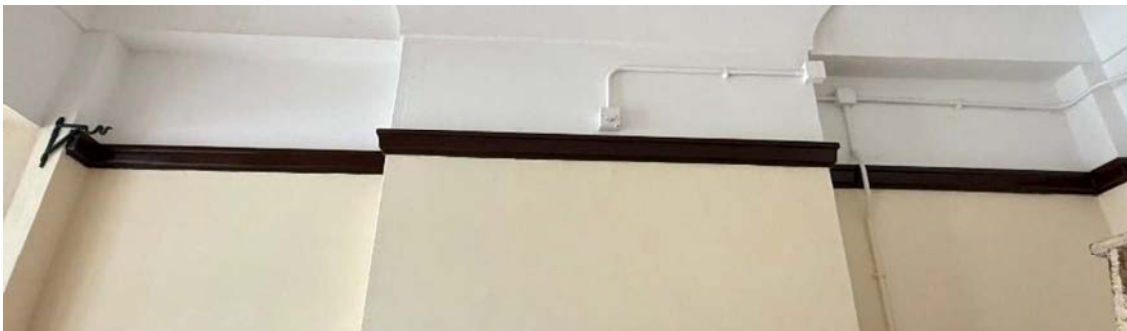
No.	Elements	Level of Significance
AI06	Timber Picture Rail in the Function Rooms, Offices and Meeting Rooms on G/F, as well as the Multi-Function Room and Offices on 1/F.	Some

It presents in all original bedrooms and sitting rooms of Block P, a characteristic feature of 1920s interiors. They reflect the building's original aesthetic as the Sisters' Quarters.

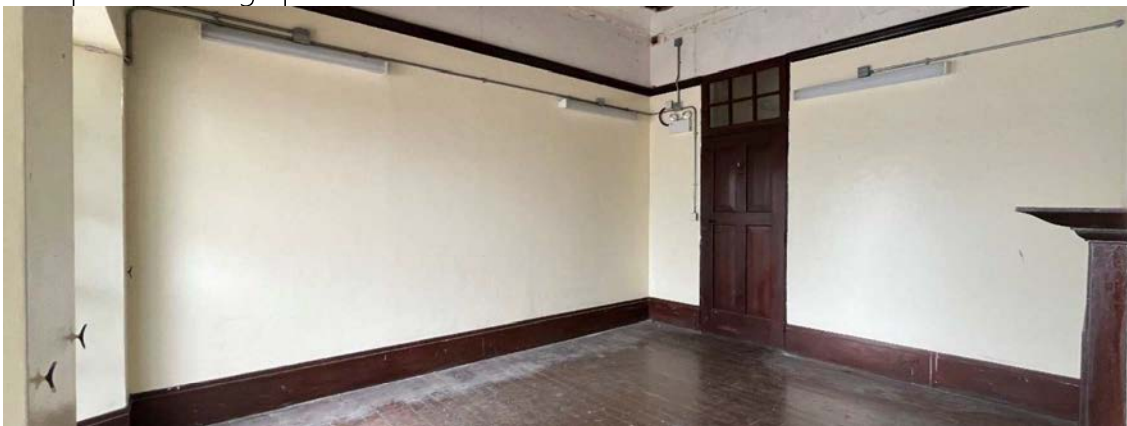
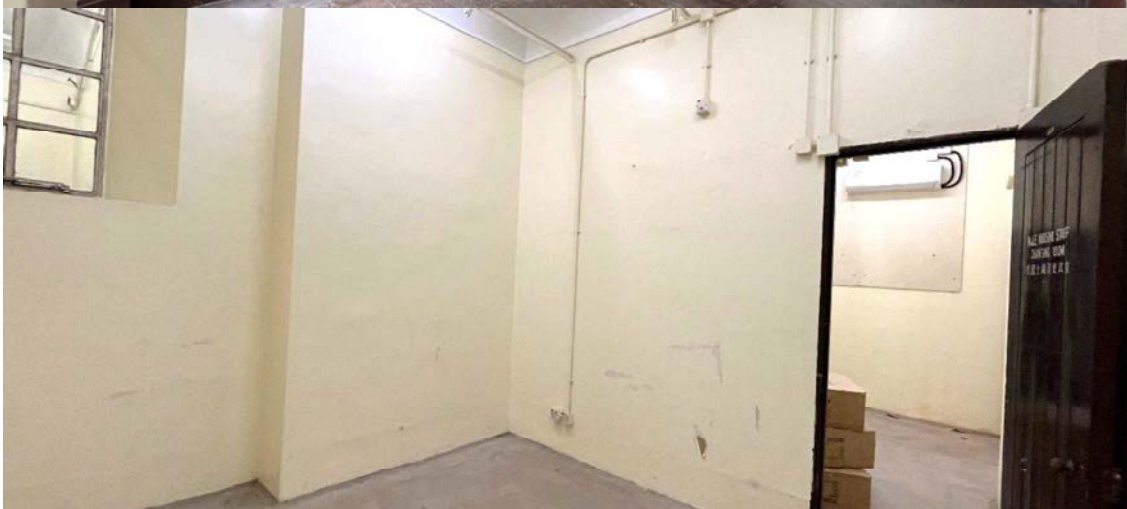
No.	Elements	Level of Significance
AI07	Painted Interior Brickwork Wall in the Pantry, Corridor, Function Rooms, Offices and Meeting Rooms on G/F, as well as the Corridor, Multi-Function Room, Toilets and Offices on 1/F.	Little

All interior walls except utility space, e.g. kitchen and toilet, are all painted. It reflects the period's design preferences for clean and functional finishes.

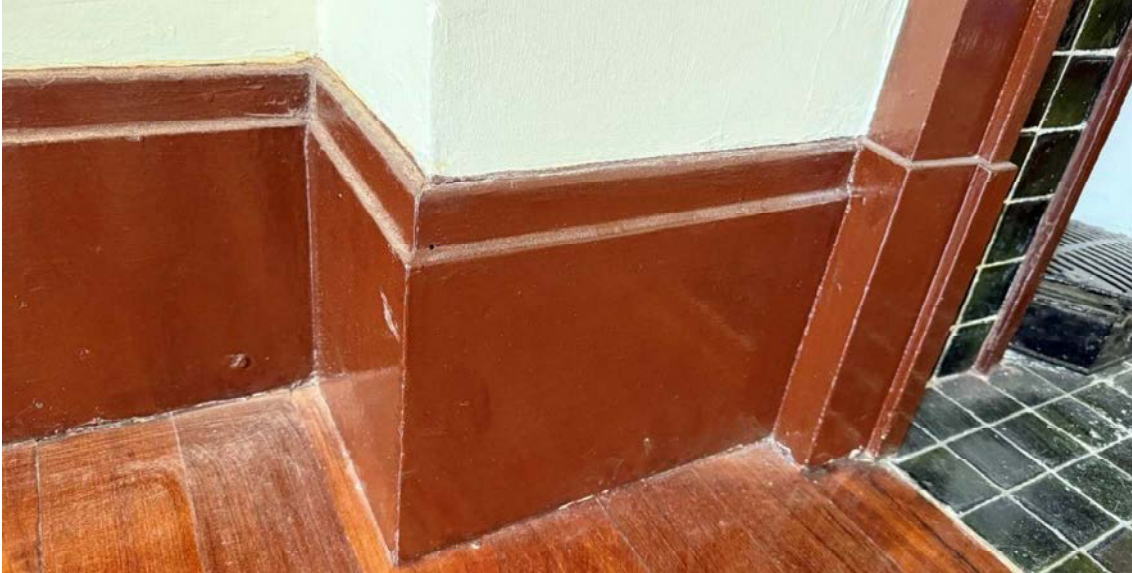
No.	Elements	Level of Significance
AI08	Plastered Skirting on all Internal Walls of the Corridors, Function Rooms, Offices, Meeting Rooms Multi-Function Room, and 1/F Toilets.	Some

It is a typical feature of 1920s interiors, providing protection and a finished appearance, enhancing the transition between wall and floor.

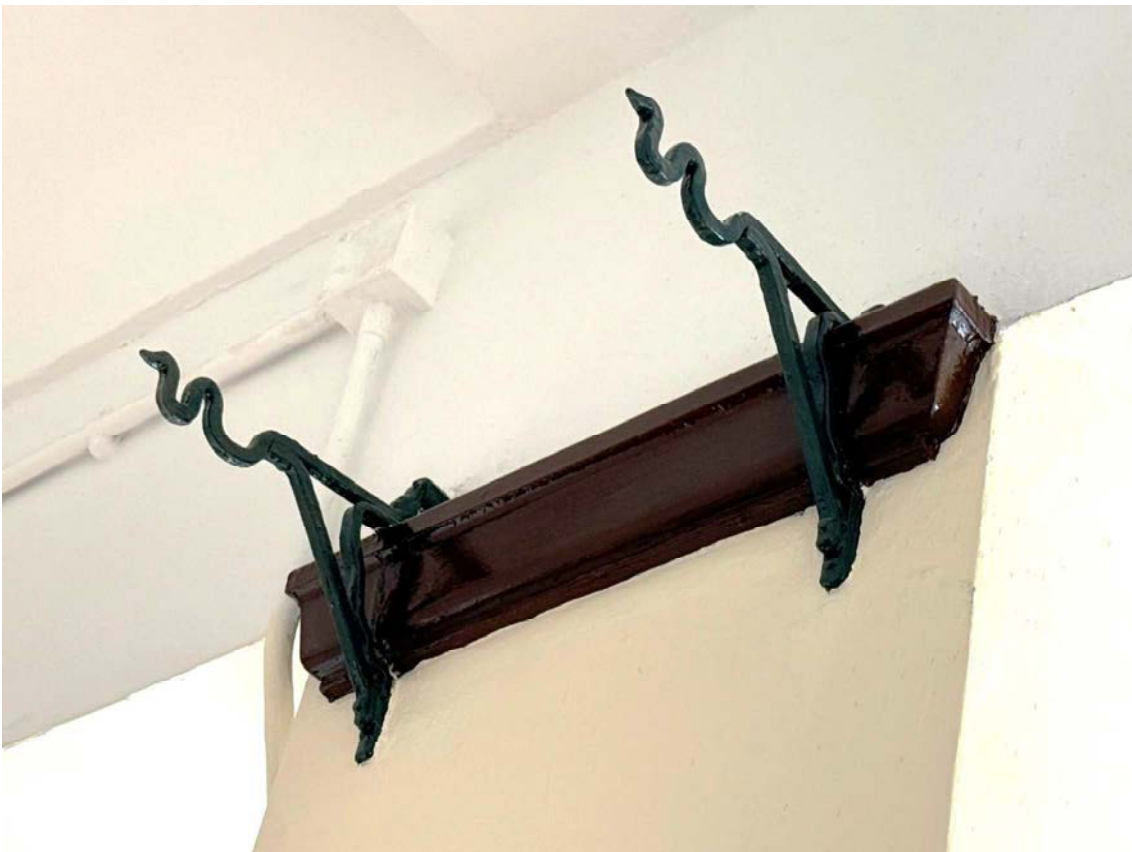
No.	Elements	Level of Significance
AI09	Metal Curtain Pelmet in all Offices on G/F.	Some

It is a typical feature of 1920s interiors, reflecting the period's attention to decorative detail.

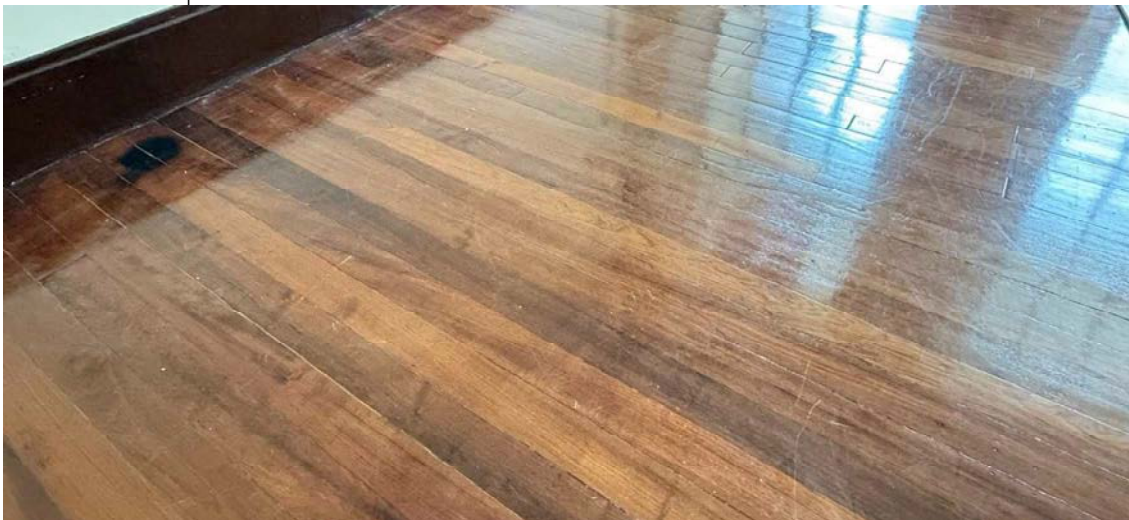
No.	Elements	Level of Significance
AI10	Teak Floor in all Function Rooms, Offices, Stores, Corridor and Meeting Rooms, and Multi-Function Room.	Considerable

It is a high-quality feature of 1920s interiors, showcasing durable and elegant craftsmanship.
