RENOVATION OF BLOCK P IN KOWLOON HOSPITAL

HOSPITAL
AUTHORITY

Heritage Impact Assessment

June 2026

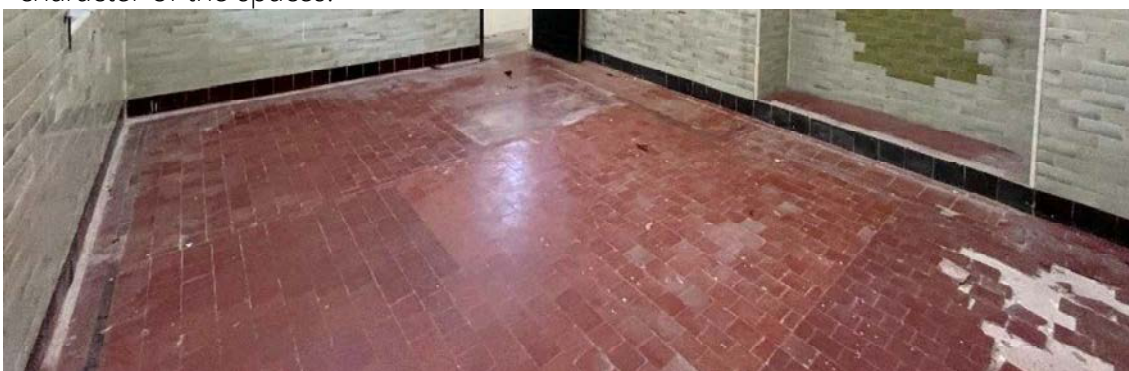
No.	Elements	Level of Significance
AI11	Red Tiled Flooring in Toilets, Pantry, Staff Common Room on G/F, and 1/F Verandah.	Some

It is representing 1920s functional and aesthetic design, enhancing the visual character of the spaces.

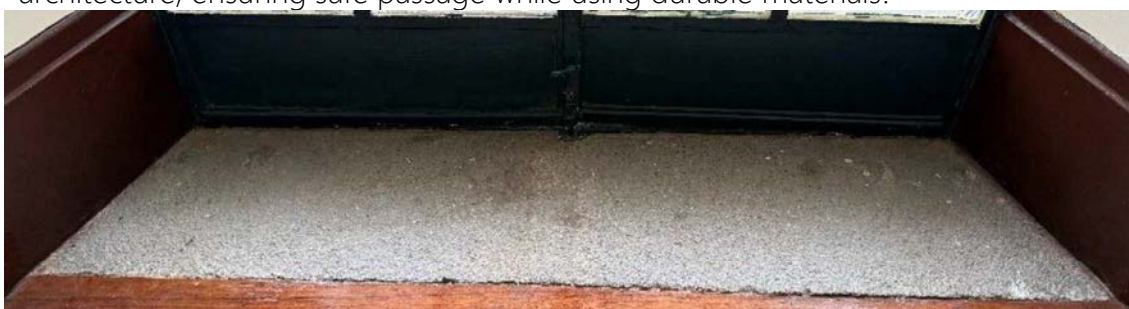
No.	Elements	Level of Significance
AI12	Indoor Granite Threshold in G/F Offices	Some

They present at the doors to 1/F Verandah. It is a typical feature of 1920s architecture, ensuring safe passage while using durable materials.

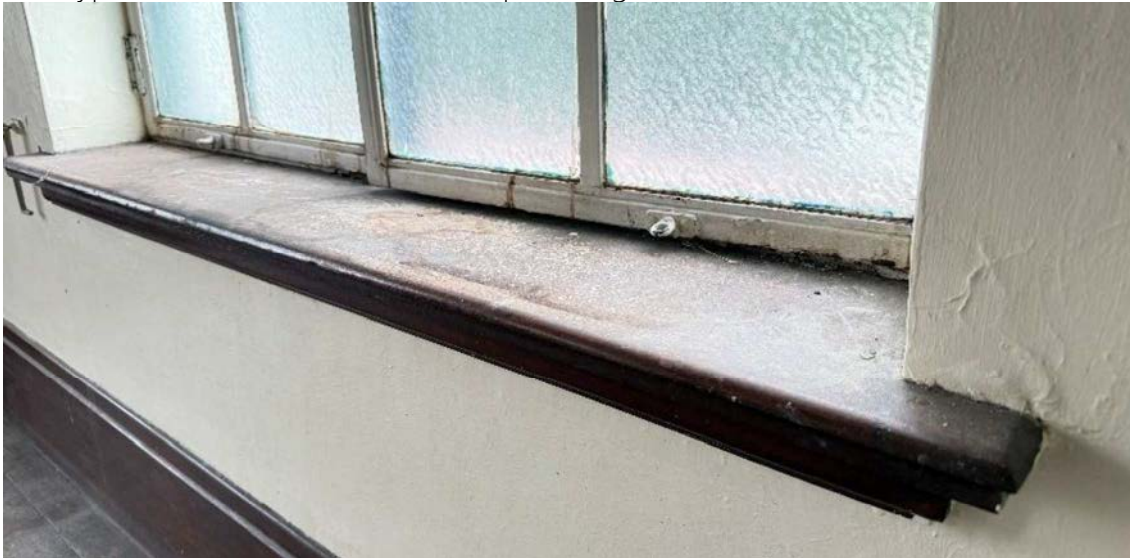
No.	Elements	Level of Significance
AI15	Timber Window Sill in every Rooms	Some

It a typical feature of 1920s interiors, providing a functional and decorative element.

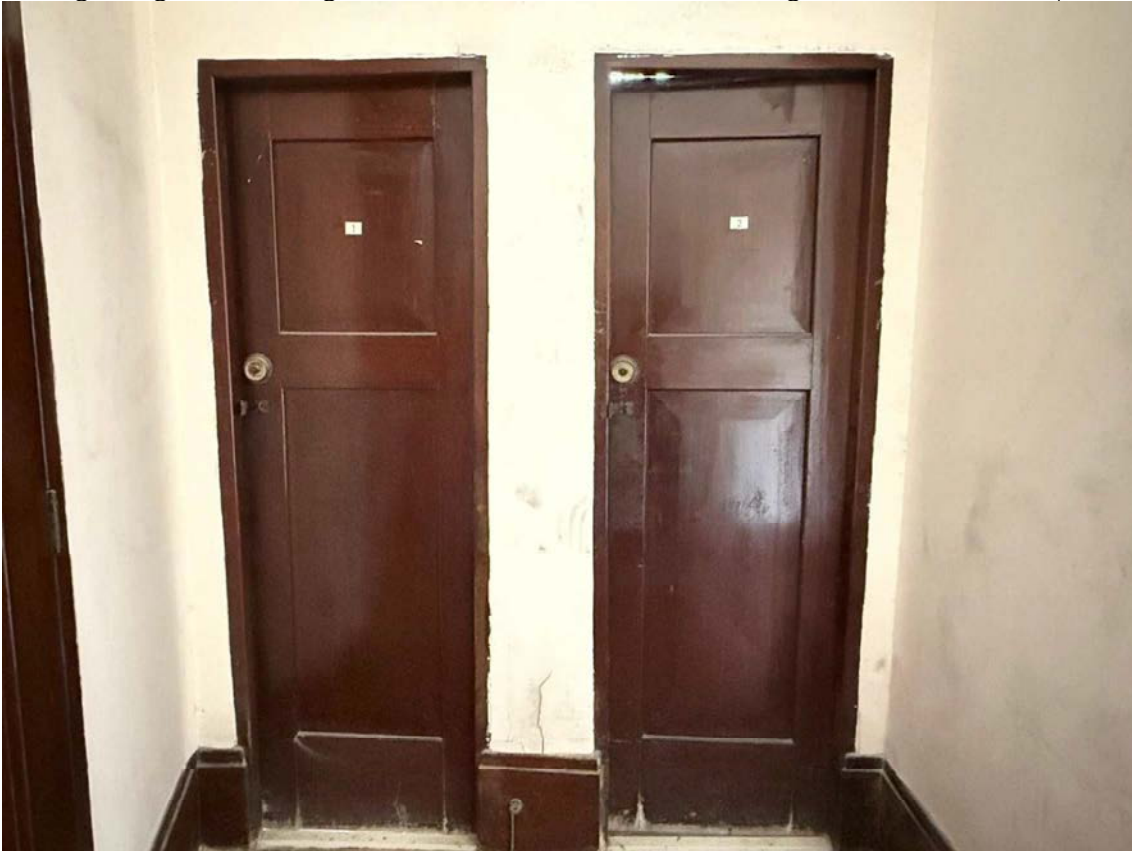
No.	Elements	Level of Significance
AI16	Timber Toilet Cubicle Door in the 1/F Toilet	Exceptional

Only two remaining timber toilet cubicle doors. They are rare surviving elements in Hong Kong, showcasing 1920s institutional bathroom design and craftsmanship.

Repair the two original cubicle doors and reuse them in the renovated toilet.

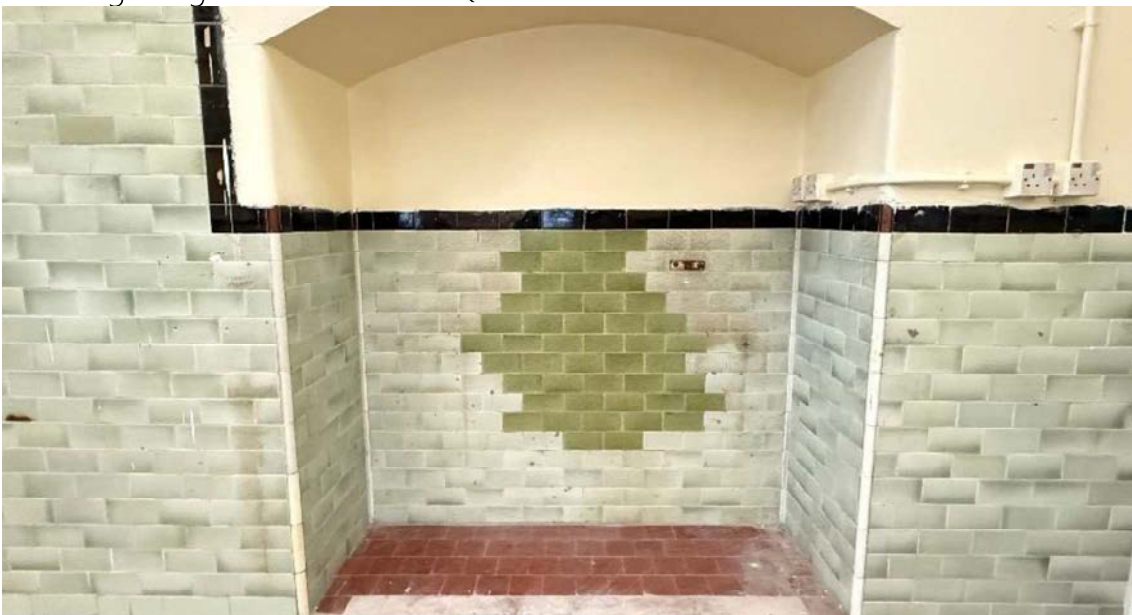
No.	Elements	Level of Significance
AI17	Alcove in the G/F Staff Common Room.	Considerable

This alcove possibly for a sink or stove as this was the kitchen in the past. It is a feature of 1920s kitchens, providing insight into the daily operations of the sisters. It also defines the old kitchen's 1920s layout with its functional design, reflecting the building's original use as Sisters' Quarters.

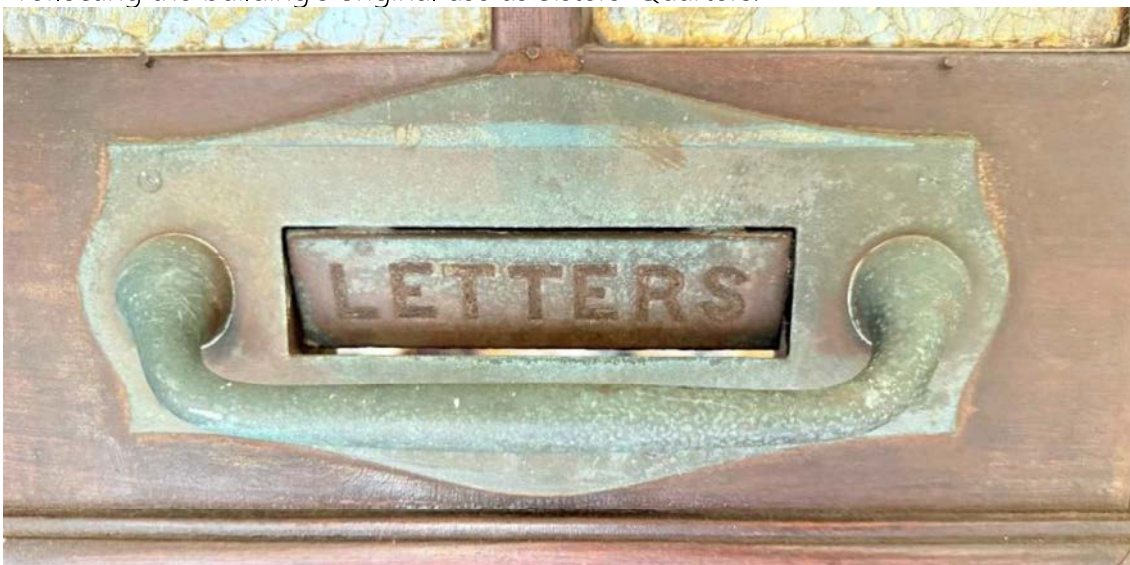
No.	Elements	Level of Significance
AI18	Metal Letter Slot in the Main Entrance Door.	Considerable

It is at the main entrance door. Letter slots were commonly used in the late 19th and early 20th centuries, before modern mailboxes became more widespread. It is reflecting the building's original use as Sisters' Quarters.

Category	Architectural Elements (Interior)
Proposed Work	Upgrading Works for Statutory Compliance Reverse the swing of the main entrance door to open outward.
Reasons for Work	Achieve the required functional changes (e.g., outward swing for fire escape compliance) while preserving the more significant heritage element, in accordance with conservation principles.
Affected CDE	Timber door (A114, Considerable)
Impact Grading	Acceptable Impact with mitigation measures. <i>Modify the door frame (which has lower heritage significance) while retaining the original door panel (which has higher heritage significance).</i>
Mitigation Measures	<ul style="list-style-type: none"> • Modify the door frame using a minimal intervention approach to allow the original door panel to swing outward. • Conserve all CDEs on the existing door including ironmongeries glass panels and letter box.

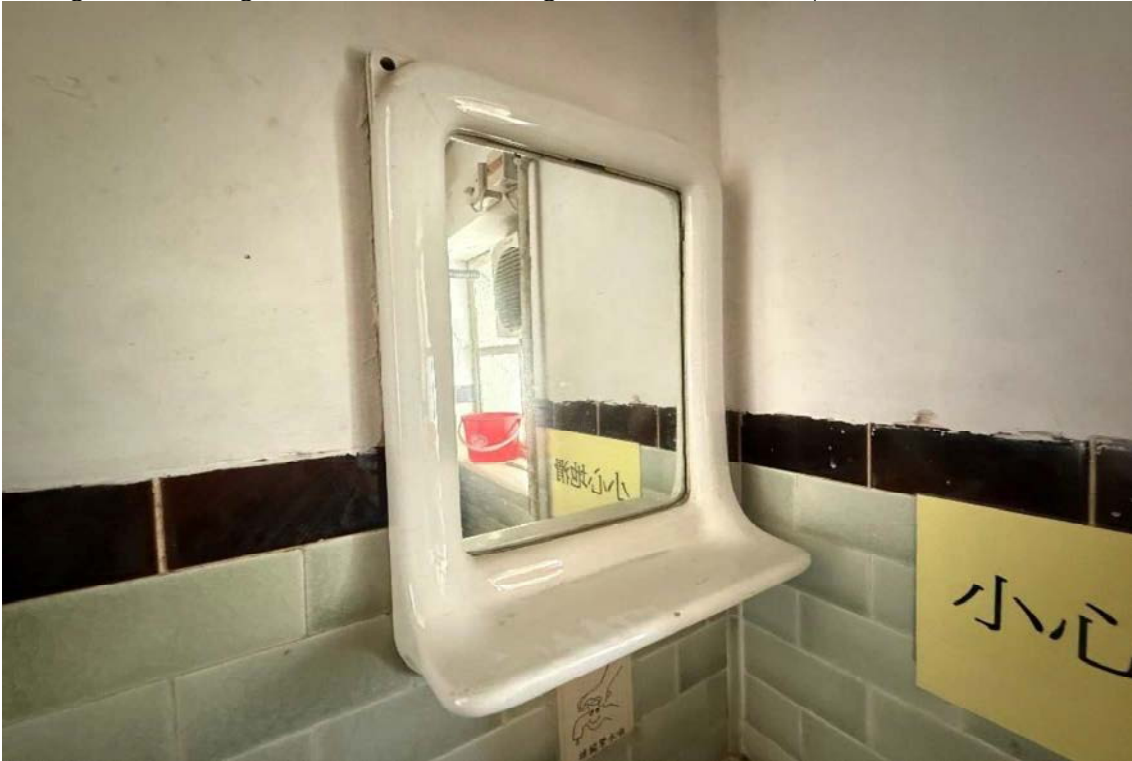
No.	Elements	Level of Significance
AI20	Mirror with Ceramic Frame in G/F Toilets next to Main Entrance.	Some

The only one in the toilet on G/F. It is a rare surviving feature in modern-day Hong Kong, showcasing 1920s bathroom design and craftsmanship.

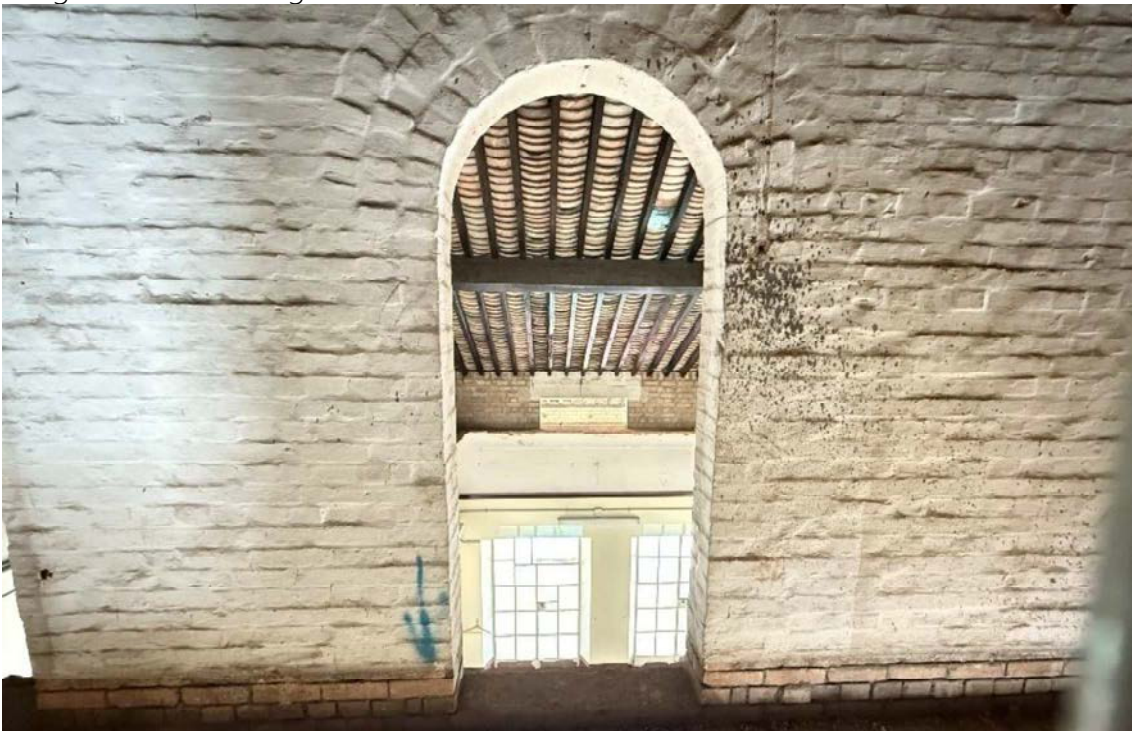
No.	Elements	Level of Significance
AI21	Brick Arch in The Roof Void (Above Ceiling Level)	Considerable

It defines the roof void with its old structural design, facilitating circulation above the original timber ceiling.

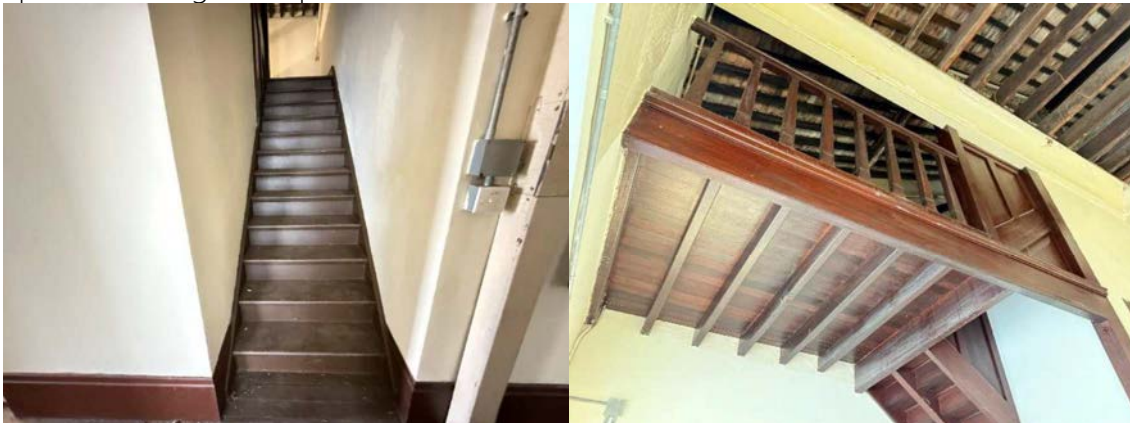
No.	Elements	Level of Significance
AI22	Timber Staircase Leading to The Roof Void	Exceptional

It is facilitating access to the roof void for maintenance and reflecting the building's practical design for operational needs.

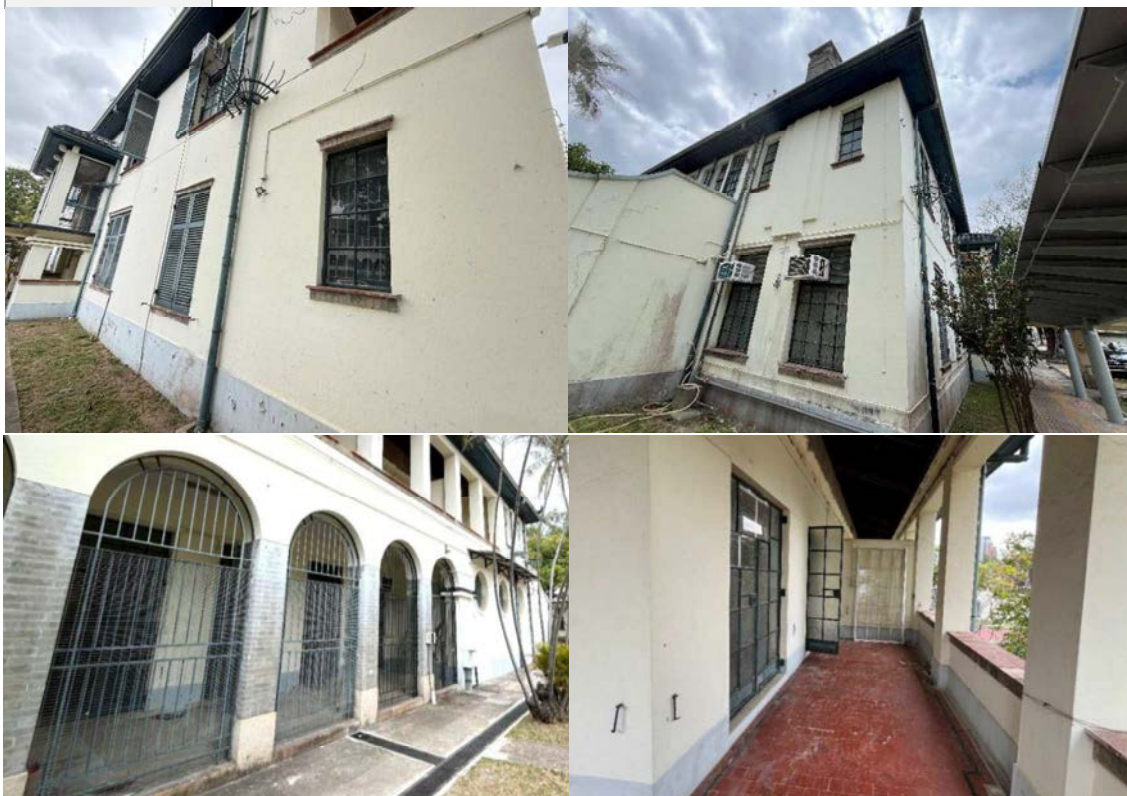
Category	Architectural Elements (Exterior)
Proposed Work	Restoration Works Stripping existing paint, de-dusting, repainting with primer and synthetic paint of metal windows. Replacement defective glasses, hinges/locks to match existing.
Reasons for Work	To restore the windows' functionality and appearance, addressing wear while maintaining their heritage value.
Affected CDE	Metal Crittall window painted dark green with red tiled and grey gauged brick window sill (AR19, Some)
Impact Grading	Beneficial Impact. <i>Restoration maintains the windows' historic character.</i>
Mitigation Measures	<ul style="list-style-type: none"> • Retain the original dark green colour of the windows during repainting, preserving their historic appearance. • Ensure new hinges and locks match the original design, avoiding structural changes to the frames. • Protect the red tiled and grey gauged brick window sill from damage during window repair. Implement protective measures, such as temporary coverings or barriers, as necessary.

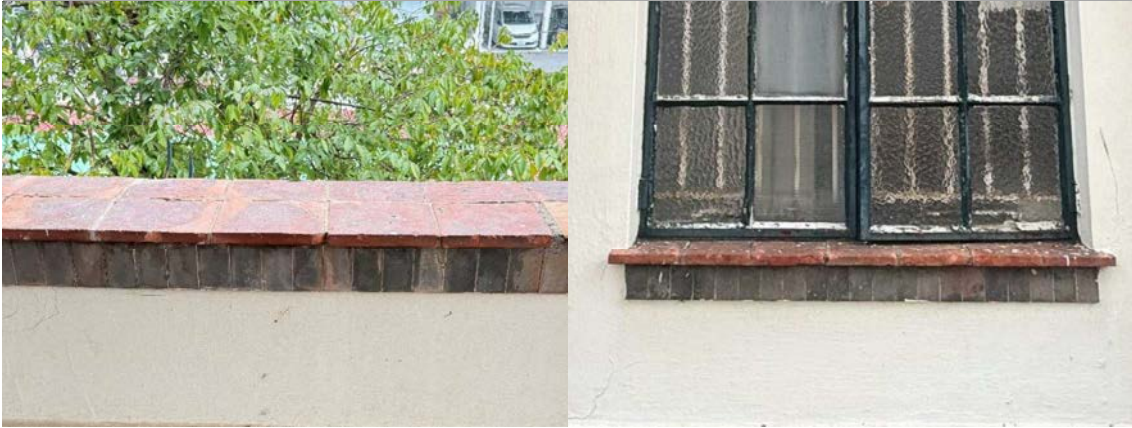
Category	Architectural Elements (Exterior)
Proposed Work	Building Services Upgrading Works Replacing/reconnecting defective drainpipes with uPVC pipes and repainting existing exposed drainpipes with polyurethane paint.
Reasons for Work	To improve drainage functionality and prevent water damage to the building's exterior, addressing defective pipes.
Affected CDE	Rendered and painted external brickwork walls (AR07, Considerable)
Impact Grading	Acceptable Impact. <i>The replacement affects external utilitarian elements with minimal visual or structural impact on the heritage fabric. Repainting is a surface treatment that does not alter the structural or historic fabric.</i>
Mitigation Measures	<ul style="list-style-type: none"> • Ensure new uPVC pipes are discreetly placed to avoid visual impact on the external walls and grey brick accents. • Match the paint colour of the drainpipes to the existing colour, minimizing visual disruption to the façade.

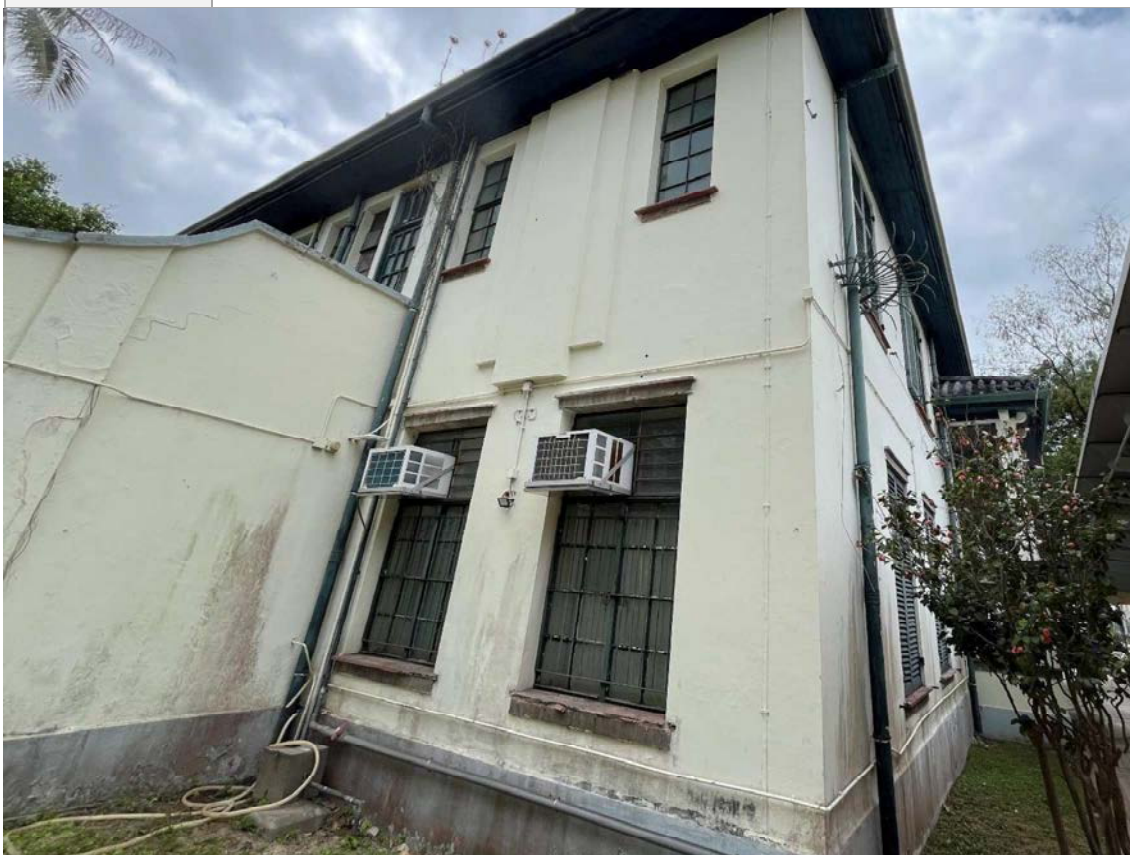
Category	Architectural Elements (Exterior)
Proposed Work	Building Services Upgrading Works Installation of new galvanized mild steel (GMS) weatherproof louvres at fanlight level for mechanical ventilation intake and exhaust.
Reasons for Work	To integrate modern A/C systems, ensuring ventilation for office use while maintaining window functionality.
Affected CDE	Metal Crittall Window (AR19, Some)
Impact Grading	Acceptable Impact. <i>Louvres are installed on removed glass panes, avoiding structural changes to window frames.</i>
Mitigation Measures	<ul style="list-style-type: none"> • Ensure louvres are painted to match the original black or dark green window colour, minimizing visual impact. • Install louvres on the glass area to avoid permanent alteration to the window frame, preserving their historic design.

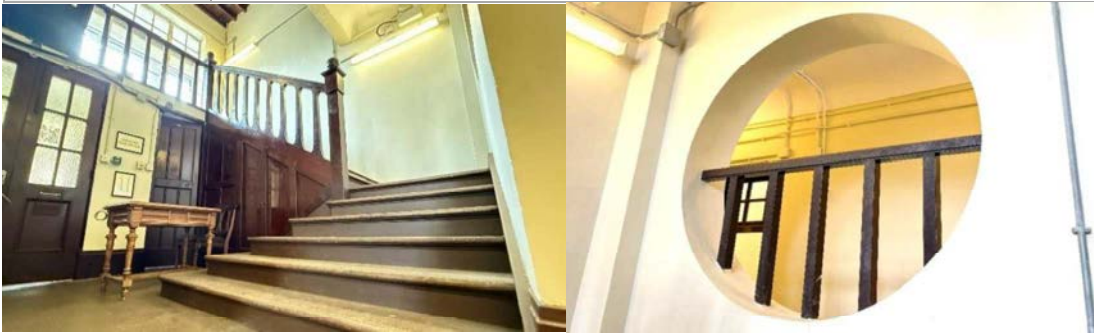
Category	Architectural Elements (Interior)
Proposed Work	Restoration Works Repair of debonded plaster on internal walls with lime plaster to restore stability and aesthetics. Repainting internal walls with mineral silicate paint after stripping existing paint.
Reasons for Work	To address plaster detachment, improving structural and visual integrity. To improve aesthetics and durability with a breathable, modern finish.
Affected CDE	Painted Interior Brickwork Wall (AI07, Little)
Impact Grading	Beneficial Impact. <i>Repairs are localized and maintain the walls' historic character. Repainting is a surface treatment with minimal impact.</i>
Mitigation Measures	<ul style="list-style-type: none"> • Use breathable mineral silicate paint matching the original cream colour to preserve visual continuity. • Apply paint carefully to avoid damaging adjacent ceramic dado tiles or timber elements. • Ensure non-invasive preparation methods to protect underlying plaster.

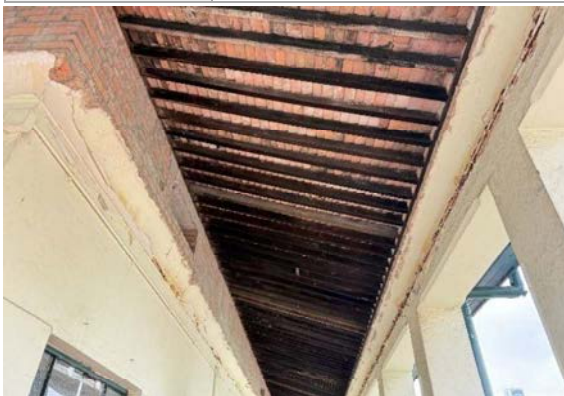
Existing condition.

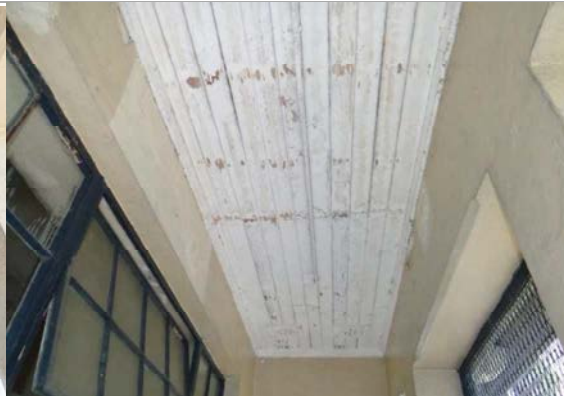
Original design (Taken in 2013).

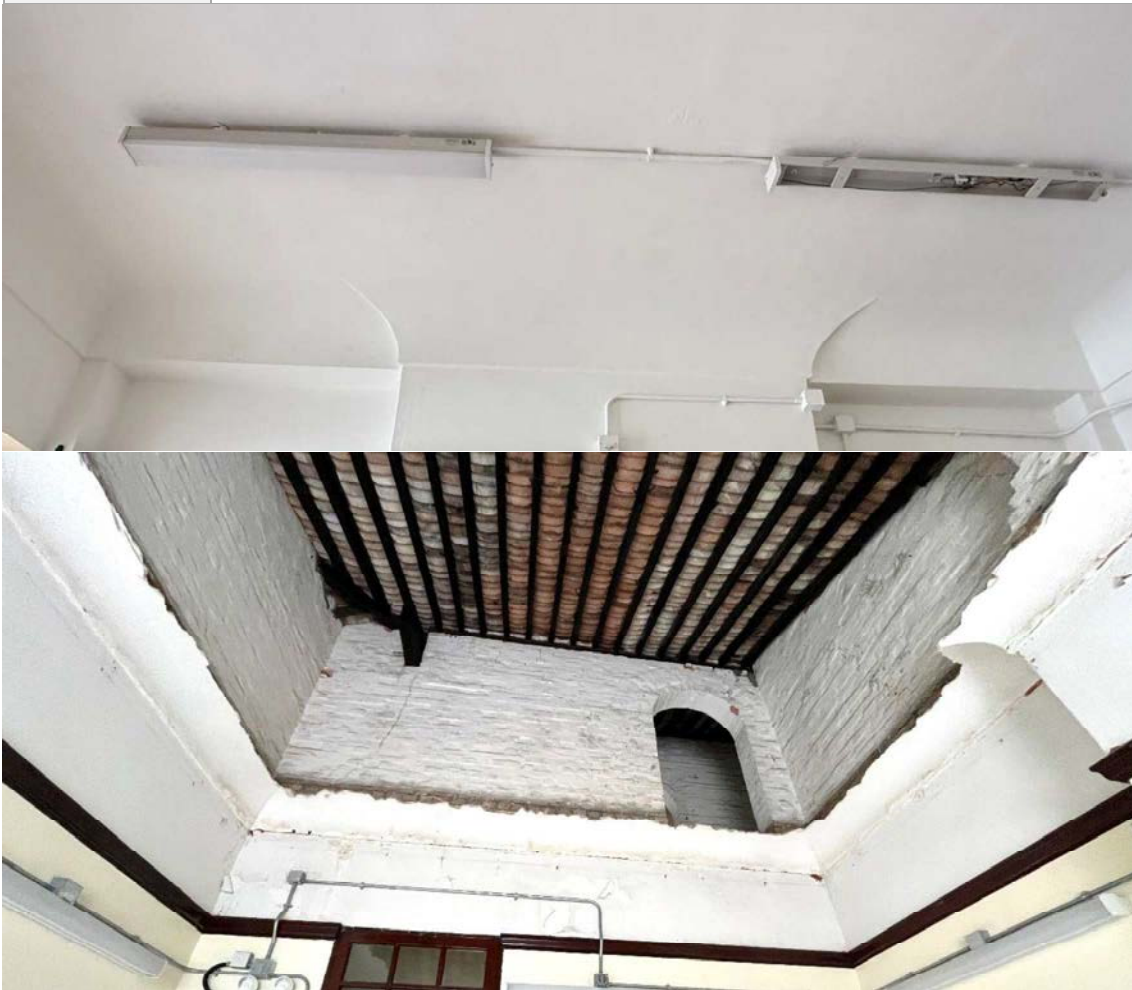
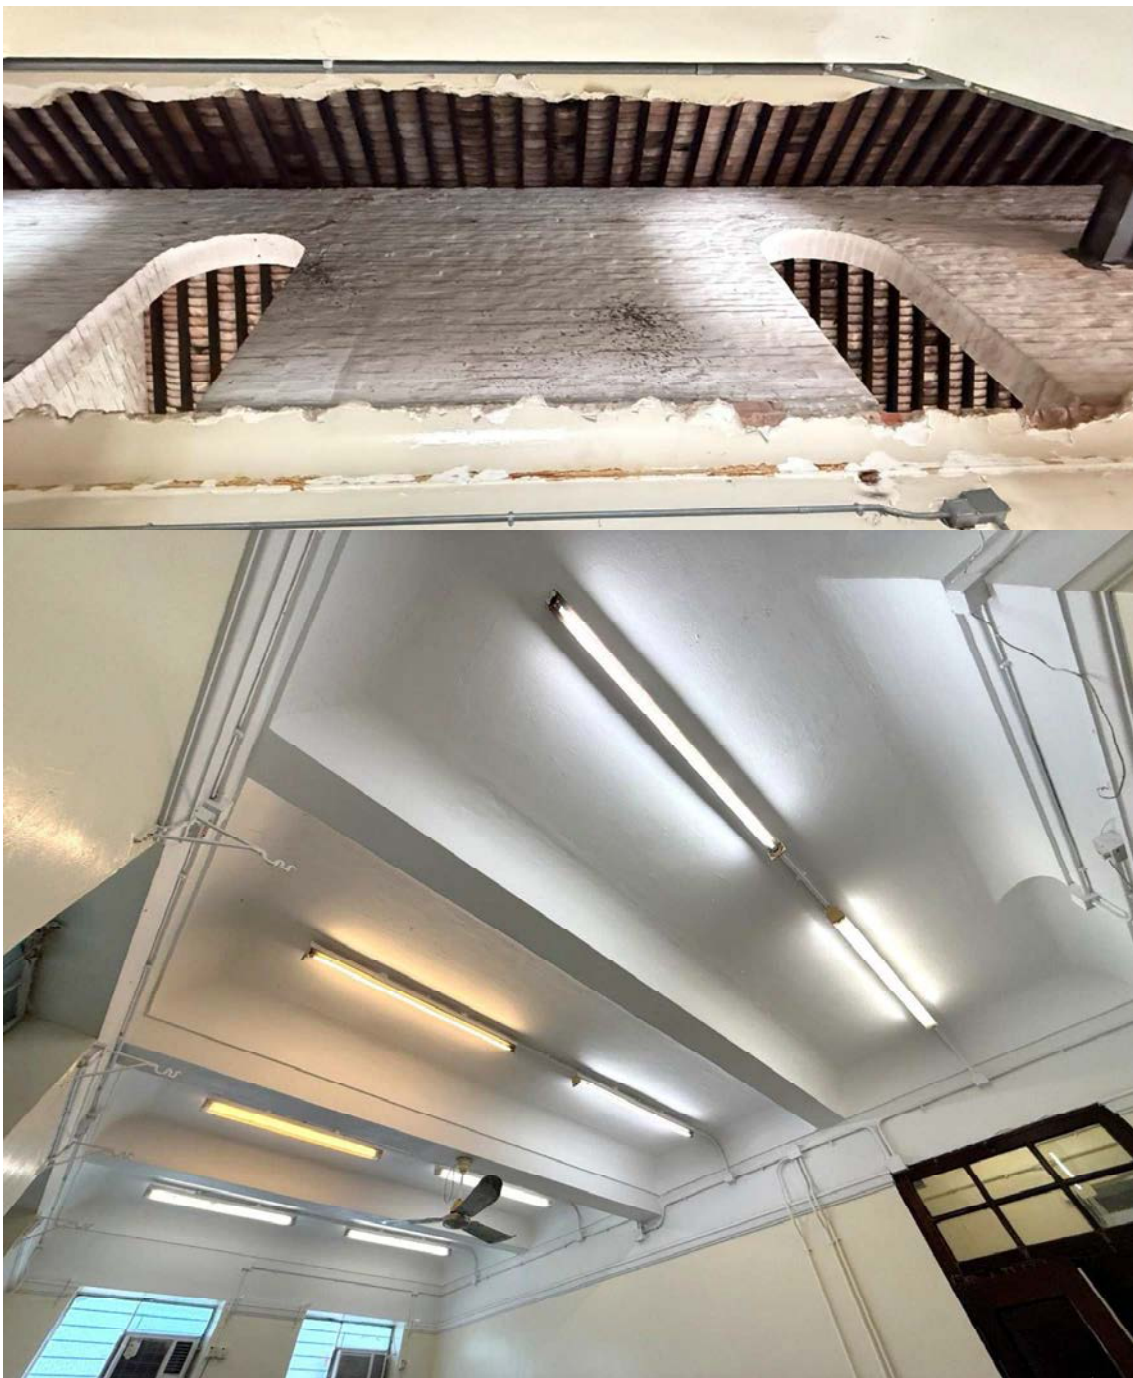
Category	Architectural Elements (Interior)
Proposed Work	Builder's Works Installation of a new GMS supporting steel frame and inspection walkway in the roof void (above 1/F ceiling level) for E&M services maintenance.
Reasons for Work	To provide safe access for maintaining modern E&M services, supporting office functionality.
Affected CDE	Rendered and painted external brickwork walls painted in cream colour and grey skirting with jointless grey gauged brick accent (AR07, Considerable)
Impact Grading	Acceptable Impact with Mitigation Measures. <i>The walkway is a reversible addition with minimal impact on the roof structure.</i>
Mitigation Measures	<ul style="list-style-type: none"> • Use lightweight materials to avoid severe damage to the brickwork walls. • Position the walkway to avoid interference with brickwork walls or chimney. • Engage a Registered Structural Engineer to review any potential impact on the brick walls.

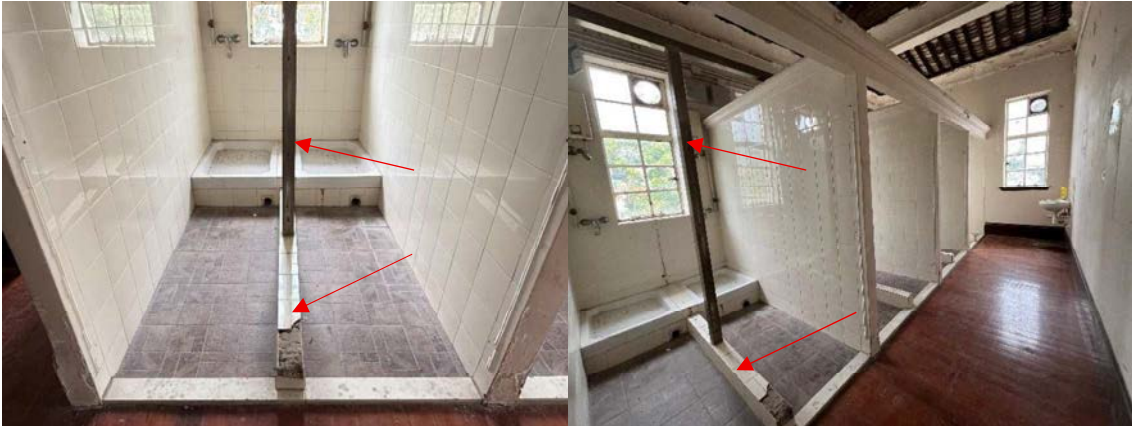
Existing layout with items to be demolished.

Proposed layout.

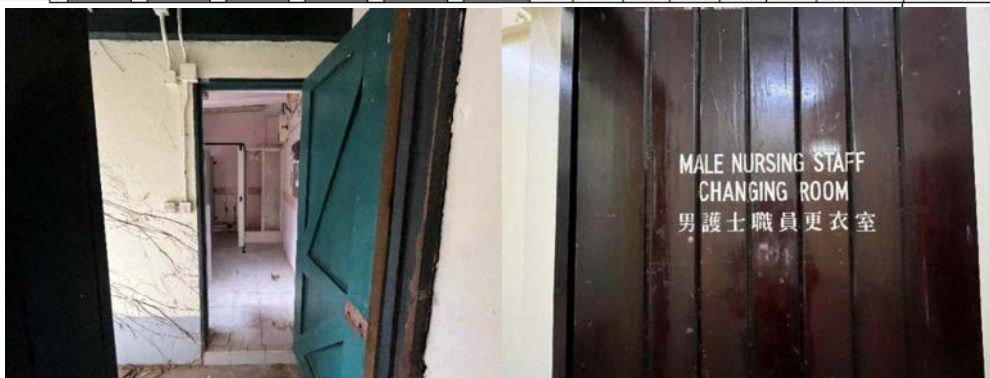
Category	Architectural Elements (Interior)
Proposed Work	Demolition Works & Builder's Works Removal of all existing sanitary fitments, plumbing pipes, and conduits. Installation of new sanitary fitments (wash basins, water closets, showers, urinals, sinks, mirrors) in toilets, with associated plumbing connections.
Reasons for Work	To install modern sanitary fitments and plumbing systems that meet current standards for office use.
Affected CDE	None
Impact Grading	Not applicable. <i>The fitments, pipes and conduits do not contribute to heritage value.</i>
Mitigation Measures	<ul style="list-style-type: none"> • Ensure new fitments are installed in a way that avoids structural changes to the original layout. • Use non-invasive methods to remove old plumbing, minimizing impact on surrounding heritage fabric.

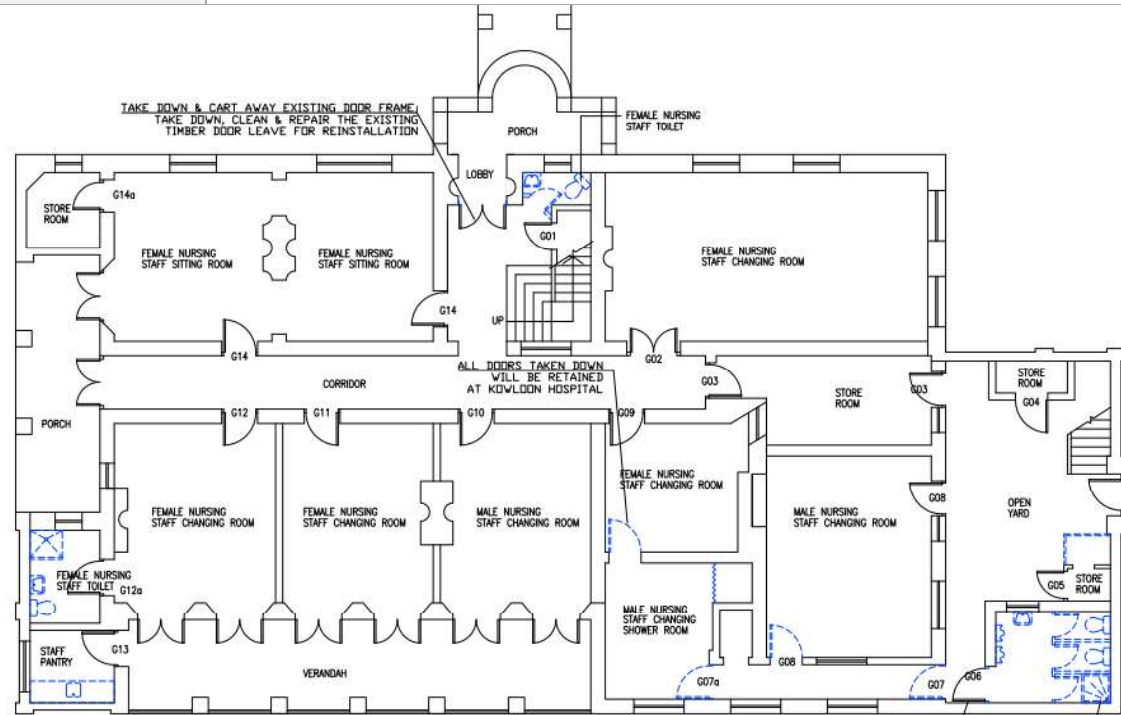
Category	Architectural Elements (Interior)
Proposed Work	Demolition Works & Builder's Works Removal of existing sink cabinets and timber shelves in the existing staff pantry. Installation of new sink cabinets with stainless steel sinks, solid surfacing countertops, and plastic laminate finishes on new pantry.
Reasons for Work	To accommodate new office layouts and install modern furniture, removing outdated fixtures.
Affected CDE	None
Impact Grading	Not applicable. <i>Shelves are likely modern or non-significant.</i>
Mitigation Measures	<ul style="list-style-type: none"> • Disturbance to the adjoining historic fabrics shall be minimized. • Ensure new cabinets are freestanding and reversible, avoiding structural changes to the functional rooms' layout.

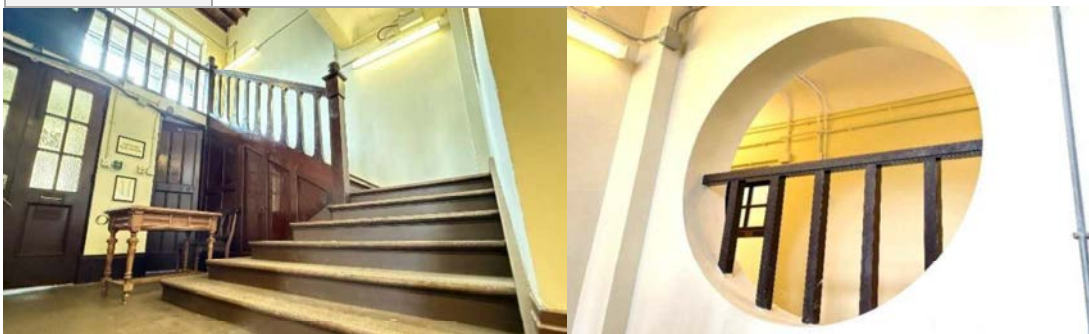
Category	Architectural Elements (Interior)
Proposed Work	Upgrading Works for Statutory Compliance Apply fire retardant paint the on surface of the entire staircase.
Reasons for Work	To enhance fire safety to comply with the current statutory requirements.
Affected CDE	Grand timber staircase, including its timber steps, handrails, and balusters (AI01, Exceptional); Circular wall opening with timber rails next to the timber staircase (AI02, Considerable)
Impact Grading	Acceptable Impact with Mitigation Measures. <i>These upgrades introduce reversible additions to the timber staircase with minimal impact on its core structure and historic character but are still reversible and do not alter the staircase's fundamental design.</i>
Mitigation Measures	<ul style="list-style-type: none"> Retain the original timber structure and design of the staircase, ensuring preserve its historic appearance after paint application.
