**N439**

**No. 3 Nam Kok Road, Kowloon City, Kowloon**

擬議三級歷史建築  
Proposed Grade 3

**Historic Building Appraisal**  
**No. 3 Nam Kok Road,**  
**Kowloon City, Kowloon**

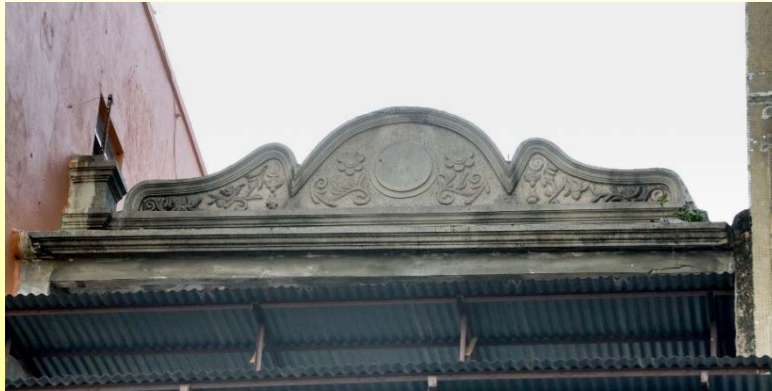
屋頂矮牆  
Roof parapet

The building at No. 3 Nam Kok Road is three stories high. Supported by two square columns, the verandah on the first floor projects over the pavement to form a covered walkway in front of the shop. The top floor is recessed and features a balcony. The front facade of the building is extensively decorated, but it is the roof that stands out, as it was delicately designed with a triple-curved pediment, featuring a central sun motif and symmetrical floral motifs on either side. Floral shaped grilles once decorated the balustrades of the verandah and the balcony, but those on the verandah have mostly been *Architectural Merit*

covered with cement, while the bottom half of the grilles on the balcony is also partially covered, leaving only the top half visible. Other ornamentation includes the moulded column capitals on the ground and first floors, and a row of dentil mouldings, typically found in Greek architecture, below the balcony. Atop the right column of the balcony on the top floor is an intact floral tassel moulding. The shop front on the ground floor features a large sign bearing the name “怡順榮機器五金”, a reminder of the metal hardware store that once occupied the premises. Two rows of metal window grilles featuring elaborate scrollwork relief in timber frames can be seen above the shop entrance at the cockloft level; the shop front, meanwhile, is protected by a sliding iron gate. To the right of the shop entrance, a metal gate prevents access to the long and steep concrete staircase that leads to the building’s upper floors. The staircase has metal handrails along either side, while the treads are finished with timber boards.

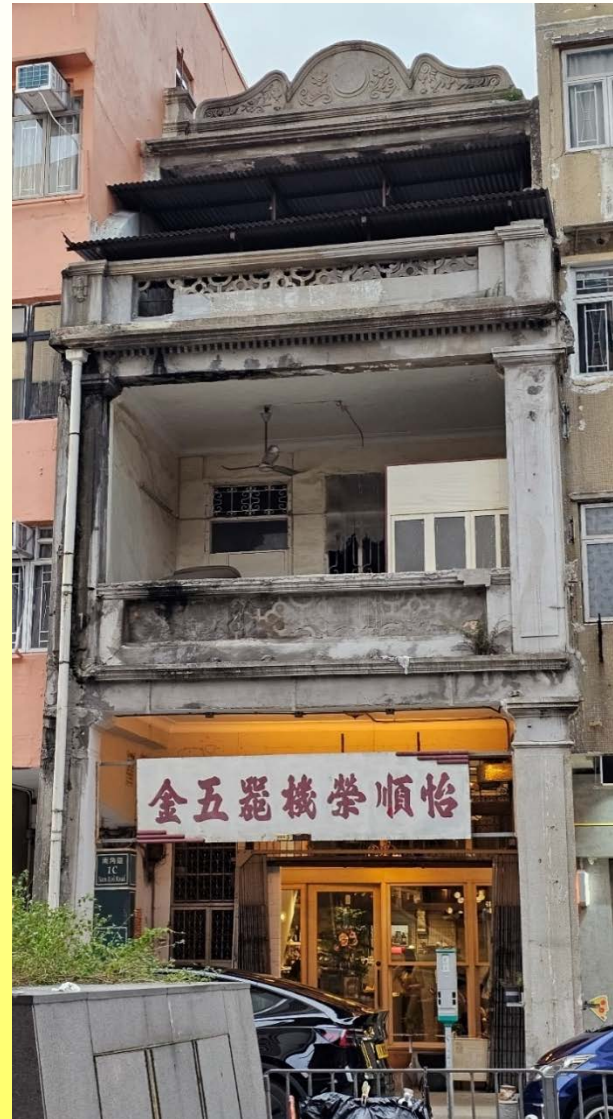
正立面  
Front elevation

The exterior of the building at No. 3 Nam Kok Road has largely retained its authenticity, although some alterations have been carried out over the years. For example, some of the mouldings on the right columns on the ground and first floors of the building have been removed to make way for a drainage pipe, with the result that the decorations on either side of the columns in the front elevation no longer appear symmetrical. Besides, the floral patterns on the verandah and balcony have been partially covered. Otherwise, the roof pediment is well-preserved and the verandah on the first floor, which was previously enclosed by windows, has been opened up again, as in the original design.<sup>10</sup> Even though the metal hardware store ceased operation in the early
