## Preservation of Nine Rock Carvings in Hong Kong

### A Consultancy Study of Ancient Rock Carvings

William Meacham Jan. 10, 2010

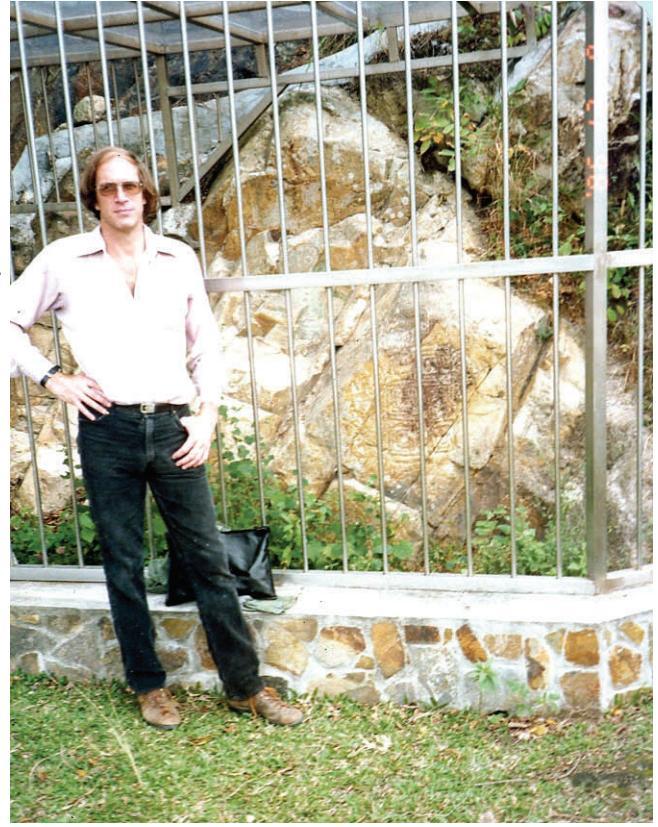
> The former cage at Shek Pik, photo taken in 1980s (?). Copyright William Meacham; All Rights Reserved.

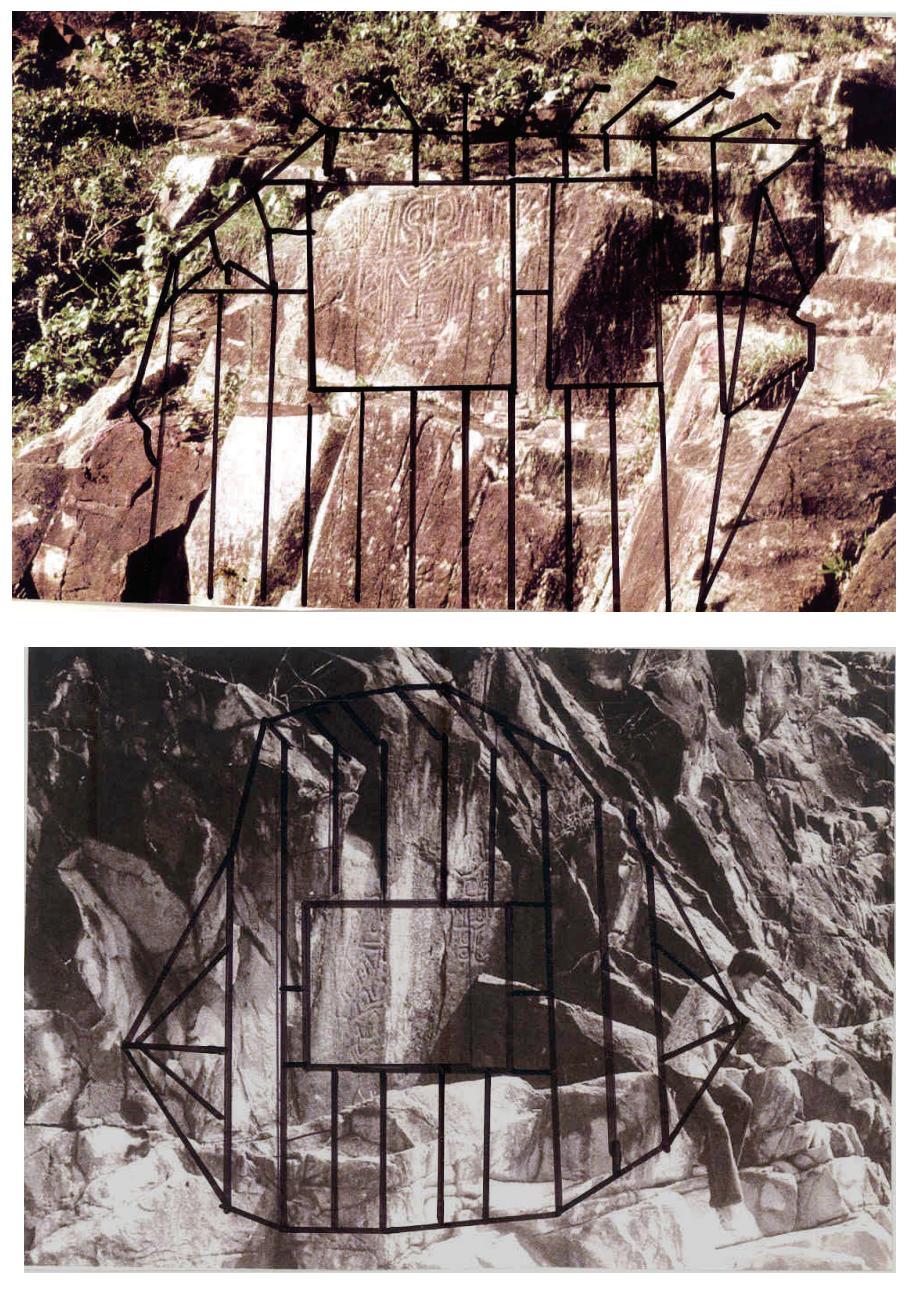
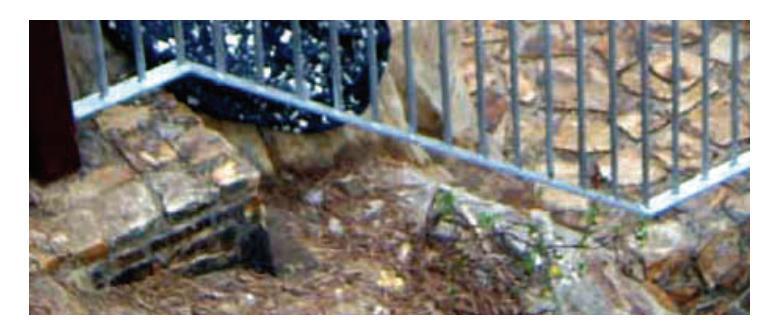
Above — Sketches of how simple metal frames could provide protection and appreciation of the original setting of the rock carvings. Below — The metal frame at Big Wave Bay rides over the contours of the rock and is only secured at the corners.

Basic cage-type structures as depicted in the two (very rough) drawings below would suffice, allowing for the visitor to take in the setting all around with minimal distraction. A single 1 x 1 metre window of bullet-proof glass of the type now at Cheung Chau would provide a good view and photo opportunity without creating a microclimate inside. The entire structure could ride over the natural rock surfaces as does the cage on each side at Big Wave Bay, being secured only at the four corners, with thus minimal instrusion on the rock outcrop.

The metal structure need not be of expensive or high quality metal, as its purpose is to deter the random miscreant from an impulsive act of graffiti or vandalism. Even high-grade steel would not stop someone armed with bolt cutters or hacksaw. The top of the structure could be of wide metal mesh, allowing all natural elements in but keeping mischievous people out. And there would be very little weight on the vertical bars.

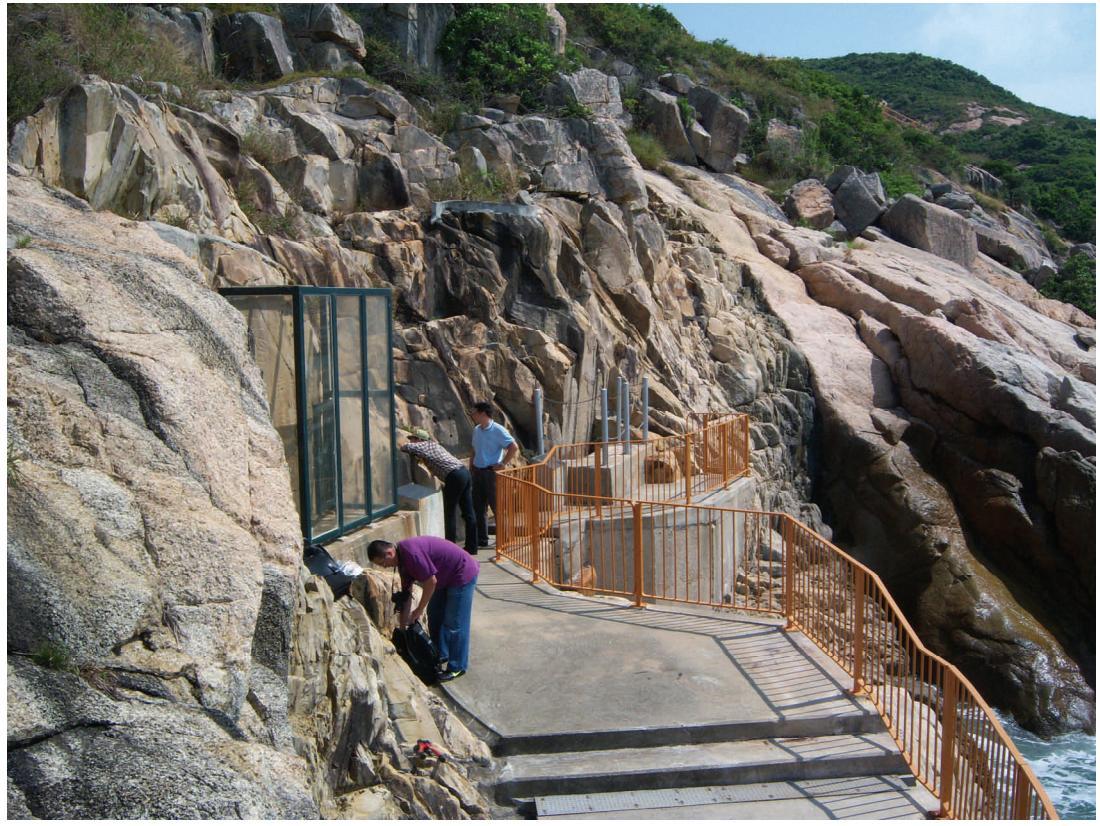
From these roadside display stands:

This would be a difficult task, and would surely leave the original rock with scratches and scars. Not all of the concrete could be removed from the nooks and crannies. But over time the rock surface would weather, and the remaining concrete would become less firmly attached and could be removed, bit by bit. The end result would certainly justify whatever minor damage is done to the rock in the short term. It is the price that needs to be paid for past mistakes.

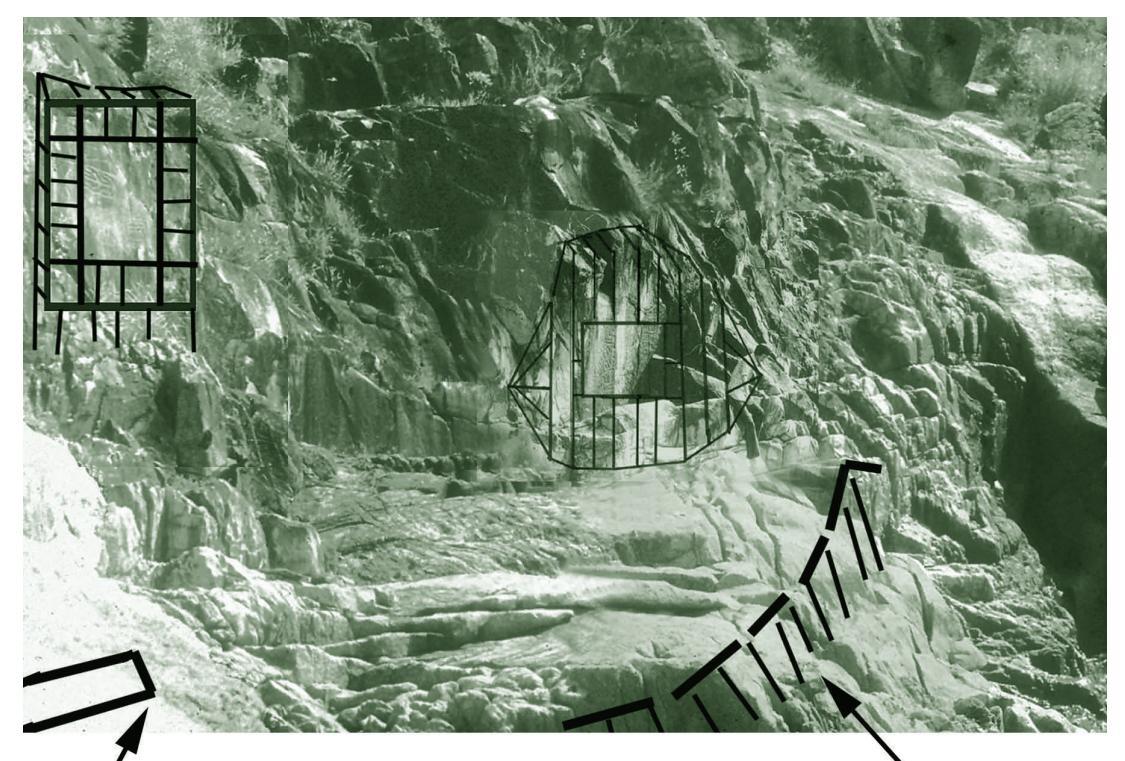
To this archaeological site:

concrete path ends

handrail at edge of rock platform

This viewing experience would be enhanced by the feeling of being out in the air, over the water, and face-to-face with Bronze Age art. For special group visits, entry into the enclosure would allow close inspection of the carving from the low flat boulder in from—the very spot where it was executed and admired by the ancient people.

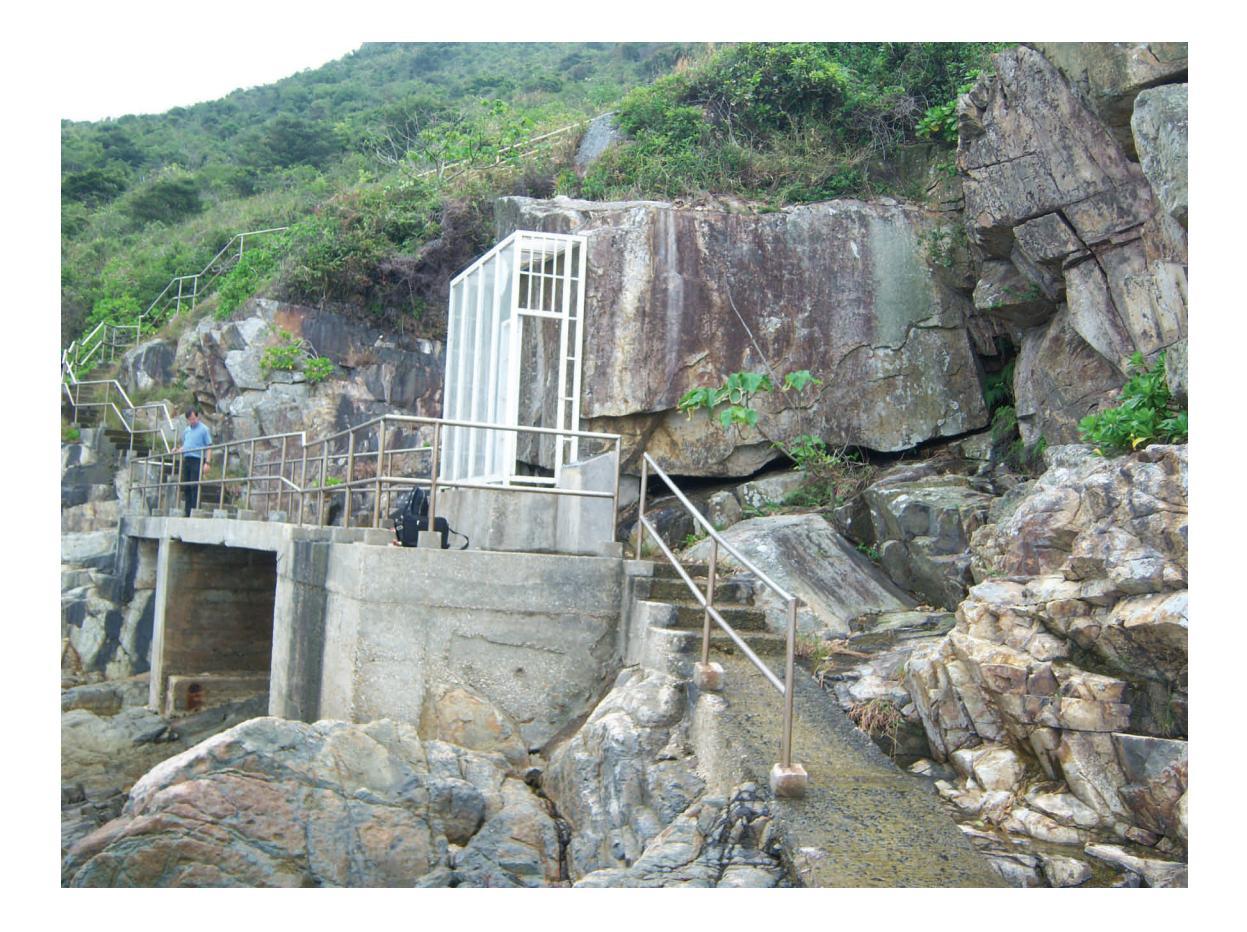
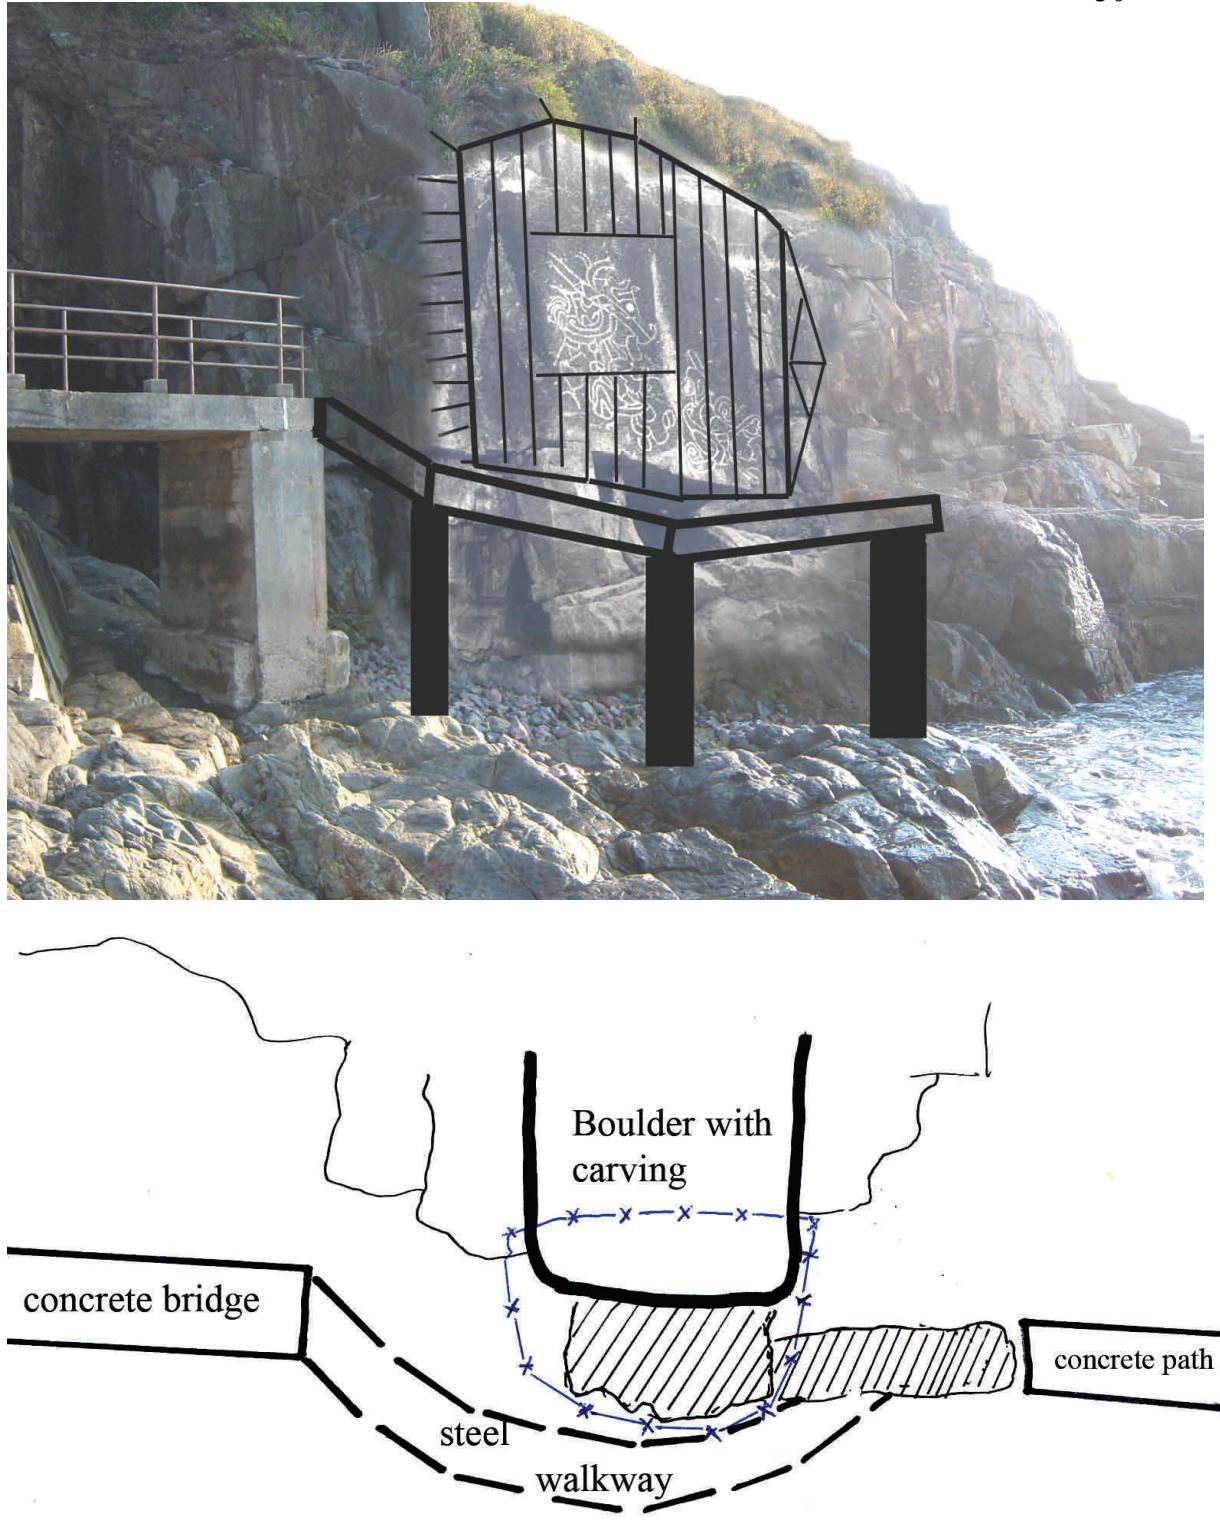
Above— Old and new photos combined to indicate how Tung Lung might look after restoration to its original state, with only a simple protective metal frame and elevated walkway.
