Development Projects/Cases related to Preservation of Historic Buildings
(Progress as at 15 November 2022)

LATEST TECHNICAL APPRAISAL FOR BLOCK 4 THE CENTRAL POLICE STATION COMPOUND

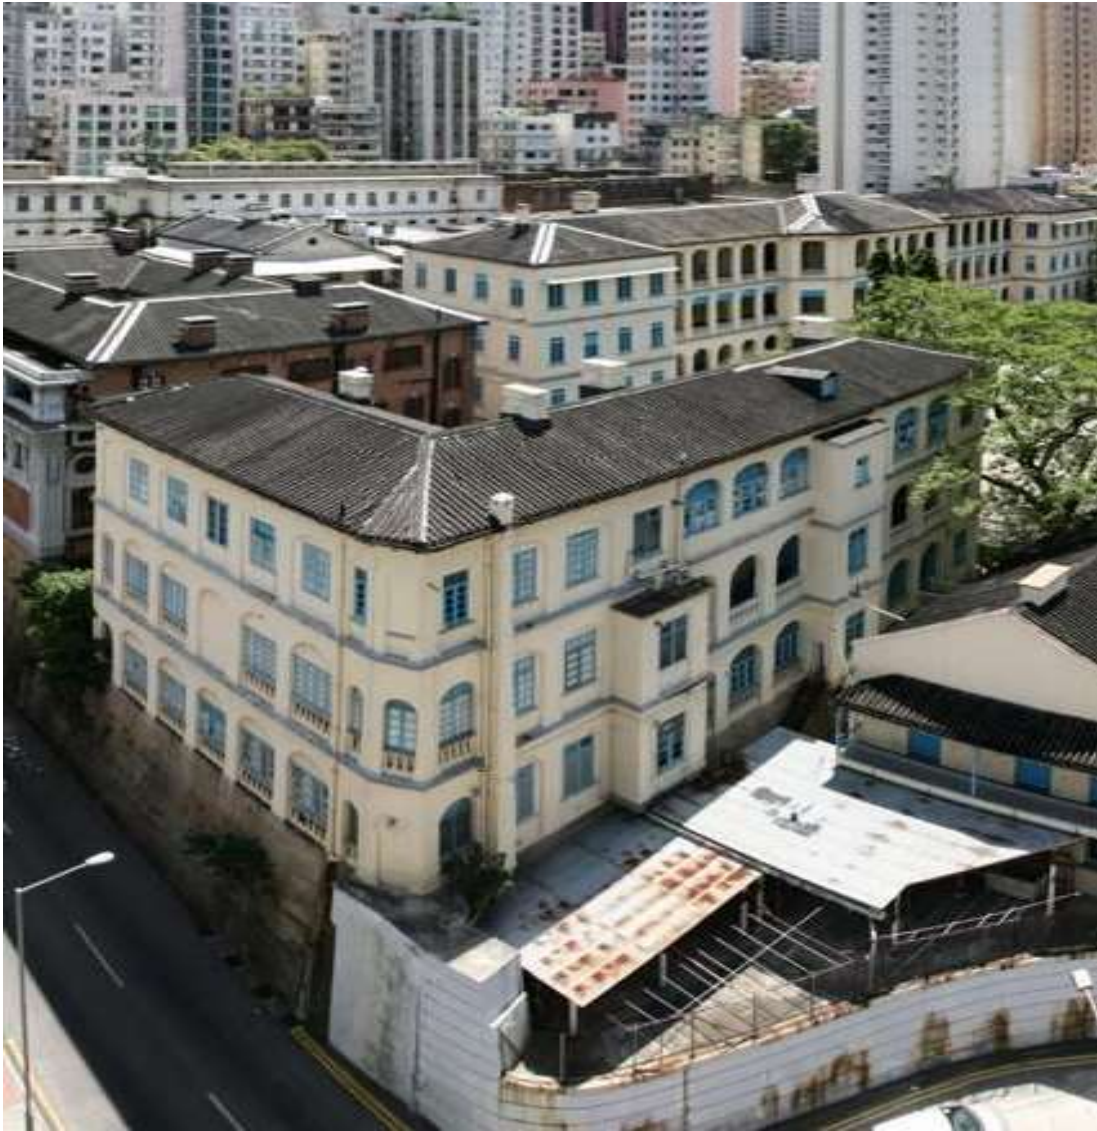
5. Block 4 was constructed in 1862–64. Its construction form followed that of traditional British architectural styles but was modified to suit Hong Kong’s sub-tropical climate. On the north and east façades (Figure 3), there are large arched openings between brick piers, and high ceilings, all intended to aid ventilation in the hot and humid weather. The building is roofed in Chinese clay tiles that are heavier than British tiles or slates.

Figure 3 – Block 4 before partial collapse. The design provides relatively tall ceiling heights and large window openings to aid ventilation in the hot and humid climate of Hong Kong, resulting in large arched openings with brick piers in between on the north and east façades

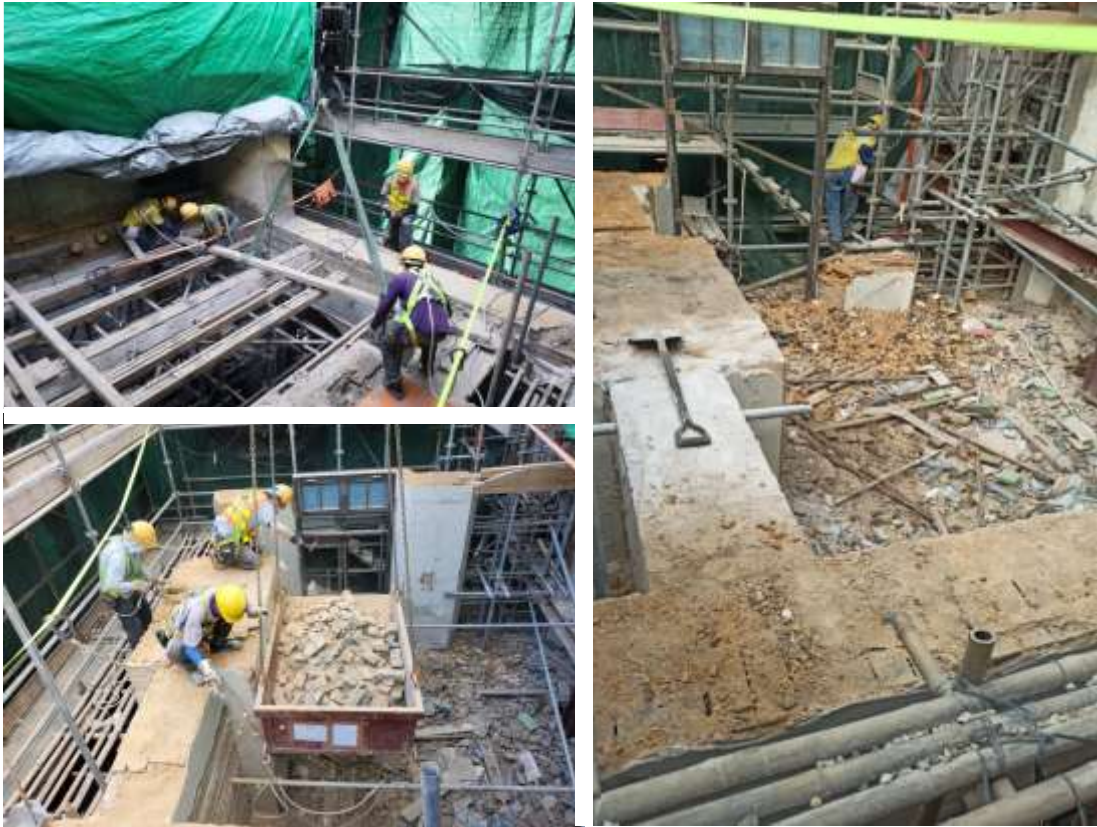
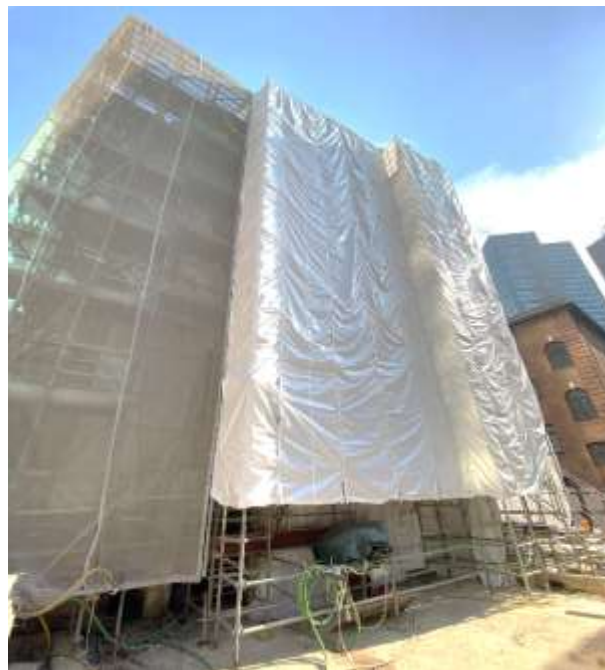
8. Preparatory work necessary to enable the Updated Recovery Plan to proceed was carried out in 2020. It comprised the removal of roof tiles, roof timber trusses, brick walls and timber floors (Figure 6). It was carried out by a Registered General Building Contractor (“RGBC”), with qualified workers using hand tools in accordance with the industry best practice and work processes approved by government authorities.

Figure 6 – (a) Work-in-progress views of preparatory work (West Room removal)
(b) Completed preparatory work (West Room removal) in December 2020

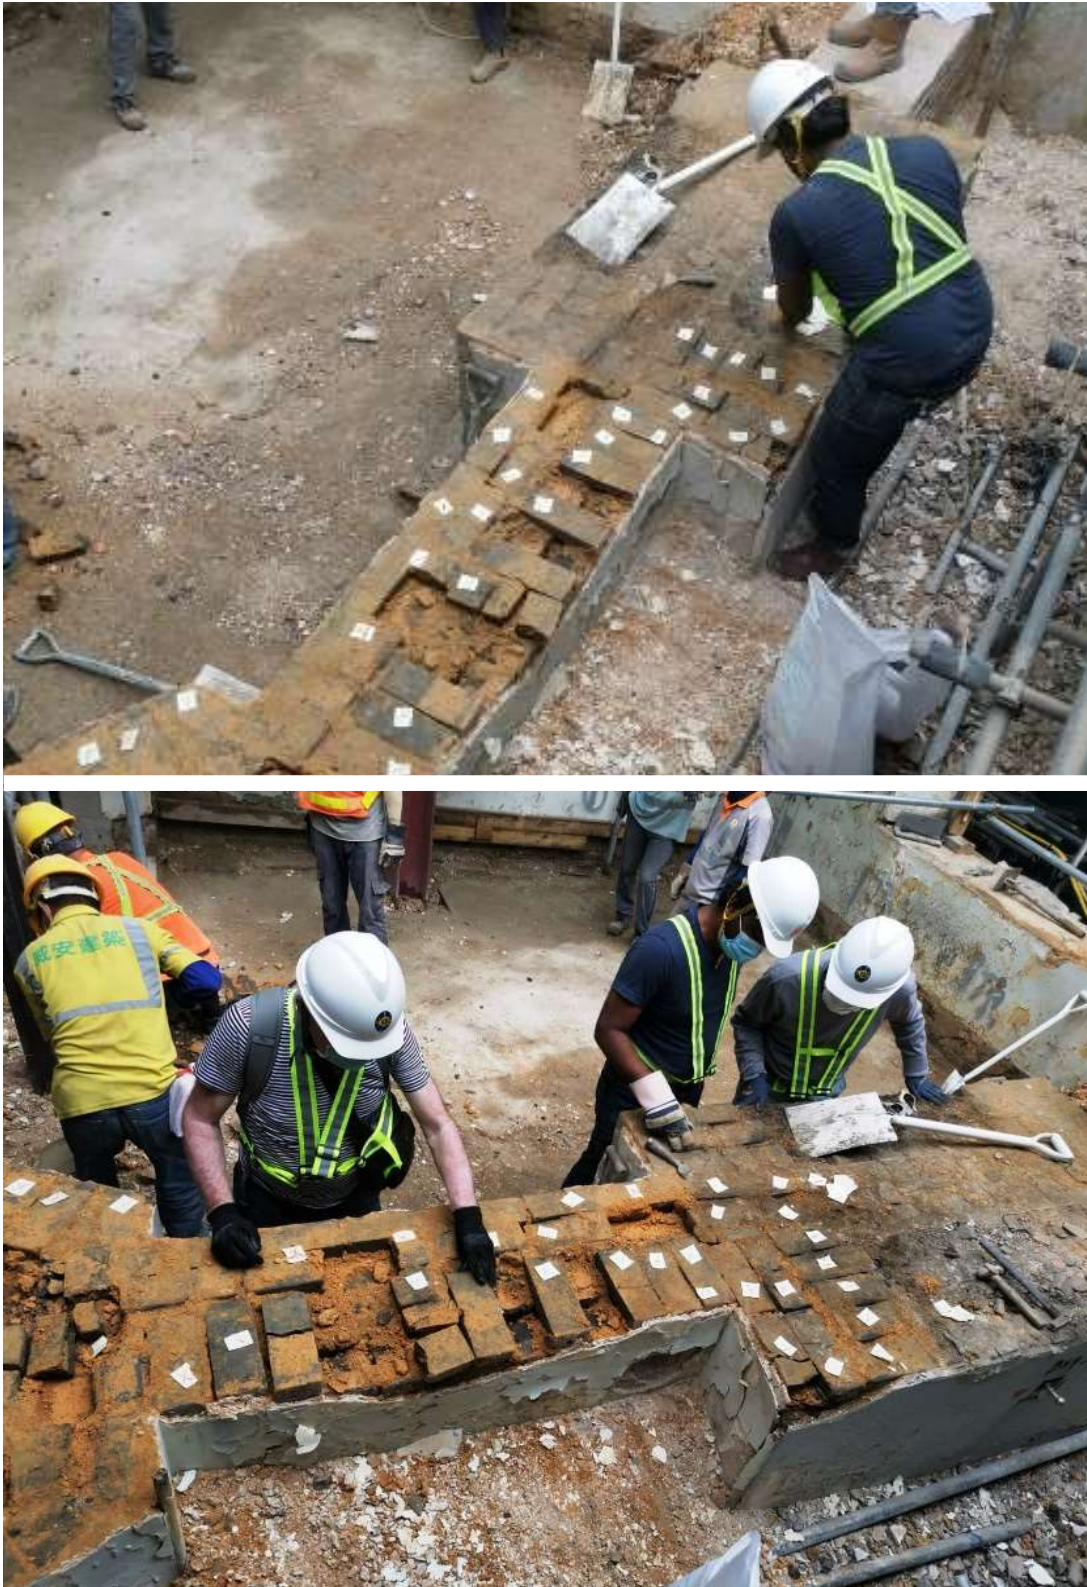
- *In-Situ Assessment of Brick Hardness* – Inspections of various brick layers, assisted by the use of hand-tools, in the walls of the West Room (Figure 10) revealed that approximately 75% of the bricks are very soft (Figure 11). The distribution of these bricks is random.

Figure 10 – Layer-by-layer inspection of brickwork during removal of the West Room by Purcell and Arup

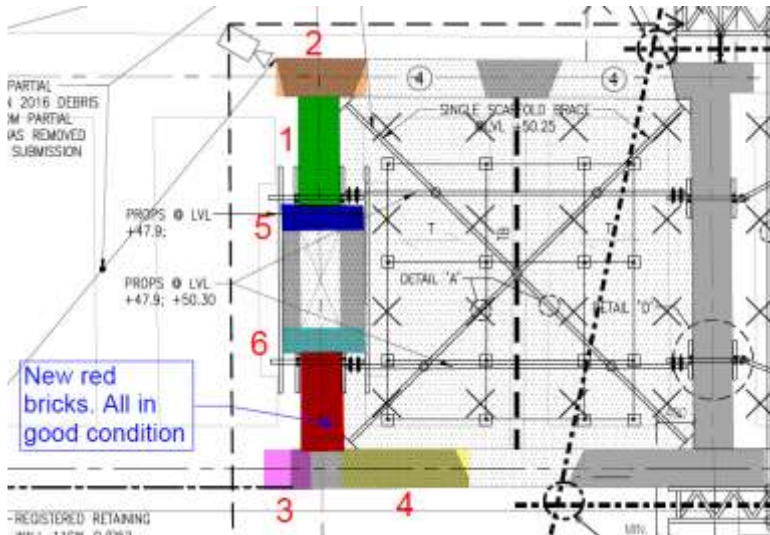
Wall layout plan of West Room.

The two images below show brick inspection findings (soft and non-soft bricks) at wall locations [1] and [6]

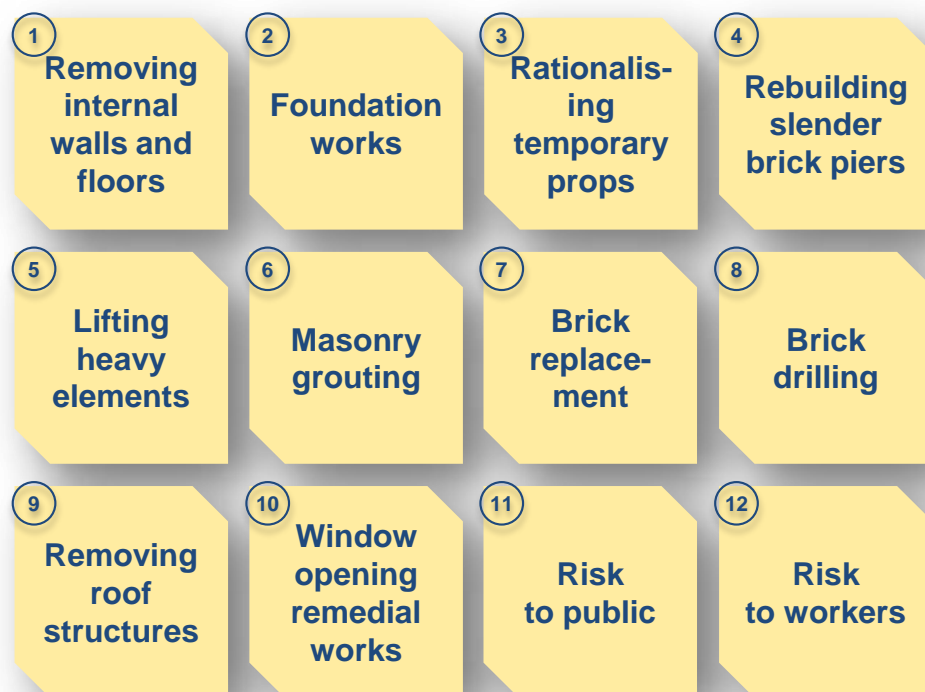
19. PAYE has assessed the risks associated with the building operations required to restore the building, which shows that:
- Of the twelve operations evaluated (Figure 21), all are considered High Risk in the initial risk rating;
 - After introducing mitigation measures, the risk level of three items can be reduced to Medium Risk; and

Figure 21 – Twelves operations considered in PAYE's standardised risk assessment

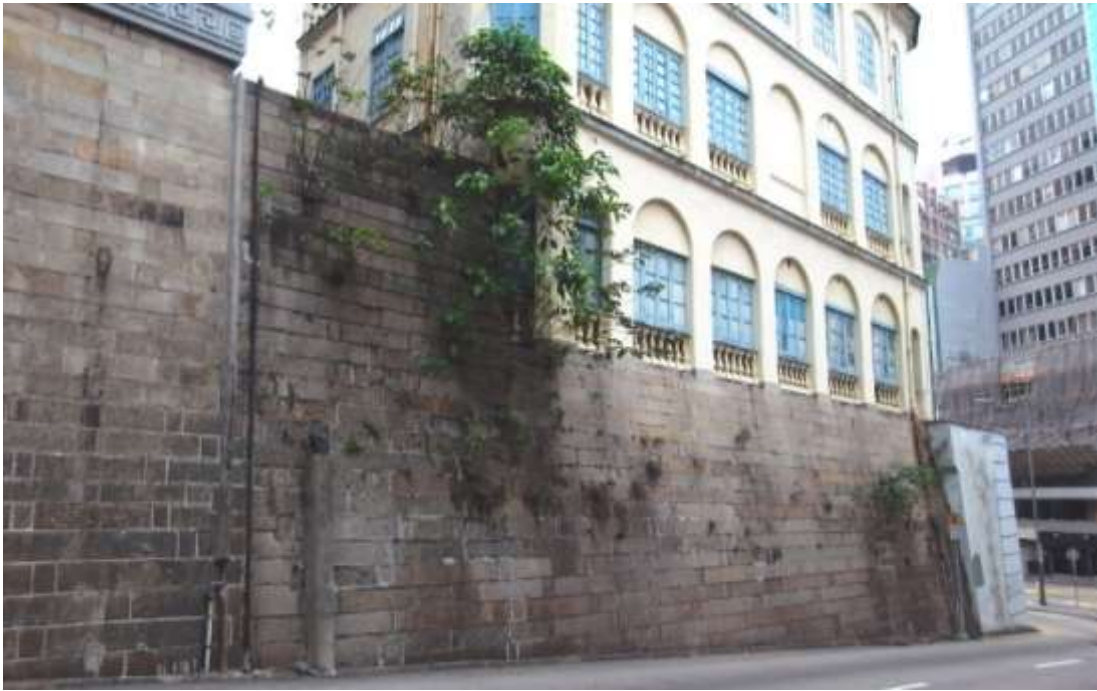
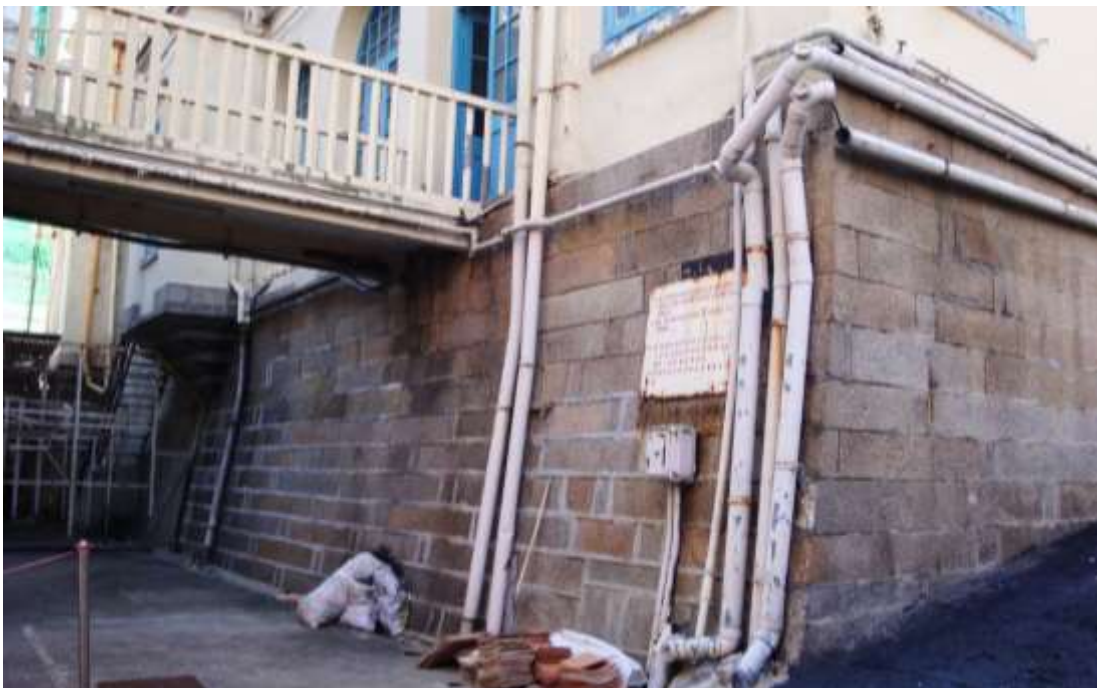
Figure 23 – Granite retaining walls being retained in both recovery options in “Ruins Approach”

25. In the meantime the Club seeks to remove only the historical fabric that is strictly necessary to make the building safe and to retain what remains as a relic. The precise extent of retained fabric will be subject to the structural expert's advice and permitted limits under the Building Regulations. What can be said at this stage is that the granite retaining walls facing Arbuthnot Road and the Sergeant's Yard (Figure 23) would be capable of retention. As to the superstructure and masonry wall foundations, it is envisaged that a series of defined stages of removal works will be completed, followed by inspections and testing to confirm the extent of historic fabric that could be safely retained. With public safety being the most important principle, the long-term safety performance of the masonry structure must be the primary criterion to determine the extent of building fabric that can be kept.
