與保護歷史建築物有關的發展項目／個案
(截至二零二二年十一月十五日的進展)

LATEST TECHNICAL APPRAISAL FOR BLOCK 4 THE CENTRAL POLICE STATION COMPOUND

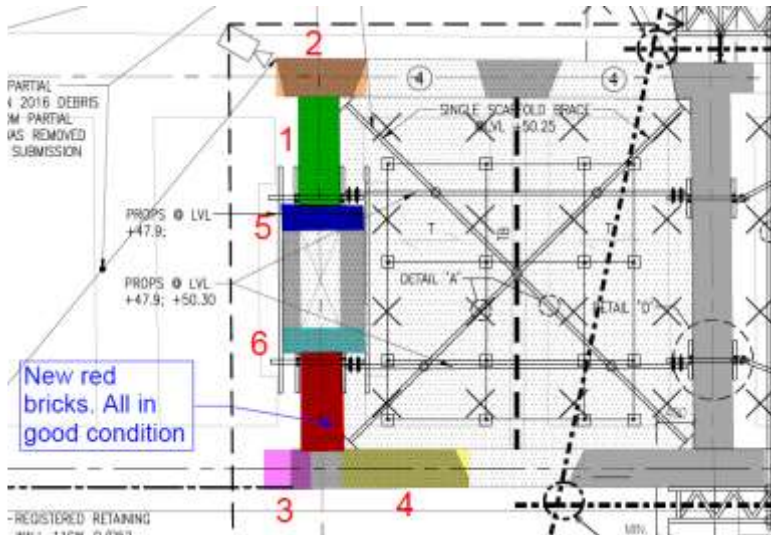
Wall layout plan of West Room.

- *In-Situ Assessment of Brick Hardness* – Inspections of various brick layers, assisted by the use of hand-tools, in the walls of the West Room (Figure 10) revealed that approximately 75% of the bricks are very soft (Figure 11). The distribution of these bricks is random.

The two images below show brick inspection findings (soft and non-soft bricks) at wall locations [1] and [6]

Figure 11 – (a) Approximately 75% of the bricks in random locations were considered soft (“X” Soft brick; “O” Not soft brick)
