AGREEMENT NO. CE 20/2020 (CE) - SITE FORMATION AND INFRASTRUCTURE WORKS FOR PUBLIC HOUSING DEVELOPMENTS AT MA ON SHAN TSUEN ROAD – INVESTIGATION, DESIGN AND CONSTRUCTION

Heritage Impact Assessment Report (Final – Issue3)

PROJECT NO.: 2512216A

DATE: JUNE 2023

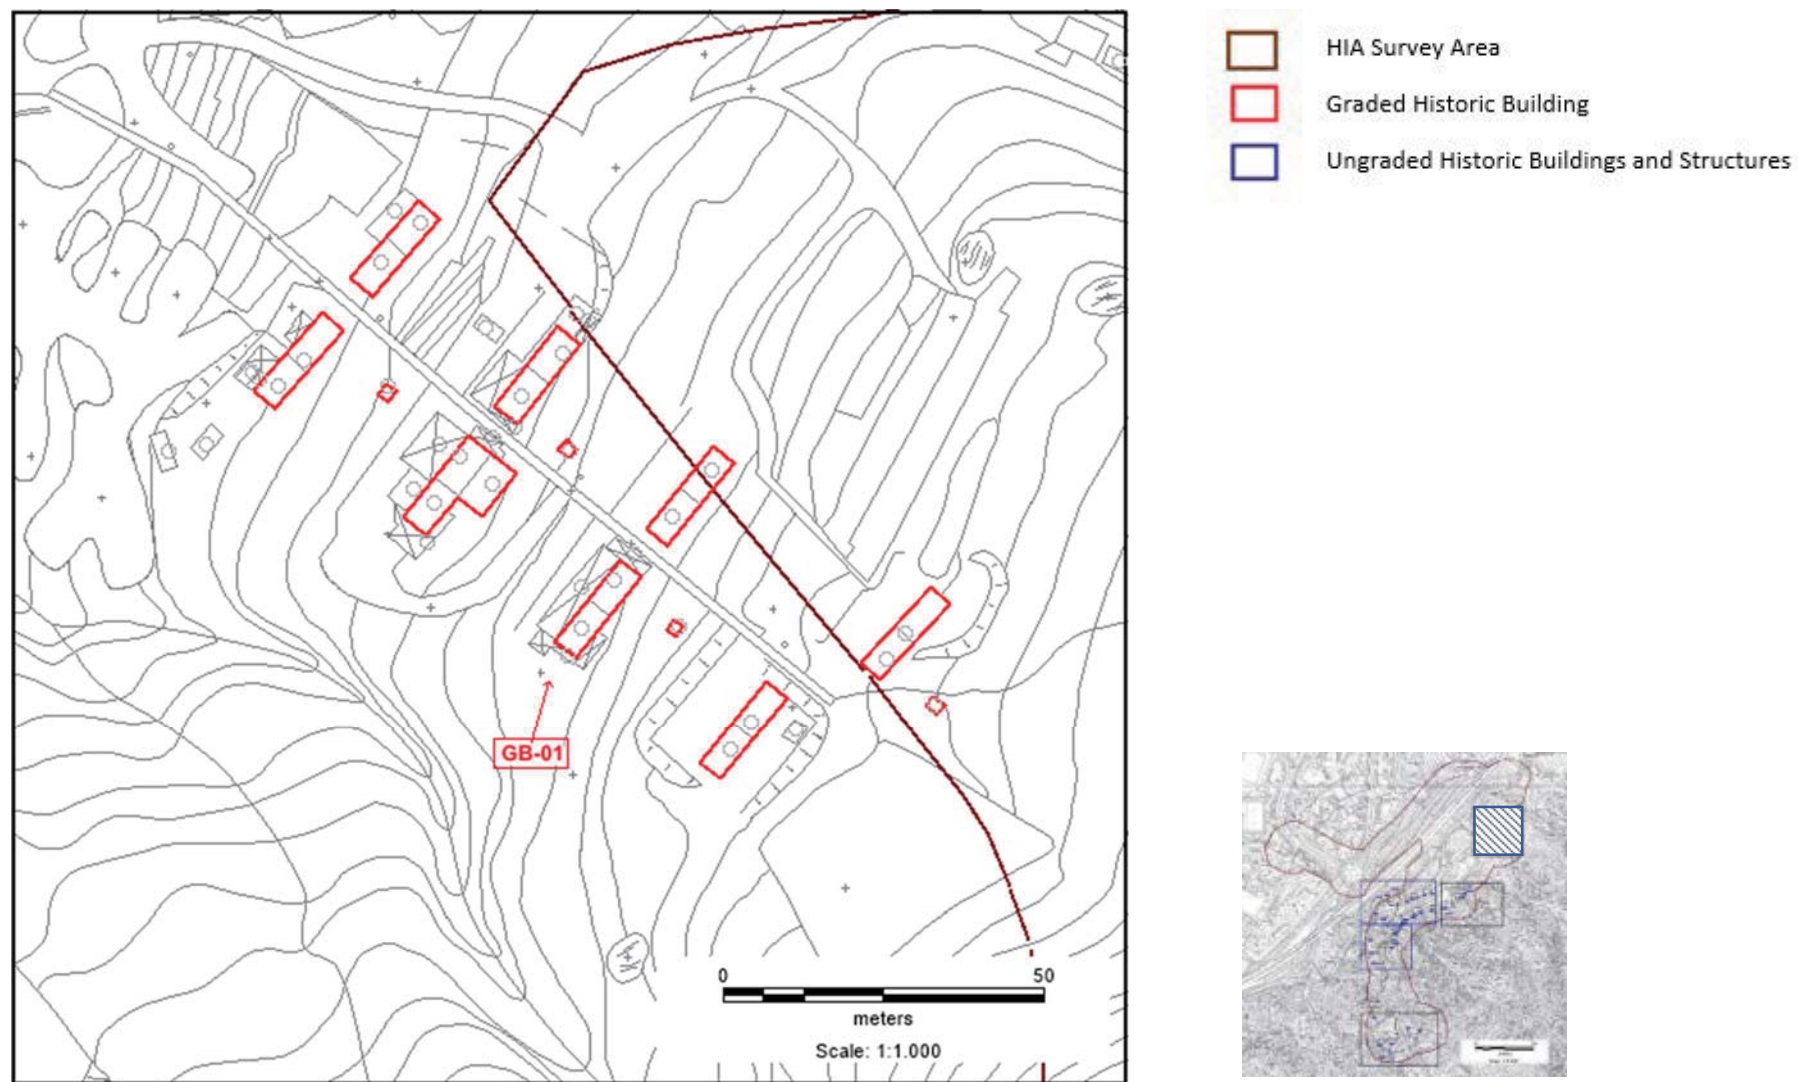
Figure 1 GB-01 Serial no. N245 – the Site Structures at Mining Settlement (Shun Yee San Tsuen), Ma On Shan Iron Mine, Sha Tin, N.T.
Grade 3 Historic Structure

GB-01 Serial no. N245 – the Site Structures at Mining Settlement (Shun Yee San Tsuen), Ma On Shan Iron Mine, Sha Tin, N.T. Grade 3 Historic Structure (**Figure 1**)

Heritage Site	Heritage significance	Potential works and distance from heritage site	Significance of affected heritage elements	Assessment
(Figure 1)				
	Shun Yee San Tsuen comprises eight rectangular residential units in two rows. With each unit consisting of two homes. They were built in the 1961 by the Lutheran missionary to rehouse some church members who were miners and had their houses destroyed by heavy rainstorms. The residential units are connected to the Graded Lutheran Yan Kwong Church and the mining landscape. The use continues to be residential.	Works are proposed to the north, west and south of the settlement. Platform and retaining wall works at a minimum distance of <u>14m</u> (to west of heritage site), bored pile wall to northwest <u>at 64m</u> and slope and bored pile wall work to north <u>at 67m</u> . Drawing No. CE20/00/GN/1013	The residential housing has group value with the Church and mining structures. The significance of the Grade 3 the Site Structures at Mining Settlement (Shun Yee San Tsuen) is deemed <u>MODERATE</u> .	The proposed works are located in very close proximity of the residential settlement and the setting of the units may be degraded. Visual impacts will not be able to be avoided due to the proximity of the housing development. The slope cutting works are in close proximity of the settlement units, in addition access to the units may be limited during construction phase. Potential impacts may arise from major earthworks and general construction, causing vibration, tilting and settlement and safe access issues. <i>Acceptable impact with mitigation</i>

<i>Individual structures belonging to the Ma On Shan Mining Landscape within Study Area</i>				
ID	Graded Historic Buildings			
GB-01	<i>Serial no. N245 – the Site Structures at Mining Settlement in Shun Yee San Tsuen, Ma On Shan Iron Mine, Sha Tin, N.T., Grade 3 Historic Structure</i>			
Grade 3 (Figure 1)	<p>Shun Yee San Tsuen comprises eight rectangular residential units in two rows. With each unit consisting of two homes. They were built in the 1961 by the Lutheran missionary to rehouse some church members who were miners and</p>	<p>Works are proposed to the north, west and south of the settlement.</p> <p>Works include: Platform and retaining wall works at a minimum</p>	<p>Landscaping works to ensure the setting of the settlement is not affected by the proposed housing development needs to be developed.</p>

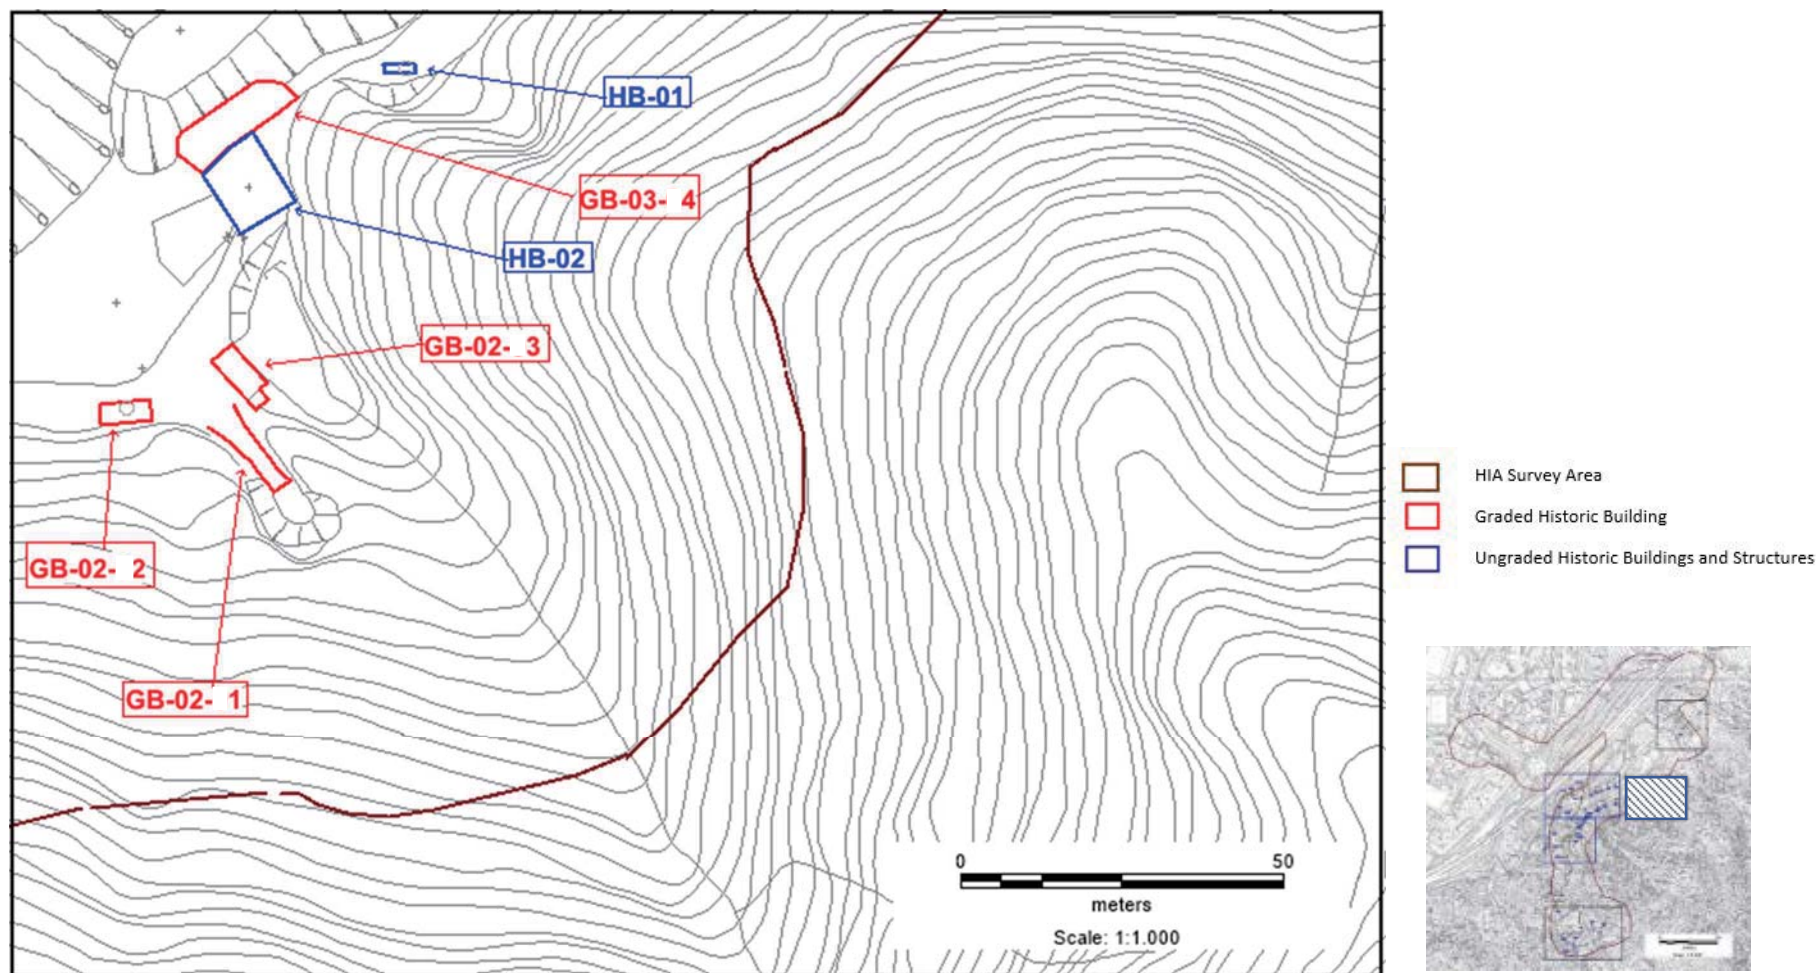
- 2.1.4 110 ML tunnel was constructed into the iron ore body in 1963 which allowed for fast delivery of raw ore to the mineral preparation plant which considerably reduced transportation costs and raised productivity. The tunnel portal is sealed off, but the exterior walls still remain in perfect condition and within the immediate vicinity some rails could still be seen. From the tunnel portal the ore would travel by rail to the mineral preparation plant to the southeast and a few remaining pillars connect the portal to the plant. The opening of this tunnel in close proximity of the coast was a significant development with cost saving implication.

- HB-01: Toilet marked on 1969 map (Ordnance survey 1969). **(Figure 2)**
- HB-02: Remains of building/location to store or repair ore bearing carts. (Ordnance survey 1969; Lands Department 1964). **(Figure 2)**
- HB-03: Electric transformer building **(Figure 3)**
- HB-04: Electric Sub-station. **(Figure 3)**
- HB-05: Stone foundation of a temporary structure visible on 1963 and 1964 aerial photos (Lands Dept 1963 and 1964). **(Figure 3)**
- HB-06: Collapsed building, function not known but is visible on 1963 aerial photo (Lands Dept 1963). **(Figure 3)**
- HB-07: Toilet built between 1969 and 1976 (Ordnance survey 1969 & 76). **(Figure 3)**
- HB-08: Concrete retaining wall with buttress. **(Figure 3)**
- HB-09A: Another pillar forming connection between 110ML portal and mineral

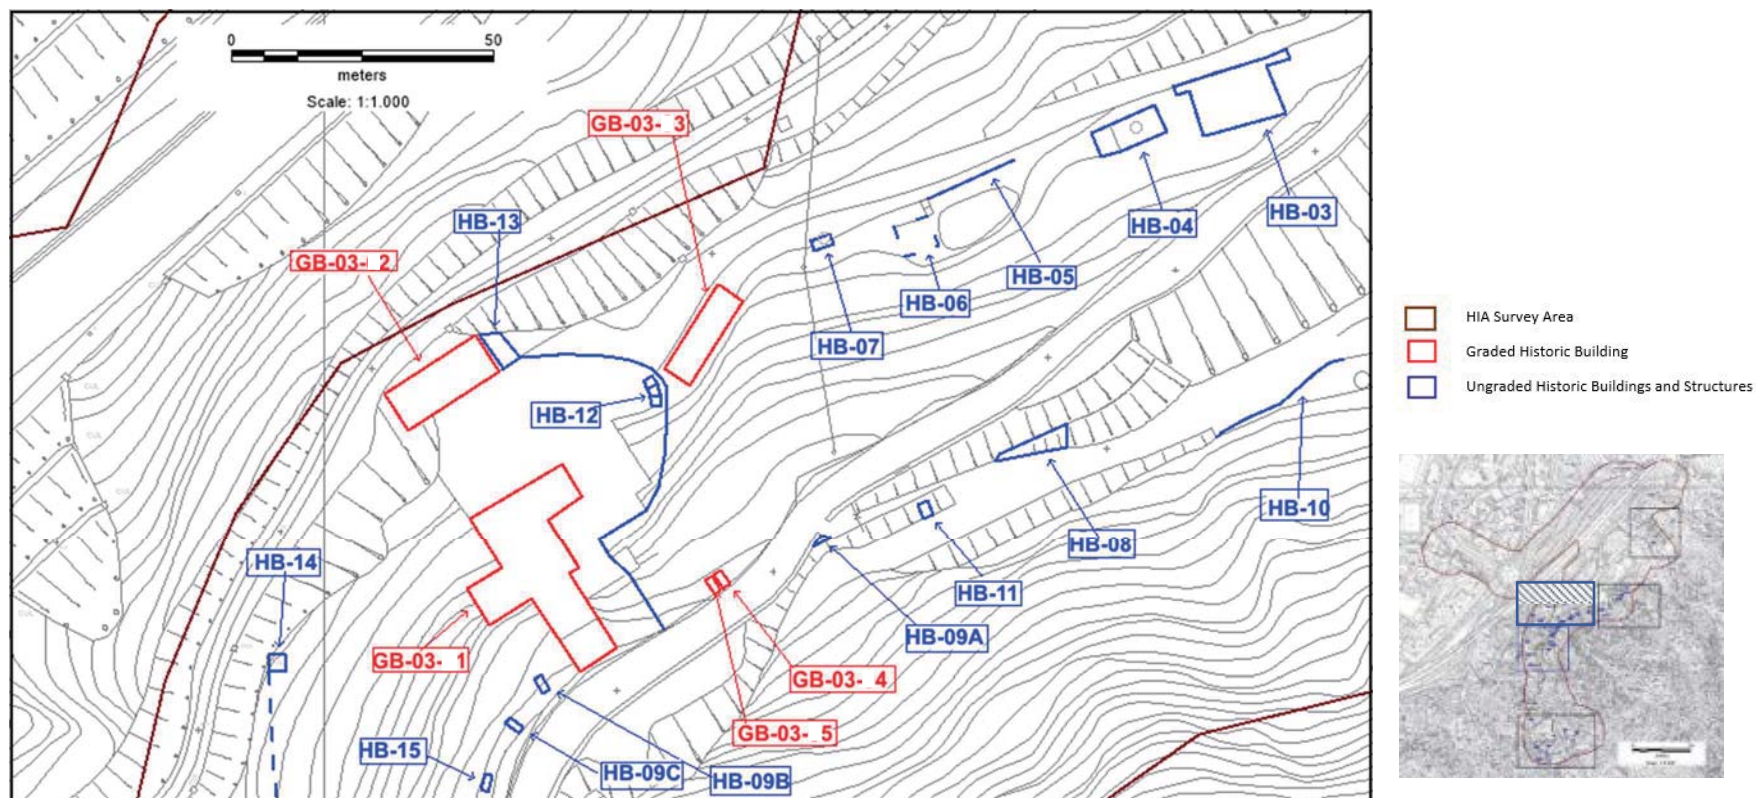
Figure 3

2.1.6 The Mineral Preparation Plant was installed in 1954 with expertise from Japan. The Mineral Preparation Plant is where the raw ore underwent crushing, grinding, etc. It transforms ore of low iron content into high grade concentrate ore and represented a significant shift in the mining production process. The reduction of bulk and shipping only the high-quality product resulted in significant reduction of freight cost. A second plant was set up in 1963. The plants have been abandoned, but traces of their structures were found scattered just below Ma On Shan Tsuen Road, it included several structures, pillars, and the upper structure has a chute. The buildings are connected by steps which are still used as a short cut from the Ma On Shan villages to Hang On and Yiu On Estates or Tai Shui Hang.

Serial no. N101 – Mineral Preparation Plant (1954), Ma On Shan Iron Mine, Sha Tin, N.T. Grade 3 Historic Structure; including **GB-03-1**: Main Mineral Preparation Plant building;

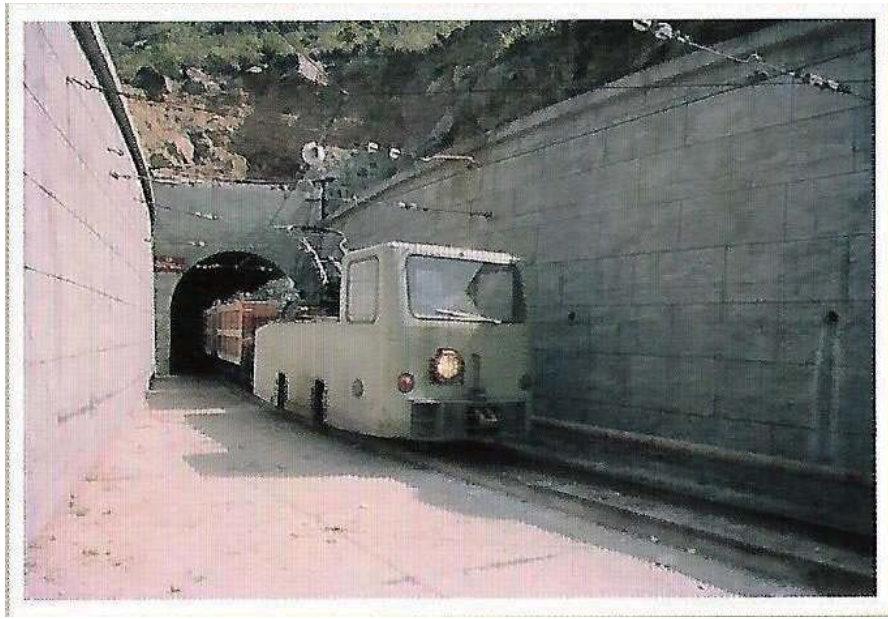
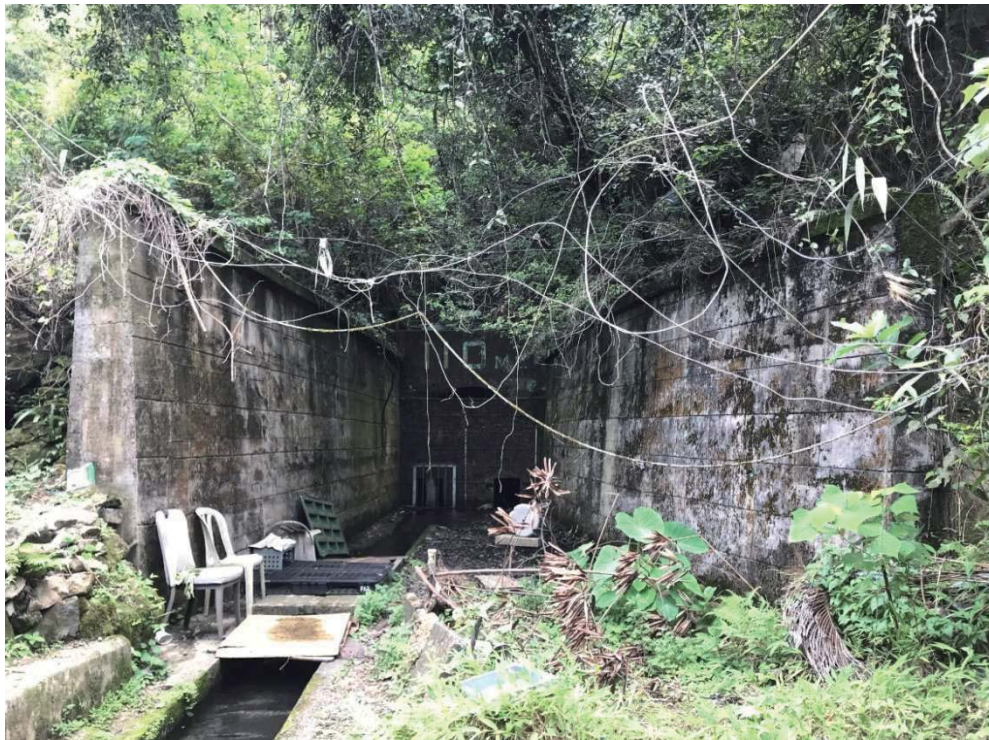
Existing Condition: the condition of the portal is obscured by the blocking wall but appears fair; the exterior wall of 110 ML despite its lack of maintenance is very good. The area with the track is under water.

Modifications: A coarse wall has been built across the entrance to prevent unauthorized access. Two rectangular openings have been left for drainage purpose. A fence was set in front of the sealed wall. Drainage channels previously built underground was exposed. Rail tracks and electricity wires have been removed.

GB-02-1 when in use (Source: 馬鞍山民康促進會, 2012, 57)

GB-02-1 general view

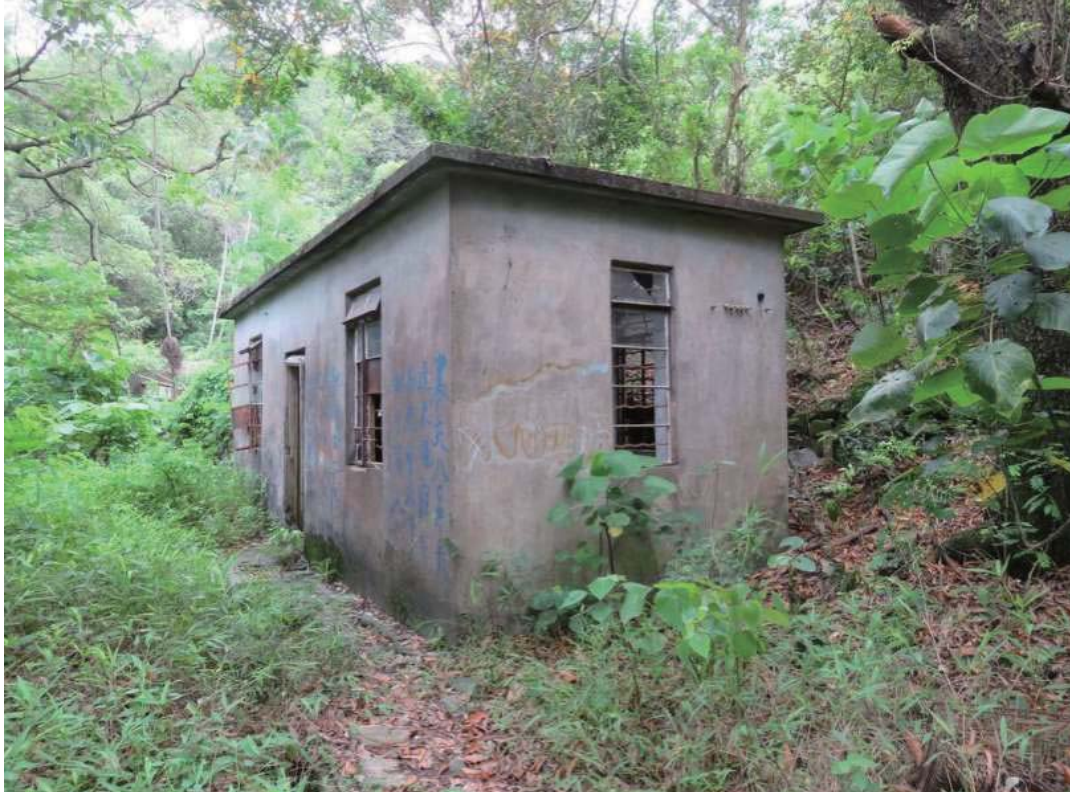
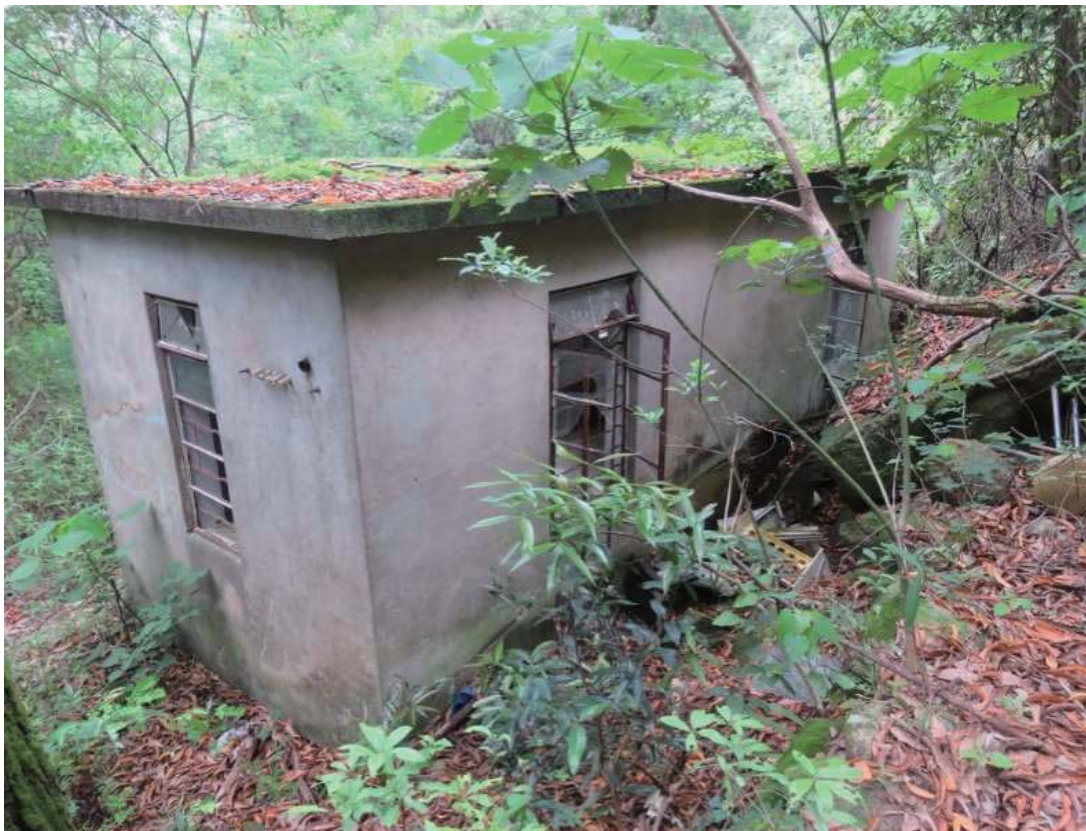
Interior: Walls, ceiling and ground intact; window glasses battered; wooden door damaged		
Existing Condition: Abandoned and some minor damage.		
Past and Present Uses: Industrial and now abandoned		
Modifications: Not observed.		
Photos:

GB-02-2 side view

GB-02-2 rear view

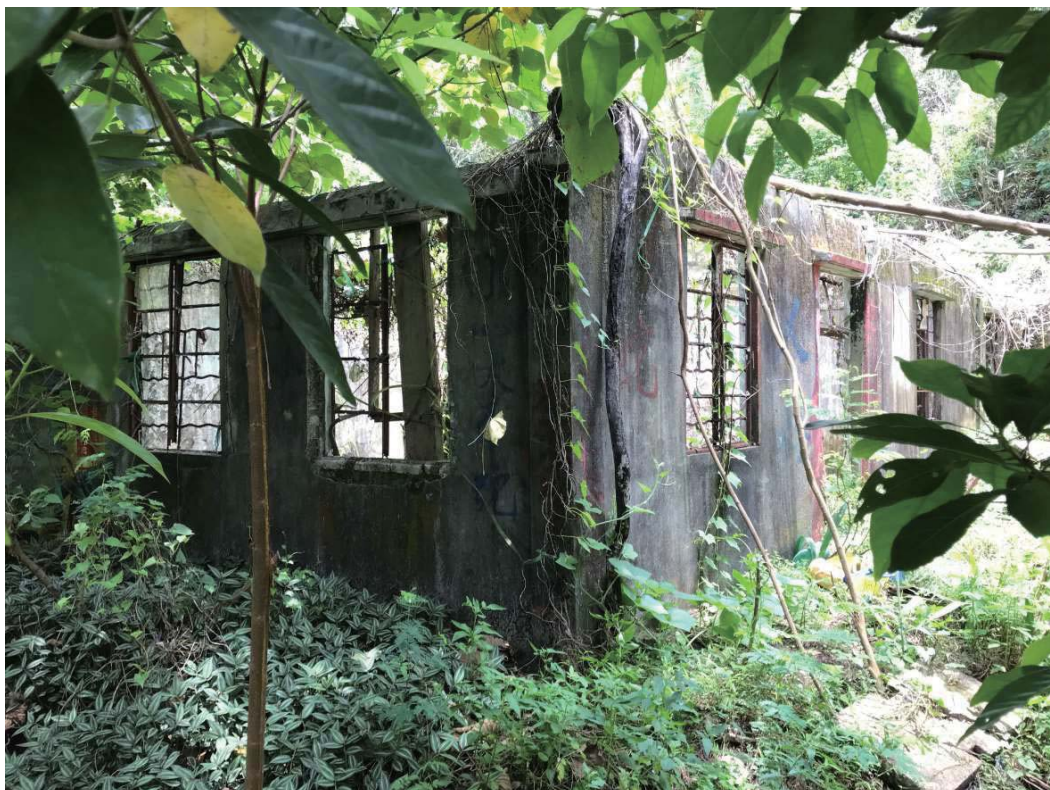
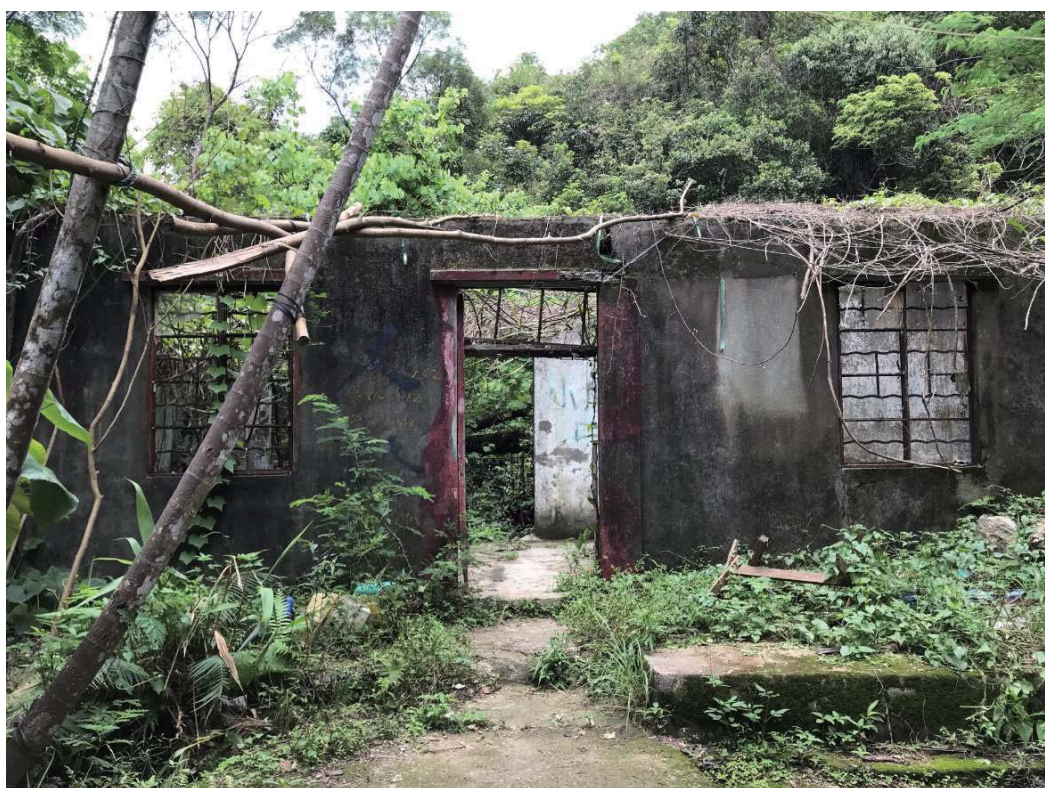
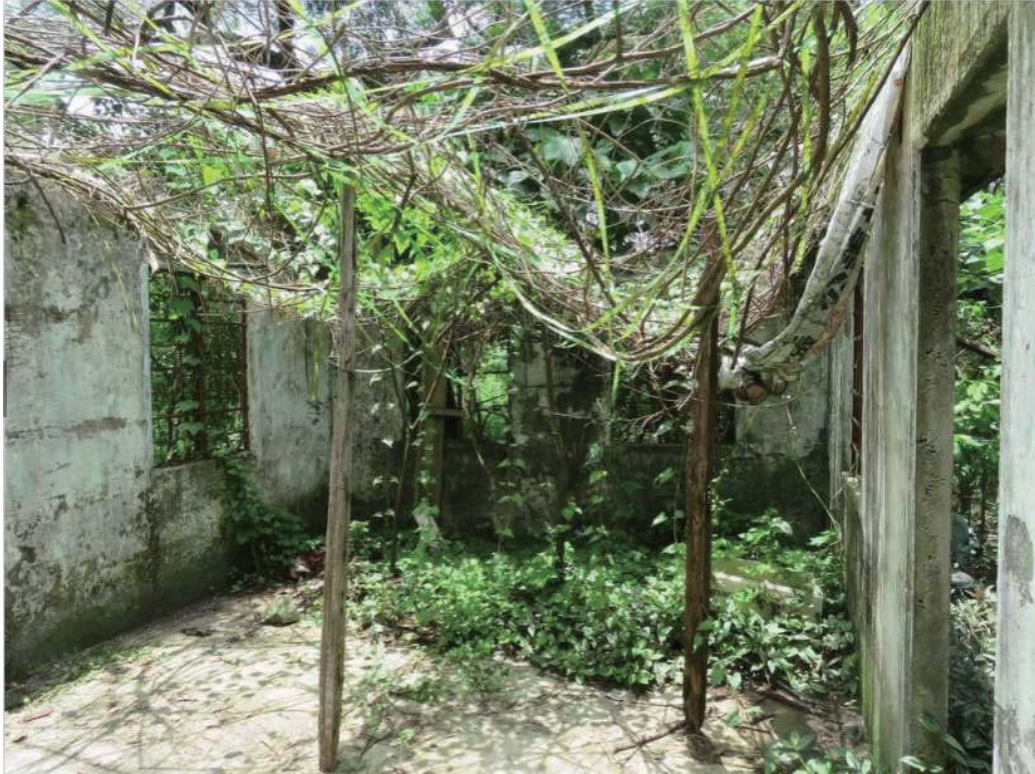
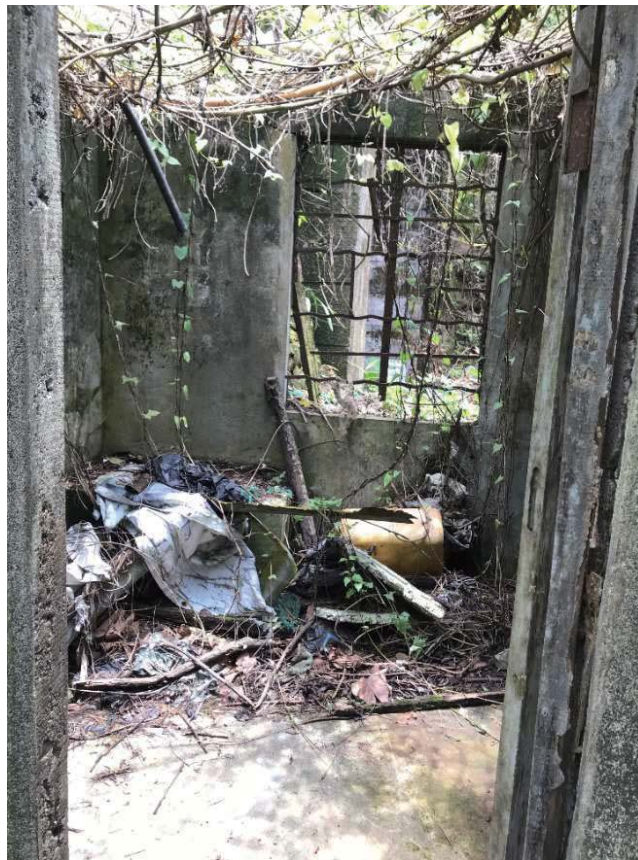
Interior: Walls and ground intact; ceiling and doors collapsed and window glasses battered.		
Existing Condition: Abandoned and partially damaged.		
Past and Present Uses: Industrial, now abandoned		
Modifications: N/A		
Photos:

GB-02-3 side view

GB-02-3 façade

GB-02-3 internal views

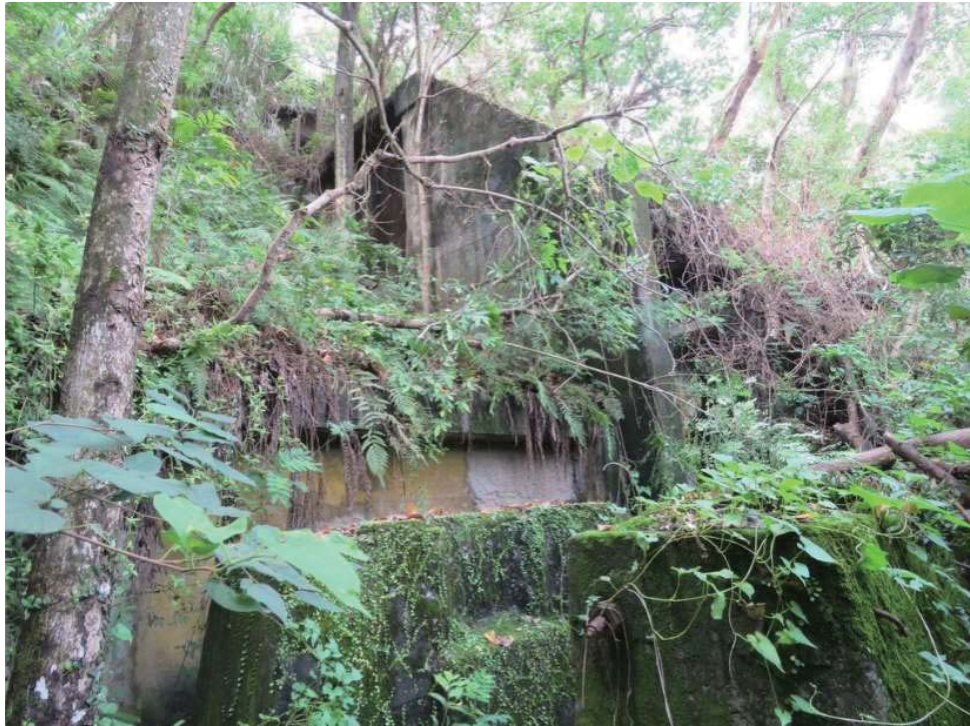
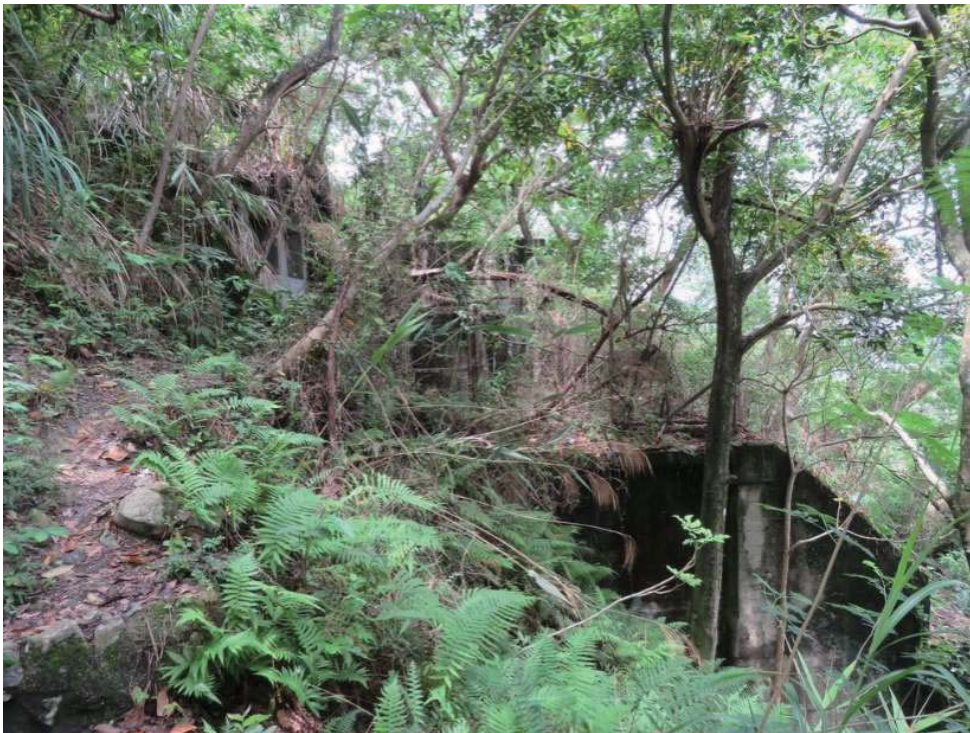
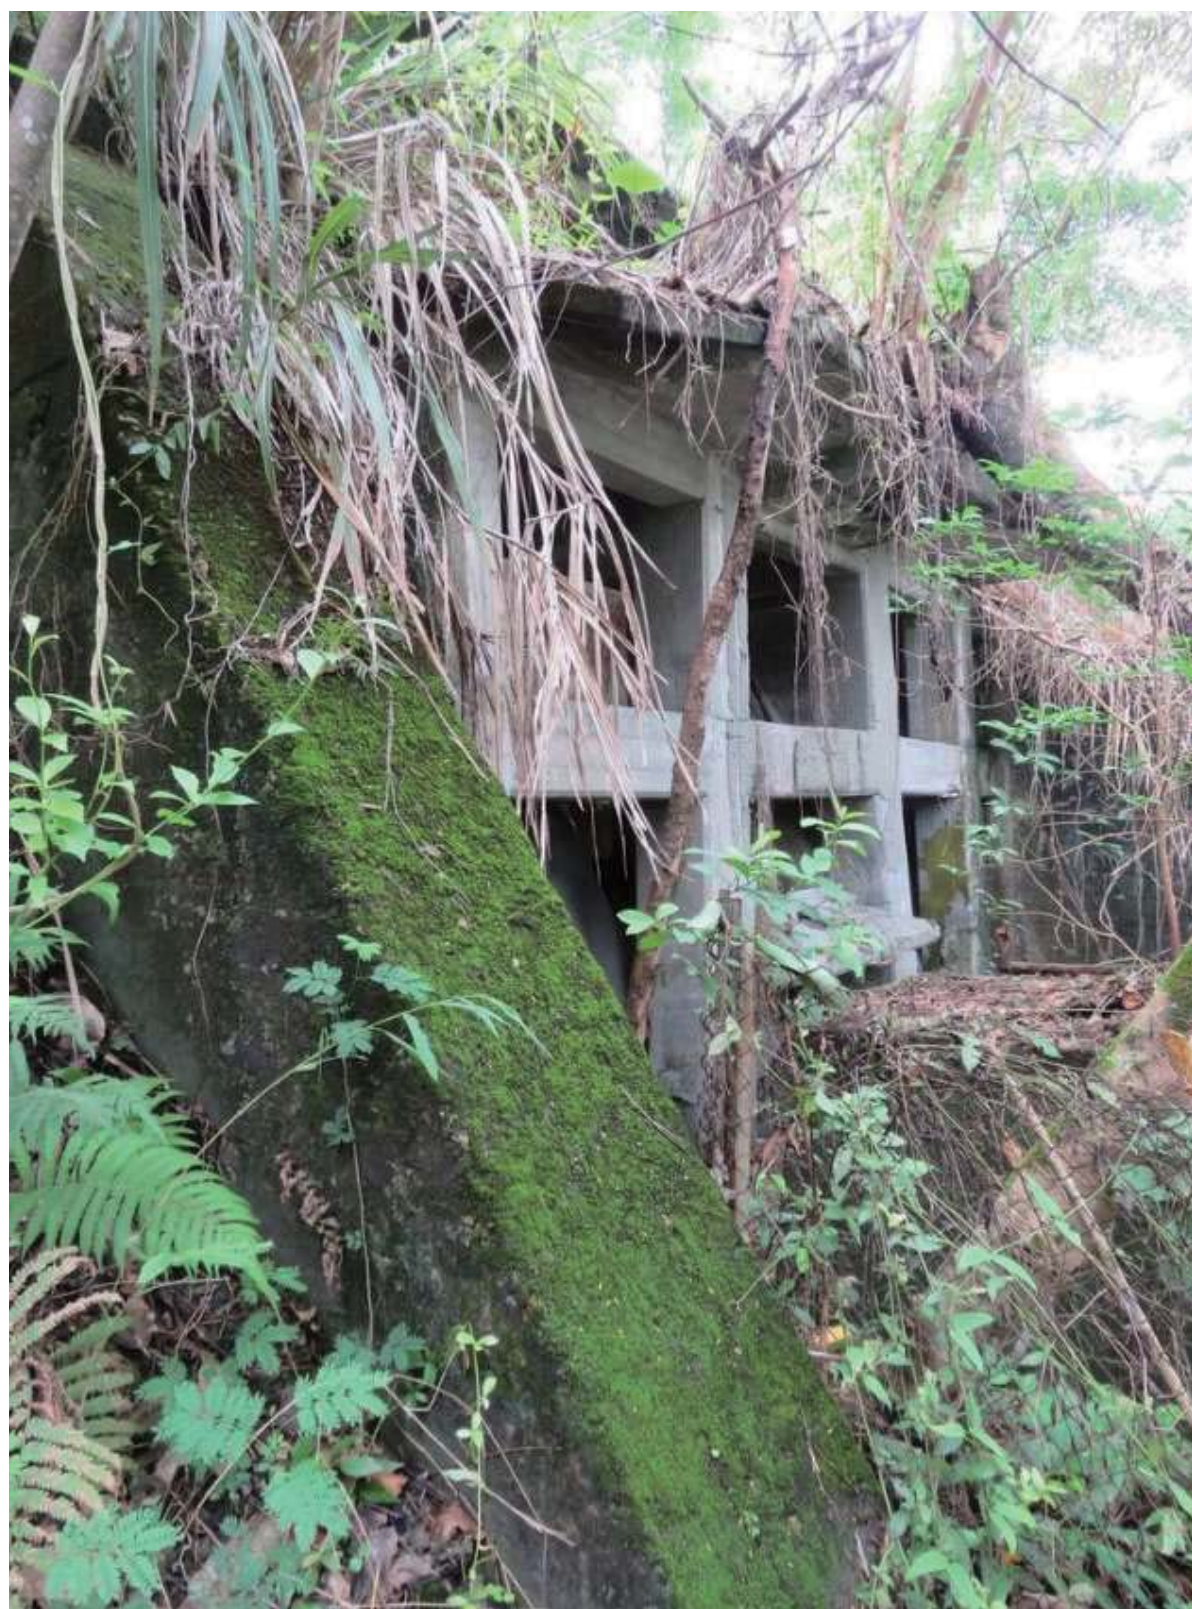
Existing Condition: Abandoned and overgrown by vegetation; could pose danger to hikers as thick vegetation covers openings on ground level.

Modifications: Conveyor belts and machines removed.

GB-03-01 general views

GB-03-01 Lower part

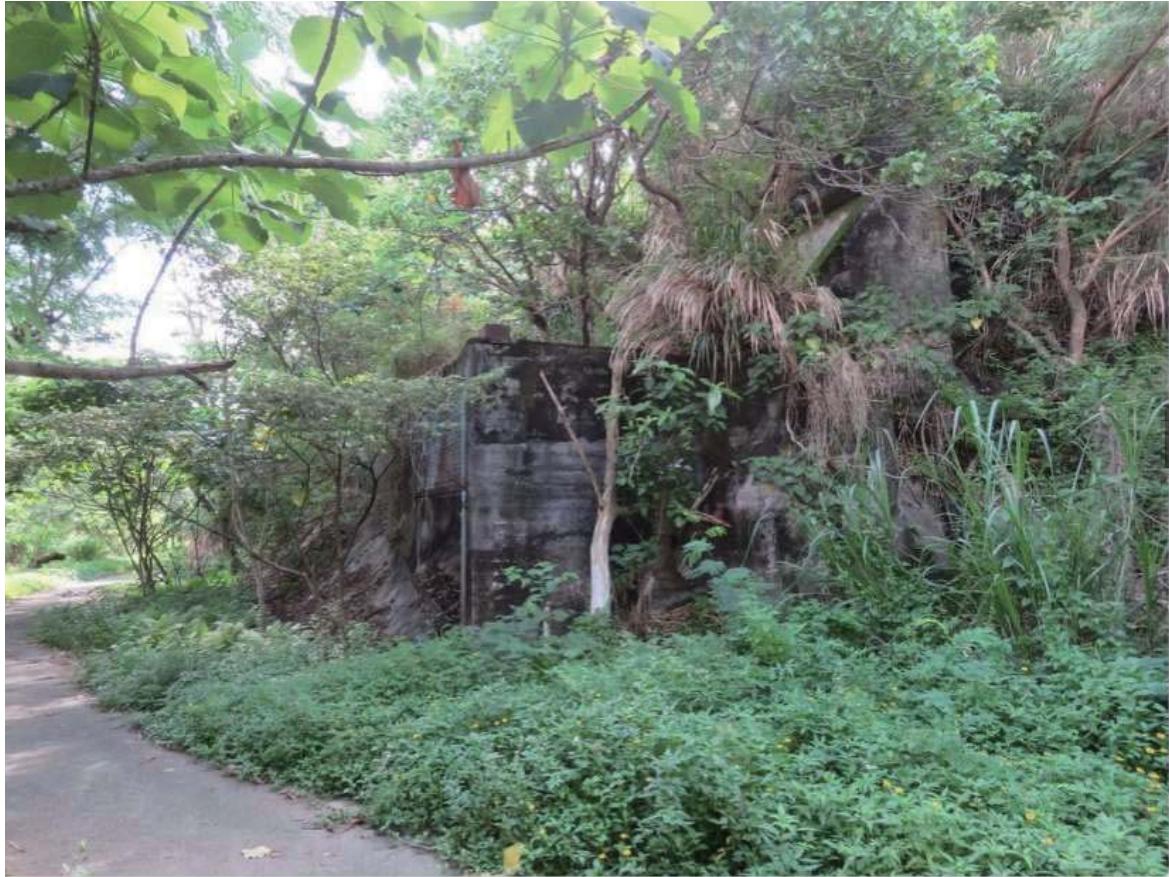
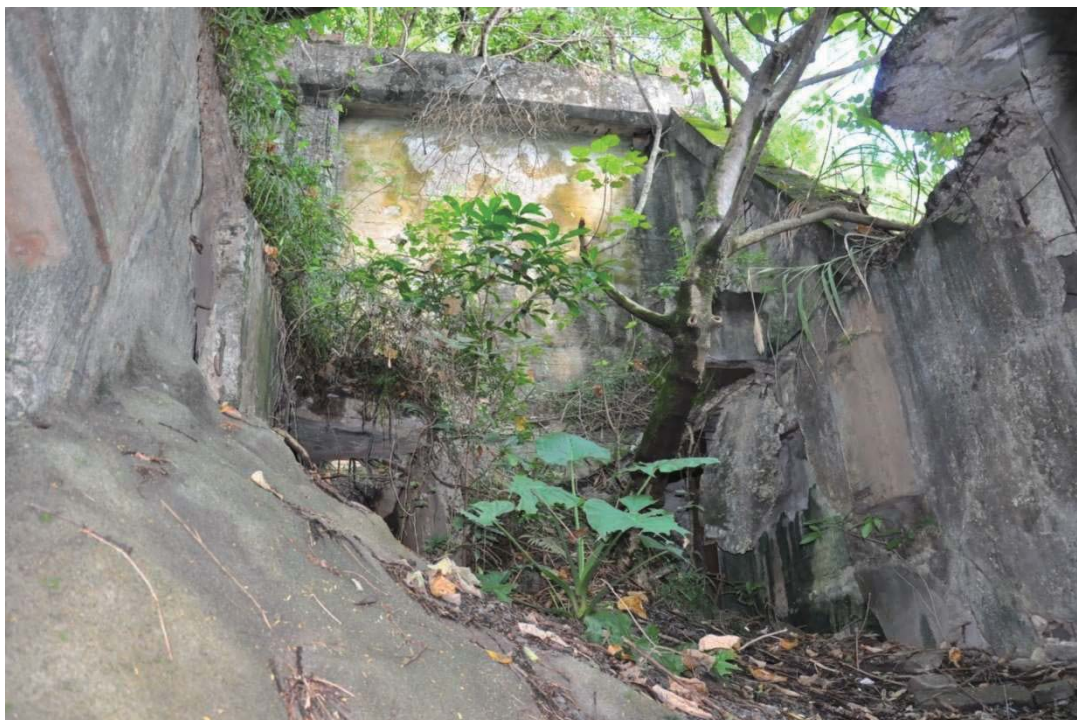
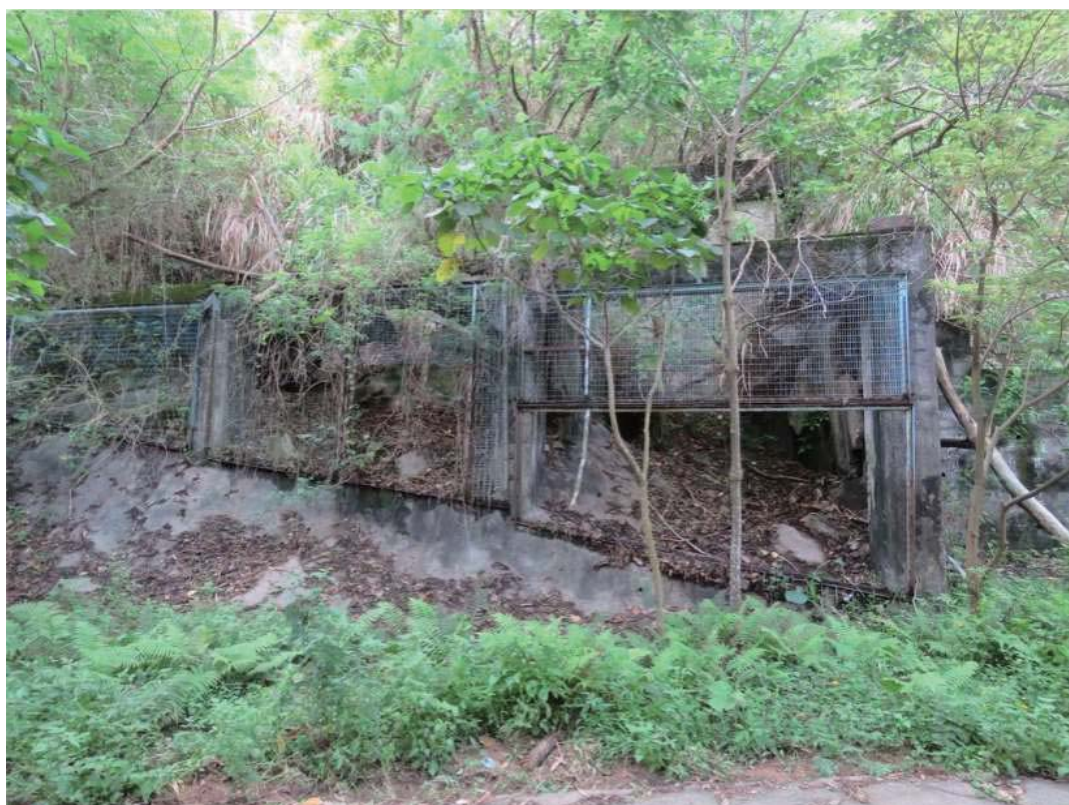
View of construction of MPP and transmission buildings in 1954 (Gwulo)		
Interior: The building was built directly on hill slope, by using cement pavement to cover the natural landscape. The building once had a second storey or platform on inside but has now collapsed.		
Existing Condition: Abandoned and partially damaged.

Modifications: Transmission facilities removed; writing with paint on exterior.

GB-03-2 general view

GB-03-2 internal view

GB-03-2 frontal view

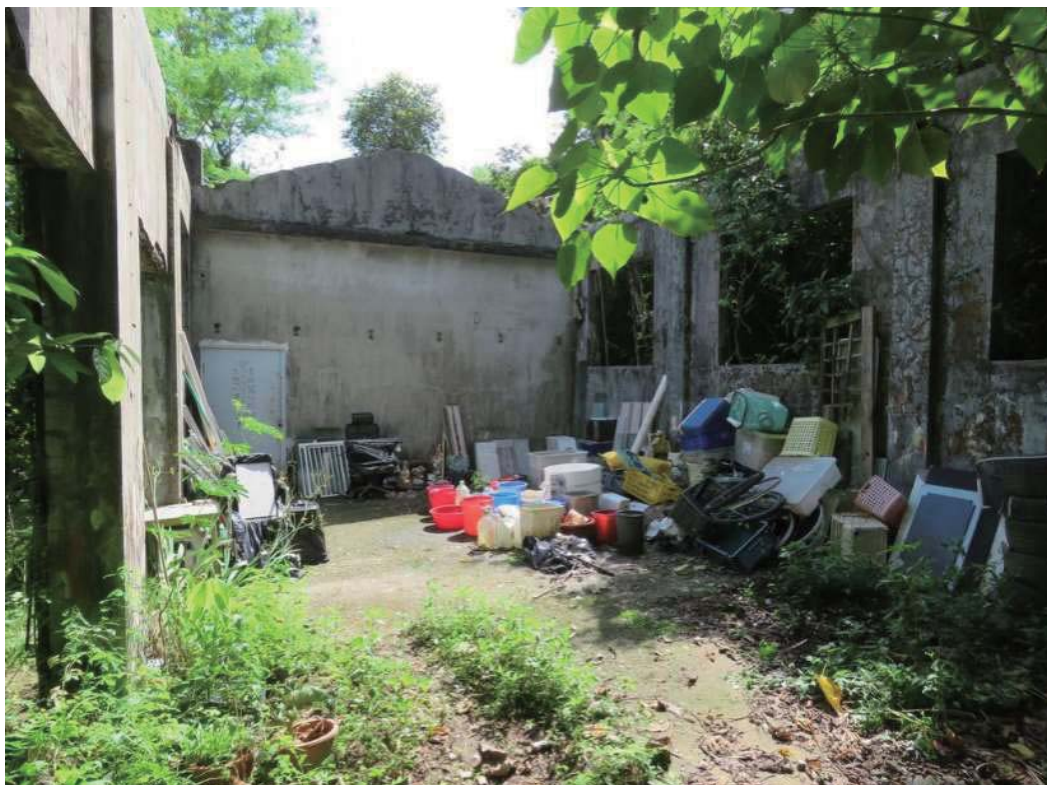
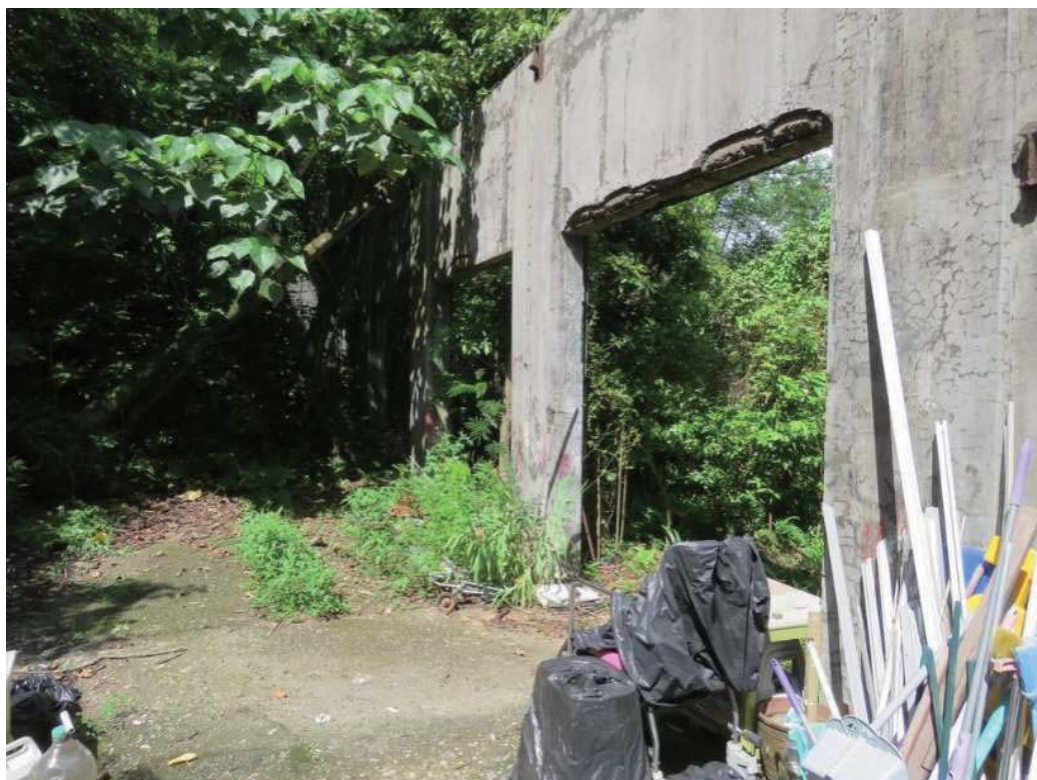
Interior: ground partially intact, partially invaded by vegetation;		
Existing Condition: Abandoned and overgrown with vegetation; storage contents include disposed deity idols, flowerpots and other living supplies, suggesting a lateral occupation.		
Past and Present Uses: Industrial		
Modifications: ceiling, windows and doors removed		
Photos:

GB-03-3 internal views
