AGREEMENT NO. CE 20/2020 (CE) - SITE FORMATION AND INFRASTRUCTURE WORKS FOR PUBLIC HOUSING DEVELOPMENTS AT MA ON SHAN TSUEN ROAD – INVESTIGATION, DESIGN AND CONSTRUCTION

Heritage Impact Assessment Report (Final – Issue3)

PROJECT NO.: 2512216A

DATE: JUNE 2023

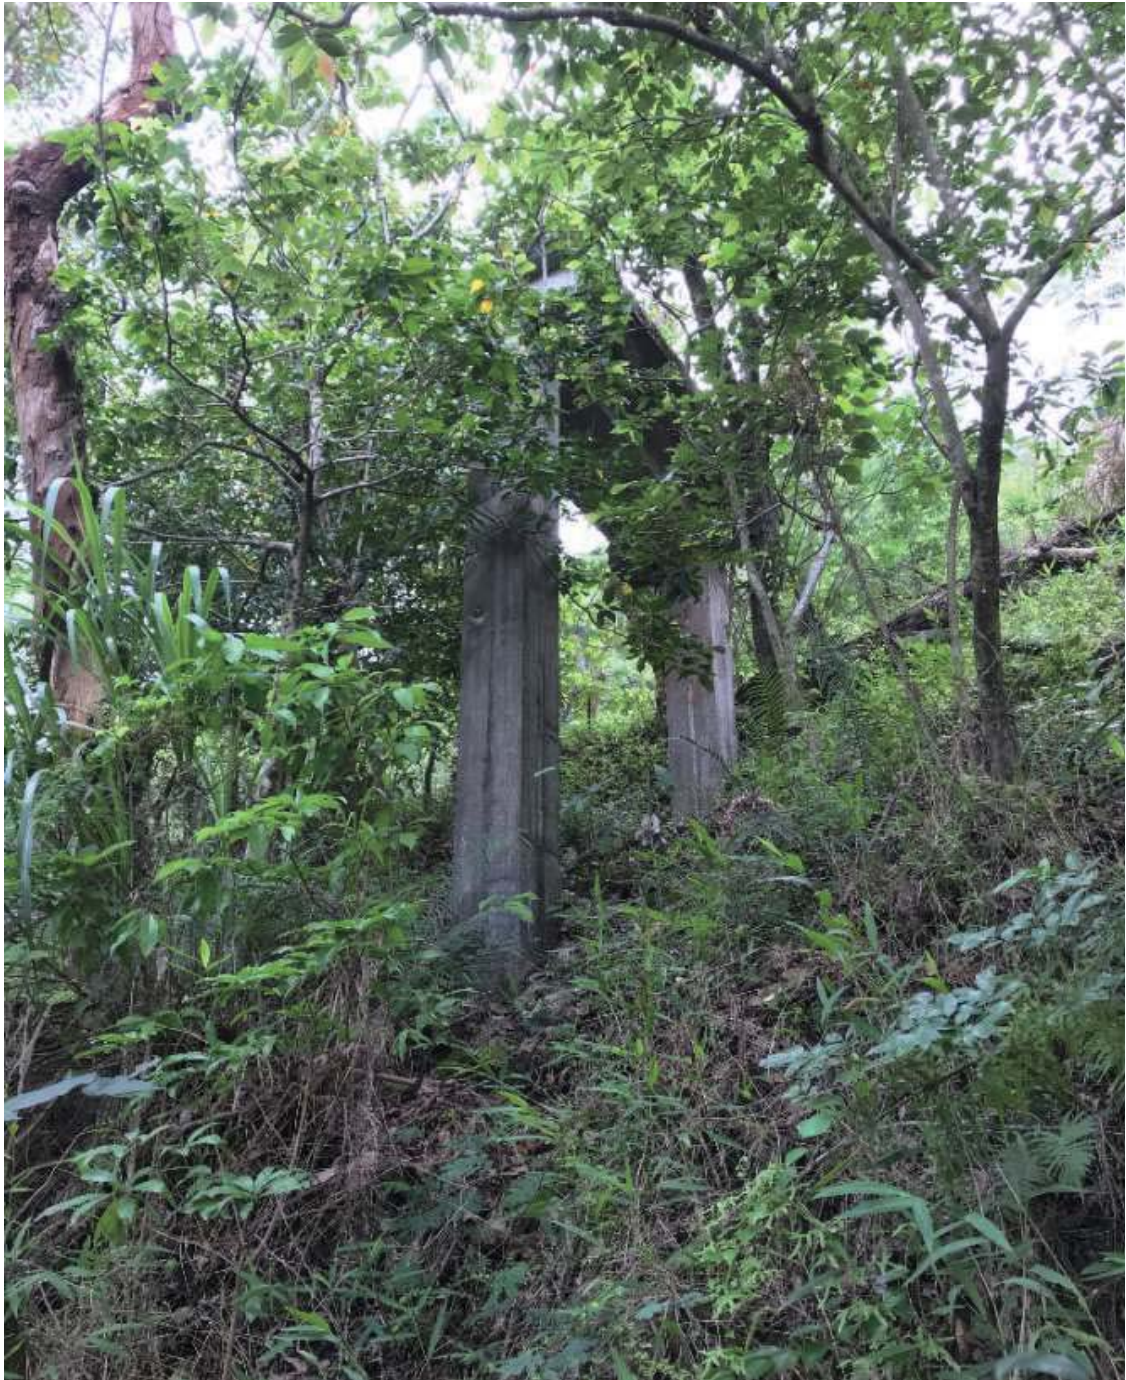
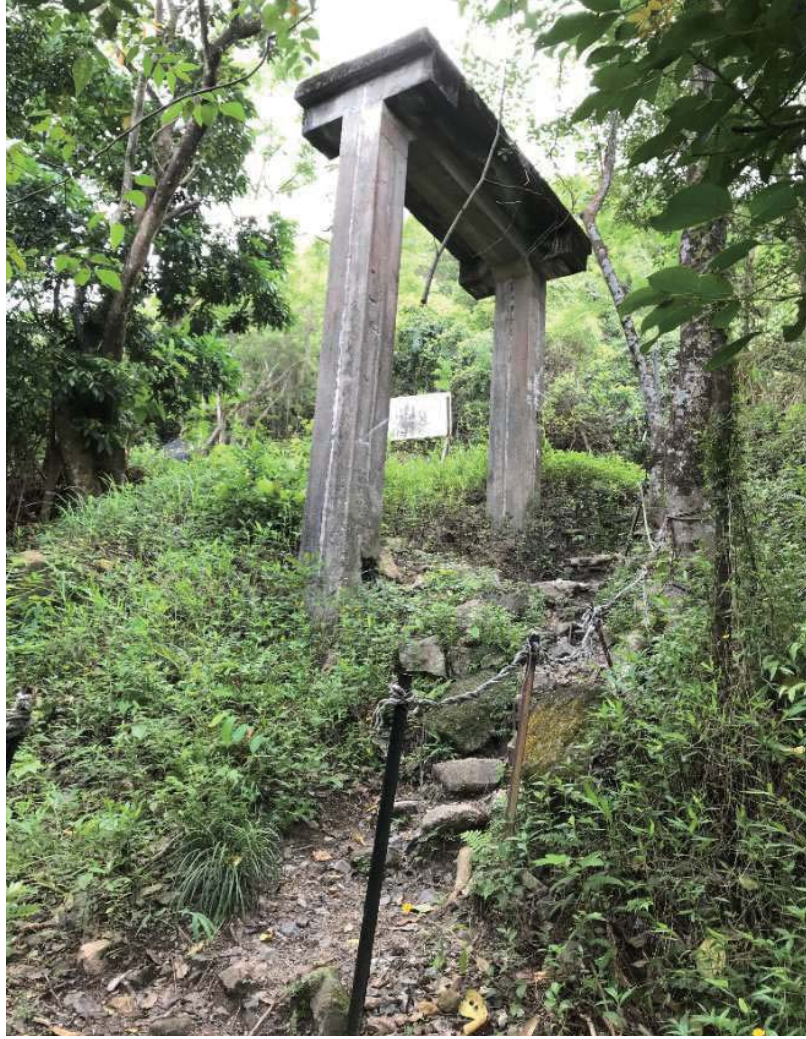
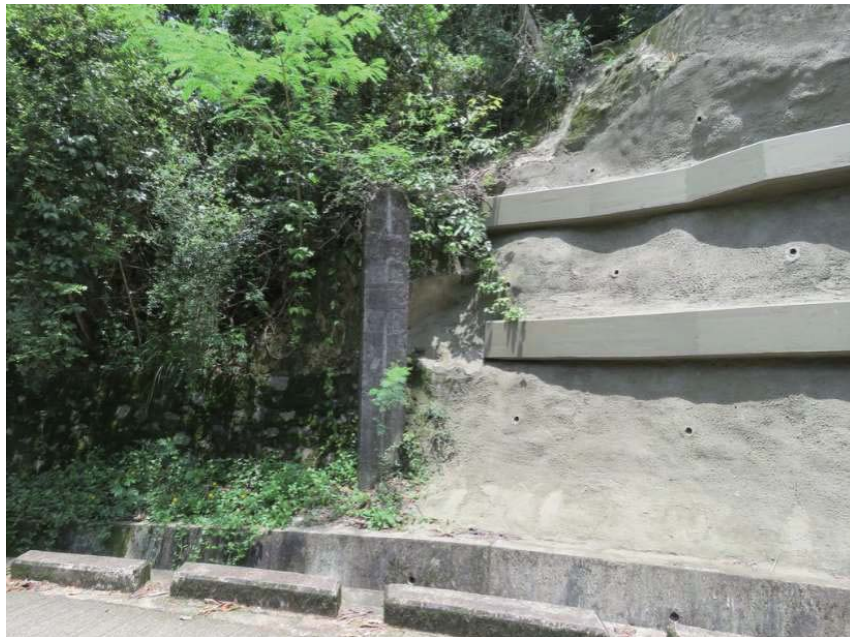
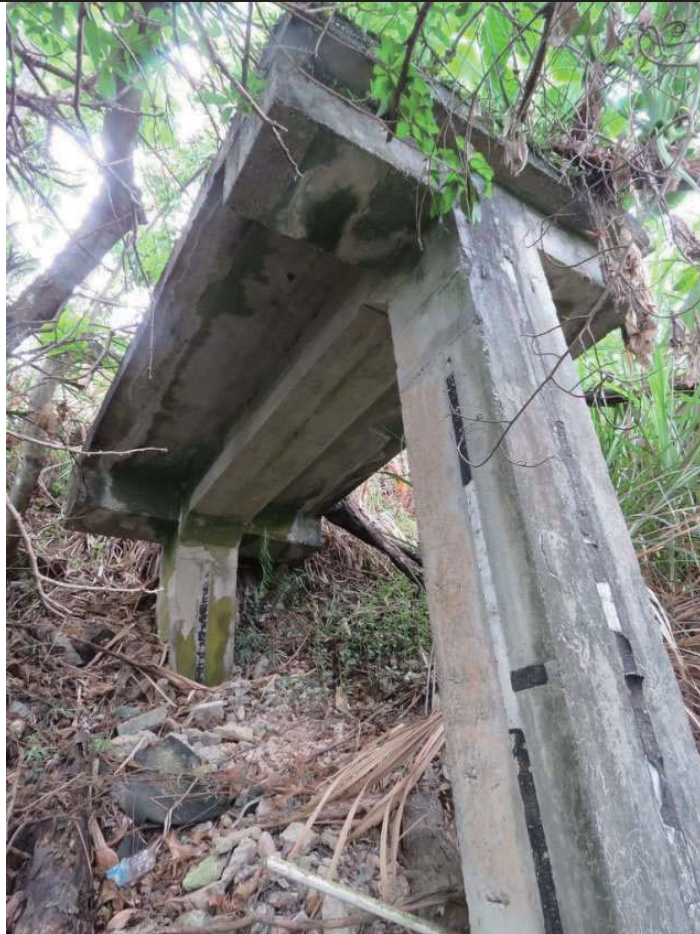
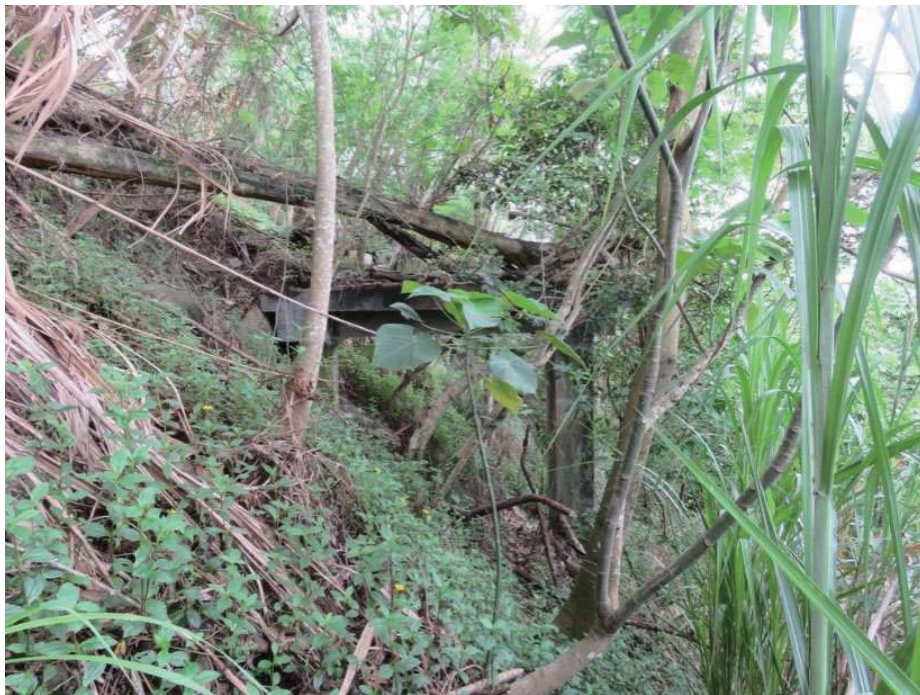
<p>Architectural Appraisal: Three pillars supported the overhead ore transit railway as shown on 1963 aerial photo below. They are made of steel reinforced concrete and consist of two pillars connected with a rectangular cap. HB-09A is damaged and has one pillar left.</p> <div data-bbox="357 987 1233 1812" data-label="Image"> </div> <p>Aerial view of Mineral Preparation Plant under construction showing location of pillars in relation to plant (Source: 馬鞍山民康促進會, 2012, 11)</p>		
Existing Condition: Partially damaged.		
Past and Present Uses: Industrial, not in use

View of pillar **GB-03-4**

View of pillar **GB-03-5** and stairs **HB-13** (to right)

View of pillar **HB-09A**

View of pillar **HB-09B**

View of pillar **HB-09C**

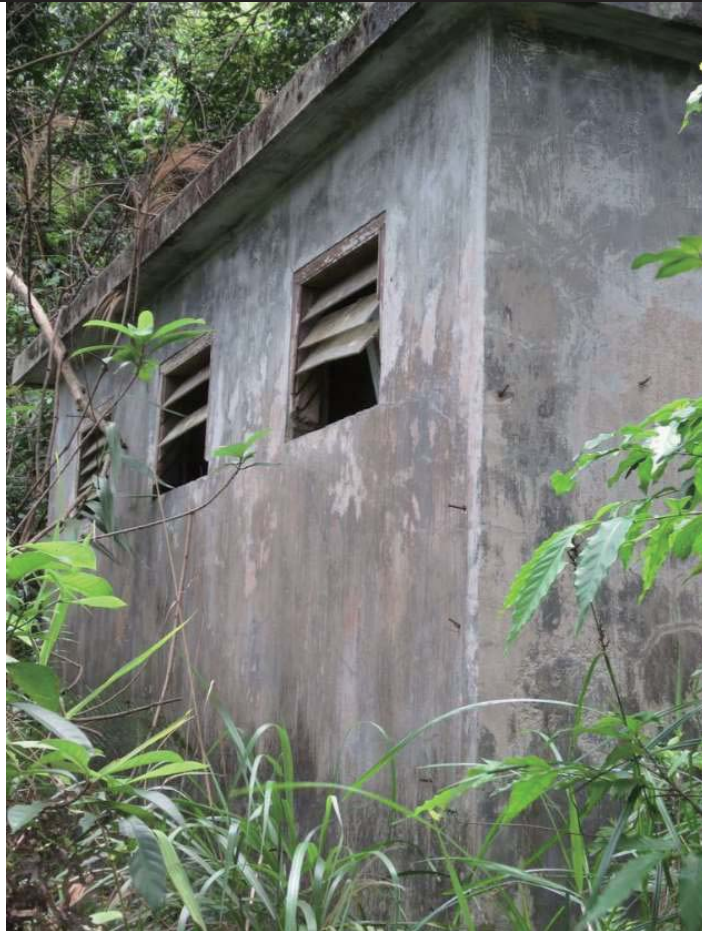
Interior: Three toilet compartments		
Existing Condition: Abandoned and partly collapsed.		
Past and Present Uses: Industrial, abandoned		
Modifications: N/A		
Photos:

HB-01 view of rear

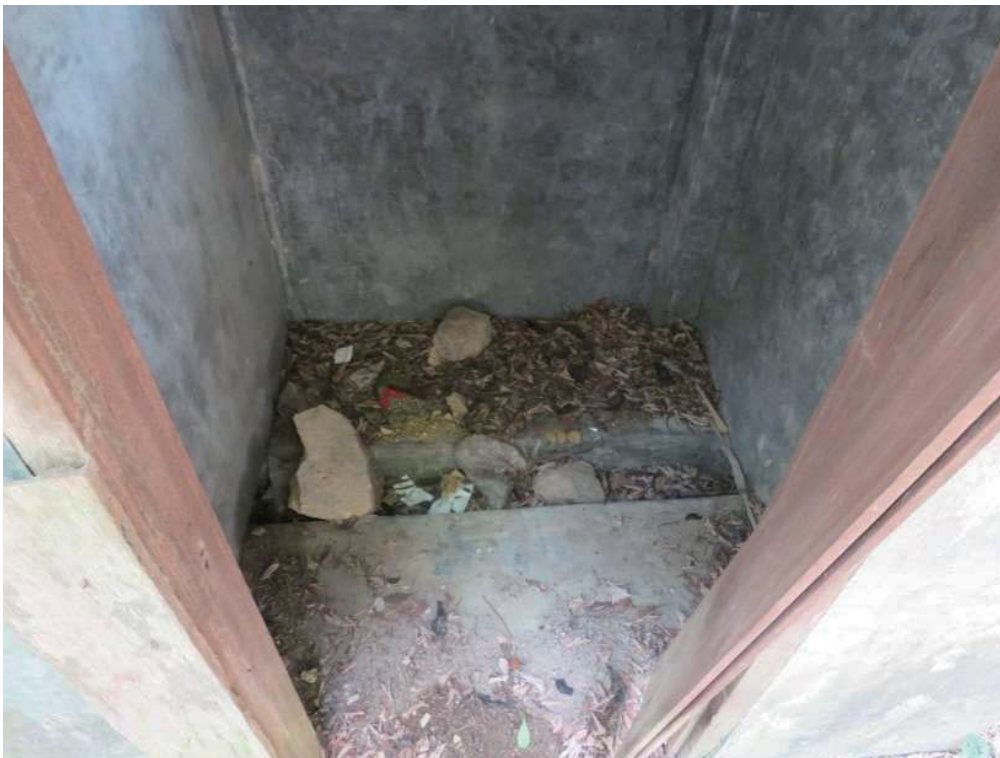
HB-01 gutter style toilet

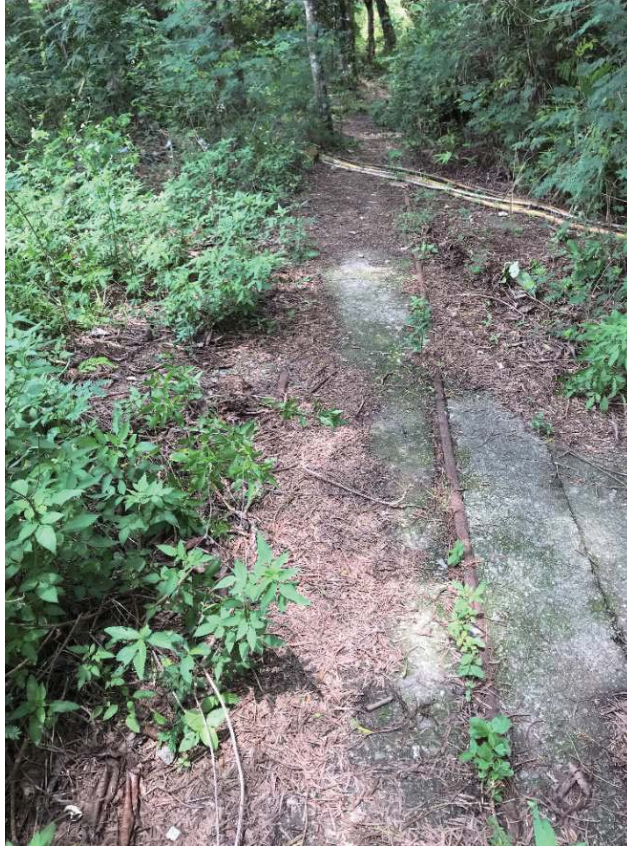
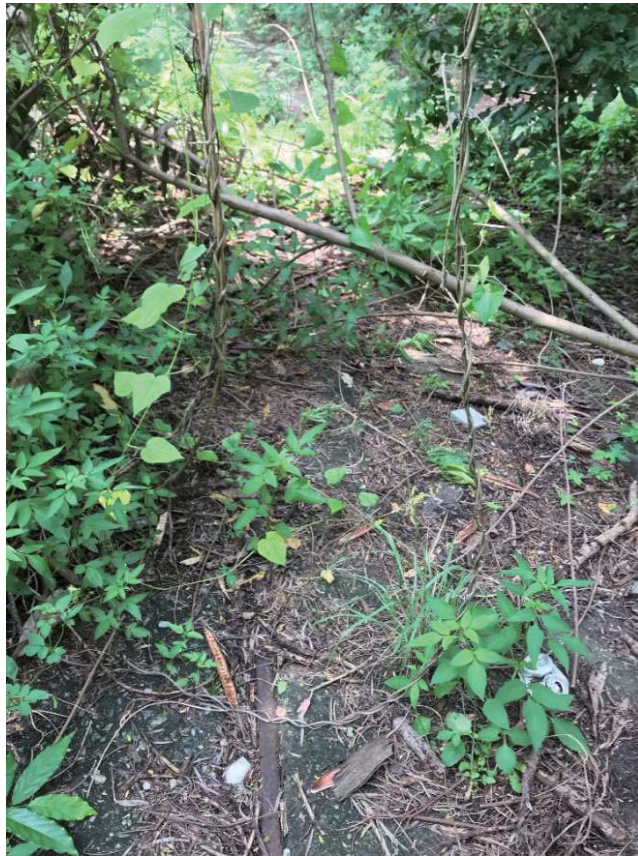
Existing Condition: Abandoned		
Past and Present Uses: Industrial, abandoned and overgrown.		
Modifications: N/A		
Photos:

HB-02 some details of rails

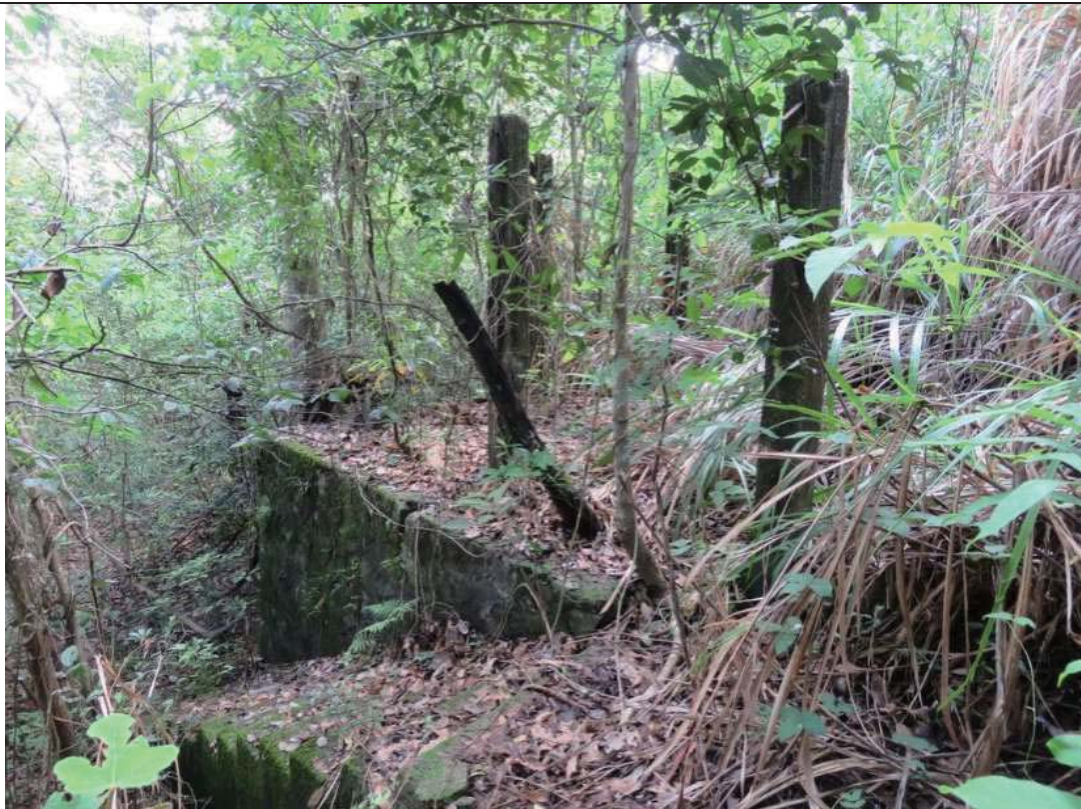
Existing Condition: Abandoned and partly collapsed.		
Past and Present Uses: Industrial, abandoned		
Modifications: N/A		
Photos:

HB-03 view of interior posts

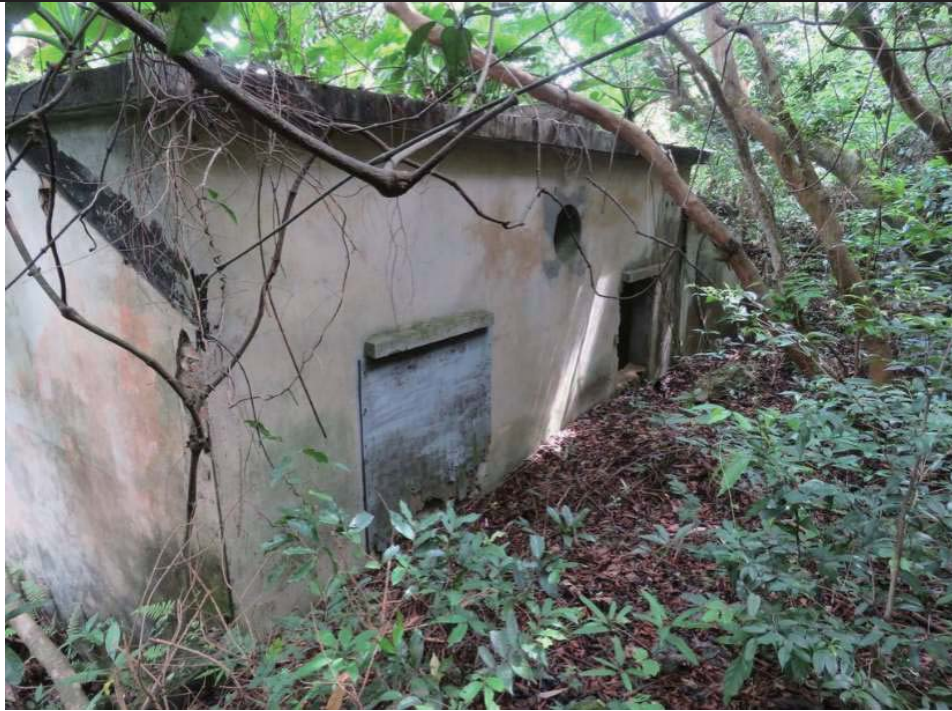
Existing Condition: Abandoned and partly collapsed.		
Past and Present Uses: Industrial, abandoned		
Modifications: N/A		
Photos:

HB-04 View of rear

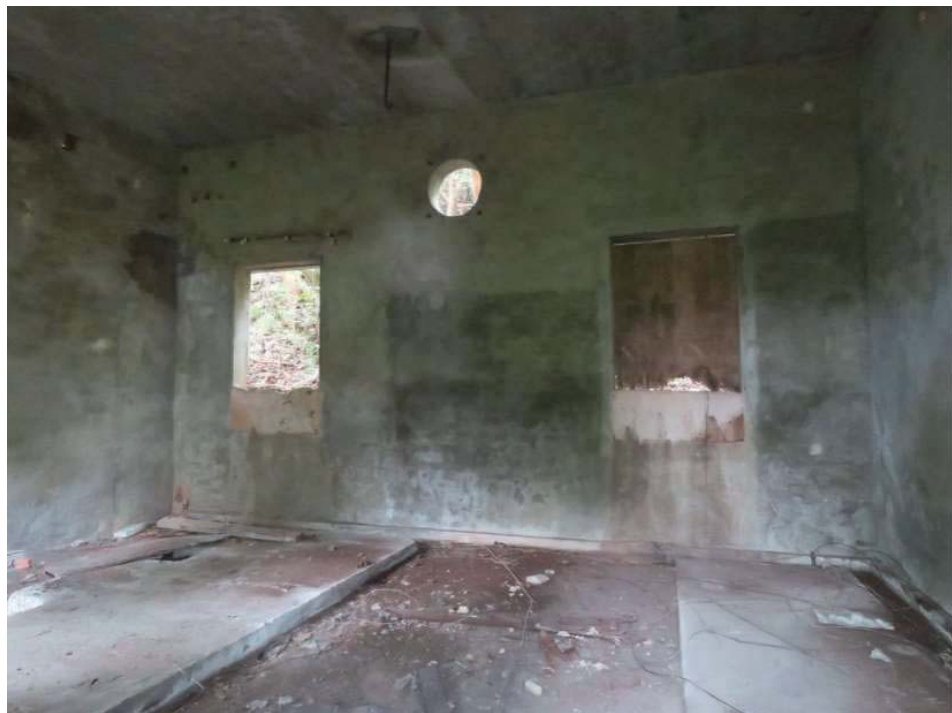
HB-04 Interior view

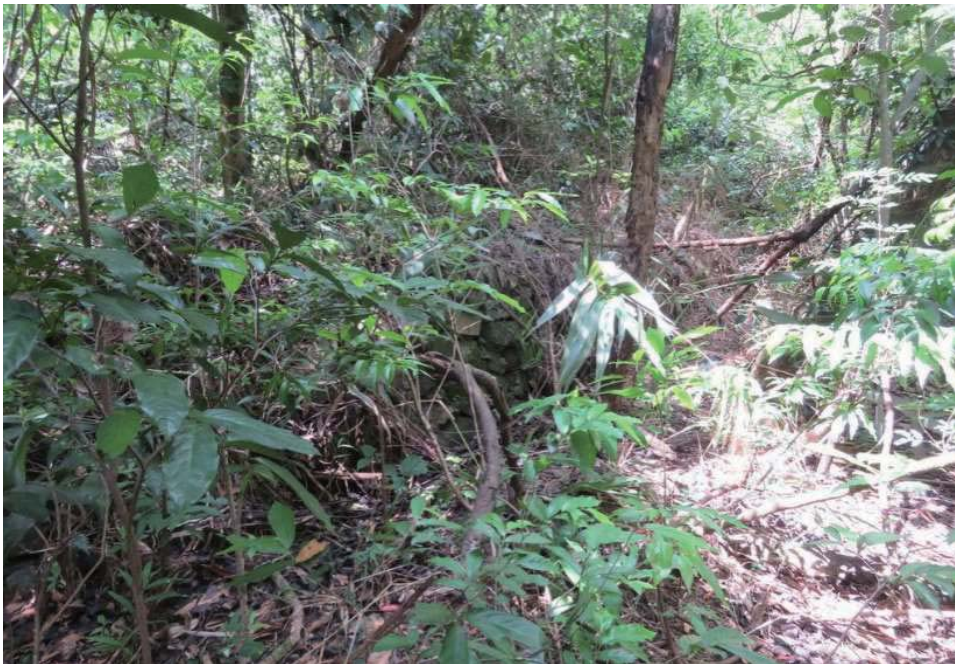
Ref: HB-05	<p>Title: Stone foundation of a temporary structure</p> <p>part of Mineral Preparation Plant, Ma On Shan Iron Mine, Sha Tin, N.T.</p>	Category: Industrial
Address: Ma On Shan Mining Landscape		Figure Ref: Figure 3
Orientation: northeast-southwest trending		Grading: Other built heritage item
Surrounding Environment: near collapsed building HB-06		
Historical Appraisal: See Historical Appraisal of GB-02-1 and GB-03-1 .		
Associated Historical/ Cultural Events or Individual: The structure is part of the Mineral Preparation Plant (important ore extraction technology innovation) which allowed for a sharp increase of productivity in Ma On Shan Iron Mine.		
Architectural Appraisal: Stone foundation of a temporary structure seen on 1963 and 1964 aerial photos (Lands Dept 1963 & 64) within the lower mining landscape. Constructed with rough blocks.		
Existing Condition: Abandoned and partly collapsed.

<p>HB-05 General view of Stone foundation of a temporary structure</p>

ID	Structure	Grading	Works	Assessment	Mitigation actions
					provided during construction phase and after.
HB-05	Stone foundation of a temporary structure Figure 3	Non graded	Closest proposed works involve proposed bored pile wall at a distance of 42m and 32m from road construction works. Drawing No. CE20/00/GN/1014	The condition of the building is poor and the proposed works are at sufficient distance and not expected to make a significant impact on the structure. Acceptable impact	No mitigation necessary, but ongoing safe public access to the heritage site should be provided during construction phase and after.
HB-06	Collapsed building, function not known Figure 3	Non graded	Closest proposed works involve proposed bored pile wall at a distance of 50m and 43m from road construction works. Drawing No. CE20/00/GN/1014	The condition of the building is poor and the proposed works are at sufficient distance and not expected to make a significant impact on the structure. Acceptable impact	No mitigation required but safe public access to the heritage sites is expected to be ongoing during construction phase and after.

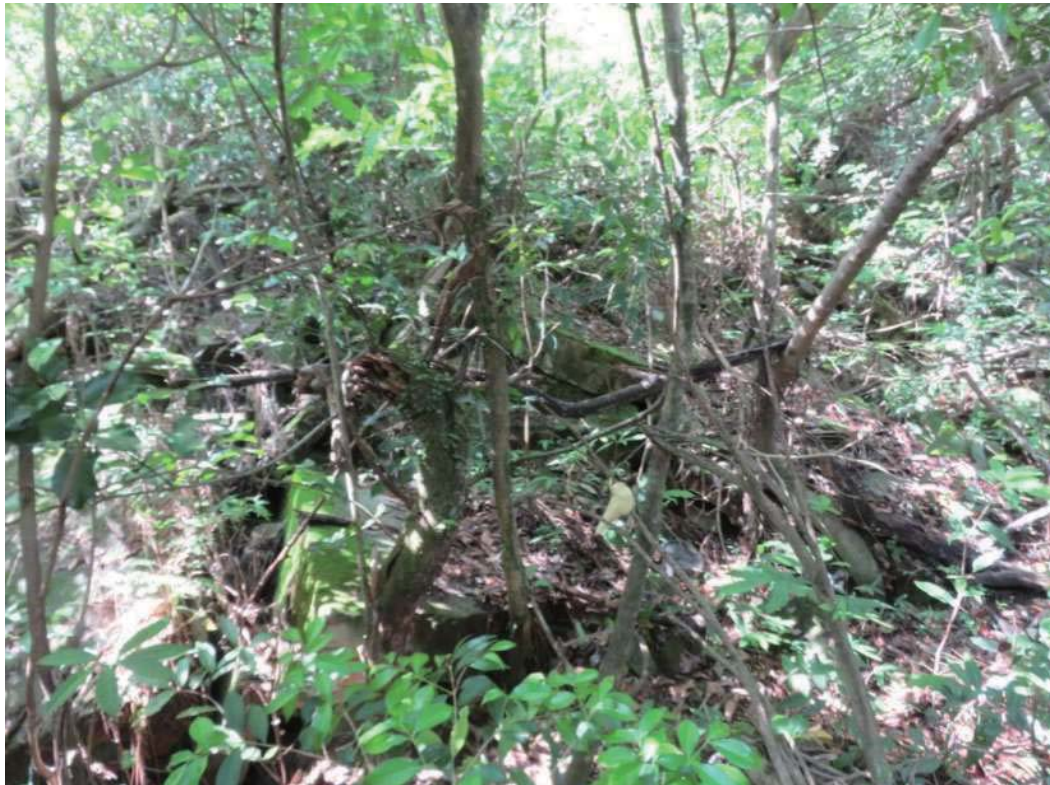
Ref: HB-06	Title: building with unknown function part of Mineral Preparation Plant, Ma On Shan Iron Mine, Sha Tin, N.T.	Category: Industrial
Address: Ma On Shan Mining Landscape		Figure Ref: Figure 3
Orientation: unknown but suspected to north		Grading: Other built heritage item
Surrounding Environment: Lower part of mining landscape near electric substation.		
Historical Appraisal: See Historical Appraisal of GB-02-1 and GB-03-1 .		
Associated Historical/ Cultural Events or Individual: The structure is part of the Mineral Preparation Plant (important ore extraction technology innovation) which allowed for a sharp increase of productivity in Ma On Shan Iron Mine.		
Architectural Appraisal: Red brick with concrete render collapsed building with unknown function seen on 1963 aerial photo (Lands Dept 1963) within the mining landscape		
Existing Condition: Abandoned and partly collapsed.		
Past and Present Uses: Industrial, abandoned

HB-06 General view of collapsed buildings

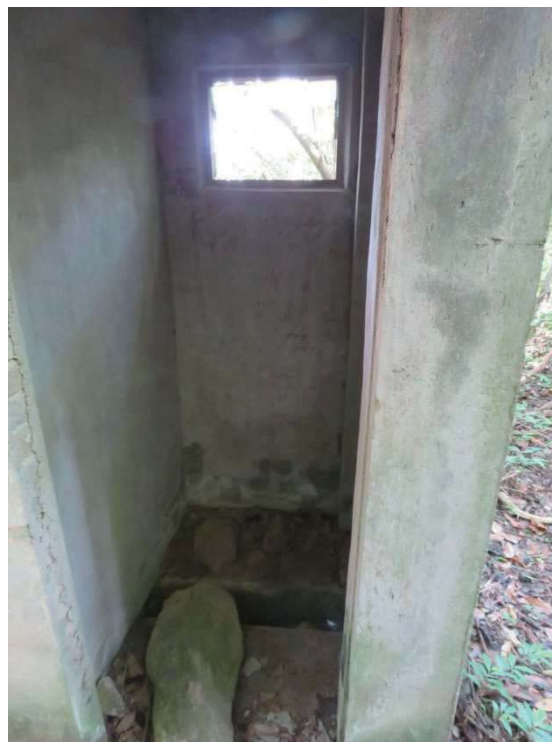
Interior: Three toilet compartments		
Existing Condition: Abandoned and partly collapsed.		
Past and Present Uses: Industrial, abandoned		
Modifications: N/A		
Photos:

HB-07 interior view of one of the compartments

HB-07	Toilet built between 1969-76 Figure 3	Non graded	Closest proposed works involve proposed bored pile wall at a distance of 68m and 61m from road construction works. Drawing No. CE20/00/GN/1014	The toilet building is in good condition and deemed at sufficient distance from the proposed works. Acceptable impact	No mitigation required but safe public access to the heritage sites is expected to be ongoing during construction phase and after.
HB-08	Concrete retaining wall with buttress. Figure 3	Non graded	Within limits of works area Closest proposed works involve flexible barrier installation at 10m, slope works at 23m, bored pile wall at a distance of 34m	Direct impacts cannot be avoided on this low significance, plain retaining wall, while it had a function in the overall mining	No mitigation necessary, but ongoing safe public access to the heritage site should be

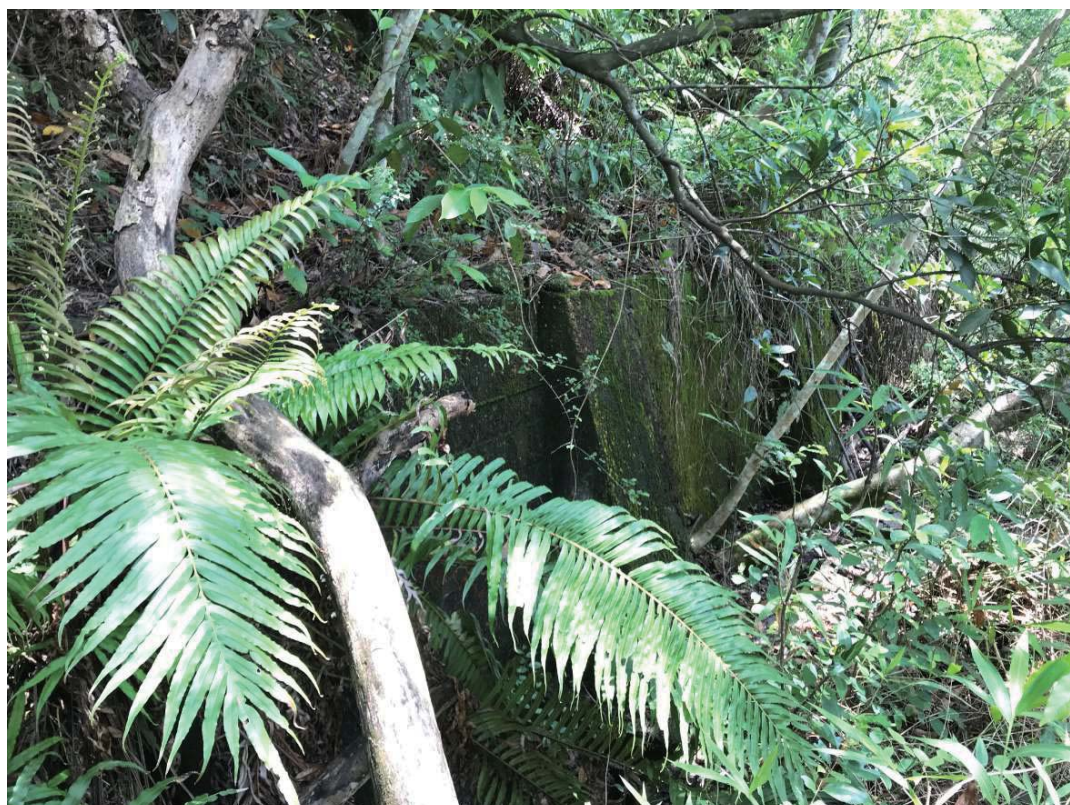
Ref: HB-08	Title: Concrete retaining wall part of Mineral Preparation Plant, Ma On Shan Iron Mine, Sha Tin, N.T.	Category: Industrial
Address: Ma On Shan Mining Landscape		Figure Ref: Figure 3
Orientation: along Ma On Shan Tsuen Road		Grading: Other built heritage item
Surrounding Environment: along Ma On Tsuen Road and below the portal area		
Historical Appraisal: See Historical Appraisal of GB-02-1 and GB-03-1 .		
Associated Historical/ Cultural Events or Individual: The structure is part of the Mineral Preparation Plant (important ore extraction technology innovation) which allowed for a sharp increase of productivity in Ma On Shan Iron Mine.		
Architectural Appraisal: concrete retaining wall with buttresses.		
Existing Condition: Abandoned and fair condition.		
Past and Present Uses: Industrial, abandoned		
Modifications: N/A		
Photos:

HB-08 General view of retaining wall

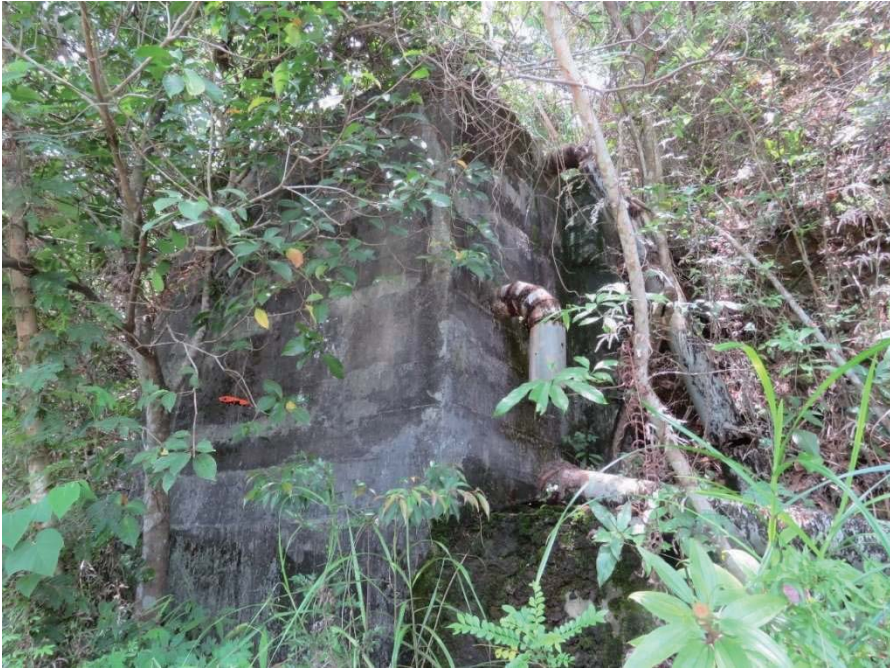
Ref: HB-11	Title: water tank part of Mineral Preparation Plant, Ma On Shan Iron Mine, Sha Tin, N.T.	Category: Industrial
Address: Ma On Shan Mining Landscape		Figure Ref: Figure 3
Orientation: Northeast/south west alignment		Grading: Other built heritage item
Surrounding Environment: Built on hill slope above Ma On Shan Tsuen Road next to way up to 110 ML entrance		
Historical Appraisal: See Historical Appraisal of GB-02-1 and GB-03-1 .		
Associated Historical/ Cultural Events or Individual: The structure is part of the Mineral Preparation Plant (important ore extraction technology innovation) which allowed for a sharp increase of productivity in Ma On Shan Iron Mine.		
Architectural Appraisal: Water tank constructed out of concrete and marked on the 1969 topographical map as water tank (Ordnance survey 1969).		
Existing Condition: fair		
Past and Present Uses: Industrial, abandoned		
Modifications: N/A

<p>HB-11 General view of water tank</p>

HB-11	Water tank part of Mineral Preparation Plant Figure 3	Non graded	Closest proposed works involve flexible barrier installation at 25m, slope works at 50m, bored pile wall at a distance of 65m and 65m from road construction works. Drawing No. CE20/00/GN/1015	The water tank is in good condition and is at sufficient distance from proposed works. No impacts are expected. Acceptable impact	No mitigation necessary, but ongoing safe public access to the heritage site should be provided during construction phase and after.

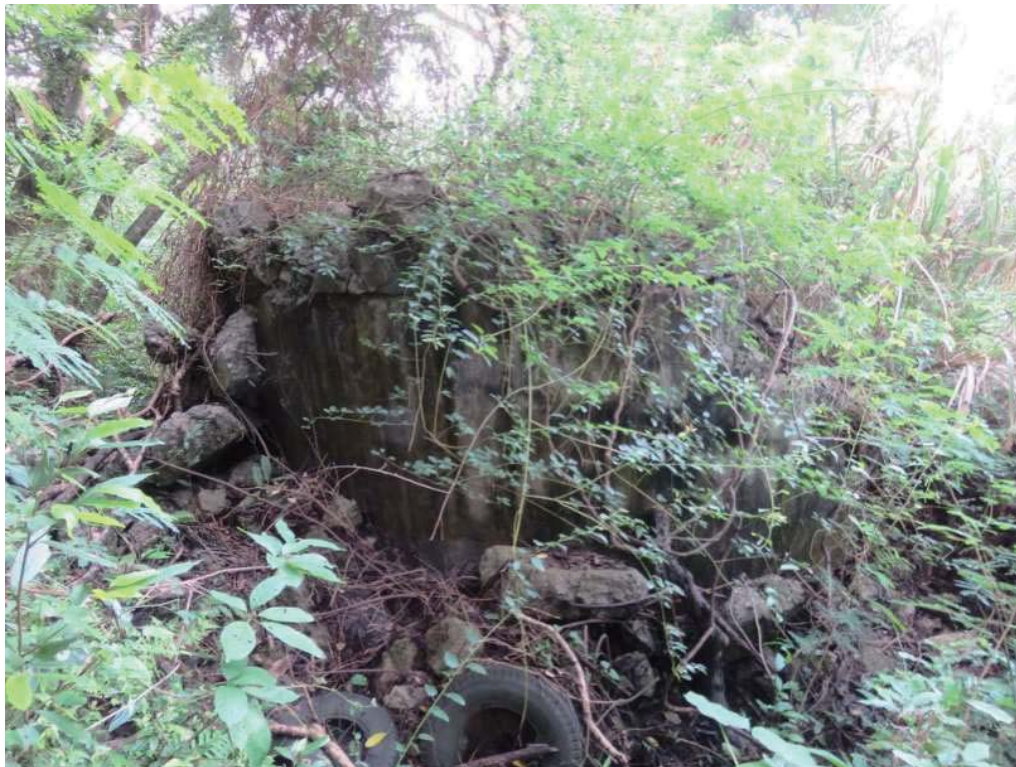
Existing Condition: Abandoned and partly collapsed.

Modifications: Tank removed.

HB-12 General view of thickener tank remains

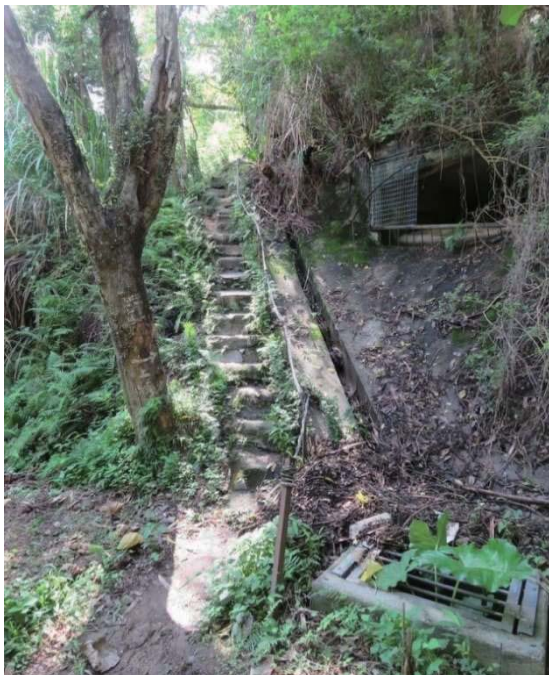
<p>HB-13 View of stairs beside transmission building GB-03-2</p>

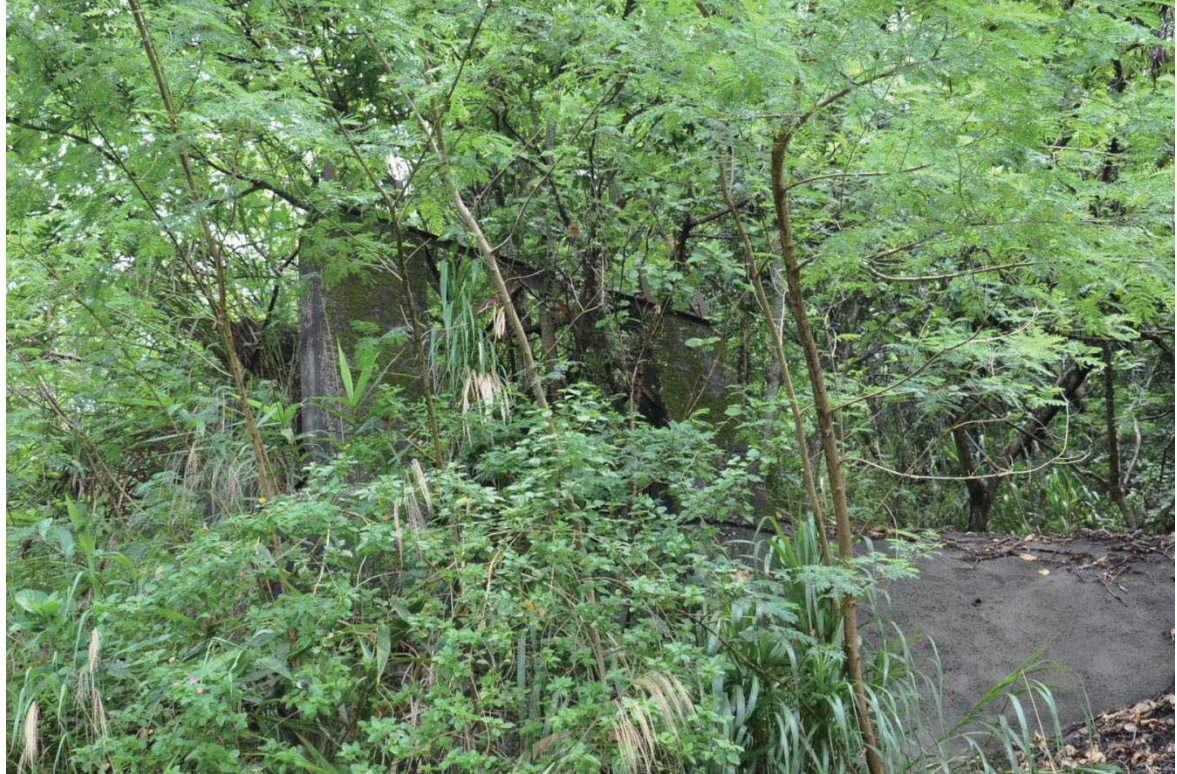
HB-14 upper part

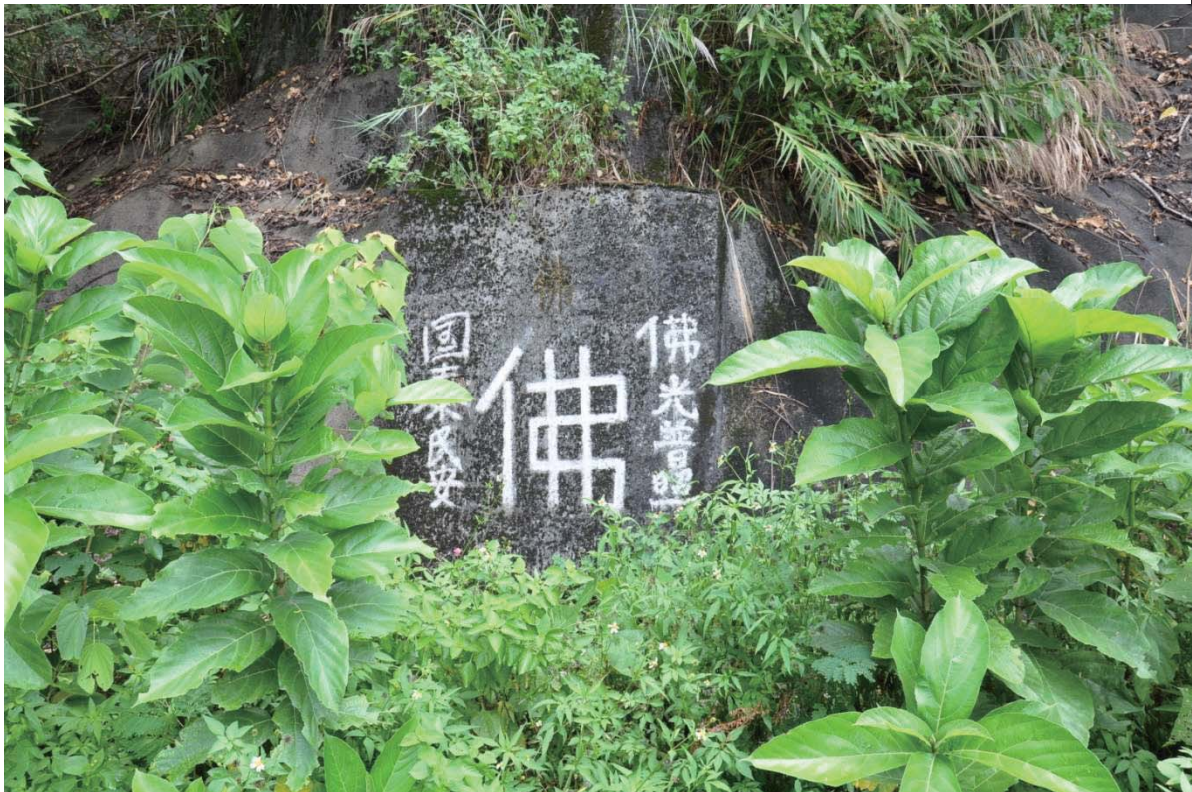
HB-14 lower part

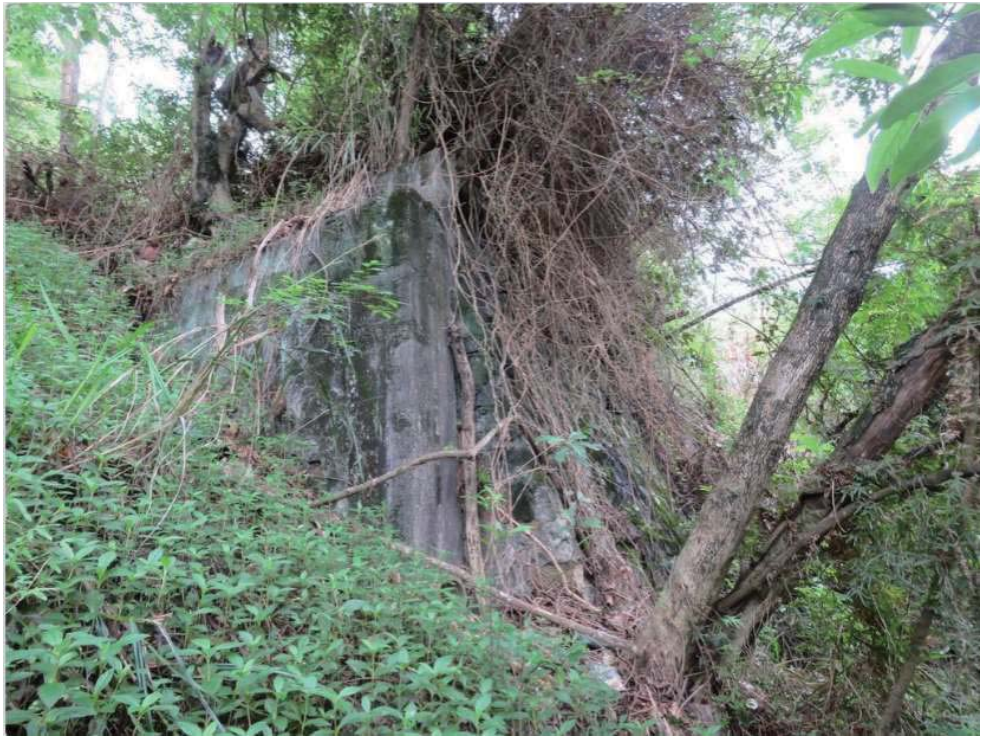
Ref: HB-15	Title: Railway support structure part of Mineral Preparation Plant, Ma On Shan Iron Mine, Sha Tin, N.T.	Category: Industrial
Address: Ma On Shan Mining Landscape		Figure Ref: Figures 3 and 4
Orientation: N/A		Grading: Other built heritage item
Surrounding Environment: below Ma On Shan Tsuen Road		
Historical Appraisal: See Historical Appraisal of GB-02-1 and GB-03-1 .		
Associated Historical/ Cultural Events or Individual: The structure is part of the Mineral Preparation Plant (important ore extraction technology innovation) which allowed for a sharp increase of productivity in Ma On Shan Iron Mine.		
Architectural Appraisal: Concrete block attached to steep hillside next to main road and supported by stone-made buttress. Hollow concrete cap built on top. 1964 AP shows a rail track running from 100ML entrance to where the water tank GB-03-6 (Lands Dept 1964).		
Existing Condition: Abandoned and overgrown

HB-15 General view

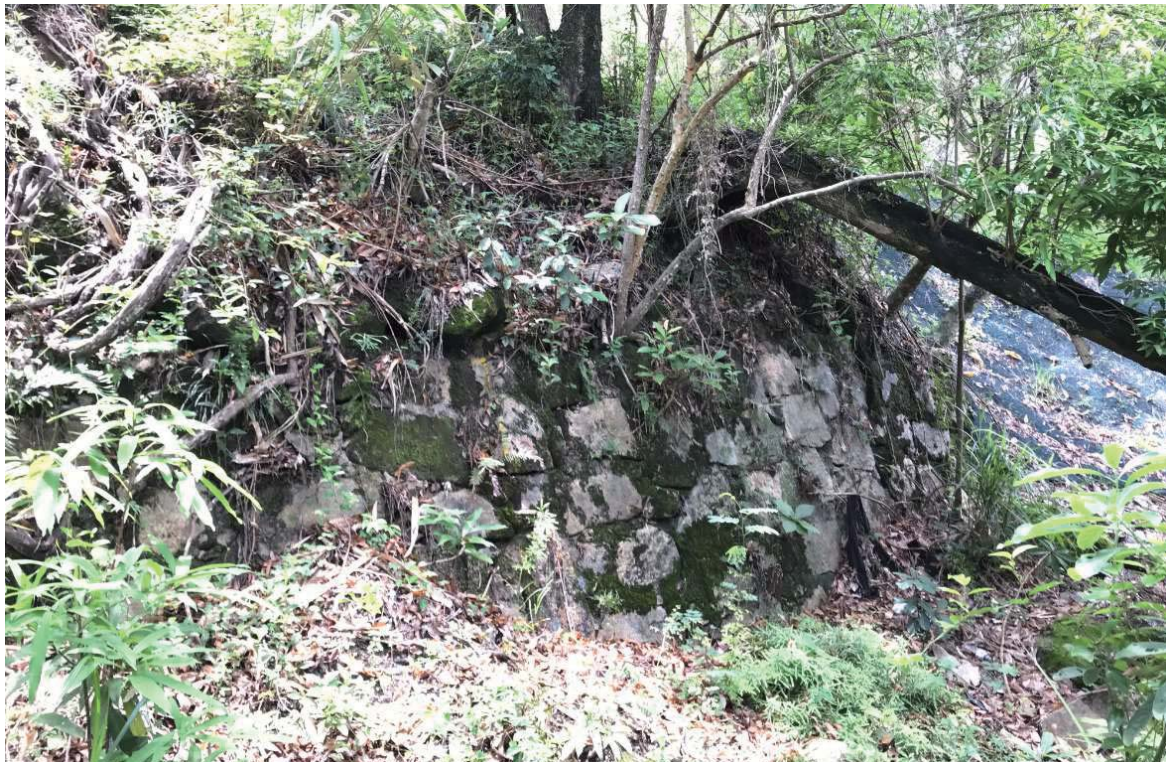
Ref: HB-17	Title: Stone retaining wall part of Mineral Preparation Plant, Ma On Shan Iron Mine, Sha Tin, N.T.	Category: Industrial
Address: Ma On Shan Mining Landscape		Figure Ref: Figure 4
Orientation: along Ma On Shan Tsuen Road		Grading: Other built heritage item
Surrounding Environment: below Ma On Shan Tsuen Road		
Historical Appraisal: See Historical Appraisal of GB-02-1 and GB-03-1 .		
Associated Historical/ Cultural Events or Individual: The structure is part of the Mineral Preparation Plant (important ore extraction technology innovation) which allowed for a sharp increase of productivity in Ma On Shan Iron Mine.		
Architectural Appraisal: Stone retaining wall below main road and above water tank. Shown on 1964 aerial photo (Lands Dept 1964). Strangely 1969 map marks the location as a temporary structure (Ordnance survey 1969).		
Existing Condition: Abandoned and overgrown		
Past and Present Uses: Industrial, abandoned

HB-17 General view

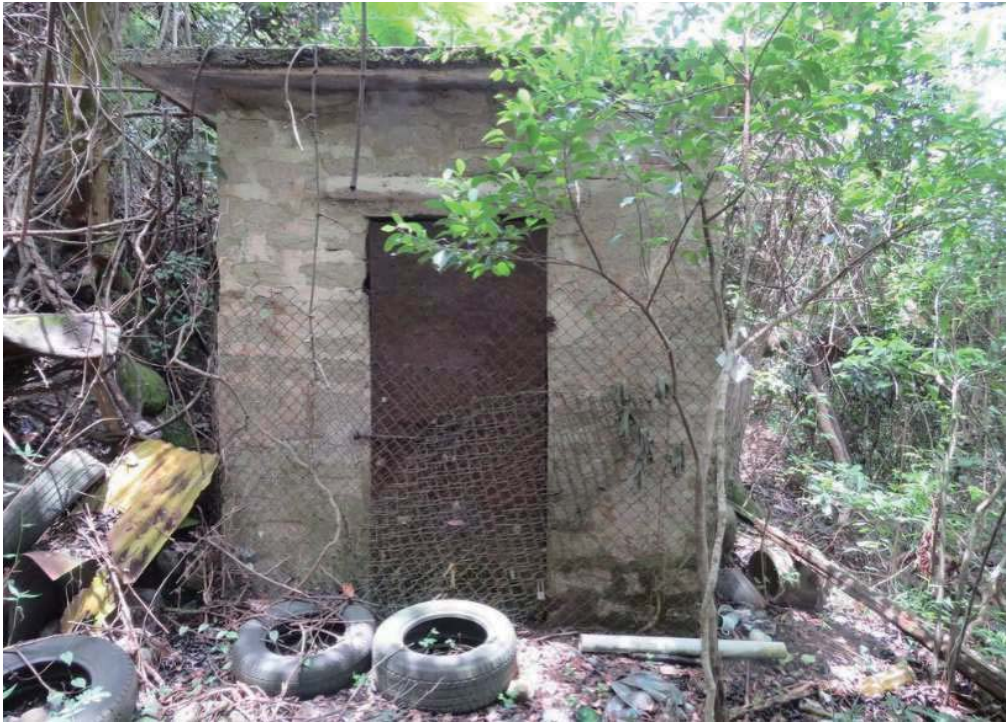
Existing Condition: Abandoned		
Past and Present Uses: Industrial, abandoned		
Photos:

HB-18 General view of front

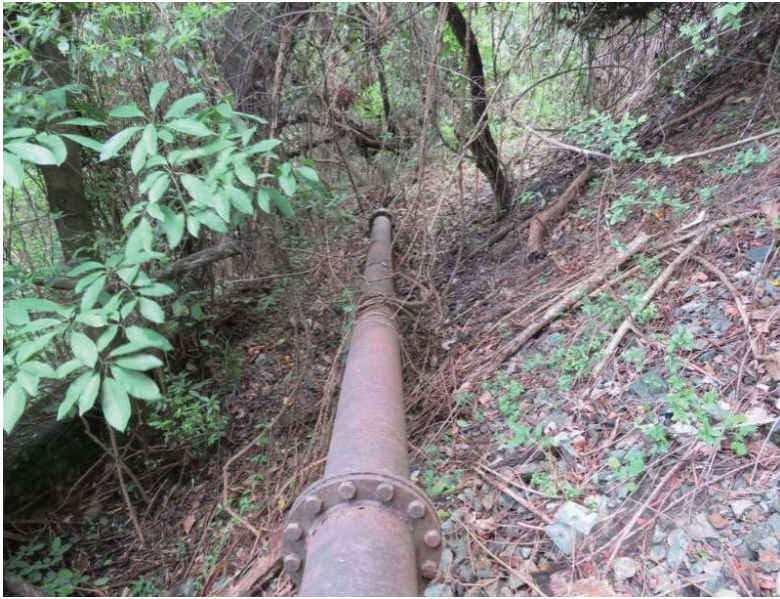
<p>HB-19 General view of pipeline</p>

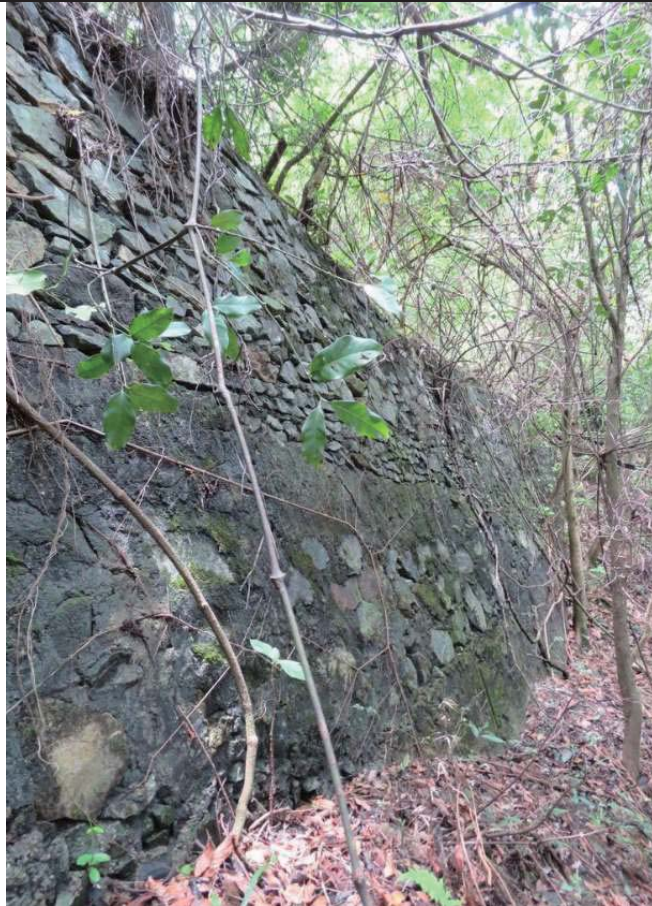
HB-19 General view of retaining wall of pipeline

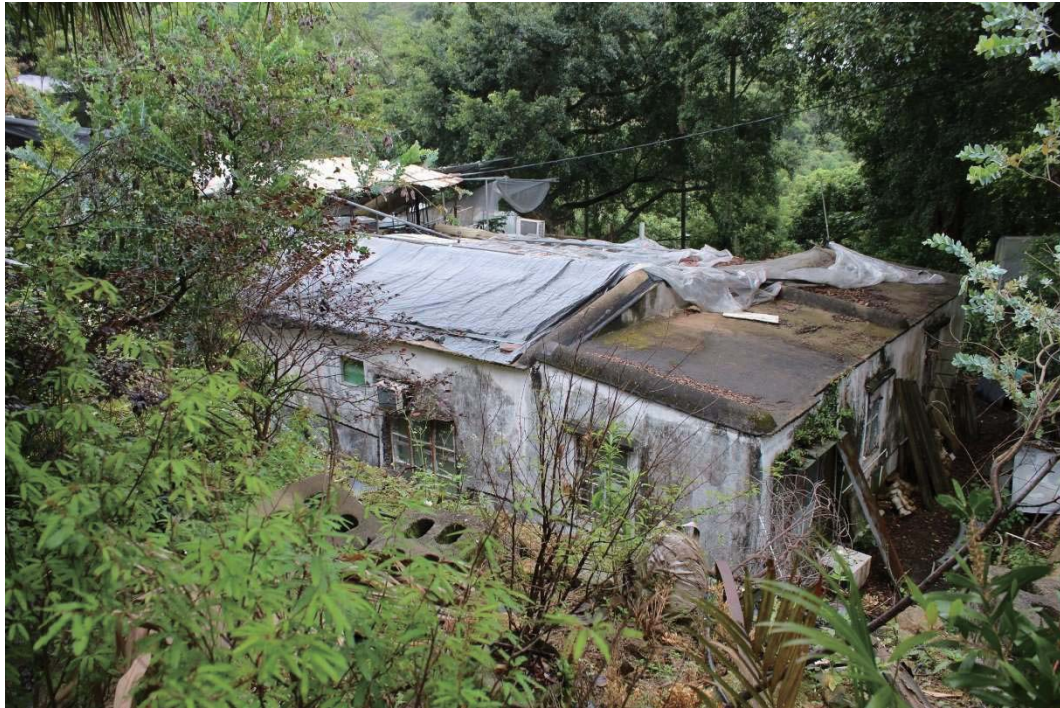
Associated Historical/ Cultural Events or Individual: None.		
<p>Architectural Appraisal:</p> <p>A single storey house having an "L-shaped" plan. The house is constructed of brick, mortar and roofed by corrugated sheets. The external walls are painted in white. The main hall has a pitched roof while the north wing has a sloping roof. Metal frame glass windows in the style of 1950-60s show on exposed elevations. The front and the southeast facing elevations are hidden by extensive temporary shades and thus cannot be observed.</p>		
Interior: No access		
Existing Condition: Fair to poor; roof showing leaking problem.		
Past and Present Uses: in the past associated with miners; now turned into gardening business.		
Modifications: Small air-conditioner window opened. Temporary shelters added to southwest and southeast sides of the house.		
Photos:

Back and side view of HB-25, showing northeast and northwest facing elevations, looking southwest.
