AGREEMENT NO. CE 20/2020 (CE) - SITE FORMATION AND INFRASTRUCTURE WORKS FOR PUBLIC HOUSING DEVELOPMENTS AT MA ON SHAN TSUEN ROAD – INVESTIGATION, DESIGN AND CONSTRUCTION

Heritage Impact Assessment Report (Final – Issue3)

PROJECT NO.: 2512216A

DATE: JUNE 2023

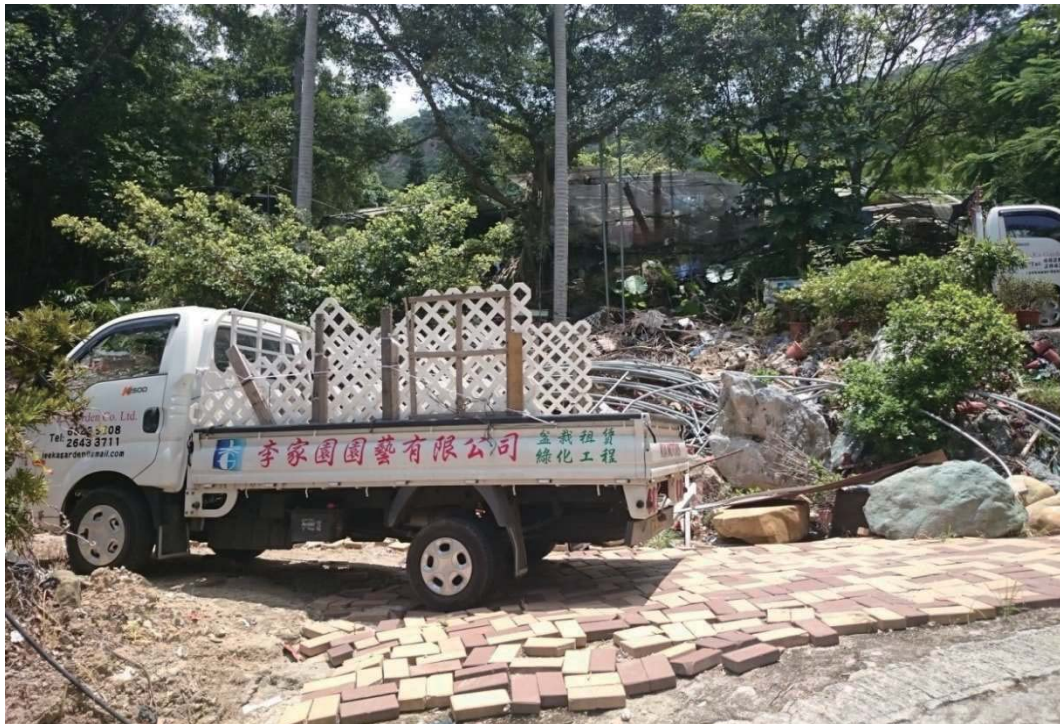
Front view concealed by temporary structures, looking northeast.

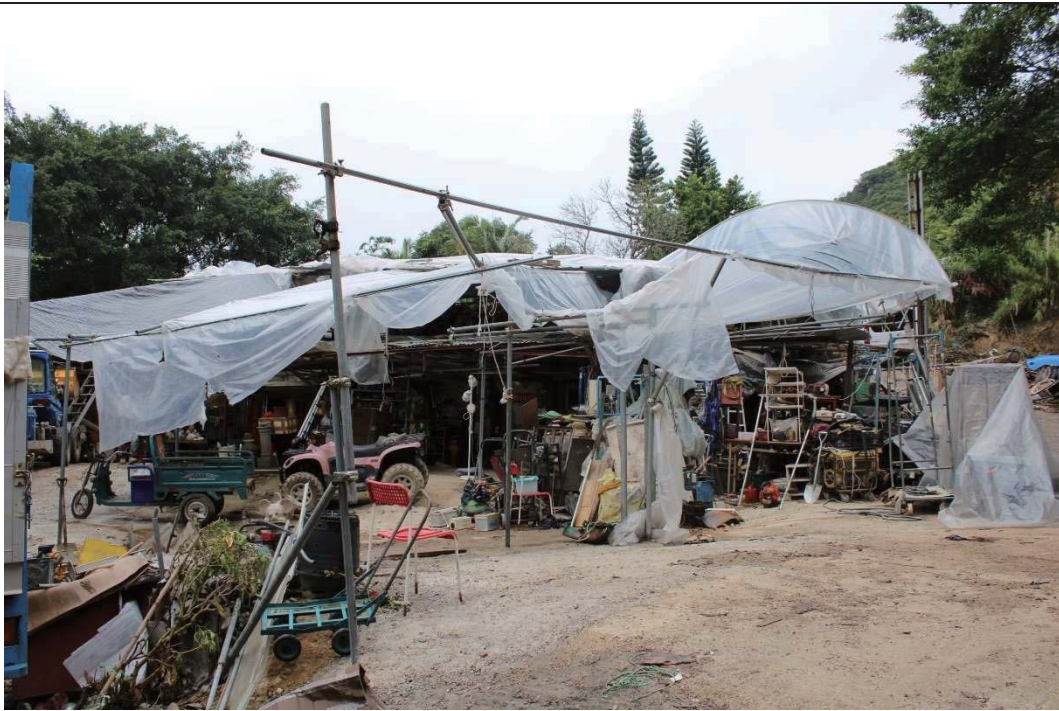
Side view concealed by temporary structures, looking northwest.

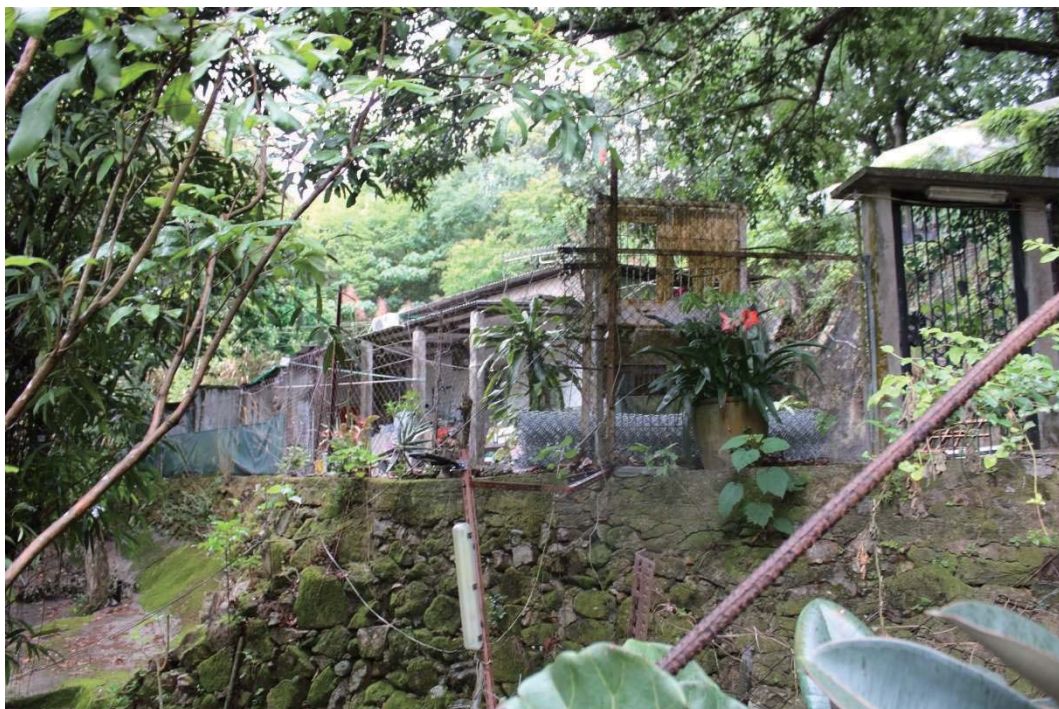
Associated Historical/ Cultural Events or Individual: None.		
<p>Architectural Appraisal:</p> <p>A single storey flat-roof house with parapet wall on top and covered porch at front. The house is constructed on brick and concrete. The external wall is painted in white. Metal frame glass windows are seen on façade beside main entrance. The porch has been extended by corrugated sheets and supported by concrete pillars. No access to the northwest and northeast elevations.</p>		
Interior: No access		
Existing Condition: Fair. Part of the building is covered by tarpaulin, suggesting leaking problem.		
Past and Present Uses: in the past associated with miners; now residential.		
Modifications: Porch extended; Roof covered by corrugated metal sheets.		
Photos:

General view of HB-26, showing stone laid terrace foundation and front view of the house inside fence, looking northeast.

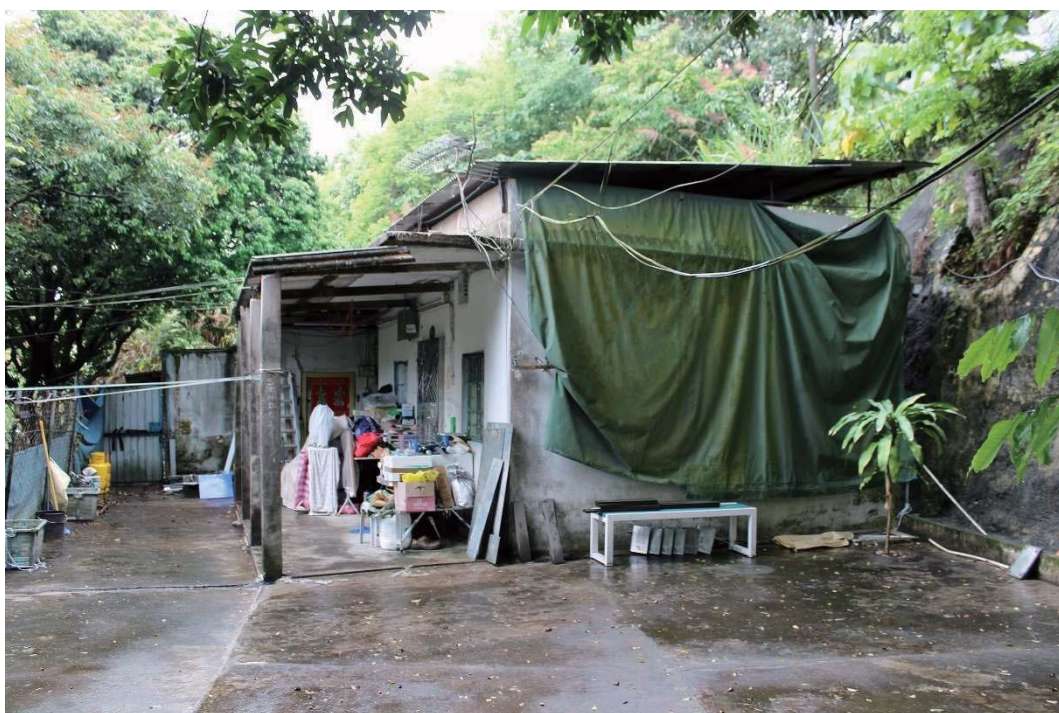
Front and side view of HB-26, showing southwest and southeast elevations, looking north.

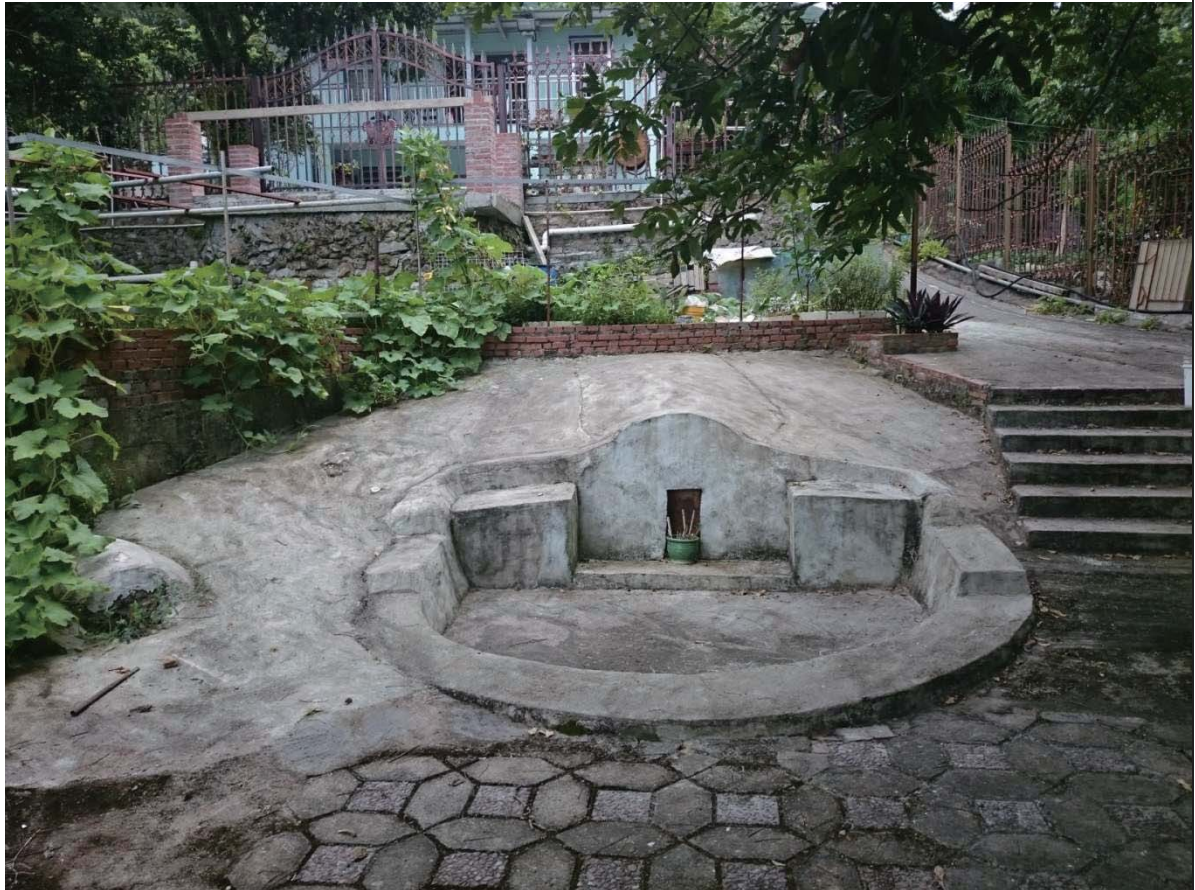
G-01 front view

<p>Associated Historical/ Cultural Events or Individual:</p> <p>Associated with miner's life and cultural tradition.</p>		
<p>Inscriptions (from perspective of viewer):</p> <p>First line: 光緒拾叁....</p> <p>Second line: 清顯考啟?邱公□府君</p> <p>Third line: 祀男宏 良 賢 萬□全□ 捷 永 開 秀 □ □ 傑</p>		
<p>Architectural Appraisal:</p> <p>G-01 is a grave paved by cement; the grave is with a semi-circular worshiping ground at front and a brick structure as furnace at one side. Gravestone seems original but inscriptions is weathered and hard to read.</p>		
Existing Condition: Good		
Past and Present Uses: Burial		
Modifications: Cement pavement and brick furnace are later modifications		
Photos:
