**Heritage Impact Assessment
for Conversion of the Former Clubhouse of Royal Hong Kong Yacht Club
at No. 12 Oil Street into a Community and Public Art Centre
– Artspace @ Oil Street**

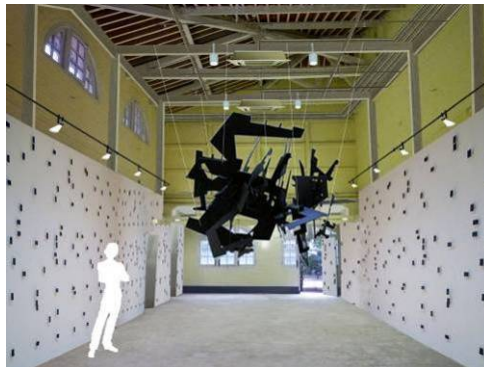
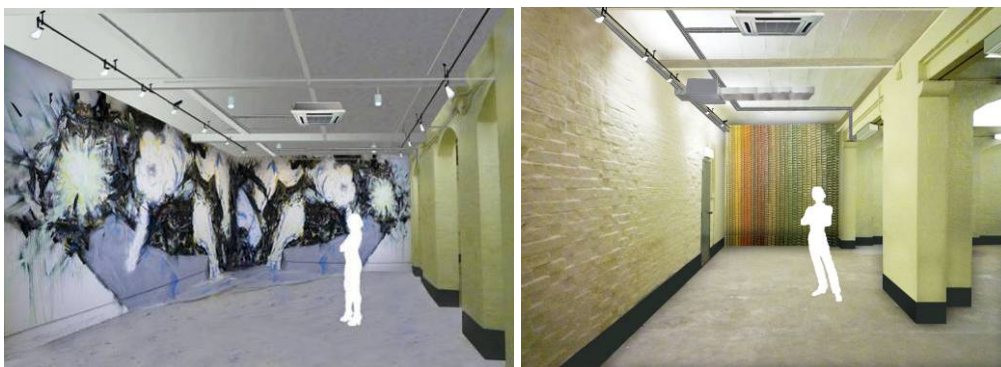
**Proposed steel structure at the multi-functional hall (above)
and exhibition gallery (below) for art display and installation**

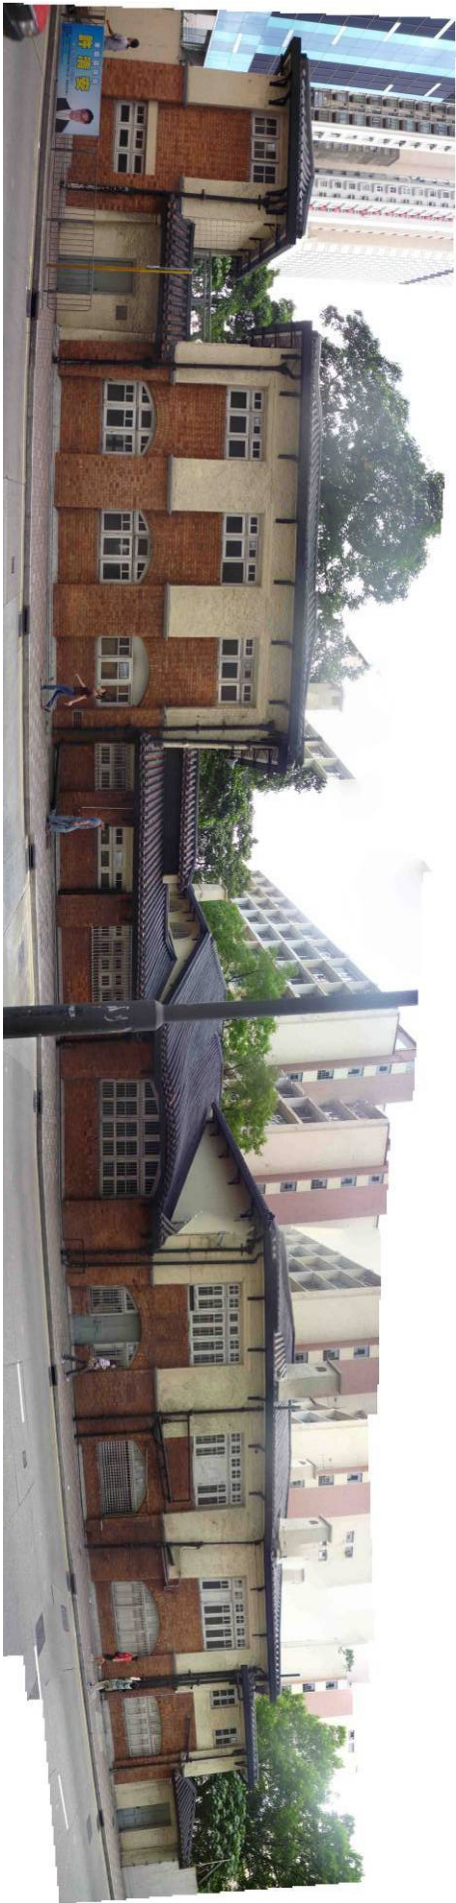
Existing elevation facing Electric Road will be maintained.

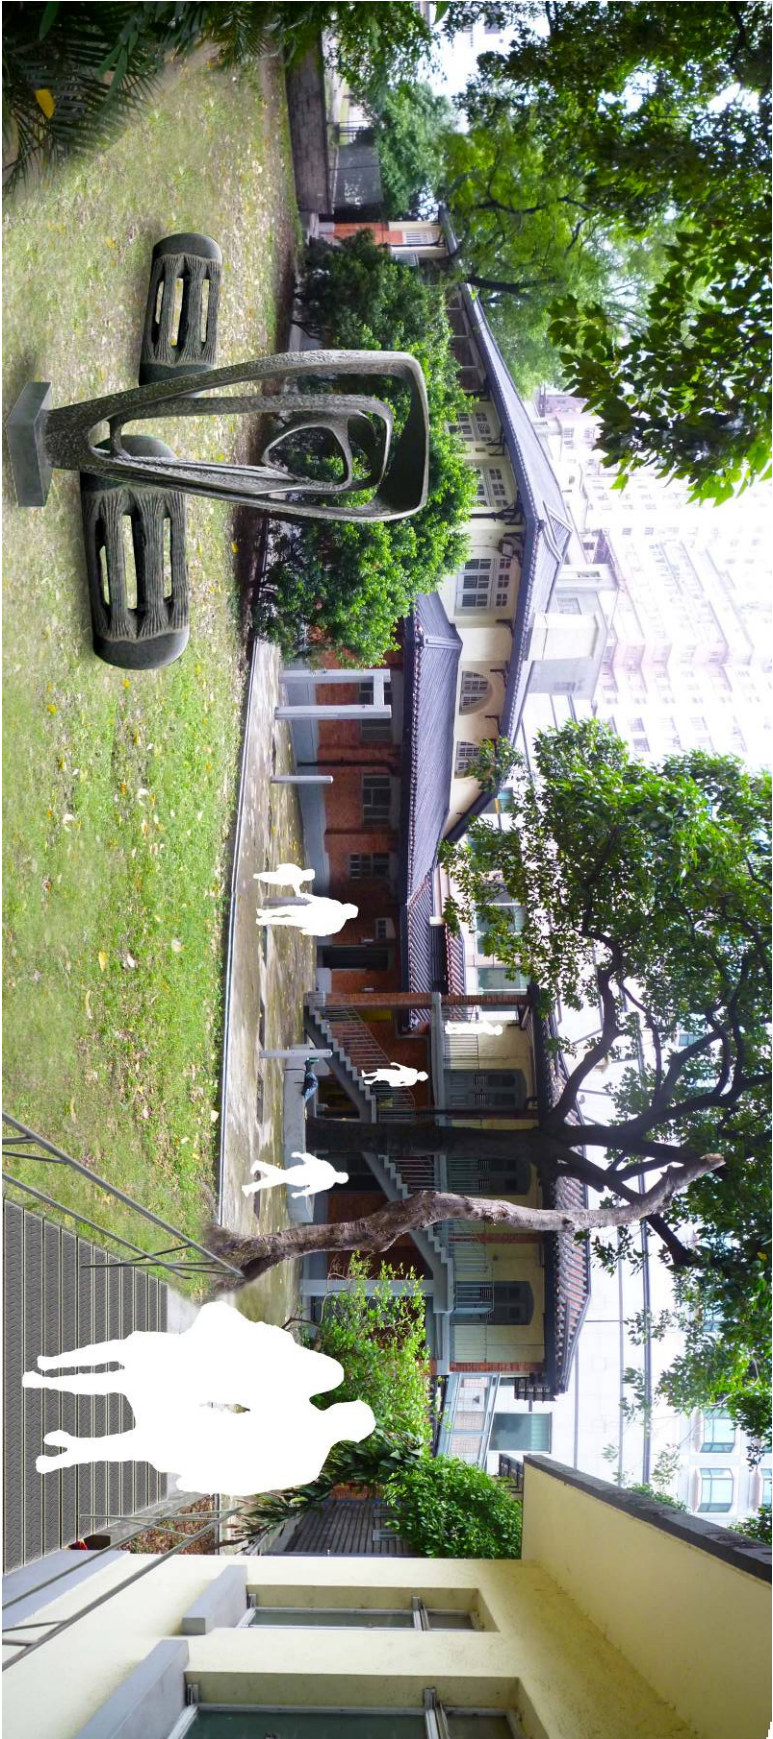
Proposed accessible ramp leading from the site entrance and in front of the existing guard house.

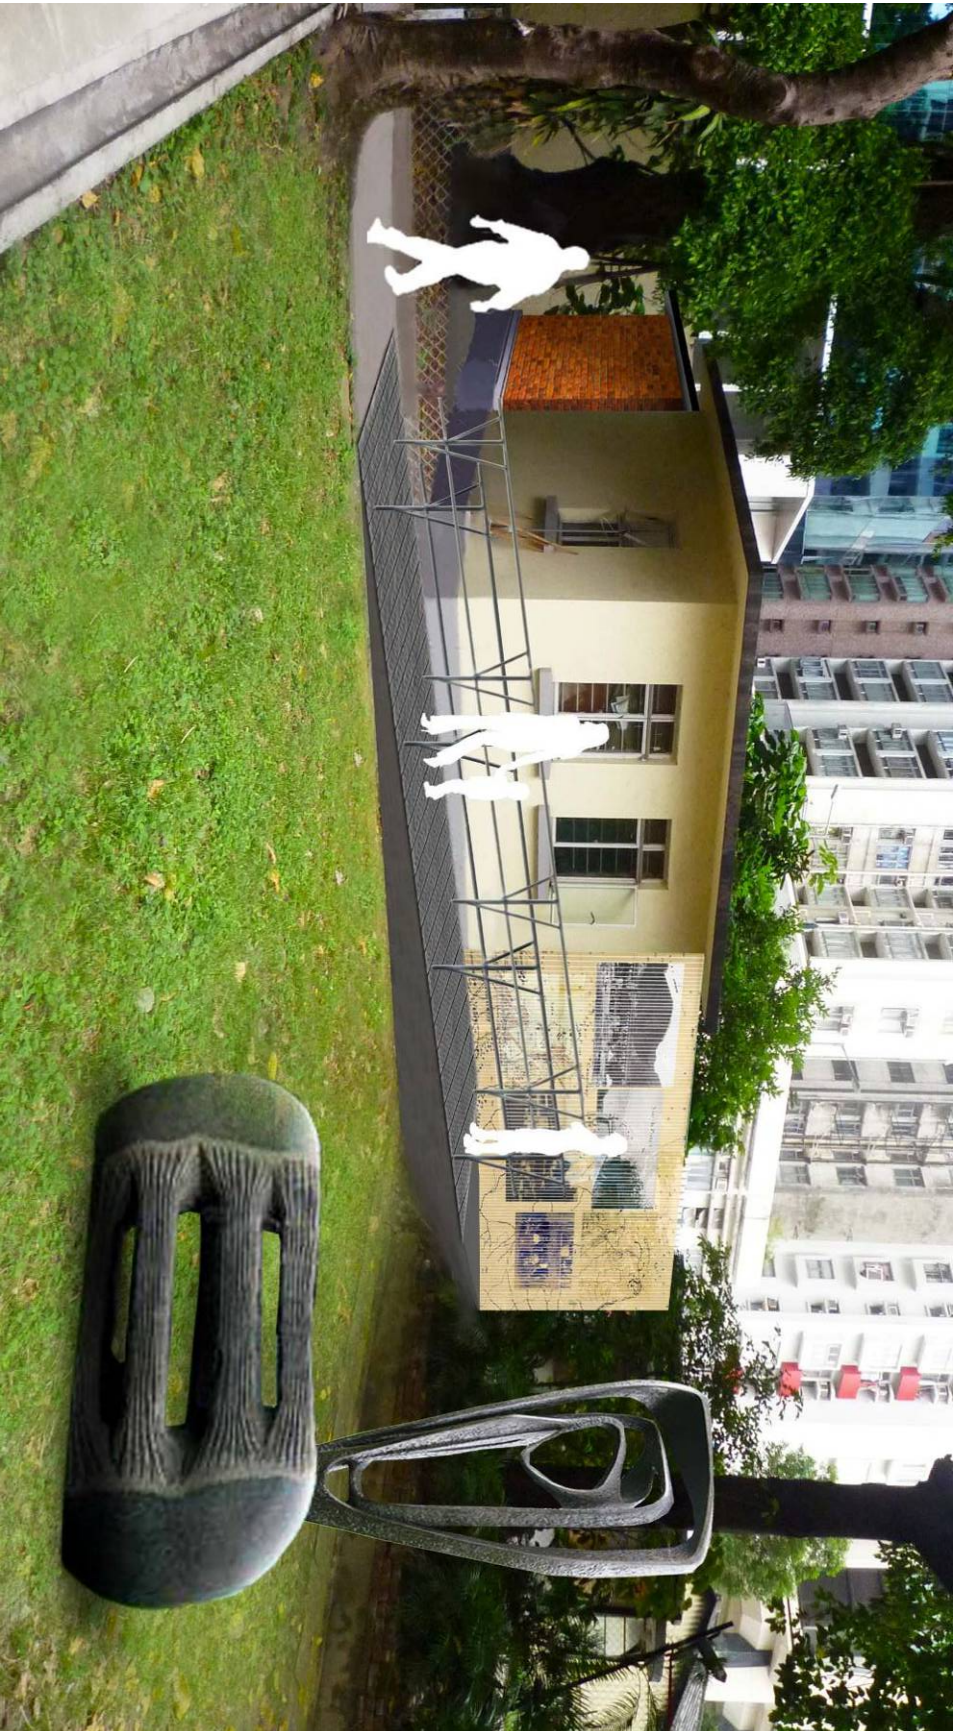
Proposed accessible ramp leading from the site entrance with the proposed combined F.S. and sprinkler tank beside the existing guard house, which would be screened off by decorated panels.

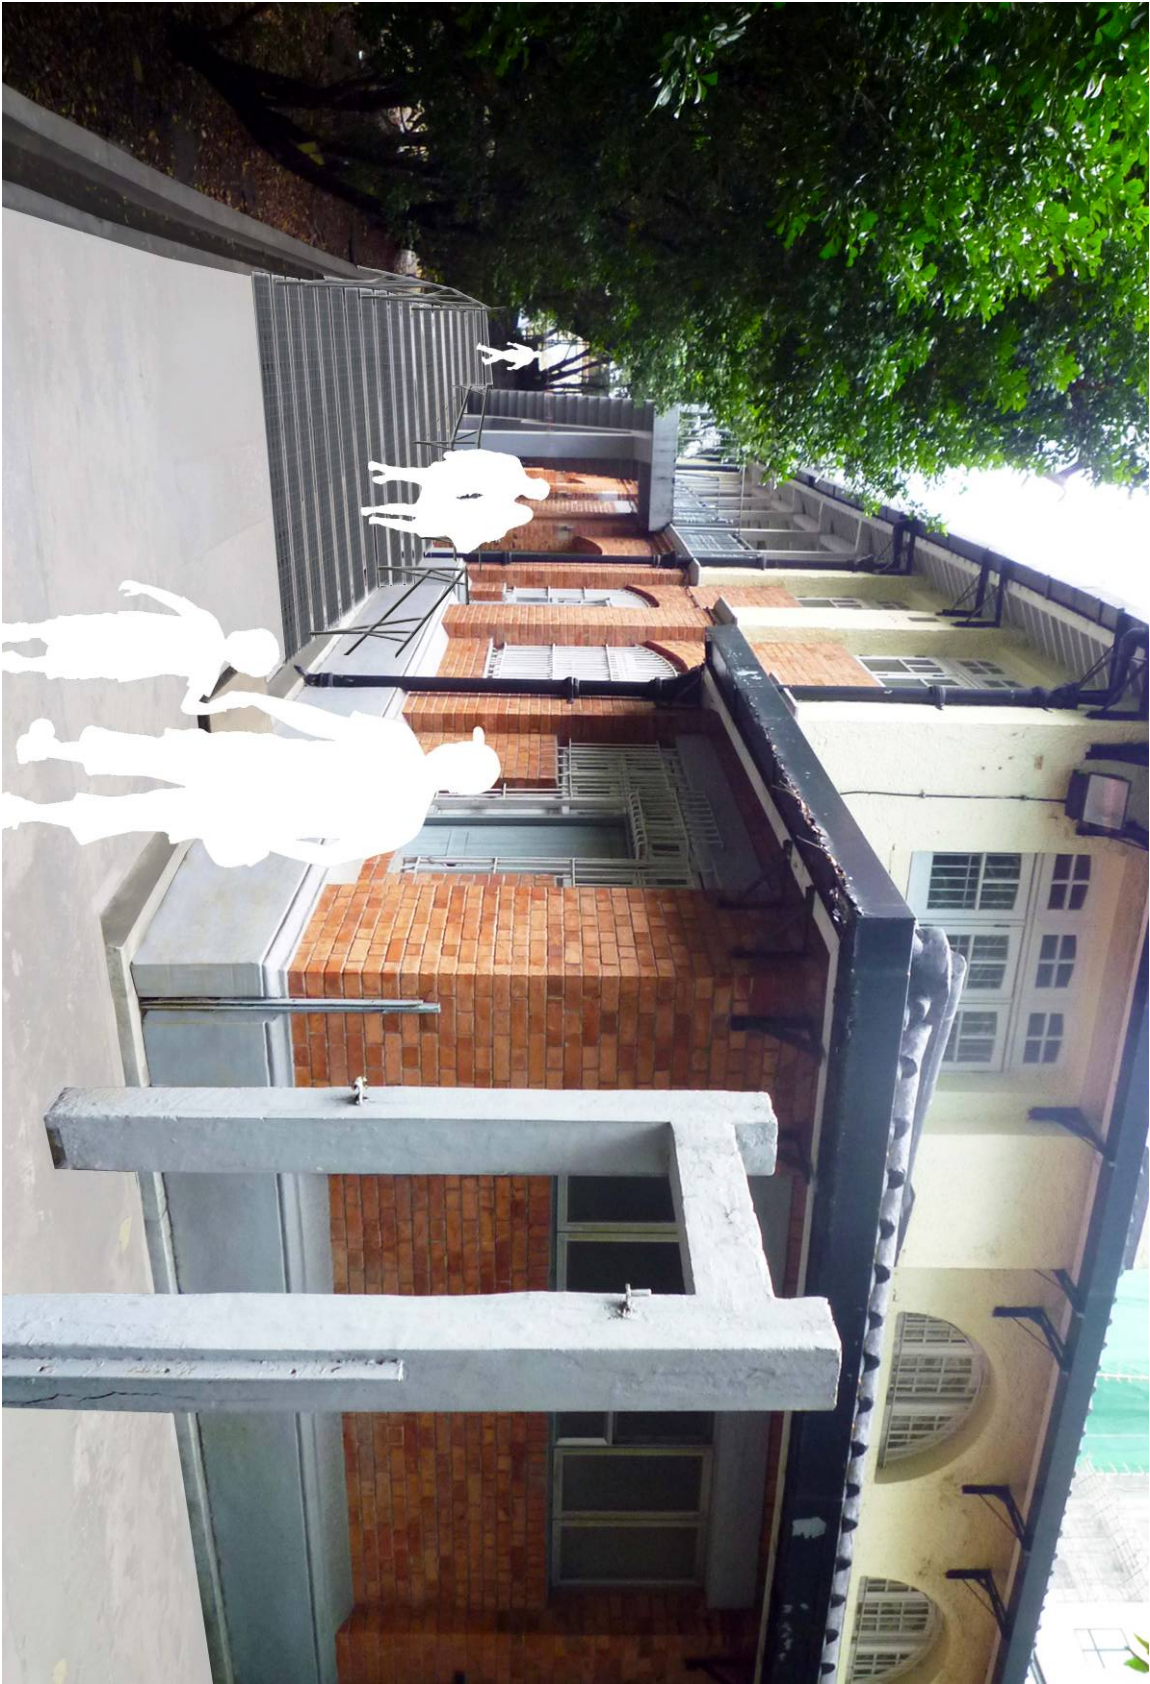
Proposed accessible ramp in front of the Main Building.
