## Heritage Impact Assessment

The Former Central Government Offices

Relocation of the Department of Justice  
to the Former Central Government  
Offices (Main and East Wings)

7 June 2012

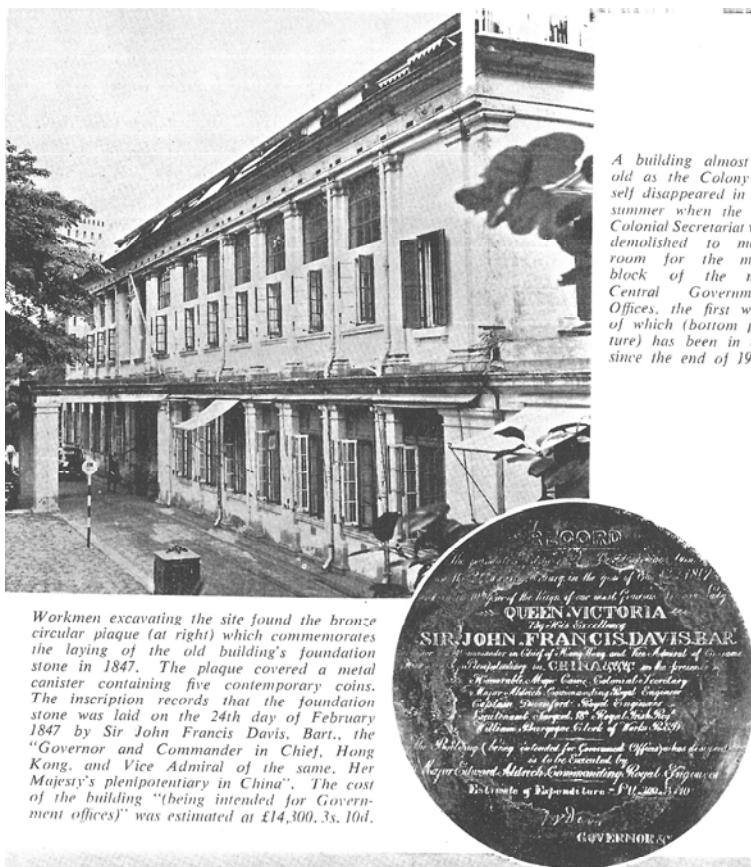
Fig. 2 A past news reporting the unearthed bronze plaque (middle) under the foundation stone of the 1847-built Old Colonial Secretariat Building (above) when it was demolished after a century in 1954.

The old Colonial Secretariat Building was built in an east-west orientation on the site where now the Main Wing is occupying. The foundation stone was laid at its northwest corner. Beneath the foundation stone, there was a granite block and a canister inside containing coins of the British Empire and covering by a bronze plaque with inscriptions about the erection of the building. This antique was discovered by workman when the old Colonial Secretariat Building was demolished in 1954 to make way for the erection of the today's Main Wing.

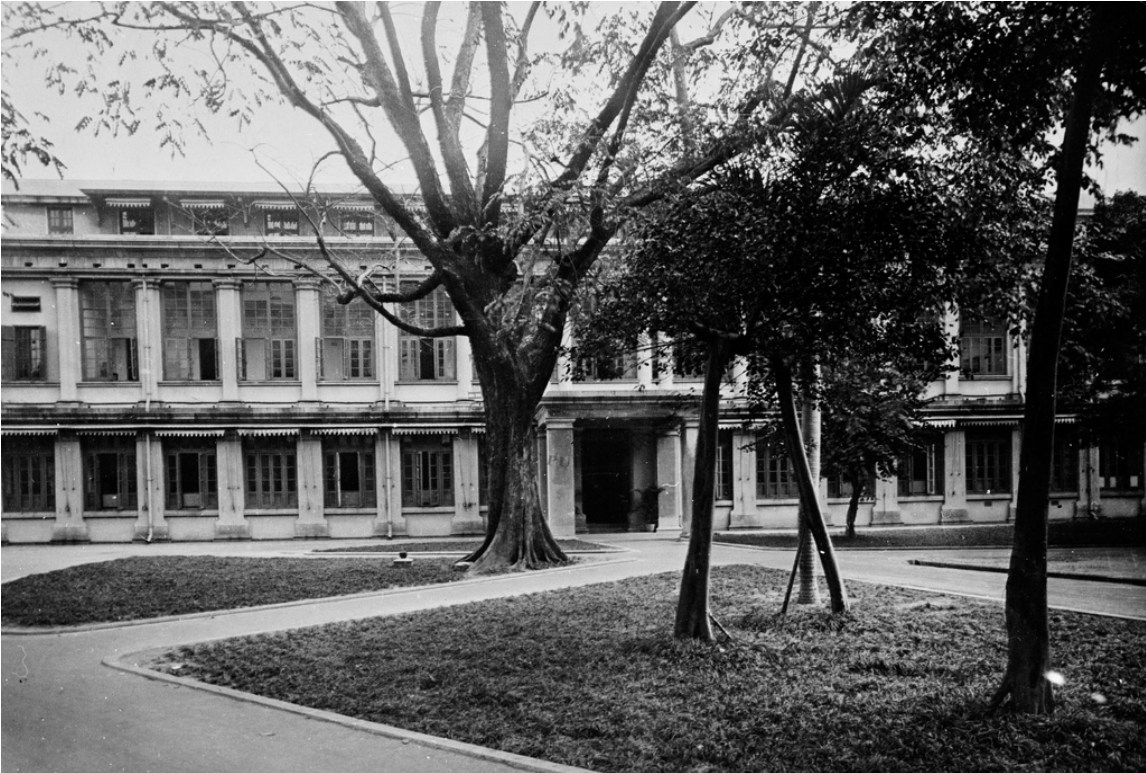
Fig. 5 The West elevation of the Old Colonial Secretariat Building and main entrance in 1930 after the extensive renovation. The original pitched roof was replaced by an additional floor. The Rosewood tree has been standing in front of the Government office as nowadays. (Source: The Heritage Hiker's Guide to Hong Kong, Pete Spurrier, FormAsia, 1<sup>st</sup> Publication, 2010)

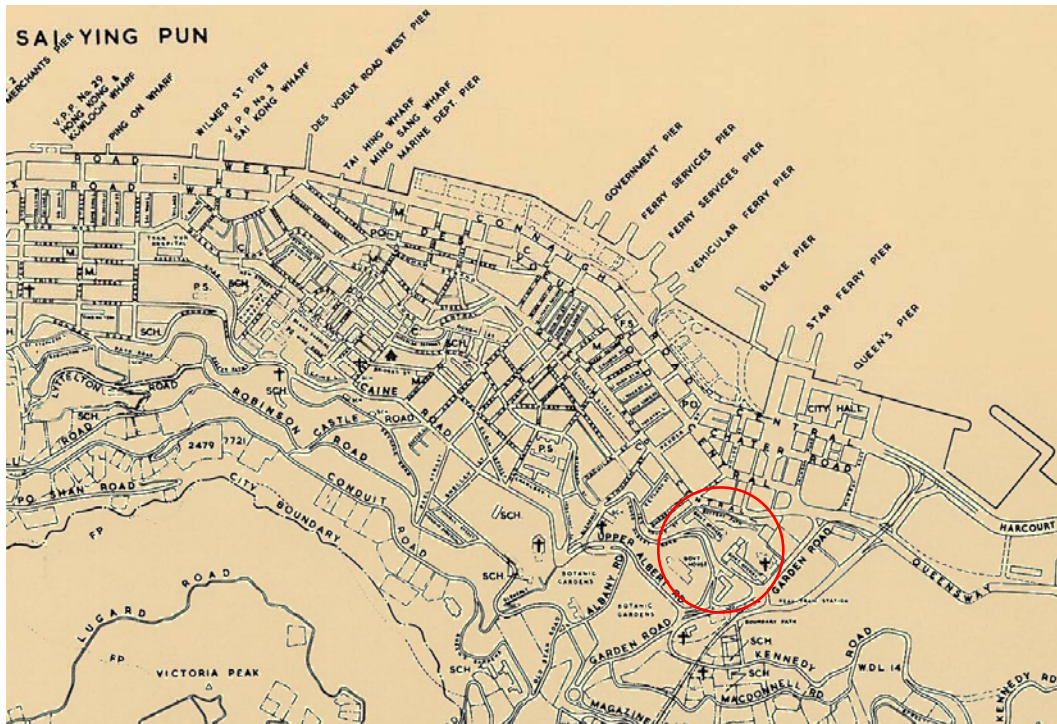
Fig. 13 (Top) and Fig. 14 (Bottom) showing the CGO Complex (circled) in 1964 and 1990 respectively. The two distinct structures (West Wing & East-Central Wing Complex) were clearly shown on the map.

The 1990 map (Bottom) still showing the fan-shaped LegCo Chamber on north of Central Wing before the demolition for extension.

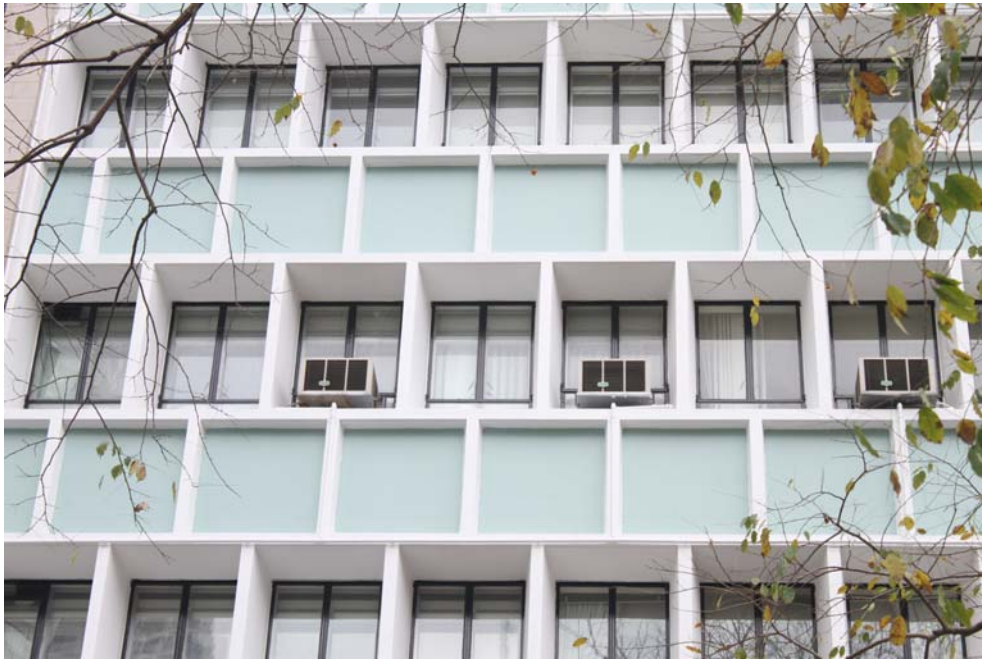
Fig. 15 The exposed concrete beam frame structures of East Wing alternate with rows of steel window and rows of green painted spandrel panels

throughout the height of the building. Their configurations are laid equally to reflect the evenly distributed internal layout design. This exposed building materials and standardized building layout become the prime decorative features of the building.

According to PMT's Appraisal, it is found that all those exposed concrete frames are with granular finish containing a white matrix with light-to-dark grey and beige-coloured granite and were originally unpainted.

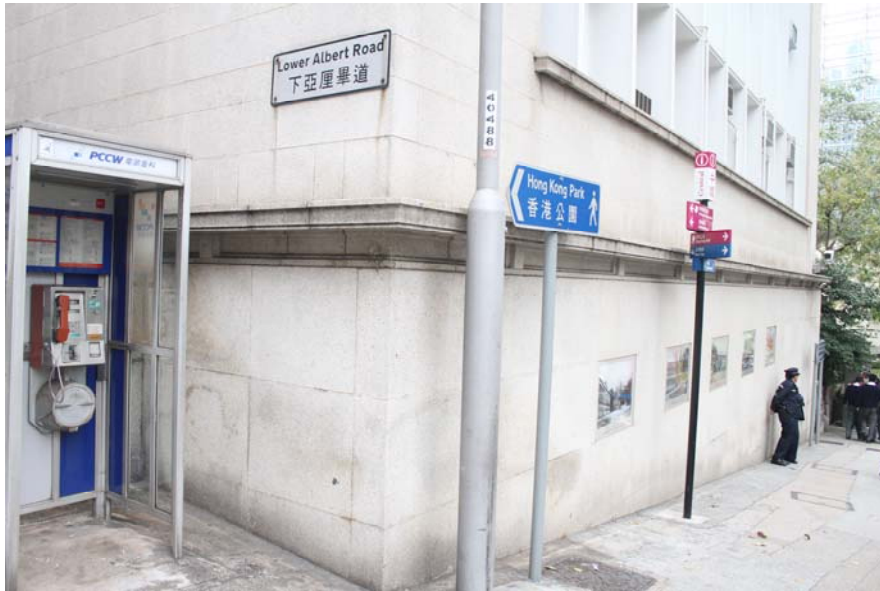
Fig. 16 The granite surface of the whole site is usually done with exposed surface without paint

Finely dressed granite slabs are commonly used in dressing part of surfaces and foundations of these two buildings. The slabs which mainly used on wall cladding are dressed in rectangular shape and laid in order and set back between layers which display a moving tectonic pattern. However, granite is an expensive material compared with reinforced concrete and was greatly reduced to use in building construction when reinforced concrete became popular. The use of granite in cladding the building surface is mainly for decorative purpose. Moreover, the used granites are carefully chosen and use only those with high quality which are durable from discolouration (discolouration usually due to presence of minute particle of iron inside).

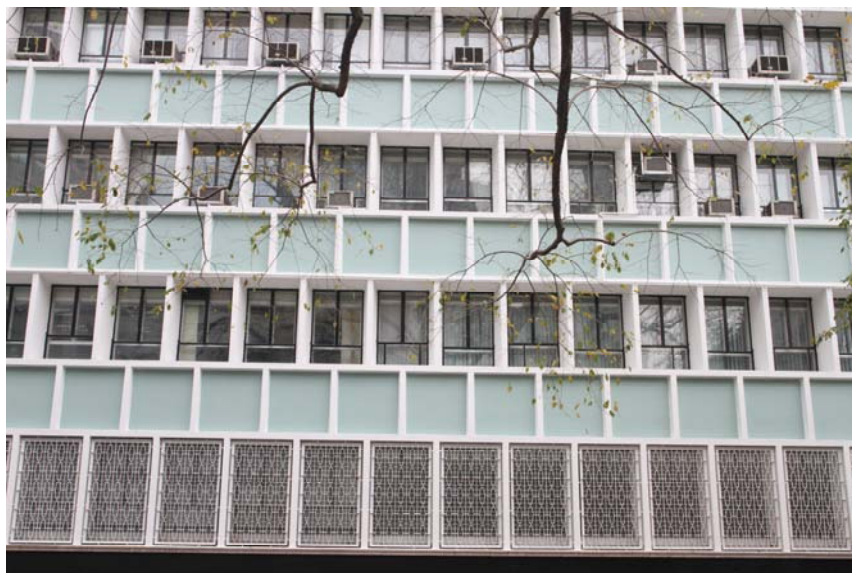
Fig. 17 Windows of the Main Wing. All windows of the CGO site are in Universal Crittall Style with a simple frame and proportional light design

All window openings are fit with steel windows commonly known as Crittall style. Crittall is a British established window frame manufacturer. They tried to introduce a universal range in window glazing and design. With proportionate sections and simple linear design, they became the popular choice for windows installing in modern architecture. In 1931, they established the Crittall Manufacturing Co. of China. Such similar design of windows is found throughout these two buildings although some variations are recognized in glazing division and opening due to later alteration.

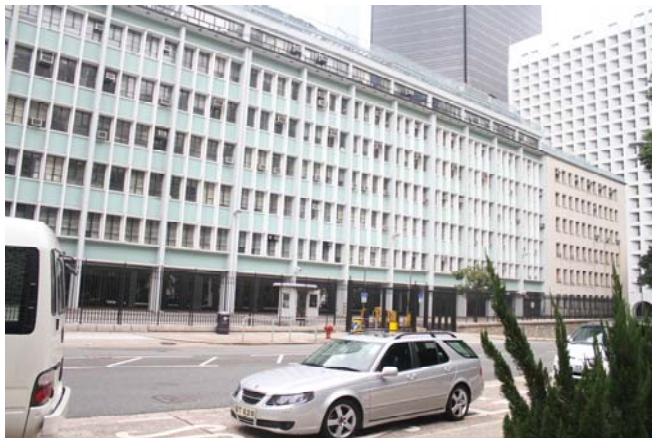
Fig. 18 (Left) showing the exposed concrete frame of central section and granite cladding right section of East Wing.

The building is generally built with 3 sections in distinct features. To the east is a two square towers structure with exposed granite slab covered surface. The central section is of exposed concrete frame structure infill with steel window glazing and spandrel panels. To the west is a “transitional” section with granite-covered surface linking the west-end of East Wing with the vertically oriented Main Wing on the central bay of its east elevation. This section is of 8-storey high with a mono-pitched roof leaning towards the East Wing compared with other flat roof sections. The G/F of central section is a covered open space with supporting beams designated as a car park. Top of the roof is for plant services surrounding with light-painted balustrades. The upper exposed concrete frame is painted in pastel green and the infill spandrel panels are painted with milky light green.

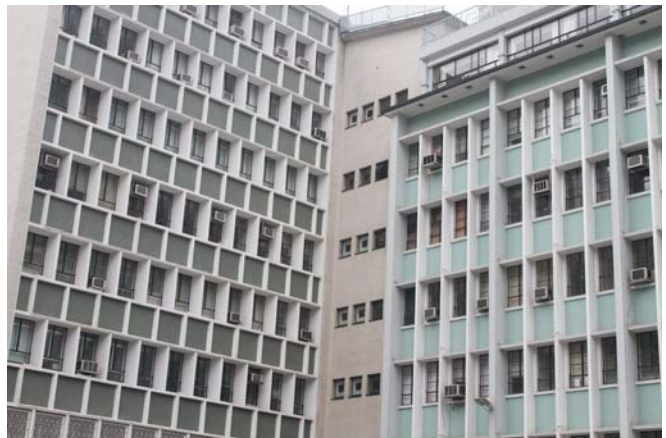
Fig. 19 (Right) showing the west granite cladding “transitional section” linking the East and Main Wing.

This section is of a transitional structure linked with the Main Wing. It is an 8-storey high mono-pitched roof structure (G/F to 7/F). Its surface is covered by finely dressed granite rectangular tiles offset on each level to create a moving effect. From 1/F to 7/F, each level is distributed with 4 square openings with steel windows and half of them are now installed with ventilation fans. The G/F is filled with 4 greater window openings filled with steel security grilles with geometric pattern decors and painted white. The grilles are of original design. Ductworks are found on the G/F exterior surface towards the Main Wing.

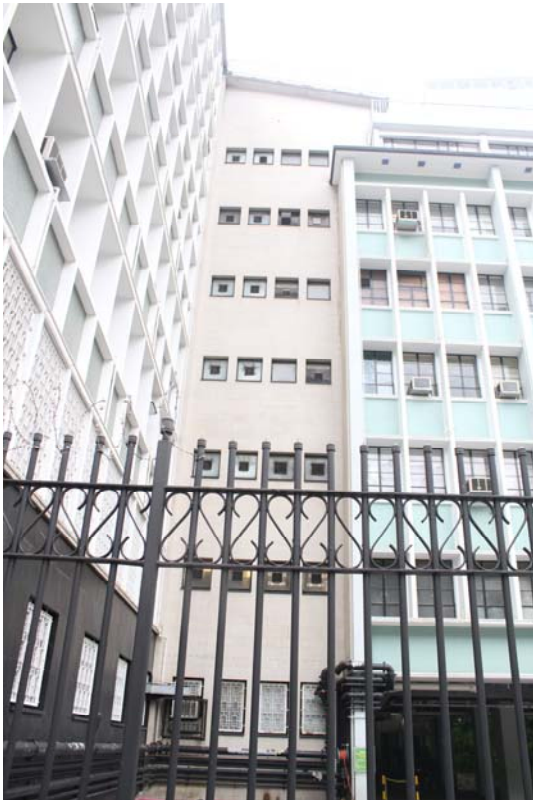
Fig. 20 The West-end transitional section which is believed to be constructed with the Main Wing on its left in 1956. (South elevation)

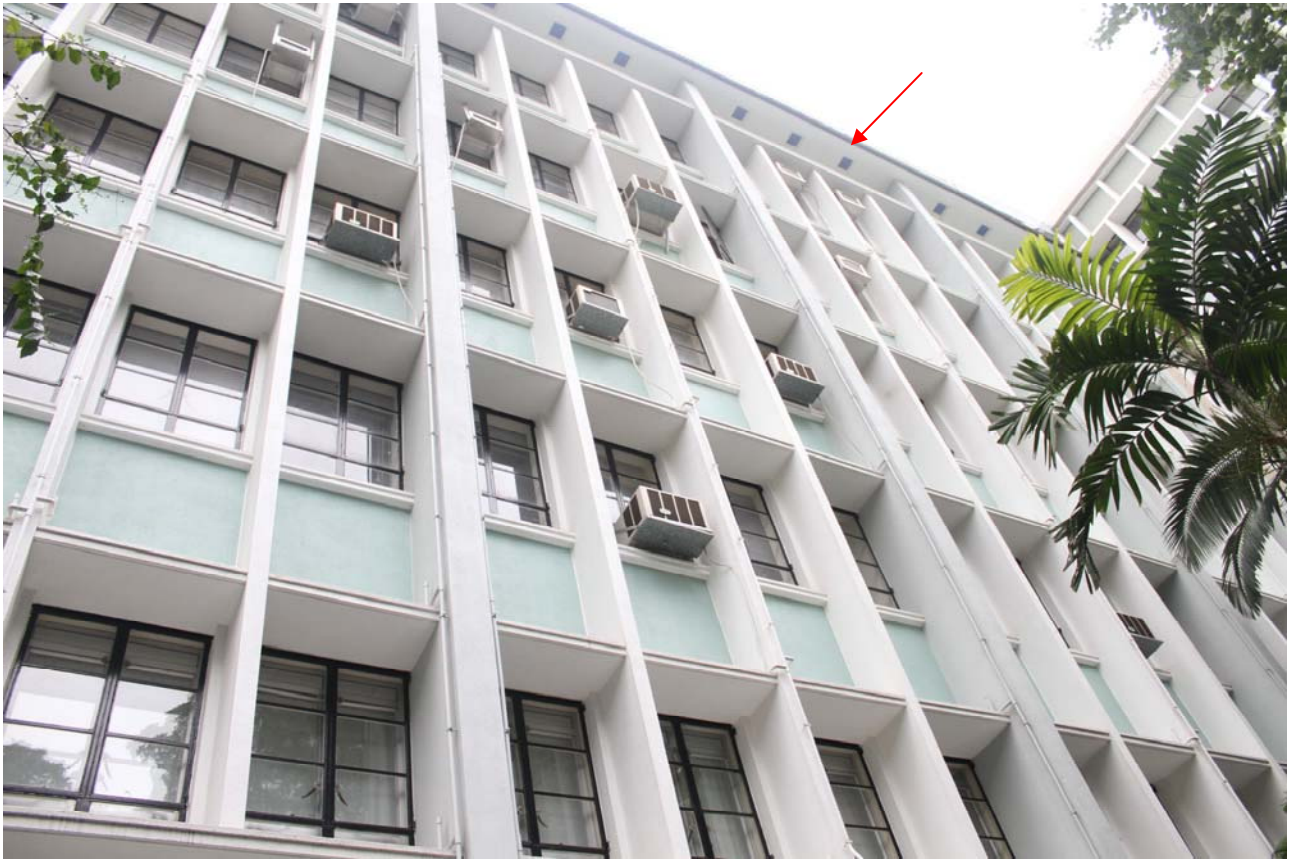
Fig. 21 A closer look to the central section of the East Wing on north elevation. The elevation with emphasis on vertical and horizontal elements divided the building into even bays. Each floor consists of a row of upper window with 8-light design, a projected window head and a shorter window sill. Under the window is a projected milky green-painted spandrel panels.

This section is dominated by its exposed concrete frame structure. This horizontal structure is divided into 12 equal bays by vertical elements penetrating G/F to 5/F. Each bay is further divided into 4 bays by shorter vertical elements a bit set up back from the outer surface of the building.

Each floor is further divided by into the upper window section and the lower spandrel panels by two horizontal elements to form the more projecting window heads and shorter window sills. Each window is in an eight-bay system (two vertical rows of four). The bottom two are fixed and the upper six form a pair of pull-aside window leaf. Comparatively, the height of the window section is a bit longer than the bottom spandrel section. The 5/F is topped with a more projecting cornice with 3 square shaped mouldings evenly distributed within each 12 bay on the down looking surface of the cornice. Those square shaped mouldings (Pointed in Fig. 21) are painted green while the tip of the cornice is painted black. The 6/F is of a later addition built in 1961-62. This level was built recess back from the original elevation and was divided into 12 equal bays by vertical elements correspondent to the lower 12 bays design. Between each bay is fitted with two horizontal rows of rectangular windows with two thicker and slender windows alternate each other. Only the slender windows can be opened in a single system.

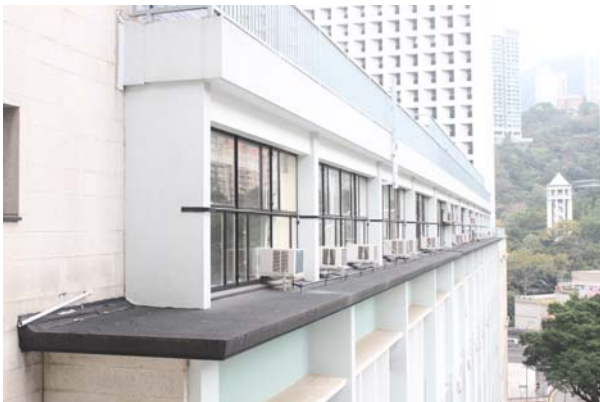
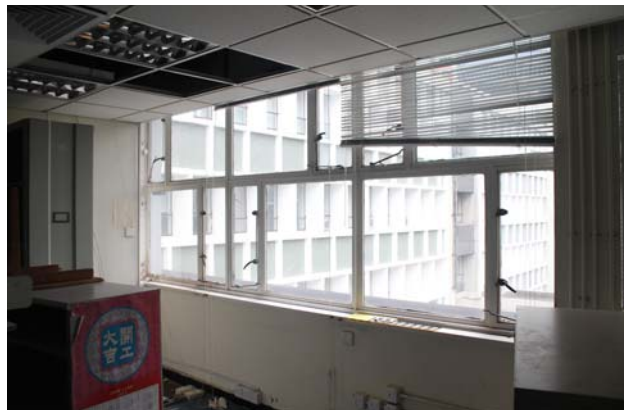
(Fig. 22, left) The additional floor added on the central part of East wing with its steel window frame design (Fig. 23, right).

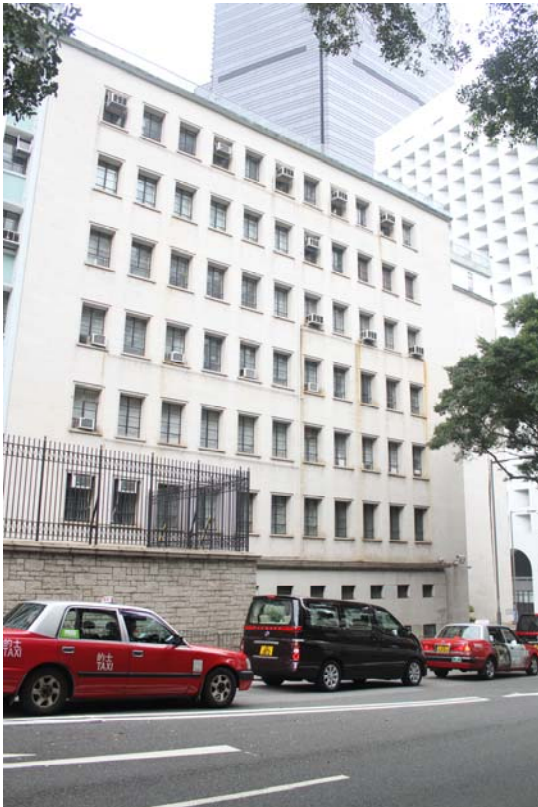
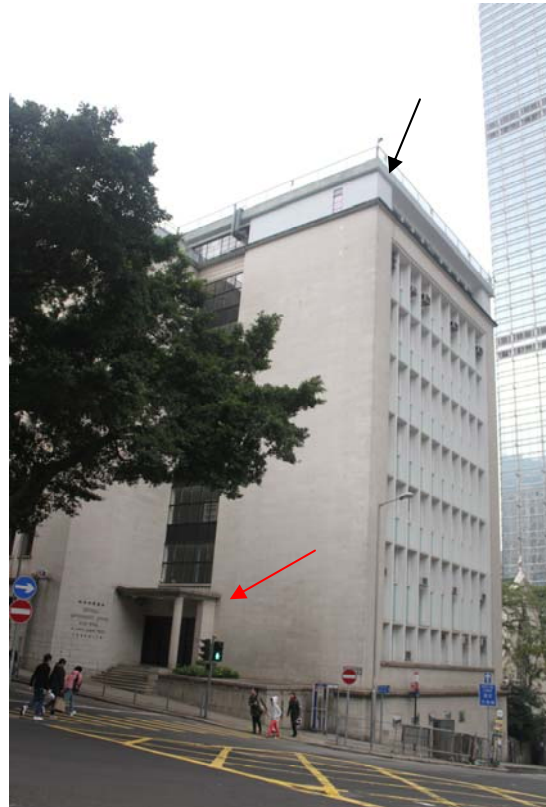
Fig. 24 (Left) and Fig. 25 (Right) showing the two-linked square tower design on the east side of the East Wing. The main entrance is design on the south junction between these 2 square tower blocks (Pointed in red). The additional floor on the top of right square tower is a much later additions done in 1970s with the original cornice flag pole demolished with marks remain. (pointed in black)

The section consists of two square tower blocks built linking each other with the right tower move further north towards the St. John's Cathedral. Both of them are covered with dressed and exposed rectangular granite slabs giving a smooth surface. Due to uneven slope of this section, Lower Ground Floor (LG/F) and Basement Floor (B/F) were built in this section. The 6/F is a later addition in 1976 with its layout followed the lower levels generally but is an exposed concrete structure. The overall structure is generally 9-storey high.

For the left block, 11 distinct rectangular steel-framed windows are evenly distributed from G/F to 5/F. All openings consist of recessed surrounds with projected sills. The windows are the 8-light system the same as the central section. The LG/F is fitted with 2 rows of smaller rectangular windows fitted with 2 light systems. The LG/F is finely divided from the upper levels with a projected cornice supporting with slender vertical granite elements alternate with thin and long rectangular flutes. In front of this LG/F is a nursery.

For the right block, a main entrance is located on its LG/F level with flight of granite steps leading from Lower Albert Road. All windows are aligned above the entrance with solid panels of rectangular granite for the rest of the finishes of this particular elevation. Each level is fitted with 2 rows of five big rectangular windows, while those located on the floor level are painted black with visible bold frames. Panel crafted with zigzag patterns is found on top of the 5/F windows which were influenced by Art Deco movement. Projected granite cornices are found on top of 5/F and the dividing floor level between B/F and LG/F. A granite nursery with plantation is found next to the main entrance

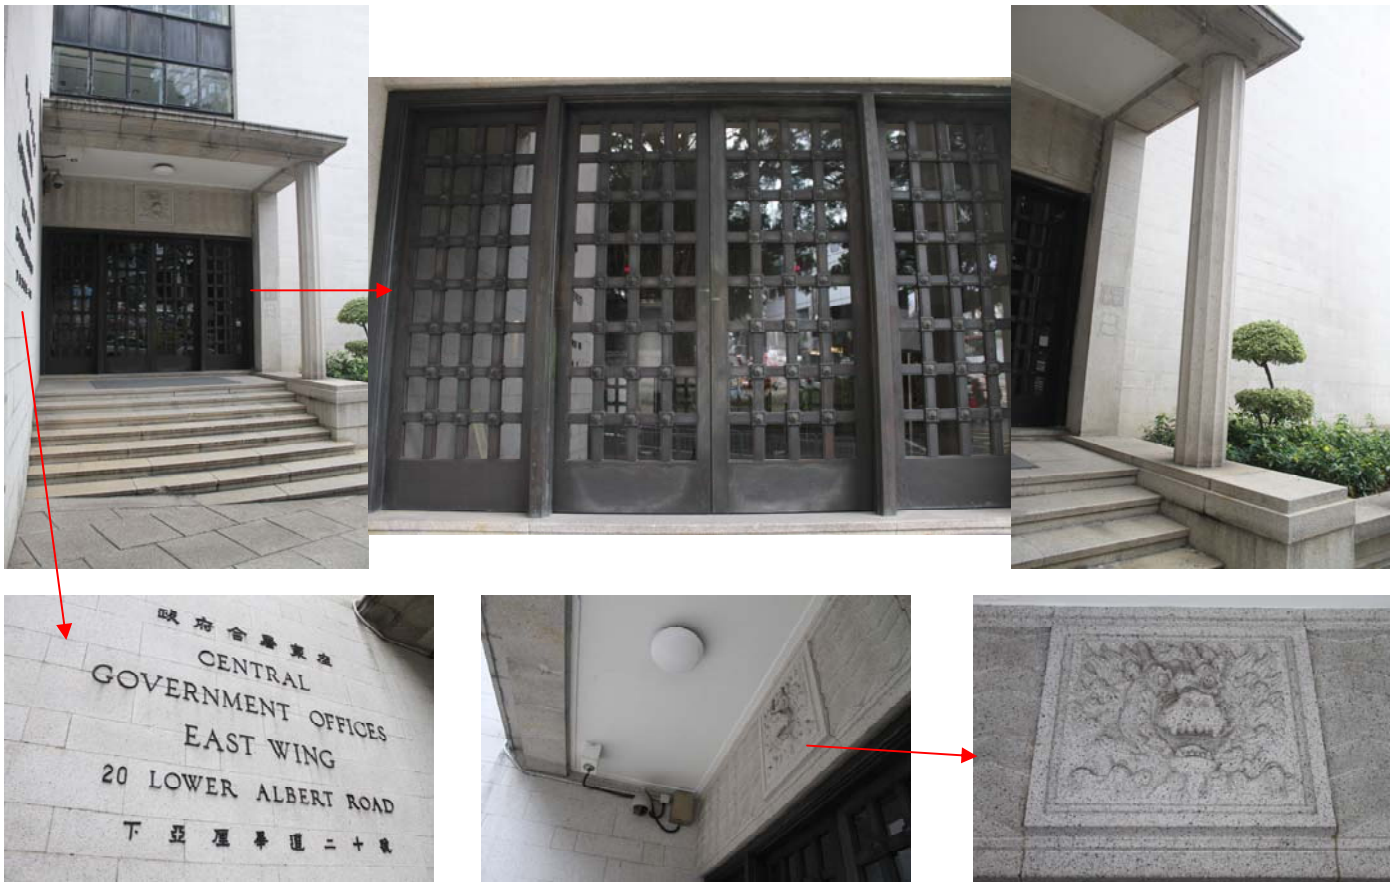
Fig. 26 -31 (Left to right, top to bottom) showing the features of the main entrance area of the East Wing

The main entrance is located on LG/F level at the corner between the left and right square block on the south elevation. However, the entrance is located a bit higher than the street level and has to be reached by eight granite steps. The entrance is topped with a projected canopy and supported with a fluted column located on its outermost right corner. The cornice of the canopy is in two levels with the lower part built recess back from the upper one. The building name and address with its Chinese and English characters are affixed on the east wall of the left block just next to the canopy.

The main entrance is fitted with a bronze doors system. There are totally 4 door panels with the middle two forms a pull-aside system. Each panel is glazed with 32 lights (eight horizontal rows of four) and with floral pattern decors on their bronze frame corners. On top of the bronze door there is a granite panel decorated with zigzag horizontal fluting. The middle sits a square block with a dragonhead craft which giving a taste of oriental style features to the entrance of the building.

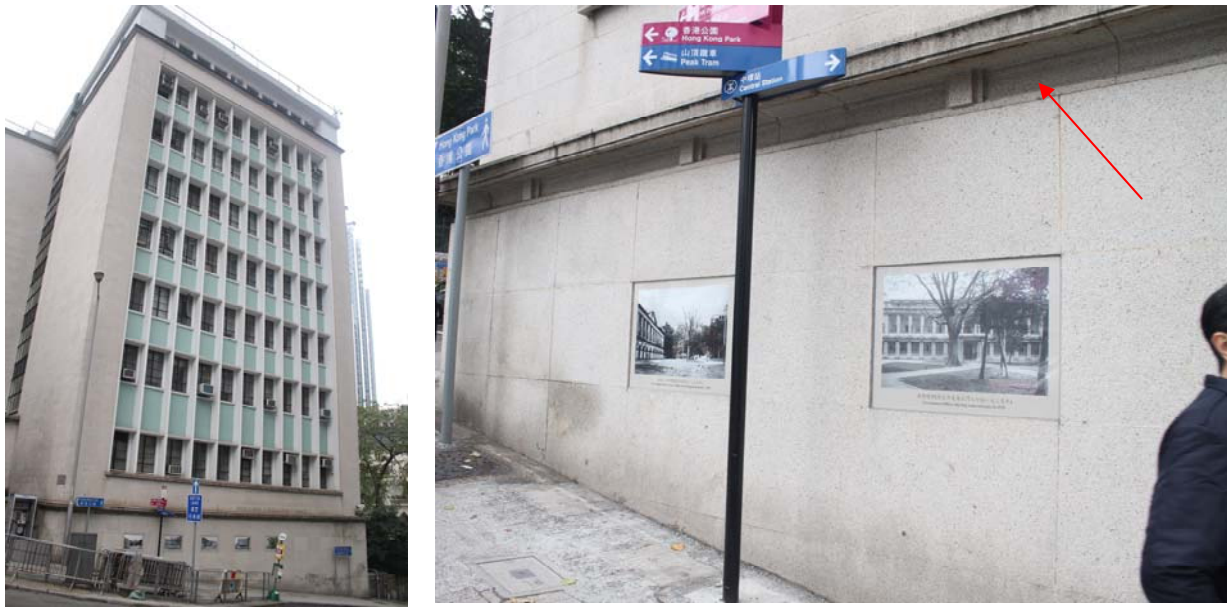
Fig. 38 (Left) & 39 (Right) show the mixture of exposed concrete frame with granite cladding surface design within one elevation. The basement of the block separated by an elaborated cornice (Pointed) was refurbished 2-3 years ago by inserting 5 glass frames with old photos of the CGO for public appreciation

It is a 9-storey high structure built on an elevated slope leading to the St. John's Cathedral. Windows are found locating between LG/F and 5/F with similar style and division similar to that of the central section of the south elevation of the East Wing. These 7 floors are equally divided into 10 bays by vertical elements. Horizontal elements integrate with the verticals and further dividing each floor into upper 8-light system windows and the lower spandrel panels. These horizontal elements flanking all windows form a more projected window heads and shorter window sills. The concrete frame is painted in pastel green and the spandrel panels are painted milky light green. Other than that, all are dressed in granite slabs. More projected cornice is found on top of 5/F (with tip painted black) and division level between B/F and LG/F (exposed granite surface). The external wall of the B/F is mostly compiling with granite slabs surface. However, recent renovation (done mainly in recent 2-3 years) has added five glass panels on its surface showing historic photos of the CGO building since the old Colonial Secretariat Building.

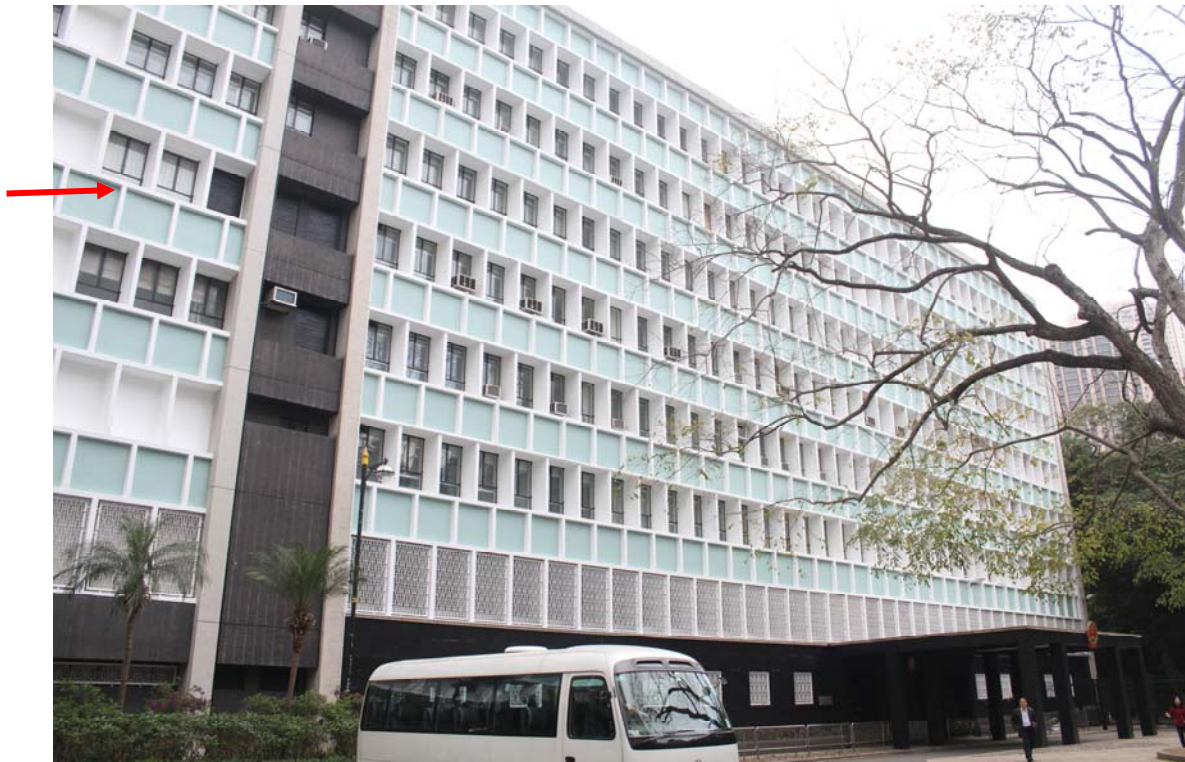
Fig. 41 The main elevation of the Main Wing. The building composed of the original 1956-built south block connecting with the 1989-built north annex block (Pointed).

The Main Wing basically underwent three stages of development. The building consists of the 1956 built south block and the 1989 built north annex block with an octagonal auditorium located on its northeast corner. This new extension is built on the former site of the 1956 built Legislative Council chamber which was a fan-shaped 2-storey structure. It was no longer used after the LegCo moved to the new site in 1985 and demolished to make way for the annex block. On the old south block, the 7/F is a later addition probably built between 1960s and 1970s with design and external materials basically matching with the original.

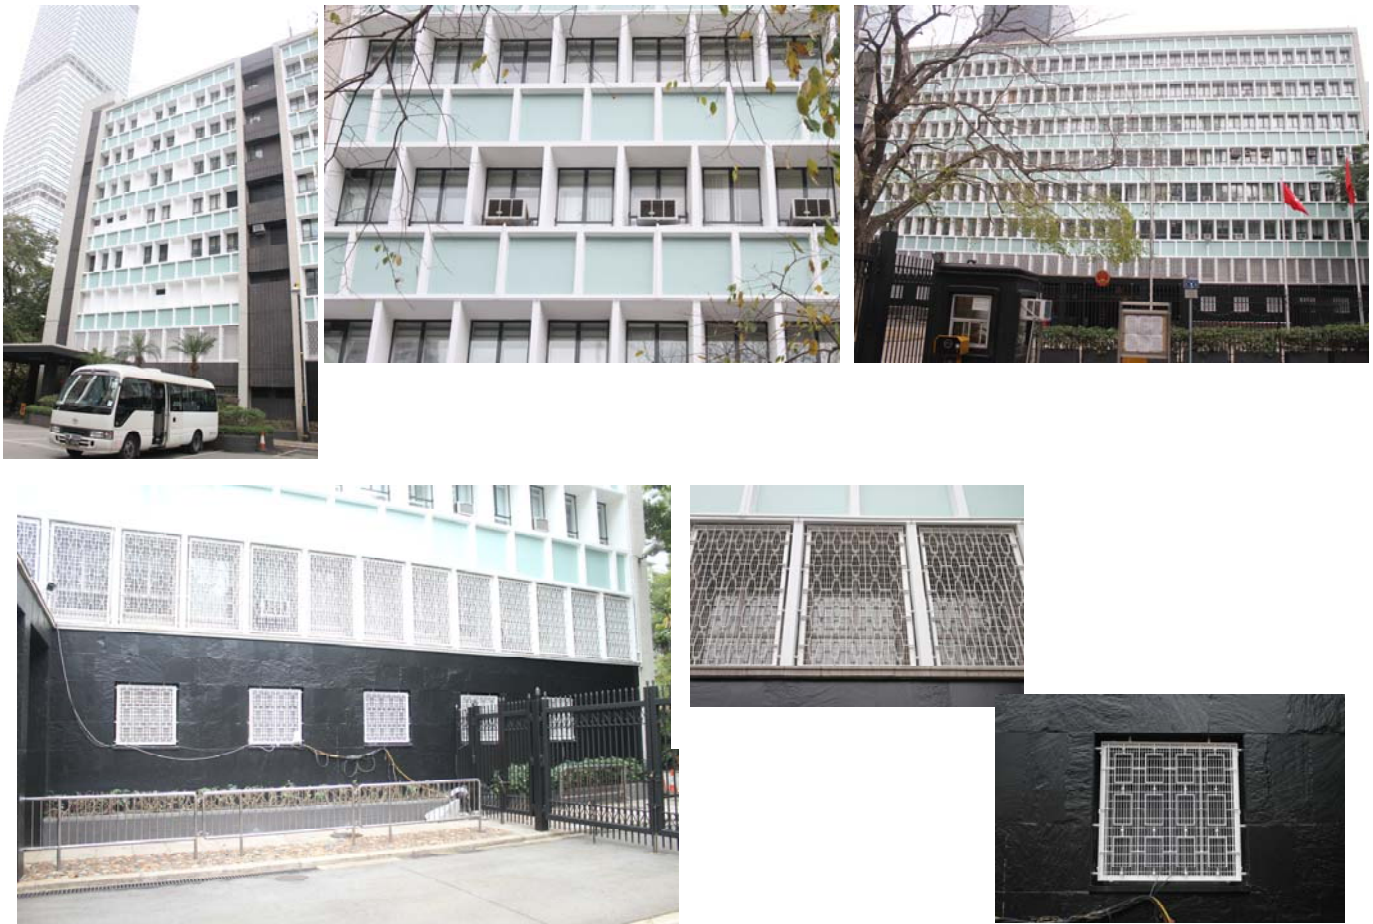
Fig. 42 – 47 (Left to right, top to bottom) The west elevation of the north annex block (Fig.42), the south old block (Fig.44) and the exposed concrete frame details (Fig. 43). Black-painted slate covered G/F (Fig.45) and the security grilles on 1/F (Fig.46) and on G/F (Fig.47) window openings.

The G/F is totally surfaced with slates painted black including the projected canopy with supporting columns. The G/F is evenly distributed with square openings secured with original white painted security grilles (7 located left of the canopy and 5 located right of the canopy). Low level nursery is found in front of the G/F wall. The whole edge of the south block elevation is finished with granite panels.

Although the new annex block attempted to build correspondent to the old south block with similar style, there are differences in materials usage in several prominent parts. For example, the surrounding building edge is covered with square ceramic tiles in light grey colours instead of granite. All the G/F is mainly covered with black tiny ceramic tiles instead of slates.

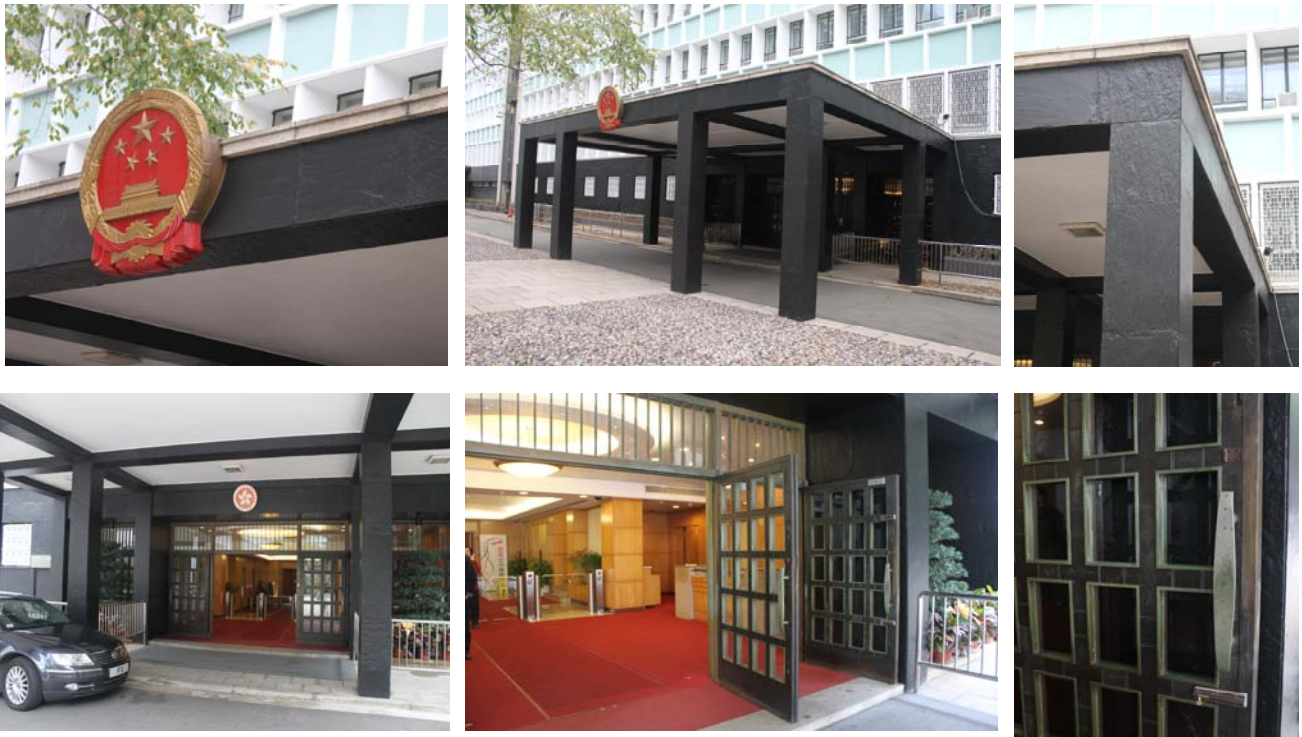
Fig. 48-53 (Left to right, top to bottom) The main entrance on the west elevation with detailed features including the PRC emblem on outer cornice level (Fig. 48), the canopy (Fig. 49), the slate surface (Fig. 50), the main entrance area (Fig. 51), the bronze entrance gates (Fig. 52) & its details (Fig. 53)

The entrance is covered with a projected canopy supported with 8 plain square columns lining in two rows. It is designed to make the space between rows wide enough for cars to pass through underneath for passenger departure or drop off. Except the ceiling surface, the entire structure is covered with slates painted black with the top edging cornice decorated with exposed granite. The emblem of People's Republic of China is hanging on the centre of the outer cornice level while the emblem of the Hong Kong Special Administrative Region (HKSAR) is placed on the centre of the inner cornice level within the canopy.

Elevated with a flight of granite step, the main entrance doors composed of 4 bronze glazed panel doors with glazing and the upper ventilation rails. The door system is designed with a pair of central open doors and 2 side openings. A French bronze French window with the same design is put on each side of the entrance gate. The central doors function during office hours while the two side doors were used in non-office hours. The whole system together with the attached locks, holding rings and handrails are of original. The upper window rails are now covered with a transparent sheet for air-conditioning reason.

##### 1a.) The Bronze Gate in Main Entrance (Fig. 52 & 53)

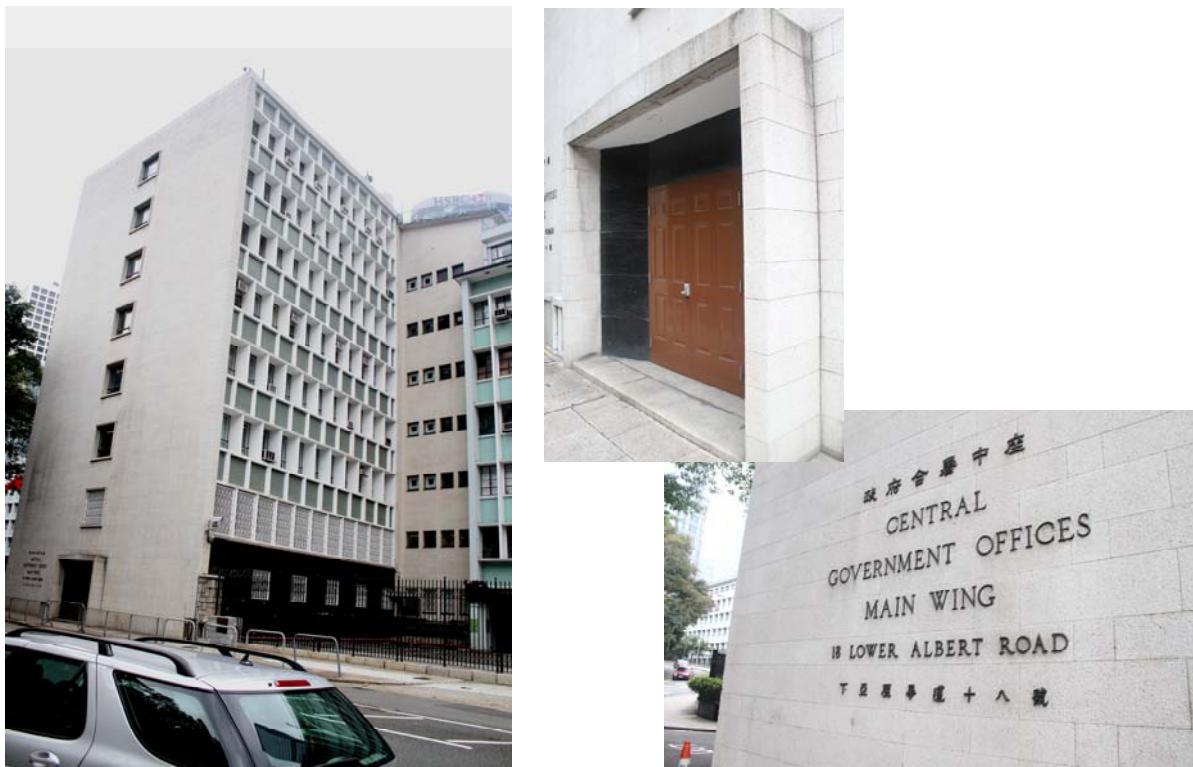
Fig. 54-56 (Left to right) The south elevation of the Main Wing. It is the only Main Wing surface solely with granite cladding. Distinct features include the granite porch old public entrance (Fig. 55) and the name of the building affixed on its left (Fig. 56).

This section is made up of dressed granite slab surface. All upper floor levels consist of a centrally placed window opening with projected surround. The 1/F window is secured with an outer steel grille.

The G/F is built with a door opening surrounds with a plain granite porch with a sighted pitched rooftop. The building name and address in both Chinese and English characters are affixed next to the entrance doorway. The timber door panels are newly refurbished and painted.

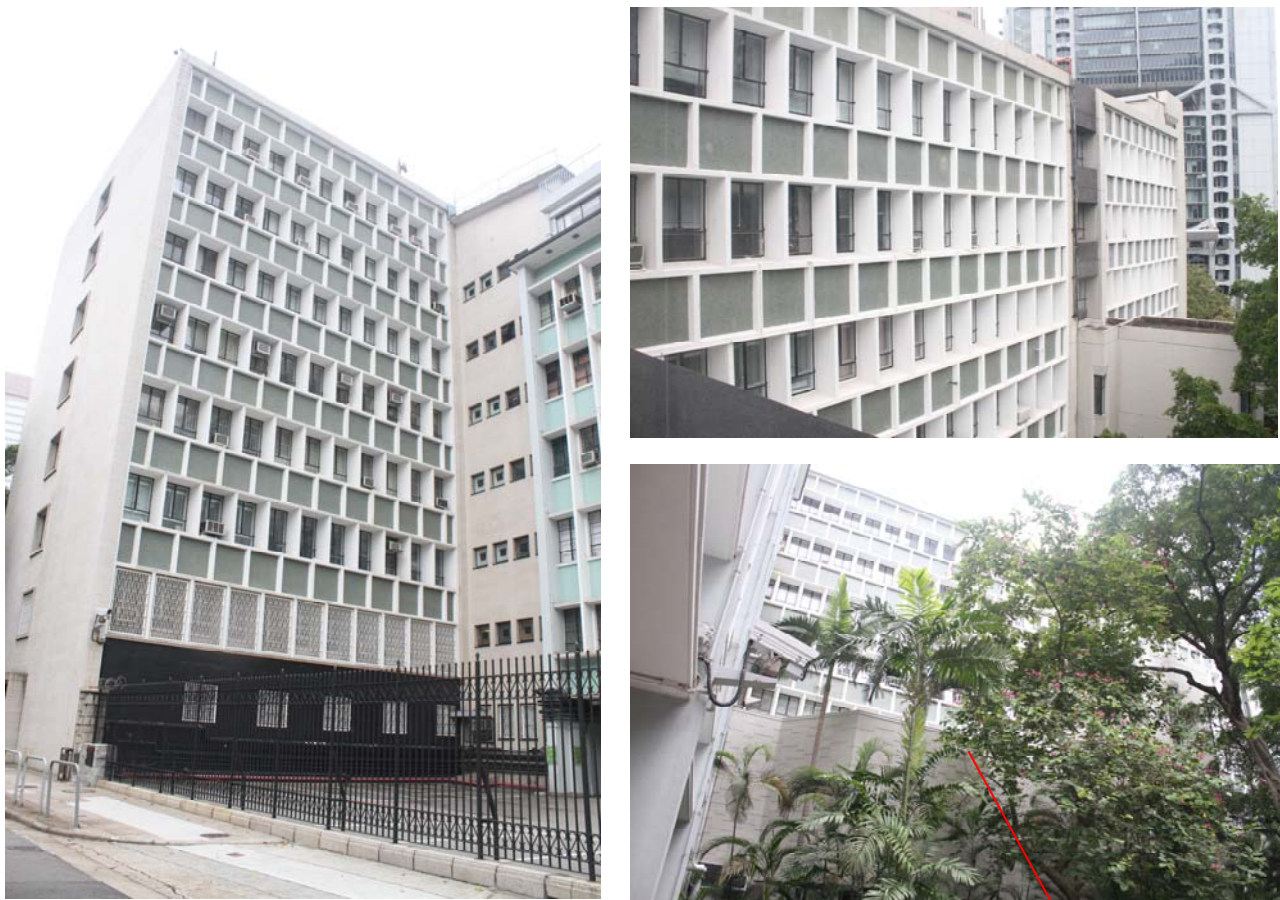
Fig. 59 (Left) The south part of the east elevation of the Main Wing facing Lower Albert Road

Fig. 60-62 (Right, top to bottom) The north part of the east elevation of the Main Wing towards the slope respectively looking on the top (Fig. 60) and from ground. (Fig.61). The exterior ceramic tile covered surface (Fig. 62) of the ExCo Chamber.

The elevation has the same design with the west elevation. Apart from the similarity, it is the interface elevation with the East Wing to form the T-shaped complex. The meeting point lies within its central part with about 11 bays apart counting from south tip and 15 bays from the north tip of the 1956-built south block.

An additional block was built in 1989 on the north junction between the Main Wing and East Wing. It is an octagonal structure in 2-storey high housing the Executive Council Chamber and rooms for storing building facilities. North of the chamber compound built a vertical structure up to the 4/F to house a new staircase. These new structures are covered with grey ceramic tiles hide behind vegetation growth.

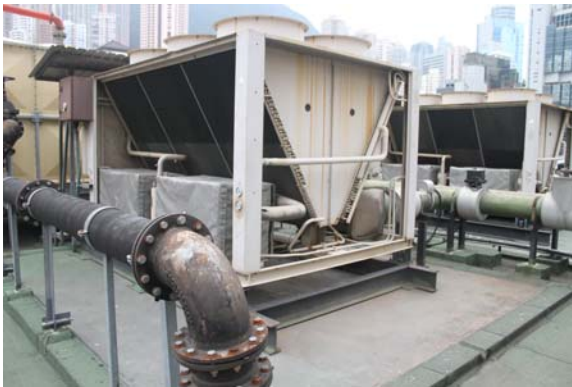
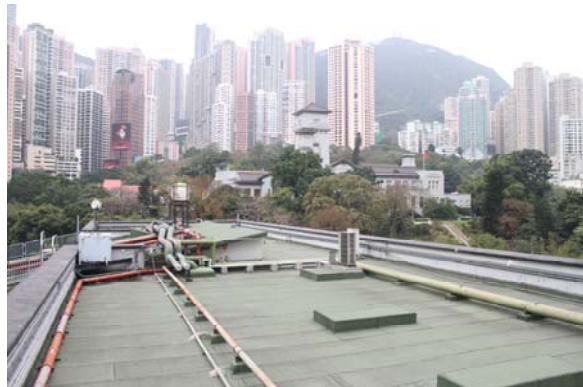
Fig. 63 (Left) showing the water tank and service located on roof of annex block & Fig. 64 (Right) showing the flat roof with a few ductworks present.

The rooftop of the south block is spacious and is connected with annex block by metal stairs. A small room is found accessing to the underside of the mono-pitched roof of the transitional west-end section of the East Wing. Generally, only some ductworks were found crossing the roof surface. A green water-proofing layer is covering the entire roof surface.

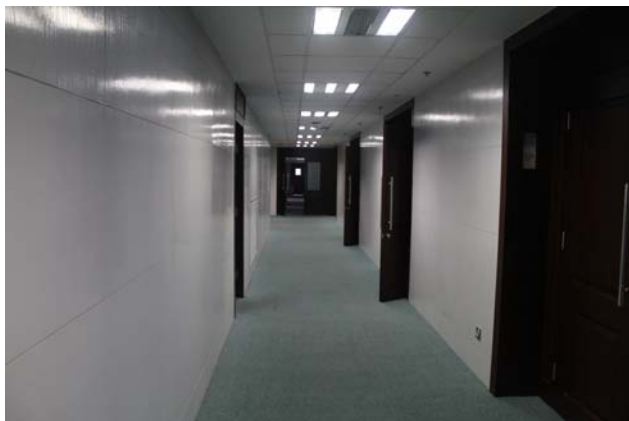
Fig. 65 (Left) General floor setting from the Main Wing and Fig. 66 (Right) from the East Wing: a centre corridor design with offices mainly partitioned on both side. Most of the floors have extensively changed over several decades which most of them are composed of modern materials without any historic significance.

Office areas are mainly situated between 1/F and 6/F. Each floor is entirely supported by 2 vertical rows of columns. Offices are mainly partitioned on both sides to form a central corridor running through the length of the overall building. All partitioning is mainly dry wall or glass partition. All floors are carpeted and false ceiling is installed to hide the duct works on ceiling level. (See Fig. 66)

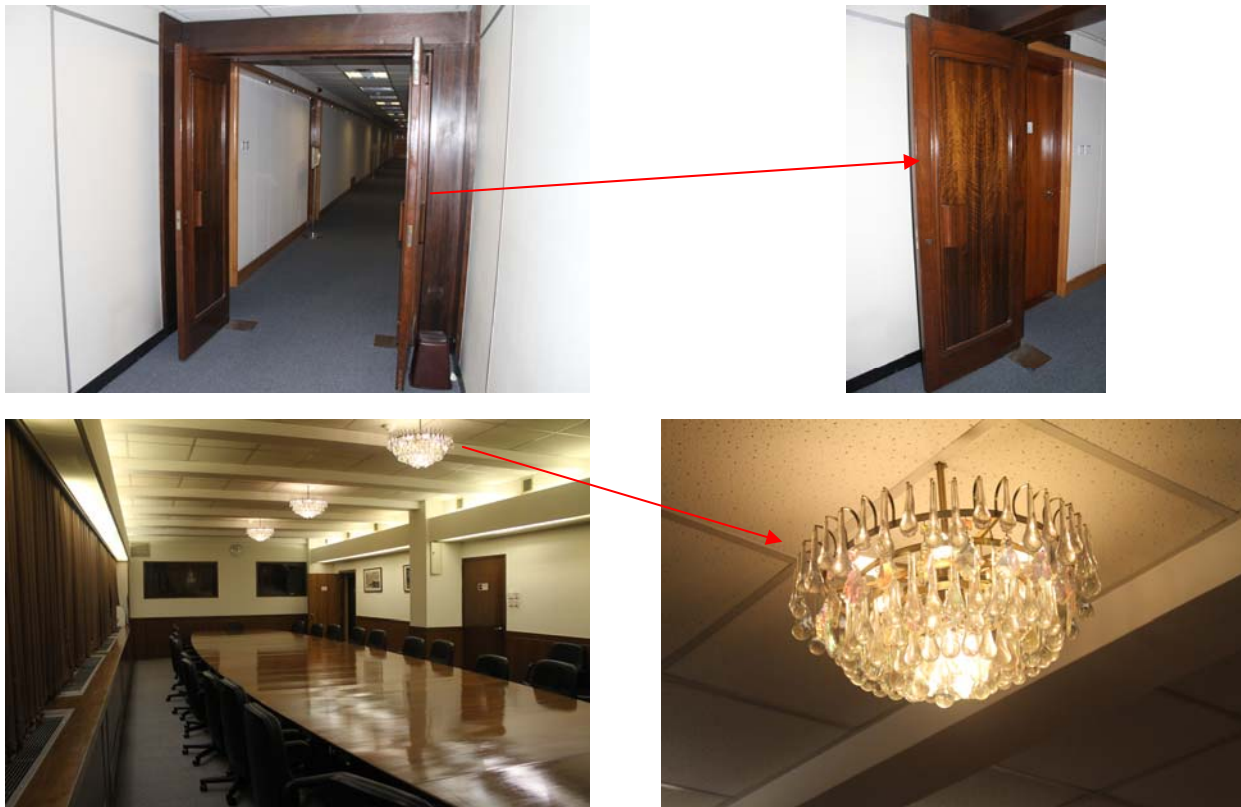
Fig. 67 – 70 (Left to right, top to bottom) Identified features in office area including the timber made fire door and frame in 1/F corridor (Fig. 67,68) and conference room in Room 150 with its internal setting (Fig. 69,70)

The whole door including the door panels, surrounds and hand rails in timber. A single square linear pattern with curved corners is found on both elevations of door panels which reflect the past craftsmanship and is the unique example found within the CGO site.

This room is located at the central south part of the building. It is one of the partitioned office spaces within this floor. Comparing with other office spaces in other floors, this floor is accessible without passing any security lock and it is also for common use purpose for the working departments for the CGO. Within this floor, the conference room found in Room 150 preserves entirely the setting of a typical design of a government conference room. The room is fit with old style fittings mainly in timber and the space is partitioned by dry walls that are commonly used within other office areas of the CGO site. The room consists of a big conference table placing at the centre, 3 overhanging crystal lamps, timber dado panels and the floor-standing timber-sealed AC units located next to the window. (Fig. 69, 70)
