## Heritage Impact Assessment

The Former Central Government Offices

Relocation of the Department of Justice  
to the Former Central Government  
Offices (Main and East Wings)

7 June 2012

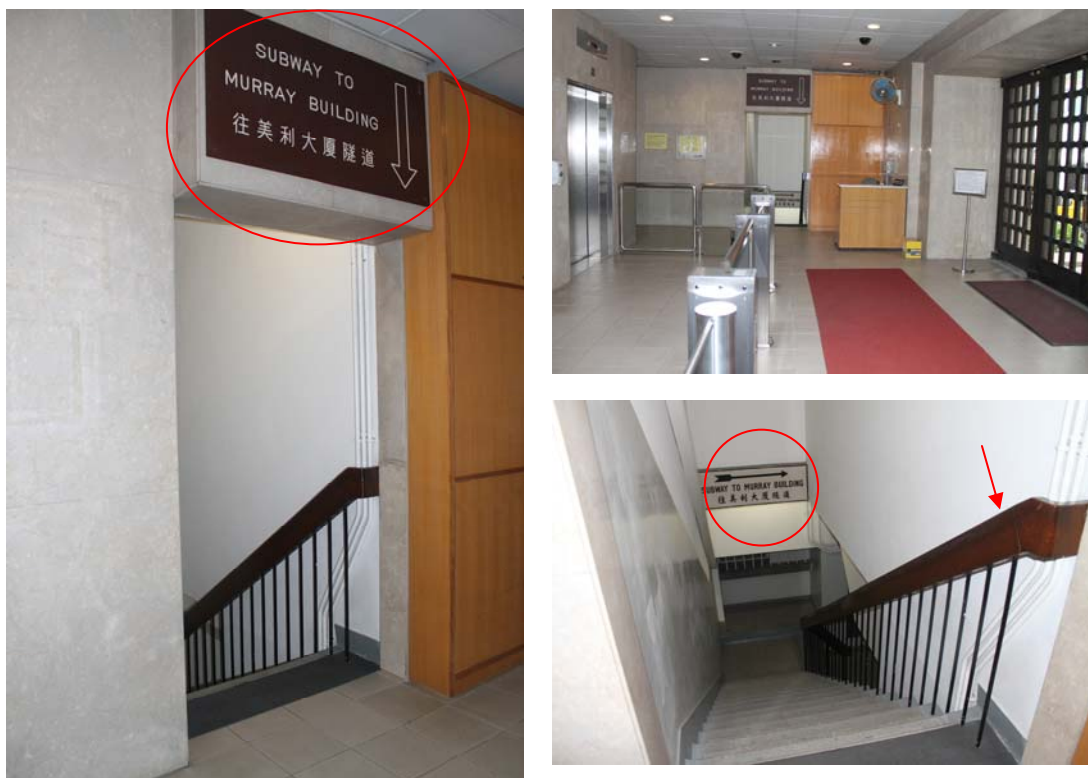
(Fig. 72, top right) showing the entrance lobby in LG/F and the subway entrance (Fig. 73, left) to Murray Building. Old style signage boards (circled) and timber handrails (pointed) (Fig. 74, bottom right) preserved.

It is located in the LG/F of the eastern side of the East Wing facing the junction of Lower Albert Road and Garden Road. It is regarded as the main entrance of the East Wing to public. Beside the whole bronze main entrance doors which are original, the entire lobby has been renovated with marble wall covers and square ceramic floor tiles. On north side of the wall stands 2 lifts which serve as the main lifts for the whole East Wing. Inside the lobby, there are 2 electronic entry gates which visitors have to use barcode card to pass through. On the right hand side of the lobby, a stair was built leading to an underground subway to the 1969-built Murray Building opposite the Garden Room. It is the earliest high-rise government office building in Hong Kong. Old style signage boards hang on top of the subway entrance and the inner wall of the stair still exist. Timber handrails with the bottom metal rails are still intact along moving down the stairs.

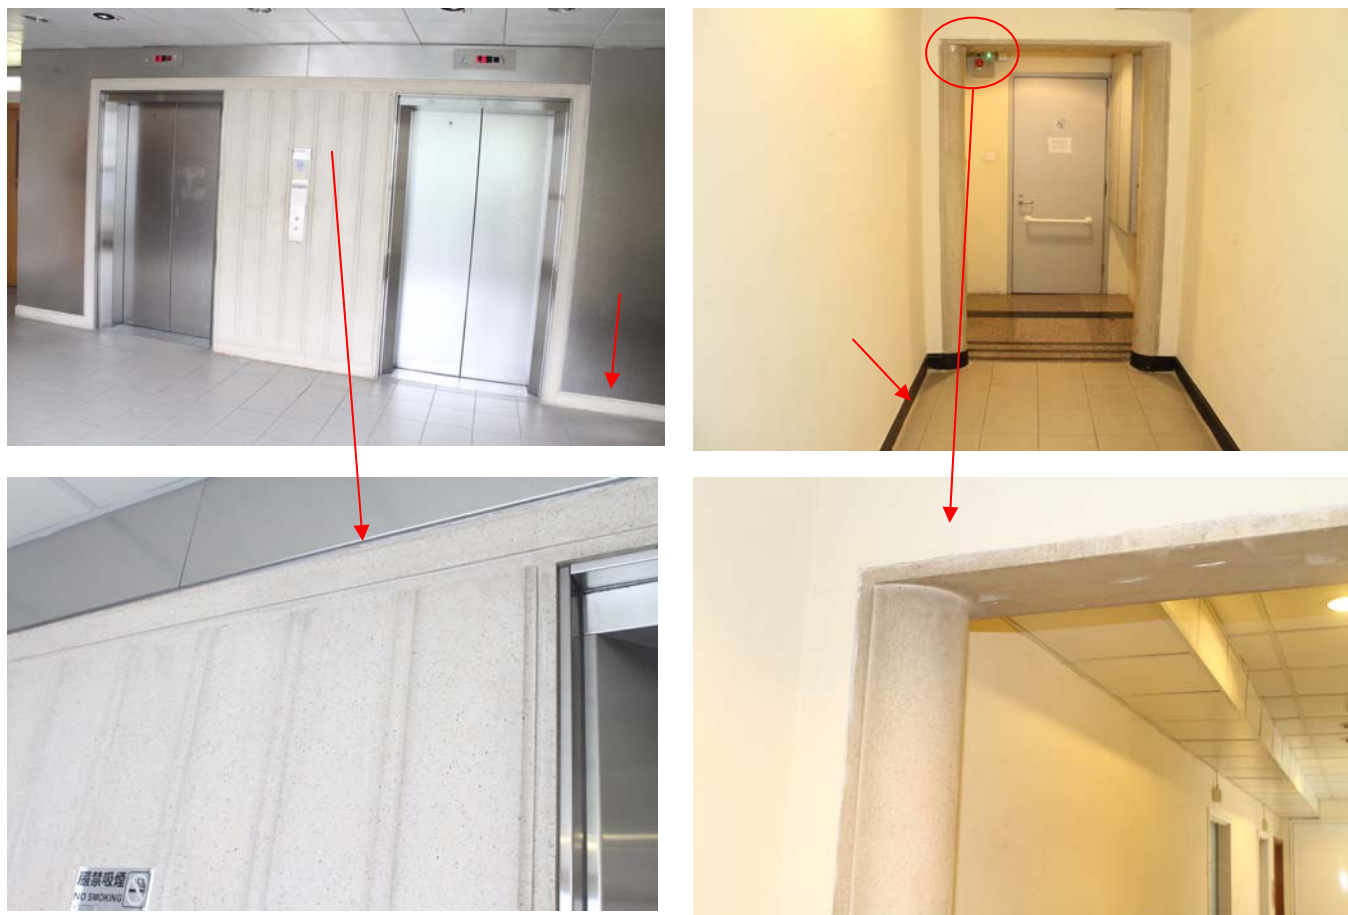
Fig. 75-78 (Left to right, top to bottom) show the original terrazzo finish found in the floor lobby area. They are preserved respectively on the lift surround (Fig. 75) with vertical fluting pattern,(Fig. 77) ,wall footings (pointed in Fig. 75 – 76) and the porch surround to the rear side toilets (Fig. 76, 78)

Rising along the floors on the same location with the LG/F entrance lobby are the lift lobby of each floor. Milky terrazzo finishes can be found on a number of locations which are believed to be the original finishes with a high preservation values. All finishes are with a smooth surface in pastel colour. The terrazzo surface of the lift surrounds are decorated with vertical fluting pattern. The porch entrance located at the rear right hand side of the lift lobby leading to the back toilets is particular interesting. The entrance is flanked by two semi-cylindrical columns and topped with an architrave which are all terrazzo made. Other than that, some wall footings are still preserving with original terrazzo finishes. Terrazzo finish is a common decorative and durable finish mainly used in building between 1950s and 1970s. It serves as decorative and protective purposes to the wall plaster and wall surfaces from damage and weathering. It is a labour-intensive craftsmanship. It was started to eliminate with modern protective paints and paneling which are of less labour cost starting from late 1970s.

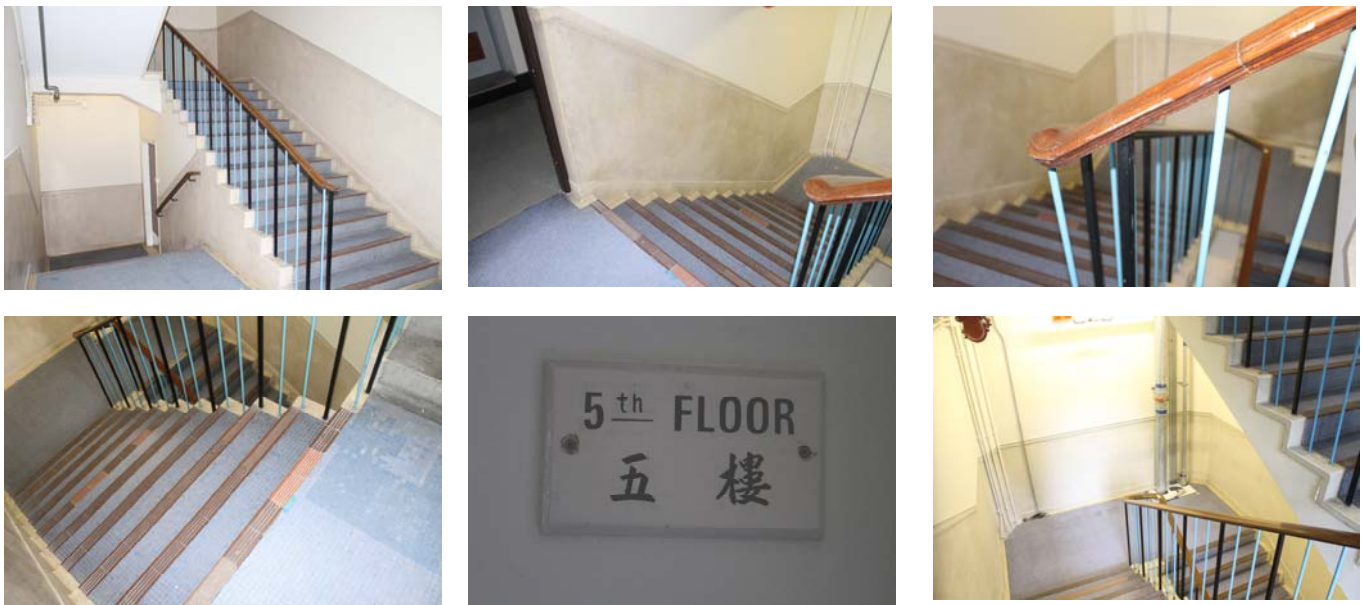
Fig. 79-84 (Left to right, top to bottom) The East Wing behind the lift lobby preserved much of its features including the terrazzo finishes on dado levels (Fig.80), the metal railing with timber handrail (Fig. 81), blue mosaic tiles (Fig. 82), old floor signage board (Fig. 83) and ceiling moulding. However, later ductworks have found penetrating the floors which visually distorted the outlook of the stairs.

The metal railing is designed with two slim blue-painted round columns alternate with a thicker black-painted square column running from the G/F to top floor. A timber handrail is fitted on top of the metal railing. The flooring is covered with blue mosaic tiles and all steps are fit with non-slip nosing. The steps level on upper 6/F and B/F are in raw cement finish. The dado wall leading to B/F is of undo cement cover and on the right hand side is fit with a wall-hung timber handrail. Original floor signage is preserving in some of the floors. The ceiling edge consists of simple moulding with white plaster finishes.

Overall, the original design and finishes of the whole staircase are preserved except some modern ducting works found penetrating vertically and running along the ceiling which visually deter its authenticity.

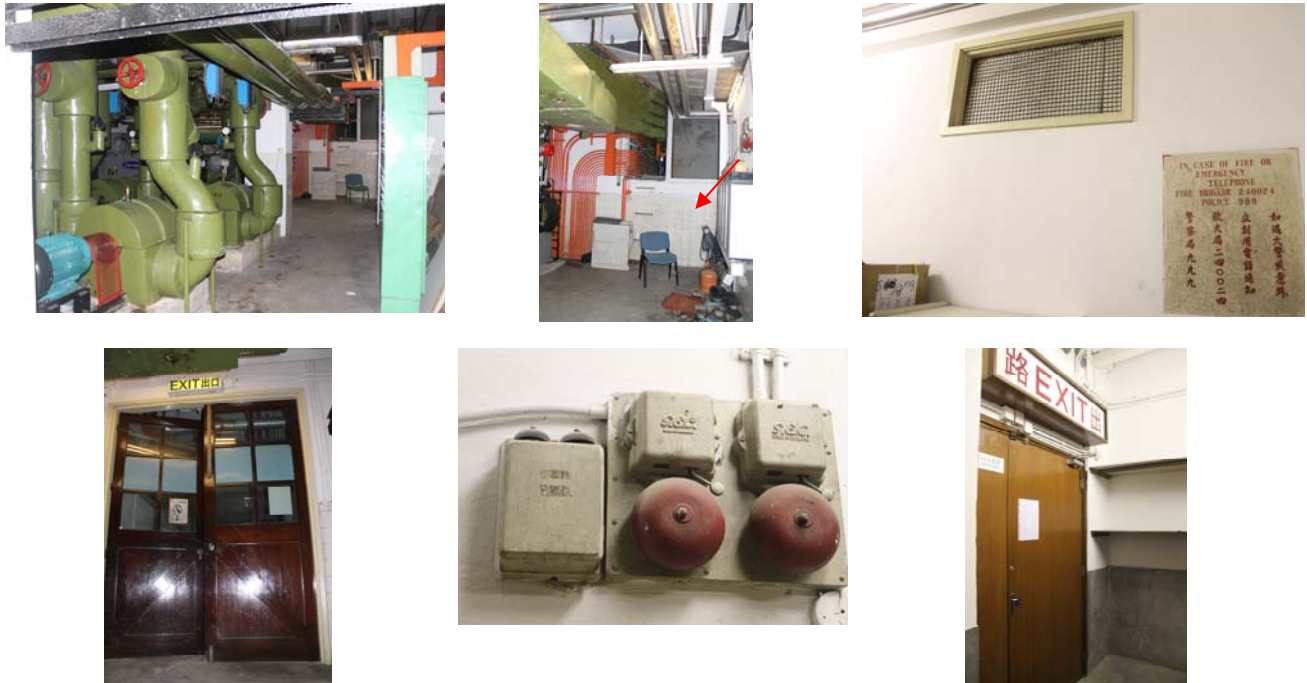
Fig. 85-90 (Left to right, top to bottom) The LG/F Plant Room with details including the service tunnel (Fig. 86), the toilet tiles covered dado wall (Fig. 86, pointed), the old stone board for emergency fire call and vent openings (Fig. 87), the old timber door panels at the plant room entrance (Fig. 88), the 2 double-bell fire alarms (Fig. 89) and the old exit signage (Fig. 89)

White square tiles are used to cover the dado walls of the plant room. A service tunnel is located on the west wall of the room where ductworks pass through here to the Main Wing.

Internal equipment basically has undergone several upgrades but some installations and fittings are discovered as old fabrics during site survey. Those equipments are with historic value and can be salvaged for display if upgrading works consider removing the existing fittings is necessary. They include the vintage fire service alarm (from UK, G.E.C., will discuss in later topic), the old fire door signage and the stone board for emergency fire call embedded on the wall of the walkway just next to the plant room.

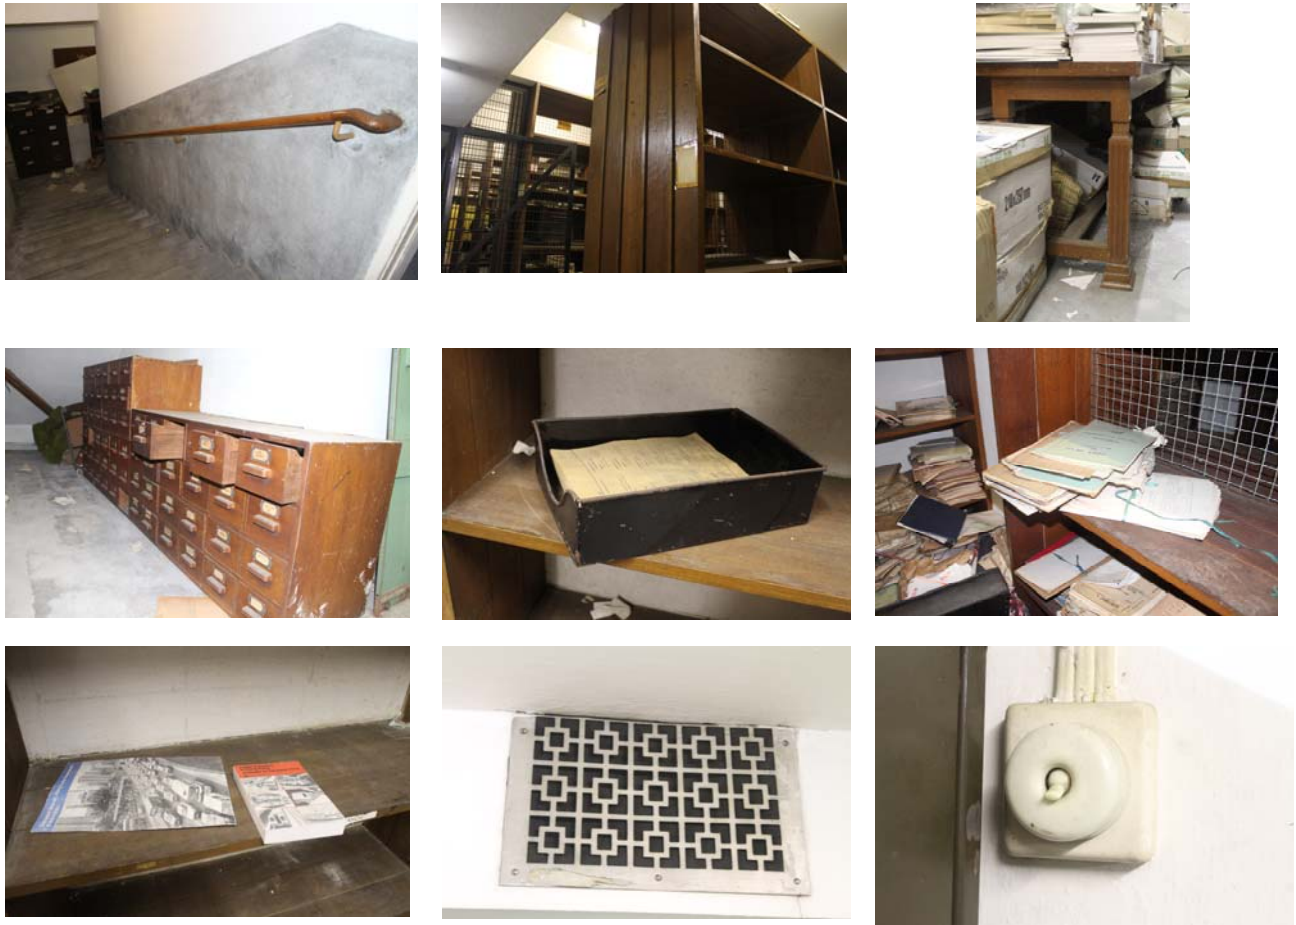
Fig. 91-99 (Left to right, top to bottom) The Basement of the East Wing was used as the storage area since its completion in 1954. This is the area where preserved most of the old furniture and fittings which cannot find everywhere within the CGO site. Those salvageable artifacts become the important component in delivering the history of CGO in the passing half century.

The whole room is built with timber shelves which are tailor-made to fit with the internal projected beams. The shelves are in teak and still in excellent condition showing old craftsmanship.

A number of old furniture are found inside the room which were used in CGO and rare to find nowadays such as teak chair, teak ornamental tables, old teak pigeon hole drawers, metal tray etc. They are in perfect condition and can be selected for display in future.

There are still certain amount of government files and past publications which are still left within the drawers and on the shelves. Some files can date back to early 1960s recording the past government operation details. Those documents should not discharge and should go to Public Records Office for preservation after confirming that no departments are responsible to take over. Some selected non-confidential documents, report covers and the colonial publications can be selected for display in reflecting the history of CGO as the place for government operation and civic publicity of government policies.

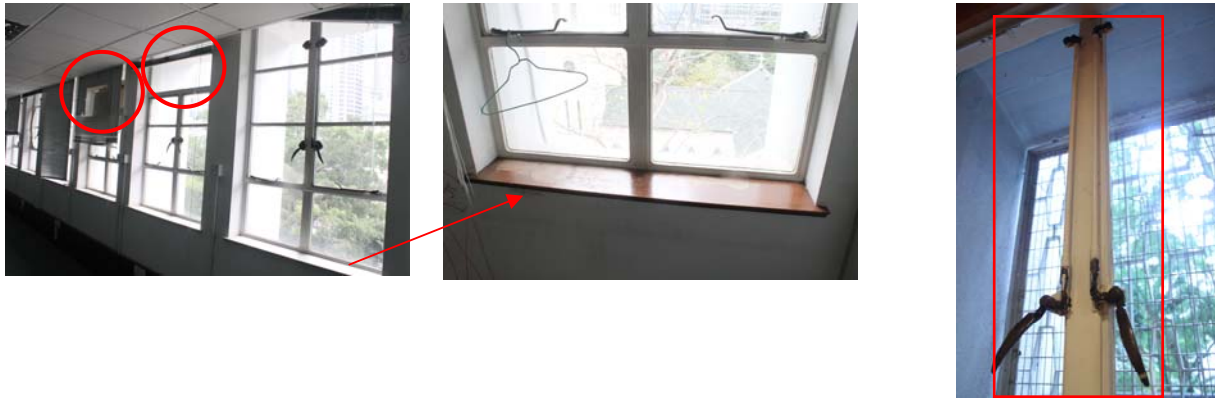
Fig. 100-102 (Left to right) show the Universal design of the East Wing windows. The design of the windows are in 8-light, alterations in later stage are found in part of windows which can be revisable. (Fig. 100 alteration with circles). The windows are bottomed by timber sills (Fig. 101) and locked in a vertical double-lock and single-handrail system (Fig. 102, squared)

All window openings are fit with a single steel window frame in universal Crittall style. Those windows are equipped with a vertical double lock controlled by a single handrail and a window hold on its bottom. The window frame is usually bottomed by a timber sill internally. The universal frame colour is painted black externally and white internally.

Some window frames are slightly modified to fit in air-conditioners and some have additional security metal bar installed inside for confidential storage. However, many of the original windows are preserved.

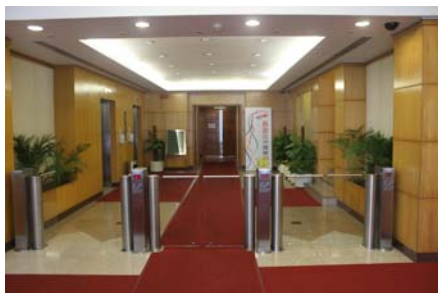
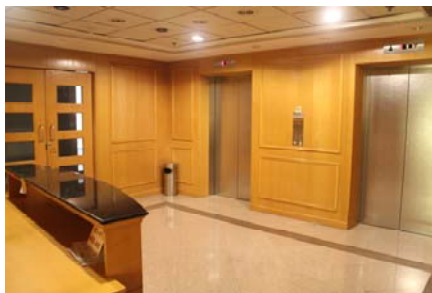
Fig. 103: Main Entrance Lobby; Fig. 104 Public Lobby Area; Fig. 105 Central Staircase

Fig. 103-105 Most of the internal areas of the Main Wing have been extensive renovated. The most extensive one was done just 2-3 years before which refreshed all the wall surfaces, flooring, ceiling and also public areas. In that case, the internal areas of the Main Wing do not bear any original architectural features.

Internally, the building has been greatly refurbished for modern office use and very few original fabrics are preserved. All rooms of each floor are partitioned on both the east and west side with a central vertical corridor passing through in-between. All walls are covered with modern panels and fitting and false ceiling is used to cover the ceiling ductworks. The old south block is accessible to the new annex block on each floor. The main lobby is located in the central part of the south block with 2 lifts and a central staircase access to all floors. An individual staircase was built on left side of the main entrance which is accessible to the ExCo Chamber in 1/F between 1989 and 1991. All the public lobbies throughout the Main Wing have been extensively renovated without any original fabrics remain.

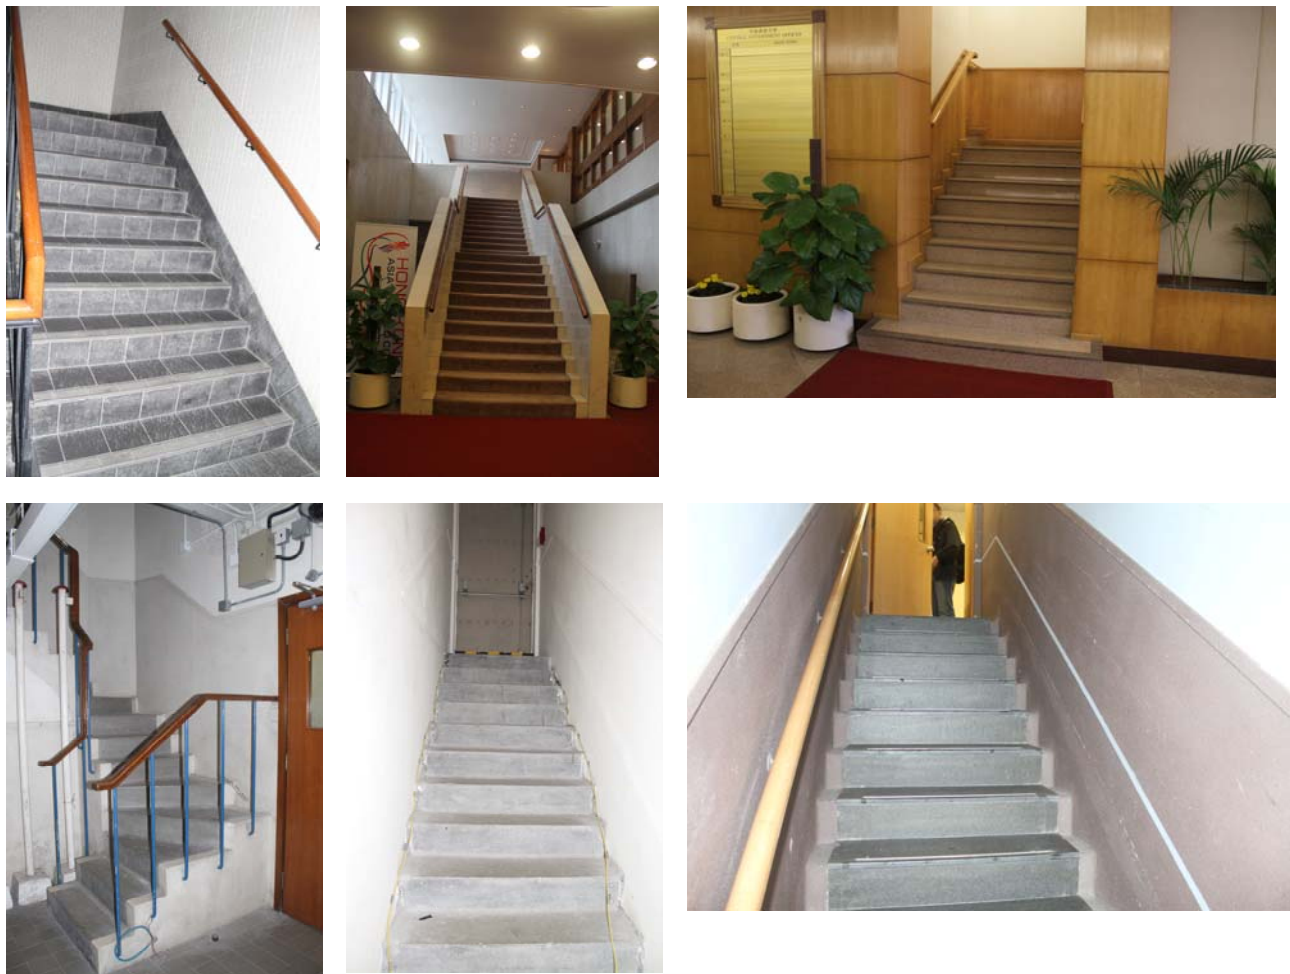
Fig. 106-111 Comparison of the condition of the staircases in the Main Wing. (Left to right, top to bottom)

There are totally 7 staircases within the Main Wing. The northern staircase in the annex block (Fig. 106), the marble cladding staircase going up to the 1/F ExCo Chamber next to main entrance (Fig. 107), the central spiral staircase (Fig. 108), the southern staircase from G/F to all upper floors (Fig. 109), the southern staircase from LG/F to G/F (Fig. 110), the staircase in the northern end of the south block from G/F to LG/F (Fig. 111) and a separate staircase connecting the ExCo Chamber to 3/F dining room (no picture provide).

Those staircases except the southern staircase from G/F to all upper floors (Fig. 109) have been either extensively renovated or newly built which do not bear any original architectural features.

The staircase located at the southwest corner of the building run through the height of the building from G/F to 7/F. Its G/F landing was built in octagonal shape just next to the old public entrance located on the south elevation.

There are two staircases and one lift built within the new annex block. A new lobby is located at the north side of the annex block with a lift and a fire staircase. Another staircase was located north of the octagonal ExCo Chamber as an independent structure generate up to the 4/F.

The staircase connecting the 1/F ExCo Chamber and G/F main entrance is a later construction but bears social and historic value. ExCo members usually came down here after meeting to greet the media in delivering their public speech which are well captured by media and well known from public. (Fig. 107)

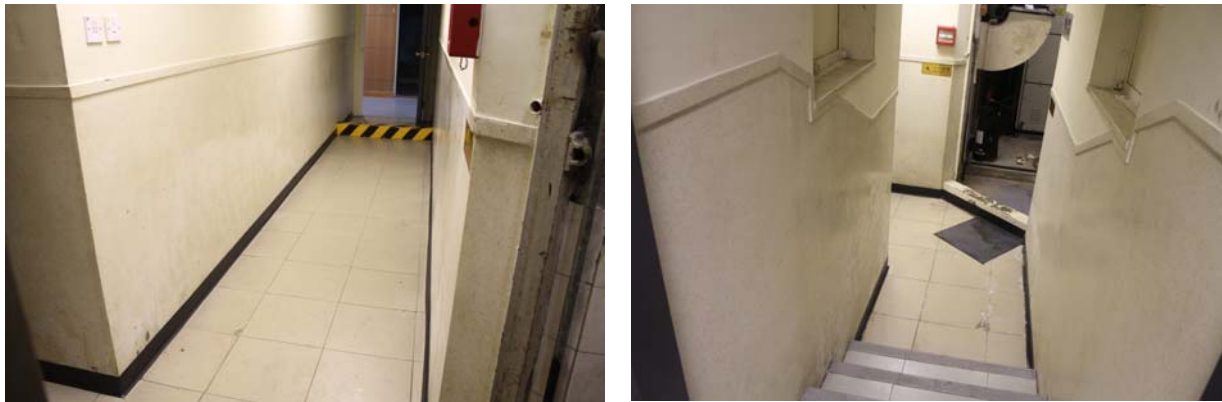
Fig. 112-113 (Left to right) The untouched terrazzo finishes at dado level and window sills located on the pathway next to the LG/F Plant Room.

Original pastel terrazzo finishes are found on dado level of the pathway located in LG/F going to plant room. Those finishes are the same as the one found in East Wing and also believed to be original finish. Apart from the pathway, walls on both sides of the north staircase leading to LG/F is also believed to be covered with terrazzo finishes on dado level but is covered with colour cement finish. Such finding may indicate the broad use of terrazzo for most of the dado wall finish in most areas at the very beginning but were either removed or covered in later alteration. Further investigation can be done to examine the wall surface if any existing old finishes can be found in other areas if possible.

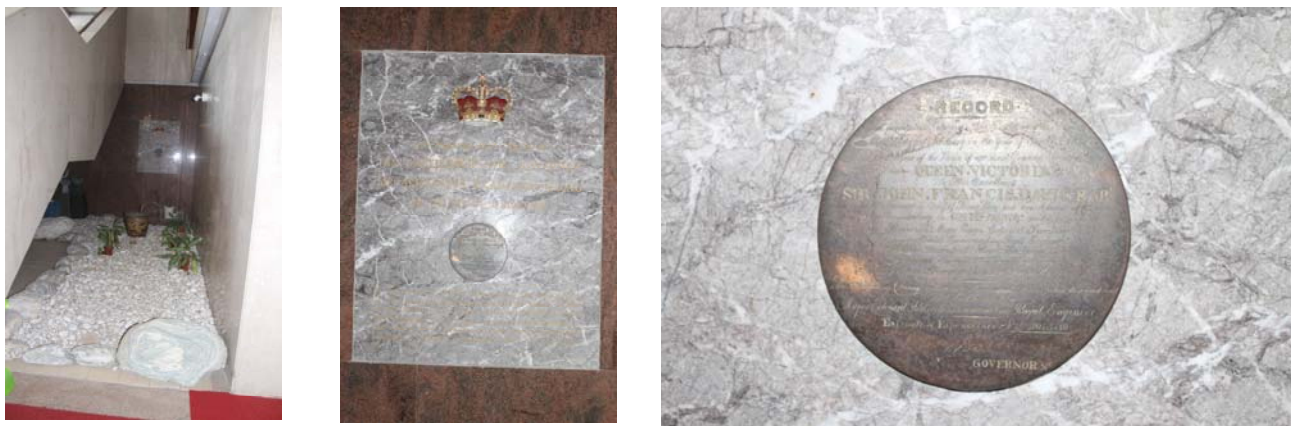
Fig. 117-119 (Left to right) The commemorative plaque next to the ExCo chamber staircase unveiled by Governor Grantham in the open ceremony of the Main Wing on 9 Jan 1957. This plaque incorporated with the 1847 bronze plaque within the design which considered the most significant artifact linking the two generations of Colonial Secretariat Building.

This marble plague incorporated with the bronze one for the 1847 old Colonial Secretariat Building unveiled on 9 Jan 1957 is the most important artifact to reflect the history of the CGO. Old floor plan shows that this area was altered in 1989-1991. The location of the plaque may not be the original location and shall have been relocated from other places. This should definitely be displayed to public for heritage interpretation if technically feasible, and most appropriately locate within the Main Wing. A marble cube is present under the plaque where a time capsule is placed inside.

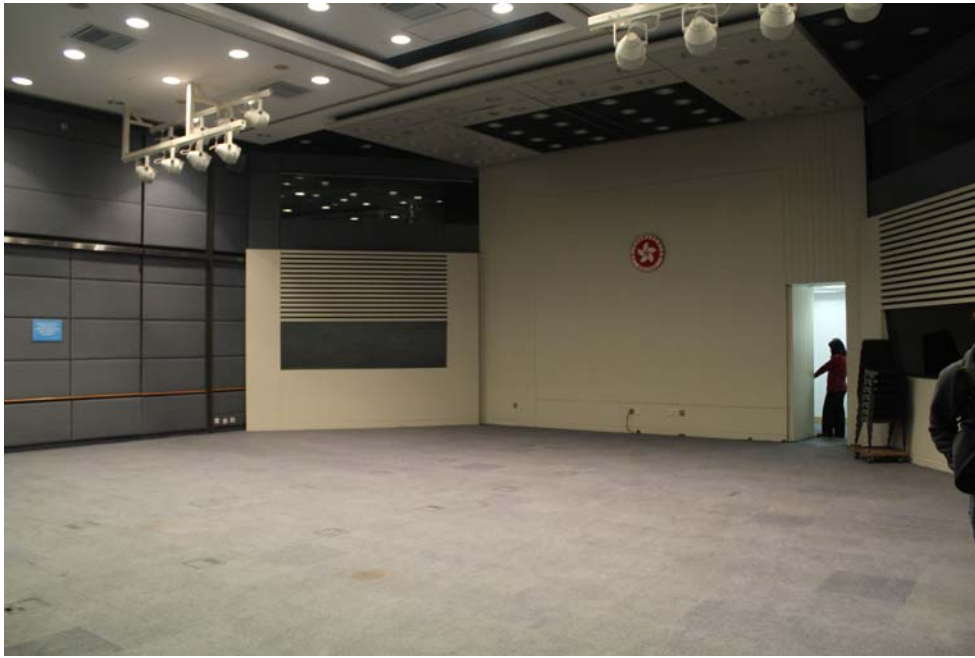
Fig. 121 The double height press hall in annex block used for press release of the Government

The press hall is located in 1/F of annex block probably in use since 1991. The hall is in double height which is a unique setting within the CGO site. The room is basically square in plan. The backdrop is pastel white partitions and occupying the entire wall surface facing south. There is an emblem of HKSAR hanging at the high position of the backdrop centre. The two angles flanking the backdrop are partitioned probably for translation rooms. All other walls are packed for acoustic reason and all fittings inside are modern including the lighting system at the ceiling. Overall, the setting inside except its double height layout does not contain any architectural features.

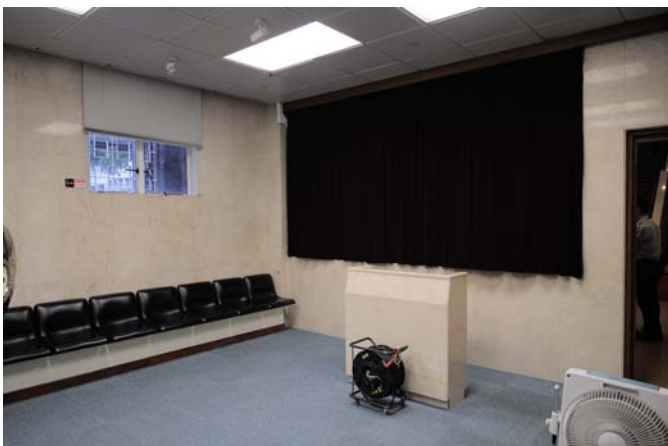
Fig. 122 (Left) showing the marble cladding internal walls and the speech stand in front

This press room is much smaller in scale. It is located in G/F of the Main Wing behind the reception of main entrance lobby. The room is marble cladding and is accessible through the northern door. Left to the door is a marble cladding speech stand put in front with a black curtain background. There are 4 timber partitioned workplaces with wall-hang telephones for media use, 9 unfolded black seats fixed on low timber board located along the western wall. The room is illuminated by two window openings with security grilles fixed outside.

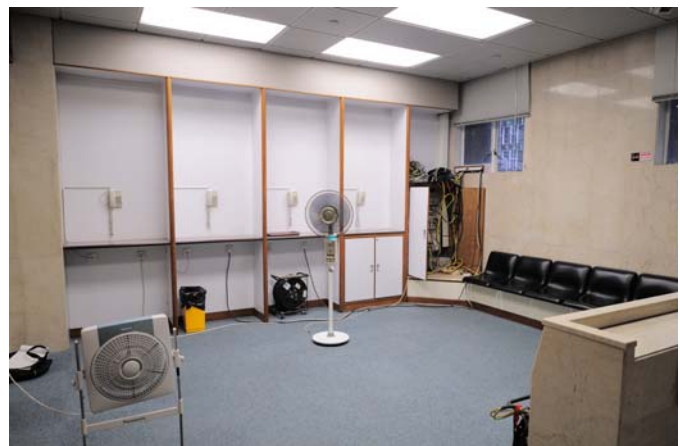
Fig. 123 (Right) Existing press room fittings such as the timber partitioned workplaces for the media and the row of black unfolded chairs can be found in this room.

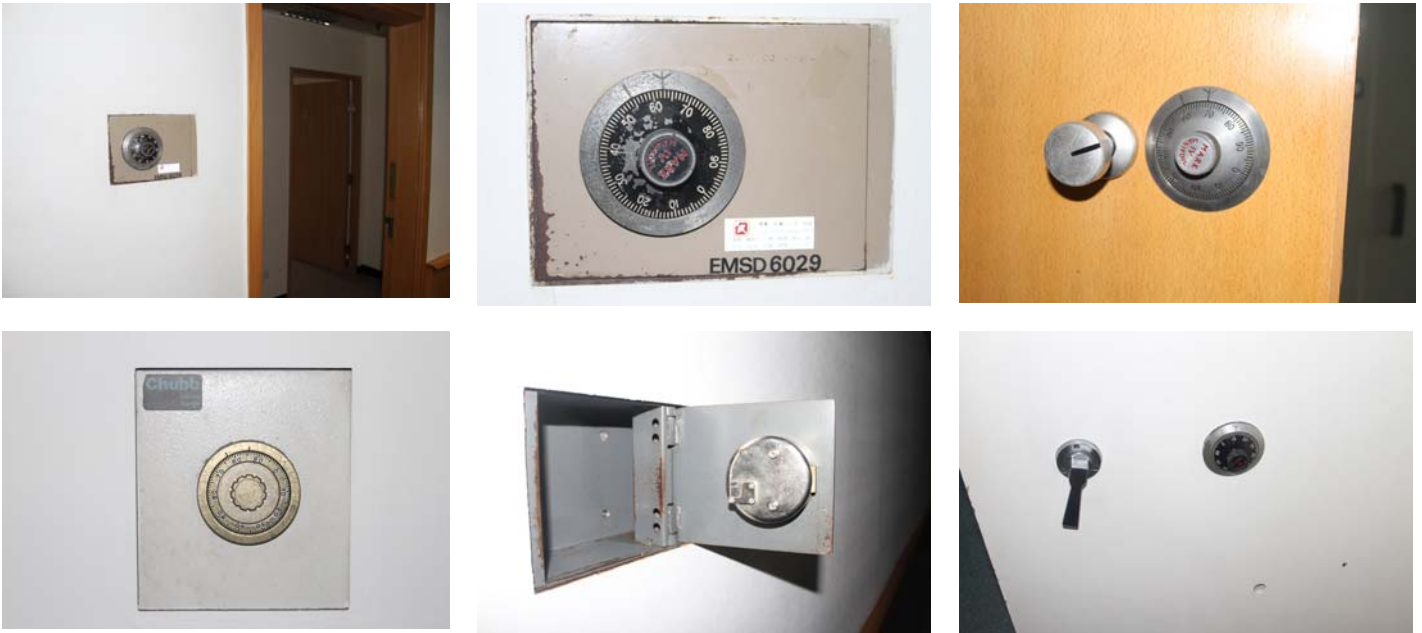
Fig. 124 – 129 (Left to right, top to bottom) Dial locks are commonly found within the CGO site. They are found on walls, some timber doors, safes and entry areas of confidential registry. They are almost manufactured from Chubb, a British-based Worldwide lock and safe making brand which its secure systems are accepted as the Government security standard.

Within the CGO Site, most of the Chubb locks are mainly Manifoil Mk IV combination dial lock. They are mostly found in the 6/F of the Main Wing, rooms for confidential registry, 4-7/F of East Wing and a few locks scattered in other parts of the floor. These combination dial lock has been the England Government's security standard since its intention in 1960s. Those locks found in the CGO site do not indicate the manufacturing date but crafted digits numbered "1984" and "1985" found on the upper surface and back of the lock suspected to be the period for its manufacturing.

The operation of the dial lock is particularly interesting, 4 numbers have to be designed as the prime password for the lock.

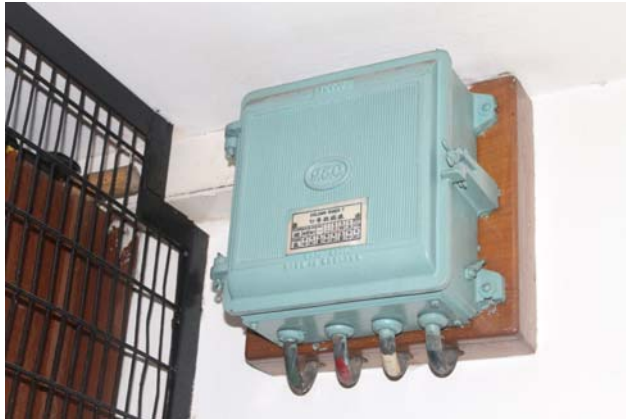
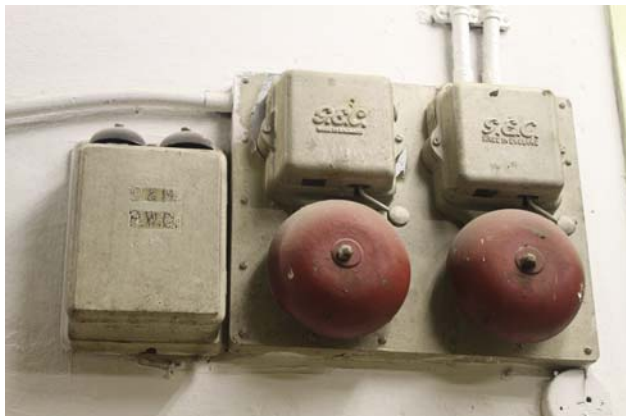
Fig. 133 (Top left) the meter located in B/F & Fig. 134 (Bottom left) the double-bell fire alarm system are old products manufactured by General Electronic Company (G.E.C.) from Britain. G.E.C. (Fig. 135, Top right) is a British-based company once being the world-pioneer enterprise in developing different kinds of electric products which make the invention of electricity enhance human life in great extent in 19<sup>th</sup> & 20<sup>th</sup> centuries. The brand was bought and renamed in 1999.

Two old building services manufactured by G.E.C. (General Electronic Company) from England are found. This company does no longer exist. They are believed to be certain old age reflecting the preference of colonial Hong Kong Government in selecting UK products for building services. With such a long service period, those building services may suffer from replacement if upgrading work is proceeded, salvaging those items as heritage interpretation are recommended to reveal the history of the CGO site. They are the meter in B/F and the fire alarm system in LG/F plant room.

The fire alarm is of the double bell system. And the brand logo “G.E.C.” is clearly visible on the cover surface.

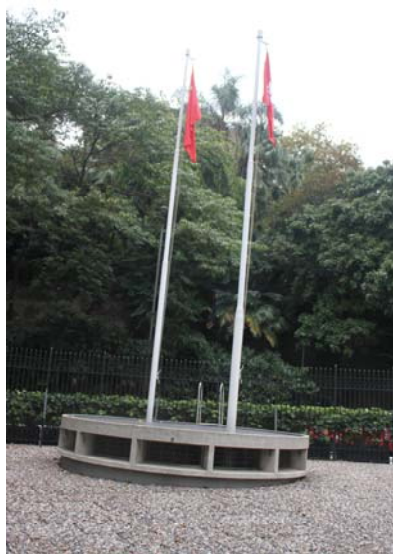
Fig. 137 (Left) and Fig. 138 (Right) Evolution of change. The flag pole site witnessing the sovereignty change of Hong Kong.

The flag pole is constructed as part of the CGO complex when the Main Wing was built in 1956. There was only one pole at the very beginning for hoisting the flag of colonial Hong Kong. After 1997, the pole platform was modified to have 2 poles on aside position to hoist the PRC flag and HKSAR flag. Though being modified, the flag pole platform still stands on its original location and serving the purpose with symbolic meaning in showing the sovereignty change.

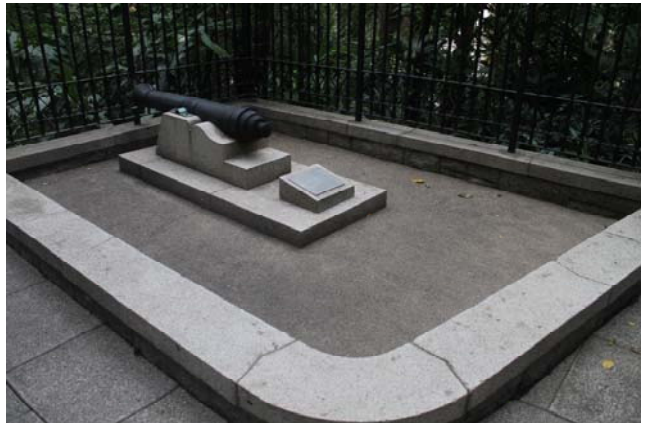
Fig. 139 (Left) and Fig. 140 (Right) Evolution of change. The site originally stood the Murray Battery to safeguard the harbour. The canon, though not from the original site and is now a replica, has a symbolic meaning to interpret the site history and gave an only linkage to the origin of Battery Path. It was there since the CGO was built in 1950s and shall be retained

A canon which was excavated in Kai Tak in 1950s had been relocated here until 1978 when it was replaced by the existing replica. Though this artifact is not related to CGO, it consists of some value in signifying the Murray Battery which had ever existed in this area in safeguarding the harbour in the old days.

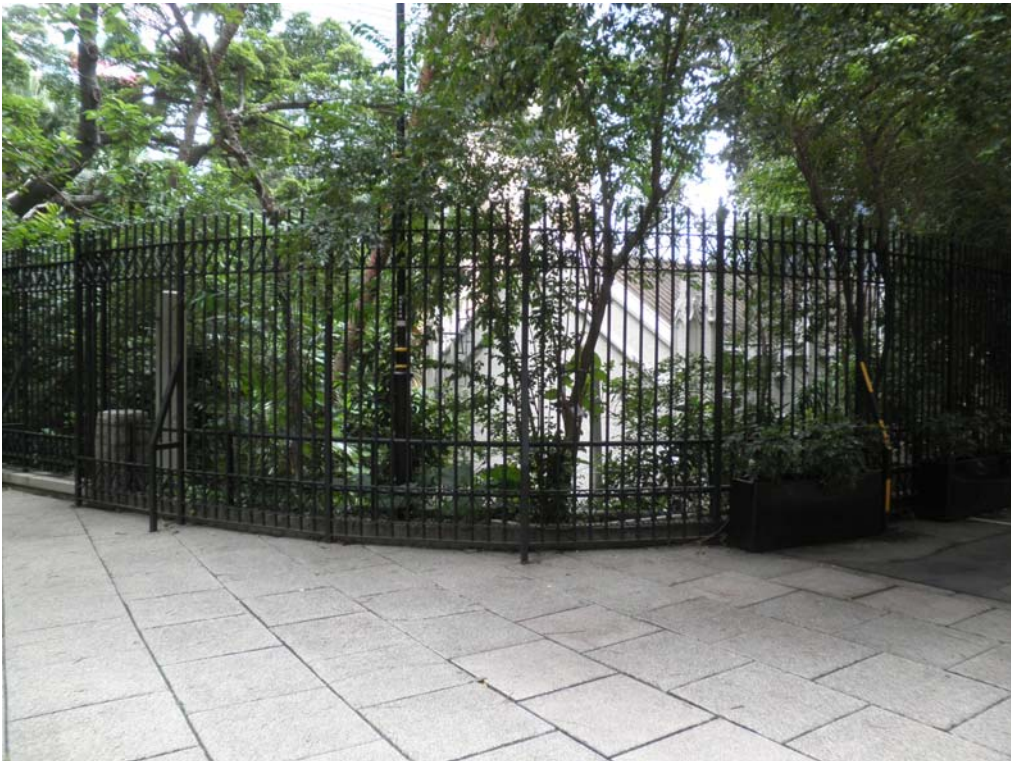
Fig. 141 The high metal fence along the north boundary linking to the north gate towards Battery Path. This was the usual destination of most of the demonstrations in the past 15 years when it was the CGO. People attempted to hang signage and tight ribbons on the railing to express their appeal. The gate was opened for big demonstration to allow demonstration groups to pass through the main entrance of the Main Wing. It becomes part of the collective memory of Hong Kong people.

Before the tall and large metal fence surrounding the whole CGO complex was built in 1997 after the establishment of HKSAR. Public is free to pass through the G/F open area of CGO from the elevated walkway and steps of Battery Path to the Lower Albert Road above. Old photos showed that metal railing erected in some areas and were in a much lower design. The current high fence design threatens the office to become a high defense structure which is not appropriate to a public building. Therefore, replace them with low railing design with compatible style is recommended, if the new users considered high rail design is not as essential. However, the portion of metal fence facing the north slope is particular interesting since it is continuous with the north gate located at the vehicle access from the Battery Bath to the open ground in front of the Main Wing. It is the usual destination for most of the demonstrations and the places for hanging signage. Because of that, the part of the fence together with the gate is socially significant as it signify the political development of Hong Kong in the past 15 years which is a collective memory of Hong Kong people. Therefore, preserving this portion of the fence and gate can retain the “latest” past of the CGO site.

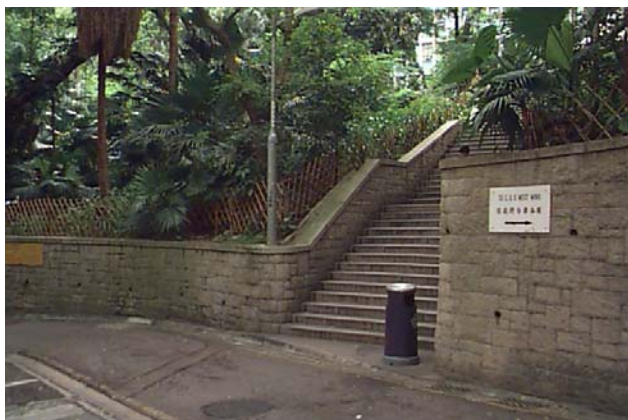
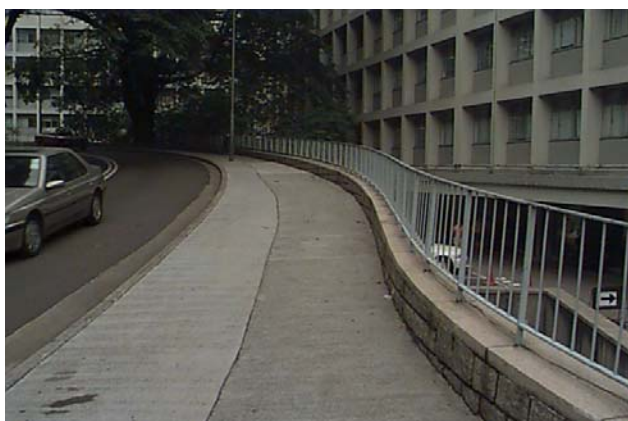
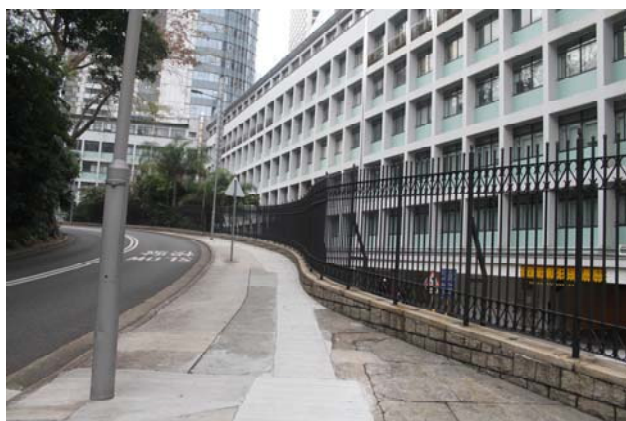
Fig. 142 – 145 (Left to right, top to bottom) Evolution of change. An overlook of the stair leading to CGO from Battery Path in 1997 and 2012 (Fig 142 & Fig. 143). The railing surrounding the CGO (The rail on Lower Albert Road next to the West Wing) in 1997 and 2012 (Fig. 144 & Fig. 145): High railing blocked all public access which make the CGO site look like a defense castle instead of a public building. To reinstate the original setting and level down the railings are therefore recommended.

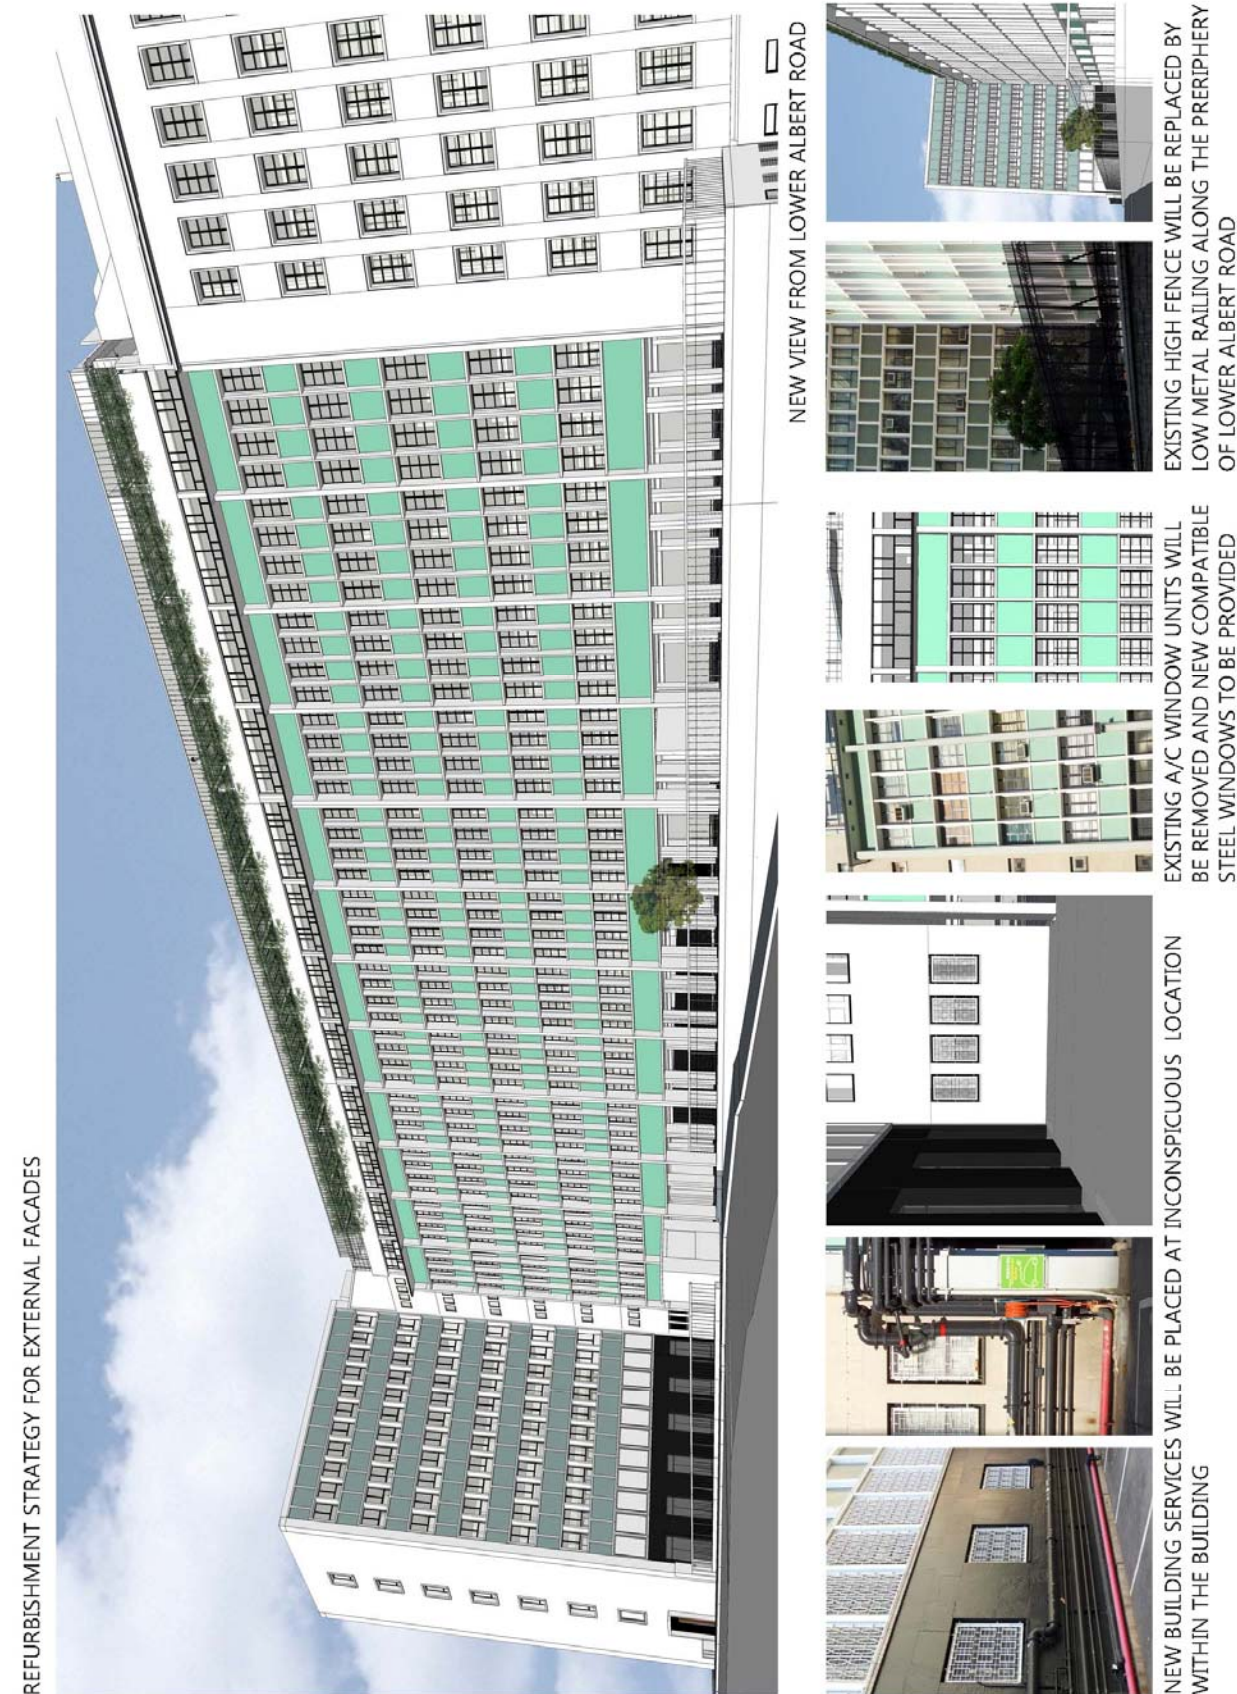
Figure 147. Diagram showing the proposed works to enhance the visual values of the

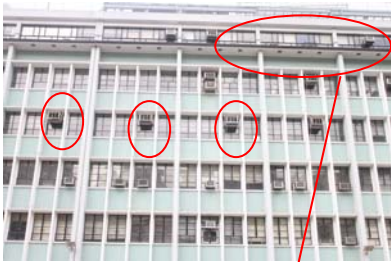
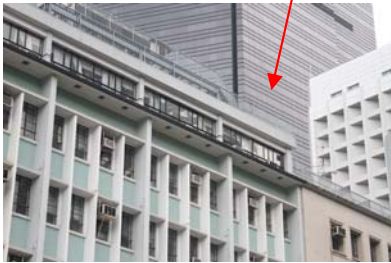
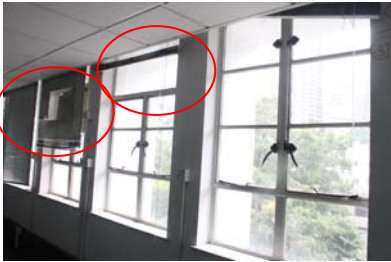
Item No.	Identifies Elements / Materials	Photo and Ref.	Level of Significance	Recommend Treatment/ Justification/ Mitigation Measures	Impact Level
1.1	Main Elevation (South elevation facing Lower Albert Road)

Moderate	<ul style="list-style-type: none"> <li>Preserve the entire elevation such as the exposed white concrete frame design, steel windows include the window heads and sills and its standard details, spandrel panel and the projected cornice and the square moulding details</li> <li>Repair defects if found to match existing</li> <li>Replace and repair defected windows to match existing. Remove all window type air conditioning units that affect the visual value of the building exterior (1.1 &amp; 1.3)</li> </ul>	Beneficial
	Part 1: Exposed concrete frame central section	1.1			
	Proposed Works/Alteration

<ul style="list-style-type: none"> <li>Remove all window type air conditioning units and replace the respective steel windows with new ones of matching details</li> </ul>	1.2

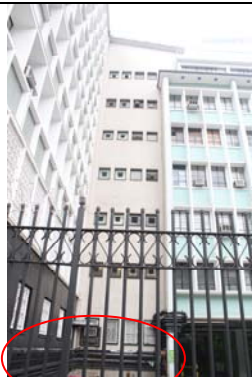
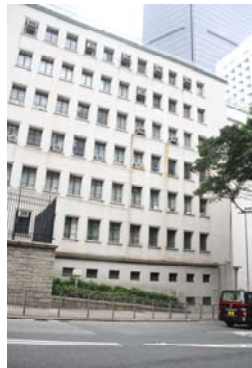
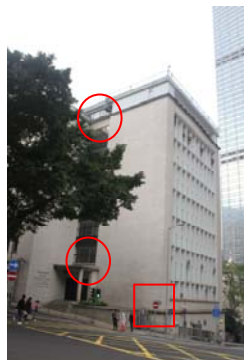
Item No.	Identifies Elements / Materials	Photo and Ref.	Level of Significance	Recommend Treatment/ Justification/ Mitigation Measures	Impact Level
1.2	Main Elevation (South elevation facing Lower Albert Road)

Moderate	<ul style="list-style-type: none"> <li>• Preserve the entire elevation and remain their exposed granite slab cladding surface including those decorative features like zigzag and vertical elements (circled in 1.6) and cornice (squared in 1.6)</li> <li>• General cleaning to granite surface by soft brush and water</li> <li>• Additional work done to granite surface should be avoided as far as necessary only if crack is discovered. Repair should use mortar mix with granite chips to match with the existing colour and material</li> <li>• Preserve the window openings, patterns and make consistent with the original window designs with matching details</li> <li>• Replace and repair defected windows to match existing. Remove all window type air conditioning units that affect the visual value of the building exterior</li> <li>• Remove the exposed building services from the exterior surface of the G/F of the west “transitional” section which causing visual effect to the building (circled in 1.4)</li> </ul>	Beneficial

Part 2: Granite cladding west “transitional” section and east double-square tower section

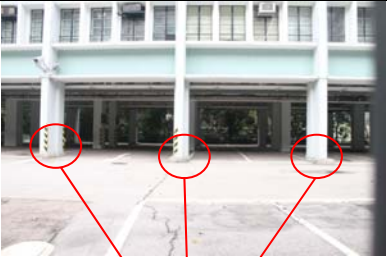
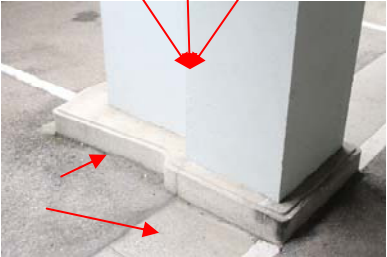
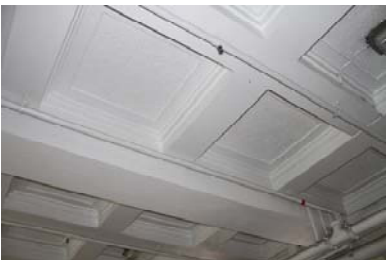
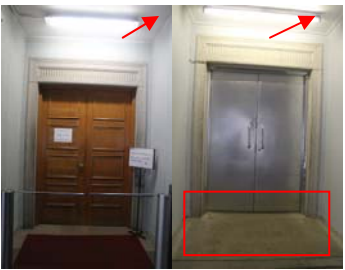
Item No.	Identifies Elements / Materials	Photo and Ref.	Level of Significance	Recommend Treatment/ Justification/ Mitigation Measures	Impact Level
1.3	<p>G/F covered car-park area</p> <p>Proposed Works/Alteration</p> <ul style="list-style-type: none"> <li>Proposed new staircase leading down from upper floors to the car park area</li> </ul> <p>Site Location</p> <p><b>Slope</b></p>

<p><b>Lower Albert Road</b> Enlarged plan of the carpark area of the East Wing in G/F showing the new staircase landing (red square)</p>

<p>1.10 a.(left) &amp; b.(right)</p>	Moderate	<ul style="list-style-type: none"> <li>Preserve the spacious setting of the covered car-park area</li> <li>Preserve those original building features including the square load-bearing columns (1.7), all granite bases under peripheral columns and granite floor bounding (pointed in 1.8), square pattern coffer on the ceiling (1.9)</li> <li>Repair if defects found to match existing</li> <li>Preserve the two granite portal frame (1.10 a&amp;b) going into the Main Wing (1.10a) and the East Wing (1.10b). Preserve the old timber doors (1.10a), the granite landing (squared in 1.10b) and also ceiling moulding (pointed in 1.10a&amp;b)</li> <li>The new staircase should be in compatible design with the existing building. The construction should minimize the impact and damage to the identified features of this area especially the granite elements at the base of the columns</li> </ul>	Acceptable with mitigation measures
