## Heritage Impact Assessment

The Former Central Government Offices

Relocation of the Department of Justice  
to the Former Central Government  
Offices (Main and East Wings)

7 June 2012

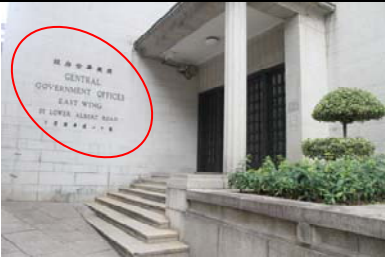
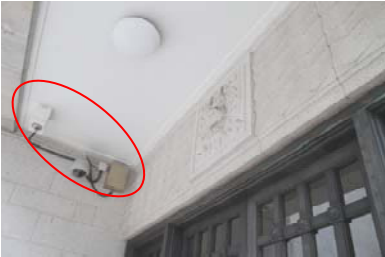
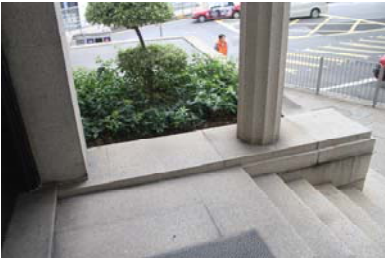
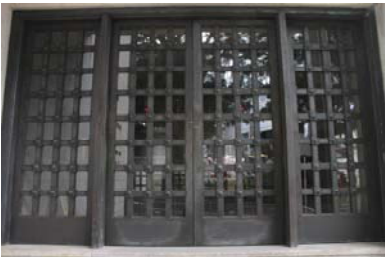
Item No.	Identifies Elements / Materials	Photo and Ref.	Level of Significance	Recommend Treatment/ Justification/ Mitigation Measures	Impact Level
1.4	<p>Main Entrance</p> <p>(located at LG/F facing the junction of Lower Albert Road and Garden Road)</p>

<p>1.14</p>	High	<ul style="list-style-type: none"> <li>• Preserve in-situ the entire main entrance and mark good to all recorded CDEs</li> <li>• Preserve, repair and clean the affixed building name and address characters located on the wall (circled, 1.11) and bronze main entrance doors (1.14)</li> <li>• Modern fittings such as CCTV (circled 1.12) should minimize its fixing area to minimize the visual impact</li> <li>• New building name signage should not cover the old building name with compatible design. The erection should minimize the damage to the granite surface using demountable materials</li> <li>• General cleaning to granite surface by soft brush and water</li> <li>• Additional work done to granite surface should be avoided as far as necessary only if crack is discovered. Repair should use mortar mix with granite chips to match with the existing colour and material</li> </ul>	N.A.

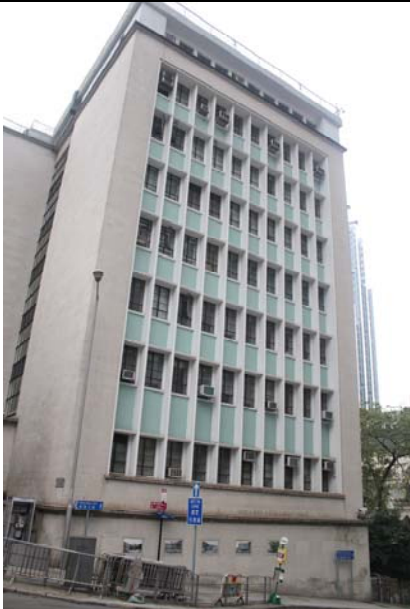
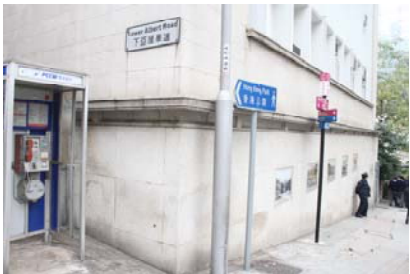
1.15  1.16

Item No.	Identifies Elements / Materials	Photo and Ref.	Level of Significance	Recommend Treatment/ Justification/ Mitigation Measures	Impact Level
1.5	East Elevation (towards Garden Road)

Moderate	<ul style="list-style-type: none"> <li>• Preserve in-situ the original external design of granite cladding surround and the middle exposed concrete frame body</li> <li>• For exposed concrete frame section, preserve the entire elevation includes the exposed white concrete frame design, steel windows include the window heads and sills and its standard details, spandrel panel and the projected cornice</li> <li>• For granite cladding surface, preserve its exposed features and all existing decorative elements</li> <li>• General cleaning to granite surface by soft brush and water</li> <li>• Additional work done to granite surface should be avoided as far as necessary only if crack is discovered. Repair should use mortar mix with granite chips to match with the existing colour and material</li> <li>• Replace and repair defected windows to match existing. Remove all window type air conditioning units that affect the visual value of the building exterior</li> </ul>	Beneficial

Proposed Works/Alteration  <ul style="list-style-type: none"> <li>• Remove all window type air conditioning units and replace the respective steel windows with new ones of matching details</li> </ul>

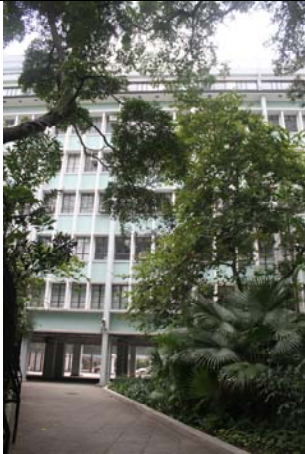
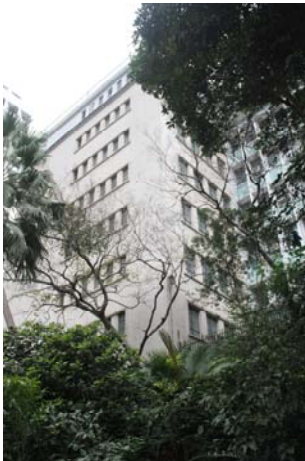
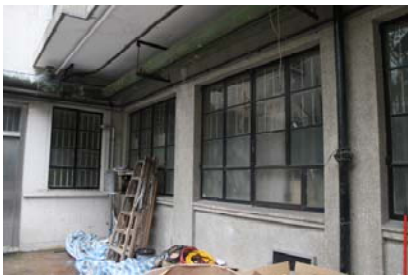
Item No.	Identifies Elements / Materials	Photo and Ref.	Level of Significance	Recommend Treatment/ Justification/ Mitigation Measures	Impact Level
1.6	North Elevation (facing the slope towards St. John's Cathedral)

Moderate	<ul style="list-style-type: none"> <li>The North elevation consist of the same design as the south elevation</li> <li>The treatment to this elevation can refer to that for the south elevation in Item No. 1.1 &amp; 1.2</li> <li>The plant room area is an enclosed area from public and its exterior is in plain concrete surface which does not bear any architectural features. Modification of the existing windows and doors do not cause any visual impact to the overall outlook of the elevation. Modification should keep to minimum and do not cause damage and affect the CDEs (1.19)</li> <li>Exact locations and details will be agreed to AMO prior commencement of works</li> </ul>	Beneficial

<ul style="list-style-type: none"> <li>Remove all window type air conditioning units and replace the respective steel windows with new ones of matching details</li> <li>Modification of existing plant room windows into doors in LG/F facing to the open back yard for functional requirement (plant room facilities)</li> </ul>

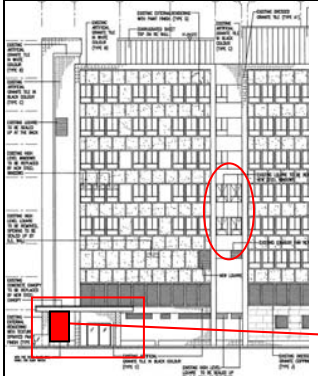
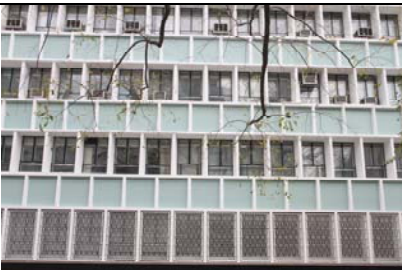
Item No.	Identifies Elements / Materials	Photo and Ref.	Level of Significance	Recommend Treatment/ Justification/ Mitigation Measures	Impact Level
1.7	<p>Main Elevation (West elevation to the open ground between the West Wing)</p> <p>Proposed Works/Alteration</p> <ul style="list-style-type: none"> <li>Remove all window type air conditioning units and replace the respective steel windows with new ones of matching details</li> <li>Installation of a dumb waiter under the canopy of annex block for file storage purpose in LG/F</li> <li>Replace the existing louvers (circled below) with new windows</li> </ul> <p>Site Location</p>

<p>NORTH - WEST ELEVATION Elevation of annex block</p>

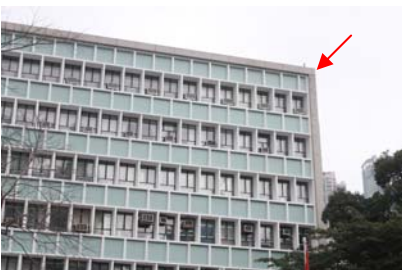
<p>1.21</p>

<p>1.23</p>	Moderate	<ul style="list-style-type: none"> <li>Preserve the entire elevation such as the exposed white concrete frame design, steel windows with standard pattern and spandrel panels.</li> <li>Preserve and retain the original design such as the granite cladding edge (1.21), the G/F black slates with square openings installed with security grilles (1.22)</li> <li>Replace and repair defected windows to match existing. Remove all window type air conditioning units that affect the visual value of the building exterior</li> <li>The new dumb waiter will be an independent structure and compatible design with the existing structure using light weight structure such as steel and glass to minimize the visual impact to the existing building. Details will be submitted to AMO for agreement.</li> <li>The new replacing windows should match with existing</li> <li>The north annex block is a later addition with style look like the old south block but with different construction materials. When repair should try matching the “tone” with the south block but no need to replace it by original materials to match with old one</li> </ul>	Acceptable with mitigation measures

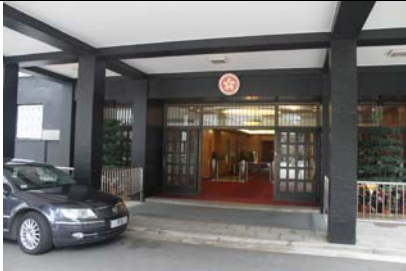
<p>1.24</p>

<p>1.27</p>	Moderate	<ul style="list-style-type: none"> <li>• Preserve the main entrance and the projected car-stopping canopy (1.24)</li> <li>• Remain the design and material use as its original such as back-slate surface (1.26), exposed granite cornice cladding (pointed in 1.25), and the overhanging two emblems</li> <li>• Preserve and repair the entrance bronze doors, side French window panels, upper ventilation vents and all associated ironmongeries on the doors and on the entrance floors (all pointed in 1.27)</li> </ul>	N.A.

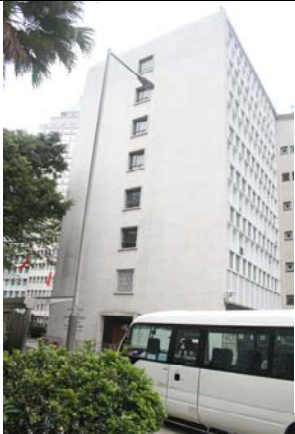
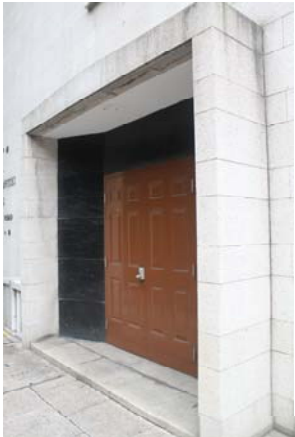
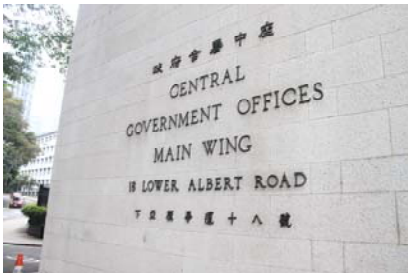
Item No.	Identifies Elements / Materials	Photo and Ref.	Level of Significance	Recommend Treatment/ Justification/ Mitigation Measures	Impact Level
1.9	South Elevation (facing to Lower Albert Road)

<p>1.30</p>	Moderate	<ul style="list-style-type: none"> <li>• Preserve the entire granite cladding elevation including the identified features such as window openings, entrance porch, and the affixed building name and address characters</li> <li>• General cleaning to granite surface by soft brush and water and remain its exposed surface</li> <li>• Additional work done to granite surface should be avoided as far as necessary only if crack is discovered. Repair should use mortar mix with granite chips to match with the existing colour and material</li> <li>• New building name signage should not cover the old building name with compatible design. The erection should minimize the damage to the granite surface using demountable materials</li> </ul>	N.A.

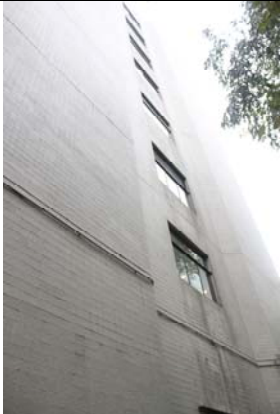
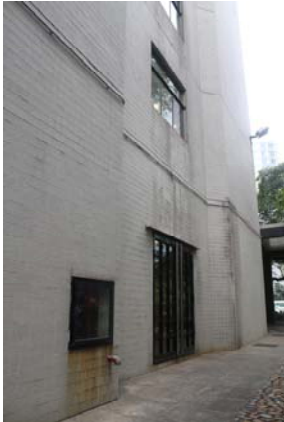
Item No.	Identifies Elements / Materials	Photo and Ref.	Level of Significance	Recommend Treatment/ Justification/ Mitigation Measures	Impact Level
1.10	North Elevation

<p>1.32</p>	Low	<ul style="list-style-type: none"> <li>The elevation is the new addition in 1989 and have no historic and architectural features are identified to be significant</li> <li>Repair using similar materials to match existing tone is acceptable</li> </ul>	N.A.

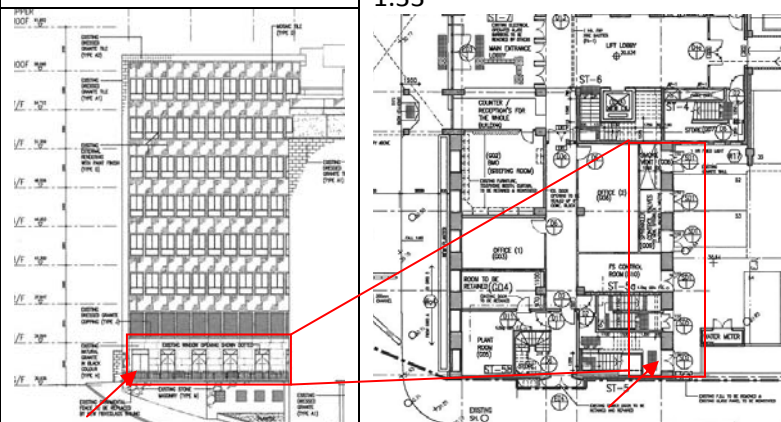
<p>Part plan showing the south block of the Main Wing in G/F</p>	Moderate	<ul style="list-style-type: none"> <li>This part has entirely preserved both the original design and materials same as the west elevation of old south block</li> <li>The treatment to this elevation can refer to first three points stated in the Section 1.7 of <i>Recommended Treatment</i> in this Appendix</li> <li>The fire services facilities will be grouped together and house inside G/F of the south block. Existing windows will be modified to provide access from open ground. New doors should match with existing</li> <li>Modification works should take down the affected covered black slates and security grilles carefully. Those are in good condition should salvage and reuse on site as much as possible</li> <li>The existing spandrel panels on upper floors are covered with dark green mosaic tiles. Check the structural stability of the tiles. Preserve them in-situ as much as possible if they are structurally stable.</li> </ul>	Acceptable with mitigation measures

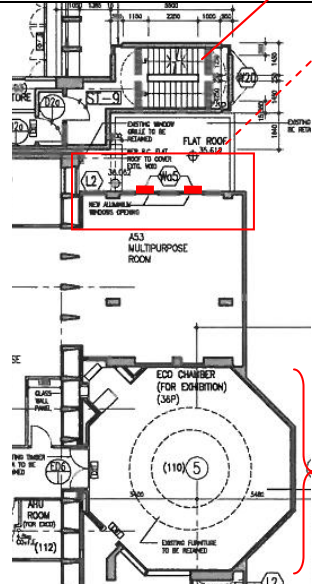
<p>Floor Plan of 1/F ExCo Chamber showing two new window openings</p>

Item No.	Identifies Elements / Materials	Photo and Ref.	Level of Significance	Recommend Treatment/ Justification/ Mitigation Measures	Impact Level
1.12	<p>East Elevation Part 2: (on the north end towards the slope)</p> <p>Proposed Works/Alteration</p> <ul style="list-style-type: none"> <li>Remove all window type air conditioning units and replace the respective steel windows with new ones of matching details</li> <li>Two new window openings on the northern wall of the square block extension</li> </ul> <p>Site Location</p>

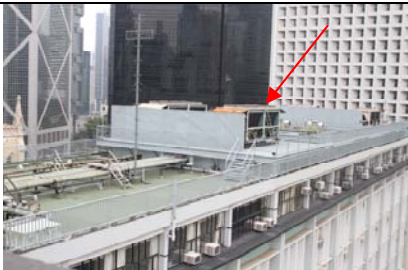
<p>1.37 (East Wing Roof)</p>

<p>1.39 (Roof of the Main Wing south block facing Government House)</p>	Low	<ul style="list-style-type: none"> <li>The existing facilities should rearrange and group together (1.37 &amp; 1.38)</li> <li>All facilities should set back from the main elevations and covered under a planting platform (East Wing) to reduce the visual impact</li> <li>Check the water-proofing surface and implement the re-rofing works if necessary</li> <li>The newly constructed steel platform supporting the green roof and building facilities will be supporting by the existing load bearing columns which does not impose excessive loading to the existing roof</li> <li>The edge of the roof (balustrades) shall be softened by greenery to enhance the external facade</li> <li>Preserve the flat roof setting. The new erection should not block the view looking towards the coast from the Government House, the declared monument (1.39), locating on the upper slope of the site</li> </ul>	Acceptable with mitigation measures

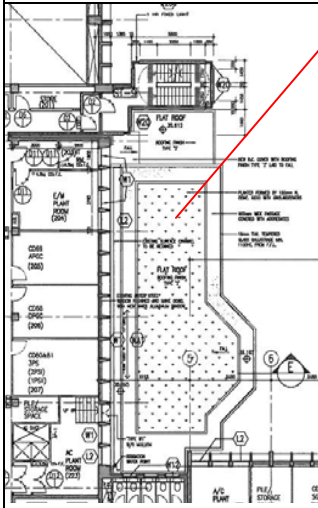
<p>Part plan showing the proposed green roof surface on the ExCo Chamber</p>

Item No.	Identifies Elements / Materials	Photo and Ref.	Level of Significance	Recommend Treatment/ Justification/ Mitigation Measures	Impact Level
1.14	<p>Roof surfaces of the ExCo Chamber</p> <p>Proposed Works/Alteration</p> <ul style="list-style-type: none"> <li>Erect green roof and light weight balustrades</li> </ul> <p>Site Location</p>

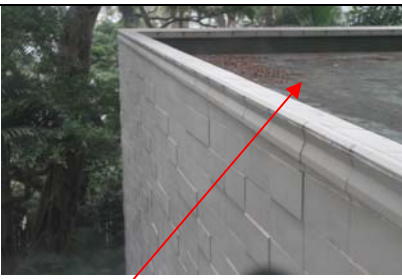
<p>1.40 (East Wing Roof)</p>	Low	<ul style="list-style-type: none"> <li>Check the water-proofing surface and ensure the structural stability with a Structural Engineer to judge if upgrading works are necessary</li> <li>Check the structural loading capacity of the roof surface for building the green roof here</li> </ul>	Acceptable

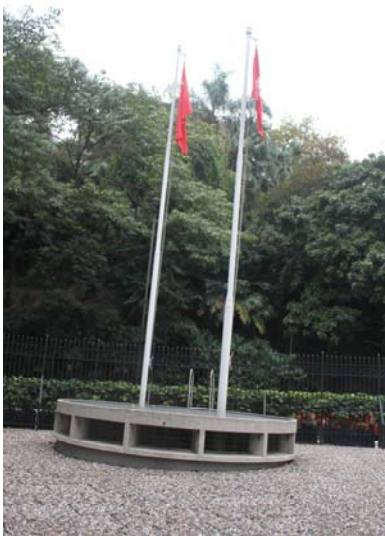
<p>1.43</p>	High	<ul style="list-style-type: none"> <li>The pole and the platform is the construction of the CGO in 1956 with historic significance</li> <li>Take good care or carefully fence off before and during works to prevent any unexpected damage and harm to the structure including its base</li> </ul>	N.A.

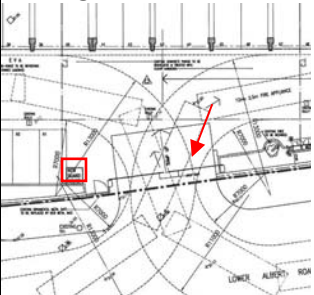
<p>Part Plan showing the new car entrance to the East Wing by modifying existing</p>

Item No.	Identifies Elements / Materials	Photo and Ref.	Level of Significance	Recommend Treatment/ Justification/ Mitigation Measures	Impact Level
1.18	<p>Two car entrances and guard houses facing Lower Albert Road</p> <p>Proposed Works/Alteration</p> <ul style="list-style-type: none"> <li>Replace by new drop bars (pointed) and new guard houses (red squares) for vehicle control</li> </ul> <p>Site Location</p>

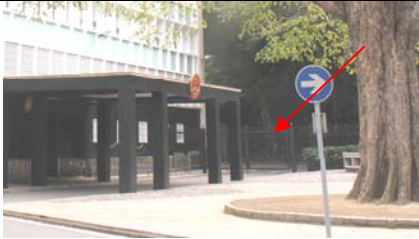
<p>1.47</p>

<p>1.48</p>	low	<ul style="list-style-type: none"> <li>The new guard house should be compatible design with the existing building with light weight structure</li> </ul>	Beneficial

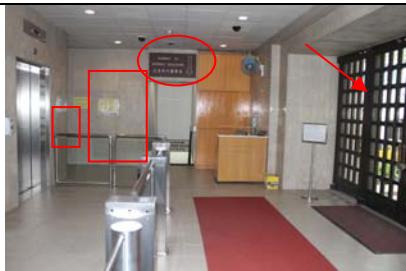
Low	<ul style="list-style-type: none"><li>The entrance lobby was extensively renovated and does not carry any original architectural features except the subway to Murray Building and the entrance bronze doors (pointed in 2.01)</li><li>Preserve and not to block the subway at least the section visible from the lobby including the identified features such as the handrails and signage boards (2.01 &amp; 2.02)</li><li>The proposed dumb waiter is designed for file transferring purpose as the lift cannot be built to B/F (small red square in 2.01)</li><li>The proposed new lift is designed to improve vertical circulation for the new users (big red square in 2.01)</li><li>The new additions are chosen to place in less prominent locations to preserve the integrity of the building and enhance the working environment which have operation needs</li><li>New additions should be constructed in reversible method, and compatible and distinguishable with the existing building structure</li></ul>	Acceptable with mitigation measures

Proposed Use/Alteration	2.01			
	<ul style="list-style-type: none"><li>Remain as entrance</li><li>Addition of a dumb waiter to the basement area for file transferring purpose (upper square in the floor plan)</li><li>Addition of a new lift going from LG/F to 6/F to enhance vertical circulation (lower square in the floor plan)</li></ul>

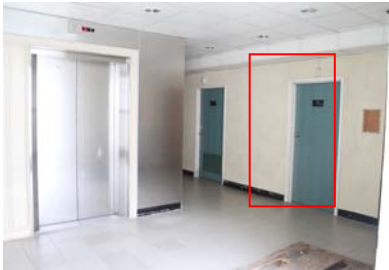
Part plan of 1/F East Wing lobby showing the location of new lift (red square) and terrazzo finishes (red line) found with preservation values. They are the same for all other upper floor lobbies at the same locations of the East Wing

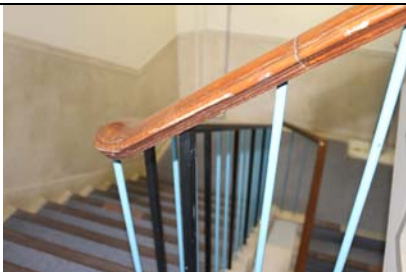
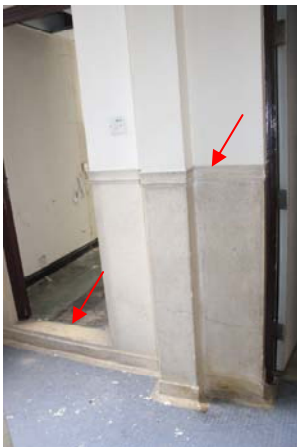
moderate	<ul style="list-style-type: none"> <li>Preserve and do touch-up repair to the original architectural features including terrazzo finishes on dado level and blue mosaic floor tiles (2.07 &amp; 2.08), timber handrail and railing design (2.07), ceiling moulding and old floor signage</li> <li>Remove the existing ductworks to reinstate the heritage value of the stairs (2.09)</li> <li>Repair those original fittings (the terrazzo finishes and timber rails) using similar materials and colours by skilled tradesman</li> <li>The new tactile dots should try to minimize the affected area to the blue mosaic tiles if practicable</li> </ul>	Acceptable with mitigation measures
	Proposed Use/Alteration

<ul style="list-style-type: none"> <li>Preserve in-situ</li> <li>Remove the existing duct works away from the staircase</li> <li>This staircase has to use as a fire staircase for universal passage. Discrete stainless steel tactile dots are used instead of using square tactile to minimize the impact done to the blue mosaic tiles floor</li> </ul>

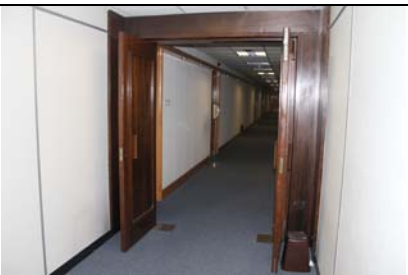
<p>2.10</p>

<p>2.12</p>	moderate	<ul style="list-style-type: none"> <li>• Preserve the timber corridor partition on 1/F corridor and reuse it as the fire-door (2.10)</li> <li>• If preserve in-situ is not possible, take down the timber elements carefully and relocate it on site if it is in good condition</li> <li>• Preserve the setting of the conference room (2.11) including the long table, 3 crystal lamps, timber dado panels, the timber-sealing cover of the cupboard-type AC units next to windows and the window openings</li> <li>• The new glass partition should remain the configuration of the original space setting of this room</li> <li>• For the timberworks, retain, clean and restore to make good for them</li> <li>• Replacement only limit to timber member who is rotted or in poor condition which beyond repair</li> <li>• Apply anti-termite treatment to all timberworks</li> <li>• Do general cleaning and strengthening to the crystals of the lamps using water and soft brush</li> </ul>	Acceptable with mitigation measures

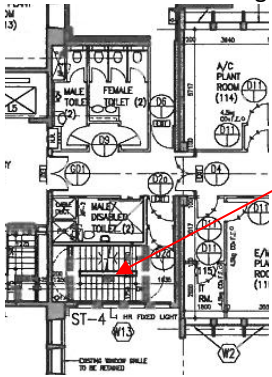
<p>A new staircase at the south central part of the middle section of the East Wing</p>

<p>A new staircase at the south part of the west transactional section of the East Wing</p>	<p>2.13</p>

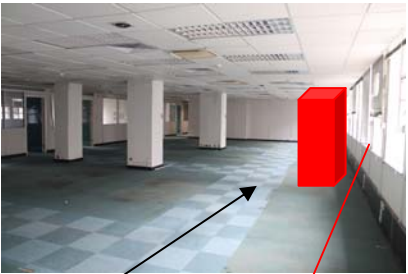
<p>2.14</p>

<p>Proposed new staircases</p>	Low	<ul style="list-style-type: none"> <li>• The proposed locations for the two new staircases do not bear any architectural features</li> <li>• The two new staircases are of functional requirement to provide access for MOE of the buildings</li> <li>• Capacity of floor loading will be ascertain to ensure that the building including its exterior will not be affected by new facilities</li> <li>• New additions should be constructed in reversible method and compatible and distinguishable with the existing building structure. The alignment should not cause visual impact to the building when looking from outside and should incorporate the existing window openings to the new design</li> </ul>	Acceptable with mitigation measures

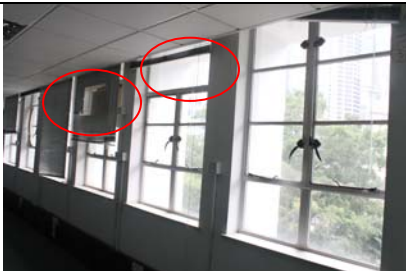
<p>2.15</p>

<p>2.17</p>	moderate	<ul style="list-style-type: none"> <li>• Preserve and fix the external steel frame windows</li> <li>• Replaced windows shall match existing (circled in 2.15)</li> <li>• Remove those window-type air-conditioners (circled in 2.15)</li> <li>• Preserve and repair those internal window features and make good to them including the vertical double lock system and window holds (2.17)</li> <li>• New inner-side windows should not affect the building exterior outlook</li> <li>• Existing internal security grilles which consider no use can dismantle and reframe in other rooms if useful to maintain the authenticity of the building fabric. (2.16)</li> <li>• The new internal office layout should incorporate the existing window openings into the design</li> </ul>	Acceptable with mitigation measures

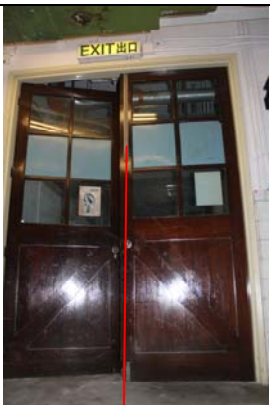
<p>2.18</p>

<p>2.20</p>	low	<ul style="list-style-type: none"> <li>The plant room should remain its servicing function and preserved the original fitting found such as the timber entrance panels and the ironmongeries (2.18 &amp; 2.19)</li> <li>Do a thorough survey to identify any vintage equipment (mainly old British brand like 2.20) inside. If upgrading work is necessary. Salvage them for the use of heritage interpretation</li> </ul>	N.A.

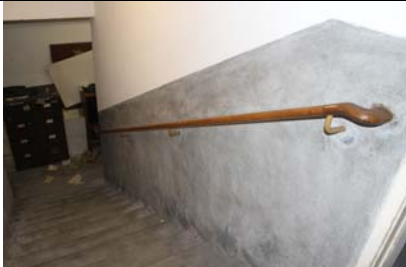
<p>2.21</p>

<p>2.22</p>	moderate	<ul style="list-style-type: none"> <li>This is the area which preserved much of its original setting and features. A considerable amount of vintage items included original storage shelves, furniture, fittings, archive and old publications were discovered in site visit.</li> <li>Try to preserve in-situ on site the fittings if not affecting future use and do general cleansing to them</li> <li>Do a careful screening before discharging the internal items</li> <li>The new staircase is of functional requirement to provide individual MOE for basement level of the building</li> <li>The new staircase and dumb waiter should be constructed in reversible method and compatible and distinguishable with the existing building structure. The extent of alteration should minimize as much as possible</li> <li>The list of vintage items identified in good condition to preserve for heritage interpretation and storage shall be agreed with AMO and building users in future</li> </ul>	Acceptable with mitigation measures

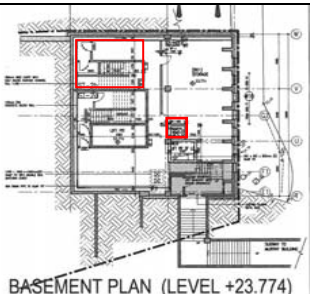
<p>BASEMENT PLAN (LEVEL +23.774)</p>

Proposed Use/Alteration				
	<ul style="list-style-type: none"> <li>Remain its storage purpose</li> <li>Adding an individual fire-rated staircase with protected lobby to upper open ground for MOE purpose</li> <li>Installation of a dumb waiter up to LG/F for file transferring purpose</li> </ul>				
	Site Location

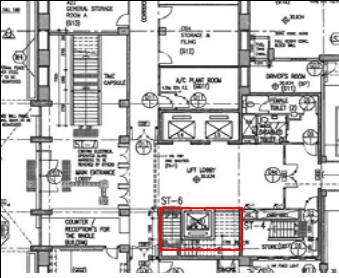
Item No.	Identifies Elements / Materials	Photo and Ref.	Level of Significance	Recommend Treatment/ Justification/ Mitigation Measures	Impact Level
2.9	<p>G/F Entrance Lobby</p> <p>Proposed Use/Alteration</p> <ul style="list-style-type: none"> <li>Reconstruct the spiral staircase with a central lift core for barrier free access down to LG/F and up to all floors (red square in plan)</li> </ul> <p>Site Location</p>

<p>Part Plan of G/F Main Wing showing the main entrance lobby</p>

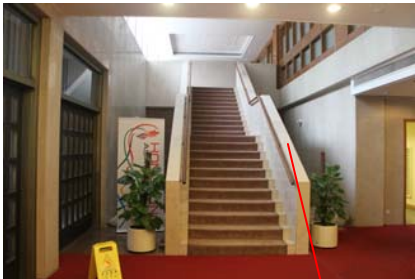
<p>2.25</p>

<p>2.26</p>	<p>Plaque and time capsule -High</p> <p>ExCo Stair – moderate</p>	<ul style="list-style-type: none"> <li>• Preserve the marble cladding staircase (2.25), the commemorative plaque and the underside time capsule (2.26). Do a general cleansing to them.</li> <li>• Redesign the current marble-stone filling landscape surrounding the floor area of the plaque and the lighting to provide a user friendly and accessible pathway. (2.26)</li> </ul>	Acceptable with mitigation measures
	<p>Proposed Use/Alteration</p> <ul style="list-style-type: none"> <li>• Preserve the marble staircase leading to 1/F ExCo Chamber</li> <li>• Preserve the commemorative plaque and marble time capsule under</li> </ul> <p>Site Location</p>

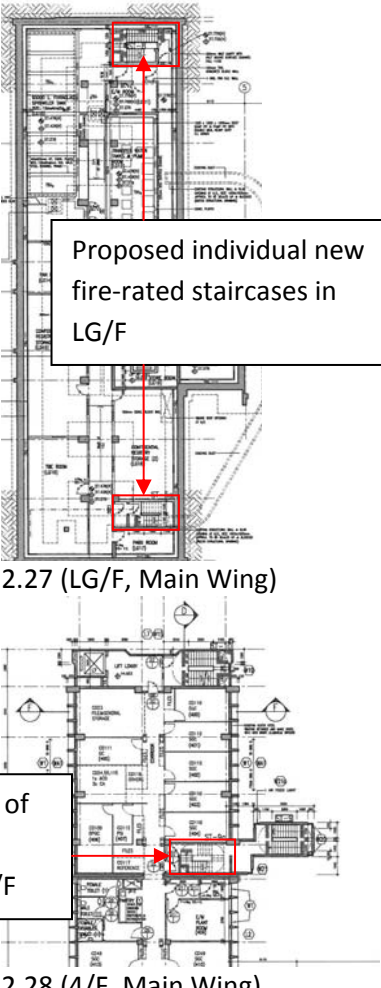
<p>Proposed individual new fire-rated staircases in LG/F</p> <p>2.27 (LG/F, Main Wing)</p> <p>2.28 (4/F, Main Wing)</p> <p>The proposed extension of the ExCo Chamber staircases from 4/F to 7/F</p>	Low	<ul style="list-style-type: none"> <li>The proposed locations for the two new staircases do not bear any architectural features</li> <li>The two new staircases are of functional requirement to provide access for MOE of the buildings</li> <li>Capacity of floor loading will be ascertain to ensure that the building including its exterior will not be affected by new facilities</li> <li>New additions should be constructed in reversible method and compatible and distinguishable with the existing building structure. The alignment should not cause visual impact to the building when looking from outside and should incorporate the existing window openings and the new design</li> </ul>	Acceptable with mitigation measures

Proposed Use/Alteration				
	<ul style="list-style-type: none"> <li>Adding an individual fire-rated staircase with protected lobby for LG/F to upper open ground for MOE purpose</li> <li>Extension of the staircase north of ExCo Chamber from 4/F to 7/F.</li> </ul>				
	Site Location				
	Please refer to Photo and Ref.

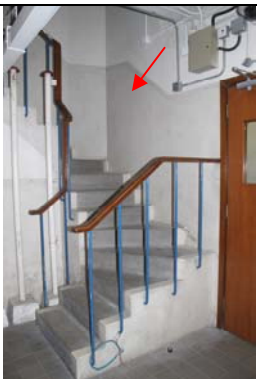
<p>2.29</p>

<p>2.31</p>	moderate	<ul style="list-style-type: none"> <li>• Preserve the entire staircase with features identified with heritage values including terrazzo finishes on dado level (pointed 2.29), timber handrail (2.31), its spiraling design (2.30) and the sole unfinished steps and landing</li> <li>• Repair those original fittings (the terrazzo finishes and timber rails) using similar materials and colour by skilled tradesman, do general cleaning and make good to them</li> <li>• The proposed locations for the new staircases do not bear any architectural features</li> <li>• The new staircases are of functional requirement to provide access for MOE of the buildings</li> <li>• Capacity of floor loading will be ascertain to ensure that the building including its exterior will not be affected by new facilities</li> <li>• New additions should be constructed in reversible method and compatible and distinguishable with the existing building structure</li> </ul>	Beneficial

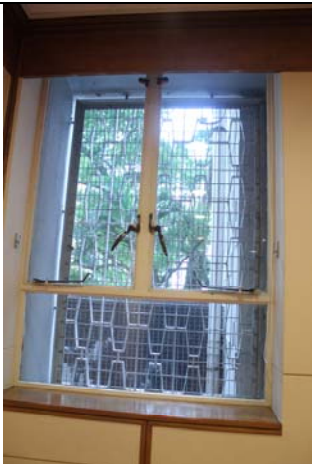
2.32	moderate	<ul style="list-style-type: none"> <li>The treatment of this part can refer to points stated in the Section 2.6 of <i>Recommended Treatment</i> in this Appendix</li> </ul>	Acceptable with mitigation measures
	Proposed Use/Alteration				
	<ul style="list-style-type: none"> <li>Preserve in-situ</li> <li>Repair to match existing</li> <li>Replace the later altered windows with new ones to match existing</li> <li>Install second layer windows at the inner side of the window openings to improve the environmental condition with design not impair the external steel frame windows</li> </ul>				
	Site Location				
	All existing window openings

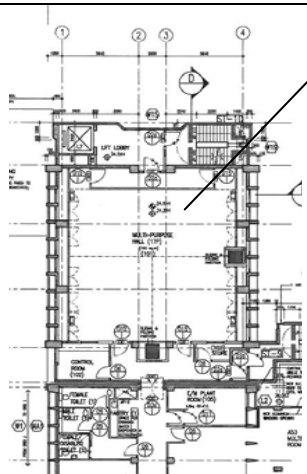
Item No.	Identifies Elements / Materials	Photo and Ref.	Level of Significance	Recommend Treatment/ Justification/ Mitigation Measures	Impact Level
2.14	<p>Press Hall (1/F Annex Block)</p> <p>Proposed Use/Alteration</p> <ul style="list-style-type: none"> <li>Reuse as the multi-purpose hall</li> </ul> <p>Site Location</p>

<p>1/F of the annex block</p>

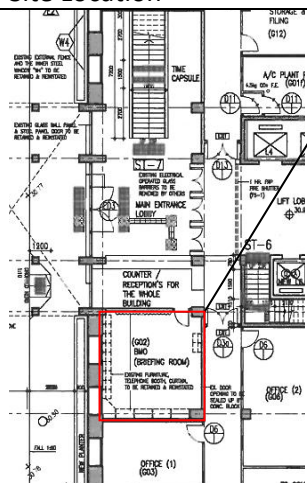
Item No.	Identifies Elements / Materials	Photo and Ref.	Level of Significance	Recommend Treatment/ Justification/ Mitigation Measures	Impact Level
2.15	<p><b>Small Press Room (G/F)</b></p> <p><b>Proposed Use/Alteration</b></p> <ul style="list-style-type: none"> <li>Preserve the general layout for future interpretation purposes</li> </ul> <p><b>Site Location</b></p>

<p>Part plan of G/F Main Wing showing the small press room</p>

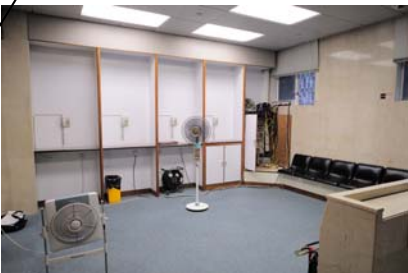
<p>2.38</p>	Moderate	<ul style="list-style-type: none"> <li>The old press room preserve its old setting with facilities for media use before the broad use of internet</li> <li>Preserve the overall setting of this room for future interpretation purpose including its timber partition (2.38), marble covered wall surface, black curtain covered background with marble cladding stand and black seats fixed on timber cupboards</li> <li>If in-situ preservation is not feasible, carefully take down the parts and store them for interpretation purpose. However, intervention should keep minimum</li> </ul>	Acceptable with mitigation measures

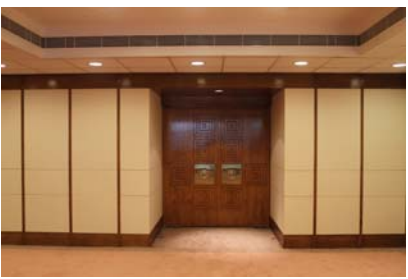
<p>2.40</p>	High (the space)	<ul style="list-style-type: none"> <li>Preserve the setting of the ExCo Chamber</li> <li>The round table, SAR emblem, carpet decors and the main entrance (2.40) are of the features which shall retain. Any modification works done inside this room are acceptable but should maintain the setting with minimum intervention</li> </ul>	Acceptable with mitigation measures

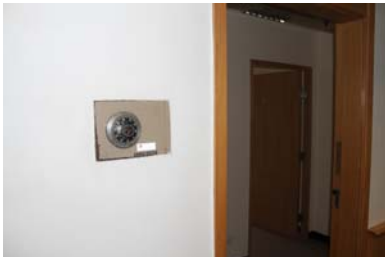
3.02

3.04	Moderate	<ul style="list-style-type: none"> <li>There are a number of dial lock (mainly from the British brand Chubb manufactured from UK) which bears value to recall the colonial past and the past technological standard</li> <li>Preserve those wall inserted dial lock if not affecting the future office use as the CGO features as far as practicable</li> <li>Those which are not preserving in-situ should be salvaged for heritage interpretation if consider not usable</li> <li>The list of vintage items identified in good condition to preserve for heritage interpretation and storage shall be agreed with AMO and building users in future</li> </ul>	N.A.
	Proposed Use/Alteration				
	<ul style="list-style-type: none"> <li>Remain in-situ if practically feasible. Salvage them if dismantle needs</li> </ul>
