ACTIVITY CENTRE FOR THE PROMOTION OF CHINESE HISTORY AND CULTURE
IN KOWLOON PARK
Heritage Impact Assessment

May 2023 | Rev. E
Prepared by

ANG Studio Ltd.

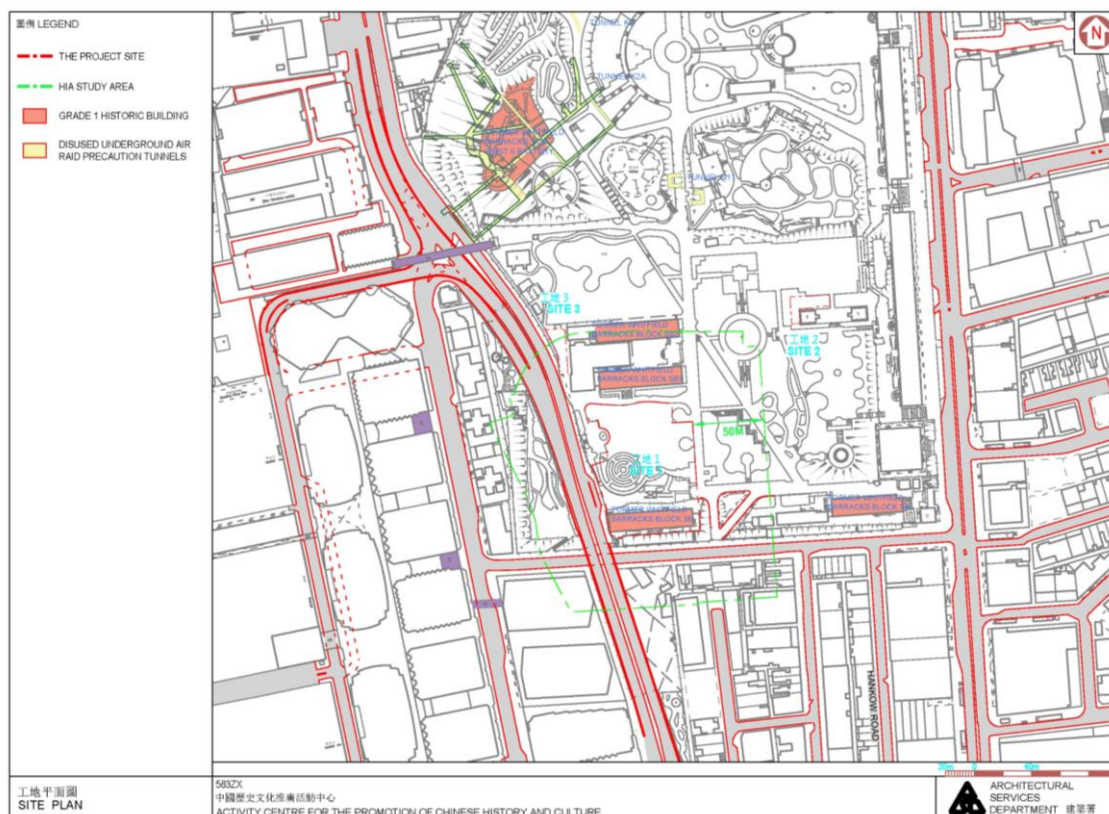
Figure 1-1 The Project Site and HIA Study Area. (Source: Architectural Services Department, with the Author's edition)

The Project Site comprises the Former Whitfield Barracks Block 58 and an adjoining open space in Kowloon Park. The HIA Study Area is an area within 50m from the Project Site. They are shown in Figure 1-1.

As shown in Figure 1-1 above, three Grade 1 Historic Buildings fall within the HIA Study Area and they all belong to the Former Whitfield Barracks, namely:

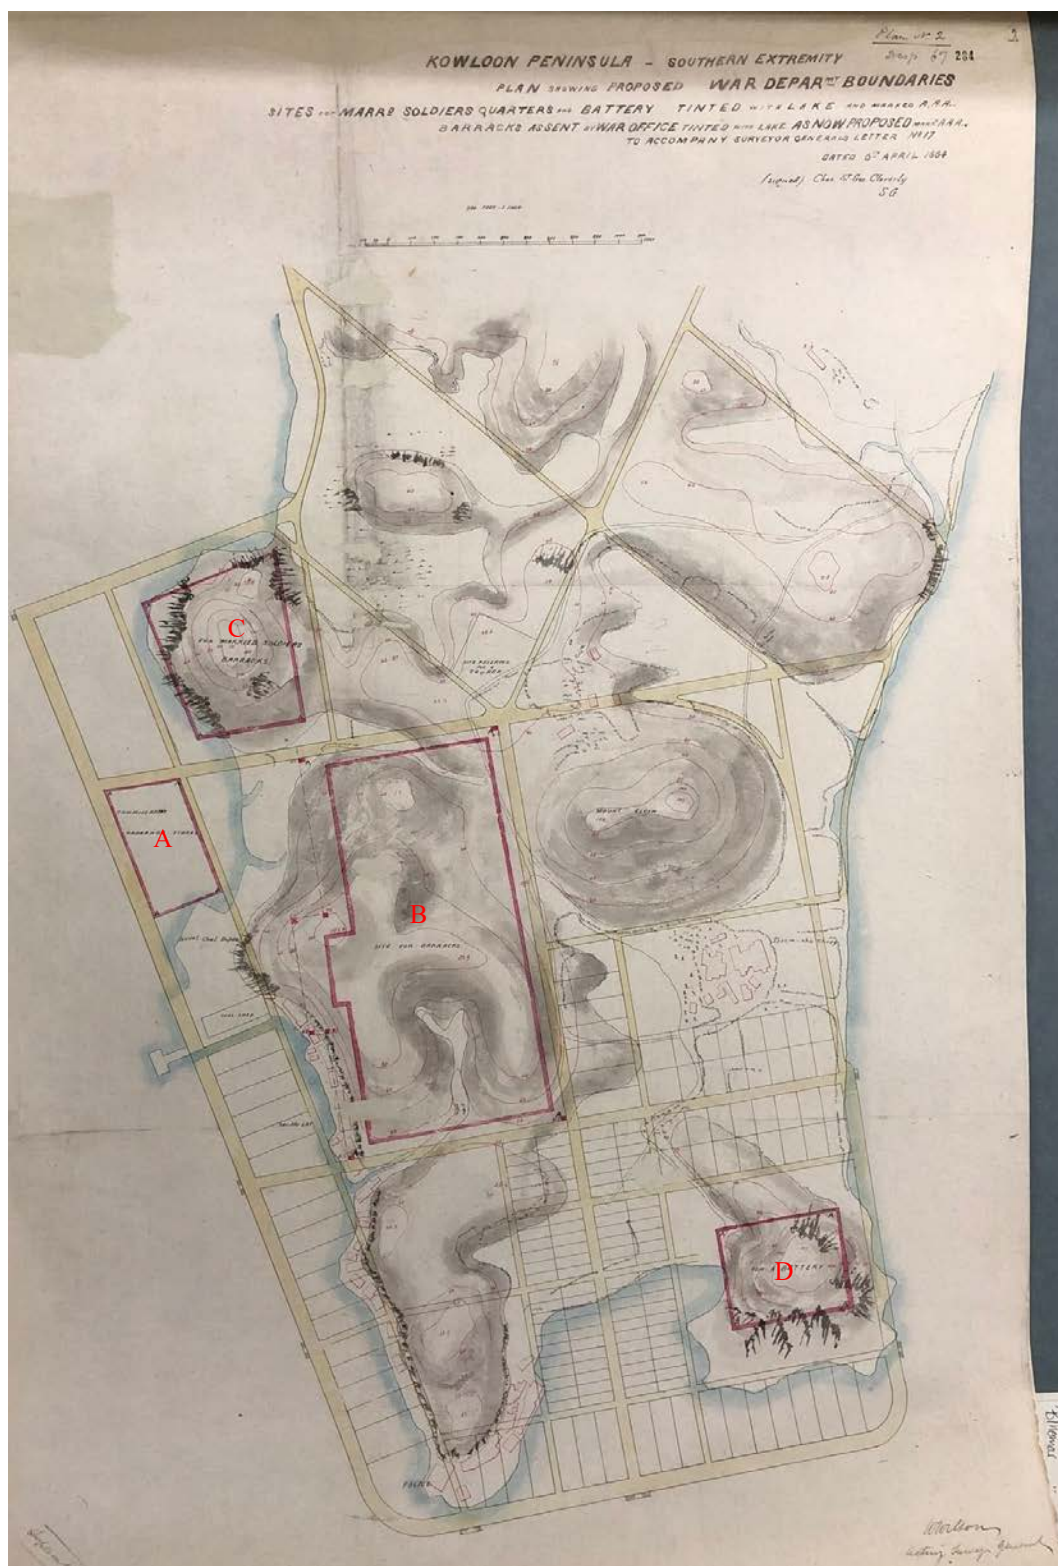
Figure 2-3 Kowloon Peninsula - Southern Extremity, Plan showing proposed War Department Boundaries, 6 April 1864, signed by Charles St George Cleverly, Surveyor General. The plan similarly shows 4 sites in Kowloon to be assigned to War Department, overlaid with the proposed roads (no name yet) and private lots of the surrounding land. Site A was designated as Commissariat Ordnance Stores, B as Site for Barracks (later Whitfield Barracks), C as Site for Married Soldiers Barracks and D as Site for a Battery (later Blackhead Point or Signal Hill). (Source: The National Archives MFQ 1/1372/5 and CO129/98)

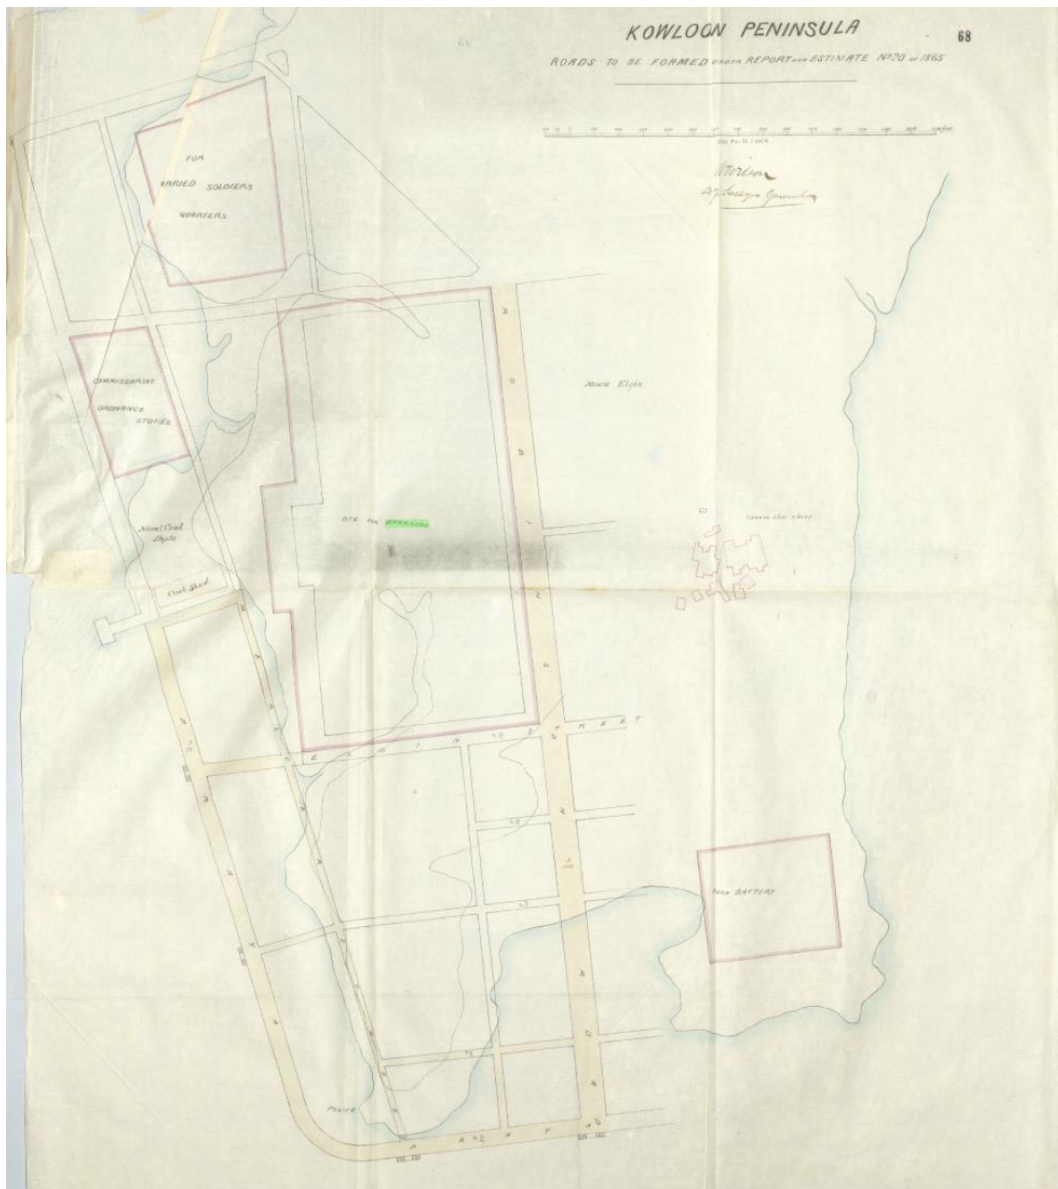
Figure 2-4 Kowloon Peninsula – Roads to be formed under Report and Estimate No. 20 of 1865, dated 2 January 1865. The plan was enclosed in the Report and Estimate No. 20 of 1865, prepared by Wilberforce Wilson, Acting Surveyor General and approved by Governor [Sir] Hercules G R Robinson. Roads to be formed (tinted yellow in the map) included Robinson Road (current Nathan Road), Elgin Street (current Haiphong Road), Mercer Street (current Canton Road) and the southwest Praya. (Source: The National Archives CO129/104)

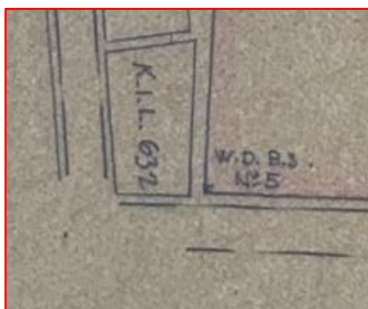
Figure 2-5 Plan of W.D. Lot No. 12 "War Department Land Central Block Kowloon", dated 22 July 1909. Note the mark "W.D.B.S. No.5" at the southwest corner of the site plan, which means War Department Boundary Stone No. 5. The one at southeast corner was "W.D.B.S. No.4" while the one in the middle of west boundary was "W.D.B.S. No.6". (Source: Public Records Office, File No. HKRS 337-4-110)

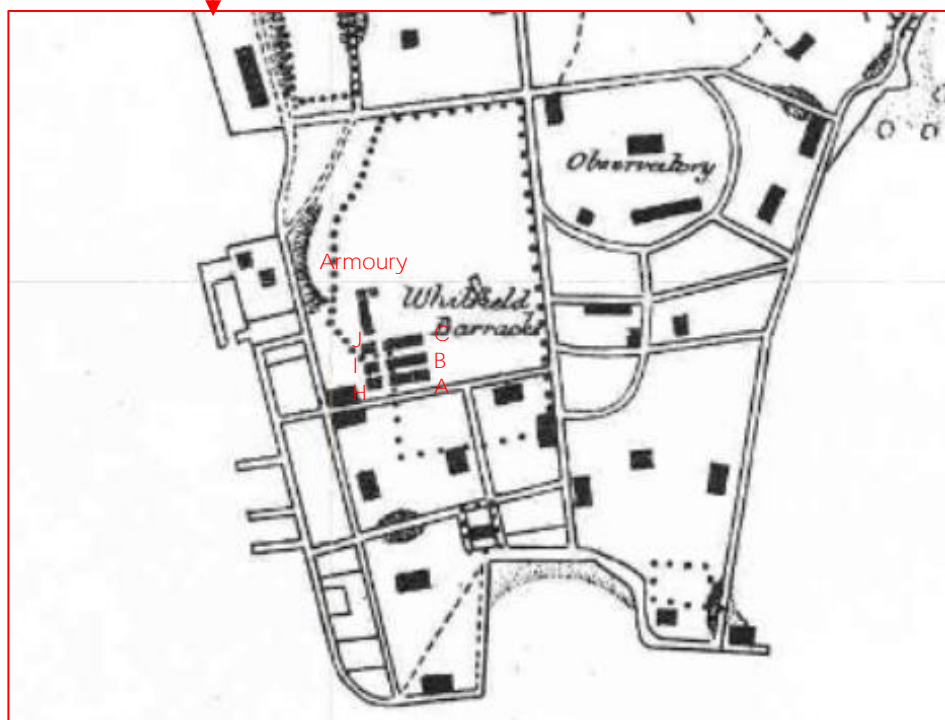
Figure 2-7 Hong Kong from Ordnance Map surveyed by Lieut. Collinson, Royal Engineer 1845 and updated and signed by W H Mulloy, Colonel on the Staff Commanding Royal Engineer in China on 11 October 1895. The name “Whitfield Barracks” first appeared on a survey map of Hong Kong. 7 buildings inside Whitfield were recorded, which should be **Block A, B, C, H, I, J and the Armoury**. (Source: Hong Kong Maps. Accessed on 12 November 2022, <https://hkmaps.hk/map.html?1896>)

On the other hand, "barracks at Kowloon (Whitfield)" were first recorded in list of military quarters and buildings in Hong Kong Blue Book in 1891¹⁴, while "Whitfield Barracks" with its very first 7 buildings were in a map in 1895 of Hong Kong (Figure 2-7). These show that the name "Whitfield Barracks", named after Lieutenant General Henry Wase Whitfield, the commander of the British Troops in China, Hong Kong and the Straits Settlements in 1869-1874 and Lieutenant Governor of Hong Kong in 1872, has been officially adopted and these very first 7 buildings were erected during 1891-95. Block A, a 2 storeys barrack building for soldiers (later named Block S58 or now commonly known as Block 58) was one of them. Other 6 buildings were Blocks B, C, H, and I (barrack buildings for soldiers), Block J (a school building) and Armoury, all of 2 storeys.

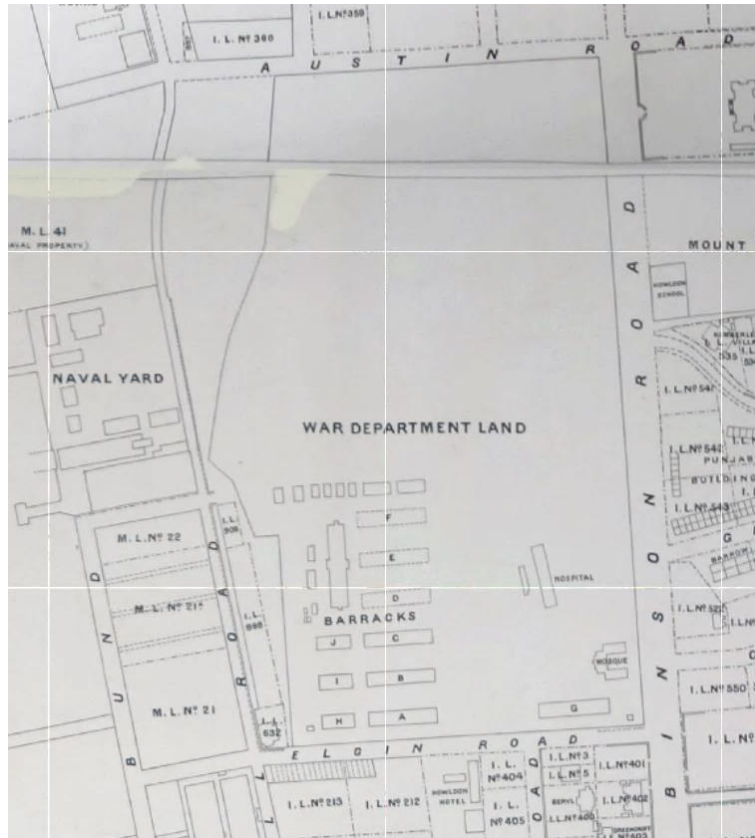
Figure 2-8 An extract from Map of Kowloon, 1901. Blocks A, B, C, G, H, I, J, Armoury, [Asiatic] Hospital and Mosque were recorded, while Blocks D, E, F were drawn in hidden lines (estimated to be under planning/ construction). (Source: Hong Kong Maps. Accessed on 12 November 2022 <https://www.hkmaps.hk/map.html?1901.2>)

By 1895, Asiatic Hospital Kowloon, which was listed the second in 1895 schedule of barrack services, had been completed and added to list of military quarters and buildings in Hong Kong¹⁵. By 1901, Block G (another 2 storeys barrack building, later named Block S4) had been further added to the site (Figure 2-8). By 1911, 66 buildings had been constructed in the south half of Whitfield Barracks site (Figure 2-10), including Block D (later named Block S61), Block E (later named Block S62) and Block F.

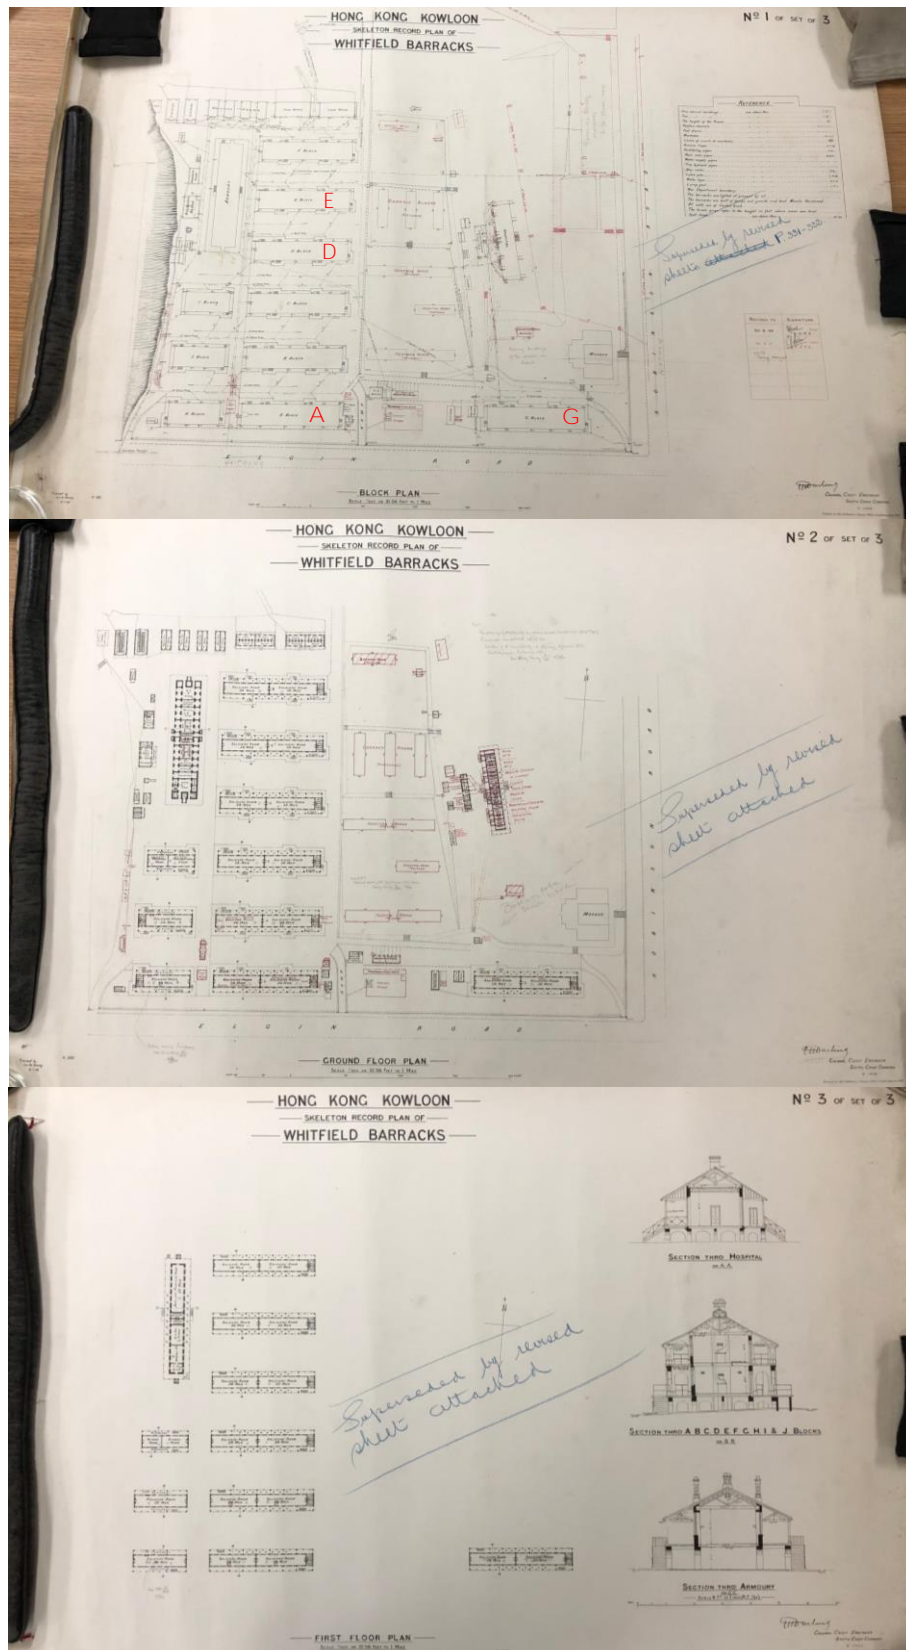
Figure 2-10 Hong Kong Kowloon, Skeleton Record Plan of Whitfield Barracks, 1906 and further amended in 1909 and 1911, 3 sheets. 66 buildings were built in south half of Whitfield Barracks site, among which 11 were of 2 storeys (Blocks A, B, C, D, E, F, G, H, I, J and Armoury). (Source: The National Archives, WO 78#3744)

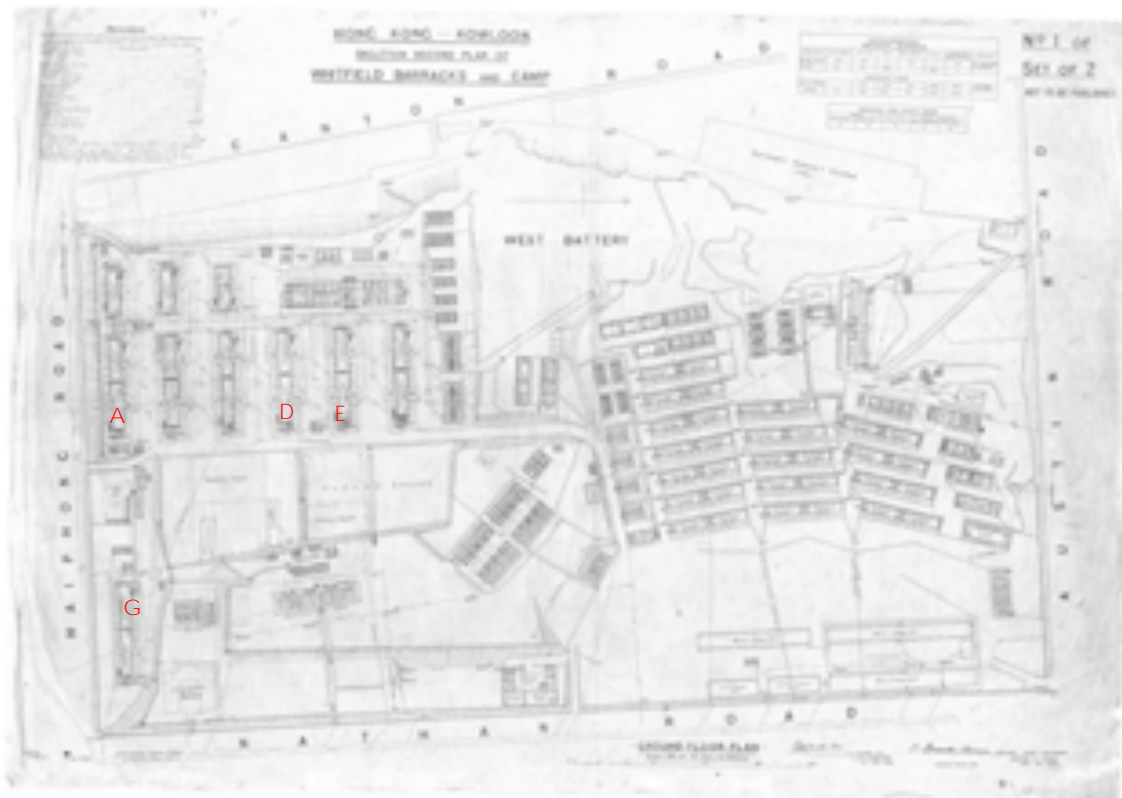
Figure 2-16 Hong Kong Kowloon, Skeleton Record Plan of Whitfield Barracks and Camp, Ground & First Floor Plans, 1926. (Source: Public Records Office, File No. HKRS913-1-119)

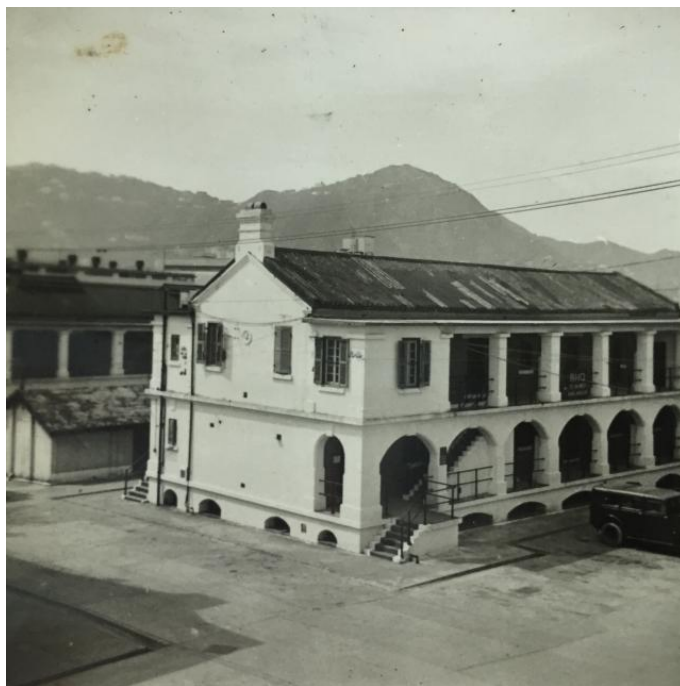
Figure 2-18 A photo of Whitfield Barracks in the 1950s. Note that the pitch roofs on verandahs has become flat roofs already. (Source: Gwulo: Old Hong Kong.)

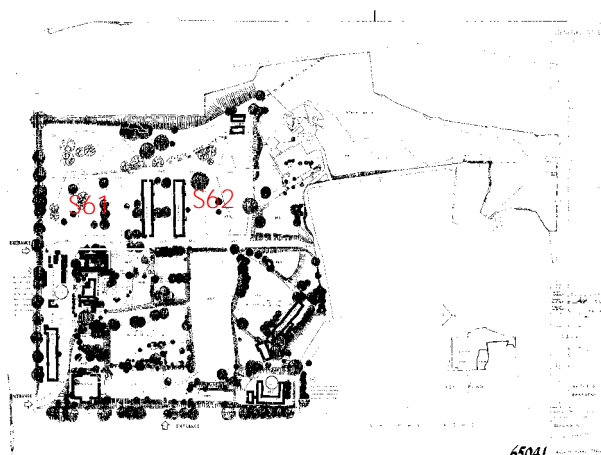
Figure 2-25 Whitfield Barracks, Park Layout Plan, Drawing No. A/39570, dated April 1968. (Source: Architectural Services Department, Microfilm No. 65041)

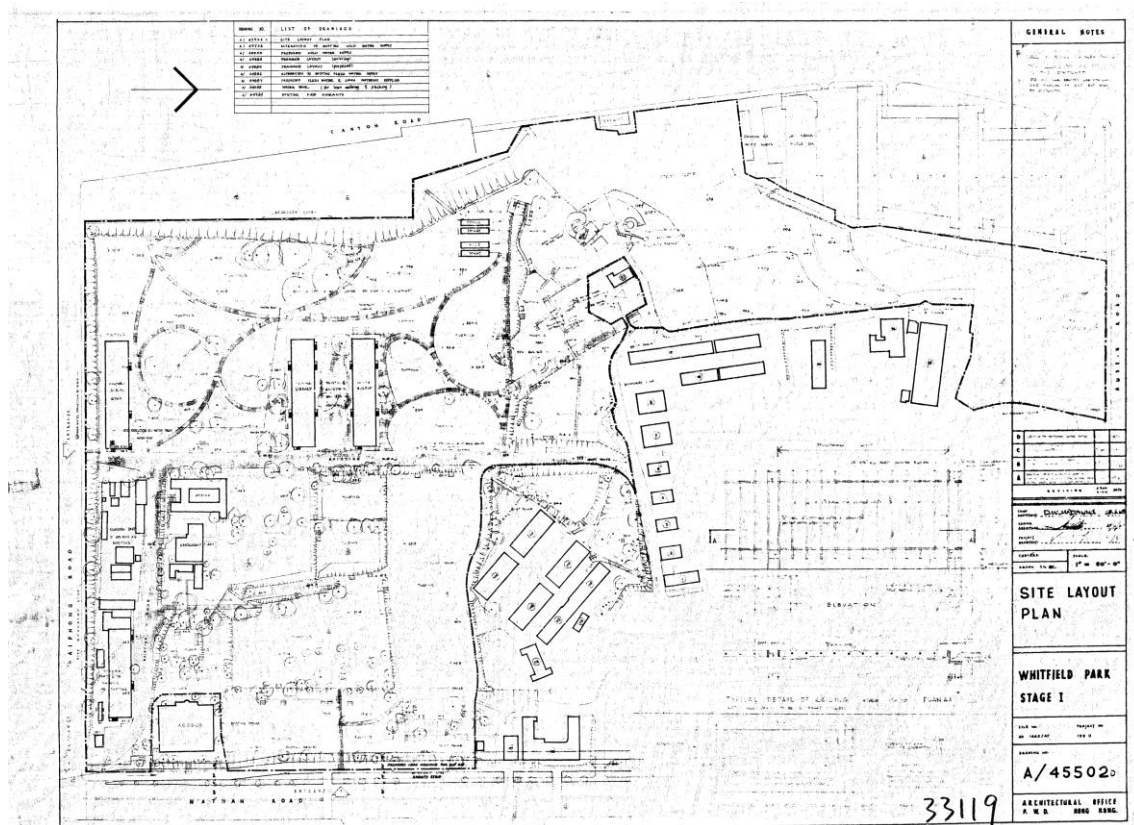
Figure 2-27 Whitfield Park Stage 1, Site Layout Plan, Drawing No. A/45502D, first issued in March 1969, revision D issued on unknown date. (Source: Architectural Services Department, Microfilm No. 33119)

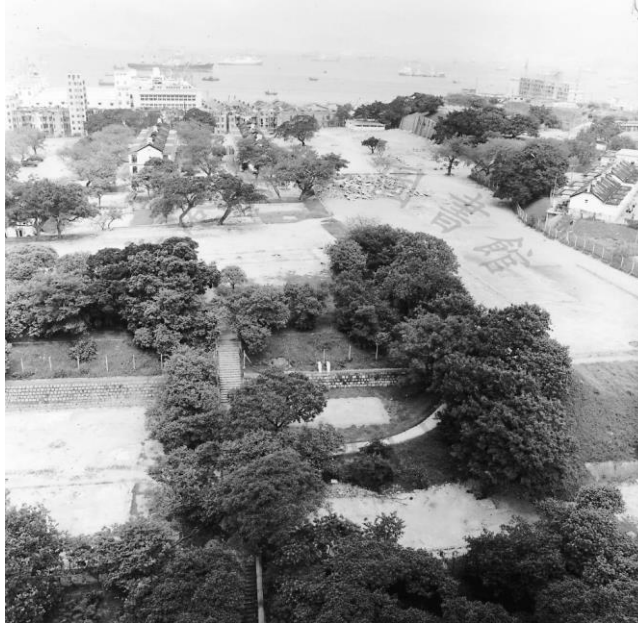
Figure 2-29 Site formation for Kowloon Park, viewing from Nathan Road to the West, 9 May 1969.

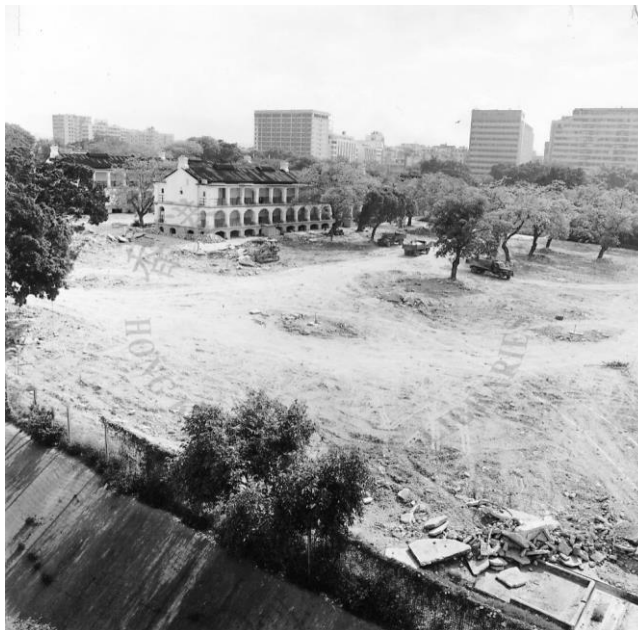
Figure 2-30 Site formation for Kowloon Park, viewing from Nathan Road to the West, 9 May 1969. Note Block E (or Block S62) in the middle and Block D (or Block S61) behind it. (Source: Hong Kong Public Library MMIS, 24 November 2022 accessed: [https://mmis.hkpl.gov.hk/coverpage/-](https://mmis.hkpl.gov.hk/coverpage/-/coverpage/view?p_r_p_-1078056564_c=QF757YsWv59%2F9WIUSQ5I71Kc2BRatUKt&coverpage=WAR_mmisportalportlet_ref=LPEC03)

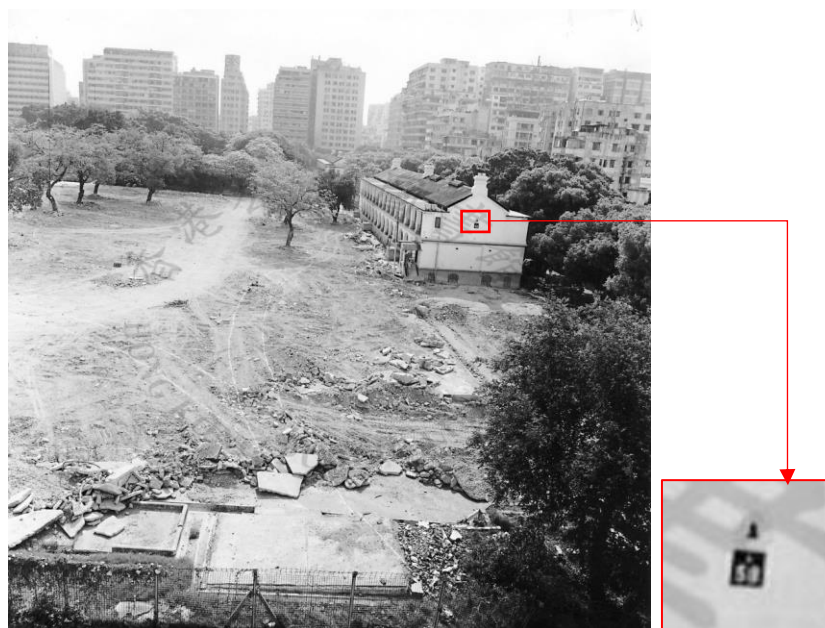
Figure 2-31 Site formation for Kowloon Park, viewing from Canton Road to the East, 9 May 1969. Note Block A (or Block S58 on the right and Block G (or Block S4) on the far right. (Source: Hong Kong Public Library MMIS, 24 November 2022 accessed: [https://mmis.hkpl.gov.hk/coverpage/-/coverpage/view?p_r_p-](https://mmis.hkpl.gov.hk/coverpage/-/coverpage/view?p_r_p-1078056564_c=QF757YsWv59%2F9WIUSO5I7yLPYu3tRdqs&coverpage_WAR_mmisportalportlet_o=2&coverpage_WAR_mmisportalportlet_actual_q=%28%20%28%20%2Ball_dc.title%3A%28whitfield%29%20%29%29%20AND+%28%20verbatim_dc.category.category%3A%28%22Image%22%29%20%29%29&coverpage_WAR_mmisportalportlet_sort_order=desc&coverpage_WAR_mmisportalportlet_sort_field=score&coverpage_WAR_mmisportalportlet_log=Y&tabs1=FILE_DOWNLOAD)

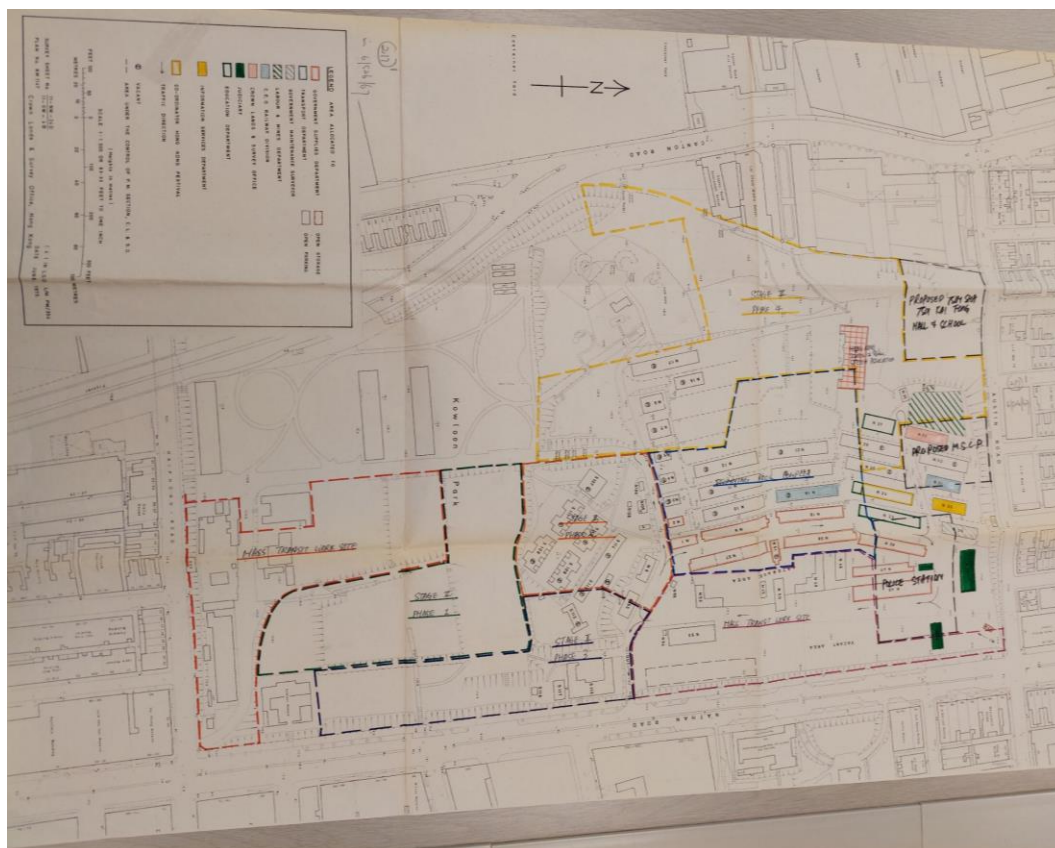
Figure 2-37 Proposed phasing plan of Kowloon Park Development, June 1975. (Source: Extract from an Urban Council Discussion Paper, Public Records Office, File No. HKRS 1105-1-9)

Despite the approval of Outline Use Zoning Plan LK1/44 in 1967, the Urban Council had continued to fight for years since after, to ensure that Whitfield Barracks site could become a park in the very congested Kowloon⁶¹. A proposed phasing plan of Kowloon Park Development in June 1975 (Figure 2-37) showed that the planned extent of Kowloon Park was enlarged to include the north portion of Whitfield Barracks site, except the land reserved for the proposed Tsim Sha Tsui Kai Fong Hall and School, the proposed multi-storey car park, and a police station near Austin Road. Excluding the park portion at Haiphong Road-Nathan Road junction and another park portion facing Nathan Road that were occupied by Mass

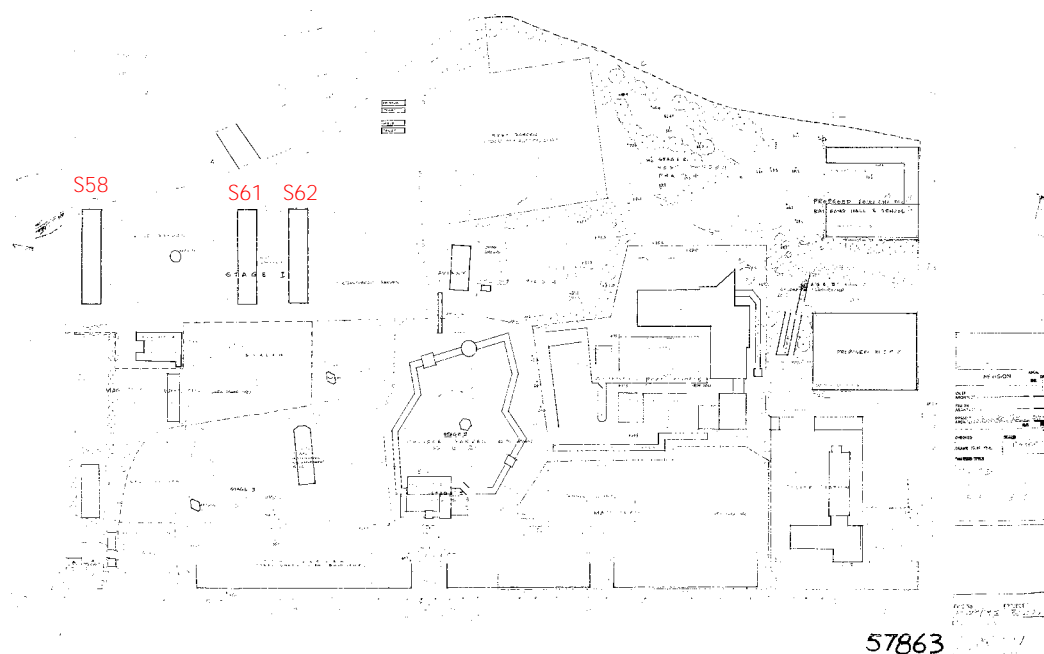
Figure 2-38 Master Plan of Kowloon Park Development, Drawing No. A/80081A, dated July 1976. (Source: Architectural Services Department, Microfilm No. 57863)

About the same time, the Hong Kong Government exhibited a revised Outline Zoning Plan LK1/56 (Figure 2-36), which mostly align the Kowloon Park enlargement shown in the 1975 phasing plan, except the inclusion of a strip of “under-park” shops fronting Nathan Road. This inclusion of shops, although being officially objected by the Urban Council and denounced by its then Chairman, Mr. A. de O. Sales as a “disastrous” town planning proposal⁶², was incorporated in the proposed master plan of Kowloon Park Development prepared by the Architectural Office of Public Works Department in 1976 (Figure 2-38).

Buildings in the north portion of Whitfield Barracks had yet been demolished and a number of them were occupied temporarily by various government departments, such as Information Services Department, Government Supplies Department, Judiciary, Labour & Mines Department, etc. (Figure 2-38)

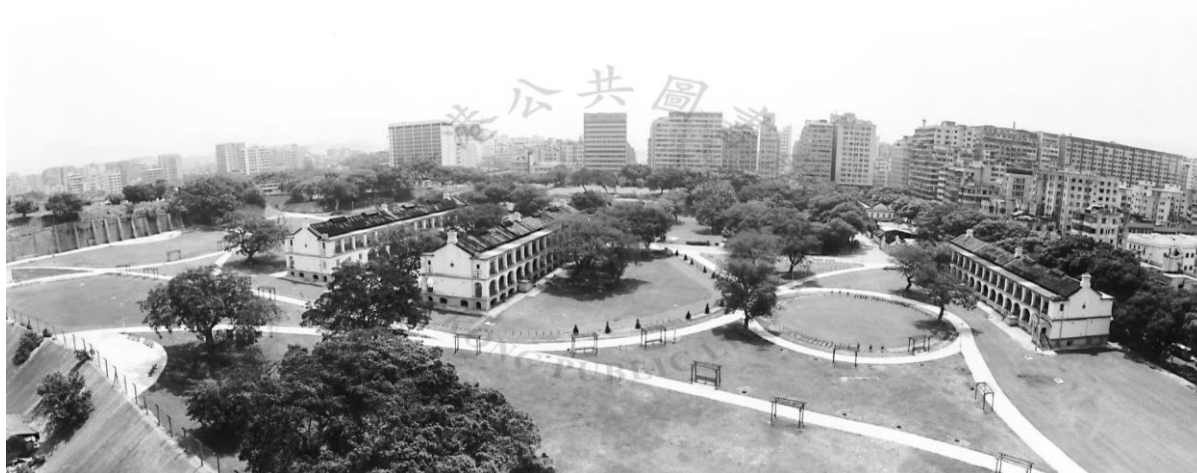
Figure 2-39 A general view of Kowloon Park from Canton Road, 16 June 1976. Note Block S58 on the right and Blocks S61 & S62 in the middle. Kowloon Park Drive had yet been built so Block S58 west side elevation was still fronting a turfed area. (Source: Hong Kong Public Library MMIS, 24 November 2022 accessed: <https://mmis.hkpl.gov.hk/coverage/-/coverage/view?coverage=WAR:mmisportalportlet:hsf=kowloon+park+&coverage=WAR:mmisportalportlet:actual:q=%28%20%28%20allTermsMandatory%3A%28true%29%20OR+all+dc.title%3A%28kowloon+park+%29%20OR+all+dc.creator%3A%28kowloon+park+%29%20OR+all+dc.contributor%3A%28kowloon+park+%29%20OR+all+dc.subject%3A%28kowloon+park+%29%20OR+fulltext%3A%28kowloon+park+%29%20OR+all+dc.description%3A%28kowloon+park+%29%20%29%20AND+%28%20dc.category:category%3A%28Photo%29%20OR+dc.category:category%3A%28Poster%29%20OR+dc.category:category%3A%28Image%29%20%29%20%29&coverage=WAR:mmisportalportlet:sort:field=score&p:1078056564+c=QF757YsWv59ZSBEnL5PPdj5UqCf2yc1Q&coverage=WAR:mmisportalportlet:o=5&coverage=WAR:mmisportalportlet:sort:order=desc&coverage=WAR:mmisportalportlet:filter=dc.publicationdate:dt%3A%5B1970-01-01T00%3A00%3A00Z+TO+1979-12-31T15%3A59%3A59Z%5D>)

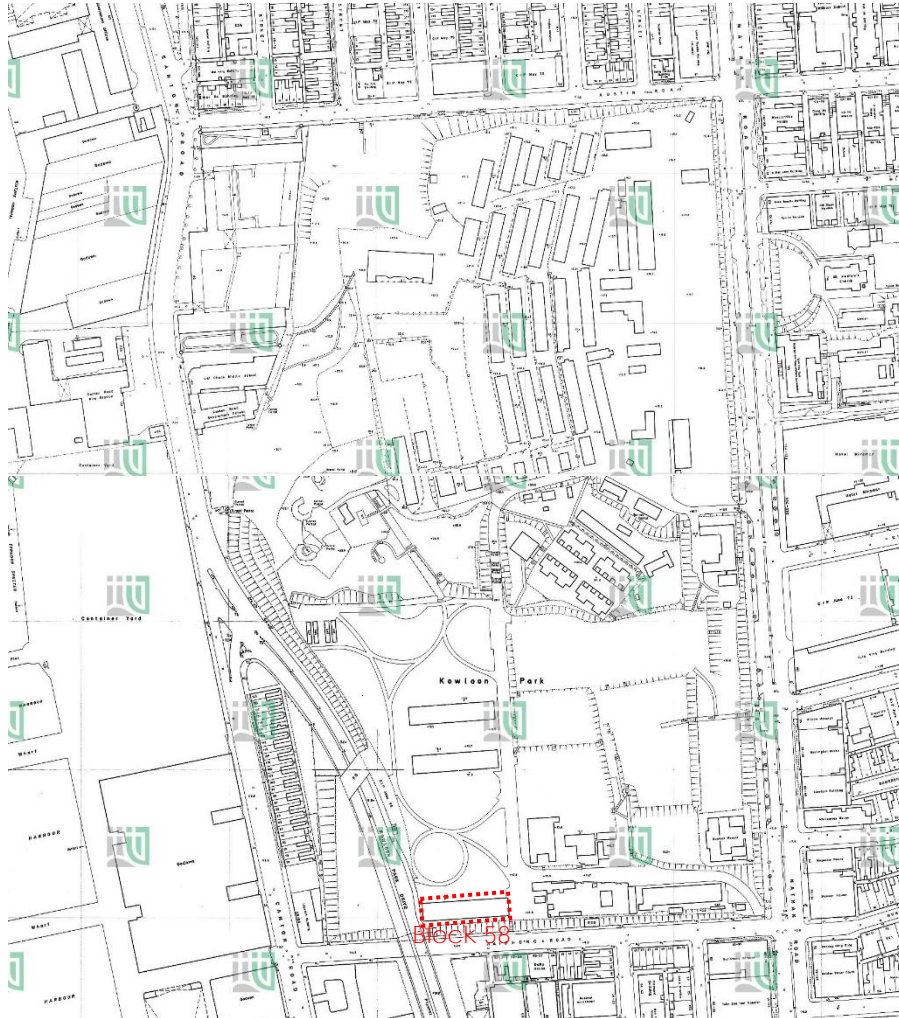
Figure 3-2 Survey Map of Hong Kong, 11-NW-24D dated May 1975 & 11-SW-4B dated June 1975. Note Kowloon Park Drive was established by crafting in the site of Whitfield Barracks/ Kowloon Park. (Source: Survey & Mapping Office, Lands Department)

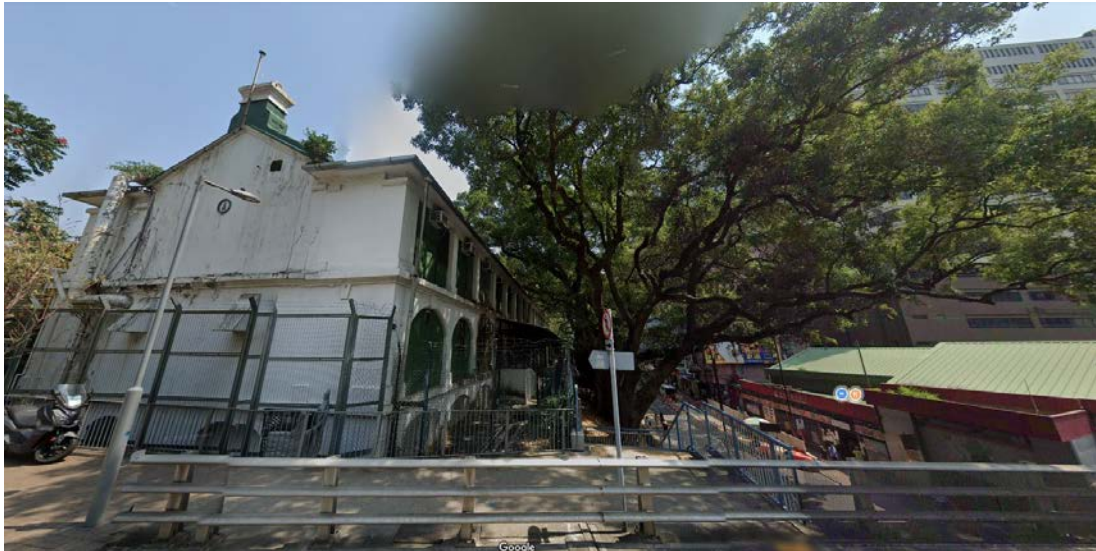
Figure 3-3 View to Block 58 from Kowloon Park Drive. The road level of Kowloon Park Drive is higher than Haiphong Road and external ground level of Block 58 (Source: Google Map)

Nowadays Block 58 still enjoys a view over Haiphong Road from the higher plateau where it sits, but Kowloon Park Drive, which is an elevated highway, is slightly higher than the ground level of Block 58.

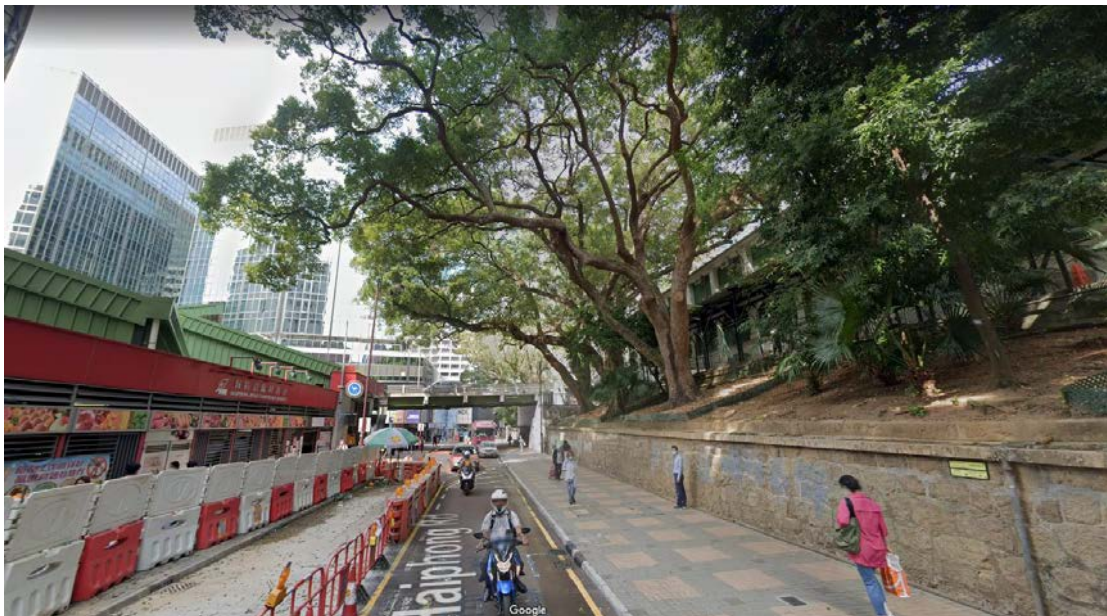
Figure 3-4 View to Block 58 from Haiphong Road. Note Block 58 sitting on a plateau higher than Haiphong Road, and Kowloon Park Drive as an elevated highway crossing Haiphong Road (Source: Google Map)

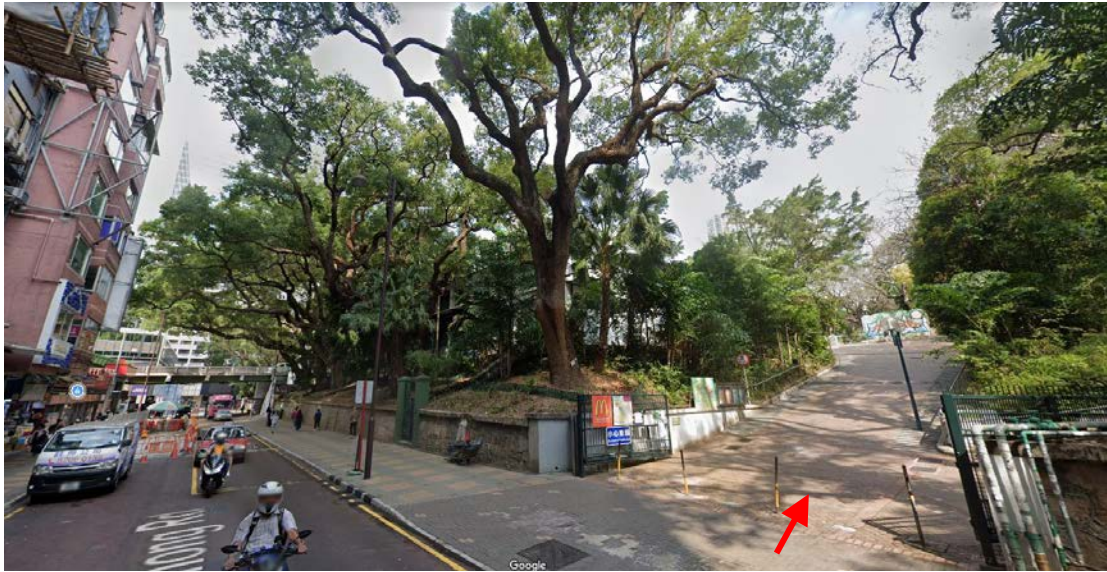
Figure 3-5 A vehicular and pedestrian entrance (red arrow) of Kowloon Park on Haiphong Road, where Block 58 is on its immediate west (Source: Google Map)

There are several entrances of Kowloon Park. The one on Haiphong Road is on the immediate east of Block 58, serving as both pedestrian and vehicular access up to Kowloon Park level. It then leads to a road inside the Park and enters Block 58 on the building's north.

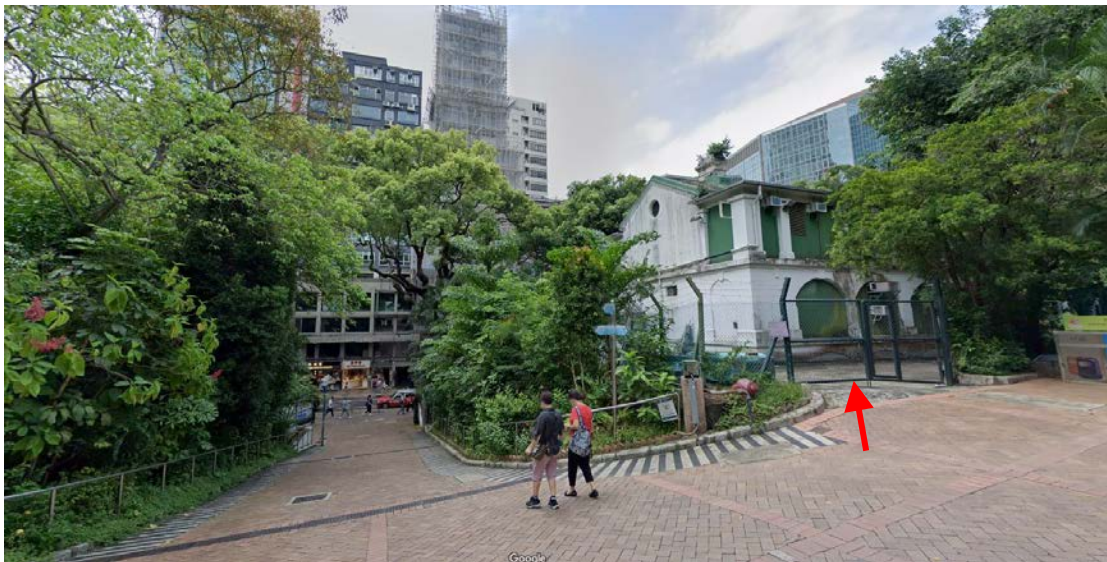
Figure 3-6 The Haiphong Road entrance of Kowloon Park leads to a road inside the Park that gives access to Block 58 on the building's north (red arrow) (Source: Google Map)

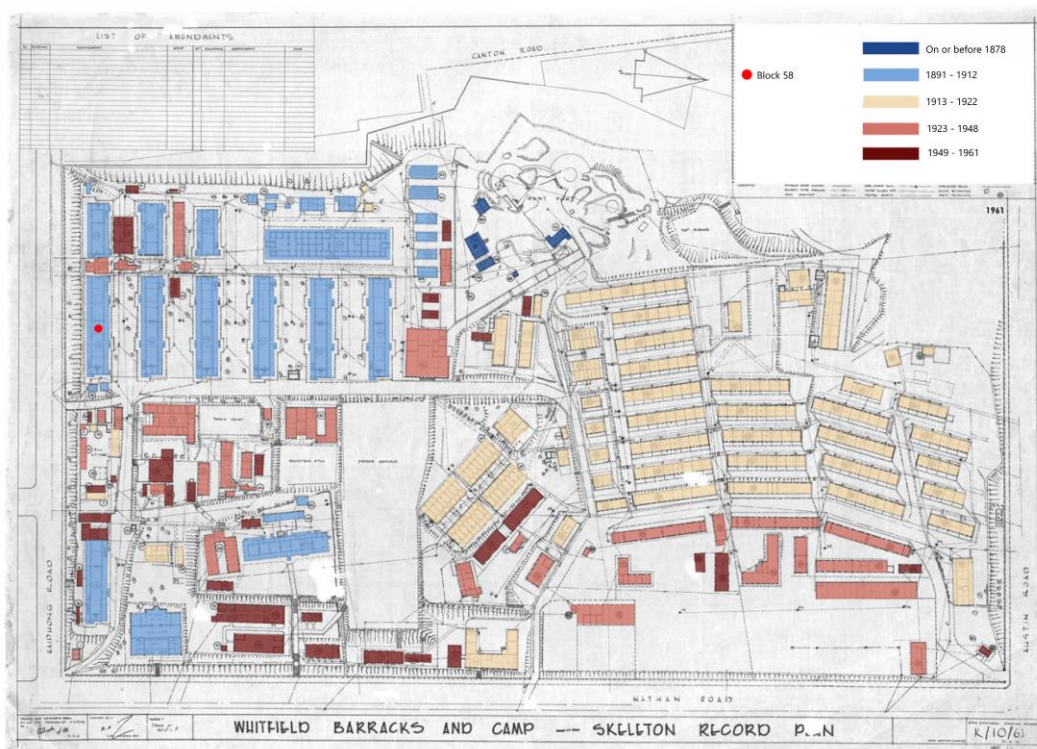
Figure 3-7 Development sequences of buildings in Whitfield Barracks, based on the layout shown in Whitfield Barracks and Camp, Skeleton Record, 18 May 1961, Drawing No. K/10/61. (Source: Public Records Office, File No. HKRS913-1-122 with the Author's edition.)

The development of Whitfield Barracks was an accumulative effort of addition and removal of structures from 1864, when the land was assigned to the British War Department, to 1962, when the land was confirmed to be returned to the Hong Kong Government. The "Whitfield Barracks and Camp, Skeleton Record, Drawing No. K/10/61" dated 18 May 1961 (Figure 3-7), captured the last state of Whitfield Barracks and its buildings. The colour coding in Figure 3-7 indicates the built year period of these buildings, derived from this study, using the 1961 Skeleton Plan as a base. These periods are further discussed in the following paragraphs.

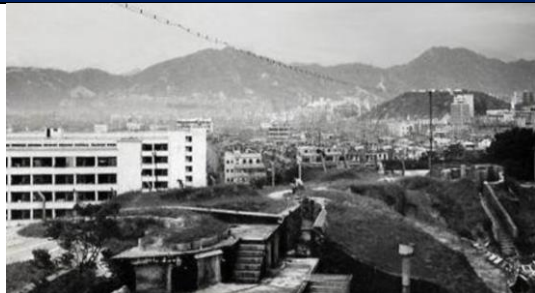
Building/ Structure	Built Year	Photo
Kowloon West II Battery (Or an area housing Blocks Block S92-S98 in 1961)	First established in 1878

<p>Photo taken in 1958 (Source: Gwulo)</p>

The earliest set of buildings to be established in the War Department Lot. No. 12 was the West Battery (or Kowloon West II Battery), to strategically defend the waterway entrance to Victoria Harbour. It is worthy noted that, though located within the lot area of the War Department Lot No. 12, the West Battery was not established and managed as part of Whitfield Barracks, thus was not shown in the skeleton record plans of Whitfield Barracks in early years. However, in the 1960s, it was considered for handing over to the Hong Kong Government together with Whitfield Barracks, so was (the first time and the only time) also included in the 1961 Whitfield Barracks and Camp Skeleton Record Plan. Also, though 7 building blocks (Blocks S92-98) were found in the area of Kowloon West II Battery in the 1961 skeleton record plan, it is unsure if they were all built in 1878.

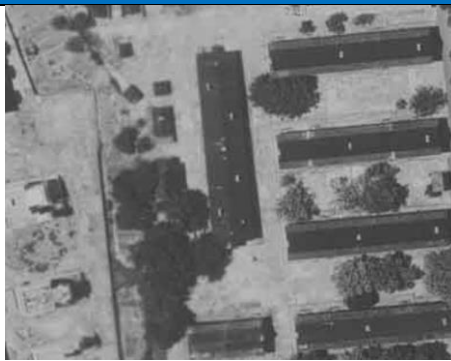
Building	Built Year	Photo
The Armoury (Or Block S67 in 1961) (Permanent building) Originally used for storing weapons and military accessories, 2-storeys	1891-1895

Buildings of this era were classified as “permanent buildings” in the 1961 skeleton record plan. It is believed that they were buildings built in load-bearing brick walls and timber roof and floor structures, similar to Block A (i.e. current Block 58).

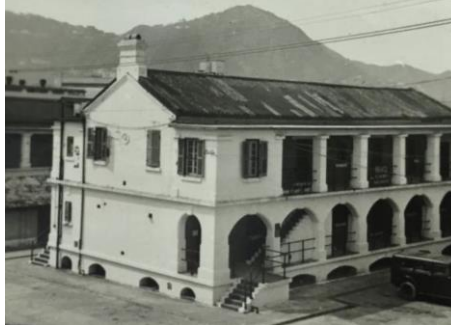
Photo taken in 1949 (Source: ArchSD)
Blocks A, B, C, H, I (Or Block S58, S59, S60, S64 & S65 in 1961) (Permanent building) Originally 2- storeys barrack buildings to house the British Indian Garrisons	1891-1895

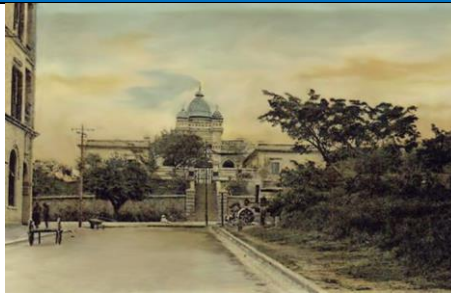
Building	Built Year	Photo
The Kowloon Mosque (Or the Mosque in 1961) Originally built by the Hong Kong Regiment for the 'Mohammedans of Upper India' in 1896, then reconstructed in 1902 ⁸⁰ (the current one was a further reconstruction in 1984, due to extensive damage caused by MTR construction on the 1902 one)	1896

Photo taken in 1900 (Source: Gwulo)

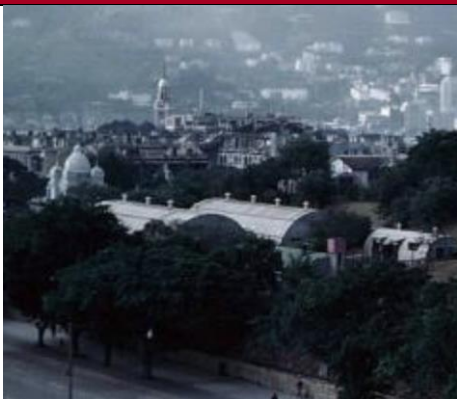
Building	Built Year	Photo
Block S33, 34, 68 as named in 1961 (Romney huts)	1950s

Photo taken in 1952 (Source: Gwulo)

Nissen hut is one of the most famous temporary structures for being the first successfully mass-produced prefabricated wartime building. It is a semi-circular structure made of steel and timber. The Romney hut has a similar look with the Nissen hut, as they both have a semi-circular form. Other than that, the Romney hut has an unlined, tubular steel frame. It is observed that Nissen hut also appeared in earlier eras.

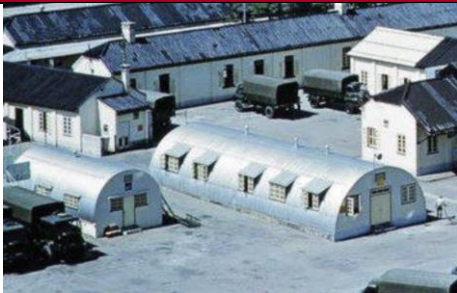
Building	Built Year	Photo
Block S6, S19, S22, S24, S28, S30, S31, S35 – S37, S39, S47, S54, S72, S89, S90, S100, S101, S113, S114, S118, N44, N45, N50, N60 as named in 1961 (Nissen Huts)	1961

<p>Photo taken in 1960 (Source: Medium)</p>

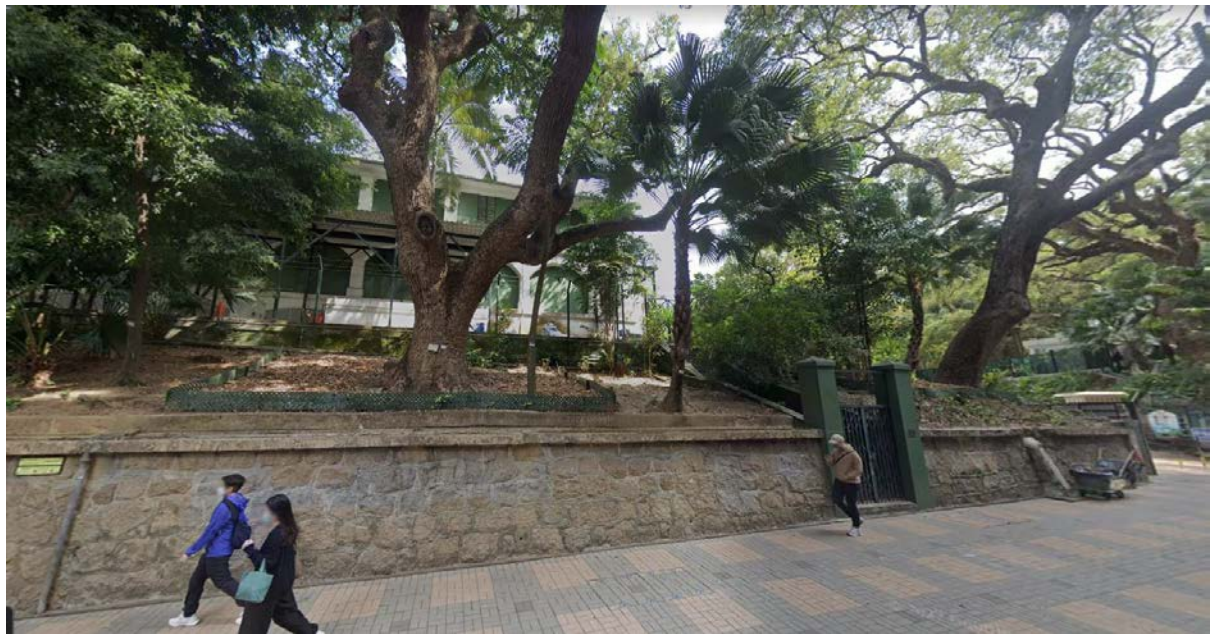
Figure 3-12 A current view of the granite retaining wall of the south boundary of the Site (Source: Google map, accessed 6 Jan 2023)
