ACTIVITY CENTRE FOR THE PROMOTION OF CHINESE HISTORY AND CULTURE
IN KOWLOON PARK
Heritage Impact Assessment

May 2023 | Rev. E
Prepared by

ANG Studio Ltd.

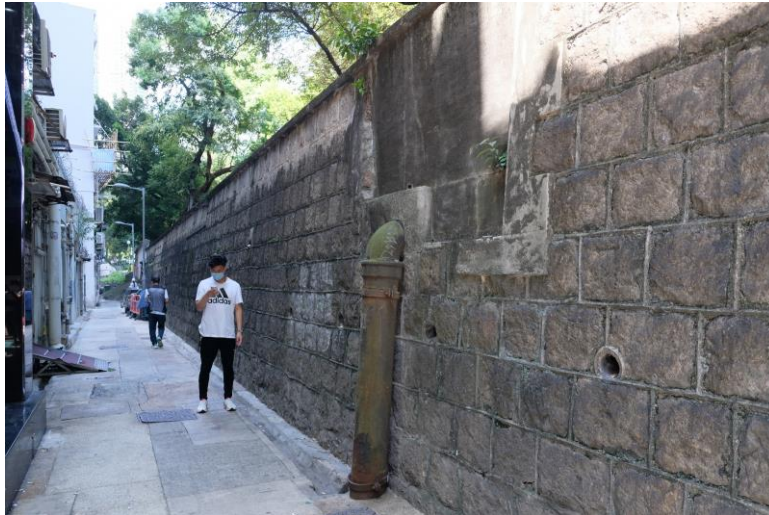
Figure 3-13 A current view of the retaining wall of the west boundary of the Site

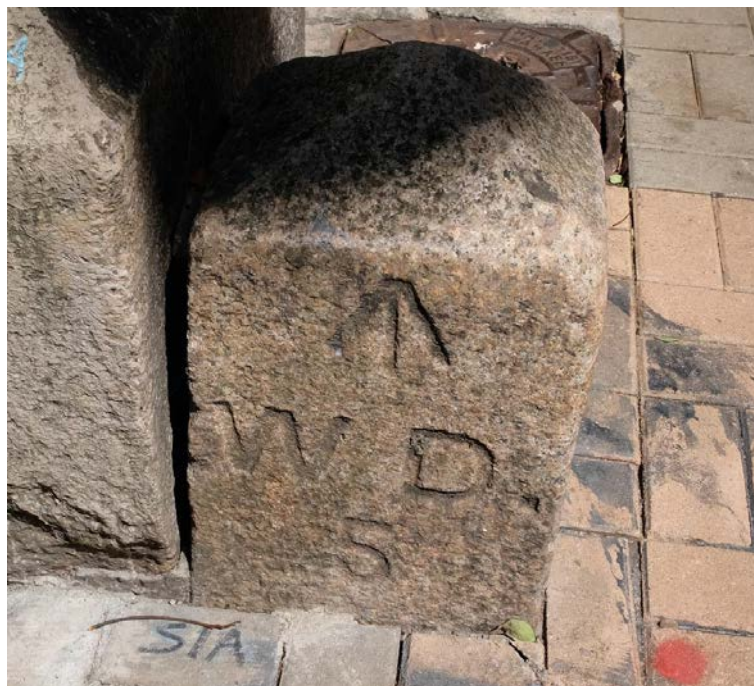
Figure 3-14 "↑ WD. 5" as in the War Department Boundary Stone No.5, is the only remaining boundary stone within the Site

According to the Plan of W.D. Lot No. 12 "War Department Land Central Block Kowloon" (Figure 2-5), originally there should have been three boundary stones located along the south and west boundaries, namely "W.D.B.S. No. 4" at the junction of the south and the east boundary walls, "W.D.B.S. No. 5" at the junction of the south and the west boundary walls, and "W.D.B.S. No. 6" in the middle of the west boundary). The only boundary stone currently remaining on site is No. 5. (Figure 3-14)

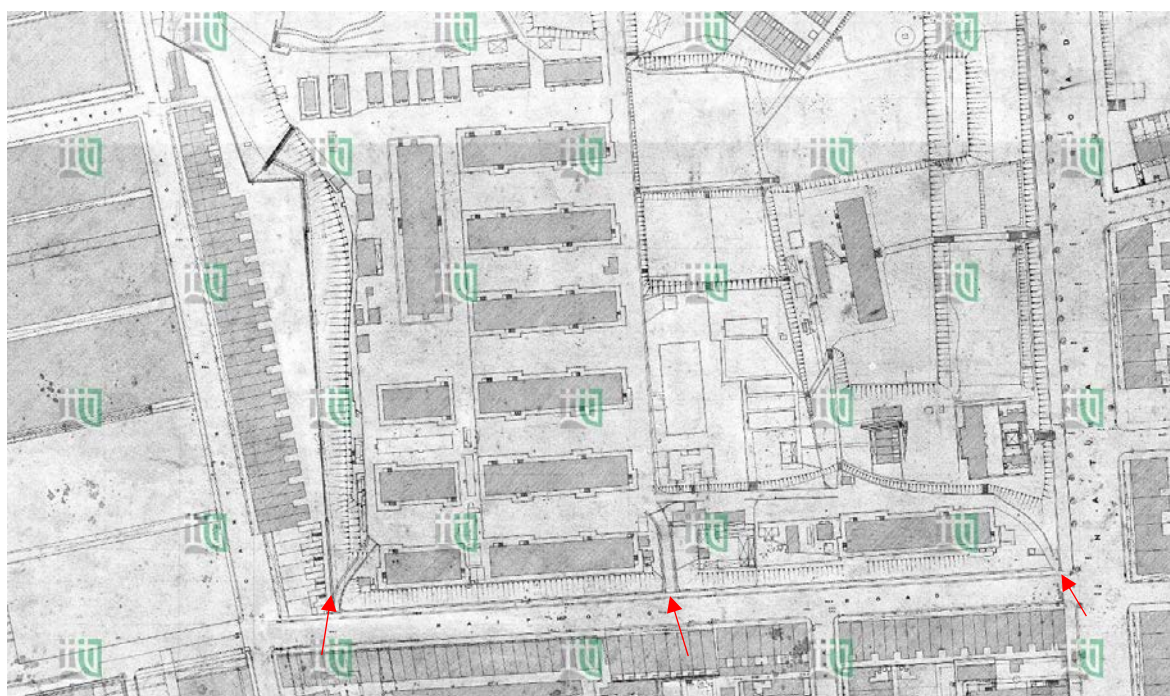
Figure 3-15 An extract of Topographic Map CL-NW-12, Crown Lands and Survey Office, 1922. Note that there were three entrances along the south boundary of the Site. (Source: Survey and Mapping Office)

In the Whitfield Barracks Skeleton Record Plans in 1906, 1913 and 1922 and a Survey Map of Hong Kong in 1922 (Figure 2-10 & Figure 3-15), there were three entrances located along the South Boundary Wall, with one at the west end, one at the middle section and one at the east end. (Figure 3-15). The general layout of the south and west boundaries had not been changed much during these when the Site was still being used as a military site.

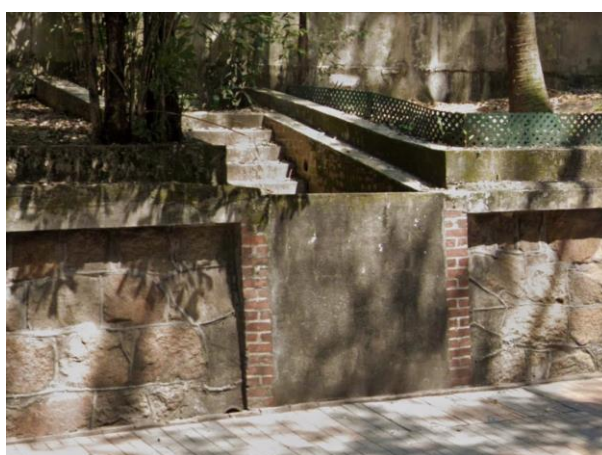
Figure 3-18 Current view of the external staircase leading to Block S4 (now blocked)

However, since after the Whitfield Evacuation Projects in the 1960s and then Kowloon Park development in 1969-1989, the south boundary layout has changed drastically, as the main entrance at the southeast corner was the only one left in 1968 while the other entrances disappeared (thus presumably were blocked). The staircase leading to Block S4 also disappeared, which perhaps was blocked as reflected the current status on site (Figure 3-17). A new external staircase could be noted at the middle section of the south boundary wall. (Figure 3-18)

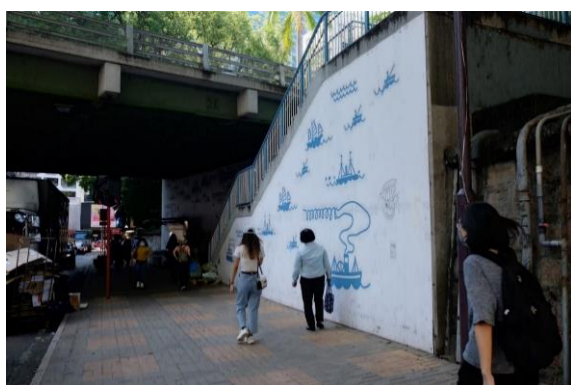
Figure 3-20 Current view of the external staircase to the footbridge

In 1974, Kowloon Park Drive and the associated new footbridge were under construction, so part of the west boundary slope/ retaining wall along the west boundary and the west end of the south boundary wall were demolished. By 1975, a new retaining structure was constructed at the new west boundary, and a new opening was made at the south boundary wall to make way for the construction of Kowloon Park Drive and the new footbridge. A new Electric Sub Station was along constructed on Haiphong Road by interrupting the south boundary wall (Figure 3-19, Figure 3-20 & Figure 3-21)

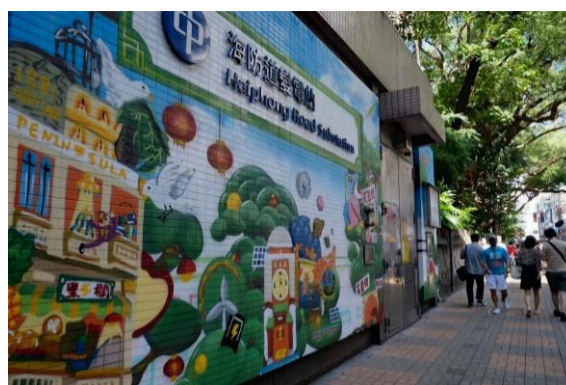
Figure 3-21 Current view of the existing Electric Sub Station

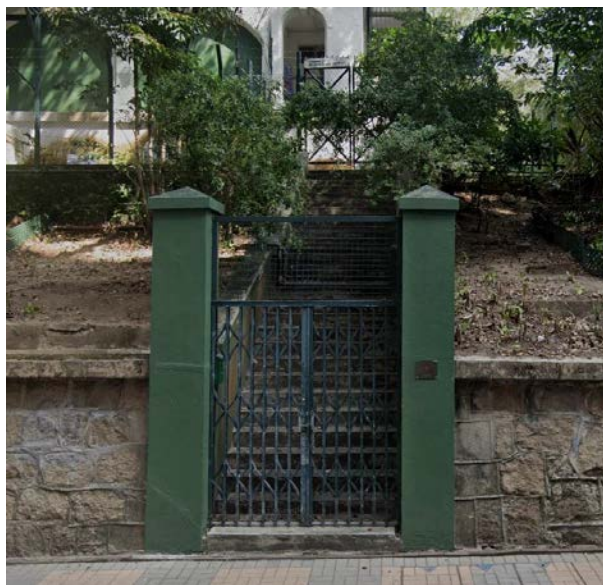
Figure 3-25 Current view of the staircase leading to Block 58

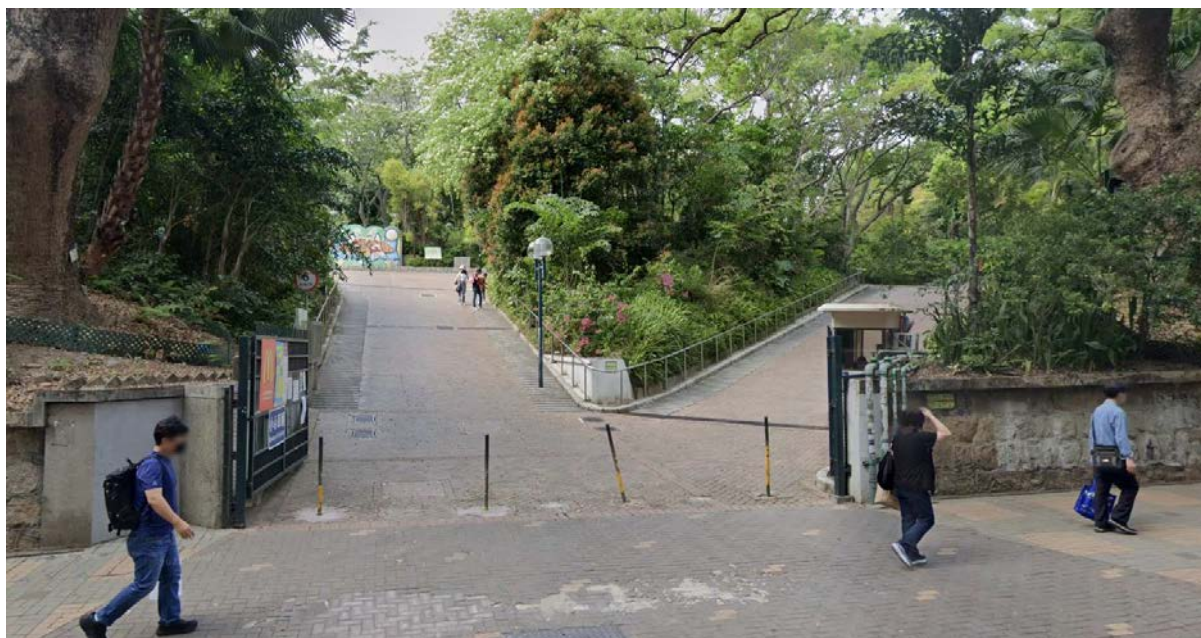
Figure 3-26 Current view of the main entrance and side path at the middle entrance on the south boundary (Source: Google Map)

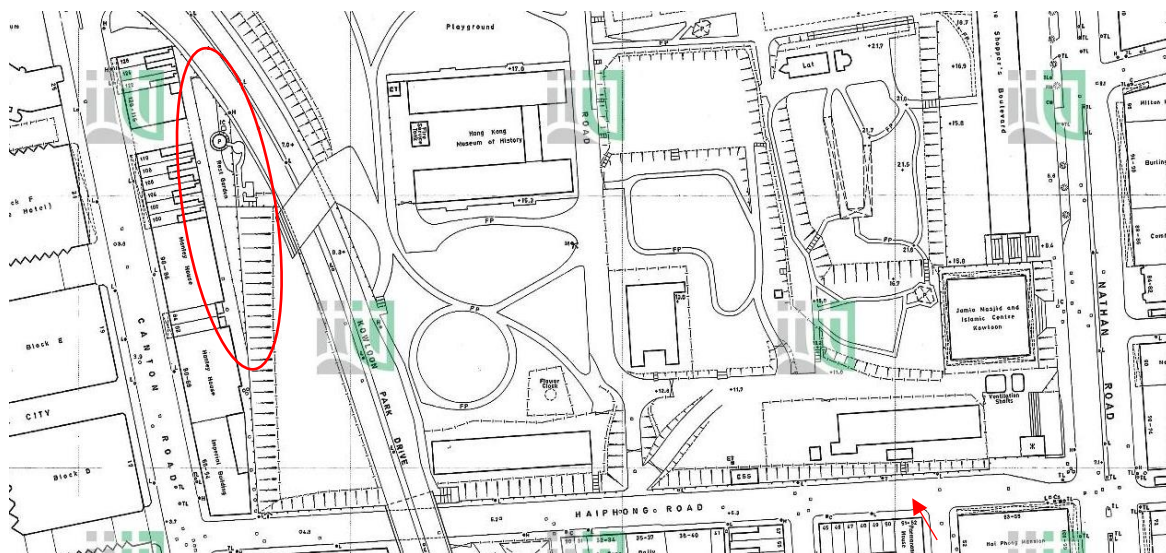
Figure 3-27 An extract of Topographic Map 11-SW-4B, Crown Lands and Survey Office, January 1986. A new garden and a back alley along the original west boundary, and the staircase leading to Block S4 reappeared. (Source: Survey and Mapping Office)

In 1986, a new garden and a back alley along the 1976 west boundary was built (Figure 3-27). The staircase leading to Block S4 appeared again in the same topographic map, but it is estimated as a drawing correction of the previous versions of survey maps.

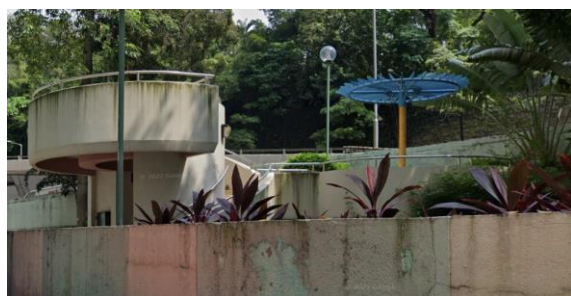
Figure 3-28 Current view of the garden along the original west boundary

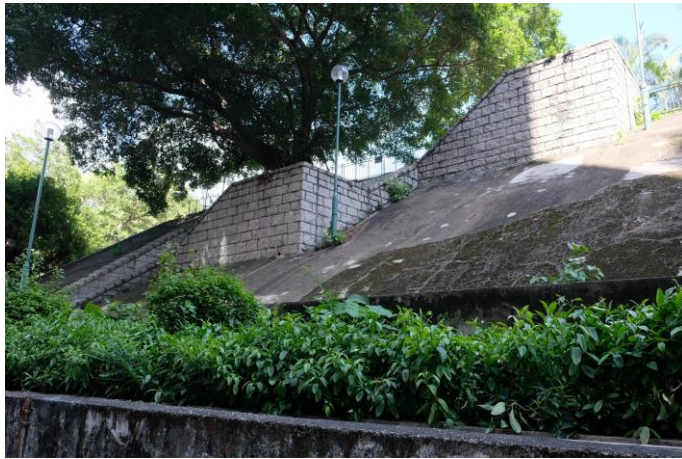
Figure 3-31 Current view of the external staircase at the original west boundary

Two external staircases leading into the site were also been constructed in around 1993, one located at the original west boundary next to the garden, and the other one located at the west end of the south boundary wall (Figure 3-30), which should be the last alterations to the south and west boundary wall of the Site.

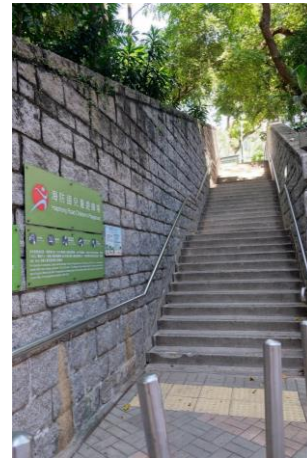
Figure 3-32 Current view of the external staircase at the original south boundary

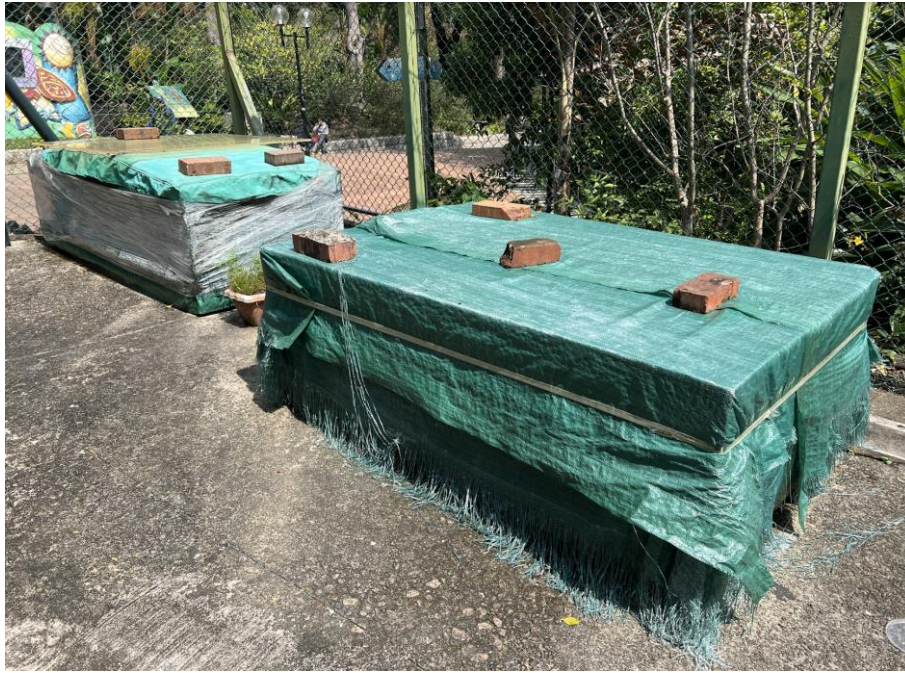
Figure 3-33 The conservation tanks, outside the east façade of Block 58

There are two conservation tanks outside the building's south façade and another two outside the east façade. The former two concrete tanks were probably introduced during the 1983 renovation (when Block S58 was renovated to support Blocks S61 and S62 being used as the temporary Museum of History), but the larger one was further replaced during the 1986-89 renovation. The latter two are suspected to be later additions, but the exact date of addition is unknown.

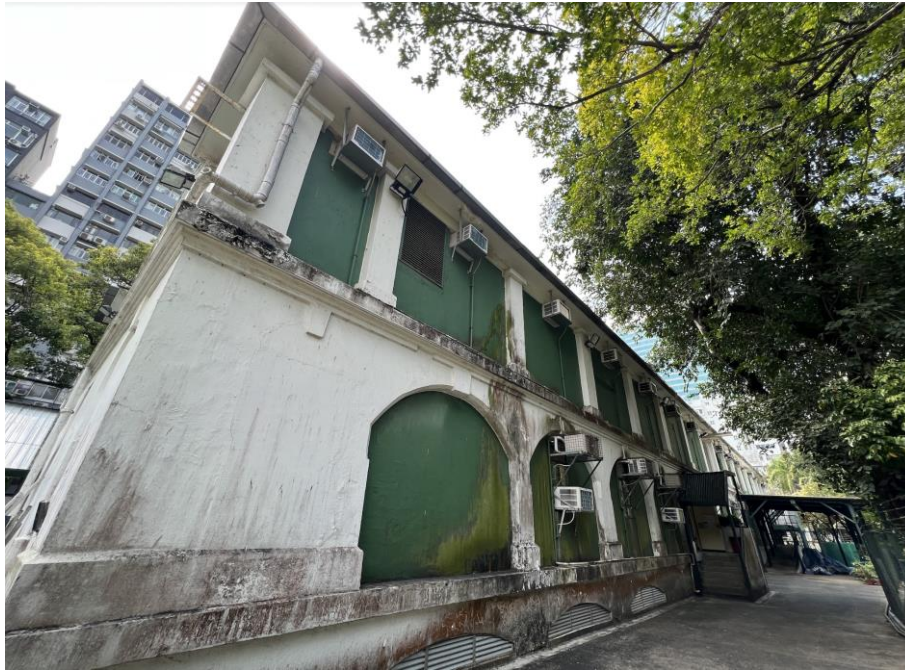
Figure 3-34 The current north façade.

The north façade faces Kowloon Park. However, with the chain-link fence installed in front of the north façade to prevent trespass into the building and heavy greenery immediate next to the fence, the north façade can only be seen from an angle that a view over the entire façade is currently not possible.

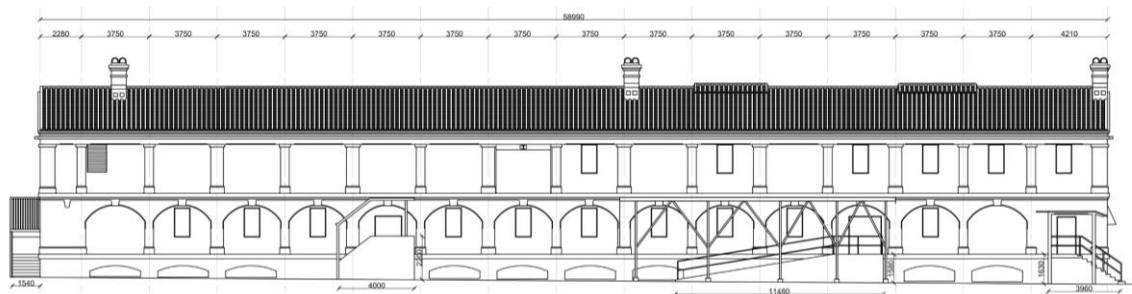
Figure 3-36 North façade, nowadays. (Source: Architectural Services Department)

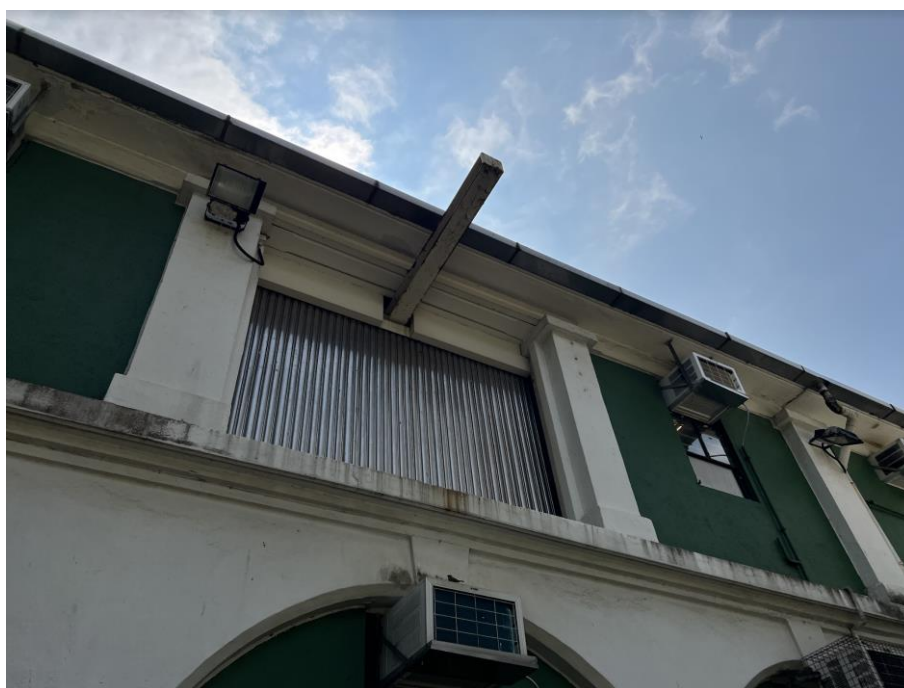
Figure 3-38 The later added hoist beam on the north façade.

The top horizontal section is formed by a verandah on the first floor, but it distinguishes itself from G/F by having rectangular openings. In between the openings, there are rendered and white colour painted columns with plain capitals and bases. The columns are supporting a plain frieze (with subtle partial chamfer edge detail) and then a protruding roof eave extending from the roof slab. It is observed from historic drawings that it was a plain roof eave protrusion but such detail cannot be observed as later installed metal gutters block the eyesight. Again, all the 16 verandah openings have been blocked since the 1986-89 renovation by infilled green walls with a recess from the façade surface, with windows and air-conditioners installed on the new walls. One of the openings is installed with a metal folding shutter and a steel overhang hoist beam from the façade, which are also 1986-89 additions to facilitate moving large and heavy storage items in and out from 1/F of the building.

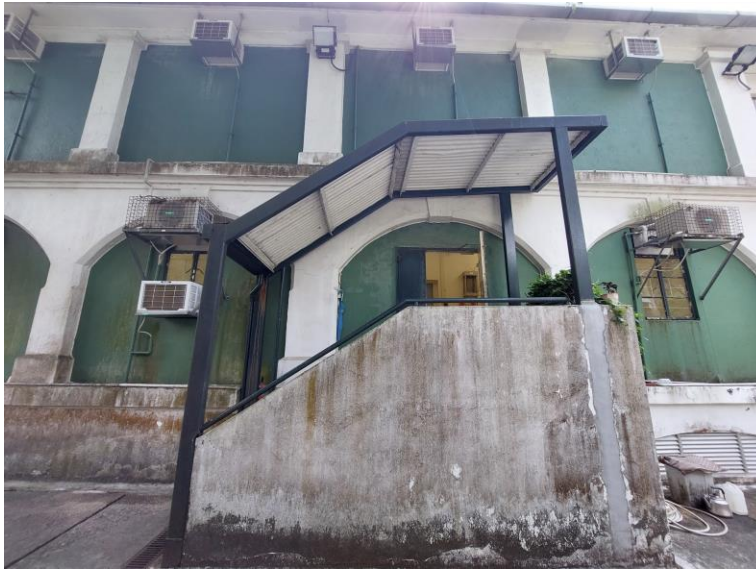
Figure 3-40 The remaining original staircase in the middle of the north façade.

There used to be three external staircases (two in the middle and one at the west end) on the north façade, once increased to four as shown in the 1961 Skeleton Record Plan (Figure 3-74) but now only two exist. The remaining one the middle has granite staircase flights partly inlaid with wash grano nosing. New metal porch and concrete parapet with a metal railing on top were added during the 1986-89 renovation.

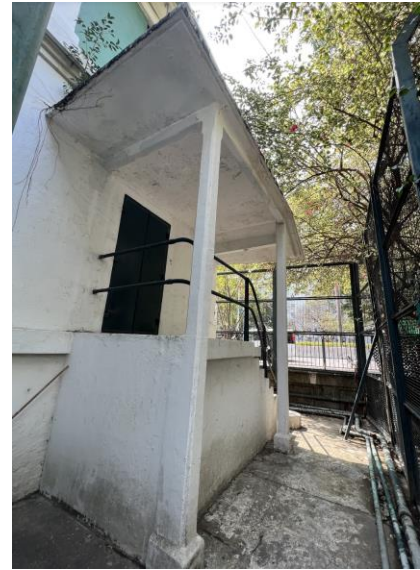
Figure 3-41 The remaining original staircase in the northwest Corner

Strangely, the other remaining external staircase at the northwest corner, though carries the same type of granite flights as the middle one, is found to be a flight direction opposite to one recorded in the Whitfield Barracks Skeleton Record Plans in 1906 to 1926 (Figure 3-70 to Figure 3-73). The 1961 Skeleton Record Plans (Figure 3-74) recorded the direction of flight correctly, showing that the staircase could have been altered and reconstructed in a reverse direction between 1926 to 1961. The cast iron railing and posts on this staircase are part of the aged fabric (if not original), except the lowest post which is inspected as a later addition. Attached to the staircase, there are the concrete flat roof and supporting beam and columns that look aged and have existed before 1970 (see the 1970 photo, Figure 3-37).

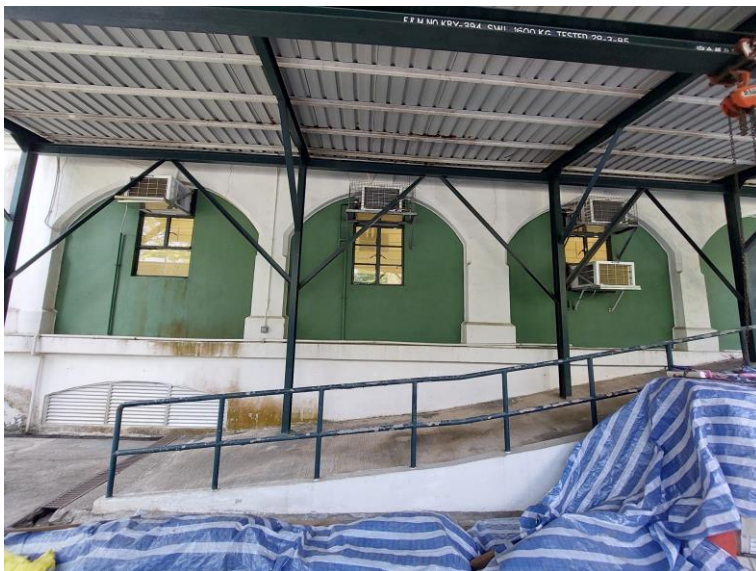
Figure 3-42 The new ramp on the north façade with the steel shed and pulley system above.

As the 1986-89 renovation aimed to equip the building with more storage spaces and supporting facilities for the Hong Kong Museum of History, one of the original middle staircases on the north elevation was replaced by a new concrete ramp with metal railings, a new steel shed above the new ramp and tracks for pulley systems with metal structure. Next to the ramp, a metal deck and supporting structure for air conditioning unit was added after 1986-89. These new additions with a purpose to facilitate the services of the building are intrusive elements to the building's exterior.

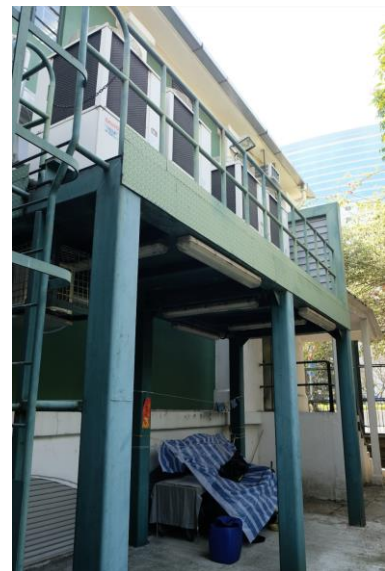
Figure 3-43 The metal structure supporting air-conditioning outdoor units.

18	Metal deck and supporting structure for air conditioning unit attaching to front façade [Later addition]	Intrusive

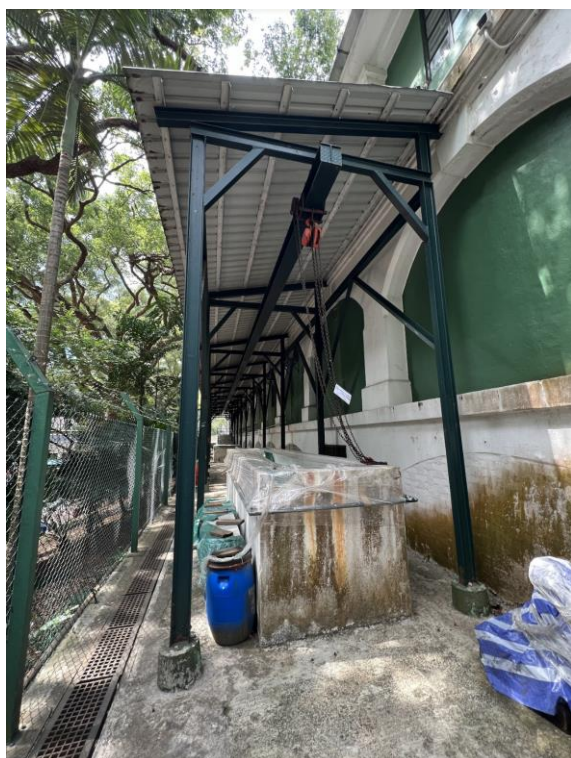
Figure 3-44 The current south façade near its east end.

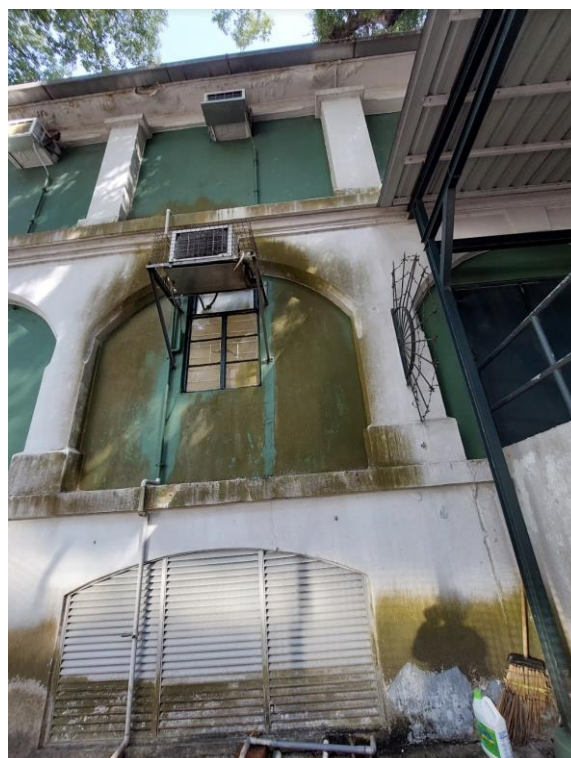
Figure 3-45 The current south façade at the middle portion.

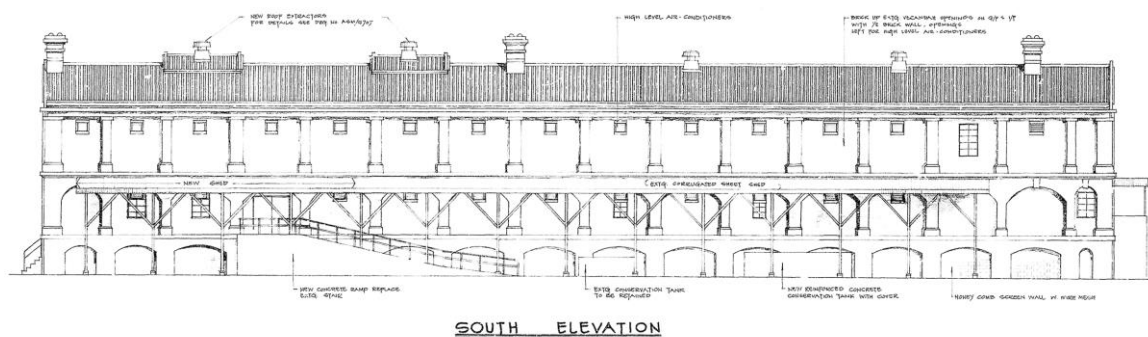
Figure 3-46 Proposed renovation on south façade, extracted from Architectural Proposed Plan for Kowloon Park, Drawing No. ASM/ 5704, dated 1986. (Source: Architectural Services Department)

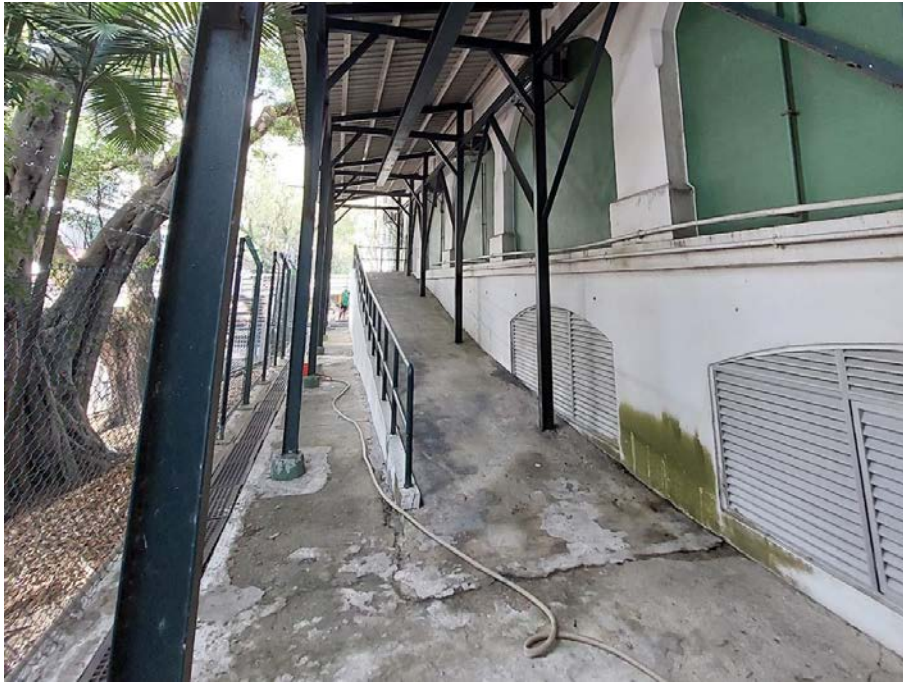
Figure 3-48 The current ramp on the south façade.

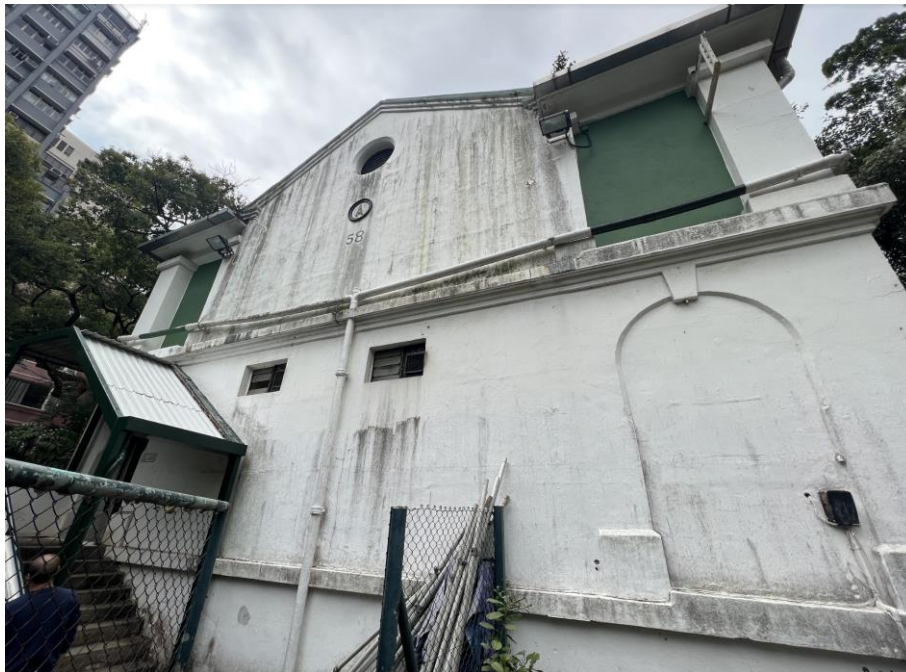
Figure 3-49 The current east façade.

The east façade is facing Kowloon Park. Standing slightly angled along the fence outside this façade, the viewer can get a full view of the east elevation.

The east façade can also be divided into three horizontal sections to distinguish the three-storeys of the building. The base (i.e the lower ground level) has four arch openings, of which two are blocked by an external staircase, and the other two should be originally filled with honey-comb patterned brickworks but are now filled up.

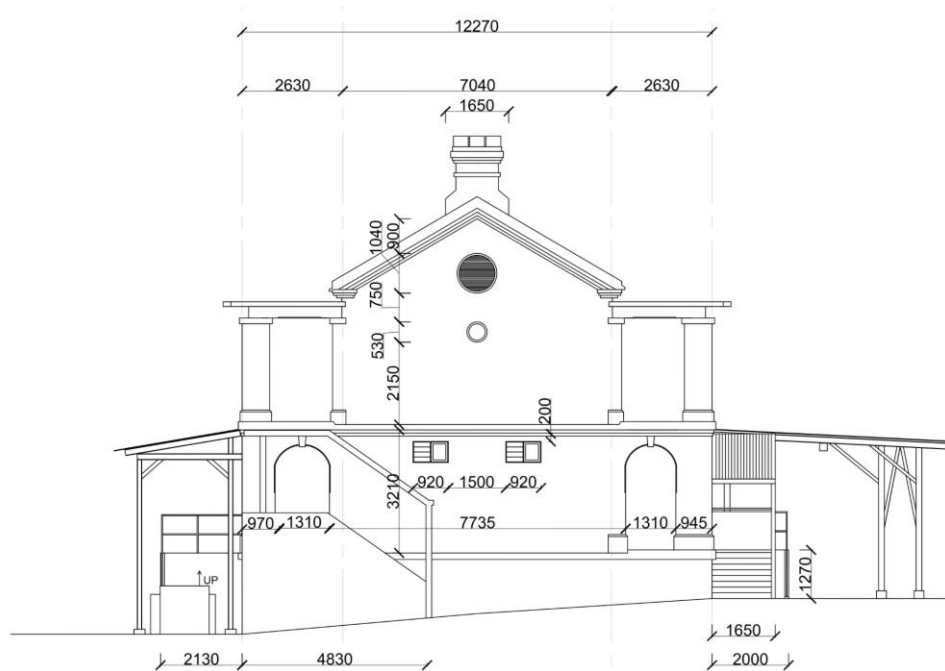
Figure 3-51 East façade, nowadays. (Source: Architectural Services Department)

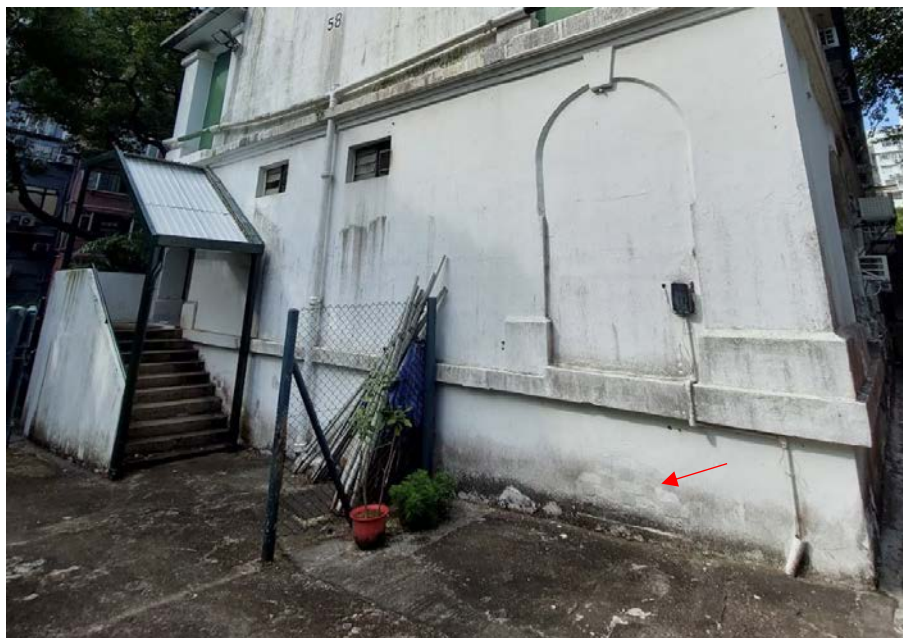
Figure 3-52 The base and middle sections of the east elevation and its attaching external staircase. Note that the original patterned brickworks of the arches at the base (arrowed) can still be traced even the arches are filled up currently.

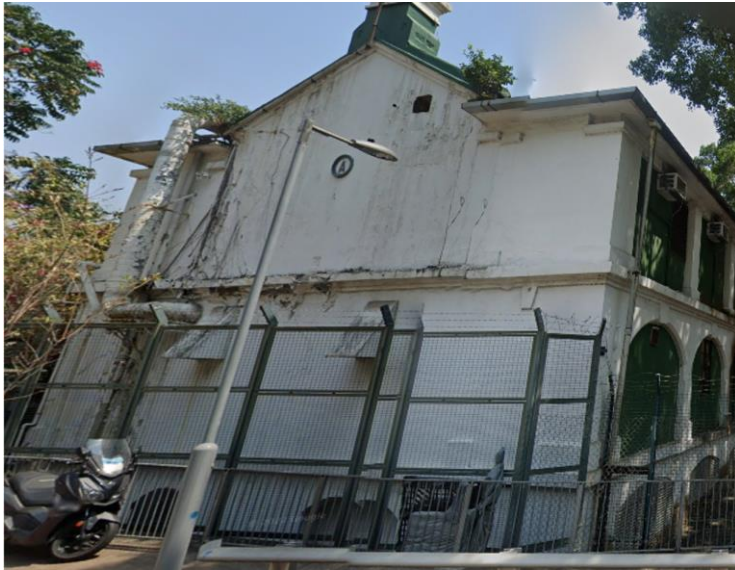
Figure 3-53 The current west façade, viewing from Kowloon Park Drive. (Source: Google Map)

The west elevation faces Kowloon Park Drive, and with limited space, the viewer can only get a view of this elevation from a side angle, though one can get a better view across Kowloon Park Drive.

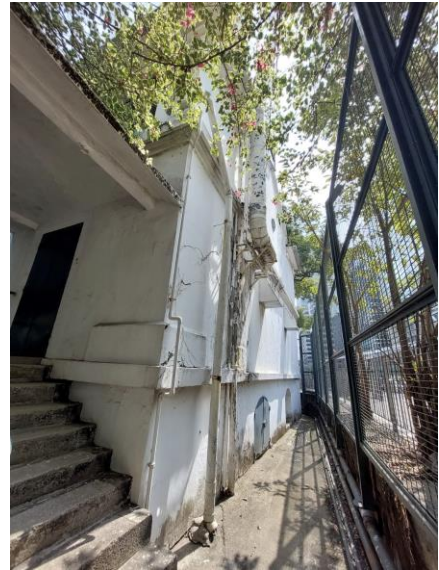
Figure 3-54 the current west façade, viewing within the fenced off area.

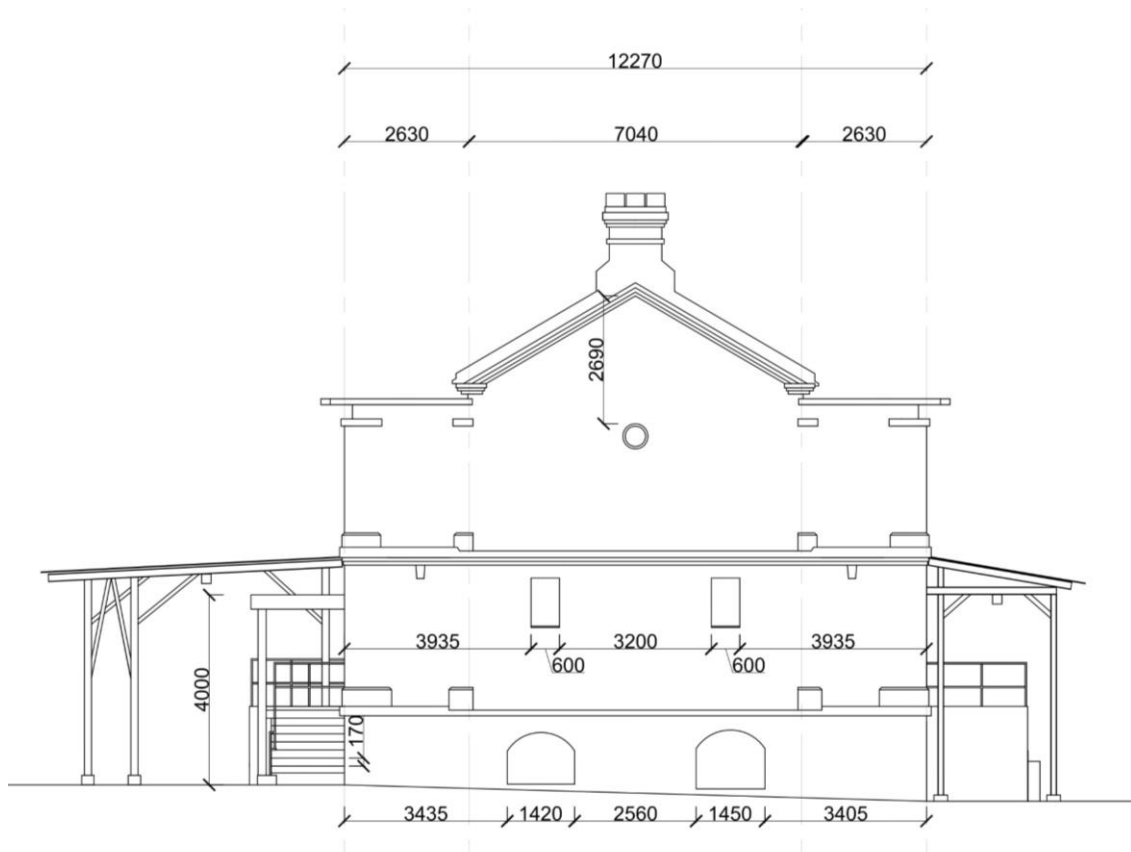
Figure 3-56 West façade, nowadays. (Source: Architectural Services Department)

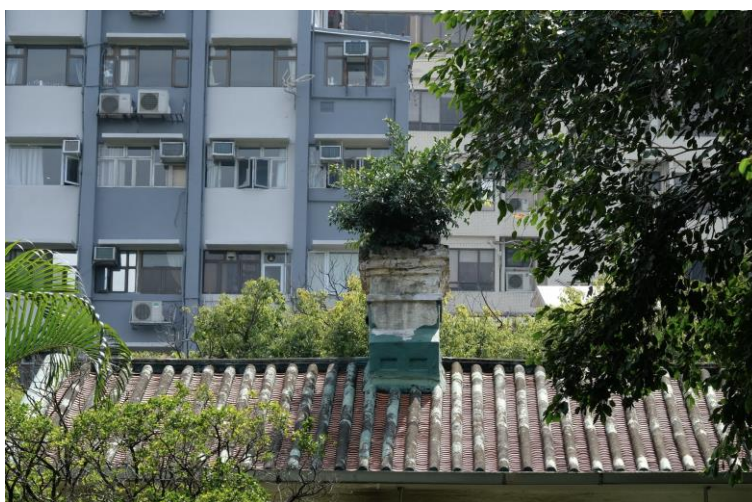
Figure 3-57 The current pitched roof and chimney.

The middle gable pitch is a pitched monitor roof characterized by double pan double roll Chinese clay tiles. There are 3 chimneys, one near the east end serving for 6 fireplaces in the building in the past, one in the middle serving for 4 and one at the west end serving for 2. They are now no longer in use but still reflect the lifestyle in the old days.

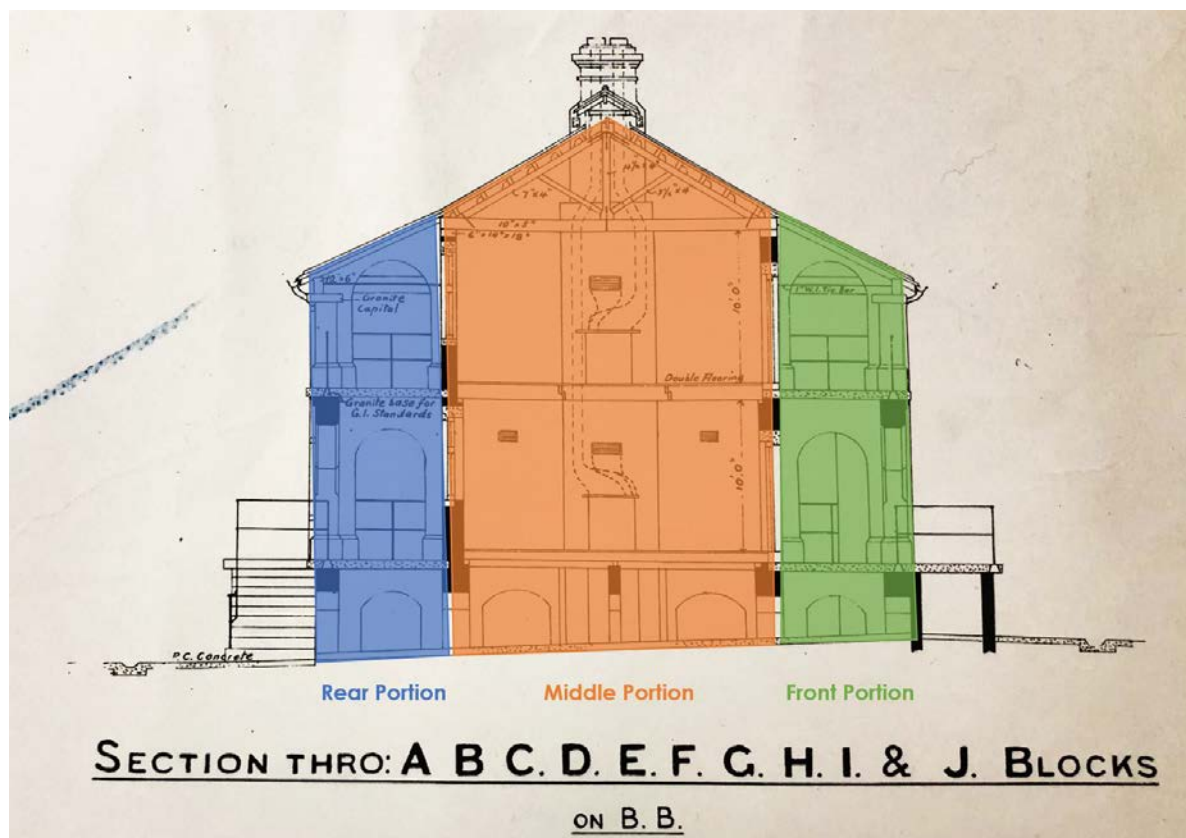
Figure 3-58 1906 Cross-Section, extracted from the 1906 Whitfield Barracks Skeleton Record Plan, sheet 3/3. Note that brick is in black; RC concrete is in dotted hatch; capital of 1/F verandah columns and verandahs balustrades' base are denoted as granite, floors of main spaces are denoted as double flooring. Between verandah internal wall and column on external side, a tie bar is indicated. There is no annotation for door thresholds, but as observed from the hatching, they may be of granite as well. (Source: TNA WO78#3744, with Author's edition).

The building structure is consisted of brick walls, arches and columns (see sectional elements coloured in black in Figure 3-58), timber joists and flooring in the middle portion (denoted as double flooring in Figure 3-58) and RC concrete slabs in the front and rear portion on G/F and 1/F (see dot-hatched sectional elements in Figure 3-58). The middle portion pitched roof is supported by timber king posts, purlins and batten system. The roofs in the front and rear portions RC were originally single pitched roof supported by rafters sitting on eave purlins tied back to brick walls by tie bars. However, the roofs have been replaced by concrete flat roof slabs sitting on RC beams, cross brick arches and columns. Door and window openings are supported by RC concrete lintels. Windows also carry concrete sills.

It is worth-noting from the 1906 section (Figure 3-58) that there are a few fabrics made of granite, including the column capitals on 1/F verandahs and the balustrade bases on G/F and 1/F verandahs. However, based on the comparison of the 1906 and 1986 sections, it is suspected that the 1/F verandah columns might have been altered (made taller) so it is unsure if the original granite capitals still exist. And, as the verandah balustrades were removed for enclosing verandahs in 1986-89, it is also unsure if the original granite balustrade bases still remain. These can only be made clear until the current render and paint finishes as well as the verandah opening infills are removed or opened up for inspection.

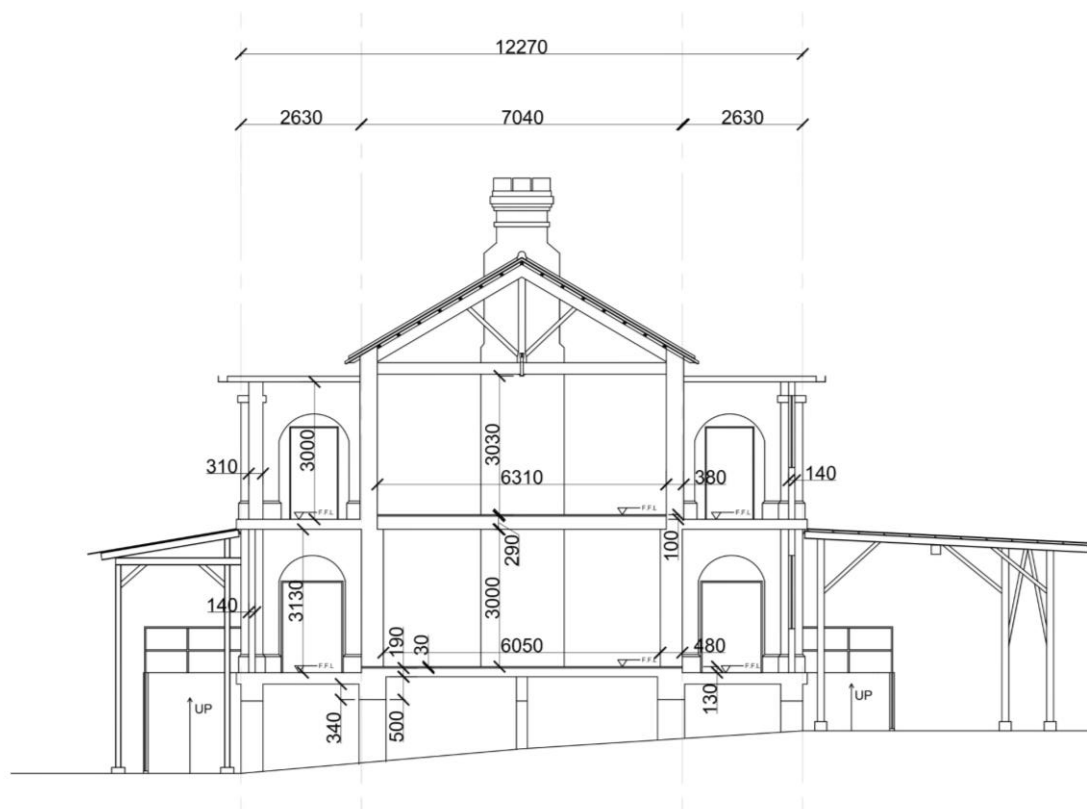
Figure 3-60 Cross section, nowadays. (Source: Architectural Services Department)

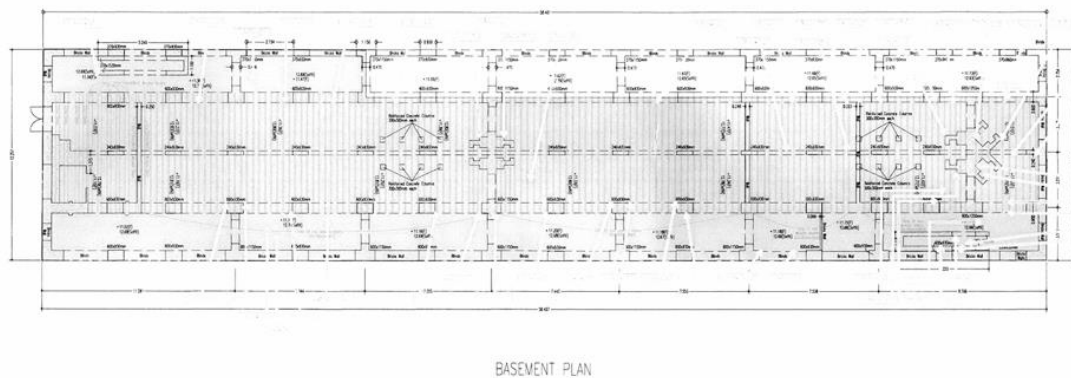
Figure 3-61 2013 Basement record framing plan. (Source: Architectural Services Department, Structural Appraisal Report 2013)

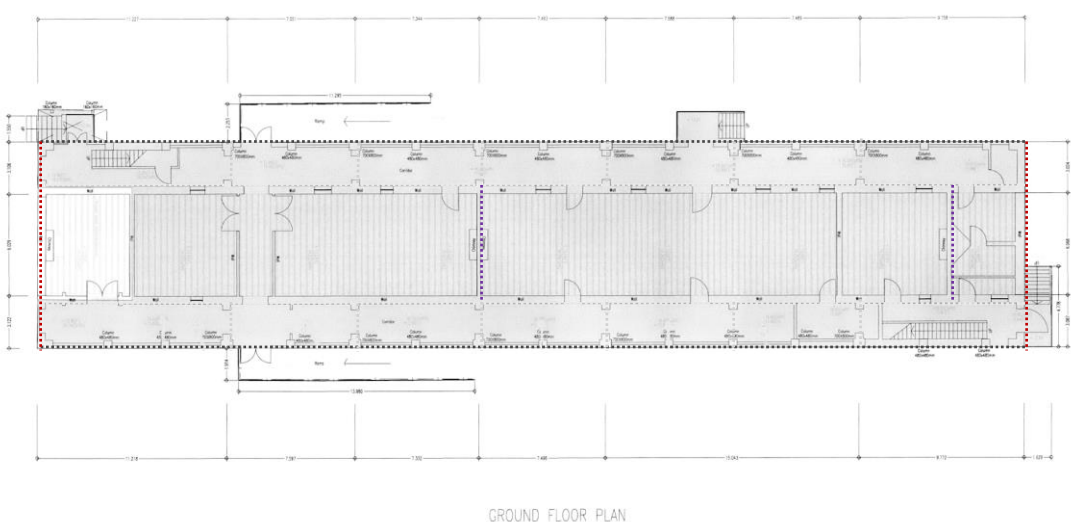
Figure 3-62 2013 G/F record framing plan, with brick structures highlighted in colour dotted lines: red = brick gable wall, purple = brick chimney stack and cross wall, light orange = brick cross wall, blue = external brick arches/ columns, light blue = internal brick wall. (Source: Architectural Services Department, Structural Appraisal Report 2013, with Author's edition)

Observing the G/F and 1/F framing plans (Figure 3-62 & Figure 3-63), the structural brick walls, arches and columns were layouted in a way to allow two large spaces in the middle portion that only divided by chimney stacks and cross walls so as to suit for accommodating soldiers, as well as to allow one long, narrow and continuous verandah space in the front and rear portions that cross arches do not disturb the continuity. The structural layout thus contributes character of the building.

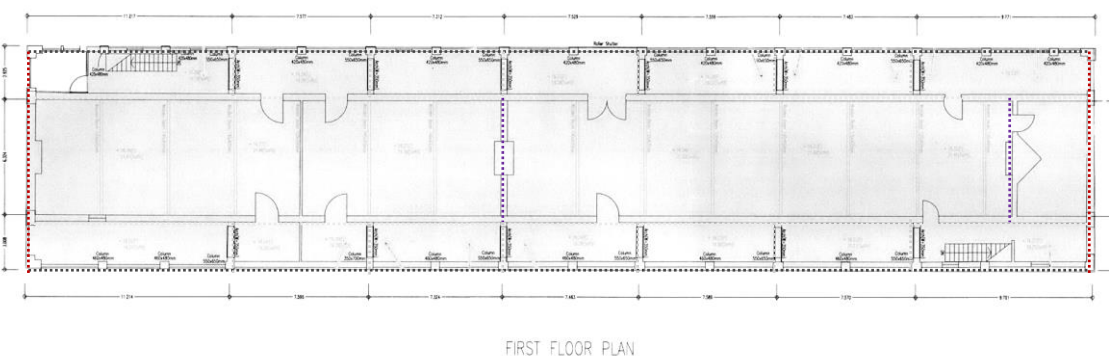
Figure 3-63 2013 1/F record framing plan, with brick structures highlighted in colour dotted lines: red = brick gable wall, purple = brick chimney stack and cross wall, light orange = brick cross wall, blue = external brick arches/ columns, light blue = internal brick wall. (Source: Architectural Services Department, Structural Appraisal Report 2013)

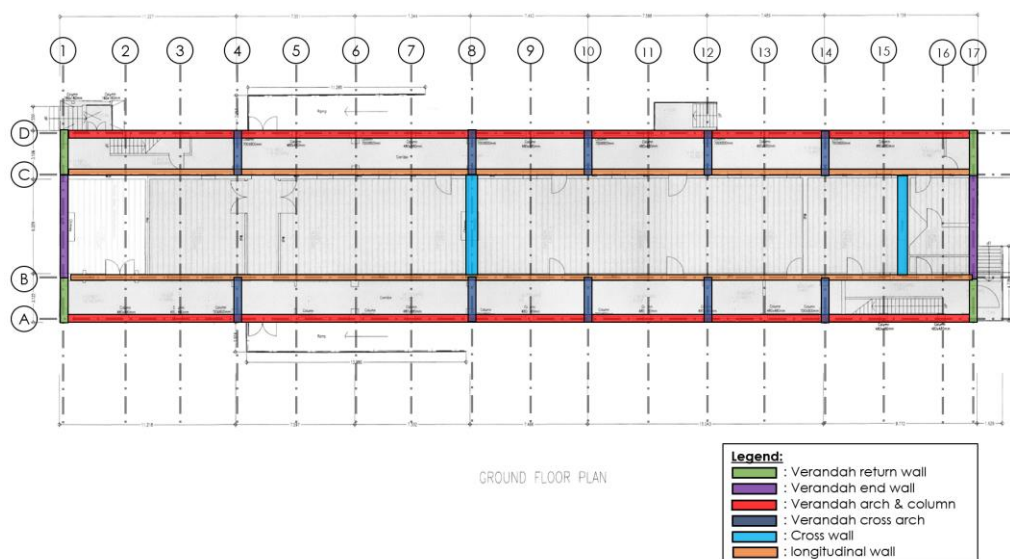
Figure 3-64 2013 G/F record framing plan, with different type of brick walls highlighted in colour dotted lines (Source: Architectural Services Department, *Structural Appraisal Report 2013*, with Author's edition)

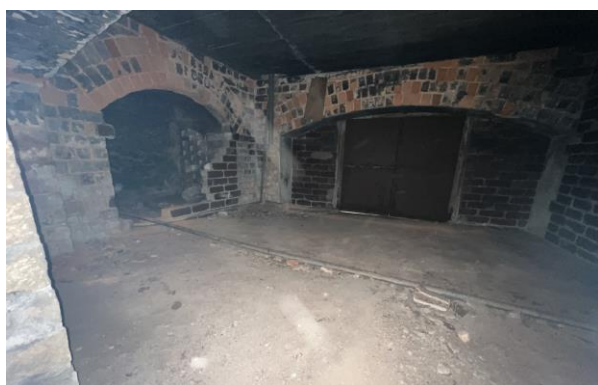
Figure 3-65 The segmental brick arches in basement.

There were lack of historic floor plans of the basement (or lower ground floor), and it is assumed to have been unused or used only as storage place. As per site observation, the basement seems rather untouched. There are segmental brick arches on the entire floor, which are structural elements that sit along the structural grids. They support the brick arches/ walls/ columns as well as timber joist & timber flooring (middle portion) or concrete floor slab (front and rear portions) of the floor above. Timber joist and flooring of the floor above can be observed from the ceiling. The brick base of the chimney stacks can also be observed. There are honey-comb patterned brick screen filling up some of the arches, which are estimated to be original fabrics. Interestingly, an old lighting power switch box with signage "Barracks South Main Switch" and a cast iron air grille, which are aged if not original, are also found.

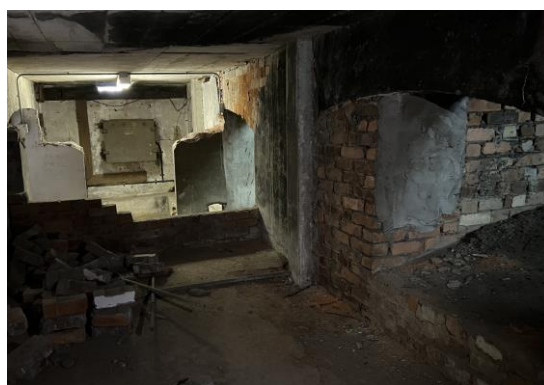
Figure 3-66 A chimney stack base.

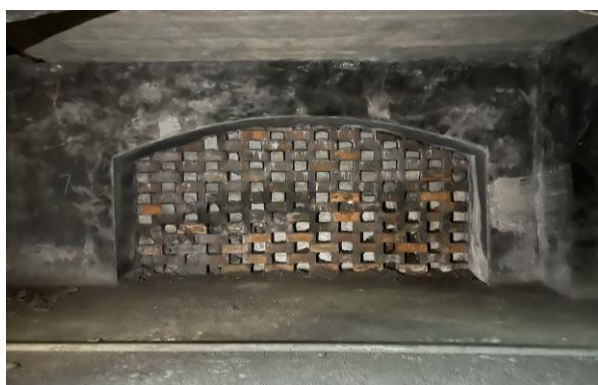
Figure 3-67 The honey-comb patterned brick screen wall.
