ACTIVITY CENTRE FOR THE PROMOTION OF CHINESE HISTORY AND CULTURE
IN KOWLOON PARK
Heritage Impact Assessment

May 2023 | Rev. E
Prepared by

ANG Studio Ltd.

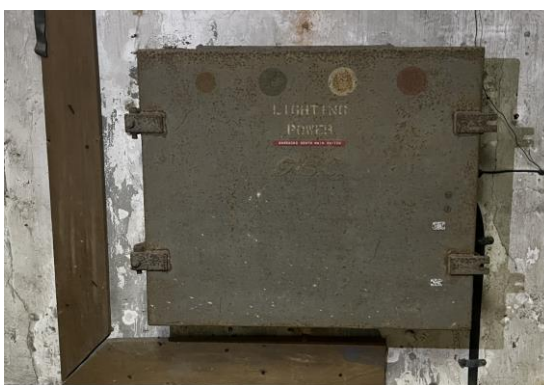
Figure 3-68 A light power switch box with "Barrack South Main Switch".

There were lack of historic floor plans of the basement (or lower ground floor), and it is assumed to have been unused or used only as storage place. As per site observation, the basement seems rather untouched. There are segmental brick arches on the entire floor, which are structural elements that sit along the structural grids. They support the brick arches/ walls/ columns as well as timber joist & timber flooring (middle portion) or concrete floor slab (front and rear portions) of the floor above. Timber joist and flooring of the floor above can be observed from the ceiling. The brick base of the chimney stacks can also be observed. There are honey-comb patterned brick screen filling up some of the arches, which are estimated to be original fabrics. Interestingly, an old lighting power switch box with signage "Barracks South Main Switch" and a cast iron air grille, which are aged if not original, are also found.

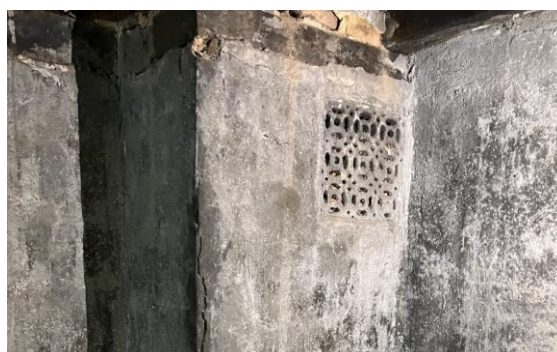
Figure 3-69 A cast iron air grille.

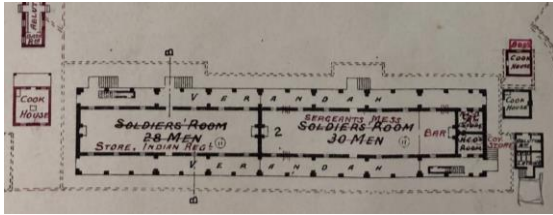
Figure 3-70 1906 G/F Plan, extracted from the 1906 Whitfield Barracks Skeleton Record Plan, sheet 2/3 (Source: TNA WO78#3744)

Strangely, the other remaining external staircase at the northwest corner, though carries the same type of granite flights as the middle one, is found to be a flight direction opposite to one recorded in the Whitfield Barracks Skeleton Record Plans in 1906 to 1926 (Figure 3-70 to Figure 3-73). The 1961 Skeleton Record Plans (Figure 3-74) recorded the direction of flight correctly, showing that the staircase could have been altered and reconstructed in a reverse direction between 1926 to 1961. The cast iron railing and posts on this staircase are part of the aged fabric (if not original), except the lowest post which is inspected as a later addition. Attached to the staircase, there are the concrete flat roof and supporting beam and columns that look aged and have existed before 1970 (see the 1970 photo, Figure 3-37).

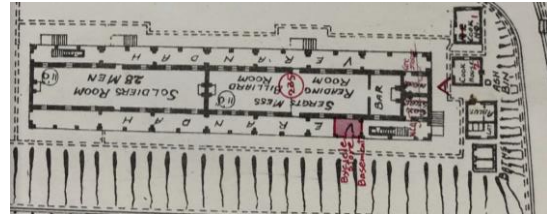
Figure 3-71 1913 G/F Plan, extracted from the 1913 Whitfield Barracks Skeleton Record Plan, sheet 2/3 (Source: TNA WO78#3744)

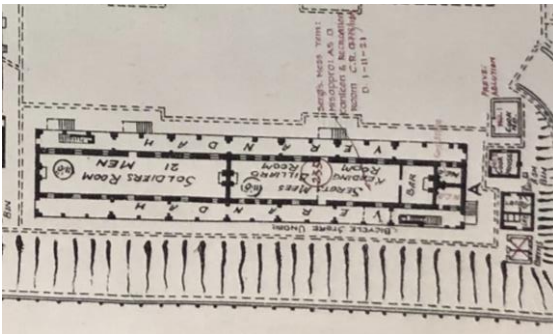
Figure 3-72 1922 G/F Plan, extracted from the 1922 Whitfield Barracks Skeleton Record Plan, sheet 2/3 (Source: TNA WO78#3744)

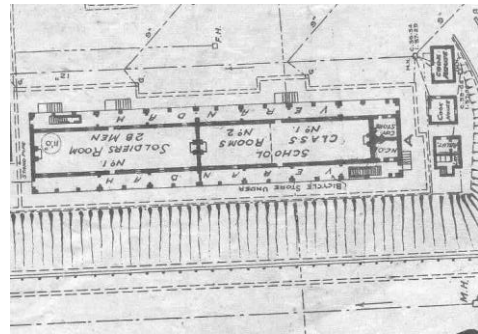
Figure 3-73 1926 G/F Plan, extracted from the 1926 Whitfield Barracks Skeleton Record Plan, sheet 1/2 (Source: PRO HKRS913-1)

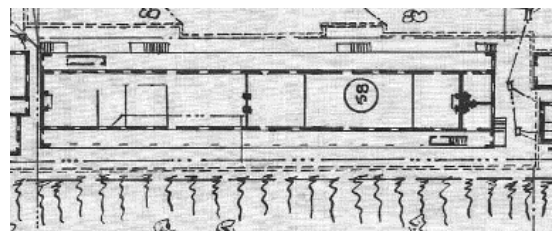
Figure 3-74 1961 G/F Plan, extracted from the 1961 Whitfield Barracks Skeleton Record Plan. (Source: PRO HKRS913-1-122)

There used to be three external staircases (two in the middle and one at the west end) on the north façade, once increased to four as shown in the 1961 Skeleton Record Plan (Figure 3-74) but now only two exist. The remaining one the middle has granite staircase flights partly inlaid with wash grano nosing. New metal porch and concrete parapet with a metal railing on top were added during the 1986-89 renovation.

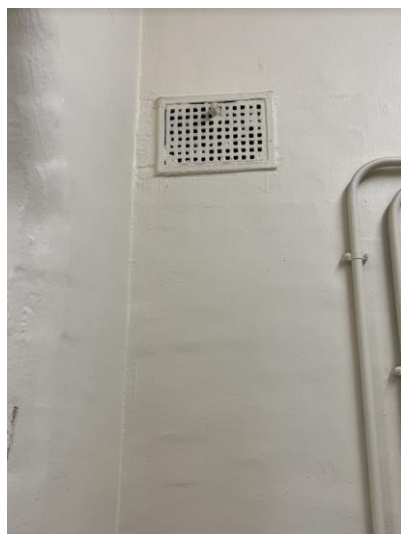
that they are likely later alterations. There are metal vent grilles on the internal wall for ventilation purposes in the old days, but some are currently being blocked up and painted over. 6 cross arches are found along each of the verandahs.

Figure 3-79 A metal vent grille found on G/F verandah internal wall.

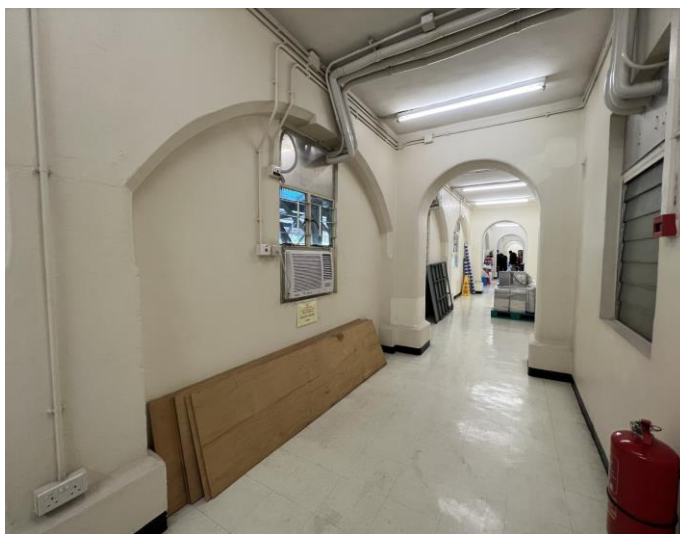
The verandahs of G/F are currently plastered and painted in white. Arches are found on the internal side of the external wall, corresponding to the bays observed from the building exterior. The opposite internal wall (sharing with the middle portion) carries windows and doors that appear in a rhythm aligning the arches. Some exceptions exist though, suggesting

Figure 3-80 A cross arch (middle) and an arch on the internal side of the external wall (left) in G/F verandah.

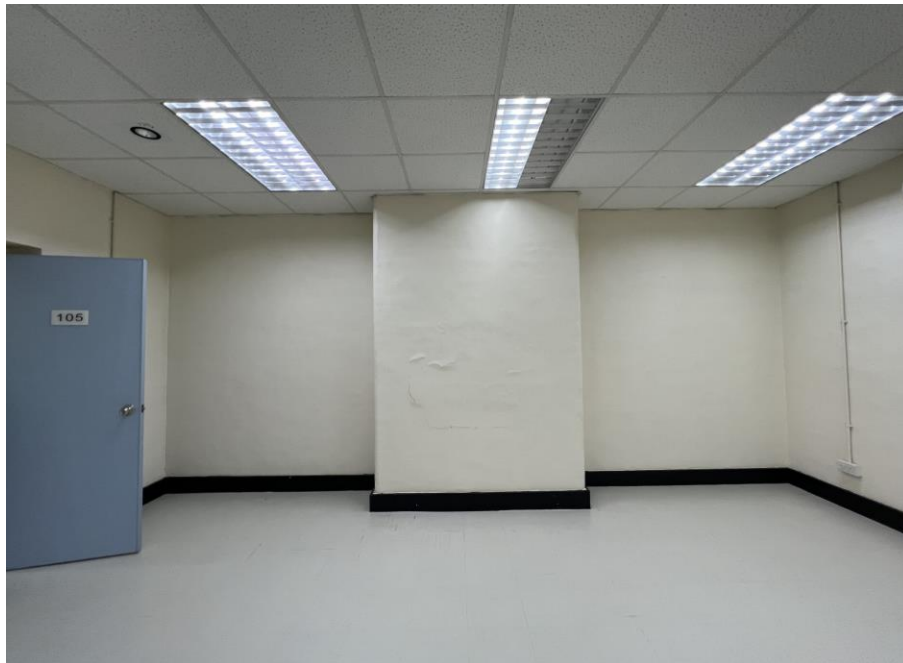
From 1906 to 1961, although functions of the rooms in the middle portion changed slightly during Whitfield Barracks era, the layout of the middle portion on the ground floor remained constant, where it was distinguished through the location of the three chimney stacks and the cross walls attaching to them. The chimney stacks divided the middle portion naturally into two large **soldiers'** rooms and two small NCO (**non-commissioners' office**) rooms originally. One of the large soldiers was partitioned to give a bar later. However, with the change of its the use into a museum storage in 1983, the two large rooms have been partitioned into rooms while two small rooms have been used as toilets. A corridor crossing the middle portion has been introduced by enlarging door openings into verandahs since 1986 to facilitate circulation across the front and rear verandahs, which is considered a rather drastic disturbance to the verandah internal walls. Luckily, the chimney stacks and their attaching cross walls remain undisturbed. The 2013 plan matches the 1986 layout.

Figure 3-81 The cross-brick walls on the two sides of a chimney stack on G/F

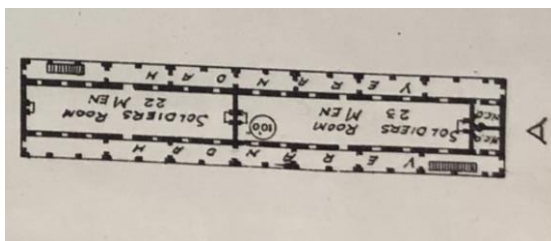
Figure 3-84 1922 1/F Plan, extracted from the 1922 Whitfield Barracks Skeleton Record Plan, sheet 3/3 (Source: TNA WO78#3744)

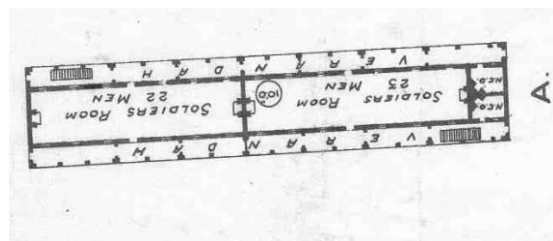
Figure 3-85 1926 1/F Plan, extracted from the 1926 Whitfield Barracks Skeleton Record Plan, sheet 2/2 (Source: PRO HKRS913-1)

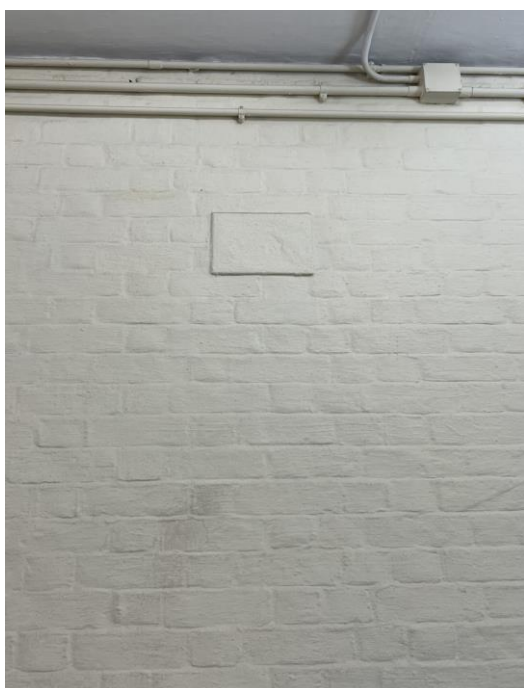
The plastered and painted column with plain capital and base on the interior side of the external wall of 1/F verandah are part of the original structure. As observed in the internal walls in the front and rear verandah, there are also metal vent grilles that were used for ventilation purposes, but some are currently being blocked up and painted over.

Figure 3-89 A blocked vent grilles on 1/F verandah.

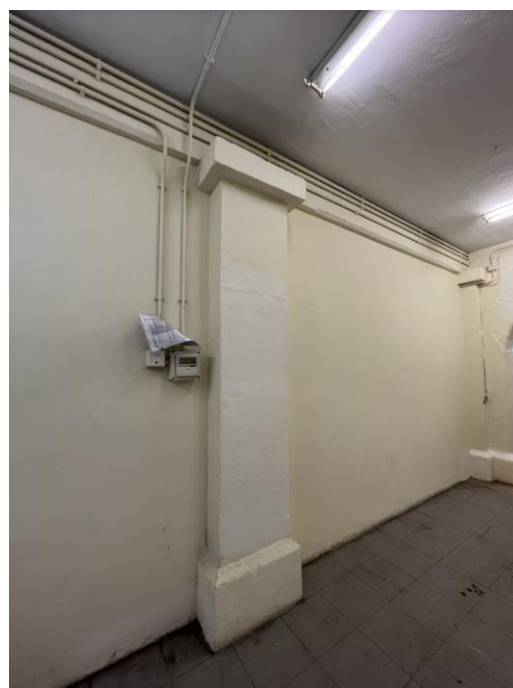
Figure 3-90 A plastered column on the internal side of the external wall of 1/F verandah.

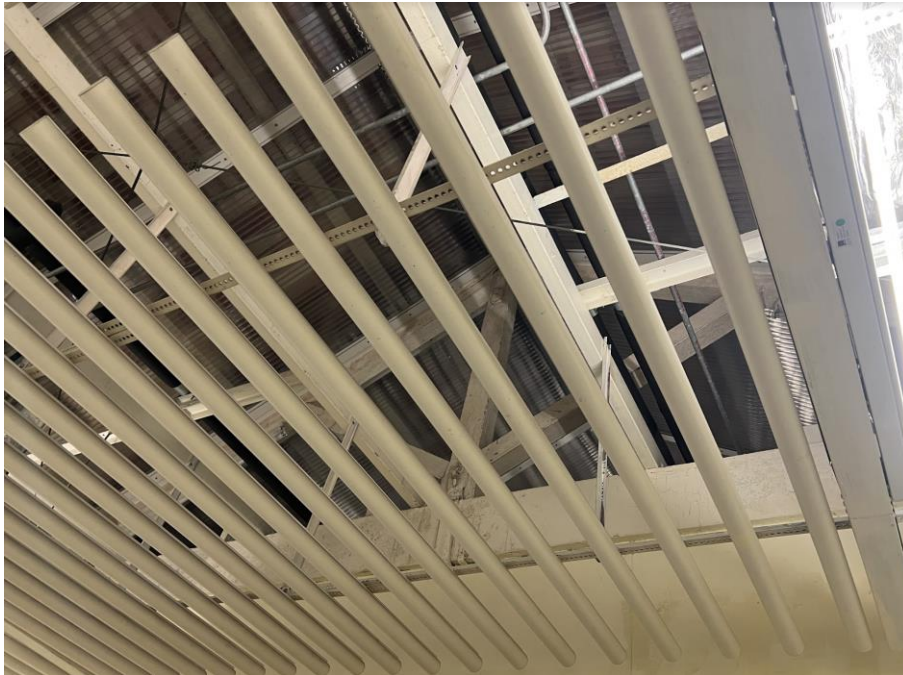
Finishes are the same as those on G/F, except the ceiling where the pitch roof structures are semi-covered by ceiling grilles.

Figure 3-91 Ceiling grilles in the middle portion.

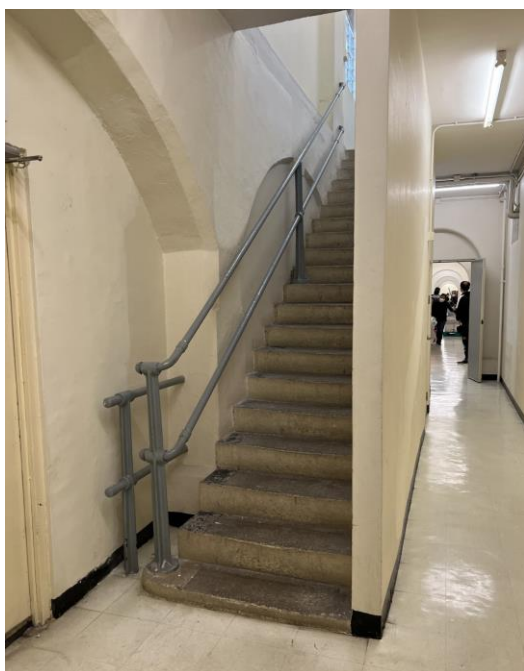
There are two granite staircases leading from G/F to 1/F, one at each end of the verandah. They are built in granite flights partly inlaid with wash grano surface, cast iron posts and railings. The interior stairs are predicted to be the original fabrics, except where some of the posts and railings are embedded in the later added enclosed walls of verandahs. The railing on the south staircases of 1/F appears not to be the original fabric. There are supporting brick walls in the middle of the underside of the flights.

Figure 3-92 An internal staircase attaching to its enclosed wall (Left).

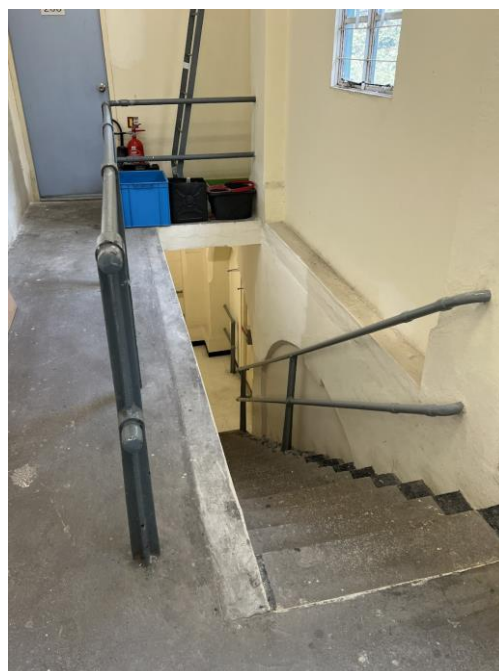
Figure 3-93 The cast iron posts and railings of the interior staircase.

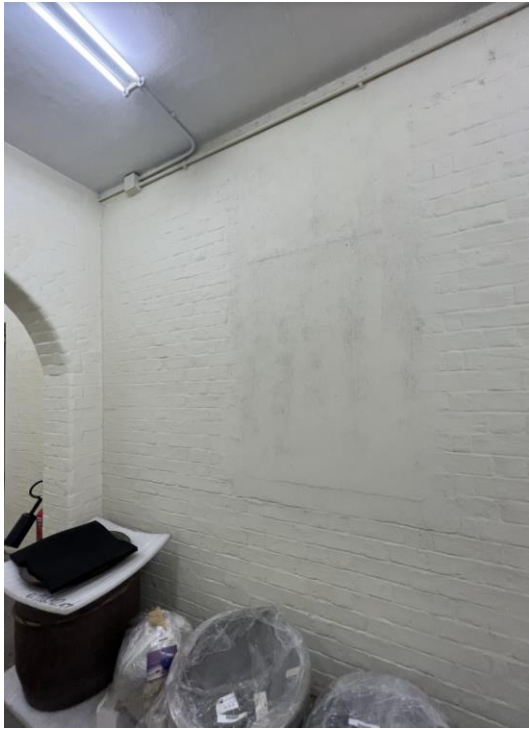
As mentioned in the above section about structure, original windows and doors should be equipped with RC concrete window and door heads and window sills. The door threshold materials is unsure (may be granite). Since all the heads, sills and thresholds are covered by renders, paints and finishes, the existence of these original features cannot be sure until determining by opening up.

Figure 3-94 Traces of a filled window.

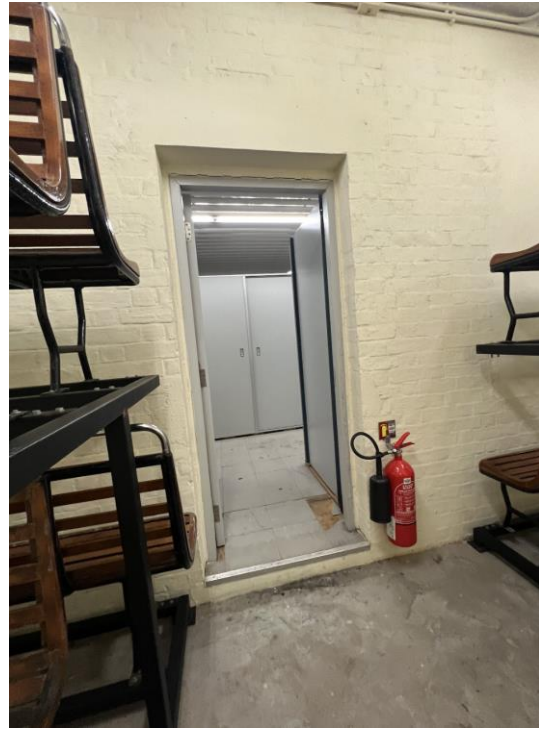
Figure 3-95 A door opening with traces of a concrete lintel at door head.

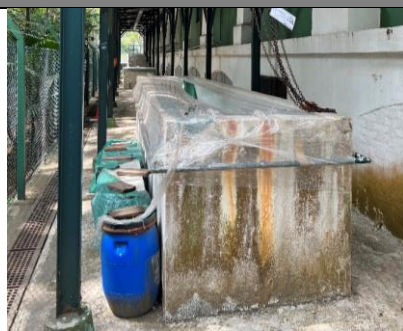
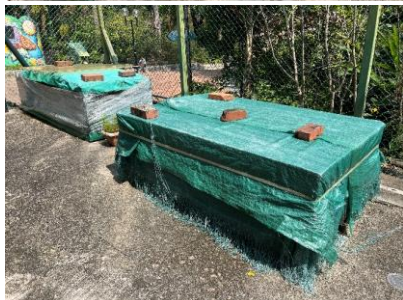
No.	Description	Level of Significance	Photo
4	Concrete tanks at northeast and south open spaces [Non original fabric]	Intrusive

There are two conservation tanks outside the building's south façade and another two outside the east façade. The former two concrete tanks were probably introduced during the 1983 renovation (when Block S58 was renovated to support Blocks S61 and S62 being used as the temporary Museum of History), but the larger one was further replaced during the 1986-89 renovation. The latter two are suspected to be later additions, but the exact date of addition is unknown.

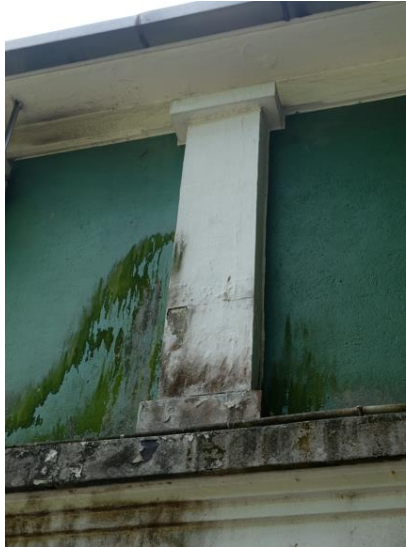
9	<p>North (front) façade facing Kowloon Park, with:</p> <ul style="list-style-type: none"> - Entablatures with plain cornices (as roof eave overhang and now hidden by gutter), no frieze and plain and chamfer-edged architrave at roof level - Verandahs with rectangular openings on facades (now blocked) on 1/F [The blockage is intrusive] - Rendered columns with plain capital and base on 1/F - String course at 1/F slab level with moulding - Verandahs, with chamfer-edged rendered brick segmental arch openings (now blocked, either by recessed or flushed walls), keystone, supported by rendered columns on two sides on G/F [The blockage is intrusive] 	<p>Very high</p> <p>Very high</p> <p>Very high</p> <p>Very high</p> <p>Very high</p> <p>Very high</p>

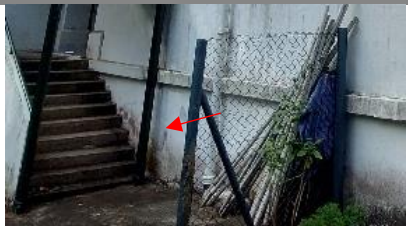
No.	Description	Level of Significance	Photo
10	East (side) façade facing Kowloon Park, with:	Very high	       
	- On its two sides, the return walls of north and south façade verandahs on G/F and 1/F (blocked except G/F left), with features similar to north and south façades [The blockage is intrusive]	Very high	
	- At the centre, gable wall with moulded cornice	Very high	
	- Bullseye window opening	Very high	
	- The painted number "58"	Very high	
	- The painted, protruded, ringed letter "A"	Very high	
	- Moulded string course at 1/F slab level	Very high	
	- Rectangular openings on G/F	Intrusive	
	- Rain water downpipe	Intrusive

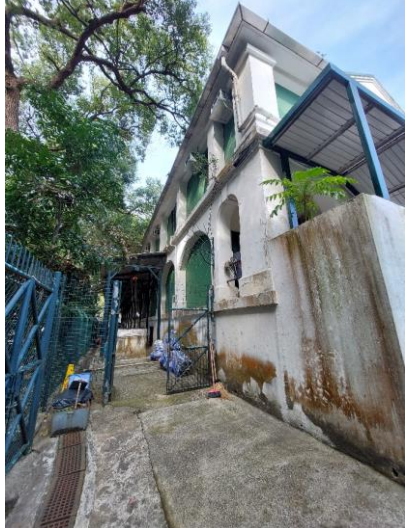
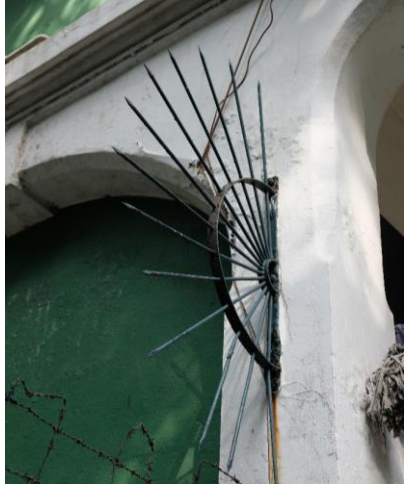
11	<p>South (back) façade facing Hoiphong Road, with:</p> <ul style="list-style-type: none"> - Entablatures - Verandahs with rectangular openings on 1/F (blocked) - Plain columns on 1/F - Moulded string course at 1/F slab level - Verandahs with arch openings on G/F [All blocked, except the right ending bay remains open, The blockage is intrusive] - Plain string course at G/F slab level - Segmental arch openings on LG/F (blocked or installed with louvres) - Cast iron railing at verandah opening (the right ending bay) on G/F - Metal spike 	<p>Very high</p> <p>Very high</p> <p>Very high</p> <p>Very high</p> <p>Very high</p> <p>Very high</p> <p>Very high</p> <p>Very high</p> <p>No value</p>

No.	Description	Level of Significance	Photo
	<ul style="list-style-type: none"> - Metal grille and rain water outlets at LG/F skirting level 	Medium

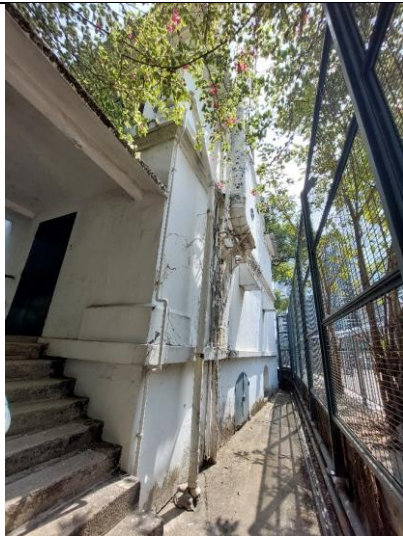
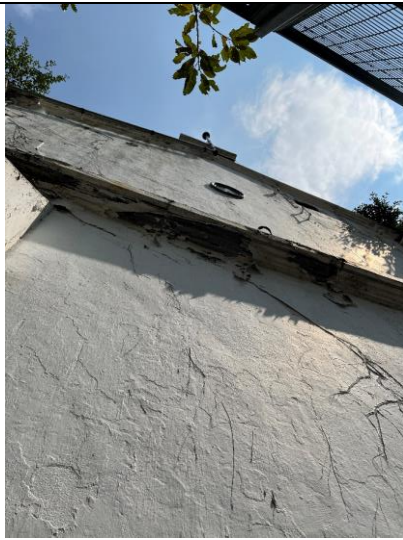
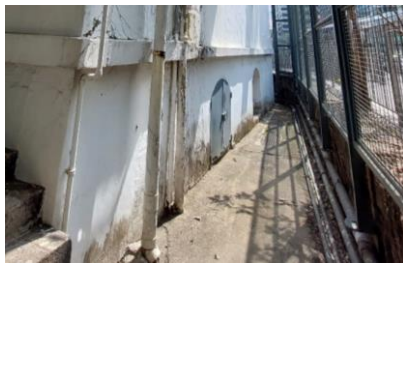
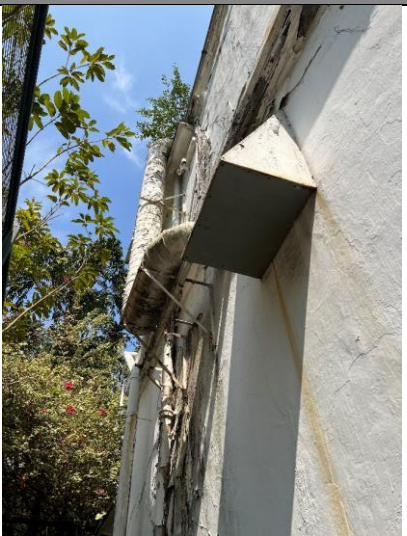
12	<p>West (side) façade facing Kowloon Park Drive, with:</p> <ul style="list-style-type: none"> - On its two sides, the return walls of north and south façade verandahs on G/F and 1/F, with features similar to north and south façades - At the centre, gable wall with moulded cornice - The painted, protruded, ringed letter "A" - Moulded string course at 1/F slab level - Plain string course at G/F slab level - Segmental arch openings on LG/F (now blocked or installed with gate) [The blockage or gate are later addition and have no value] - Later added building services installation, including vents 	<p>High</p> <p>High</p> <p>High</p> <p>High</p> <p>High</p> <p>Medium</p> <p>Intrusive</p>

No.	Description	Level of Significance	Photo
	and associated wall openings - Rain water downpipe	Intrusive

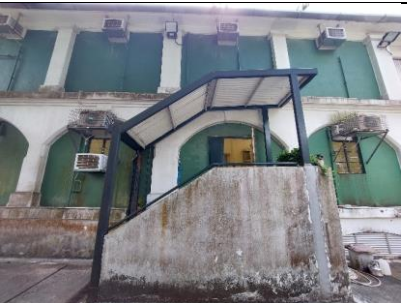
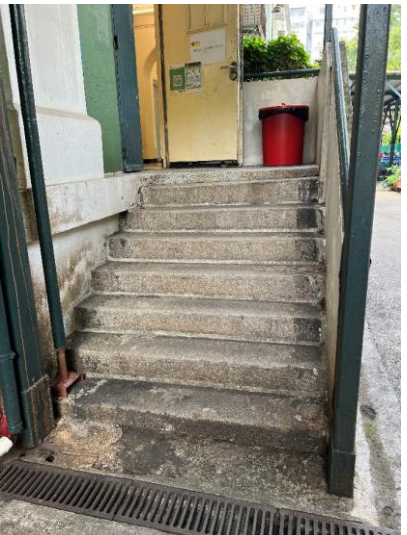
13	External staircase in front of north façade, with: <ul style="list-style-type: none"> - Granite staircase flights partly inlaid with wash grano finish on surface - Render parapet wall and painted metal railing [non-original fabric] - Corrugated metal roof with columns [non-original fabric] 	Very high Very high No value Intrusive

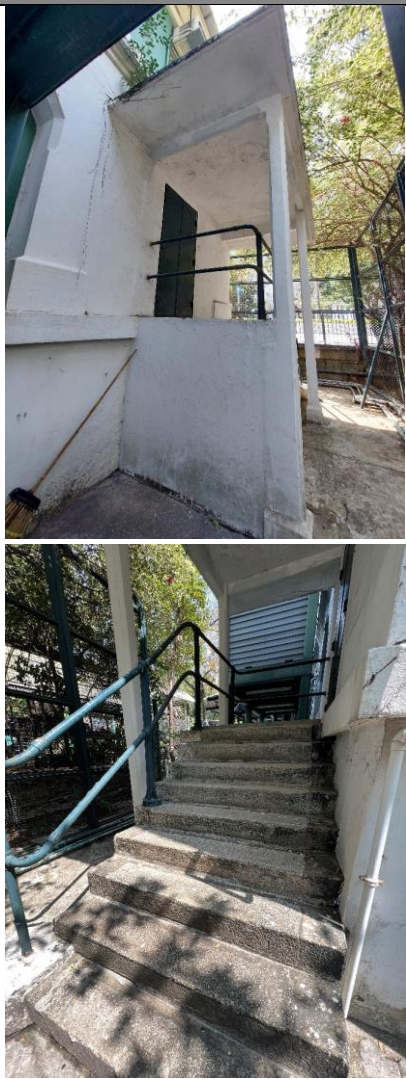
14	External staircase at the northwest corner, with: <ul style="list-style-type: none"> - Granite staircase flights partly inlaid with wash grano finish on surface - Cast iron railing and posts, except the lowest post 	High High High

No.	Description	Level of Significance	Photo
	<p>[The lowest post is not original fabric]</p> <ul style="list-style-type: none"> - Concrete flat roof and supporting beam and columns [non-original but aged fabric] 	No

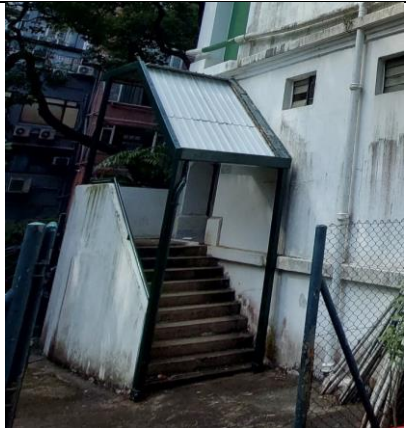
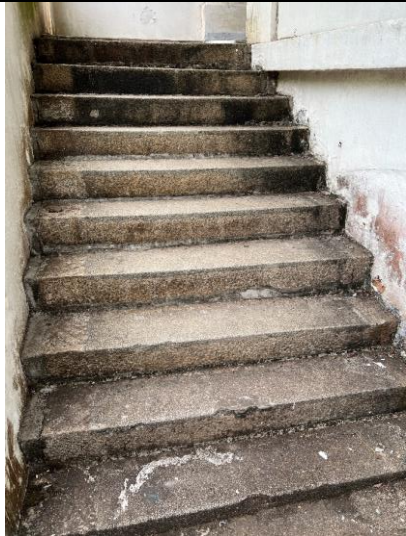
15	<p>External staircase at the southeast corner, with:</p> <ul style="list-style-type: none"> - Granite staircase flights partly inlayed with wash grano finish on surface - Render parapet wall and painted metal railing [non-original fabric] - Corrugated metal roof with columns [non-original fabric] 	<p>Very high</p> <p>Very high</p> <p>No value</p> <p>Intrusive</p>

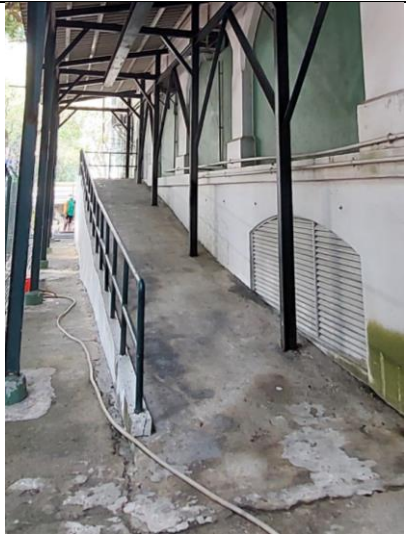
16	Ramps in front of front façade and metal railing [1986 intervention]	Intrusive

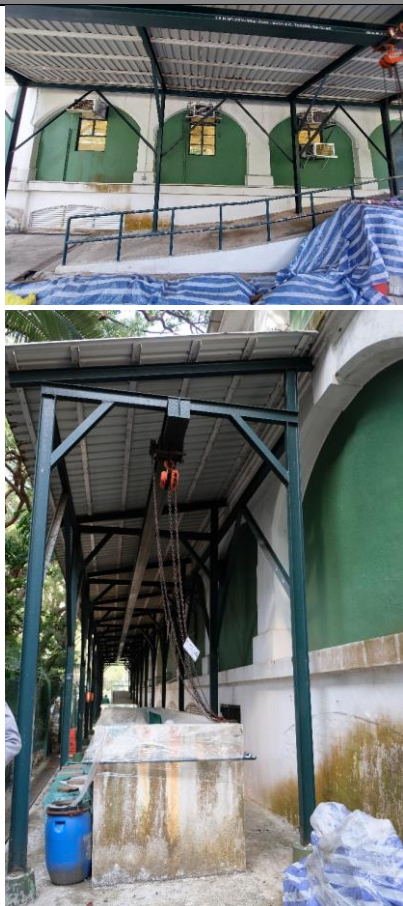
No.	Description	Level of Significance	Photo
17	Corrugated metal sheds with metal supporting structures and pulleys attaching to front and back façades	Intrusive

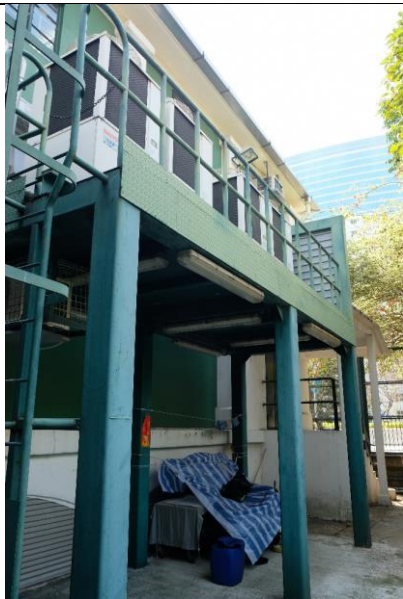
18	Metal deck and supporting structure for air conditioning unit attaching to front façade [Later addition]	Intrusive

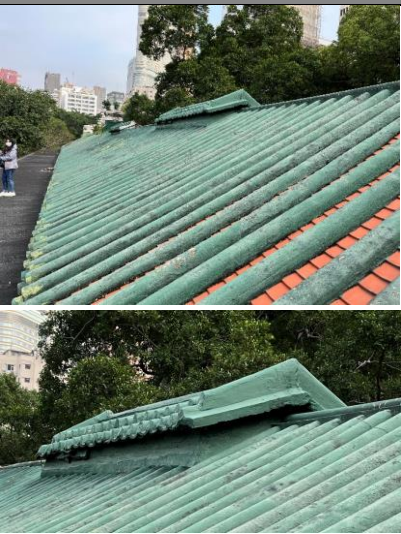
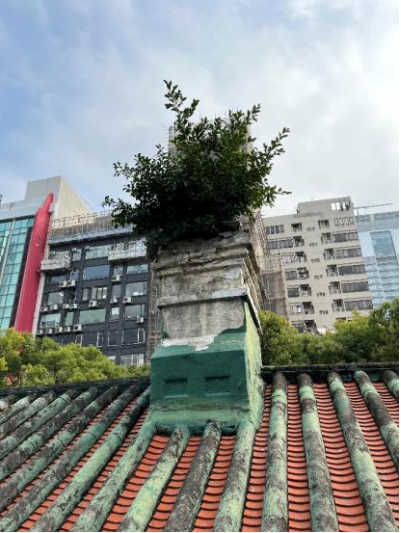
No.	Description	Level of Significance	Photo
19	Pitched roof in the middle, with:	Very high

- Double pan, double roll Chinese clay tiles	High	
	- Monitor roofs	Very high	
20	Chinmeys with moulding	Very high

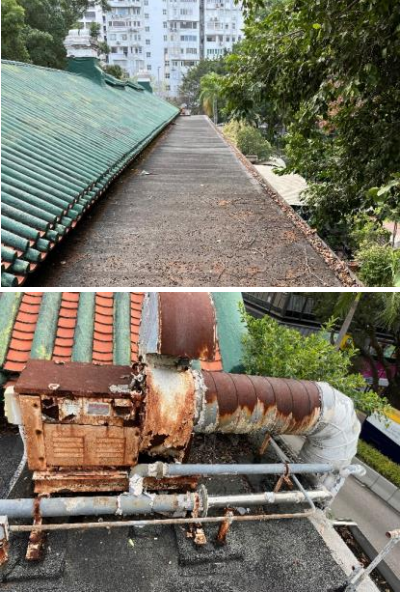
21	Flat roofs on north and south sides, with:	Medium

[Original design of the roof appears to be pitched but later altered to flat roof]	No value	
	- Access hatch opening on roof	Intrusive	
	- Building services installation, including water tank

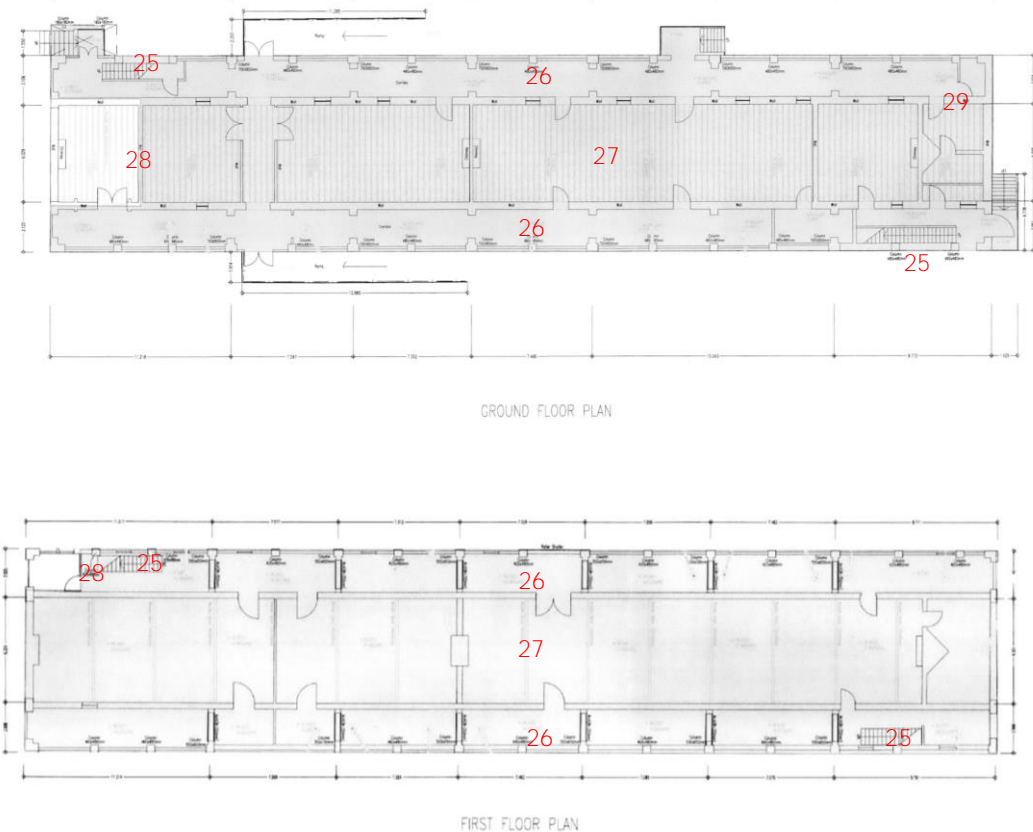
<p>GROUND FLOOR PLAN</p> <p>FIRST FLOOR PLAN</p>		
23	<p>Building layout consisted of three portions, including:</p> <ul style="list-style-type: none"> - front (north) portion – verandah and staircase at west end - middle portion – living rooms - rear (south) portion – verandah and staircase at east end 	Very high

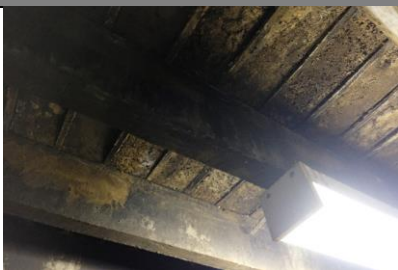
No.	Description	Level of Significance	Photo
	<ul style="list-style-type: none">- timber joist and plank flooring on G/F and 1/F at middle portion	Very high

According to the recent structural survey carried out by structural consultant for Block 58, the G/F and 1/F floor structure of Block 58 was found to be filler joist floors at verandahs and timber joist floors at central rooms. Based on the information obtained from the recent structural survey, the loading capacity of G/F floor structure and 1/F filler joist floor is assessed to be 5kPa, which aligns with the design load. However, due to the long span of timber joists at 1/F, the loading capacity of 1/F timber joist is assessed to be 4kPa by using conservative approach.

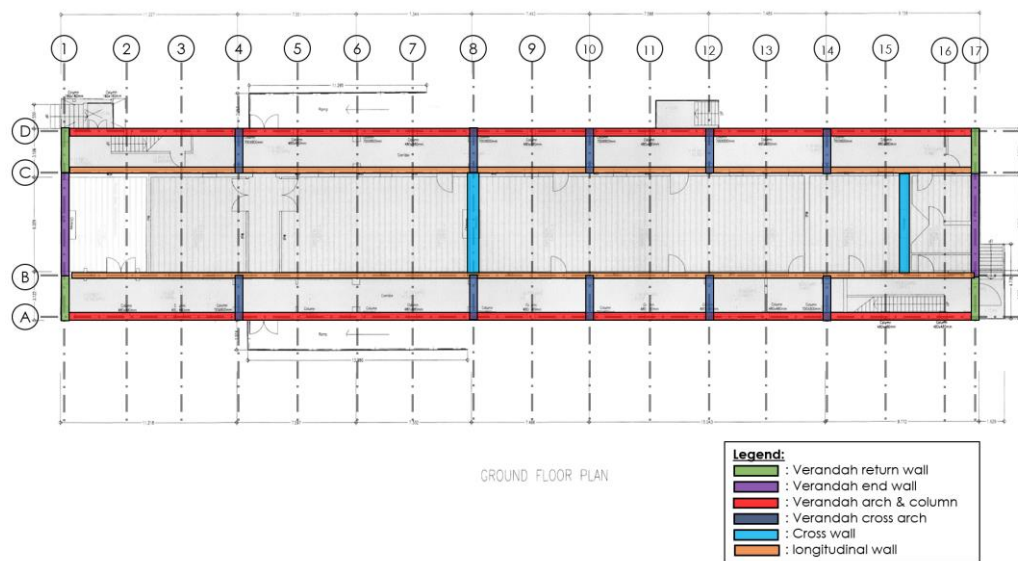
<ul style="list-style-type: none">- timber king posts, purlins and batten structure of roof at middle portion	Very high	
	<ul style="list-style-type: none">- brick arches/ walls/ columns, including verandah return wall (grid AB1, CD1, AB17, AB17), verandah end wall (grid BC1 & BC17), verandah arches/ columns (along gridline A&D), verandah cross arches (grid AB4, CD4, AB 8, CD8, AB10, CD10, AB12, CD12, AB14, CD14), longitudinal wall (along grid B & grid C), cross walls (grid BC8, between grid BC15/16) <p>[1/F verandah column substrate TBC upon opening up of rendering]</p>	Very high

<p>GROUND FLOOR PLAN</p> <p>Legend:</p> <ul style="list-style-type: none">: Verandah return wall: Verandah end wall: Verandah arch & column: Verandah cross arch: Cross wall: longitudinal wall

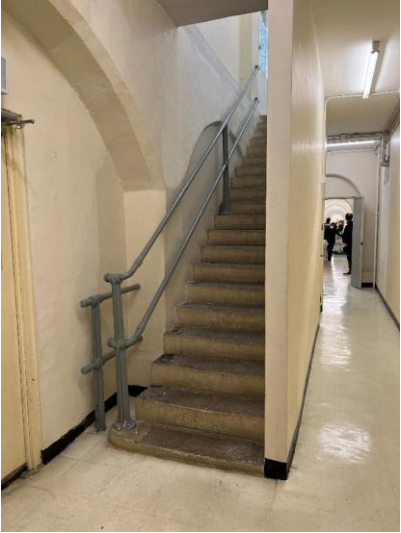
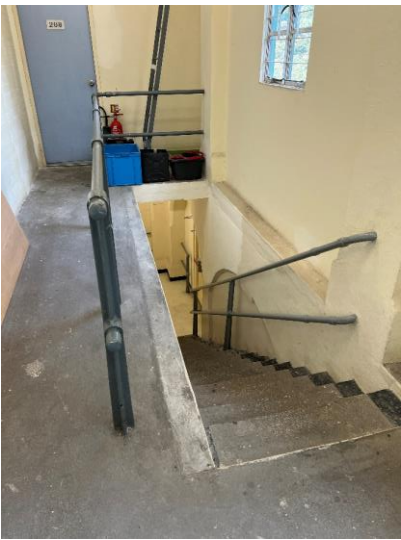
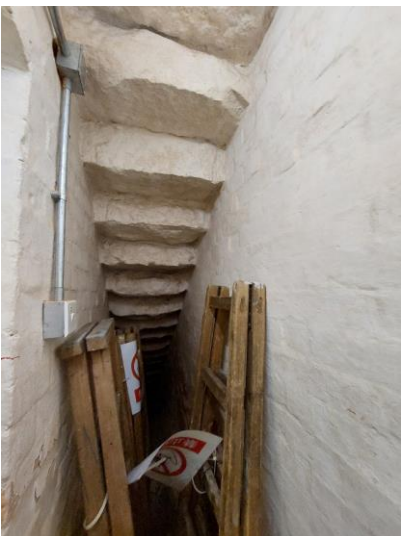
No.	Description	Level of Significance	Photo
25	<p>Two granite staircases from G/F to 1/F, one at each verandah, with:</p> <ul style="list-style-type: none"> - Granite flights partly inlaid with wash grano surface - Cast iron posts and railing [some of them are partly embedded in later added enclosure walls of verandahs] - 1/F railing of the south staircase [appears not original fabric] - Supporting brick walls in the middle of the flights - Enclosing wall [May not be original fabric] - Metal door leading to exterior 	<p>Very high</p> <p>Very high</p> <p>Very high</p> <p>No</p> <p>Very high</p> <p>Low</p> <p>No</p>

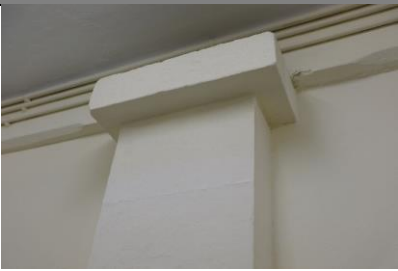
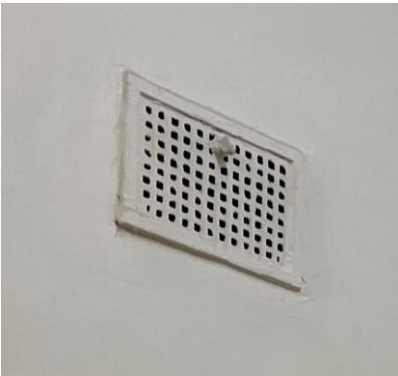
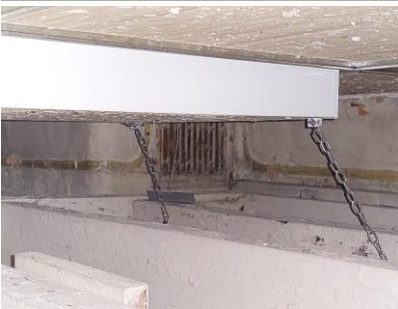
26	<p>Verandahs at both front and rear portions on both G/F and 1/F, with:</p> <ul style="list-style-type: none"> - Enclosed verandah setting - Plastered and painted segmental brick arches and columns on 1/F interior side of the external wall - Plastered and painted columns with plain capital and base on G/F interior side of the external wall [Substrate to be confirmed after plaster open up] - Plastered and painted internal walls on both G/F 	<p>Very high</p> <p>Intrusive Medium</p> <p>Medium</p> <p>Medium</p>

No.	Description	Level of Significance	Photo
	<p>and 1/F (along grid B and C)</p> <ul style="list-style-type: none"> - Metal vent grilles on the brick walls on both G/F and 1/F [now painted over] 	High

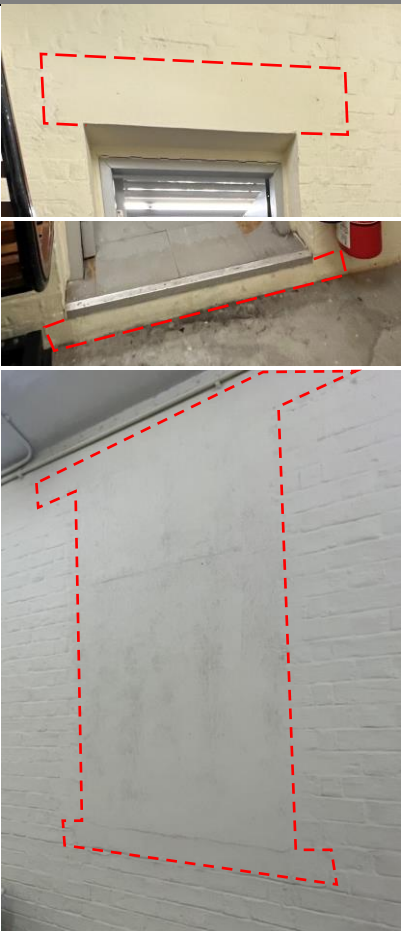
No.	Description	Level of Significance	Photo
	<ul style="list-style-type: none"> Doors, windows and louvres [All appears to be non-original fabric] 	No

<ul style="list-style-type: none"> Plastered and painted cross arches [part of structure] [Two archways have been blocked to form Room 109 and 209, which are later intrusive acts] 	Medium	Room 109:
	<ul style="list-style-type: none"> Plastered and painted ceiling 	Medium	
	<ul style="list-style-type: none"> Screeded floor 	Medium	
	<ul style="list-style-type: none"> Thermoplastic/ vinyl floor 	Intrusive	
	<ul style="list-style-type: none"> Later added partition walls 	No	Room 209:

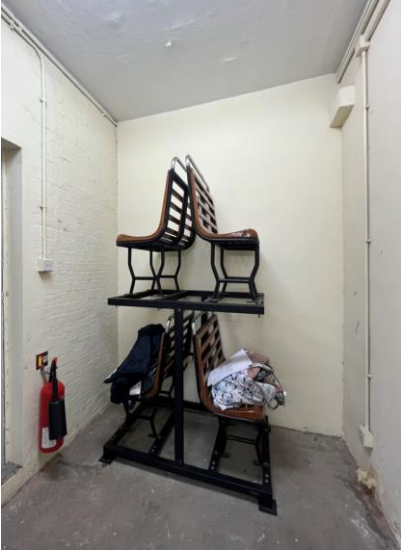
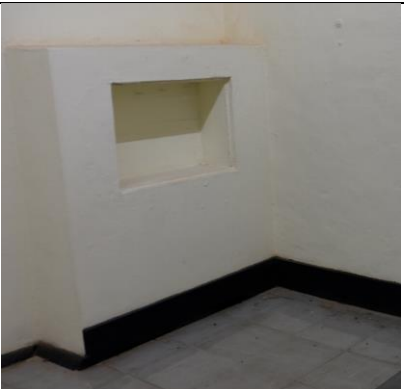
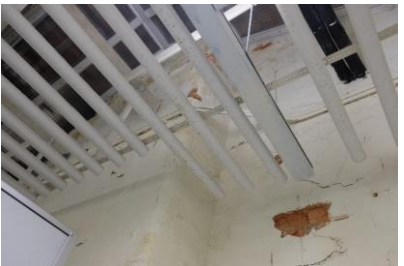
27	<p>Rooms in the middle portions, with:</p> <ul style="list-style-type: none"> - Chimney stacks (5 nos. on G/F and 5 nos. on 1/F) 	<p>Medium</p> <p>Very high</p>

No.	Description	Level of Significance	Photo
	<ul style="list-style-type: none"> - Cross walls on the two sides of the chimney stacks 	High	   
	<ul style="list-style-type: none"> - Vinyl floor tiles (later added) [Maybe hiding original timber plank flooring, TBC upon removal of vinyl floor] 	No	 
	<ul style="list-style-type: none"> - False ceiling on G/F and ceiling grilles on 1/F [Maybe hiding ceiling moulding, TBC upon removal of false ceiling] 	Intrusive

In the 1983 renovation, two openings were added to the cross-brick walls on the two sides of the middle chimney stack while one was added to a cross-brick wall of the west chimney stack. This increased accesses between the rooms but caused disturbance to the original fabric. Other changes were addition of partitions to form more rooms for stores and an office. In 1986-89, the two openings on the cross-brick walls of the middle chimney stack were filled back. There were also other changes in partition layout. Window and door openings inter-changed during the two renovations but it is unsure if there were enlargement of structural width. However, the introduction of an opening to receiving large object transferred by the hoist beam of the front façade has surely enlarged the door opening at that particular location.

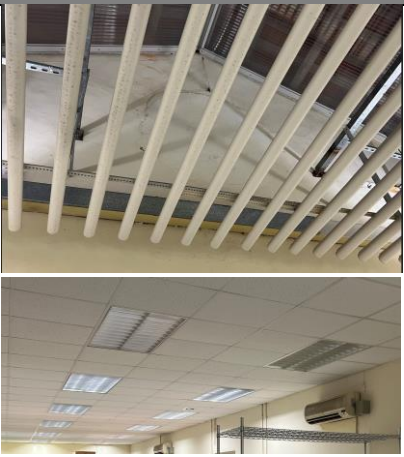
No.	Description	Level of Significance	Photo
	<ul style="list-style-type: none"> - Plastered and painted internal walls on both G/F and 1/F 	Medium

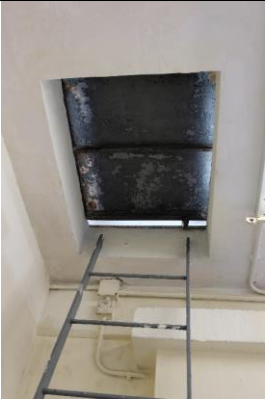
28	Metal cat ladder on 1/F, with: <ul style="list-style-type: none"> - access hatch on ceiling 	No No

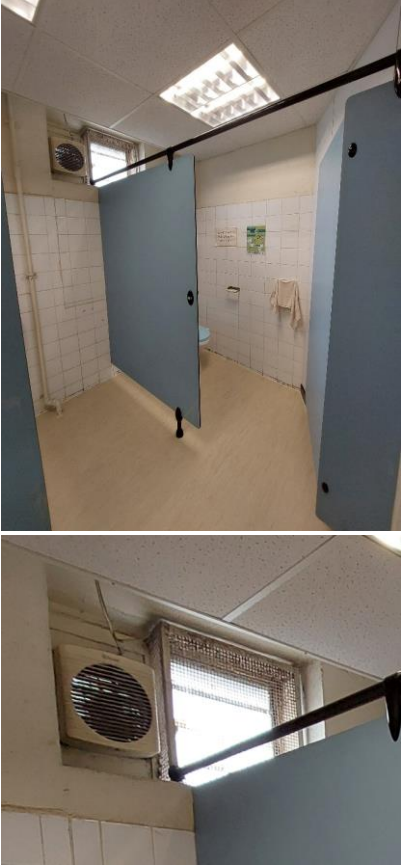
No.	Description	Level of Significance	Photo
29	<p>Lavatories, with:</p> <ul style="list-style-type: none"> - Location - Layout and fixture - Wall and floor finish - False ceiling - High louver and extract fan <p>[All are non-original fabric]</p>	No for all

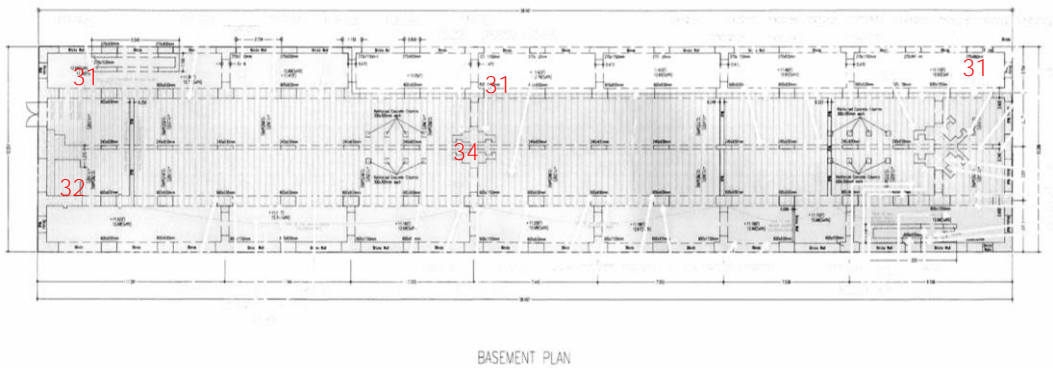
<p>BASEMENT PLAN</p>		
30	Segmental arches composed of brick on the entire floor (structure)	Very high

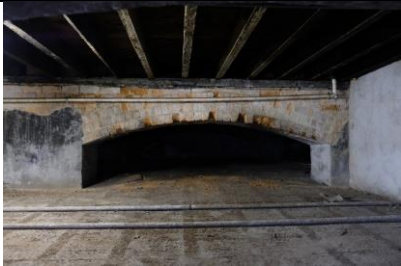
31	Chimney stack bases	Very high

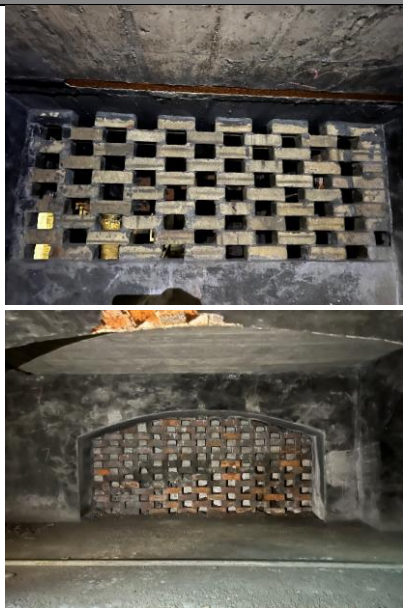
34	Cast iron air grille [Suspected original fabric]	High

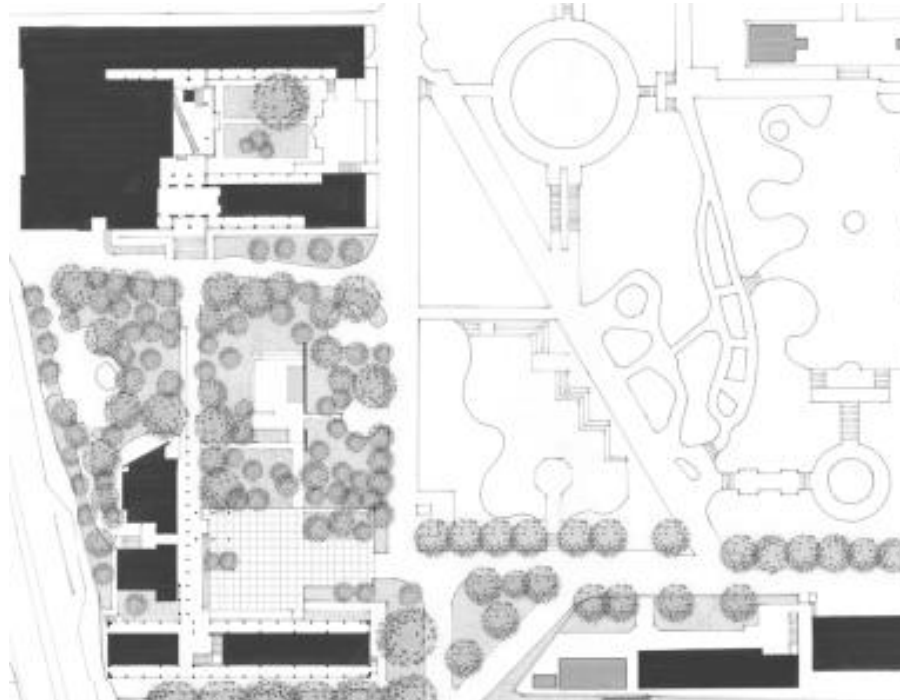
Figure 9-3 Option 2, Half Underground Option

- Option 2, Half Underground Structure (adopted): Adding the new annex to the northwest of Block 58, with FS and sprinkler tanks and pump rooms accommodated in underground
 - o PROS 1: The openness to the north of Block 58 can be largely kept and a new open plaza for outdoor event can be introduced
 - o PROS 2: Visual connection between Block 58 & Block S61 is maintained.

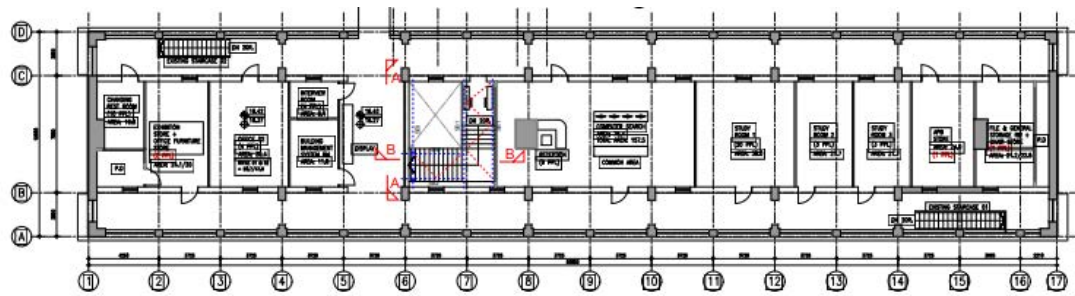
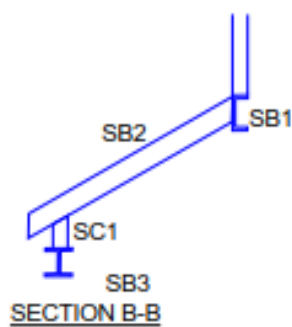
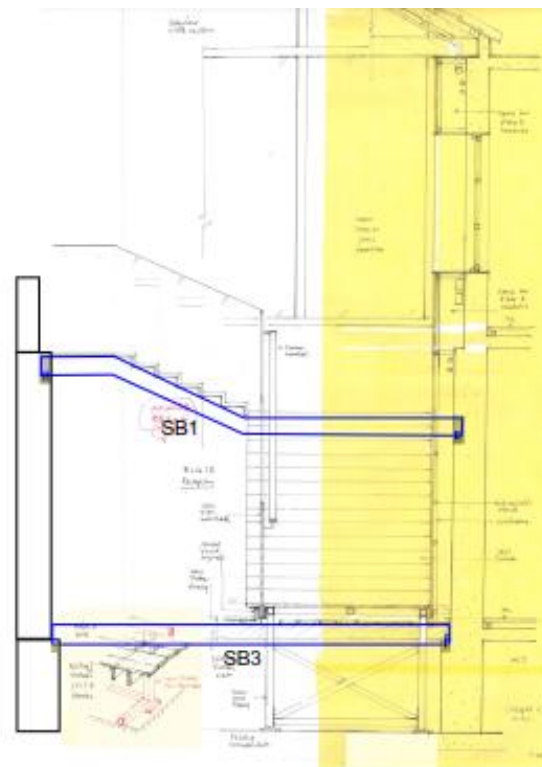
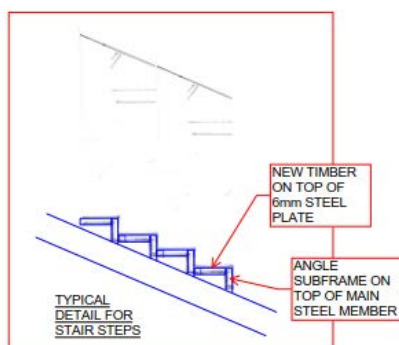
Figure 9-5 Option 2 Steel Beam on Brick Wall Option (Plan, section & details)

- Option 2 Steel Beam on Brick Wall (adopted): Using the existing brick walls of Block 58 to support the new staircase
 - o PROS 1: It creates less visual impact than option 1;
 - o PROS 2: It is a much simpler structure, easier and faster to construct;
 - o PROS 3: Load path of the existing structure of Block 58 remains unchanged. The new steel beams will be inserted into the existing brick walls at the existing recess for receiving timber joists;
 - o PROS 4: There will be no additional loading on the existing brick walls with a portion of 1/F timber floor is removed;
 - o PROS 5: No vertical bracing is required, but only bracing between stairs is required, meaning more flexible space under the new staircase;
 - o CONS 1: It is less reversible than option 1 as it creates some disturbance to the brick walls

SB1 - 305x89 Channel
 SB2 - 203x76 Channel
 SB3 - 203x203x46 UC
 SC1 - 203x76 Channel
 BR - 50x50x4 Angle bracing

A local opening on bricks wall to be refilled with grout. SB1 with concrete pad support on bricks.

TYPICAL CONCRETE PAD
 STONE DETAIL ON BRICK WALL

ELEVATION A-A

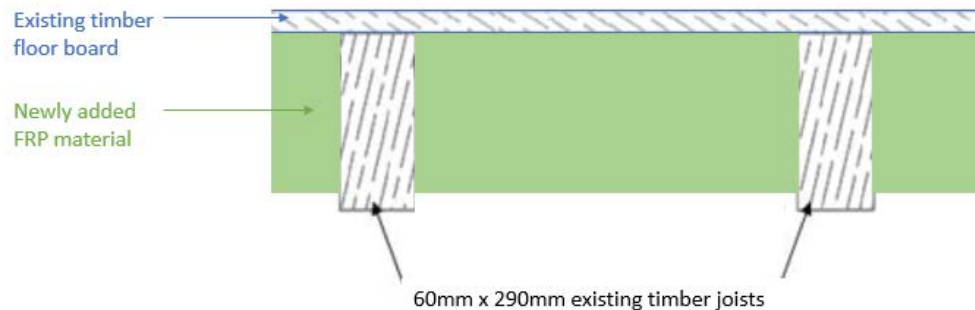
Figure 9-6 Option 1 Covering up floor board soffit only

- Option 1 Covering Up Floor Board Soffit Only (Adopted, subject to structural appraisal)
 - o PROS 1: Timber joist can be seen on ceiling of LG/F and G/F;
 - o PROS 2: Floor board can be seen on G/F and 1/F floor (subject to condition survey after removal of the later added vinyl flooring, it may need to be covered up by new timber board)

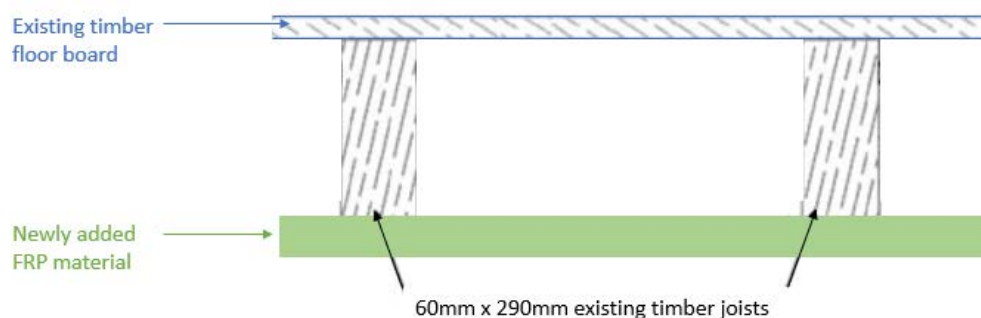
Figure 9-7 Option 1 Covering up the entire soffit of timber floor system

- Option 2 Covering Up the Entire Soffit of Timber Floor System (Not preferred, adopted only if Option 1 is found infeasible by structural appraisal)
 - o CONS 1: Original timber floor system cannot be seen on ceiling of LG/F and G/F;
 - o PROS 1: Original timber floor system are preserved;
 - o PROS 2: Floor board can be seen on G/F and 1/F floor (subject to condition survey after removal of the later added vinyl flooring, it may need to be covered up by new timber board)
