ACTIVITY CENTRE FOR THE PROMOTION OF CHINESE HISTORY AND CULTURE
IN KOWLOON PARK
Heritage Impact Assessment

May 2023 | Rev. E
Prepared by

ANG Studio Ltd.

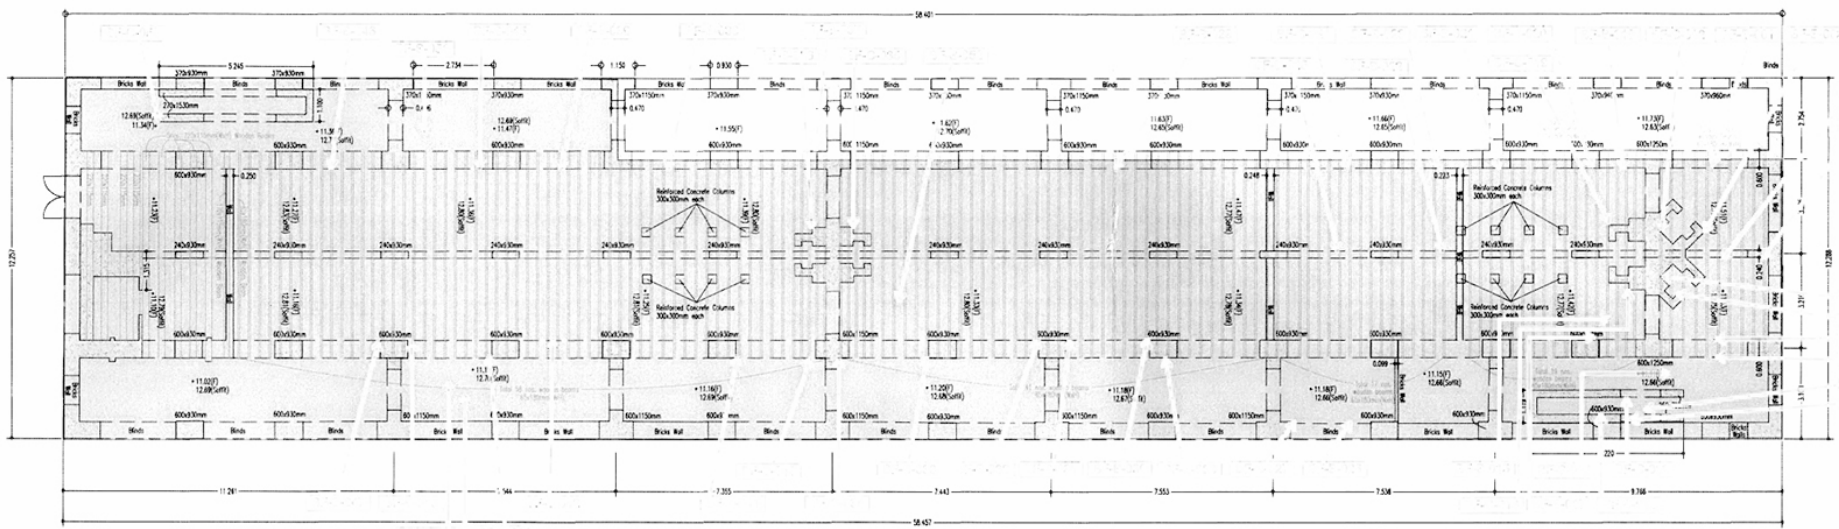
BASEMENT PLAN

2013 Record Plans of Block 58

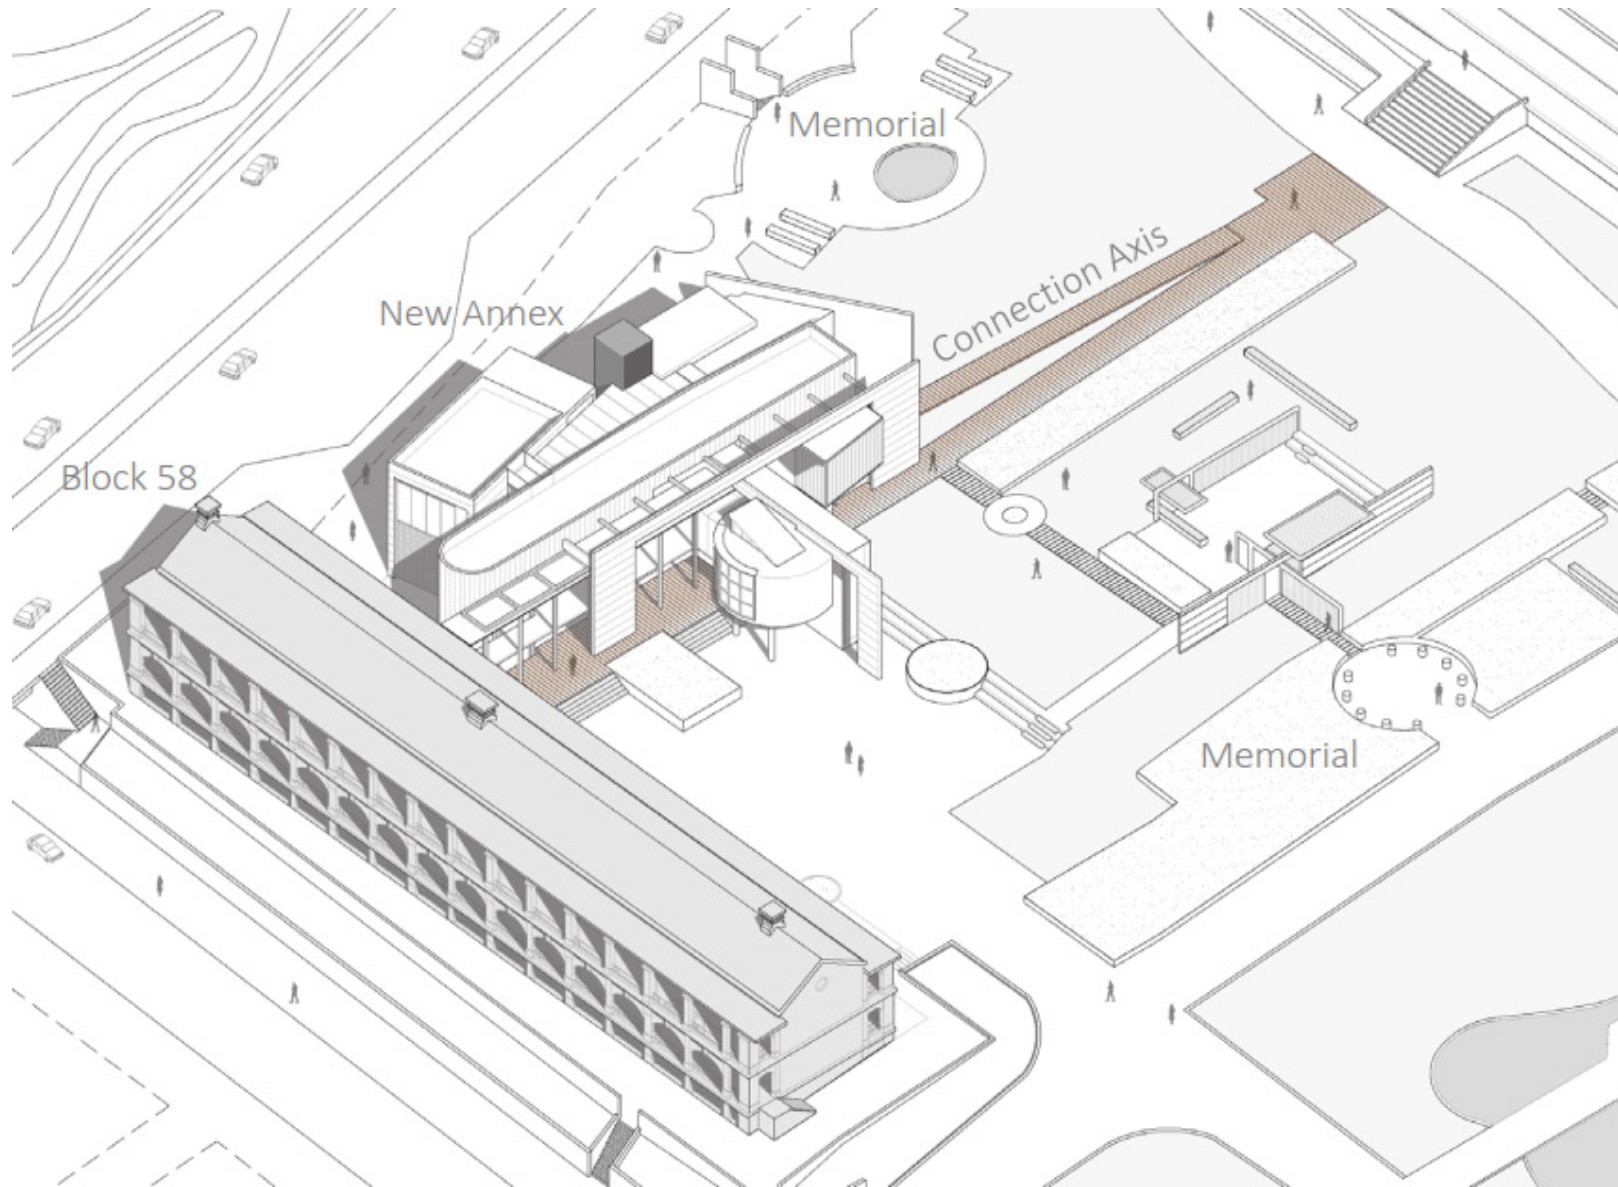
Overall disposition (Axonometric view)

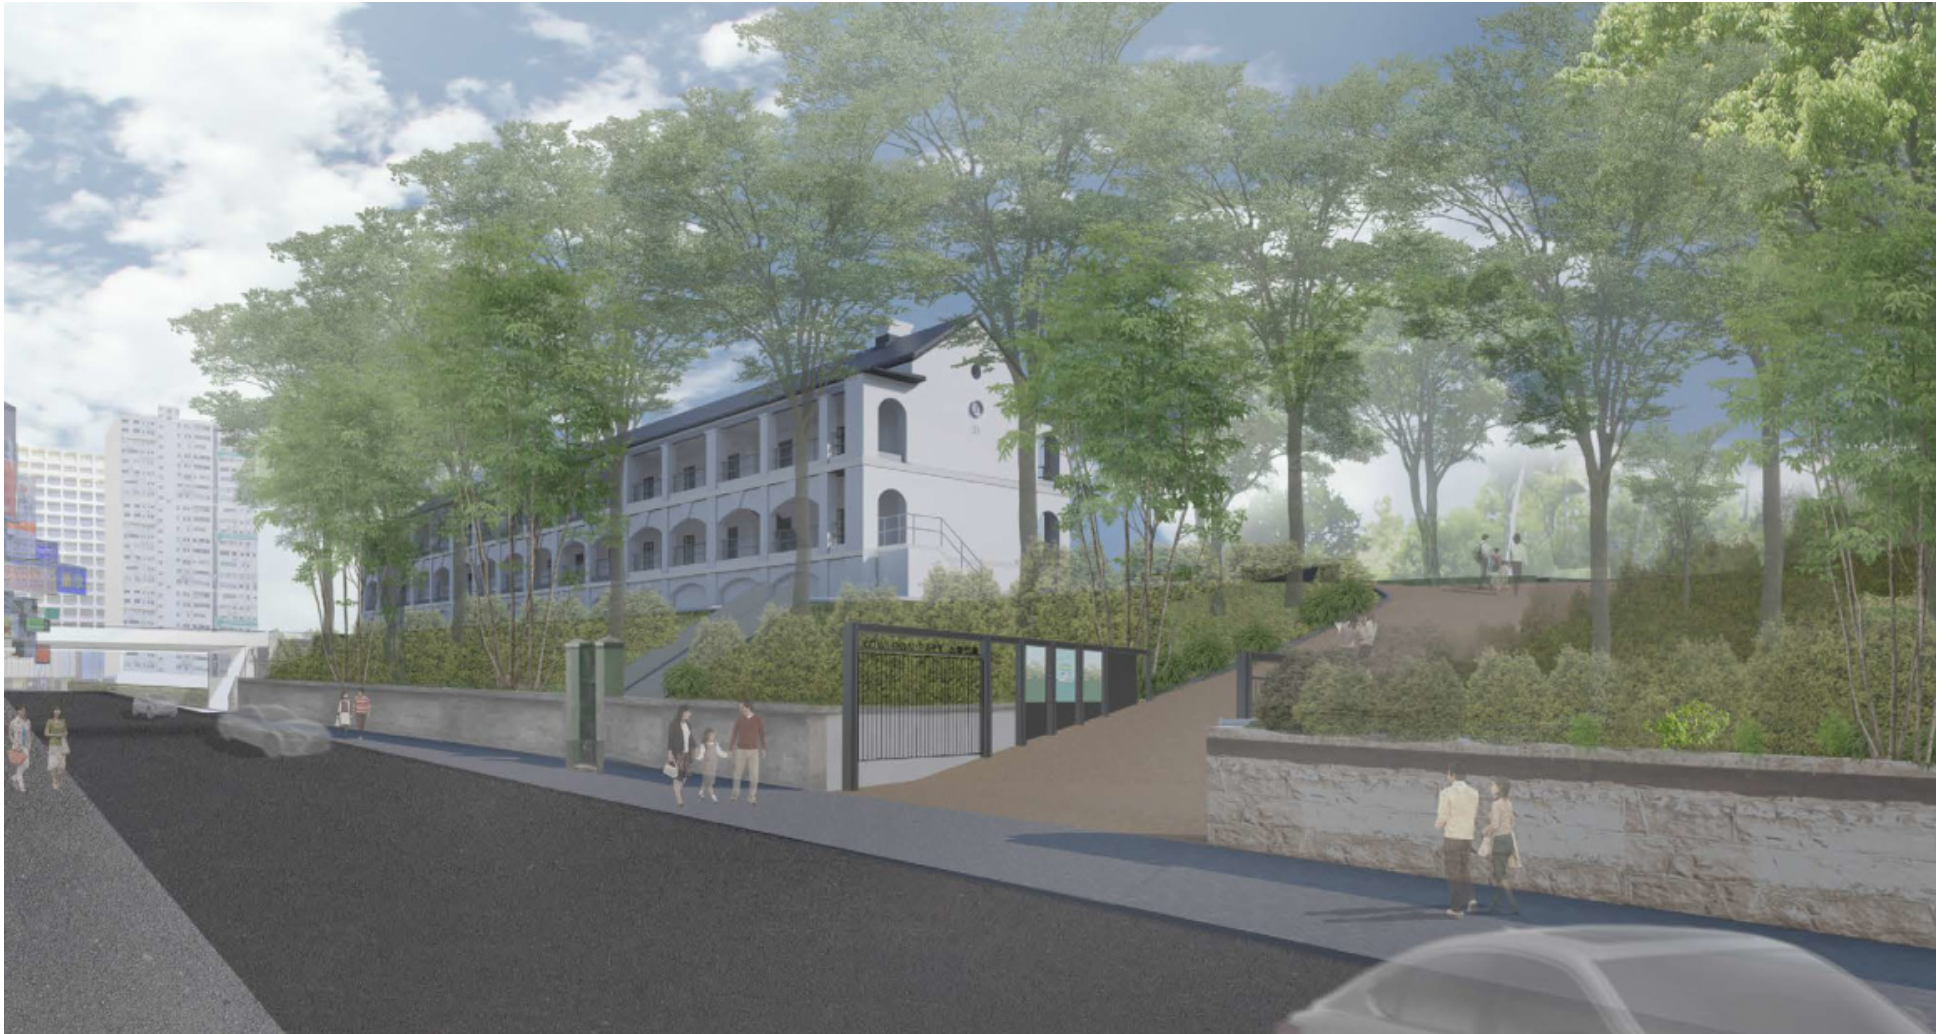
View of Block 58 from Haiphong Road park entrance (fencing on top of slope not shown for clarity)

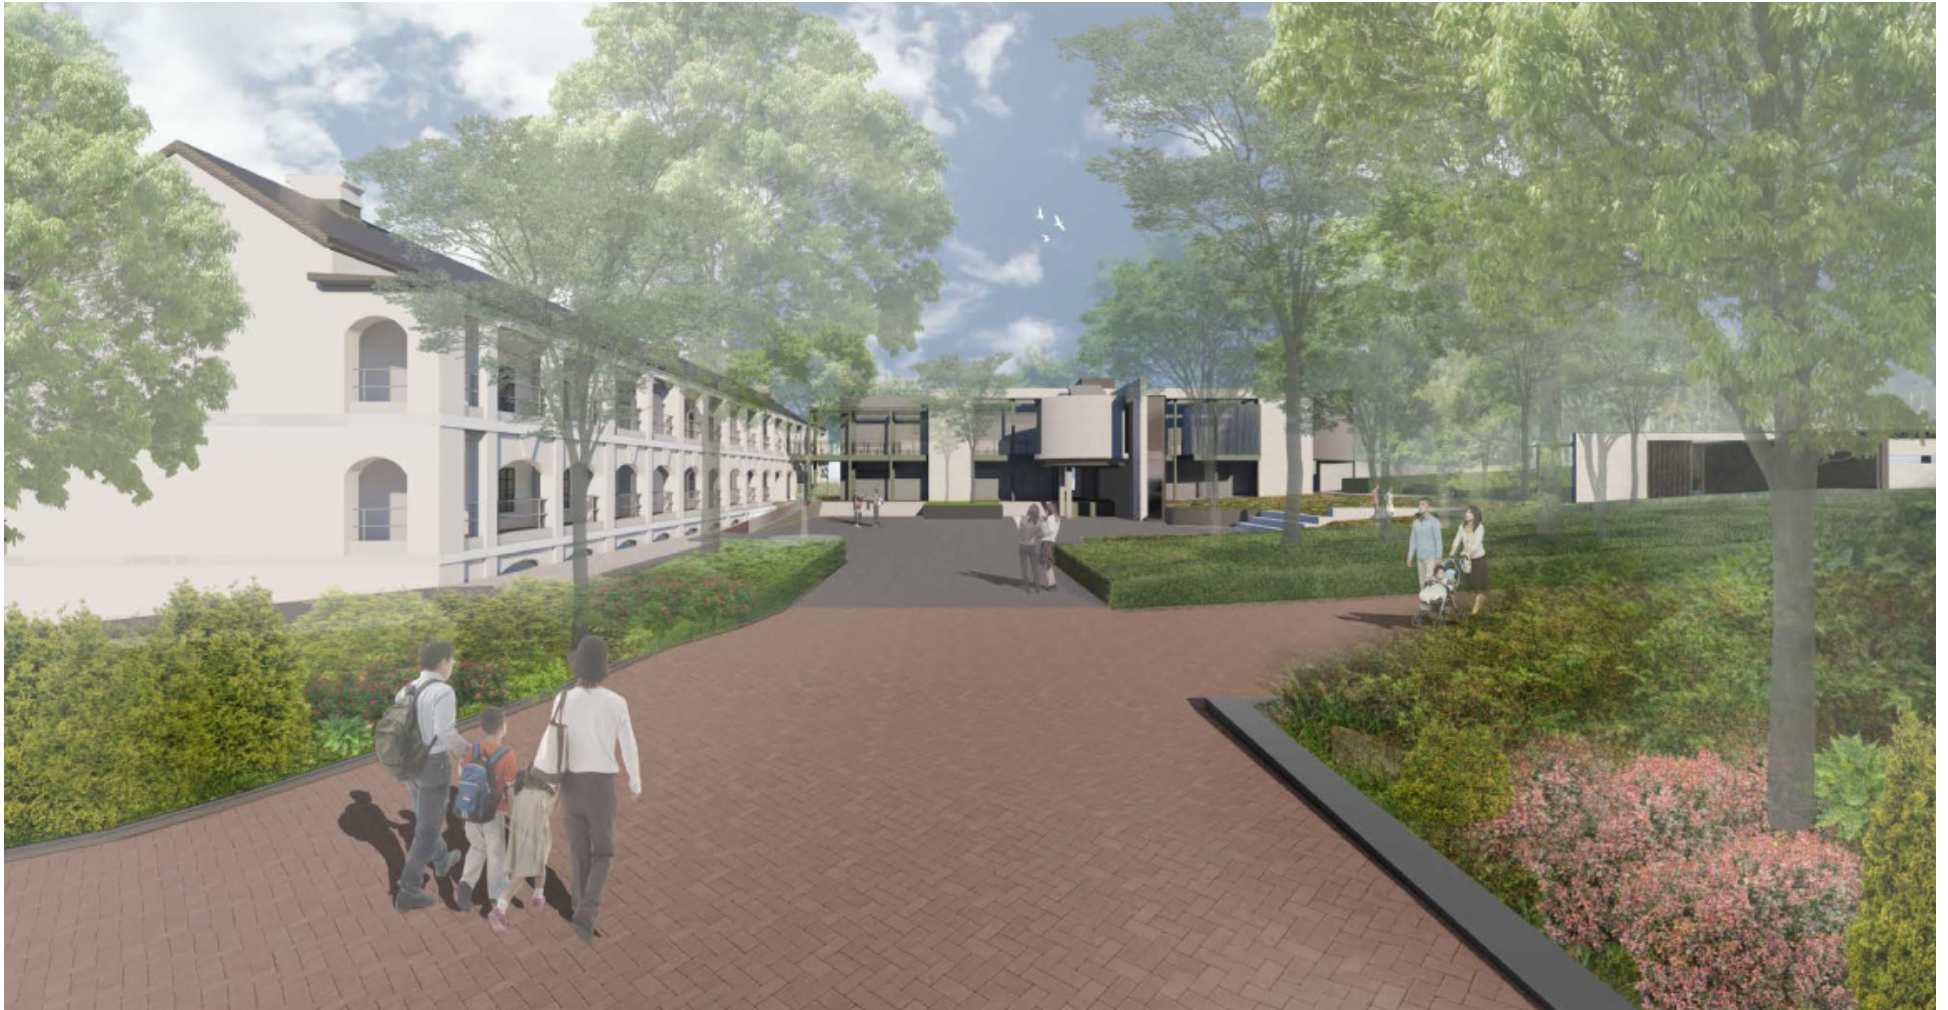
View of Block 58 and New Annex from the new entrance plaza

Block 58 – Repair using the existing material only.

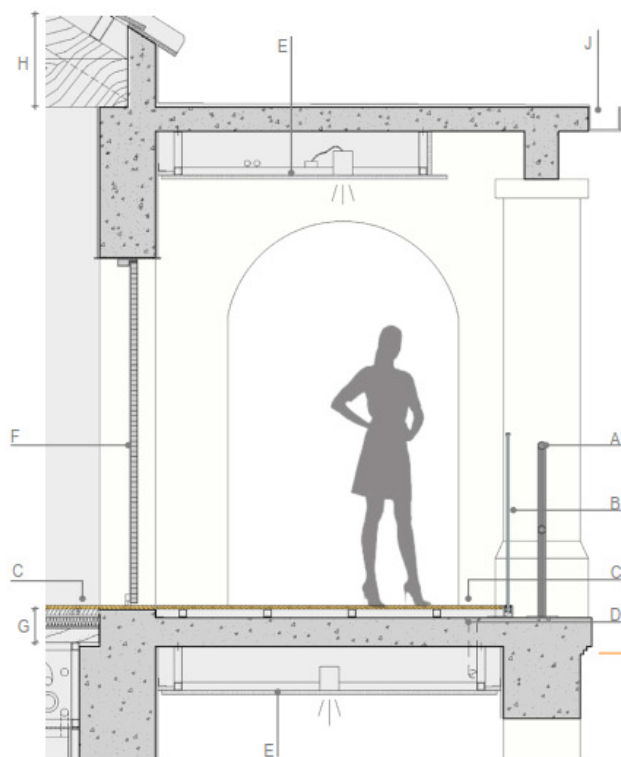
• Section of the 1/F open corridor of Block 58. (Similar for G/F)

- A. Reconstruction of GMS railing in similar style to the old railing
- B. 1100mm (H) glass balustrade
- C. New Timber deck/ floor
- D. Drain point
- E. New cement board false ceiling
- F. New GMS door
- G. Existing timber structure
- H. Existing timber truss
- J. Gutter

Item No.	Assessment Item / Proposed new works	Affected CDEs / elements	Level of significance	Reason for changes	Suggested Mitigation / Recommendation	Overall Impact level
D-9	<p>Adding 1100mm high glass balustrade behind cast iron post and railing</p> <p>Adding 450mm depth smoke barrier at high level of existing staircase exits on G/F</p> <p>Adding warning signs at the entrance to the staircase to alert occupants the geometry of the staircase</p>			<ul style="list-style-type: none"> Building code compliance (for protective barrier and for fire code compliance with fire engineering approach) 	<ul style="list-style-type: none"> Subject to structural investigation on the grading of existing concrete slab and also the strength of granite steps and thus their ability to take up the dead and live load induced by the new balustrades Designing installation detail so as to minimize disturbance to the granite steps and other CDEs 	Acceptable impact with mitigation measure

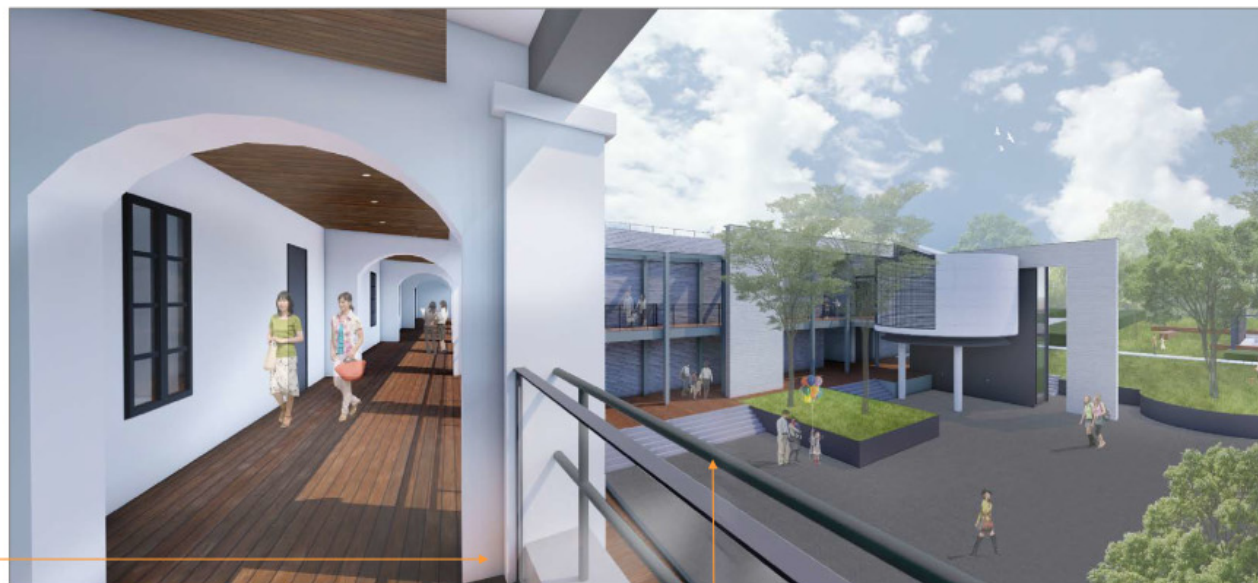
Similar to the remaining portion of old metal railing.

View of Block 58 Verandah

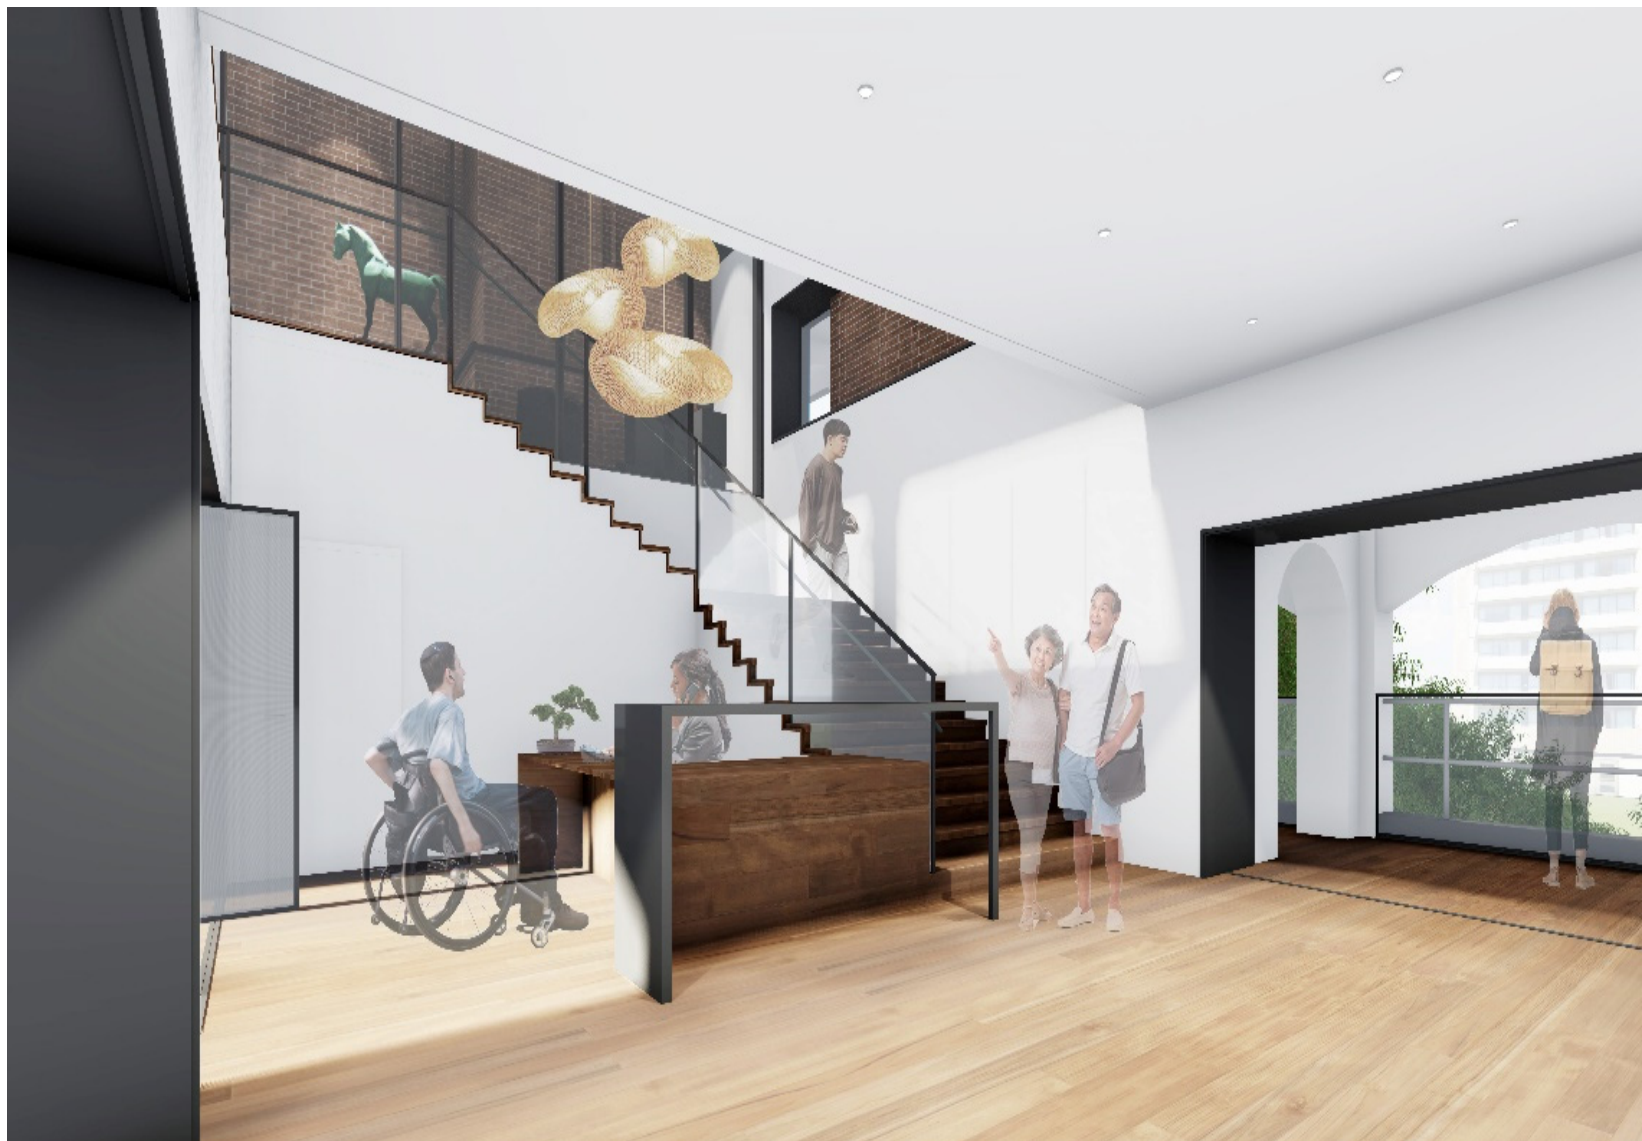
View of the proposed reception lobby (G/F) in Block 58

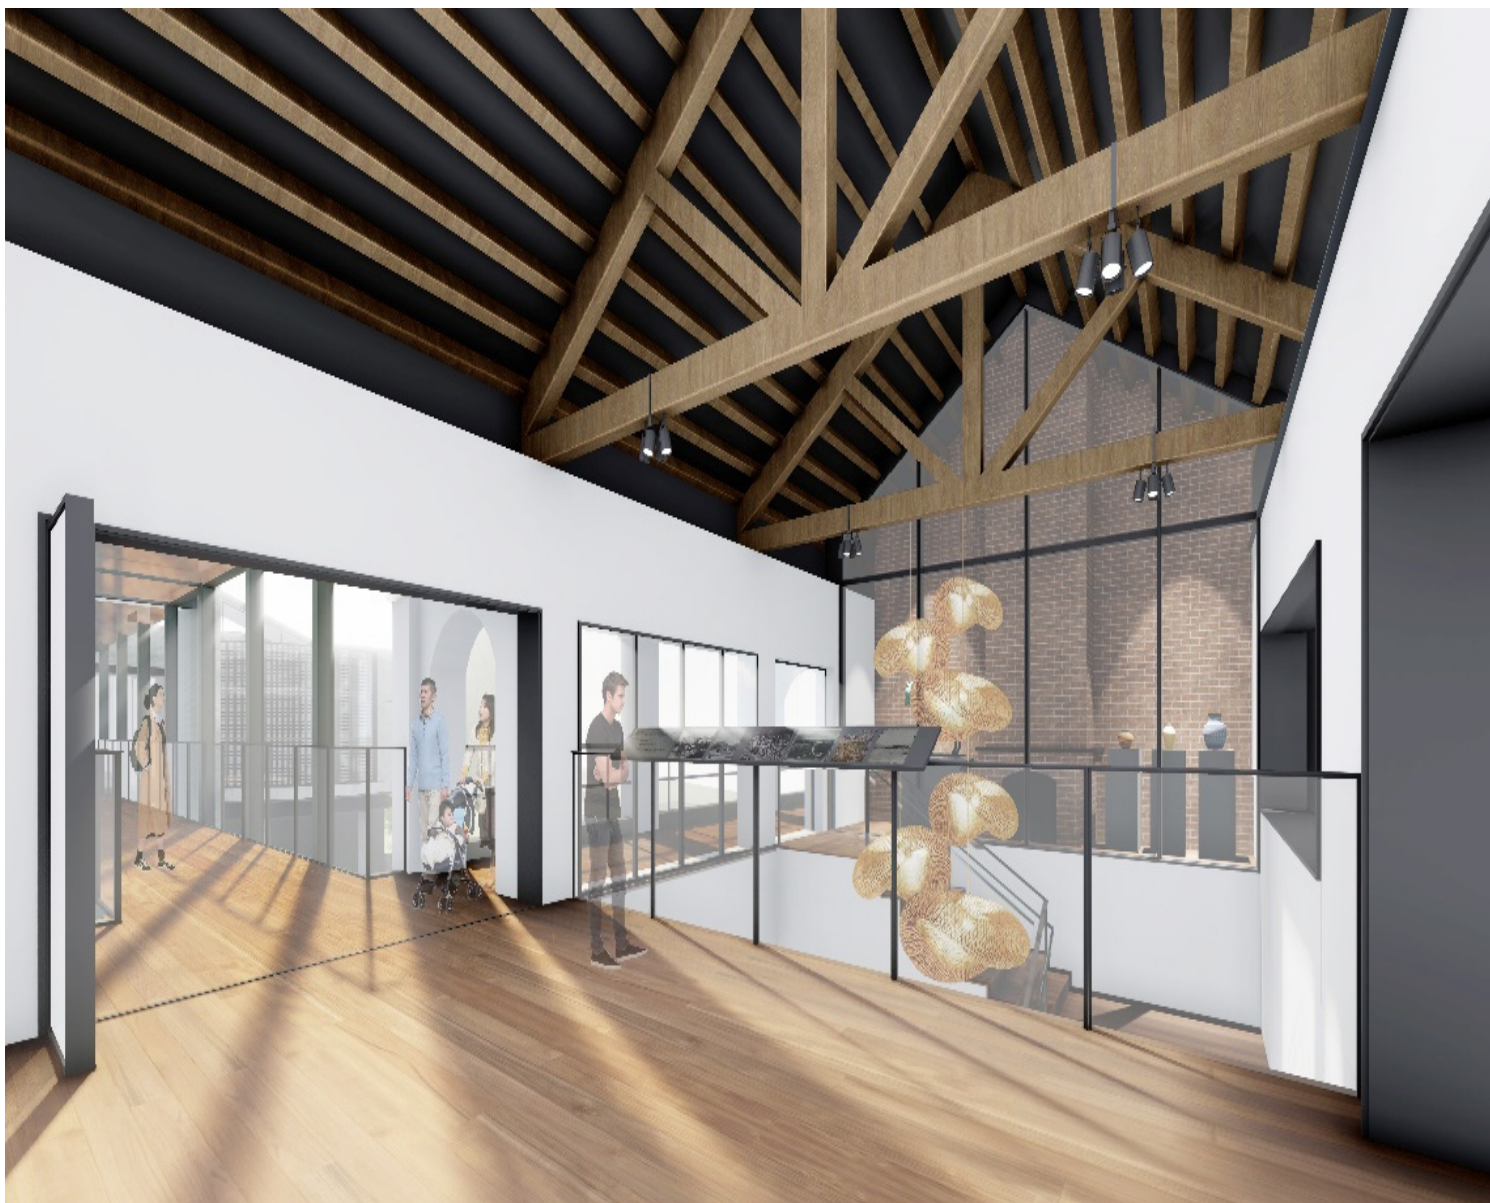
View of the proposed reception lobby (1/F) in Block 58

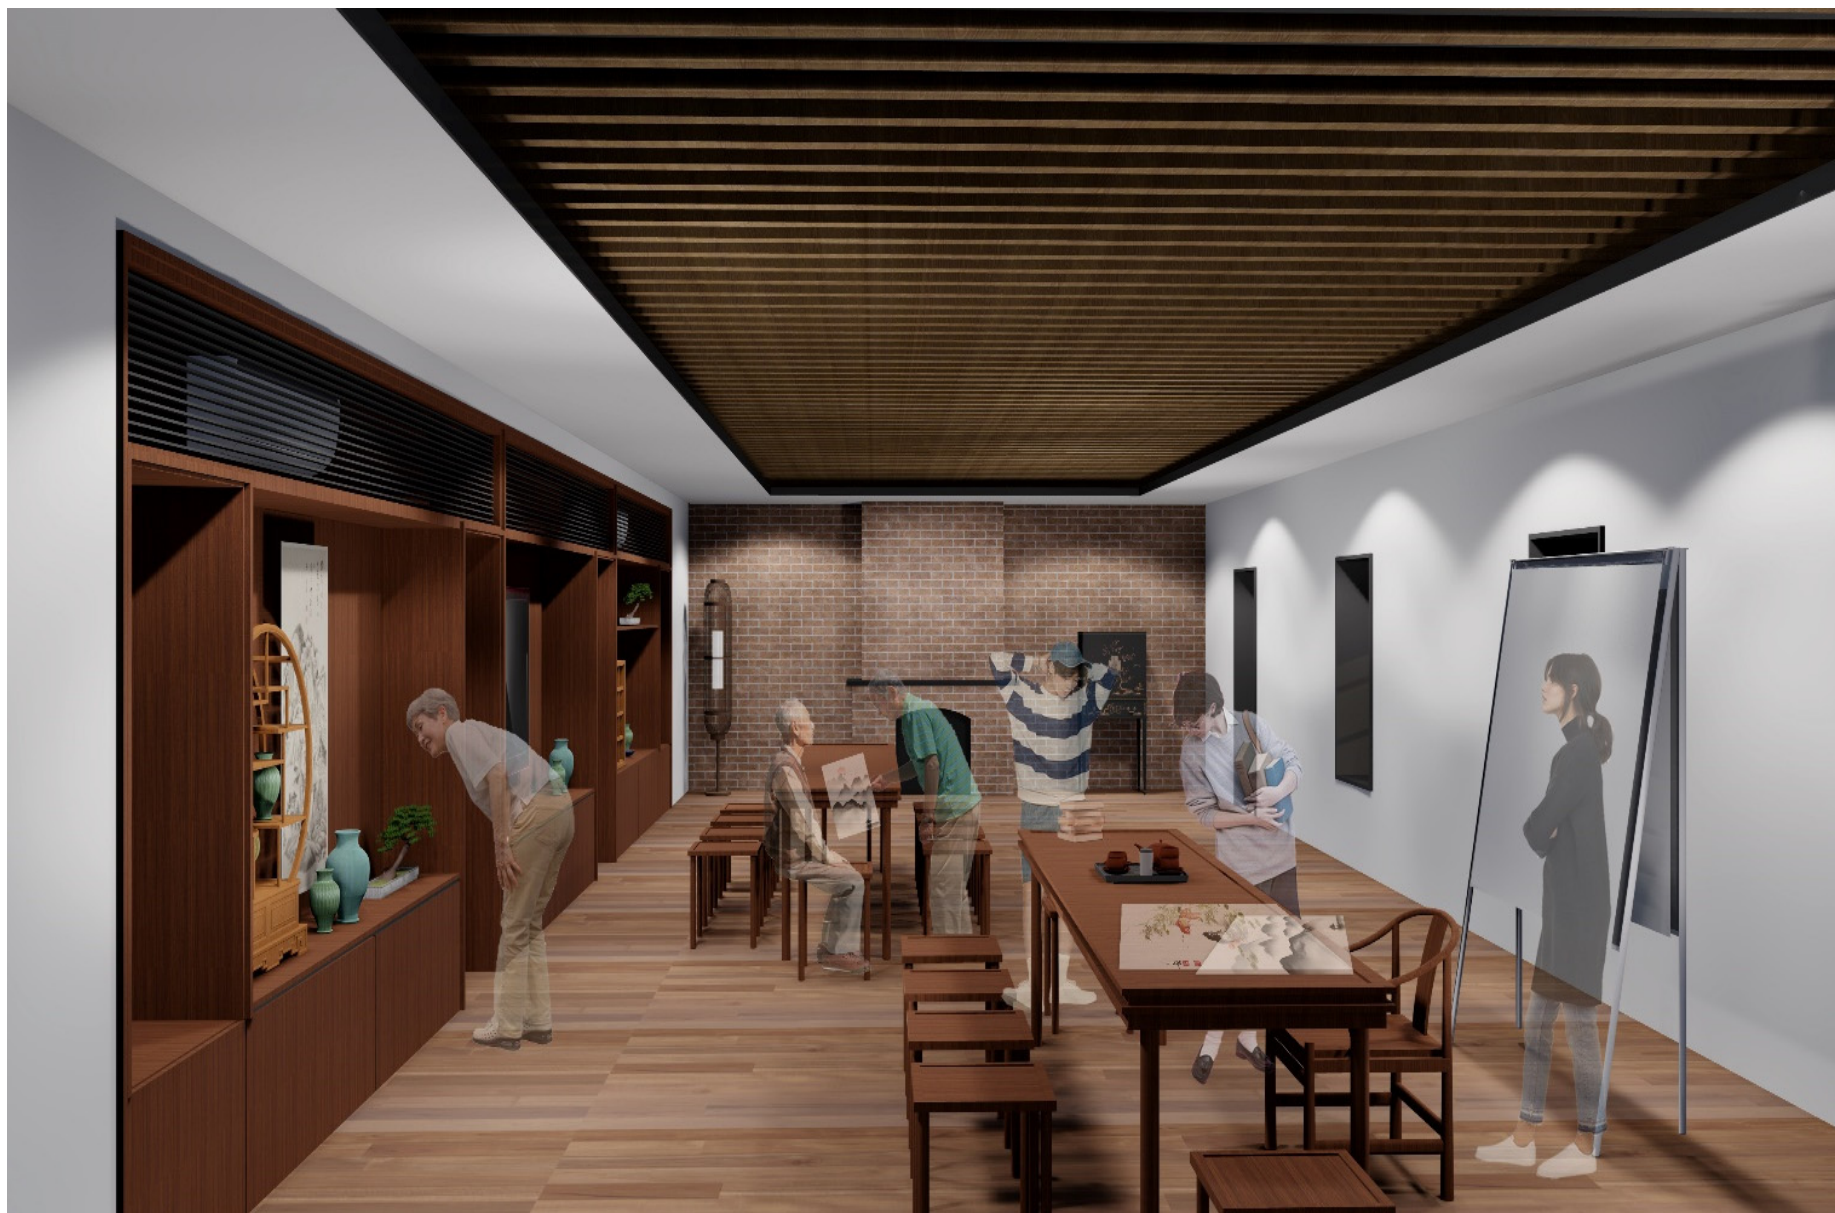
View of the proposed multi-purpose room in Block 58 (FRP enhancement option 1)

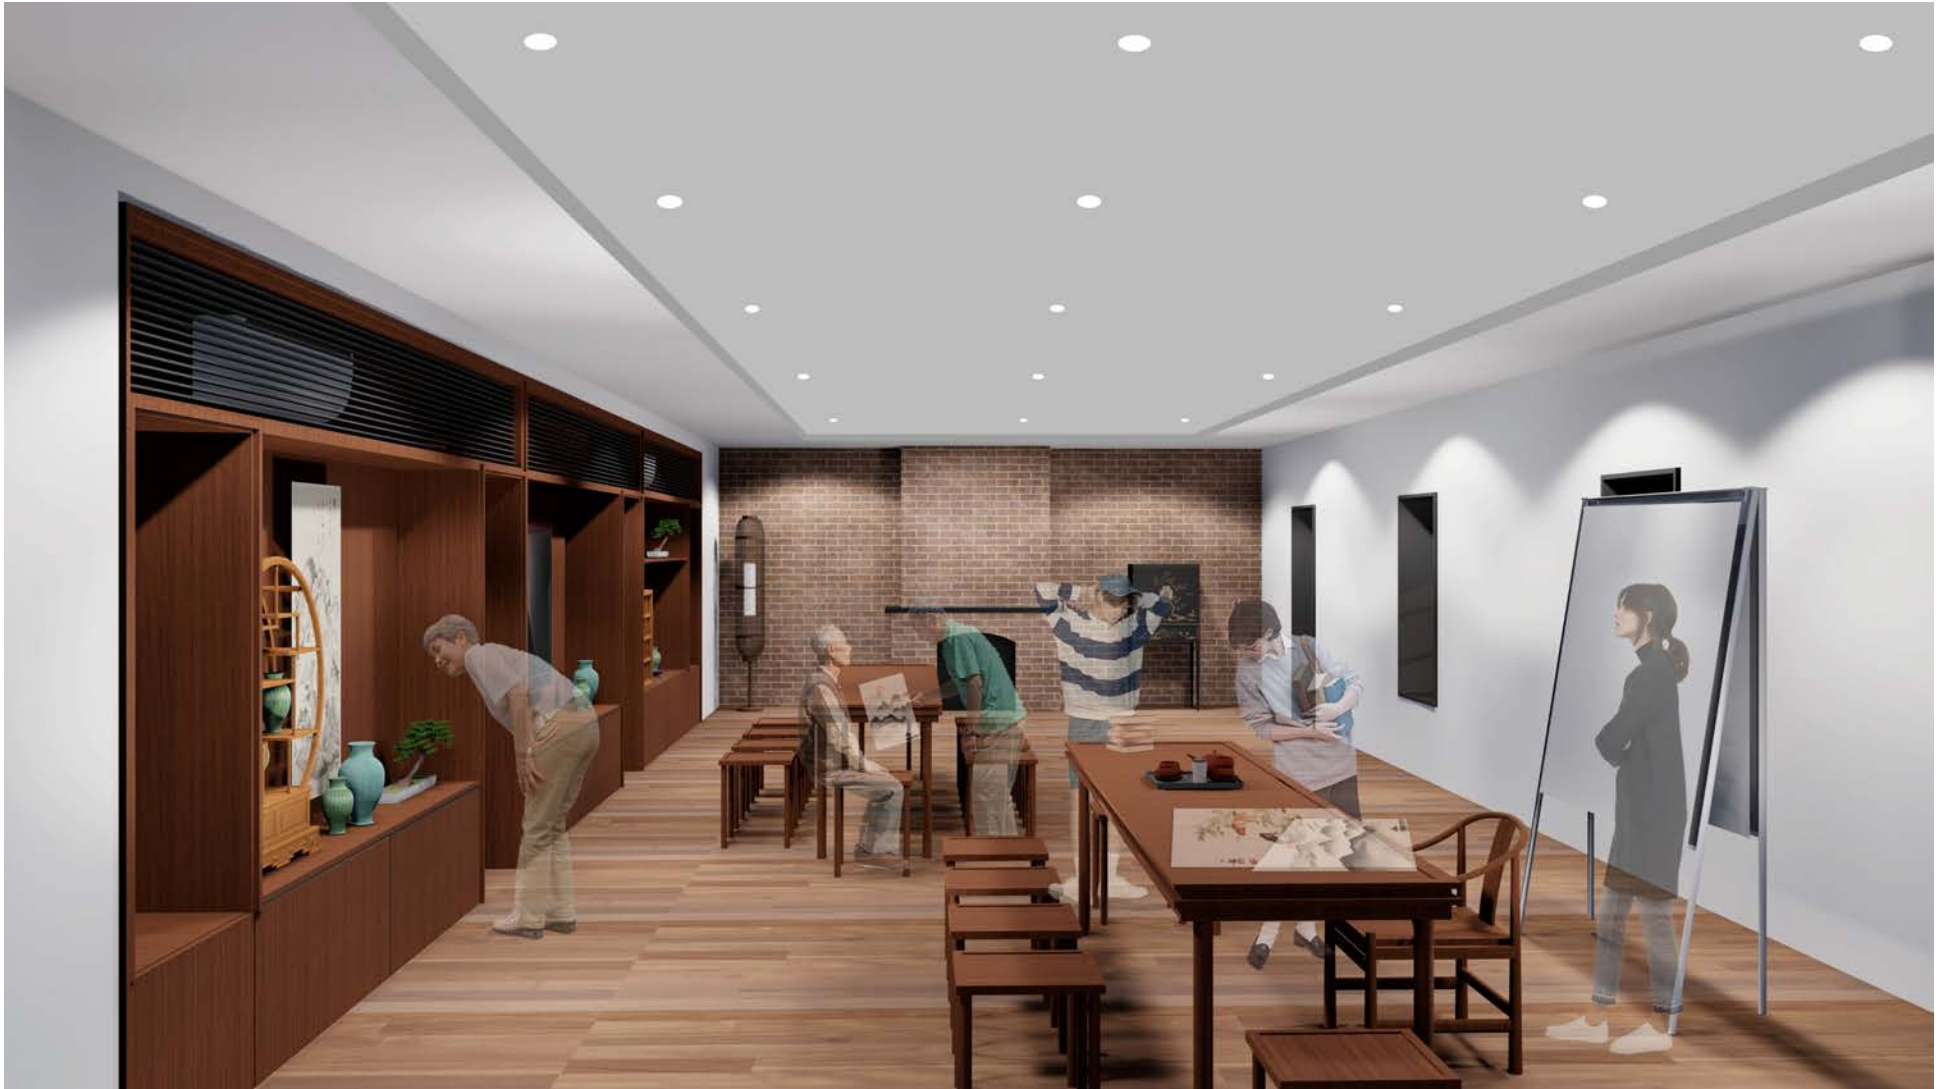
View of the proposed multi-purpose room in Block 58 (FRP enhancement option 2)

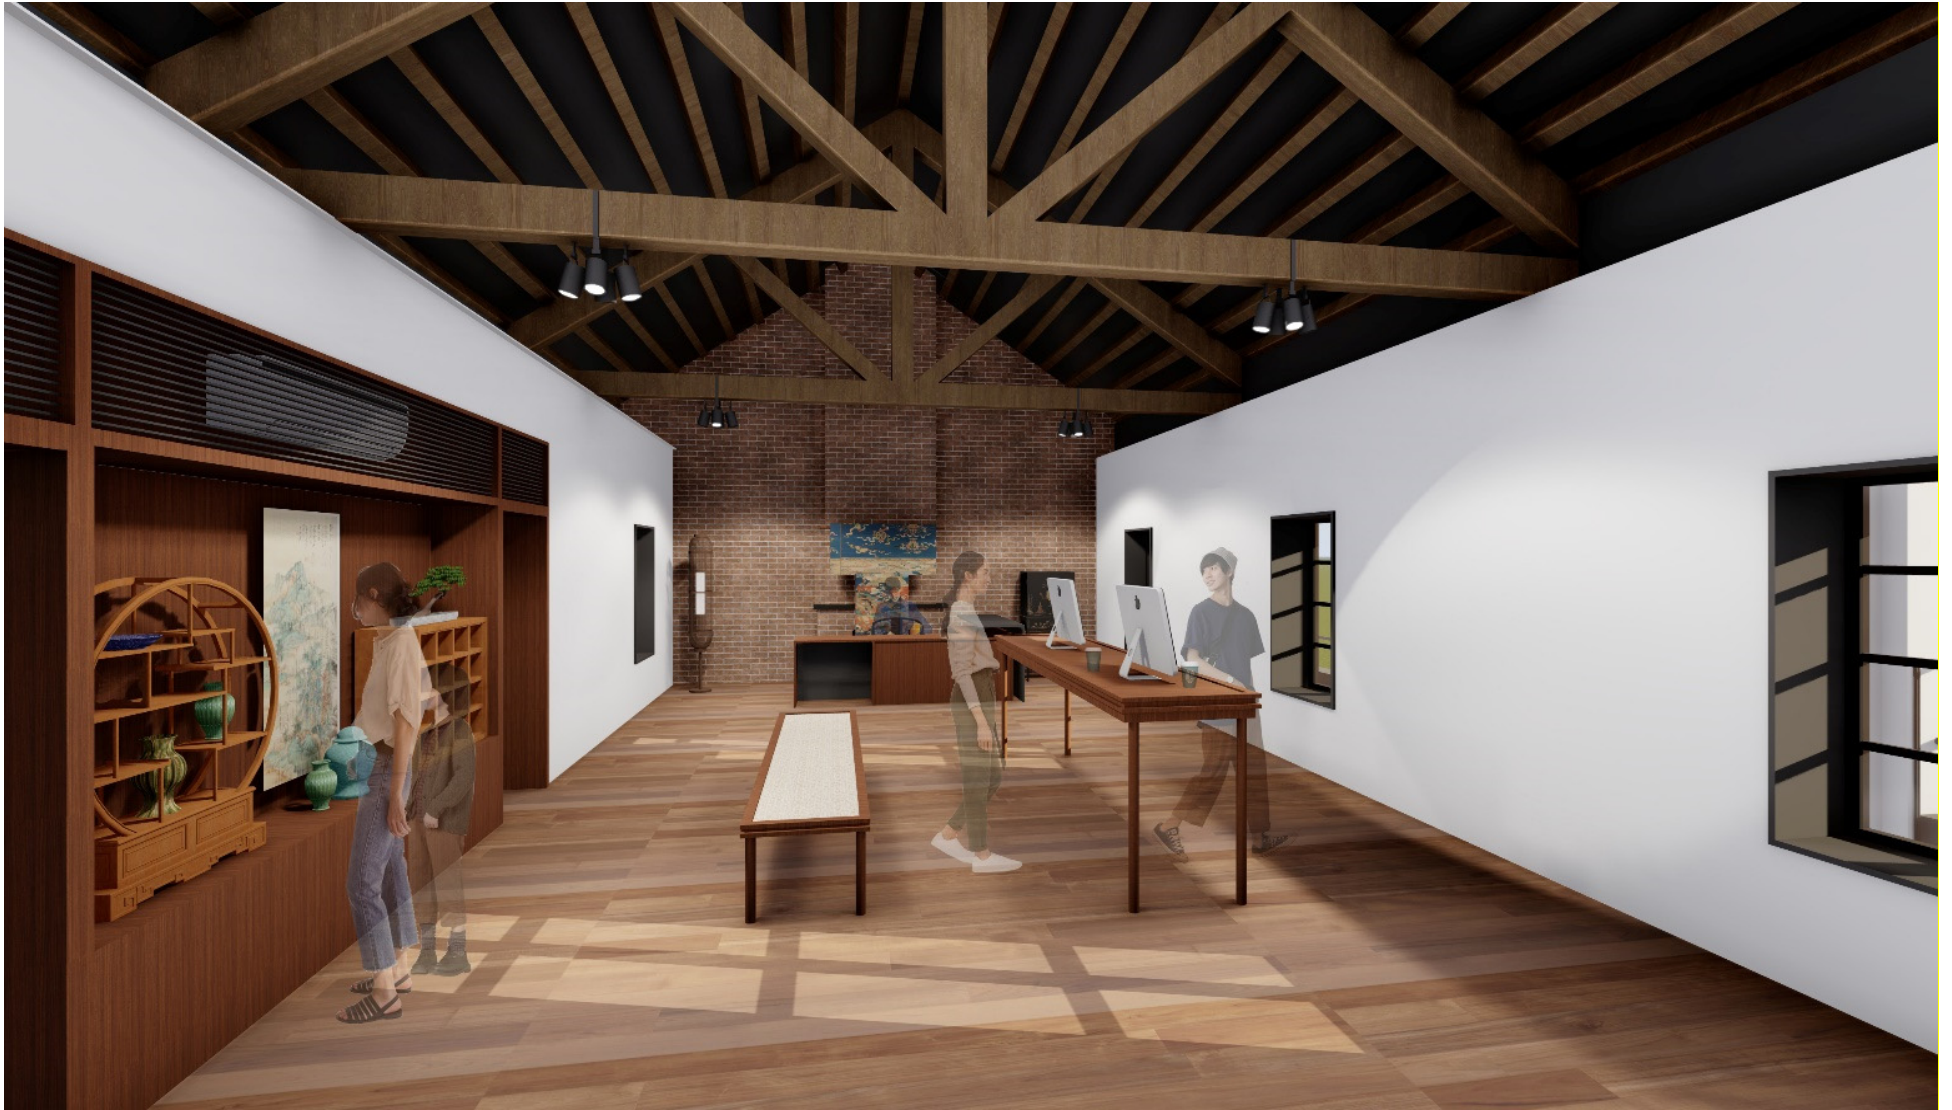
View of the proposed study room in Block 58
