**HERITAGE IMPACT ASSESSMENT IN RESPECT OF SITE FORMATION  
AND INFRASTRUCTURE WORKS FOR PUBLIC HOUSING  
DEVELOPMENTS AT MA ON SHAN TSUEN ROAD –  
INVESTIGATION, DESIGN AND CONSTRUCTION**

**BACKGROUND**

Civil Engineering and Development Department (CEDD) commissioned an Engineering Feasibility Study (EFS), “Site Formation and Infrastructural Works for Eight Housing Sites in Ma On Shan – Feasibility Study” (Agreement No. CE 80/2014 (CE)), in April 2015 to ascertain the technical feasibility of the potential sites for the public and private housing developments. Several sites at the mid-level of Mount Ma On Shan along the Ma On Shan Tsuen Road (MOSTR) have been identified as potential sites for public housing developments to suit the local community. Based on this result, CEDD is tasked to carry out the corresponding investigation, detailed design and implementation of site formation and infrastructure works so as to handover the sites to the implementation agents for construction of public housing and other supporting infrastructures. As such, CEDD commissioned a consultancy agreement, “Site Formation and Infrastructure Works for Public Housing Developments at Ma On Shan Tsuen Ro

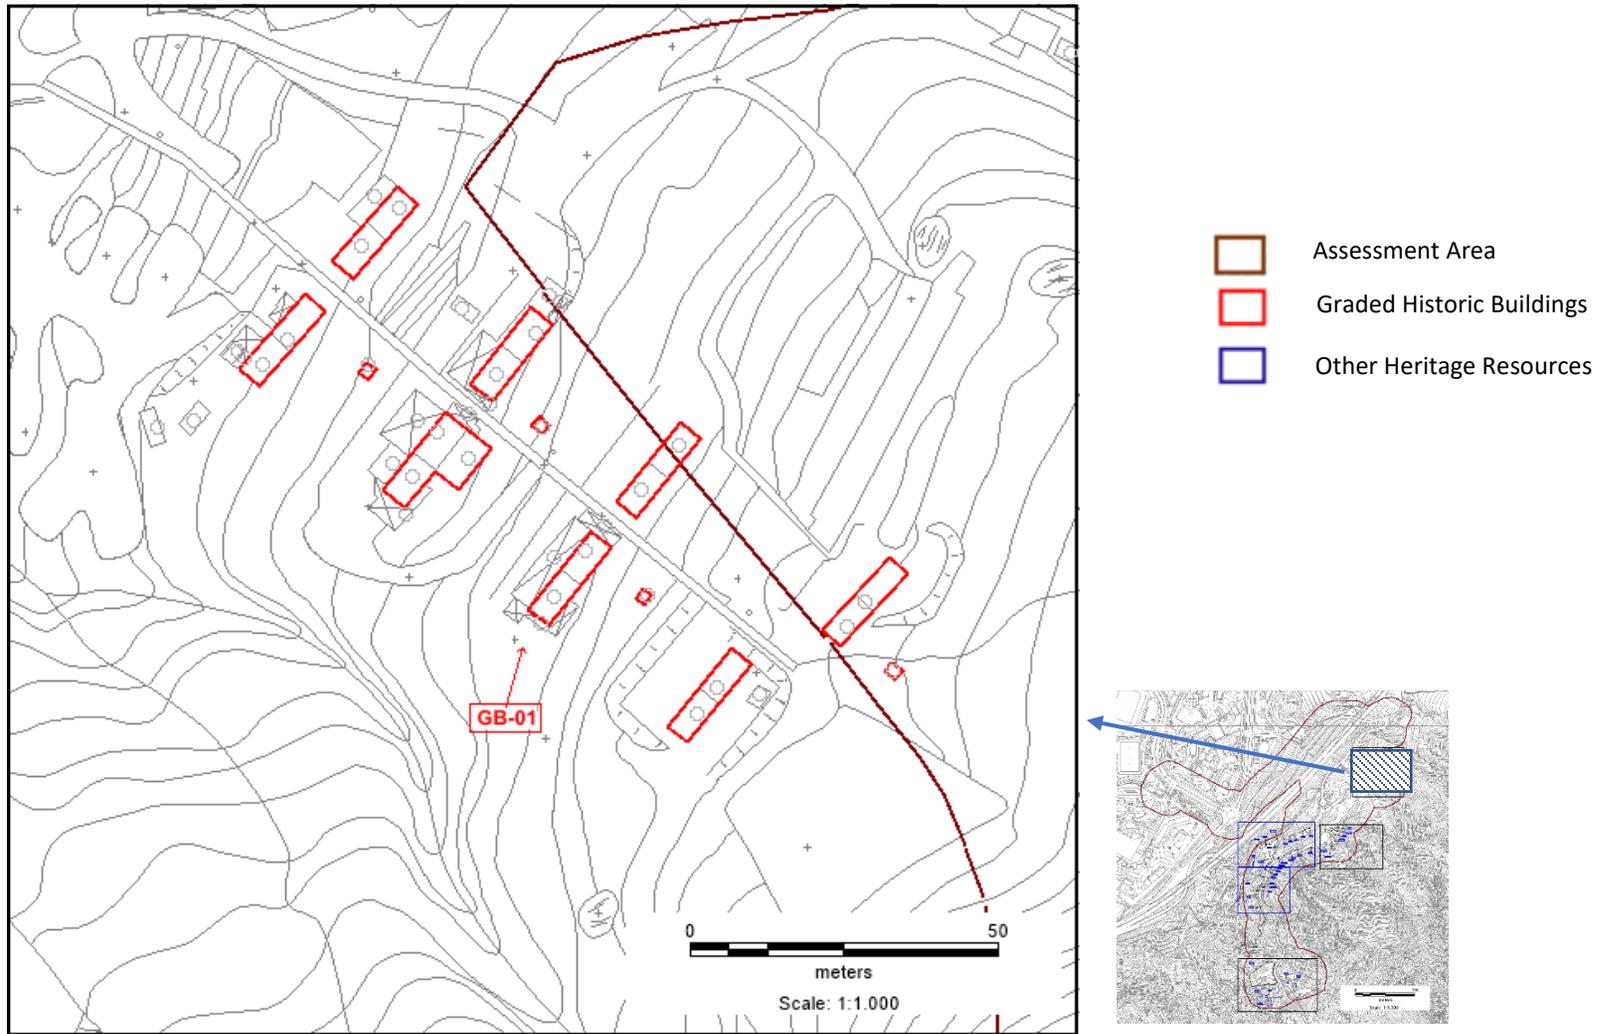
**Figure 1**  
**3 Historic Structure**

**GB-01 – the Site Structures at Mining Settlement (Shun Yee San Tsuen), Ma On Shan Iron Mine, Sha Tin, N.T. Grade**

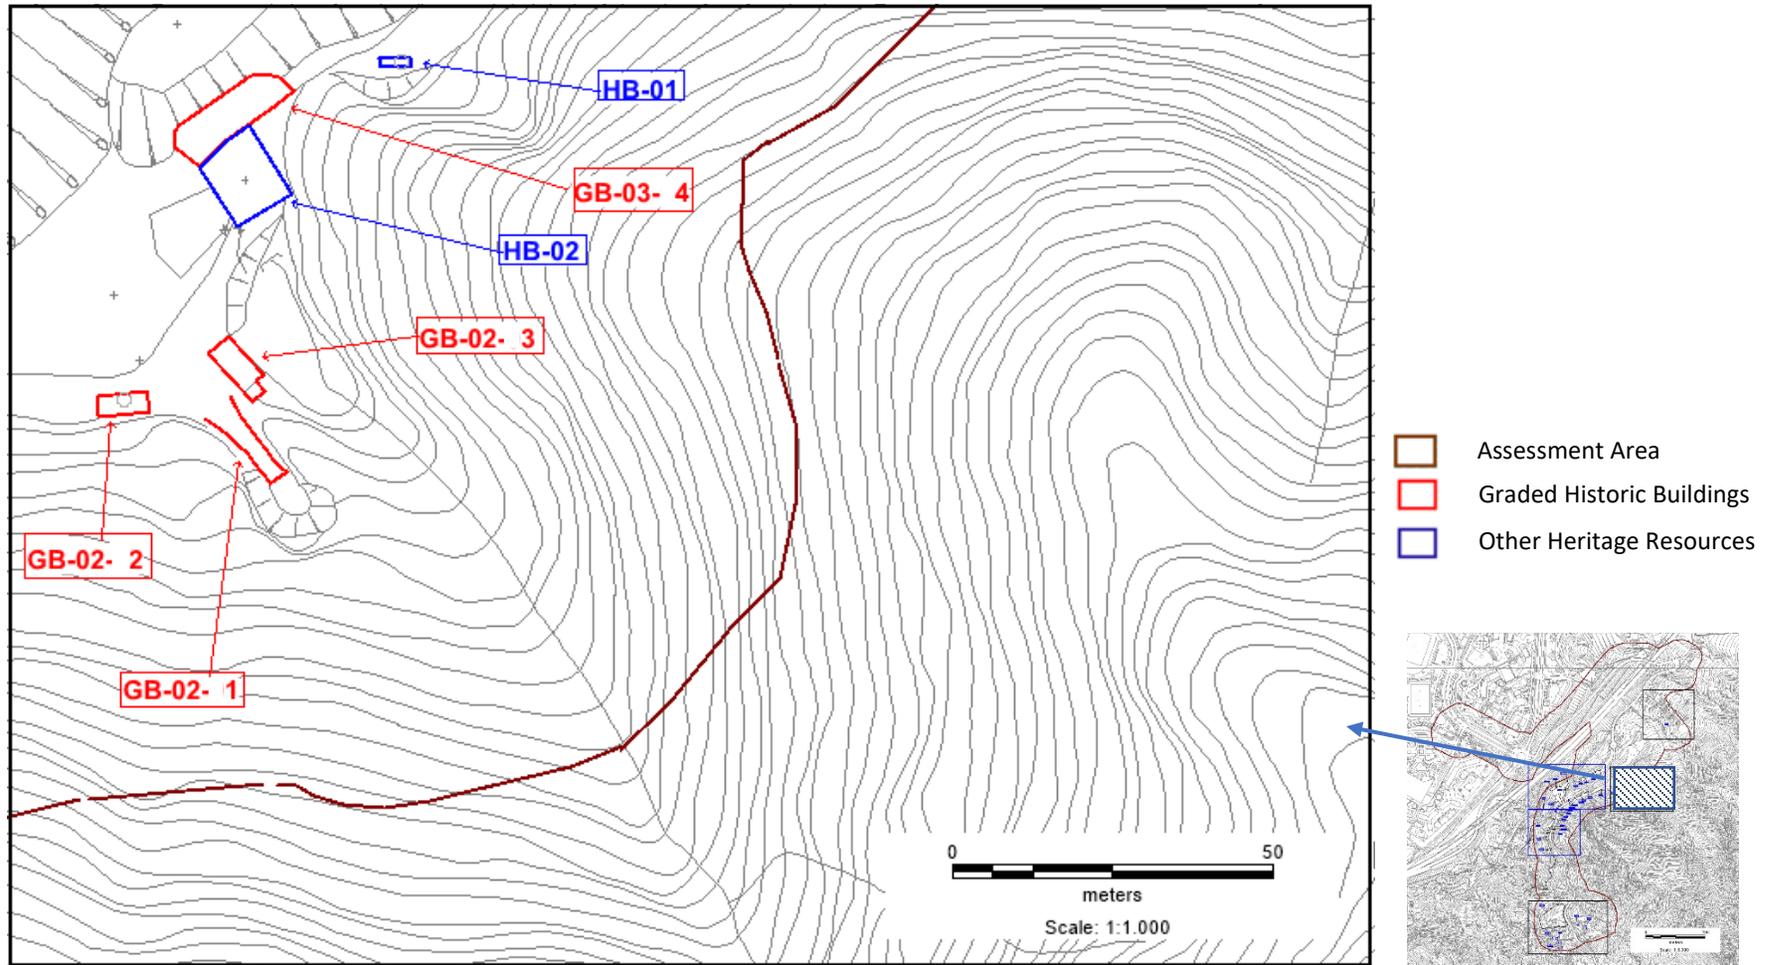
**Figure 2** *The Exterior Wall of 110ML (1963) part of Grade 2 Historic Structure Exterior walls of 240 ML and 110 ML, Ma On Shan Iron Mine, Sha Tin, N.T.; including GB-02-1: 110 ML exterior walls and portal; GB-02-2: Office; GB-02-3: Engine room; GB-02-4: Rail tracks, and other heritage resources: HB-01: Toilet building and HB-02: Remains of building/location to store or repair ore bearing carts.*

HIA Report item	Heritage Site	Remarks	Mitigation Measures
<b>GB-02</b> Grade 2	The Exterior Wall of 110ML (1963) part of Grade 2 Historic Structure Exterior walls of 240 ML and 110 ML, Ma On Shan Iron Mine		
	<ul style="list-style-type: none"> <li>• <b>GB-02-1</b> (110 ML exterior walls and portal) (<b>Figure 2</b>)</li> </ul>	Outside the limits of works area.	Preserved in-situ
	<ul style="list-style-type: none"> <li>• <b>GB-02-2</b> (Office) (<b>Figure 2</b>)</li> </ul>	Outside the limits of works area.	Preserved in-situ
	<ul style="list-style-type: none"> <li>• <b>GB-02-3</b> (Engine room) (<b>Figure 2</b>)</li> </ul>	Outside the limits of works area.	Preserved in-situ
	<ul style="list-style-type: none"> <li>• <b>GB-02-4</b> (Tail tracks) (<b>Figure 2</b>)</li> </ul>	Outside the limits of works area.	Preserved in-situ
<b>GB-03</b> Grade 3	Mineral Preparation Plant, Ma On Shan Iron Mine, Sha Tin, New Territories

HIA Report item	Heritage Site	Remarks	Mitigation Measures
HB-01	Toilet marked on 1969 map ( <b>Figure 2</b> )	Within the limits of works area.	Preserved in-situ
HB-02	Remains of building/location to store or repair ore bearing carts ( <b>Figure 2</b> )	Within the limits of works area.	Preserved in-situ
HB-03	Electric transformer building ( <b>Figure 3</b> )	Within limits of works area.	Preserved in-situ
HB-04	Electric Sub-station ( <b>Figure 3</b> )	Outside the limits of works area.	Preserved in-situ

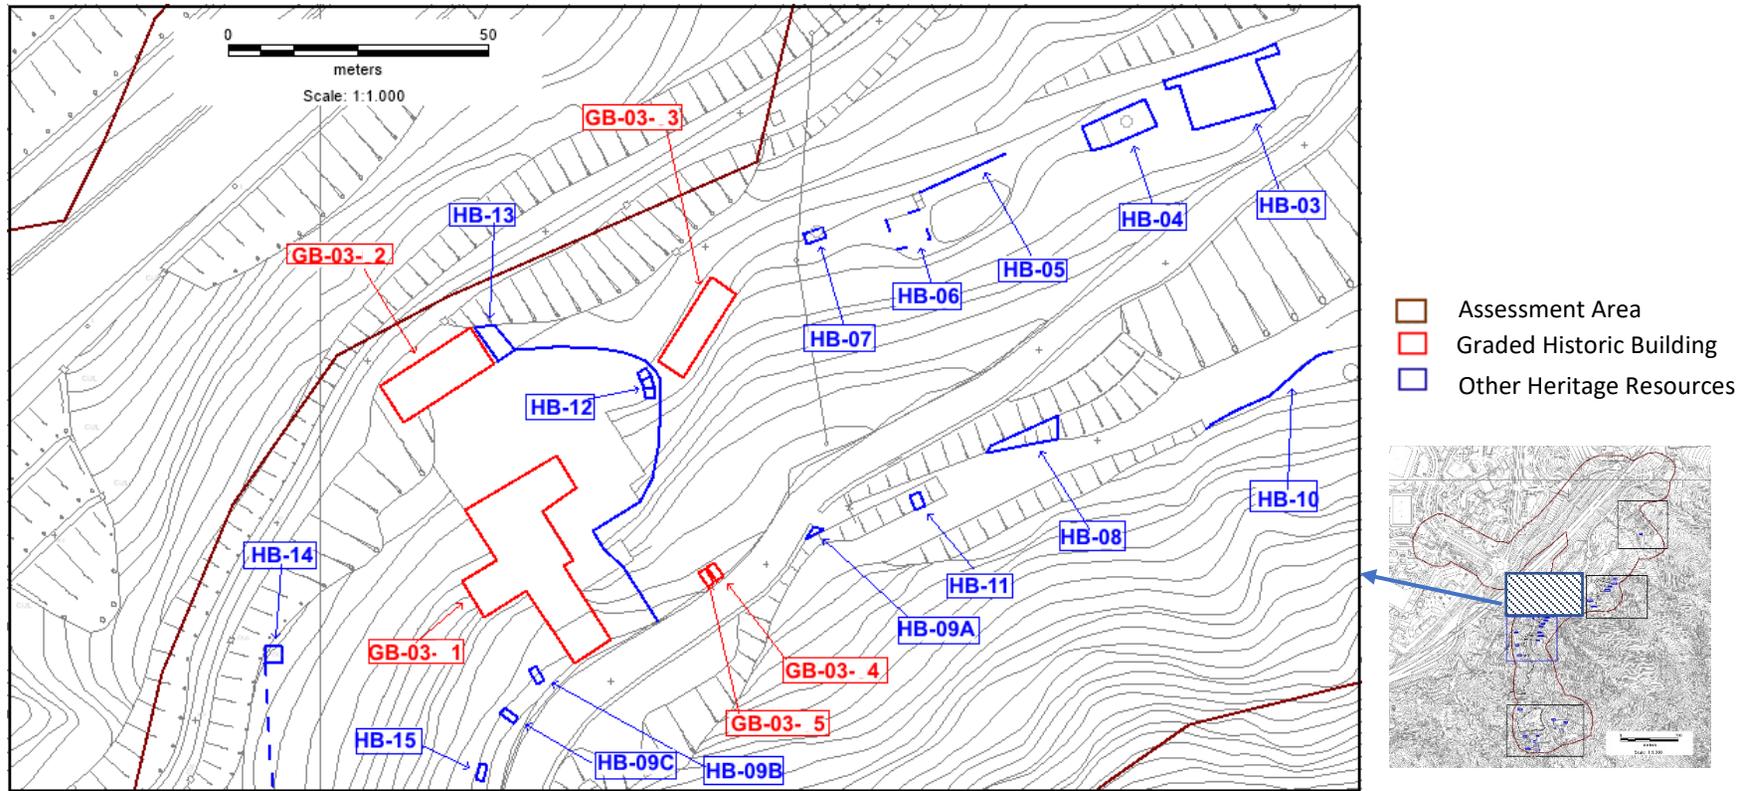
**Figure 3** *Mineral Preparation Plant (1954), Ma On Shan Iron Mine, Sha Tin, N.T. Grade 3 Historic Structure; including GB-03-1: Main Mineral Preparation Plant building; GB-03-2: Structure for Stock-piles; GB-03-3: An office set up there to supervise the operation of the ore-dressing plant; GB-03-4 and GB-03-5: Pillars forming connection between 110ML portal and mineral preparation plant, and other heritage resources: HB-03: Electric transformer platform; HB-04: Electric Sub-station; HB-05: Stone foundation of a temporary structure; HB-06: Collapsed building; HB-07: Toilet building; HB-08: Concrete retaining wall with buttress; HB-09A to 9C: pillar; HB-10: stone and concrete retaining wall; HB-11: water tank; HB-12: Thickener tank; HB-13: two sets of stairs part of the Mineral preparation plant; HB-14: Transmission building connected to main MPP by overhead conveyor belt and HB-15: Concrete solid support for rail track*

<ul style="list-style-type: none"> <li>• <b>GB-03-1</b> (Main Mineral Preparation Plant (MPP) building) (<b>Figure 3</b>)</li> </ul>	Outside the limits of works area.	Preserved in-situ
	<ul style="list-style-type: none"> <li>• <b>GB-03-2</b> (Structure for stock-piles) (<b>Figure 3</b>)</li> </ul>	Outside the limits of works area.	Preserved in-situ
	<ul style="list-style-type: none"> <li>• <b>GB-03-3</b> (An office set up there to supervise the operation of the ore-dressing plant) (<b>Figure 3</b>)</li> </ul>	Outside the limits of works area.	Preserved in-situ

HIA Report item	Heritage Site	Remarks	Mitigation Measures
	<ul style="list-style-type: none"> <li><b>GB-03-4, GB-03-5</b> (Pillars forming connection between 110ML portal and MPP) (<b>Figure 3</b>)</li> </ul>	Outside the limits of works area.	Preserved in-situ
	<ul style="list-style-type: none"> <li><b>GB-03-6</b> (Water tank) (<b>Figure 4</b>)</li> </ul>	Outside the limits of works area.	Preserved in-situ

HB-05	Stone foundation of a temporary structure visible on 1963 and 1964 aerial photos <b>(Figure 3)</b>	Outside the limits of works area.	Preserved in-situ
HB-06	Collapsed building, function not known but is visible on 1963 aerial photo <b>(Figure 3)</b>	Outside the limits of works area.	Preserved in-situ
HB-07	Toilet built <b>(Figure 3)</b>	Outside the limits of works area.	Preserved in-situ
HB-08	Concrete retaining wall with buttress <b>(Figure 3)</b>	Within limits of works area.	Preserved in-situ
HB-09A	Another pillar forming connection between 110ML portal and mineral preparation plant <b>(Figure 3)</b>	Outside the limits of works area.	Preserved in-situ
HB-09B and HB-09C	Two further pillars recorded to the west of the Mineral Preparation Plant <b>(Figure 3)</b>	Outside the limits of works area.	Preserved in-situ
HB-10	Stone and concrete retaining wall <b>(Figure 3)</b>	Within limits of works area.	Preserved in-situ

HB-11	Water tank <b>(Figure 3)</b>	Outside the limits of works area	Preserved in-situ
HB-12	Former thickener tank <b>(Figure 3)</b>	Outside the limits of works area.	Preserved in-situ
HB-13	Two sets of stairs part of the main MPP <b>(Figure 3)</b>	Outside the limits of works area.	Preserved in-situ

HB-14	Transmission building connected to main MPP by overhead conveyor belt <b>(Figure 3)</b>	Outside the limits of works area.	Preserved in-situ
HB-15	Concrete solid support for rail track. <b>(Figure 3)</b>	Outside the limits of works area.	Preserved in-situ
HB-16	Concrete and stone support for rail track with stone barrier wall.  Support part of the first electric train operation in Hong Kong <b>(Figure 4)</b>	Outside the limits of works area.	Preserved in-situ
HB-17	Stone retaining wall next to main road above water tank <b>(Figure 4)</b>	Outside the limits of works area.	Preserved in-situ
HB-18	Small stone building next to water tank <b>(Figure 4)</b>	Outside the limits of works area.	Preserved in-situ
HB-19	Pipeline with retaining wall on steep slopes <b>(Figure 4)</b>	Outside the limits of works area.	Preserved in-situ
HB-20	Catchwater <b>(Figure 4)</b>	Outside the limits of works area.	Preserved in-situ

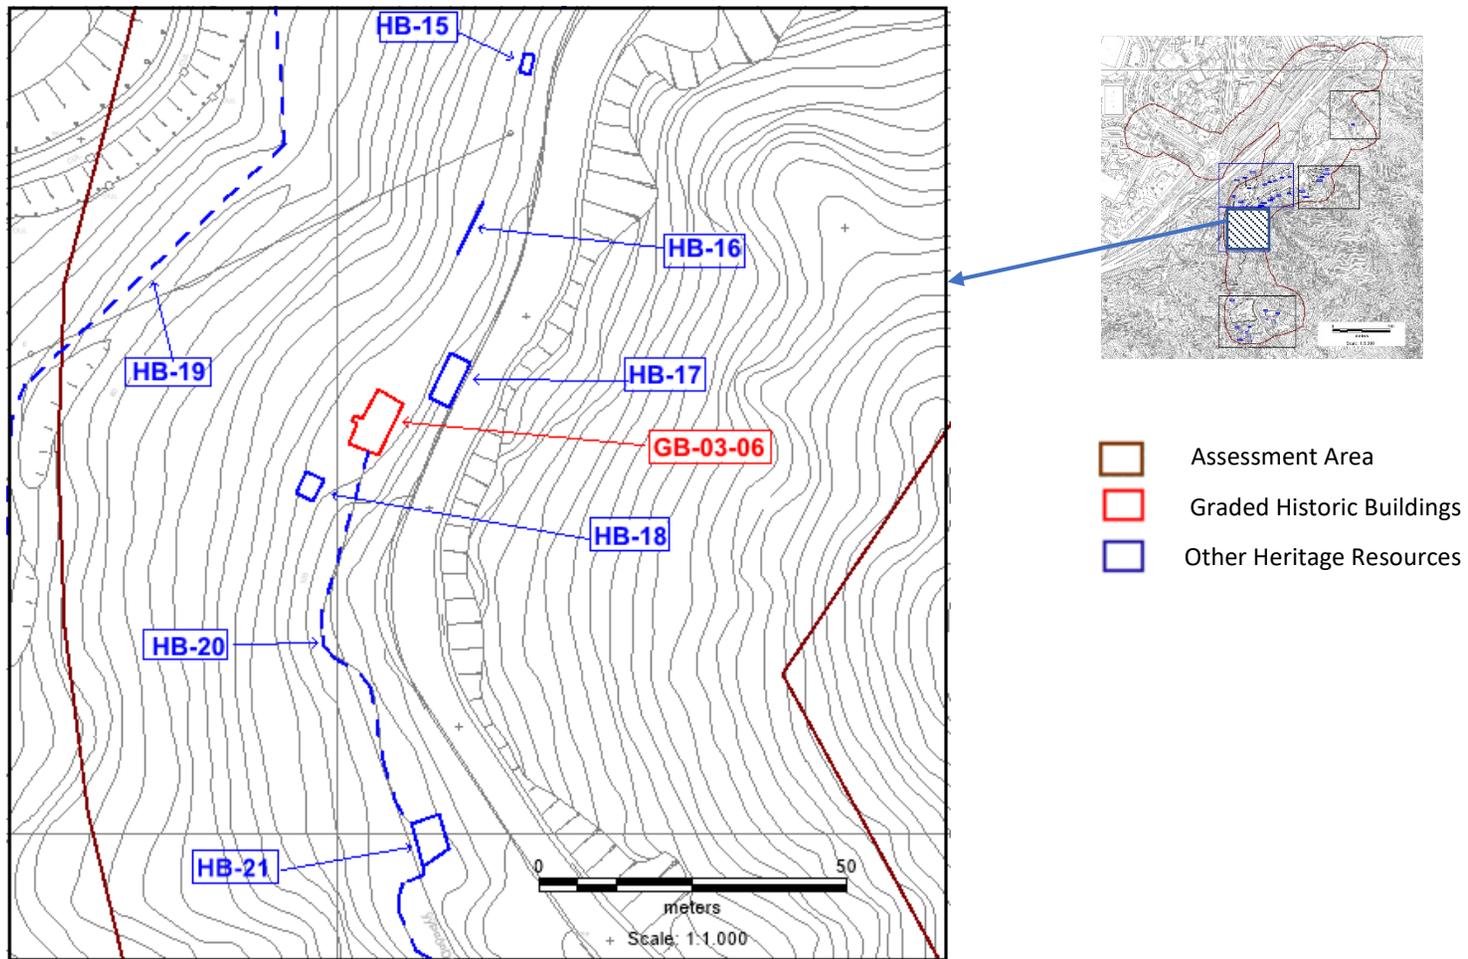
**Figure 4** *Mineral Preparation Plant (1954), Ma On Shan Iron Mine, Sha Tin, N.T. Grade 3 Historic Structure; GB-03-6: Water Tank, and other heritage resources: HB-15: concrete solid support for rail track; HB-16: concrete and stone support for rail track with stone barrier wall; HB-17: Stone retaining wall next to main road above water tank; HB-18: Small stone building next to water tank; HB-19: Pipeline with retaining wall on steep slopes, HB-20: Catch water and HB-21: Catch water tank*

HB-21	Catchwater tank <b>(Figure 4)</b>	Outside the limits of works area.	Preserved in-situ
HB-22	Ore waste dump <b>(Figure 5)</b>	Within the limits of works area.	Preserved in-situ

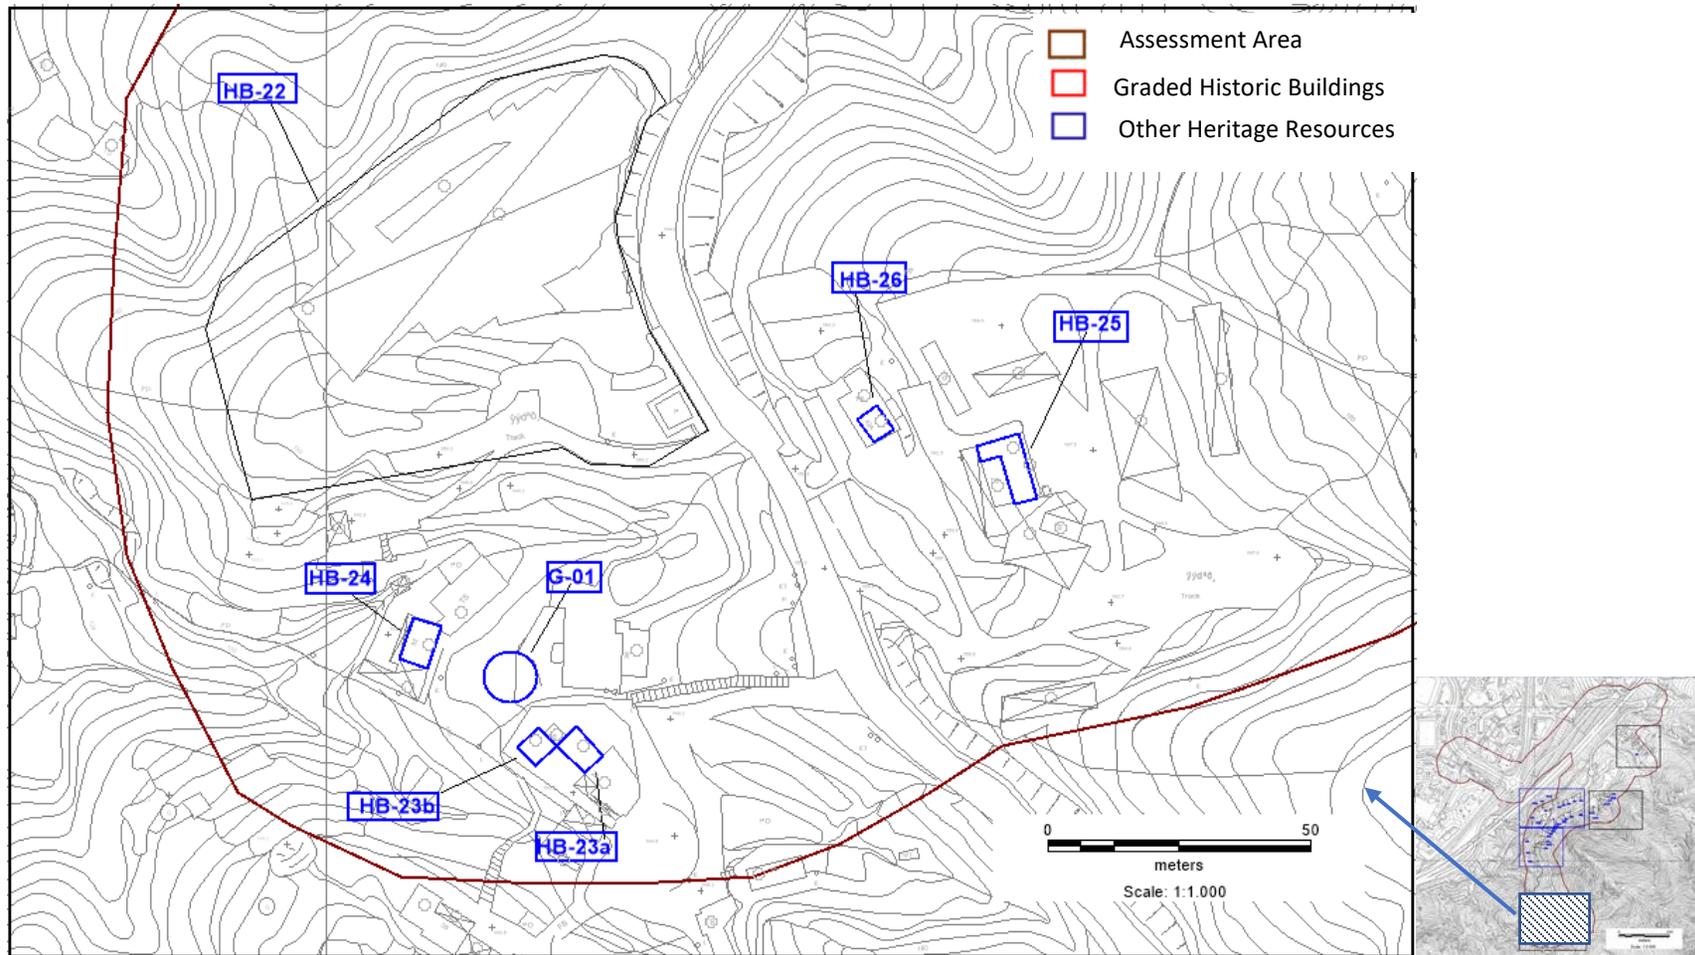
**Figure 5** Other heritage resources: HB-22: ore waste dump, HB-23 to 26: residential houses and G-01: the Yau family Qing dynasty grave dated to 13<sup>th</sup> year of Guangxu period

HB-23a and HB-23-b	Village houses ( <b>Figure 5</b> )	Outside the limits of works area.	Preserved in-situ
HB-24	Village house ( <b>Figure 5</b> )	Outside the limits of works area.	Preserved in-situ
HB-25	Village house ( <b>Figure 5</b> )	Outside the limits of works area.	Preserved in-situ
HB-26	Village house ( <b>Figure 5</b> )	Within the works area of construction of service reservoir.	To be preserved by record before demolition
G-01	A Qing dynasty grave dated to 13 <sup>th</sup> year of Guangxu period of (1884) Yau family ( <b>Figure 5</b> )	Outside the limits of works area.	Preserved in-situ
