AGREEMENT NO. CE 41/2022 (CE) - SITE FORMATION AND INFRASTRUCTURE WORKS FOR PUBLIC HOUSING DEVELOPMENT AT A KUNG NGAM VILLAGE, EASTERN – INVESTIGATION, DESIGN AND CONSTRUCTION

Heritage Impact Assessment Report (Final – Issue 2)

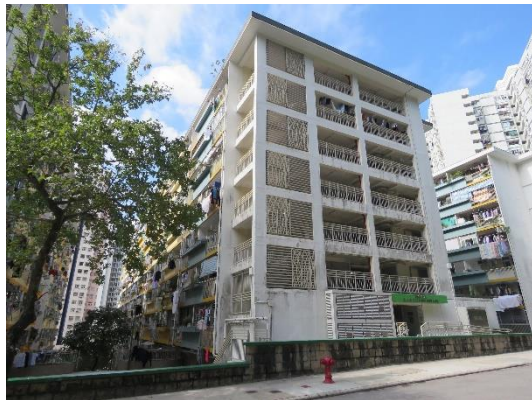
General view of Block C, showing south and east elevations, looking northwest.

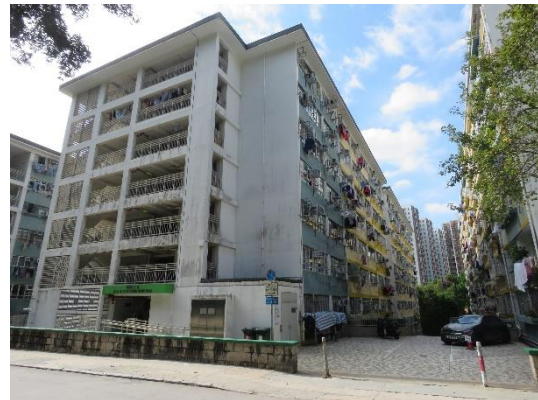
General view of Block C, showing east and north elevations, looking southwest.

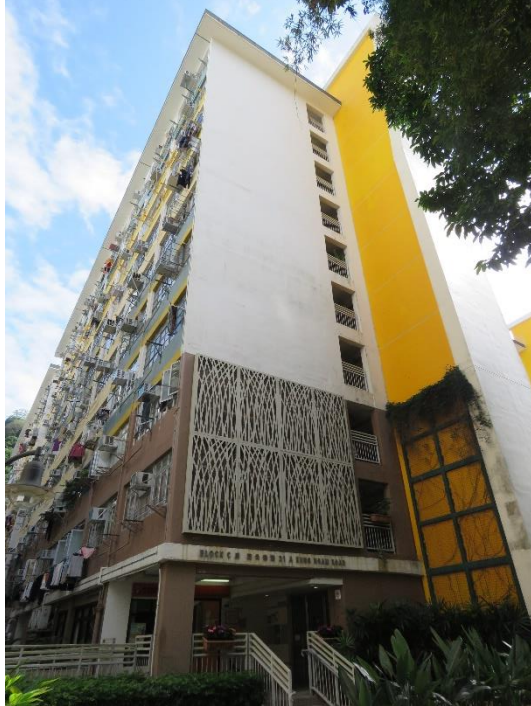
General view of Block C, showing north and west elevations, looking southeast.

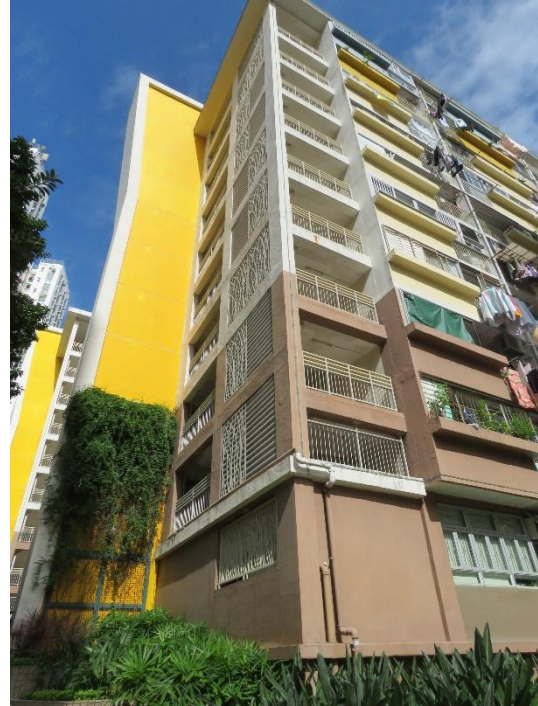
General view of Block C, showing west and south elevations, looking northeast

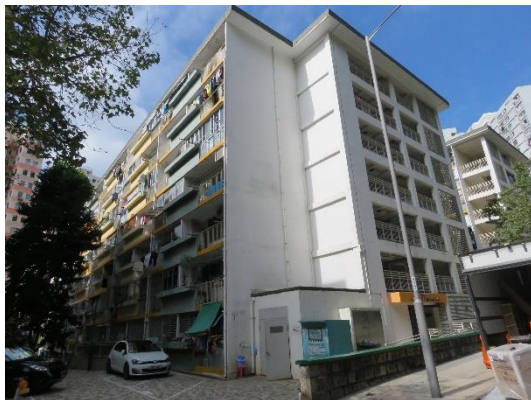
General view of Block D, showing south and east elevations, looking northwest.

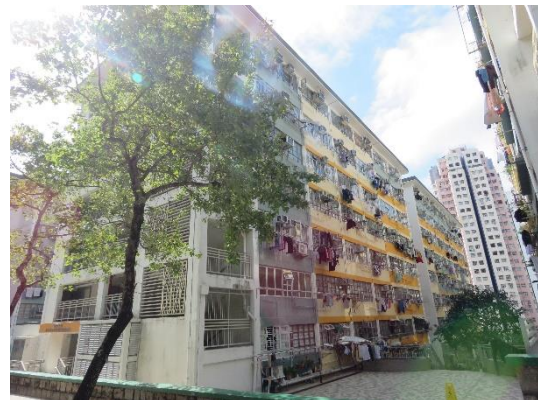
General view of Block D, showing east and north elevations, looking southwest.

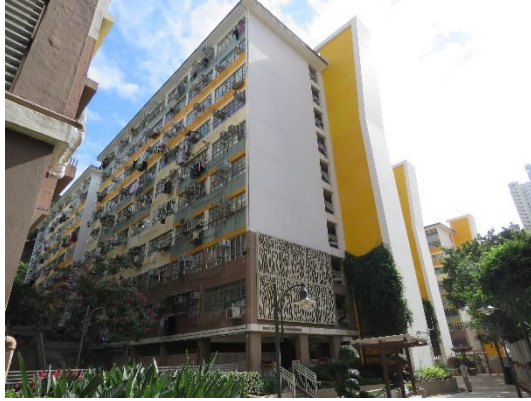
General view of Block D, showing north and west elevations, looking southeast.

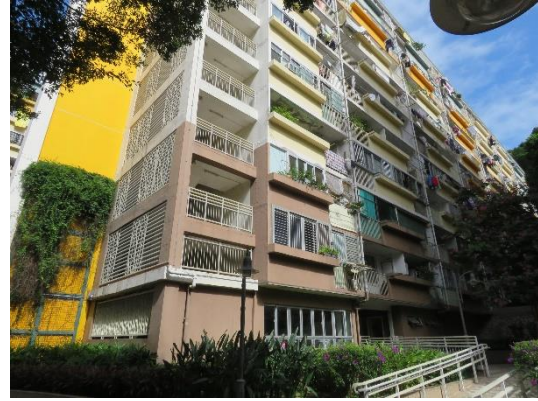
General view of Block D, showing west and south elevations, looking northeast.

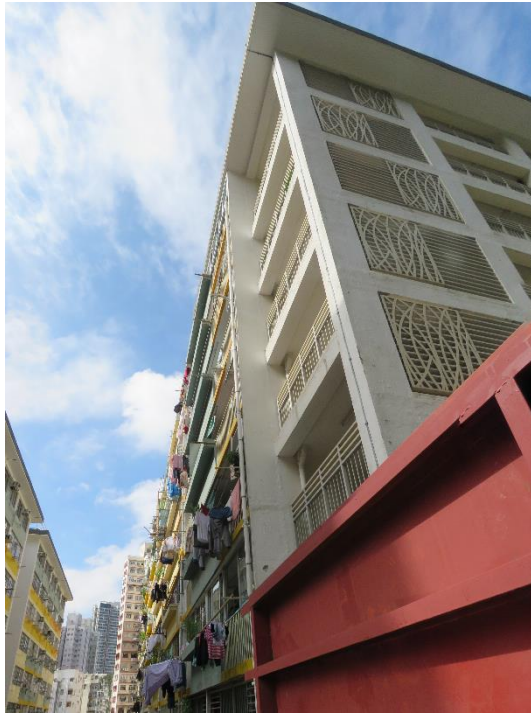
General view of Block E, showing south and east elevations, looking northwest.

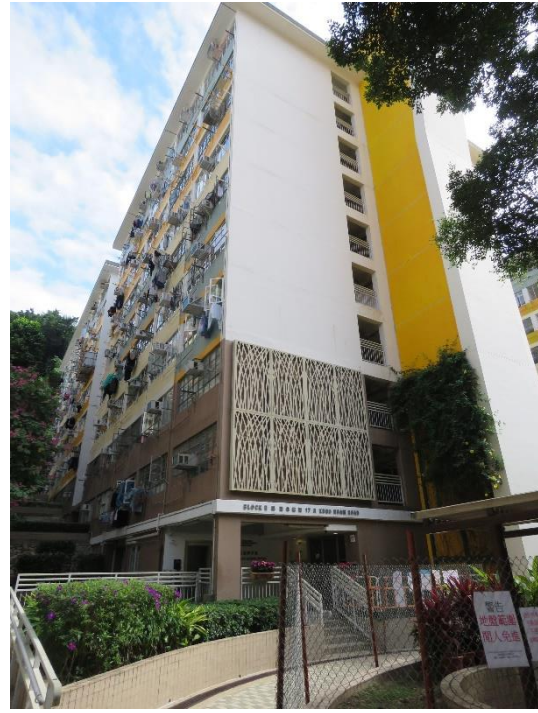
General view of Block E, showing north and west elevations, looking southeast.

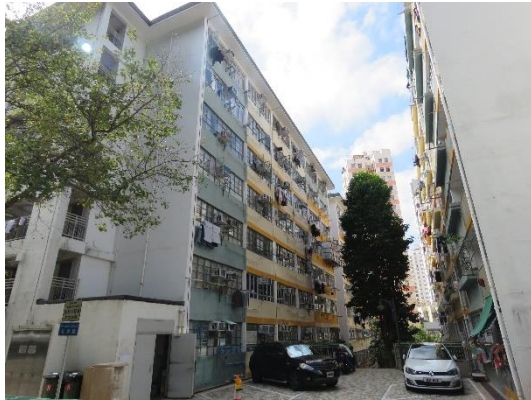
General view of Block E, showing east and north elevations, looking southwest.

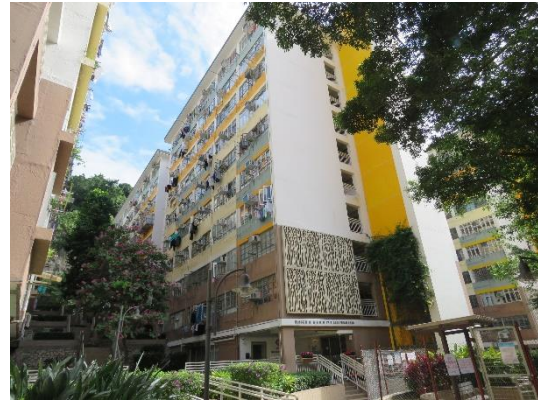
General view of Block E, showing north and west elevations, looking southeast.

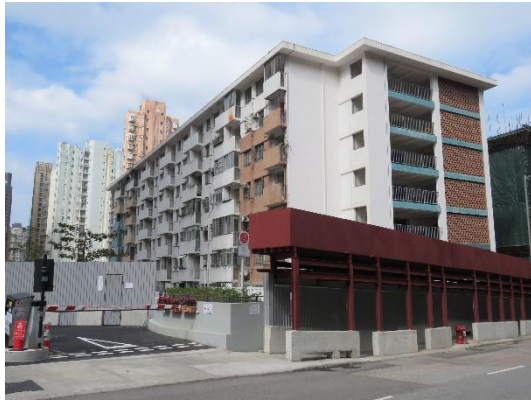
General view of Block J, showing southwest and southeast facing elevations, looking northwest.

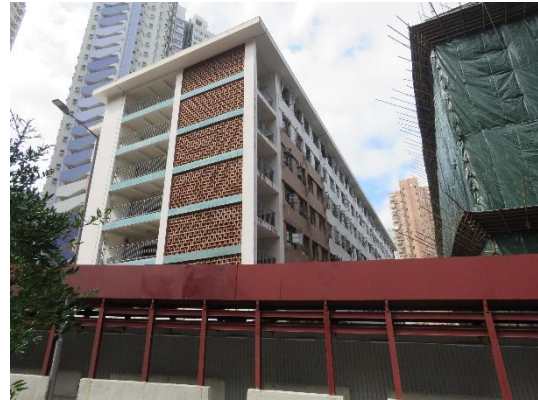
General view of Block J, showing southeast and northeast facing elevations, looking west.

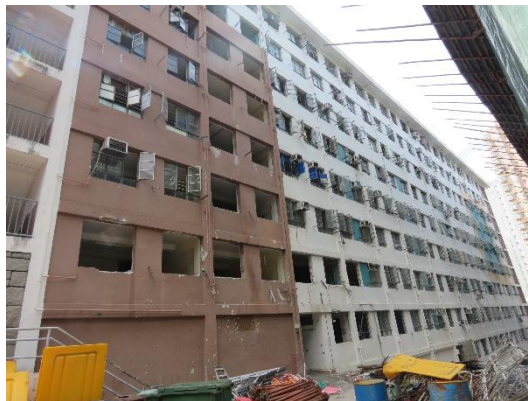
Side view of Block J, showing northeast facing elevation, looking southwest. Note building under deconstruction.

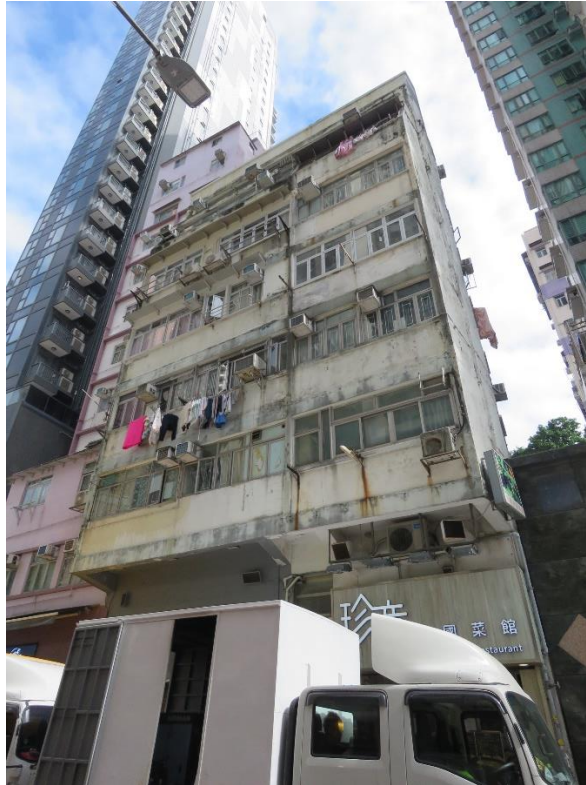
Façade view of HB-05, showing west-northwest facing elevation, looking east.

Associated Historical/ Cultural Events or Individual: None.		
<p>Architectural Appraisal:</p> <p>T-overhang twin block with central staircase and commercial ground level; seven-storey. The buildings housed 28 apartment units (HAD 2022). The top level is recessed from the façade wall. Windows on façade wall forms continuous lines spaced by wall at different levels. The ground level consists of two shops parted by staircase set in the middle. Windows are on all elevations.</p>		
Interior: No access.		
Existing Condition: Good.		
Past and Present Uses: Residential and commercial.		
Modifications: Alteration and addition works on roof in around 2016 (BRAVO no date).		
Photographic Records

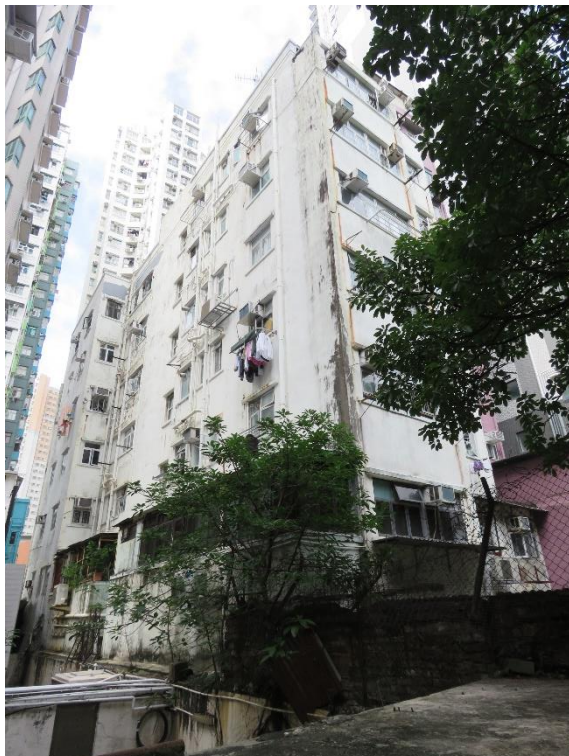
Rear and side view, showing southwest and east facing elevations, looking northwest.

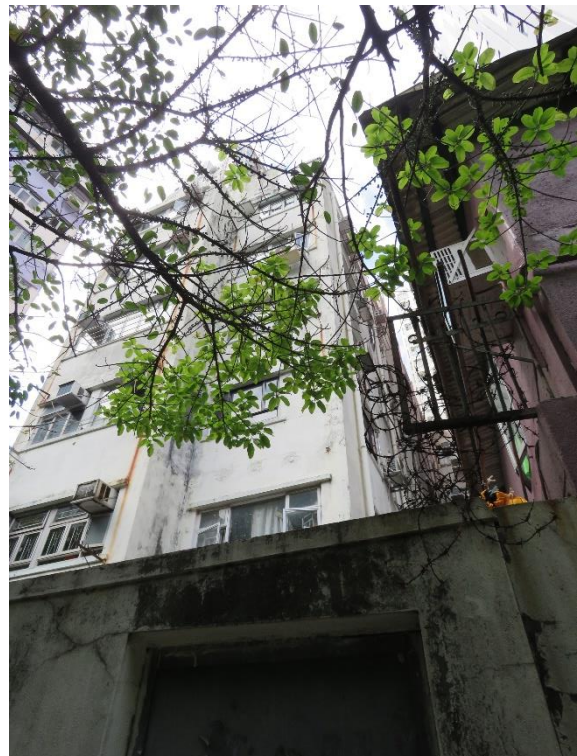
Rear and side view, showing northeast and east facing elevations, looking west.

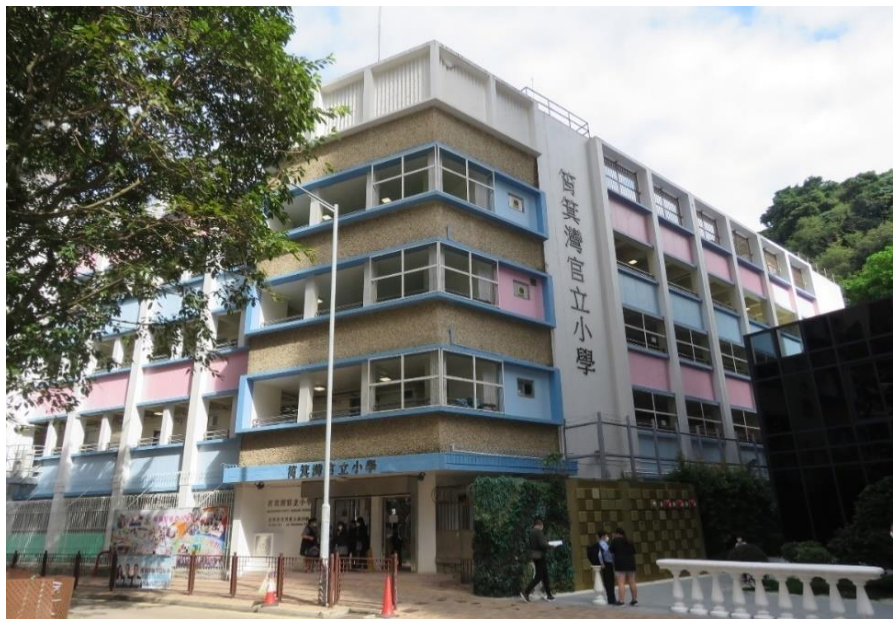
General view of HB-06, showing façade at west face and southwest facing elevation, looking northeast.

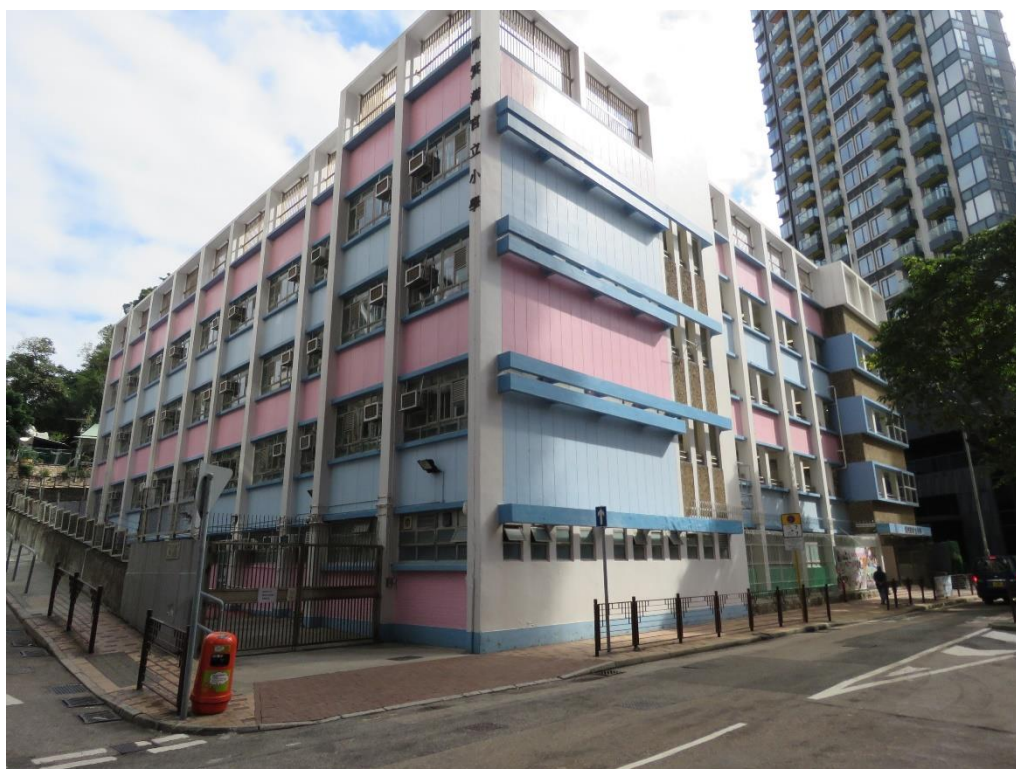
General view of HB-06, showing façade at west face and north facing elevation, looking southeast.

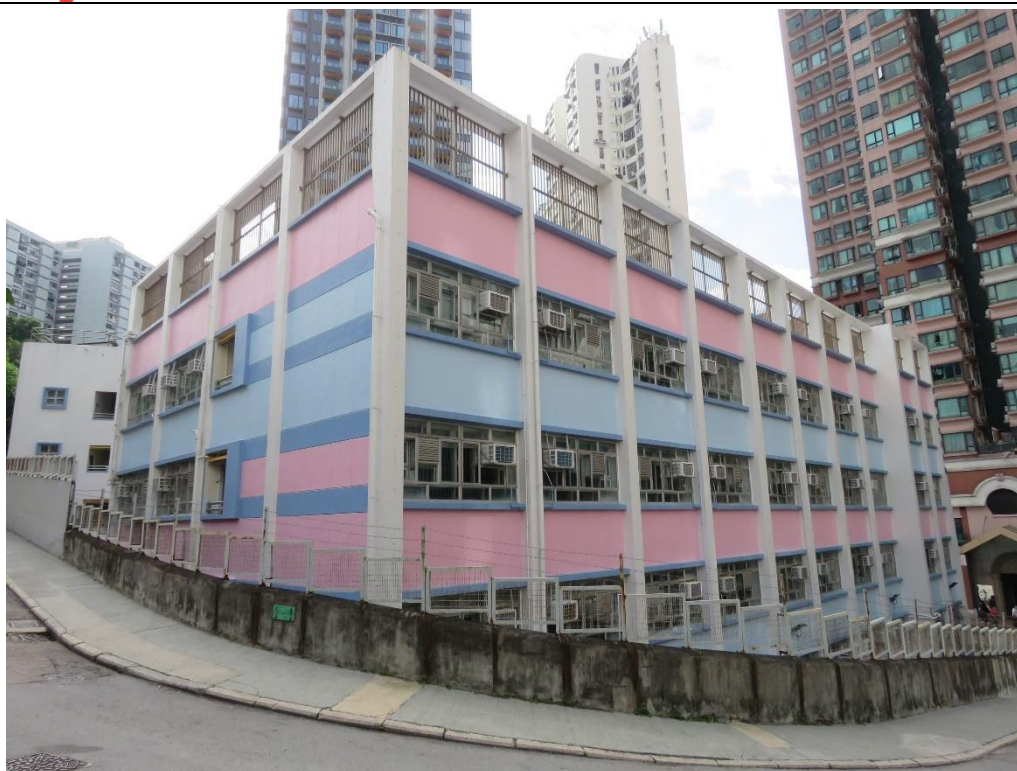
General view of HB-06, showing north and east facing elevations, looking southwest.

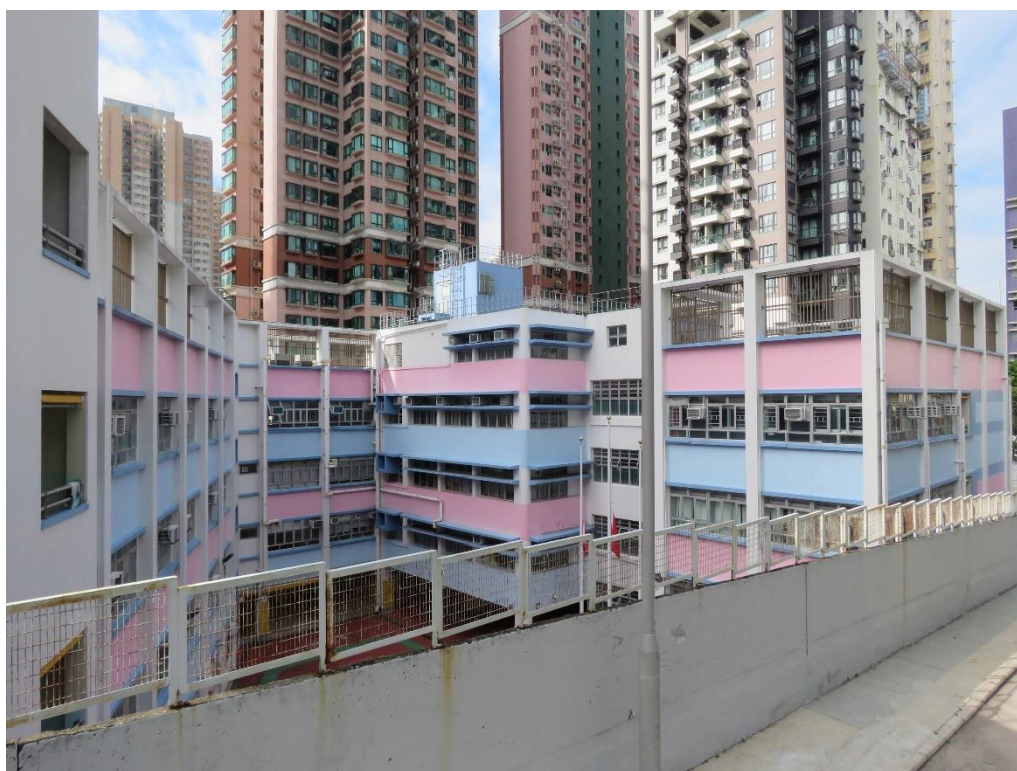
General view of HB-06, showing elevations facing the inside of the school campus, looking northwest.

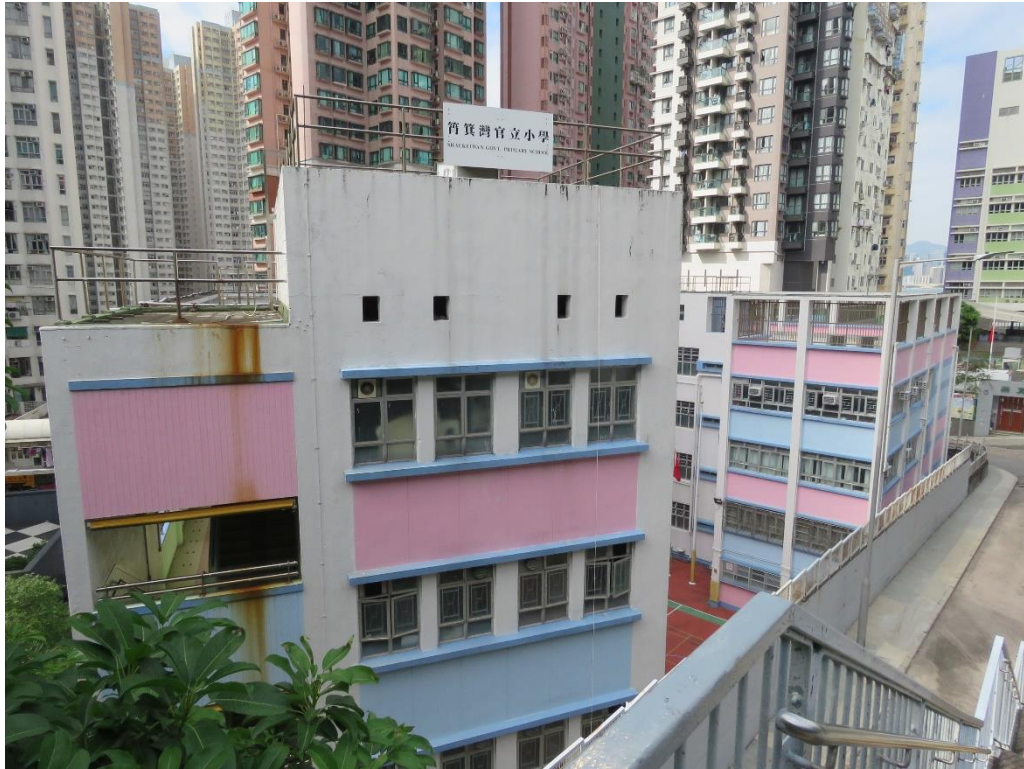
Southeast facing elevation of south wing, looking northwest.

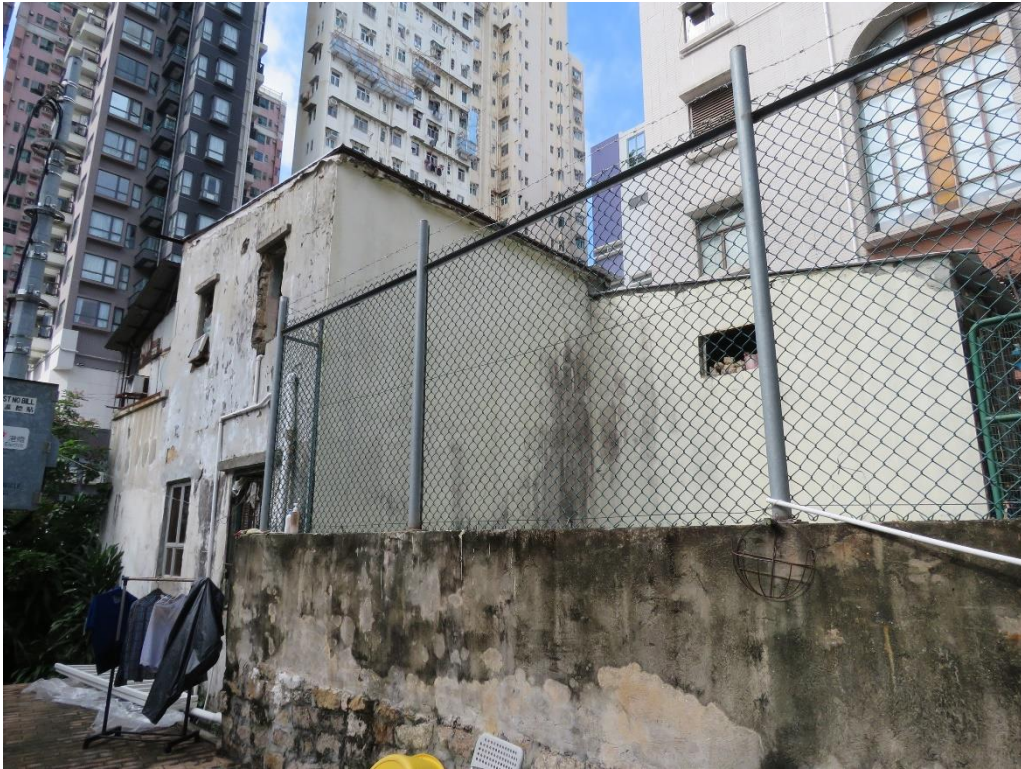
Rear and side view of HB-08, showing east and south elevations, looking northwest.

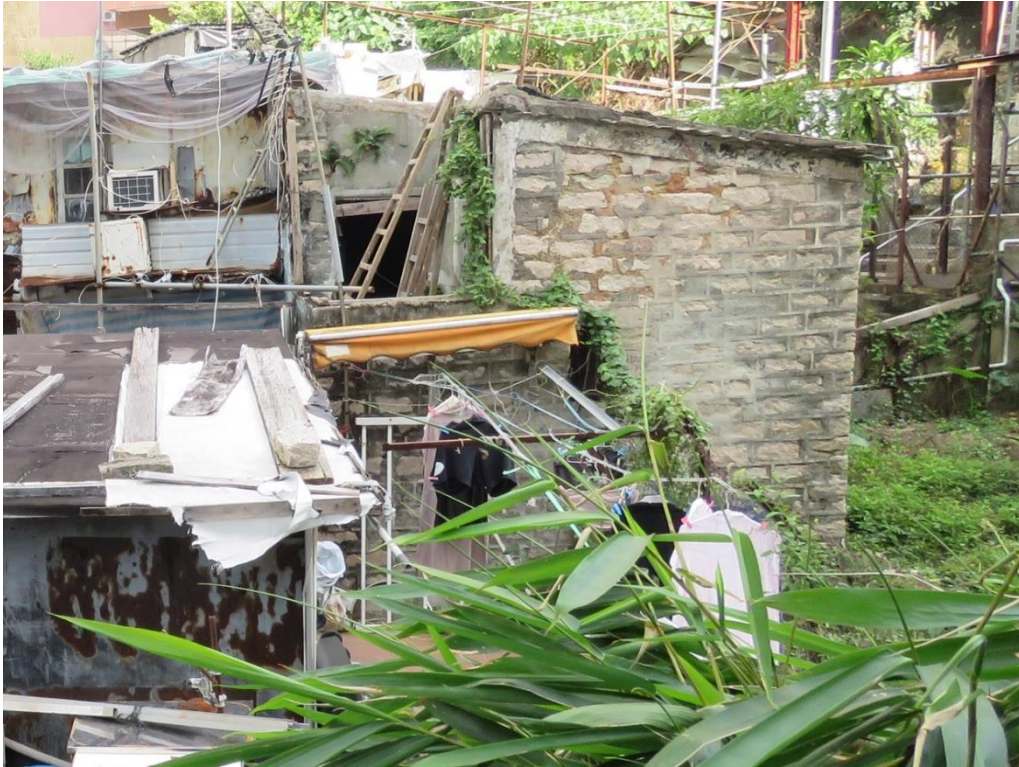
General view of HB-09, showing west-southwest facing elevation, looking east.

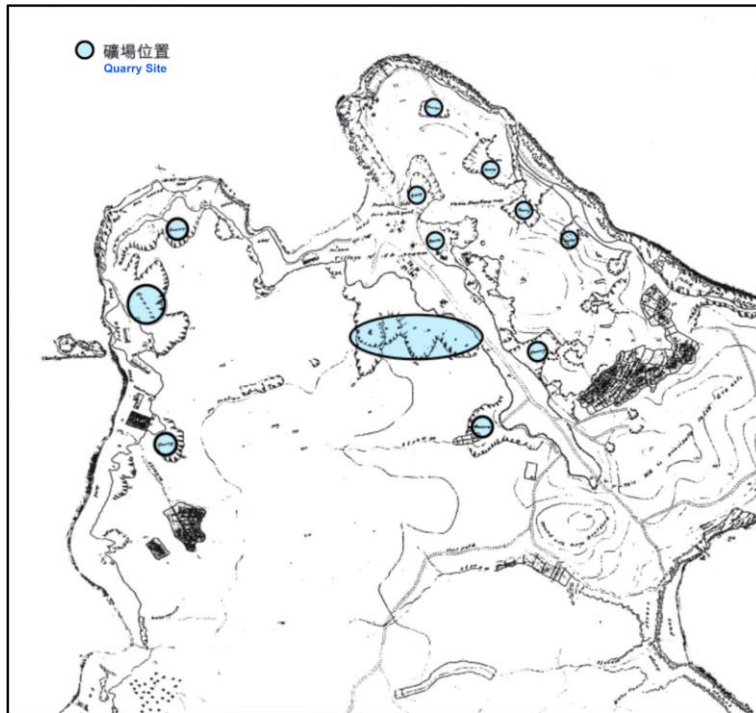
</div> <p>1845 map showing various quarry sites at A Kung Ngam hillock (Source: Chan 2018:67 fig 2-2; highlighted in blue by AAL).</p> <p>An 1845 map shows that there were many quarry sites around A Kung Ngam (see map above); although some sites were later developed into other uses, including coastal defense fortifications on the headland. In the later 19th century “the Shau Kei Wan quarries were then much more important than any elsewhere on the Island and rivalled those in Old British Kowloon” (Hayes 1970:186). Government’s yearly reports show that the number of operating quarry sites here counted 72 in 1872, 82 in 1874, 49 in 1881 and 51 in 1891 (Hayes 1970:186; Chan 2018:68 tab 2-1). Cross-refencing with old topographic map and aerial photos does show multiple remaining quarrying sites on the hillock during 1950s to 60s (SMO1964; NCAP 1954; HKMS 1963). Prior to the colonial period, the quarries supplied for constructions in mainland China. And after the British colonization, they chiefly provided for the construction of Victoria City (Chu and Chan 2015:253).</p>

Figure 4 1845 map showing various quarry sites at A Kung Ngam hillock (Source: Chan 2018:67 fig 2-2; highlights in blue by AAL).

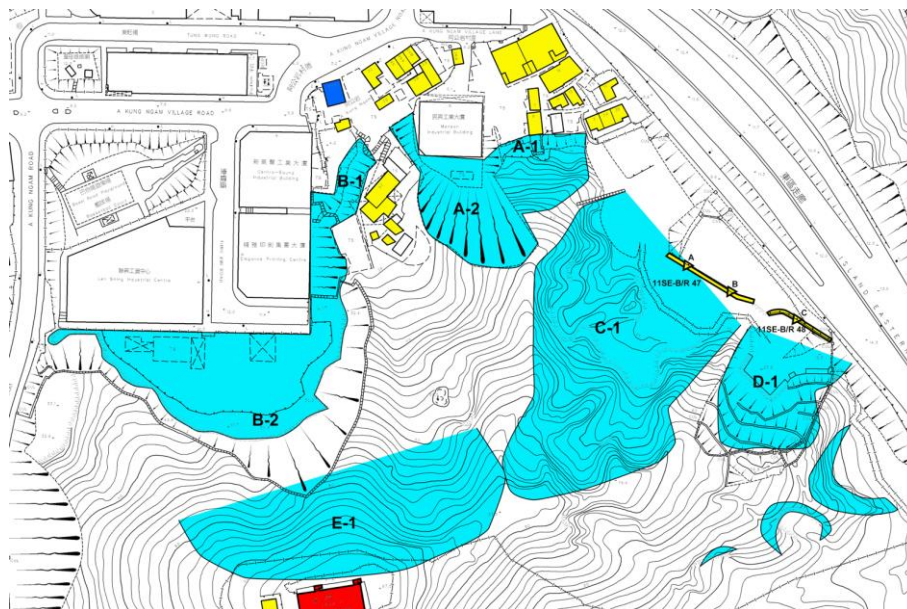
Index map showing photographed quarry locations;

- 5.1.8 The proposed site formation and infrastructure works include former granite quarrying areas (HB-10). Initial attempt at mapping the areas was conducted as part of this HIA based on identification of artificial contours lines and aerial photography. Little beyond the quarrying area exists of the industrial activity, but full mapping including 3D scanning, cartographic and photographic documentation is recommended to document and preserve by record the testimony of the quarrying which enabled the growth of urban areas.

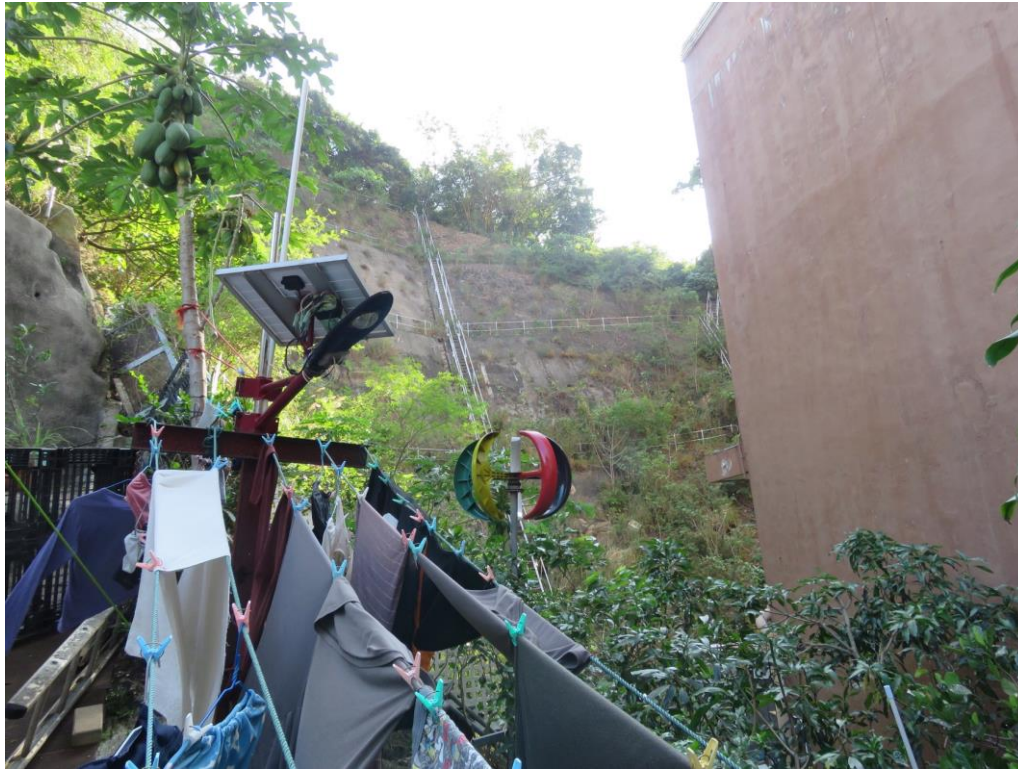
Quarry location A-2, looking southwest.

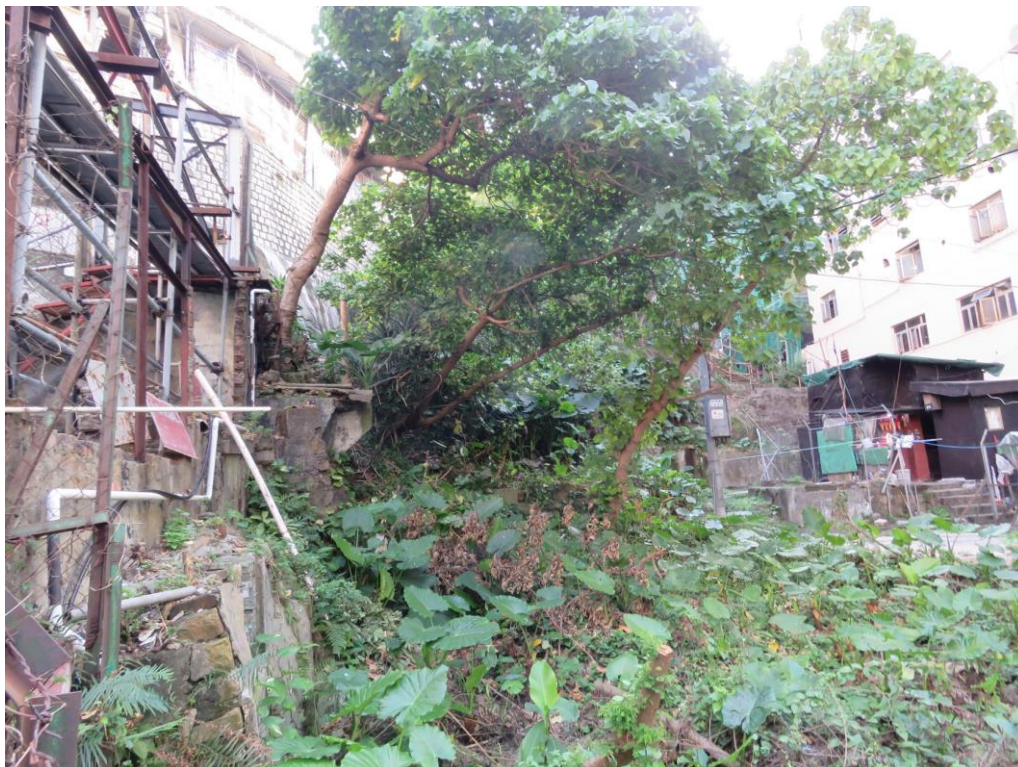
Quarry location B-1, looking southwest. Note the quarried face is complete concealed.

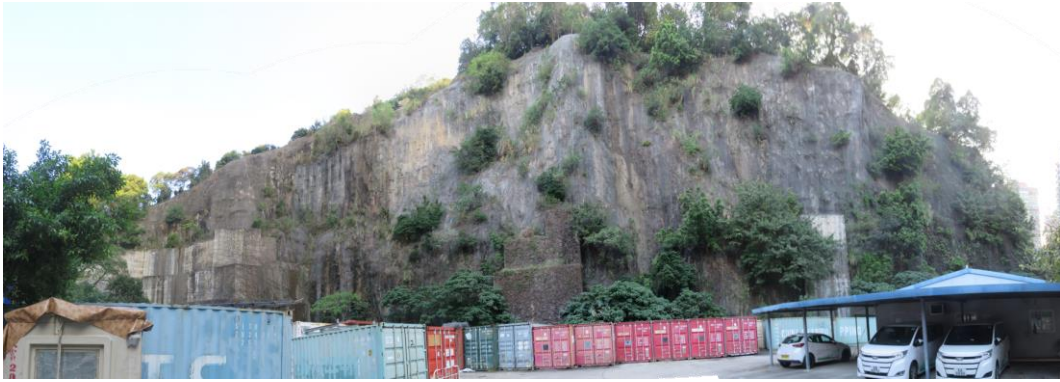
Panoramic view of quarry location B-2, looking generally south.

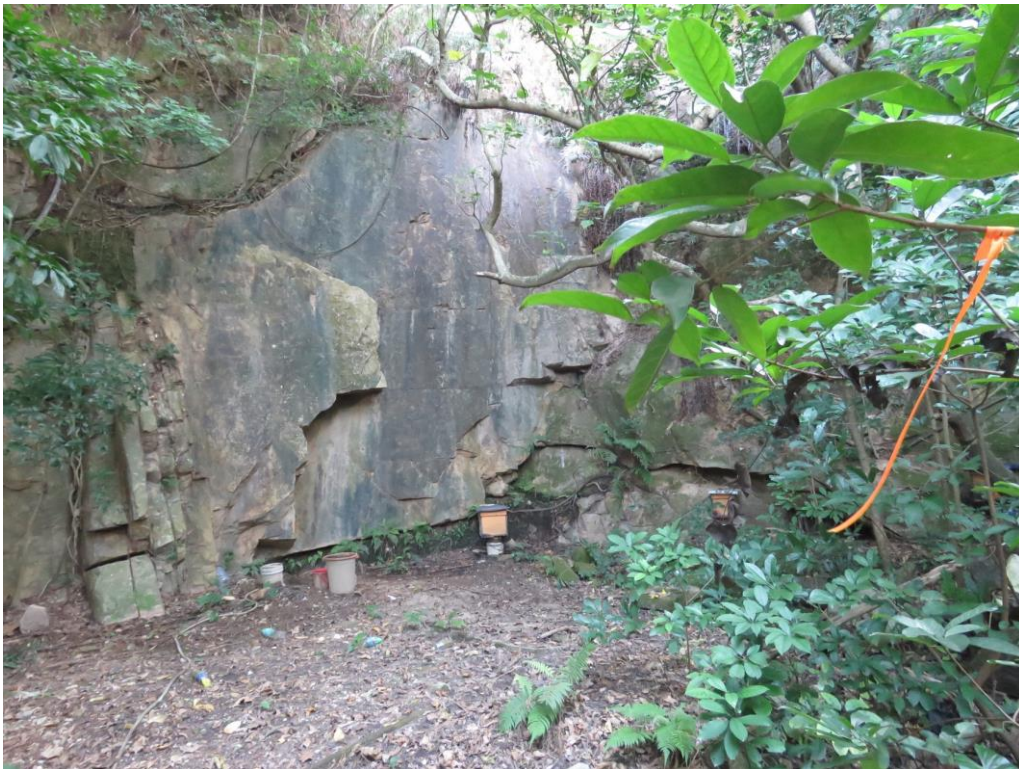
Quarry location C-1, looking southeast.

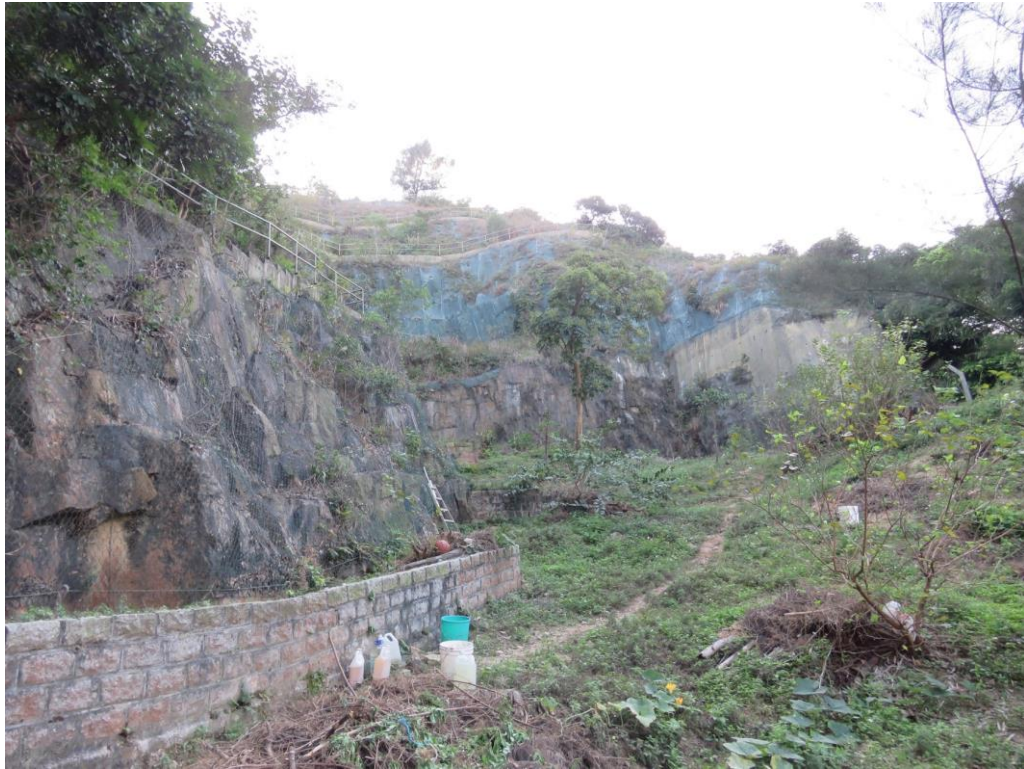
Quarry location D-1, looking southwest.

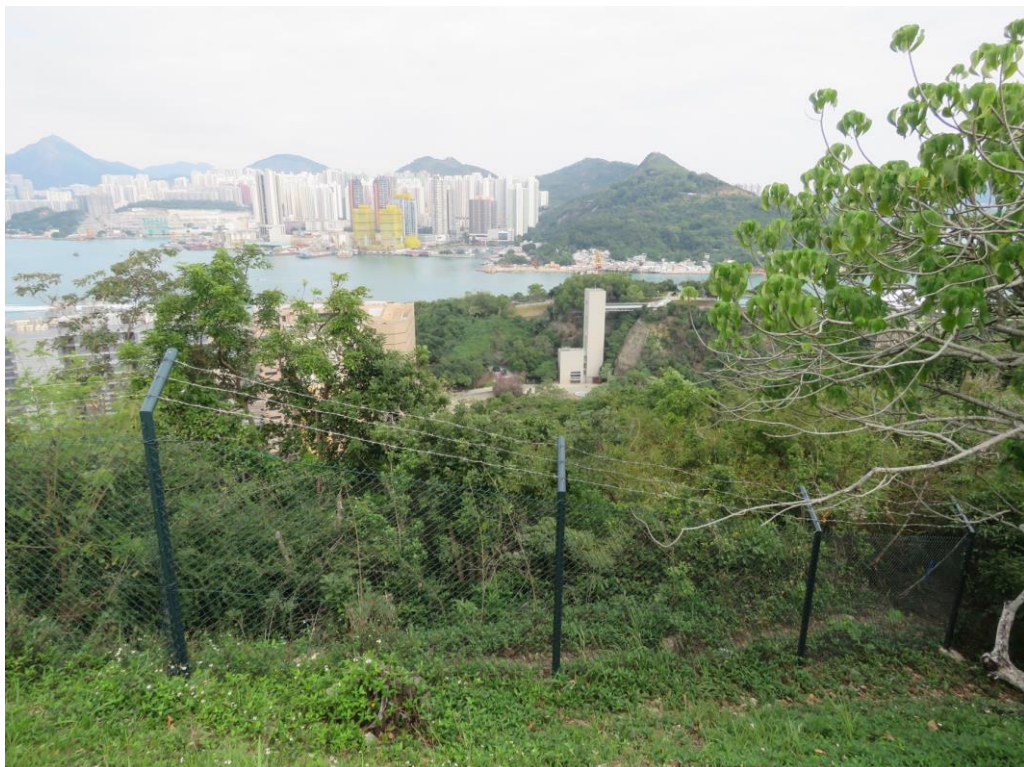
Quarry location E-1, looking north at the top of the quarry. Note quarry face now overgrown.

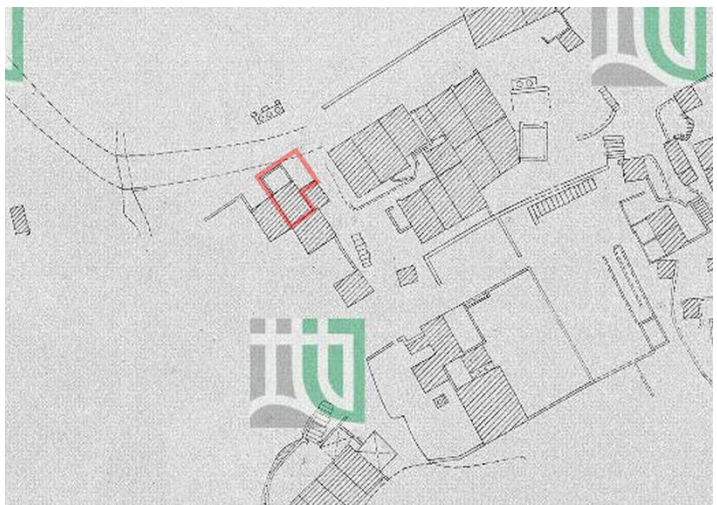
<p>1922 topographic map showing the existence of a courtyard style house at the location of No.32. Red outline shows the current building footprint. (Source: SMO 1922).</p>

Ref: HB-11	Name: A Kung Ngam Village House	Category: Residential
Address: No.32 A Kung Ngam Village, Shau Kei Wan		Figure 5
Orientation: Northwest facing		Grading: N.A.
Surrounding Environment: Set at roadside of A Kung Ngam Village Lane below quarried hillside.		
<p>Historical Appraisal: For general background of the village, see counterpart section in N-01.</p> <p>A review of old maps and aerial photos suggests a courtyard style house already existed in the location in 1922 (SMO 1922). In around 1951 to 52, the government received application for conversion to a mantle factory at the site (BRAVO no date-c). By 1954, the current layout is set (NCAP 1954). The building was built in phases and / or had renovation at various times.</p>

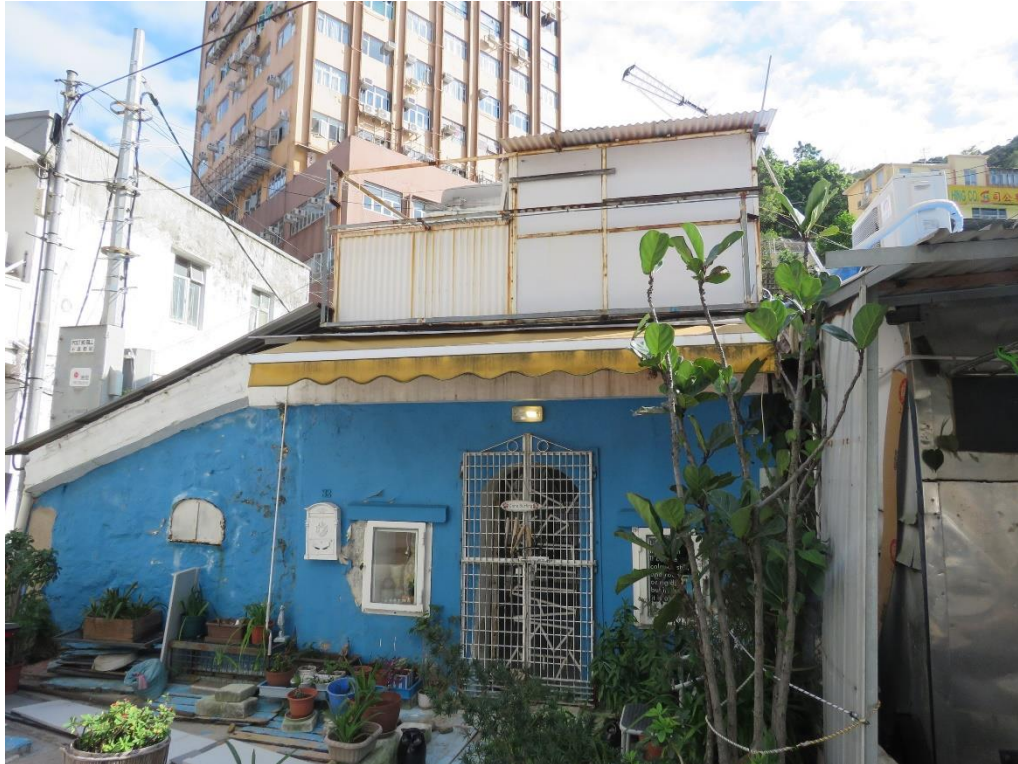
Façade view of HB-11, showing northwest facing elevation, looking southeast.

Associated Historical/ Cultural Events or Individual: None.		
<p>Architectural Appraisal:</p> <p>It is a two-storey building with an open courtyard later sealed and an extended portion in the northeast side. The building materials included stone, mud and concrete. The main building is covered by a slightly pitched roof potentially paved or remolded with concrete. A staircase is attached to the northeast face. The extended portion only has one storey and is covered by a slopping roof. The façade wall is painted in vivid blue.</p>		
Interior: No Access.		
Existing Condition: Fair		
Past and Present Uses: Residential		
Modifications: Building once extended and perhaps partially rebuilt / renovated. Temporary materials added to upper level and the roofs.		
Photographic Records

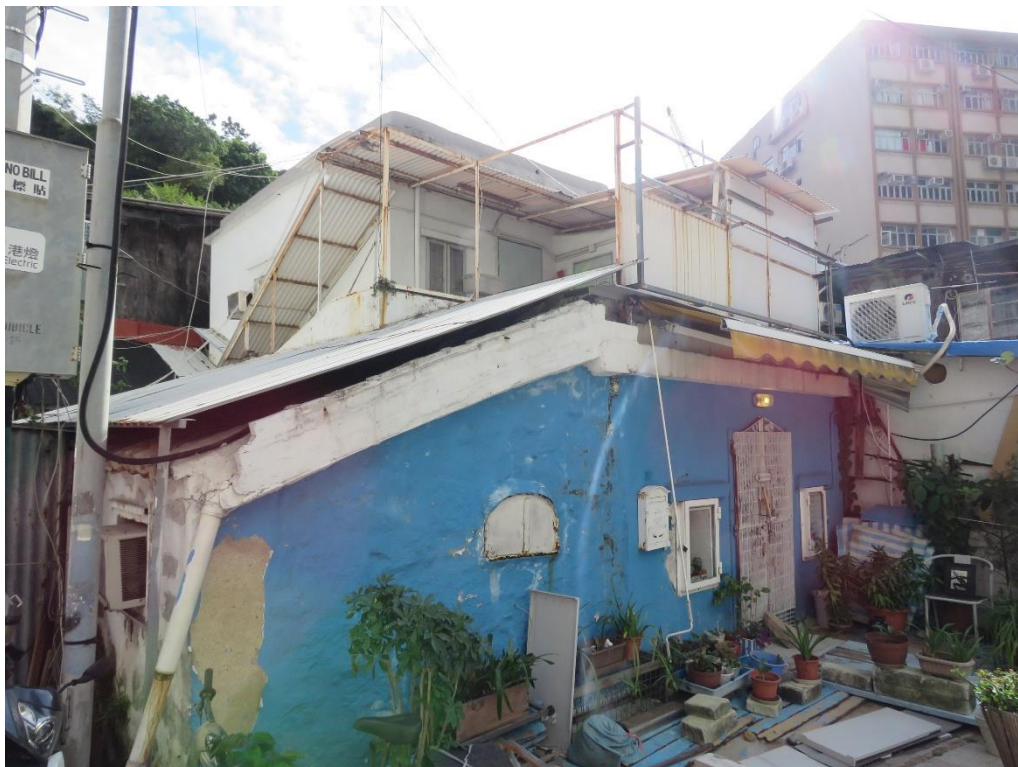
General view of HB-11, looking south.

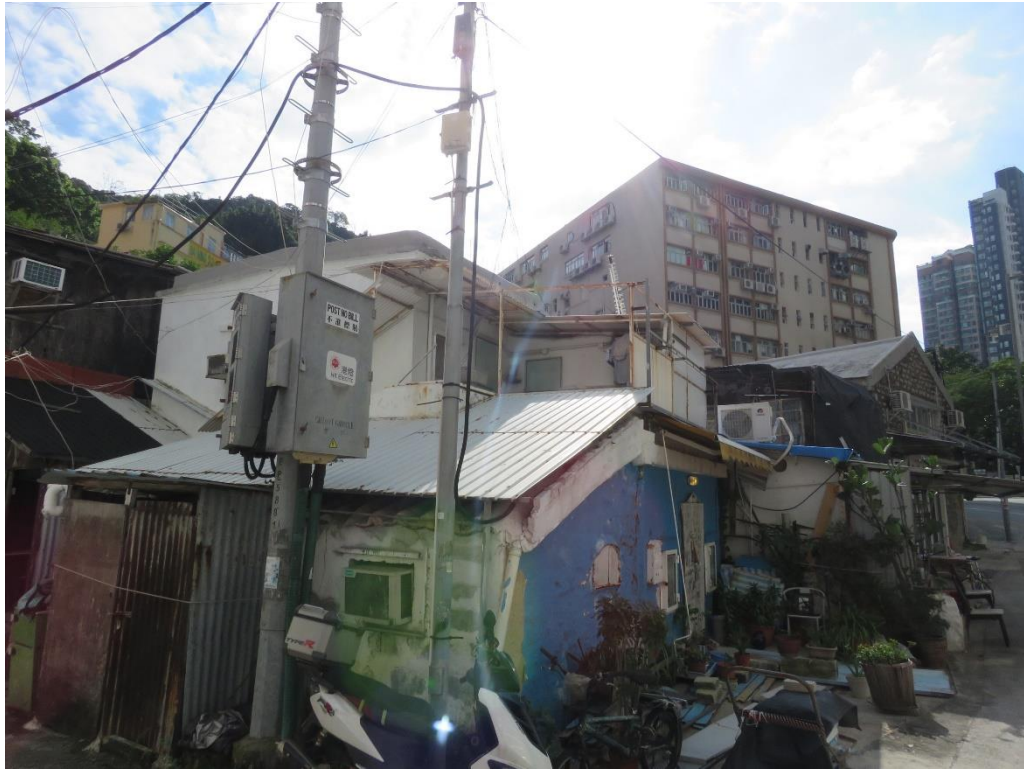
Front and side view of HB-11, showing northwest and northeast elevations, looking southwest.

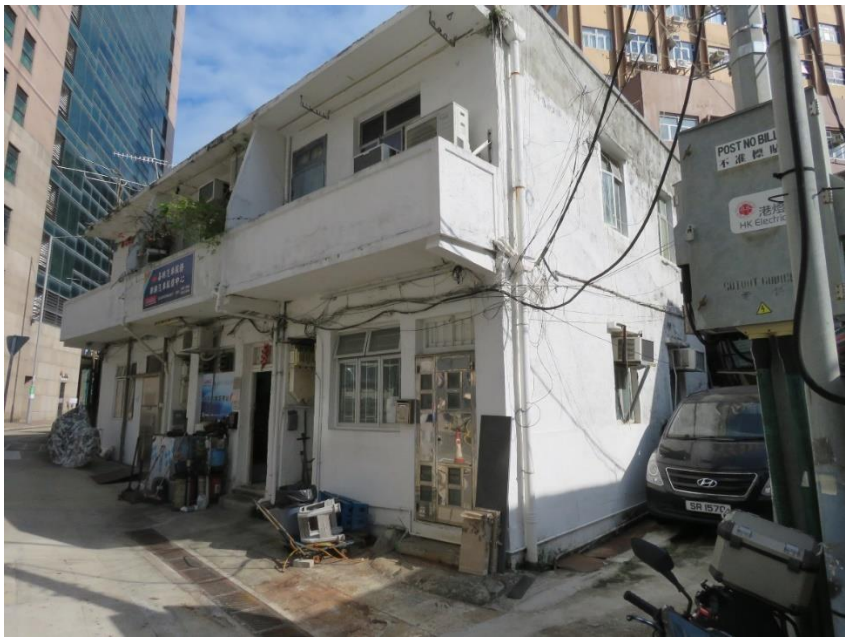
General view of HB-12, showing northwest and southwest facing elevations, looking east.

Ref: HB-12	Name: A Kung Ngam Village Houses	Category: Residential
Address: Nos. 29, 29A, 29B A Kung Ngam Village, Shau Kei Wan, H.K.		Figure 5
Orientation: Northwest facing		Grading: N.A.
Surrounding Environment: Set at roadside of A Kung Ngam Village Lane below quarried hillside.		
<p>Historical Appraisal: For general background of the village, see counterpart section in N-01.</p> <p>A review of old aerial photos suggests the house row was constructed between 1949 and 1954 (NCAP 1949 and 1954).</p>		
Associated Historical/ Cultural Events or Individual: None.		
<p>Architectural Appraisal:</p> <p>The building consists of three flat-roof two-storey concrete houses with open protruding balconies. The building houses five to six apartments. The ground level has three individual units; each has their own gate and windows. Two staircase hallways can be seen leading to the upper-level units on ground level. Partition walls between units are seen on balcony on the upper level. Windows are also on side walls.</p>

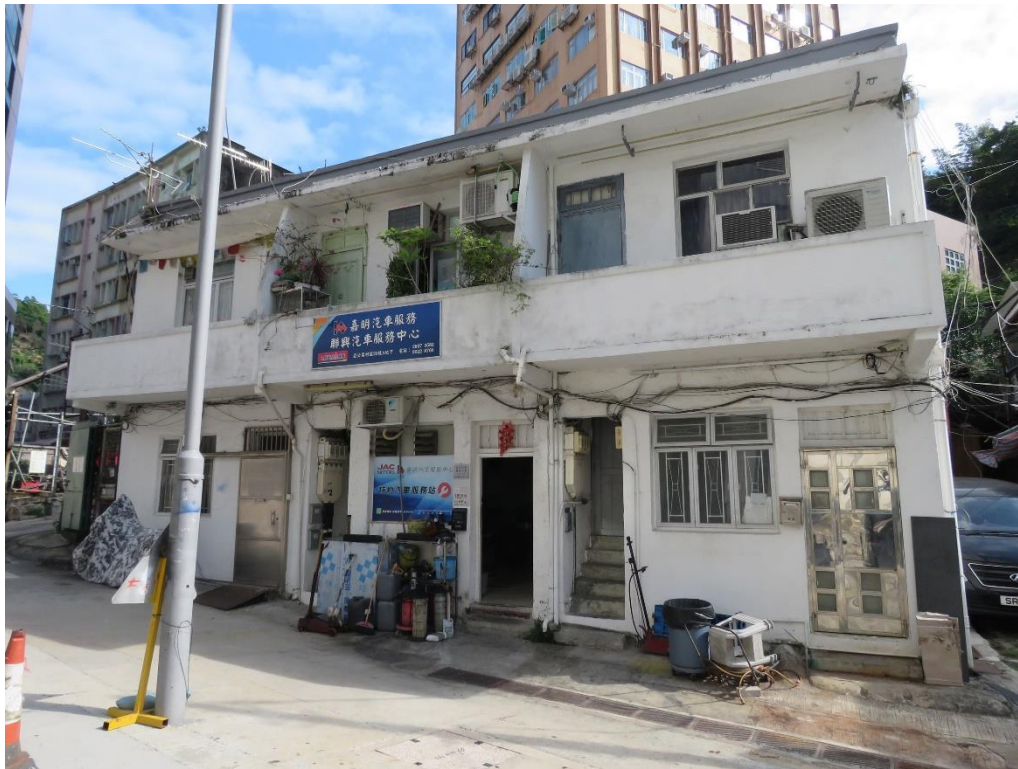
Façade view of HB-12, showing northwest elevation, looking southeast.

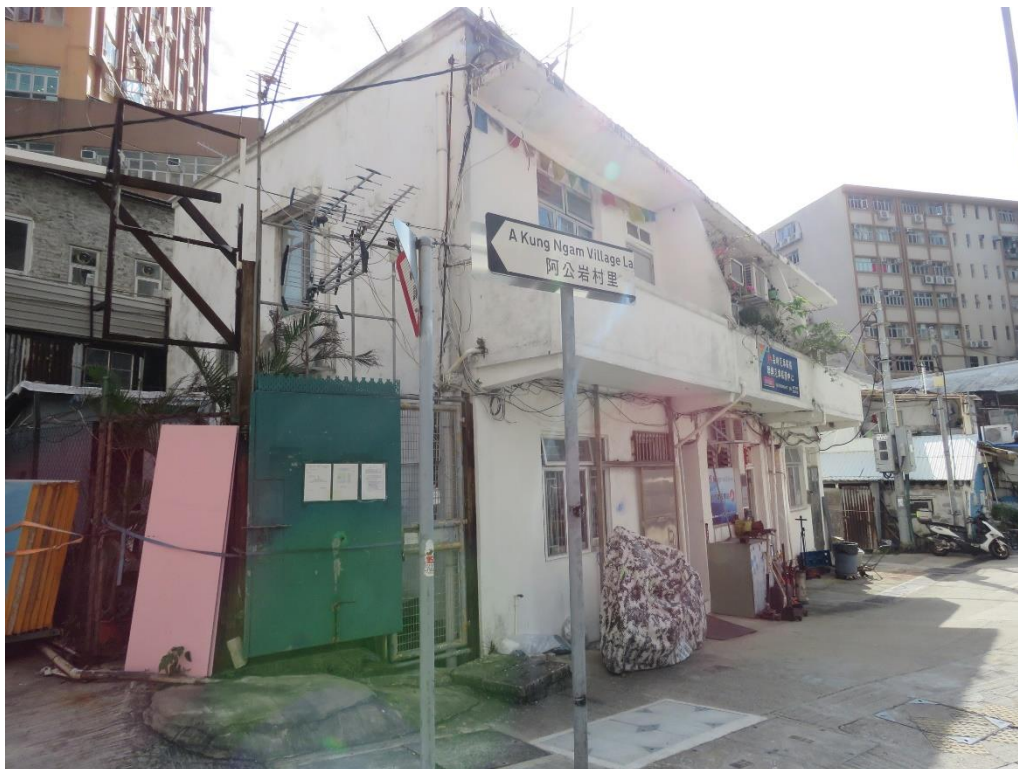
General view of HB-12, showing northwest and northeast elevations, looking southwest.
