AGREEMENT NO. CE 41/2022 (CE) - SITE FORMATION AND INFRASTRUCTURE WORKS FOR PUBLIC HOUSING DEVELOPMENT AT A KUNG NGAM VILLAGE, EASTERN – INVESTIGATION, DESIGN AND CONSTRUCTION

Heritage Impact Assessment Report (Final – Issue 2)

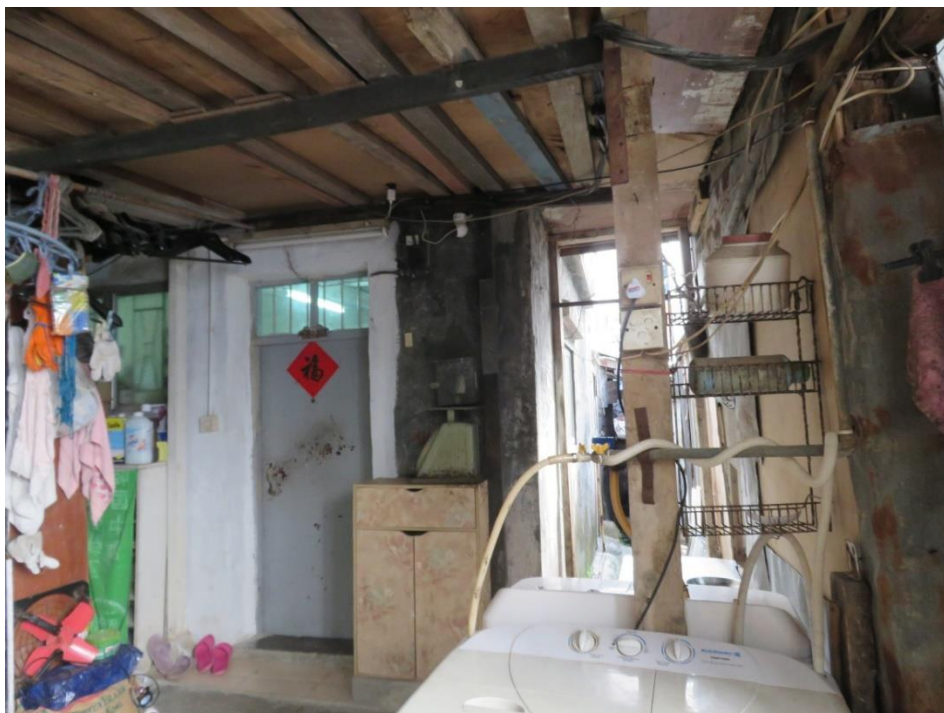
Façade view of HB-13, showing northeast facing elevation, looking southwest.

Ref: HB-13	Name: A Kung Ngam Village House	Category: Residential
Address: 28 A Kung Ngam Village, Shau Kei Wan, H.K.		Figure 5
Orientation: Northeast facing		Grading: N.A.
Surrounding Environment: Built at second row of the village; situated below quarried hillside.		
Historical Appraisal: For general background of the village, see counterpart section in N-01. A review of old aerial photos shows the building existed between 1949 and 1954 (NCAP 1949 and 1954).		
Associated Historical/ Cultural Events or Individual: None.		
Architectural Appraisal: A concrete residential building in rectangular plan. Its surrounding is encroached by temporary structures and rendered its assessment difficult. The iron entrance gate reflects a style dated to 1950-60s.		
Interior: No Access.		
Existing Condition: Good to Fair		
Past and Present Uses: Residential		
Modifications: undetermined.		
Photographic Records

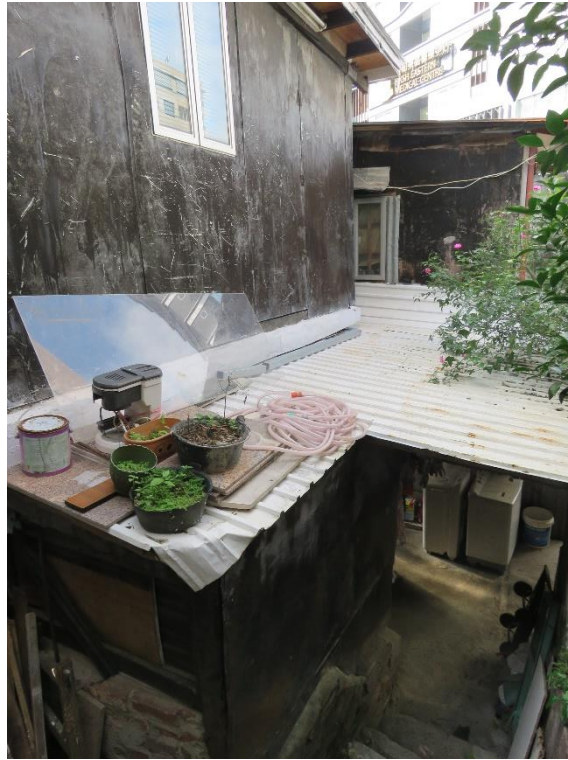
General view showing temporary structures wrapping around of HB-13 at its entrance, looking northwest.

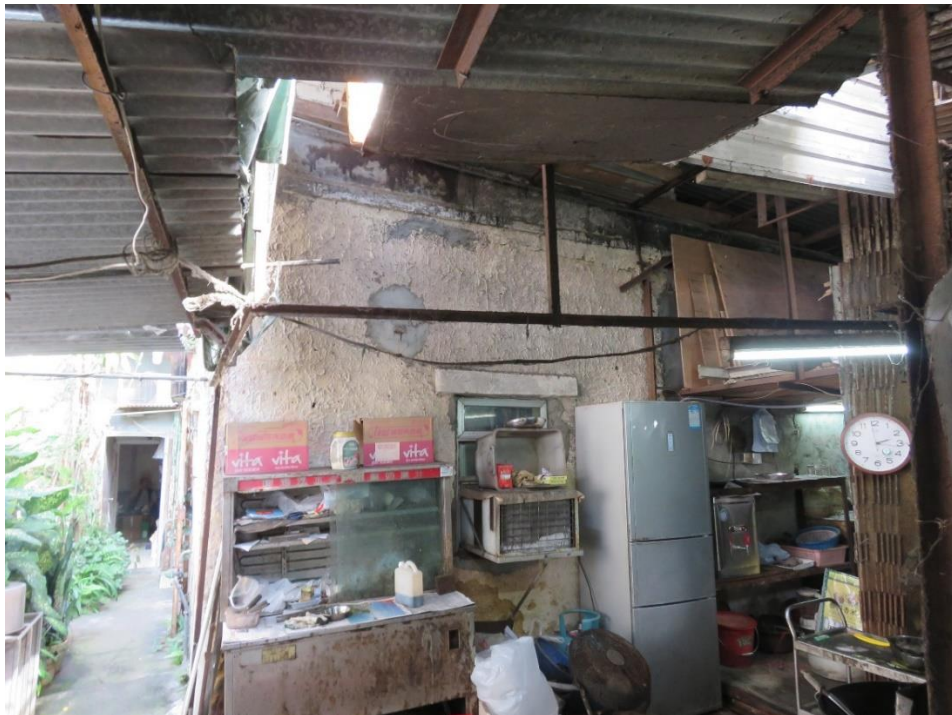
General view of HB-14, showing southwest and northwest elevations, looking east.

Ref: HB-14	Name: A Kung Ngam Village House	Category: Residential
Address: No. 29 A Kung Ngam Village, Shau Kei Wan, H.K.		Figure 5
Orientation: Northwest facing		Grading: N.A.
Surrounding Environment: Built at second row of the village; situated below quarried hillside.		
Historical Appraisal: For general background of the village, see counterpart section in N-01. A review of old aerial photos suggests No. 29 was constructed between 1934 to 1949 (NCAP 1934 and 1949).		
Associated Historical/ Cultural Events or Individual: None.		
Architectural Appraisal: No.29 features a single-storey flat roof residential structure. The walls are paved with textured creamy-white mortar. Roof line shows a band of concrete frieze board. Façade is not approachable due to presence of occupant.		
Interior: No Access		
Existing Condition: Fair		
Past and Present Uses: Residential		
Modifications: Temporary roofing and repairs on wall noticed.

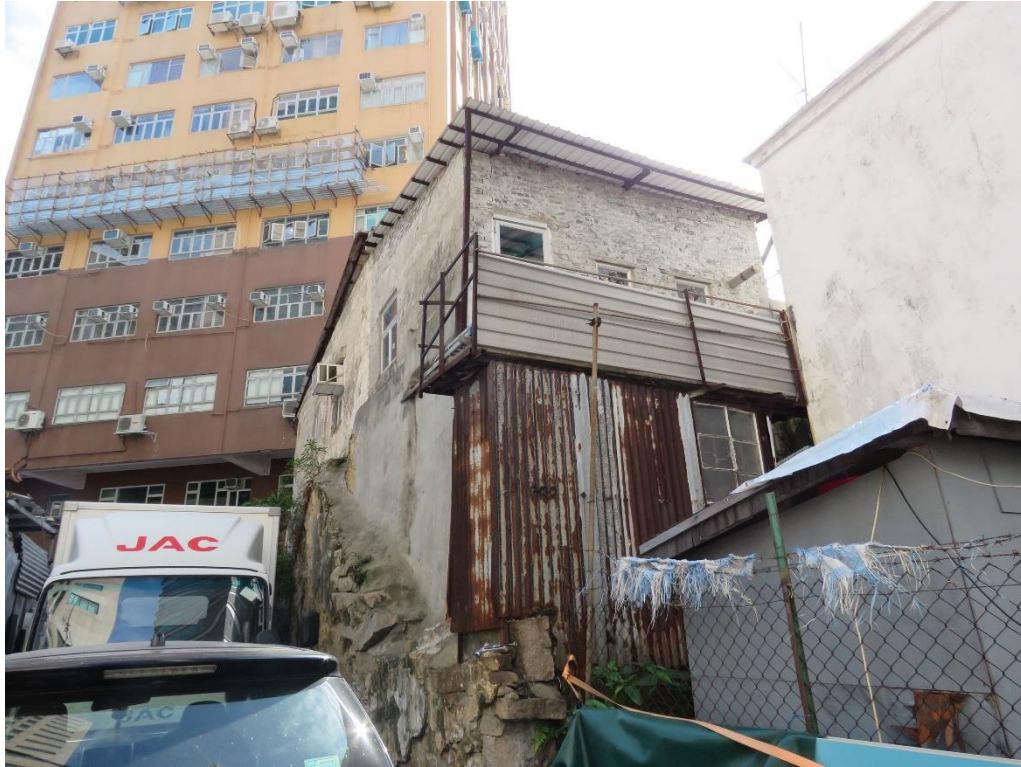
General view of HB-15, showing northwest and northeast facing elevations, looking south.

Associated Historical/ Cultural Events or Individual: None.		
<p>Architectural Appraisal:</p> <p>It is a two-storey brick structure built upon clay-bound masonry foundation. Phases of surface finishes including brickwork, stonework, and concrete pavement, are noticed. The roof is covered by corrugated metal sheets which rest on red bricks. The façade has been wrapped with metal sheets. A temporary balcony made of metal bars are seen attached on the second level. Windows are seen on three elevations.</p>		
Interior: No access.		
Existing Condition: Fair.		
Past and Present Uses: Used to be residential, now vacant.		
Modifications: Phases of modification observed. Windows replaced. Air-conditioners added.		
Photographic Records

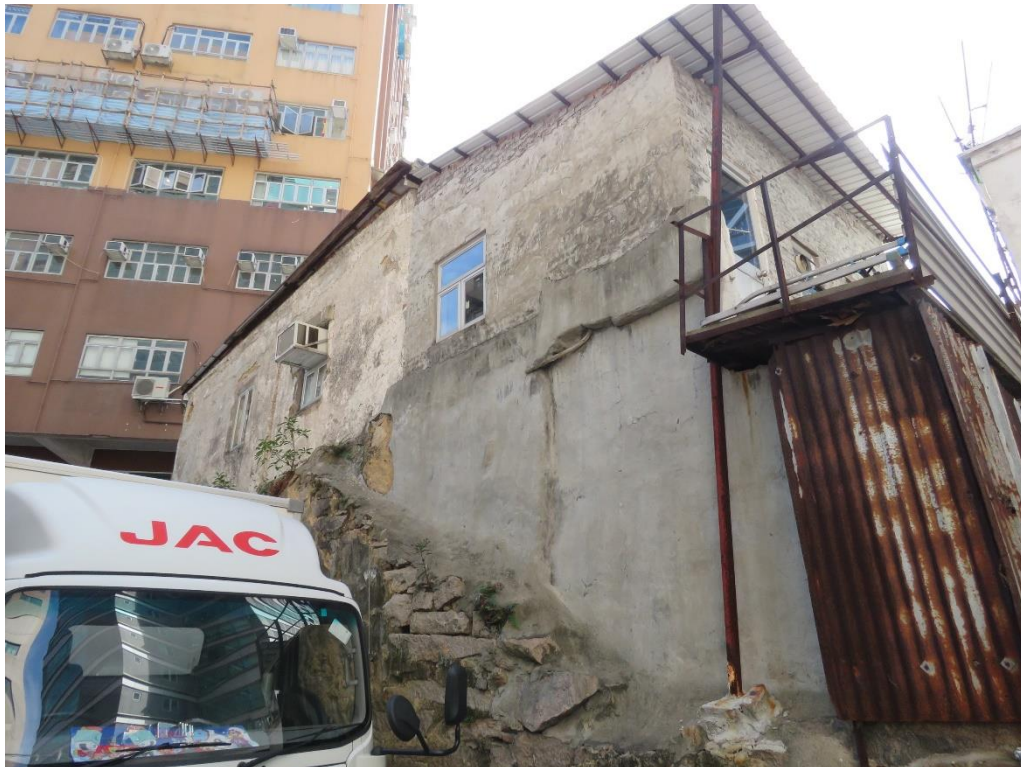
Side view of HB-15, showing northeast elevation, looking southwest.

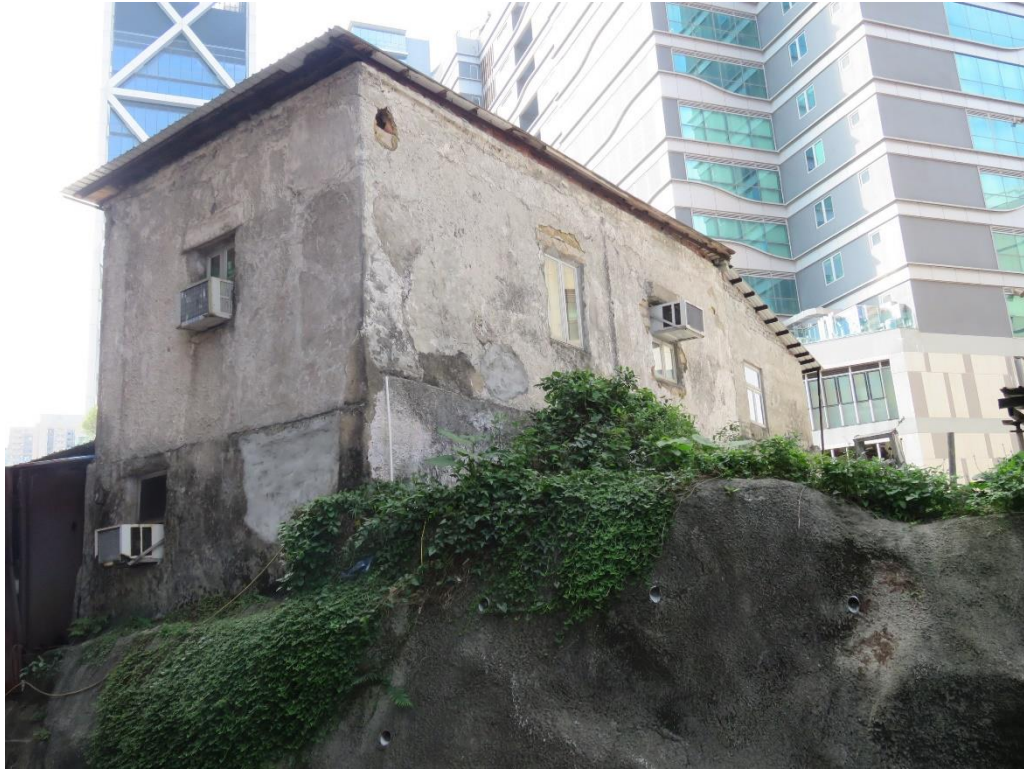
Rear and side view, showing northeast and southeast facing elevations, looking northwest.

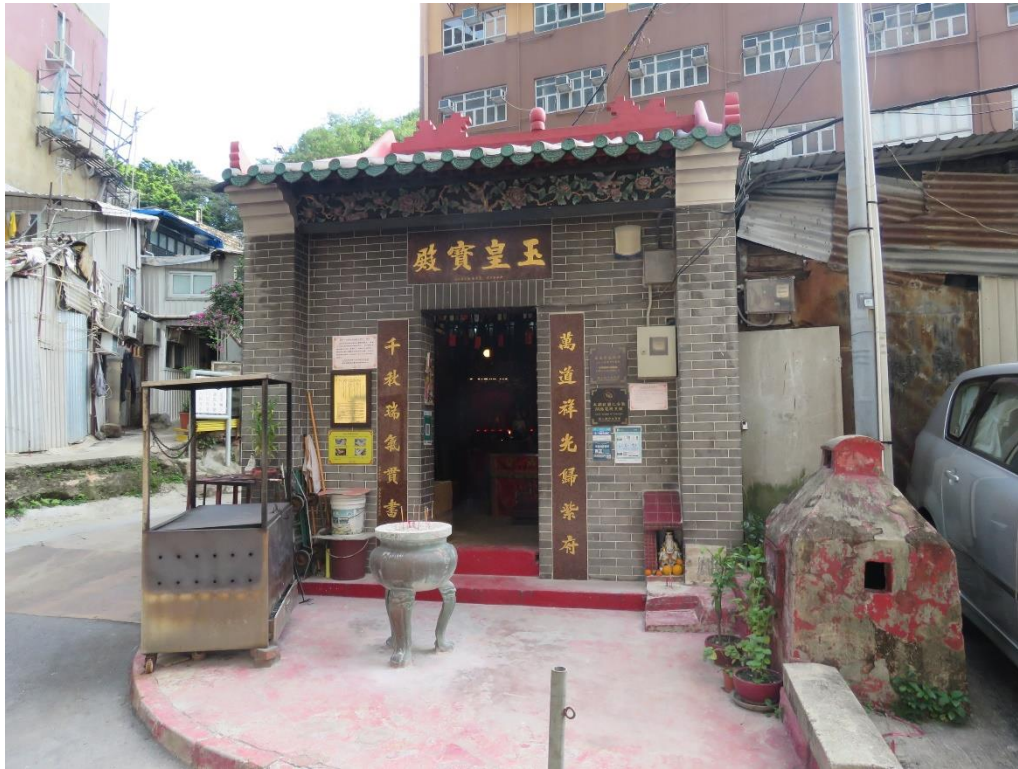
Façade view of HB-16, showing the north elevation, looking south.

- 5.1.9 The retaining of same location of Yuk Wong Po Din (of considerable significance) within area is in line with the first proposed conservation guideline. Mitigation will be required during site formation and infrastructure to ensure the structural stability and structure will not be damaged and safe public access to the Temple is guaranteed.

<p>Architectural Appraisal:</p> <p>It is a single-storey one hall vernacular temple building with pitched roof. The building materials consist of green bricks, timber, mortar, and ceramic tiles. The roof is covered by green-glazed ceramic tiles. Moldings featuring symbolic animal figurines chasing a pearl stand on red painted roof ridge. Under the roof is a recessed entrance façade. On the eave is a painted motif plater frieze band in bird and flower theme. A name board and a pair of couplets bracket the brick-framed doorway. A small air window is seen on the east elevation.</p>		
Interior: Altars set on end wall.		
Existing Condition: Good		
Past and Present Uses: Religious, Funerary and Ritual		
Modifications: renovations in 1992 and 1996 (CTC Website 2019).		
Photographic Records

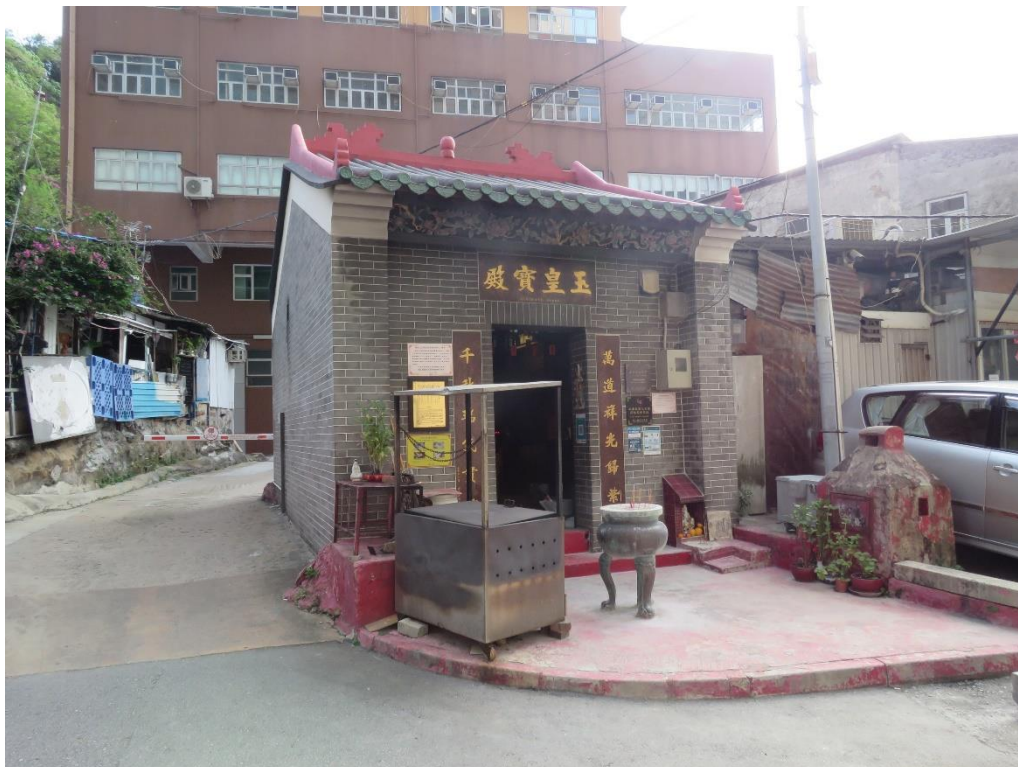
General view of HB-16, showing north and east elevations, looking southwest.

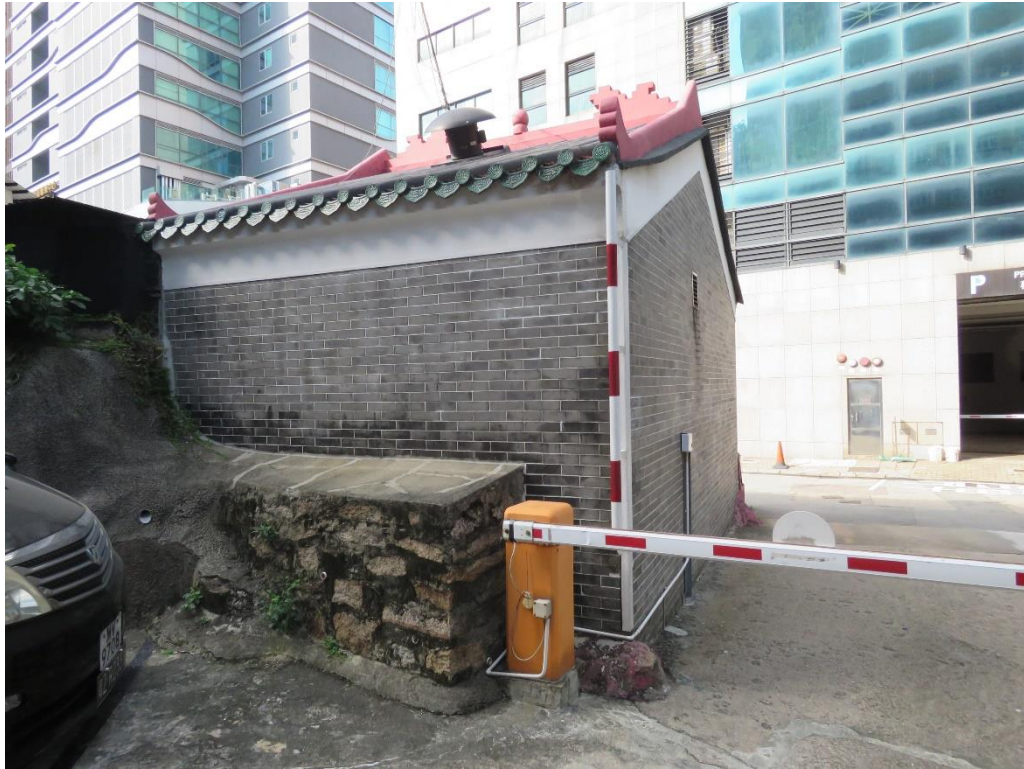
Rear and side view of HB-16, showing south and east elevations, looking northwest.

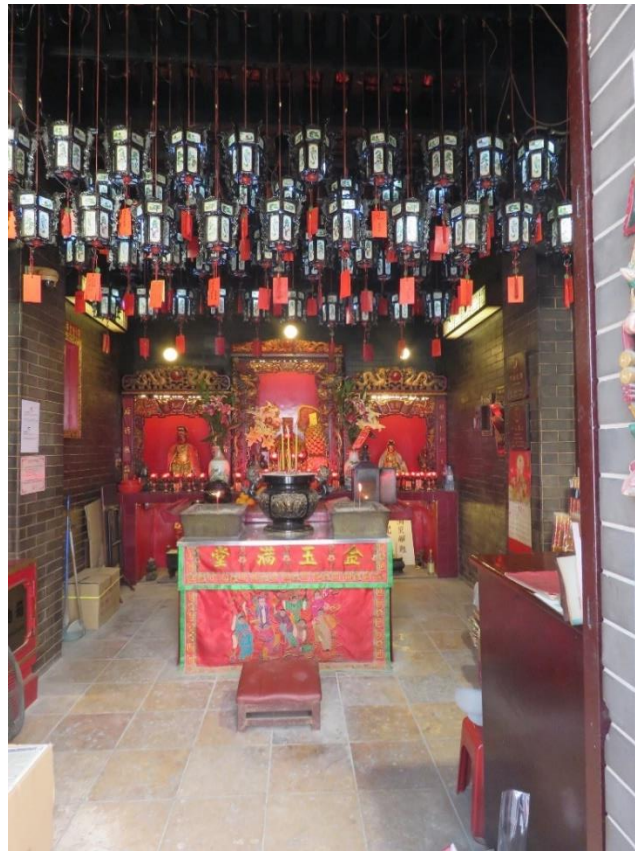
Internal view of HB-16, looking south.

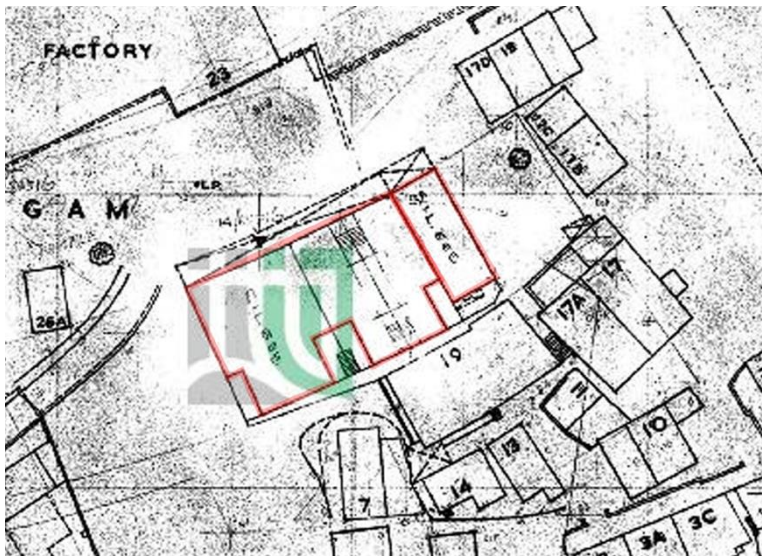
<p>1962 topographic map showing the plan of the factory building blocks. (Source: SMO 1962)</p>

Ref: HB-17	Name: A Kung Ngam Building Block	Category: Industrial and Commercial
Address: in front of No.19 A Kung Ngam Village, Shau Kei Wan, H.K.		Figure 5
Orientation: Northwest facing		Grading: N.A.
Surrounding Environment: Set at roadside of A Kung Ngam Village Lane; Located at hill foot in front of village houses.		
Historical Appraisal: A review of old aerial photos and topographic maps suggests the buildings were completed between 1954 and 1962 (NCAP 1954; SMO 1962).		
Associated Historical/ Cultural Events or Individual: None		
<p>Architectural Appraisal:</p> <p>The two twin blocks with central open staircases on the west share a same design in number of floors (7 to 8 storey), appearance, and footprint. The design is typically modernist with setback windows, protruding lintels and fins and the light and shade play of the façade. The ground level is occupied by shops and stores.</p> <p>The other block on the east side is a three-storey low-rising building.</p>

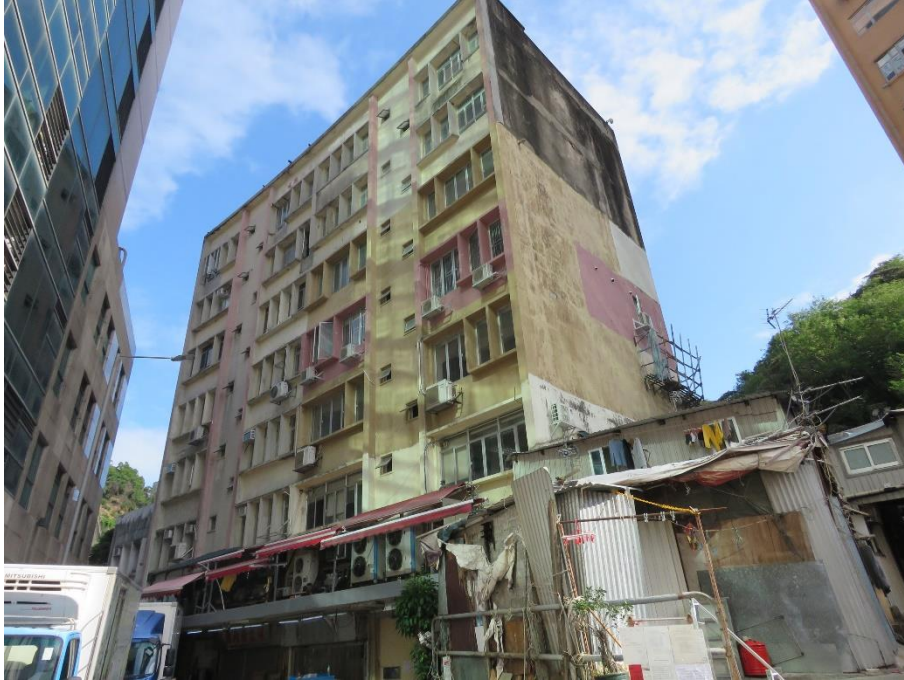
General view of HB-17, showing northwest and southwest facing elevations, looking east.

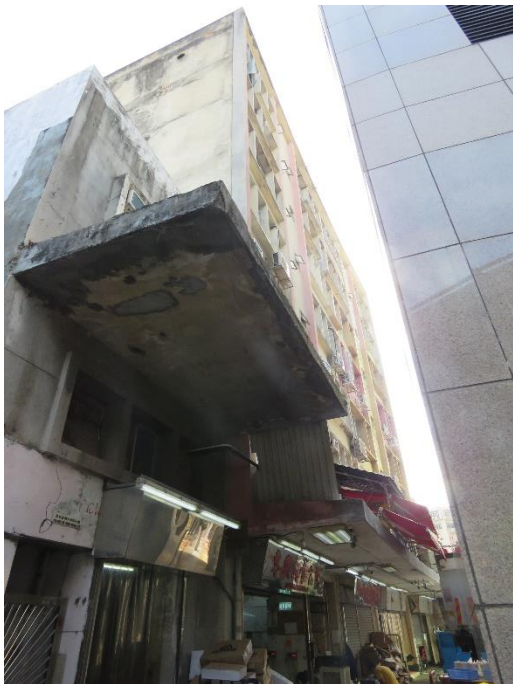
Front and side view of HB-17, showing northeast and northwest elevations, looking southwest

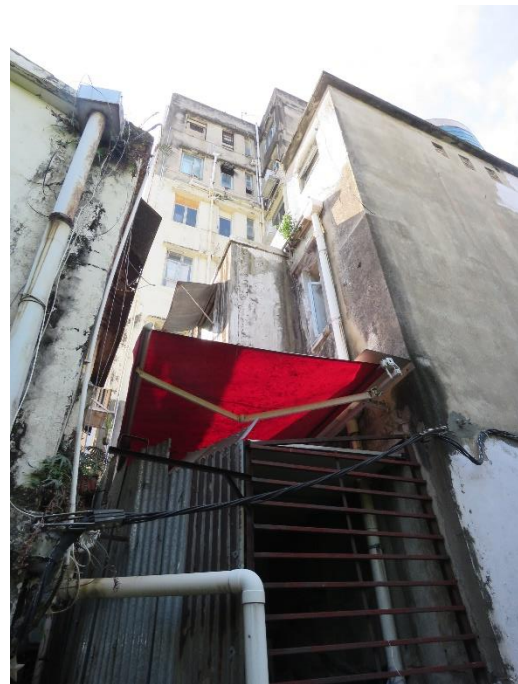
Side and rear view of HB-17, showing northeast and southeast elevations, looking west.

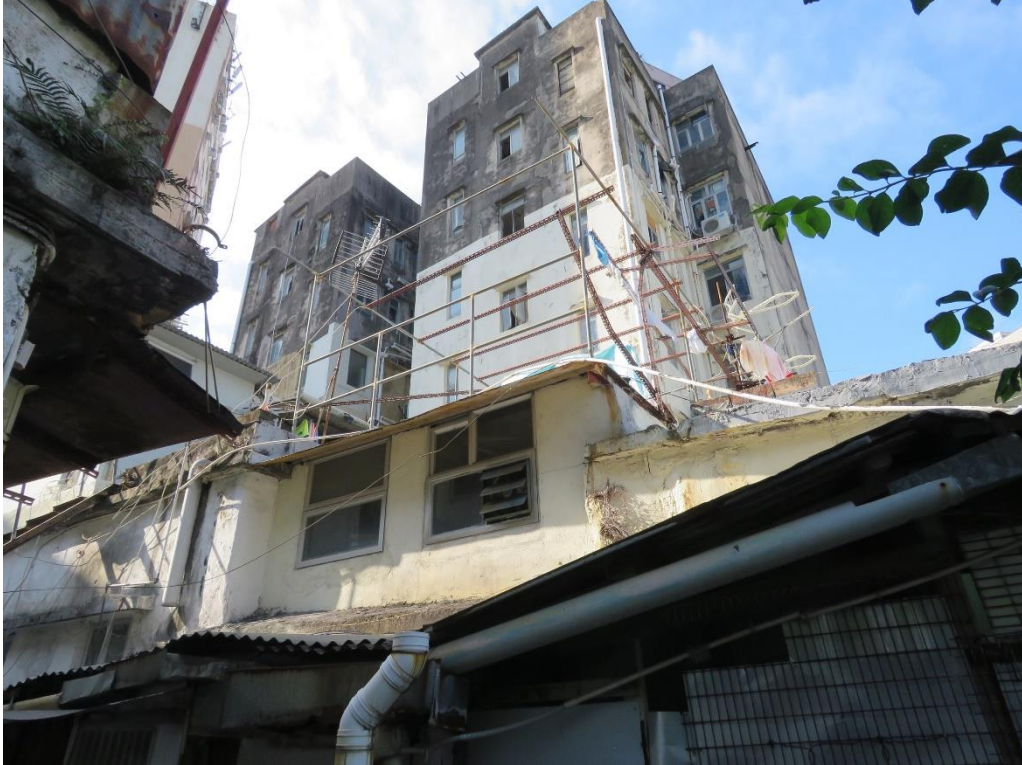
Rear view, showing southeast elevation, looking northwest.

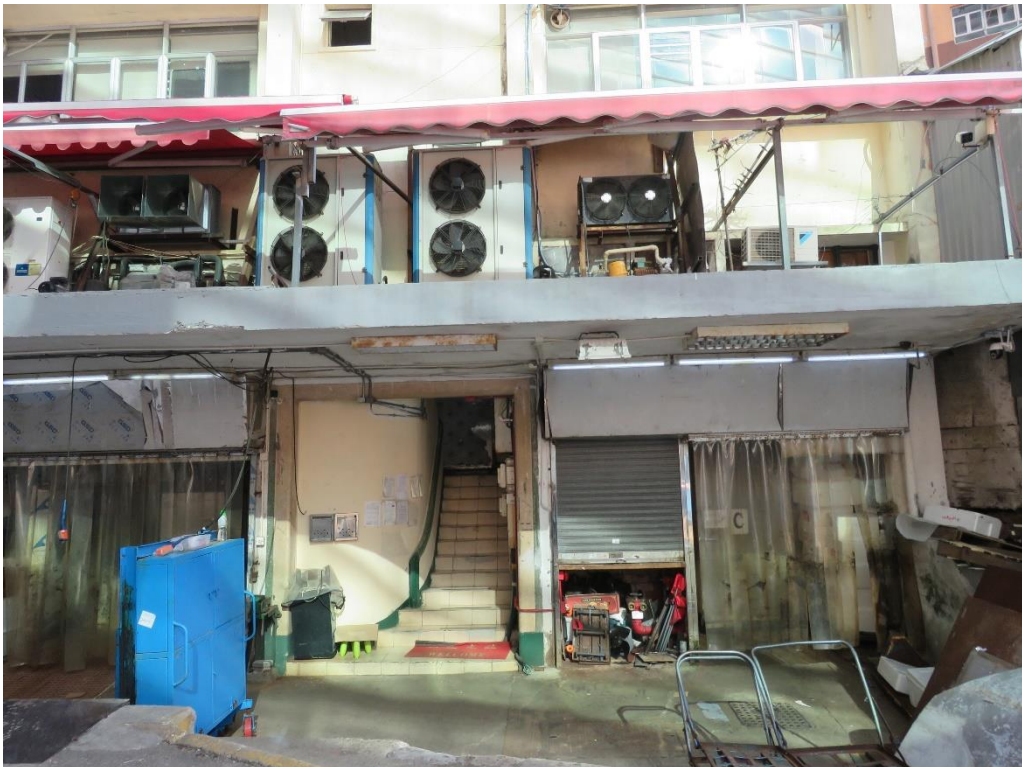
Shops, store, and staircase on ground level on façade, looking southeast.

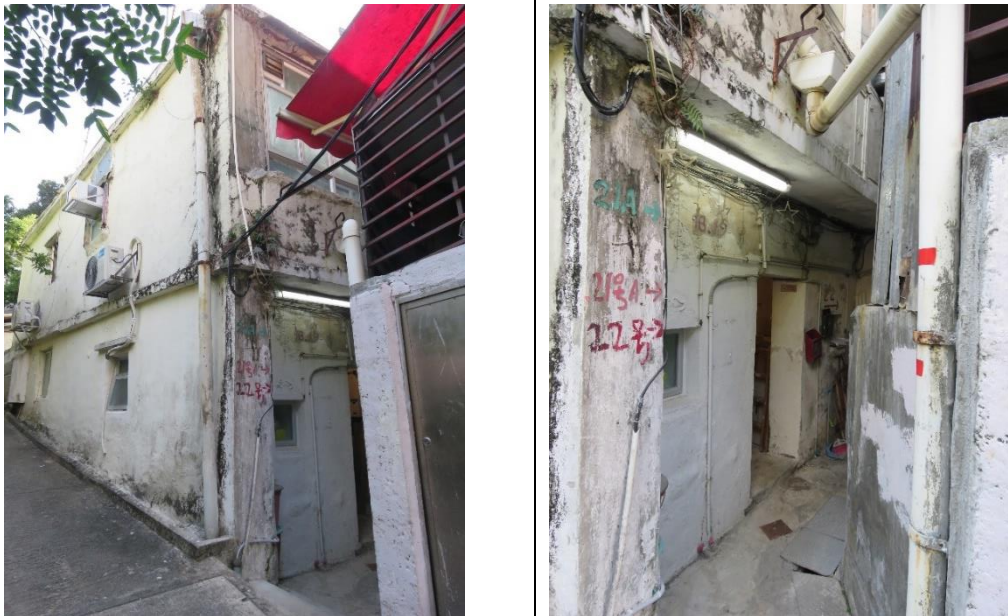
General view of HB-18, showing northeast and part of northwest elevations, looking southwest.

Ref: HB-18	Name: A Kung Ngam Building Block	Category: Residential (?)
Address: 19 A Kung Ngam Village, Shau Kei Wan, H.K.		Figure 5
Orientation: Northwest facing		Grading: N.A.
Surrounding Environment: Located behind HB-17.		
Historical Appraisal: The structure consists of three buildings (see rear view photo) which are currently joined. The 1954 aerial photo suggests the buildings on the sides were constructed first (NCAP 1954) and by 1962, a topographic map shows a same footprint as the current building (SMO 1962).		
Associated Historical/ Cultural Events or Individual: None.		
Architectural Appraisal: Set on levelled low slope, the two-storey building block is comprised of three attached buildings in different designs. Concrete is the major building material. The roofs are flat but in various levels. Entrances are also seen on temporary structures added the rear wall the building.		
Interior: No Access.

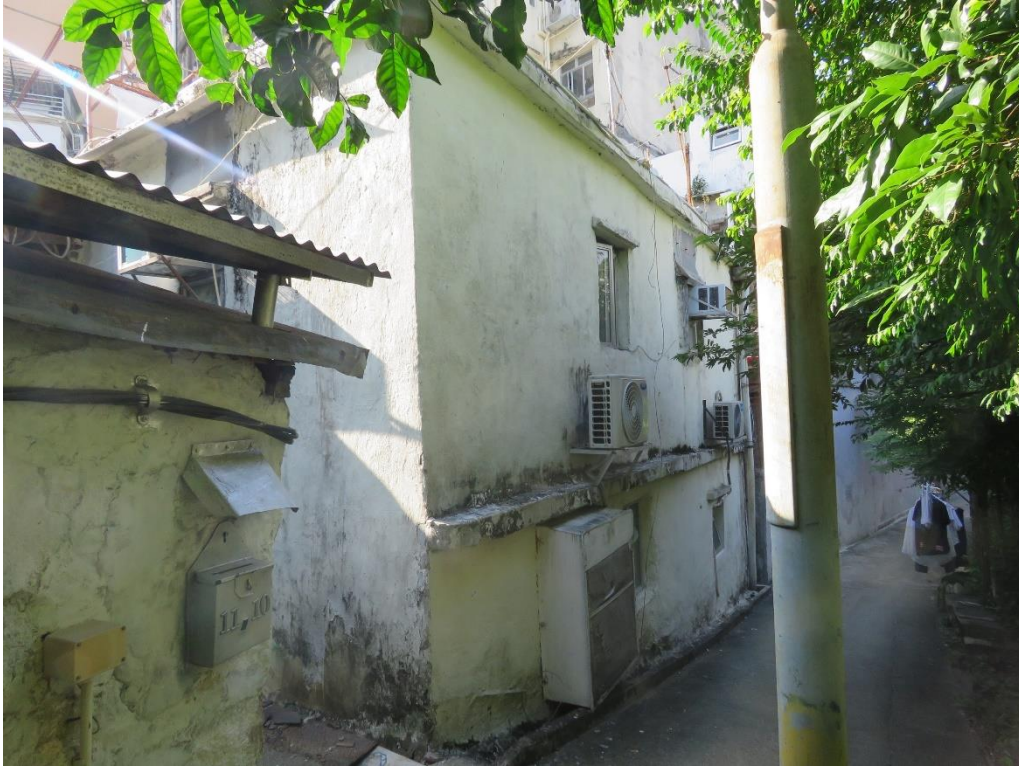
Side and rear view of HB-18, showing northeast and part of southeast elevations, looking northwest.

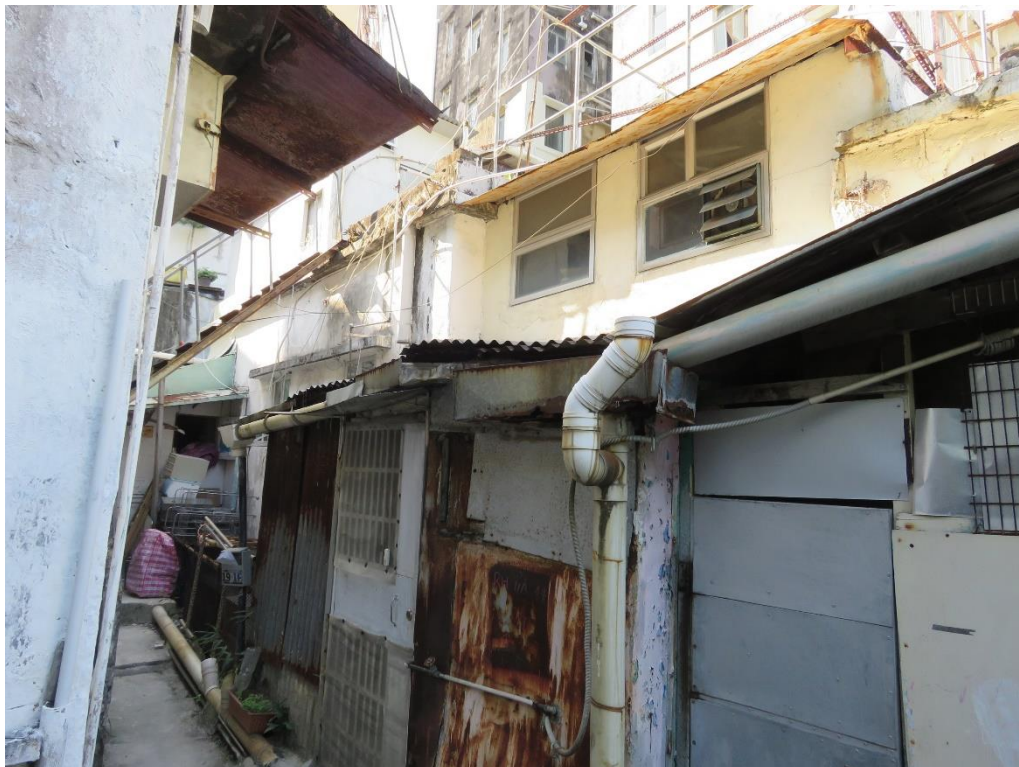
Rear view of HB-18, showing southwest part of southeast facing elevation, looking northwest.

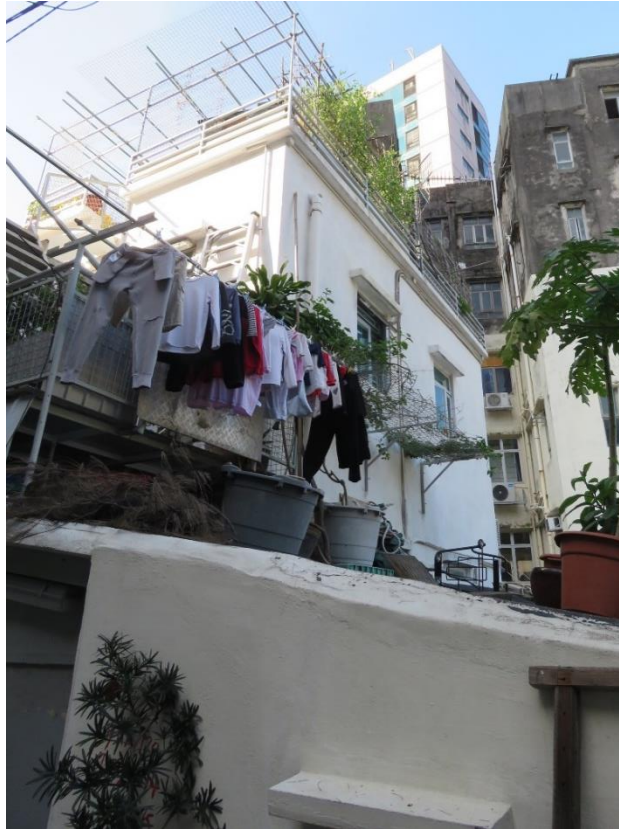
General view showing the south and east elevations, looking northwest.

Ref: HB-19	Name: Stone Village House	Category: Residential
Address: No.7 A Kung Ngam Village, Shau Kei Wan, H.K.		Figure 5
Orientation: Undetermined due to temporary structures around		Grading: N.A.
Surrounding Environment: Set on quarried low slope.		
<p>Historical Appraisal: For general background of the village, see N-01.</p> <p>The house can be spotted on a 1954 aerial photo and a same footprint is recorded on a 1962 topographic map (NCAP 1954; SMO 1962); indicating the house is a pre-1969 building.</p>		
Associated Historical/ Cultural Events or Individual: None.		
<p>Architectural Appraisal:</p> <p>It is a two-storey rectangular building with a top balcony. Due to surrounding temporary structures, the façade wall cannot be identified. Hooded windows on walls reflect a 1950s-60s style. The top balcony is fenced with metal bars. The building wall has a thick white finish. Its building style looks similar to HB-20 (No.6), a stone house. It has the potential being a stone house too.</p>

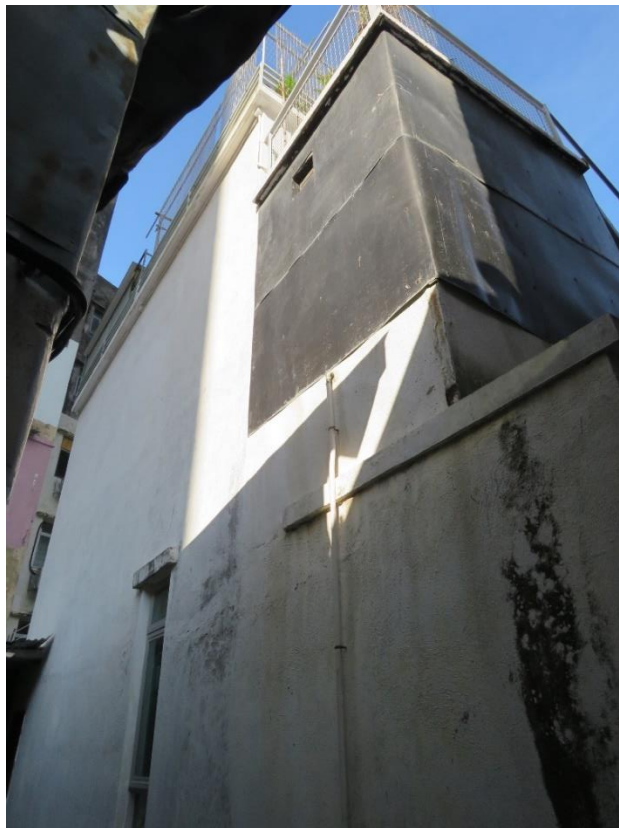
General view showing west and north facing elevations, looking northeast.

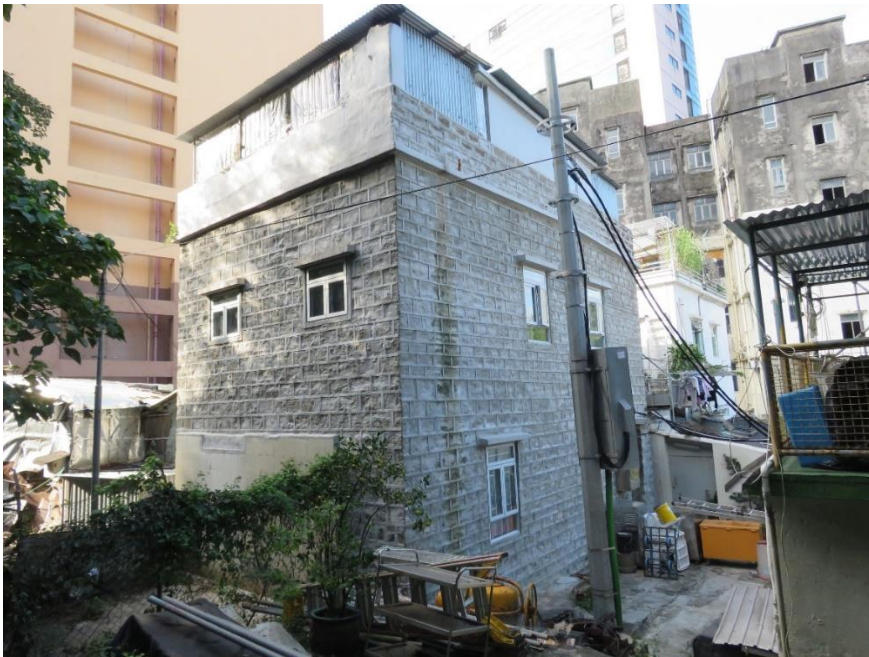
<p>General view of HB-20, showing south and east elevations, looking northwest. Note: HB-19 in white in the background.</p>

Ref: HB-20	Name: Stone Village House	Category: Residential
Address: No.6 A Kung Ngam Village, Shau Kei Wan, H.K.		Figure 5
Orientation: East facing		Grading: N.A.
Surrounding Environment: Set on quarried hillside terrace.		
Historical Appraisal: For general background of the village, see N-01. No.6 is on the 1954 aerial photo and absent on 1934 aerial (NCAP 1954 and 1934).		
Associated Historical/ Cultural Events or Individual: None.		
<p>Architectural Appraisal:</p> <p>It is a two-storey rectangular masonry house with a top balcony. An added roof structure seen on the 1954 aerial photo is set on one side of the parapeted balcony (NCAP 1954). The walls are stone with pointing. An entrance gate is set to side of the façade and canopied under a semi-circular hood. Hooded windows are on all elevations.</p>		
Interior: No Access		
Existing Condition: Good.		
Past and Present Uses: Residential		
Modifications: Temporary structures added to roof. Windows replaced.

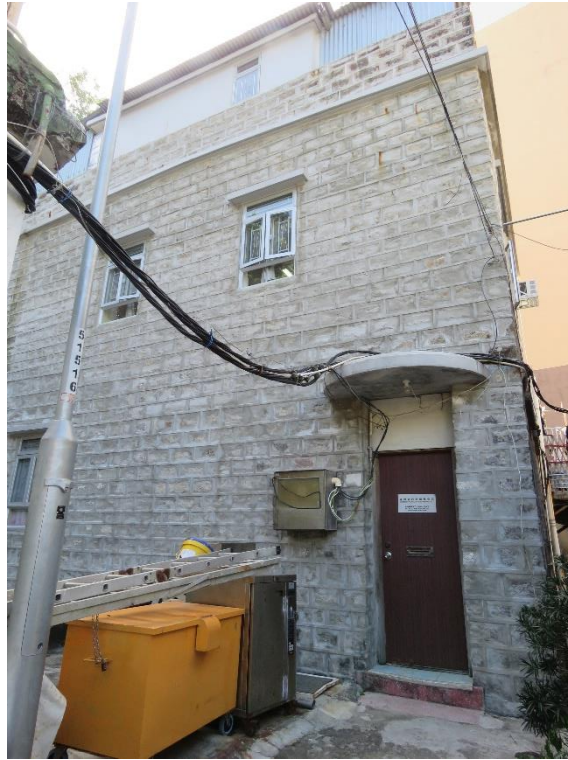
Entrance of HB-20 on east elevation, looking west.

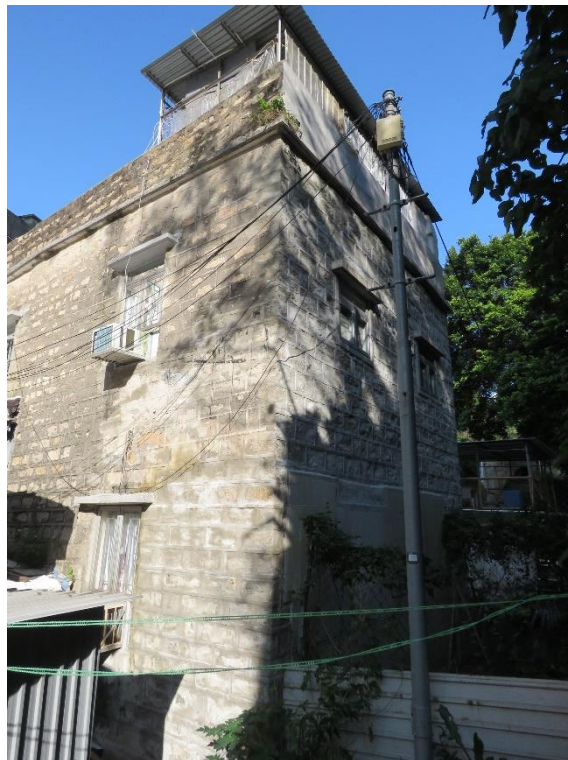
Rear and side view of HB-20, showing south and west elevation, looking northeast.

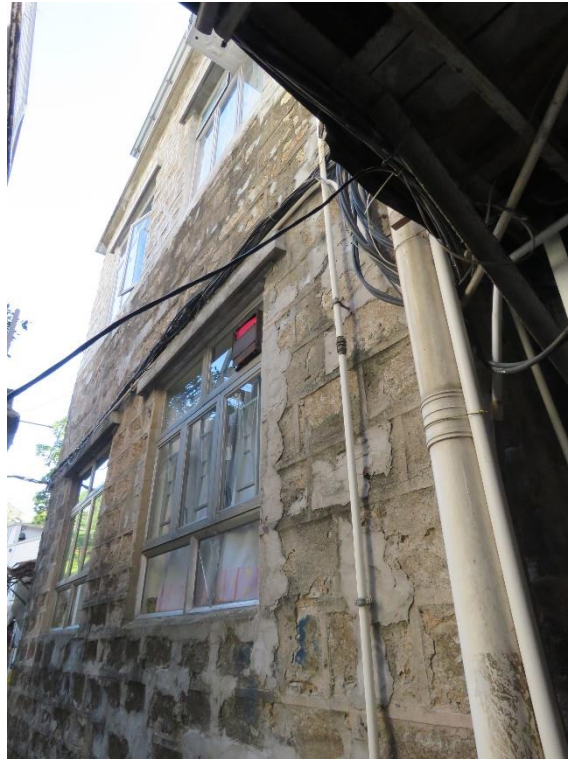
Side view of HB-20, showing north elevation, looking southeast.

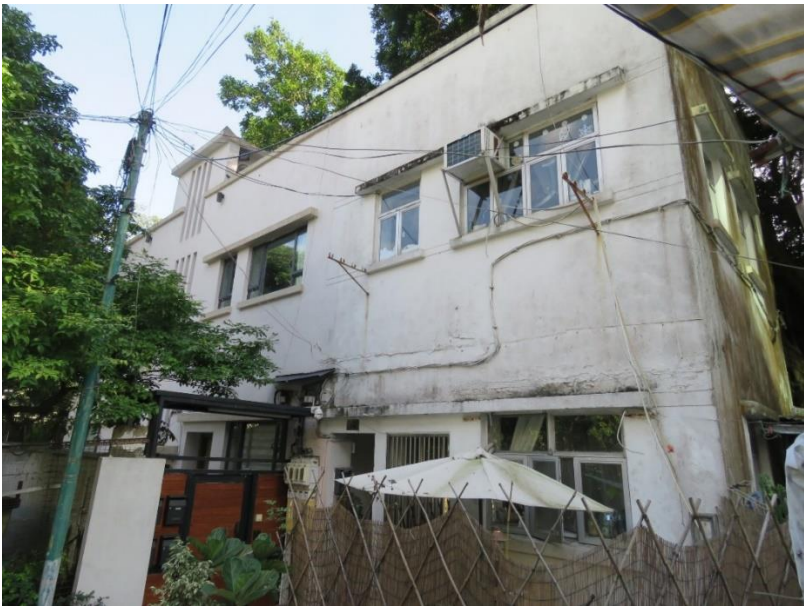
General view of HB-21, showing northwest facing elevation, looking east.

Ref: HB-21	Name: A Kung Ngam Village Houses	Category: Residential
Address: Nos. 3, 3A and 3B A Kung Ngam Village, Shau Kei Wan. H.K.		Figure 5
Orientation: Northwest facing		Grading: N.A.
Surrounding Environment: Set in the rear row of village at hill side.		
Historical Appraisal: For general background of the village, see N-01. The three houses are seen on a 1954 aerial photo (NCAP 1954). Government records show they were proposed to be constructed at the same time in 1953 (BRAVO no date-d).		
Associated Historical/ Cultural Events or Individual: None.		
Architectural Appraisal: Three two-storey buildings designed and constructed as an unit. Each of the building has a rectangular plan with recessed corners at the rear sides. It is made of concrete and featuring a modernist style village house with flat roofing. A central staircase hallway rises above the flat roof. On façade, the staircase is hinted by rows of narrow vertical windows. Windows are with modest hoods and windowsills and are opened on four elevations. Due to no access the entrance cannot be observed.

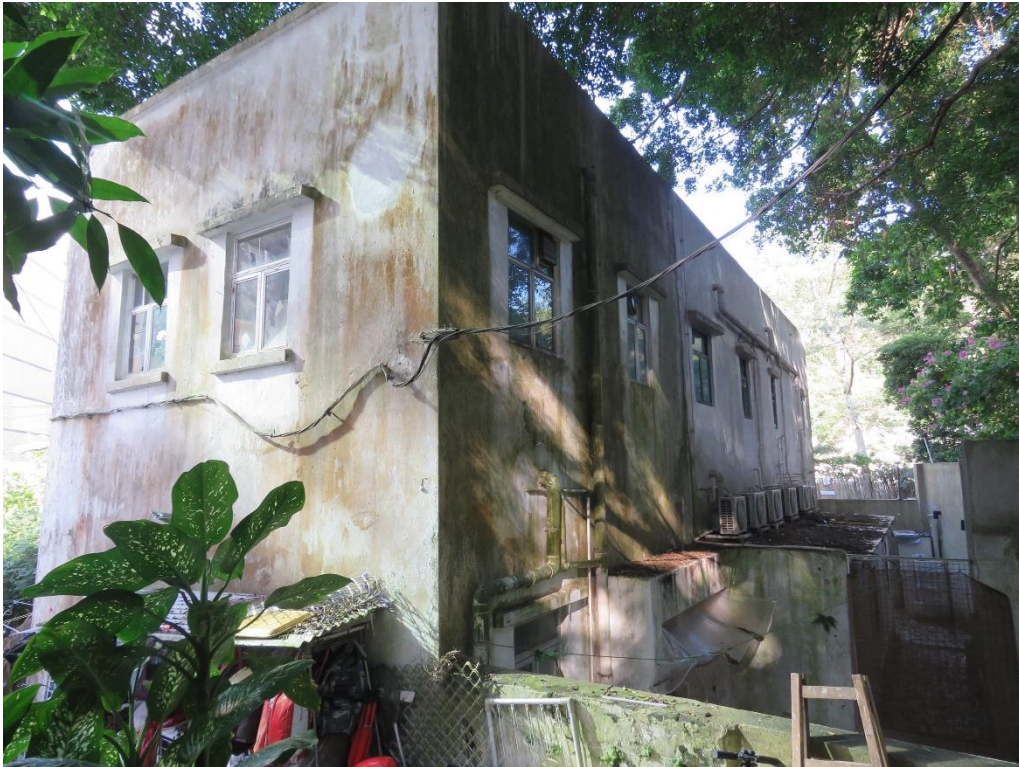
Side and rear view of HB-21, showing southwest and southeast facing elevations, looking east.

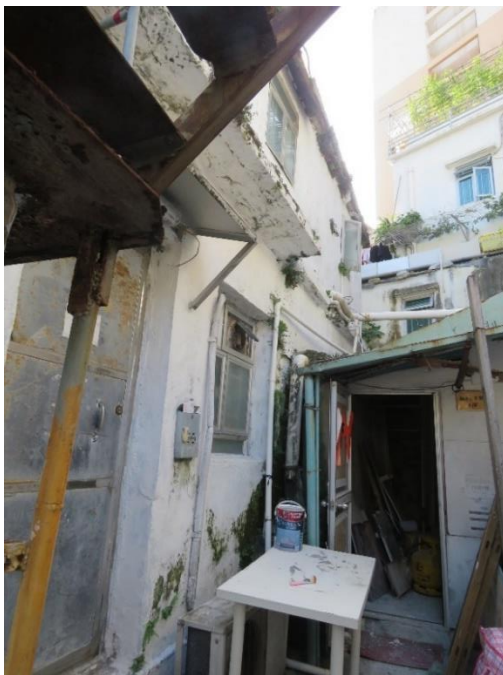
<p>Façade view of HB-22, showing northwest facing elevation, looking southwest.</p>

Ref: HB-22	Name: A Kung Ngam Village Houses	Category: Residential
Address: No.14 A Kung Ngam Village, Shau Kei Wan, H.K.		Figure 5
Orientation: Northwest facing		Grading: N.A.
Surrounding Environment: Set in the middle row of the village houses.		
Historical Appraisal: For general background of the village, see N-01. The building can be seen on a 1954 aerial photo (NCAP 1954).		
Associated Historical/ Cultural Events or Individual: None.		
Architectural Appraisal: It is a single-storey concrete structure with flat roof. A cockloft level is observed in the front part of the building. The building takes a L-shape plan. Besides the front gate shaded by concrete canopy on façade, there is also a rear door paired with steps at the back. Windows are on all faces. Some parts of the roof are covered by corrugated sheets whereas the other part by concrete flat roof.		
Interior: No Access.		
Existing Condition: Fair

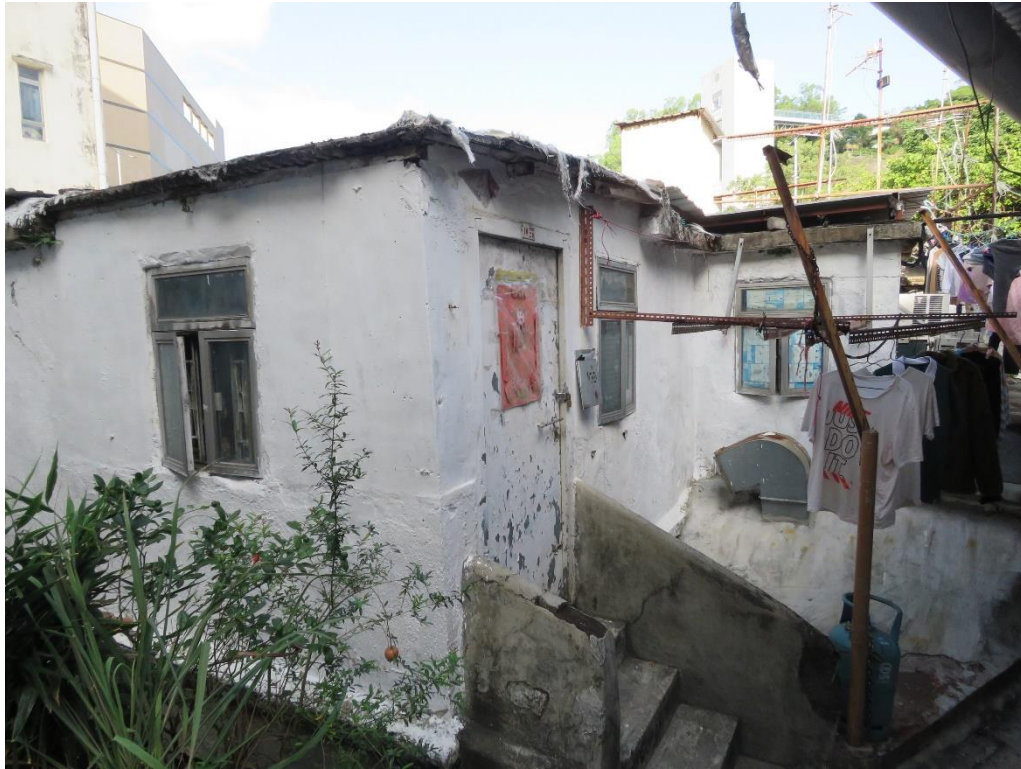
Side and rear view of HB-22, showing southwest and southeast facing elevations, looking northeast.

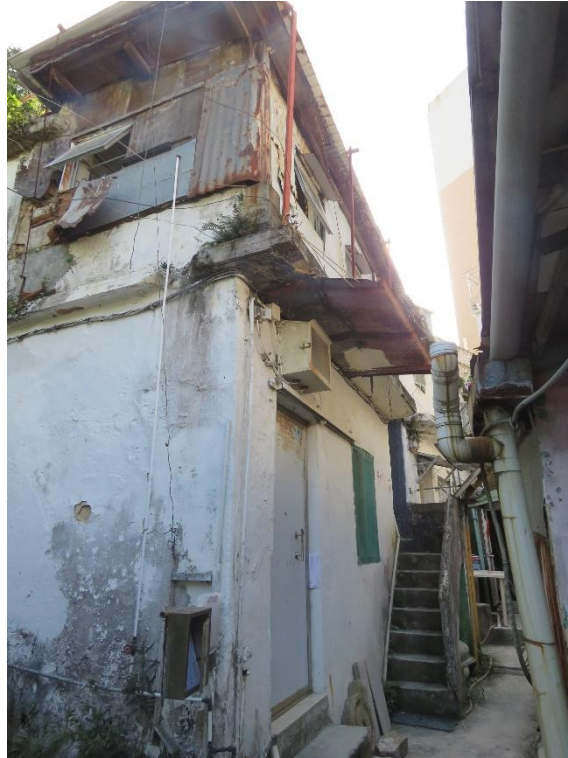
Façade view of HB-23, showing northwest facing elevation, looking southwest.

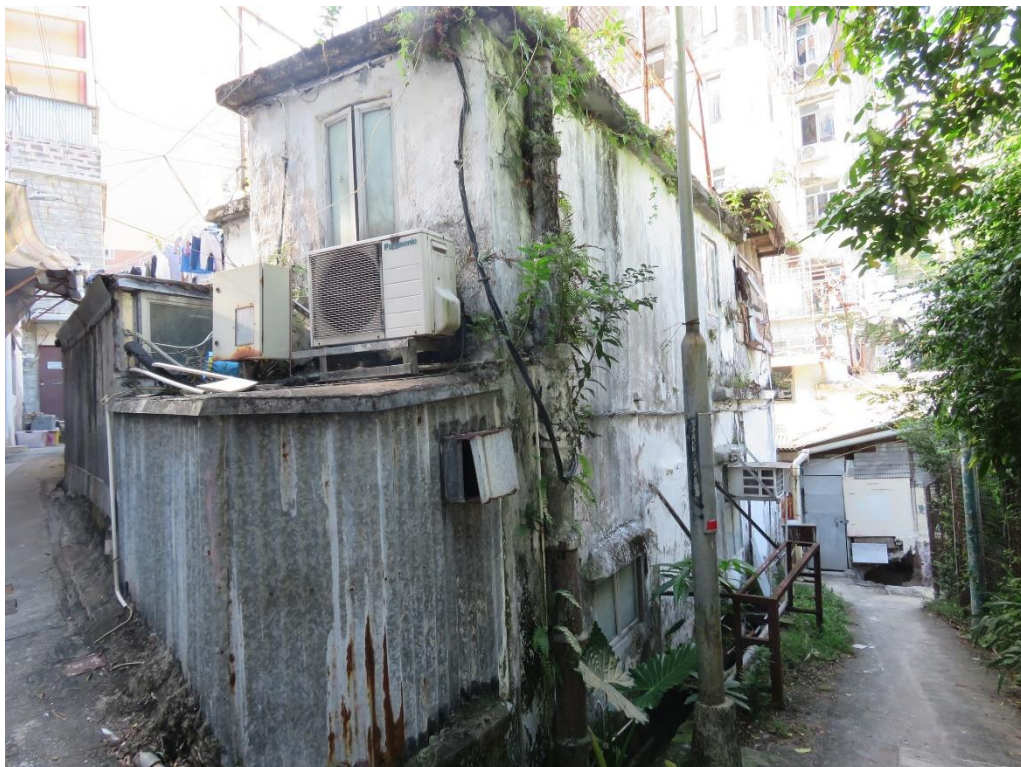
Rear and side view of HB-23, showing southeast and northeast elevations, looking northwest.
