AGREEMENT NO. CE 41/2022 (CE) - SITE FORMATION AND INFRASTRUCTURE WORKS FOR PUBLIC HOUSING DEVELOPMENT AT A KUNG NGAM VILLAGE, EASTERN – INVESTIGATION, DESIGN AND CONSTRUCTION

Heritage Impact Assessment Report (Final – Issue 2)

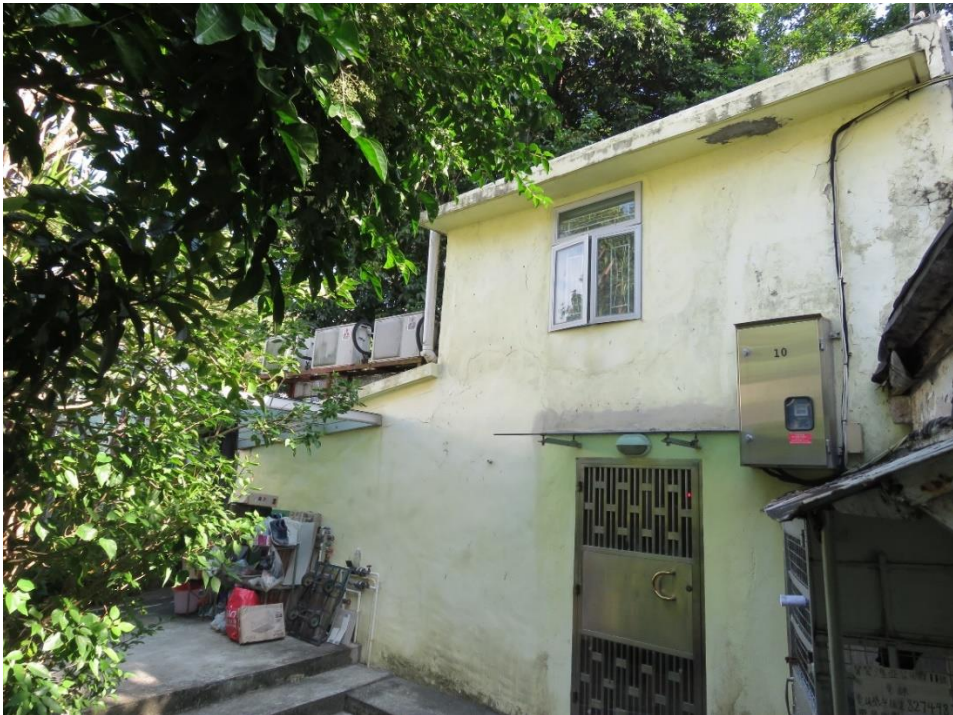
Façade view of HB-24, showing northwest facing elevation, looking southeast.

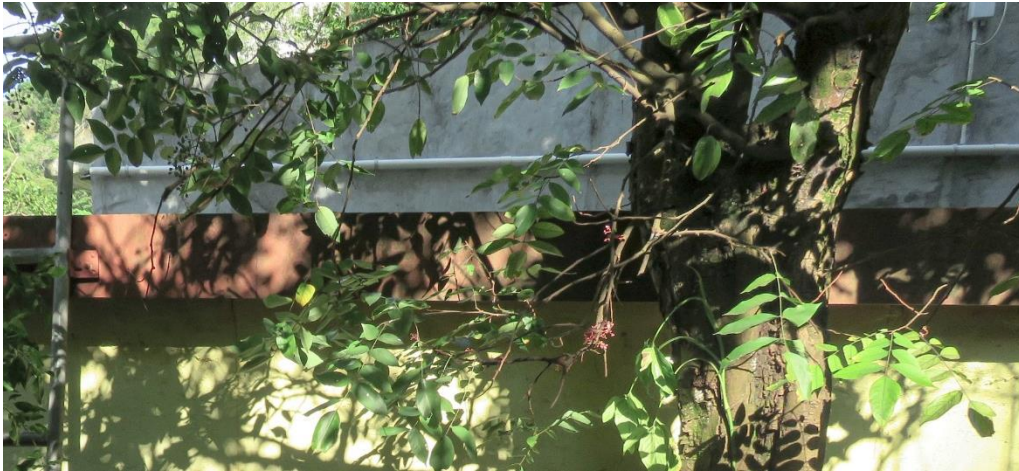
Side view of HB-24, showing pitched roof behind the tree on southwest facing elevation, looking northeast.

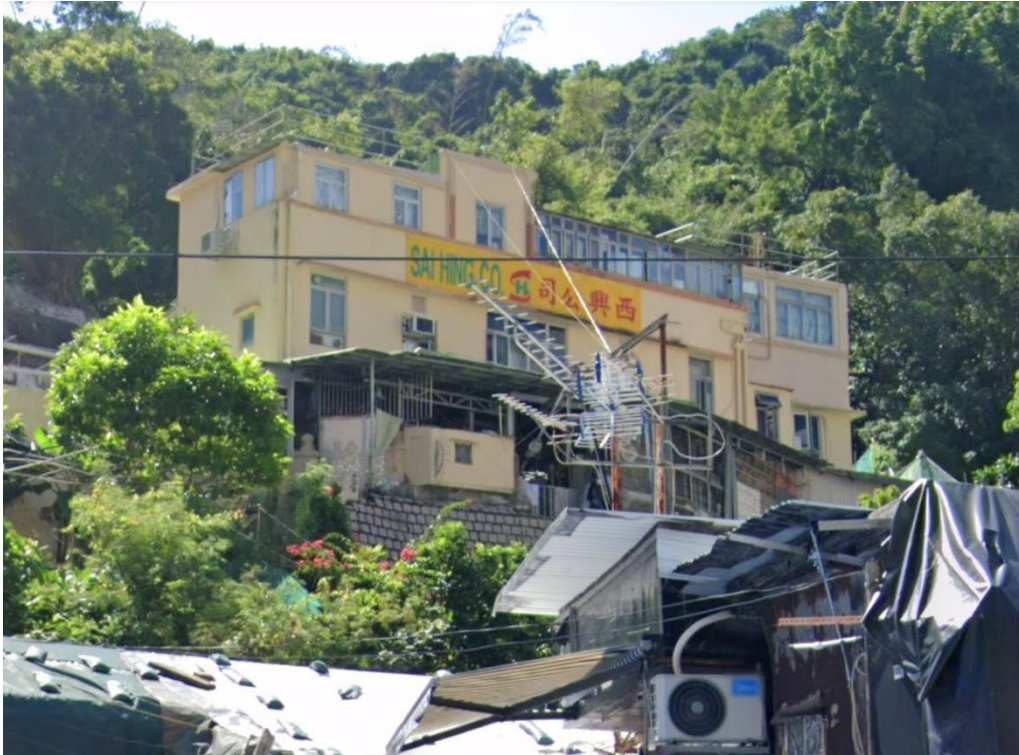
General view of HB-25, showing northeast and northwest facing elevations, looking south.

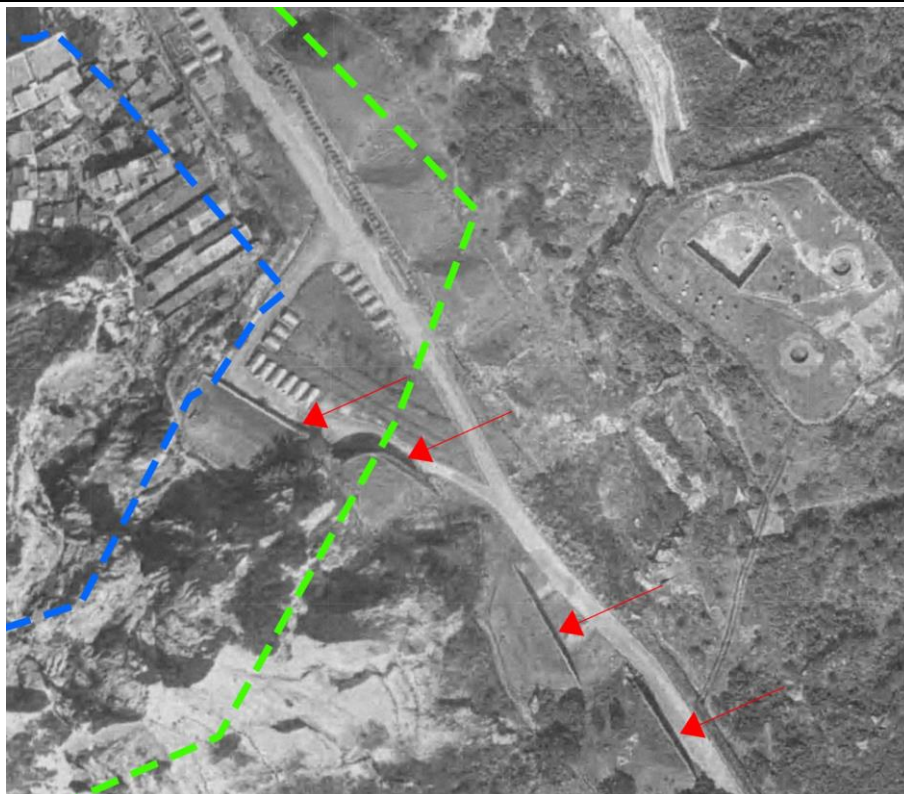
1963 aerial photo showing Nissen Huts in front of the bunker terraces. Bunker terraces are marked by red arrows. Note two more potential bunker terraces by roadside at the bottom right of the photo. (Source: HKMS 1963)

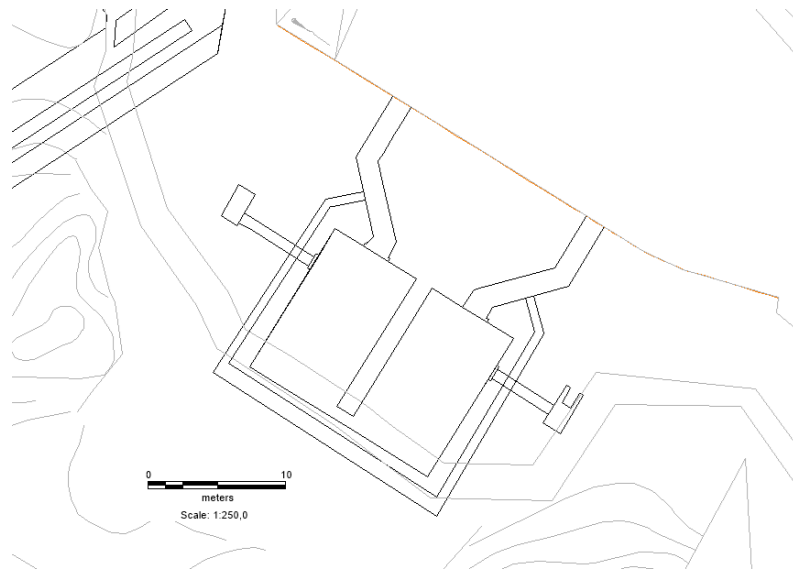
Bunker HB-26 locations with photo ref A-C.

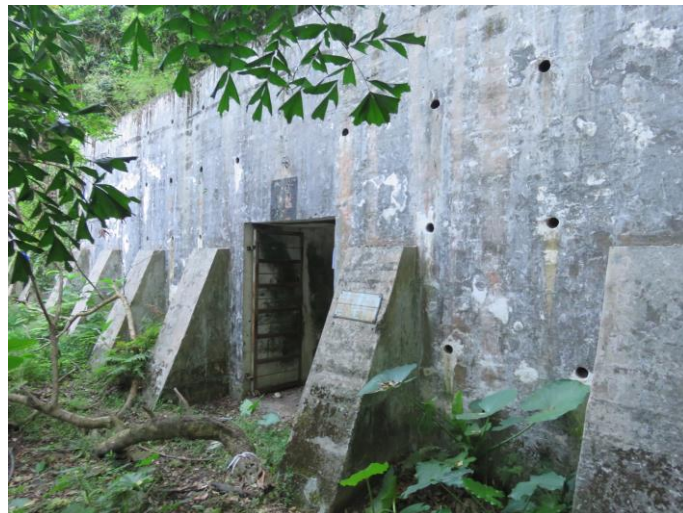
Bunker entrance location A, showing reinforced concrete terrace with buttresses, looking south. Note black paint above the entrance which shows the bunker number.

They are three bunkers built on two separated terraces made of reinforced concrete facings. Terrace 11SE-B/R 47 features a vertical terrace wall with regularly spaced weepholes and buttresses. Two rectangular bunker entrances are set 30m-ish apart on the terrace. Both bunkers have a black-grounded paint above their entrance once bearing the bunker code now no longer readable. Gates are made of heavy-duty iron bars. Inside the gates, each bunker has a tunnel leading to the inner space. But it is observed that a bent turn existed at the end of the entrance tunnel. The internal walls

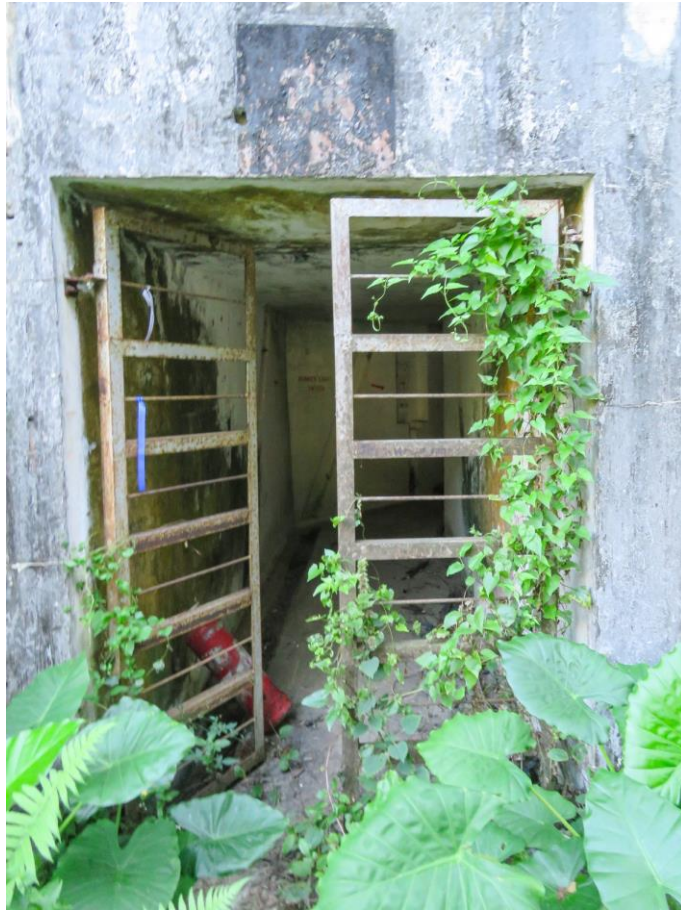
Bunker entrance location B, looking southwest.

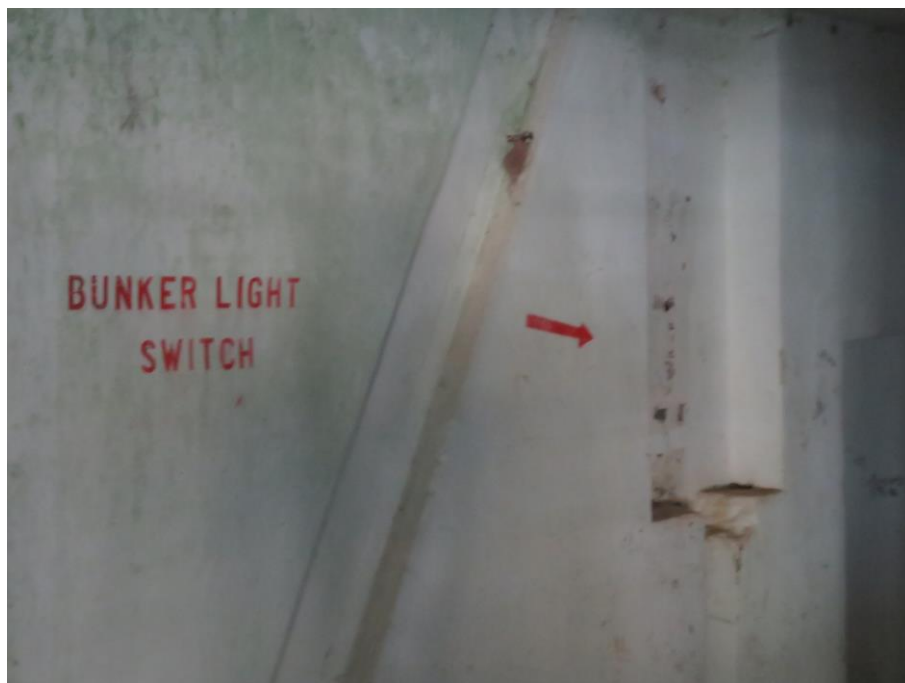
Close-up view of inscription on wall near the end of the entrance tunnel.

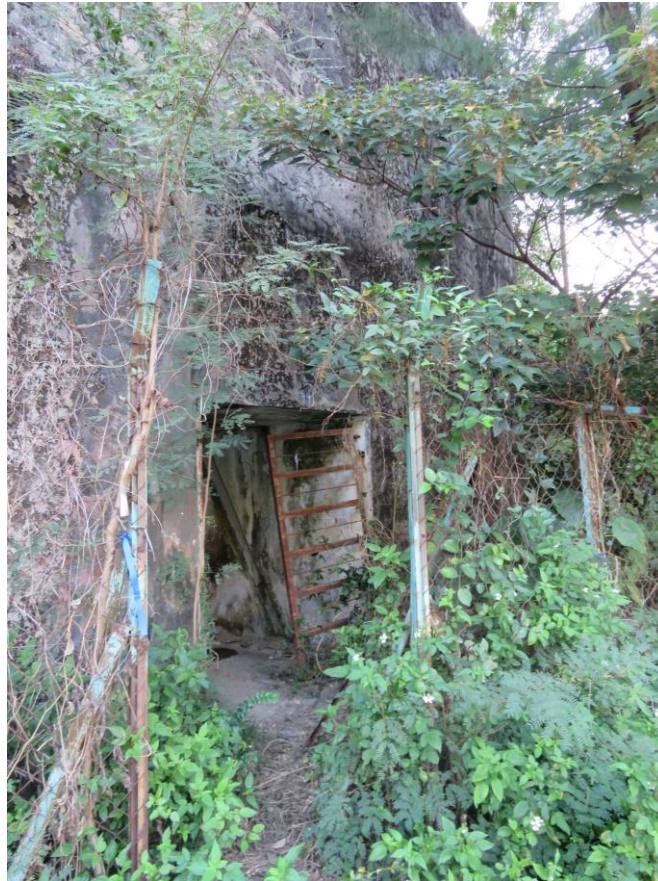
Bunker entrance location C, looking west

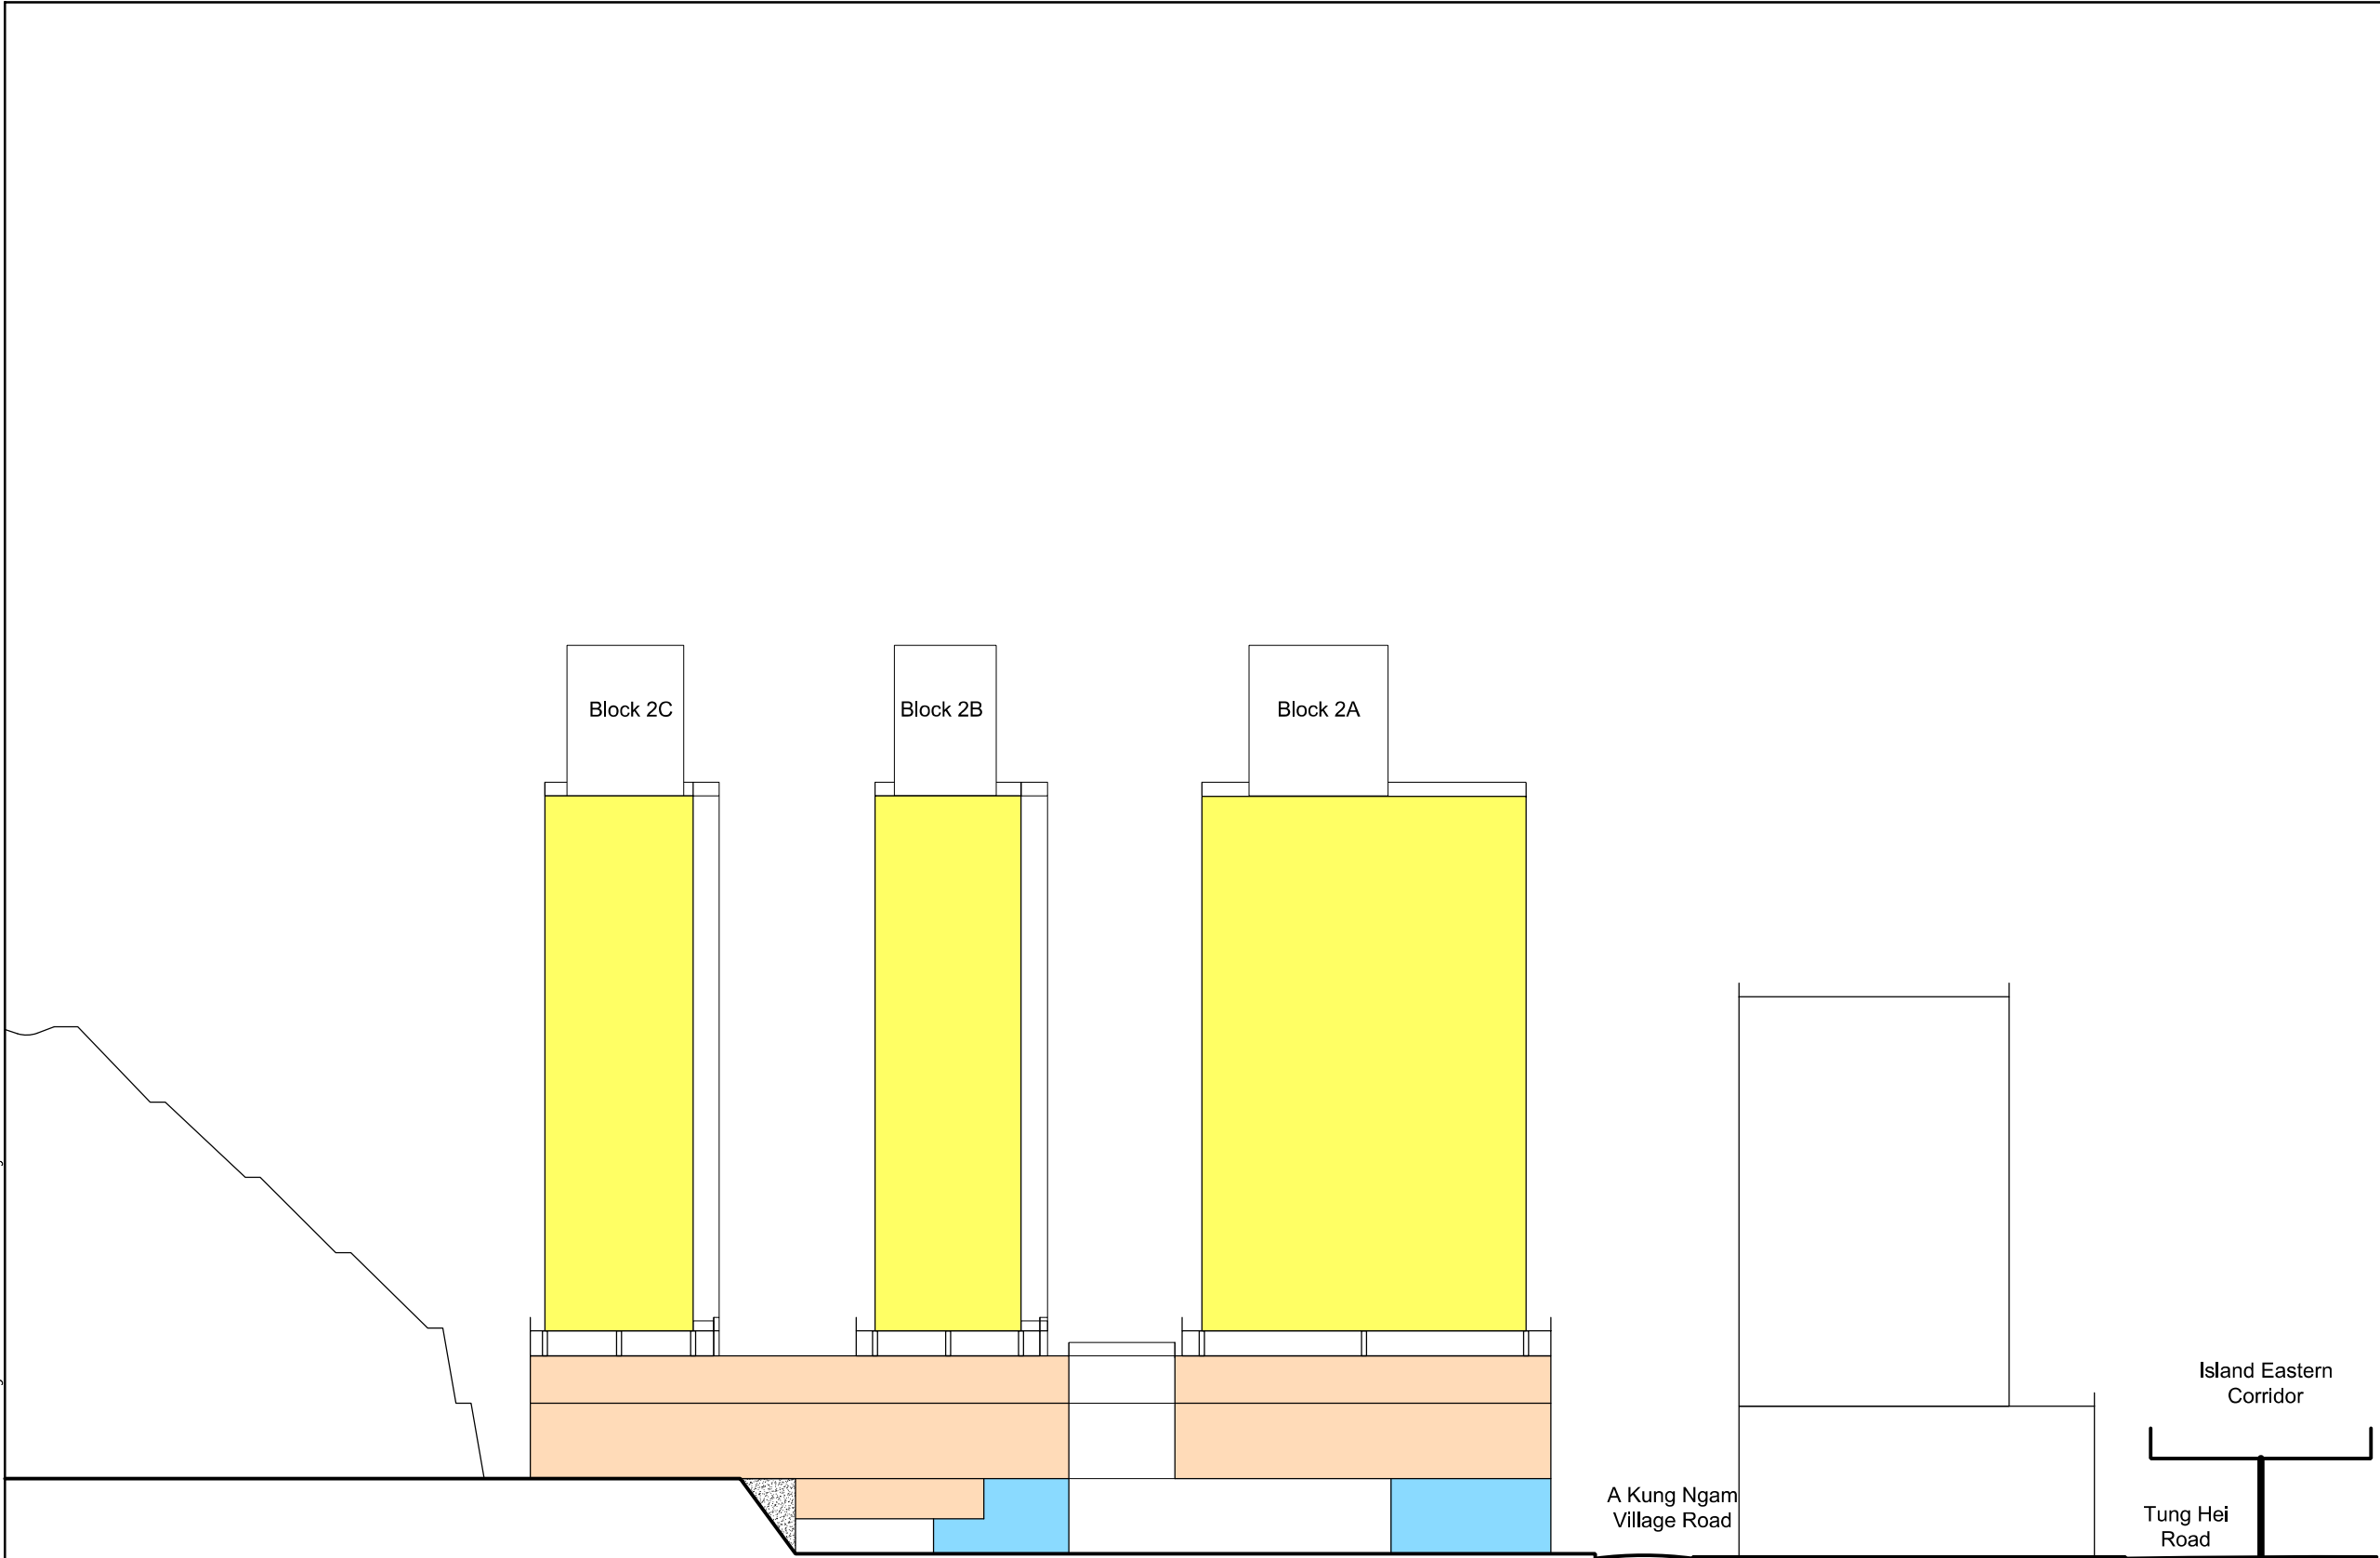
Rev	Description	By	Date
Consultant			
wsp			
Project title			
AGREEMENT NO. CE 41/2022 (CE) SITE FORMATION AND INFRASTRUCTURE WORKS FOR PUBLIC HOUSING DEVELOPMENT AT A KUNG NGAM VILLAGE, EASTERN -INVESTIGATION, DESIGN AND CONSTRUCTION			
Drawing title			
CROSS SECTION FOR THE PROPOSE HOUSING DEVELOPMENT SHEET 2			
Drawing no.			Rev.
CE41/F IG/126			-
Drawn	Date	Checked	Approved
CAD	09/03/2023	PL	CL
Scale	Status		
1:700 (A3)	-

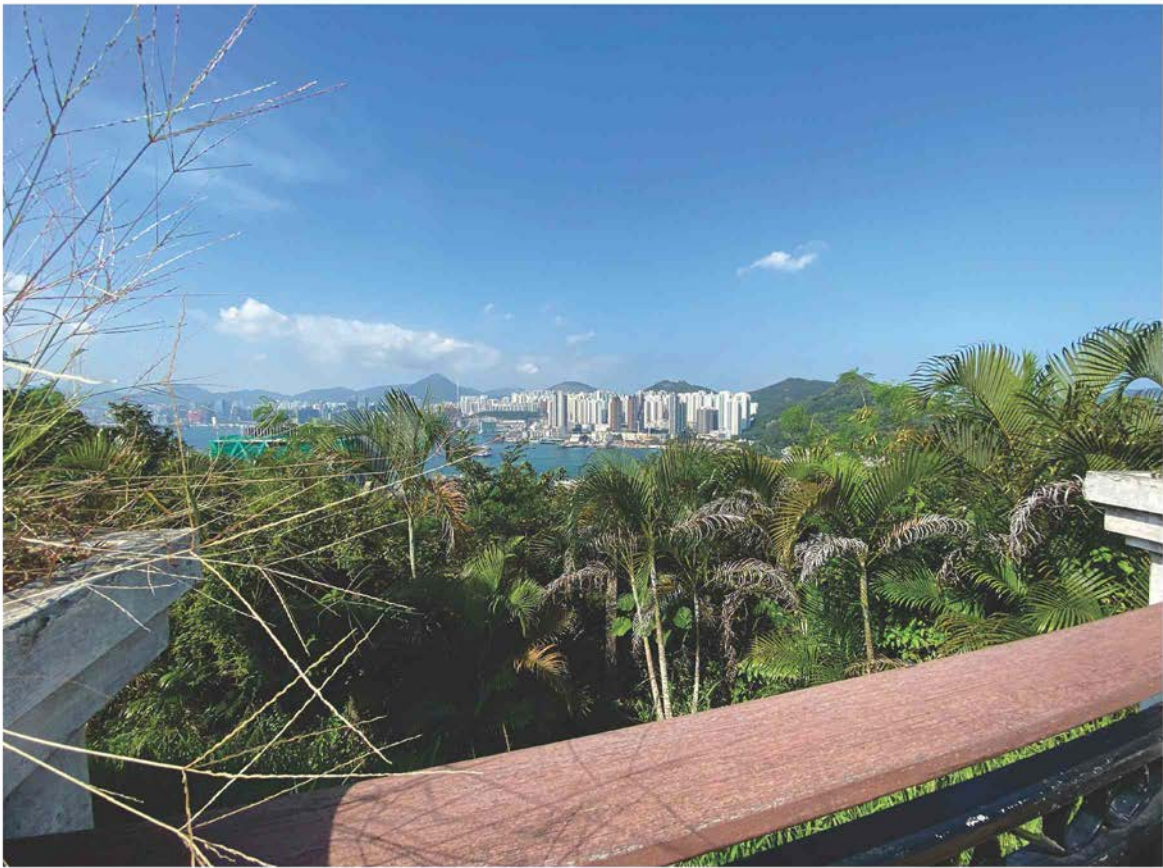
VIEW FROM LEI YUE MUN BARRACKS BEFORE DEVELOPMENT

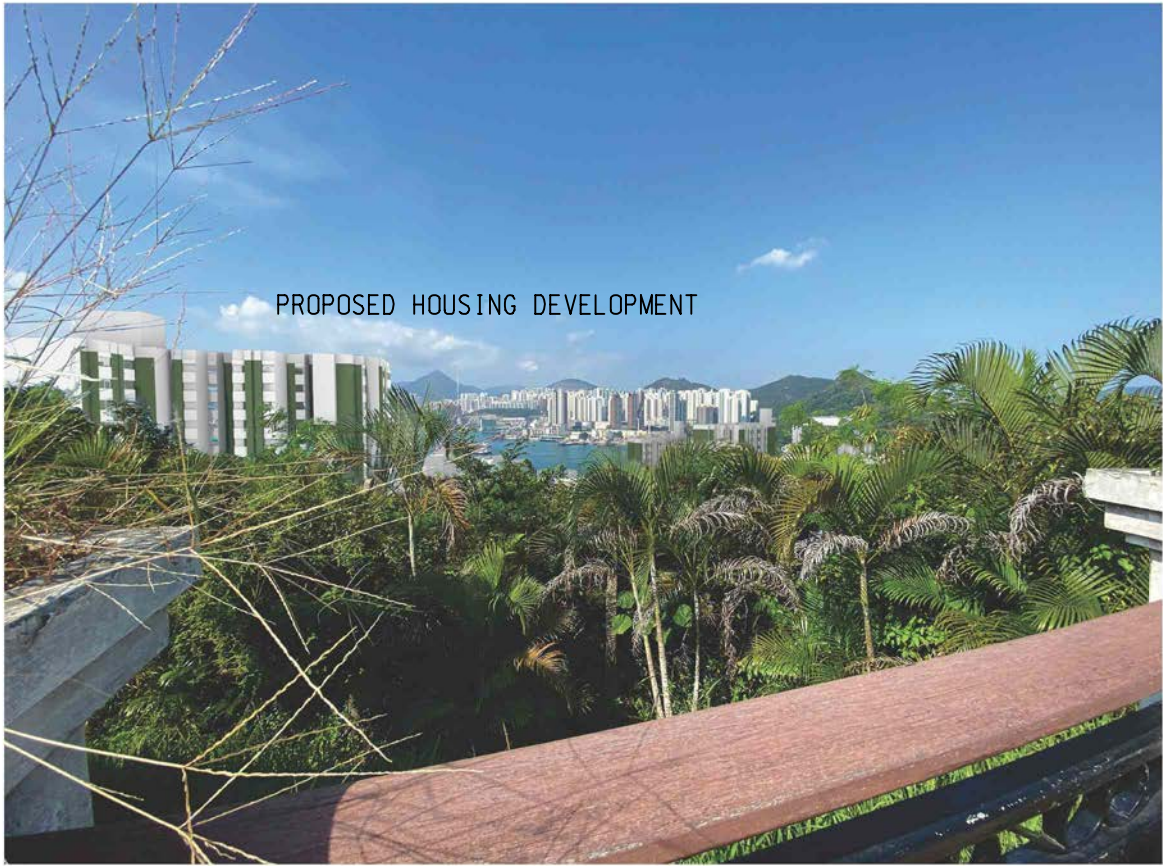
VIEW FROM LEI YUE MUN BARRACKS AFTER DEVELOPMENT
