**HERITAGE IMPACT ASSESSMENT FOR
THE CONVERSION OF
OLD WAN CHAI POLICE STATION
INTO THE HEADQUARTERS OF AN INTERNATIONAL
INTER-GOVERNMENTAL ORGANIZATION**

Applicant:
ARCHITECTURAL SERVICES DEPARTMENT

Heritage Consultant:
AGC DESIGN LTD

Dec 2023

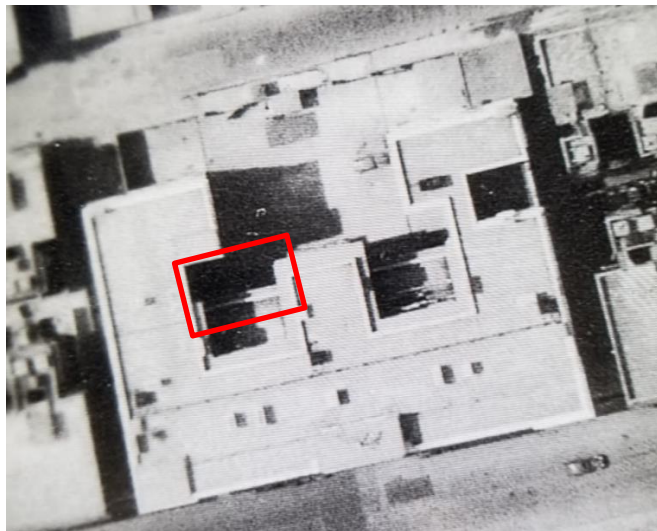
Fig.5.1.2 1949 aerial photo outdoor alcove space still existed [Lands Department]

¹ In comparison with another set of 1956 plan from PWD on which the alcove space at the east wing facing the courtyard on G/F was enclosed with a new cell and corridor. This alcove space was not yet filled up in 1949 aerial photo.

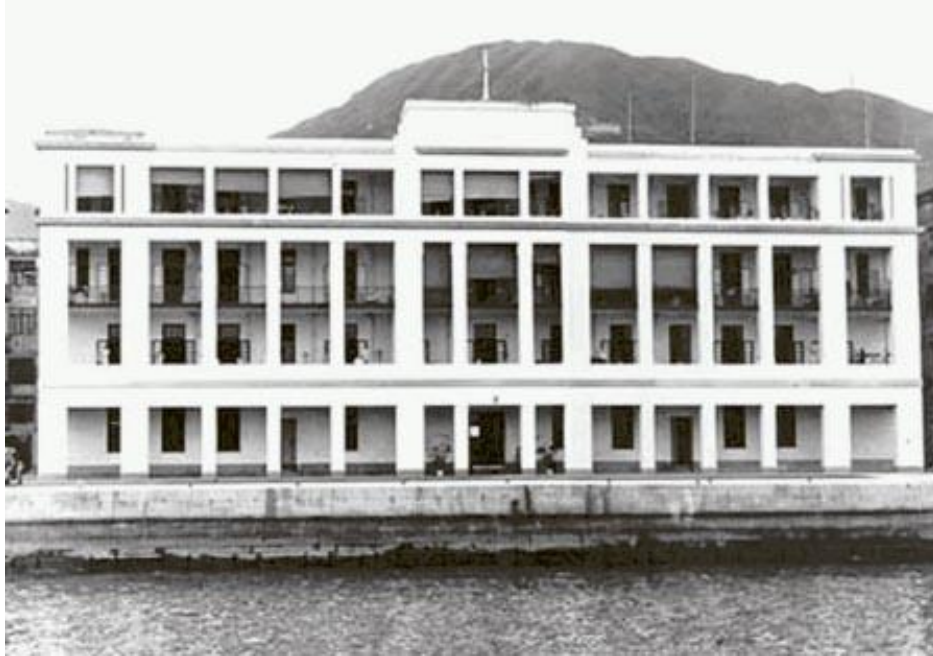
Fig.5.1.4 Front elevation shortly taken after WWII [Colin Crisswell and Mike Watson, *The Royal Hong Kong Police (1841-1945)*, p.143]

The front elevation of the OWCPS is in symmetrical design which captures some essences of Neo-classical architecture with Art Deco movement influence. Arcade is found on ground floor while verandahs are found on the first, second and third floors. The frontal façade facing Gloucester Road has divided vertically into five portions or 13 bays by tall concrete piers. It is divided into three layers horizontally by cornice strips. This kind of pattern is commonly used in Western Classical architecture. Columns on the façade can be seen as a simplified version of classical orders which consists of a base, shaft and stylized capitals. The capitals are simply crafted with simple lines and volutes. The rectilinear projection feature standing above the attic storey at the upper centre resembles a Greek classical pediment. Together with the main entrance being located at the centre of ground floor, they give the façade focus on the central portion. The minimal or abstracted ornamentation and plain appearance show the influence of the Art Deco style, which was popular during the period when this police station was constructed. Designed by the then Public Works Department, the long and deep verandah is a typical feature of buildings in Hong Kong at that time.

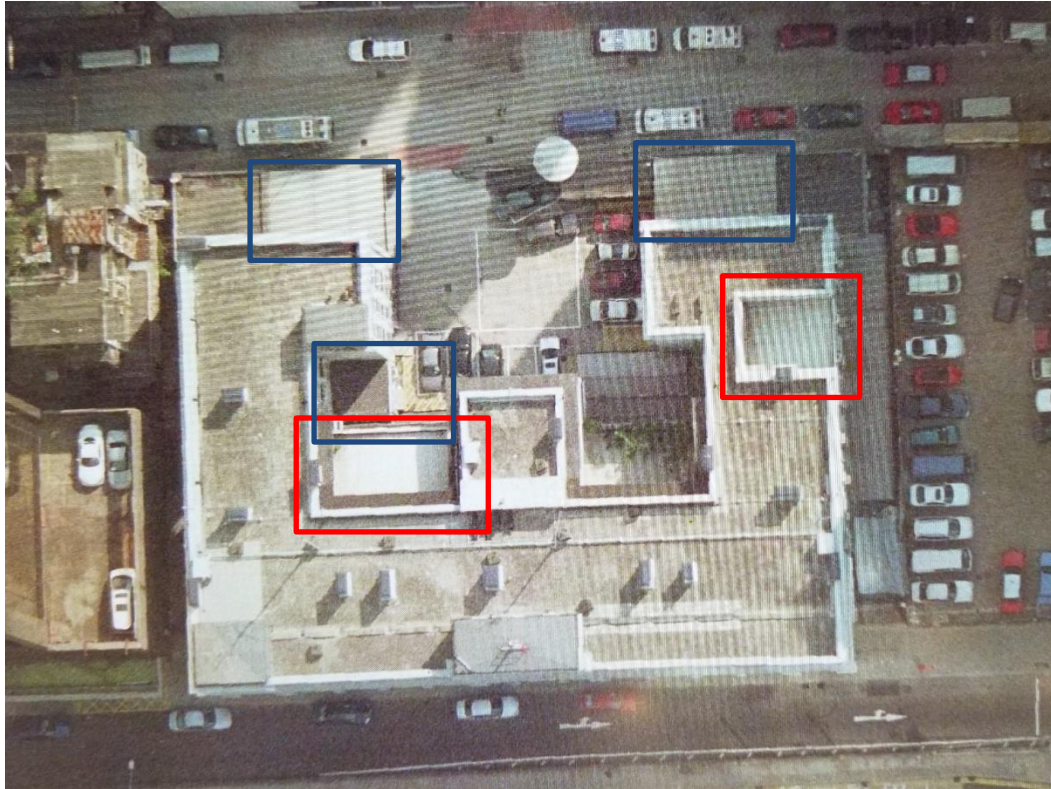
Fig.5.2.1 Aerial photo 2002 showing later-added on G/F (blue), terraces on 2/F (red)
[Lands Department modified by author]

- i) There was a barber shop on first floor at the east wing above the mezzanine floor on 1956 plan.
- ii) The roof terraces at the east wing on the 2/F was enclosed to form an internal office on 1992 plan.
- iii) The roof terrace facing the side lane on 2/F of west wing was covered up for office use on 1992 plan.

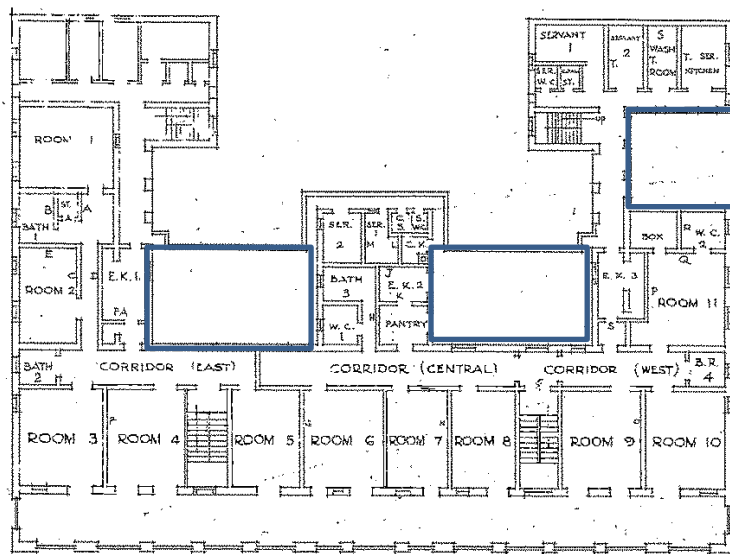
Fig.5.2.2 Roof terraces on 2/F plan before 1949 [ArchSD plan modified by author]

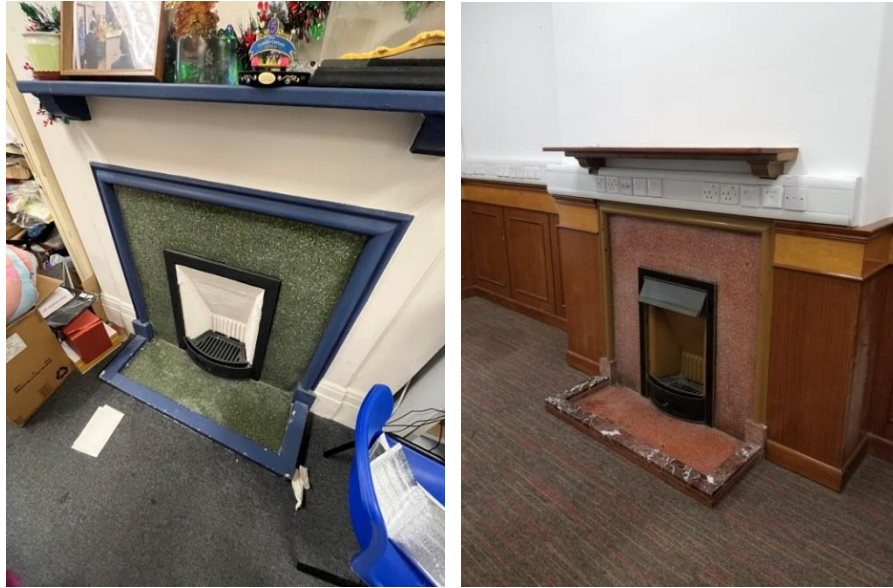
Fig.5.2.5 Different appearance of fireplaces 2023 [ArchSD]

The stacks at roof are blocked. 7 number of original fireplaces are exposed. Others are blocked and some with the remains of timber top with corbels. According to the site survey on the fireplaces in 2023, the remaining fireplaces are identified as follows:

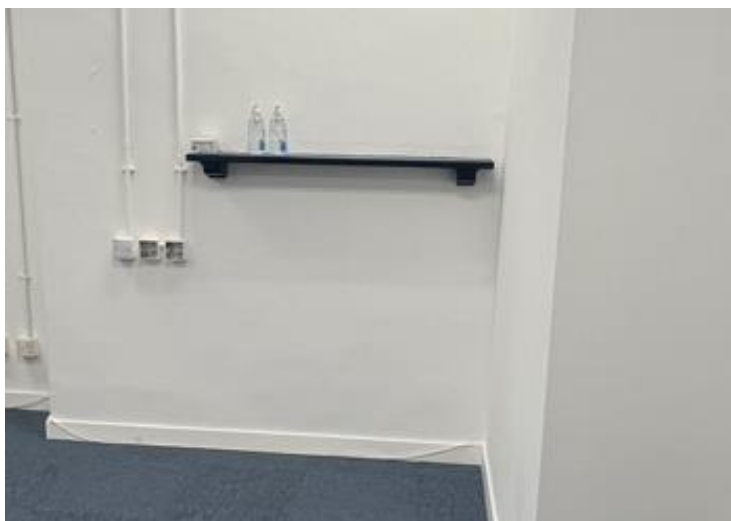
Fig.5.2.7 Blocked fireplace with timber top 2023 [by author]

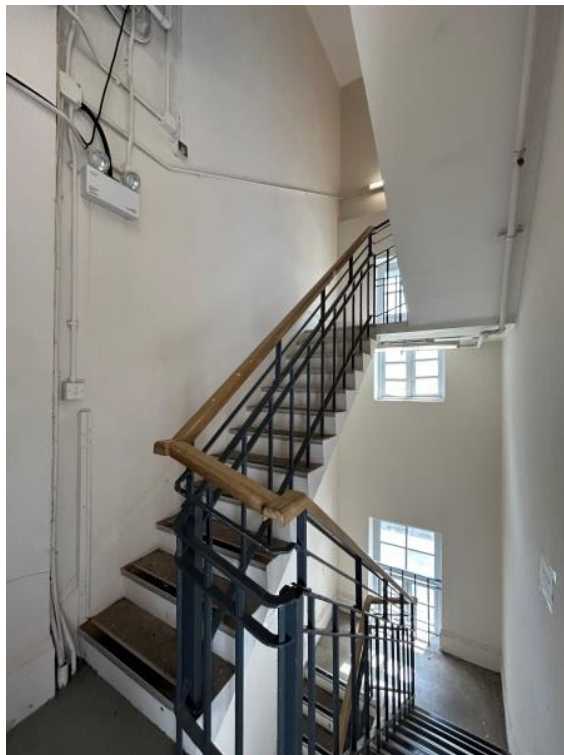
Staircase 1 & 4 are with similar design with metal railing posts in between flights. Staircase 2 & 3 are with similar design with timber railing posts in between flights. Metal ladders are found in staircase 2 & 3. There were upgrading works in all four stairs in the past. The railing heights of all staircases are extended. Due to a mezzanine floor in between G/F and 1/F, a single flight is at the end of east wing on 1/F.

Fig.5.2.13 Stair 1 with steel post
2023 [by author]

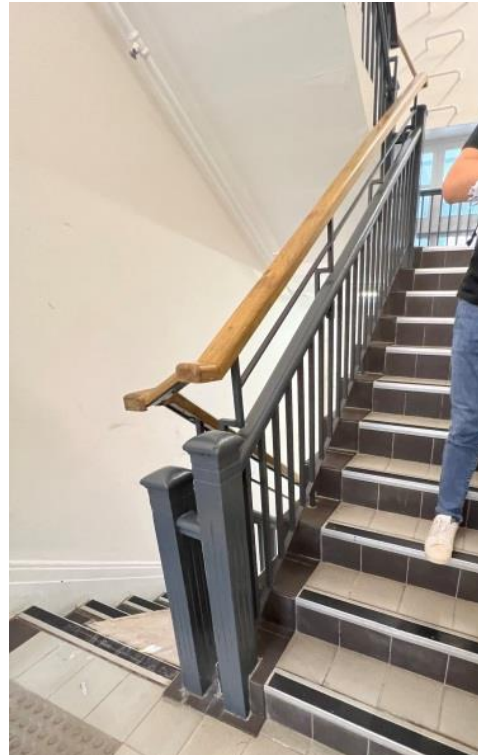
Fig.5.2.14 Stair 2 with timber post
2023 [by author]

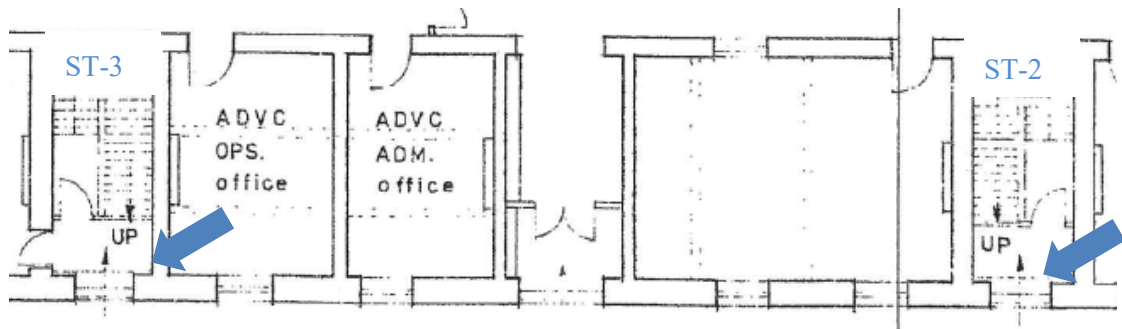
Fig.5.2.15 Direction of exit for Stair 2 & 3 in 1988 G/F plan [ArchSD modified by author]

There are 4 enclosed staircases named from 1 to 4. Staircase 2 & 3 are facing Gloucester Road. Staircase 1 & 4 are facing the yard at the west and east wings respectively. Staircase 2 & 3 were connected to the arcade on the north on 1988 plan. They were converted to connect with the internal corridor on the south on 1992 plan.

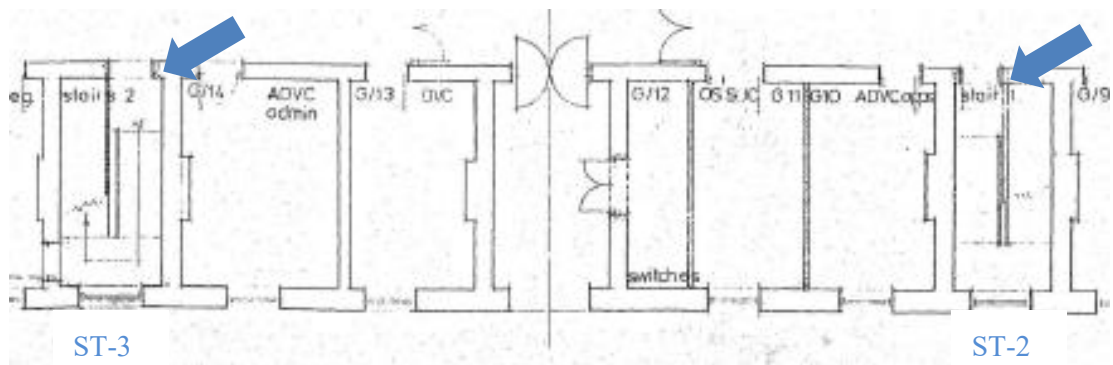
Fig.5.2.16 Direction of exit for Stair 2 & 3 in 1992 G/F plan [ArchSD modified by author]

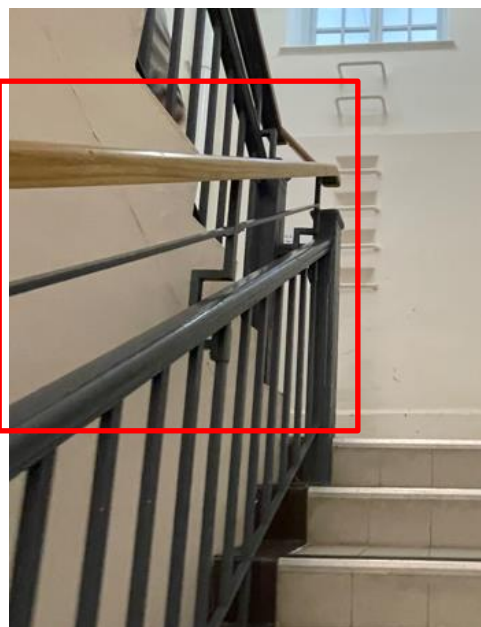
Fig.5.2.17 Stair railing extended, 2023
[by author]

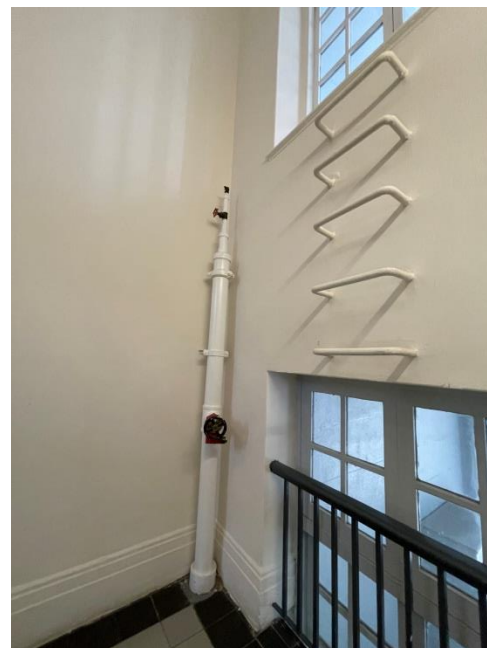
Fig.5.2.18 Ladder within Stairs 2 & 3, 2023
[by author]

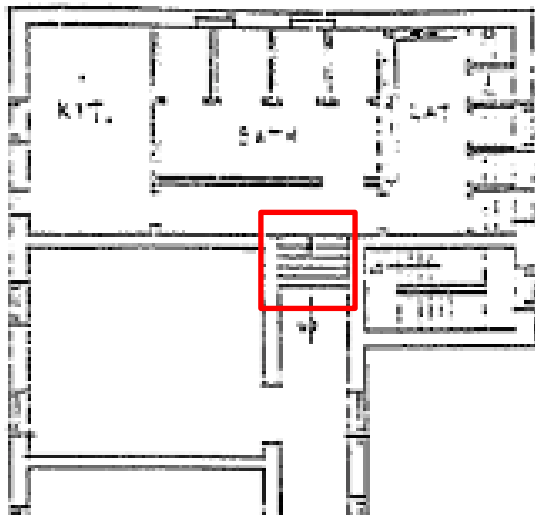
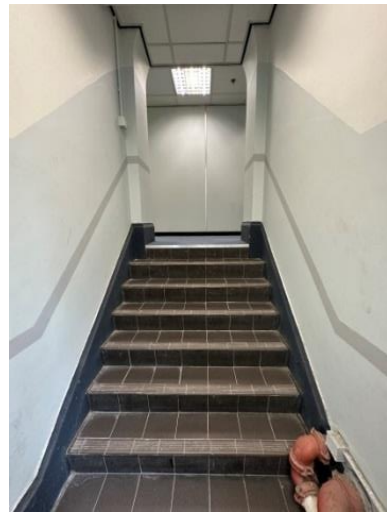
Fig.5.2.19 Stair above mezz.floor at 1/F before 1949 plan (left) [ArchSD modified by author]
Single flight stair at 1/F 2023 (right) [by author]

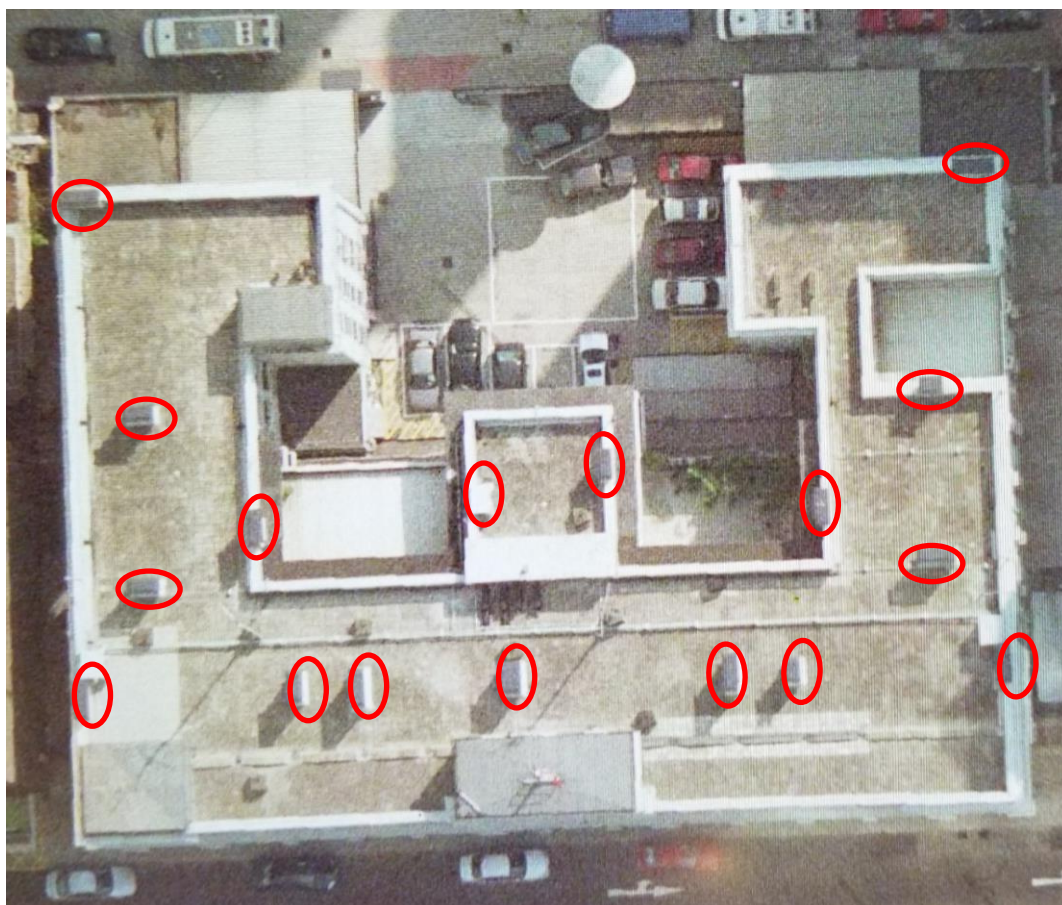
Fig.5.2.20 Chimneys at the main roof in 2002 aerial photo
[Lands Department modified by author]

There are 17 numbers of chimneys on the main roof. Their location matches the layout on the floor plans on the before 1949 plan for the dormitories, kitchens and bathrooms. At the north east corner above the 3rd floor verandah, there is a pitched roof structure. The function of this structure is unknown. The ceiling height of the verandah on 3/F is raised at this location. No such kind of feature is found at the north west corner. This is also found in the 1949 aerial photo and early elevation photo.

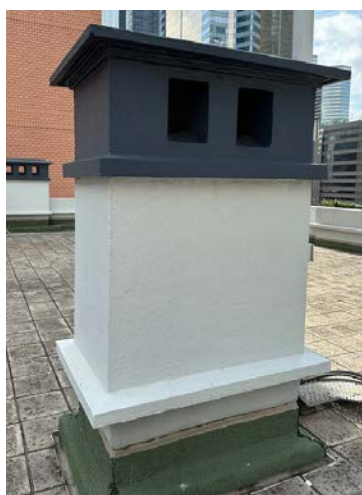
Fig.5.2.21 Chimneys at the roof 2023
[by author]

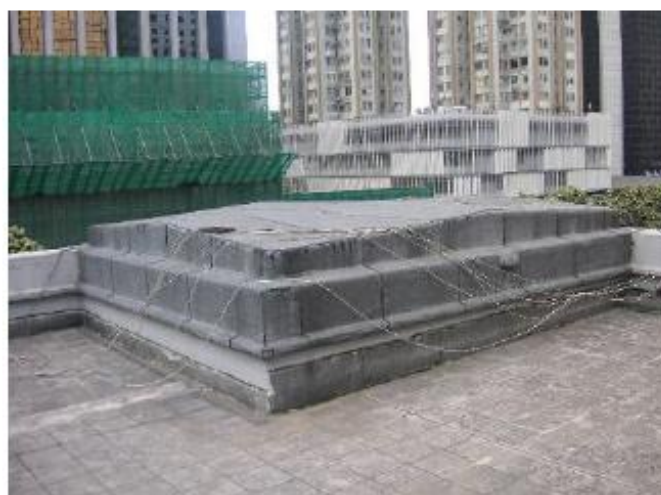
Fig.5.2.22 Raised roof at north east corner 2023
[by author]

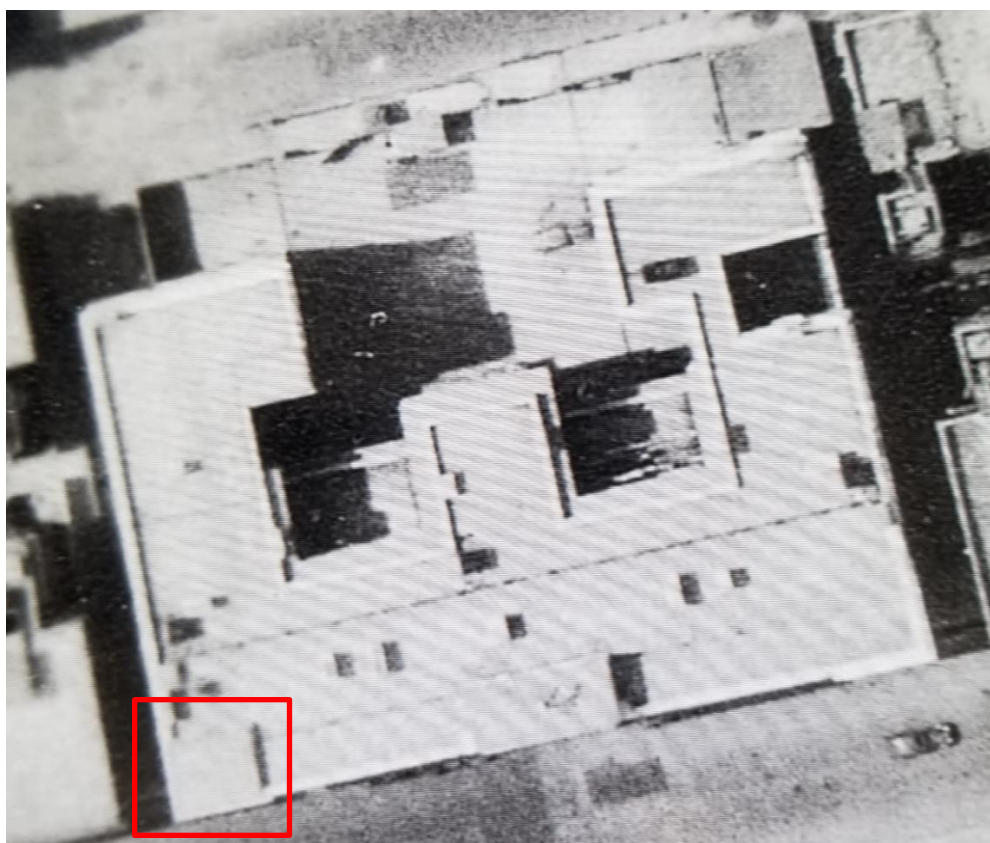
Fig.5.2.23 Pitched roof at north east corner in 1949 aerial photo
[Lands Department modified by author]

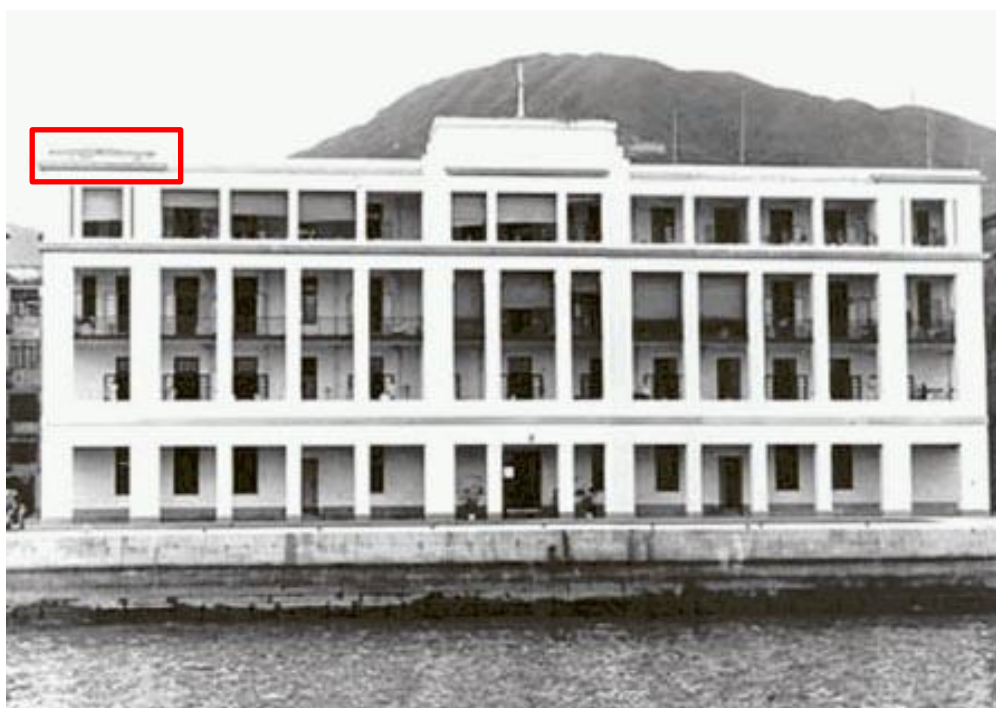
Fig.5.2.24 Pitched roof at north east corner, photo taken shortly after WWII
[Colin Crisswell and Mike Watson, *The Royal Hong Kong Police (1841-1945)*, p.143]

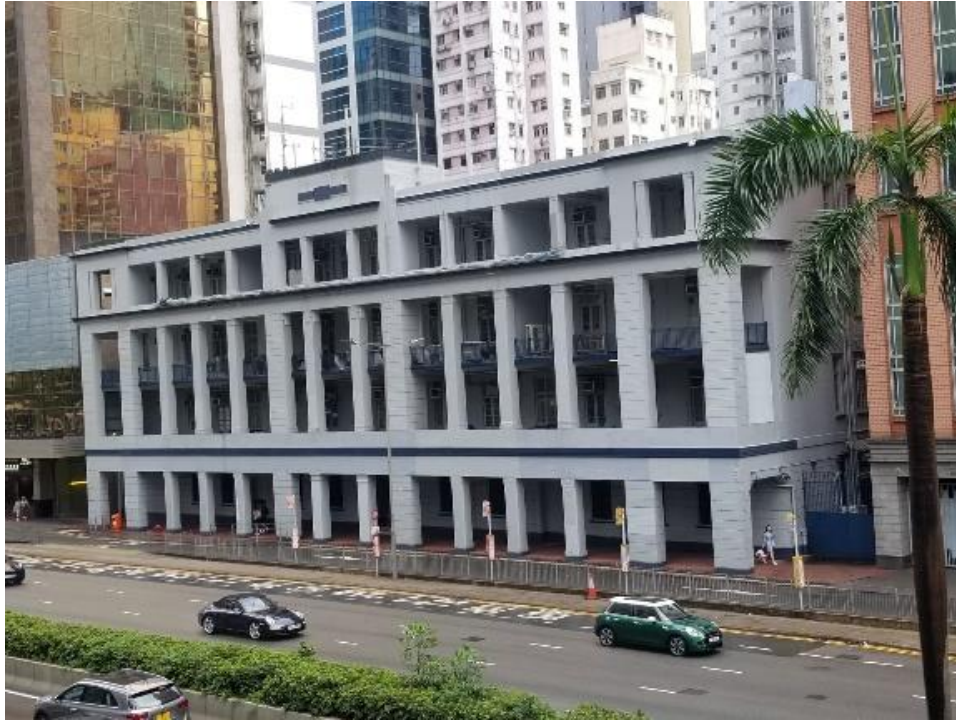
The front elevation facing Gloucester Road has been the trademark of the OWCPS which remains intact since its completion. The original façades of the OWCPS have been retained despite alterations done to the building in the past years in general. The main entrance was altered with aluminum cladding. The two exit openings at the ground floor arcade were blocked in 1990s due to change of stair exit direction.

Fig.5.2.25 No major change of front elevation 2023 [by author]

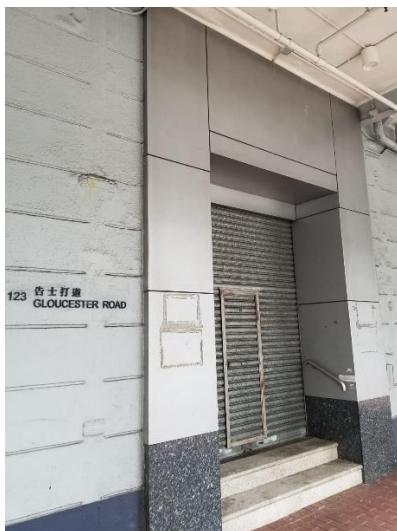
Fig.5.2.26 Main entrance redecorated 2023 [by author]

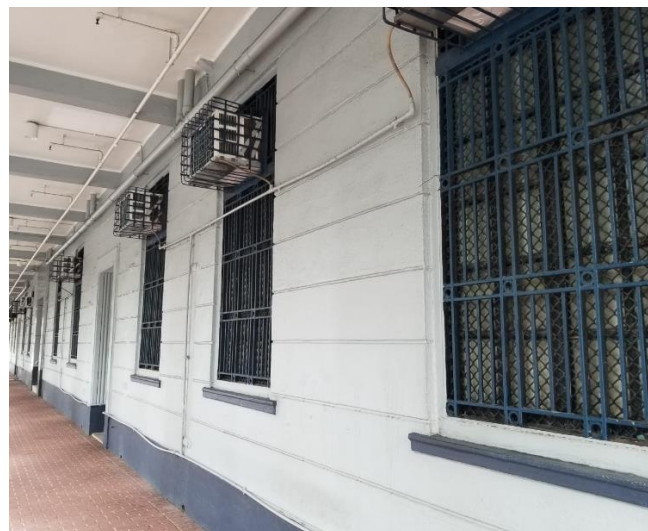
Fig.5.2.27 Security mesh and grill bar at windows 2023 [by author]

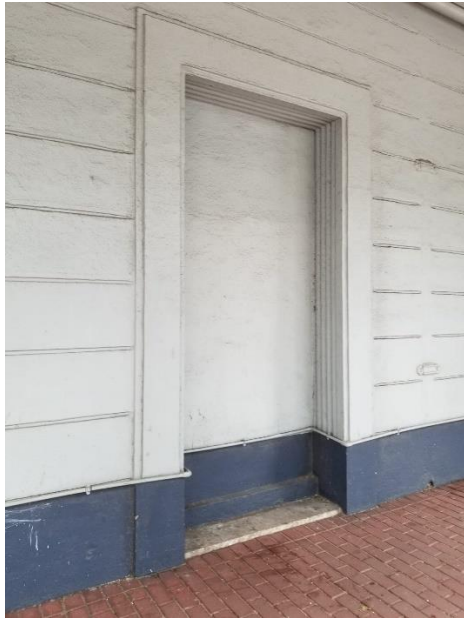
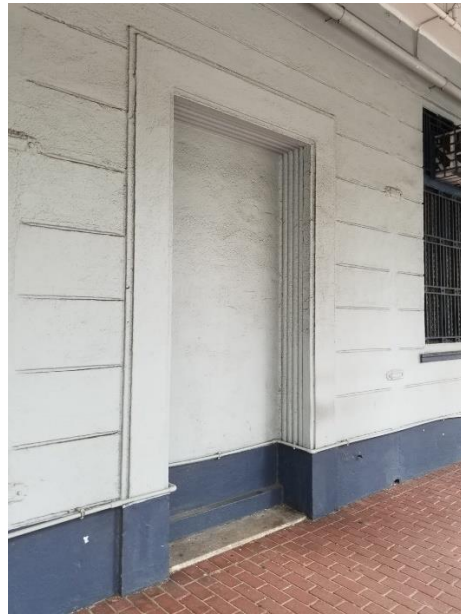
Fig.5.2.28 Both Stair 2 & 3 exit openings are blocked on ground floor, 2023
[by author]

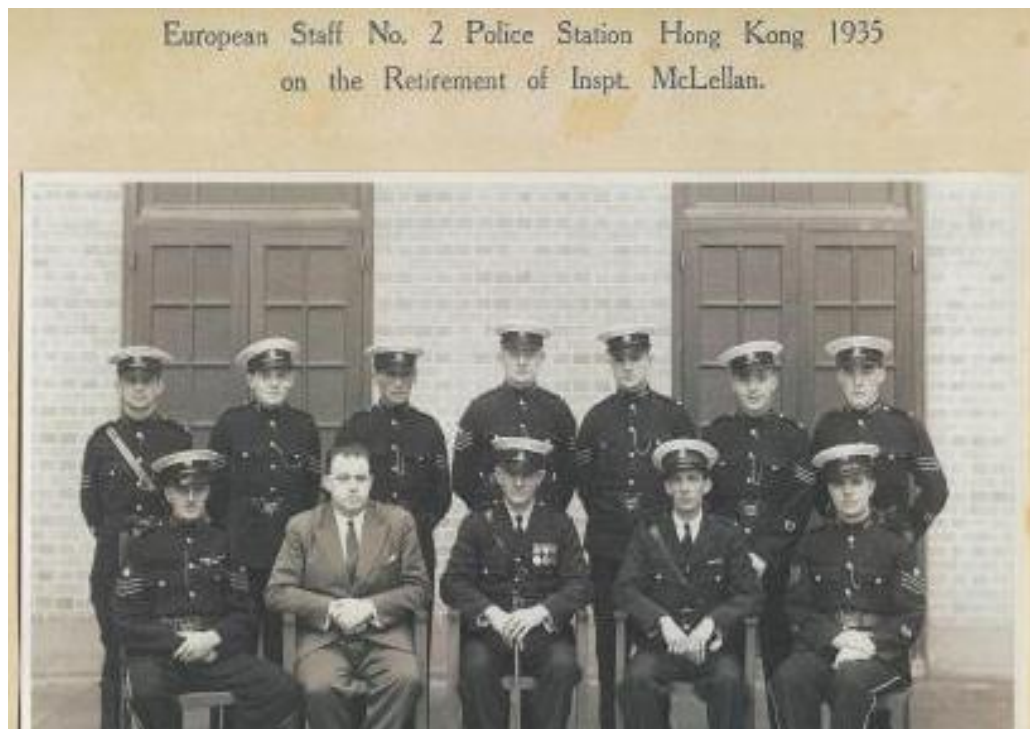
The “*rear faced with Canton facing bricks*” as described in 1932 S.C.M.P. cannot be found on the existing building. There is a 1935 photo showing the brick wall background. It may be covered by plaster and paint.

Fig.5.2.29 1935 photo showing facing brick wall [Gwulo.com modified by Author]

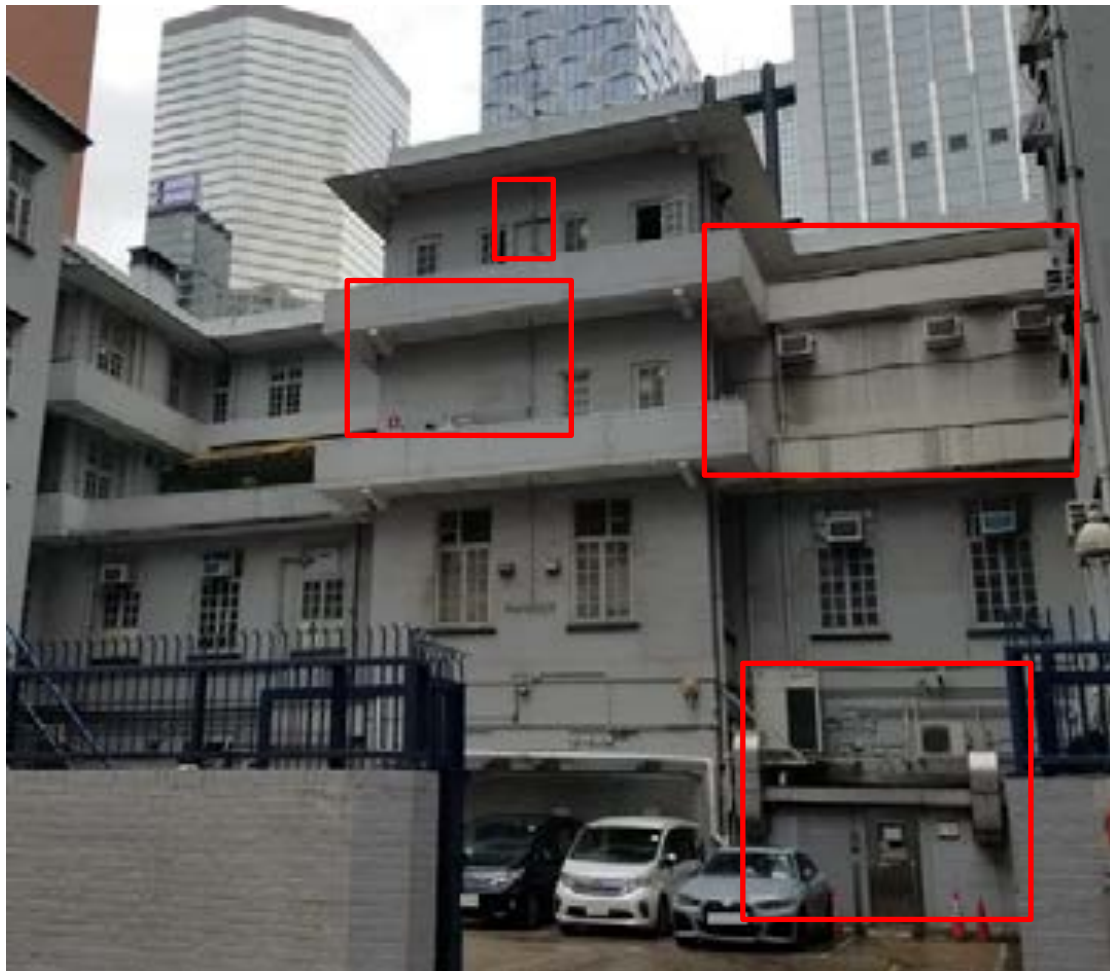
The facades facing courtyard have certain degree of alteration in the past years. There were alterations to the courtyard facades due to newly built extension, windows/door openings due to change of circulation and air-conditioner installation. The central portion of the rear elevation is recessed from Jaffe Road to form the courtyard. Other than some later-added window-type air-conditioners/ other BS on façade, door and window openings at the middle of 2 & 3/F floors were blocked. Rooms were added on the east wing 2/F roof terrace. The original external brick wall enclosed by these later-added rooms can be seen from inside. New structure was added at the recessed area at the east wing G/F. The wall & openings at the Centre wing of ground floor were blocked by wooden backdrop which was believed to be added for the weapon loading and unloading area introduced in the police station in 70/80s. It was covered up by metal panels.

Fig.5.2.30 Major alterations at the rear façade 2023 [by author]

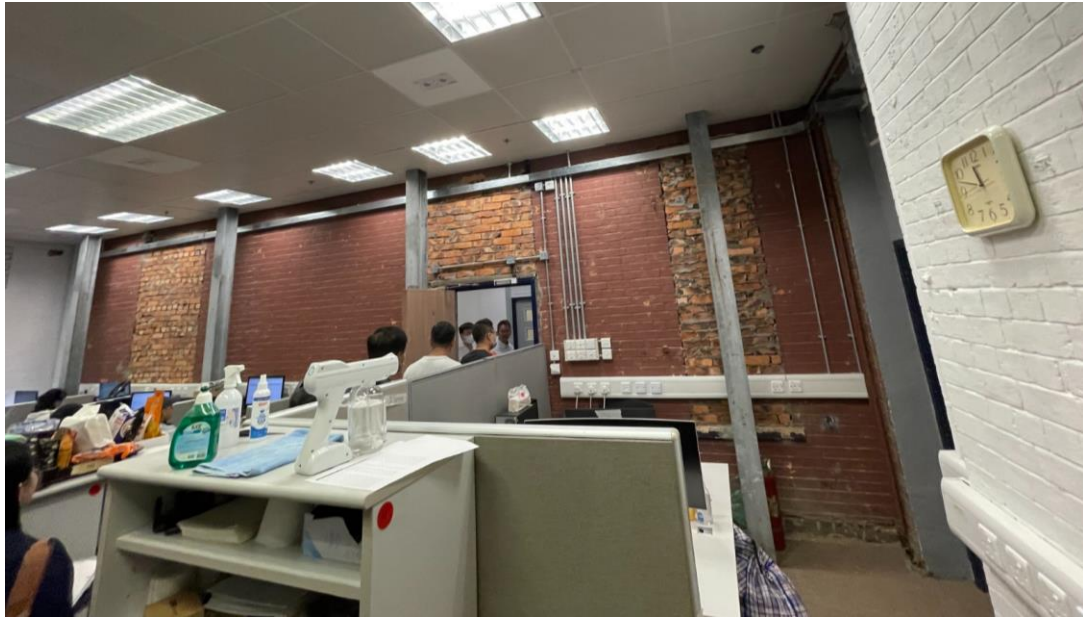
Fig.5.2.31 Original external wall at 2/F east wing rear façade is enclosed by later-added room 2023 [by author]

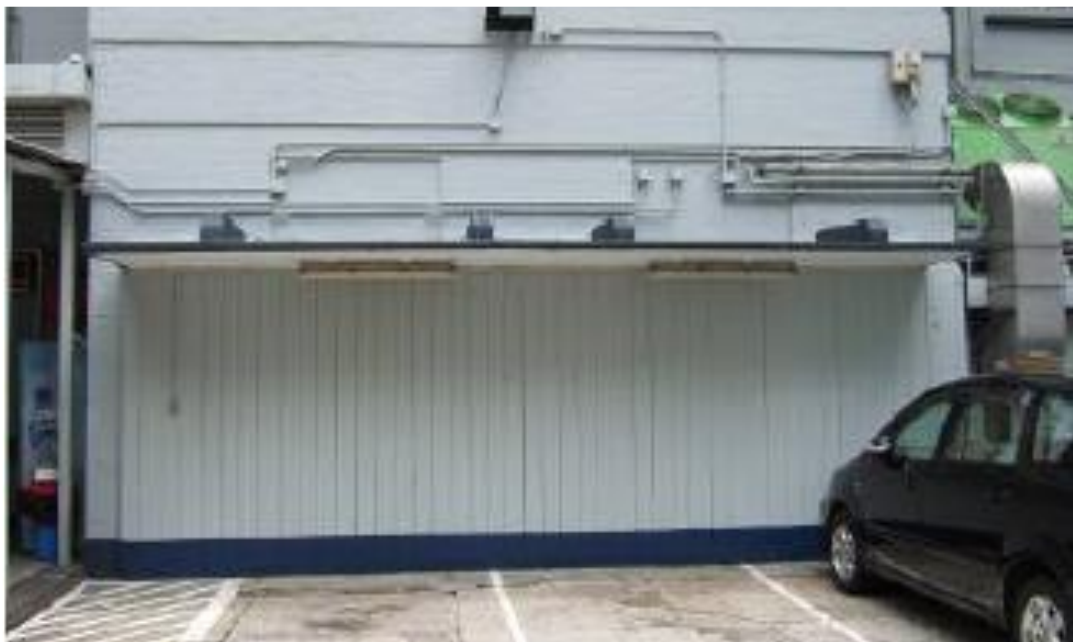
Fig.5.2.32 Centre wing wall & openings are blocked by wooden backstop which was further covered up by metal panels 2023 [by author]

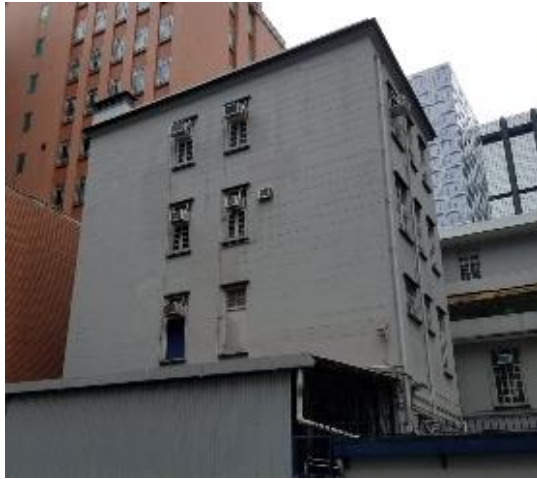
There is no change on the two end walls of east and west wing facing Jaffe Road except some changes of opening on G/F, some later-added window-type air-conditioners / other BS on the façades. The later-made opening and the windows at the ground floor are blocked by the later addition on the west wing end wall.

Fig.5.2.33 West wing end wall 2023
[by author]

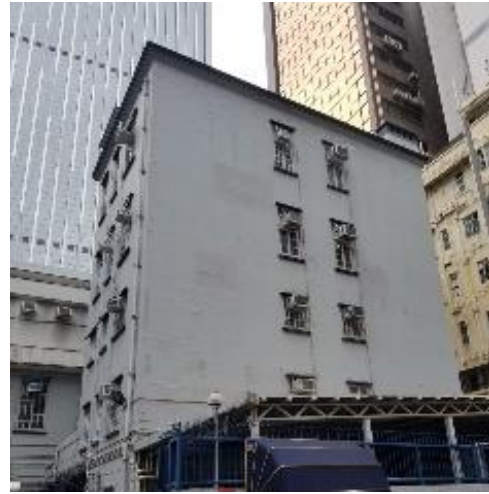
Fig.5.2.34 East wing end wall 2023
[by author]

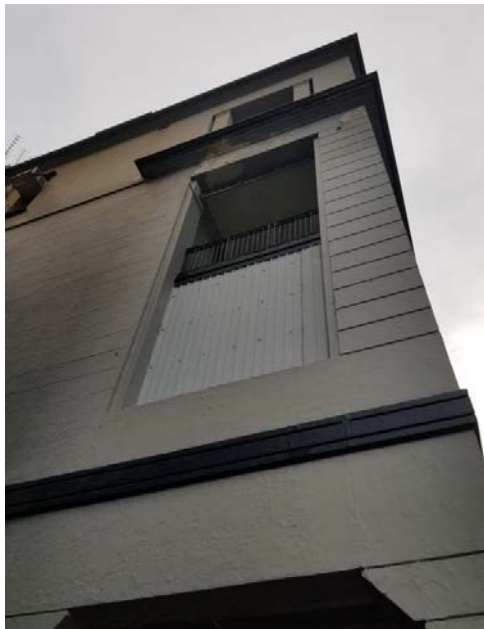
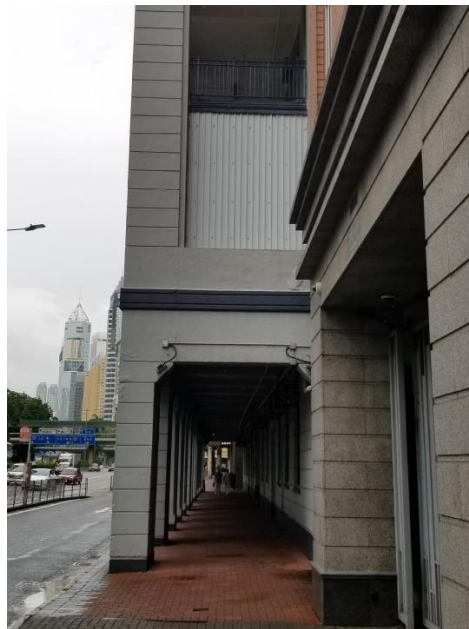
There are intrusive elements both on east and west elevations. Metal boards were added to the opening of the verandah on the first floor. Air-conditioners were added to the timber windows

Fig.5.2.35 Later-added metal boards on east and west elevations at 1/F verandah 2023
[by author]

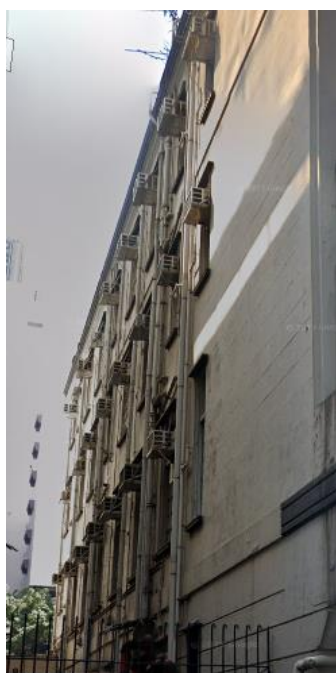
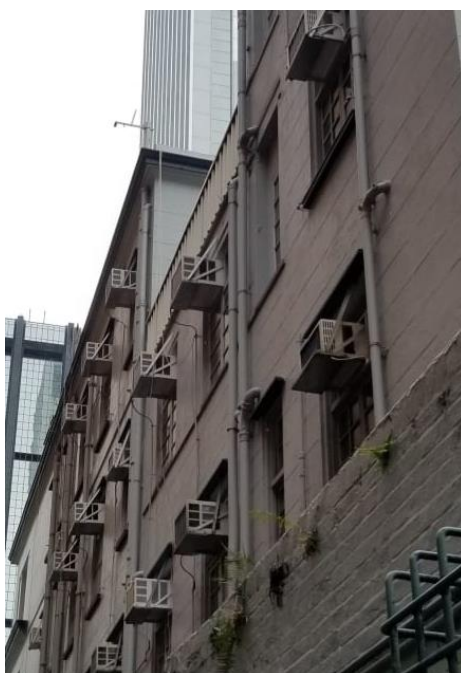
Fig.5.2.36 A/C window units on east and west elevations 2023 [by author]

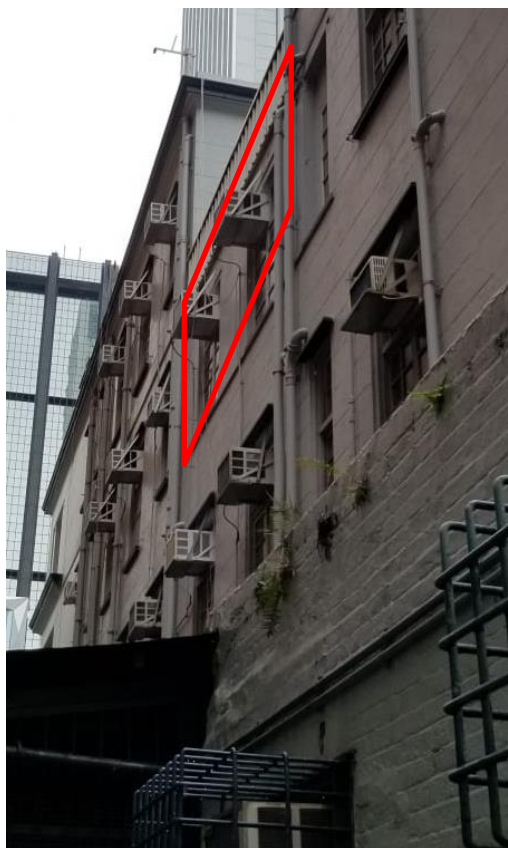
The west elevation has been changed at the 2/F with a later addition of a room on top of the 2/F roof terrace.

Fig.5.2.37 Later-added room on west wing 2/F terrace facing adjacent lot 2023 [by author]

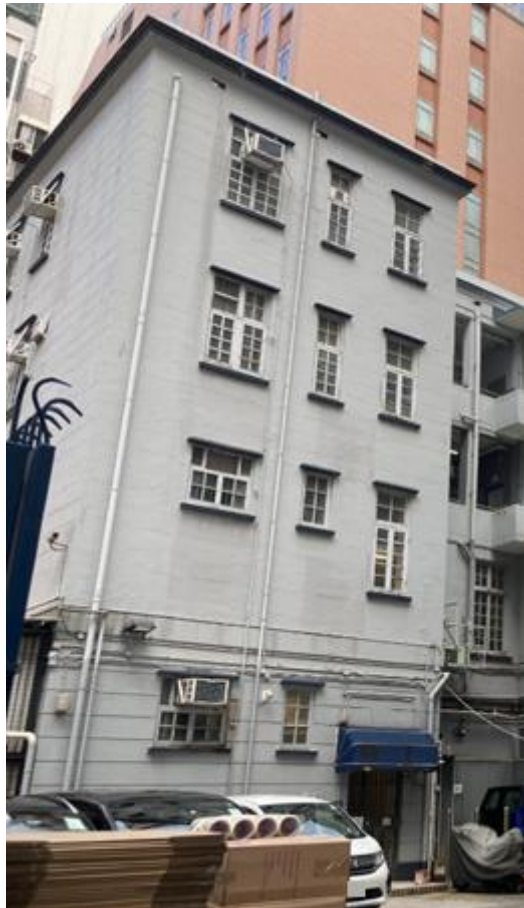
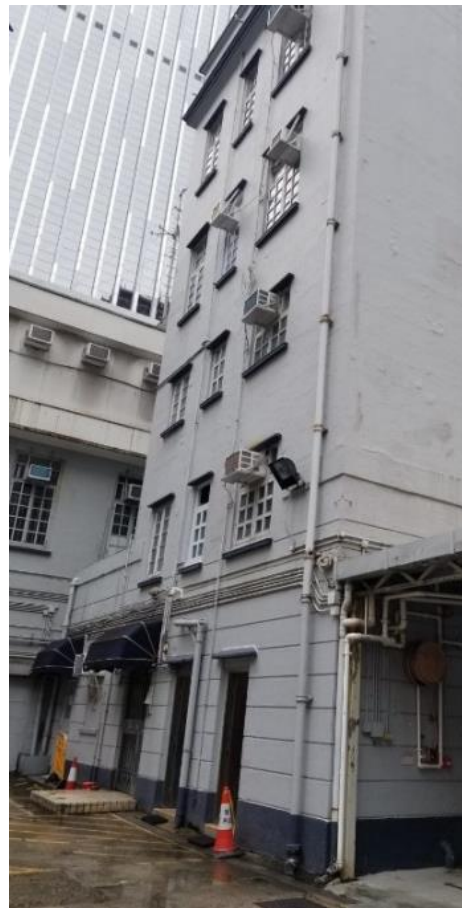
The existing inner side elevation of the west wings matches the drawing on the 1988 plan. There is no inner side elevation drawing of the east wing on the 1988 plan. The location of window openings on east wing and west wing is slightly different on G & 1/F due to the mezzanine floor at east wing. Changes of openings at east wing G/F have been made over the years.

Fig.5.2.38 Existing inner side elevations of west & east wing 2023 [by author]

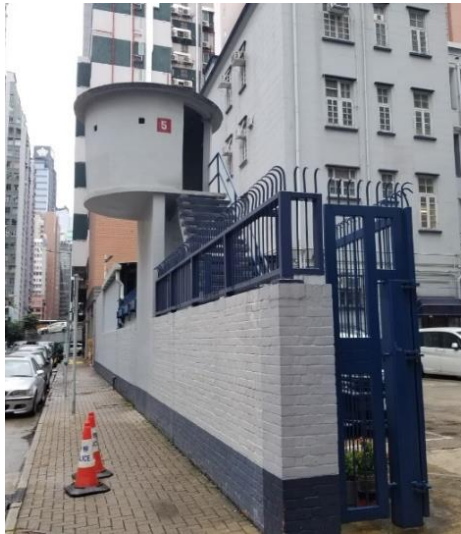
Although the courtyard has been altered many times over the years, it still serves as parking and loading/unloading area. The heavy weigh-bridge which was removed from the Central Station as described in 1932 SCMP is no longer there. According to the original G/F plan before 1949, although the turret was not in place at the very beginning, from the 1949 aerial photo, a circular shadow was casted on the ground at the location of the existing turret. Therefore the existing turret should be constructed before 1949. The turret with

Fig.5.2.39 Turret and access staircase 2023 [by author]

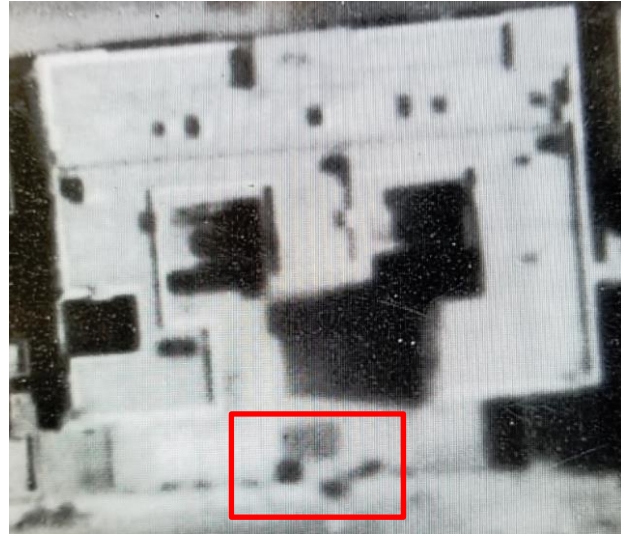
Fig.5.2.40 aerial photo 1949 showing the turret [Lands Department modified by author]

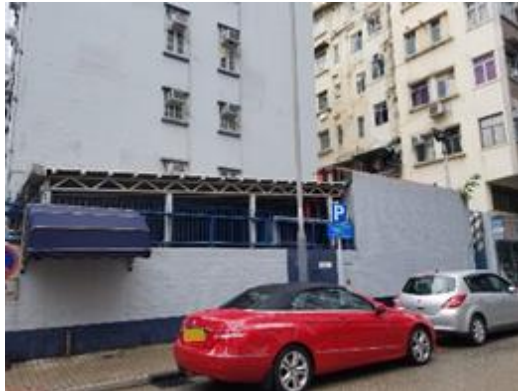
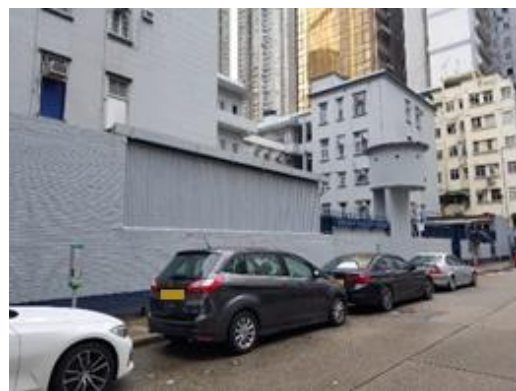
The open spaces in between east & west wings and Jaffe Road are occupied by a temporary steel structure for parking and storage purposes respectively.

Fig.5.2.41 Temporary structures at the open spaces adjacent to east and west wings 2023 [by author]

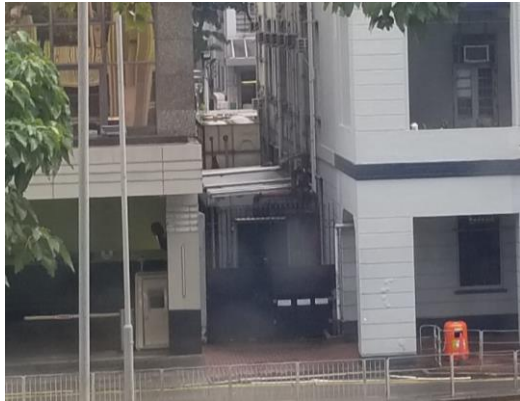
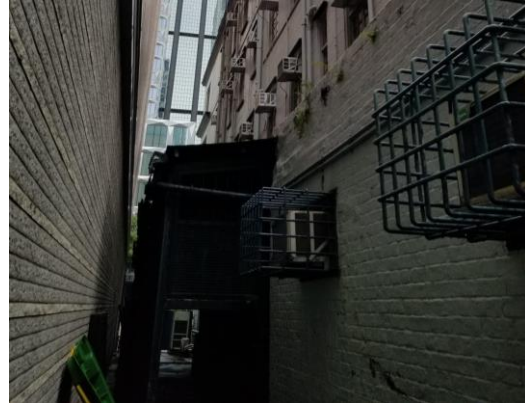
The east side lane is occupied by a later-added FS tank and pump room. The west side lane is occupied by a temporary steel structure for storage purpose.

Fig.5.2.42 FS tank & pump room at east side lane and storage at west side lane 2023

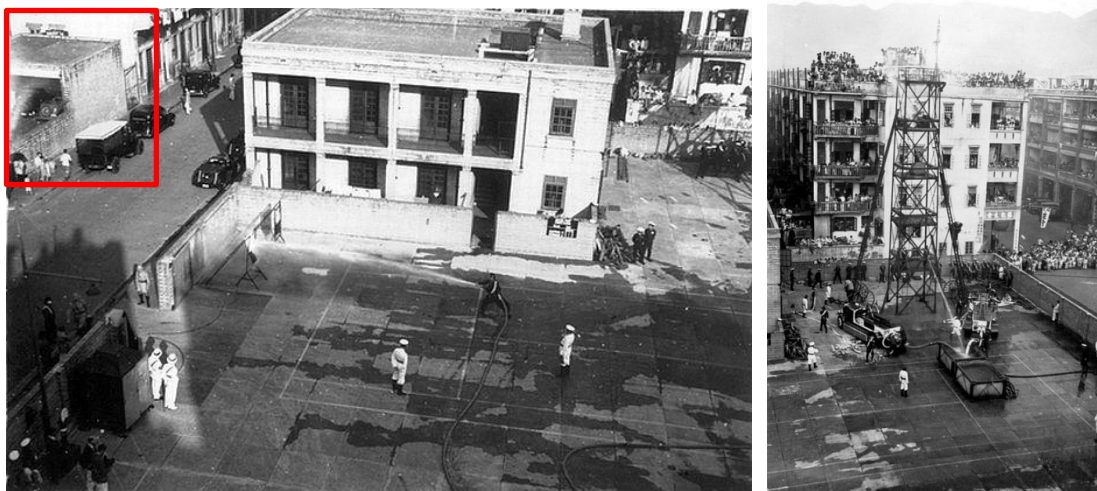
A photo taken around 1935-37 regarding the annual fire drill display on 1935 was carried out in the No 2 Police Station compound in Wanchai. It is likely that the photo was taken at the site opposite the OWCPS between Jaffe and Lockhart Roads. From the photo, the south east corner of the OWCPS is shown. It matches with the before 1949 plan that this corner had a single storey covered space. From this photo, it also shows the exposed brick wall and security bars were on top of the fence wall. The existing security bars on top of the fence wall may be later replacement.

Fig.5.2.43 South east corner fence wall and 2-Storey Married Quarters for Indians,1935-37

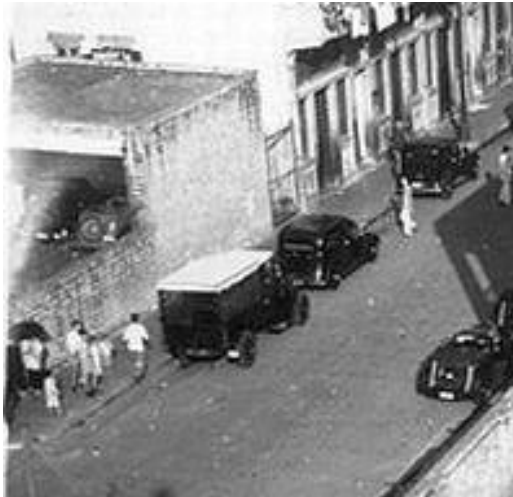
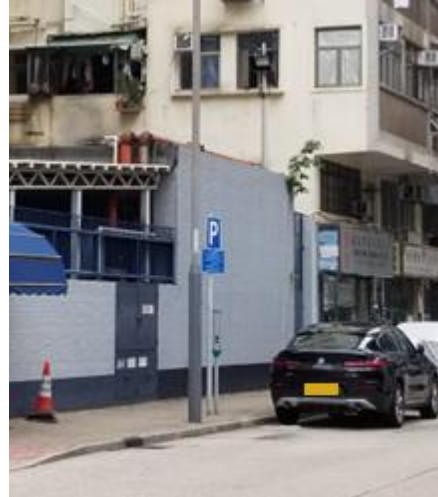
Fig.5.2.44 Fence wall at south east corner of the old Wan Chai Police Station [by author]

The fence wall may be rebuilt with the construction of turret in early days. Part of the fence wall facing Jaffe Road in an area about 4 x 10 meters was collapsed on 5 February 2018 during a truck accident. The fence wall was reinstated.

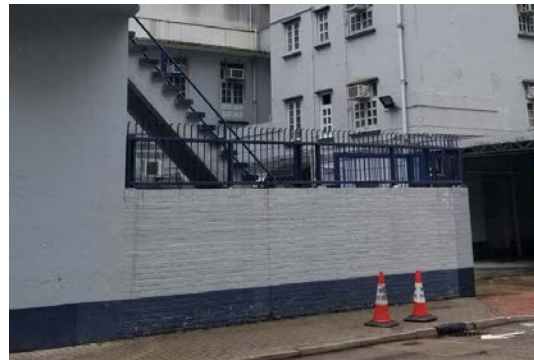
Fig.5.2.46 Fence wall after reinstatement
2023 [by author]

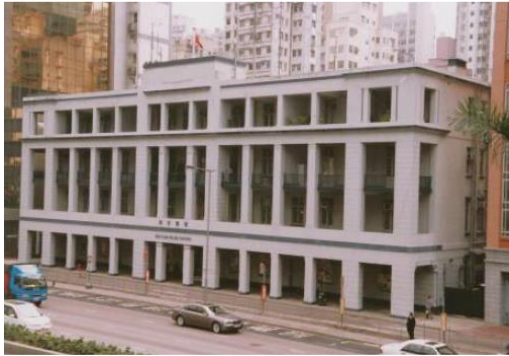
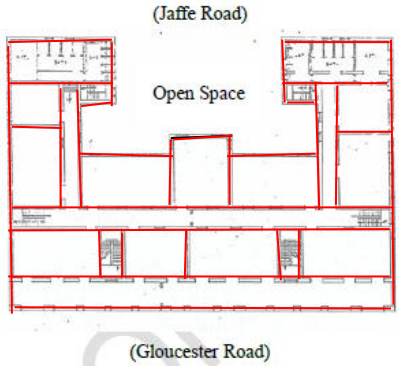
| A2 | <p><u>Building Structure</u></p> <ul style="list-style-type: none"> - Reinforced concrete cum brick structure - Mostly rendered and painted at exterior and interior - Canton facing bricks at rear are covered by plastering & paint | | <p>High</p> <p>- The brick structure was altered for many times to suit the changing operation needs</p> | |
