**HERITAGE IMPACT ASSESSMENT FOR
THE CONVERSION OF
OLD WAN CHAI POLICE STATION
INTO THE HEADQUARTERS OF AN INTERNATIONAL
INTER-GOVERNMENTAL ORGANIZATION**

Applicant:
ARCHITECTURAL SERVICES DEPARTMENT

Heritage Consultant:
AGC DESIGN LTD

Dec 2023

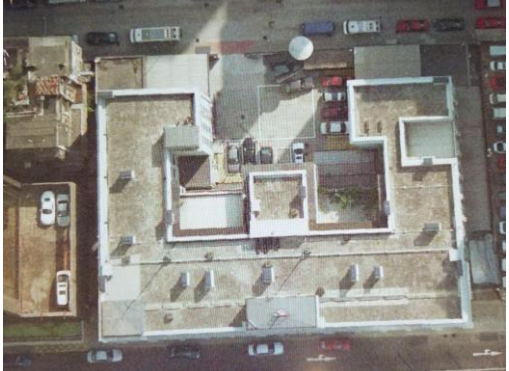
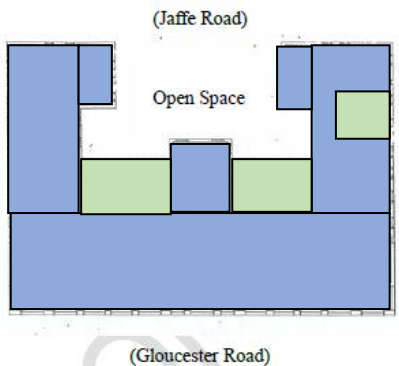
| A3 | <p><u>U-shape layout</u></p> <ul style="list-style-type: none"> - open space at rear adjacent to Jaffe Road - open lanes at both sides | | <p>High</p> <p>- Although additional structures had been erected over these years, the U shape layout with a courtyard enclosed is generally kept intact</p> | |

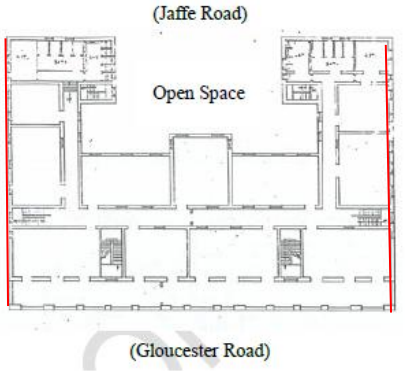
| <p>B2</p> | <p><u>Side elevation facing adjacent lots</u></p> <ul style="list-style-type: none"> -Rendered and painted -Horizontal projecting cornices running the full length of the façade -Timber doors and windows with projected window/door heads and window sills -Grooved rendered walls -Entrance door openings with granite steps connecting to the side lanes | <div> </div> <div> <p>West elevation</p> <p>East elevation</p> </div> | <p>Moderate</p> <ul style="list-style-type: none"> -Window openings are retained with window type A/C units -less visible <p>Intrusive</p> <ul style="list-style-type: none"> -Later added rooms on 2/F West wing terrace facing side lane | |

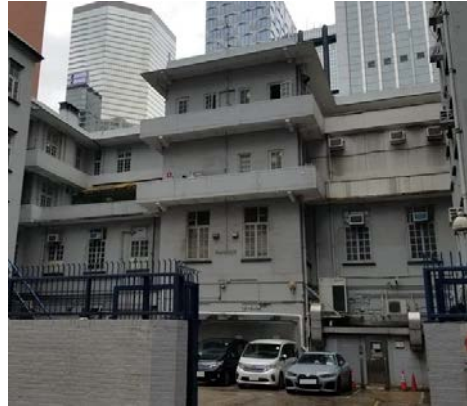
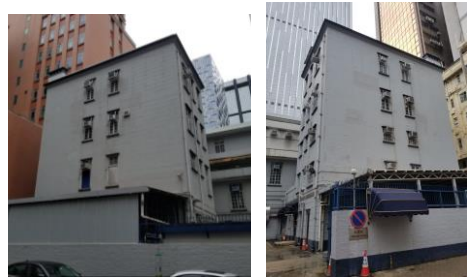
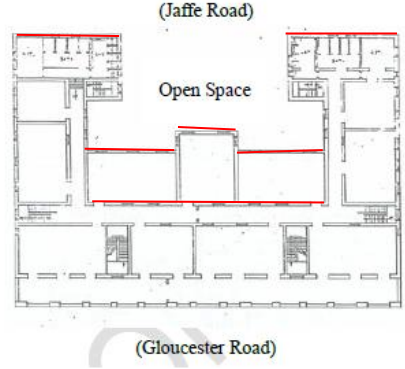
| B3 | <p><u>Rear elevation (facing Jaffe Road)</u></p> <ul style="list-style-type: none"> -Horizontal projecting cornices running the full length of the façades -Timber doors and windows with projected window/door heads and window sills -Grooved rendered walls on ground, west and east wings facing Jaffe Road -Painted wall without rendering facing courtyard at above ground floor -Deep and thin sunshades, overhangs and projections | <p>West wing East wing</p> | <p>High</p> <ul style="list-style-type: none"> -Window openings are retained with window type A/C units - visible from Jaffe Road <p>Intrusive</p> <ul style="list-style-type: none"> -Later-added corrugated sheet covers for carpark and storage -Later added rooms on G/F and east wing terrace on 2/F | |

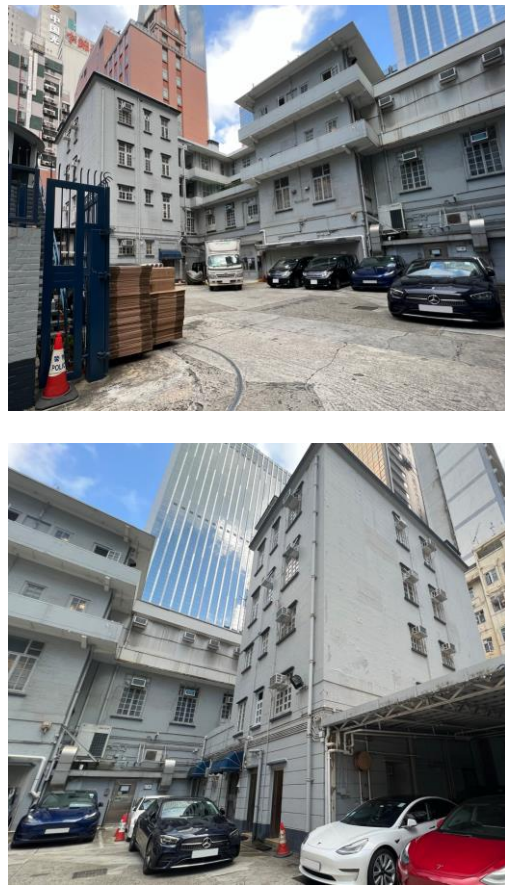
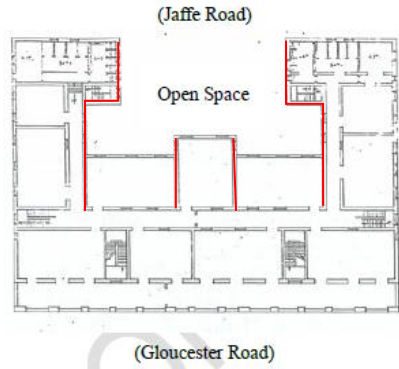
| <p>B4</p> | <p><u>Inner Side Elevations facing rear courtyard</u></p> <ul style="list-style-type: none"> - Horizontal projecting cornice - Concrete canopies - Balconies and terrace - Timber doors and windows with projected window/door heads and window sills - Grooved rendered side walls of East and West wings - Painted wall without rendering at centre projecting bay and walls facing balconies, covered walkways and terraces -Deep and thin sunshades, overhangs and projections | | <p>Moderate</p> <ul style="list-style-type: none"> -alteration and addition works have been done over the years -recessed from public road, less visible <p>Intrusive</p> <ul style="list-style-type: none"> -Later added rooms on east wing G/F and east wing terrace at 2/F. | |

The facades facing courtyard have certain degree of alteration in the past years. There were alterations to the courtyard facades due to newly built extension, windows/door openings due to change of circulation and air-conditioner installation. The central portion of the rear elevation is recessed from Jaffe Road to form the courtyard. Other than some later-added window-type air-conditioners/ other BS on façade, door and window openings at the middle of 2 & 3/F floors were blocked. Rooms were added on the east wing 2/F roof terrace. The original external brick wall enclosed by these later-added rooms can be seen from inside. New structure was added at the recessed area at the east wing G/F. The wall & openings at the Centre wing of ground floor were blocked by wooden backdrop which was believed to be added for the weapon loading and unloading area introduced in the police station in 70/80s. It was covered up by metal panels.

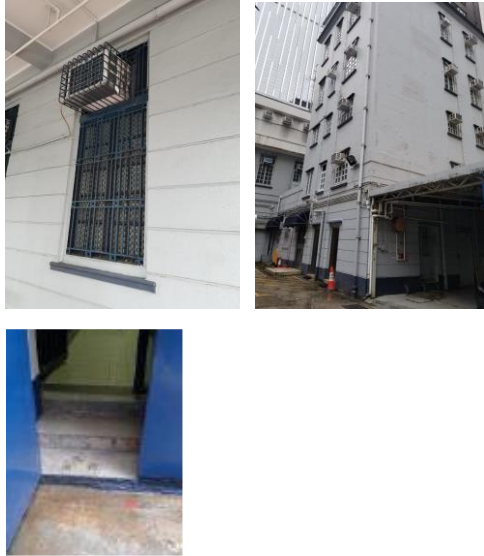
| <p>B5</p> | <p><u>Historic timber windows/doors on all elevations</u></p> <ul style="list-style-type: none"> - Original openings (some windows and doors openings facing the verandahs, courtyard and side lanes have been modified over the years) - Historic timber framed fanlight/ windows and French windows - Projected window/door heads & sills at external side - Ironmongeries - Granite thresholds - Concrete window sills at internal side - Metal gates, grilles and mesh installed in 1970s | | <p>High</p> <ul style="list-style-type: none"> -Historic timber doors and windows are with historic and architectural values -Granite thresholds are original <p>Moderate</p> <ul style="list-style-type: none"> -metal gates and grilles are features of police station <p>Intrusive</p> <ul style="list-style-type: none"> -Later-added window type air conditioners | <p>Within the building in general</p> |

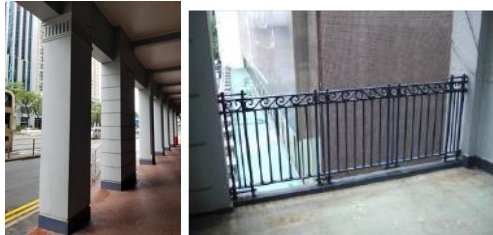
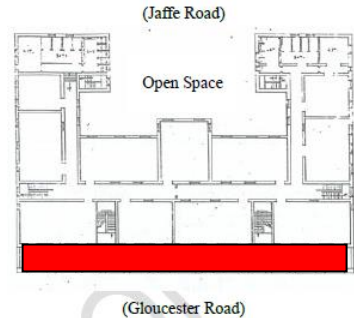
| <p>B6</p> | <p><u>Arcade and verandahs on front elevation</u></p> <ul style="list-style-type: none"> -Rectangular and square columns with base, shaft and crafted capitals, -Solid parapet on 1/F and 3/F -Iron balustrades on 2/F -Sun-blade on 2/F facing east -Bell hood on 1/F | | <p>Exceptional</p> <ul style="list-style-type: none"> -the elements within the verandah of the front façade gives special characteristic to the historic building <p>Moderate</p> <ul style="list-style-type: none"> -Sun-blade on 2/F facing east | |

| | <p>-Rendered and painted with grooved lines on walls and columns</p> | | <p>Intrusive</p> <p>-Only one partition wall on 1/F verandah is original on before 1949 plan, other partition walls with openings on 1/f to 3/F dividing the verandahs into 3 bays are later added.</p> | |

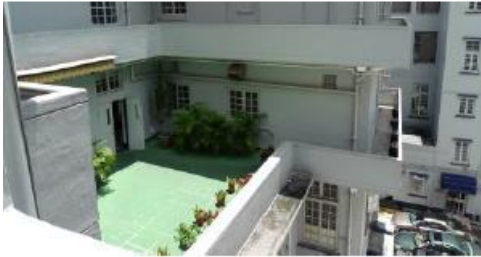
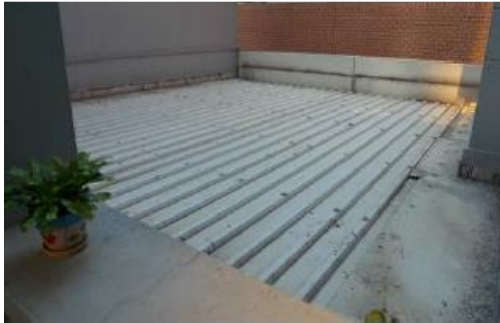
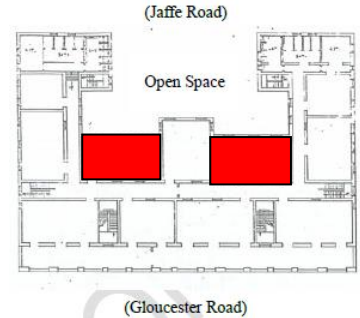
| B7 | <p><u>Terraces</u></p> <ul style="list-style-type: none"> - At west wings facing courtyard - At east wing facing courtyard (now enclosed and covered with solid parapet wall) - At west wing facing adjacent lot (now enclosed and covered with solid parapet wall) | <p>2/FWest wing facing courtyard</p> <p>2/FEast wing facing courtyard (enclosed)</p> | <p>High</p> <p>-high level of authenticity</p> <p>Intrusive</p> <p>-later-added covers on enclosing east wing facing courtyard and west wing facing adjacent lot terraces</p> | <p>2/F plan</p> |

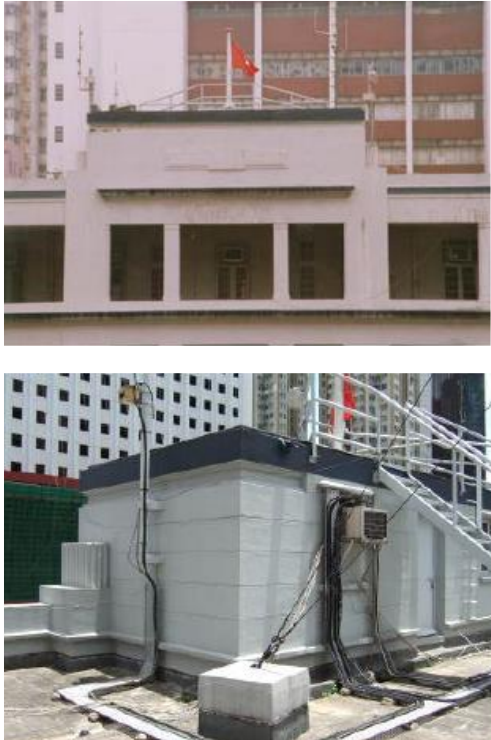
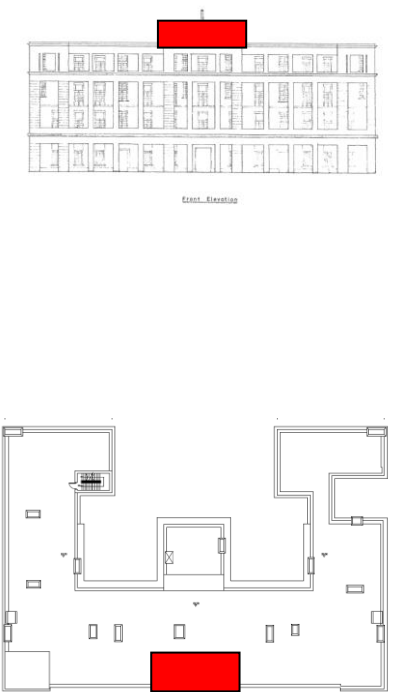
| <p>B9</p> | <p><u>Rectangular pediment with a flagpole</u></p> <ul style="list-style-type: none"> -In the centre of the front façade formed by the attic storey on roof -Rendered walls with grooved lines on attic storey at the other sides -Steel flagpole in the middle | | <p>Exceptional</p> <ul style="list-style-type: none"> -outstanding feature at the centre highest position of the building -flagpole is one of the characters in Art-Deco style -original features in good Condition <p>Neutral</p> <ul style="list-style-type: none"> -Later-added antenna at the side | <p>Front Elevation</p> <p>R/F plan</p> |

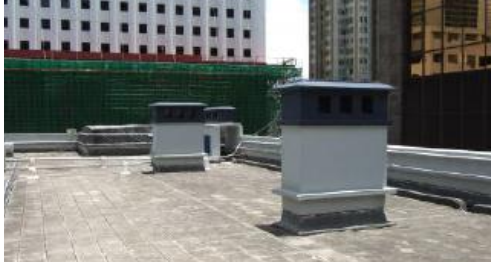
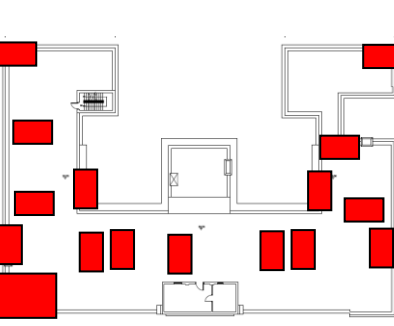
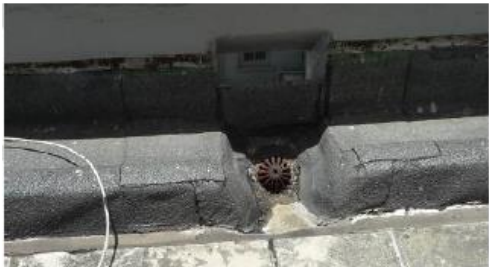
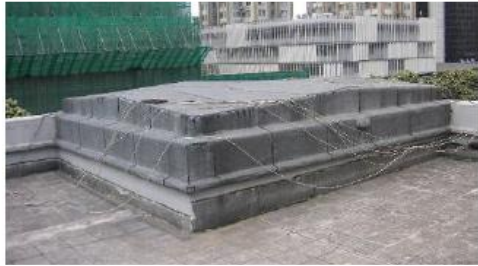
| <p>B10</p> | <p><u>Main roof</u></p> <ul style="list-style-type: none"> -Chimneys -Rain water surface channels -Dome shaped rain water outlets -Overflows -Pitched roof structure at the north-east corner | | <p>High</p> <ul style="list-style-type: none"> -chimneys are feature of pre-war historic building -the roof drainage system is still functioning for over 90 years -overflows are seldom seen nowadays | <p>R/F plan</p> |

| | | | -pitched roof structure is an original feature | |

There are 17 numbers of chimneys on the main roof. Their location matches the layout on the floor plans on the before 1949 plan for the dormitories, kitchens and bathrooms. At the north east corner above the 3rd floor verandah, there is a pitched roof structure. The function of this structure is unknown. The ceiling height of the verandah on 3/F is raised at this location. No such kind of feature is found at the north west corner. This is also found in the 1949 aerial photo and early elevation photo.

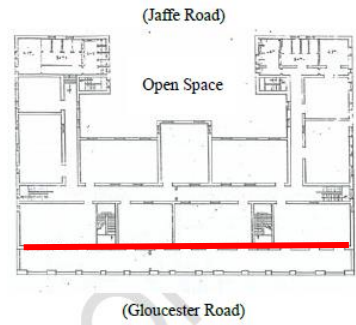
| B11 | <u>Historic cast iron rainwater pipes, hoppers and fittings with anchors</u> - At G/F arcade and verandahs | | High -Original features of the building | |

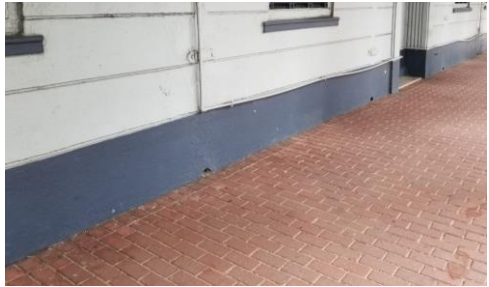
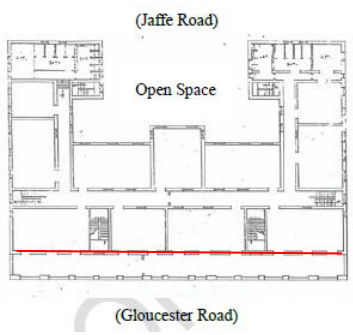
| B12 | <p><u>Drain hole</u></p> <ul style="list-style-type: none"> - At G/F arcade to street pavement | | <p>Moderate</p> <ul style="list-style-type: none"> -Not easily recognized | |

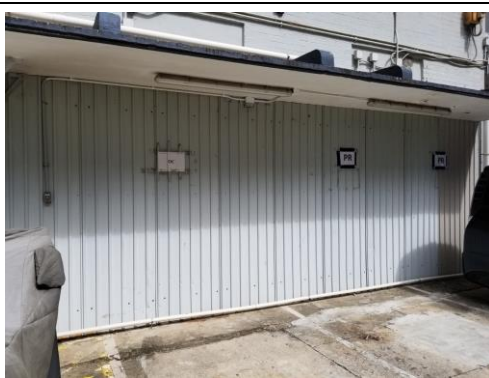
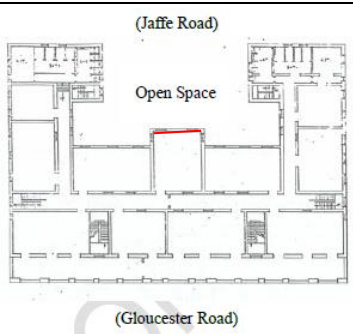
| B13 | <p><u>Former weapon loading/unloading area</u></p> <ul style="list-style-type: none"> -At rear elevation centre on G/F -Concrete canopy - Wooden strip panels backstop (it was now covered up with metal panels) | | <p>Moderate</p> <ul style="list-style-type: none"> -Although it is not part of the original layout, it is an important space of a police station which can reflect the operation of police station -Become less significant as the weapon loading/unloading area has been relocated to the west in between 1992 to 2011 leaving this area unused afterwards. | |

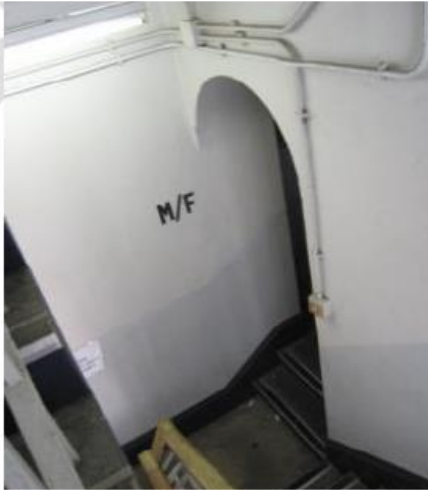
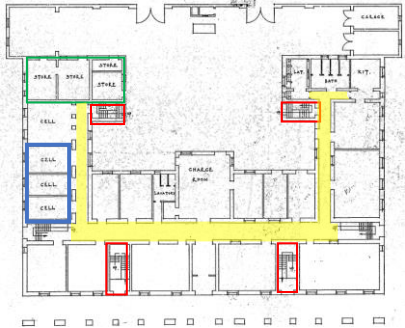
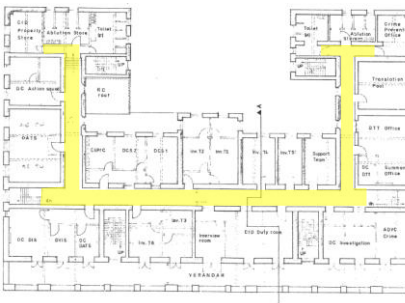
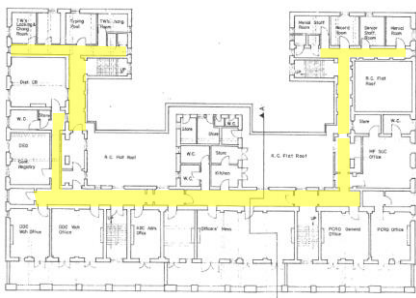
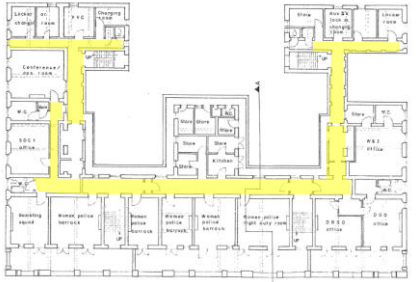
| Item No | Elements/Materials | Photo and Reference | Level of Significance | Location |
|---|--|--|---|--|
| C1 | <p><u>Internal layout</u></p> <p>-General layout</p> <p>Authentic spaces:</p> <ul style="list-style-type: none"> - cell no.1-3 - 4 enclosed staircases - Mezzanine floor between G/F and 1/F at south east corner -Corridors with archways on G/F to 3/F | | <p>Low (general layout)</p> <p>-Has been altered for several times to suit the Police Station's changing needs.</p> <p>High (Authentic spaces)</p> <p>-Little altered in the past</p> | <p>G/F plan</p> <p>Cells no.1-3 (blue)</p> <p>Staircases (red)</p> <p>Corridor with archway (yellow)</p> <p>Mezz. Floor above (green)</p> <p>1/F plan</p> |

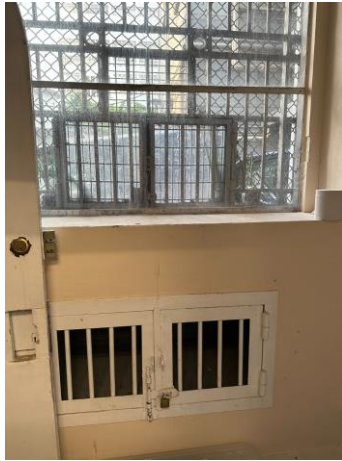
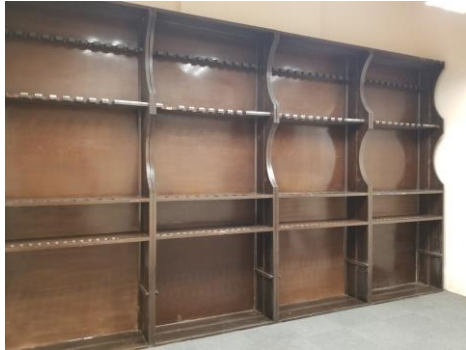
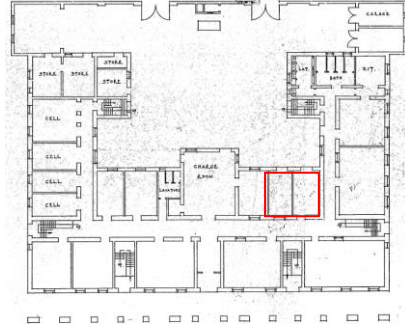
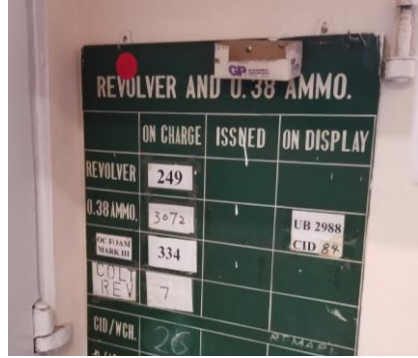
| C2 | <p><u>Armoury Room</u></p> <ul style="list-style-type: none"> -Double layered steel doors -Steel shutter to windows with metal grilles and doors -Metal grilles and mesh -Service hatch for weapon with steel shutters and metal grilles -Signage with wording 'Armoury Wanchai Division' -Arm shelves -Blackboard showing the weapon record | <p>Service hatch</p> <p>Arm shelves</p> | <p>High</p> <ul style="list-style-type: none"> -Although they were not built in this location at the beginning and have been redecorated for several times in the past, the use retained the same since 1970s /80s -They are important features of police station | <p>G/F plan</p> <p>Armoury room (red)</p> <p>Charge room (blue)</p> |

| | | <p>Blackboard</p> | | |

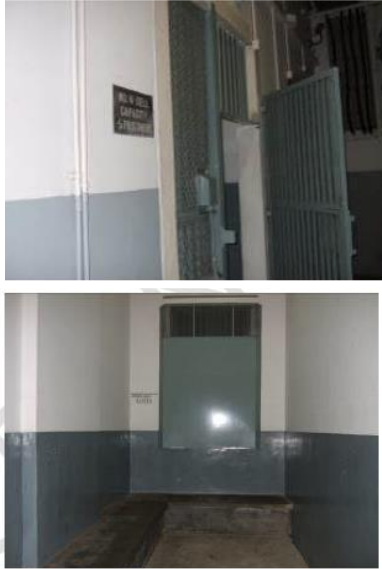
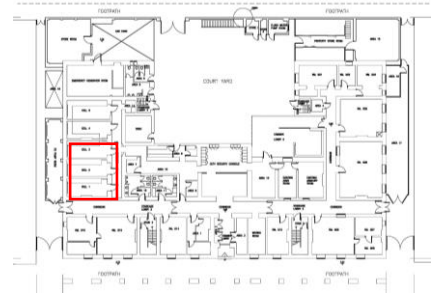
| C3 | <p><u>Cells no.1-3</u></p> <ul style="list-style-type: none"> -Signages -Metal grilles, meshes and gates with grilles, meshes, mortise locks, bolt locks and hatches -Metal windows and metal board covers -Concrete benches -Sanitary fittings -Moulding at door opening -Controlled corridor in front of the cell area with metal gate, grilles and meshes connecting to report room (corridor right in front is original but not the portion behind the gate) | | <p>High</p> <ul style="list-style-type: none"> -These elements reflected the operation of a police station with retention facilities -The cells were built since 1932 and the configurations of the rooms remain the same till today | <p>Cell no.1-3 G/F plan</p> |

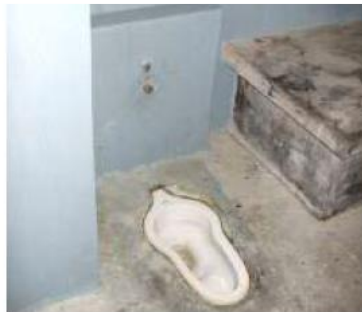
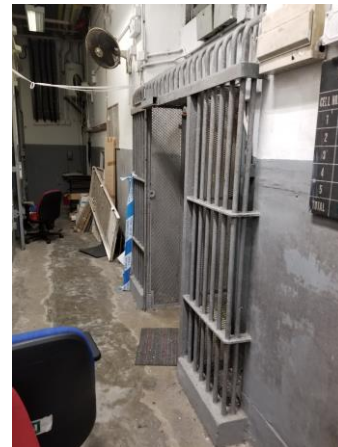
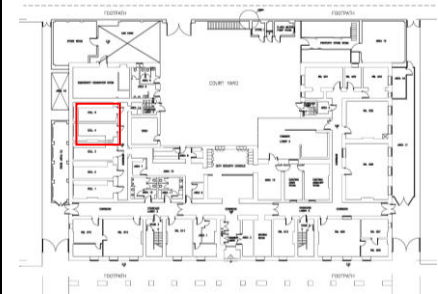
Cell no.4-5 G/F plan

-These elements reflected the operation of a police station with retention facilities

-The space was built as cells since 1932 but the configurations have been altered over the years

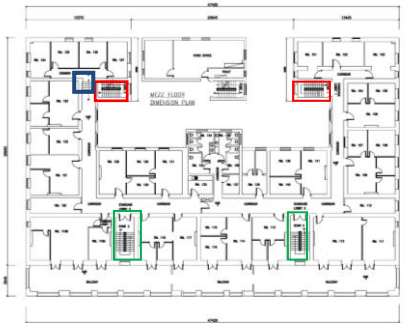
| <p>C4</p> | <p><u>Staircases</u></p> <p>-3 types</p> <p>I. <u>2 staircases leading to rear courtyard (red)</u> (Staircase 1& 4)</p> <p>-Metal balustrades and rails (top parts are later added)</p> <p>-Cement sand/shanghai plaster finished treads and risers</p> <p>-Metal barriers at windows</p> <p>II. <u>Single flight at end of east wing on 1/F (blue)</u></p> <p>III. <u>2 staircases next to Gloucester Road (green)</u> (Staircase 2 & 3)</p> <p>-Timber balustrades and rails (top parts are later-added)</p> <p>-Ladder access (with recesses on walls) to high level windows</p> <p>-Metal barriers with timber rails</p> <p>-Flights to G/F and 1/F were altered in 1992</p> <p>-Blocked openings with moulded frames remains on G/F of front elevation facing Gloucester Road</p> | <div data-bbox="768 236 987 523"> </div> <div data-bbox="790 531 965 560"> <p>Type I staircase</p> </div> <div data-bbox="1010 260 1229 555"> </div> <div data-bbox="768 584 972 850"> </div> <div data-bbox="748 863 990 893"> <p>Type I: Steps to M/F</p> </div> <div data-bbox="1010 603 1202 863"> </div> <div data-bbox="1025 868 1180 893"> <p>Type II staircase</p> </div> <div data-bbox="752 908 972 1193"> </div> <div data-bbox="748 1197 972 1235"> <p>Type III staircase: finished with tiles and stainless steel nosing (non-historic)</p> </div> <div data-bbox="987 908 1202 1193"> </div> <div data-bbox="981 1193 1202 1235"> <p>Type III: Ladder access to high level window with recesses on wall</p> </div> | <p>High</p> <p>-Most of the elements within the staircases are authentic especially the timber balustrades and metal ladders</p> | |

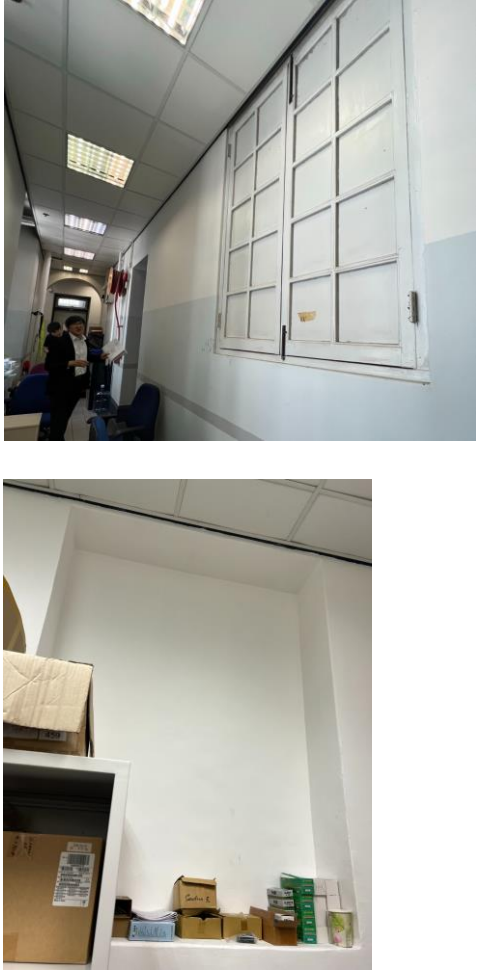
| <p>C5</p> | <p><u>Internal windows</u></p> <ul style="list-style-type: none"> - Original openings (some internal windows have been modified or blocked over the years) -Historic timber framed glazed/timber panelled windows -Brass ironmongeries | | <p>High</p> <ul style="list-style-type: none"> -Historic design to reflect the 1930s | <p>Within the building in general</p> |

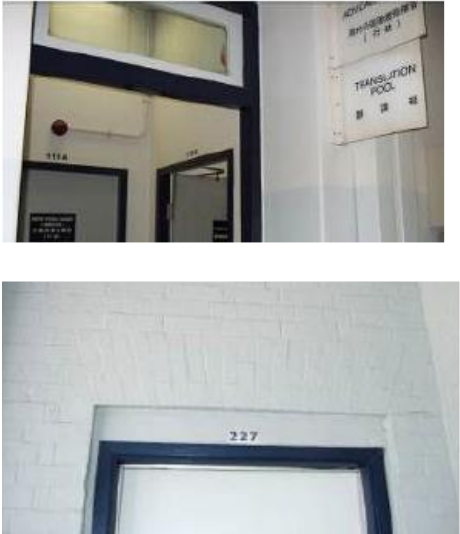
| <p>C6</p> | <p><u>Timber doors</u></p> <ul style="list-style-type: none"> -Original openings (some with voussoirs on top) -Historic fanlights -Historic timber frames | | <p>High</p> <ul style="list-style-type: none"> -Historic design to reflect the 1930s | <p>Within the building in general</p> |

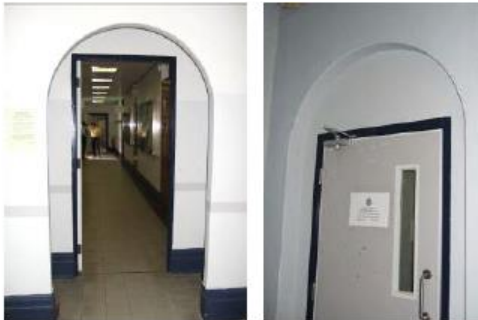
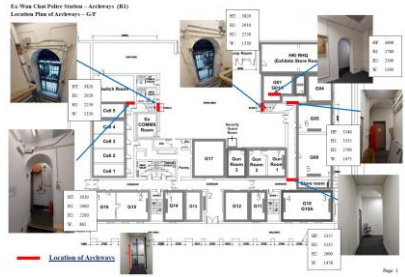
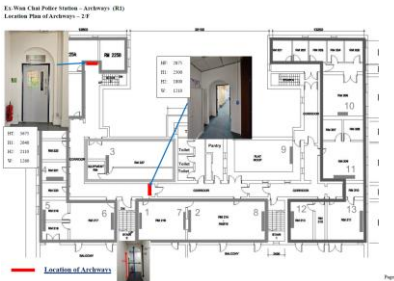
| <p>C7</p> | <p><u>Archway</u></p> <ul style="list-style-type: none"> -Some archways are filled up with doors and walls -The shape of the archway remains visible | | <p>High</p> <ul style="list-style-type: none"> -authentic structural element of the historic building | <p>Within the building in general</p> <p>G/F plan</p> |

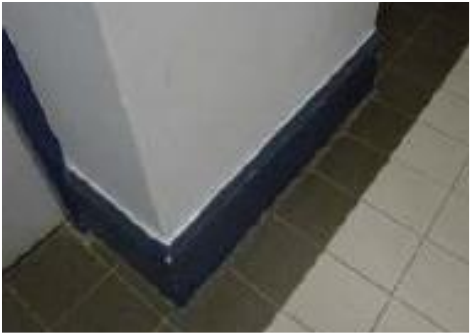
| C8 | <p><u>Skirting with paint</u></p> <p>-Cement sand plastered skirting with paint</p> | | <p>Moderate</p> <p>-This is commonly seen in historic buildings</p> | <p>Within the building in general</p> |

Repair and repaint the timber frames of windows, historic paneled or glazed doors, fanlights and skirting as necessary. Remove the later-added aluminum windows and fanlights and replace with timber framed windows of

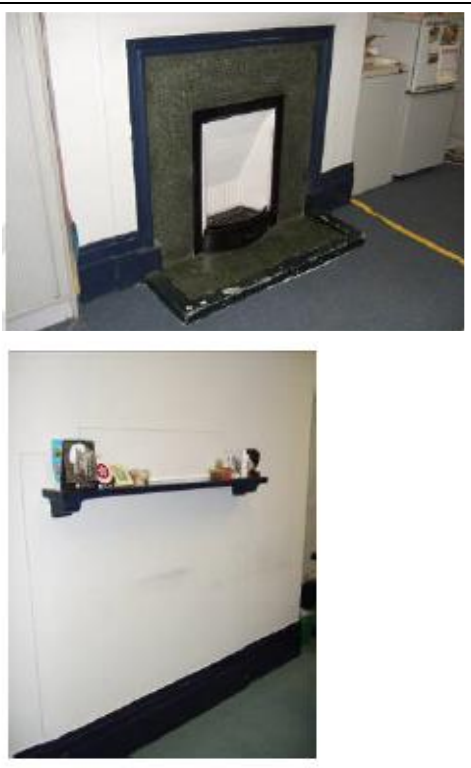
| C9 | <p><u>Fireplaces and stacks</u></p> <p>3 levels of remains:</p> <p>-Exposed fireplace with terrazzo finish, cast iron, marble and timber parts and a stack</p> <p>-blocked fireplaces & timber top with corbel</p> <p>-Remains of chimney stack</p> | | <p>High (Fireplace exposed)</p> <p>-Most of the fireplaces were no longer existed</p> <p>-Design and material of fireplaces reflects the lifestyle in 1930s</p> <p>Moderate (Fireplace blocked)</p> <p>- timber top with corbel only reflects part of the CDE</p> <p>Low (stack only)</p> | <p>For Location refers to Chapter 5</p> |

design following the original windows. Replace all false ceilings and repair the coved and detailed ceiling as necessary. Remove the gates at French windows on 1/F. Restore the modified fanlights and windows due to installation of air-conditioners or other later-added building services; and restore all blocked windows (blocked by brickworks/ panels/ fixture/ furniture/ partitions) and painted glazing as necessary. Apply 3M security films to window and door glazed panes to enhance security. Install secondary windows and doors/ fire-rated fixed glass to door and window openings for acoustic purpose. Repartition the internal layout of G/F to 3/F and the associated structural strengthening works including demolition of two side walls at the corridor adjacent to the main entrance; enlarge the existing report room wall opening to increase waiting area; and demolish the walls in between rooms and corridor to form larger rooms on 1/F and 2/F respectively. Preserve the archways and openings with voussoirs as much as possible. Preserve armoury rooms and cells no. 1-3 on G/F with original configurations for new use and will be opened to visitors if possible. Restore blocked fire places at original locations as many as possible.

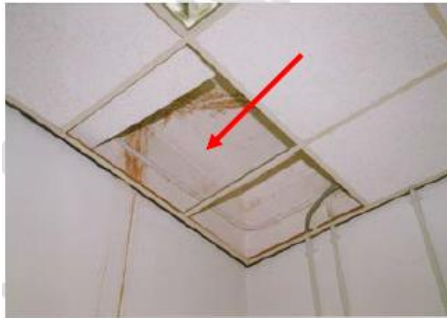
| C10 | <p><u>Ceiling</u> with cove details (now covered up by false ceilings)</p> | | <p>Moderate</p> <p>-This is commonly seen in historic buildings of western style.</p> | <p>Within the building in general</p> |

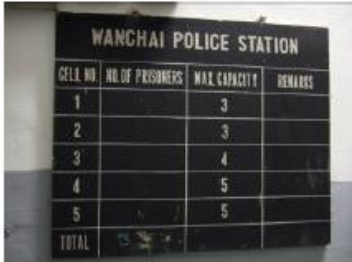
| C11 | <p><u>Furniture and fixtures</u> related to the operation of the Police Station, for example:</p> <p>G/F <u>Cell Area and corridor</u>: notice plaque for “Notice to persons detained”, “Police” wooden boxes, tower hooks and the blackboard for recording prisoners’ information.</p> <p><u>Corridor outside Rm. G05 – Resources Centre</u>: directional sign for “Report Room” and “Notice” to officers and staff regarding the display of warrant card.</p> <p><u>Landings of Stair 2 & Stair 3 at G/F</u>: tower hooks.</p> <p><u>Armoury Room</u>: blackboard and shelves for rifle</p> | <p> Blackboard marking prisoners’ information outside the detention cells </p> <p> Tower hook corresponding to the detention cell numbers outside the cells </p> | <p>Moderate</p> <p>-These elements reflect the operation in the police station</p> | <p>Within the building in general</p> |

| | <p><u>Charge Room</u>: blackboard, shelves for cuffs, revolvers and walkie talkie etc.</p> <p><u>Outside the hatch of the Charge Room nearby Common</u></p> <p><u>Lobby 2</u>: 4 numbers of notice plaques with illustration on gun usage.</p> <p><u>2/F Landings of Stair 1 and Stair 4</u>: “Notice” of officers and staff regarding the display of warrant card.</p> <p><u>Corridor outside Rm. 214 and Rm. 216</u>: cloth hooks</p> <p><u>3/F Corridor outside Rm. 313</u>: cloth hooks</p> <p><u>Landings of Stair 4</u>: “Notice” to officers and staff regarding the display of warrant card.</p> | (photos of furniture and fixtures are not exhaustive) | | |

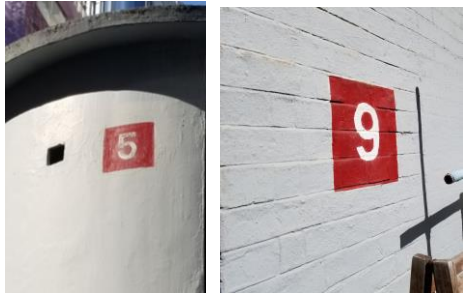
| D4 | Guarding post numbers painted on wall in building, turret and fence wall | | Moderate -it reflected the operation of police station | Within/ outside the building in general |

Preserve the turret and staircase structure in-situ. Enlarge fence wall opening with new metal gate for vehicular access and repaint the fence walls. Preserve, repair and repaint guarding post numbers painted on wall in building, turret and fence wall. Replace the gates with a new one for the rear entrance and the side lanes. Enhance the landscape of courtyard area with new paving materials and design.

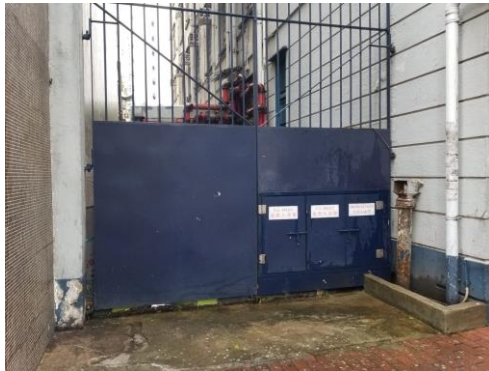
| D5 | Metal gates at side lanes | | Low -Later design | <p>NOTE: All information on this drawing does NOT represent an accurate copy or account of the building. Users should verify positions and dimensions on site BEFORE using.</p> |

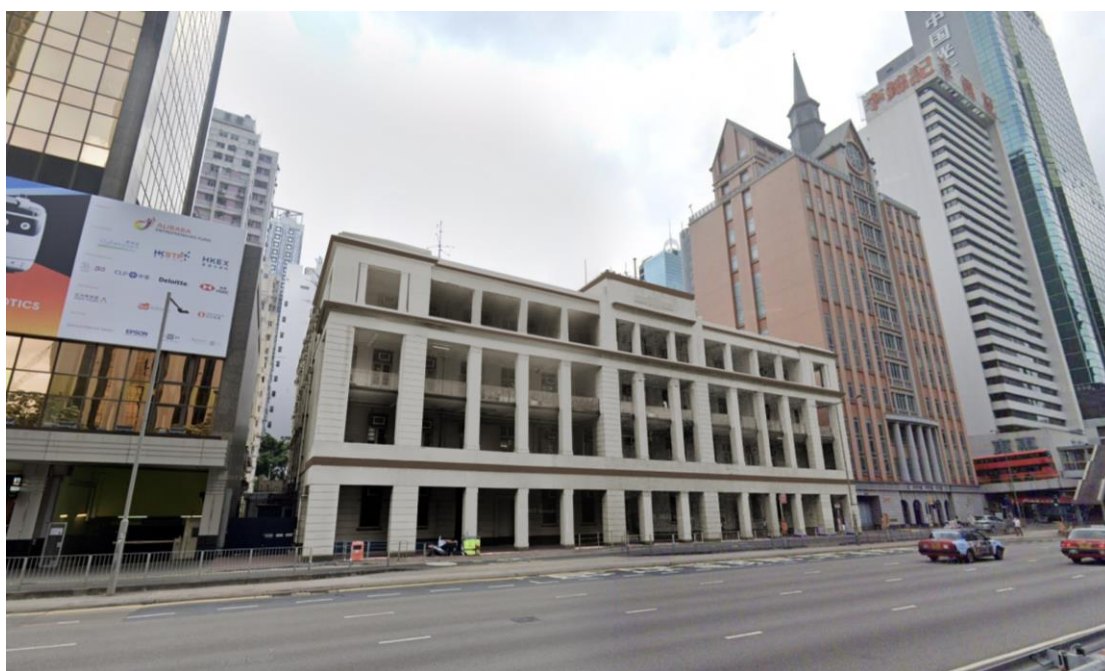
The original window openings being blocked on the front elevation, side elevations, rear elevation and inner elevations facing rear courtyard will be restored if possible. There will be no change in the general appearances of the front elevation. Due to security reason, the existing intrusive metal panels at the west and east side elevations on 1/F verandah will be removed and replaced by transparent laminated glasses. The major addition works which will affect the building form are the external lift shaft and external staircases from G/F to 1/F at the recess of inner elevations facing the rear courtyard. Glass canopy and corridor will be added at the G/F of rear elevation. External corridor with glass façade will be added at east and west terraces on 2/F.

Fig.8.1.6 Proposed front elevation [by author]

Remove all redundant pipes, ducts, conduits, etc as necessary and remove all window type air-conditioners and their metal supports, restore and reinstate altered windows. Preserve in-situ and repair original façades, window or door heads and sills, metal grilles on windows and granite door thresholds. Repaint external walls with reversible paint system.

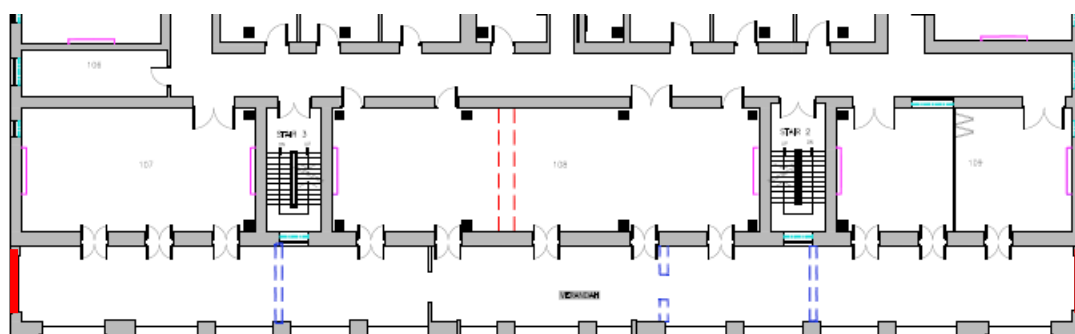
Fig.8.1.7 metal panels on 1/F verandah west & east side elevations will be replaced by transparent laminated glasses

Preserve and repair historic metal grilles and meshes on G/F. Reinstate door openings of staircases 2 and 3. Remove later-added aluminum cladded frame and door at main entrance on G/F. Replace later-added metal panels with clean laminated glass at 1/F verandah, facing east & west. Restore blocked windows and their openings. Preserve and repair in-situ the bell hook on 1/F verandah and the sun-blades at 2/F verandah.

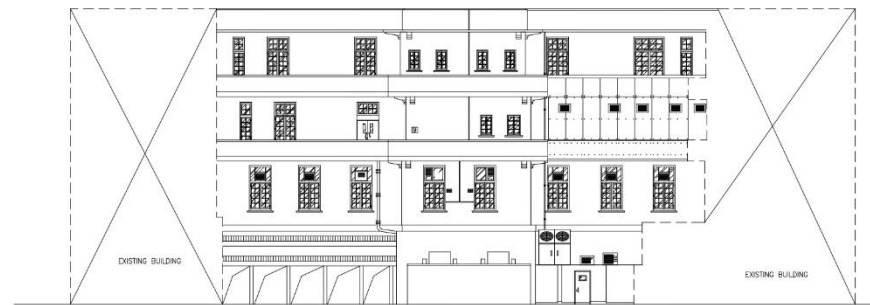
SIDE ELEVATION (COURTYARD FACADE OF CENTRAL WING)

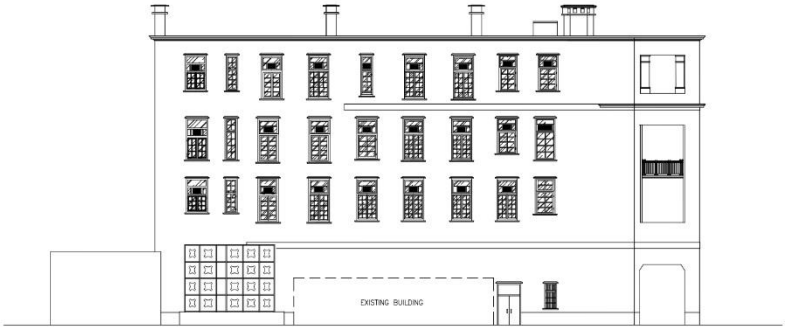
SIDE ELEVATION (EAST FACADE)

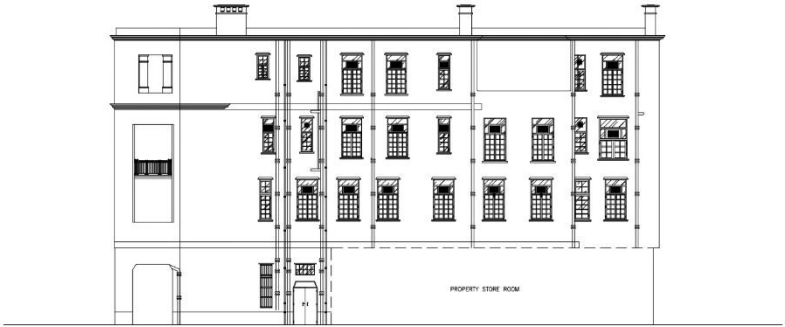
SIDE ELEVATION (WEST FACADE)

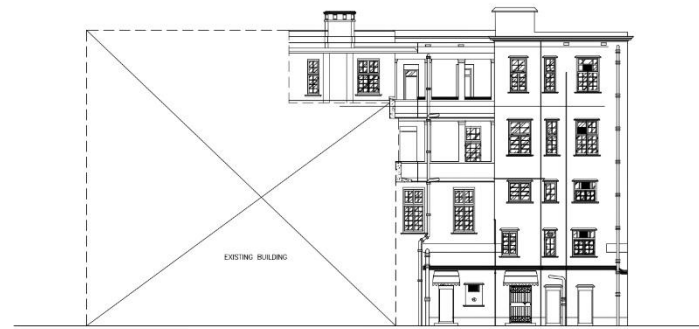
SIDE ELEVATION (COURTYARD FACADE OF EAST WING)

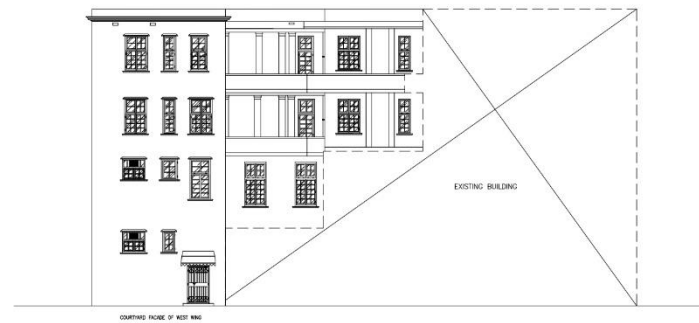
SIDE ELEVATION (COURTYARD FACADE OF WEST WING)

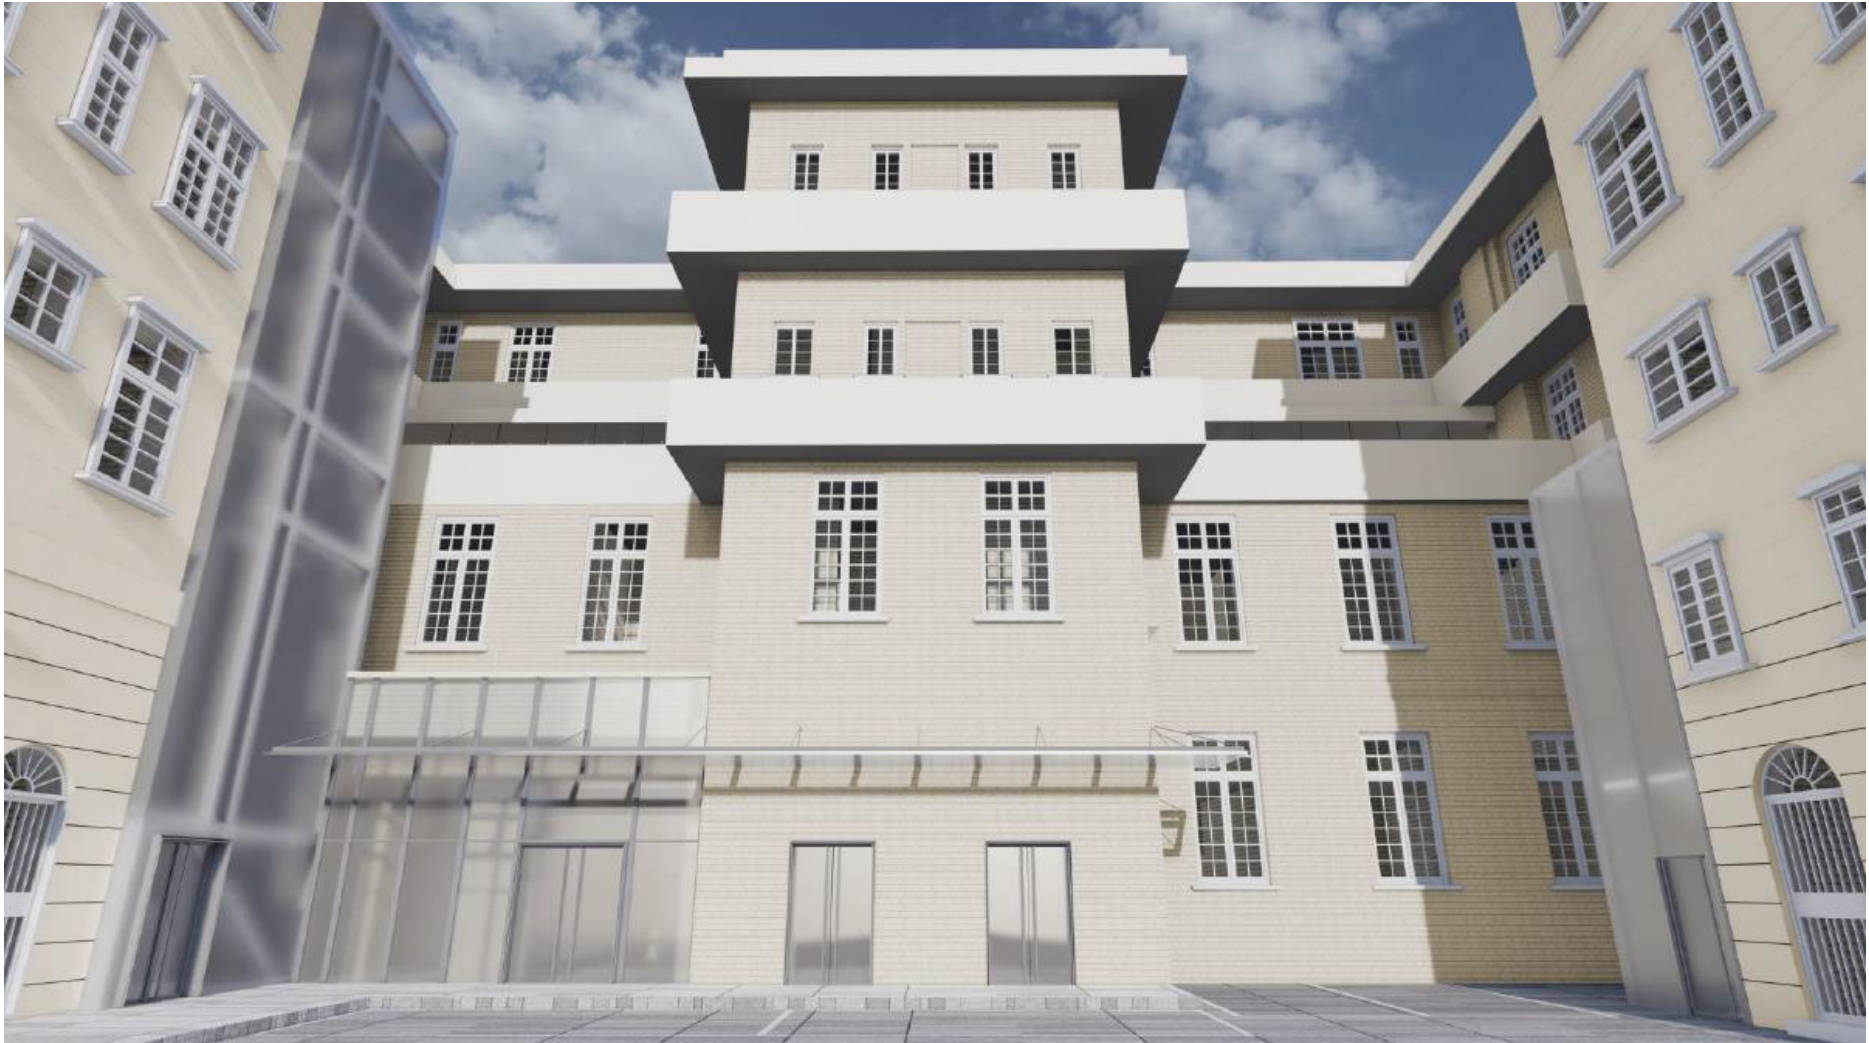
B. Proposed Rear Elevation

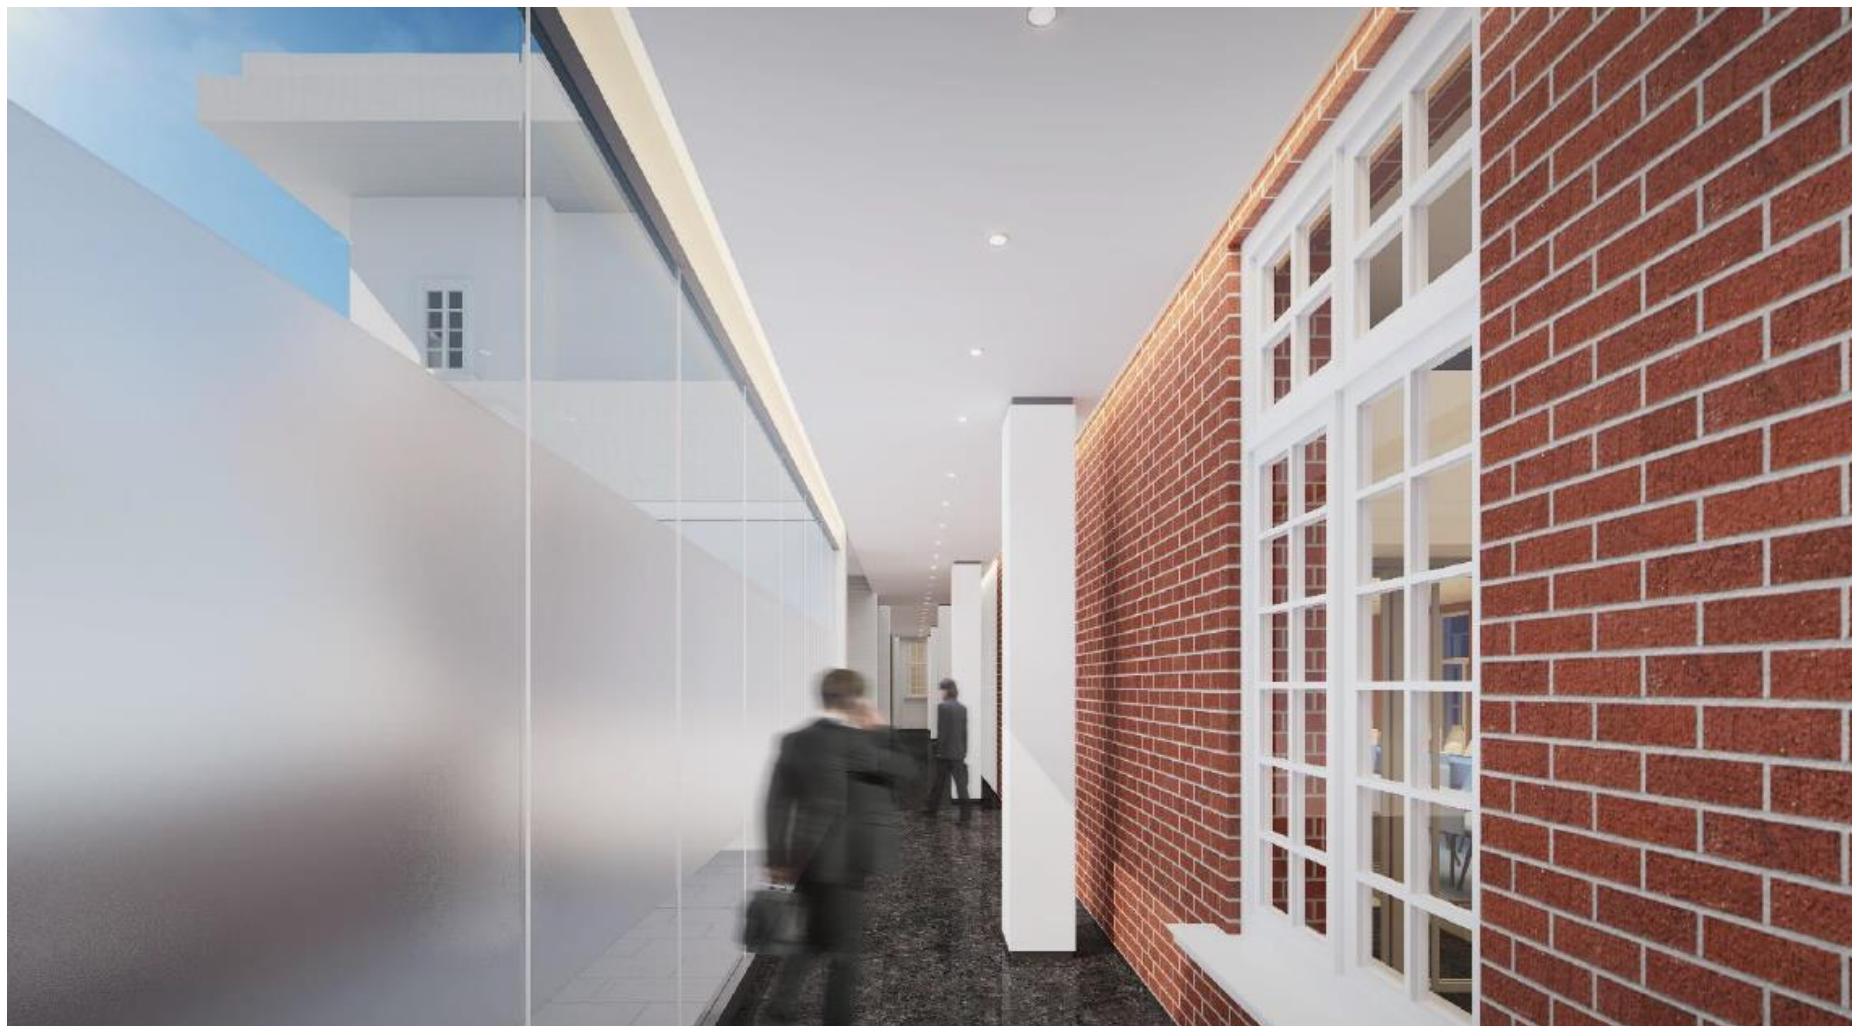
C. Proposed Glass Corridor at 2/F

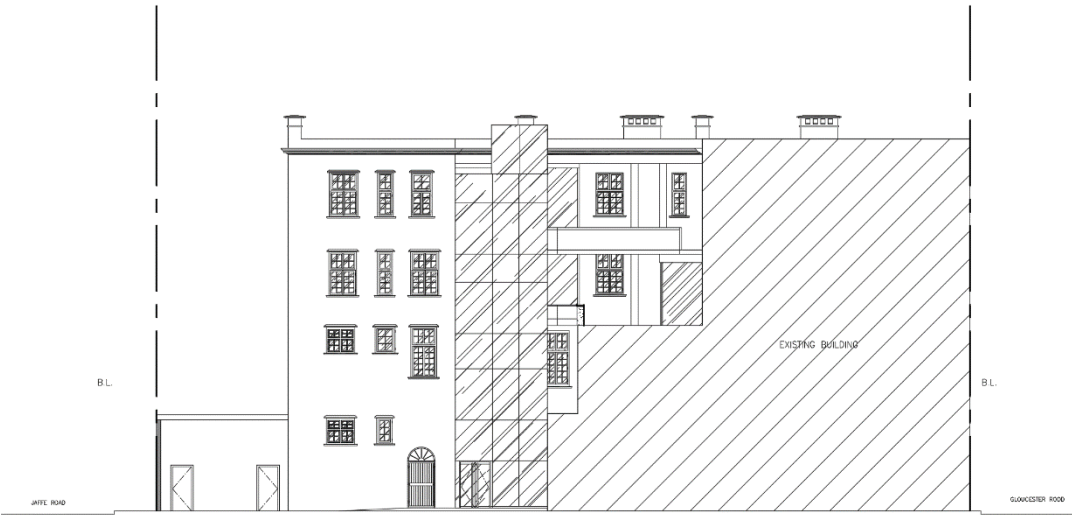
INNER SIDE ELEVATION (COURTYARD FACADE OF WEST WING)

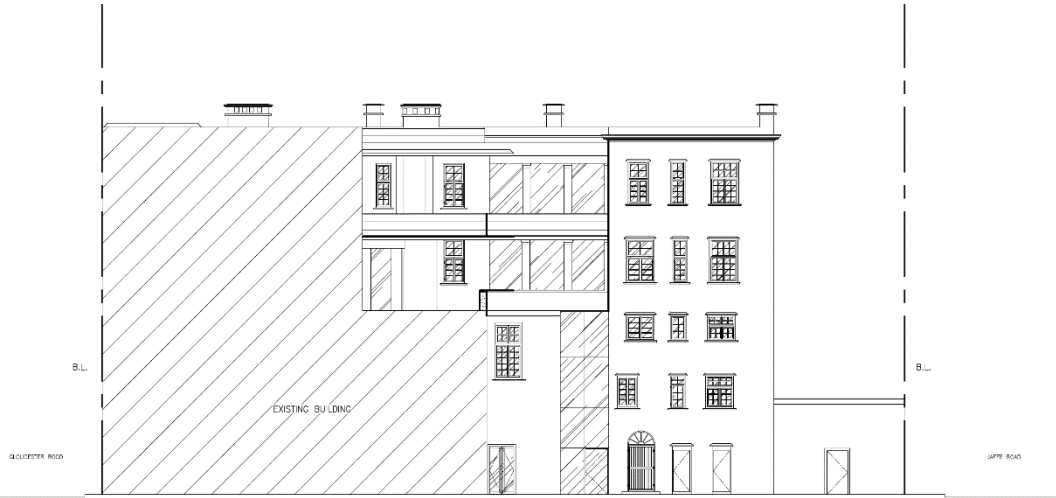
INNER SIDE ELEVATION (COURTYARD FACADE OF EAST WING)
