**Revitalising Historic Buildings Through Partnership Scheme
Batch IV Project**

**Tai Hang Fire Dragon Heritage Centre at
No. 12 School Street, Tai Hang**

**Tai Hang Fire Dragon Heritage Centre Limited
P.K. Ng & Associates (H.K.) Limited
and The Team Consultant
June, 2017**

**Revitalization of No. 12 School Street as
Tai Hang Fire Dragon Heritage Centre
Heritage Impact Assessment Report**

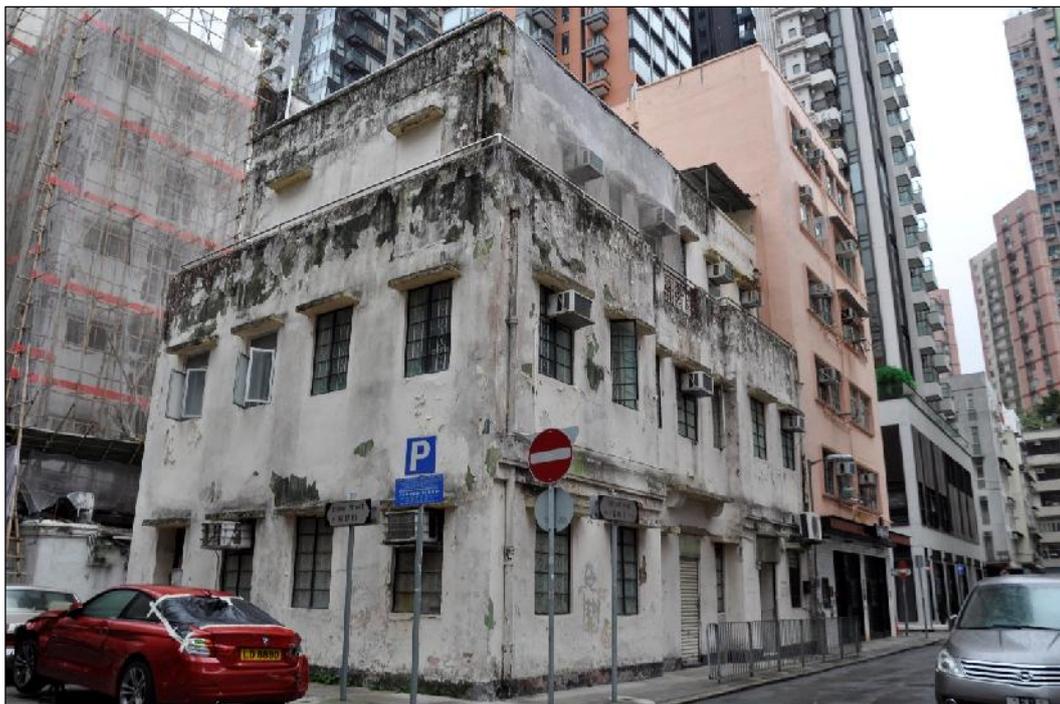
Photo 1-01 – external (front and side) view of the Building,
(view from corner of School Street and Brown Street),
(photo taken on 11th March, 2017)

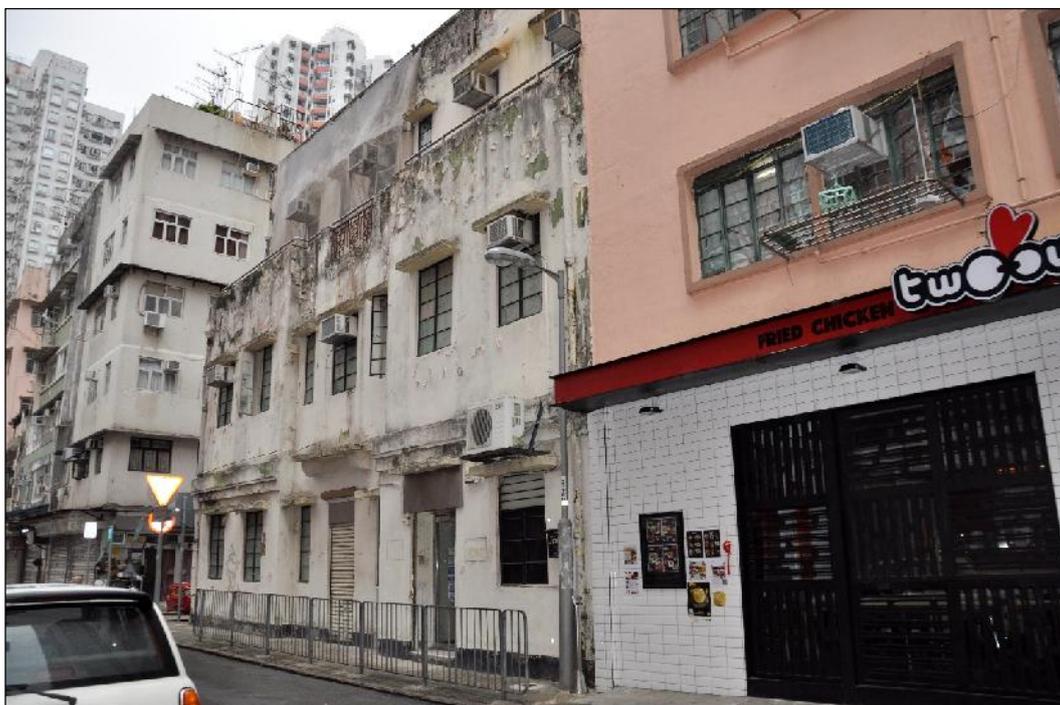
Photo 1-02 – external (front) view of the Building,
(view from School Street near corner of School Street and Warren Street),
(photo taken on 11th March, 2017)

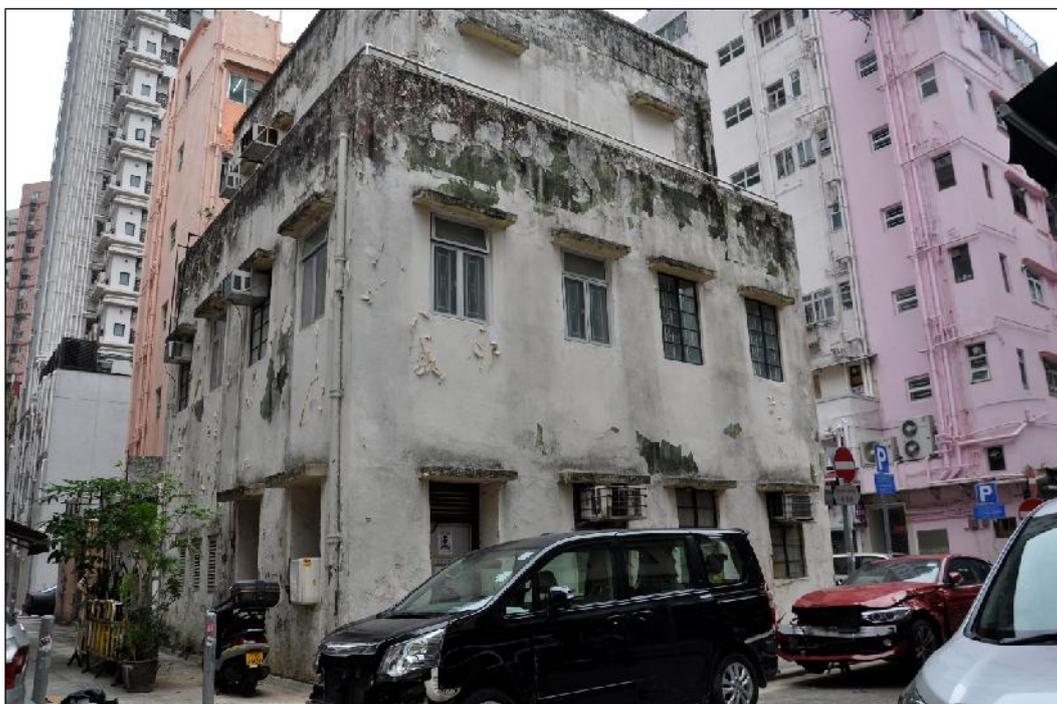
Photo 1-03 – external (side and rear) view of the Building,
(view from corner of Brown Street and First Lane),
(photo taken on 27th May, 2017)

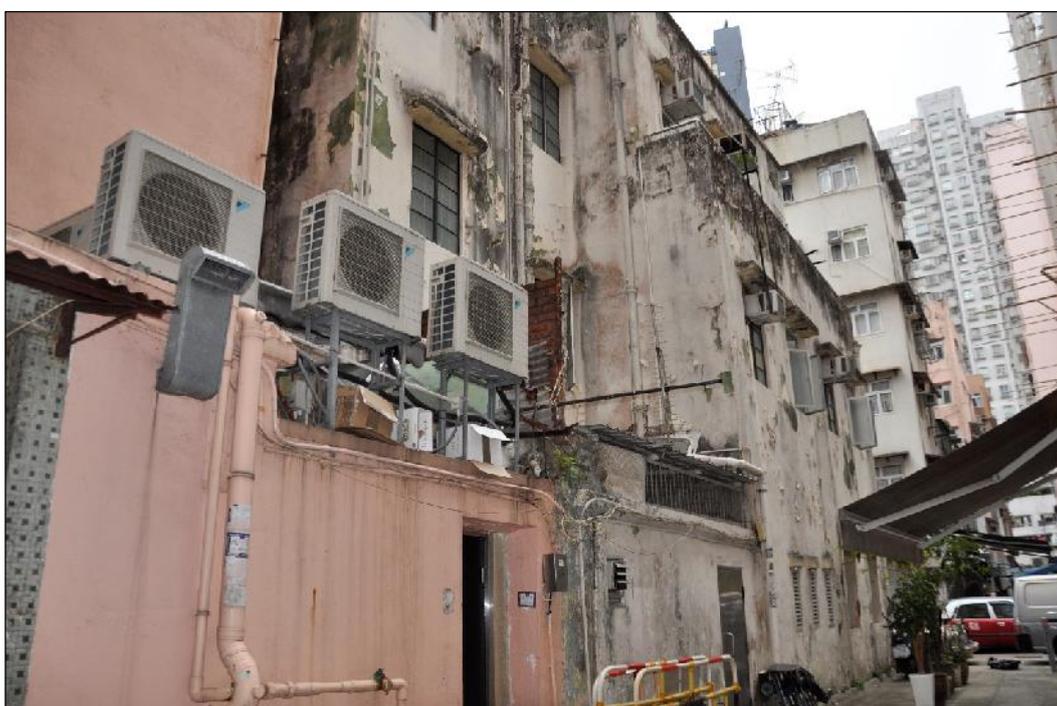
Photo 1-04 – external (side and rear) view of the Building,
(view from First Lane near Warren Street),
(photo taken on 11th March, 2017)

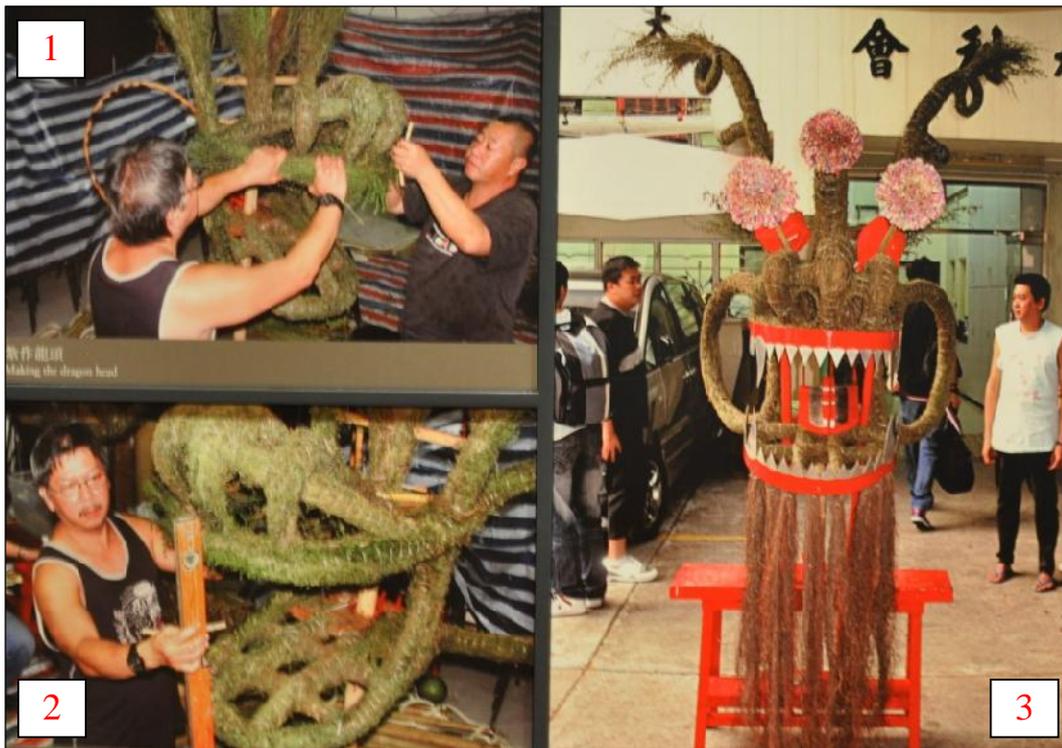
Photo 2-05 – Making the Tai Hang Fire Dragon head

- (1) Making the dragon head.
- (2) Measuring the angle of the dragon head.
- (3) The dragon head is done.

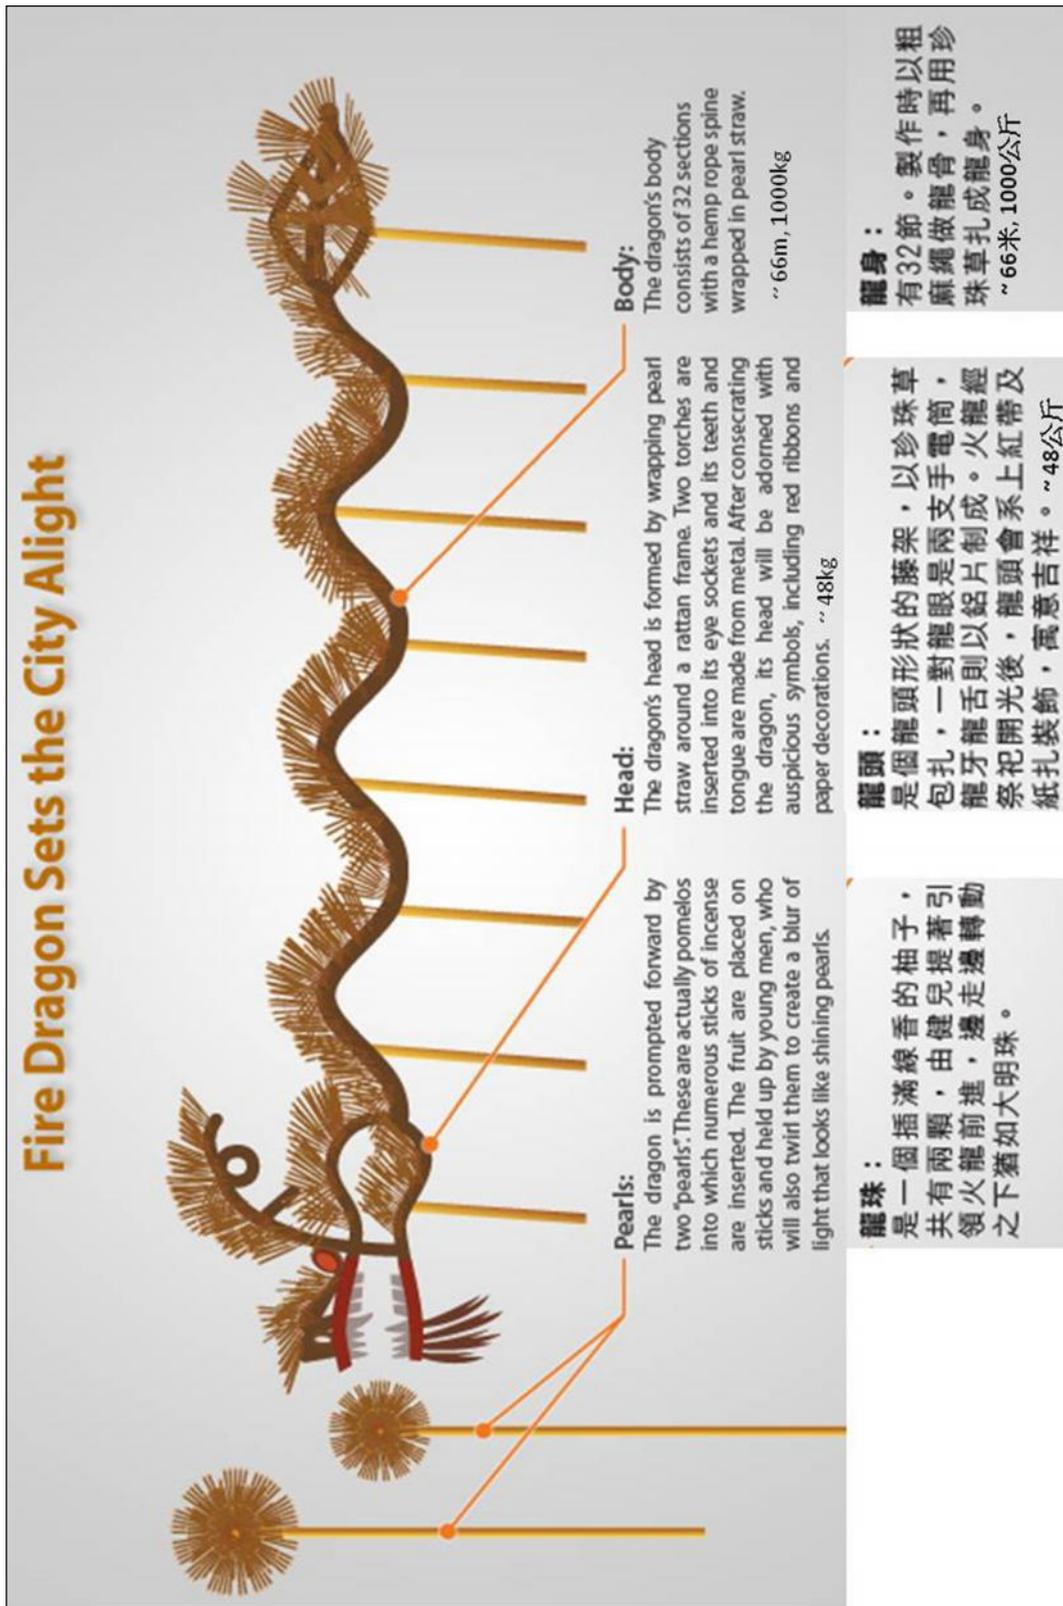
Drawing 2-01 – Schematic drawing of the “Tai Hang Fire Dragon”
(source of drawing: Hong Kong Tourist Association website.)

A new Tai Hang Fire Dragon is made by the Tai Hang residents every year. The Tai Hang Fire Dragon is 220 feet long, and makes up by the “dragon head (龍頭)”, the “32 sections dragon body (龍心)”, and the “dragon tail (龍尾)”. The “dragon head” consists of “combed hair (龍髻)”, “horns (龍角)”, “eyes (龍眼)”, “ears (龍耳)”, “mouth (龍口)” “nose (龍鼻)”, “eyes (龍眼)”, and weighs more than 60 kilogram. The head and tail sections of the frame are made of flexible rattan (籐枝), while the ridge of the back is a rope of 2 centimetres thick. The rattan and rope are covered by a special kind of grass called “pearl grass” (Common Leafflower Herb 珍珠草) and “banyan tree aerial roots” (榕樹氣根). According to Mr. Chan Tak Fai (陳德輝), title “Holder of National-level Masterpiece of Intangible Cultural Heritage”, the “pearl grass” rope form “dragon body” is tough and the gaps between the fine “pearl grass” provides the base in which the 45-centimetre-high burning “longevity joss sticks (長壽香)” are plugged in to form a shining dragon with glimmers. The local inhabitants believe that the “banyan tree aerial root can dispel the evil spirit.

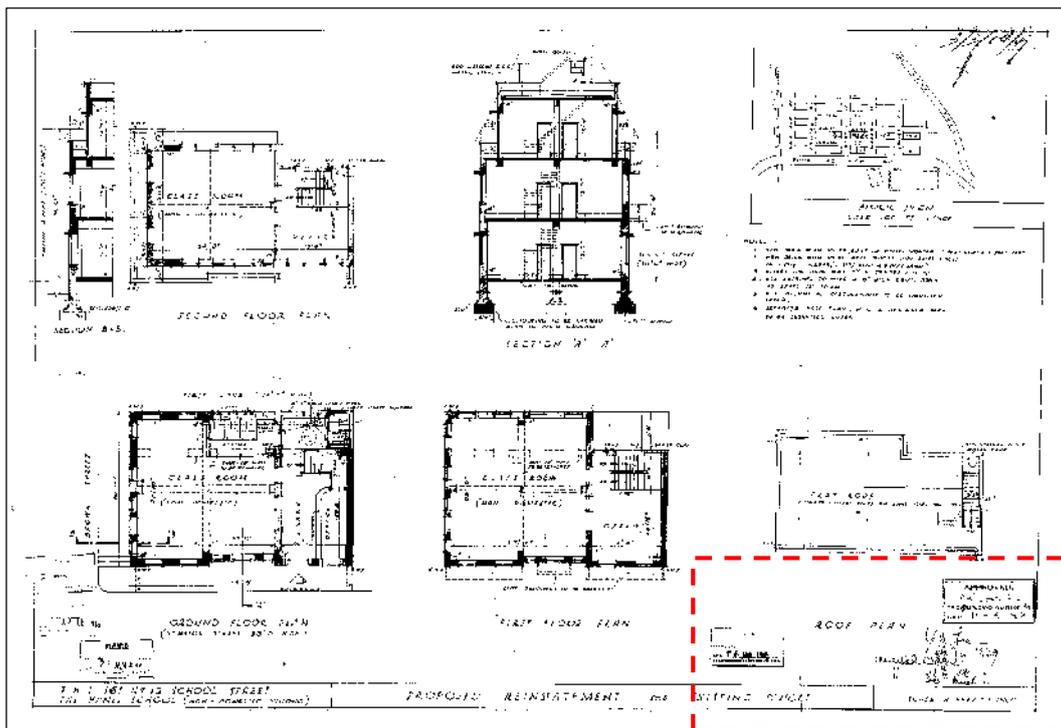
Drawing 2-02 – Record drawing retrieved from Buildings Department

It is hand-written on the record drawing retrieved from Buildings Department drawing below that the drawing was first submitted on 6th January, 1949, and with the Building Authority approval chop dated 11th April, 1949.

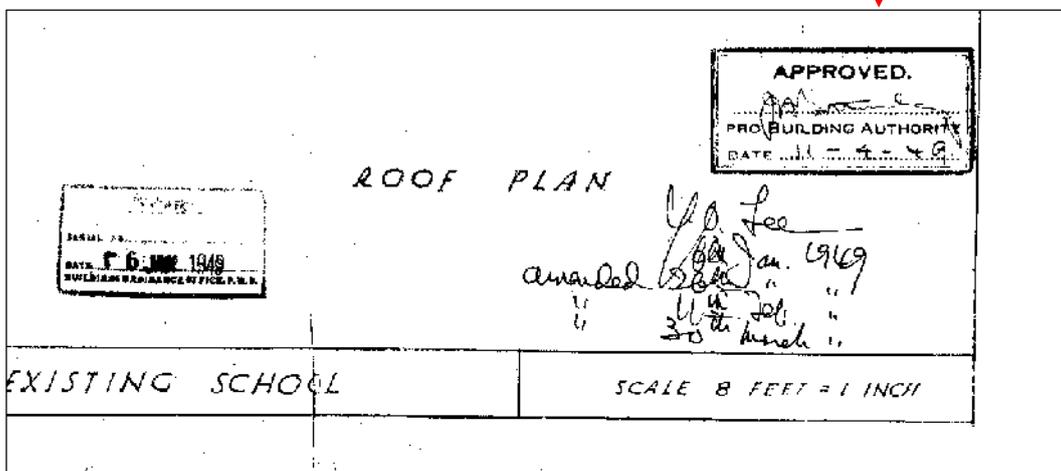
Drawing 2-03 – Enlarged part of above drawing

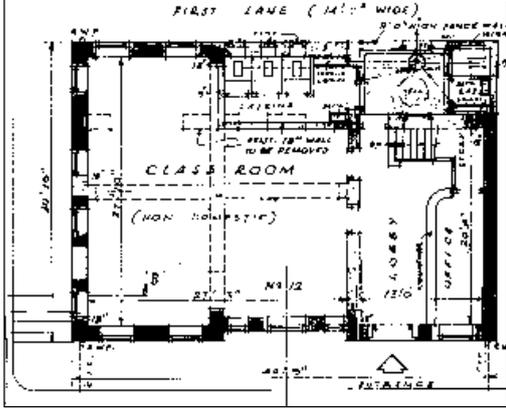
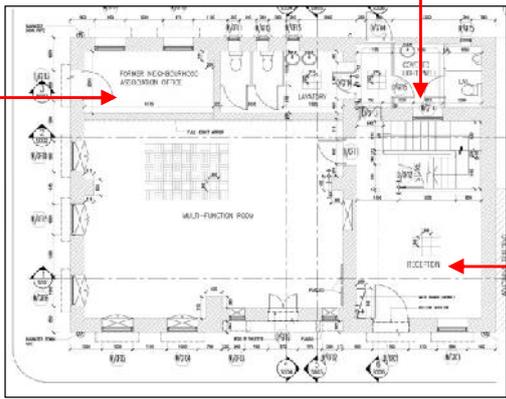
| <u>Layout and usage shown in 1949</u> <u>Buildings Department approved drawing</u> | <u>Current layout</u> |
|--|--|
| <ul style="list-style-type: none"> • one big classroom, • lobby, • office, • big latrine toilet, and • light well with a small latrine. | <ul style="list-style-type: none"> • one big classroom, but with the small part at the First Lane side partitioned into a separate room with independent entrance from Brown Street, • lobby extended, • office deleted and space taken out by lobby, • big toilet remains, and • light well covered and converted into another toilet. |

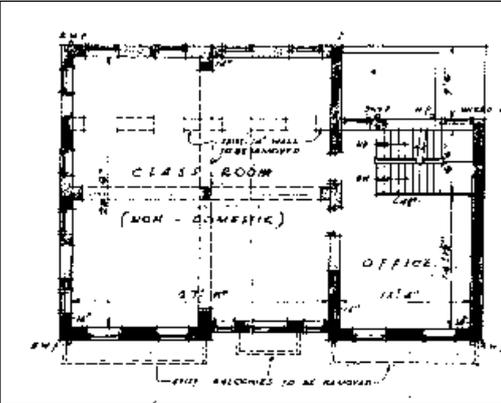
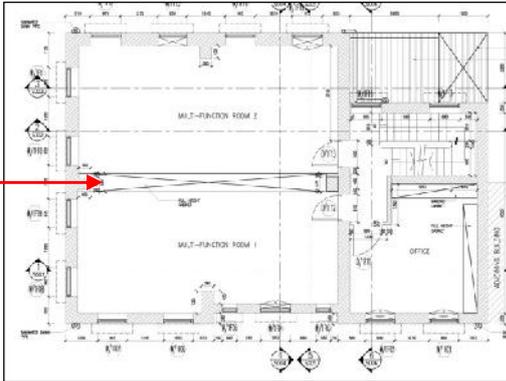
| <u>Layout and usage shown in 1949 Buildings Department approved drawing</u> | <u>Current layout</u> |
|---|---|
| <ul style="list-style-type: none"> • one big classroom, and • office. | <ul style="list-style-type: none"> • the big classroom divided into two classroom by full height cabinets, and • office remains un-changed. |

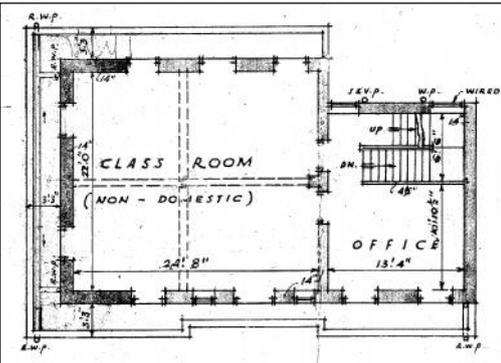
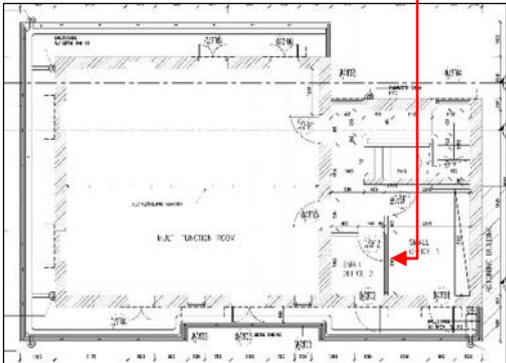
| <u>Layout and usage shown in 1949 Buildings Department approved drawing</u> | <u>Current layout</u> |
|---|--|
| <ul style="list-style-type: none"> • one big classroom, and • office. | <ul style="list-style-type: none"> • sliding panels installed at the middle of the room such that the big classroom can be partitioned into two rooms when necessary, and • office partitioned into two smaller offices. |

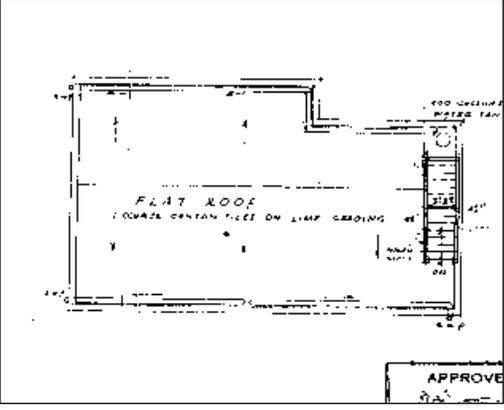
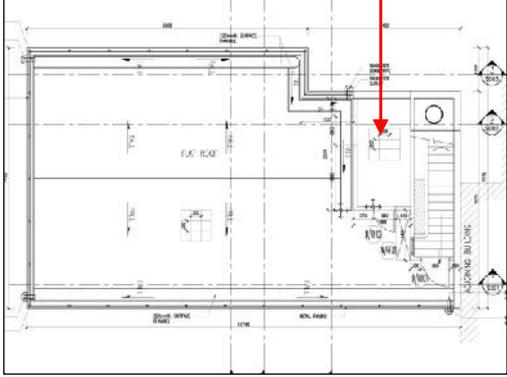
| <u>Layout and usage shown in 1949 Buildings Department approved drawing</u> | <u>Current layout</u> |
|---|--|
| <ul style="list-style-type: none"> flat roof. | <ul style="list-style-type: none"> flat roof, and kitchen added. |

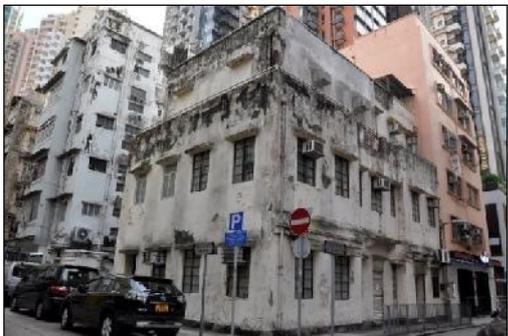
| <u>No.</u> | <u>CDE/architectural elements</u> | <u>Level</u> | <u>Photo</u> |
|---|--|---|--|
| A1. | The “rectangular box” shaped building form with set-back about 1.00 m. creating a narrow flat roof running through the entire second floor. (photo dated – 6 th October, 2016) | High | |

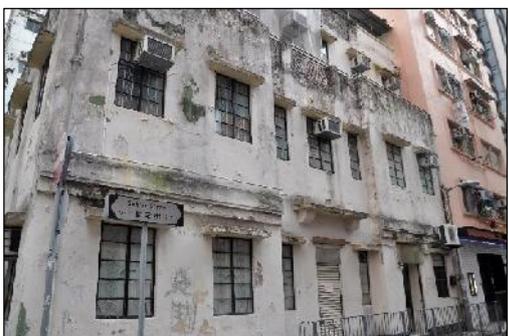
| <u>No.</u> | <u>CDE/architectural elements</u> | <u>Level</u> | <u>Photo</u> |
|---|--|---|--|
| A2. | The configuration of the three-bays front elevation facing School Street with narrow and wide (single and double leaf) casement windows rhythm, and skirting. (photo dated – 6 th October, 2016) | High | |

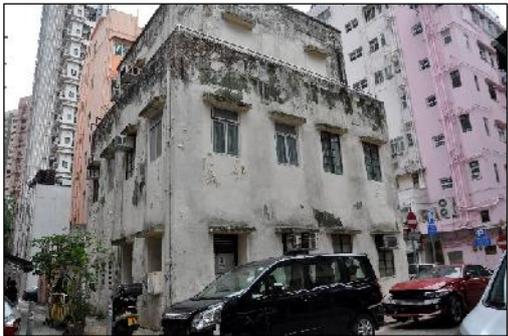
| <u>No.</u> | <u>CDE/architectural elements</u> | <u>Level</u> | <u>Photo</u> |
|---|--|---|--|
| A3. | The configuration of side elevation facing Brown Street and main part of rear elevation with double leaf casement windows pattern, and skirting. (photo dated – 6 th October, 2016) | High | |

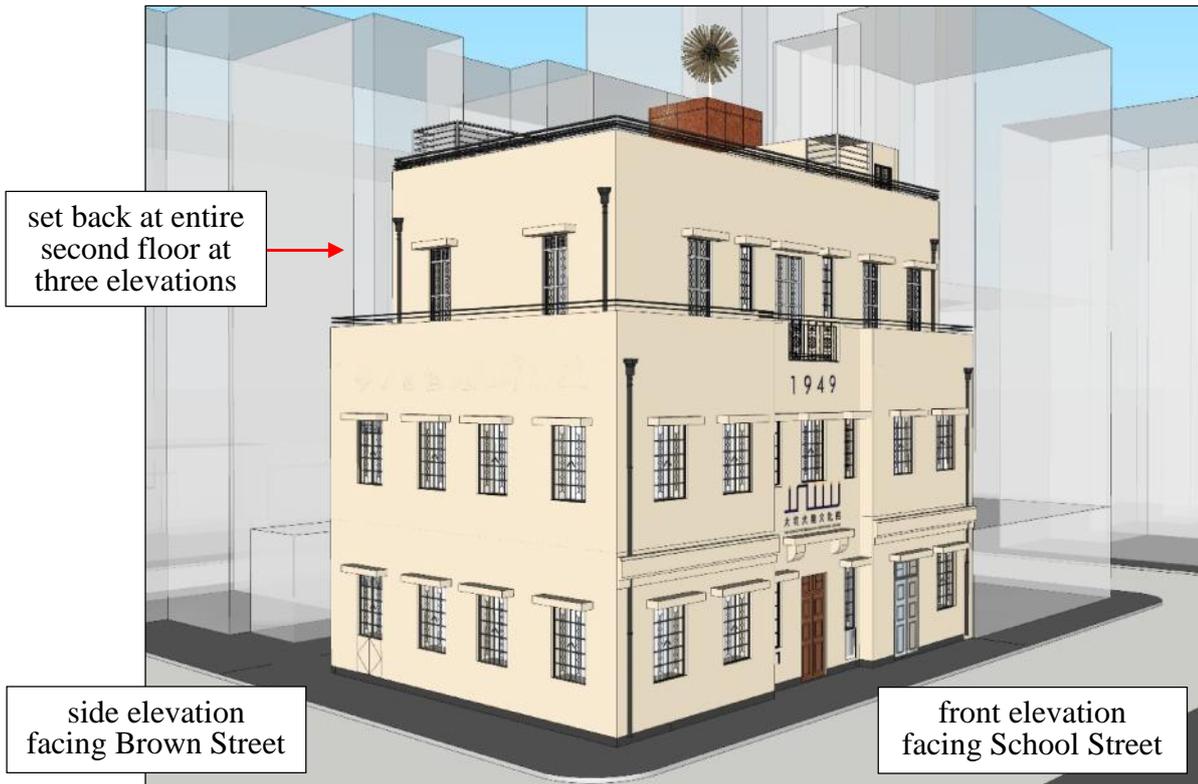
Drawing 2-04 – Perspective view of the Building from corner of School Street and Brown Street

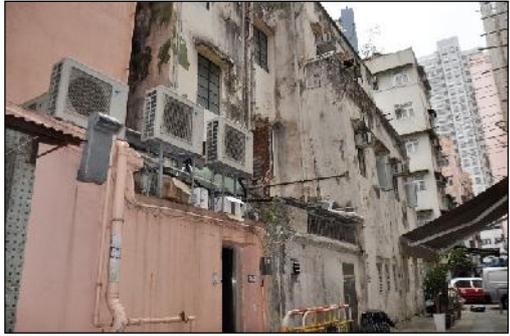
| <u>No.</u> | <u>CDE/architectural elements</u> | <u>Level</u> | <u>Photo</u> |
|---|--|---|--|
| A4. | The configuration of rear elevation facing First Lane with the fence wall and light well (recess portion) adjoining the adjacent building. (photo dated – 11 th March, 2016) | High | |

- The light well fence wall will also be removed, (character defining element no. A4).
- (c) Structure of the new lift shaft
- The new lift will serve ground floor to roof, about 14.5 m. high. The lift shaft will be constructed of structural steel frame, attached to the existing building for lateral stability, and supported on a new raft foundation. To avoid differential settlement between existing and new footings, vertical sliding joints will be provided between the new structure along the interface of existing building. The design of new lift structures and footing will be in accordance with the latest codes of practice.

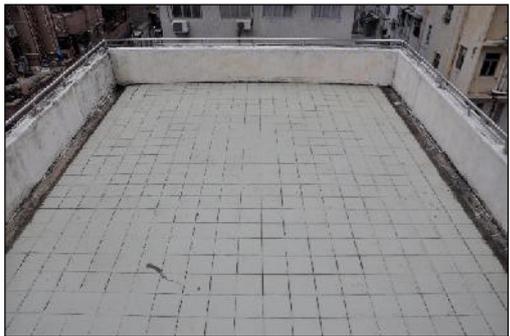
| <u>No.</u> | <u>CDE/architectural elements</u> | <u>Level</u> | <u>Photo</u> |
|---|--|---|--|
| A5. | Flat roof and parapet wall at the perimeter of the roof. (photo dated – 22 nd November, 2016) | High | |

- The parapet wall on both of the second floor flat roof and main roof are made up of solid wall at the lower and with additional two stainless steel tubular railings on top (diameter of top tubular railing is 50 mm and lower tubular railing is 30 mm; around 250 mm high overall), except a 1.80 m wide ornamental ironwork open grilles balustrade at the middle part of the School Street elevation, ((character defining element no. A5, A6 and B4).
- The stainless steel tubular railings are not compatible with the existing building fabric and should be replaced.

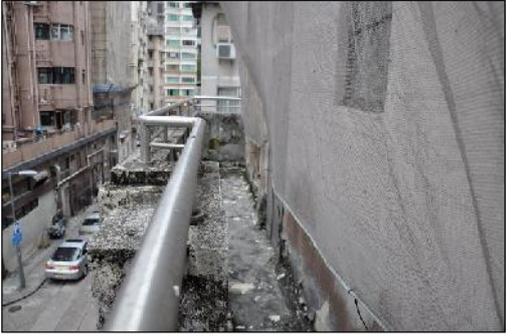
| <u>No.</u> | <u>CDE/architectural elements</u> | <u>Level</u> | <u>Photo</u> |
|---|---|---|--|
| A6. | <p>The narrow flat roof along the three elevations at second floor.</p> <p>(photo dated – 22nd November, 2016)</p> | High | |

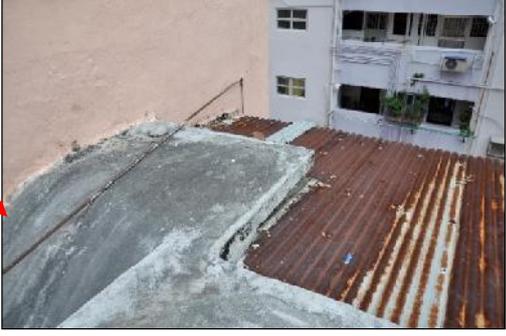
| <u>No.</u> | <u>CDE/architectural elements</u> | <u>Level</u> | <u>Photo</u> |
|---|---|---|--|
| A7. | <p>The staircase hood on the roof with sloping roof.</p> <p>(photo dated – 22nd November, 2016)</p> | High | |

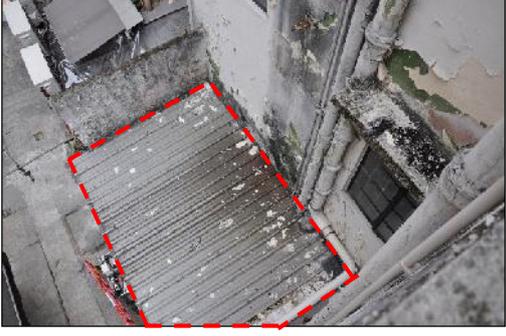
| <u>No.</u> | <u>CDE/architectural elements</u> | <u>Level</u> | <u>Photo</u> |
|---|---|---|--|
| A8. | <p>Corrugated sheet roofing at ground floor light well (photo on right) and beside roof staircase hood (above photo).</p> <p>(photo dated – 22nd November, 2016)</p> | Intrusive | |

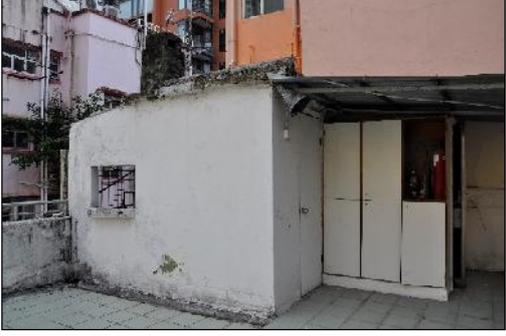
| <u>No.</u> | <u>CDE/architectural elements</u> | <u>Level</u> | <u>Photo</u> |
|---|---|---|--|
| A9. | <p>Kitchen and chimney on the roof of kitchen on flat roof.</p> <p>(photo dated – 22nd November, 2016)</p> | Low | |

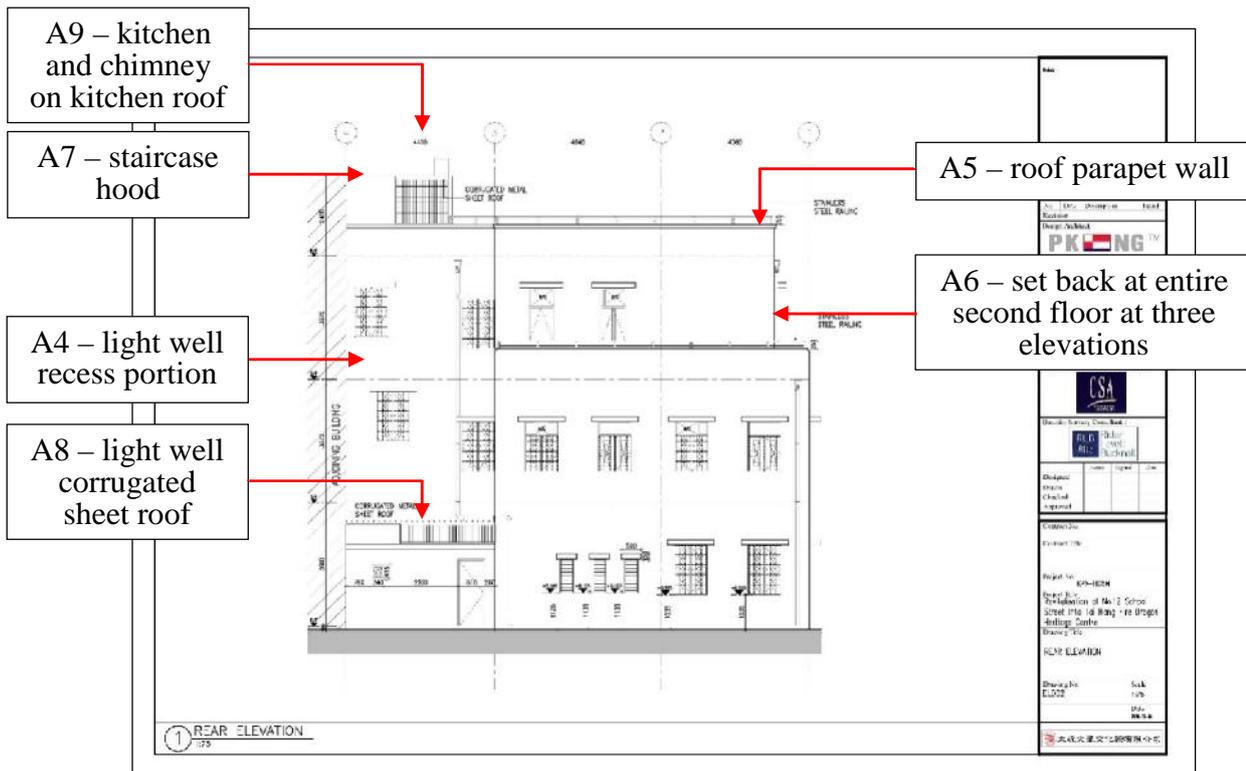
Drawing 2-05 (drawing no. EL002) – First Lane (rear) elevation

2.7.2 Architectural features on the elevations, (the locations are shown on the drawings at the end of this sub-section) –

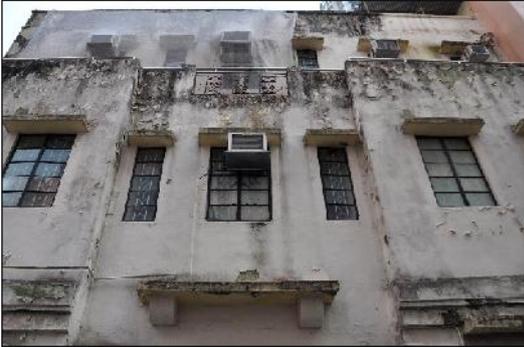
| No. | <u>CDE/architectural elements</u> | <u>Level</u> | <u>Photo</u> |
|---|--|---|---|
| B3. | The horizontal projection (typhoon canopy) above the windows and French windows and door at ground floor, first floor and second floor. (photo dated – 6 th October, 2016) | High | |

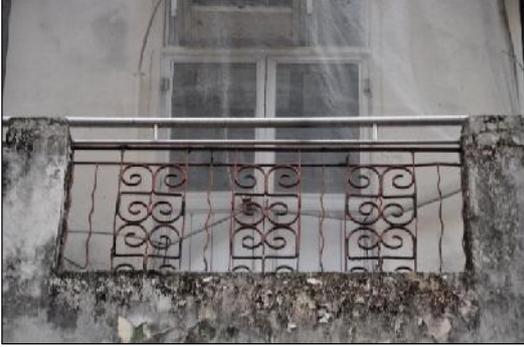
| No. | <u>CDE/architectural elements</u> | <u>Level</u> | <u>Photo</u> |
|---|--|---|---|
| B4. | The ornamental ironwork open grille steel balustrade at front elevation middle bay of second floor flat roof parapet wall. (photo dated – 6 th October, 2016) | High | |

- The existing stainless steel railing will be taken down and replace with galvanized mild steel tubular railing with paint finish to match the architectural style of the Building.

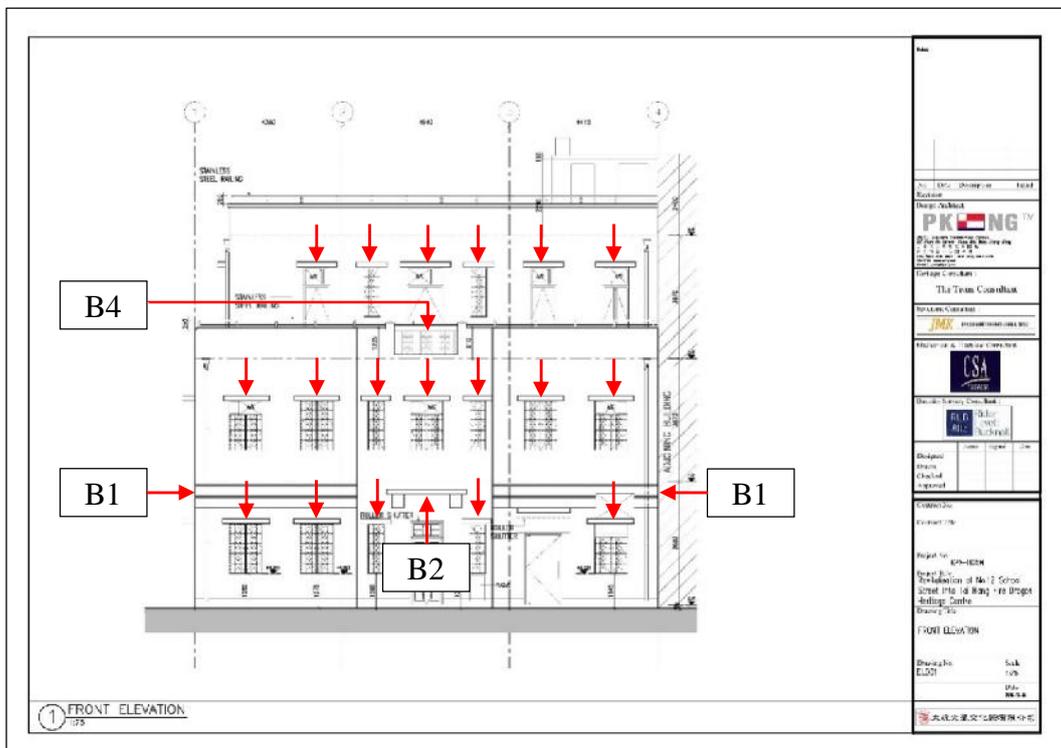
Drawing 2-06 (drawing no. EL001) – School Street (front) elevation

Note – red arrow pointing downwards ↓ denotes character defining element B3.

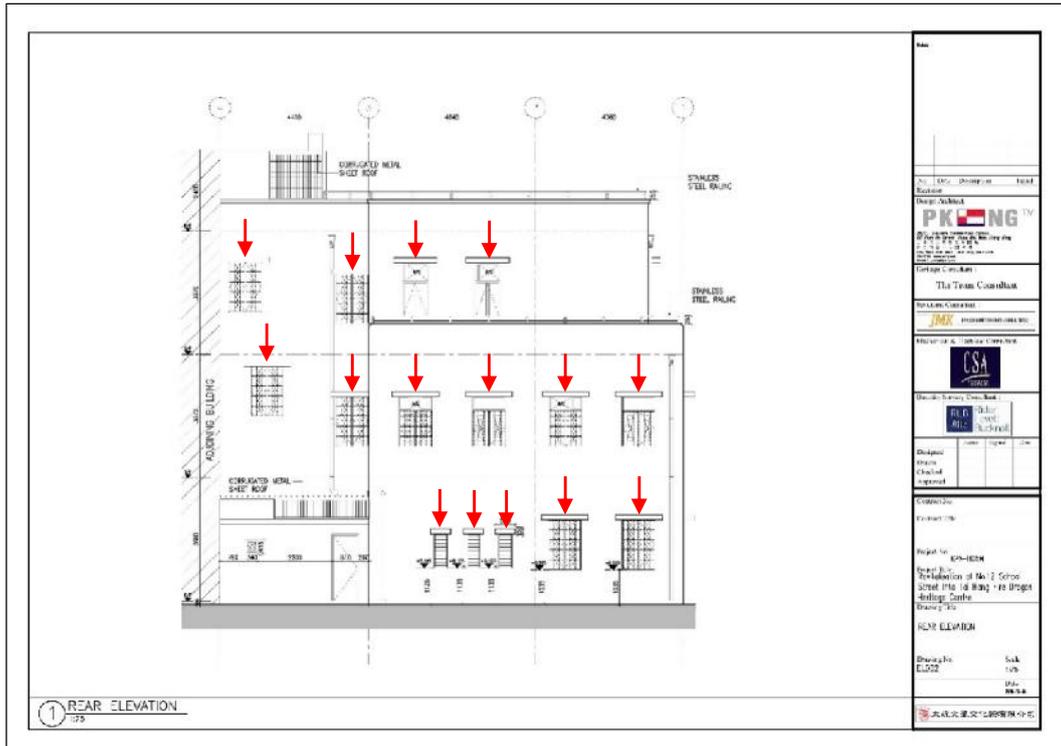
Drawing2-07 (drawing no. EL002) – First Lane (rear) elevation

Note – red arrow pointing downwards ↓ denotes character defining element B3.

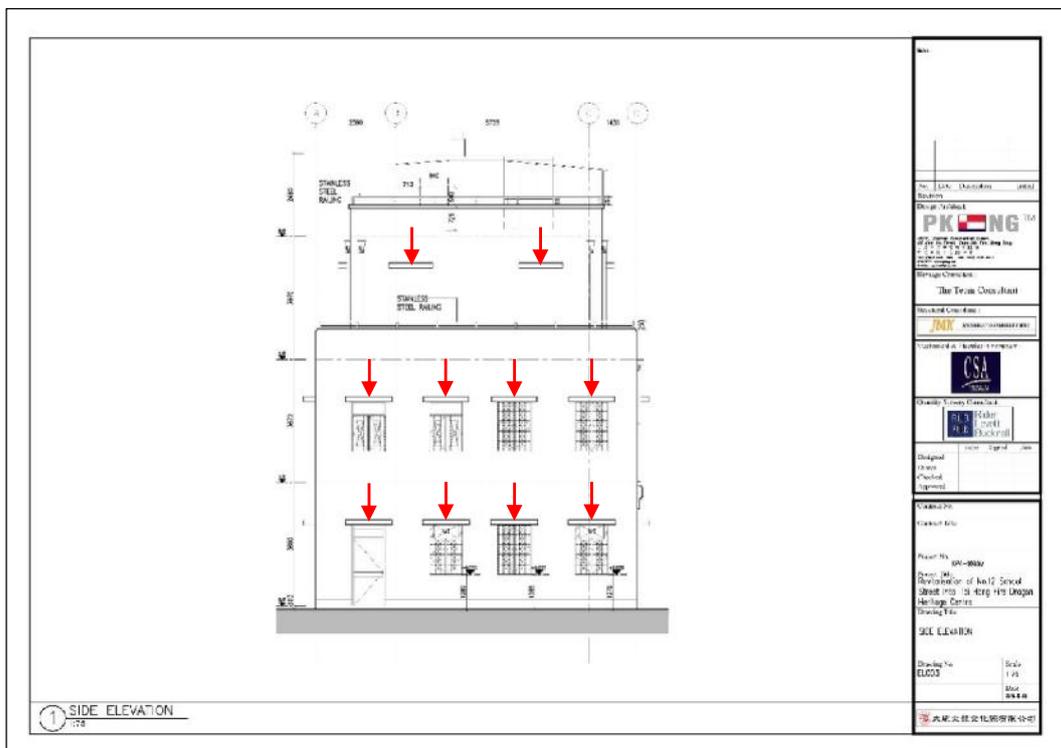
Drawing 2-08 (drawing no. EL003) –Brown Street (side) elevation

Note – red arrow pointing downwards ↓ denotes character defining element B3.

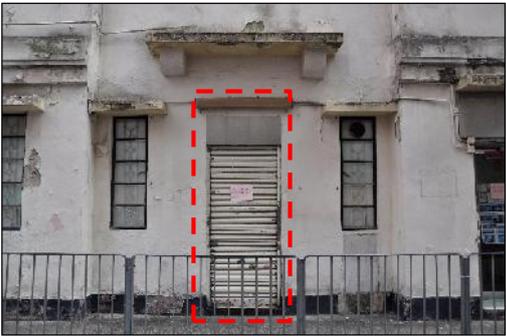
| <u>No.</u> | <u>CDE/architectural elements</u> | <u>Level</u> | <u>Photo</u> |
|---|---|---|--|
| C1. | <p>Front elevation ground floor middle bay – the roller shutter on the external side of the timber entrance door.</p> <p>(photo dated – 6th October, 2016)</p> | Intrusive | |

- (a) Front elevation (facing School Street) – main entrance door at middle bay –
 - the roller shutter on the external side will be taken down, (character defining element no. C1),
 - the double leaf timber paneled door with fanlight will be re-varnished, damaged and missing ironmongery replaced, (character defining element no. C2).

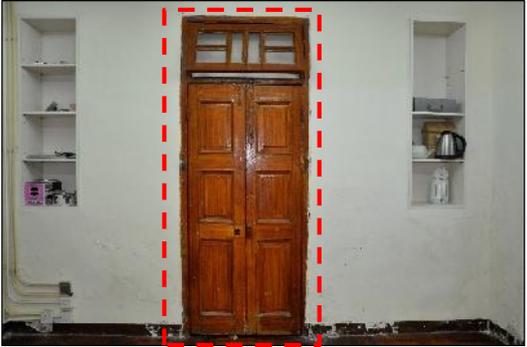
| <u>No.</u> | <u>CDE/architectural elements</u> | <u>Level</u> | <u>Photo</u> |
|---|---|---|--|
| C2. | <p>Front elevation ground floor middle bay – the timber paneled door with fanlight.</p> <p>(photo showing internal side dated – 6th October, 2016)</p> | High | |

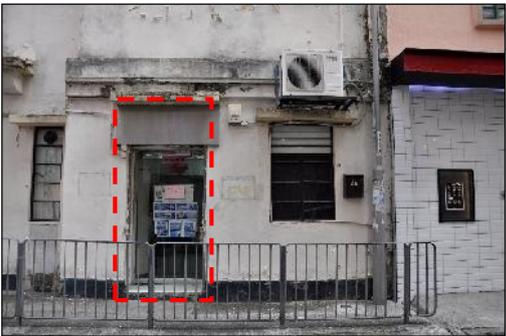
| <u>No.</u> | <u>CDE/architectural elements</u> | <u>Level</u> | <u>Photo</u> |
|---|---|---|--|
| C3. | <p>Front elevation ground floor right (west) bay – the glass entrance door.</p> <p>(photo dated – 6th October, 2016)</p> | Neutral | |

- (b) Front elevation facing School Street – the glass entrance door at right (west) side bay will be replaced with a steel frame glass to distinguish from the original design, (character defining element no. C3).
- (c) Side elevation facing Brown Street – the aluminium door will be replaced by a steel window matching with existing, and bottom part will be the cabinet for the sprinkler valve, (character defining element no. C4).

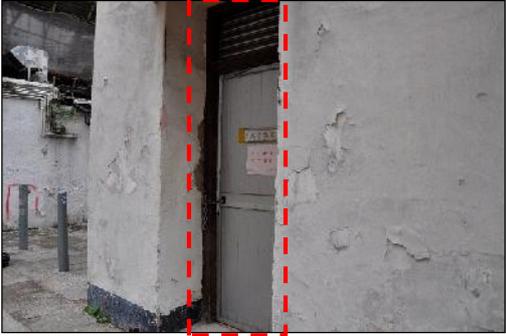
| <u>No.</u> | <u>CDE/architectural elements</u> | <u>Level</u> | <u>Photo</u> |
|---|---|---|--|
| C4. | <p>Side (Brown Street) elevation – aluminium entrance door.</p> <p>(photo dated – 11th March, 2017)</p> | Intrusive | |

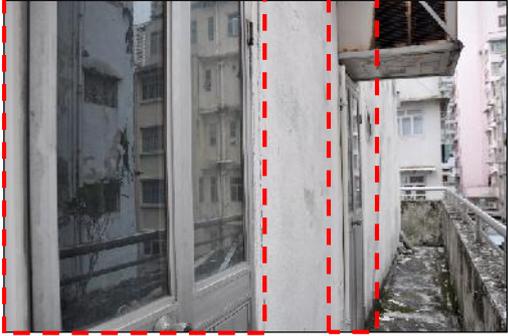
| <u>No.</u> | <u>CDE/architectural elements</u> | <u>Level</u> | <u>Photo</u> |
|---|---|---|---|
| C5. | <p>Aluminium French window at second floor flat roof.</p> <p>(photo dated – 22nd October, 2016)</p> | Intrusive | |

- (a) The existing six aluminium French windows on second floor will be replaced by new steel frame glass French window with design matching the architectural style of the building when it was built, (drawing 3-02 shown below is an example, and to be finalized after further study), (character defining element no. C5).
- (b) The blocked up three French windows on second floor will be opened up, and install with new steel frame glass French window with design matching the architectural style of the building when it was built.

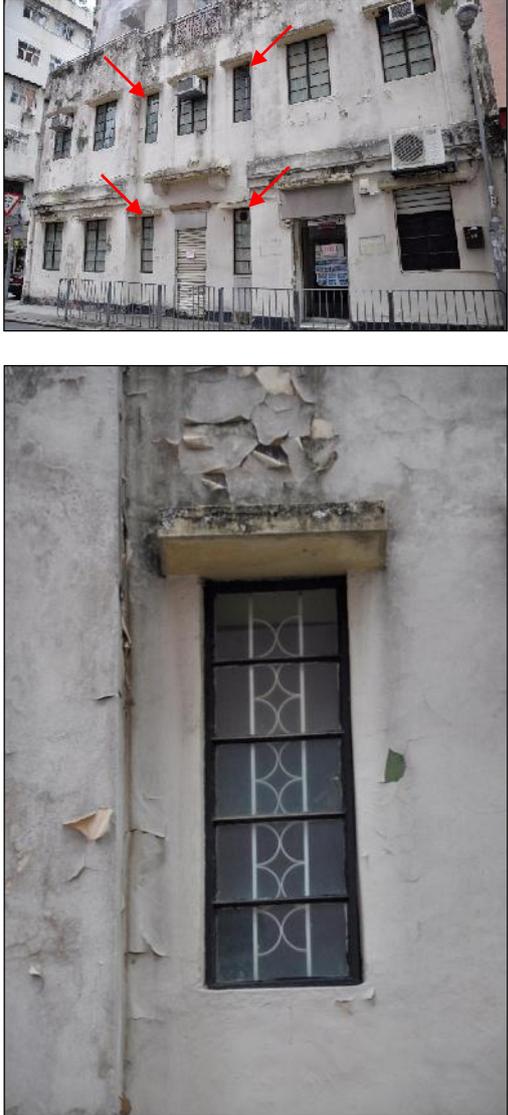
| <u>No.</u> | <u>CDE/architectural elements</u> | <u>Level</u> | <u>Photo</u> |
|---|---|---|---|
| C6. | <p>Single leaf casement window at front elevation with grilles including the brass ironmongery (casement fastener with lever and casement stay), (6 nos.), ground floor – 2 nos., first floor – 2 nos., and second floor – 2 nos.</p> <p>(upper photo dated – 6th October, 2016, and lower photo dated – 22nd November, 2016)</p> | High | |

- (a) Six single leaf casement window at Front elevation facing School Street – remove the timber cabinet at the internal side and repair the window including replacement of the damaged and missing ironmongery, (character defining element no. C6).

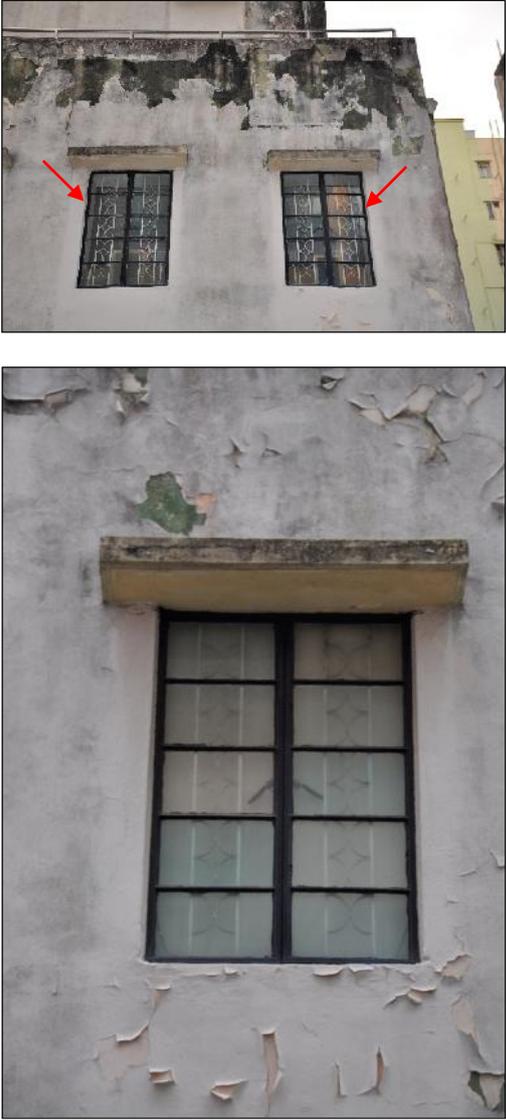
| <u>No.</u> | <u>CDE/architectural elements</u> | <u>Level</u> | <u>Photo</u> |
|---|--|---|--|
| C7. | <p>Double leaf casement window with the grilles including the brass ironmongery (casement fastener with lever and casement stay), (23 nos.), ground floor (excluding staircase part) – 8 nos., first floor (excluding staircase part) – 9 nos., and staircase from ground to second floor – 5 nos.</p> <p>(upper photo dated – 6th October, 2016, and Lower photo dated – 22nd November, 2016)</p> | High | |

- (b) Double leaf casement window – remove the timber cabinet at the internal side, if exist, and repair the window including replacement of the damaged and missing ironmongery, (character defining element no. C7).

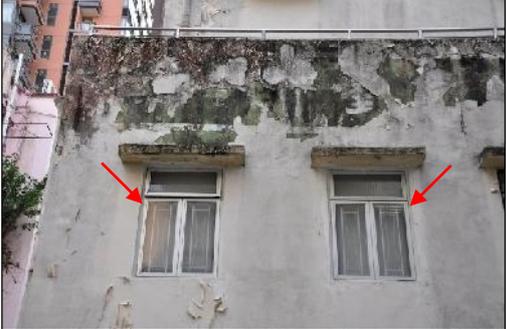
| <u>No.</u> | <u>CDE/architectural elements</u> | <u>Level</u> | <u>Photo</u> |
|---|--|---|--|
| C8. | <p>Aluminium windows on side (Brown Street) elevation and rear elevation, (4 nos.).</p> <p>(photo dated – 6th October, 2016)</p> | Intrusive | |

- (c) Aluminium window – take down the aluminium window and replace with steel window with ironmongery matching the existing, (character defining element no. C8).

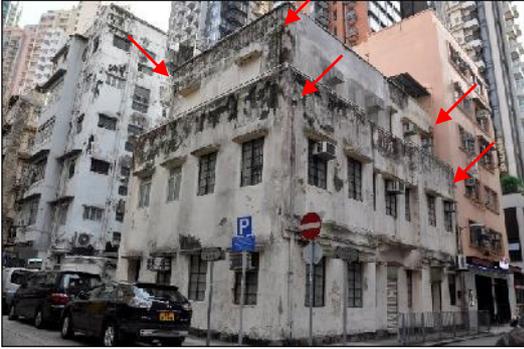
| No. | CDE/architectural elements | Level | Photo |
|---|---|---|---|
| C9. | The cast iron rainwater downpipes with hopper at front and side elevations, (3 sets at front elevation, 2sets at side elevation, and 1 set at rear elevation. (photo dated – 6 th October, 2016) | High | |

- (a) The rainwater collected from the main roof and second floor flat roof will be discharged via vertical stack by gravity to the new underground stormwater drainage system.
- (b) The existing cast iron rainwater downpipes with hopper will be preserved in-situ and repaired as necessary to retain the appearance, (character defining element no. C9). Some of them will be blocked or restored its function if feasible to suit the new rainwater disposal system.

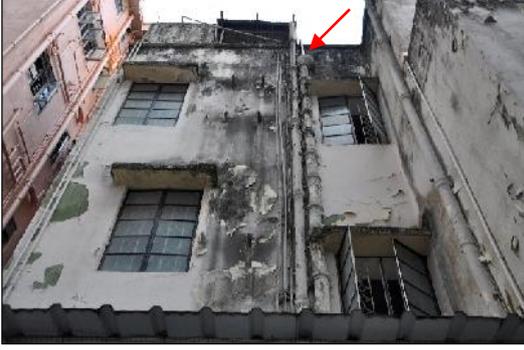
| No. | CDE/architectural elements | Level | Photo |
|---|---|---|---|
| C10. | The clayware rainwater down-pipe and the clayware rainwater hopper (indicated by red arrow) at rear elevation (1 set). (photo dated – 6 th October, 2016) | High | |

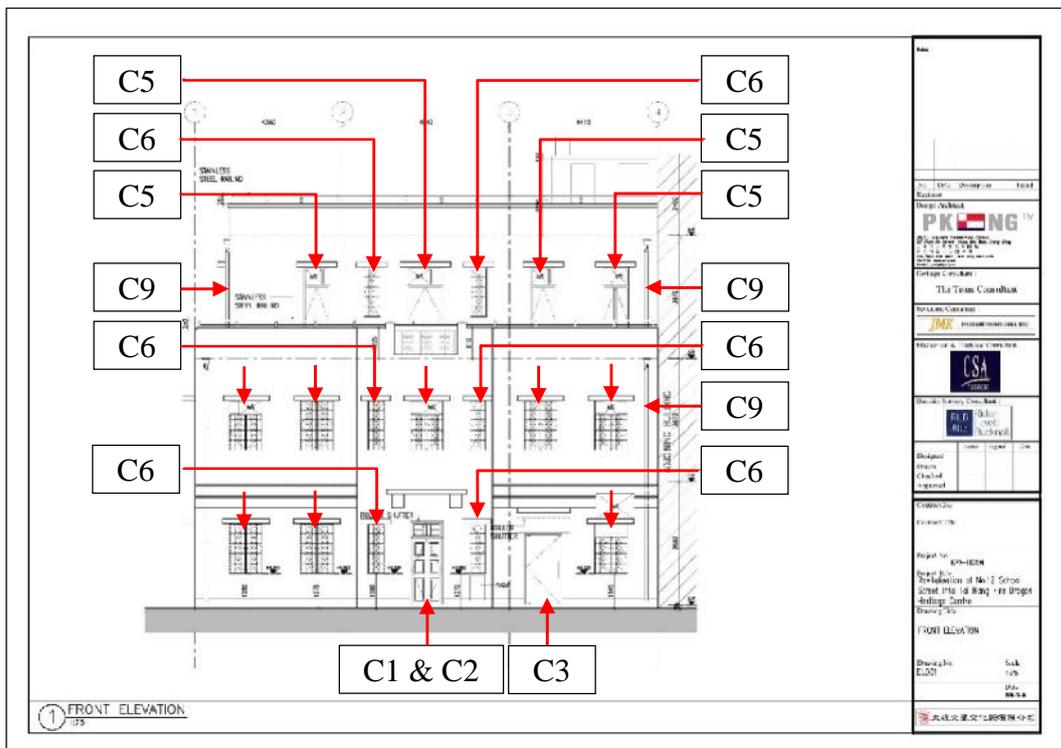
Drawing 2-09 (drawing no. EL001) – School Street (front) elevation

Note – red arrow pointing downwards ↓ denotes character defining element C7.

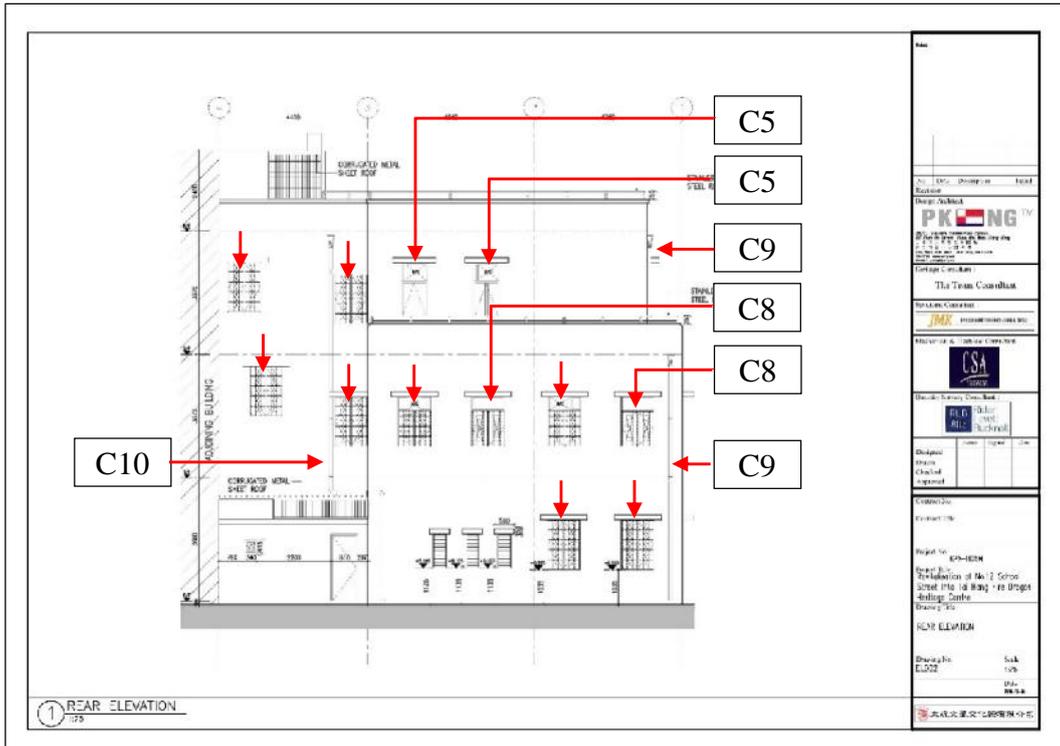
Drawing 2-10 (drawing no. EL002) – First Lane (rear) elevation

Note – red arrow pointing downwards ↓ denotes character defining element C7.
