**Revitalising Historic Buildings Through Partnership Scheme
Batch IV Project**

**Tai Hang Fire Dragon Heritage Centre at
No. 12 School Street, Tai Hang**

**Tai Hang Fire Dragon Heritage Centre Limited
P.K. Ng & Associates (H.K.) Limited
and The Team Consultant
June, 2017**

**Revitalization of No. 12 School Street as
Tai Hang Fire Dragon Heritage Centre
Heritage Impact Assessment Report**

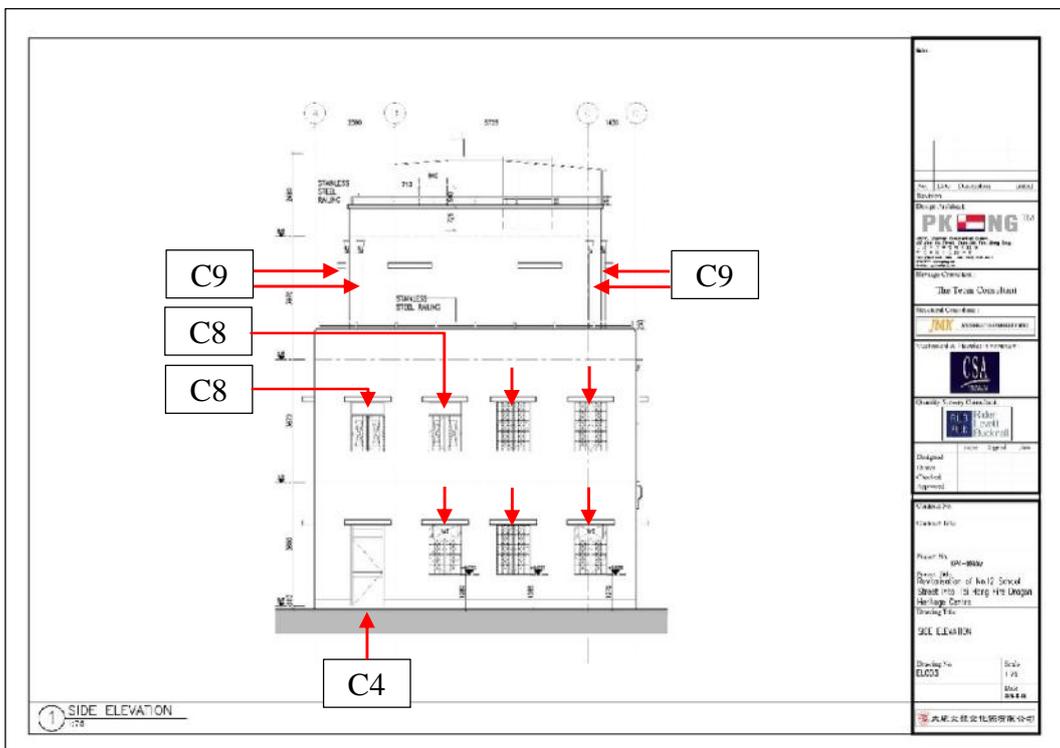
Drawing 2-11 (drawing no. EL003) – Brown Street (side) elevation

Note – red arrow pointing downwards ↓ denotes character defining element C7.

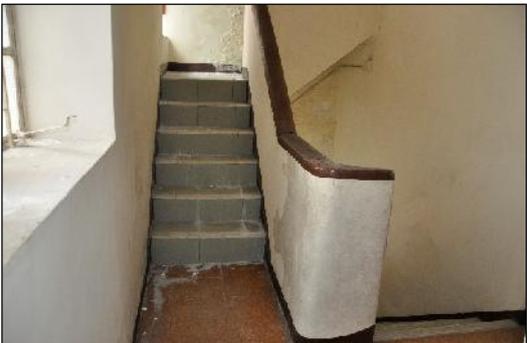
| <u>No.</u> | <u>CDE/architectural elements</u> | <u>Level</u> | <u>Photo</u> |
|---|---|---|--|
| D1. | <p>The staircase and continuous solid balustrade leading from ground floor to roof.</p> <p>(photo dated – 6th October, 2016)</p> | High | |

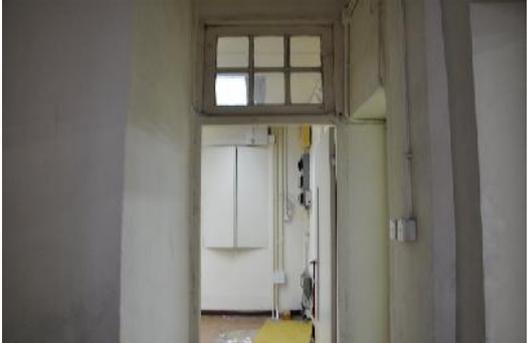
| <u>No.</u> | <u>CDE/architectural elements</u> | <u>Level</u> | <u>Photo</u> |
|---|---|---|--|
| D2. | <p>The door frame with fanlight at first floor, (the door is not included because it is not the original door).</p> <p>(photo dated – 6th October, 2016)</p> | High | |

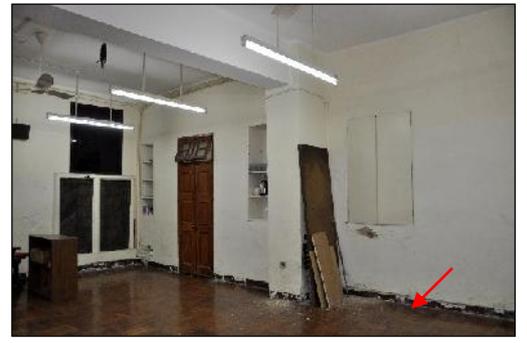
| <u>No.</u> | <u>CDE/architectural elements</u> | <u>Level</u> | <u>Photo</u> |
|---|---|---|--|
| D3. | <p>Ground floor main room 150 x 150 mm teak parquet flooring.</p> <p>(photo dated – 6th October, 2016)</p> | Low | |

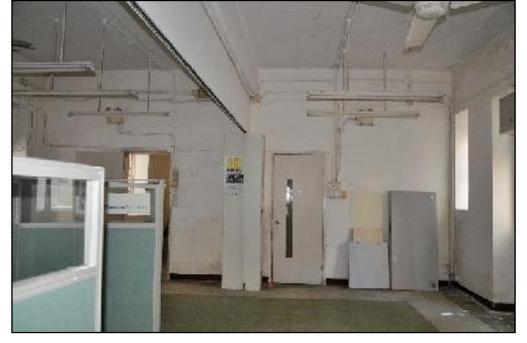
| <u>No.</u> | <u>CDE/architectural elements</u> | <u>Level</u> | <u>Photo</u> |
|---|---|---|--|
| D4. | <p>Internal layout, (photo on right – second floor).</p> <p>(photo dated – 6th October, 2016)</p> | low | |

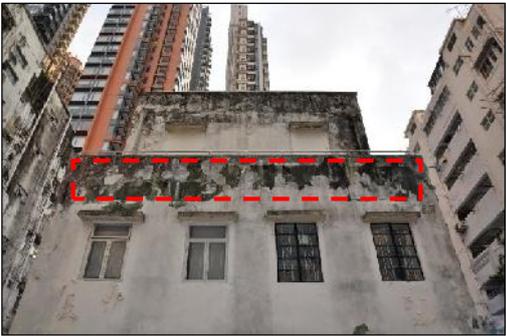
| <u>No.</u> | <u>CDE/architectural elements</u> | <u>Level</u> | <u>Photo</u> |
|---|---|---|--|
| E1. | Traces of the old mark of the former school, suspected to be 政府津貼孔聖會小學 on the side elevation facing Brown Street second floor parapet wall, (some are currently covered up by paint), (photo dated – 6 th October, 2016) | High | |

- (b) All defective plaster will be repaired and re-painted with a colour of a similar tone.
- (c) The Chinese characters of previous school name (exact Chinese wordings to be confirmed after removal of the existing “covering paint” during site work) on the second floor side elevation facing Brown Street parapet wall will be preserved and partially exposed, (character defining element no. E1).

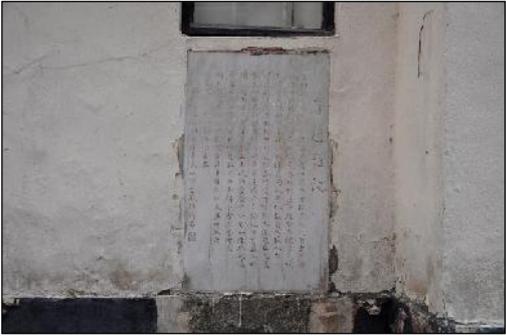
| <u>No.</u> | <u>CDE/architectural elements</u> | <u>Level</u> | <u>Photo</u> |
|---|---|---|--|
| E2. | The Stone plaque commemorating the re-opening of the school at the front elevation beside the main entrance. (photo dated – 6 th October, 2016) | High | |

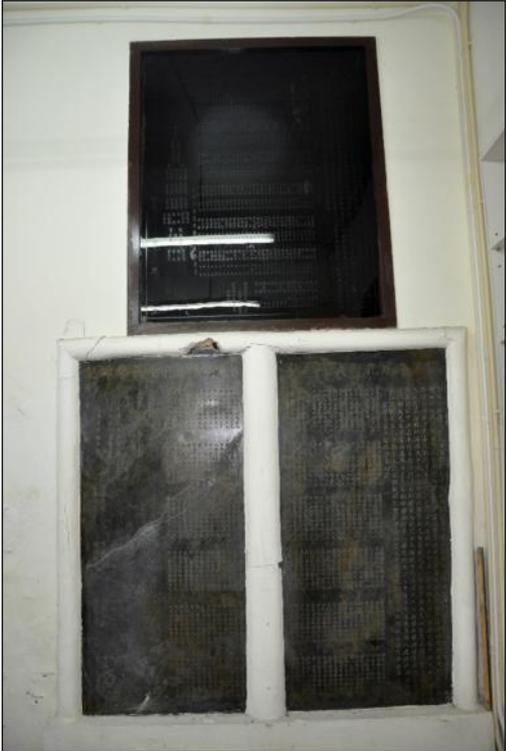
| <u>No.</u> | <u>CDE/architectural elements</u> | <u>Level</u> | <u>Photo</u> |
|---|---|---|--|
| E3. | Three stone plaques commemorating the founding of “Hung Shing Yi Hok” (孔聖義學) in Qing Dynasty, and re-construction of the Building in 1949 inside ground floor main room. (photo dated – 6 th October, 2016) | High | |

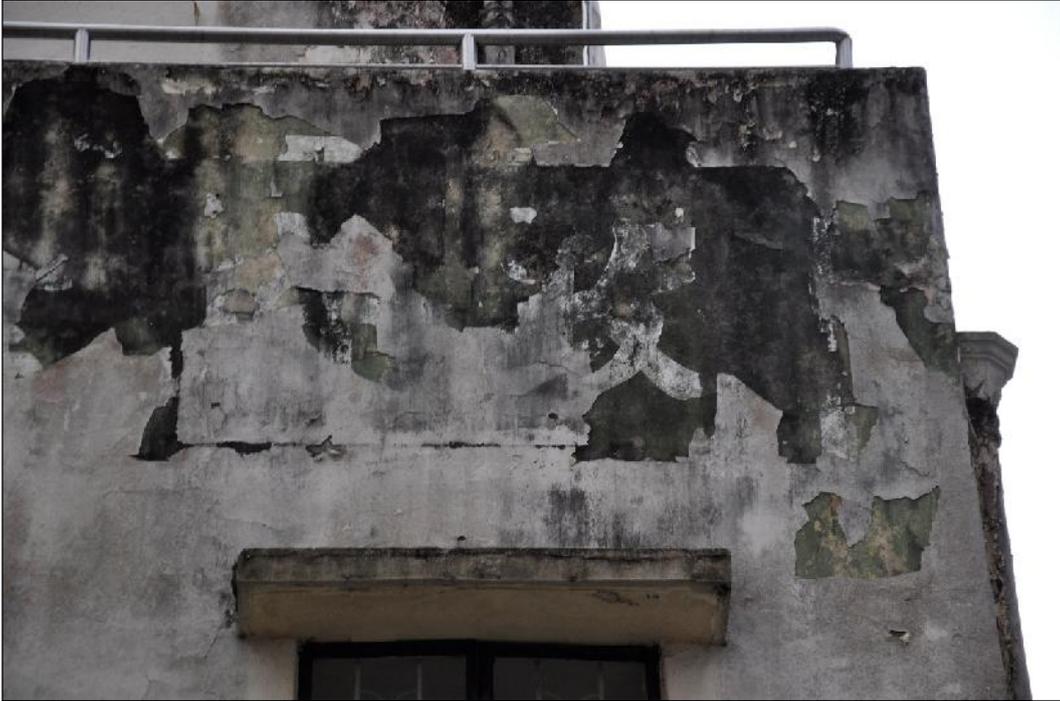
Photo 2-07 – Traces of the old mark of the former school, suspected to be 政府津貼孔聖會小學 on the side elevation second floor parapet wall – the north end part, (some are currently covered up by paint), (photo dated – 6th October, 2016)

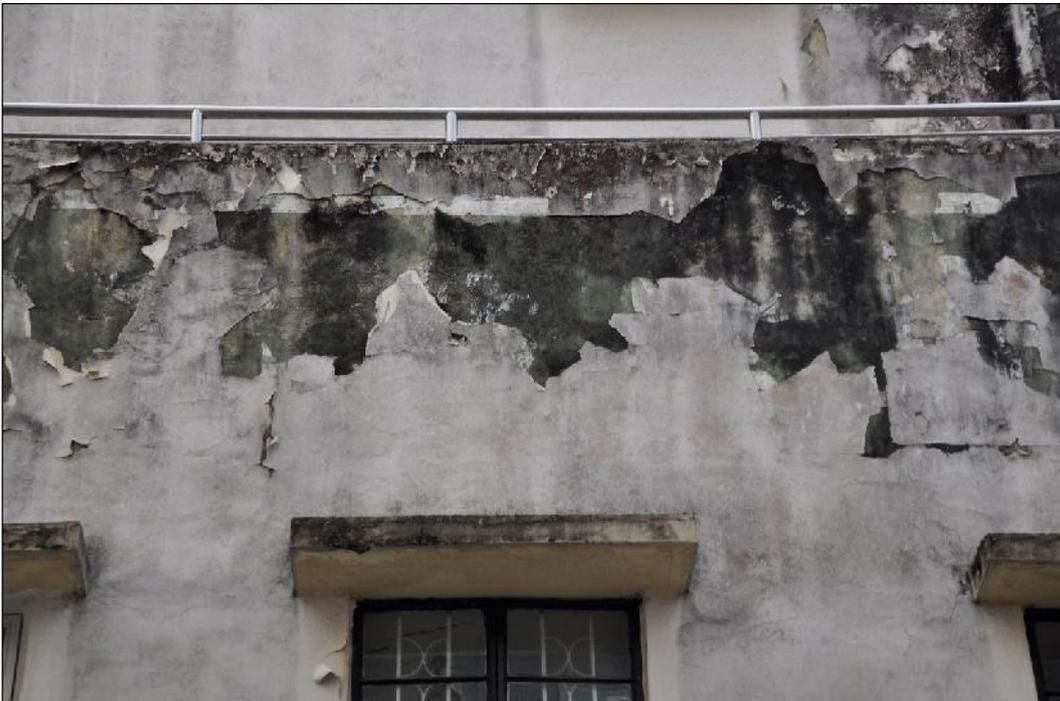
Photo 2-08 – Traces of the old mark of the former school, suspected to be 政府津貼孔聖會小學 on the side elevation second floor parapet wall – the centre north part, (some are currently covered up by paint), (photo dated – 6th October, 2016)

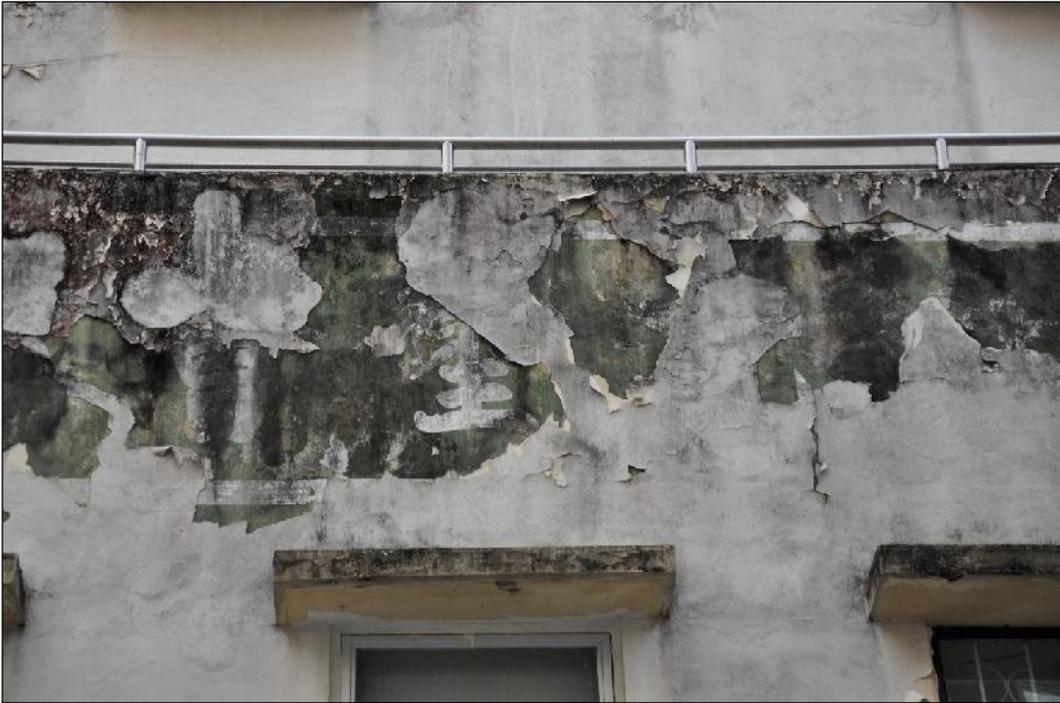
Photo 2-09 – Traces of the old mark of the former school, suspected to be 政府津貼孔聖會小學 on the side elevation second floor parapet wall – the centre south part, (some are currently covered up by paint), (photo dated – 6th October, 2016)

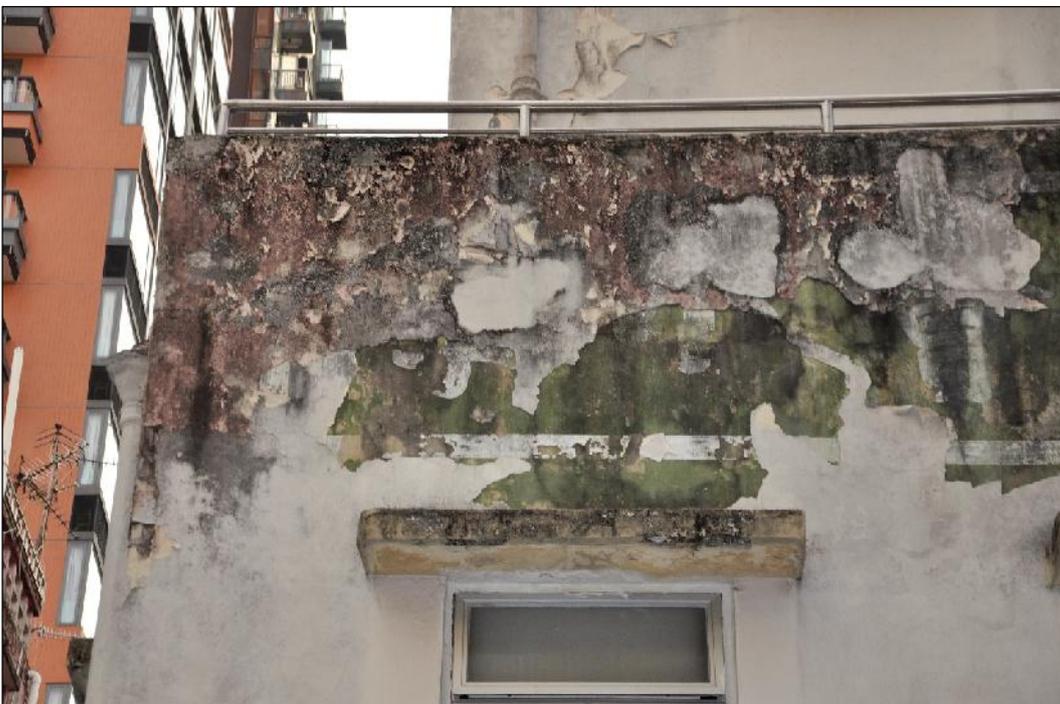
Photo 2-10 – Traces of the old mark of the former school, suspected to be 政府津貼孔聖會小學 on the side elevation second floor parapet wall – the south end part, (some are currently covered up by paint), (photo dated – 6th October, 2016)

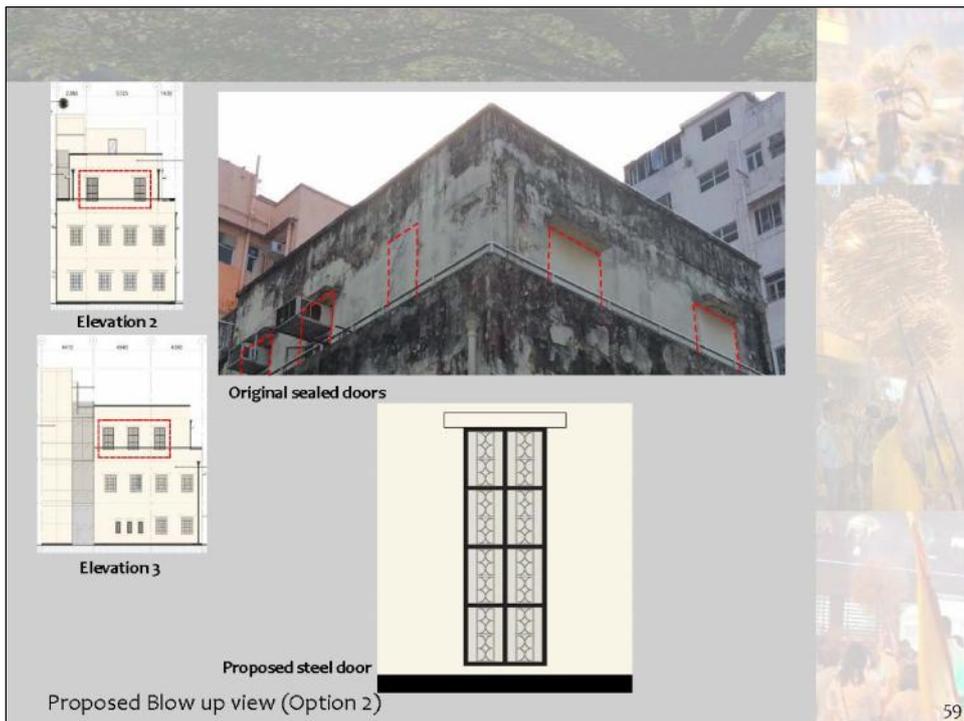
Drawing no. 3-01 – Design of the new steel frame French window with steel grilles matching the design of the existing steel window

- (a) The existing six aluminium French windows on second floor will be replaced by new steel frame glass French window with design matching the architectural style of the building when it was built, (drawing 3-02 shown below is an example, and to be finalized after further study), (character defining element no. C5).
- (b) The blocked up three French windows on second floor will be opened up, and install with new steel frame glass French window with design matching the architectural style of the building when it was built.

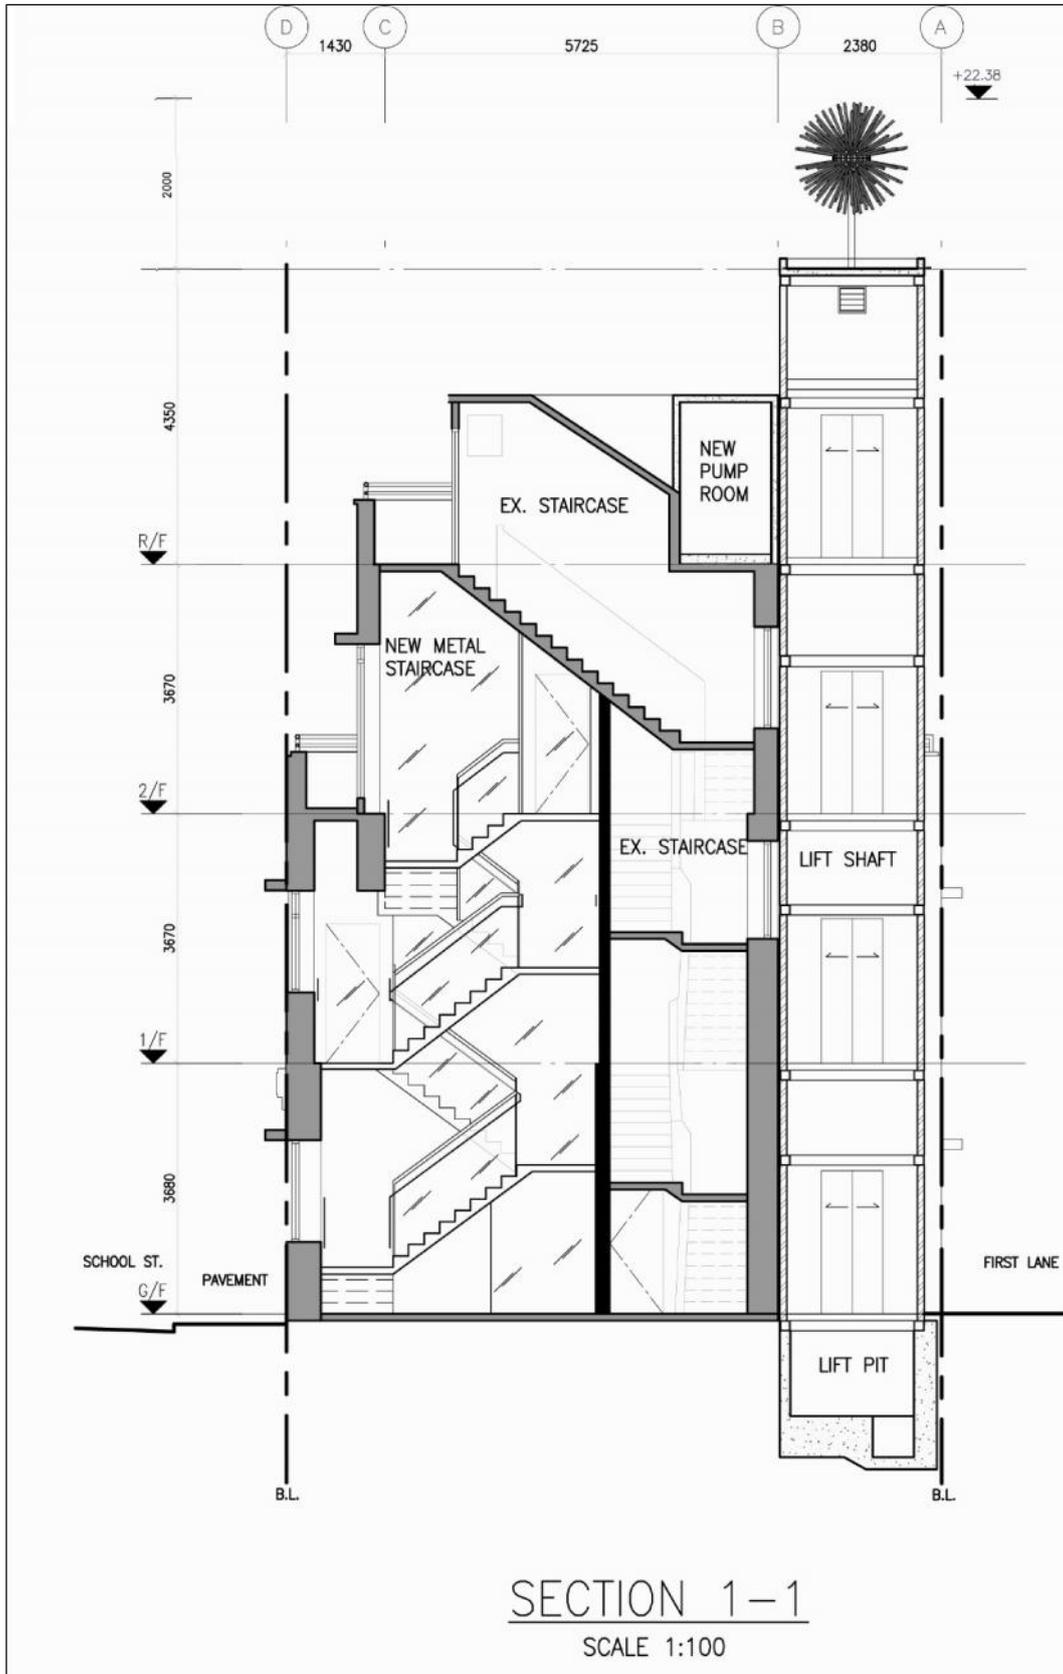
Drawing 3-18 – Traverse section through the west portion of the building showing the new added staircase and lift shaft

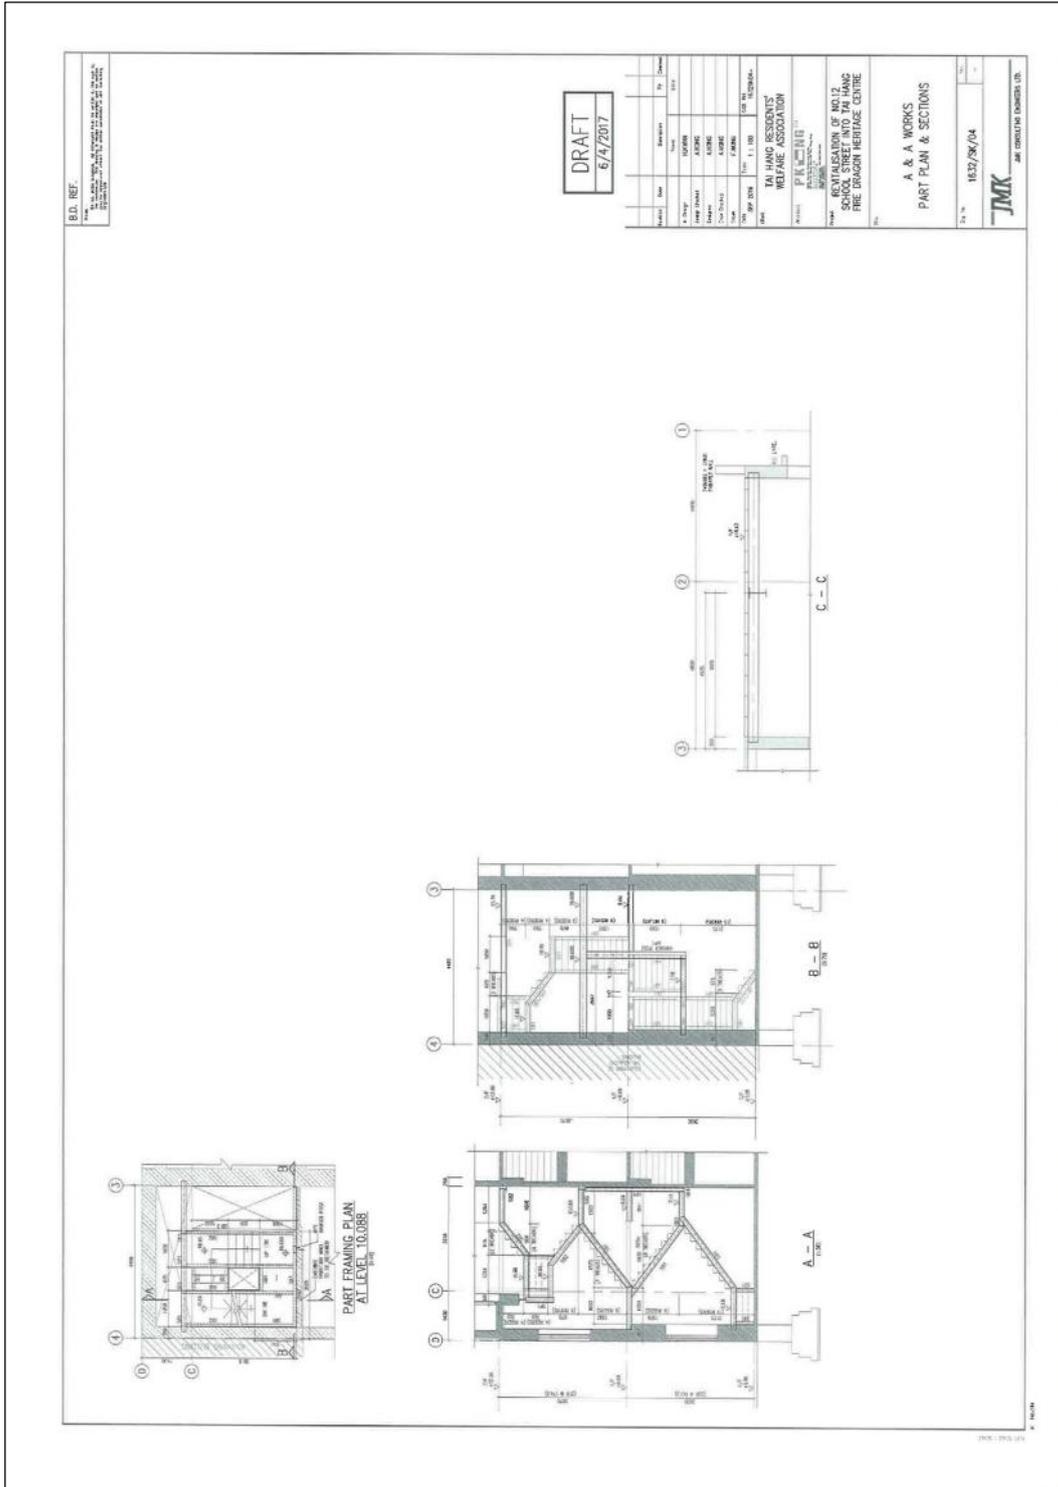
Drawing 3-21 – Structural alteration and addition works part plan and sections

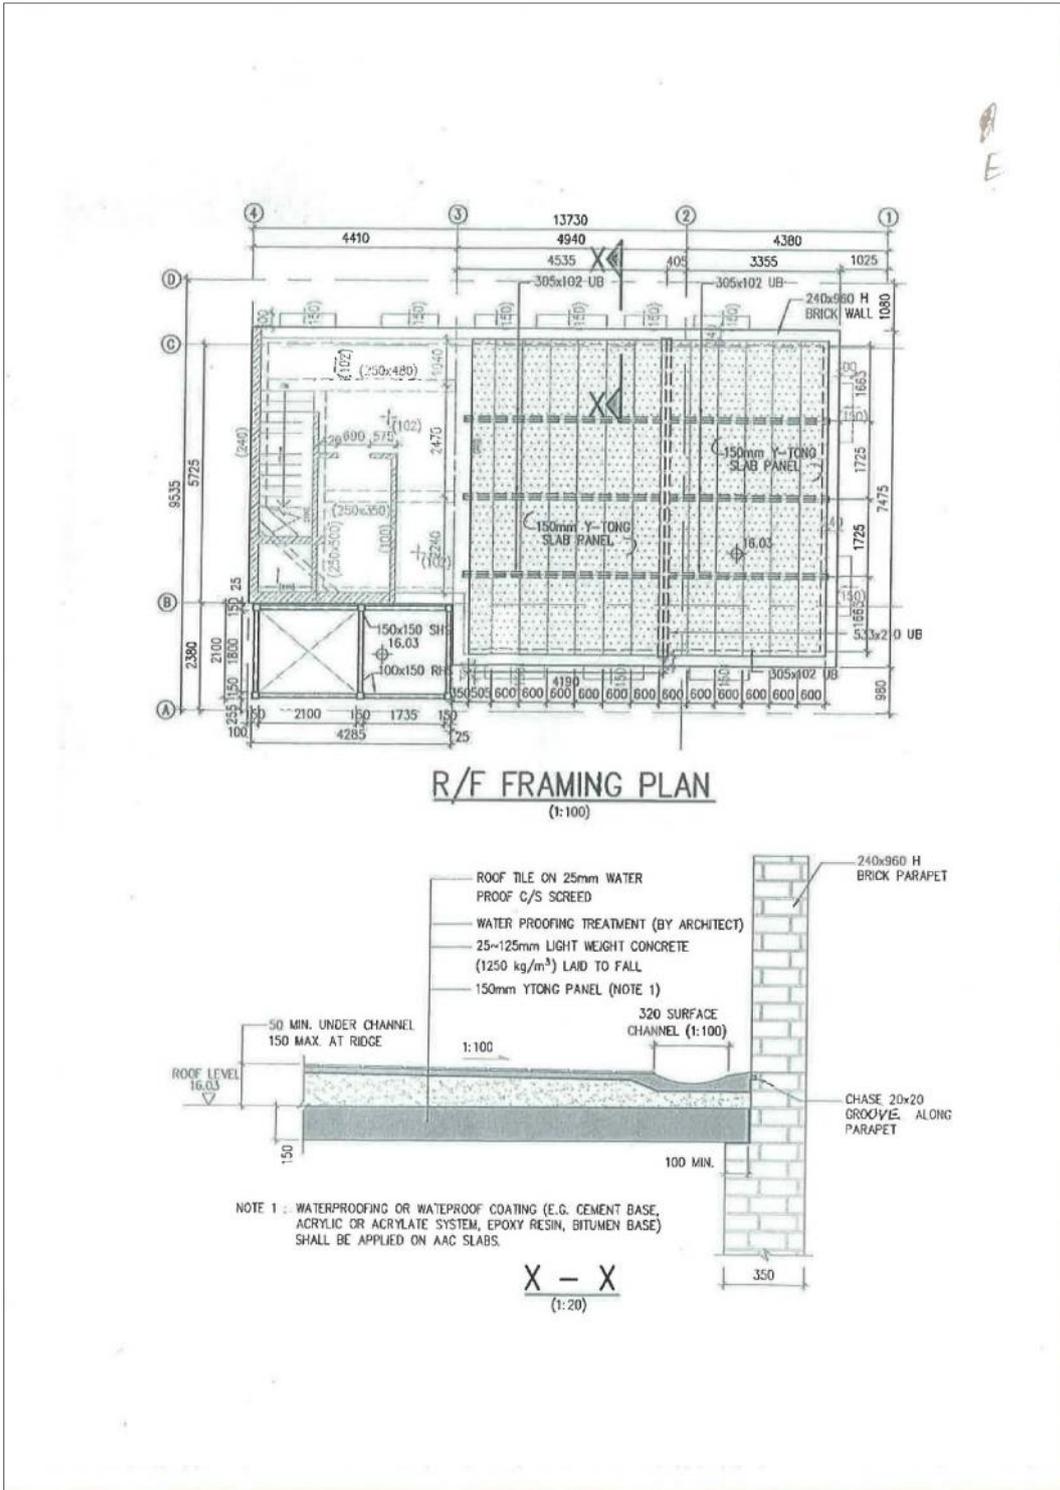
Drawing 3-22 – Roof framing plan and construction detail

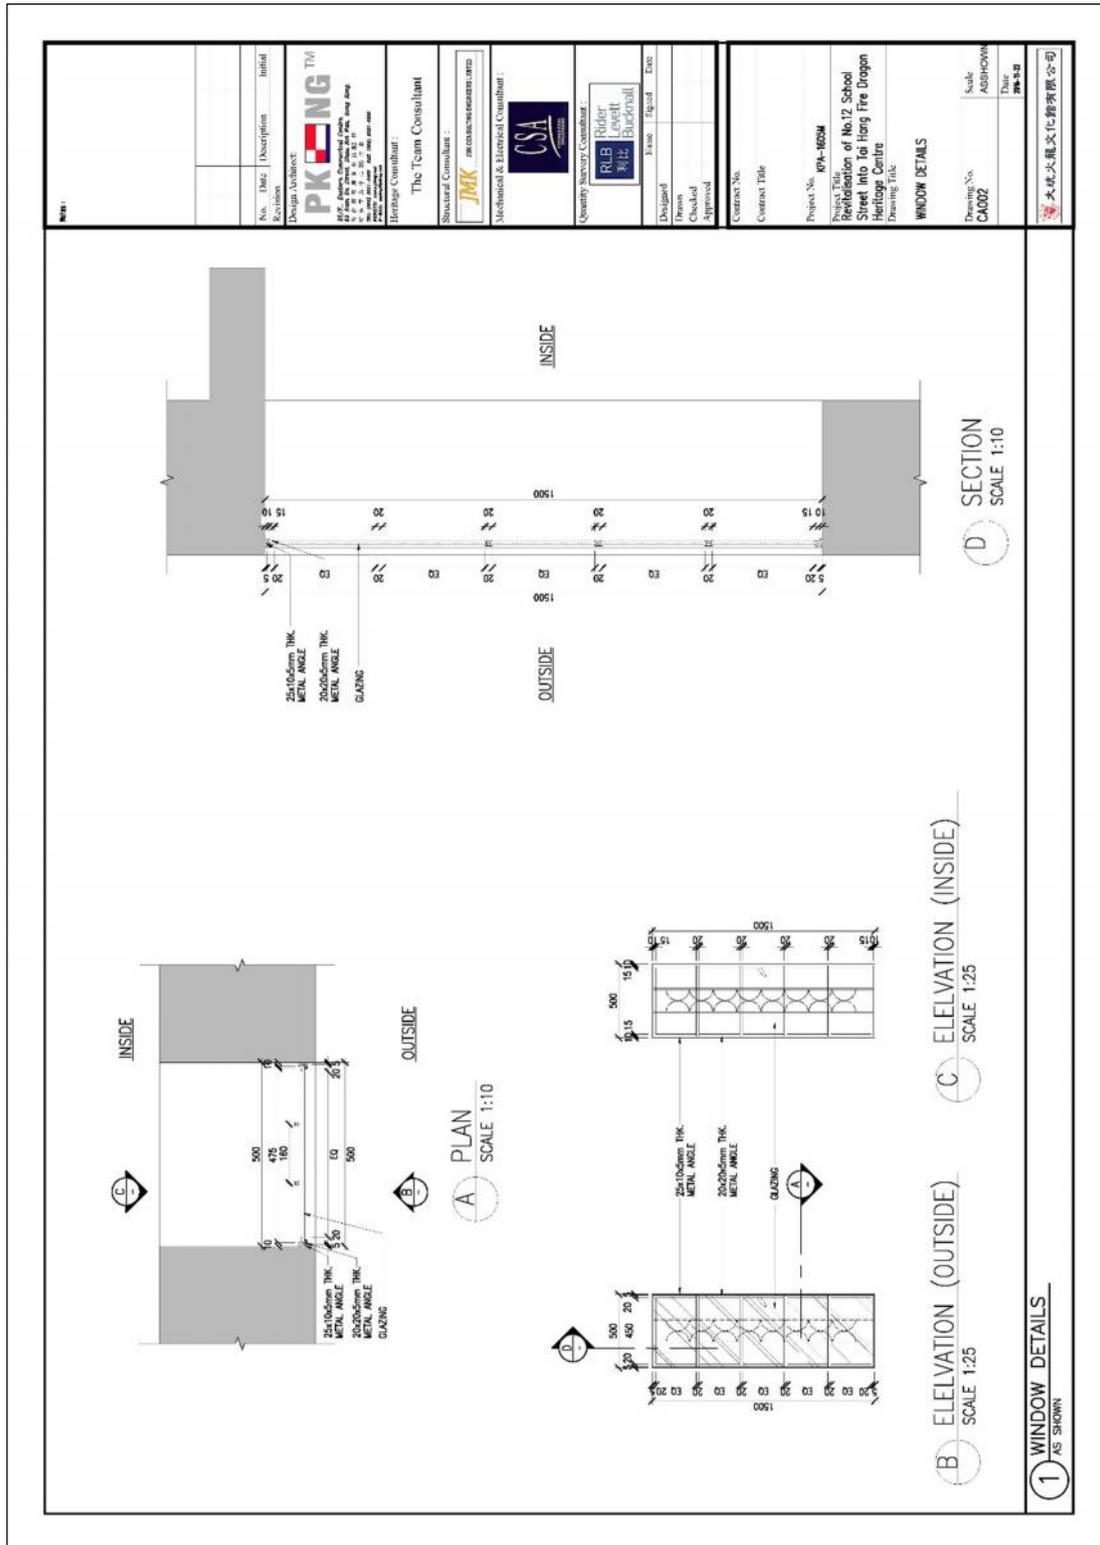
Drawing App1-19 (drawing no. CA002) – Single leaf casement steel window detail

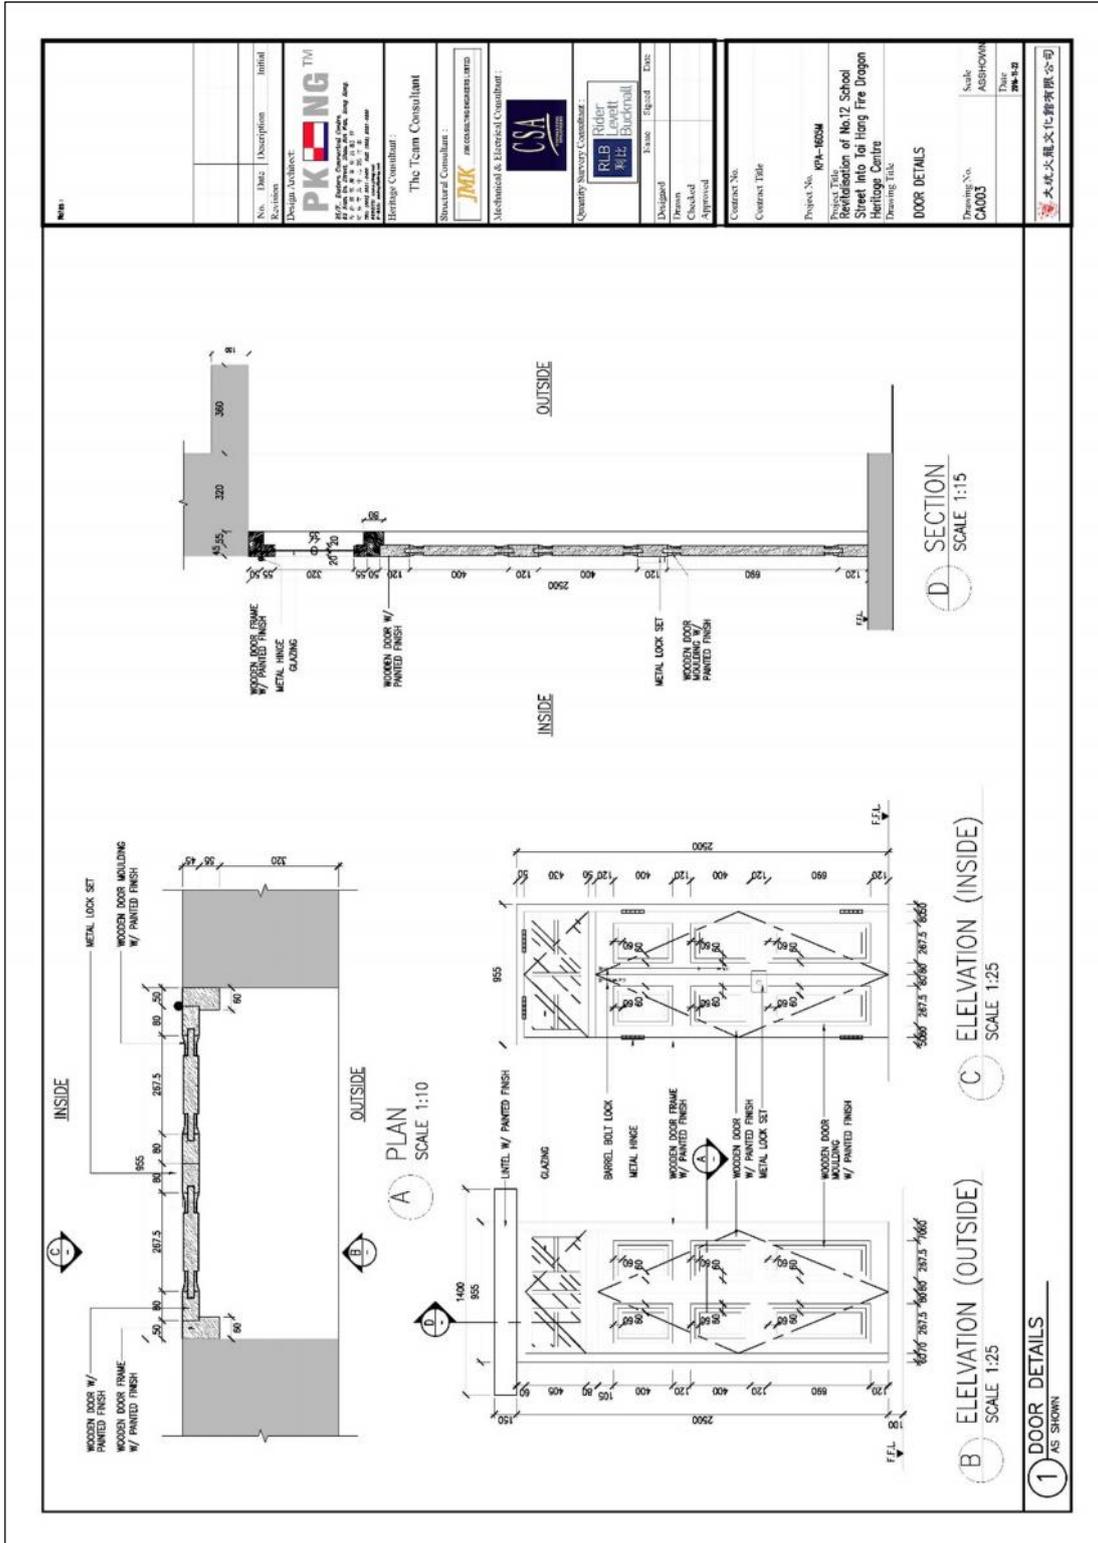
Drawing App1-20 (drawing no. CA003) – Timber entrance door

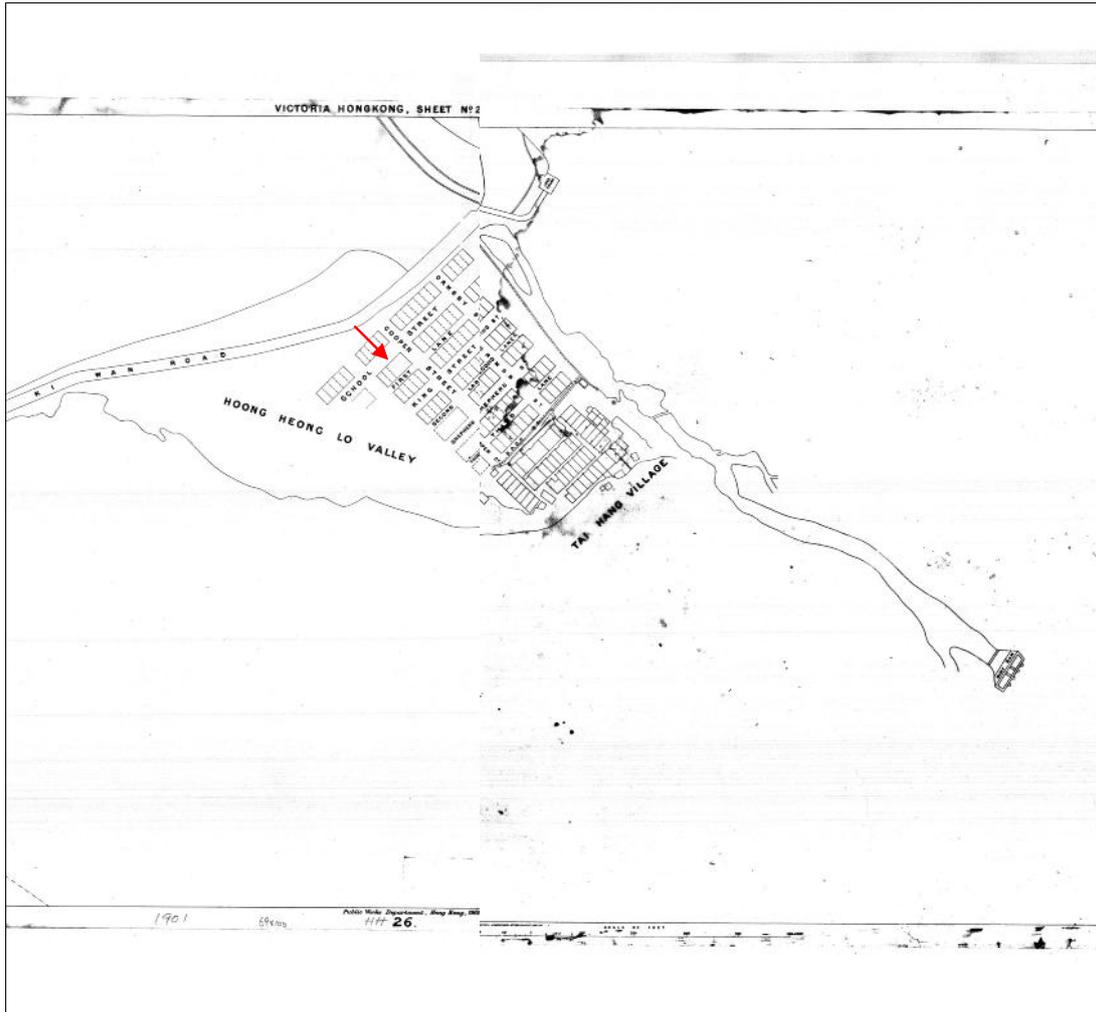
Map App2-03 – Historic map nos. HH-26 and HH-29, 1901 (part)

(note: the red arrow indicates the location of No. 12 School Street.)

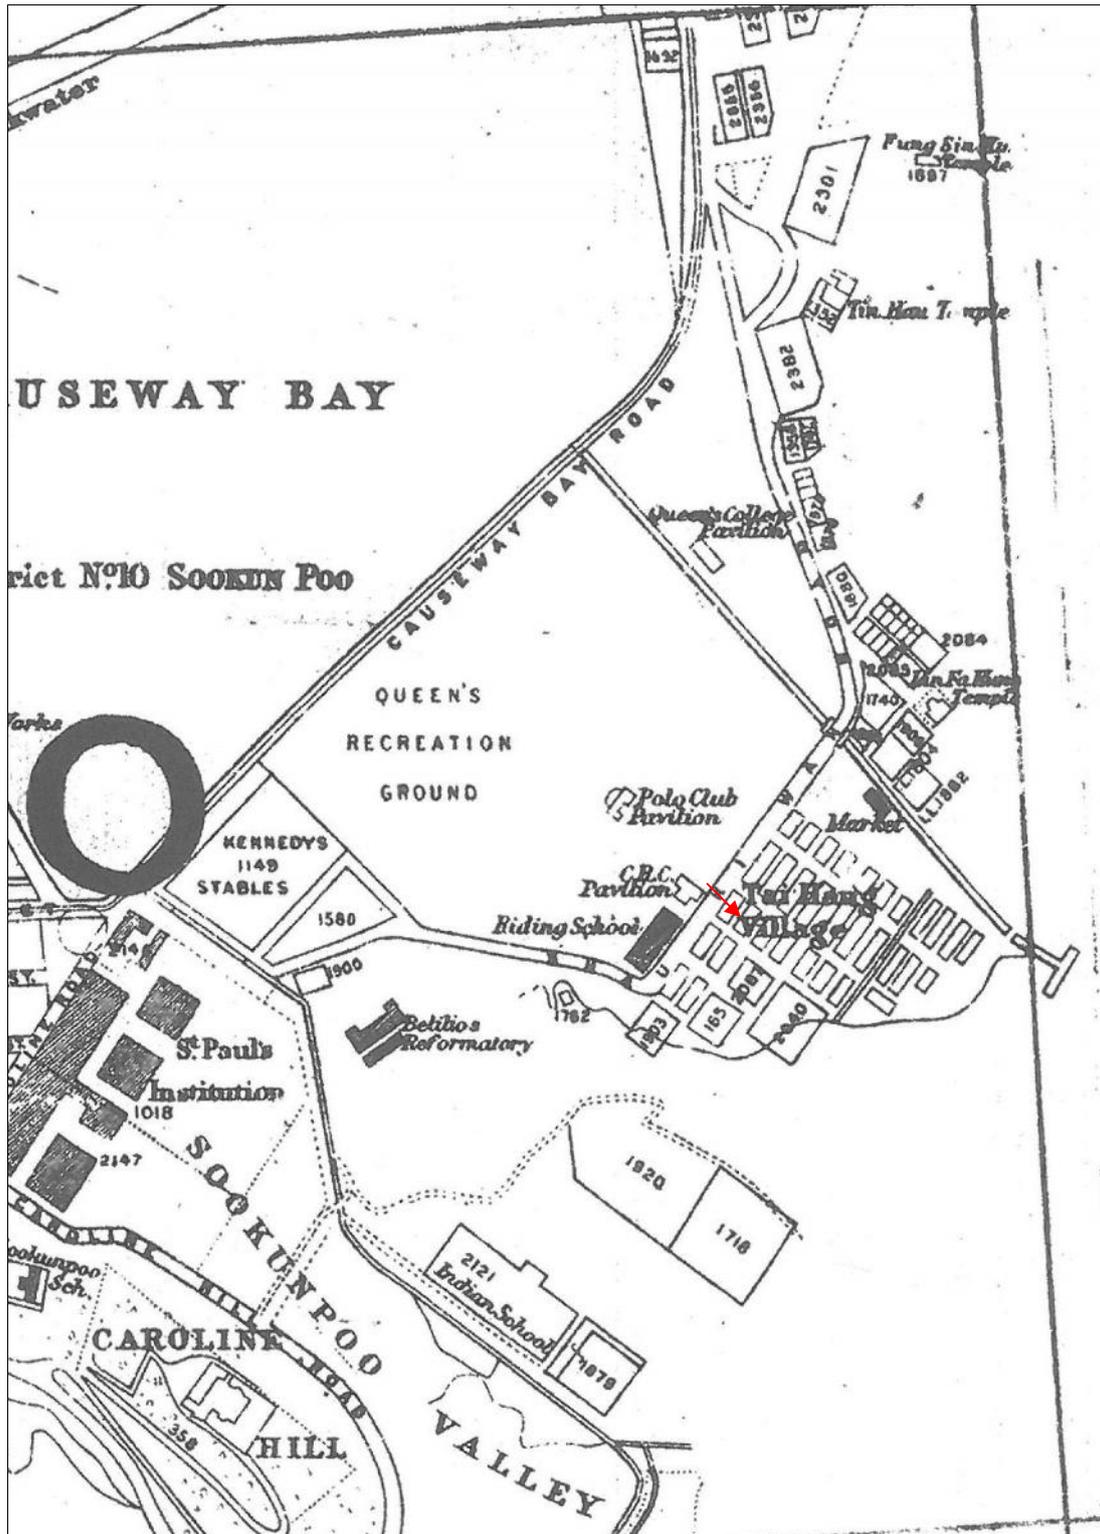
Map App2-04 – Historic map no. HD-34, 1922 (part)

(note: the red arrow indicates the location of No. 12 School Street.)

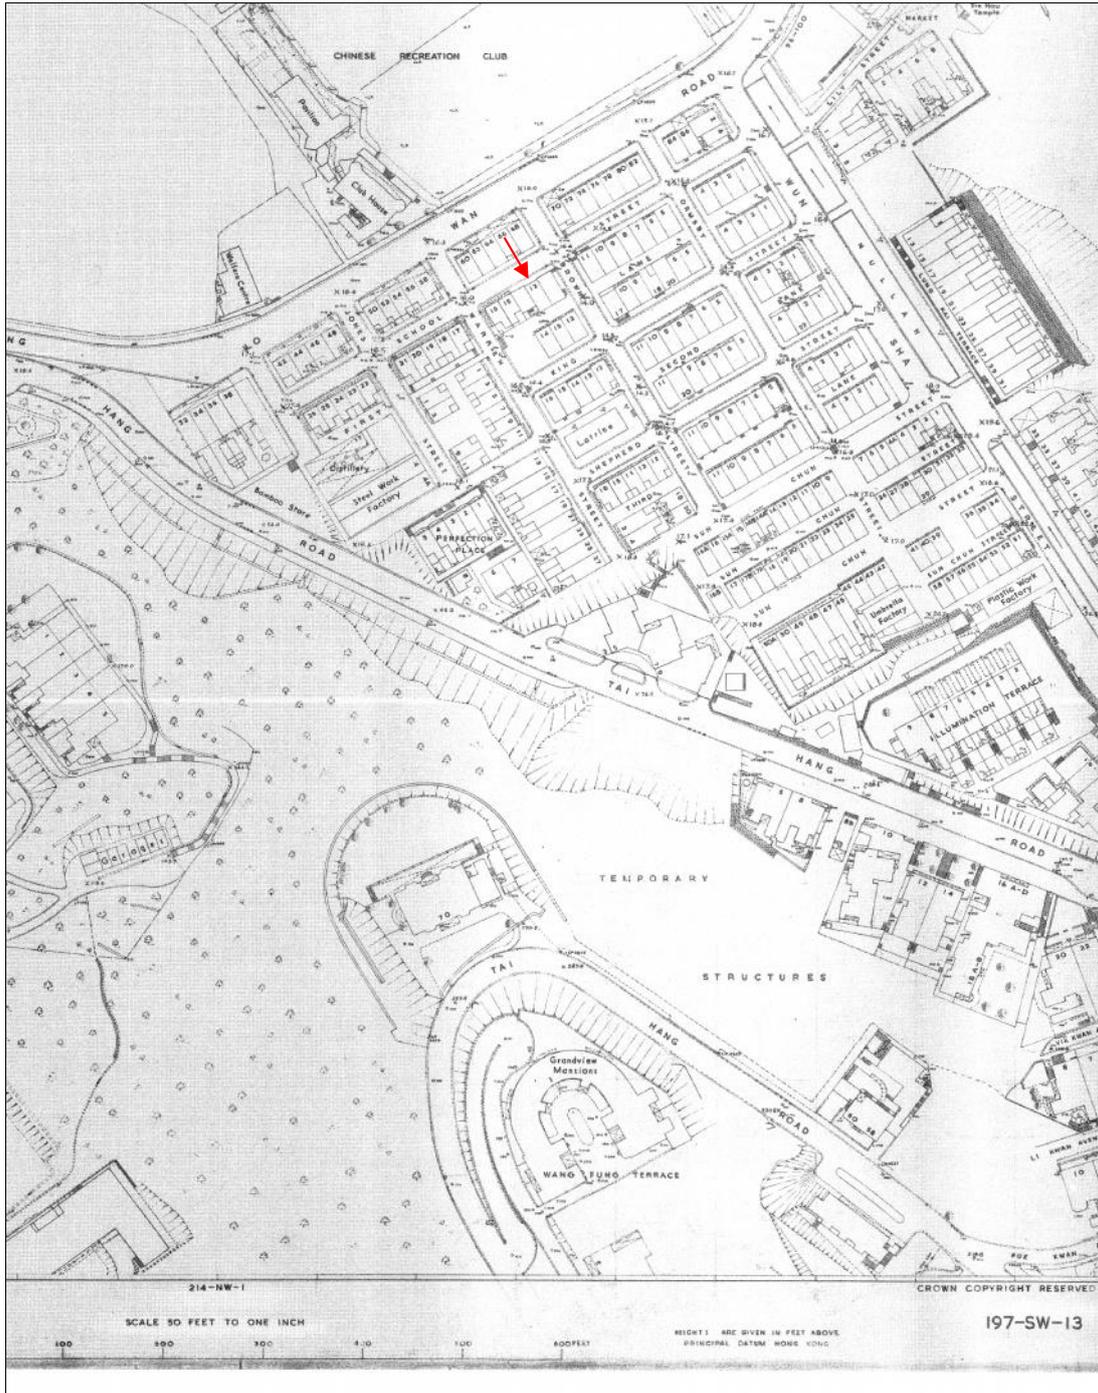
Map App2-05 – Survey sheet no. C-197-SW-13, 1959

(note: the red arrow indicates the location of No. 12 School Street.)

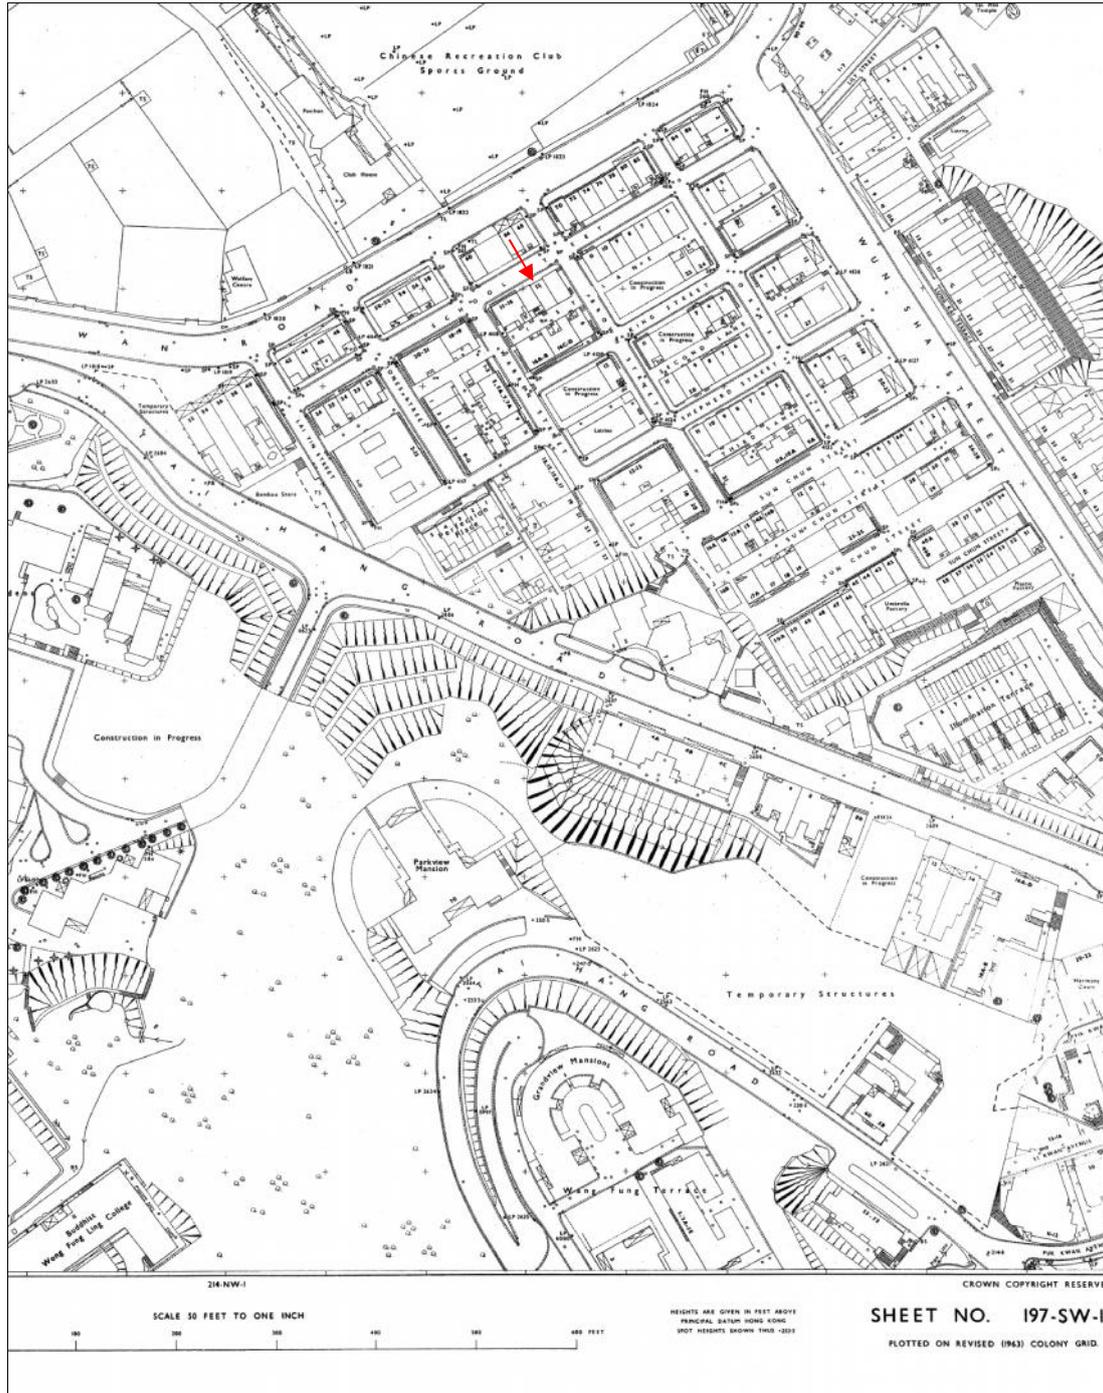
Map App2-07 – Survey sheet no. C-197-SW-13, surveyed 1959, revised 1966 and partial revision 1967

(note: the red arrow indicates the location of No. 12 School Street.)
(The “Survey sheet no. C-197-SW-13, surveyed 1959, revised 1966 and partial revision 1967” is available from Survey and Mapping Office, Lands Department, Hong Kong Special Administrative Region.)

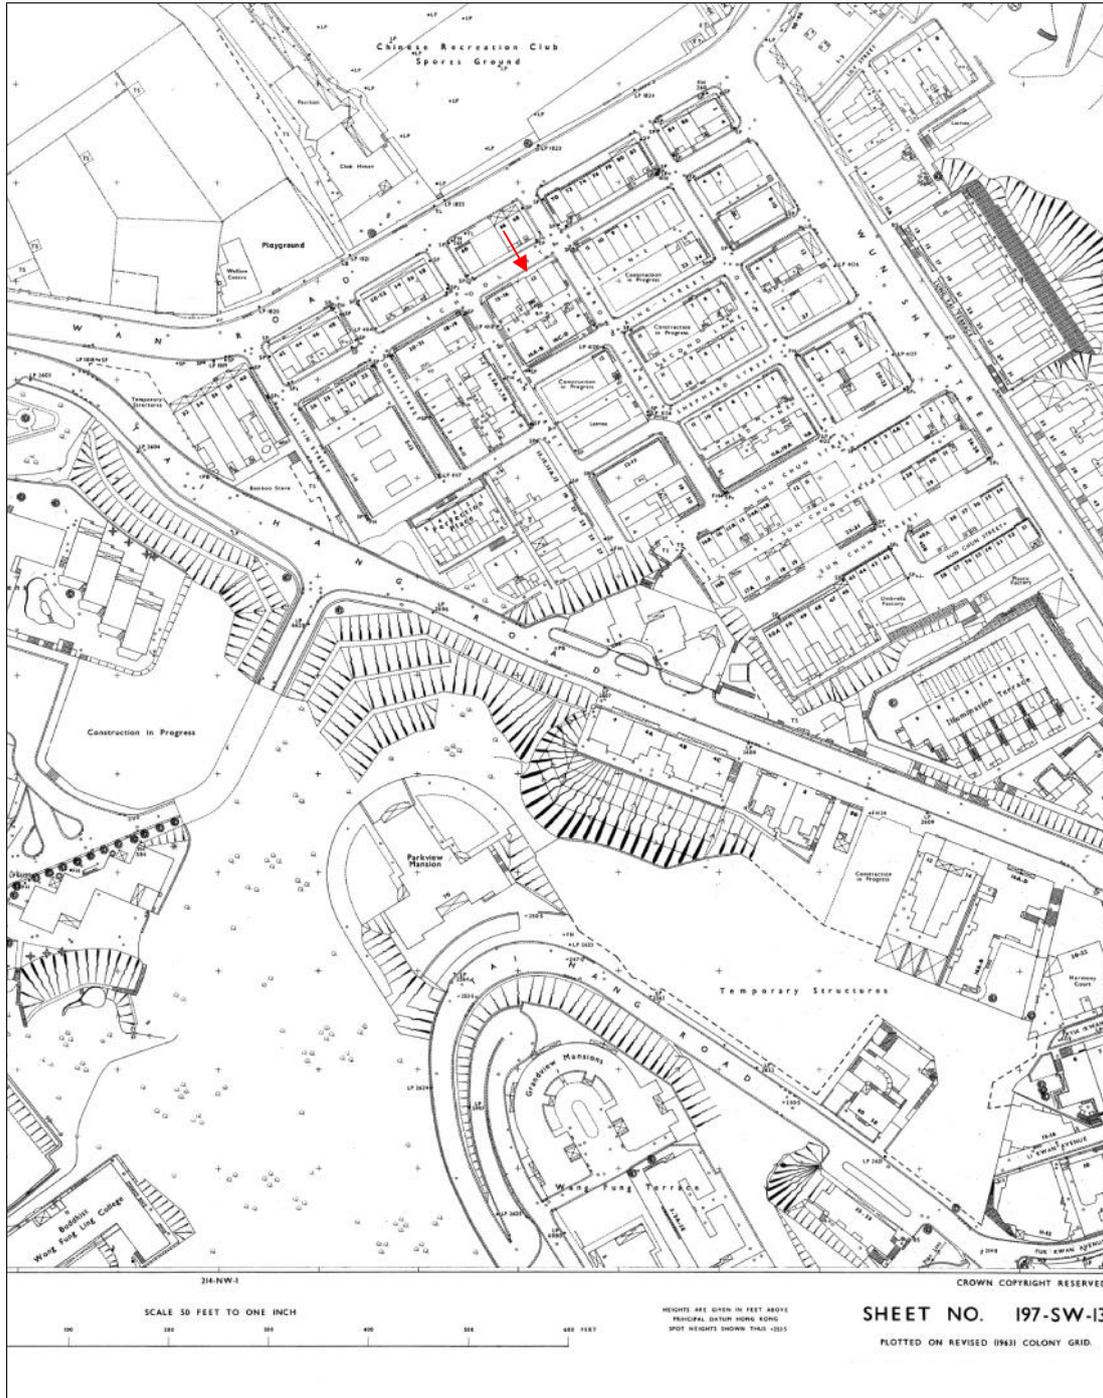
Map App2-09 – Survey sheet no. C-197-SW-13, surveyed 1959, revised 1966 and minor amendment April, 1970

(note: the red arrow indicates the location of No. 12 School Street.)
