**Revitalising Historic Buildings Through Partnership Scheme
Batch IV Project**

**Tai Hang Fire Dragon Heritage Centre at
No. 12 School Street, Tai Hang**

**Tai Hang Fire Dragon Heritage Centre Limited
P.K. Ng & Associates (H.K.) Limited
and The Team Consultant
June, 2017**

**Revitalization of No. 12 School Street as
Tai Hang Fire Dragon Heritage Centre
Heritage Impact Assessment Report**

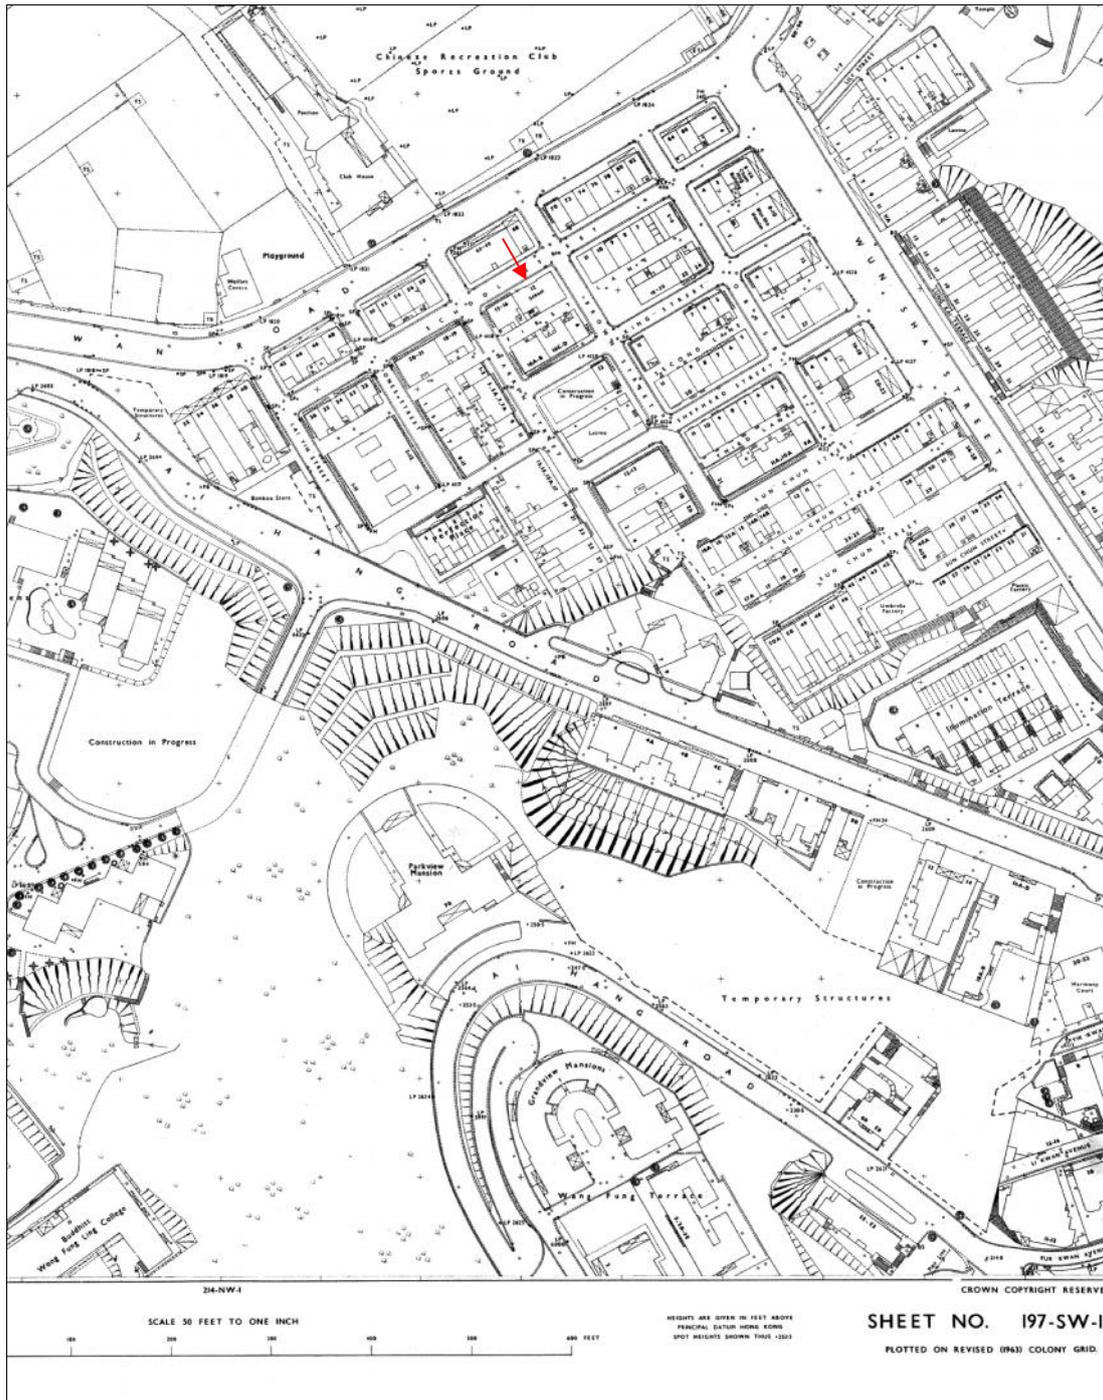
Map App2-11 – Survey sheet no. C-197-SW-13, surveyed 1959, revised 1966 and minor amendment December, 1970

(note: the red arrow indicates the location of No. 12 School Street.)

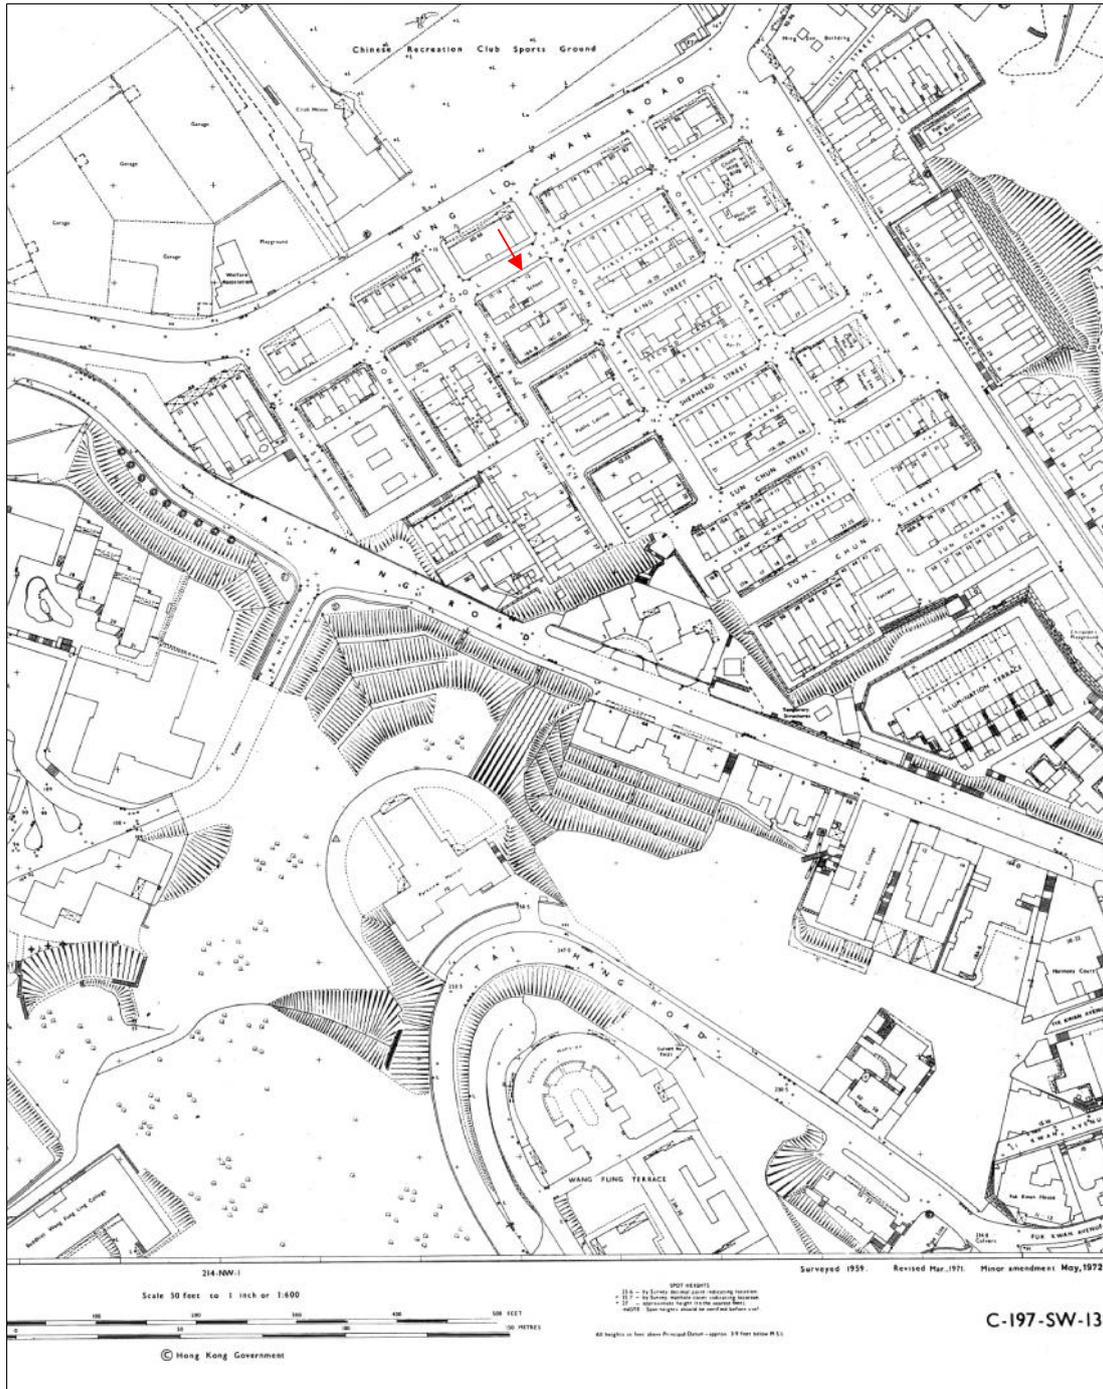
Map App2-13 – Survey sheet no. C-197-SW-13, surveyed 1959, revised March, 1971 and minor amendment May, 1972

(note: the red arrow indicates the location of No. 12 School Street.)
