**Agreement No. CE 74/2015 (CE)
Site Formation and Infrastructures for
Development at Pok Fu Lam South
– Investigation, Design and Construction**

**Heritage Impact Assessment (HIA) Report
(Rpt Ref. 250269-REP-090-06)**

Heritage Impact Assessment Report

250269-REP-090-06

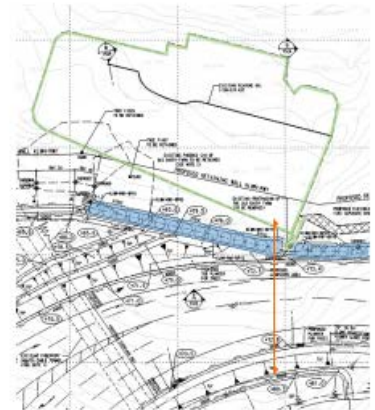
**Figure 4** Sections showing the Selection of Design Scheme near Paddock C18

Proposed Design Scheme – Bored Pile Wall

**Location Plan****Alternative Design Scheme – Rock Slope (Not Feasible)**

4.2.12 The rock cut slope scheme in-lieu of the (bored pile) retaining wall scheme for the formation of proposed new access road near Paddock C18 was explored but the formed slope profile, despite generally considered to impose less visual impact, will be in conflict with the road alignment of the proposed new access road, or otherwise the alignment shall be shifted southern (further away from Old Dairy Farm, Paddock C18) to allow sufficient space for the new rock cut slope. Relatively steep slope angle for rock cut slope was also considered. As such, the rock cut slope scheme is considered not feasible, as illustrated in **Figure 4**.

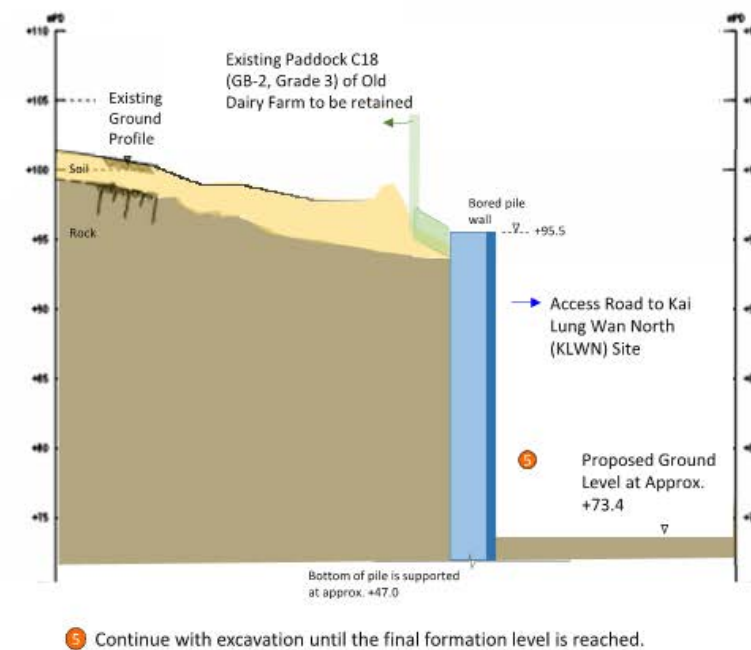
Figure 5 Construction Method of Proposed Works near Paddock C18

- 4.2.15 As illustrated on **Figure 5**, the site formation works for the proposed access road will be constructed by gradual excavation and removal of the soil and rock from existing ground level to the proposed road level together with the construction of the proposed cut slopes at two sides of the road. For the portion with bored pile wall / RC retaining wall, the walls will be constructed to retain the level difference prior to the excavation for the proposed access road.

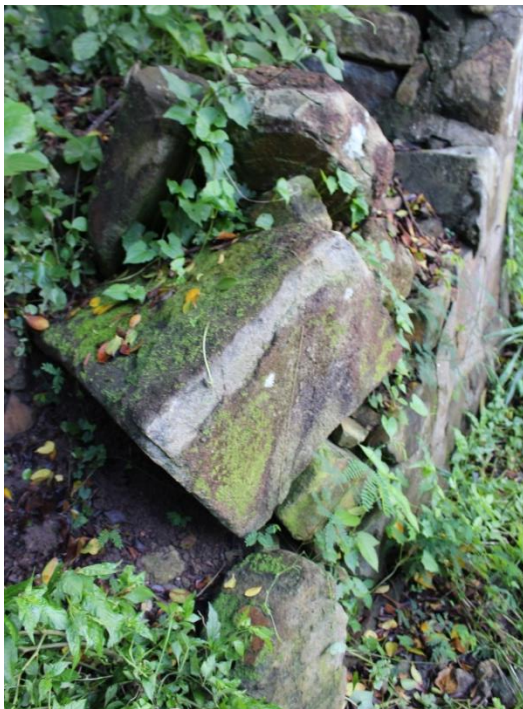
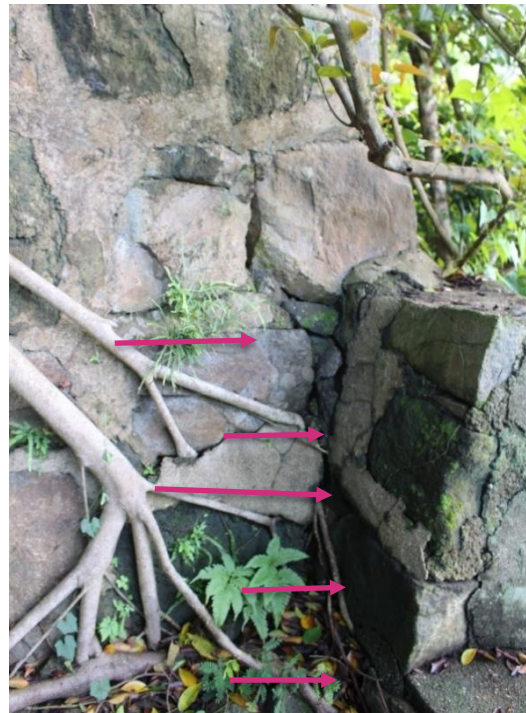
Figure 7b Buttress Wall at Paddock C18 (GB-2)

Heavily damaged buttress end

Buttress wall separating from main wall

Paddock C18 is located within the Project Site Boundary and works are located immediately adjacent to the buttress at the southern corner of the Paddock and enclosure wall of Paddock along the east. The buttress wall (see **Figure 7**) is in relative good condition for the first 1.95m and remainder is damaged. The buttress is found separating from the main wall, likely by slope erosion (**Figure 7b**). Evidence of repointing (reapplying of bonding material between stones) suggests that it is not the first time the integrity of the south east corner is affected by the steep slope. The space between the proposed access road and the existing Paddock C18 of the Old Dairy Farm is limited and the level difference cannot be retained by a slope option due to space constraint. As such immediately adjacent to Paddock C18 and in particular the buttress, a pile wall will be bored. To avoid affecting the buttress wall, local modification to the design of the bored pile wall is made as shown on drawings in **Appendix D**. Further works in close proximity include the construction of a flexible barrier to the south and cutting of a rock slope.

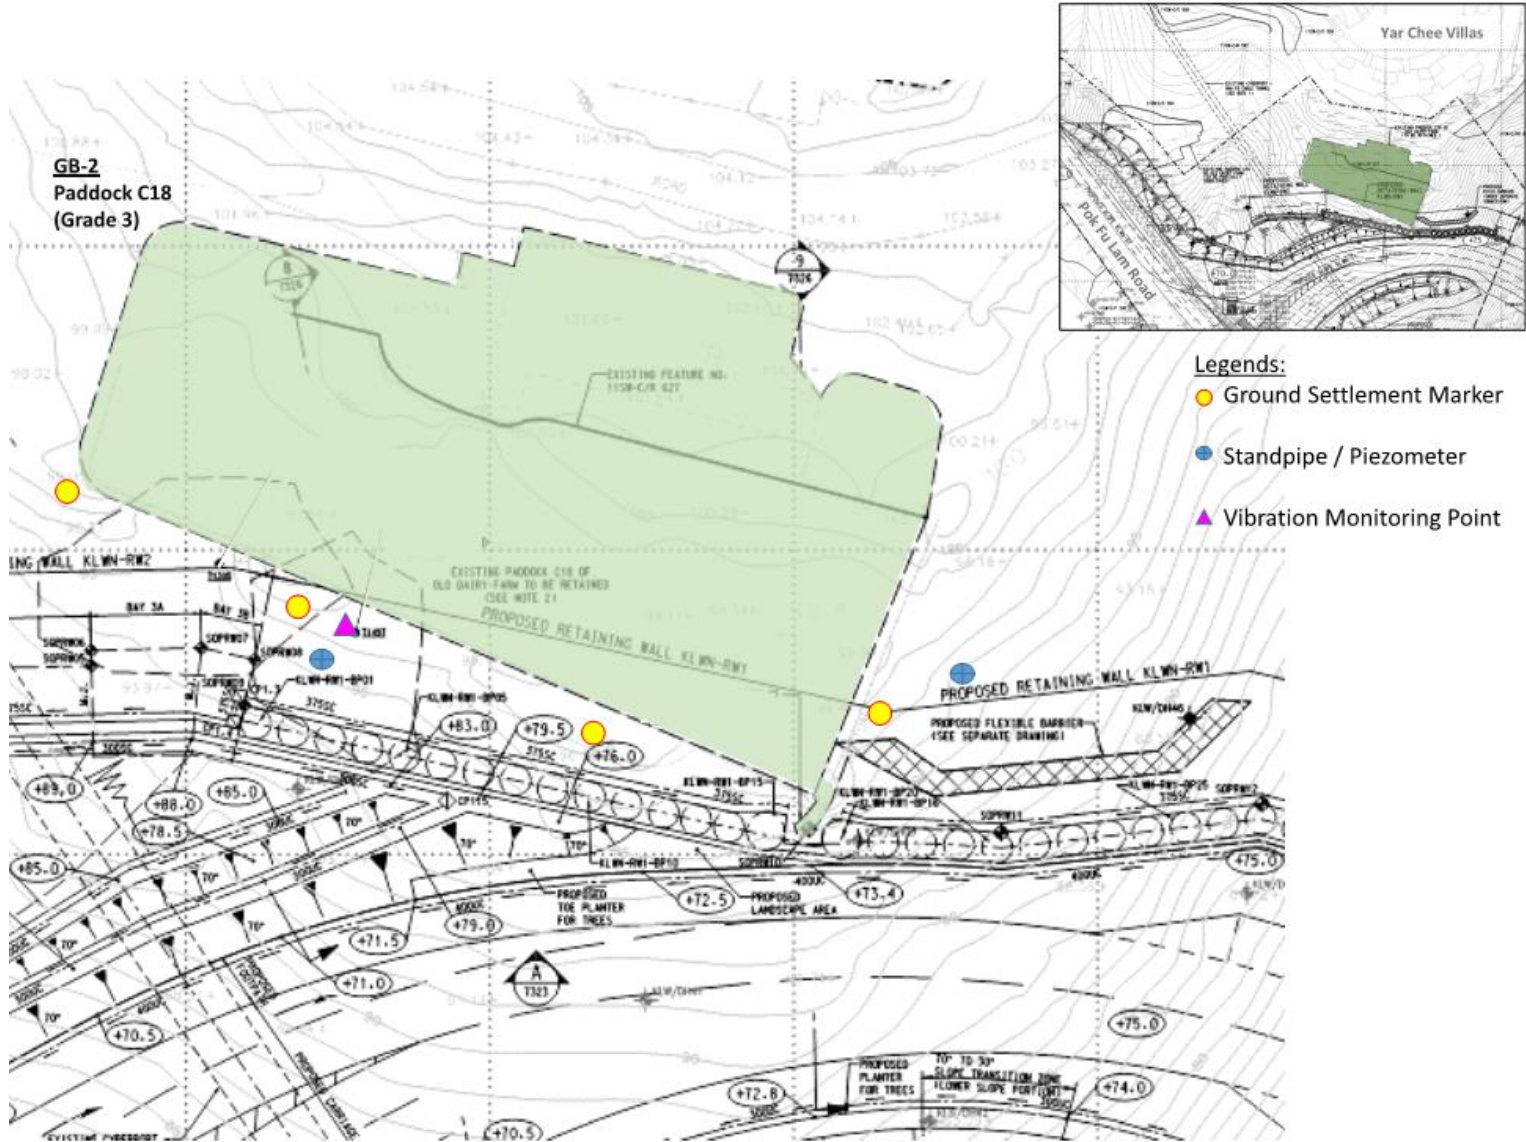
Figure 8 Indicative Locations of Monitoring Instruments (Subject to further detailed geotechnical design)

4.3.6 Construction impacts arising from vibration, settlement, tilting, or possible structural integrity impacts may be expected as well as possible access issues may arise. Tentative monitoring measures against vibration and settlement are shown on **Figure 8**. Upon contract award of the construction works, AMO will be consulted to confirm the monitoring measures to be adopted after conducting the condition survey prior to commencement of construction works.

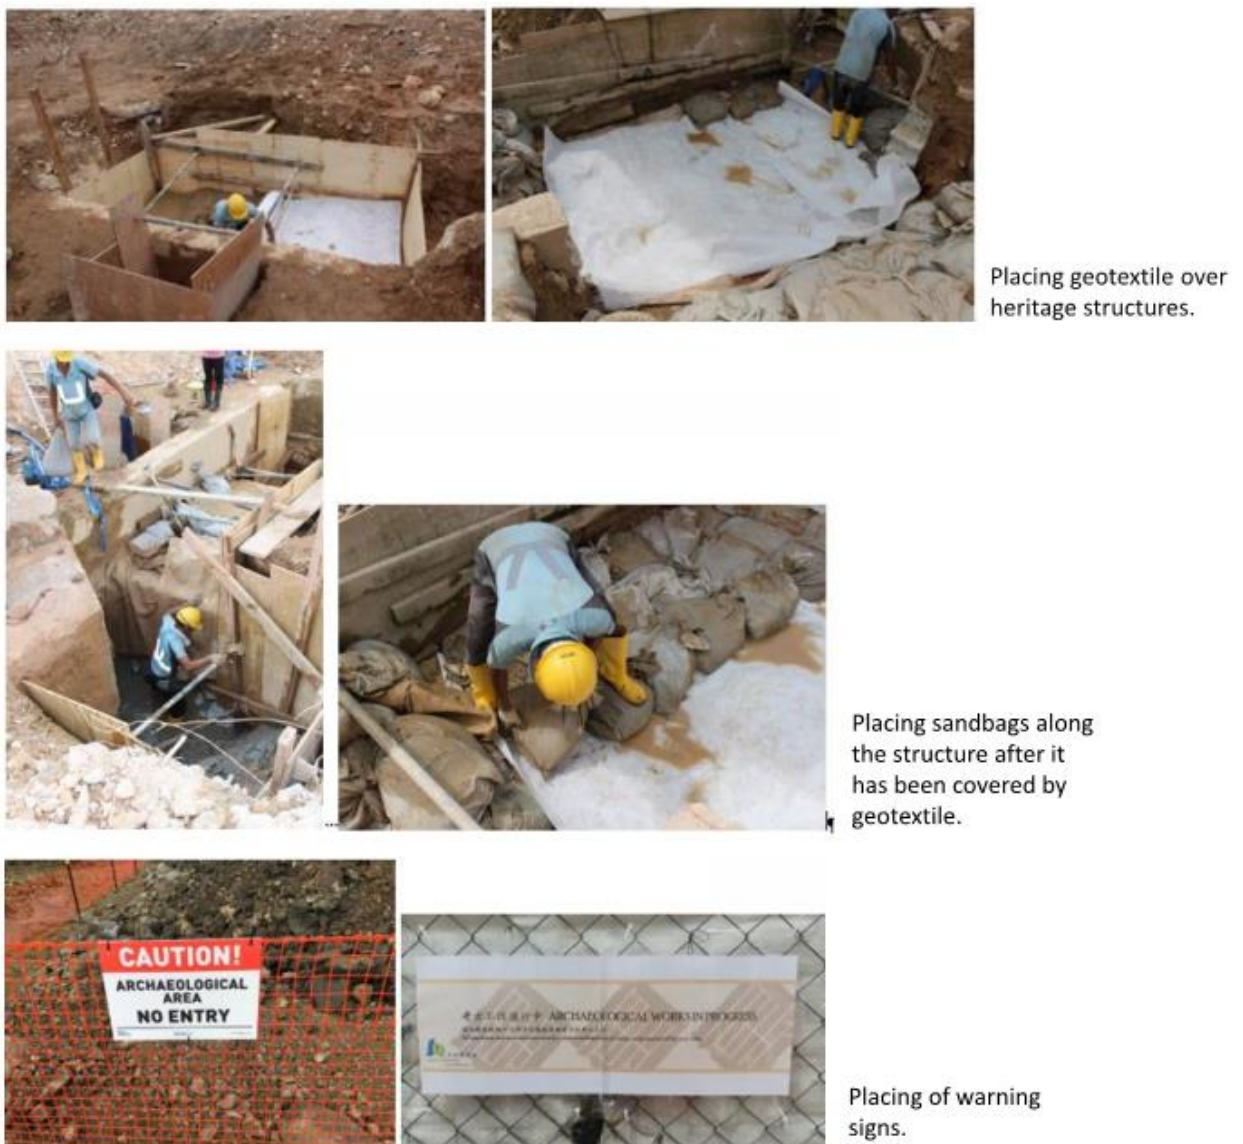
Figure 9 Proposed Protection Provision for Historical Elements

- 4.3.19 Protective covering in the form of geotextile sheeting and sandbag covering (**Figure 9**) should be provided for external walls and surfaces (that contain historical elements) in close proximity to works areas, i.e. areas where a buffer zone alone cannot provide protection from equipment and works activities.

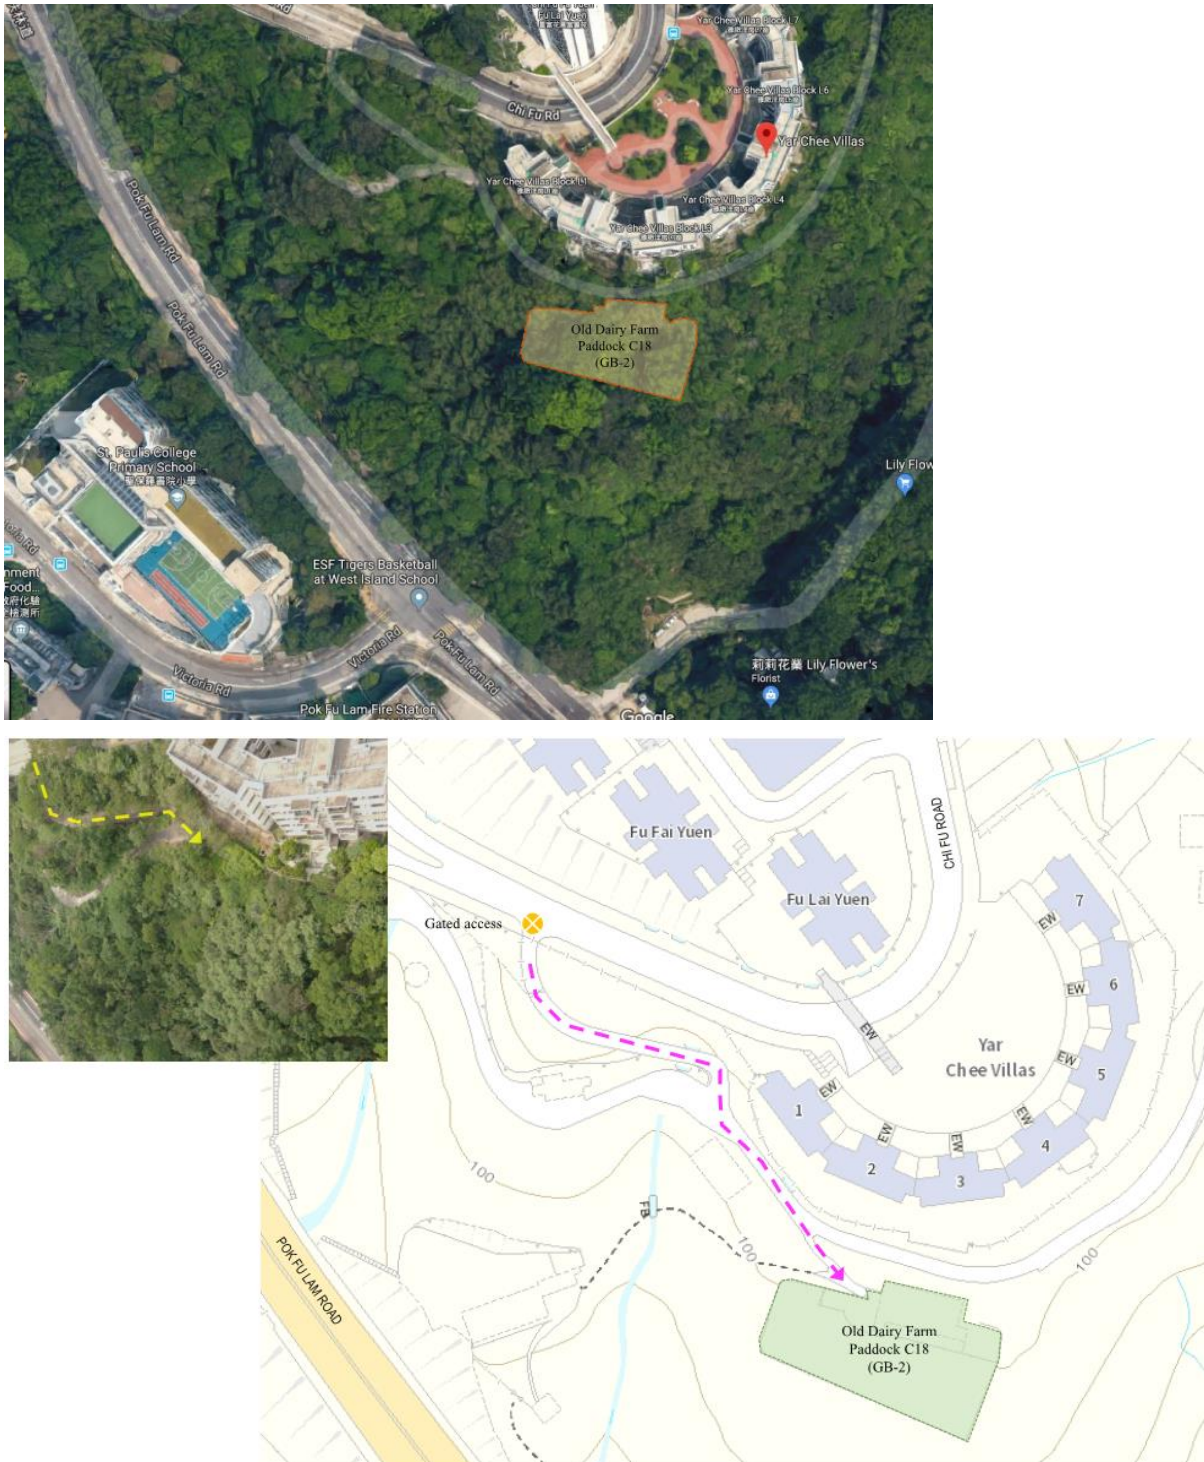
Figure 10 Current Location of Paddock C18 and Existing Footpath to Paddock C18

- 4.3.28 Upon development of the housing sites, no further impact on the heritage sites is anticipated during operation of the development. Existing access path to the heritage sites as shown on **Figure 10** is not affected by the proposed works and development, which is further illustrated on the photomontage in **Appendix C**. Therefore, no mitigation measures are deemed necessary.

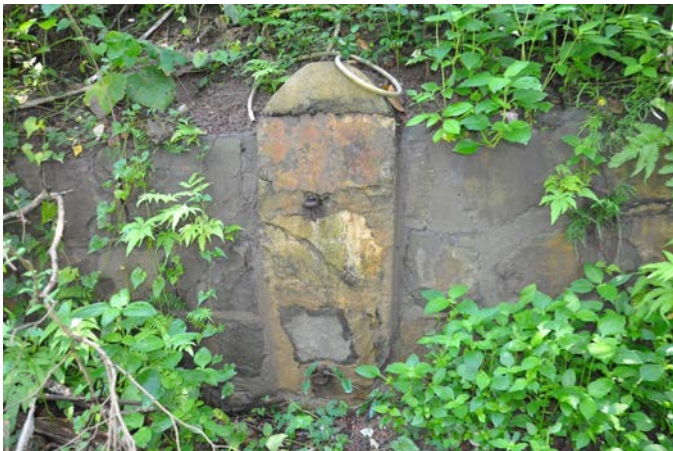
Pier attached to side wall of track, looking east.

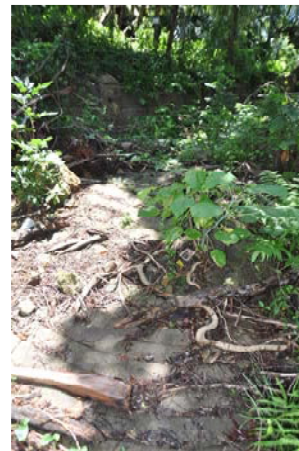
Track with grooved concrete pavement, looking northeast.

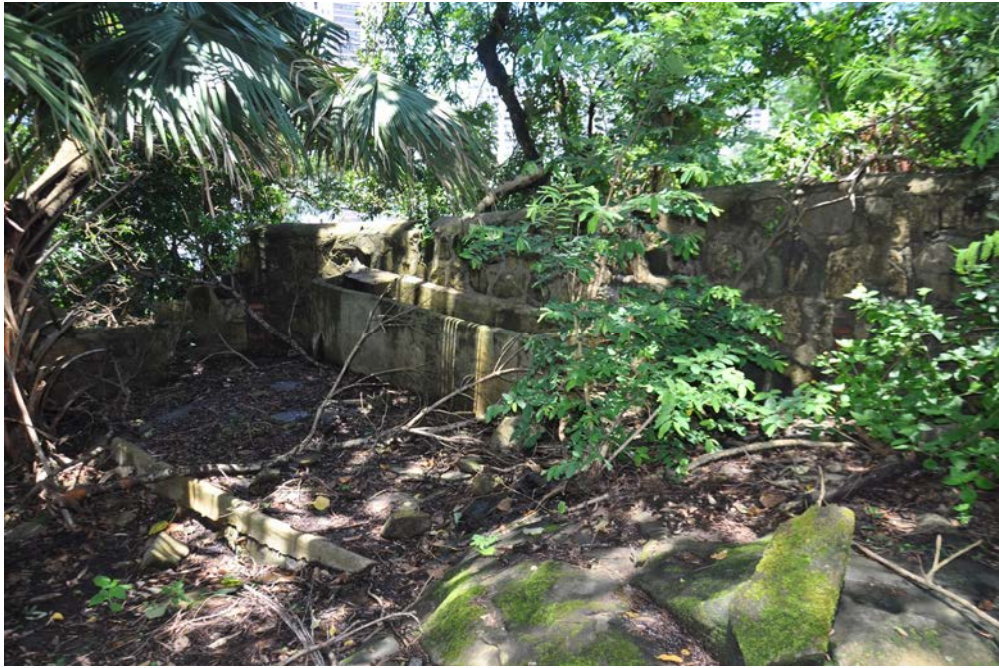
Possible bull pen with a concrete water tank, looking southwest.

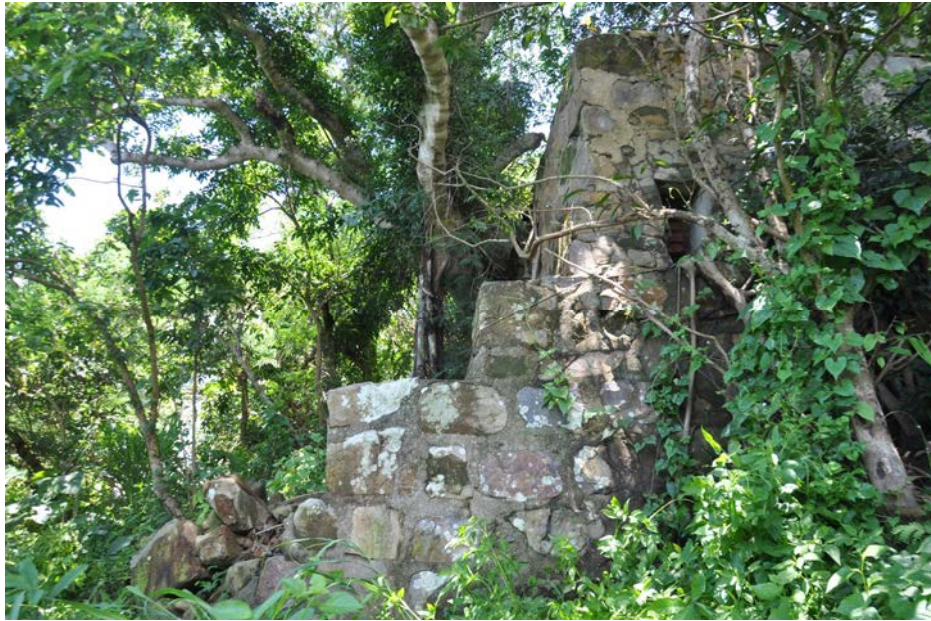
External view of protruding buttress at southeast corner of Paddock C18; also showing a possible draining hole at ground level (from inside), now sealed with red bricks, looking west.

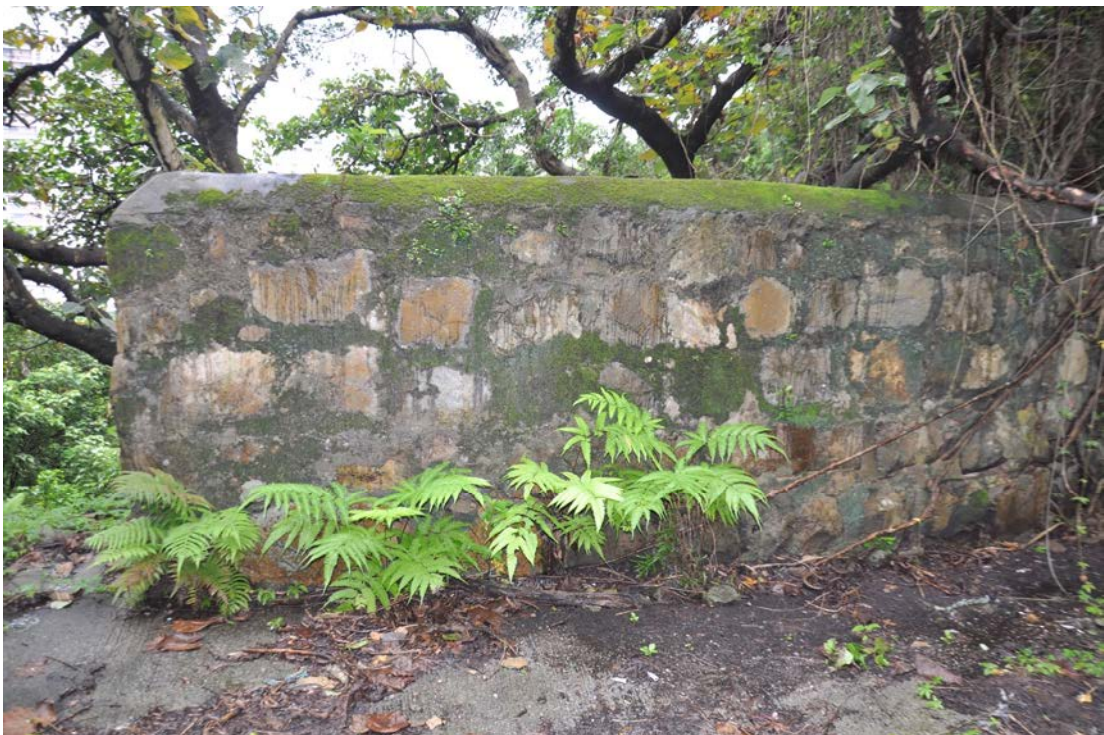
Front view of internal southwest paddock wall showing masonry style, looking Southeast.

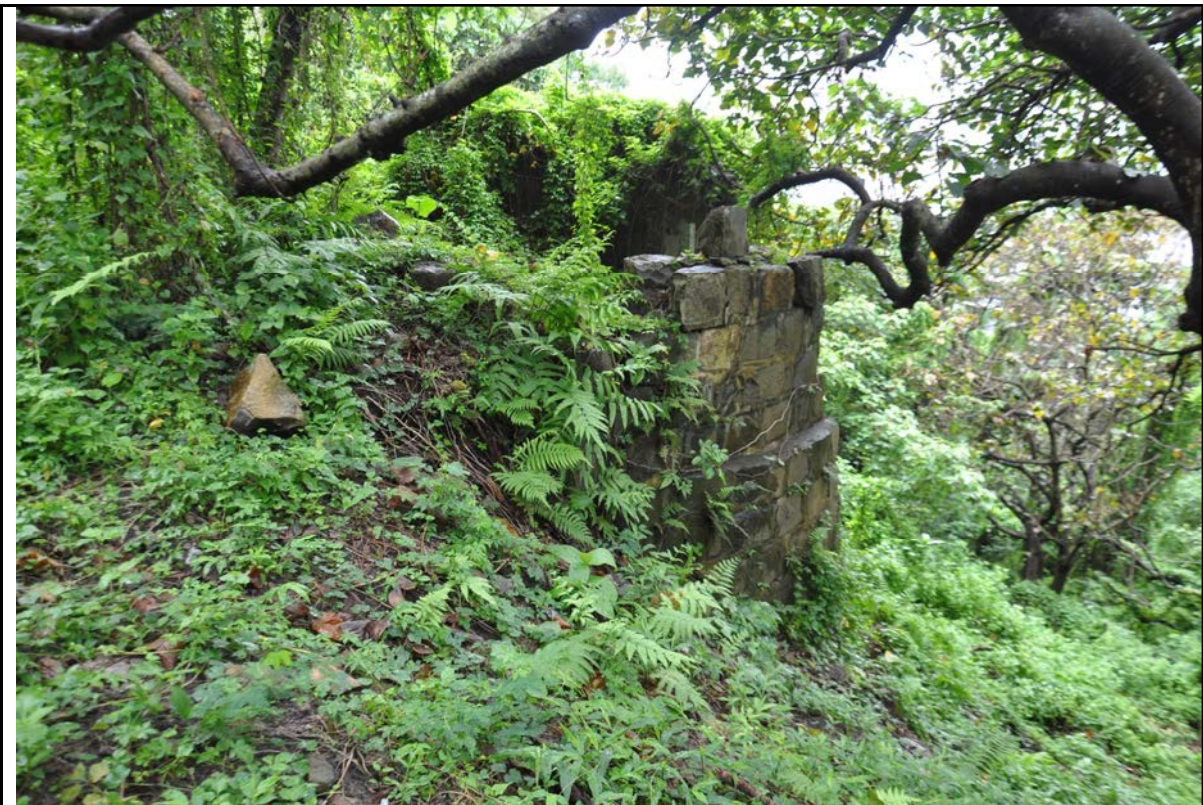
General view, looking southeast.

Interior: N/A		
Existing Condition: Poor, vegetation overgrown, stones near top come loose.		
Past and Present Uses: Used to be a silo for fodder conversion; now abandoned.		
Modifications: No obvious modification were noticed.		
Photographic Record:

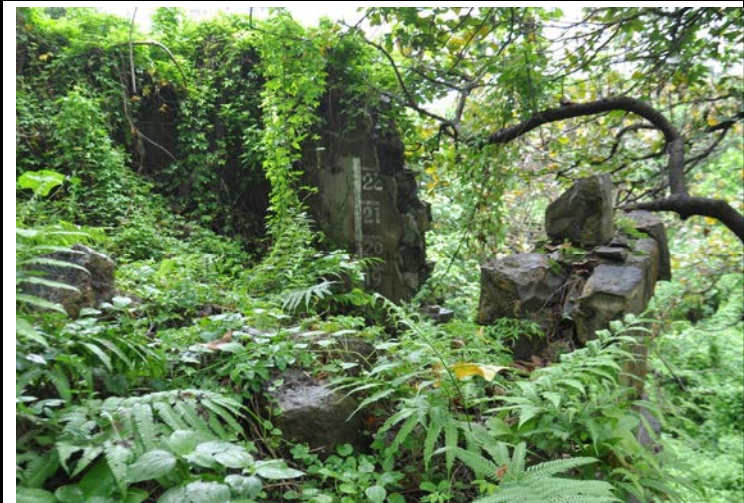
Inscriptions of scale marked on interior, looking southeast.

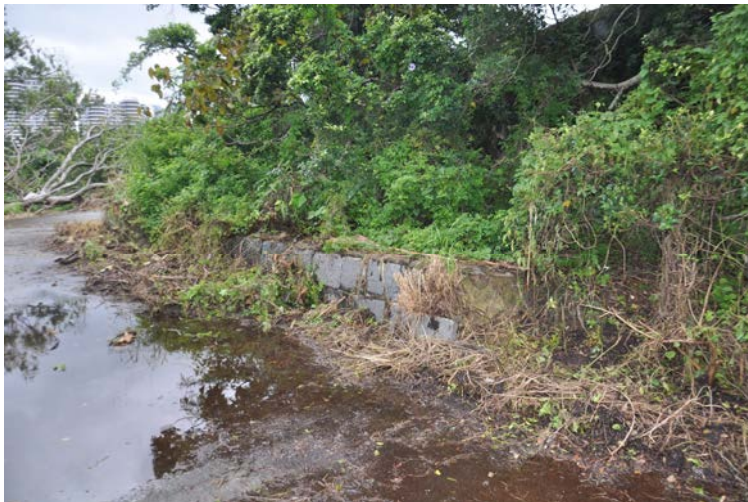
<p>General view, looking northwest.</p>

Inscriptions: N/A		
<p>Architectural Appraisal: The building was largely damaged, only a masonry base/foundation left. The base is constructed of coursed-rubble volcanic rocks (AMO 2019c). Concrete steps is located on the west side, leading to the top of the base. The floor is with cement pavement. Breakage of internal wall shows that the upper building was made of red bricks and concrete.</p>		
Interior: N/A		
Existing Condition: Poor, vegetation overgrown, building largely demolished.		
Past and Present Uses: used to be a dairy; now abandoned.		
Modifications: No obvious modification were noticed.		
<p>Photographic Record:</p>

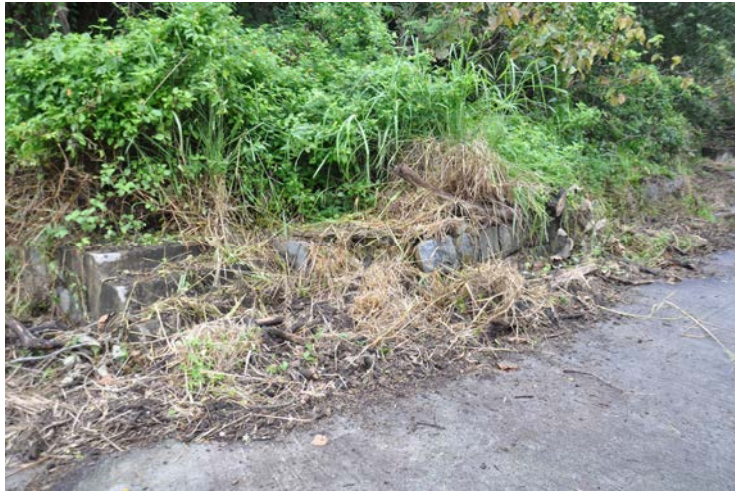
General view, looking northeast.

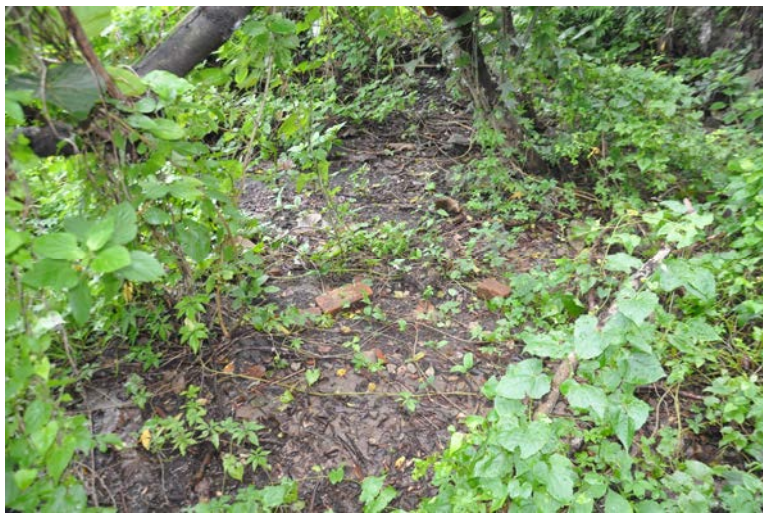
Internal view of floor pavement, looking northeast.

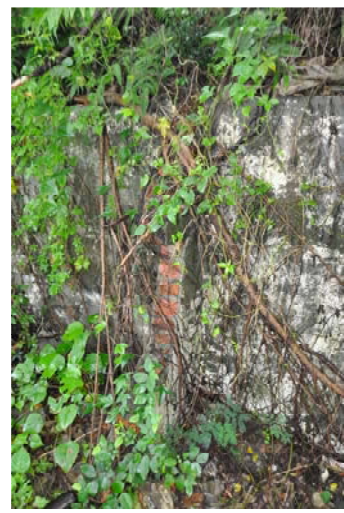
Close-up view showing buiding material inside the Dairy, looking northeast.

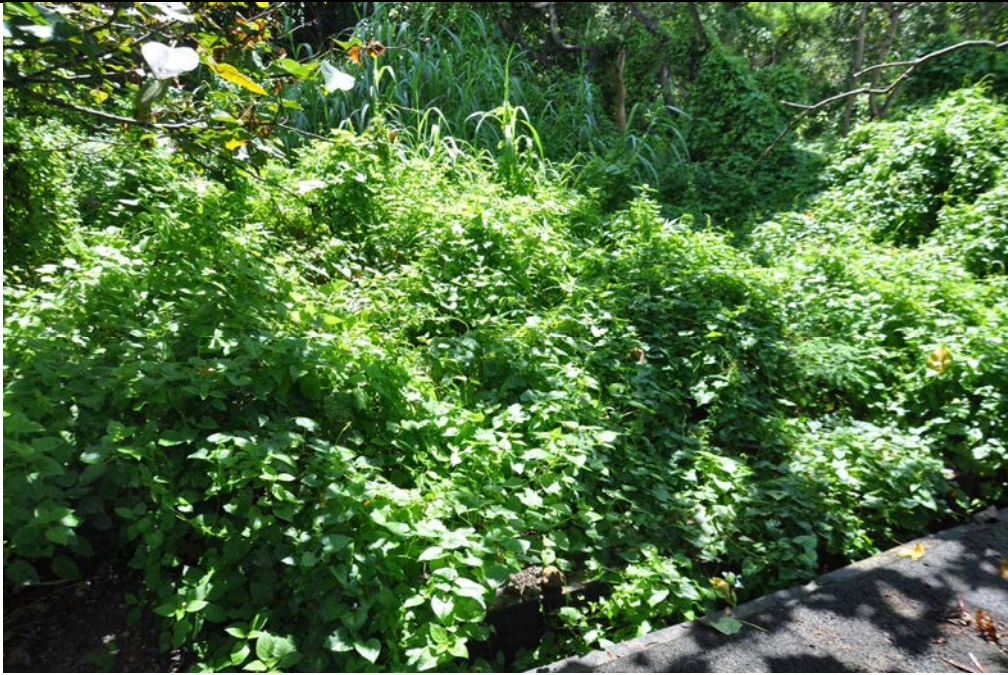
General view of Paddock C32, covered by overgrown vegetation, looking northeast.

Inscriptions: N/A		
<p>Architectural Appraisal: Paddocks are one of the main farm structures designed for cows to rest or exercise. Each paddock had an associated with cowsheds. Paddock C32 is associated with cowshed C32 as marked on the 1941 to 1945 Japanese survey map (PRO 1942 to 45), which building was demolished. The paddock area is now covered in thick vegetation and became habitat of wild boar. An identifiable feature is a red brick structural remain, which is believed part of cowshed building. According to AMO (2019f) there is still part of perimeter wall remain made of volcanic rocks.</p>		
Interior: N/A		
Existing Condition: Poor, vegetation overgrown.		
Past and Present Uses: Used to be a paddock and cowshed; now building demolished and abandoned.		
Modifications: Southwest part of the Paddock was truncated by road and slope works and removed.		
Photographic Record:

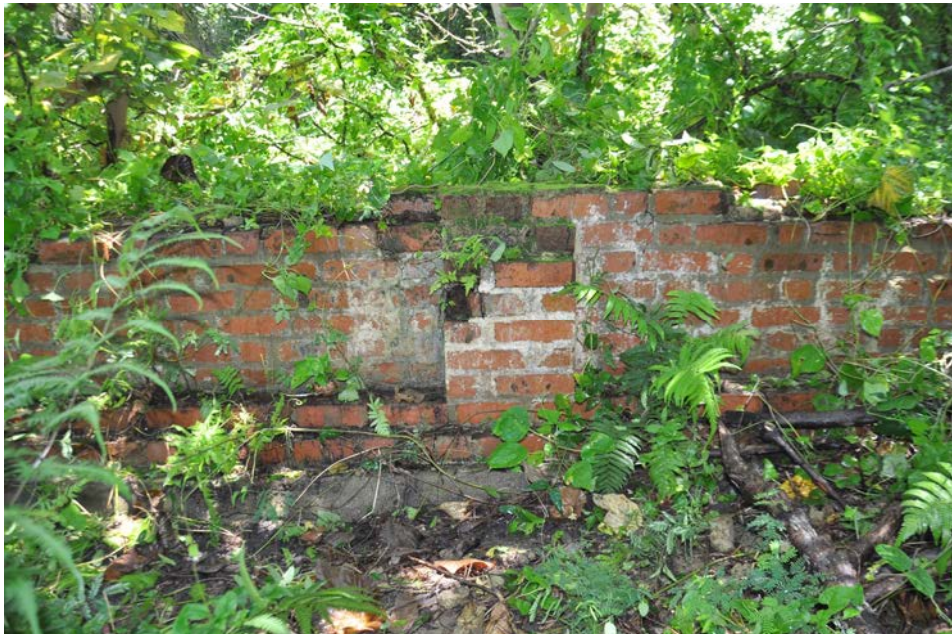
Possible remain of cowshed building, looking northwest.

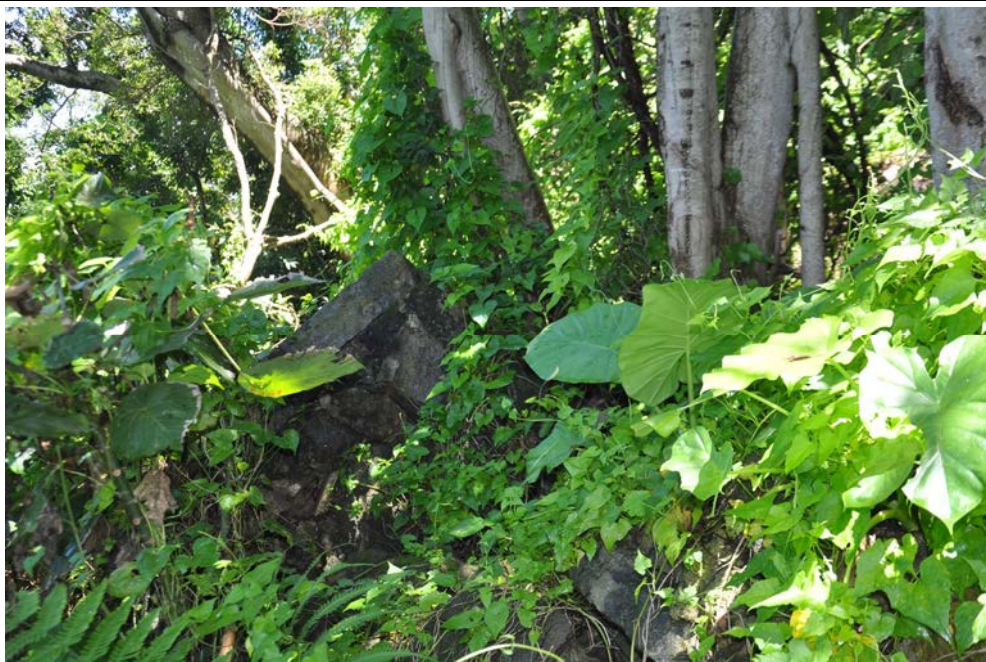
Masonry structural remain at Paddock 32, looking southwest.

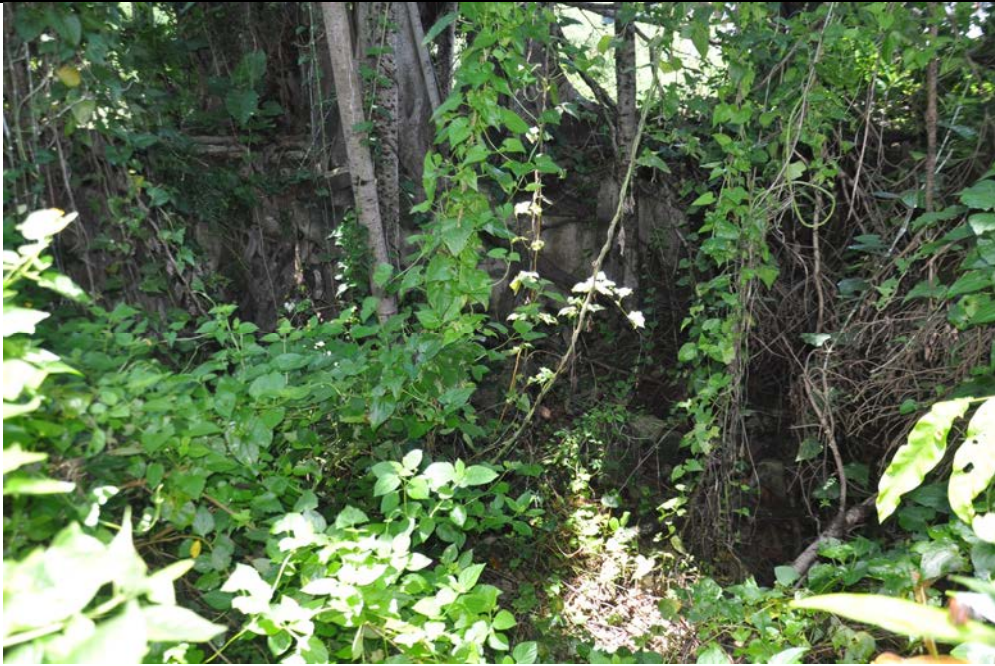
General view towards inside from top, showing internal walls wrapped by tree roots and vines looking southeast.

Interior: N/A		
Existing Condition: Poor, damaged, severely wrapped by tree roots and vines.		
Past and Present Uses: Used to be a manure pit; now abandoned.		
Modifications: No obvious modification to the manure pit were noticed.		
Photographic Record:
