HERITAGE IMPACT ASSESSMENT IN RESPECT OF THE LANDSLIP PREVENTION AND MITIGATION WORKS FOR SLOPE FEATURES NOS. 11SW-B/FR7 AND 11SW-B/CR13 WITHIN/NEAR FORMER CENTRAL GOVERNMENT OFFICES, SITE

Civil Engineering and Development Department December 2018

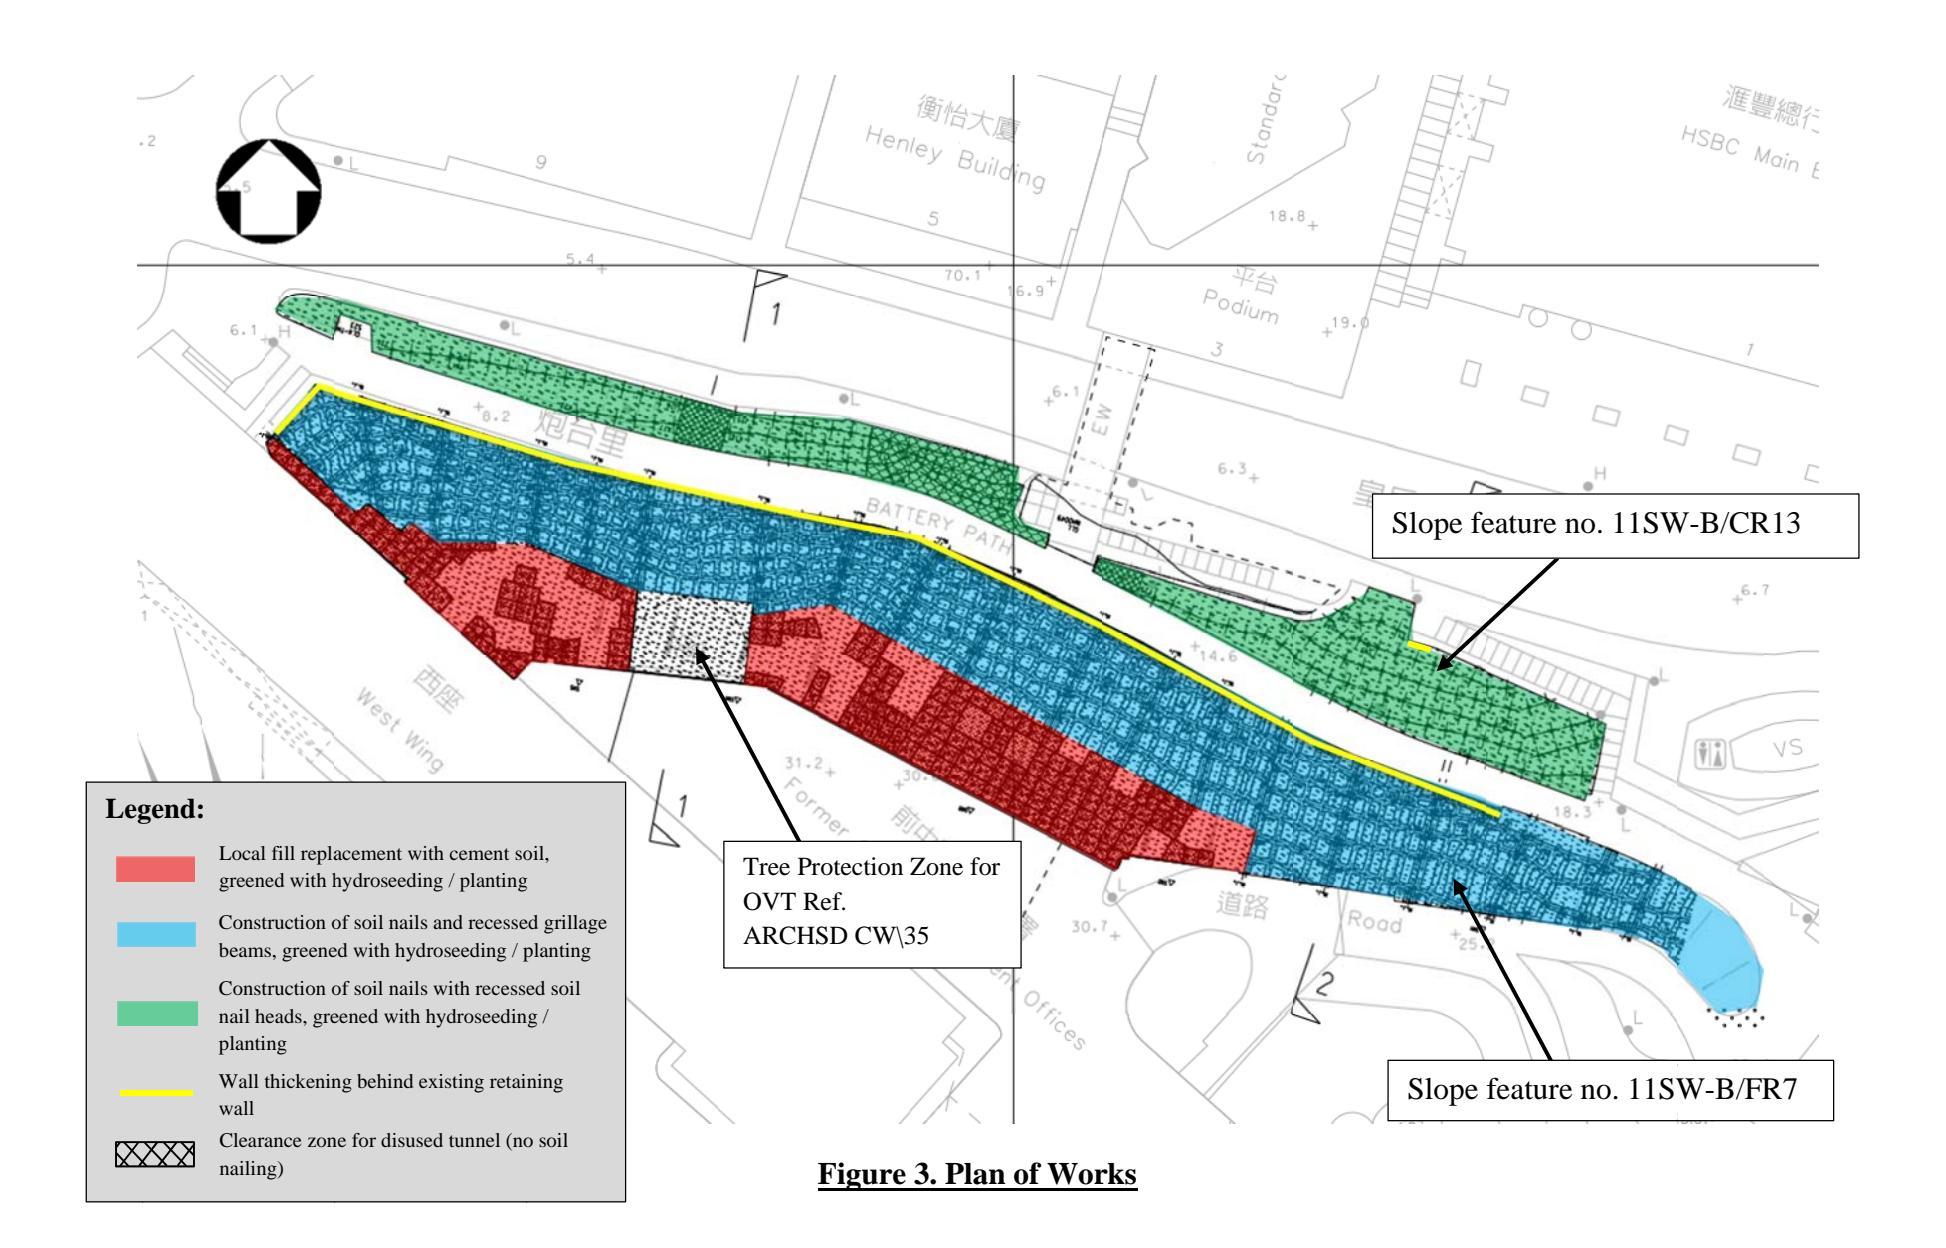
i) The project is to implement landslip prevention and mitigation works for man-made slope features nos. 11SW-B/FR7 and 11SW-B/CR13. Plan of works and typical sections of proposed slope upgrading works are at <u>Figures 3 to 5</u>. ii) Considerations

- The fill replacement along the slope crest will be designed to avoid adverse impact to existing trees and the registered Old and Valuable Tree;
- The wall thickening is proposed at the back of the existing masonry retaining wall, instead of at the front of the retaining wall. This will retain the appearance of the existing masonry retaining wall;
- The adoption of recessed soil nail with grillage beam system will avoid exposure of bare concrete on the slope, to minimise visual impact. The existing trees and generally green appearance of the slopes would be retained;
- The soil nails are designed to avoid disturbance of the existing air raid tunnels; and
- The provision of landscape treatment including hydroseeding and native planting will restore the greening of the completed slope works.
- iii) The proposed works are as described below:

- Fill replacement with cement soil at slope crest of western portion adjacent to the Former CGO, West Wing;
- Wall thickening at the back of existing masonry retaining wall;
- Provision of recessed soil nails with grillage beam system at slope feature above masonry wall;
- Provision of landscape treatment including hydroseeding and native shrubs planting on slope feature; and
- Provision or making good of drainage channels at crest and toe of the slope feature.

- Wall thickening at the back of a portion of the existing masonry retaining walls at a short length of the eastern portion;
- Construction of recessed soil nails at the slope feature;
- Making good of drainage channels at crest and toe of the slope feature; and
- Provision of landscape treatment including hydroseeding and native shrubs planting on slope portion of the slope feature.
